# Inspection Report

**Property Address:**  
20455 Elfin Forest Rd  
Escondido CA 92029

**The Property Inspection Pros**

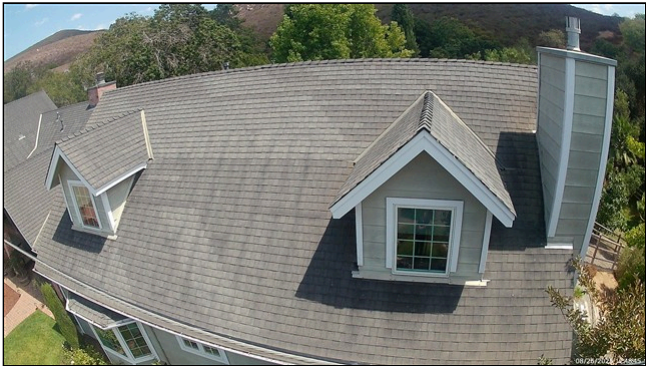
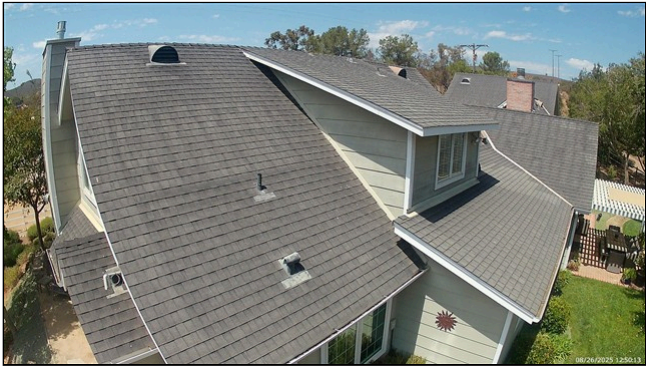
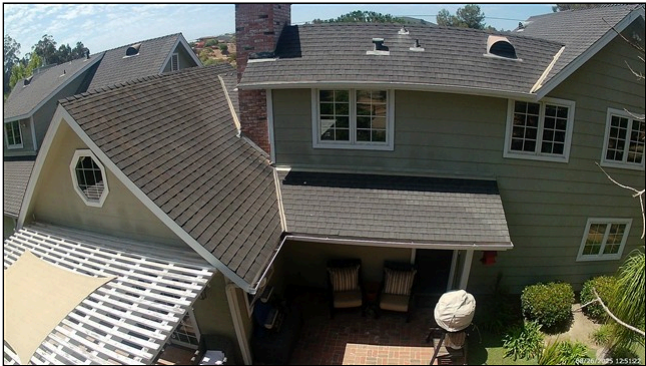
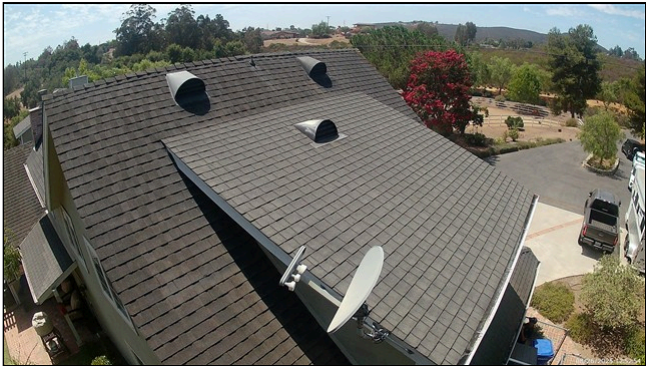
(2) There are several damaged roof shingles observed. We recommend necessary

repairs by a licensed roof contractor.

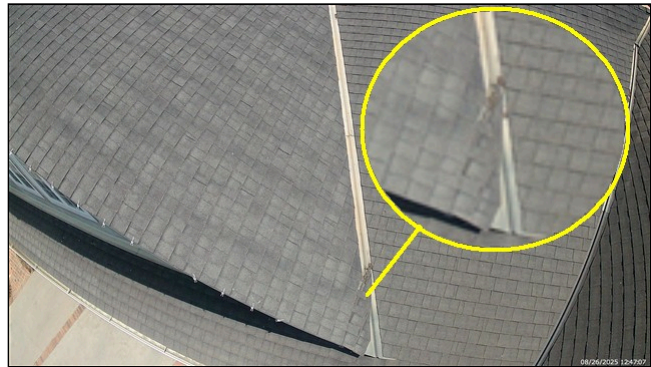
1.0.A Item 7 (Picture)

- (3) The asphalt roof shingles are observed to be installed in a sub-standard manner. The tab or pattern lines at the roofing material are exposed indicating that the top shingles do not overlap the bottom shingles properly. We recommend further evaluation and necessary corrections by a licensed roof contractor prior to the end of your contingency period.

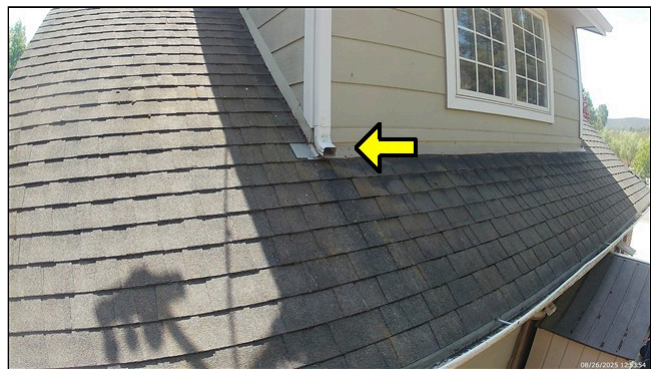
1.2.A Item 2 (Picture)

(2) There are several upper level roof downspouts that discharging water onto the lower roof. This causes excessive water to flow in a concentrated portion of the roof causing wear, and staining. During heavy rain water can also be forced under the roofing material causing leaks. We recommend rerouting these downspouts to direct water away from the lower roofs to an approved location such as a lower gutter, or a downspout all the way to the ground by a qualified contractor.

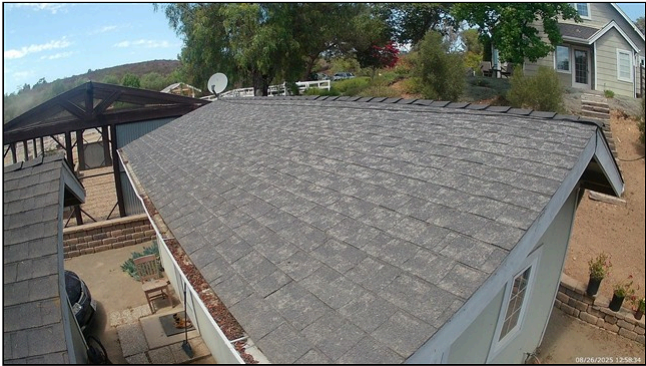
1.0.B Item 4 (Picture)

(2) The asphalt roof shingles are observed to be installed in a sub-standard manner. The tab or pattern lines at the roofing material are exposed indicating that the top shingles do not overlap the bottom shingles properly. We recommend further evaluation and necessary corrections by a licensed roof contractor prior to the end of your contingency period.

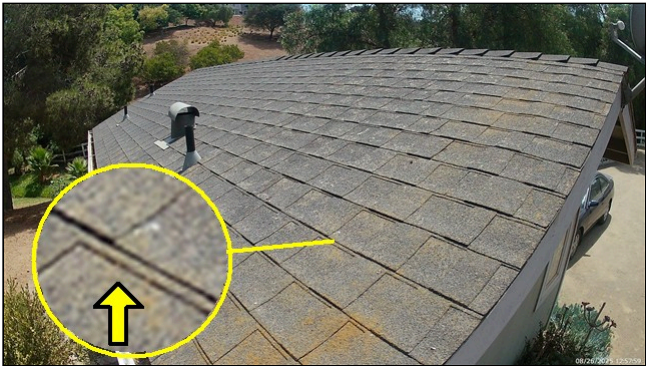
1.0.B Item 5 (Picture)

(3) Excessive granules have come off the roof shingles in some areas. This indicates that the roof is aged, and could be approaching the end of its useful life. We recommend having the roof evaluated by a licensed roof contractor to obtain an estimate of life remaining, and the potential cost to replace prior to the end of your contingency period.

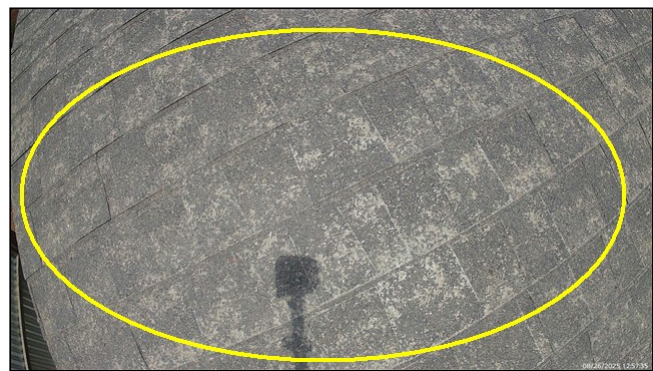
1.0.B Item 6 (Picture)

(4) The roofing material is noted to be brittle and showing signs of wear and aging. The roof appears to be near the end of its useful life. We recommend consulting with a licensed roof contractor for an estimate of life remaining, or cost to replace prior to the end of your contingency period.

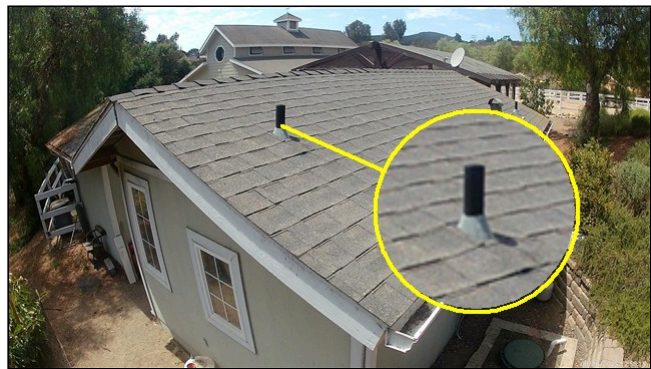
1.1.B Item 1 (Picture)

(1) Sheet metal flashings at the roof penetrations were not lapped into the shingles in a weather board fashion. The lower portion of the flashing should extend on top of the roof shingles. This condition could cause the roof to leak in these areas. We recommend further evaluation and necessary repairs by a licensed roof contractor prior to the end of your contingency period.

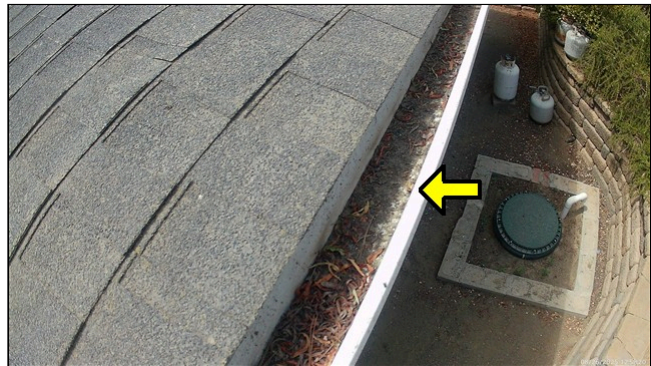
1.2.B Item 1 (Picture)

(1) Gutters are observed full of debris in areas and need to be cleaned. The debris in gutters can also conceal rust, deterioration or leaks that are not visible until cleaned, and I am unable to determine if such conditions exist. We recommend having the gutters cleaned and checked by a qualified contractor.

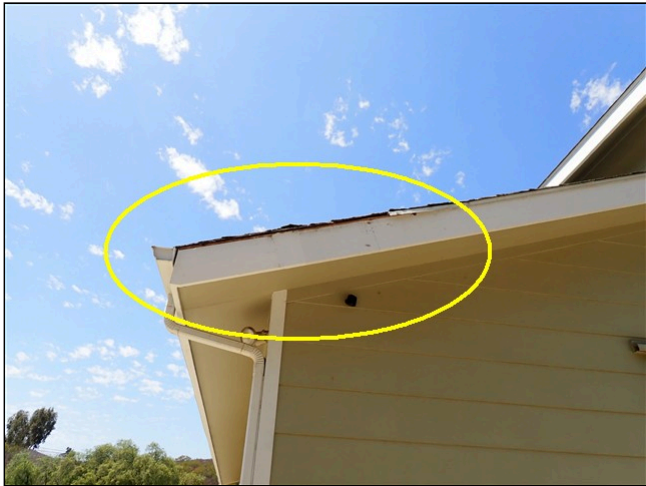
1.1.C Item 1 (Picture)

A section of the drip edge flashing is missing.We recommend having drip edge flashing installed where needed by a licensed roof contractor.

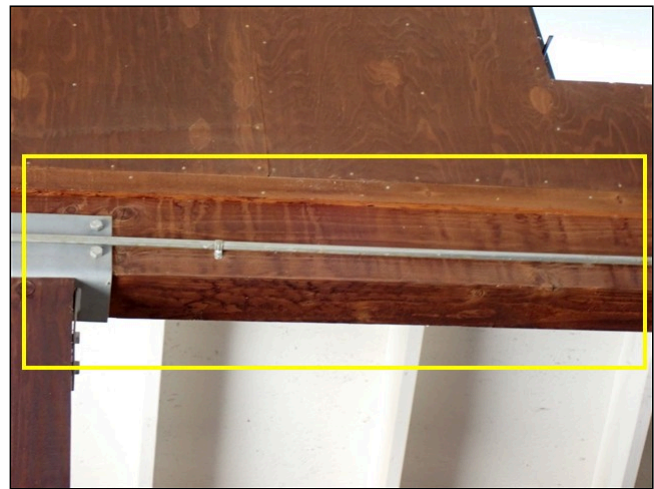
1.3.C Item 1 (Picture)

Stain(s) observed on several wood framing members at various areas. Water stains on the ceilings or on the framing will not necessarily confirm an active leak without some corroborative evidence (or recent rain), and such evidence can be deliberately concealed. Due to the lack of recent rain, I was unable to confirm.

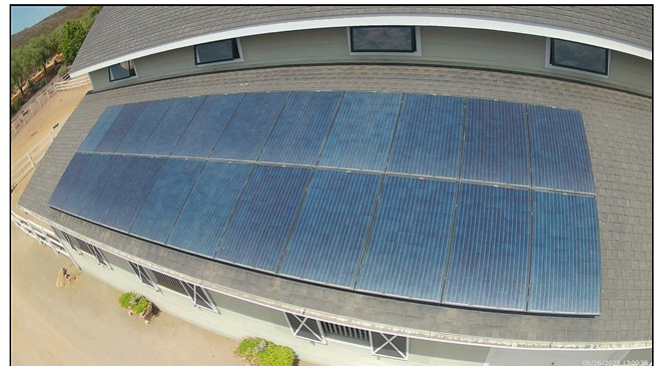
1.4.C Item 1 (Picture)

The electric solar system and its related components are beyond the scope of the home inspection and was not inspected. We recommend verifying that the electric solar system is operational prior to the end of your contingency period.

We also recommend having all the solar panels cleaned by a qualified person.

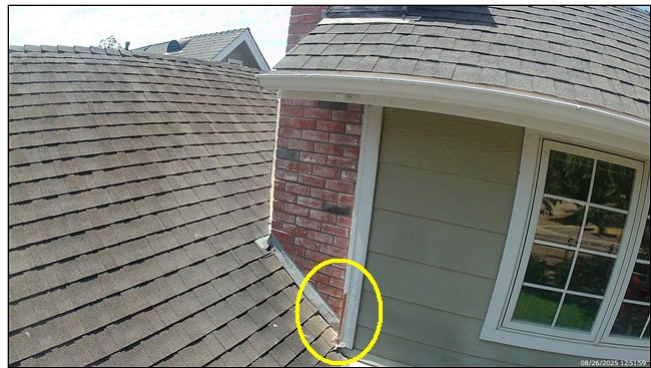
2.3.A Item 6 (Picture)

(4) Paint is worn and failing at the wood trim at several areas. We recommend prep and paint as needed to protect the trim by a qualified paint contractor.

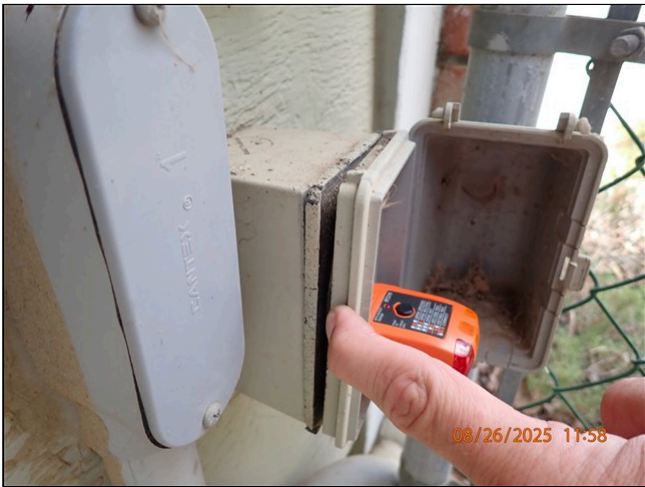
2.11.A Item 1 (Picture)

**Comments:**  
(1) Several exterior weatherproof switch covers are damaged or missing. We recommend necessary repairs or replacing where needed by a qualified person.

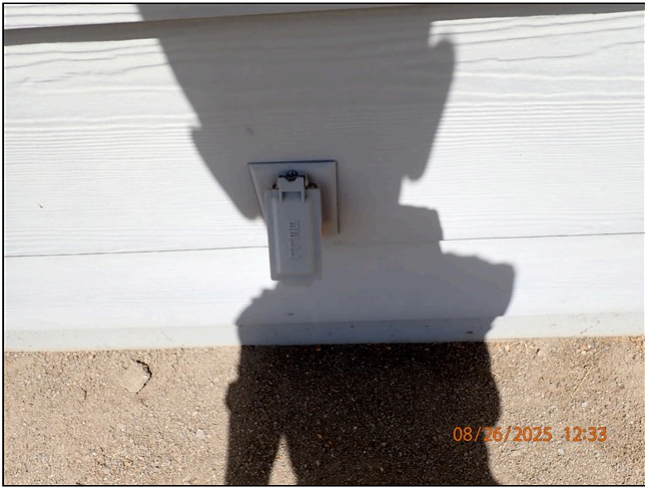
2.11.A Item 2 (Picture)

(2) Several GFCI receptacles are not operating properly, or have failed as they did not trip when tested. These outlets may be defective or mis-wired. We recommend replacement as needed by a qualified licensed electrician.

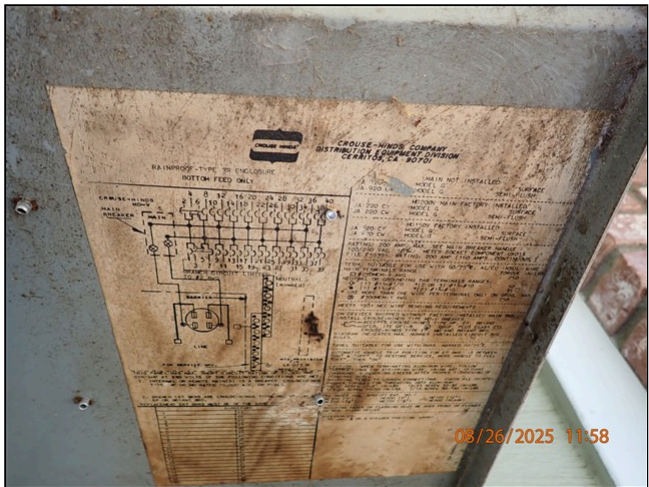
3.0 Item 2 (Picture)

(2) The main panel breakers are illegible or confusing. We recommend having the breakers properly labeled for safety by a qualified person.

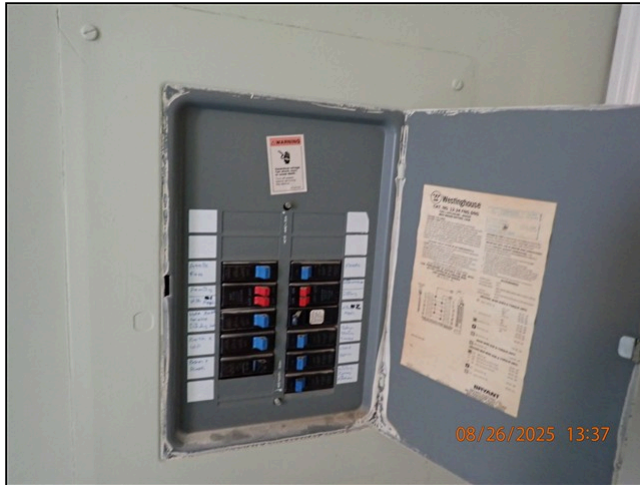
3.1 Item 3 (Picture)

(2) The sub panel breakers are illegible or confusing. We recommend having the breakers properly labeled for safety by a qualified person.

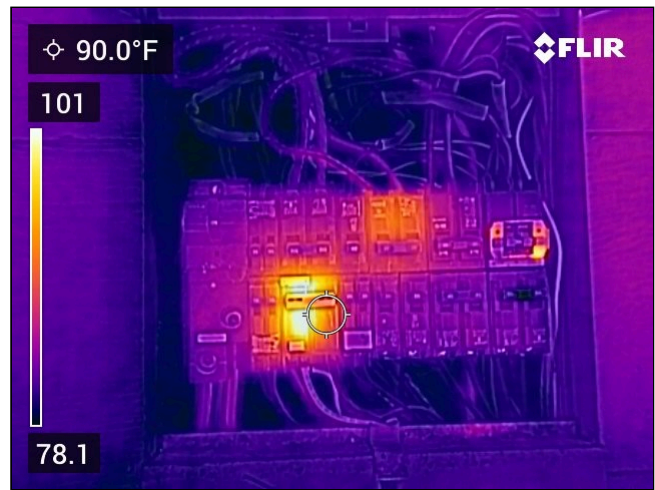
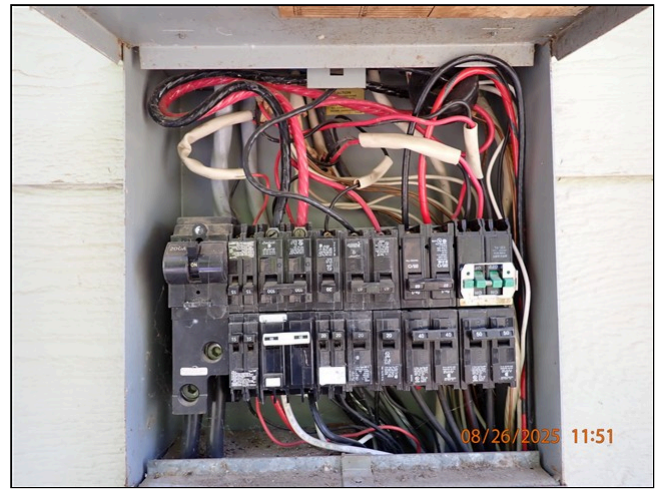
- (1) **Photo inside of the main electrical panel.**

The dead front cover was removed at the time of the inspection and the breakers, wiring and grounding were inspected. Appears to be functioning as intended.

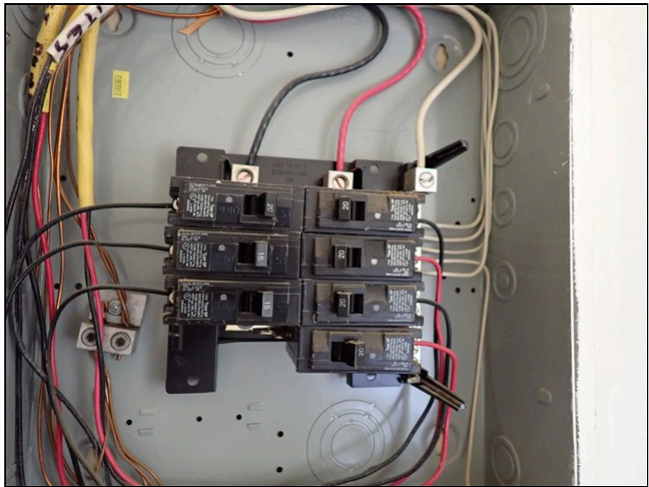
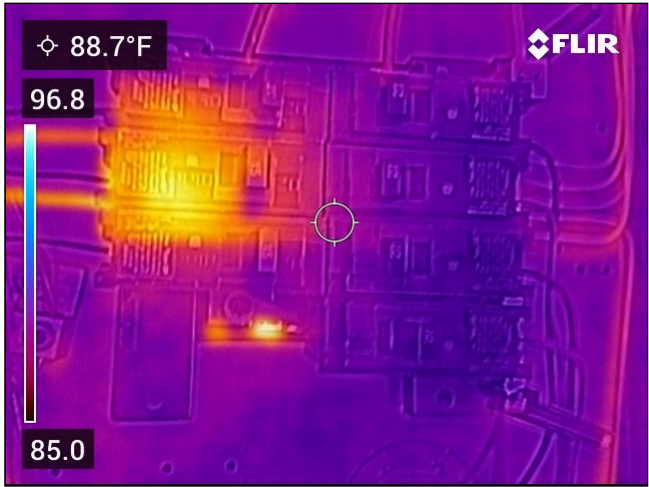
(2) **Photo inside of the sub electrical panel(s).**

The dead front covers were removed at the time of the inspection and the breakers, wiring and grounding were inspected. Appears to be functioning as intended.

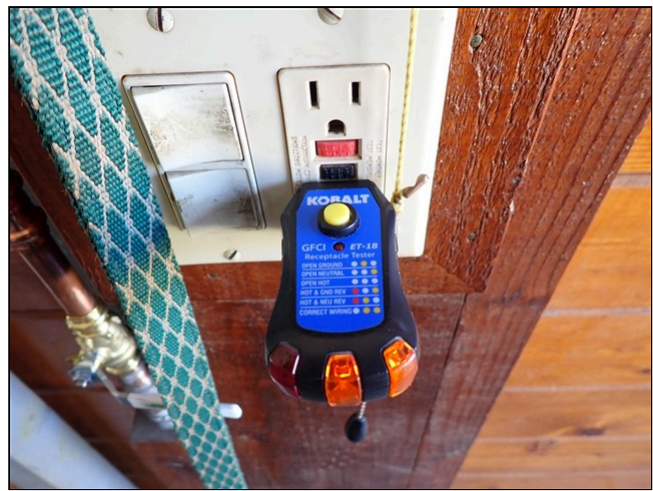
3.7 Item 1 (Picture)

Photo of a receptacle being tested.

A representative number of receptacles throughout the property were tested for power, polarity and grounding according to our standards-of-practice. These receptacles observed to be ok at the time of the inspection unless otherwise noted.

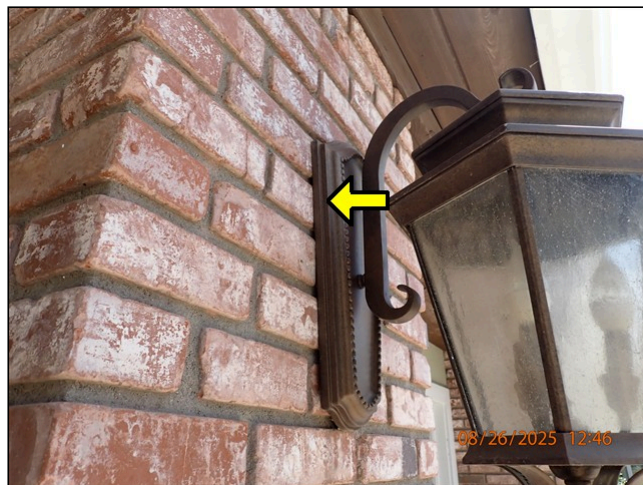
3.11 Item 1 (Picture)

(1) The exterior light fixtures were not sealed where the fixture meets the wall. This condition could allow moisture intrusion in this area. We recommend sealing exterior light fixtures where they meet the wall by a qualified person.

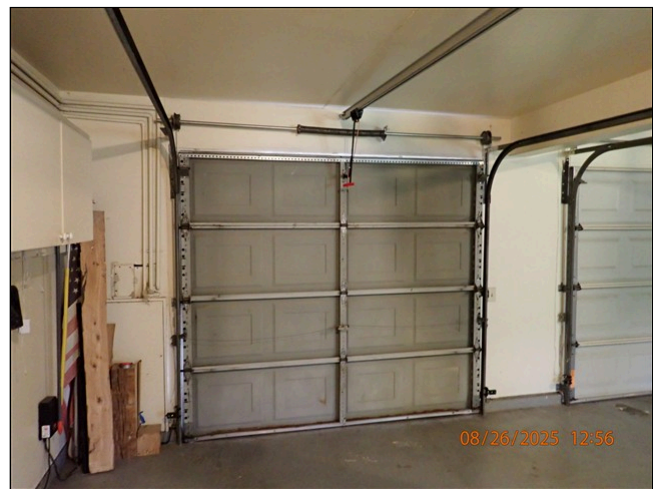
4.0.A Item 3 (Picture)

(3) **Garage door photo(s).**

The garage vehicle door hardware including the door, track, and springs appear to be functioning as intended.

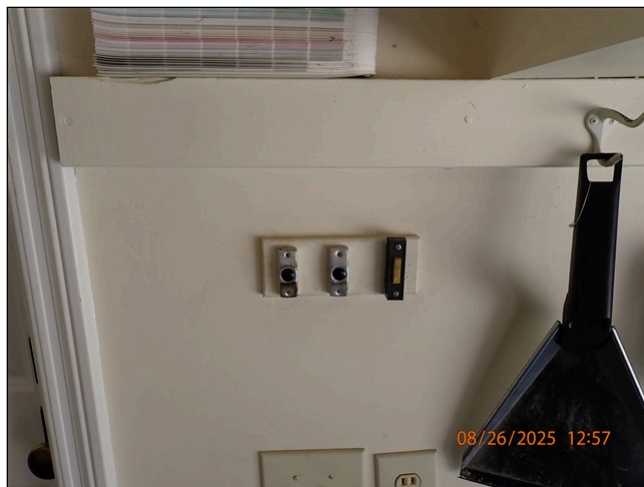
4.1.A Item 1 (Picture)

(1) As of July 1, 2019 all garage door openers are required to have a battery back up that is designed to operate when activated due to an electrical outage. Replacement of the garage doors connected to an automatic opener requires updating to a battery backup type. Verification of compliance is beyond the scope of this inspection. Client is advised to verify compliance and update if needed.

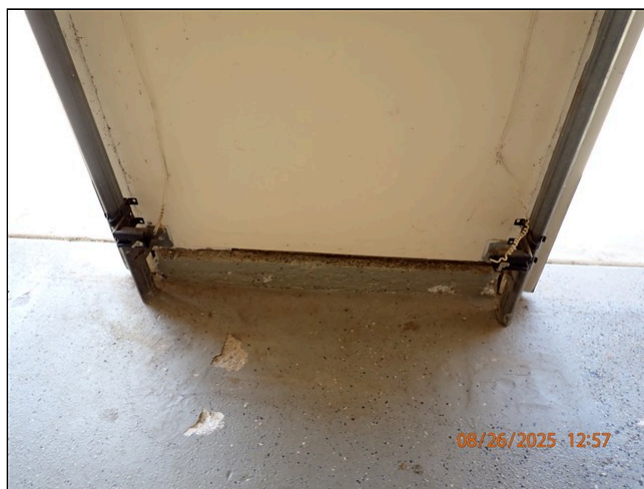
4.1.A Item 2 (Picture)

(2) All 3 sets of sensors are in place, were tested and will reverse the garage door.

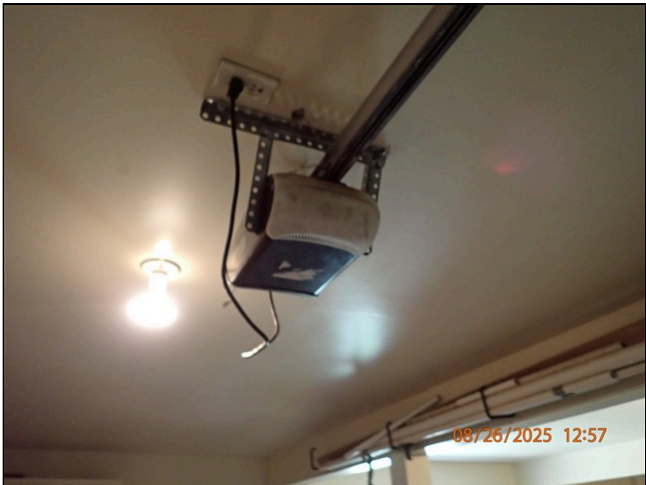
4.1.A Item 4 (Picture)

(3) The lights did not work when the center garage door opener was tested. The lights built in the garage door opener are a safety device. We recommend replacing the bulbs and testing again. If the bulbs fail to light we recommend necessary repairs or replacement by a qualified garage door contractor.

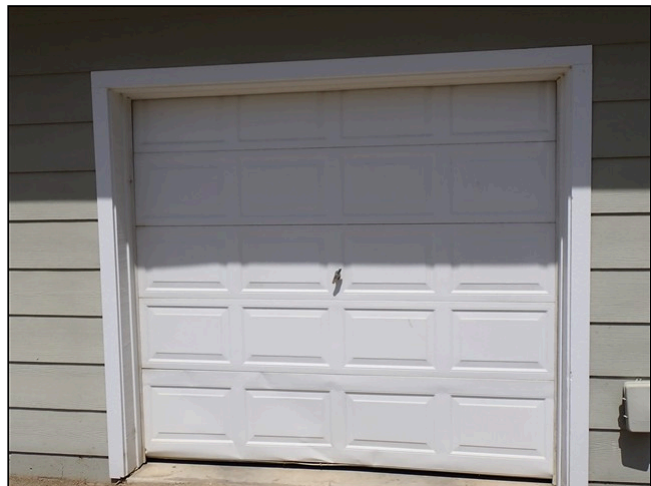
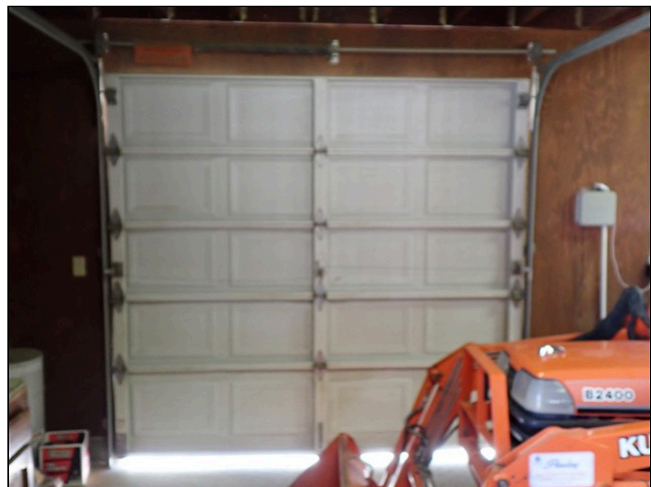
(1) [Garage door photo\(s\).](#)

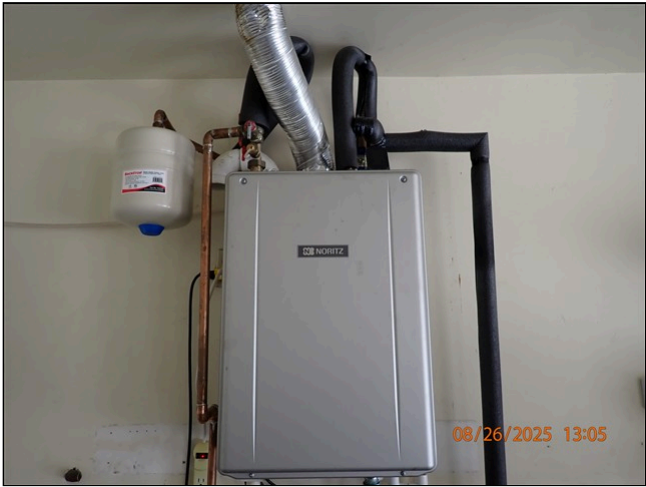
5.0.A Item 1 (Picture)

- (1) [Photo of the water heater.](#)

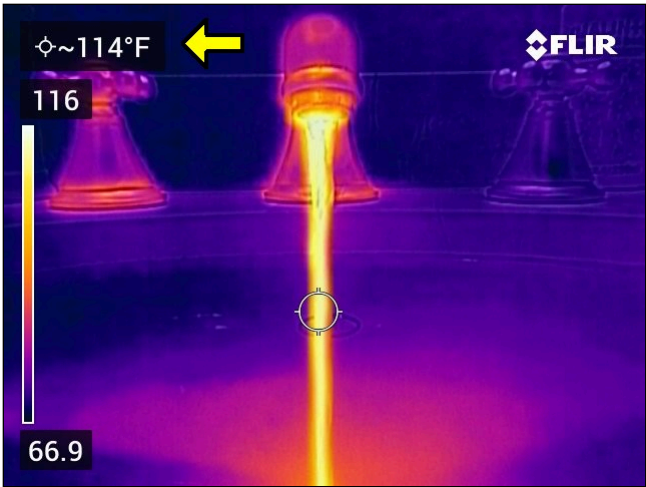
5.0.A Item 3 (Picture)

5.0.A Item 2 (Picture)  
(2) **Thermal Photo of the water temperature.**

The temperature of the water was tested using a thermal camera during the inspection and was found to be operating within normal range.

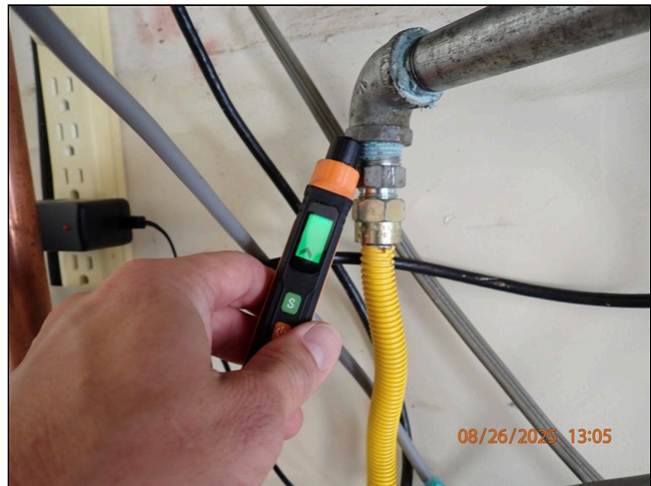
5.0.A Item 4 (Picture)

(3) A gas leak test was conducted at accessible gas fittings at the water heater using a gas leak detector. There were no gas leaks detected at the time of the inspection.

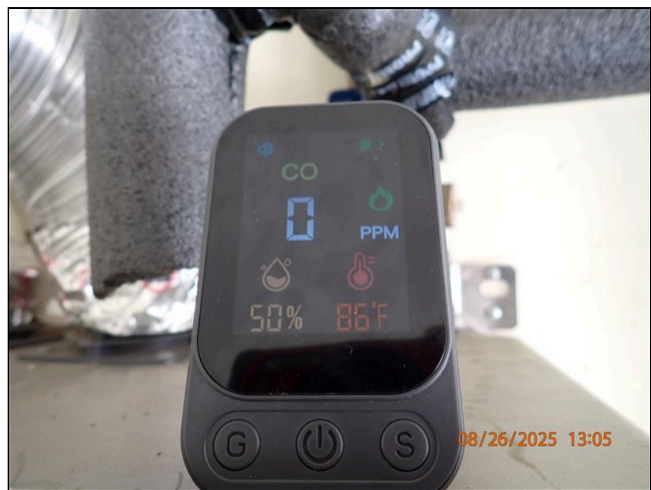
5.0.A Item 5 (Picture)

(4) A carbon monoxide test was preformed using a hand help carbon monoxide detector during the inspection while testing the gas water heater. Carbon monoxide was not detected at the time of the inspection.

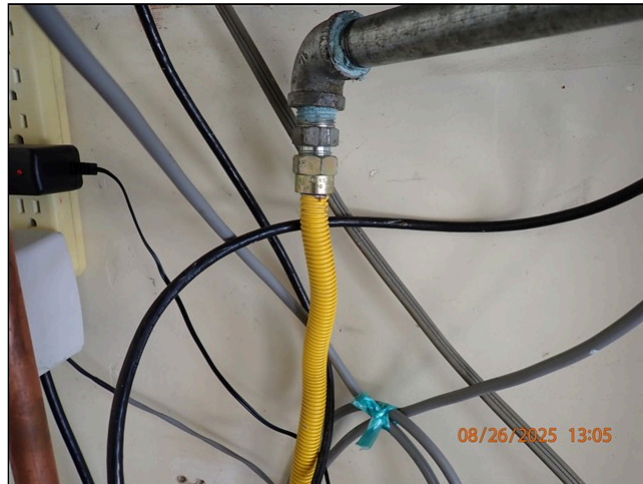
5.0.A Item 7 (Picture)

(6) The gas line was observed to be reduced down from its designed 3/4 inch fitting and this is non standard. We recommend further evaluation and any necessary repairs made by a qualified licensed plumber.

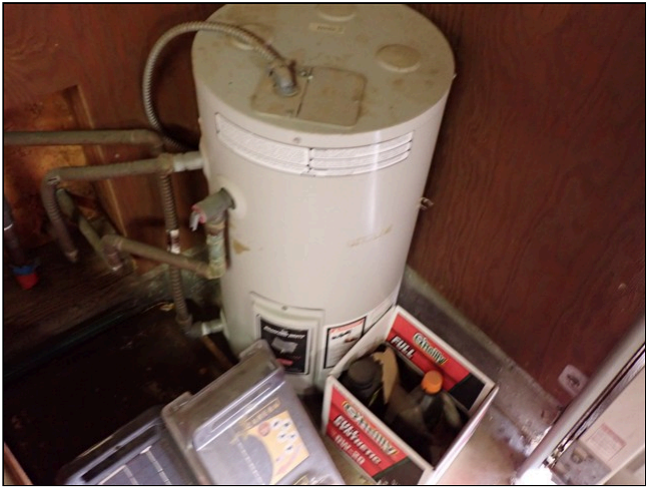
5.0.B Item 1 (Picture)

Comments:  
(1) [Photo of the water heater.](#)

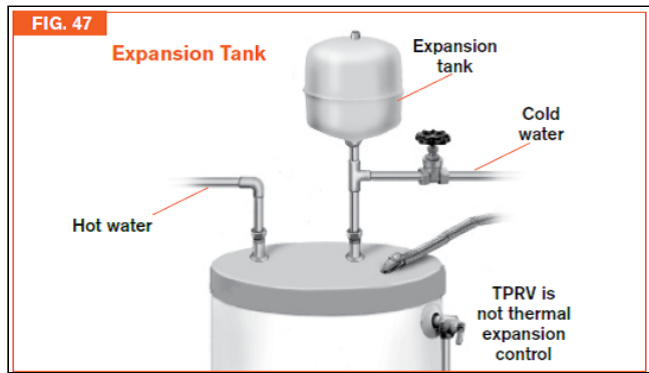
5.0.B Item 2 (Picture)

(2) The water heater does not have a "Thermal Expansion Tank" installed to prevent a possible leak at the T&P or "pop-off" valve. Recent changes in code require one when a new water heater is installed. This change is not retroactive on older previously installed Gas/LP water heaters. There were no leaks or drips at the T&P valve during inspection. If your water heater does begin to drip or leak, then a thermal expansion tank may be needed. We recommend installing a thermal tank by a qualified licensed plumber as an upgrade.

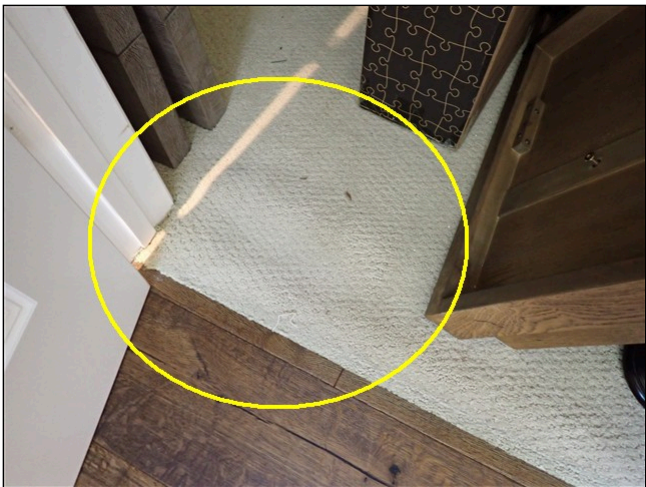
**Comments:**  
(1) Carpet in several throughout the house is loose which could be a tripping hazard and lead to premature wear. We recommend having the carpet stretched by a qualified licensed floor contractor.

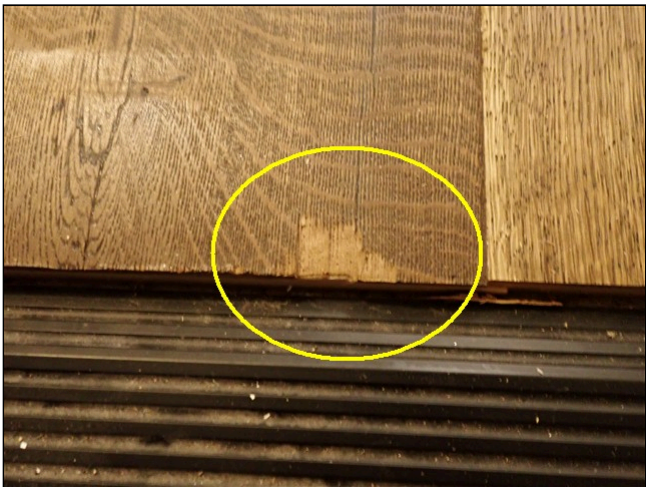
6.3.A Item 1 (Picture)  
(2) There is damaged wood flooring observed in the left side 2nd floor family room. We recommend necessary repairs or replacing by a qualified licensed flooring contractor.

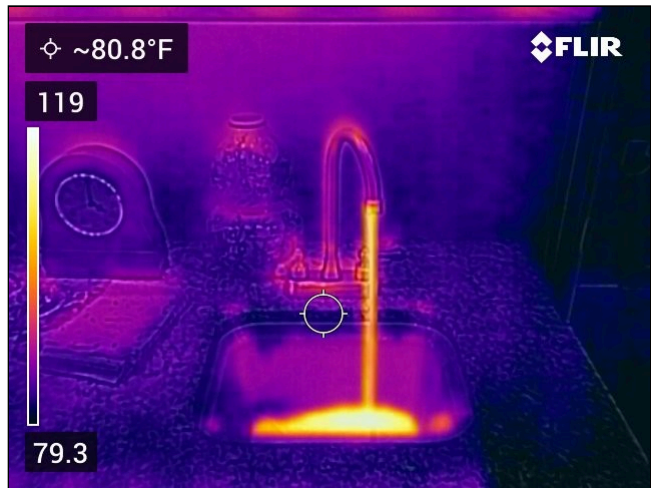
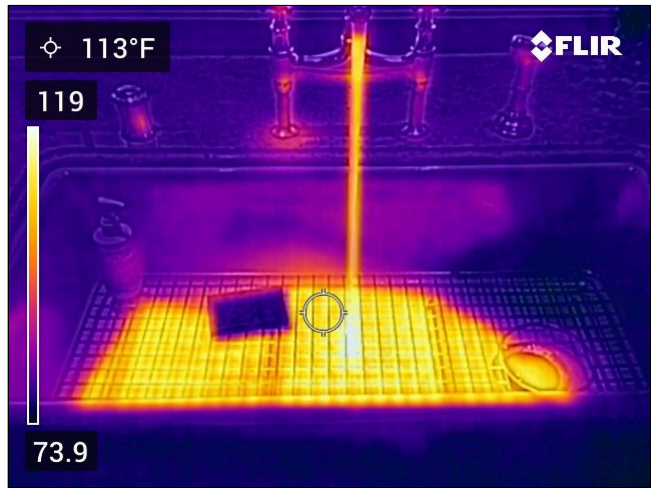
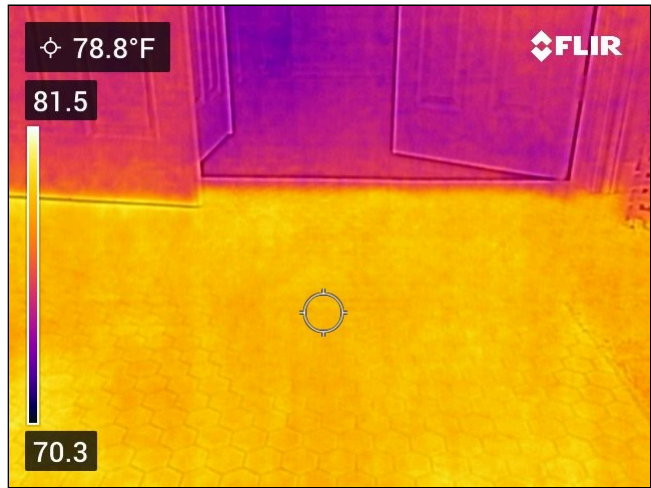
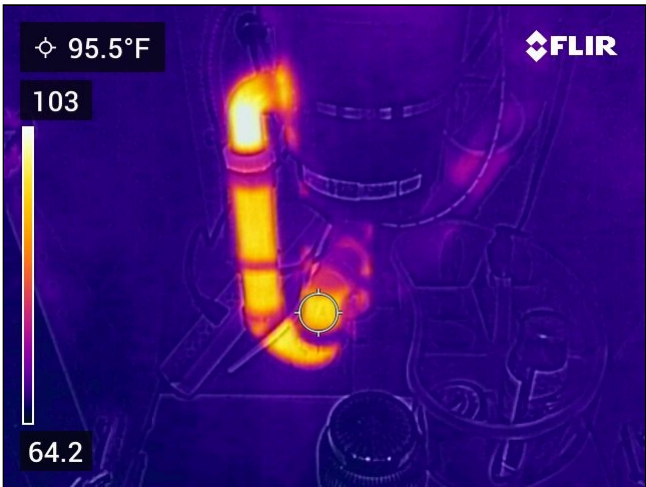
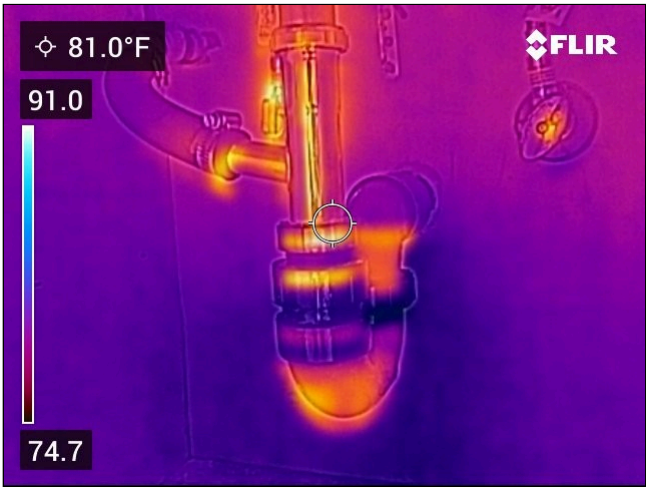
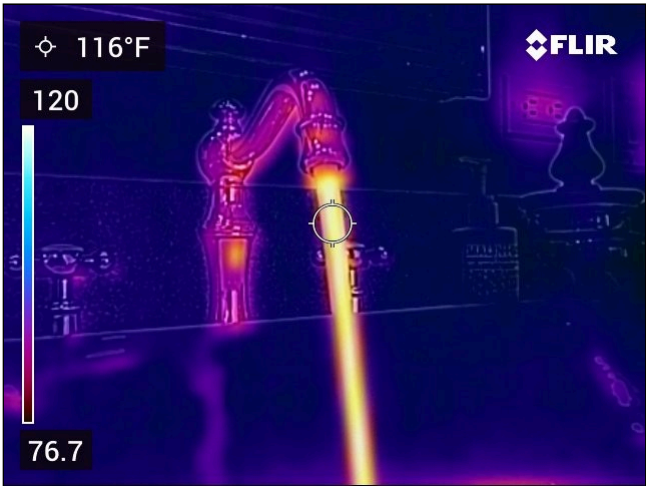
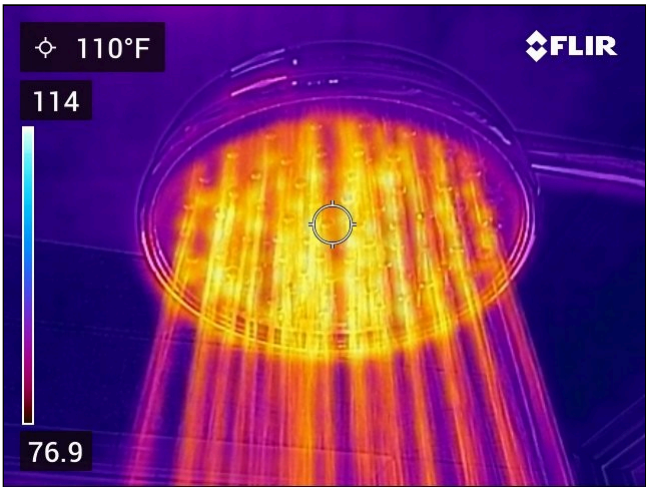
(1) Infrared Camera Thermal Photos.

(2) An infrared (thermal imaging) scan was performed throughout the property at the time of the inspection using a hand held infrared (thermal imaging) inspection camera. No anomalies were found at the time of the inspection using this camera unless otherwise noted.

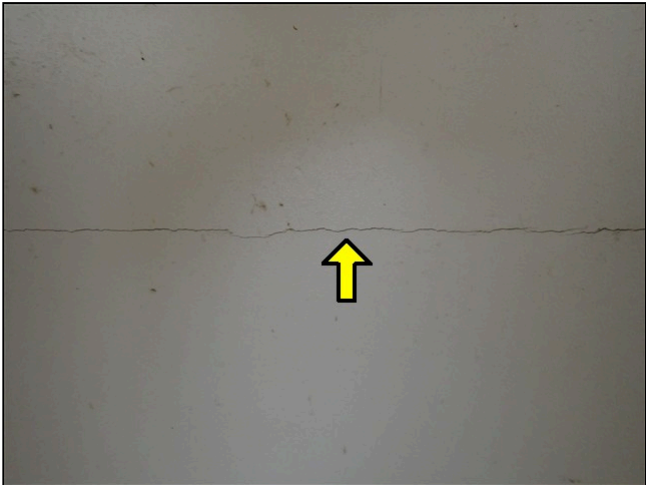
6.2.B Item 1 (Picture)

**Comments:**  
(1) Hairline cracking was observed at several locations throughout the property. These hairline cracks are likely due to material shrinkage or settlement of the structure. We recommend prep and paint where needed by a qualified licensed painter.

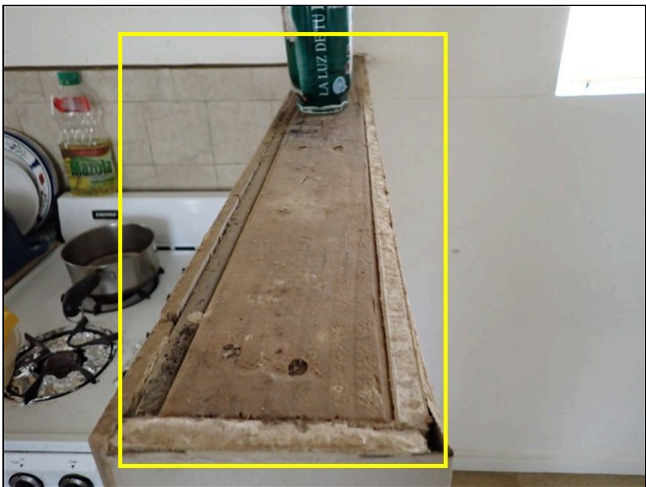
6.2.B Item 2 (Picture)

(2) The wall near the kitchen area is damaged. We recommend repairs made by a qualified licensed contractor.

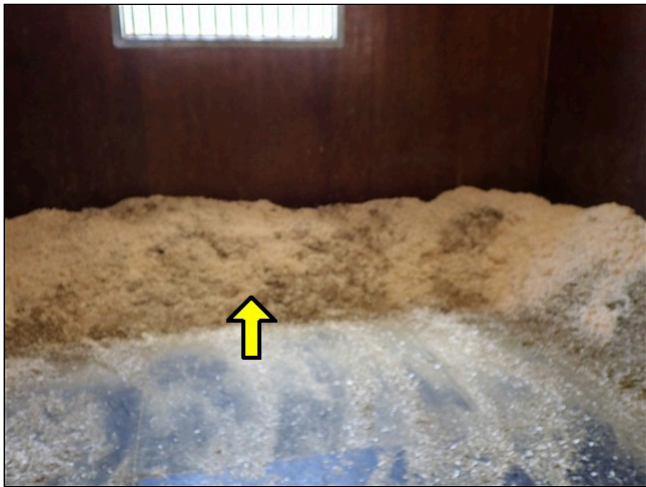
6.1.C Item 1 (Picture)

**Comments:**  
(1) Several walls are covered with the bedding for the horses. This material can trap moisture against the woof walls. We recommend removal of the bedding and the walls be reinspected by this company or a qualified licensed contractor.

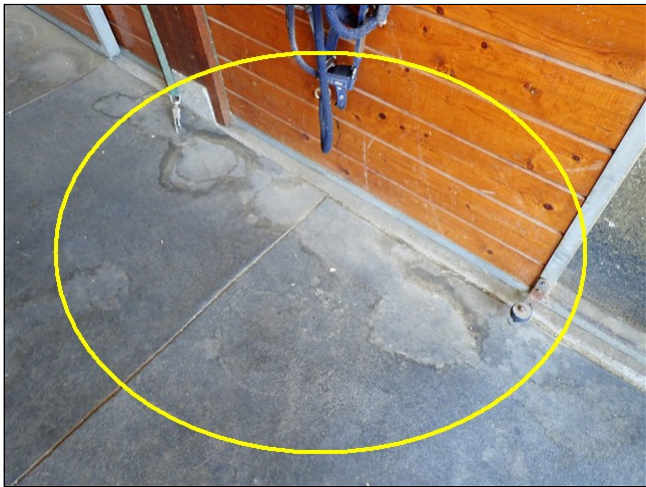
6.2.C Item 1 (Picture)

**Comments:**  
(1) The flooring shows areas of ponding (standing water) noted by dirt on the floor covering. We recommend further evaluation by a licensed qualified contractor prior to the end of your contingency period and ground drain lines added or other corrections made.

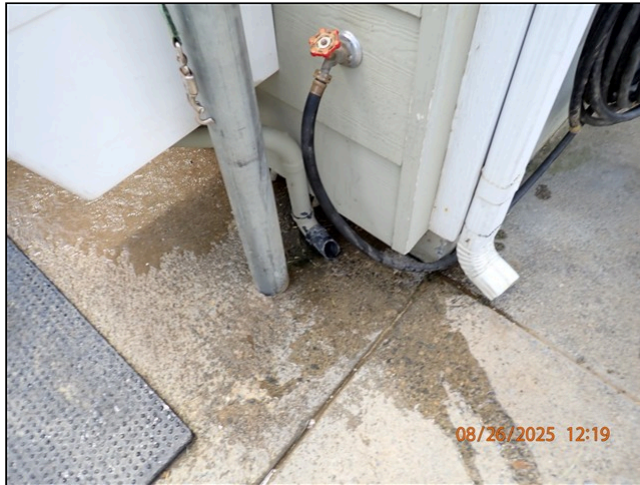
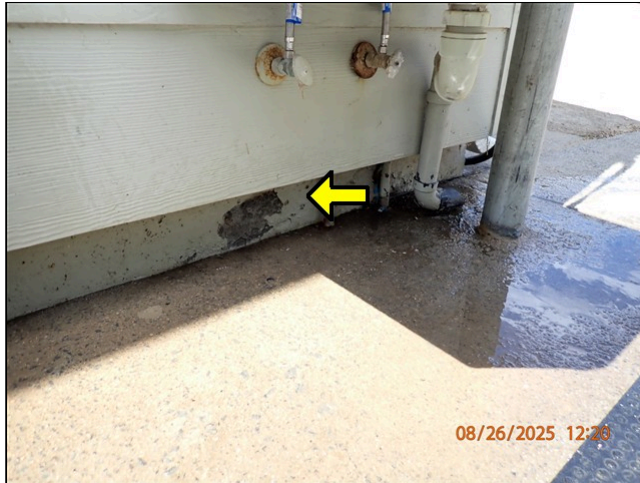
(1) The barn exterior sink waste line was observed to discharge close to the foundation and has caused skim coat damage. We recommend directing the water away from the foundation and any necessary repairs made by a qualified licensed plumber.

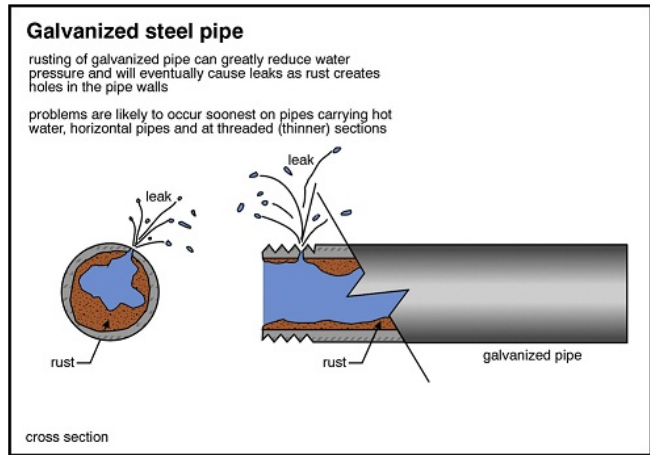
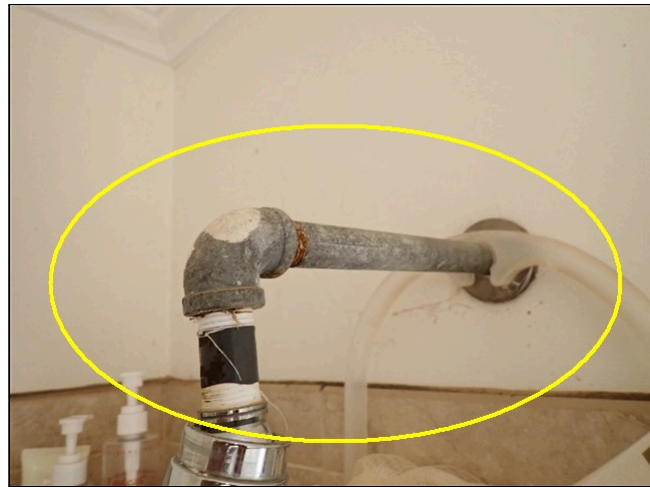
(2) Galvanized steel pipes are installed in the ADU. These pipes are known to become clogged with rust which reduces water flow. We recommend further evaluation and replacing these pipes where needed by a qualified licensed plumber.

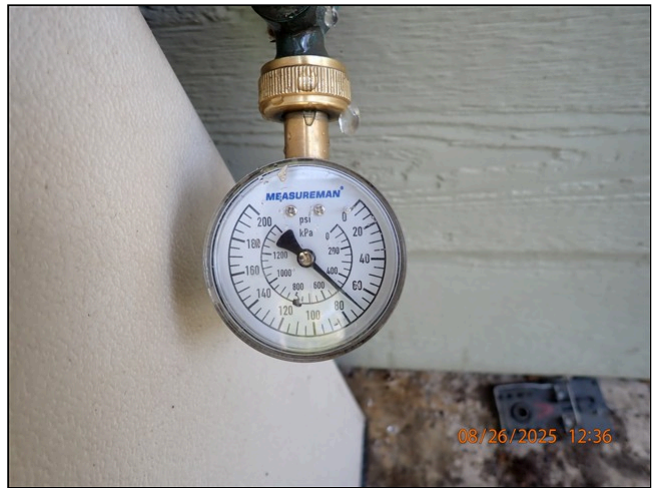
7.2 Item 2 (Picture)

(2) The water pressure was checked with a water pressure gauge and was measured and was found to be within the acceptable range at the time of the inspection.

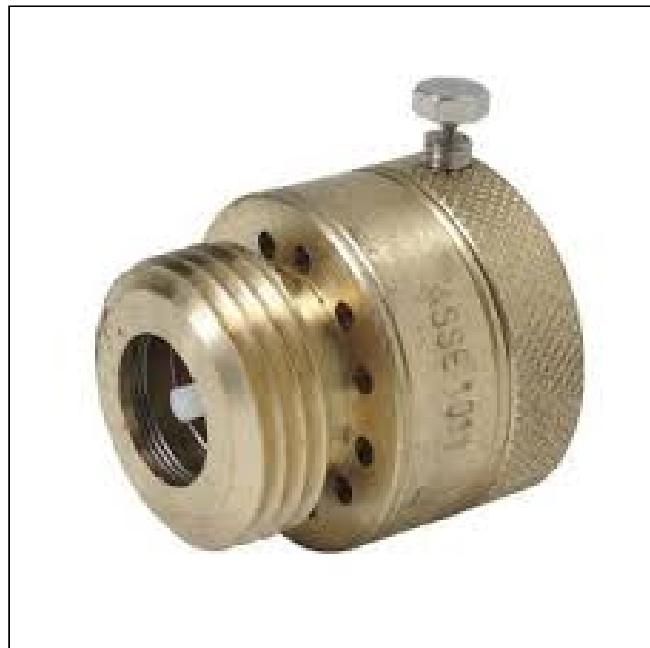
7.3 Item 2 (Picture)

(2) The exterior hose spigots do not have anti-siphon or anti-backflow devices installed on them. These anti-siphon or anti-backflow devices help prevent contaminated water from flowing back into the the house water supply system. We recommend installing anti-siphon or anti-backflow devices at the every exterior hose spigots by a qualified person.

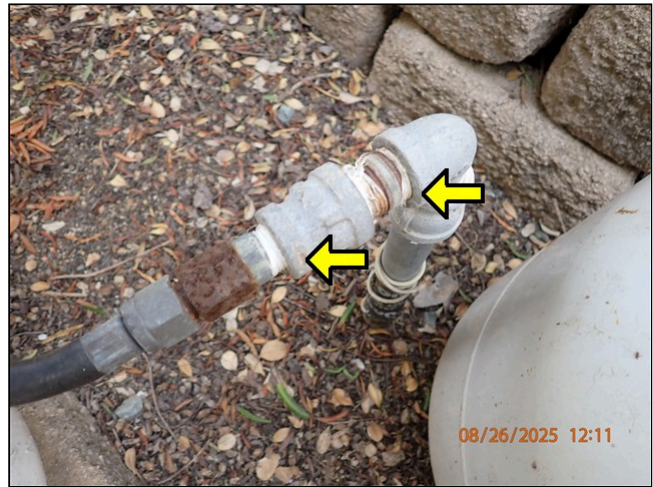
7.4 Item 1 (Picture)

(1) Several gas pipe fittings appear to have white teflon tape installed on them throughout the property. This is non standard. White teflon tape is intended for use on water pipe fittings. We recommend necessary corrections by a qualified licensed plumber.

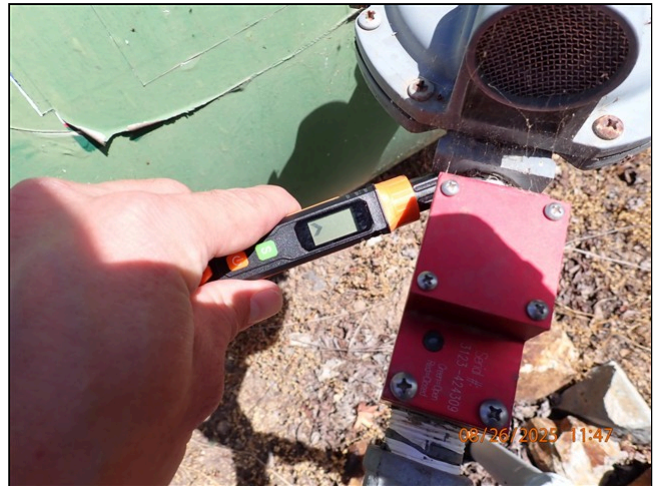
7.4 Item 2 (Picture)

(2) A gas leak test was conducted at accessible gas fittings and appliances using a gas leak detector. There were no gas leaks detected at the time of the inspection.

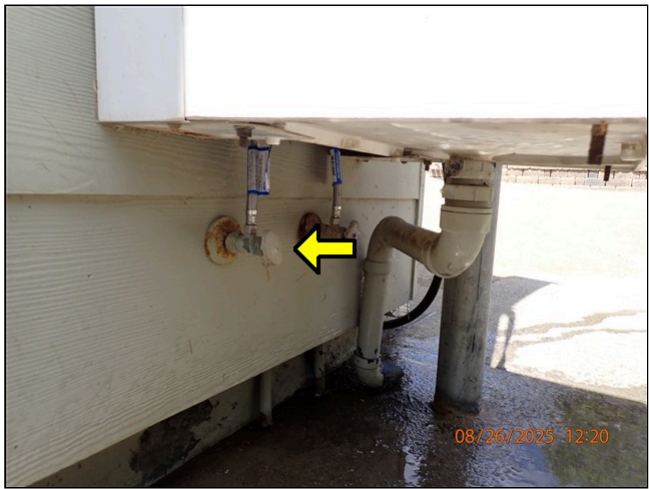
7.5 Item 1 (Picture)

(1) There are older one piece angle stop valve(s)/ supply line(s) observed at the sink(s). These one piece angle stop valve(s)/ supply line(s) have a reputation to corrode from the inside and possible fail. A white power substance or corrosion/ calcification is observed at the one piece angle stop valve(s)/ supply line(s). We recommend that these one piece angle stop valve(s)/ supply line(s) be replaced by a qualified licensed plumber as an upgrade.

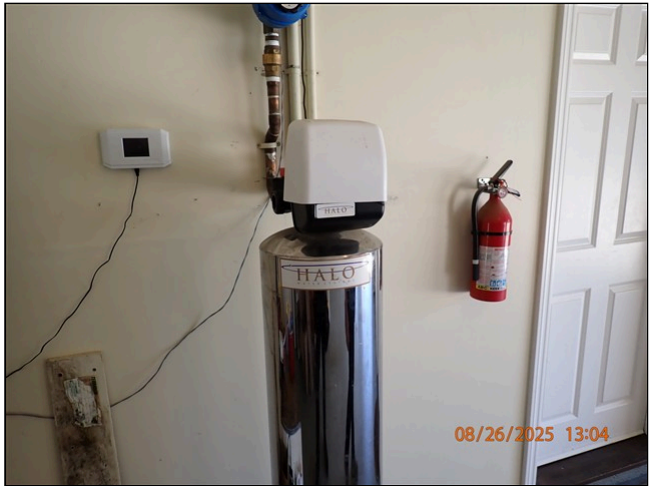
7.6 Item 1 (Picture)

There is a water filter installed which we did not inspect. Water filters are out of the scope of a general home inspection. We recommend further evaluation by a qualified person if concerned.

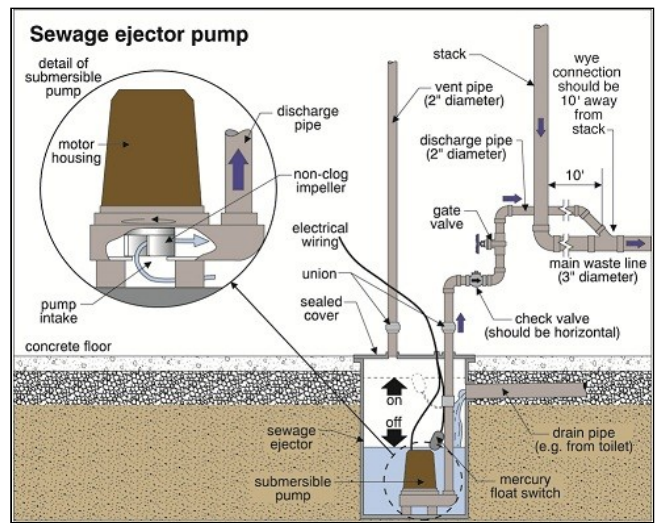
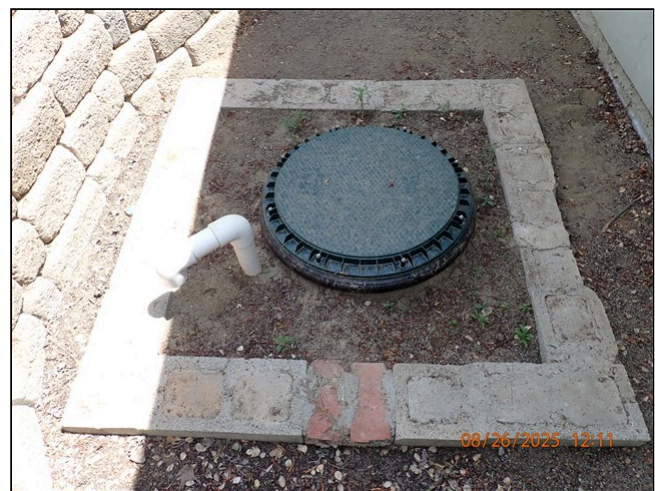
**Comments:**  
There is a sewer ejector pump installed at the ADU. Sewer ejector pumps are out of the scope of a general home inspection. We recommend further evaluation by a qualified person if concerned.

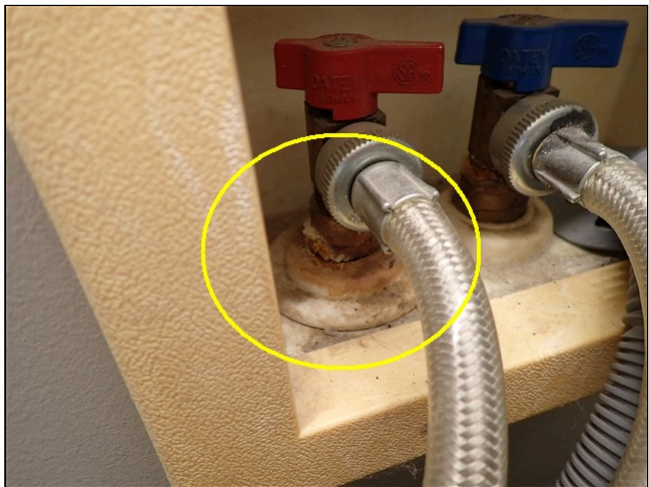
8.0 Item 1 (Picture)

**Comments:**  
The laundry faucet valves are corroded. We recommend replacement by a qualified licensed plumber.
