# Inspection Report

**Property Address:**  
20455 Elfin Forest Rd  
Escondido CA 92029

**The Property Inspection Pros**

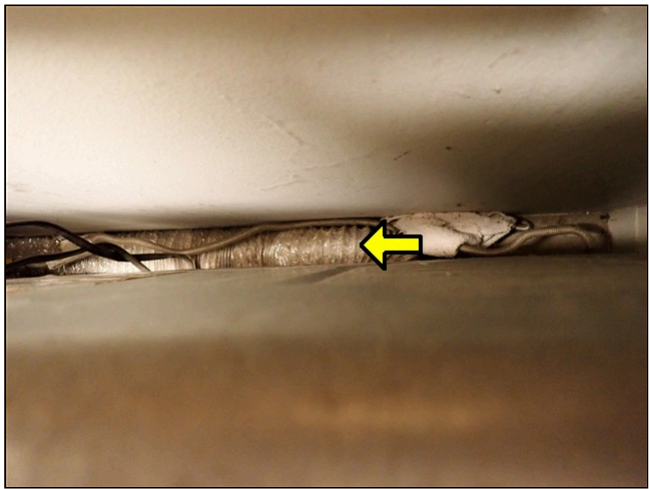
8.1 Item 1 (Picture)

- (1) We recommend having the dryer vent cleaned by a qualified person.
- (2) The dryer is equipped with a foil, accordion-type duct. The U.S. Consumer Product Safety Commission considers these types of ducts to be unsafe and a fire hazard. The flexible foil type duct can more easily trap lint and is more susceptible to kinks or crushing, which can greatly reduce the airflow. We recommend replacing the duct with a rigid or corrugated semi-rigid metal duct.

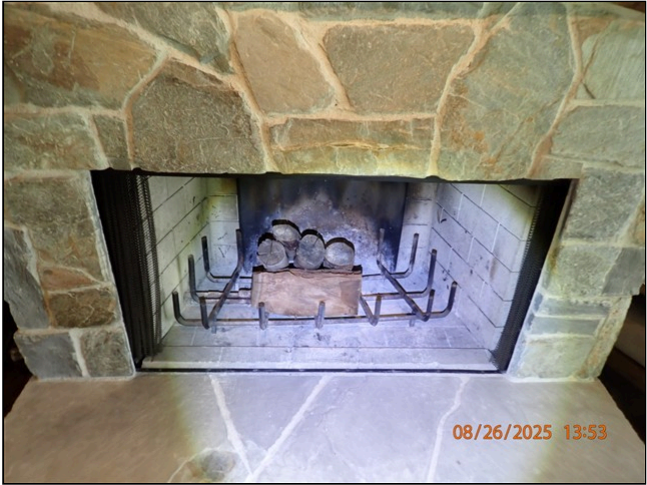
| IN | NI | NP | RR | IO | Items |
|---|---|---|---|---|---|
| | | | | <div><div></div><div></div><div></div><div></div><div></div></div> | <div><div>9.1 FIREPLACE(S)</div><div><div>Comments:</div><div>There are no glass doors installed at the fireplace. We recommend having glass doors installed by a qualified licensed chimney contractor as a safety upgrade.</div></div></div> <div><div><div></div><div>9.1 Item 1 (Picture)</div></div></div> |

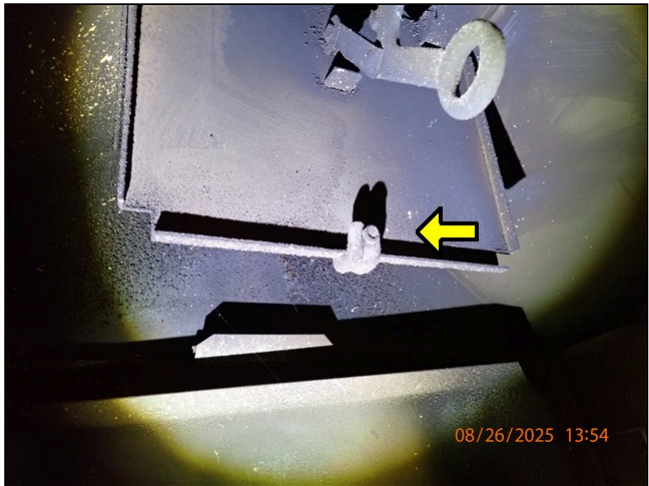
9.2 Item 1 (Picture)

There is a damper clamp installed at the family room fireplace for safety.

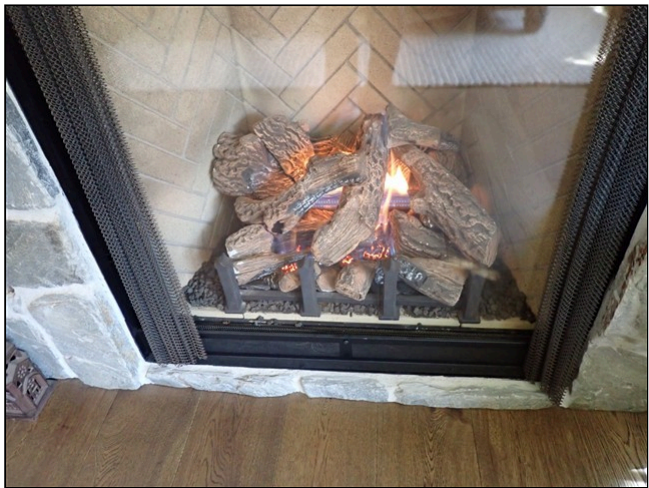
9.4 Item 1 (Picture)

**Comments:**  
(1) We do not light gas log lighters or concrete log kits installed at the fireplace. This is beyond the scope of the home inspection. However, the fireplace gas valve was tested and gas was noted to come out of the fireplace gas pipe.  
(2) The remote activated gas fireplace in the master bedroom was functional at the time of the inspection.

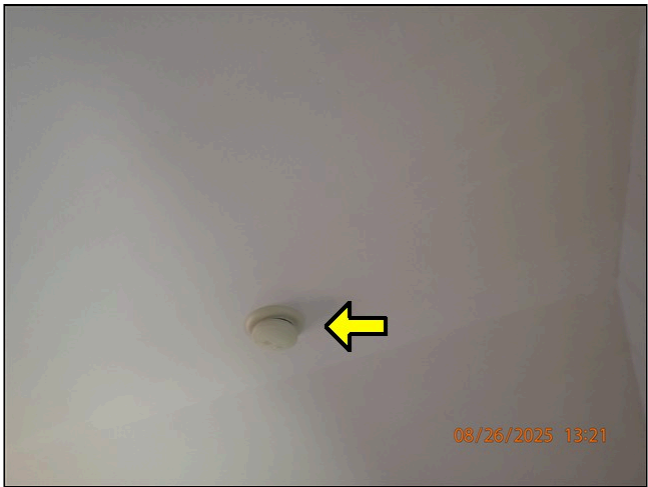
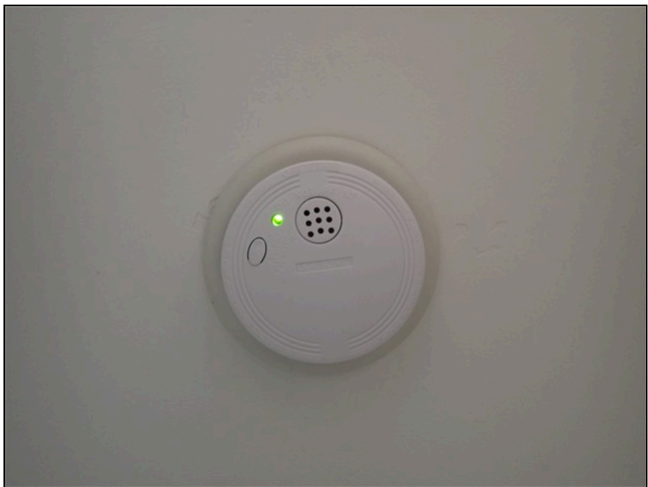
**Comments:**  
(1) The smoke detectors in the property are older. Studies show that detectors that are more than 10 years old have a high rate of failure. Many old detectors do not have battery back-up, and will not work if the electricity is off. We recommend that all old detectors be replaced prior to occupancy of the house for safety.

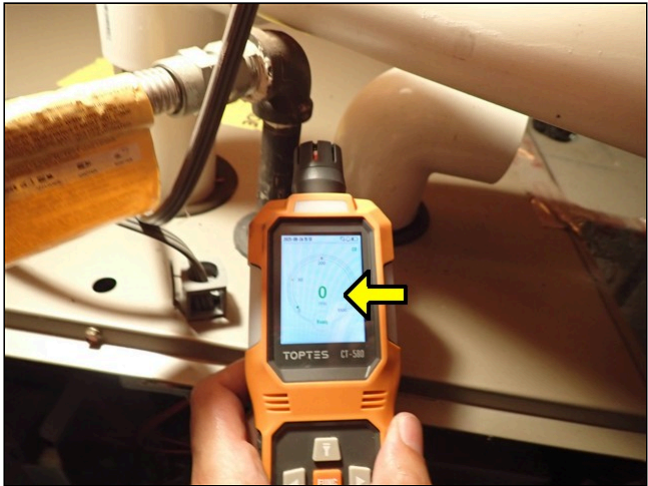
10.1 Item 1 (Picture)

during the inspection while testing the gas appliances. Carbon monoxide was not detected at the time of the inspection.

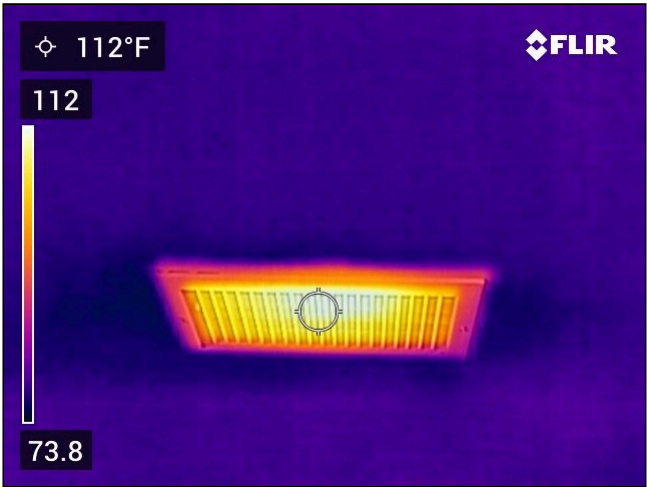
11.0 Item 1 (Picture)

- Comments:
- (1) The furnace was tested and was functional/ operated at the time of the inspection.
  - (2) **Infrared Thermal photo of the furnace(s) being tested.**

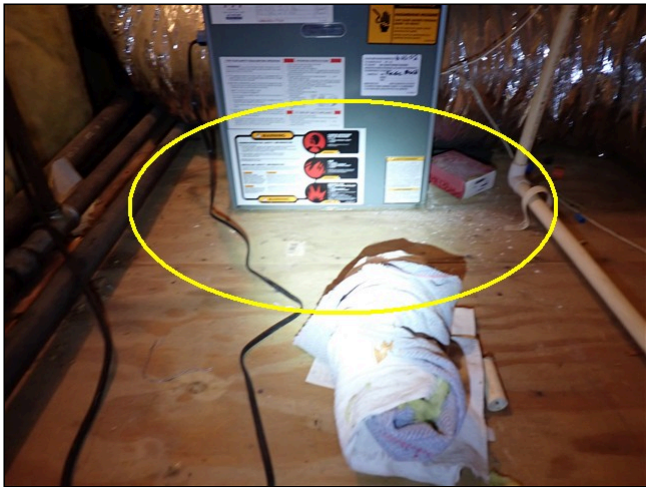
11.0 Item 4 (Picture)

(4) The gas furnace is installed on a wood floor in the left side attic space. Most gas fired appliances need to be elevated off the floor. The furnace burn chamber should be approximately 20 inches above the floor. We recommend contacting a licensed HVAC contractor or SDG&E to confirm that this furnace installation is correct prior to the end of your contingency period.

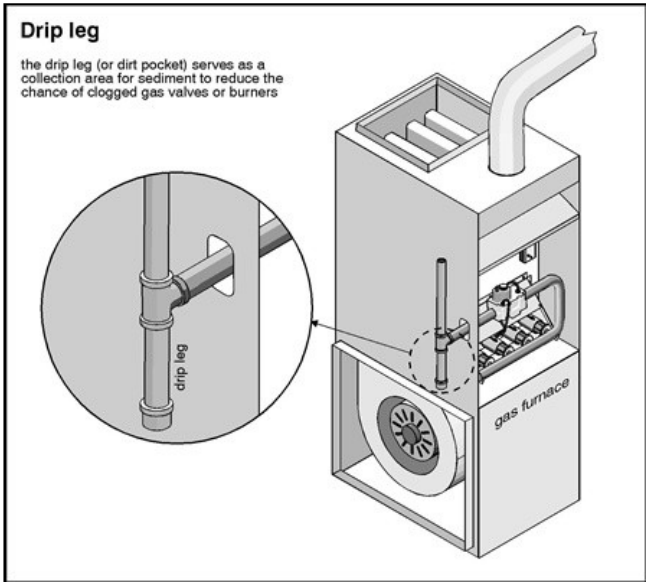
11.0 Item 5 (Picture)

(5) The gas supply pipe at the furnaces did not contained a drip leg/ sediment trap. This may have been standard at the time of installation but now is highly recommended. The purpose of a drip leg is to help prevent sediment/ debris from entering and clogging the furnace gas valve which could cause the furnace to shut down. We recommend having a drip leg installed at both furnaces by a qualified licensed HVAC contractor.

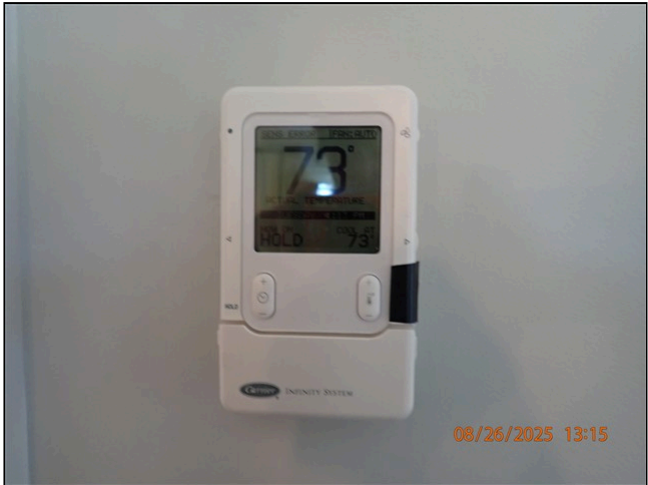
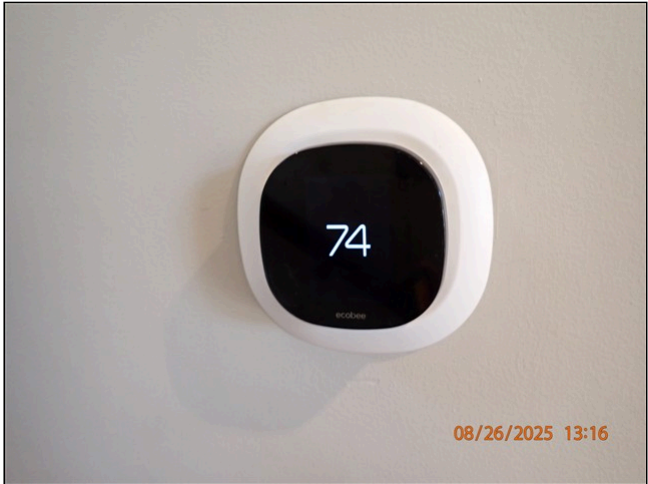
(1) Both of the thermostats in the house were operational when used to operate the HVAC systems at the time of the inspection. Programmable thermostats are not adjusted and no testing is done to check the accuracy or programmed settings of the thermostat. If concerned we recommend verifying proper operation of the programmable settings by a qualified person.

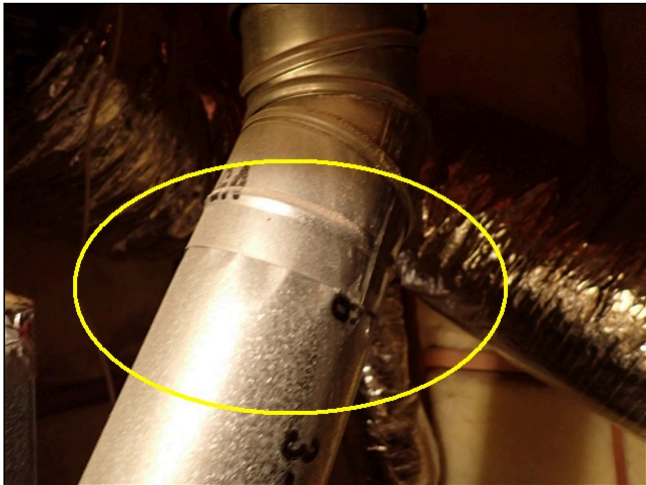
11.2 Item 1 (Picture)

**Comments:**  
The left side furnace flue sections are not fastened together. Flue sections must be secured with 3 sheet metal screws at each junction. We recommend adding sheet metal screws by a qualified person.

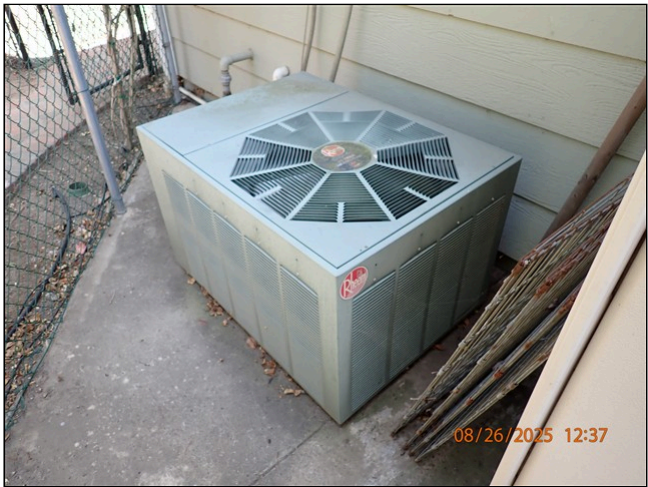
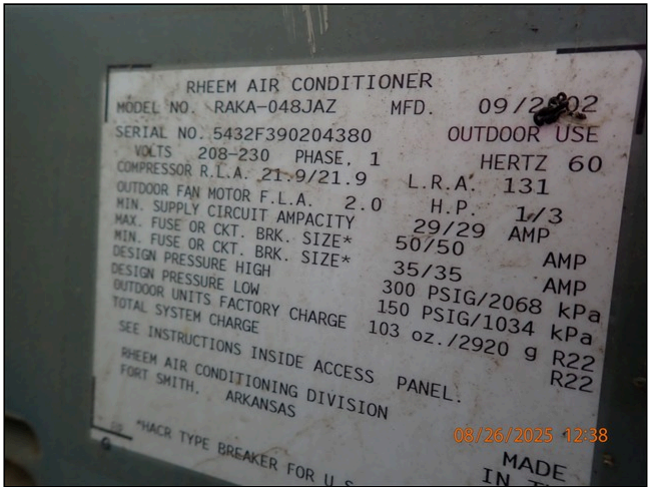
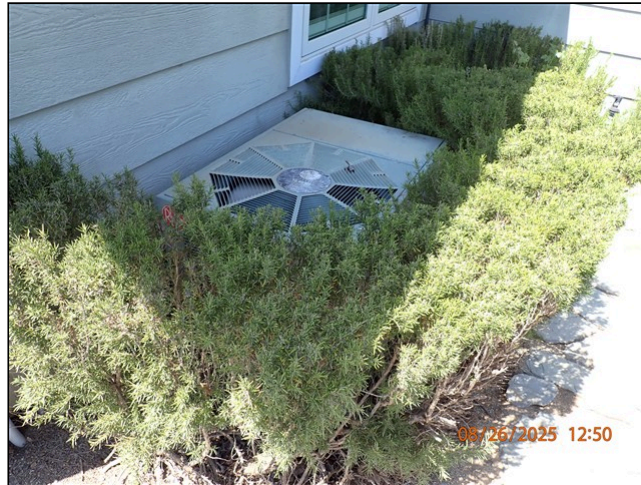
Comments:  
(1) **Photo of the A/C unit(s).**

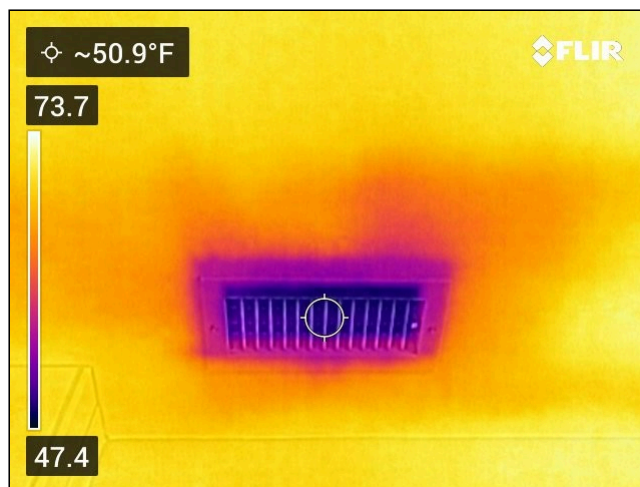
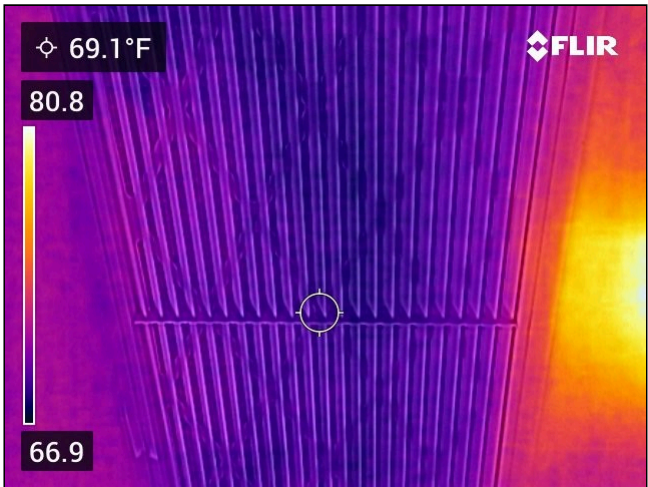
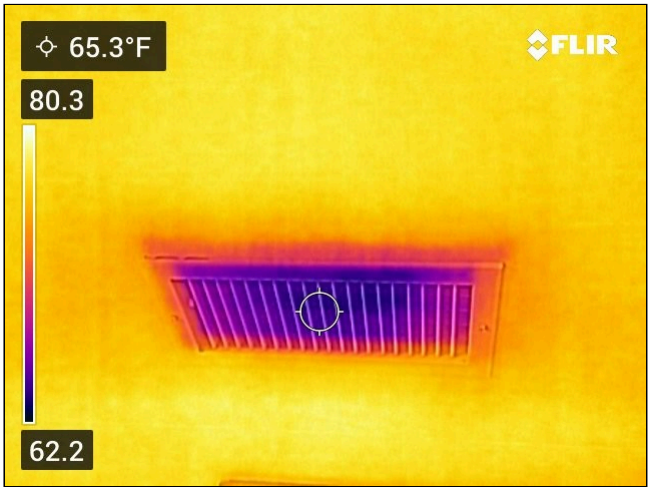
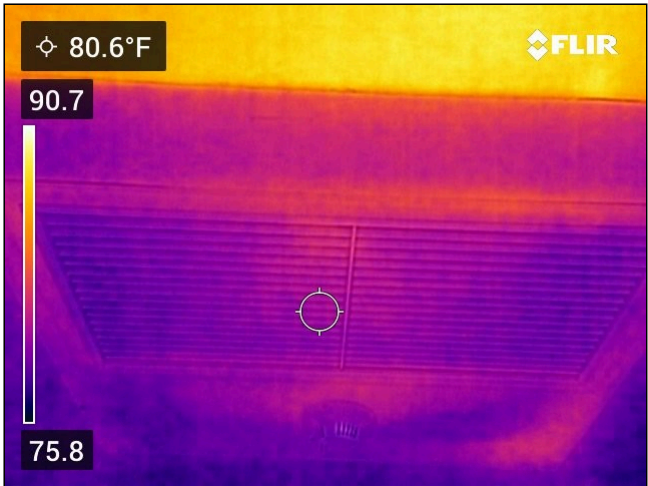
(2) An ambient air test was performed by using a thermal camera on both of the AC systems to determine if the difference in temperatures of the supply and return air was between 14 degrees and 22 degrees which indicates that the AC systems are cooling as intended.

The air returning to the system (return) to the right side of the house was measured at **80 degrees**.

This indicates that the range in temperature drop is normal at both AC systems. This is not an exhaustive test and cannot predict the performance of the AC systems on extremely hot or humid days.

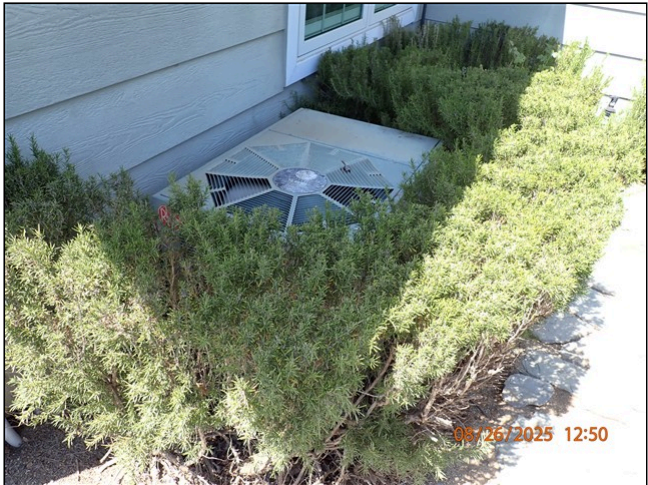
12.0 Item 8 (Picture)

(3) Vegetation is growing on and around the AC condenser. This can cause damage/ deterioration of the unit and reduces the overall performance/ efficiency. We recommend removing or trimming the vegetation away from the condenser.

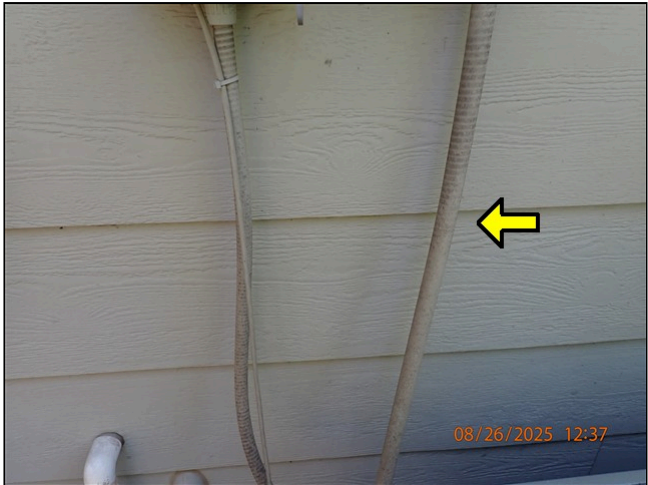
12.0 Item 9 (Picture)

(4) The AC unit electrical conduit is not secured to the wall as required. We recommend having the AC unit conduit secured to the wall by a qualified person.

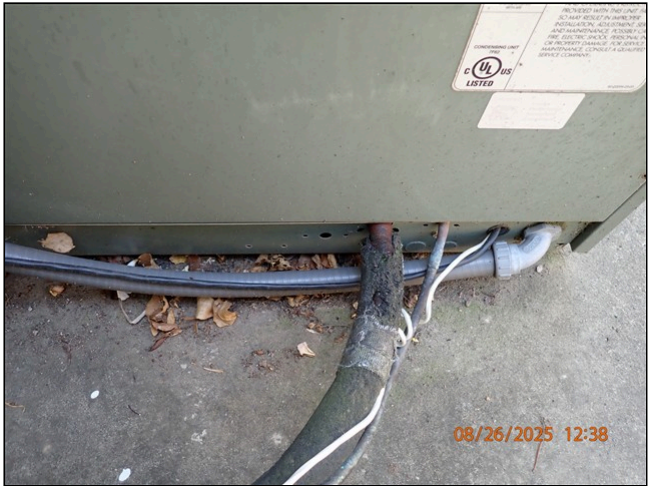
12.0 Item 10 (Picture)

(5) The insulation is damaged at the exterior refrigerant lines. We recommend replacing the damaged insulation by a qualified person.

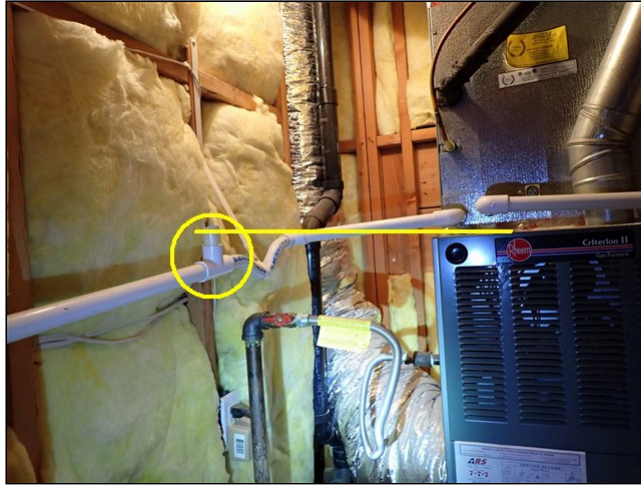
12.1 Item 1 (Picture)

(1) The vent pipe for the AC condensation drain was installed too low in the left side attic space. The vent pipe should extend above the drain pan or primary drain by 2 inches. We recommend necessary corrections by a qualified licensed HVAC contractor.

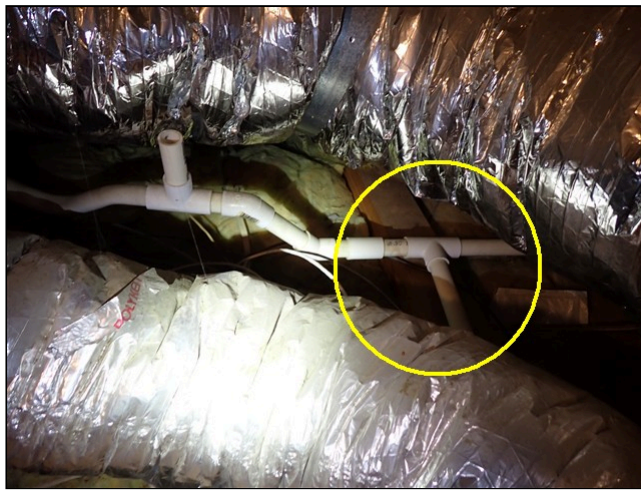
12.1 Item 2 (Picture)

(2) The primary and drafting condensation drain lines have been joined together in the right side attic space. This is a non-standard installation. We recommend further evaluation by a qualified licensed HVAC contractor and necessary repairs made as needed..

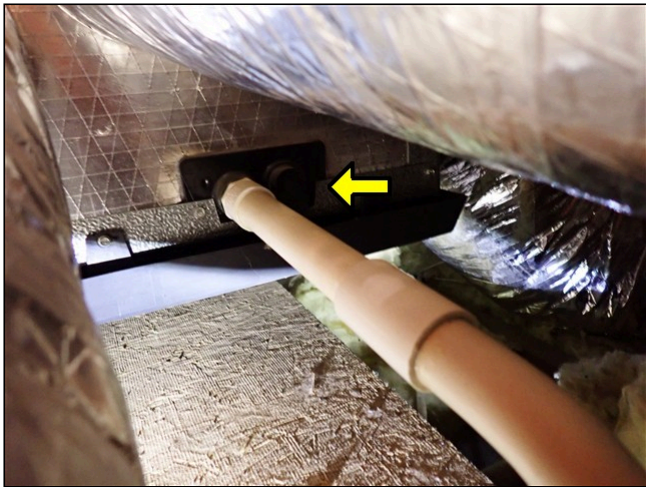
12.1 Item 3 (Picture)

(3) There is no secondary AC condensation drain installed at the right side FAU. This may have been acceptable at time of installation. However, today a secondary drain or alternate device is required to prevent damage in case of a clog in the primary drain. We recommend installing a secondary drain or alternate device by a qualified licensed HVAC contractor.

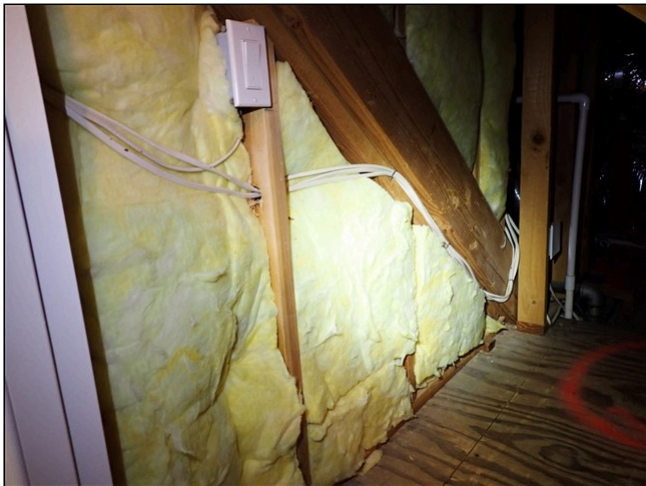
- 13.0 Item 1 (Picture)
- (2) The insulation in the attic appears to be functioning as intended.
- (3) The attic space access hatch cover is not insulated. We recommend insulating the attic access hatch cover to reduce unwanted heat loss/gain by a qualified person.

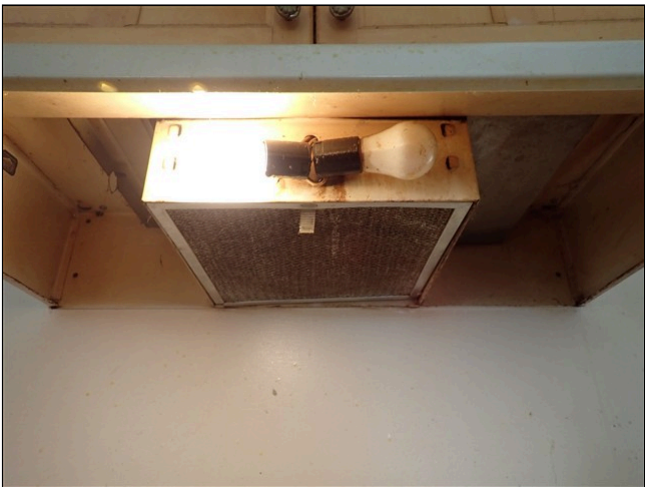
15.0.B Item 1 (Picture)

**Comments:**  
(1) The range exhaust vent was tested and was functional at the time of the the inspection. This is not an exhaustive test, and does not evaluate the performance or effectiveness of the unit.  
(2) The range exhaust vent filter is dirty. We recommend replacing by a qualified person.

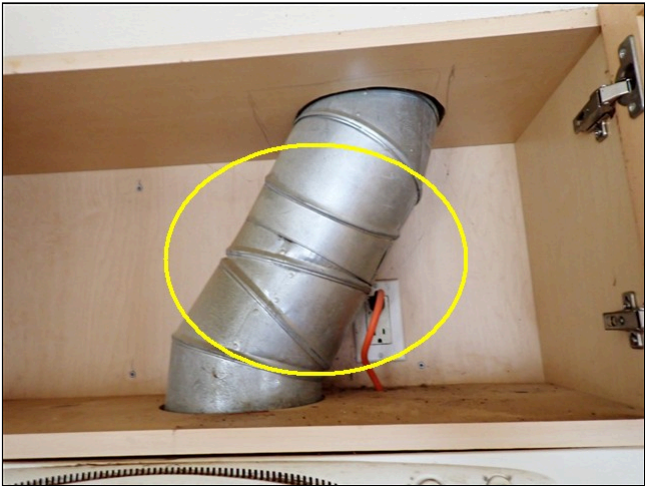
15.0.B Item 2 (Picture)

(3) The vent duct is missing duct tape. We recommend re-taping the duct by a qualified person.

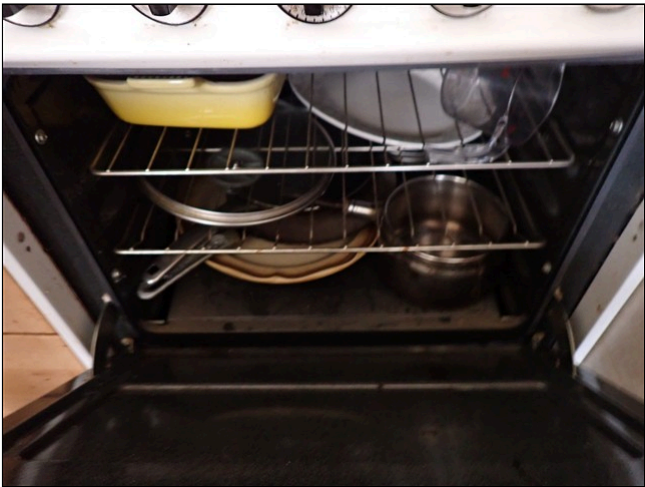
15.1.B Item 2 (Picture)

(2) The oven was not tested due to stored items inside the oven at the time of the inspection. We did not remove these items to inspect. We recommend having these items removed and verifying that the oven operates properly prior to the end of your contingency period.

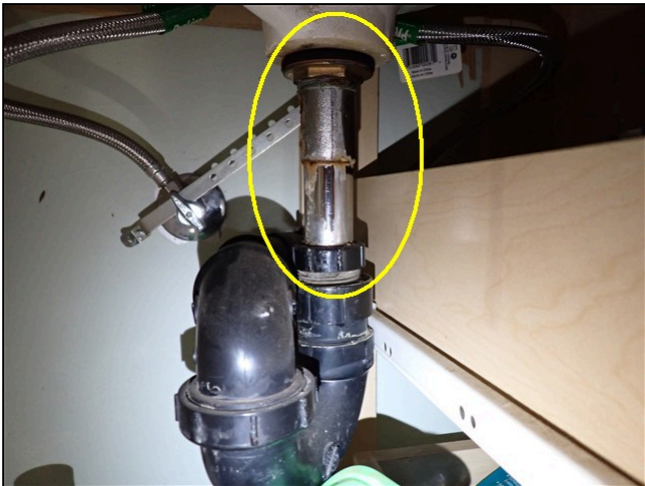
17.0.A Item 1 (Picture)

**Comments:**  
(1) The metal portions of the sink drain are rusted or corroded. A leak was not observed at this sink drain pipe at the time of the inspection. However, we recommend replacing this drain pipe by a qualified licensed plumber to help prevent future leaks or damage.

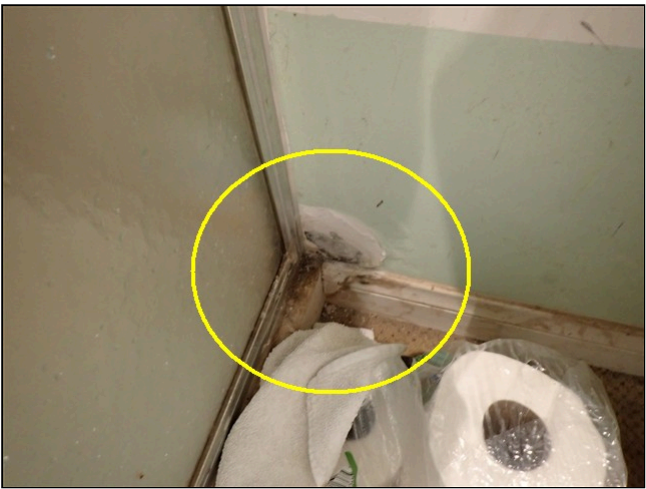
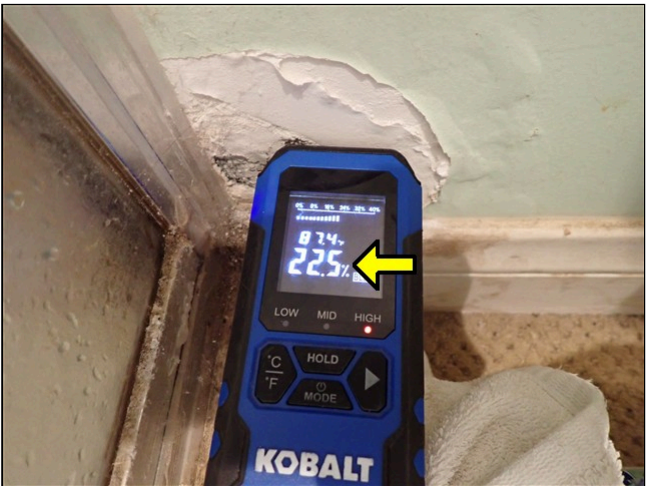
Staining and an elevated level of moisture was detected at the wall adjacent to the shower. This can be caused by plumbing leaks or water leaking through grout or the enclosure. There may be moisture damage behind the wall which is concealed, and cannot be identified within the scope of a home inspection. To determine if moisture damage exists inside the walls, a more invasive inspection is required. We recommend further evaluation by a leak detection company, remediation contractor, or a licensed general contractor and necessary repairs made as needed.

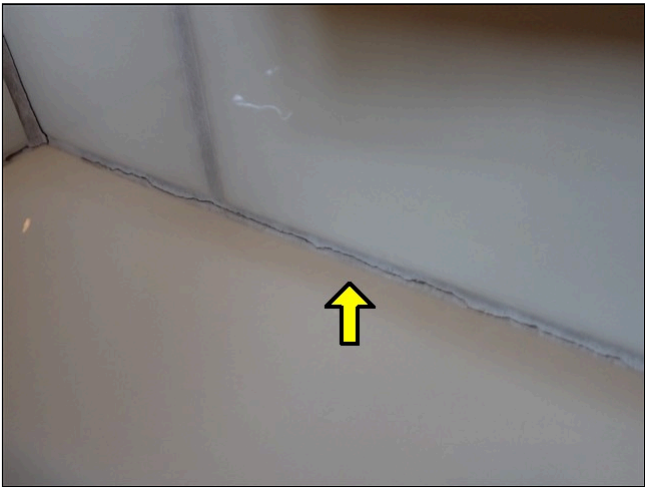
17.1.B Item 1 (Picture)

**Comments:**  
(1) The shower wall tiles have cracked or missing grout between the tiles and needs repair or replace. There may be water damage to the wall behind the tiles which is not visible. Determining if water damage exists in the wall behind tiles is beyond the scope of our general home inspection. We recommend having the tiles repaired by a licensed tile contractor. Additional repairs may be required when tiles are removed. This area should be evaluated further by a qualified licensed tile contractor prior to the end of your contingency period.

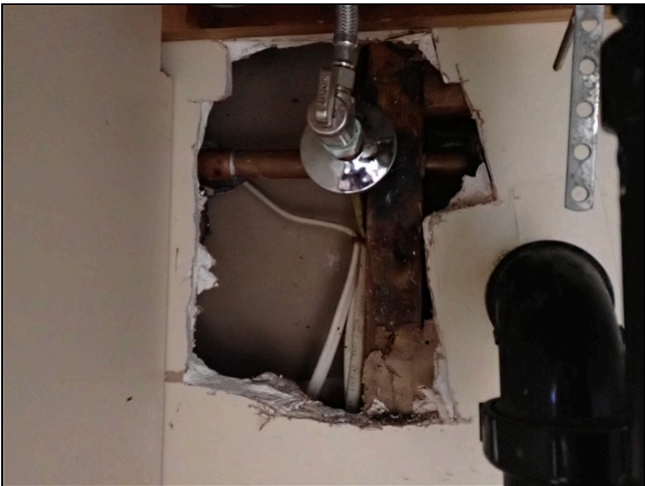
17.2.C Item 1 (Picture)

repairs. We recommend necessary repairs where needed by a qualified person.

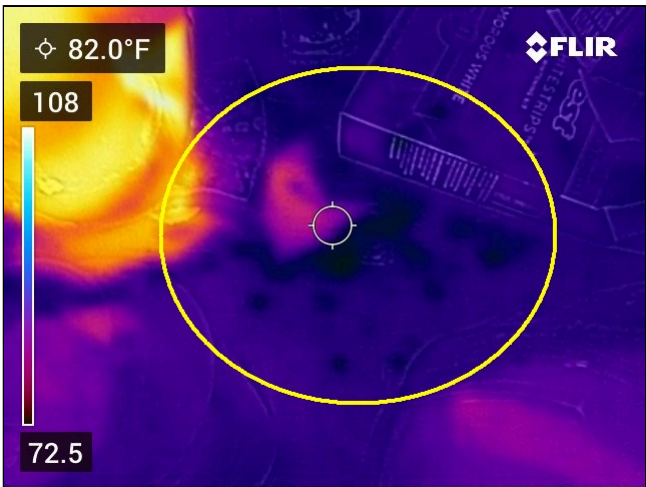
17.0.D Item 1 (Picture)

**Comments:**  
(1) An active leak is present at the drain pipe under the left sink. We recommend necessary repairs by a qualified licensed plumber.

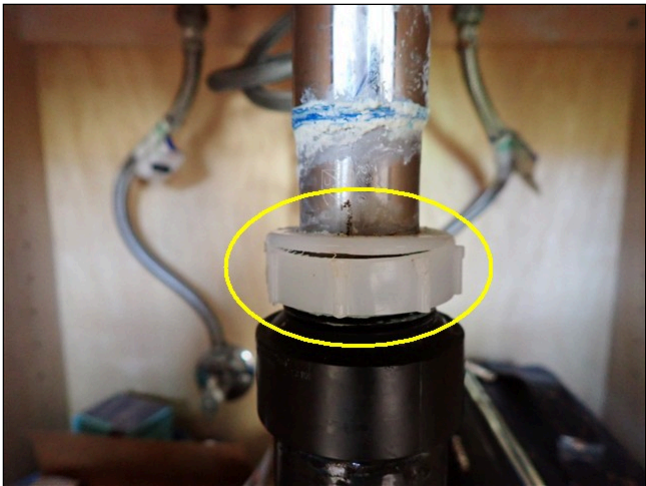
17.0.D Item 2 (Picture)

(2) A cracked fitting is observed at a drain pipe under the sink. We recommend necessary repairs or replacement by a qualified licensed plumber.

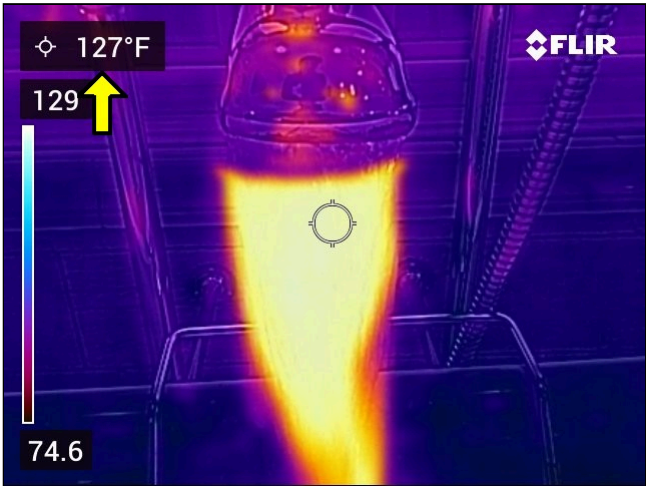
17.2.D Item 1 (Picture)

The temperature of the water at the tub was tested using a thermal camera at the time of the inspection and found to be above 125 degrees. Water temperatures above 125 degrees can cause scalding or burns. We recommend further evaluation and corrections made as needed by a qualified licensed contractor.

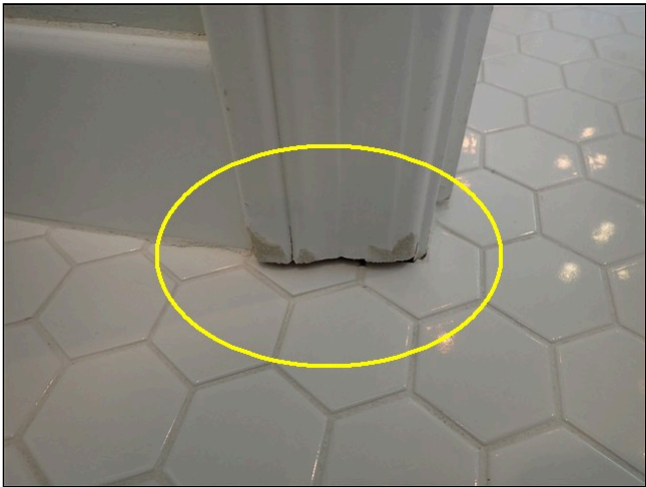
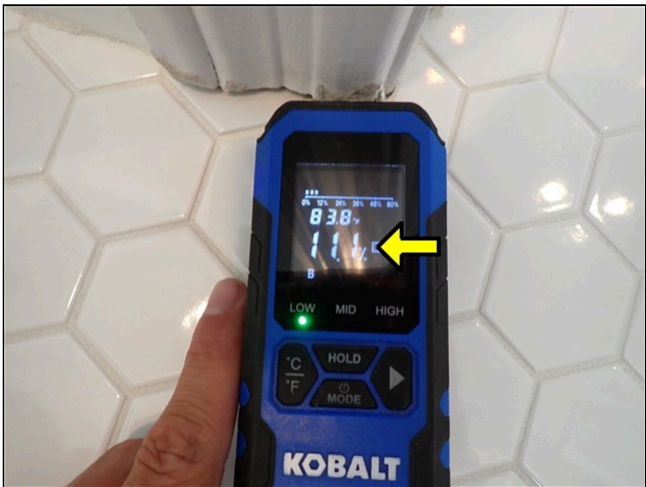
Moisture damaged is noted at the baseboard. These baseboards were tested for moisture and were found to be dry at the time of the inspection. We recommend further evaluation by a licensed termite inspector and repair as needed.
