Property Address:

2030 Black Canyon Rd  
Ramona Ca 92065

January 10, 2018

RE: 2030 Black Canyon Rd #29  
Ramona, CA 92065

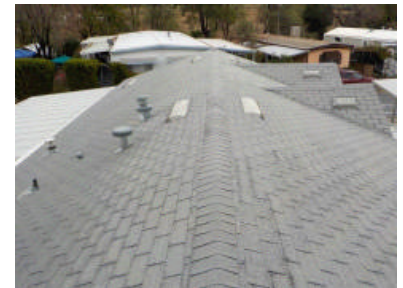
Roof shingles show signs of deterioration, especially at the front south facing field. The aggregate surface has shed, leaving the matrix exposed. The roof is near the end of its useful life. Water penetration may occur. Roof replacement will be necessary in the near future and should be budgeted for.

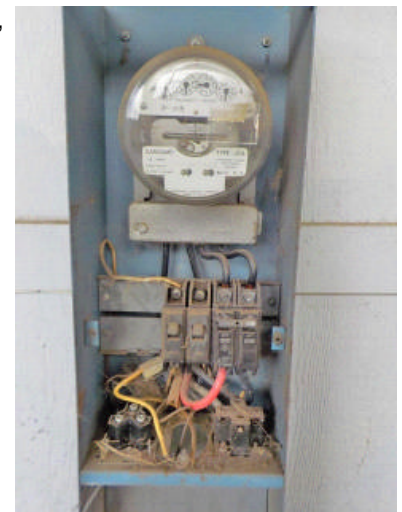
p " " Underground, Circuit breakers,  
Appears serviceable.

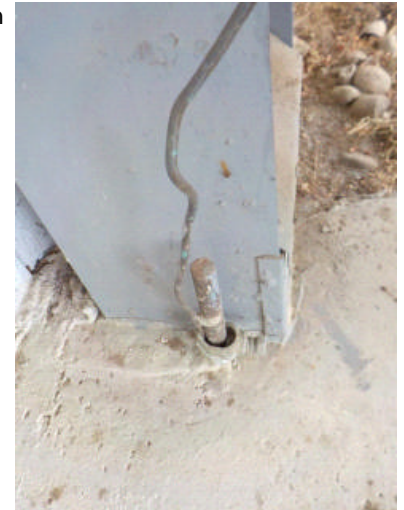
Grounding Equipment:

⌋ " " Grounded via plumbing and rod in ground.

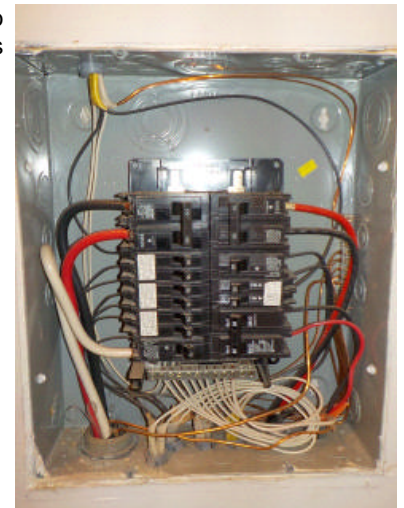
Subpanel:

⌋ " " Circuit and wire sizing correct so far as visible, Grounding system is present.

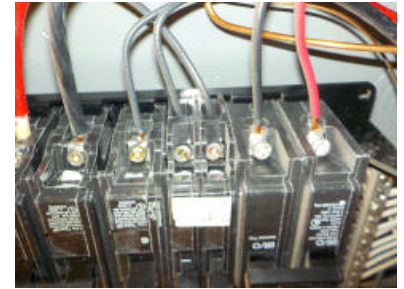
600' of 12 AWG Copper, Appears serviceable.

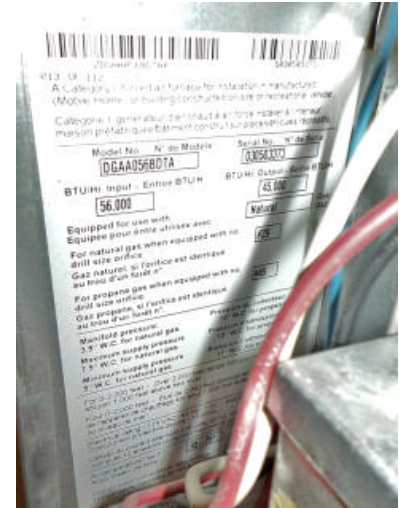
Operational at time of inspection. Heater is dirty, recommend annual cleaning / servicing by a qualified HVAC professional.

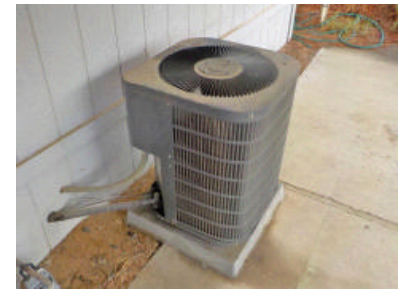
No electrical disconnect in line of site / next to exterior condenser. This item is required. Recommend further evaluation by a qualified HVAC professional.

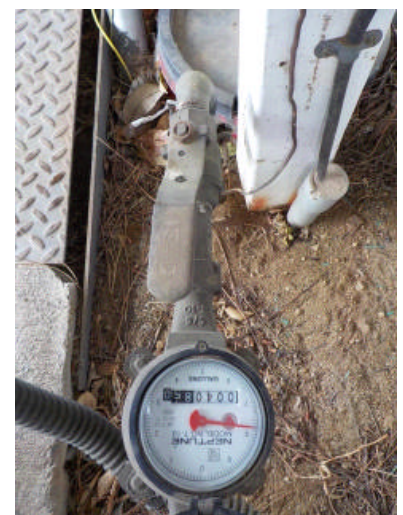
Pressure: 55 PSI. Water pressure appears adequate.

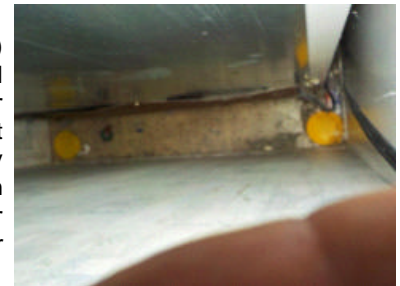
### Dishwasher:

Operational at time of inspection. A proper air gap IS NOT installed in the dishwasher drain line. A air gap is required to prevent dirty water from being sucked back into water supply. Recommend installation of air gap by qualified plumber.

<i>Condition:</i>	"   "   p	Operational at time of inspection. A proper air gap IS NOT installed in the dishwasher drain line. A air gap is required to prevent dirty water from being sucked back into water supply. Recommend installation of air gap by qualified plumber.
-------------------	-----------	---

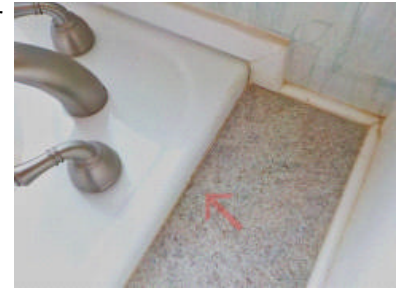
Hall Bath:

OK MM RR  
p .. .. Caulk and seal all tub and shower areas as a precaution.

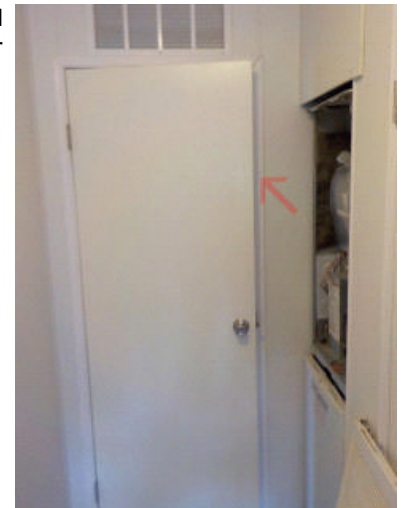
OK	MM	RR	
<i>Main Entry Door:</i>	p	..	..	Hardware operational.
<i>Other Exterior Doors:</i>	p	..	..	Hardware operational.
<i>Overall Interior Door Condition:</i>	p	..	..	
<i>Master Bath:</i>				Hardware operational.
<i>Hall Bath:</i>				Hardware operational.
<i>Laundry:</i>				Doorframes are not square. Some binding is noted Door hardware needs some adjustment or repair for it to function appropriately.
