Inspection Report

Property Address: 450 E Bradley Ave #46

El Cajon CA 92021

BHI San Diego / Bailey's Home Inspections

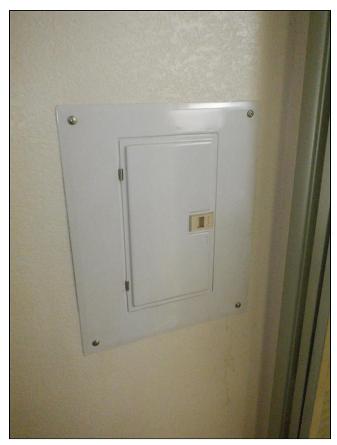
8.0 The electrical panel is a 100 amp panel. The panel is labelled, clean on the inside, no corrosion found at grounding/neutral boards, none of the circuit breakers are double tapped with wires, and all connections were in tact.

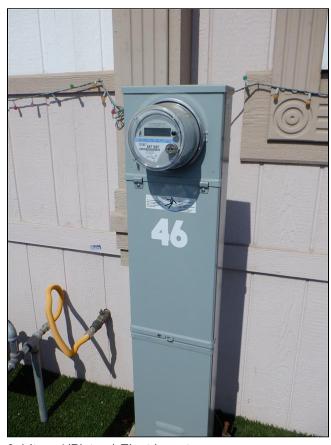
8.4 The electric meter and main breaker are located on front of home. The electrical panel is located in the laundry room.
