REAL ESTATE INSPECTION SUMMARY.

LOCATED AT:
686 S Camino Real
Palm Springs, CA 92264

Report# 10777

Executive Summary

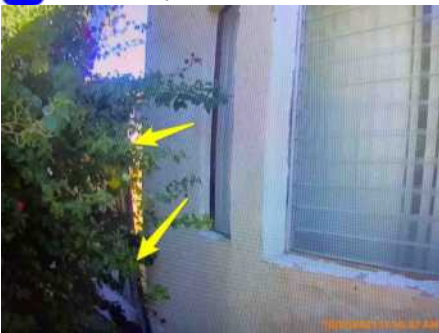
NR 1: Loose posts noted at left side of house

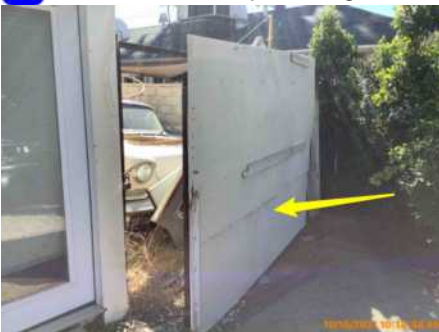
NR 2: Gate needs repair at right side

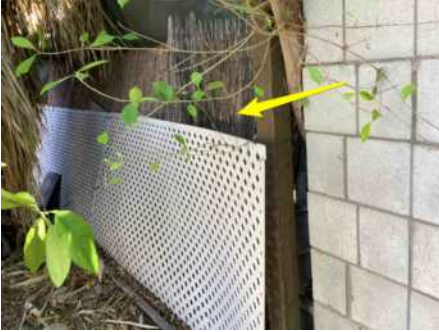
NR 3: Repair needed to fencing

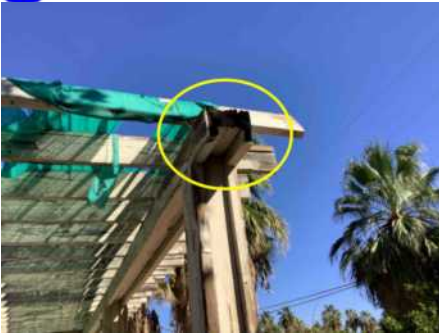
NR 4: Damage noted to wood. Recommend further evaluation by a qualified Termite Company

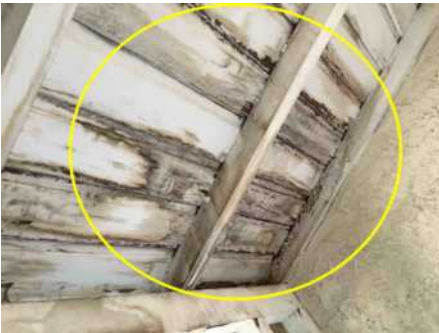
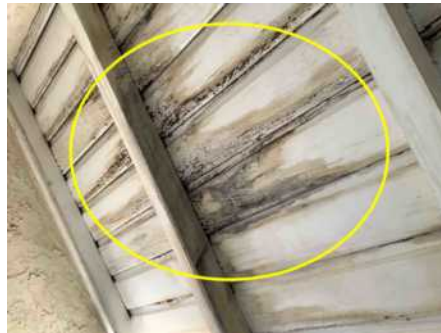
NR 5: Moisture damage noted to front porch roof sheathing, Recommend further evaluation by a qualified Termite Company

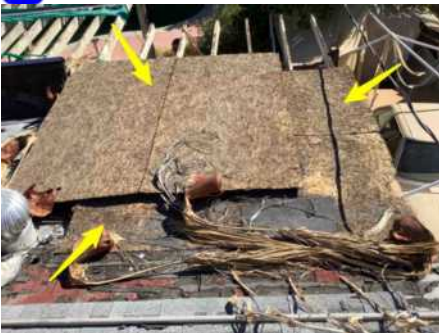
NR 6: Roofing material missing on patio roof

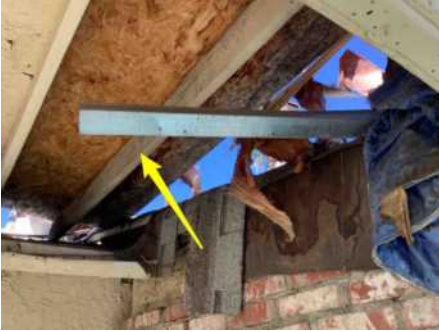
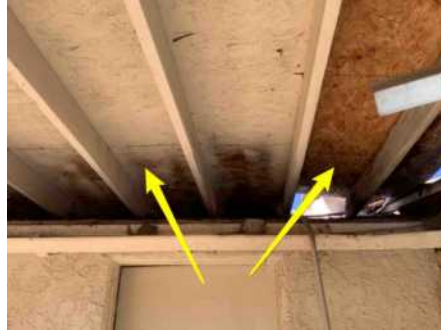
NR 7: Improper installation at patio roof.

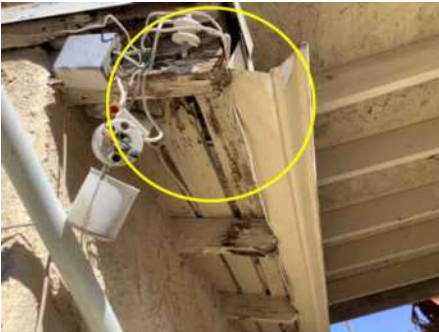
NR 8: Damage noted at roof rafter(s). We recommend further review and repairs by a qualified specialist in the appropriate trade.

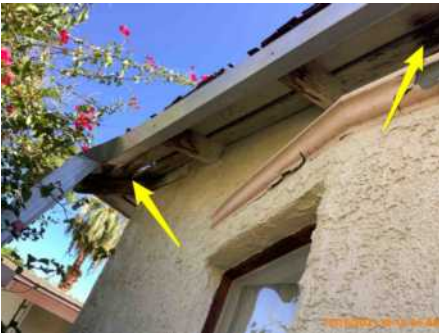
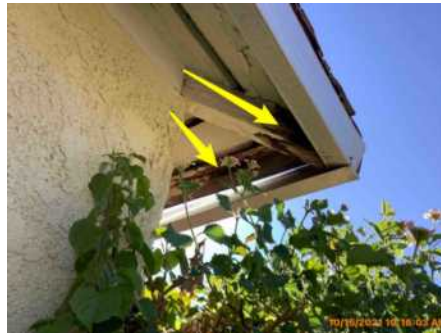
NR 9: Staining noted at eaves, We recommend further review and repairs by a qualified specialist in the appropriate trade.

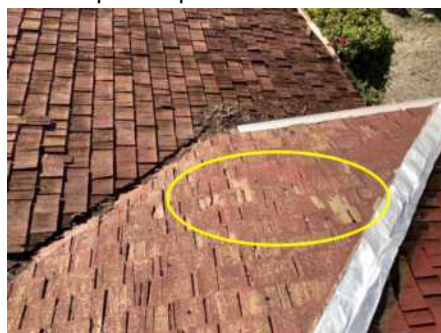
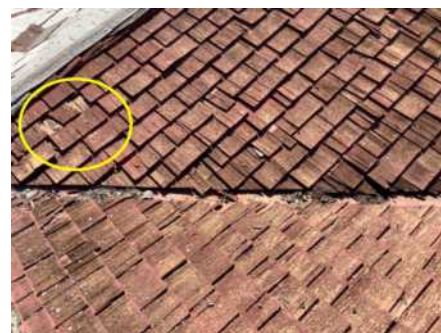
NR 12: Damaged or missing Shingles noted. Repair/Replacement needed.

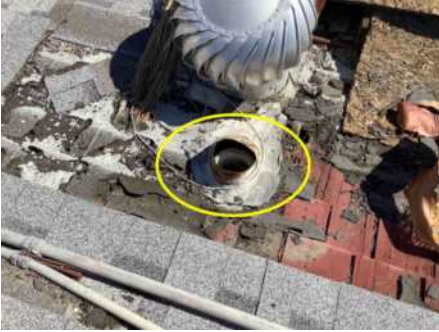
NR 13: Cap missing on roof vent for water heater .

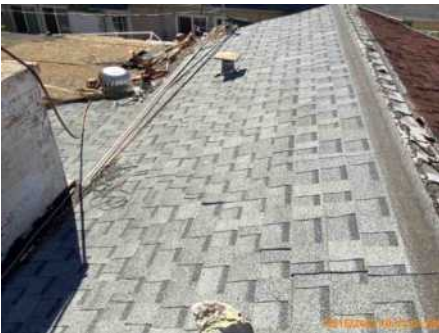
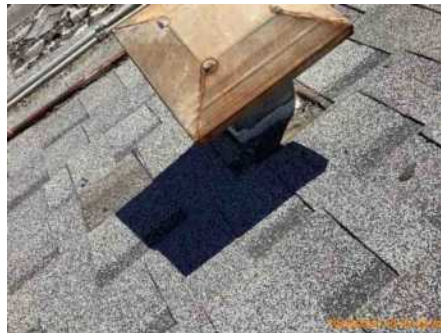
NR 15: The only way to determine whether a roof is absolutely water tight is to observe it during a prolonged rainfall. Many times, this situation is not present during the inspection. Recommend roof be evaluated and certified by a qualified Roofing Contractor due to its age.

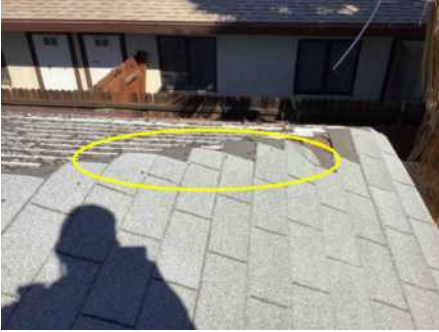
NR 16: Nails/Fasteners are protruding from the roof surface. Recommend the entire roof be evaluated and repaired by a qualified Roofing Contractor

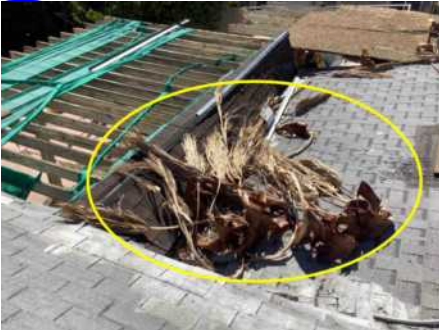
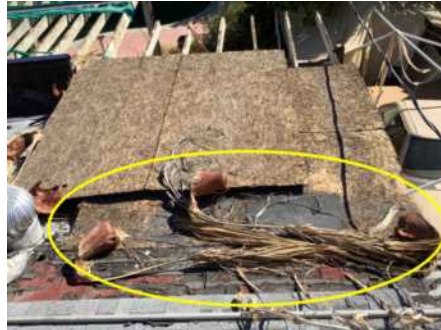
NR 17: Debris should be removed from roof, Recommend further review and repair by a qualified Roofing Contractor

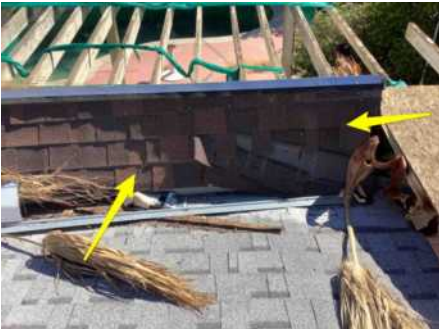
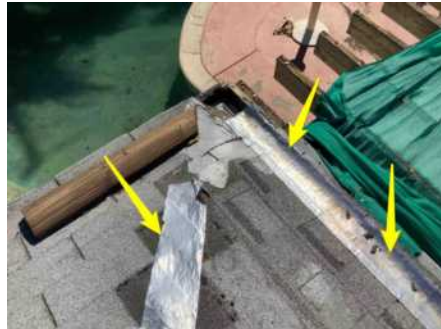
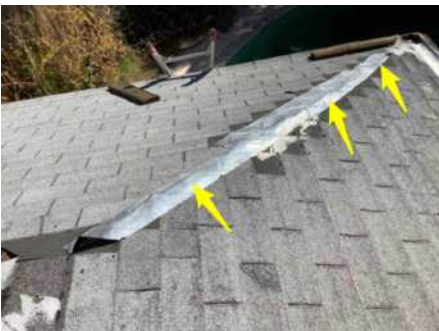
NR 18: Improper installation is found, Recommend the entire roof be evaluated and repaired by a qualified Roofing Contractor

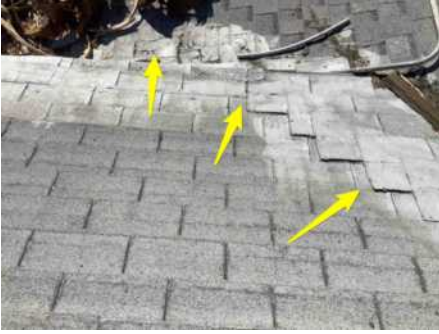
NR 19: Repairs appear to be substandard. Recommend the entire roof be evaluated and repaired by a qualified Roofing Contractor

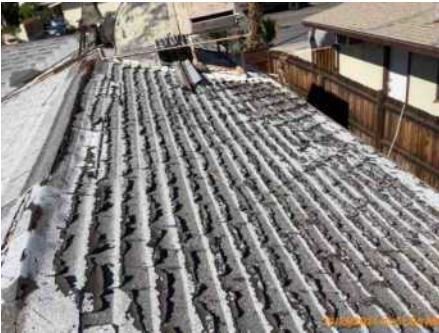
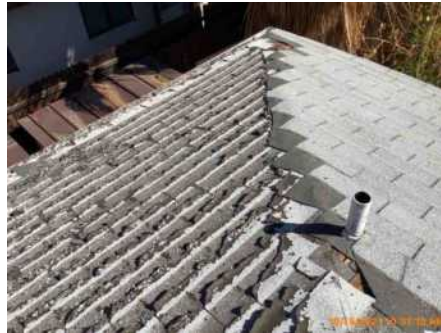
NR 20: Heavy Wear noted to composition roof, composition roof appears to be at its end of its service life. Recommend the entire roof be evaluated and repaired by a qualified Roofing Contractor.

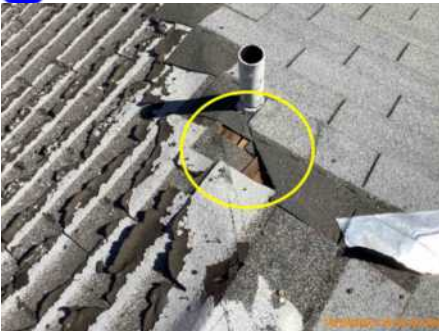
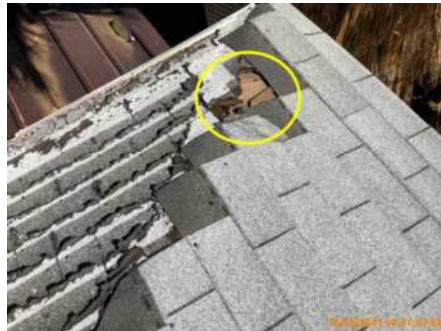
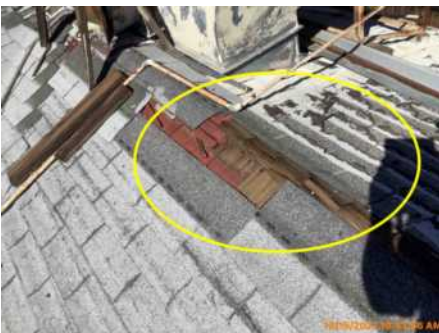
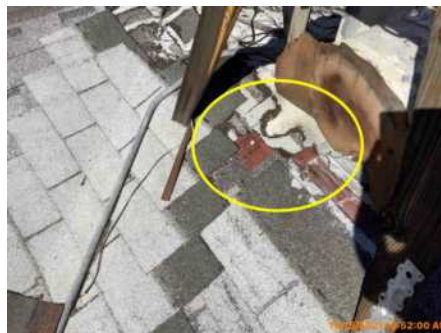
NR 21: Missing composition shingles in several areas

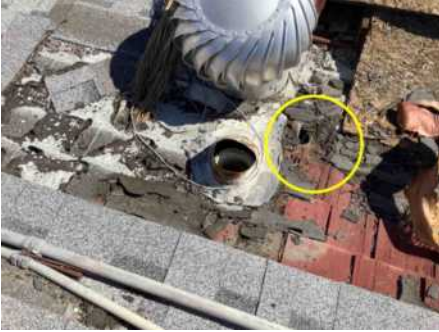
NR 22: Damage noted to roof sheathing

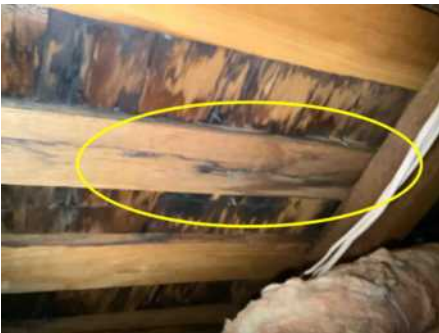
NR 24: Stains seen in attic, unable to determine the status of the stains. Active leakage may be present. We recommend the advice and services of a qualified Roofing Contractor

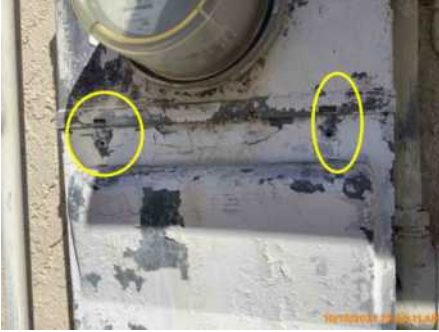
NR 25: Panel cover hinges missing and or damaged.

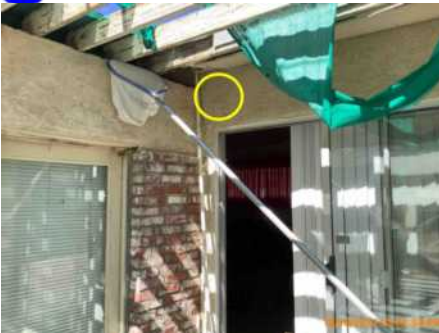
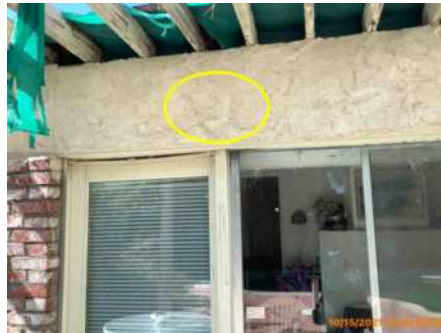
NR 26: Light fixture missing, light fixture required at all grade level doors

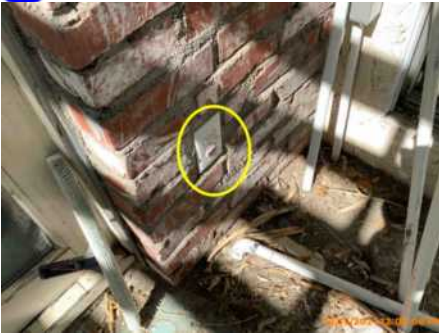
NR 27: Weather proof cover missing at pool light switch.

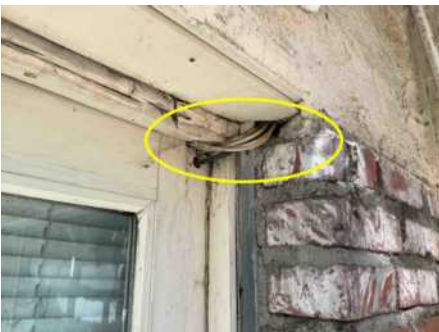
NR 28: Exposed wiring should be properly protected. Recommend further review and repair by qualified Electrical Contractor.

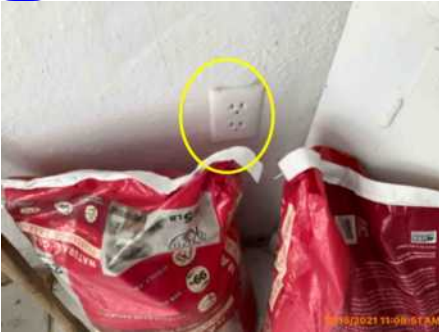
NR 29: Receptacle did not work at rear room

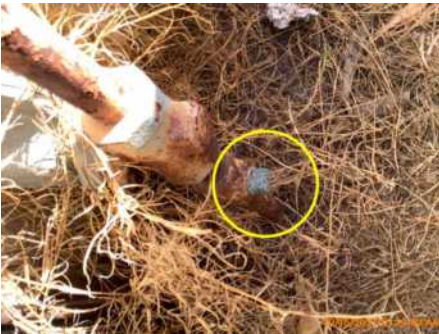
NR 30: Gas service off at time of inspection We recommend the utility provider be notified in order to turn on gas before the close of escrow so a full inspection can be done. Fee for re inspection after gas in turned on is 225.00.

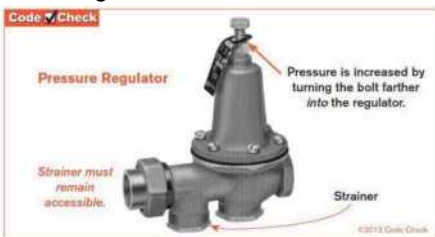
NR 31: The homes water supply pressure exceeded the 80 pounds per square inch (PSI) limit considered the maximum allowable by generally-accepted current standards. Excessively high water pressure is likely to cause leaks. Water pressure noted at time of inspection was **100** psi, recommend the installation of a pressure regulator by a qualified Plumbing Contractor.

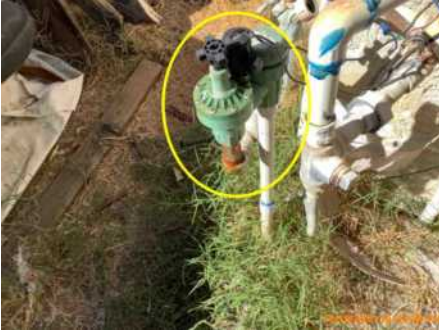
NR 34: Sprinkler supply valve at rear right

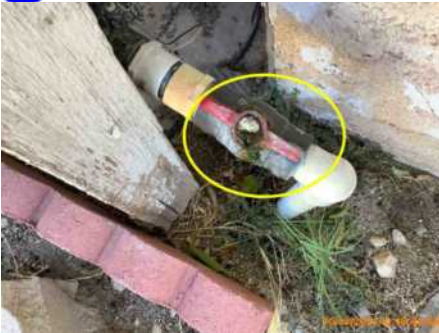
NR 35: Sprinkler main supply line shut off valve handle leaking at front

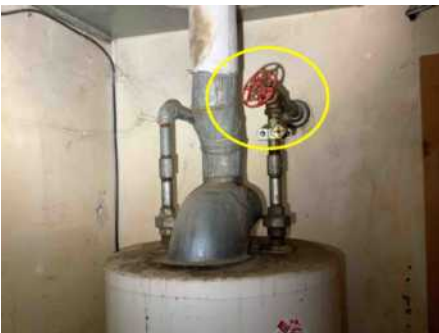
NR 37: Shut off valve at water heater is seized, We recommend the advice and services of a State Licensed Plumbing Contractor

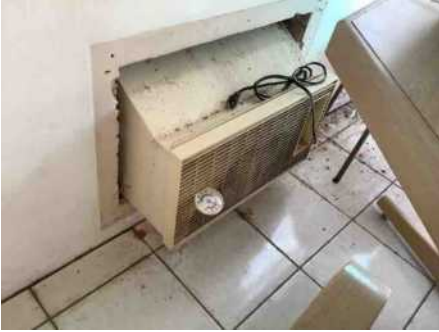
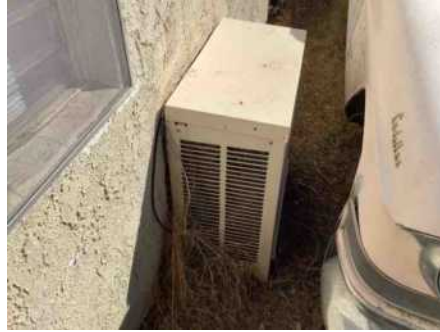
NR 43: Evaporative cooler is no longer operable. Unit should be removed

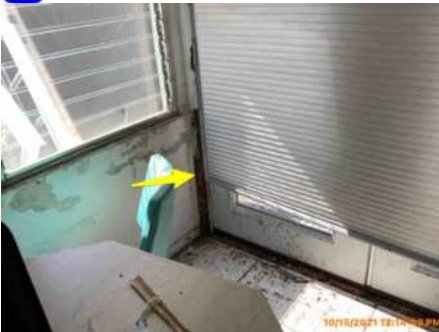
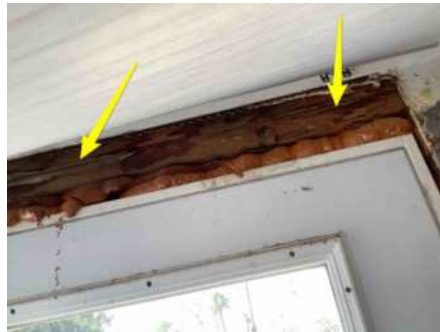
NR 44: Damage and missing wall covering to dining area

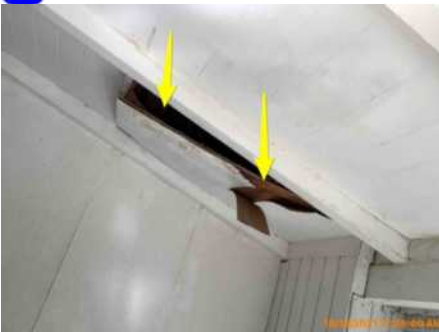
NR 45: Moisture damage noted to rear room ceiling

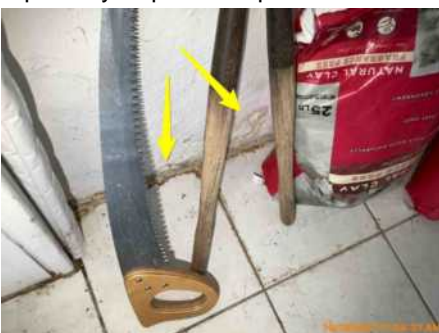
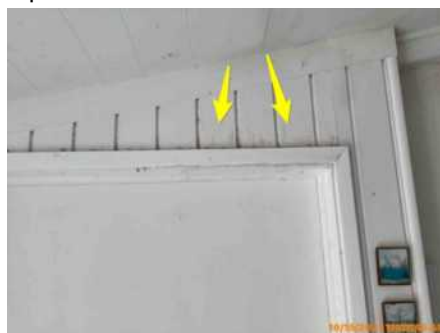
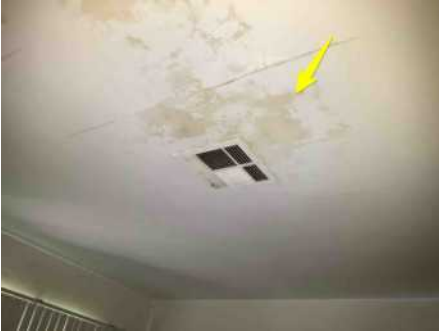
NR 46: Stains noted at throughout home ceilings and walls, possible roof leak . We recommend further review and repairs by a qualified specialist in the appropriate trade.

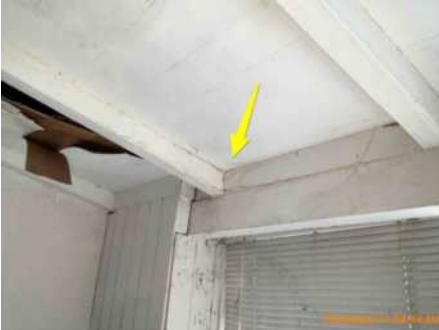
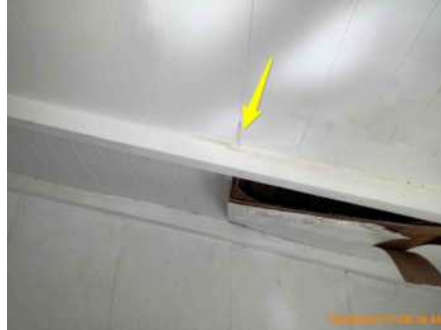
NR 47: Stains noted to ceiling in rear room, roof appears to be leaking. We recommend further review and repairs by a qualified specialist in the appropriate trade.

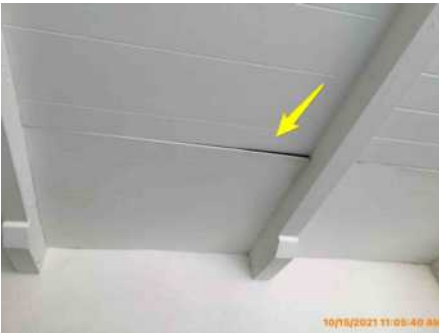
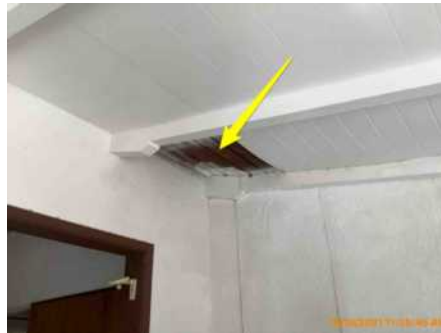
NR 48: Ceiling panels separating, damaged and missing in rear room. We recommend further review and repairs by a qualified specialist in the appropriate trade.

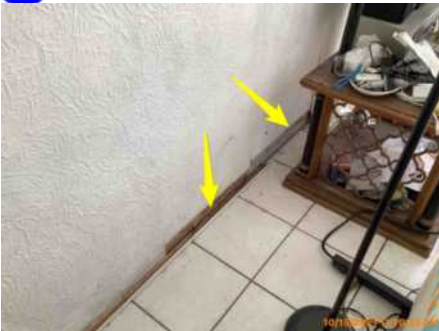
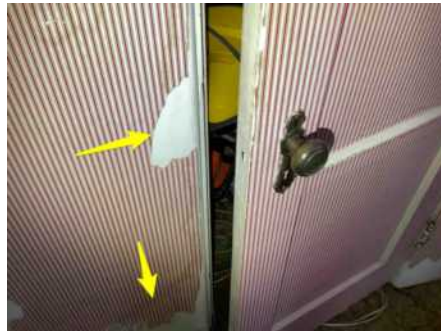
NR 49: Wallpaper peeling/ missing in several areas

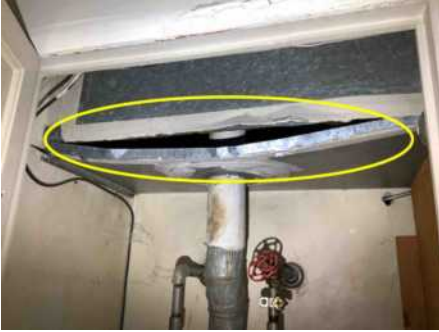
NR 50: Ceiling is damaged at water heater area

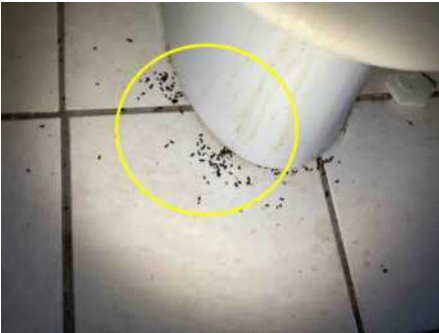
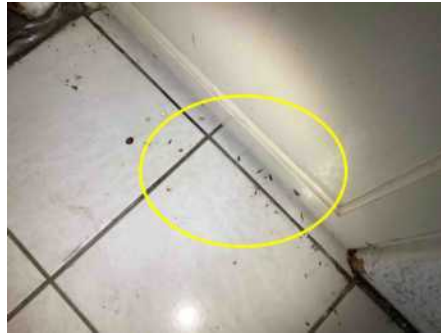
NR 51: I observed evidence of rodents in the hallway and hallway throughout the interior .Ask the Sellers about the rodent history and/or contact a qualified Pest Control Operator to further evaluate.

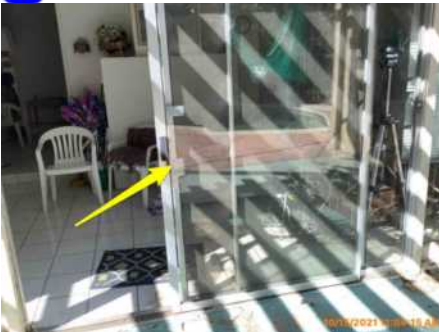
NR 52: All accessible doors were opened and closed. Exterior door would not slide properly at rear.

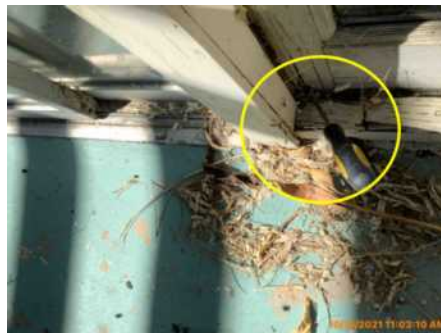
NR 54: Window casing moisture damaged at rear

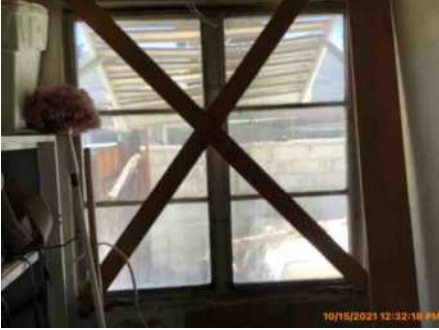
NR 60: Window is damaged and would not open

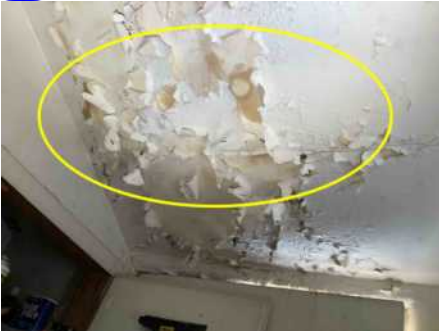
NR 61: Moisture stains noted to ceiling at laundry room, roof appears to be leaking

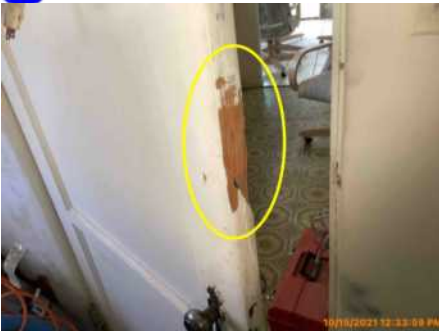
NR 62: Damage noted to door.

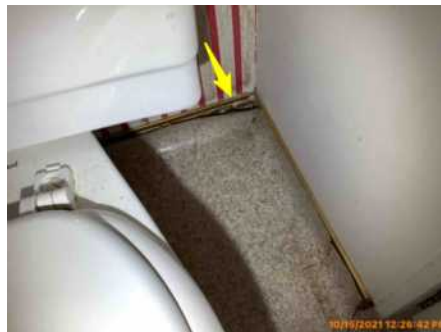
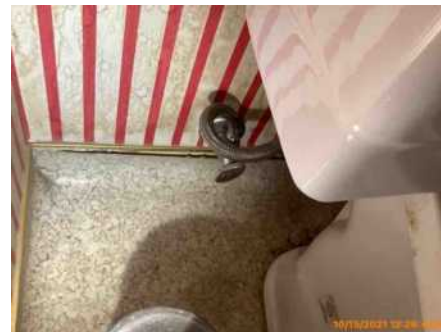
NR 66: Damage noted to floor

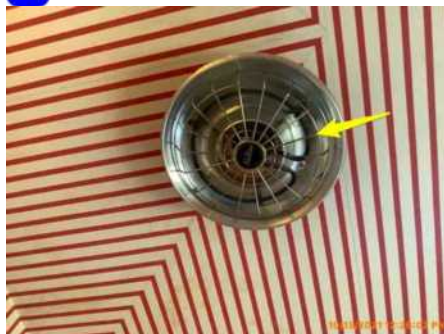
NR 68: Heater fan did not work.

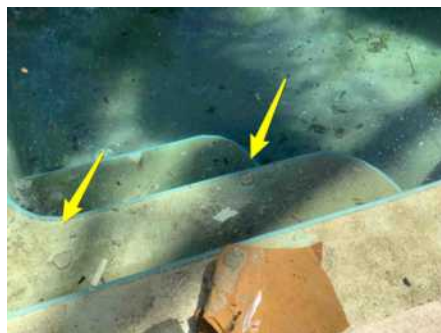
NR 72: Pool surface is worn through, re plastering is needed. We recommend the advice and services of a qualified Pool Contractor

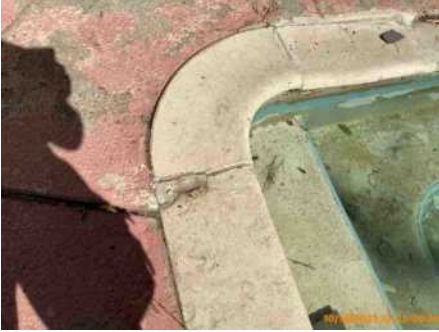
NR 73: Cracking is noted, We recommend the advice and services of a qualified Pool Contractor

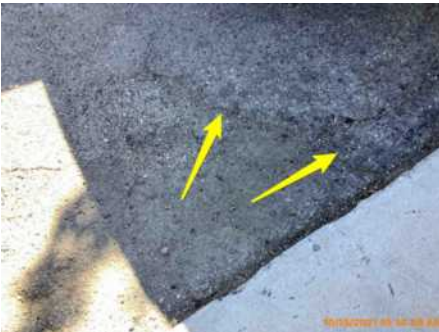
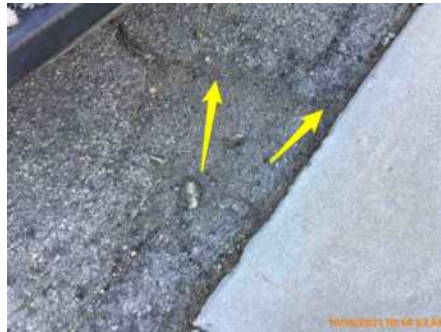
SC 75: Tripping hazards noted at driveway. We recommend further review and repairs by a qualified specialist in the appropriate trade.

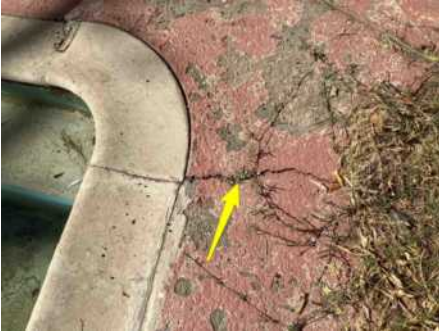
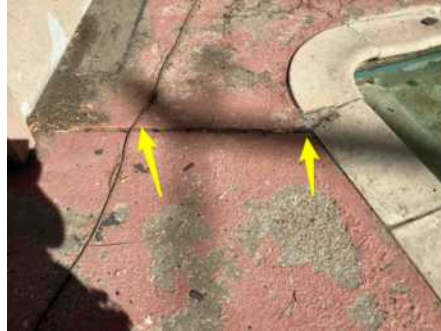
SC 77: Patio surface raised/settled, this has created a TRIP - HAZARD at rear decking near pool. We recommend further review and repairs by a qualified specialist in the appropriate trade.

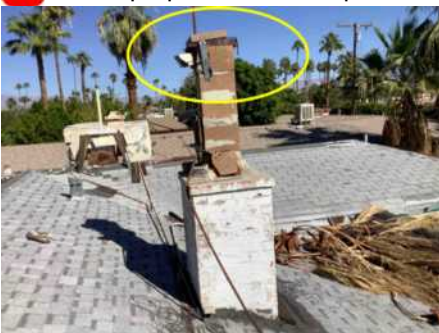
SC 78: Improper cover and spark arrestor noted at chimney. Recommend further evaluation by a chimney specialist.

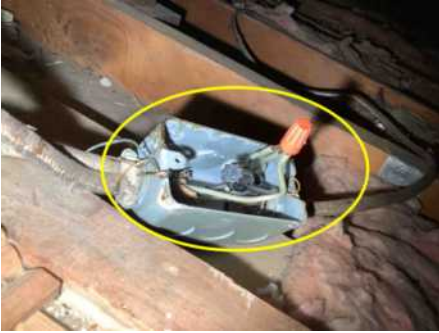
SC 79: Junction box cover(s) missing in attic area, this is a fire hazard, all attic electrical be reviewed. Recommend further review and repair by qualified Electrical Contractor.

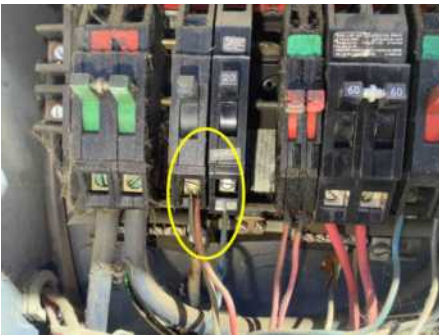
SC 81: Multiple wires are connected to a single lug on a circuit breaker where only one wire should be connected. Recommend further review and repair by qualified Electrical Contractor.

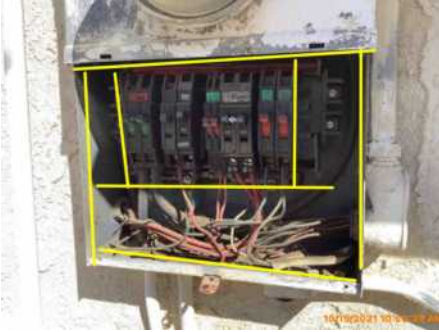
SC 82: Dead front cover missing at main electrical panel, this is a safety concern, installation is needed for safety, Recommend further review and repair by qualified Electrical Contractor.

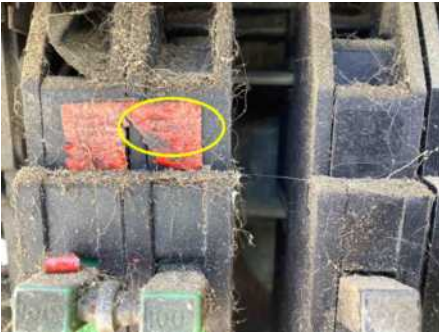
SC 83: The main electrical service panel was made by Zinsco. Zinsco panels are reputed to have a high rate of circuit breaker failure which can result in a fire or shock/electrocution. The Inspector recommends that before the expiration of your Inspection Objection Deadline, you consult a qualified Electrical Contractor to have panel inspected for any issues and possible replacement. Information about defective Zinsco panels is widely available on the internet.

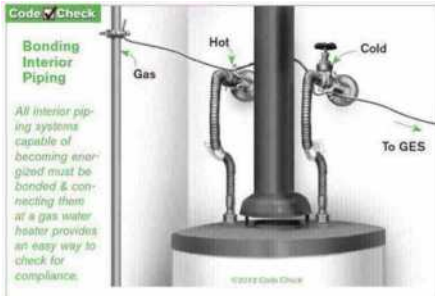
SC 85: Bonding is recommend at the gas and water lines near the water heater for safety. Bonding may be present at other locations but could not be seen or verified. Electrical bonding is the practice of intentionally electrically connecting all exposed metallic items not designed to carry electricity in a room or building as protection from electric shock. Recommend further review and repair by qualified Electrical Contractor.

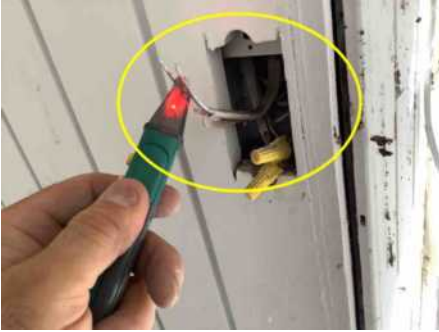
SC 86: Exposed live wires noted at rear room

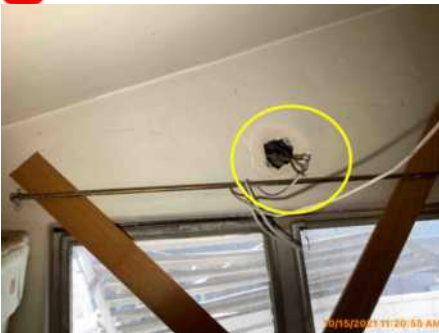
SC 89: Exposed splices are noted, junction box should be installed

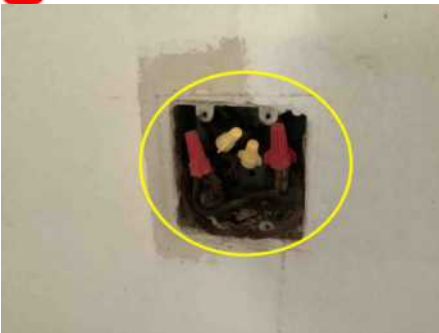
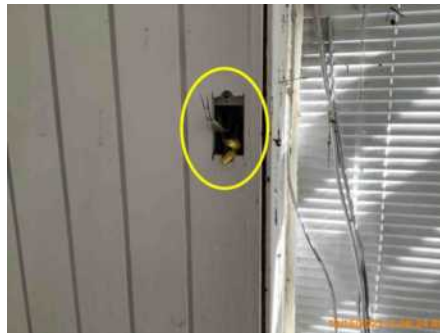
SC 90: Junction box cover(s) are missing

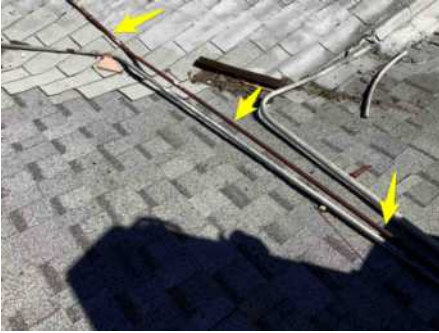
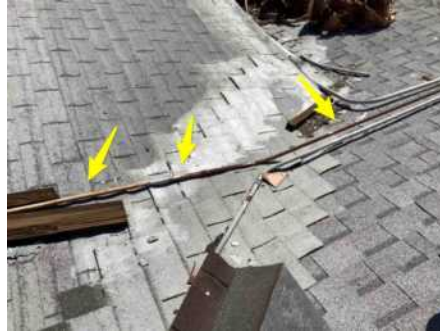
SC 91: Rusting lines noted on roof, We recommend further review and repairs by a qualified specialist in the appropriate trade.

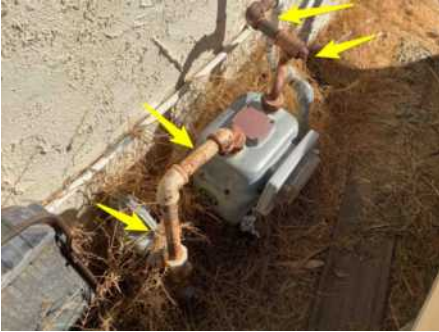
SC 92: Rusting gas line noted at gas meter , We recommend the advice and services of a qualified Plumbing Contractor

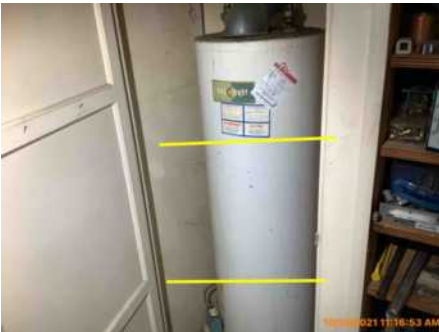
SC 93: Seismic straps missing, Seismic straps need to be installed per manufactures instructions, We recommend further review and repairs by a qualified specialist in the appropriate trade.

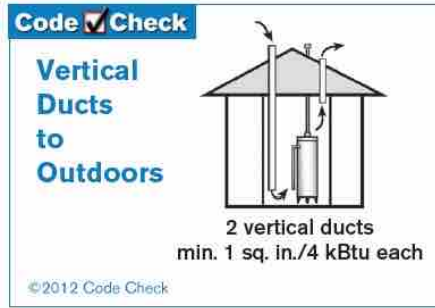
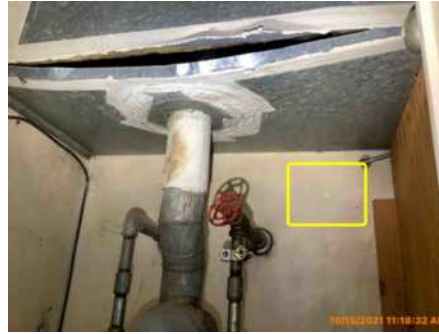
SC 94: Combustion air vents missing. We recommend further review and repairs by a qualified specialist in the appropriate trade.

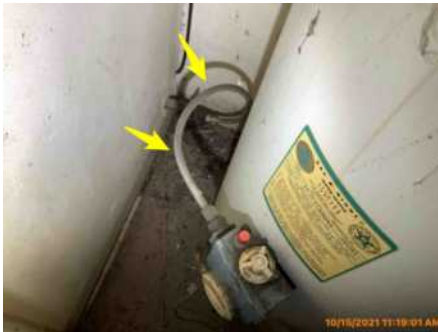
SC 95: Solid aluminum gas line noted, Modern standards recommend the installation/ upgrade of a flexible gas line. Recommend further review and repairs as needed by a Qualified, State Licensed Plumbing Contractor.

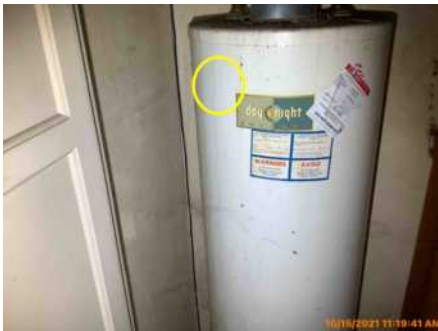
SC 96: No temperature pressure relief valve is installed at water heater, This is a Safety Hazard-Correction is needed. We recommend the advice and services of a qualified Plumbing Contractor

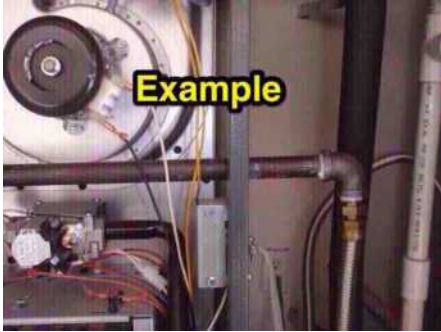
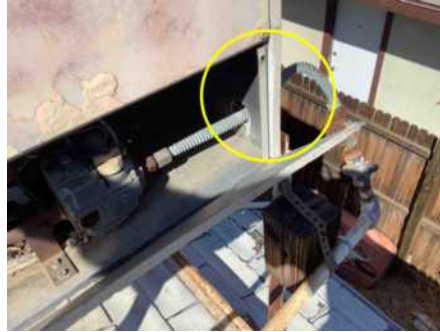
SC 97: Flexible gas line connection shall not be concealed within or extended through any wall, floor, partition or appliance housing, this is a Fire Hazard due to Seismic Issues. The flexible gas line manufacture and the building code no longer permits this installation. We recommend the advice and services of a qualified Plumbing Contractor

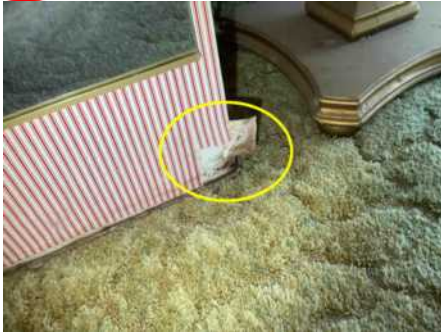
SC 98: Mold like substance noted

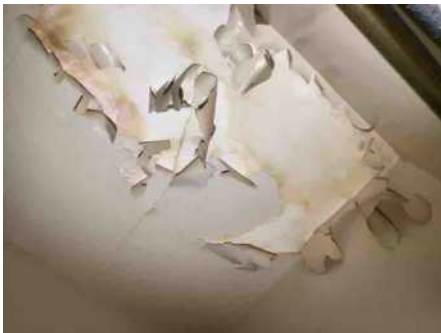
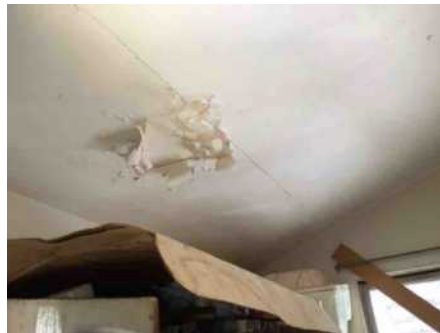
SC 99: Possible lead base paint in walls and ceilings, paint is peeling in several areas throughout home. We recommend further review and repairs by a qualified specialist in the appropriate trade.

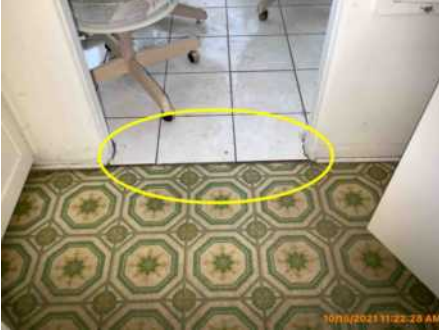
SC 100: Tripping hazards noted.

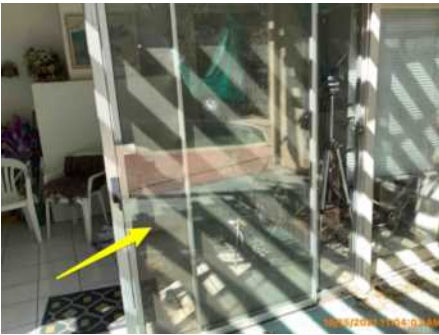
SC 101: Glass tempered markings are not visible at some exterior doors, replacement should be considered to all non tempered sliding doors and fixed windows. Fed law requires companies to replace none tempered glass doors. They are not allowed to repair them.

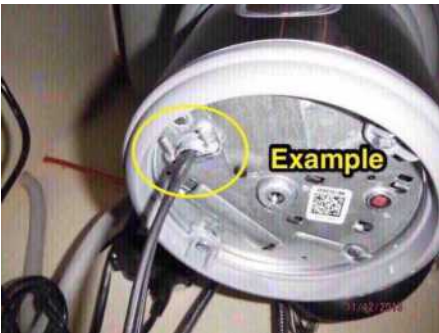
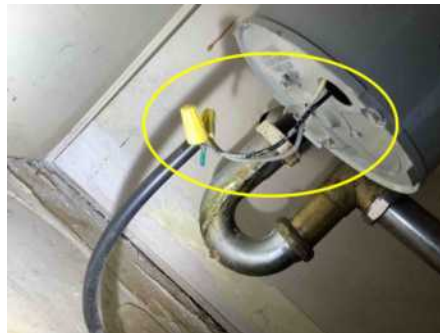
SC 102: Missing wire clamp at disposal connection, wire should be clamped for safety. We recommend further review and repairs by a qualified specialist in the appropriate trade.

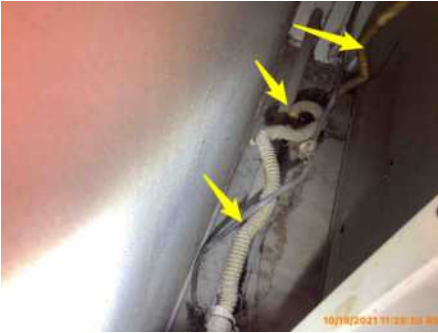
SC 103: The unit is equipped with a flexible gas line. The type of flexible gas line used is an uncoated brass. The Consumer Product Safety Commission issued a news warning in September 1997 that all uncoated brass flexible gas line connectors should be upgraded with newer stainless steel models. The older brass models are prone to cracking or leaking and can cause a serious gas leak, explosion or fire. We recommend the advice and services of a qualified Plumbing Contractor

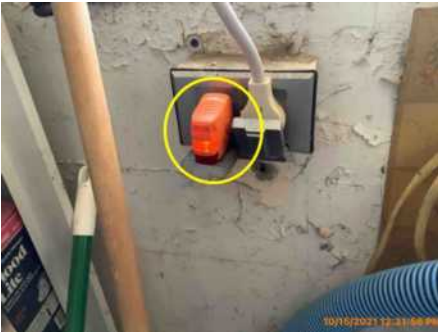
SC 104: The washing machine receptacle(s) are not grounded, this is a safety hazard correction is needed. We recommend further review and repairs by a qualified specialist in the appropriate trade.

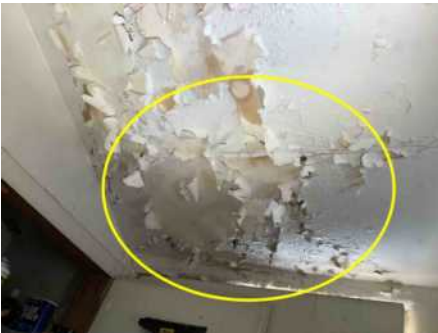
SC 105: Mold like substance noted on ceiling. We recommend further review and repairs by a qualified specialist in the appropriate trade.

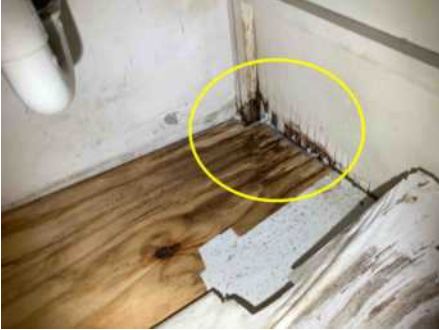
SC 106: Moisture damage and mold like substance noted at cabinet under sink. We recommend further review and repairs by a qualified specialist in the appropriate trade.

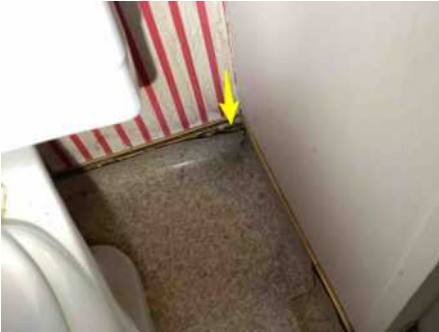
SC 107: Mold like substance observed, We recommend further review and repairs by a qualified specialist in the appropriate trade.

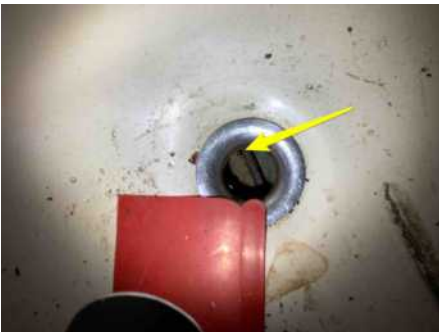
SC 108: Rodent droppings noted in bathtub drain . We recommend further review and repairs by a qualified specialist in the appropriate trade.

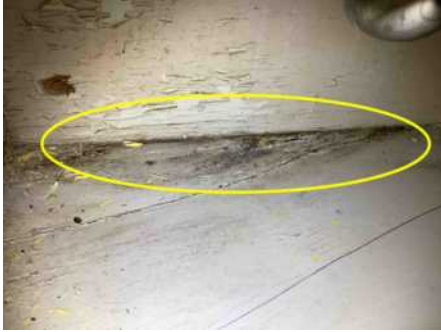
SC 109: Moisture damage and mold like substance noted at cabinet under sink. We recommend further review and repairs by a qualified specialist in the appropriate trade.

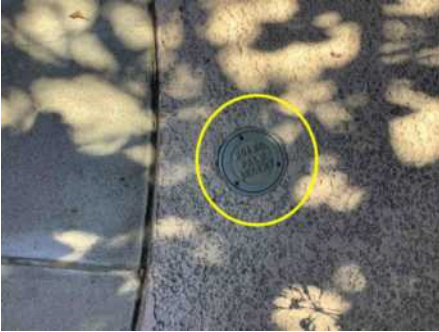
SC 112: Older type light with deck splice box, light and connection should be updated for safety. Pool lighting should be protected by a wet niche 4 ft min from pool water and 8 inch min max above water level. Pool/Spa should not be used until the light is updated due to the possibility of electrocution. We recommend the advice and services of a qualified Pool Contractor or Recommend further review and repair by qualified Electrical Contractor.

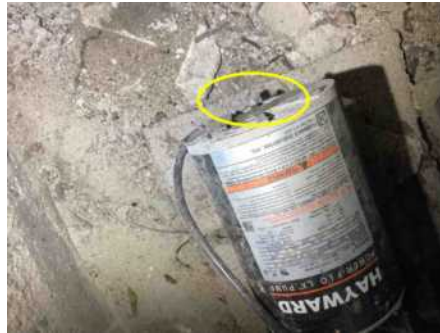
SC 113: External bonding of equipment frames is lacking at the pool pump(s) and the pool heater, All metal pool equipment needs to be bonded to a pool structure. Pool/Spa should not be used until full bonding of the pool system is completed due to the possibility of electrocution. We recommend the advice and services of a qualified Pool Contractor

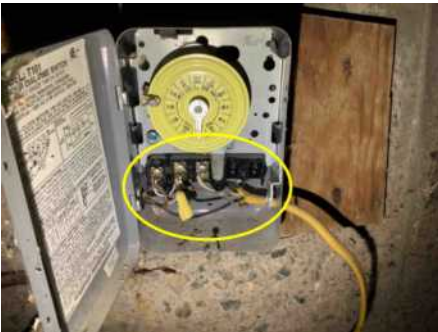
SC 116: Terminal protector is missing from within timer. this is a safety hazard, recommend installing a clock timer insulator.

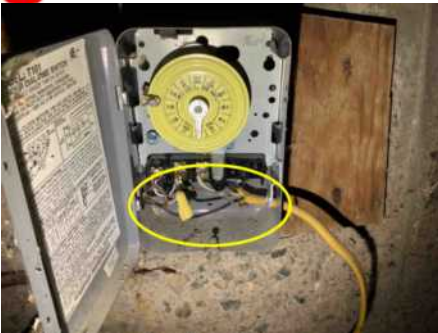
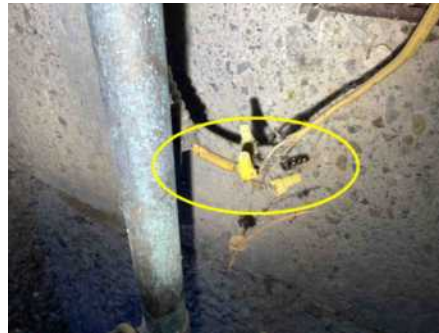
SC 117: Exposed splices are noted, junction box should be installed

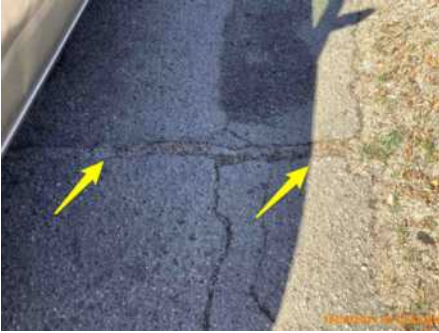
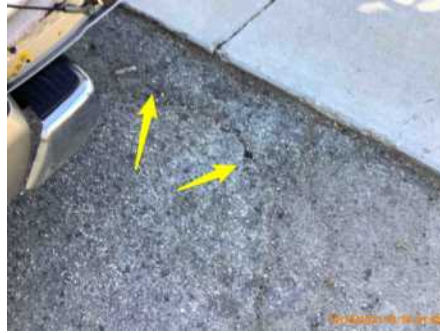
RM 118: Cracks noted to driveway, We recommend further review and repairs by a qualified specialist in the appropriate trade.

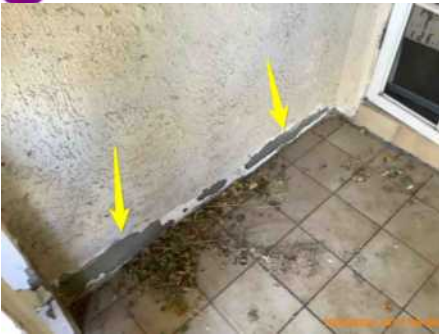
RM 119: Damaged stucco noted at front

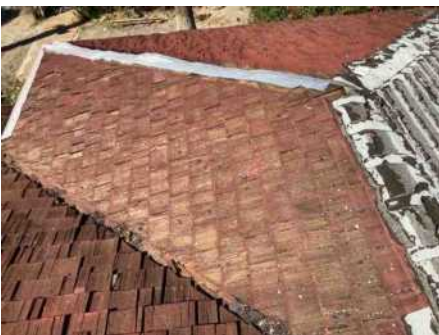
RM 120: The only way to determine whether a roof is absolutely water tight is to observe it during a prolonged rainfall. Many times, this situation is not present during the inspection. Recommend asking the seller for further information on the roof and if they have had any leaks or modifications. Recommend roof be evaluated and certified by a qualified Roofing Contractor.

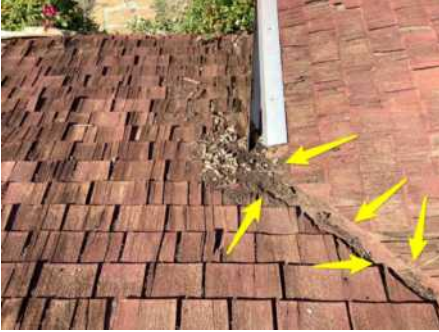
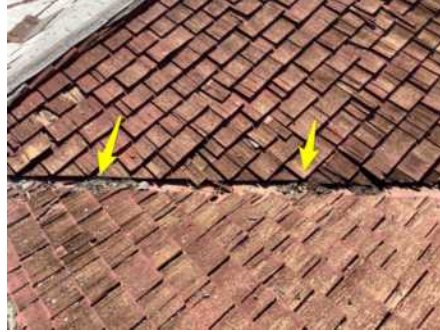
FLASHING CONDITION

RM 121: Clean debris from valley flashing to allow for proper drainage so roof does not leak when it rains. We recommend further review and repairs by a qualified specialist in the appropriate trade.

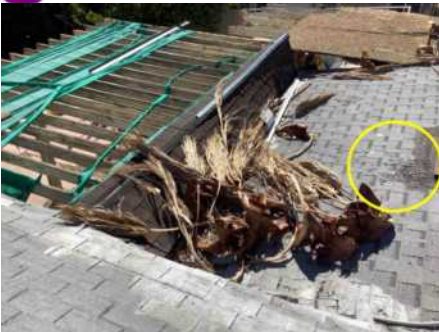
#2 ROOF CONDITION

RM 122: Recommend all unused nails be removed from roof by a roofing contractor.

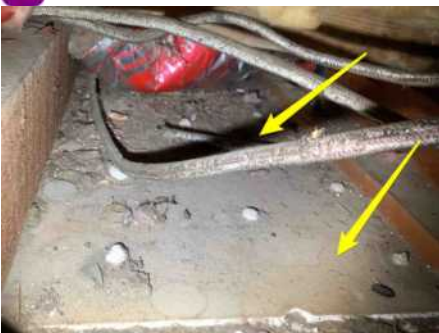
Attic ATTIC INSULATION TYPE & CONDITION

RM 123: Uneven insulation noted, recommend adding addition insulation.

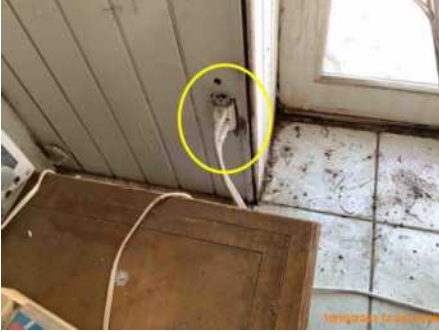
INTERIOR RECEPTACLES

RM 124: There is a receptacle with a missing cover plate at rear room

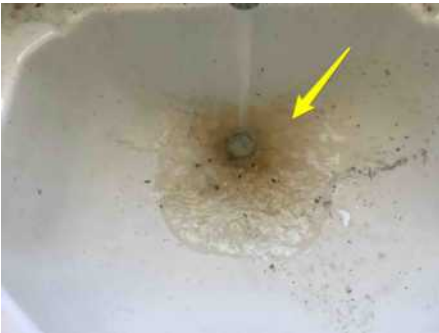
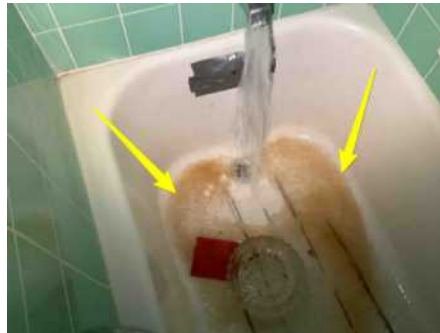
WATER SUPPLY TYPE/CONDITION

RM 125: The home appears to contain some older galvanized steel water distribution pipes along with newer copper water supply. Galvanized pipes are outdated and subject to corrosion which will eventually result in restricted flow and leakage. We recommend the advice and services of a qualified Plumbing Contractor

RM 126: Discolored water noted from galvanized pipes if water is not run for periods of time, life expectancy of galvanized piping is around 40 years, Galvanized system appears to be nearing/at end of its useful life

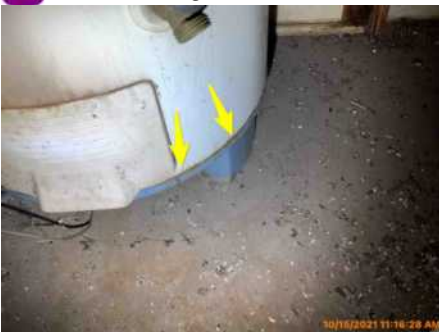
WATER HEATER TANK

RM 128: Rusting is seen at exterior of tank.

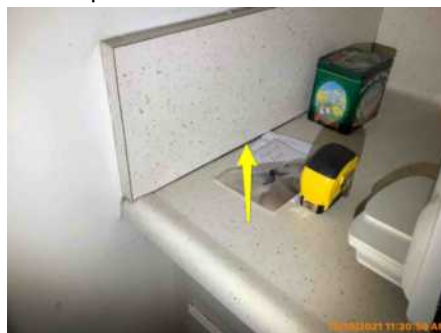
CONDITION OF COUNTERS

RM 132: Caulking / re grouting needed at backsplash

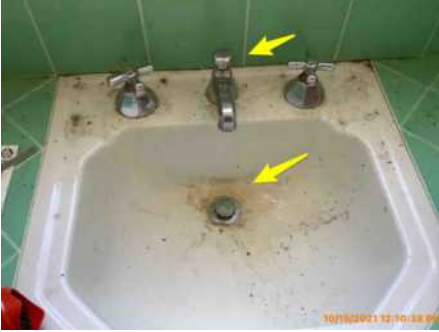
CONDITION OF SINK(S) AND DRAIN(S)

RM 136: Mechanical stopper needs adjustment at sink

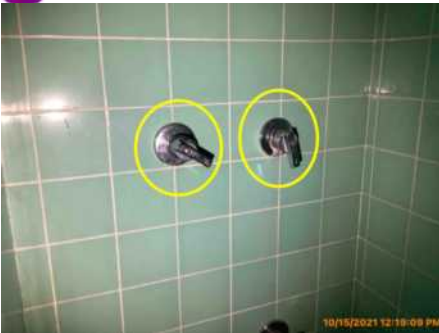
SHOWER PLUMBING FIXTURES CONDITION

RM 137: Handles don't line up

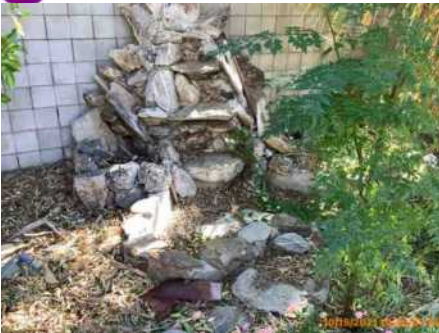
Water Features/Fountains CONDITION

RM 138: Fountain was not filled with water could not test. Inquire with seller.

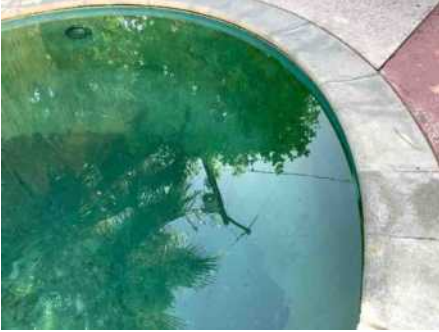
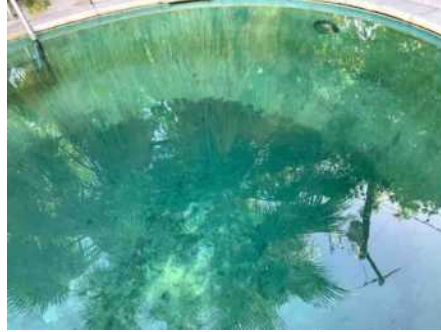
POOL SURFACE CONDITION

RM 139: Pool was extremely dirty, could not fully inspect surface, recommend further review after pool is cleaned.
