REAL ESTATE INSPECTION SUMMARY.

LOCATED AT:
686 S Camino Real
Palm Springs, CA 92264

Report# 10777

Executive Summary

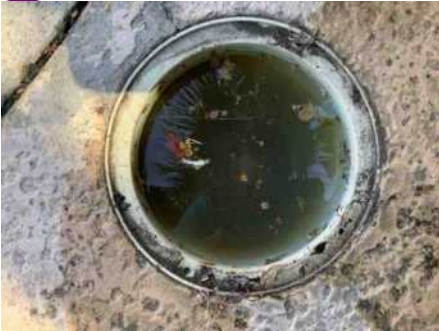
SKIMMER & BASKET CONDITION

RM 140: Debris in skimmer, cleaning is needed. Weekly cleaning is recommended.

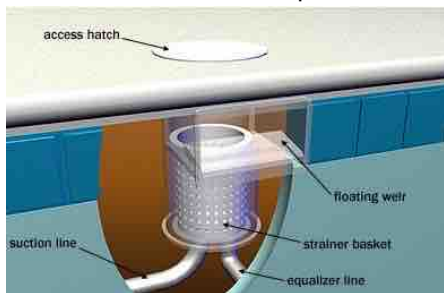
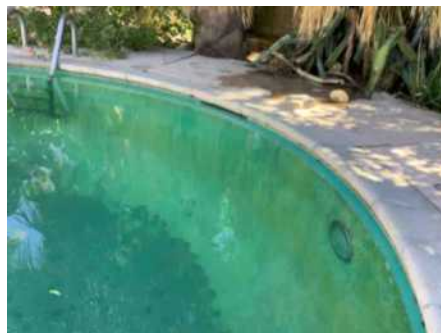
WEIR DOOR

RM 141: Weir door or weir blade or American product skimmer is missing from the skimmer basket and no skimming action is taking place because no surface tension is being created. Recommend adding a weir door. We recommend the advice and services of a qualified Pool Contractor

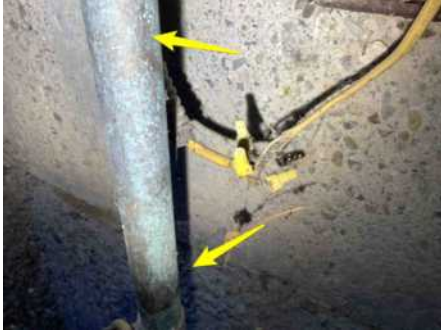
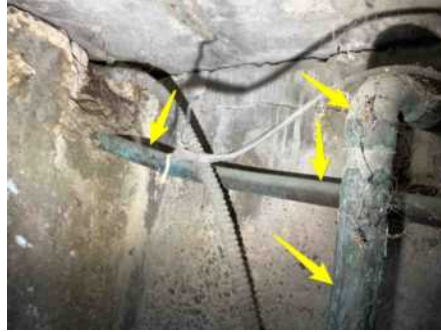
VISIBLE PLUMBING LINE CONDITION

RM 142: Older type original copper piping noted for pool, Copper piping can be a major repair if it is corroded and needs to be replaced. We recommend the advice and services of a qualified Pool Contractor

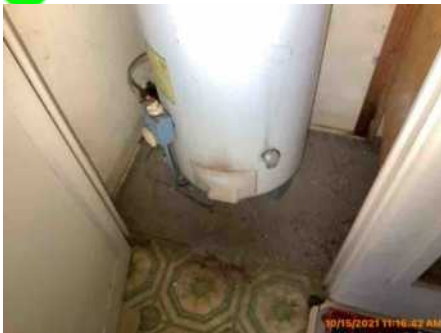
WATER HEATER PAN

UG 145: Watertight pan recommended for this installation.

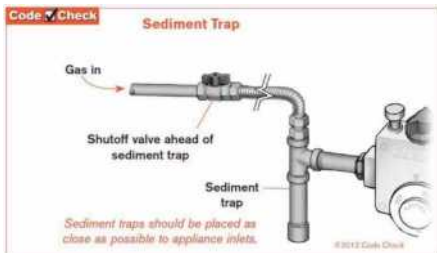
GAS LINE SEDIMENT TRAP

UG 146: Sediment trap missing on gas line for furnace heater. Gas line sediment trap may have not been required when house was built, Recommend installation. Recommend the advice and services of a qualified Plumbing Contractor

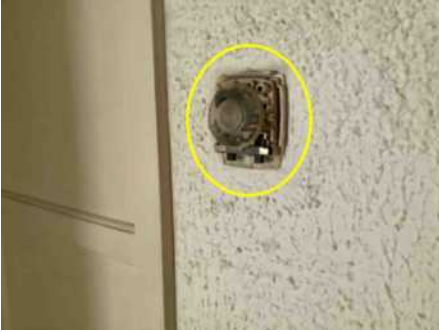
HEATING SYSTEM THERMOSTAT CONTROLS

UG 147: Thermostat is old and outdated, recommend a new thermostat be installed, Recommend further review and repairs as needed by a qualified mechanical contractor

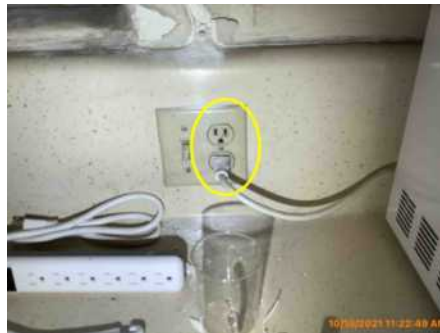
RECEPTACLE(S) CONDITION

UG 148: All Kitchen receptacles should be GFCI Protected, GFCI protected receptacles were only required by water, the new standard is every receptacles in the Kitchen should be GFCI protected for your safety, installation recommended to all unprotected receptacles, Recommend further review and repair by qualified Electrical Contractor.
