## **Famosa Terrace SB-326 Inspections**

**2828 Famosa Blvd  
San Diego, CA 92107**

**Date: November 18, 2024**

RE: **Famosa Terrace (First Inspection Cycle)**  
**2828 Famosa Blvd, San Diego, CA 92107**  
**SMR Project Number: LGL-24-045**

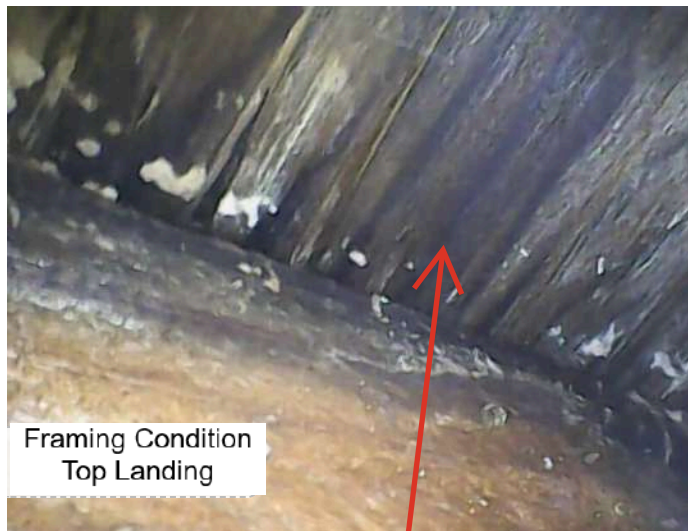
Evidence of Moisture
