## Henry Andrew Schmidt

5350 Lehrer Dr  
San Diego, California 92117

Chris Dembroski NACHI10071406  
Smart Home Inspection  
(619) 846-5737  
chris@smarthomeinspection.net  
5582 Forbes Ave  
San Diego, CA  
92120  
[www.smarthomeinspection.com](http://www.smarthomeinspection.com)

Tuesday  
September 15, 2026

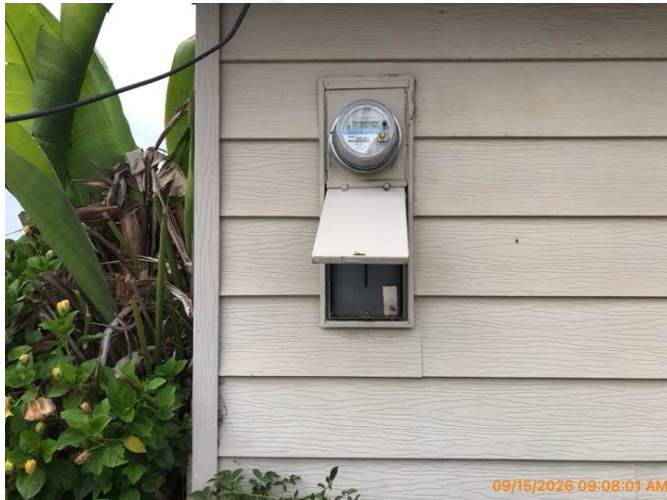
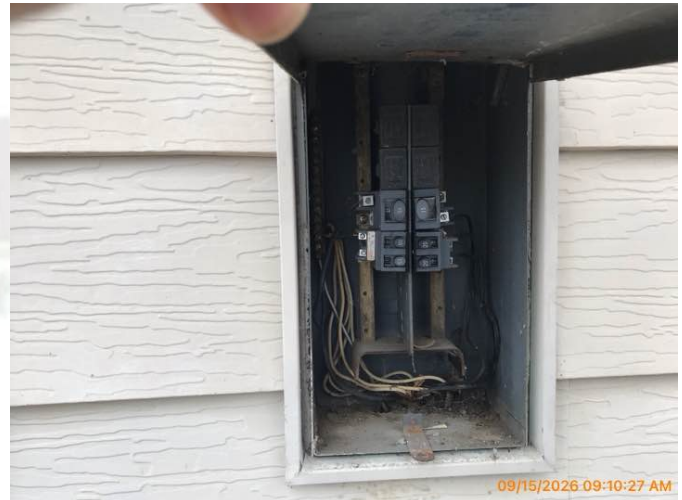
**112:** The main electric panel is located front

**U 111:** The main electrical panel is old and outdated. We suggest replacement.

**113:** The main electric panel size is 100 amp.

**U 114:** The circuitry in the panel is unlabeled. We recommend this be corrected to allow individuals unfamiliar with the equipment to operate it properly when and if it becomes necessary.

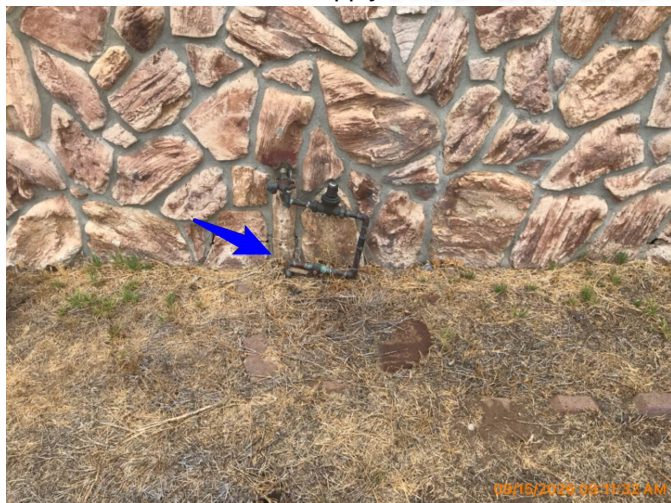
**136:** The domestic water supply main shut-off valve is outside at the front of the building.

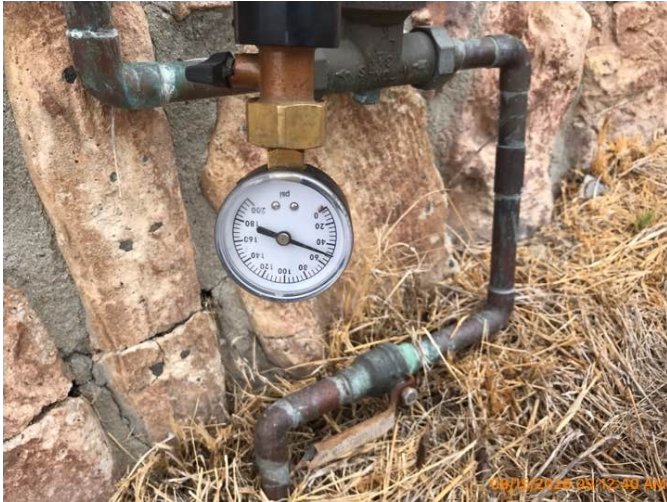
**140:** The homes water pressure measured 50 PSI (pounds per square inch).

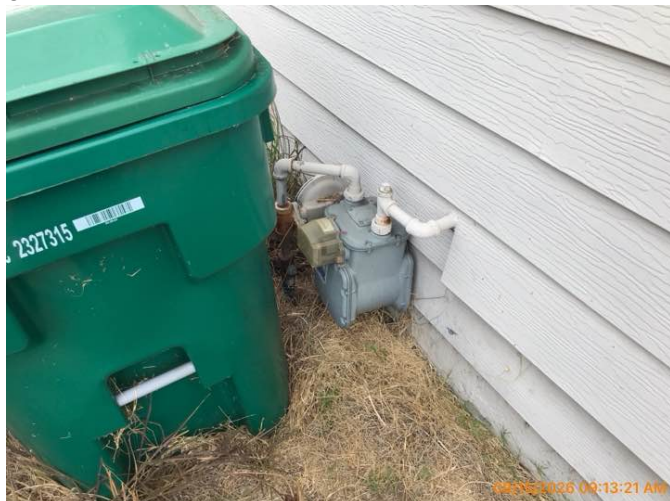
**150:** The gas meter is outside on the left side of the building. The main gas supply shutoff valve is located on the riser pipe between the ground and the meter. This valve should be turned 90 degrees (either way) in order to shut off the gas.

**151:** The gas meter appears to be in satisfactory condition.

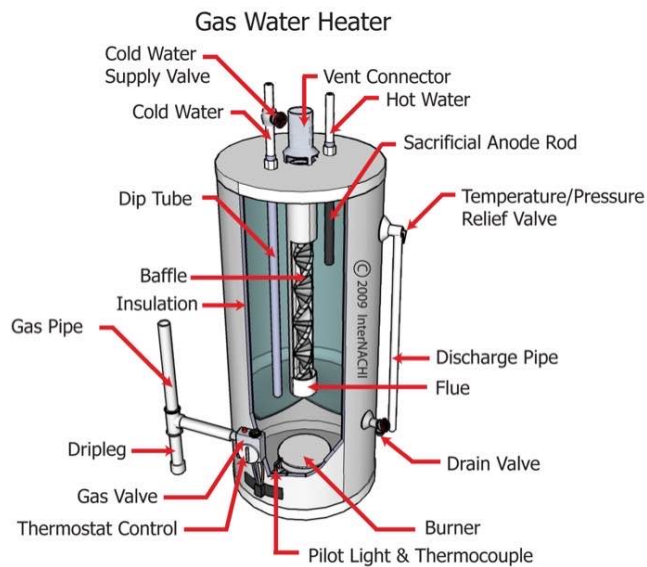
158: Unit type: Free standing tank

159: The water heater is manufactured by GE

160: The homes water heater appears to be manufactured in 2006

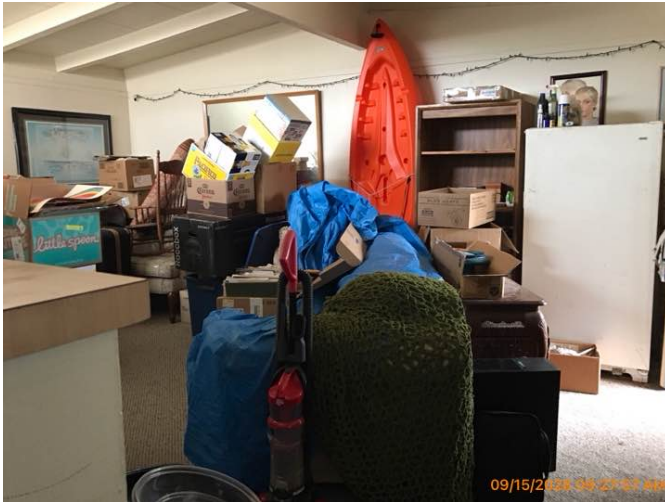
**251:** Due to the presence of personal belongings, access to portions of the area were effectively blocked at the time of our inspection. A 'walk-through' is recommended when the area is cleared and accessible.

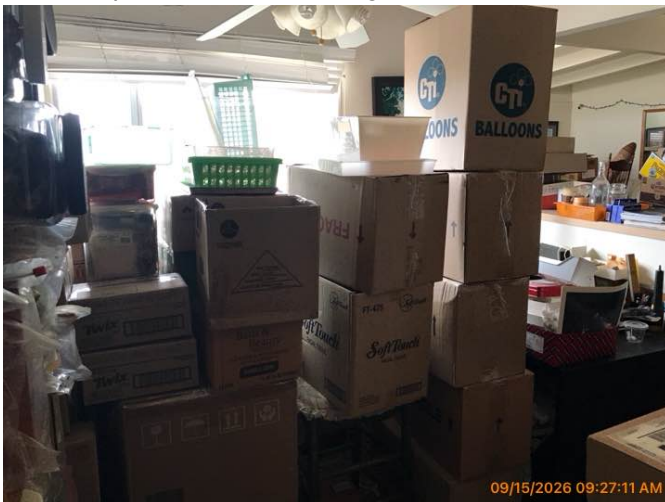
**254:** Due to the presence of personal belongings, access to portions of the area were effectively blocked at the time of our inspection. A 'walk-through' is recommended when the area is cleared and accessible.

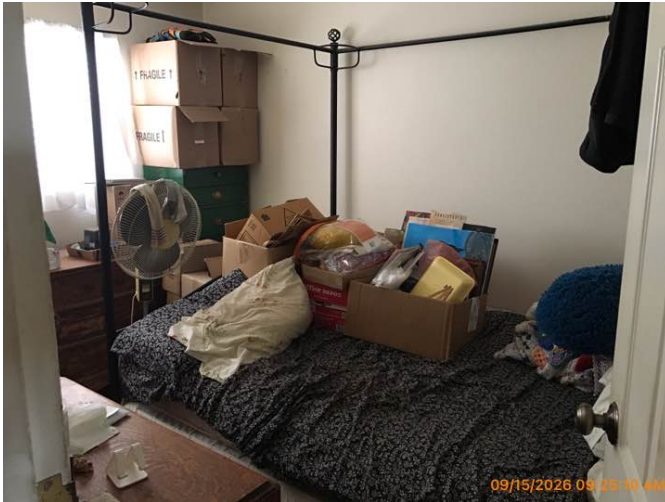
**288:** Due to the presence of personal belongings, access to portions of the area were effectively blocked at the time of our inspection. A 'walk-through' is recommended when the area is cleared and accessible.

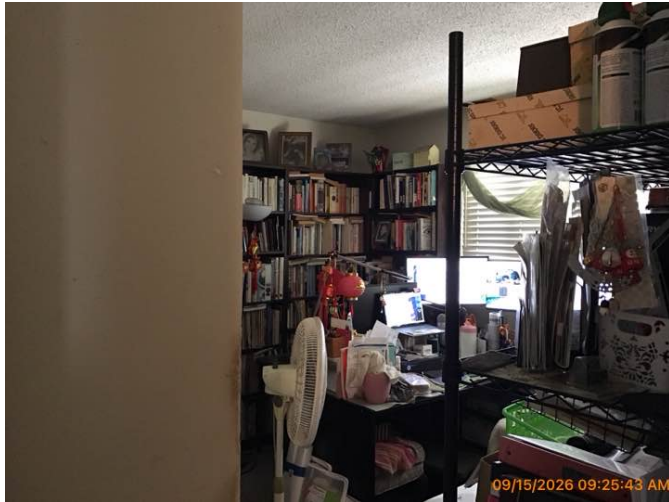
**296:** Due to the presence of personal belongings, access to portions of the area were effectively blocked at the time of our inspection. A 'walk-through' is recommended when the area is cleared and accessible.

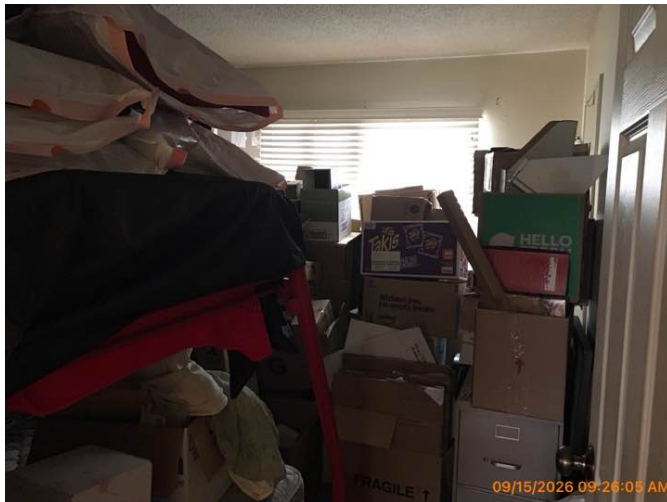
**304:** Due to the presence of personal belongings, access to portions of the area were effectively blocked at the time of our inspection. A 'walk-through' is recommended when the area is cleared and accessible.

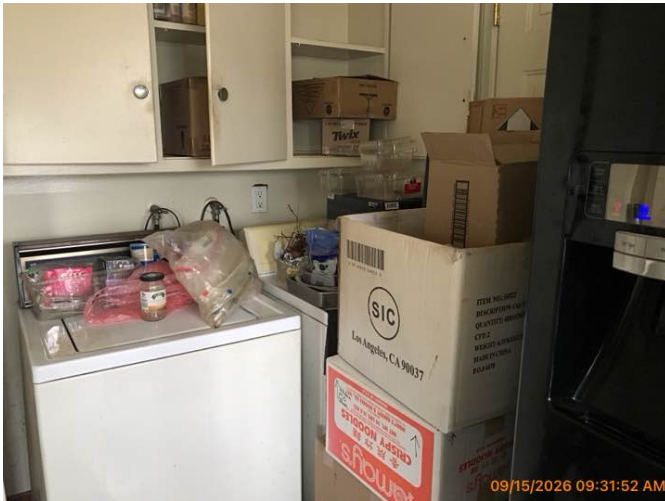
**328:** Due to the presence of personal belongings, access to portions of the area were effectively blocked at the time of our inspection. A 'walk-through' is recommended when the area is cleared and accessible.

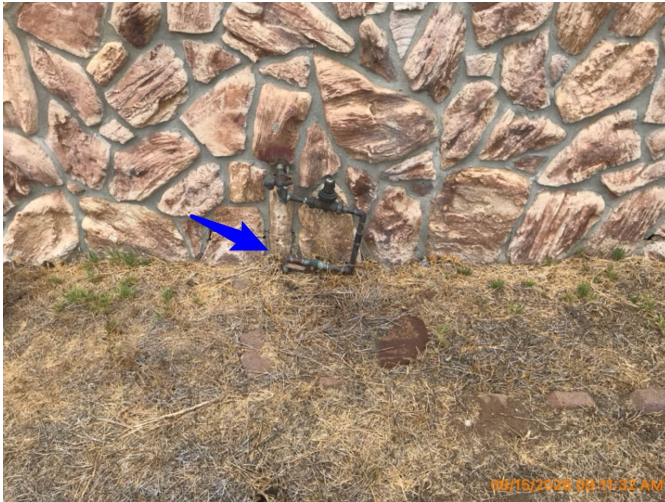
3: The domestic water supply main shut-off valve is outside at the front of the building.

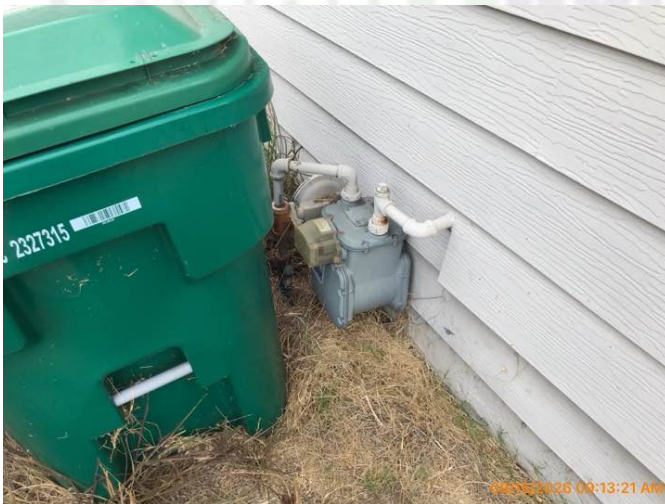
5: The gas meter is outside on the left side of the building. The main gas supply shutoff valve is located on the riser pipe between the ground and the meter. This valve should be turned 90 degrees (either way) in order to shut off the gas.
