Cornerstone Home Inspections

Home Inspection Report

20445 West Walnut Dr

Inspected on Mon, Sep 15 2025 at 9:05AM

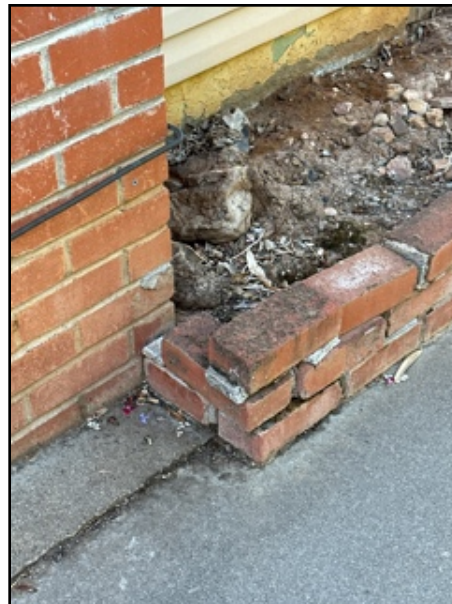
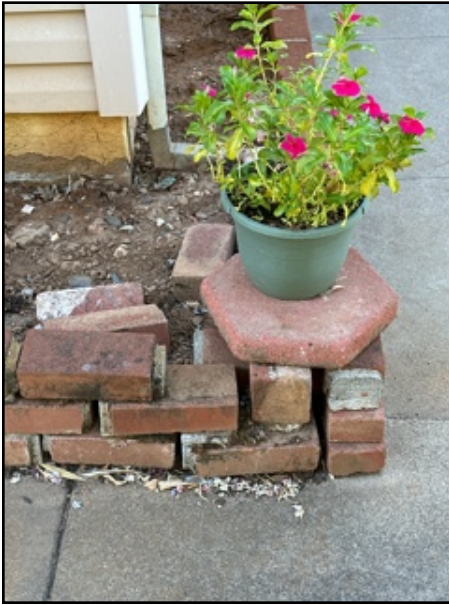
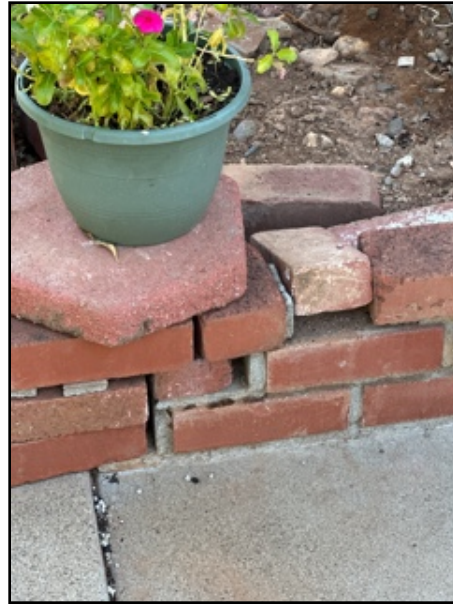
-
- ⚠ Comment 4:
Loose bricks noted on built-in brick planters surrounding home. Recommend repair.

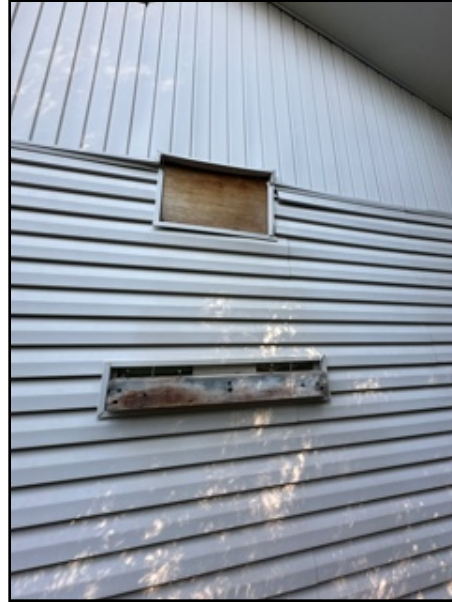
Figure 8-2

Evaporative cooler has been removed from the right side of home. Recommend properly repairing the siding in this area.

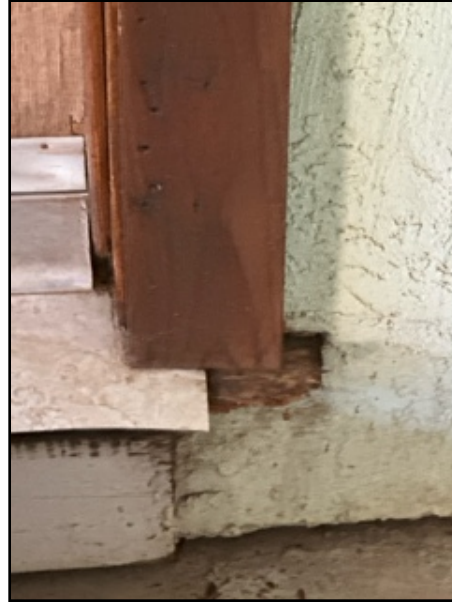
Figure 10-2

Wood decay noted below master bedroom exterior door. Refer to a licensed pest inspector.

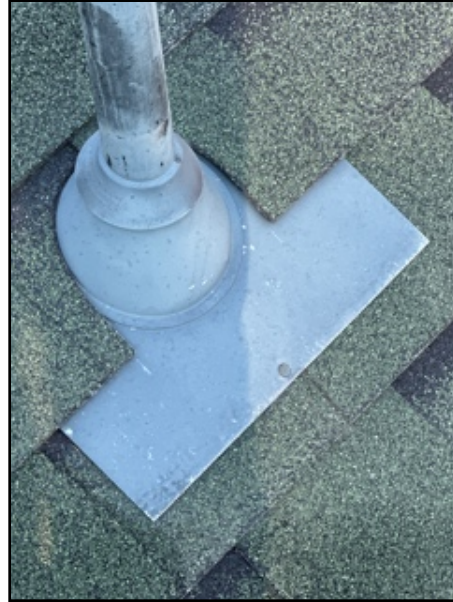
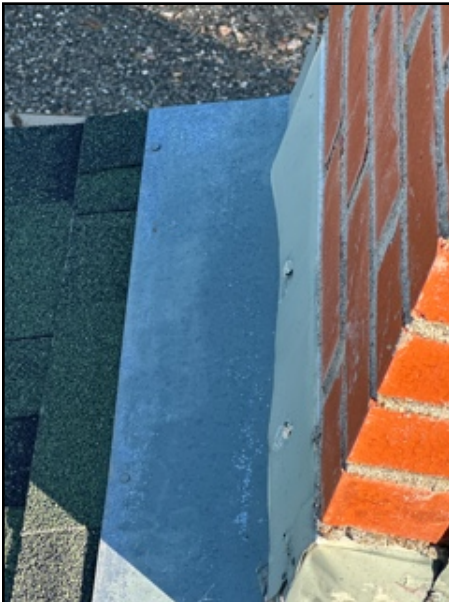
Open nails located on roof flashings. Recommend covering in tar to prevent any future leaks.

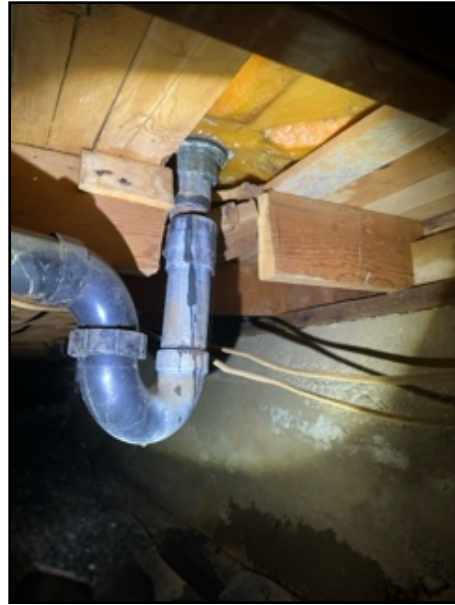
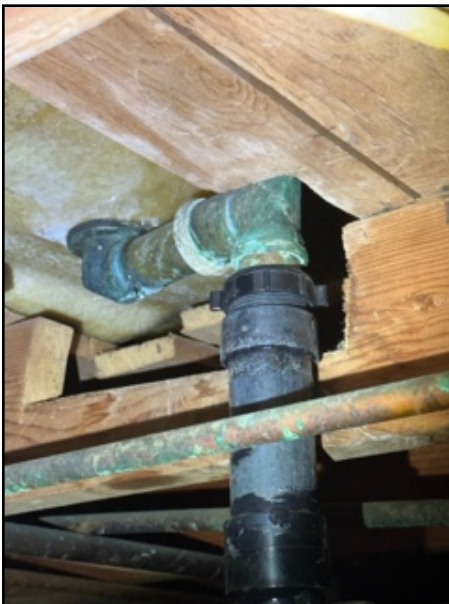
The floor joist below the tub/shower has been cut through & compromised. Refer to a licensed contractor for repair.

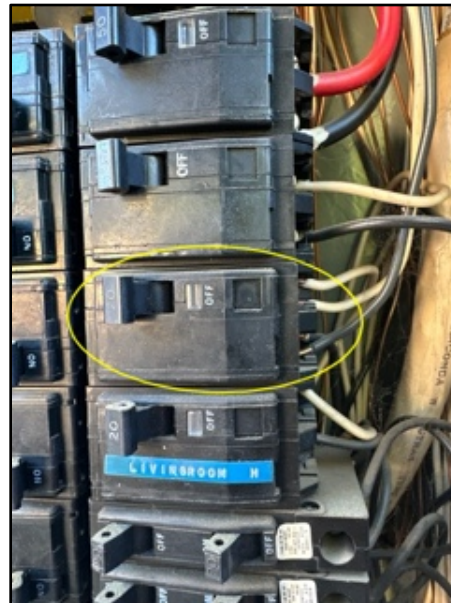
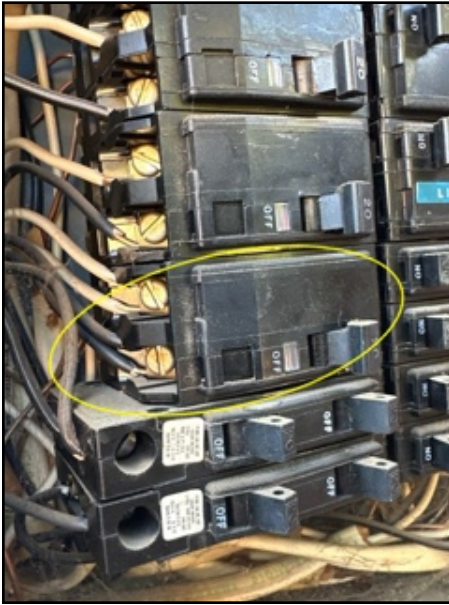
**Comment 18:**
The 2 breakers shown in main panel are double tapped. Refer to a licensed electrician for further evaluation/repair.

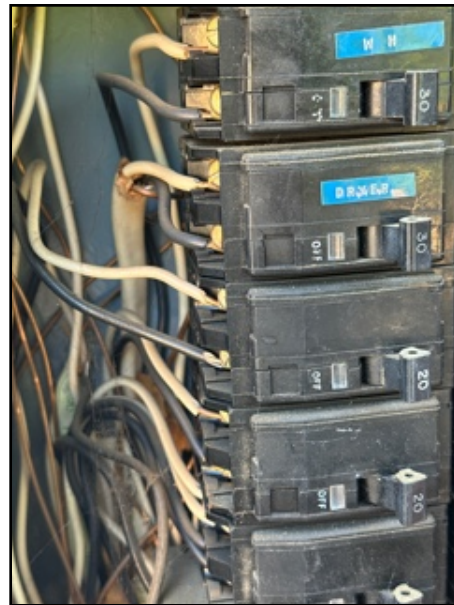
Figure 19-2

Neutral (white) wires that are attached to breakers & used as hot wires should be wrapped with red tape to indicate live current. Recommend repair.

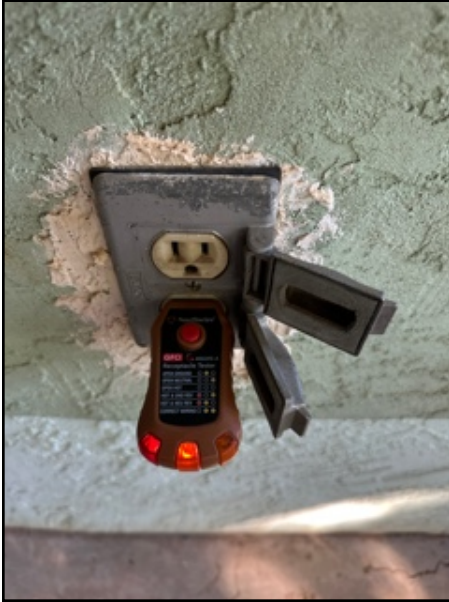
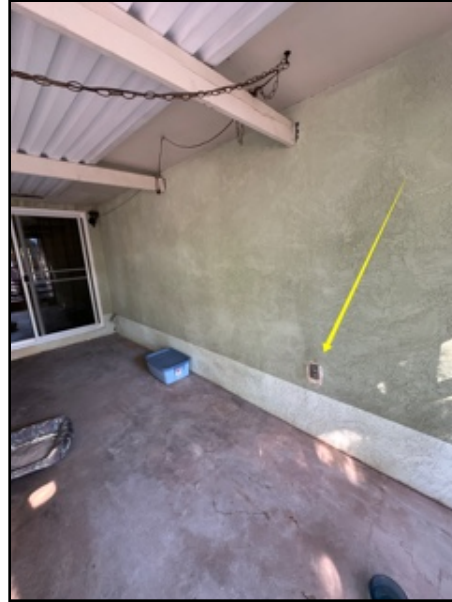
Receptacle in covered porch area shown has the hot & neutral wires reversed. Refer to a licensed electrician.

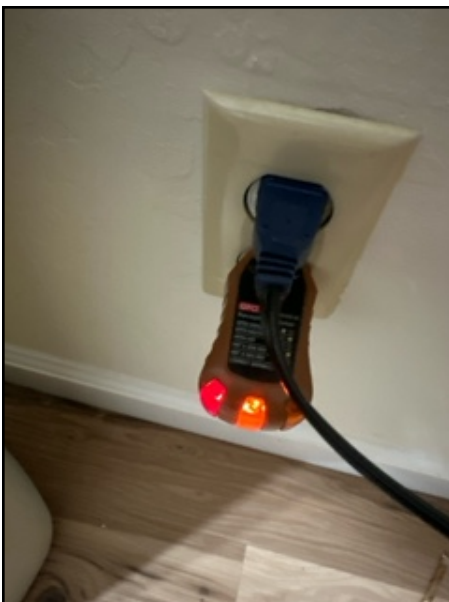
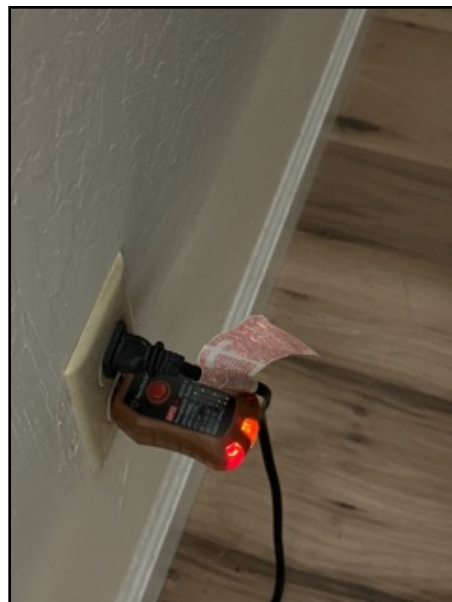
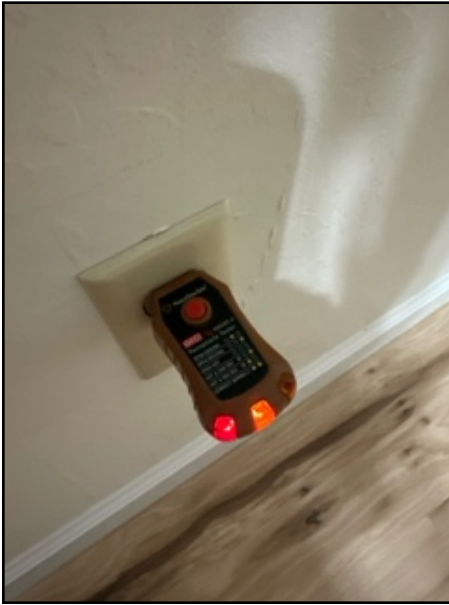
All receptacles in first right guest bedroom have hot & neutral wires reversed. Refer to a licensed electrician.

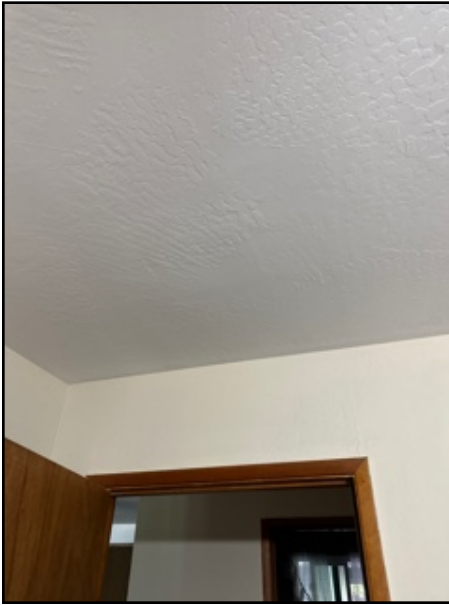
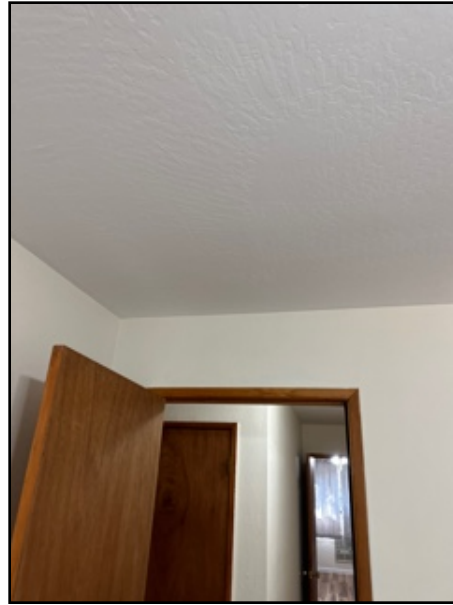
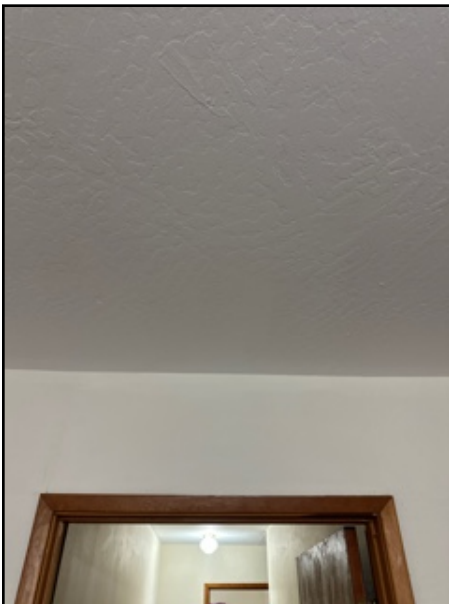
Comment 22:
Multiple smoke alarms missing in home. Recommend to install as required.

Section 310.9.1.4 of the California Building Code. One smoke alarm should be placed on each floor in non-sleeping areas. In addition, one smoke alarm must be installed in each room where sleeping occurs and one smoke alarm should be located in each hallway that leads directly to sleeping rooms.

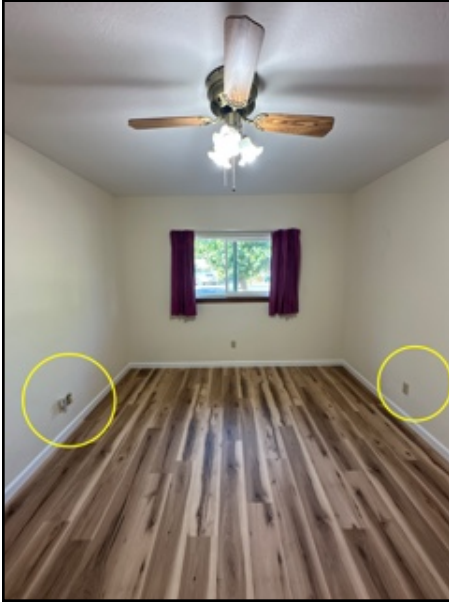
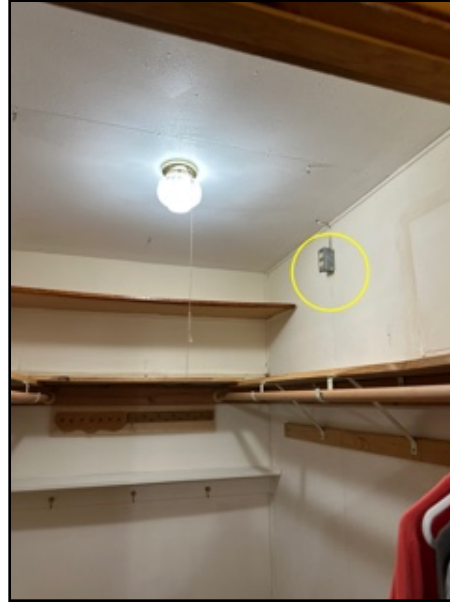
The two receptacles shown in 2nd guest bedroom plus the closet receptacle have hot & neutral wires reversed. Refer to a licensed electrician.

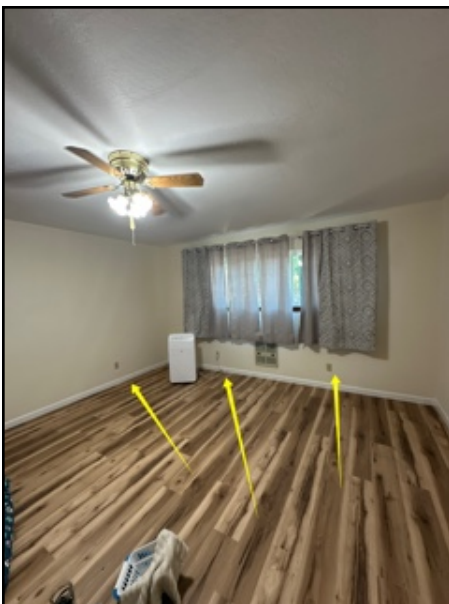
Figure 24-1

The 3 master bedroom receptacles shown have hot & neutral wires reversed. Refer to a licensed electrician.

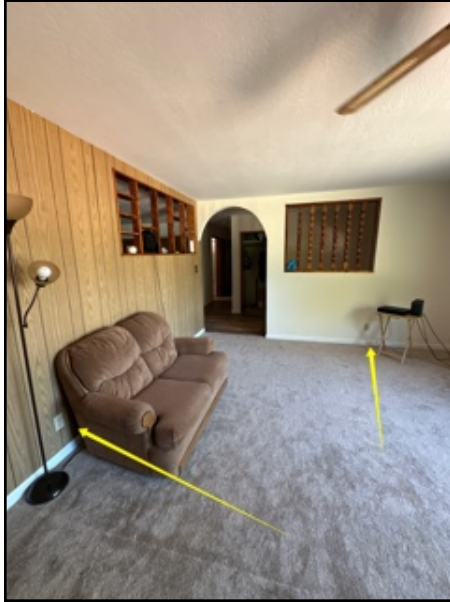
Figure 25-1

The 2 living area receptacles shown have hot & neutral wires reversed. Refer to a licensed electrician.

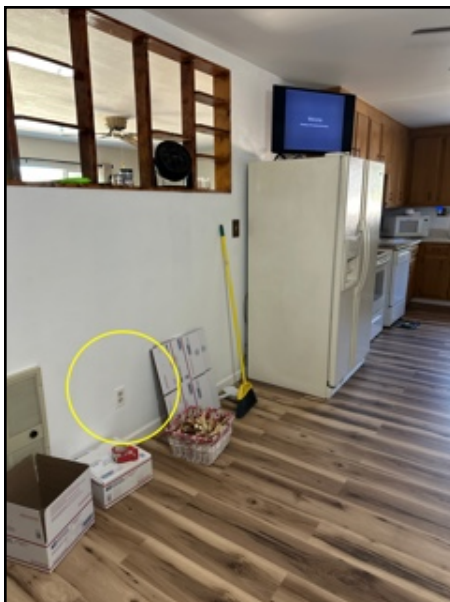
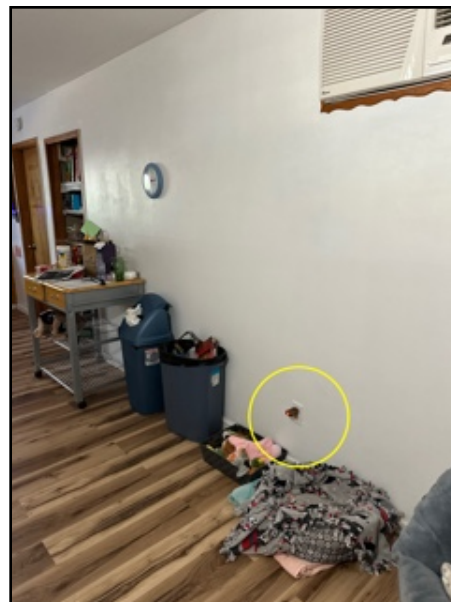
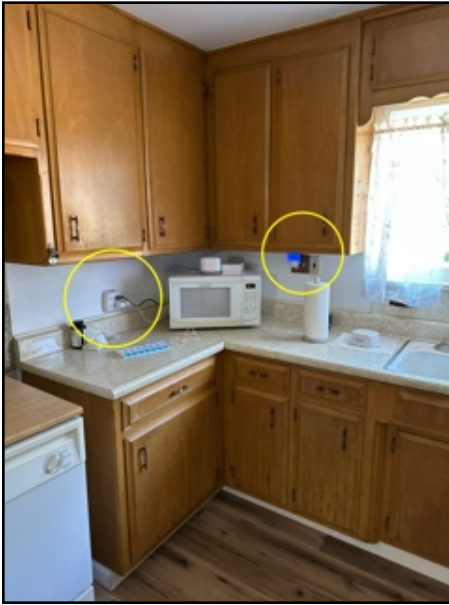
4 kitchen receptacles shown have hot & neutral wires reversed. Refer to a licensed electrician.

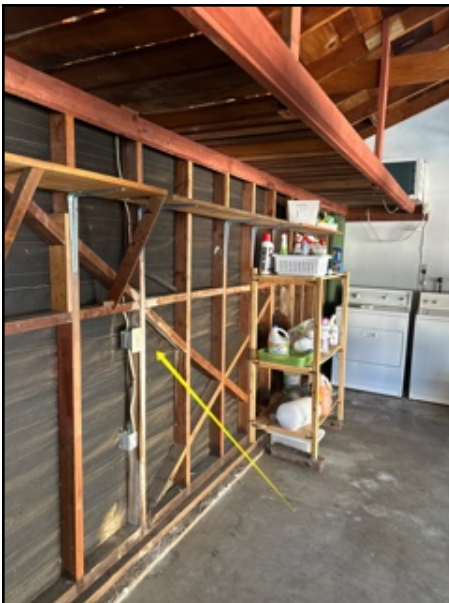
Figure 27-1

Garage receptacle shown has hot & neutral wires reversed. Refer to a licensed electrician.

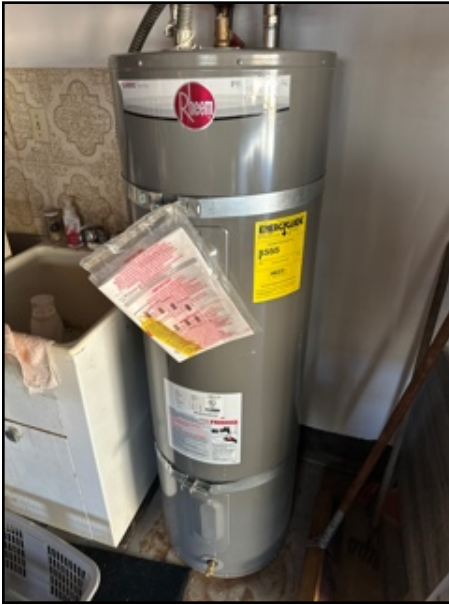
Figure 34-1

**Comment 34:**
Garage water heater is not elevated. When water heaters are installed in a garage, the burners (either gas OR electric) must be elevated 18" from the ground. Refer to a licensed plumber.

"Devices generating a glow, spark or flame capable of igniting flammable vapors shall be installed such that sources of ignition are at least 18 inches (457 mm) above the floor of any room in which Class I flammable liquids or flammable gases are used or stored."

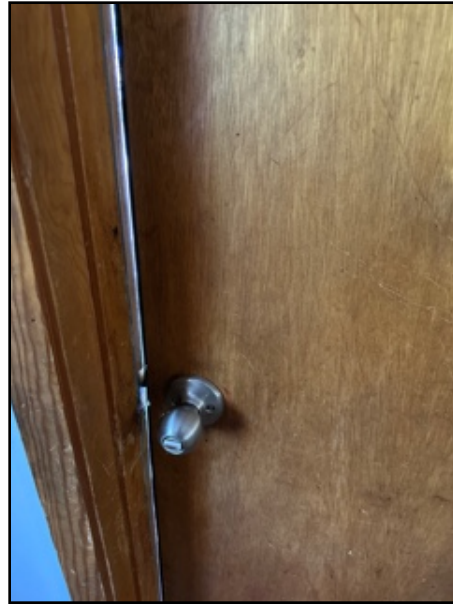
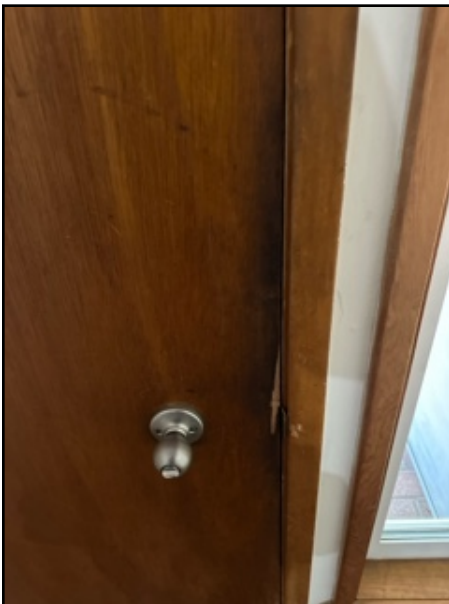
2nd guest bedroom closet door fails to fit into the frame.

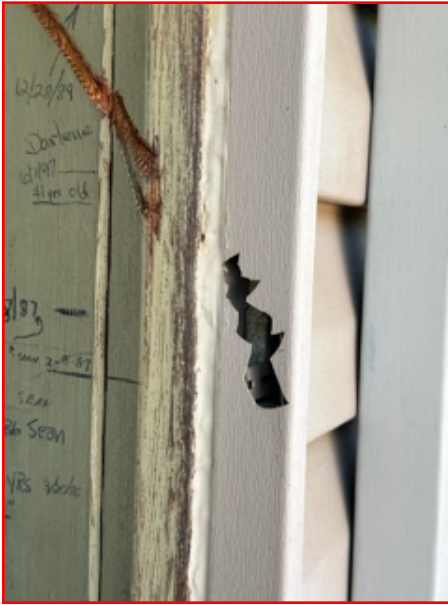
Figure 2-1

2) Vinyl trim on right side of garage overhead door is damaged.

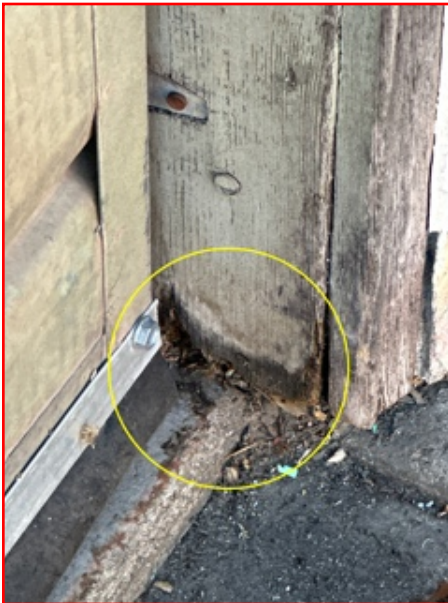
Figure 3-1

3) Wood decay noted at bottom of overhead door trim on right side. Refer to a licensed pest inspector.

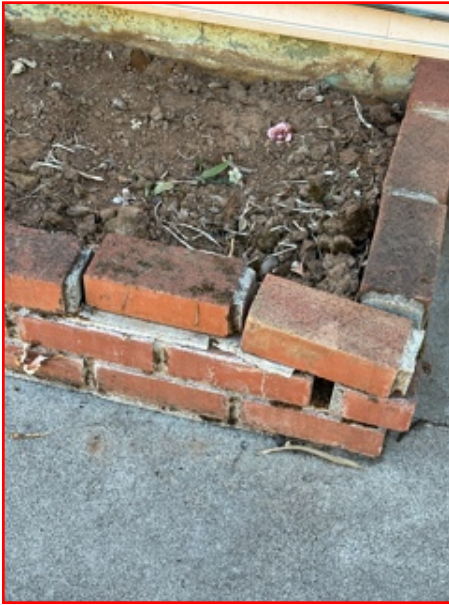
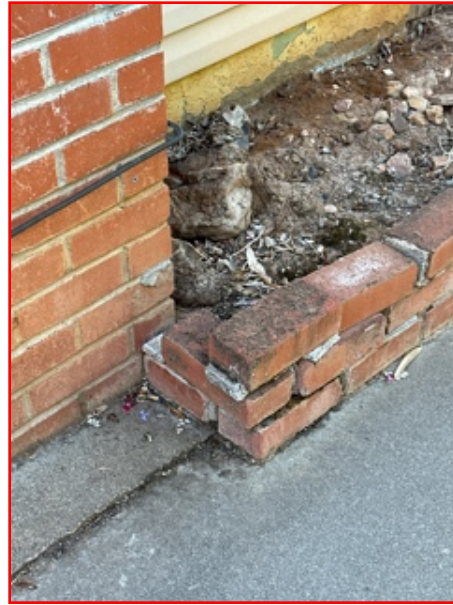
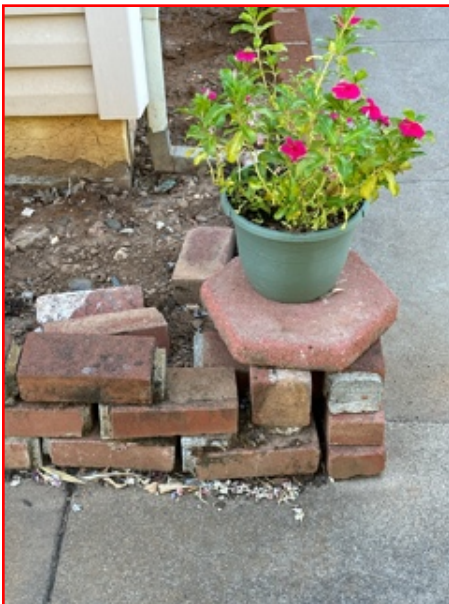
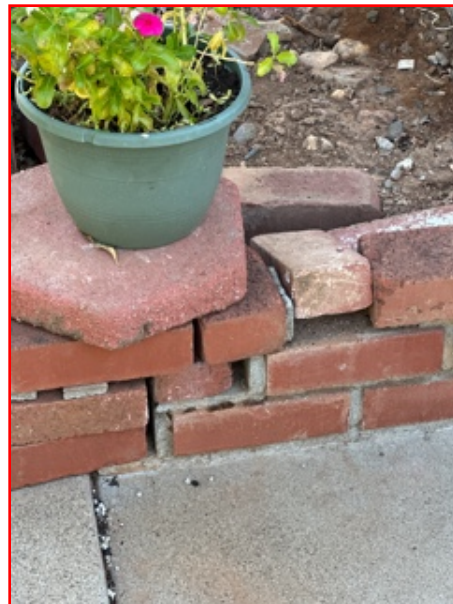
4) Loose bricks noted on built-in brick planters surrounding home. Recommend repair.

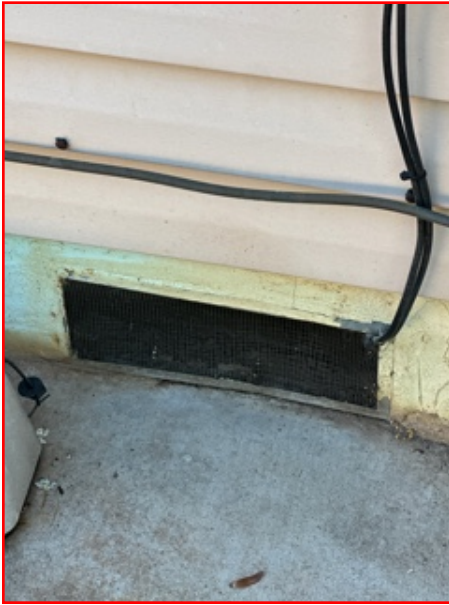
Figure 5-1

5) Crawl space vent left of chimney is at ground level. This could allow drainage to enter the sub area. Refer to a qualified tradesman for repair.

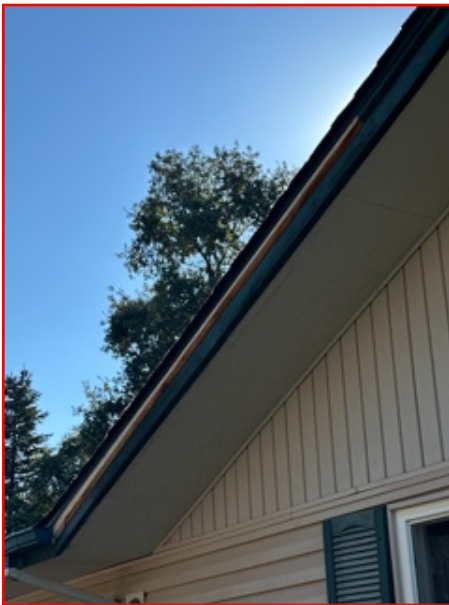
Figure 6-1

6) Recommend to paint unfinished fascia trim on right side of garage.

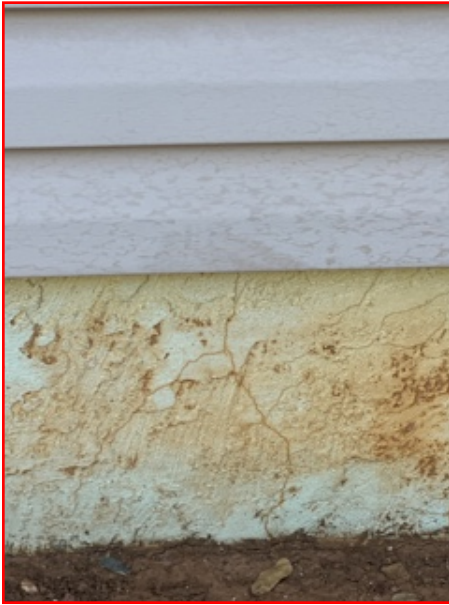
Figure 7-1

7) Minor cracks noted throughout exposed stucco siding below the vinyl. This is a common find on stucco siding.

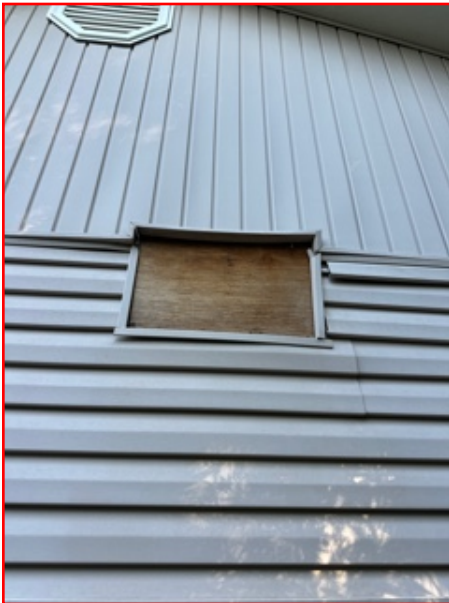
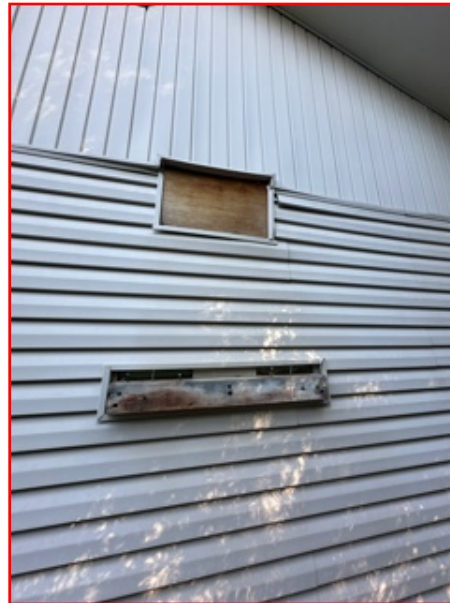
8) Evaporative cooler has been removed from the right side of home. Recommend properly repairing the siding in this area.

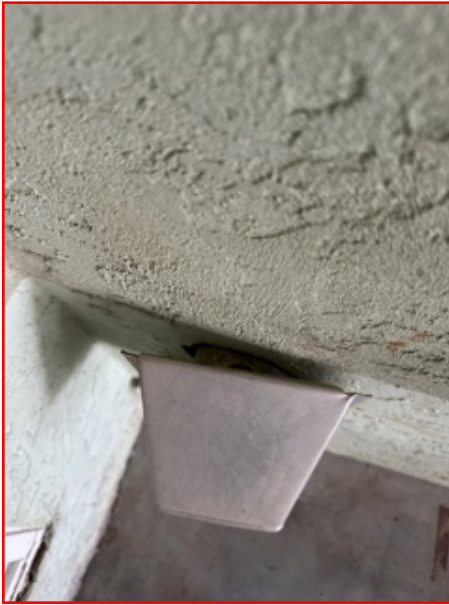
Figure 9-1

9) Dryer vent termination is not mounted to the wall. Inspector also noted this vent termination is missing the flapper.

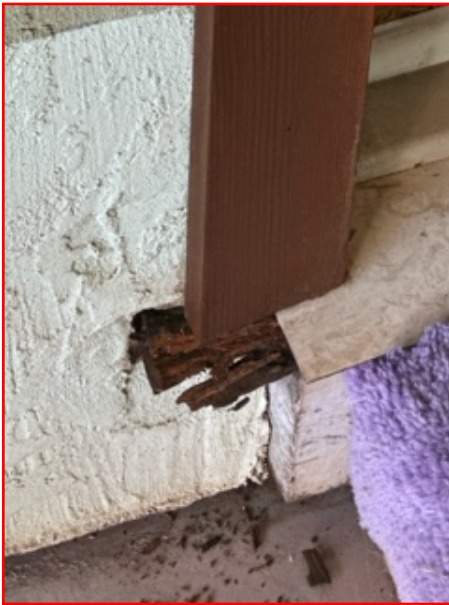
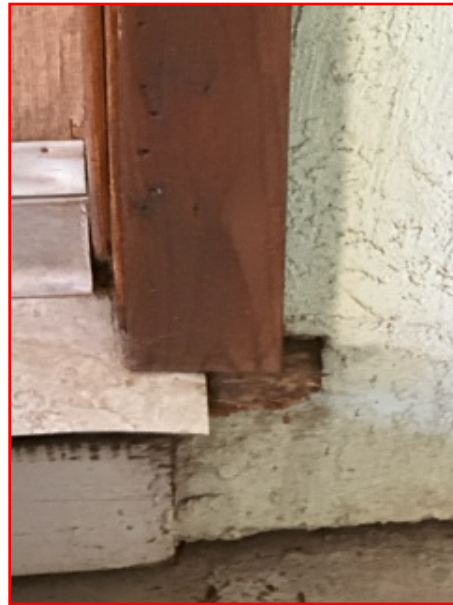
10) Wood decay noted below master bedroom exterior door. Refer to a licensed pest inspector.

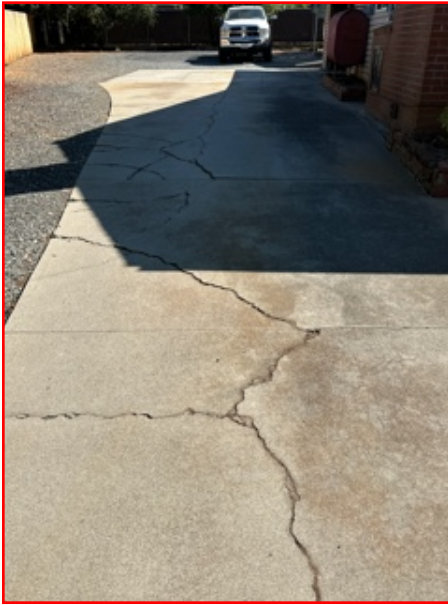
Figure 11-1

11) Driveway slabs noted as cracked.

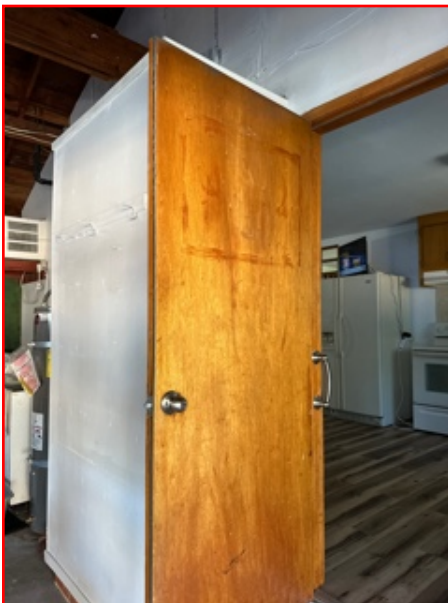
Figure 12-1

12) No self closing hinges are installed on garage door into home. Recommend installing as required to protect from carbon monoxide.

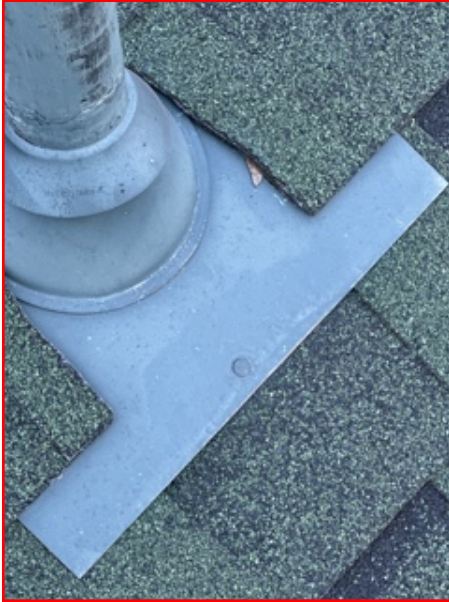
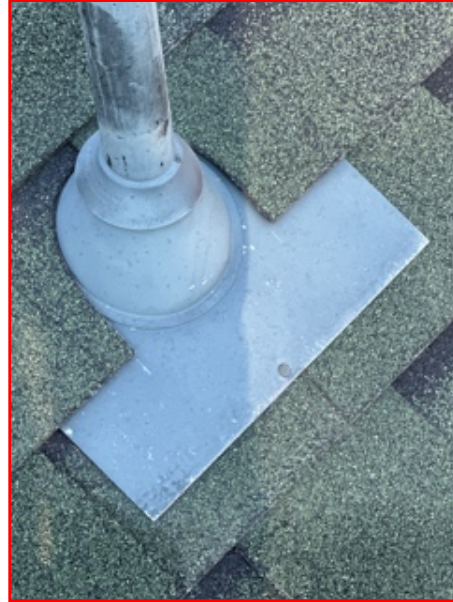
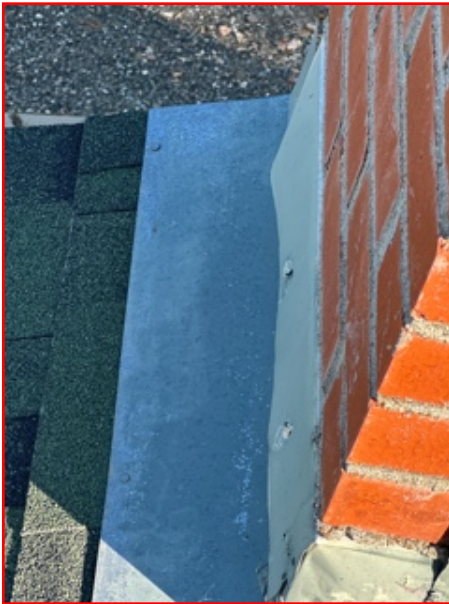
13) Open nails located on roof flashings. Recommend covering in tar to prevent any future leaks.

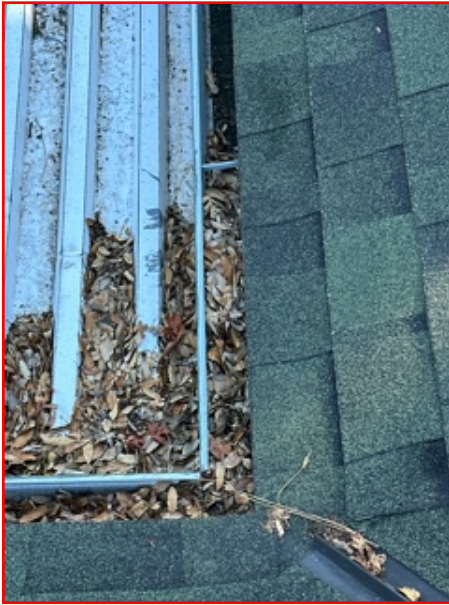
Figure 15-1

14) Recommend to clean debris from gutters to allow proper drainage.

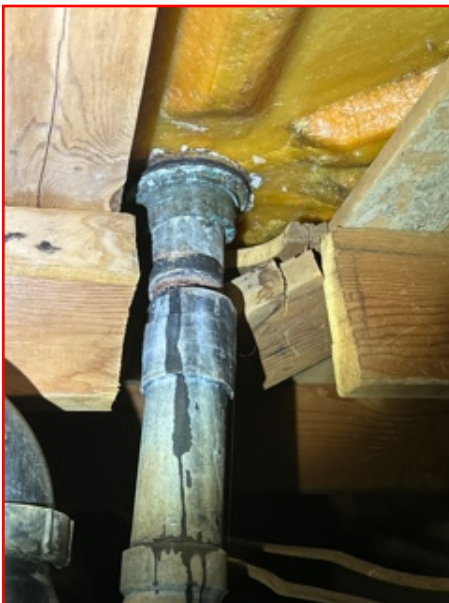
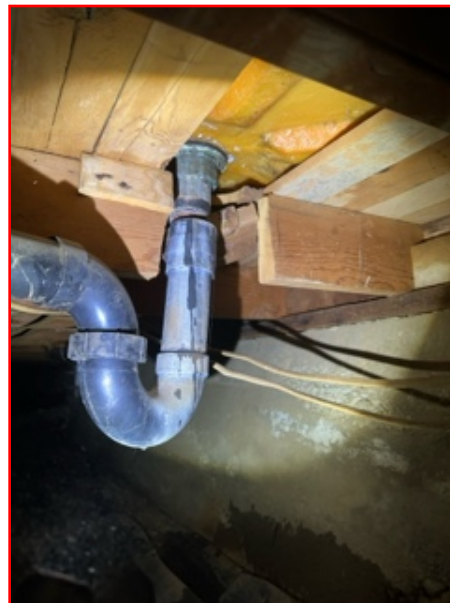
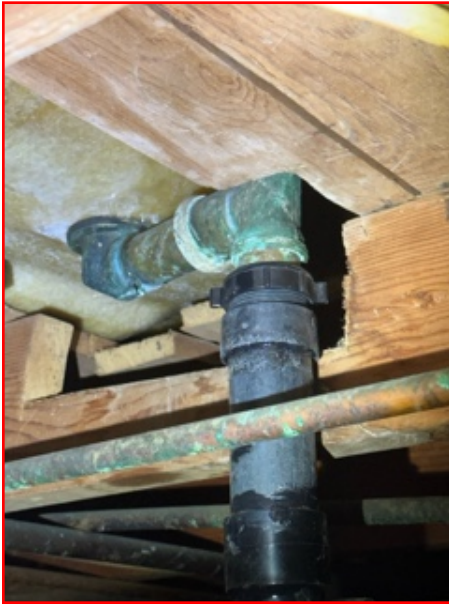
15) The floor joist below the tub/shower has been cut through & compromised. Refer to a licensed contractor for repair.

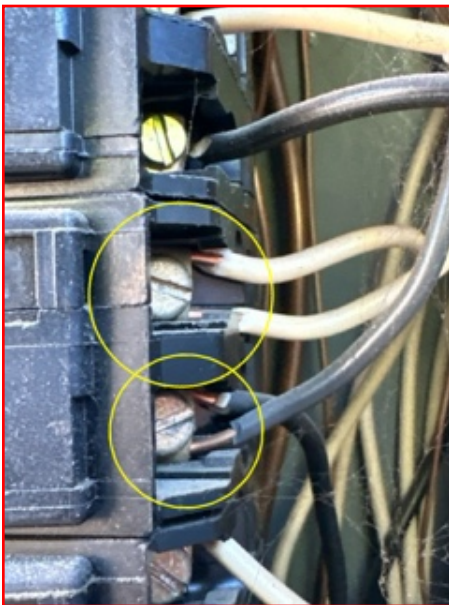
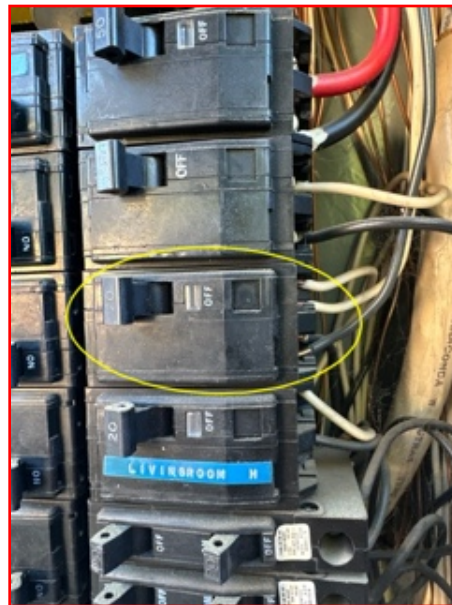
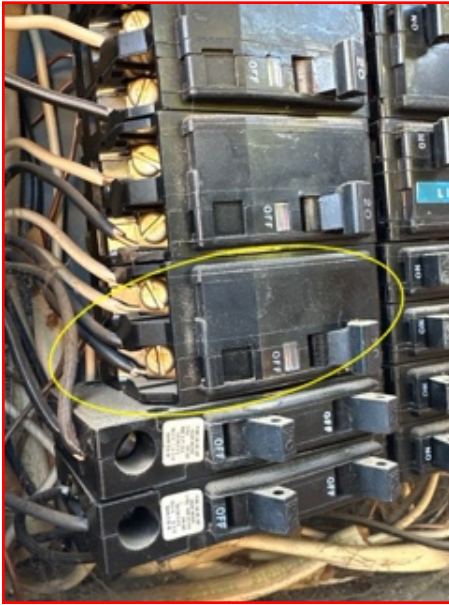
16) The 2 breakers shown in main panel are double tapped. Refer to a licensed electrician for further evaluation/repair.

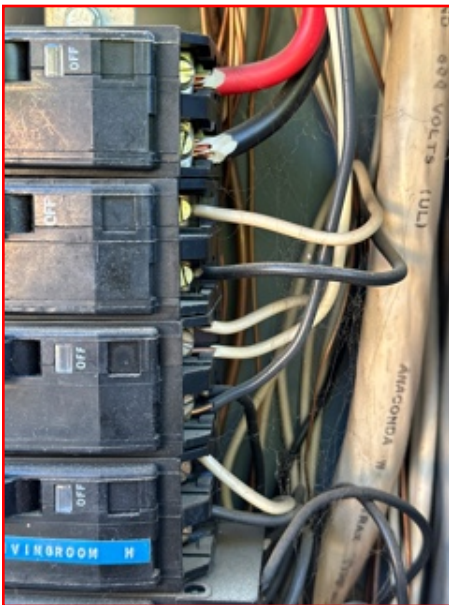
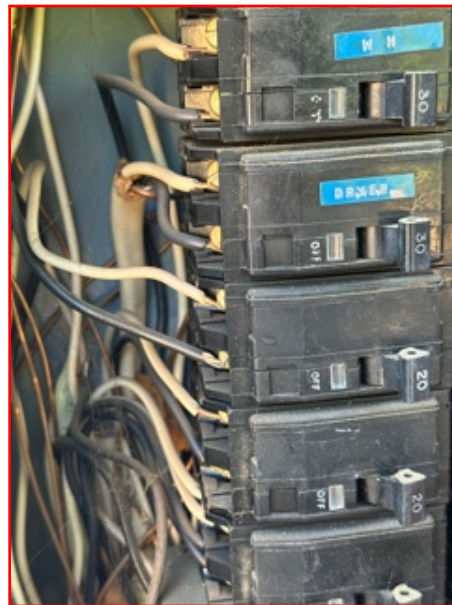
17) Neutral (white) wires that are attached to breakers & used as hot wires should be wrapped with red tape to indicate live current. Recommend repair.

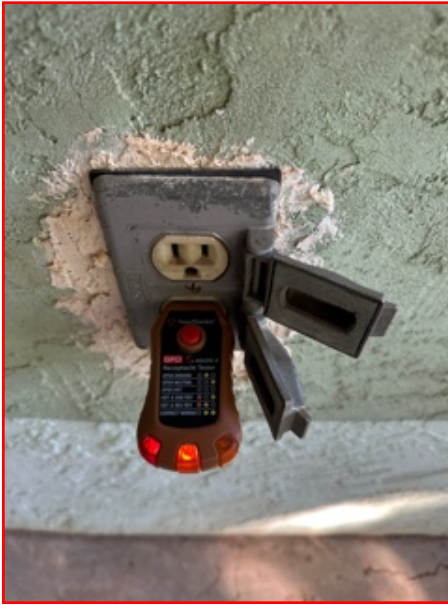
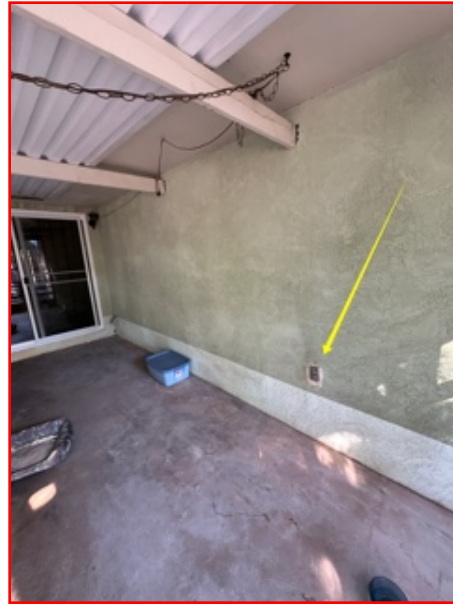
18) Receptacle in covered porch area shown has the hot & neutral wires reversed. Refer to a licensed electrician.

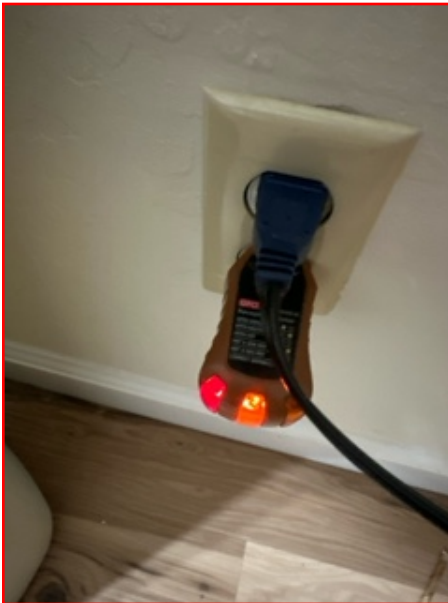
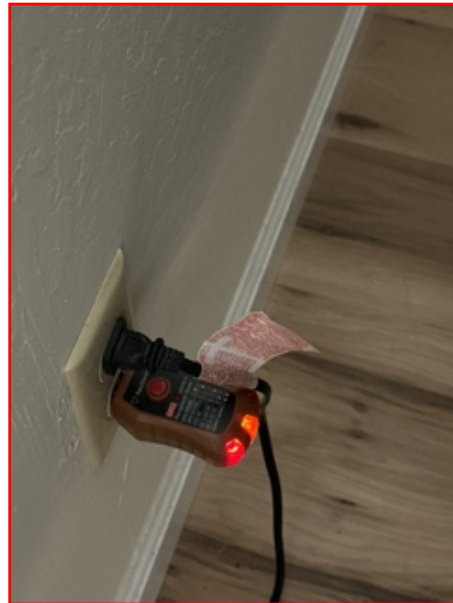
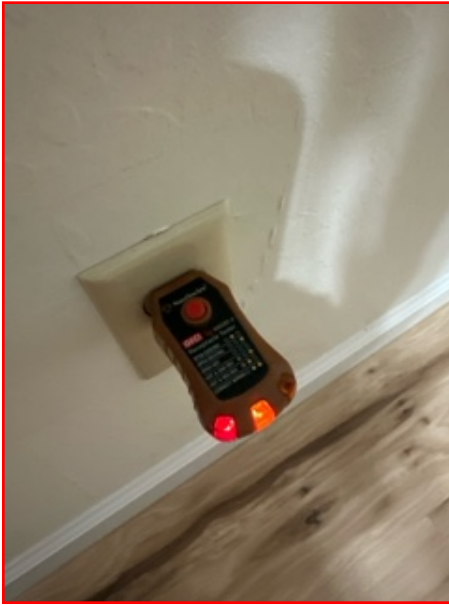
19) All receptacles in first right guest bedroom have hot & neutral wires reversed. Refer to a licensed electrician.

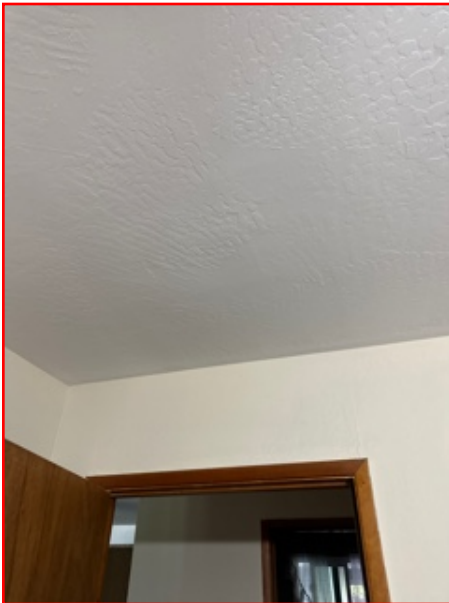
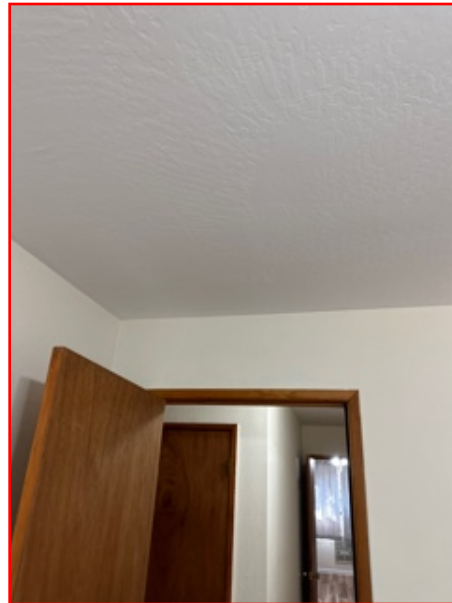
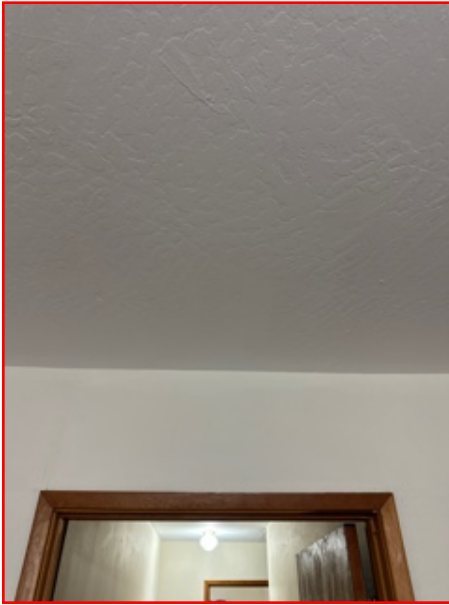
20) Multiple smoke alarms missing in home. Recommend to install as required.

Section 310.9.1.4 of the California Building Code. One smoke alarm should be placed on each floor in non-sleeping areas. In addition, one smoke alarm must be installed in each room where sleeping occurs and one smoke alarm should be located in each hallway that leads directly to sleeping rooms.

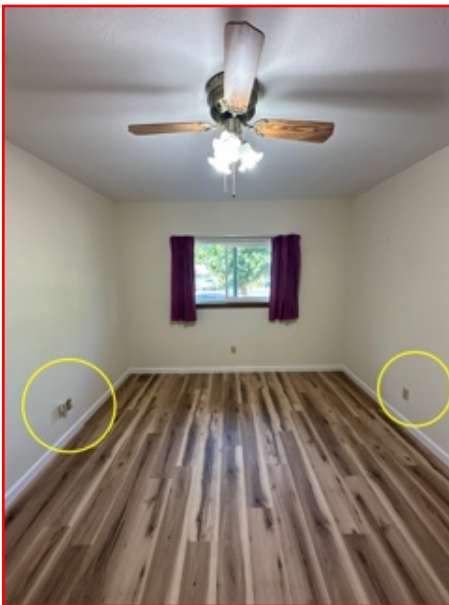
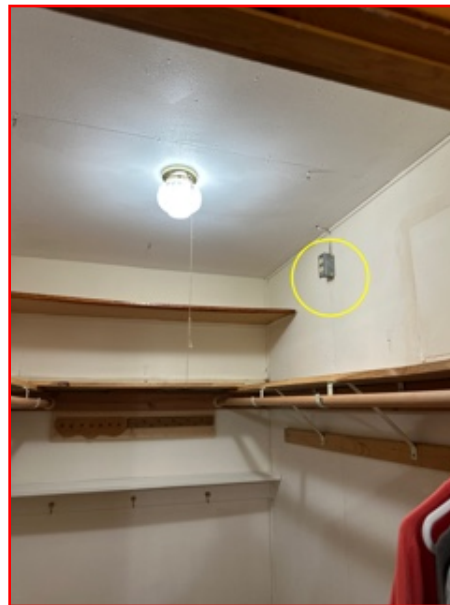
21) The two receptacles shown in 2nd guest bedroom plus the closet receptacle have hot & neutral wires reversed. Refer to a licensed electrician.

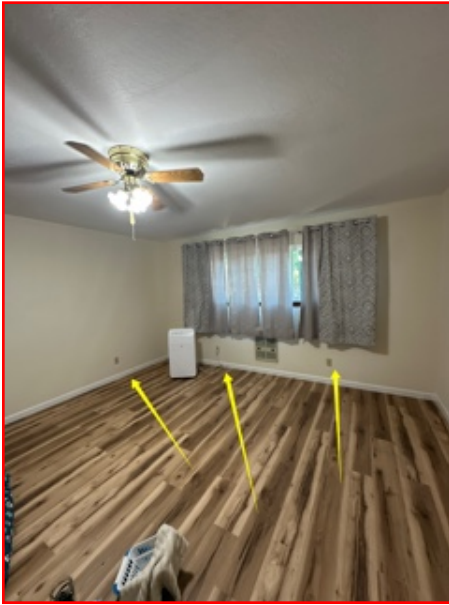
Figure 24-1

22) The 3 master bedroom receptacles shown have hot & neutral wires reversed. Refer to a licensed electrician.

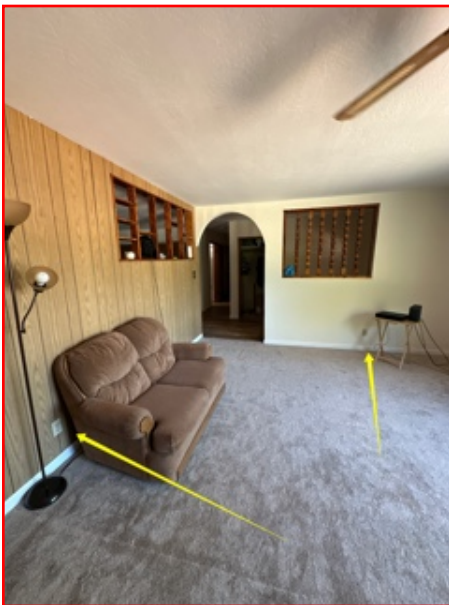
Figure 25-1

23) The 2 living area receptacles shown have hot & neutral wires reversed. Refer to a licensed electrician.

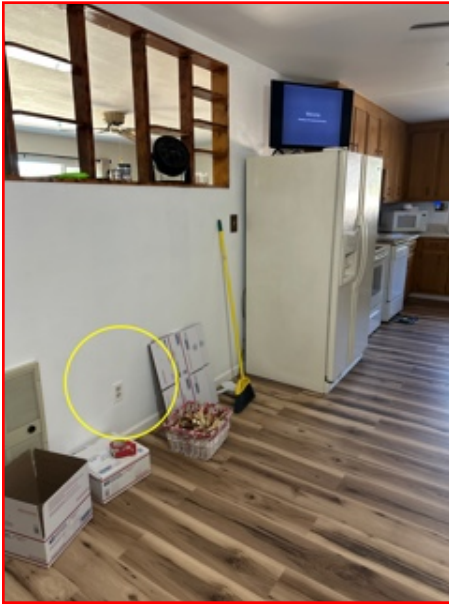
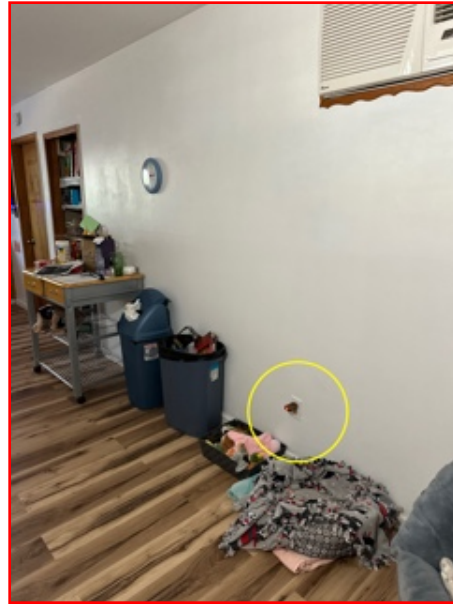
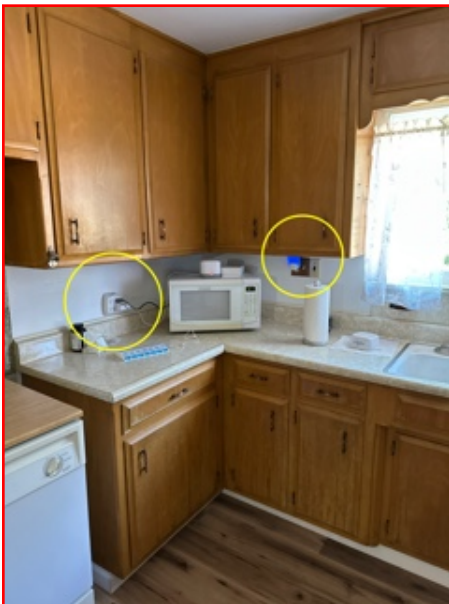
24) 4 kitchen receptacles shown have hot & neutral wires reversed. Refer to a licensed electrician.

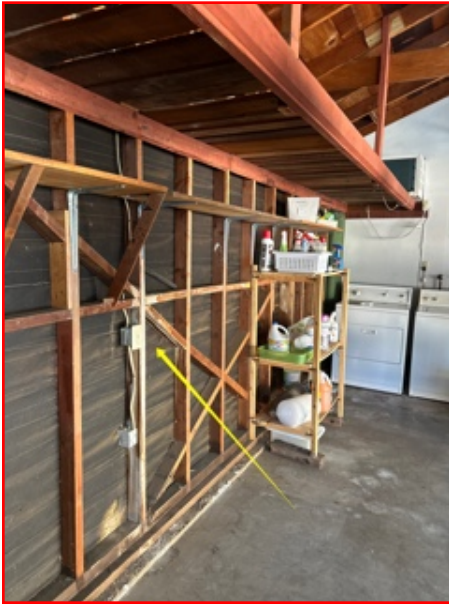
Figure 27-1

25) Garage receptacle shown has hot & neutral wires reversed. Refer to a licensed electrician.

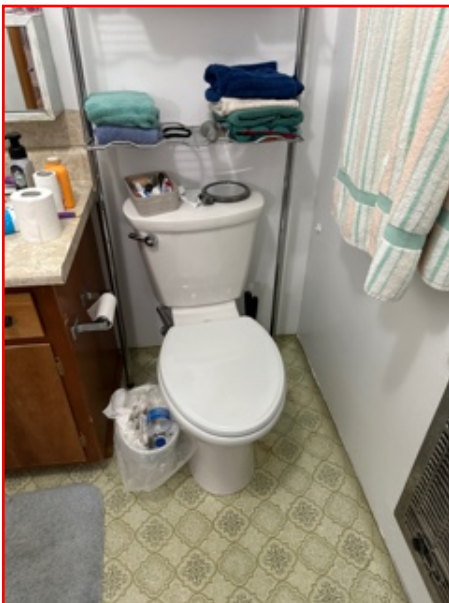
Figure 30-1

Master bathroom toilet noted as loose. Recommend tightening to prevent any future leaks.

26) Master bathroom toilet noted as loose. Recommend tightening to prevent any future leaks.

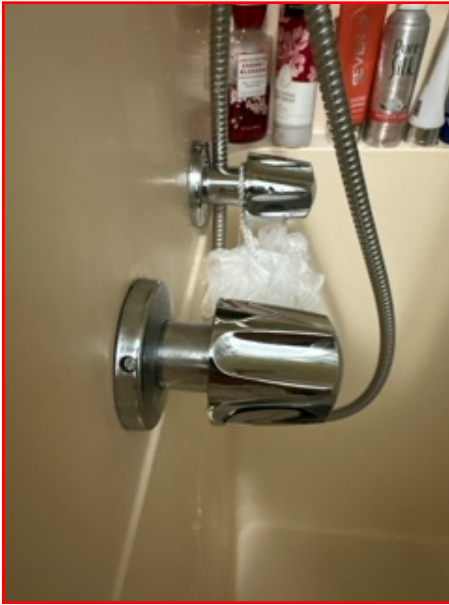
Figure 31-1

Master bathroom shower handles/valves noted to leak when on. Refer to a licensed plumber.

27) Master bathroom shower handles/valves noted to leak when on. Refer to a licensed plumber.

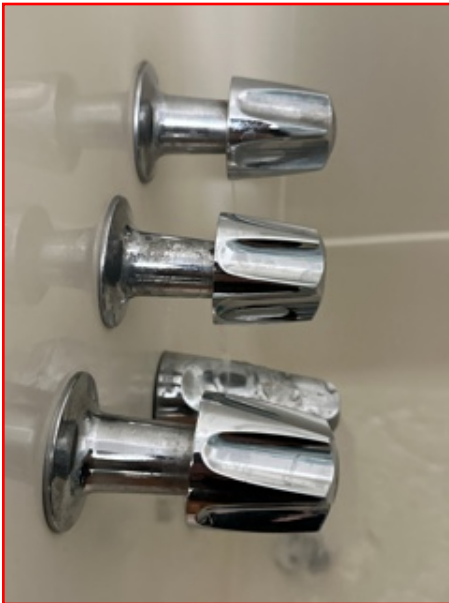
Figure 32-1

Guest bathroom shower handles/valves noted to leak when on. Refer to a licensed plumber.

28) Guest bathroom shower handles/valves noted to leak when on. Refer to a licensed plumber.
