Cornerstone Home Inspections

Home Inspection Report

20445 West Walnut Dr

Inspected on Mon, Sep 15 2025 at 9:05AM

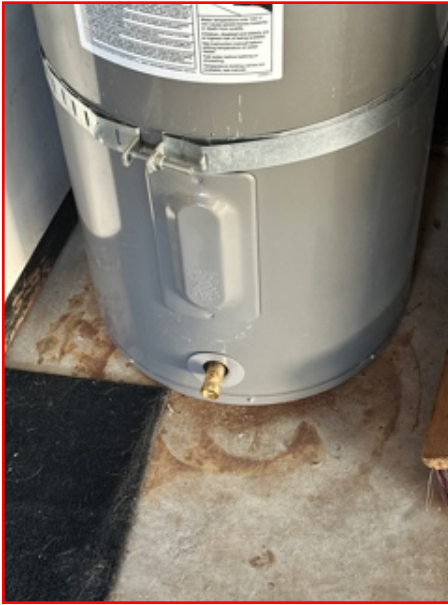
Figure 33-1

**Comment 33:**
No pan installed under water heater. Recommend installing as required.

29) No pan installed under water heater. Recommend installing as required.

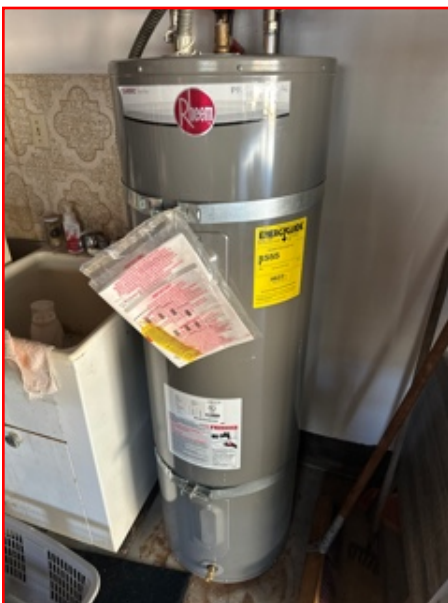
Figure 34-1

**Comment 34:**
Garage water heater is not elevated. When water heaters are installed in a garage, the burners (either gas OR electric) must be elevated 18" from the ground. Refer to a licensed plumber.

30) Garage water heater is not elevated. When water heaters are installed in a garage, the burners (either gas OR electric) must be elevated 18" from the ground. Refer to a licensed plumber.

"Devices generating a glow, spark or flame capable of igniting flammable vapors shall be installed such that sources of ignition are at least 18 inches (457 mm) above the floor of any room in which Class I flammable liquids or flammable gases are used or stored."

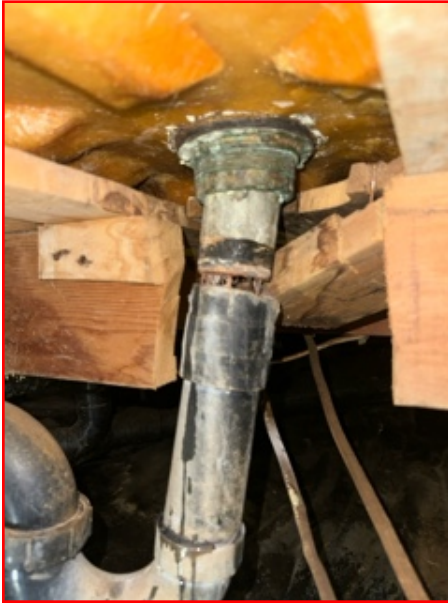
Figure 35-1

Shower drain below home is completely disconnected. Recommend repair before any further use.

31) Shower drain below home is completely disconnected. Recommend repair before any further use.

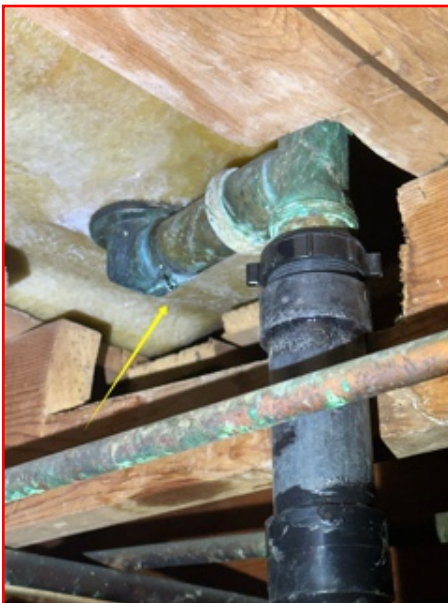
Figure 36-1

Tub drain below home noted to leak. Refer to a licensed plumber.

32) Tub drain below home noted to leak. Refer to a licensed plumber.

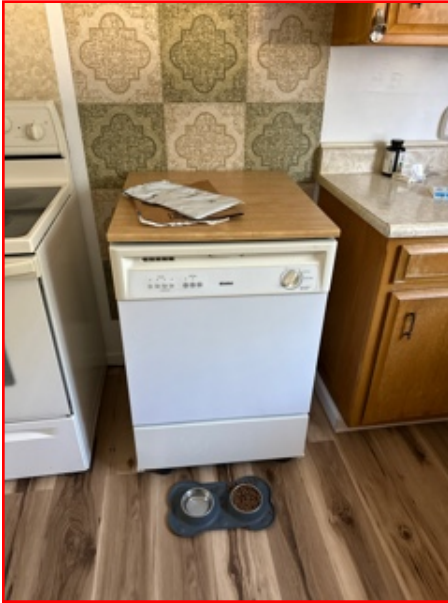
Figure 38-1

33) Dishwasher was not installed at time of inspection, therefore could not be tested.

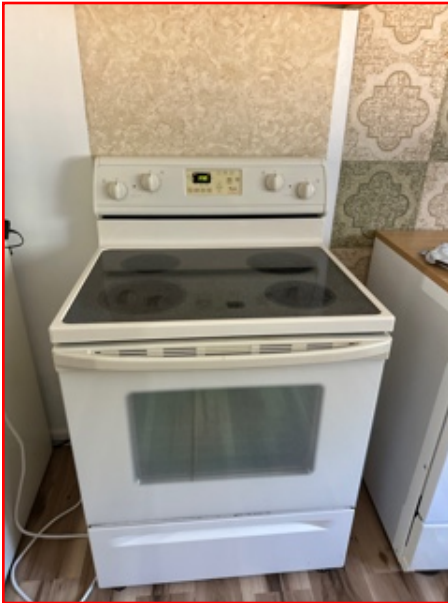
Figure 40-1

No anti-tip bracket installed on oven. Recommend installing to ensure the safety of the appliance.

34) No anti-tip bracket installed on oven. Recommend installing to ensure the safety of the appliance.

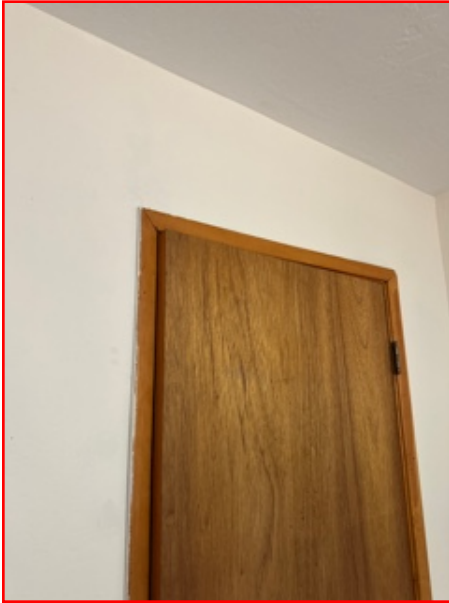
Figure 41-1

2nd guest bedroom closet door fails to fit into the frame.

35) 2nd guest bedroom closet door fails to fit into the frame.

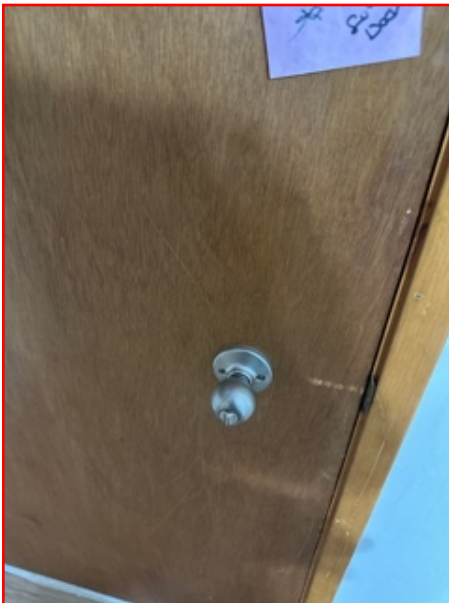
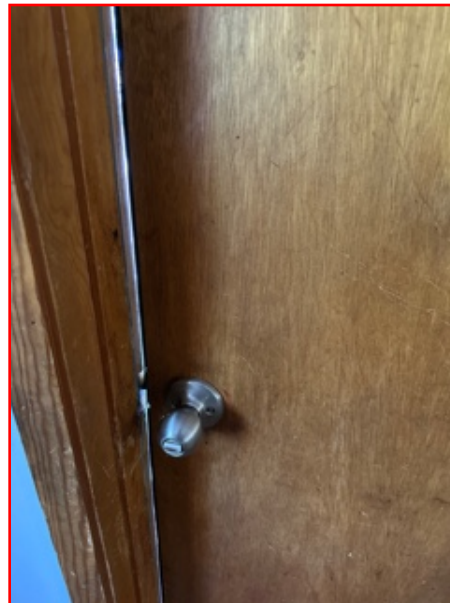
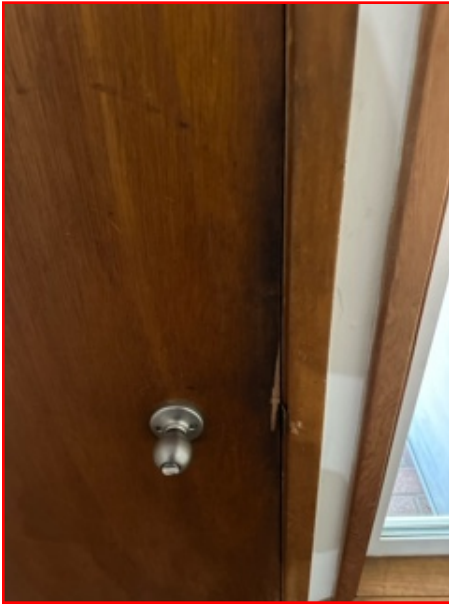
Recommend installing deadbolt style locks on all exterior doors to ensure the security of the home.

36) Recommend installing deadbolt style locks on all exterior doors to ensure the security of the home.

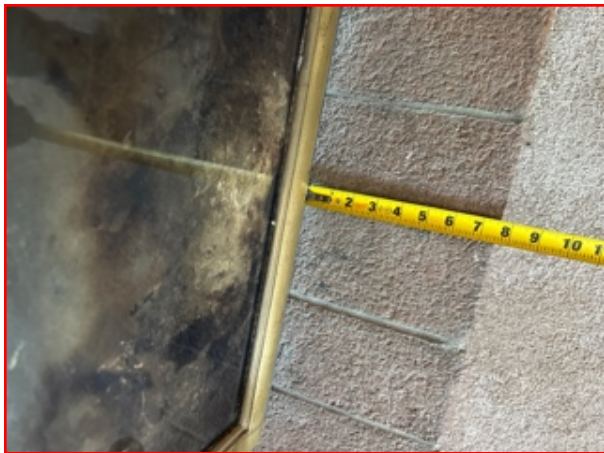
Figure 43-1

Hearth noted at 7.5" in front of wood stove. Current CA building code requires a minimum of 16". Recommend repair.

37) Hearth noted at 7.5" in front of wood stove. Current CA building code requires a minimum of 16". Recommend repair.

CA Code R1001.10 - "Hearth extensions shall extend at least 16" in front of, and at least 8" beyond each side of the fireplace opening...."
