Suzanne Markham

8605 Washington
La Mesa, California

Chris Dembroski NACHI10071406
Smart Home Inspection
(619) 846-5737
chris@smarhomeinspection.net
5582 Forbes Ave
San Diego, CA
92120
www.smarhomeinspection.com

Thursday
January 9, 2025

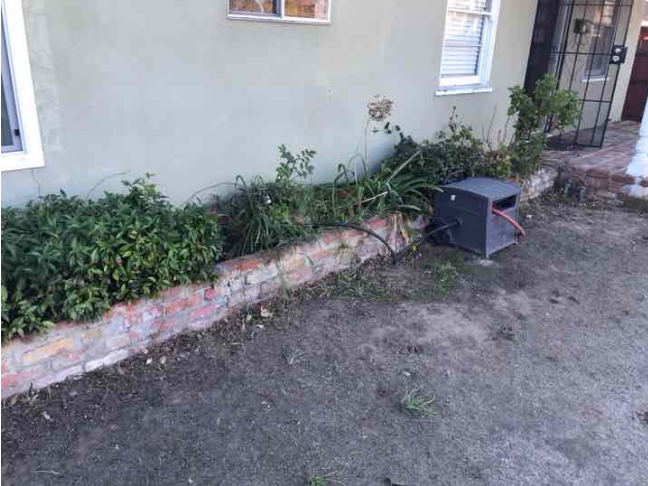
W 24: Grading is sloped toward the structure in some areas. Low spots and negative grading promote water accumulation near the building, leading to foundation problems. Regrading would help ensure that surface water flows away from the structure.

W 25: The surface drainage within 10 feet of the home is inadequate. The hard surface drainage or soil does not meet the 2% minimum slope. This can lead to water intrusion and may premature damage to the foundation.

W 26: Planters and/or areas of high grading can promote water accumulation near the building leading to foundation problems. Regrading would help ensure that surface water flows away from the structure.

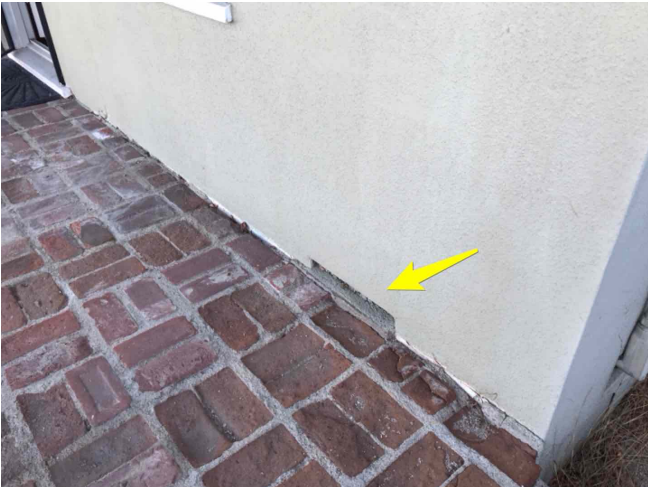
W 28: Some of the crawlspace vents are below or at grade and are susceptible to water intrusion. Preventative measures should be taken to prevent this from happening.

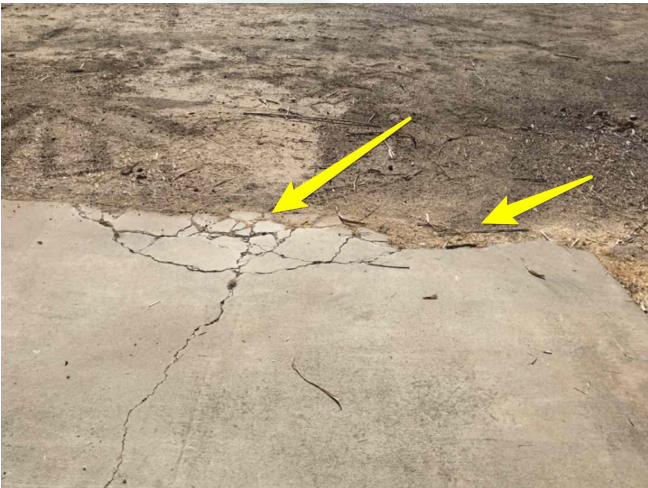
R 34: In our opinion, the major cracks in the driveway cannot be filled, sealed, or repaired effectively. We recommend that the driveway be replaced.

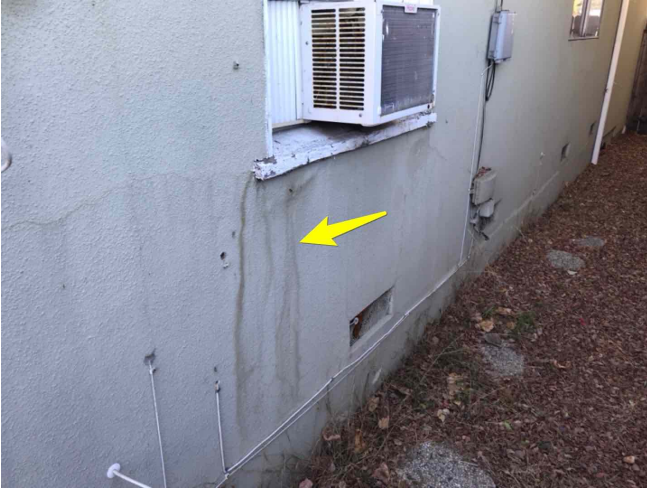
W 42: There is water staining to the exterior stucco. The gutters, flashing, exterior drainage and sprinkler system should be serviced to prevent future staining.

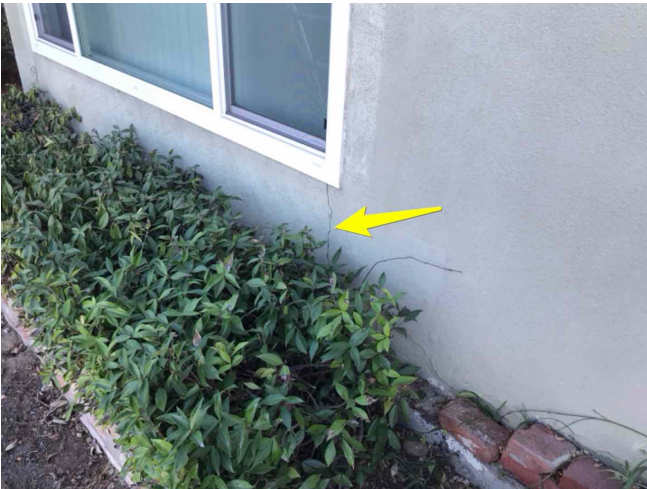
R 43: There are moderate sized cracks in the stucco that should be patched and sealed as part of preparation for the next painting. Flexible patching materials are recommended rather than rigid cementitious patching compounds.

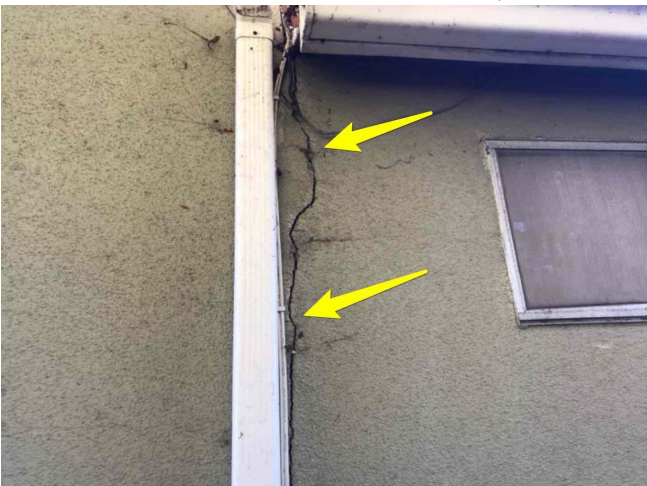
W 44: There is cracked stucco indicating movement at the addition. These surfaces can be patched, but if movement in the structure is not addressed, the cracks may return and/or become more noticeable.

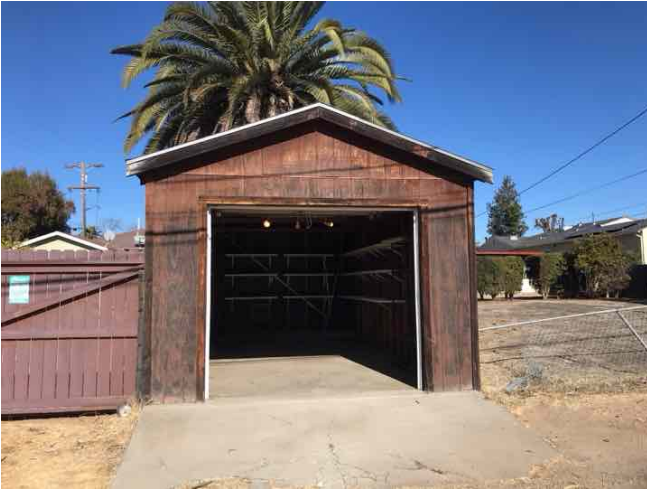
W 48: The siding shows routine wear but is generally in serviceable condition. We recommend minor maintenance to ensure maximum service life.

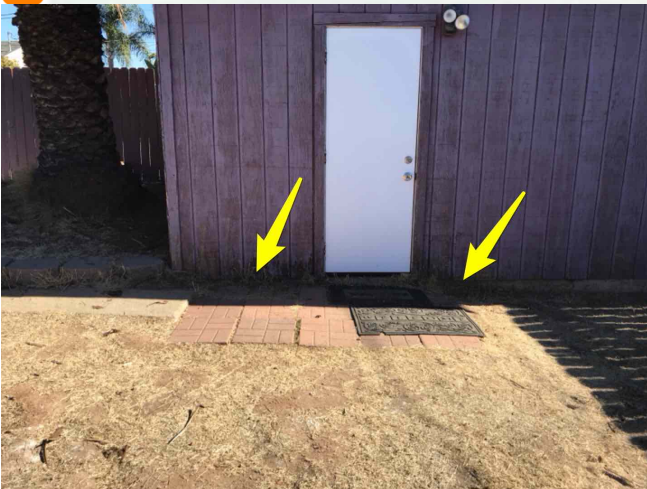
R 49: Sections of the siding are deteriorated. We recommend these sections be repaired or replaced.

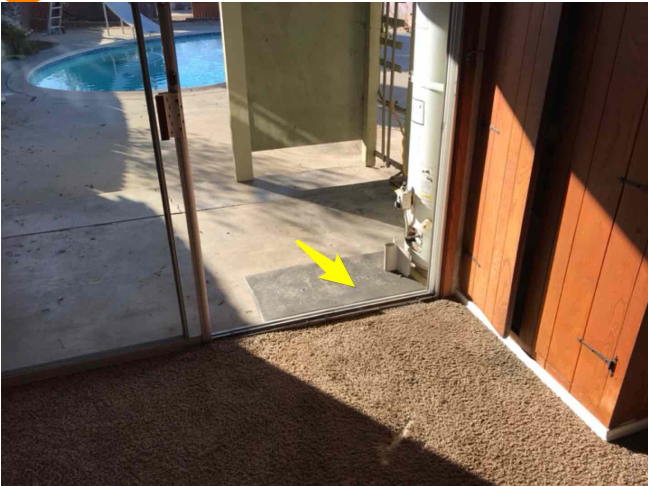
R 51: The track on the sliding door is damaged. We recommend it be replaced.

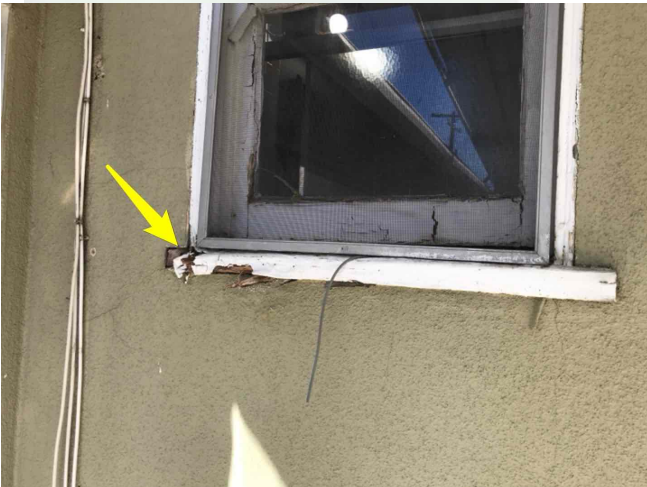
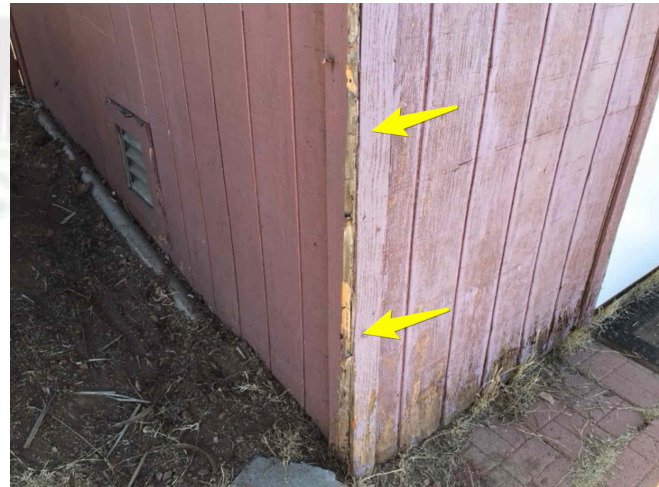
W 62: The homes trim shows signs of wood destroying pest. If the home has not yet been inspected by a pest control professional it is advised that a full inspection be preformed.

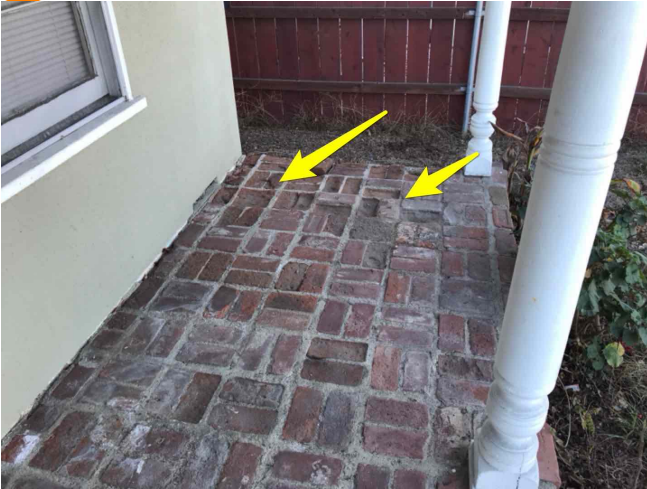
R 72: The balcony/porch surface is damaged and needs to be repaired or replaced.

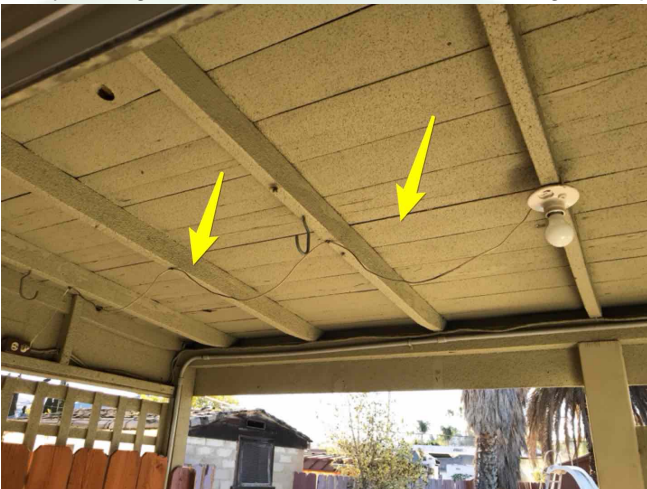
S 74: We found extension cord wiring in use at the rear of the home. This type of wiring is easy to overload and can be easily damaged. Removal of all substandard wiring and replacement with proper circuitry is recommended.

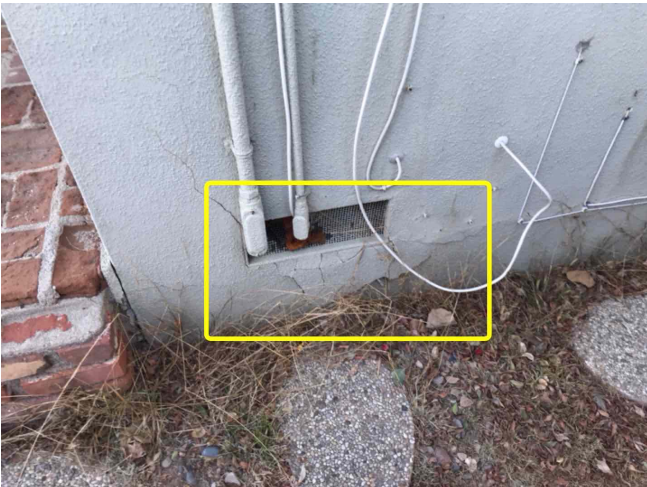
W 107: The homes foundation has moderate cracks visible. We observed no related conditions suggesting the need for immediate repairs although these cracks are close to the point of needing attention it's advised the preemptive repairs or evaluation be done to prevent any future issues. Further review from a foundation professional would be recommended.

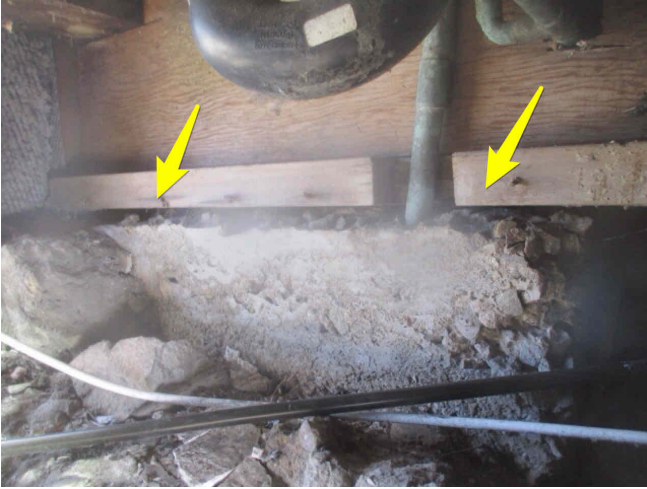
W 112: The mudsill is the wood member resting directly on the foundation. There are voids between the mudsill and the foundation which is not considered good practice. We recommend these voids be filled for full support of the framing.

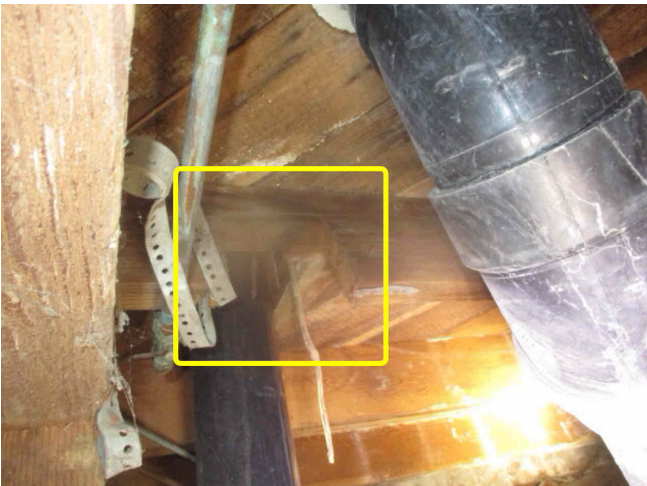
W 116: There is excessive notching in the floor framing near the crawlspace entrance. This has weakened the framing and we recommend repair or modification to conform to accepted standards.

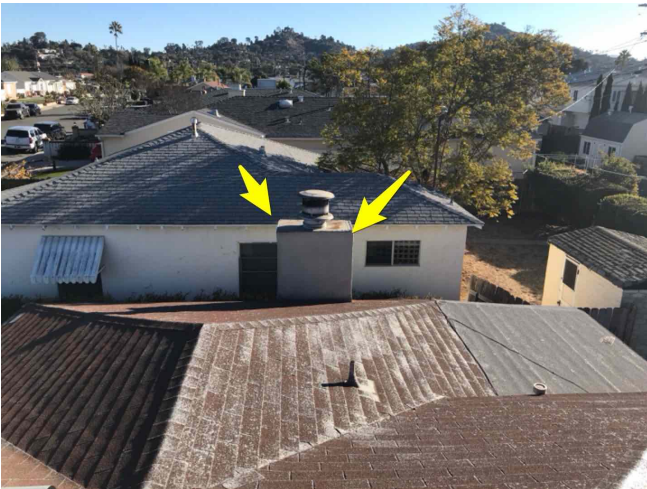
R 139: The fireplace cap is not properly installed and needs service to prevent moisture intrusion or damage to the surrounding fireplace and chimney.

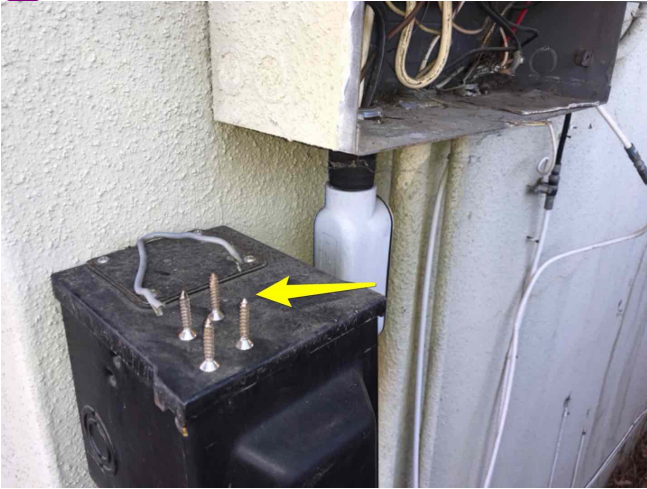
M 197: The electric panel has One or more of the wrong type of screws installed. It's advised that the screws be replaced.

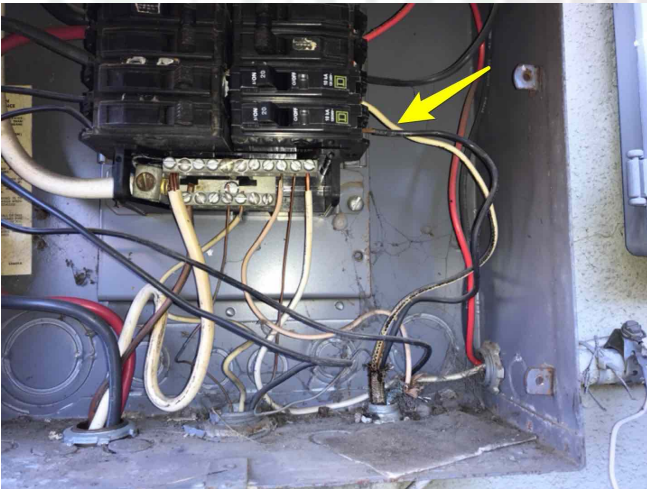
S 200: There are neutral wires in the circuit panel that are being used as hot wires. The wires have not been properly marked or labeled as hot wires. It is advised that this condition be corrected to avoid a potential shock hazard.

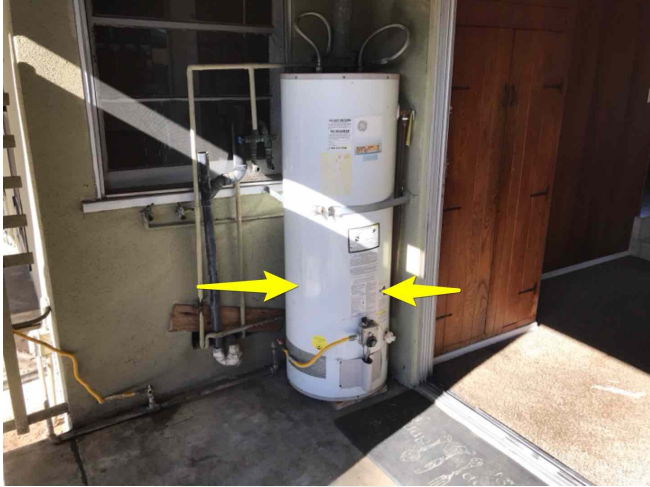
S 269: The water heater tank seismic restraint is minimal. We recommend it be upgraded to adequately secure the tank. This will help limit damage in the event of a major earthquake.

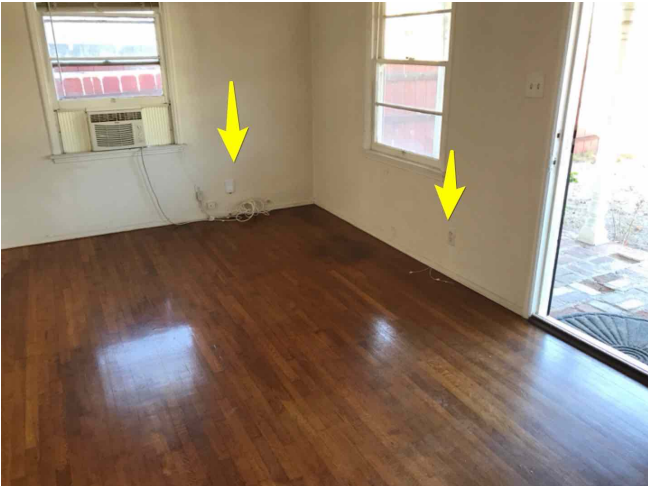
S 345: There are several ungrounded three prong receptacles in this area. We recommend they be properly grounded or restored to their original two prong configuration.

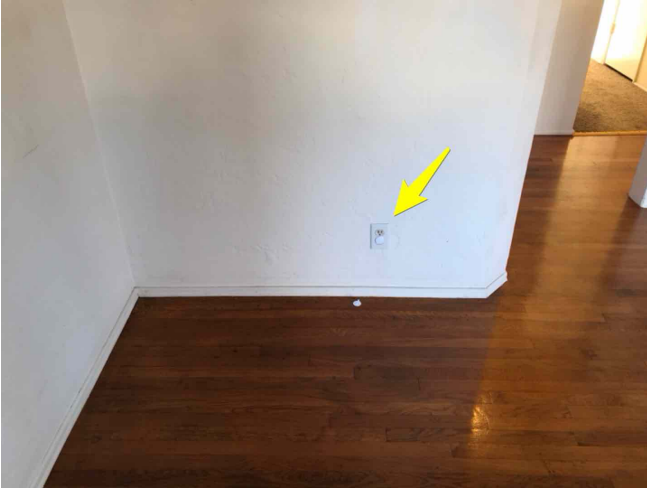
S 363: There is an ungrounded three prong receptacle at the dining room. We recommend it be properly grounded or restored to its original two prong configuration.

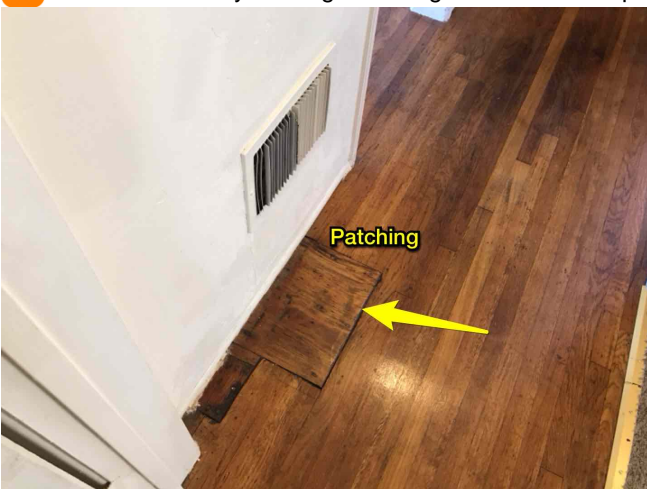
R 367: The hallway flooring is damaged and needs repair or replacement.

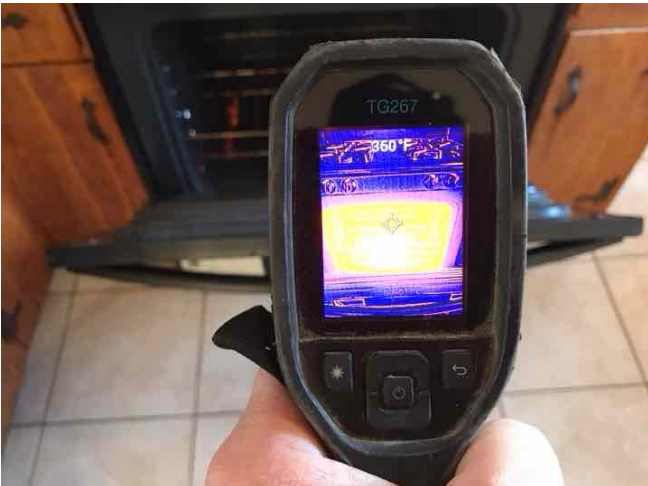
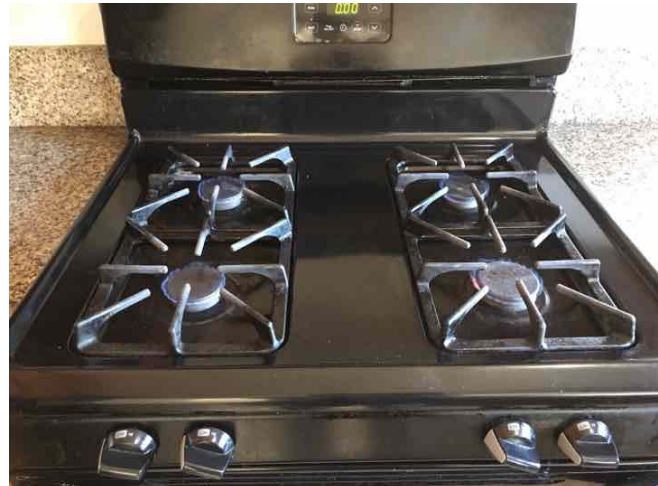
382: The range was turned on with the normal operating controls and found to be in satisfactory working condition.

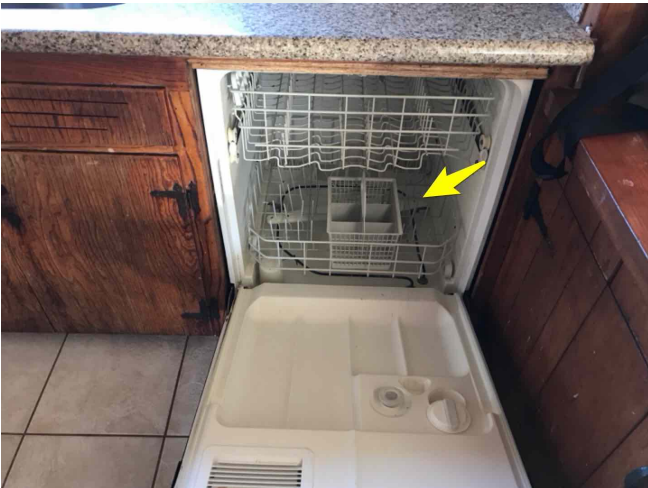
M 385: There is rust inside on the dishwasher on one or more of the dish racks. It's advised that this condition be replaced or repaired.

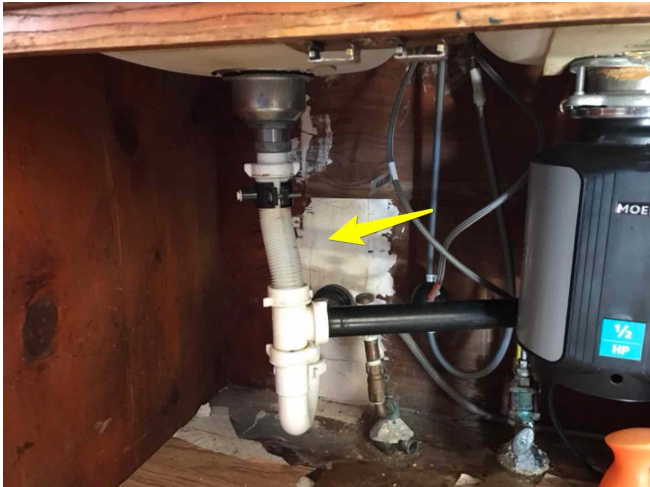
U 393: The sink drain line is corrugated plastic, it is advised that the drain line be replaced with a smooth type drain line to prevent blockage.

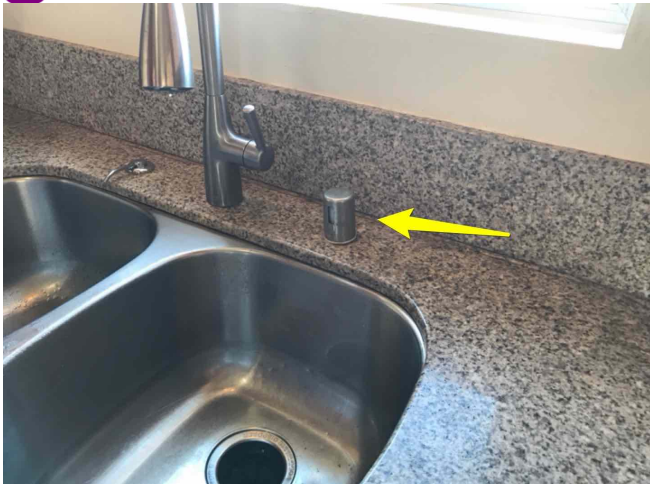
M 394: The dishwasher air gap drain is leaking and needs to be repaired or replaced.

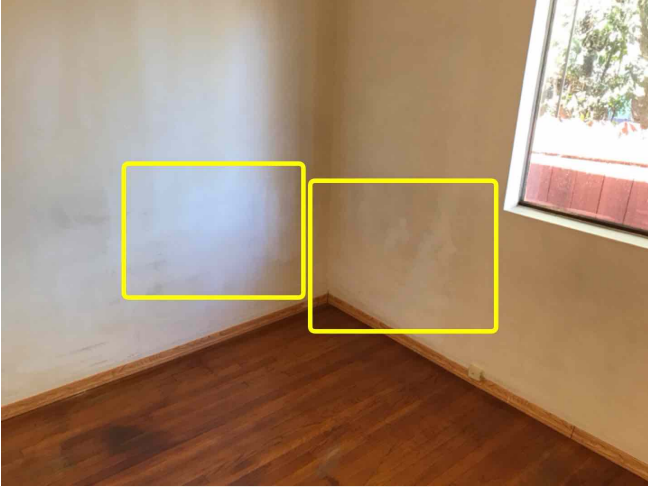
404: There is evidence of patching to the wall. It is advised that further inquiry be made regarding this condition.

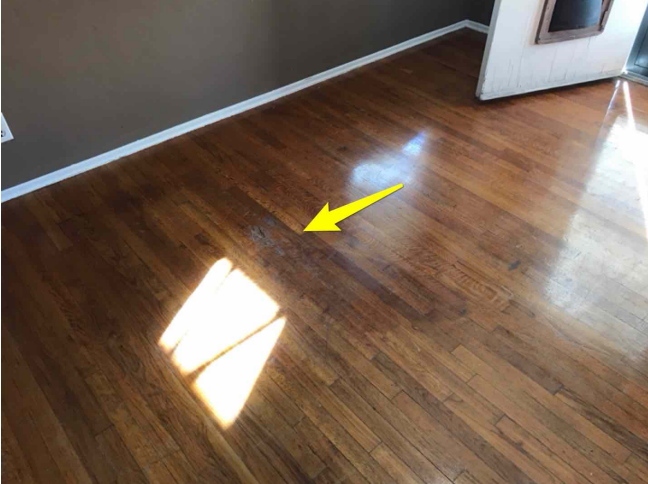
R 420: The floor is damaged or missing and needs repair.

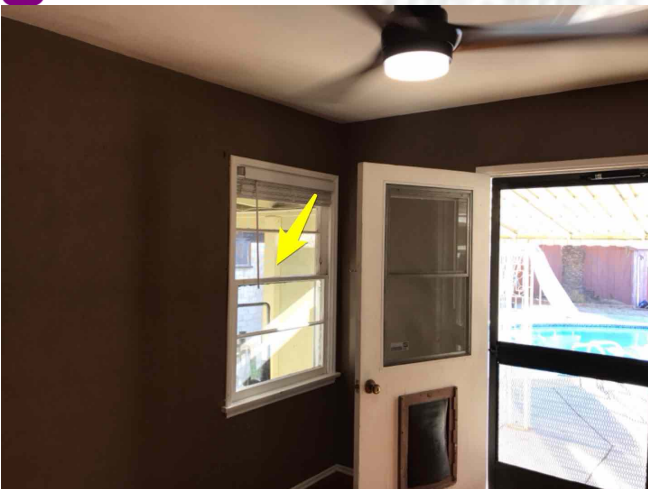
M 423: The window hardware does not latch needs service to function properly.

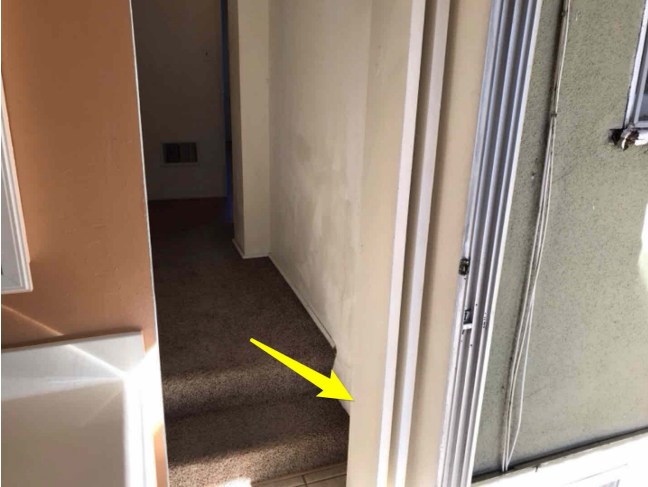
R 432: The bedroom door is damaged. We recommend it be repaired or replaced.

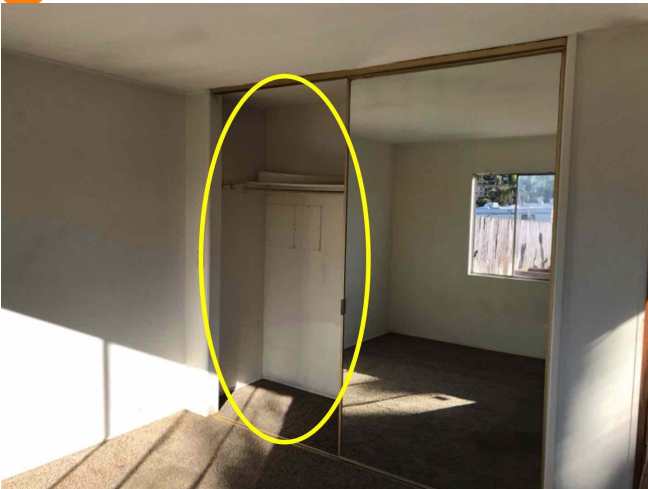
R 433: The closet doors are missing or have been removed.

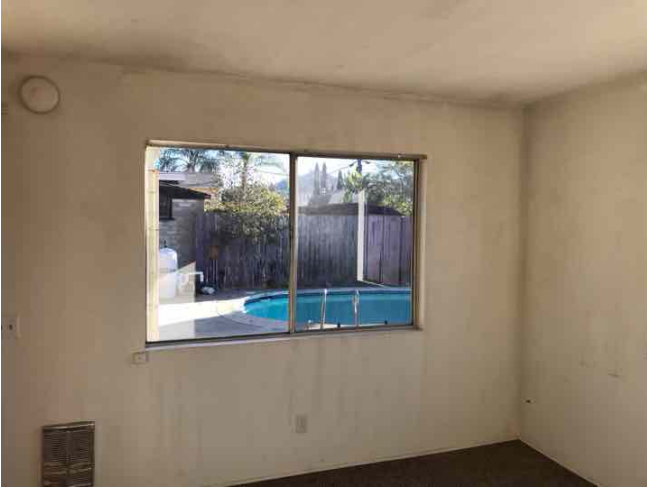
R 435: One window is stuck or has been painted shut and cannot be opened. We recommend repair to restore functional use. Careful work with a razor knife may be sufficient.

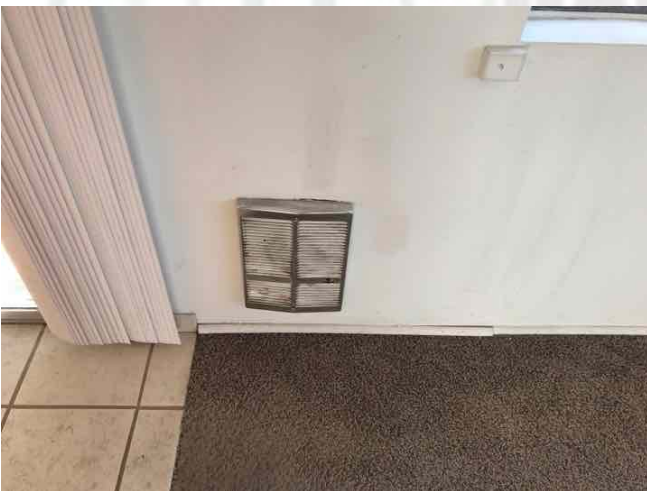
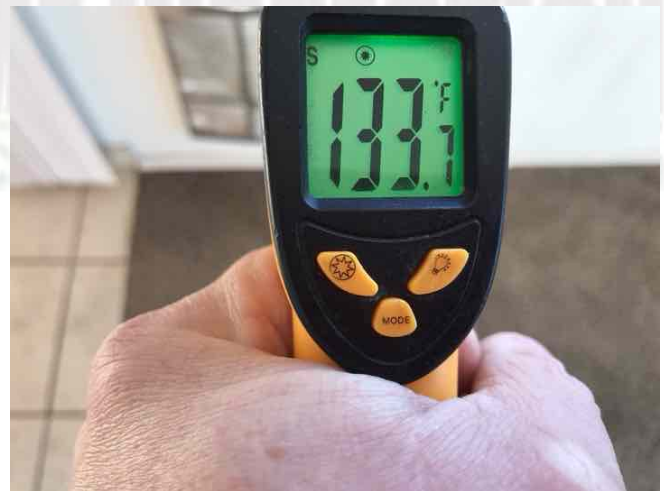
437: The electrical resistance heater appears to be properly installed and in serviceable condition and responded to the user controls.

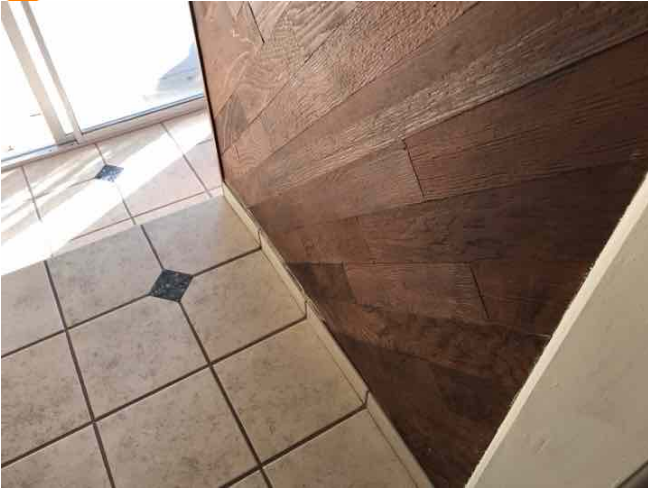
R 443: The walls are damaged at the baseboard. We recommend repair or refinishing.

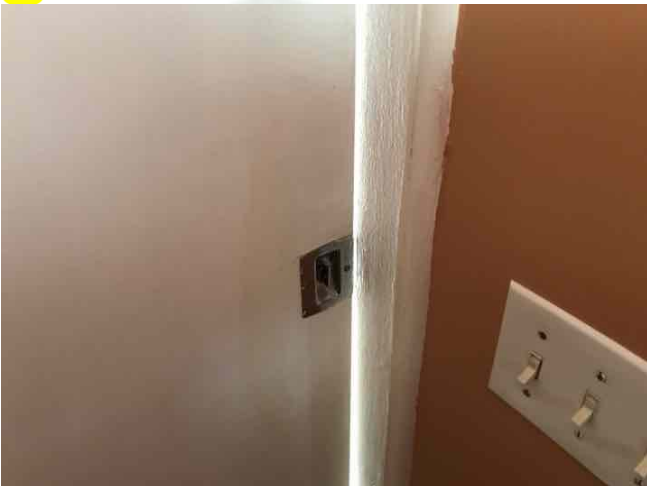
W 453: The bathroom door latch does not latch and needs service.

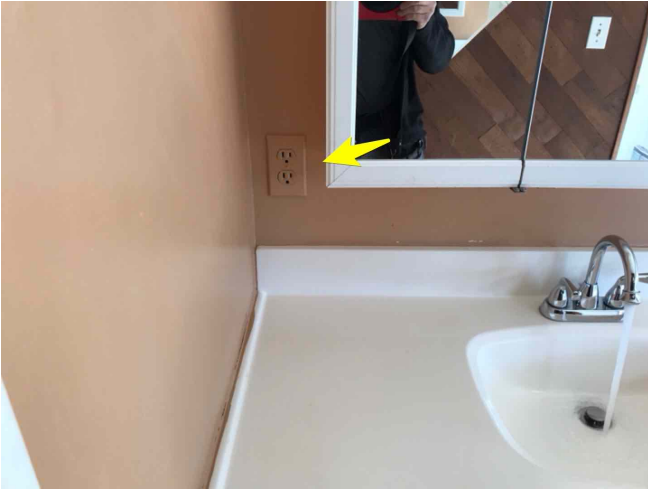
S 460: There is no GFCI (ground fault circuit interrupter) protection for this bathroom. For an increased margin of safety, we recommend the installation of a GFCI receptacle.

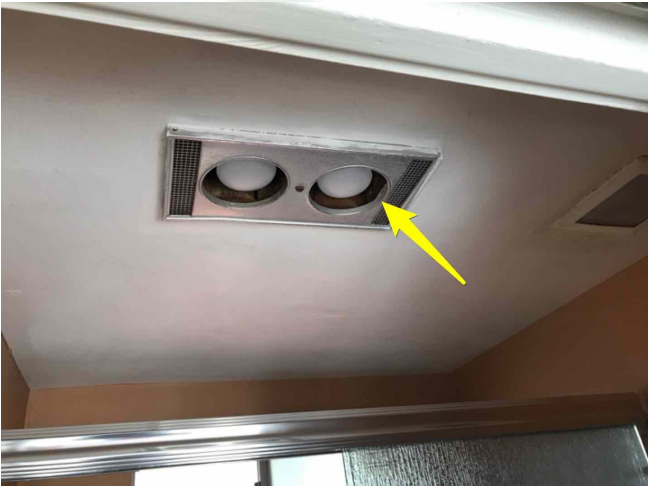
R 461: The electrical resistance heater failed to respond to normal operating controls. We recommend it be repaired or replaced.

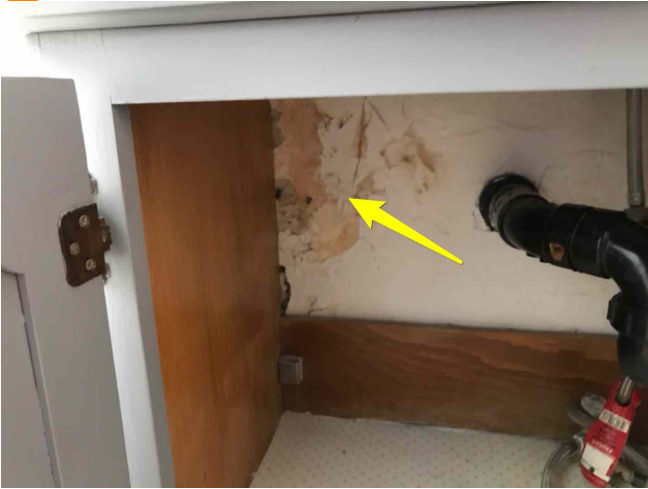
R 467: The walls are damaged at the bathroom . We recommend repair or refinishing.

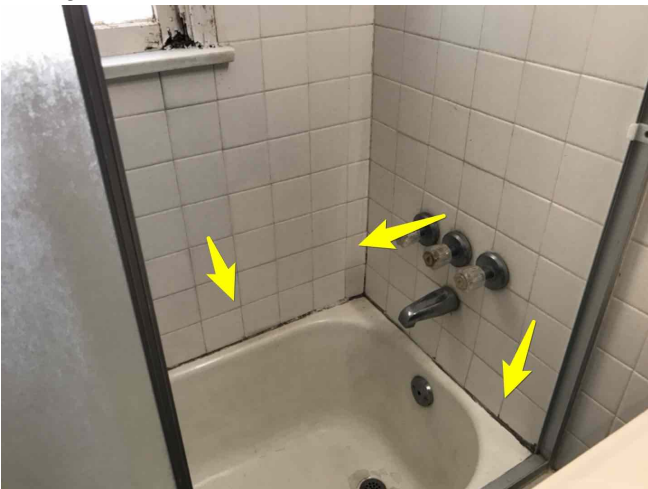
M 473: The joint caulking in and around the shower has mildewed. The joints should be scraped clean, chemically treated, and recaulked for a better appearance and to prevent moisture penetration into the surrounding materials and subsequent damage.

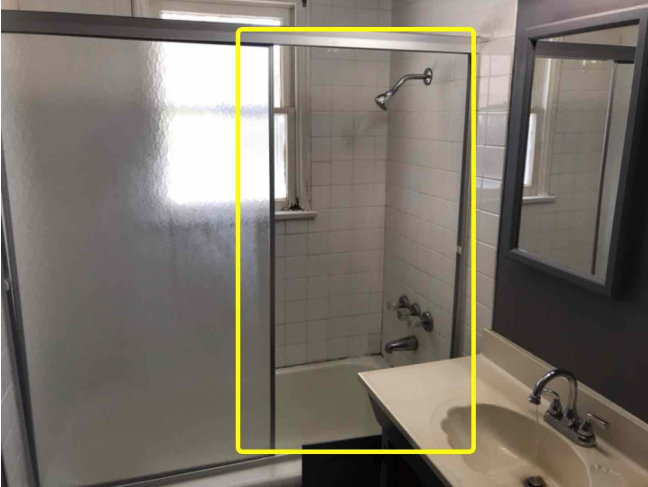
R 474: The shower doors have been removed.

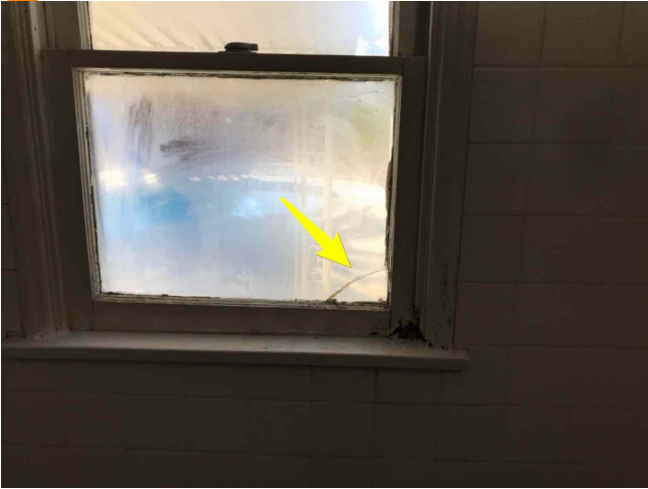
R 477: One or more panes of glass are broken. We recommend all broken glass be replaced.

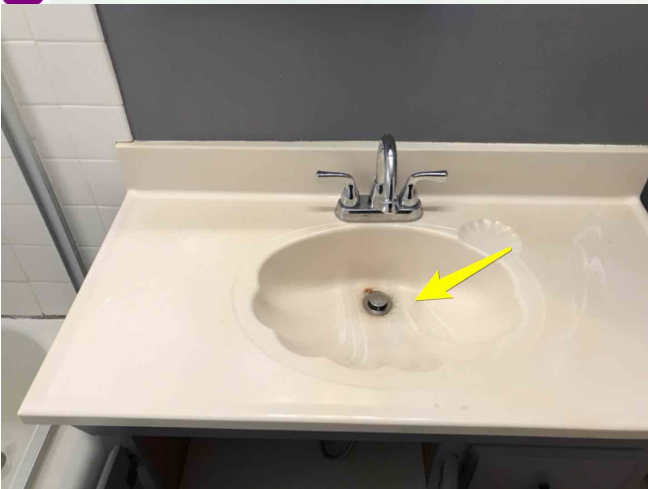
M 481: The drain stop is defective. We recommend it be repaired or replaced.

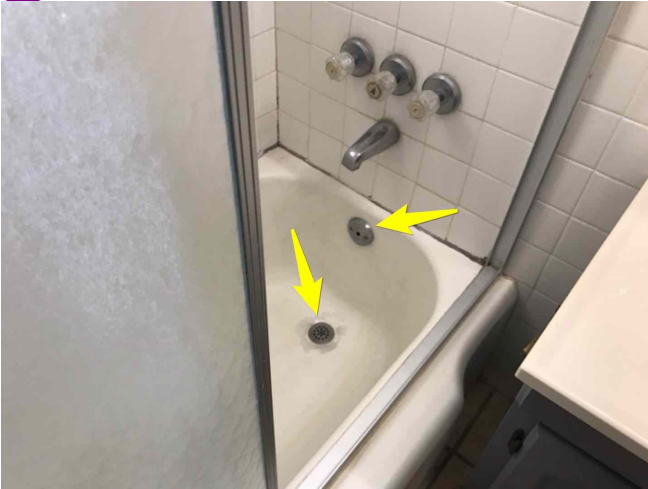
M 482: The drain stop is not operational. We recommend it be repaired or replaced.

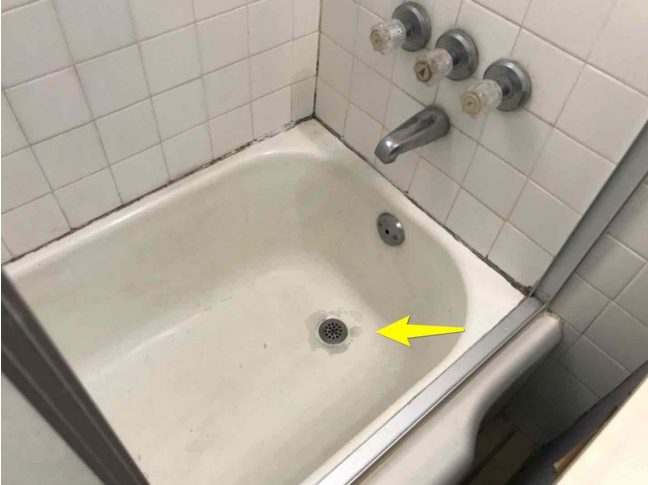
U 483: The surface finish of the bathtub is marred. Refinishing should be considered.

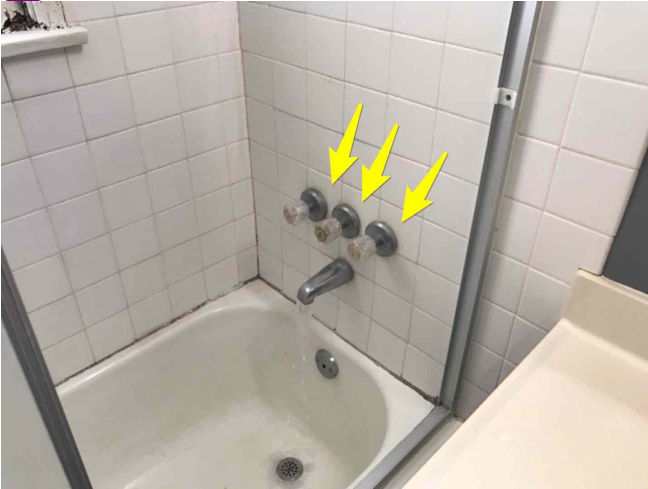
M 489: Caulking needed at shower valves to prevent moisture intrusion or damage.

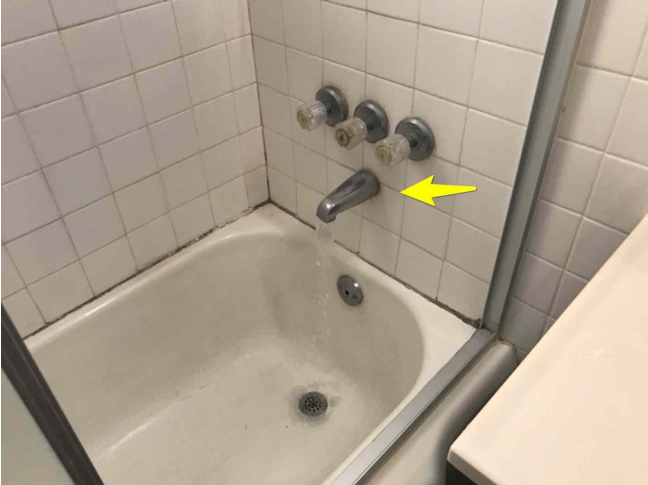
M 490: Caulking needed at tub spout to prevent moisture intrusion or damage.

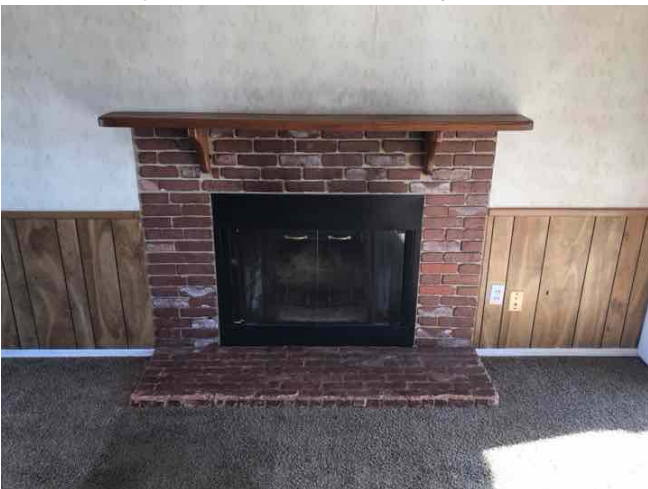
491: The fireplace is located in the family room.

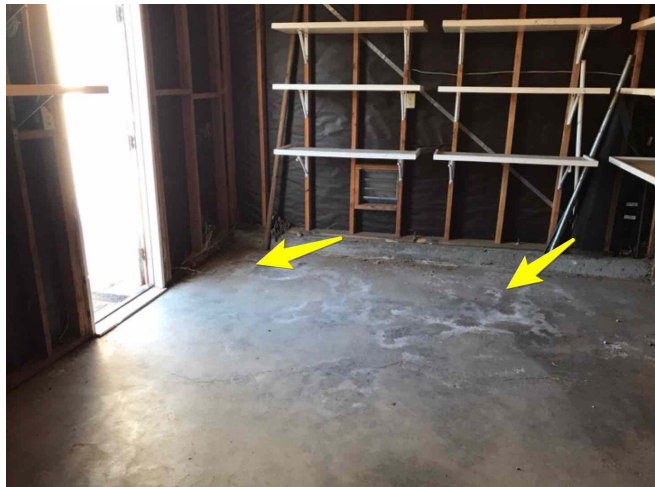
W 507: There is signs of efflorescence to the concrete in the garage. This can be a sign of a moisture or drainage issue. Further evaluation is advised by an appropriate qualified professional.

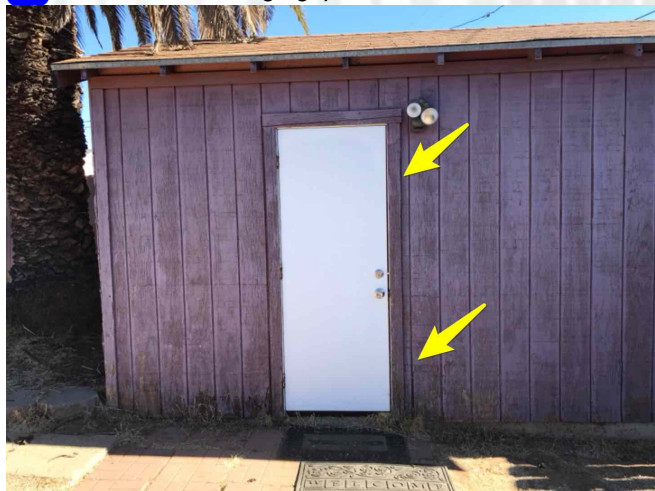
U 508: There are large gaps around door sides of the exterior garage door. It's advised that weather stripping be added.

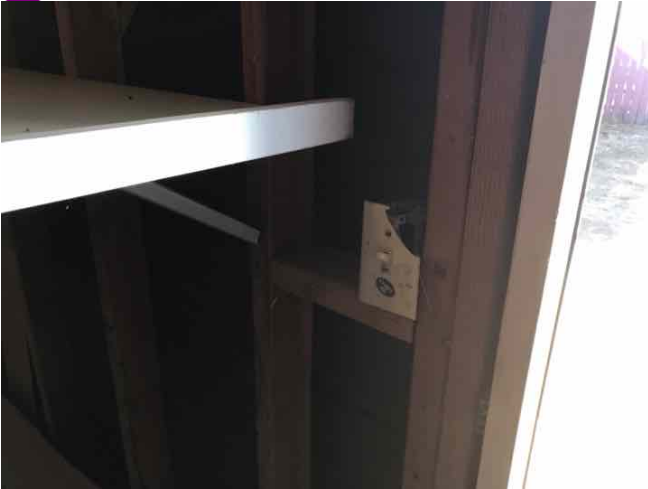
M 513: The cover plate for a switch is broken. Replacement is recommended.

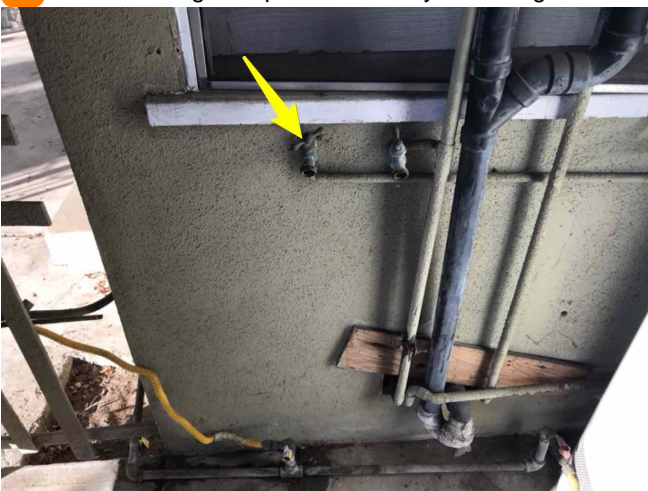
R 516: The angle stop at the laundry is leaking. We recommend it be repaired or replaced to prevent water damage.

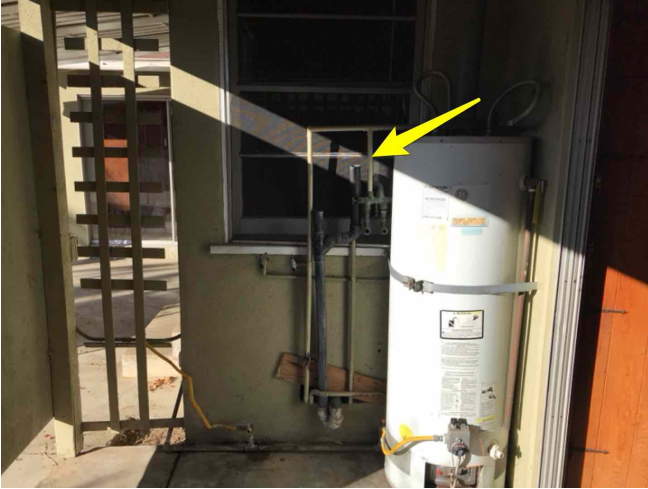
R 517: The drain trap has been installed in a substandard manner. We recommend it be repaired or replaced. Not properly vented above the roof line.

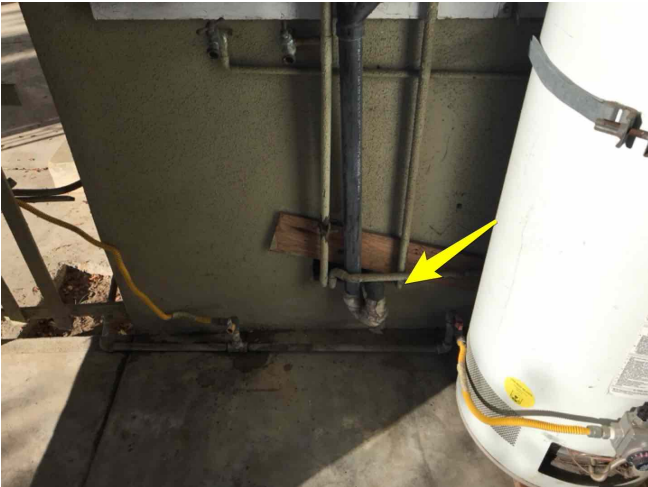
518: The drain trap is damaged. We recommend it be replaced.

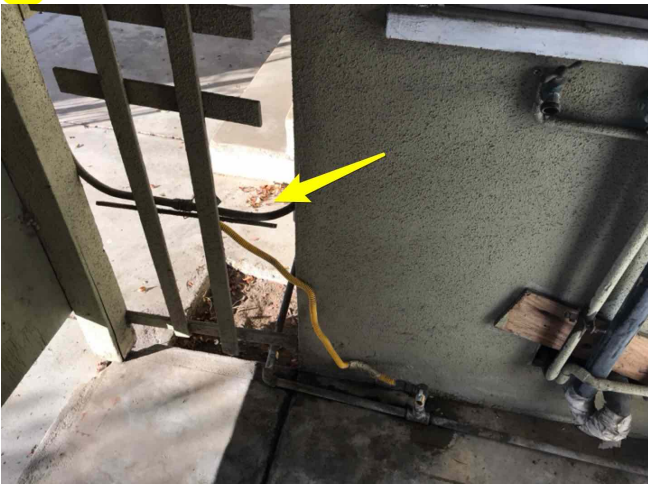
W 519: The gas valve should be capped if not in use.

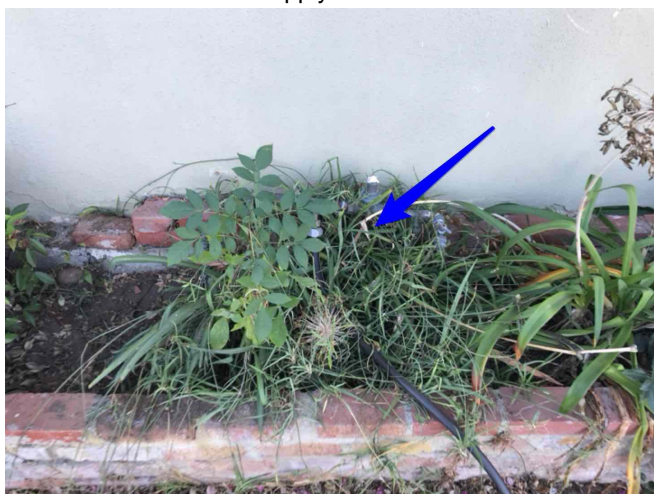
3: The domestic water supply main shut-off valve is outside at the front of the building.

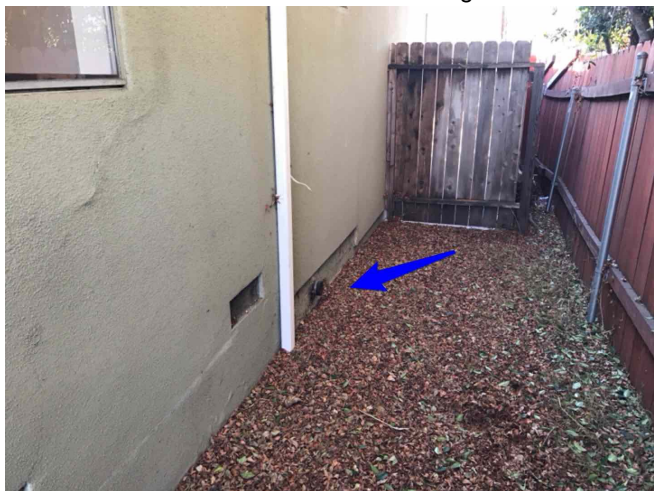
4: The sewer cleanout is located on the right side of the structure.

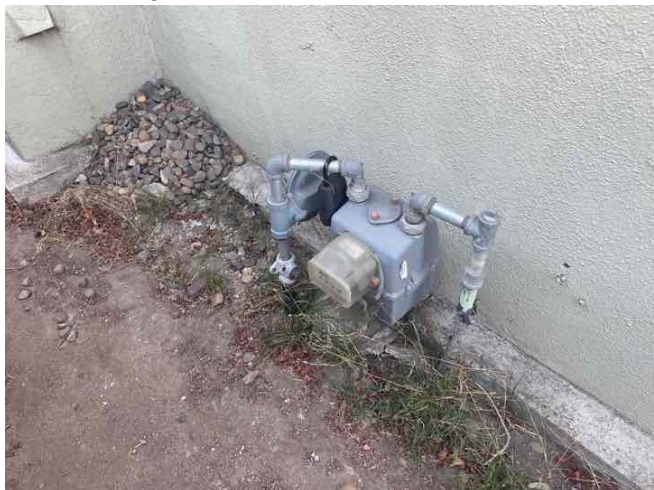
5: The gas meter is outside on the left side of the building. The main gas supply shutoff valve is located on the riser pipe between the ground and the meter. This valve should be turned 90 degrees (either way) in order to shut off the gas.
