# DeBerry / HomeSite Inspections

5702 Baltimore Drive, #255  
La Mesa, CA 91942  
File #: 201006-S1  
October 6th, 2020

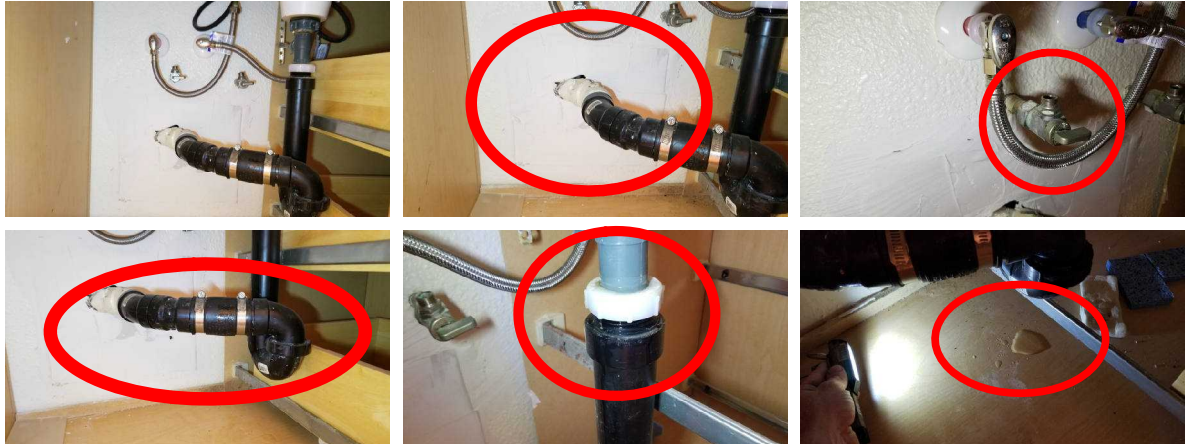
Corrosion on the faucet fixtures. Water control valve handles slightly difficult to operate. Faucet is slightly loose at the base connection. This should be secured in place & sealed.

Recommend further review & repairs by a licensed plumbing contractor.

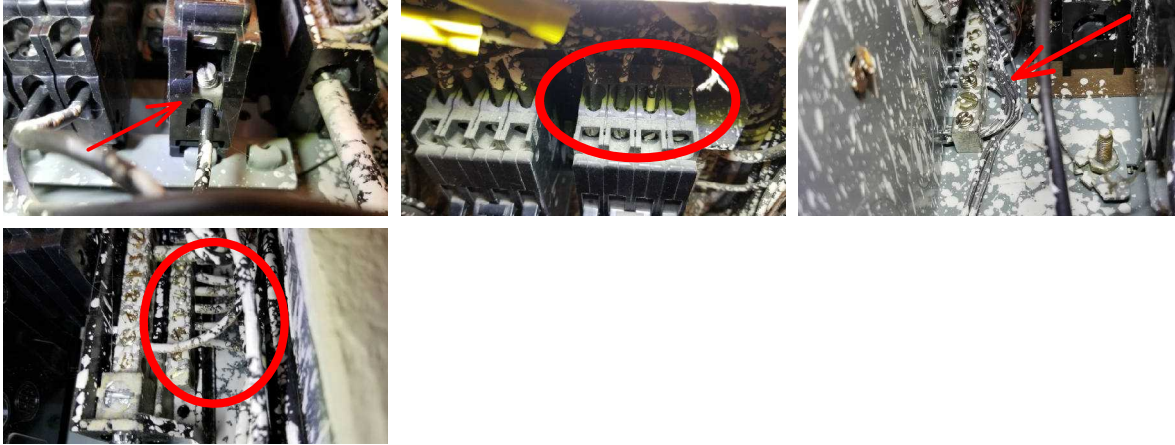
See "Panel Notes" regarding the electrical panel and panel components. Further evaluation is recommended. Recommend further review and repairs by a licensed electrical contractor.

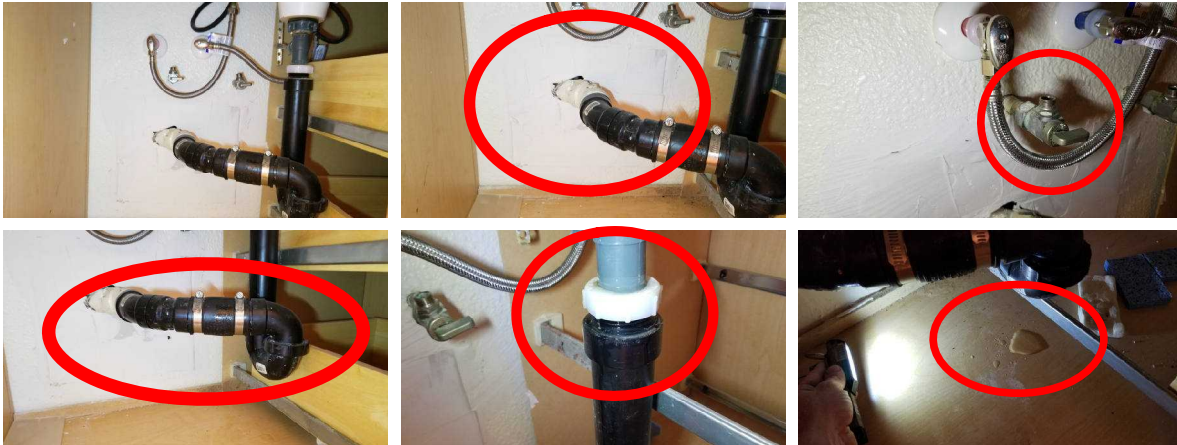
Recommend further review & repairs by a licensed plumbing contractor.
