# **Inspection Report**

**Property Address:**  
12136 St Andrews Dr  
Rancho Mirage CA 92270

**Livingston Home Inspections, Inc.**

<b>Date:</b> 4/27/2022	<b>Time:</b> 09:00 AM	<b>Report ID:</b> 20220427-12136-St-Andrews-Dr
<b>Property:</b> 12136 St Andrews Dr Rancho Mirage CA 92270	<b>Customer:</b> Garrett Saikley	<b>Real Estate Professional:</b> Jonathan Olow Big Block Realty

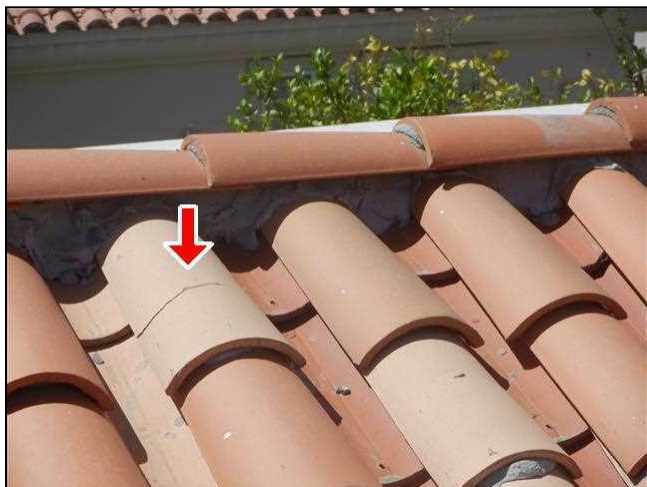
**1.0** (1) We noted several damaged and slipped tiles on the gable portion of this roof at time of inspection. Damaged roofing materials can lead to roof leaks. Recommend evaluation and replacement of all damaged tiles by a licensed roofing contractor.

1.0 Item 1(Picture) Damaged Tile

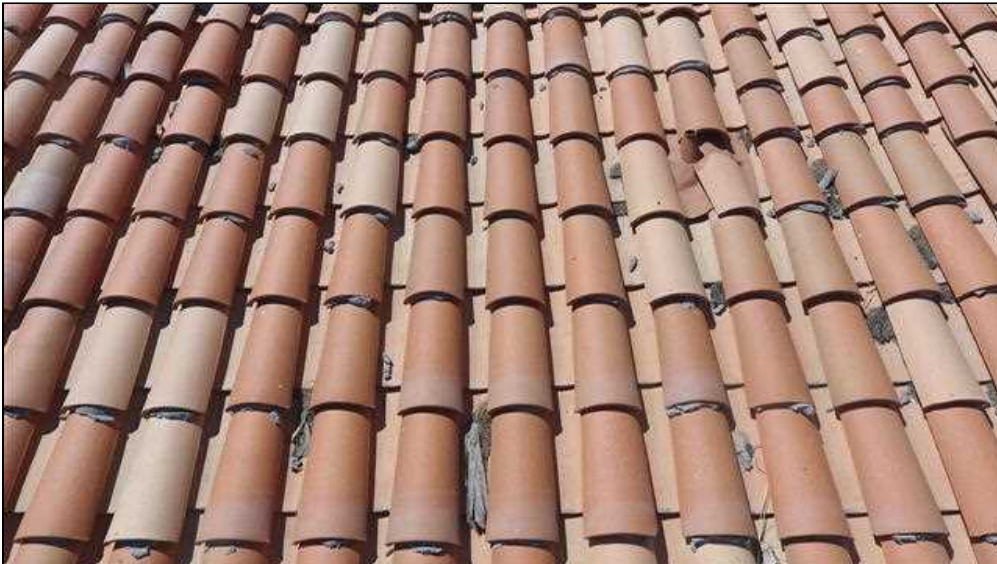
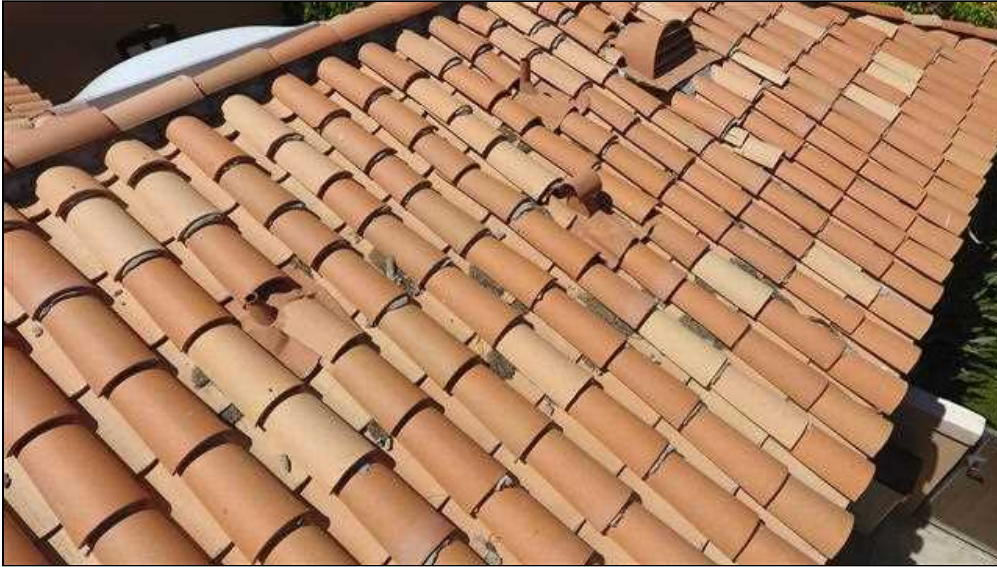
1.0 Item 9(Picture) Gable Roof Covering

1.0 Item 10(Picture) Gable Roof Covering

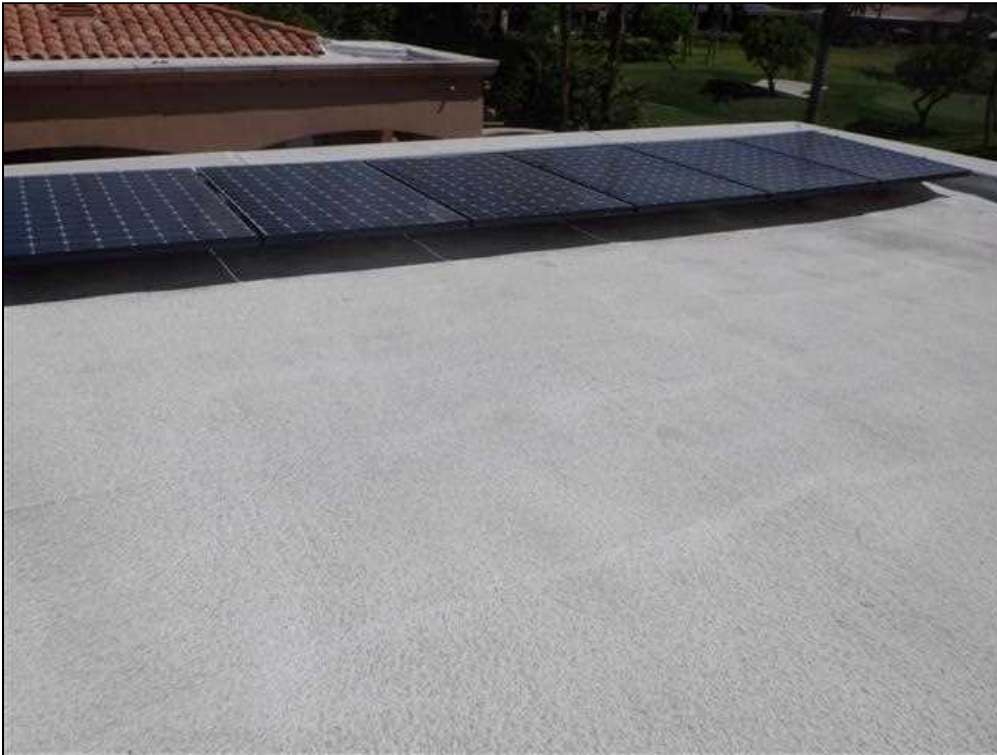
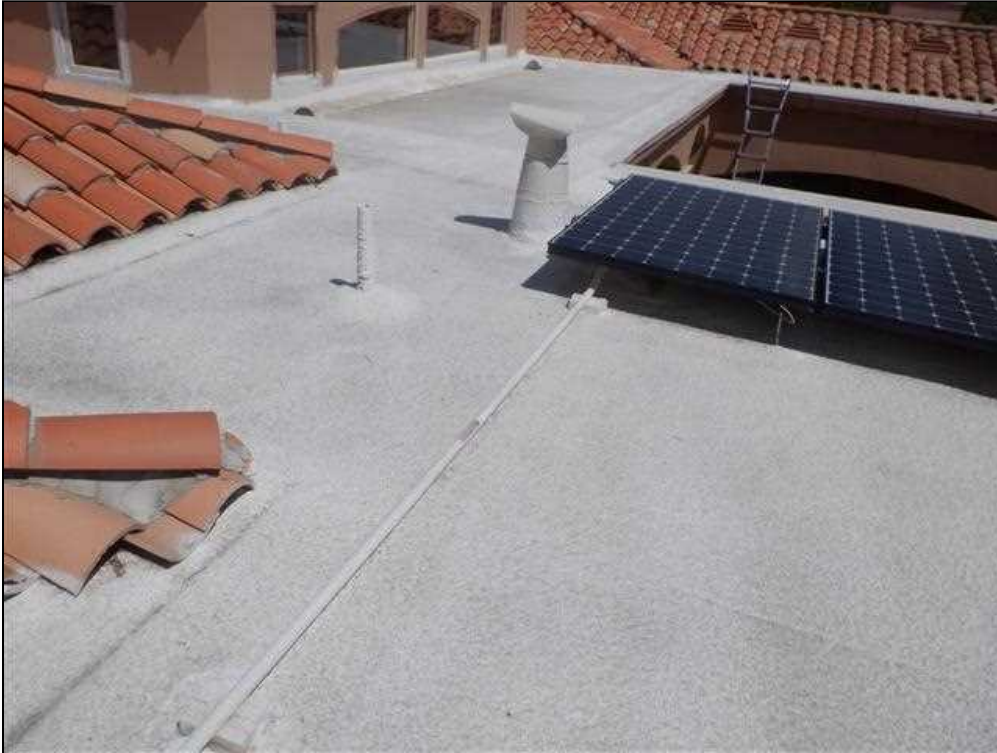
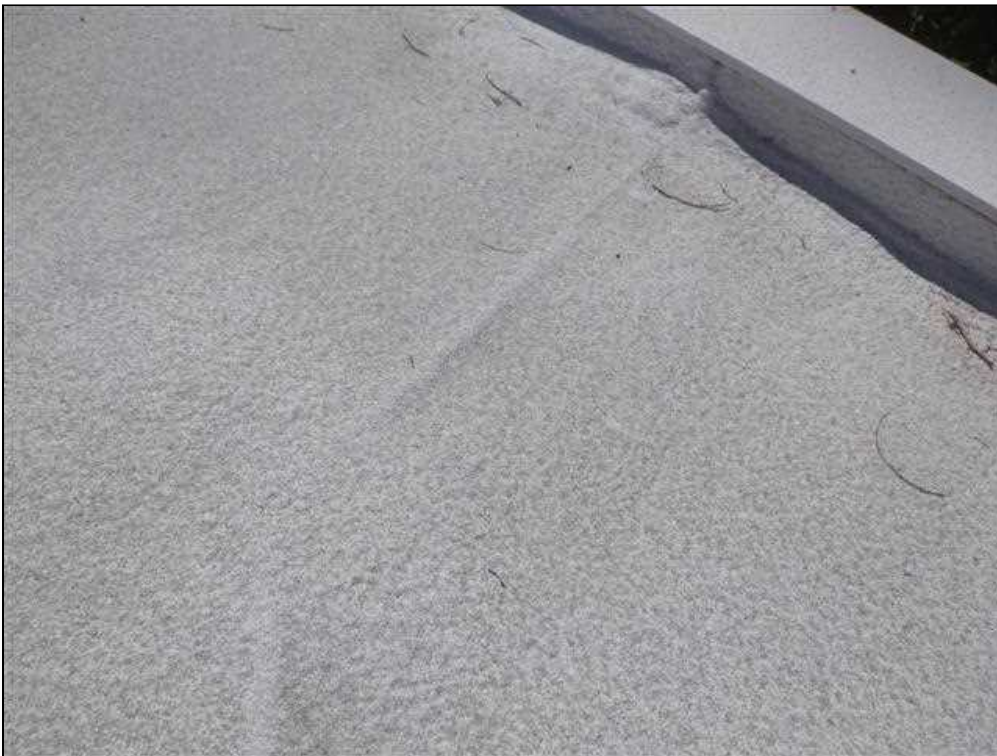
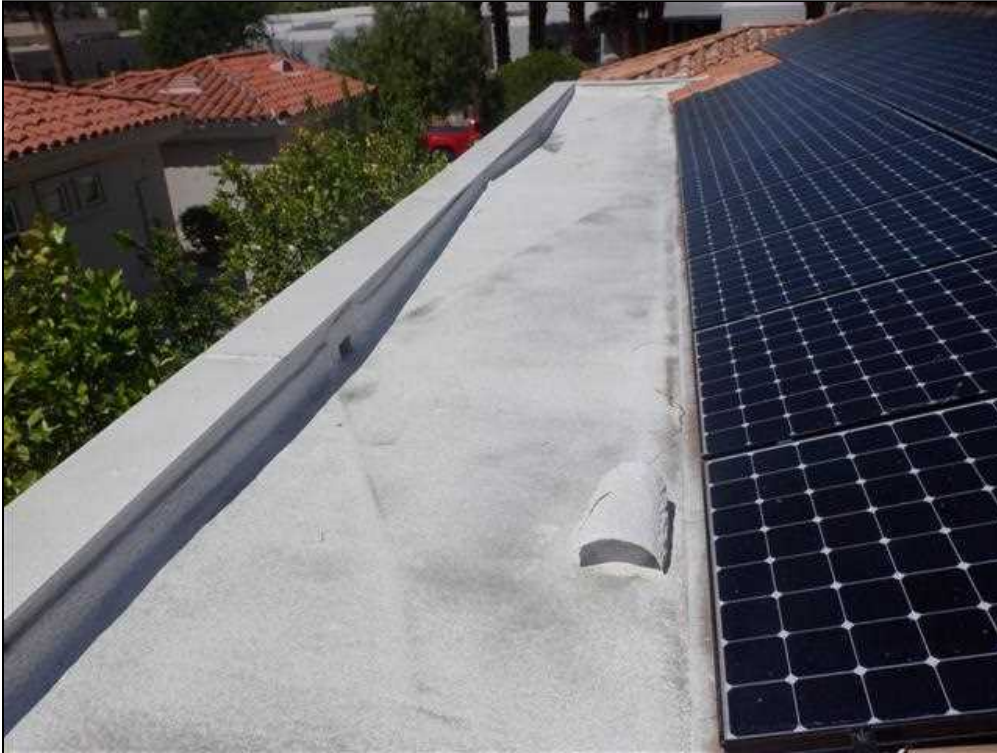
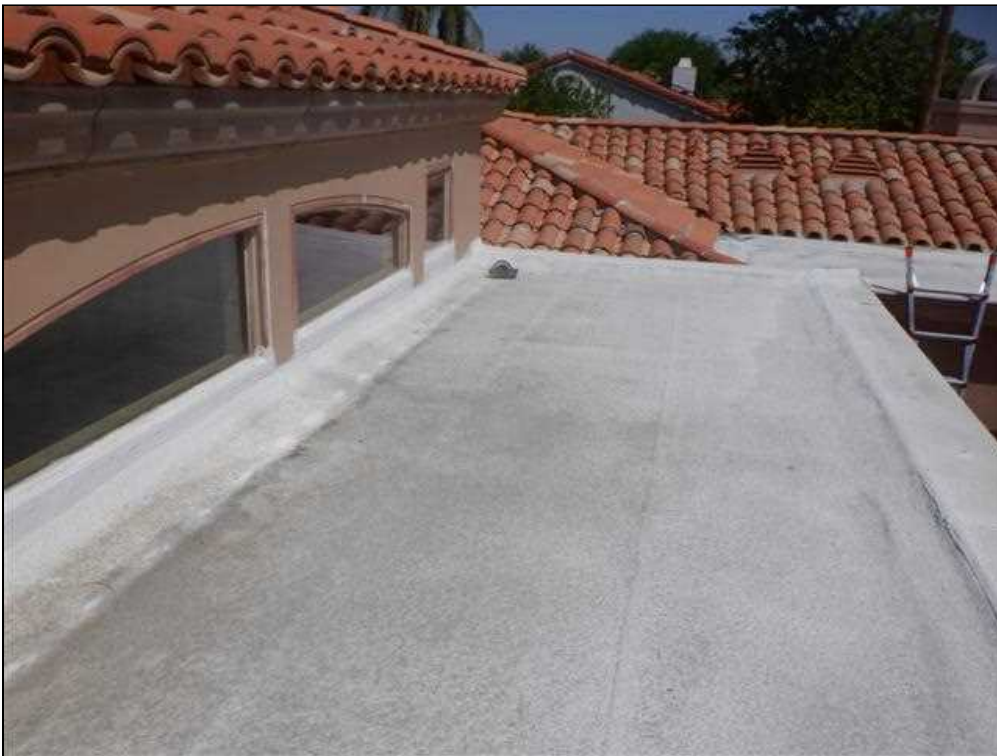
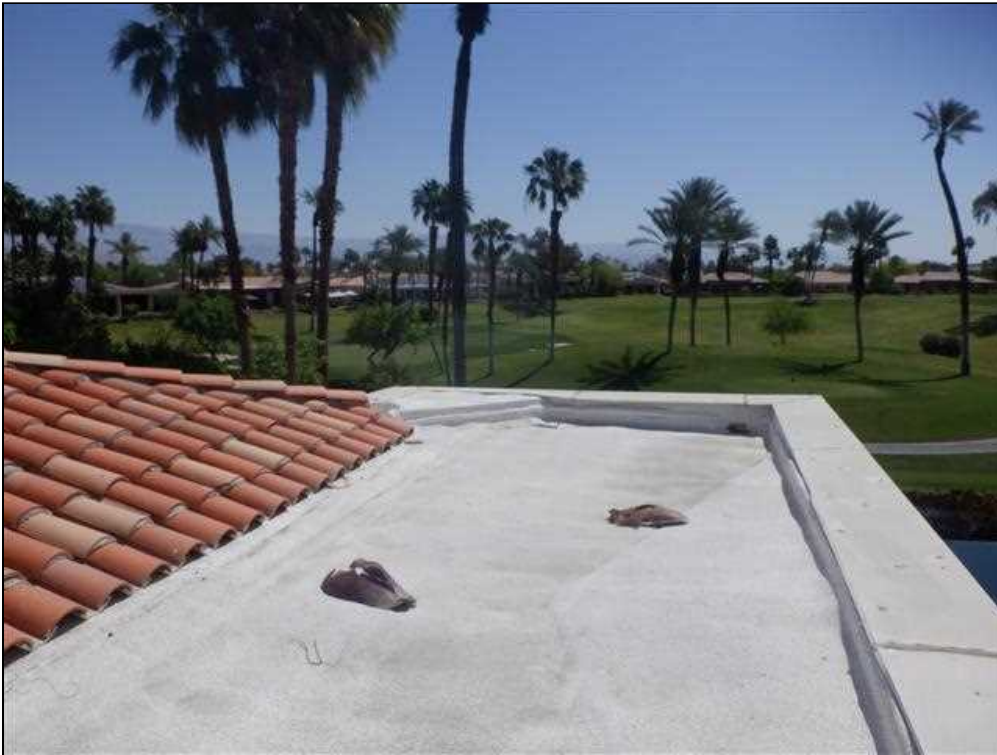
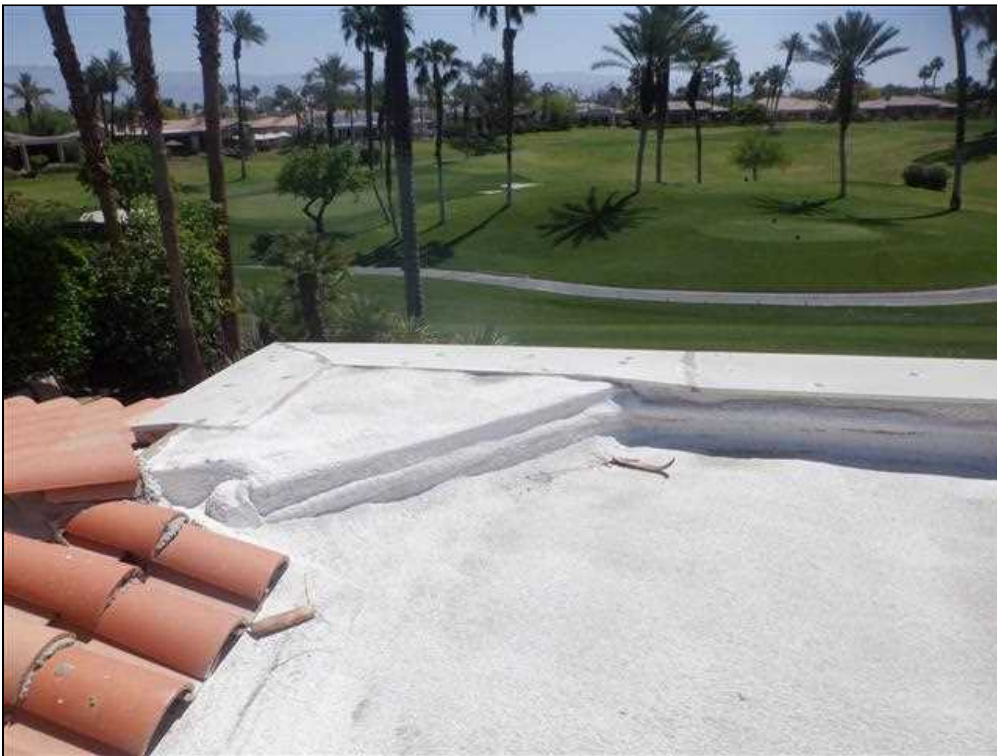
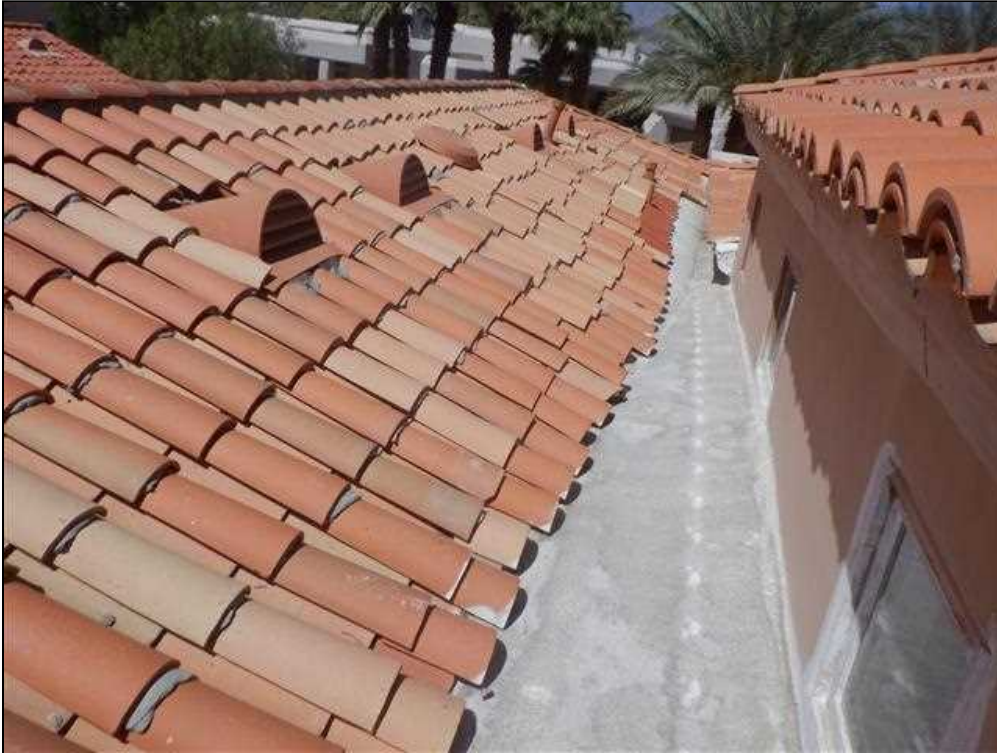
**1.0 (2)** Low slope and flat roofs are prone to leakage however we did not note any irregularities in this roof at time of inspection. This roof consist of polyurethane foam with a coating and this roof appeared to be in good condition.

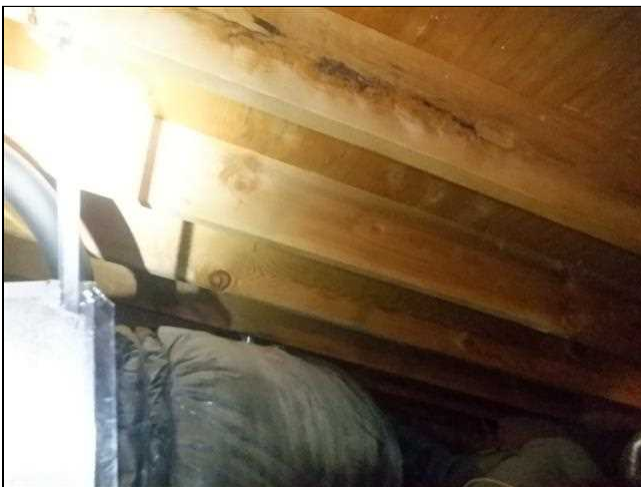
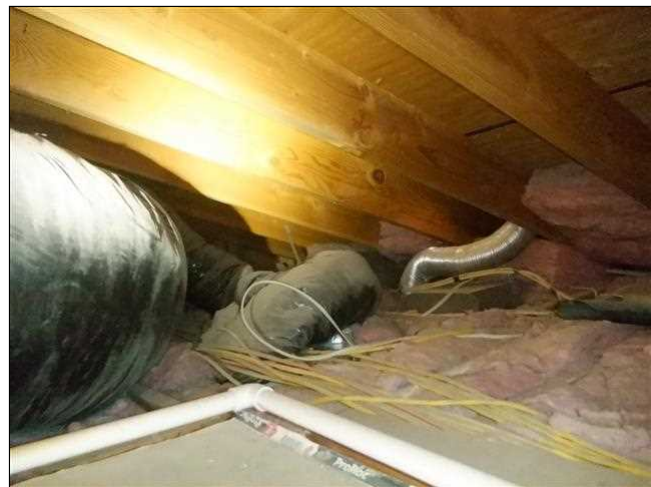
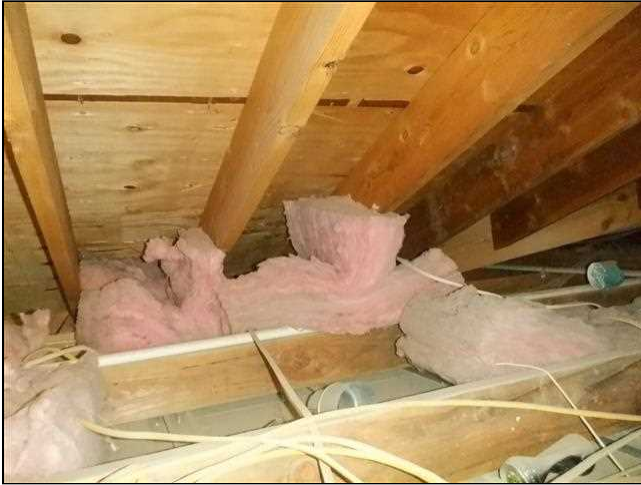
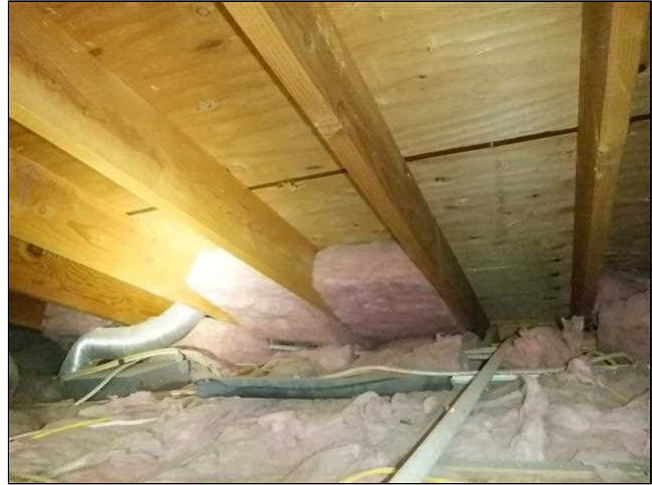
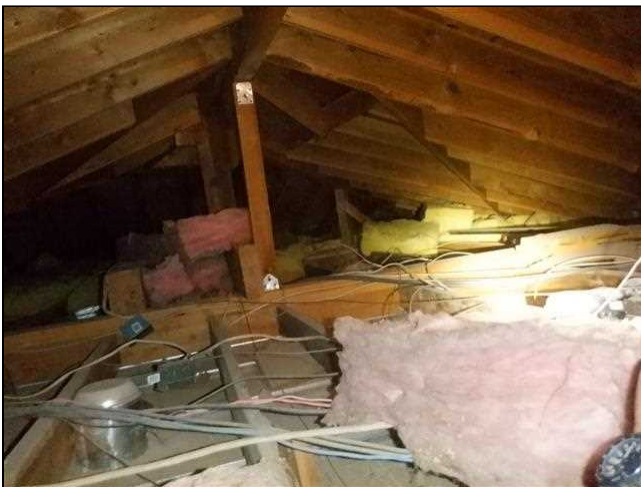
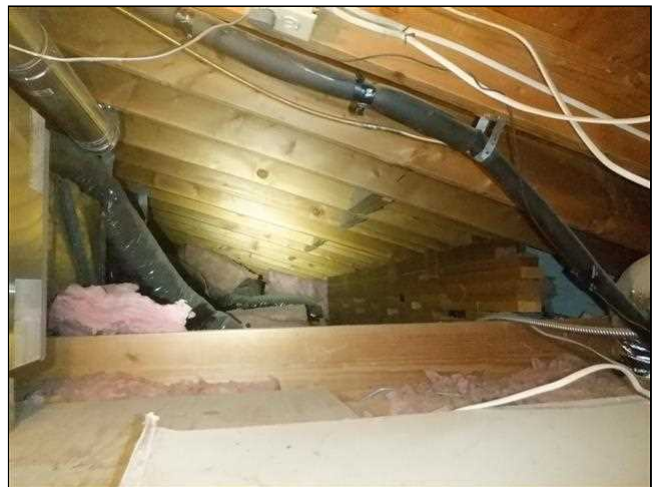
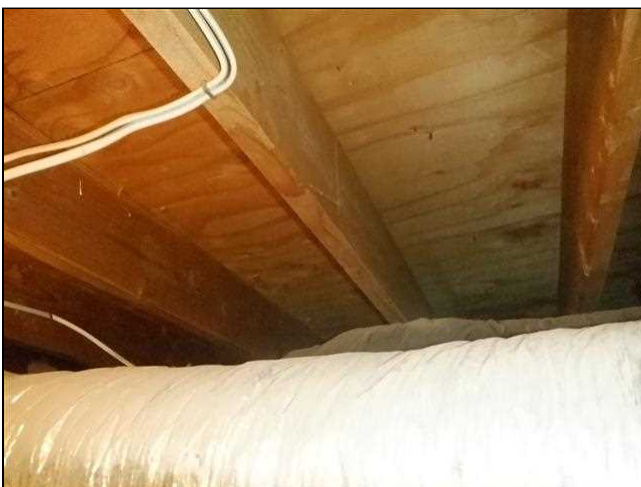
**1.5** Although we had a limited view in this attic visible portions of the roof decking/sheathing had no evidence of leaks or staining at the time of inspection, as well as all of the portions of the ceilings in the house.

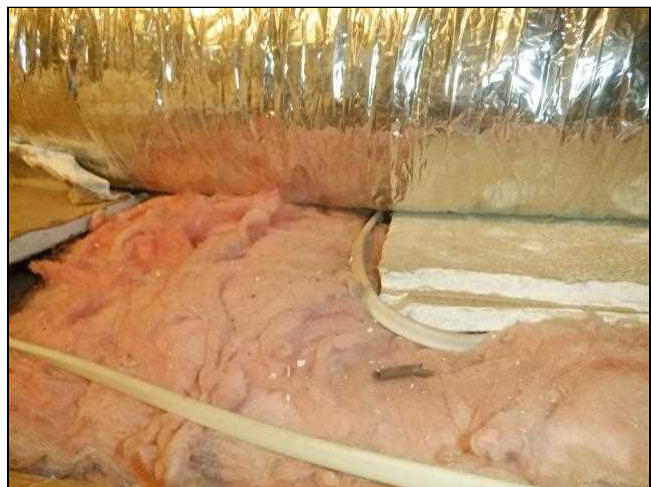
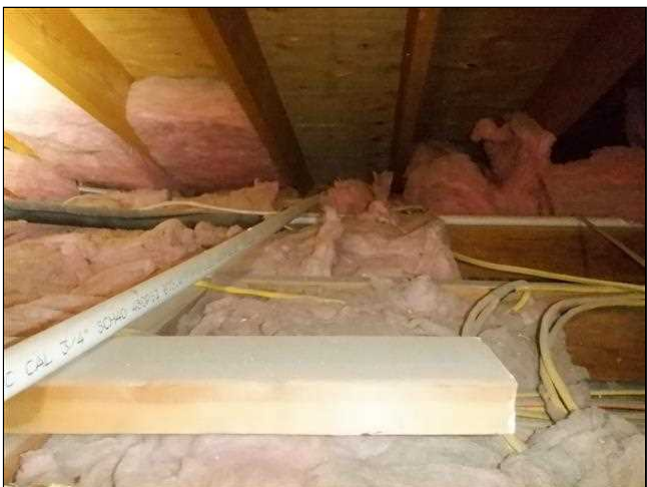
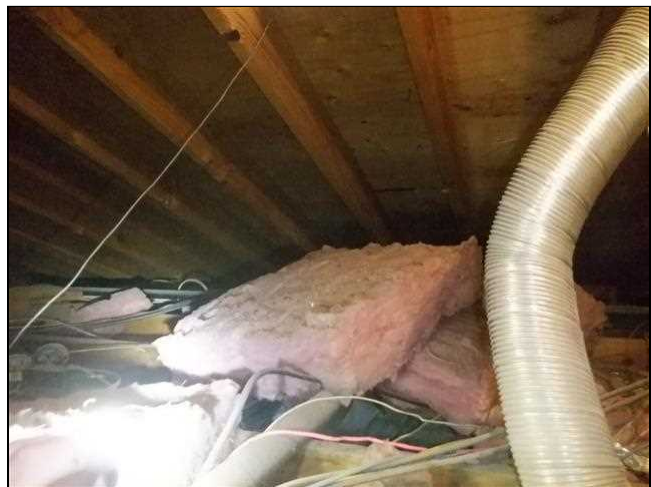
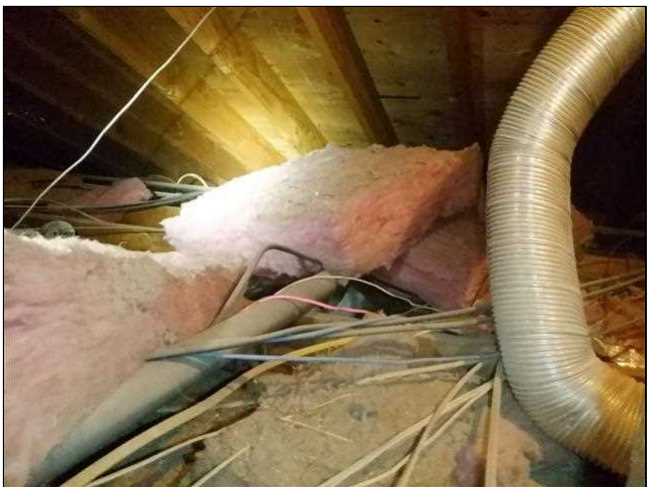
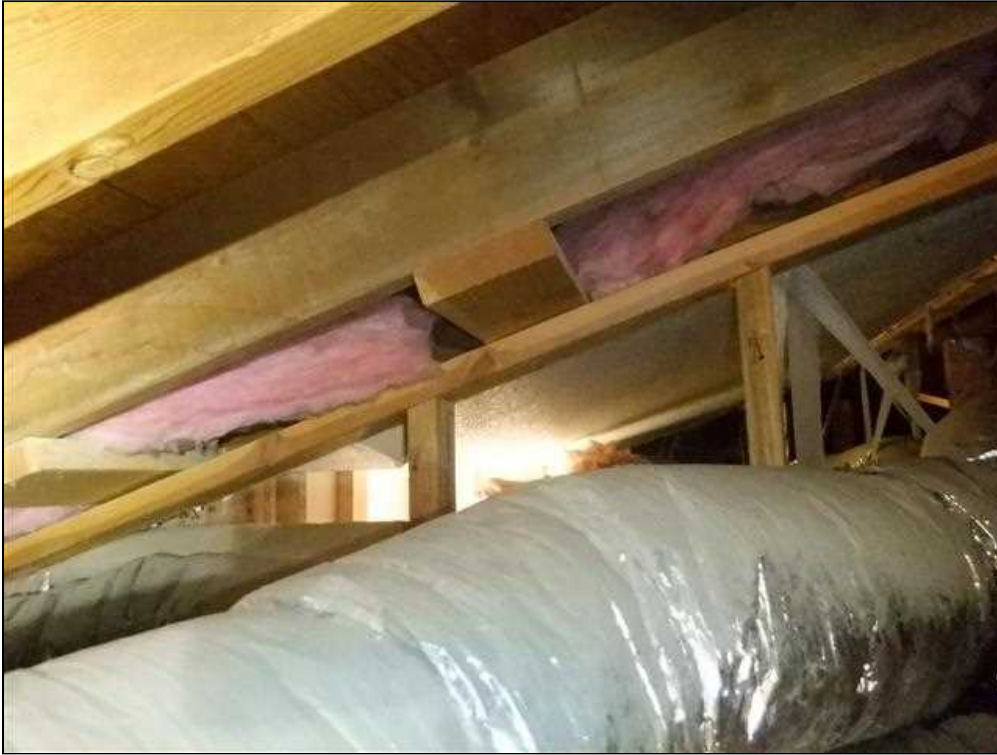
1.6 This attic was insulated with fiberglass batt that was at least 6-8 inches thick.

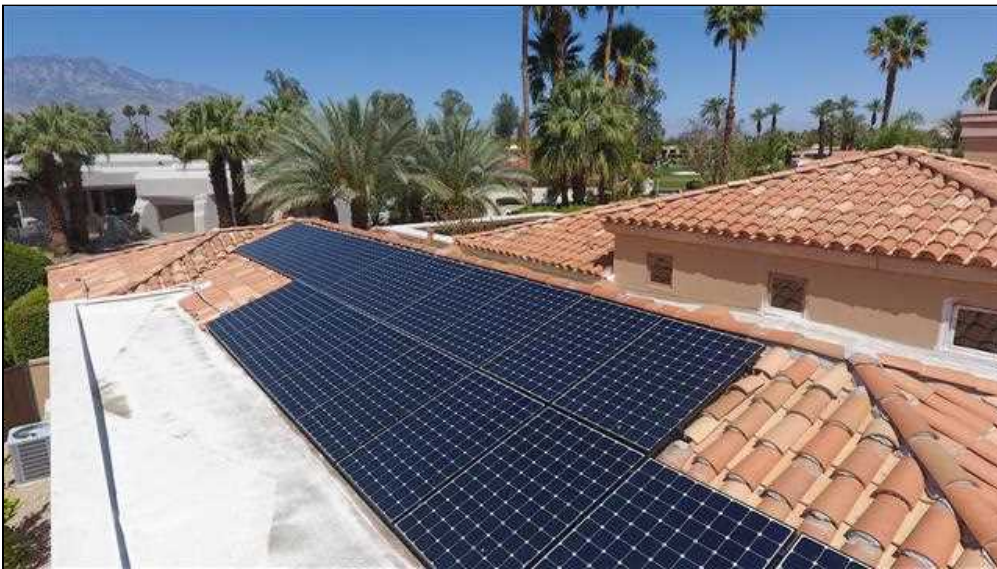
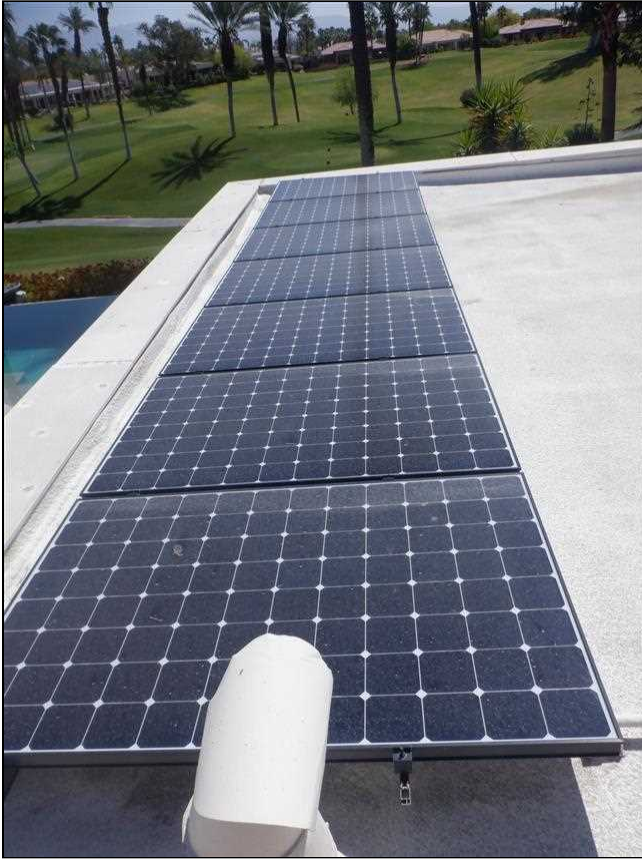
**1.9** We noted that this house is equipped with solar panels. Our company dose not inspect solar panels and we have no way of telling if they are functioning properly or if they were installed correctly. Improperly installed solar panels can lead to roof leaks. This solar equipment should be evaluated by a licensed specialist.

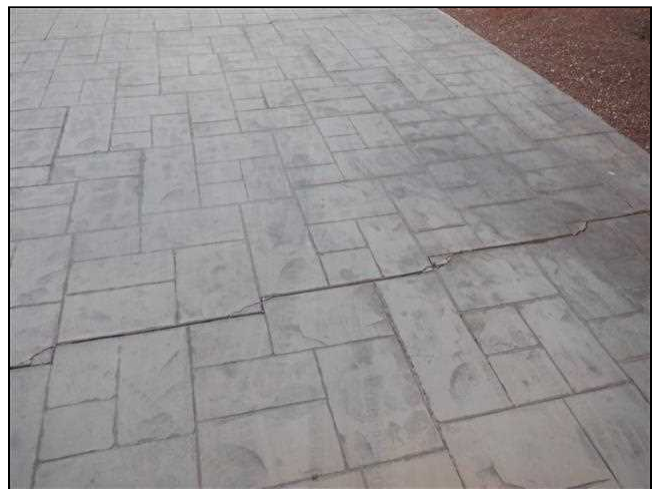
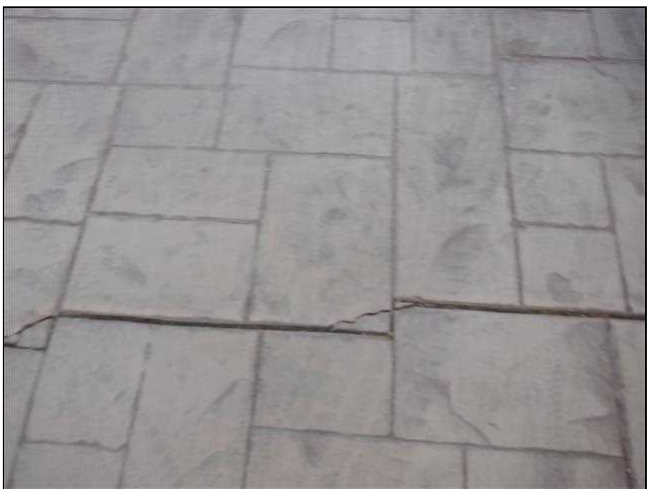
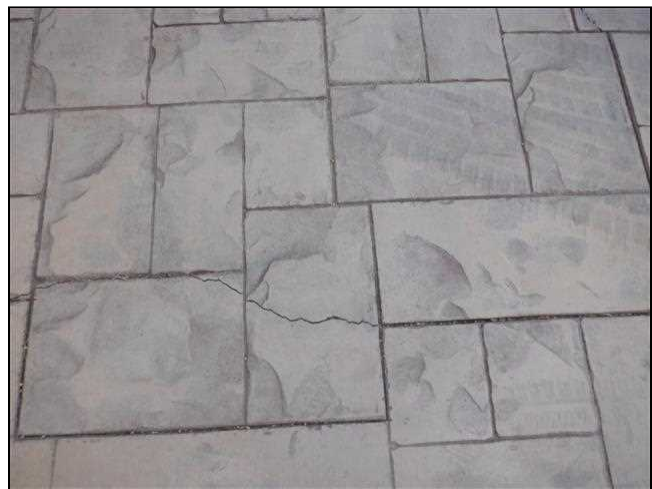
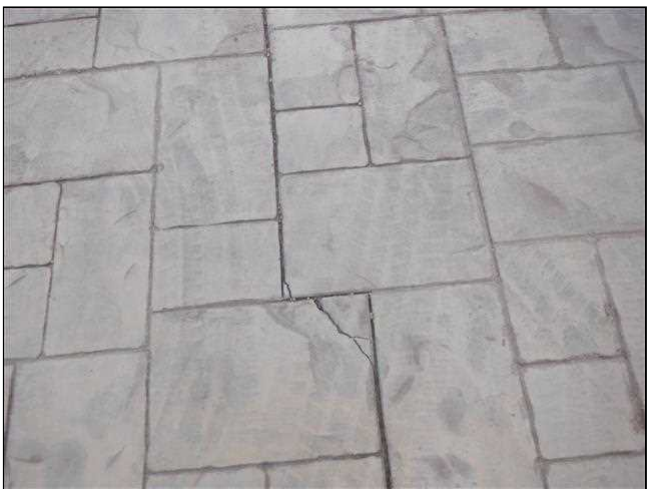
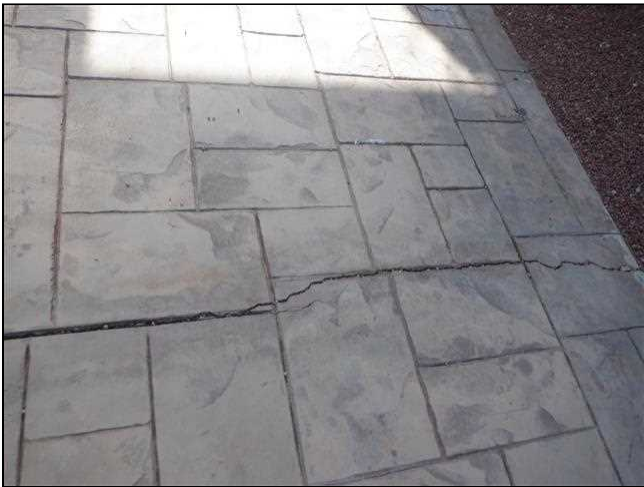
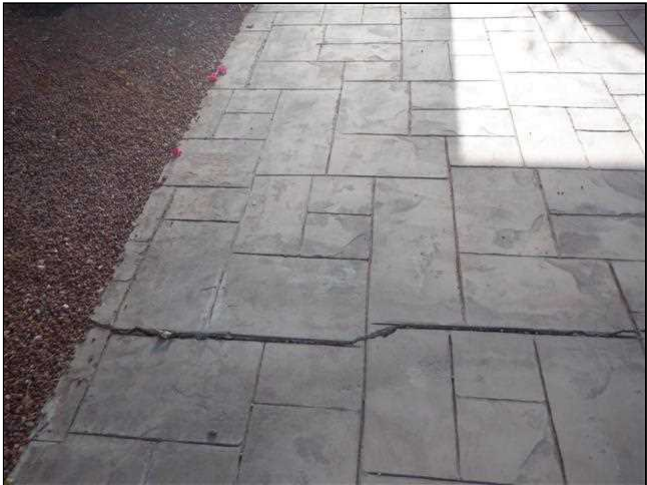
**2.4** (1) Settlement cracks were noted in the concrete driveway and walkway. These slab cracks are normal settlement cracks for a home this age, no uplift or trip hazards were noted. Recommend evaluation and repair as needed.

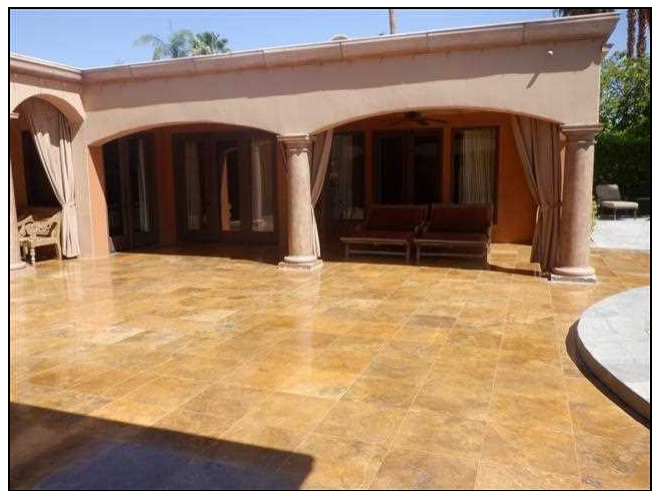
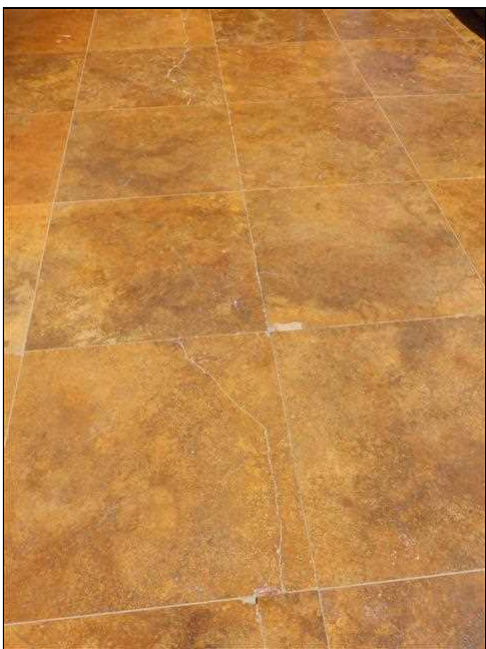
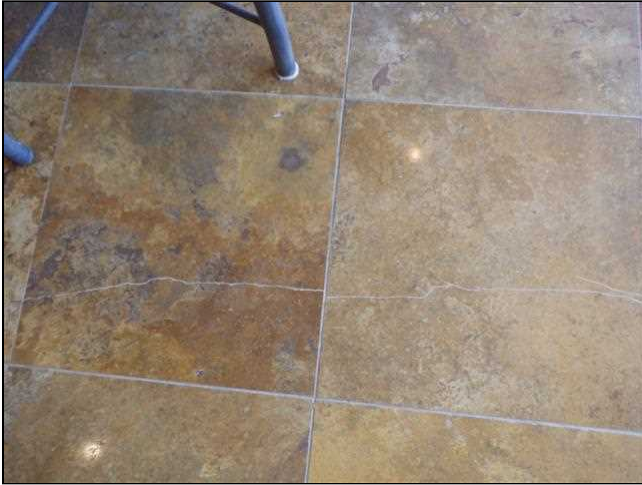
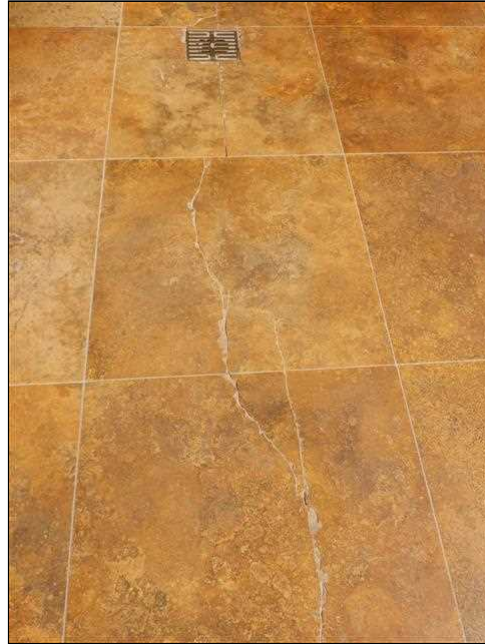
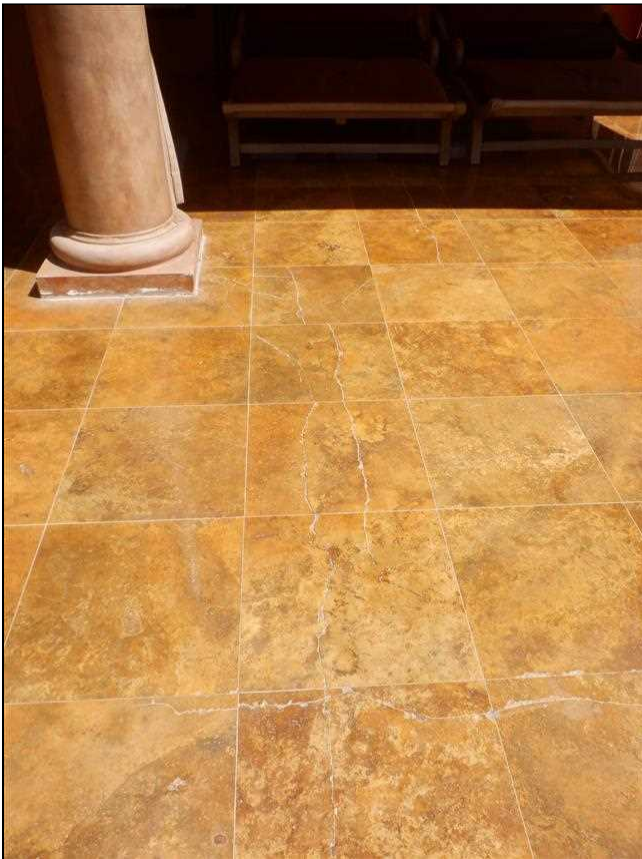
2.4 (3) We noted several cracked tiles on the exterior of the house (patio) at time of inspection. We believe that these damaged tiles are a cosmetic issue. Recommend replacement of any damaged tiles by a licensed contractor..

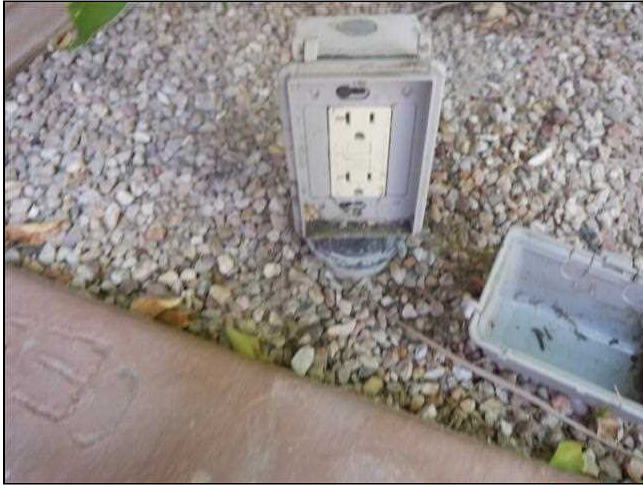
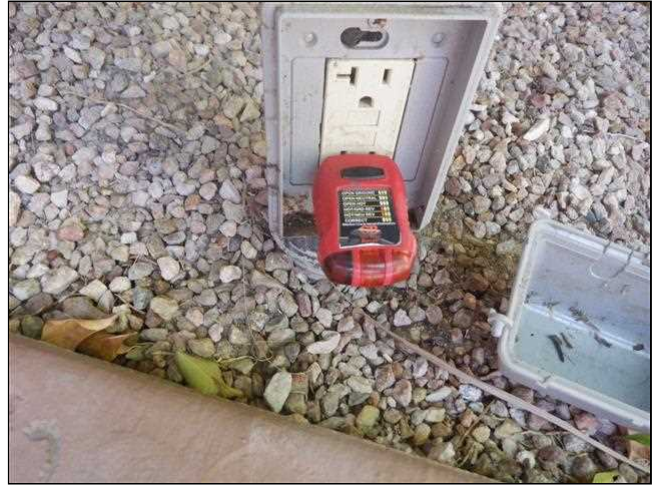
**2.7** Although exterior outlets are GFCI protected we noted that the GFCI outlet in the upper courtyard failed to re-set upon testing. Recommend replacing GFCI outlet as needed by a licensed electrical contractor.

2.7 Item 1(Picture) Upper Courtyard GFCI Failed To Reset

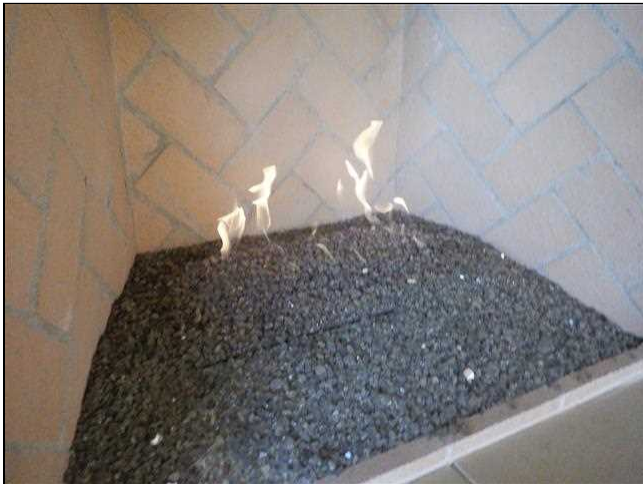
**2.9** This fireplace is a vented metal refractory brick fireplace with a gas burner and it was functioning properly at time of inspection.

2.9 Item 1(Picture) Exterior Fireplace

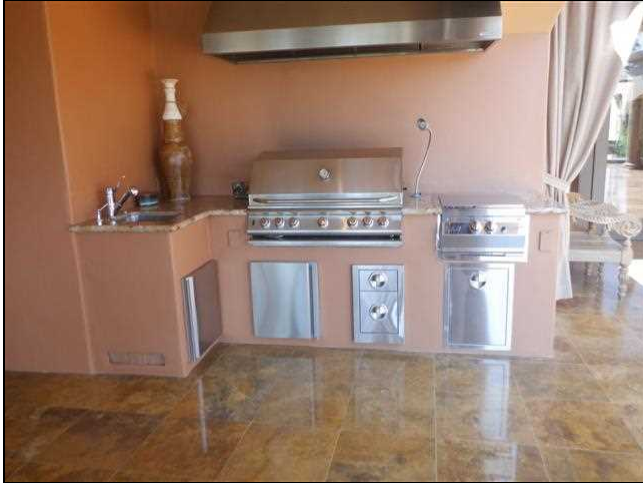
**2.15 (1)** All BBQ Island appliances appeared to be functioning properly at the time of inspection.

2.15 Item 1(Picture) BBQ Island

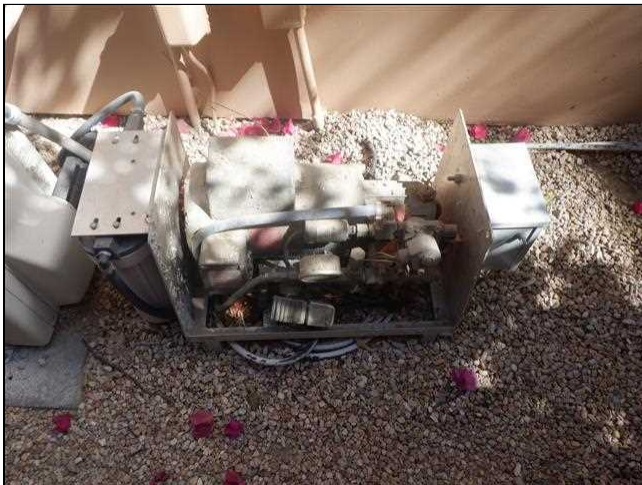
**2.17** These misting system (2 pumps total) were not functioning at time of inspection. Recommend evaluation and repair by a licensed contractor.

2.17 Item 1(Picture) Misting System Pump 1

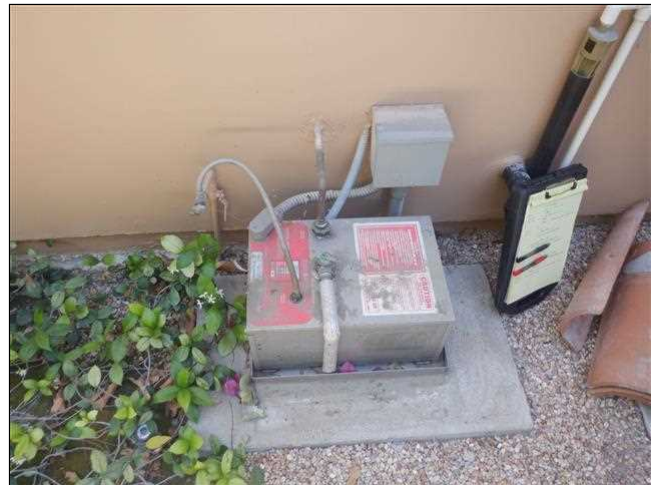
2.17 Item 2(Picture) Misting System Pump 2

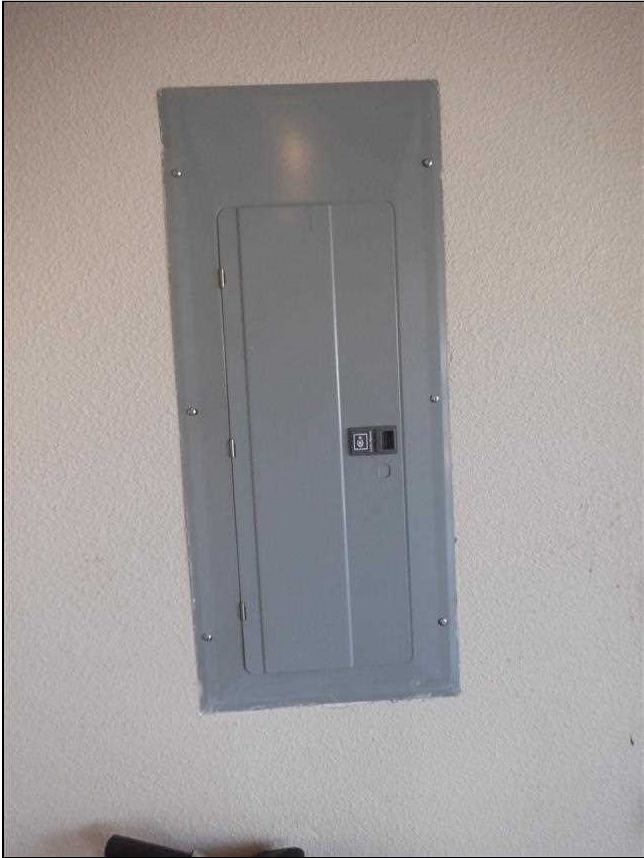
3.10 The electrical sub panel is located in the garage, this sub panel appeared to be in good condition, we did not find any irregularities in this panel.

3.10 Item 1(Picture) Electrical Sub Panel

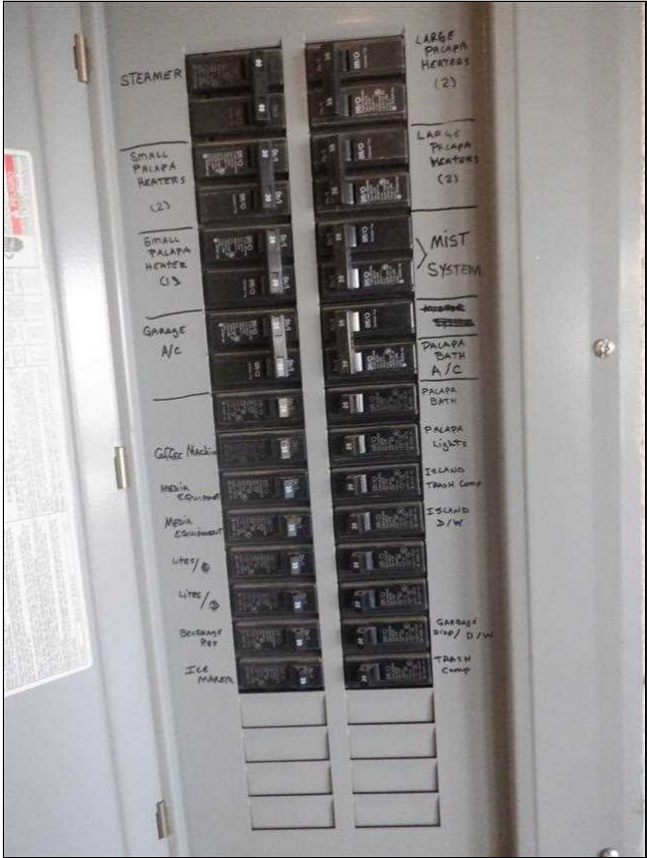
3.10 Item 2(Picture) Electrical Sub Panel Distribution

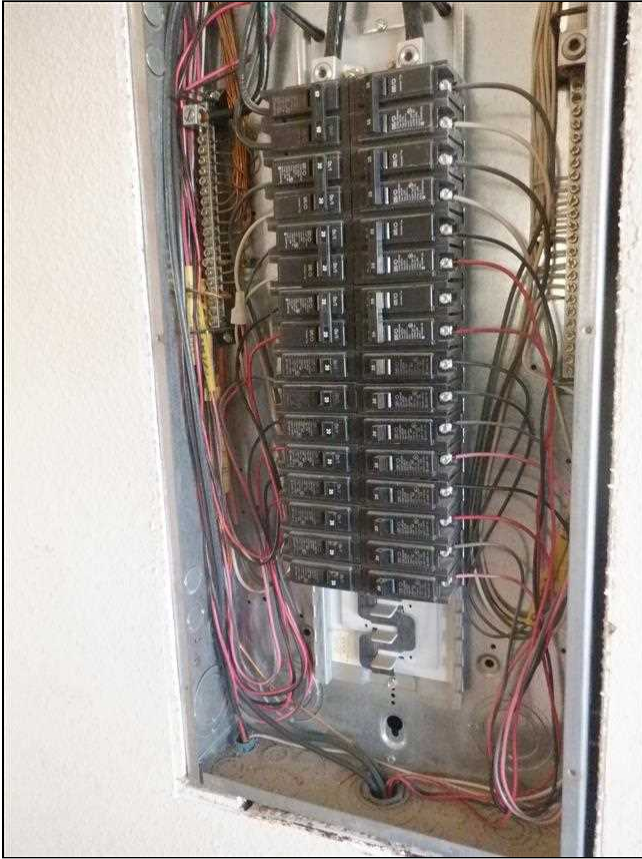
3.10 Item 3(Picture) Electrical Sub Panel Breakers/  
Conductors

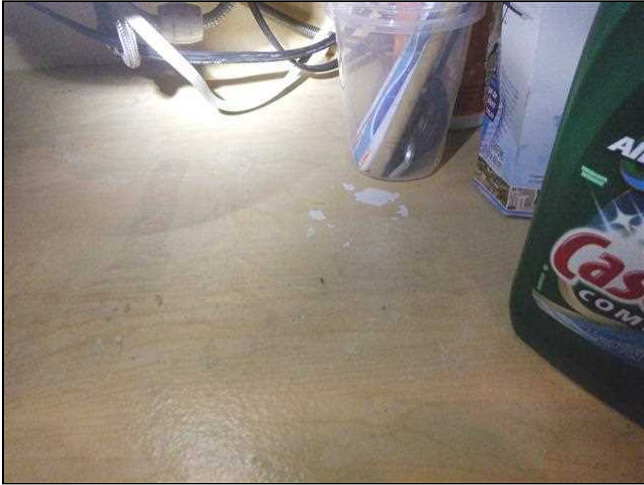
**4.5** We noted that the main sink and small (bar) base cabinet appeared to have past water damage at the bottom. No active leaks or moisture noted at time of inspection. Recommend repair replace as needed by a licensed contractor.

4.5 Item 2(Picture) Main Sink Base Moisture Damage

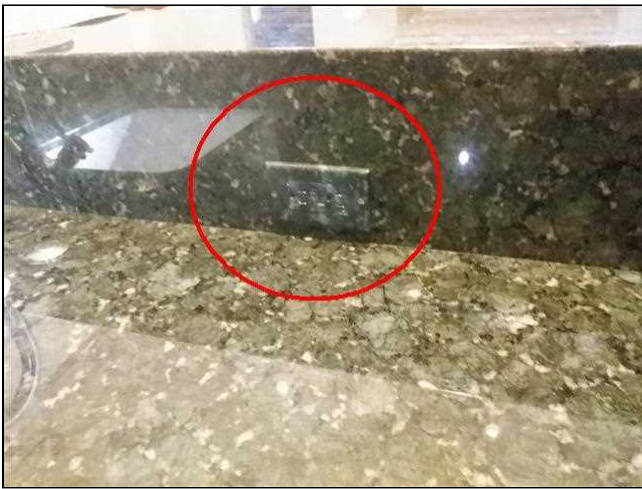
**4.8** Although all countertop outlets in this kitchen are GFCI protected we noted that they all have been painted over. We also noted that the GFCI outlet next to the small bar sink failed to reset after testing, we believe that the test buttons are damaged (stuck) due to this paint. Recommend replacement of this damaged GFCI outlet by a licensed electrical contractor. FYI electrical outlets should never be painted for obvious reasons. All the outlets for this countertop are not functioning due to this bad GFCI.

4.8 Item 2(Picture) Bad GFCI Outlet

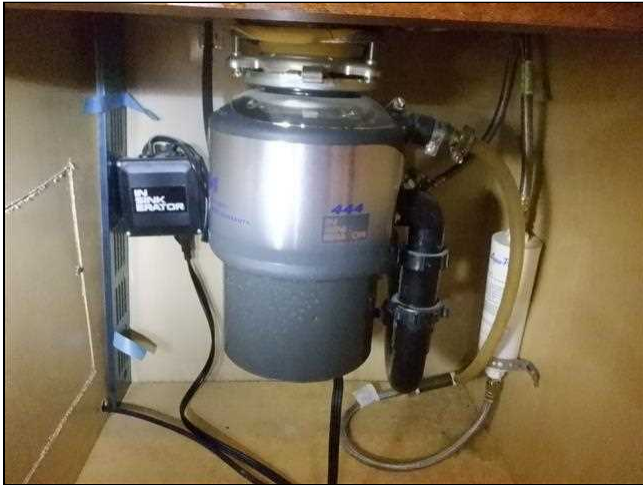
**4.12** We noted that this kitchen is equipped with 3 food waste disposers and we noted that the disposer for the small sink (bar) was frozen at time of inspection. Recommend evaluation repair replace as needed by an appliance contractor.

4.12 Item 1(Picture) Small Sink Disposer

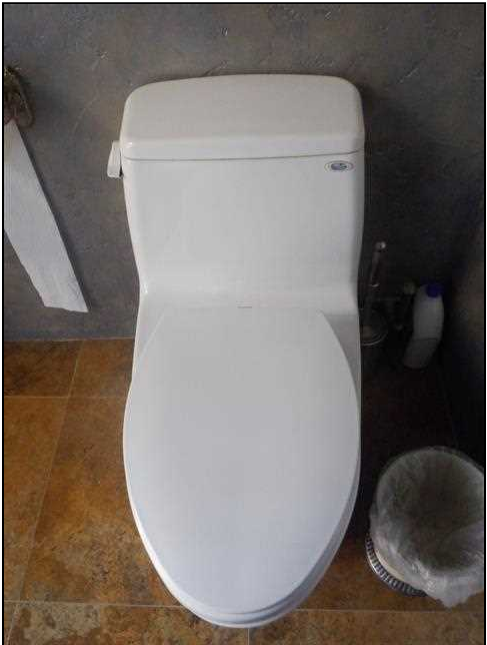
6.6.A This toilet is a 1.6 gallons per flush toilet and this toilet appeared to be functioning properly..

6.6.A Item 1(Picture) 1.6 gpf Toilet

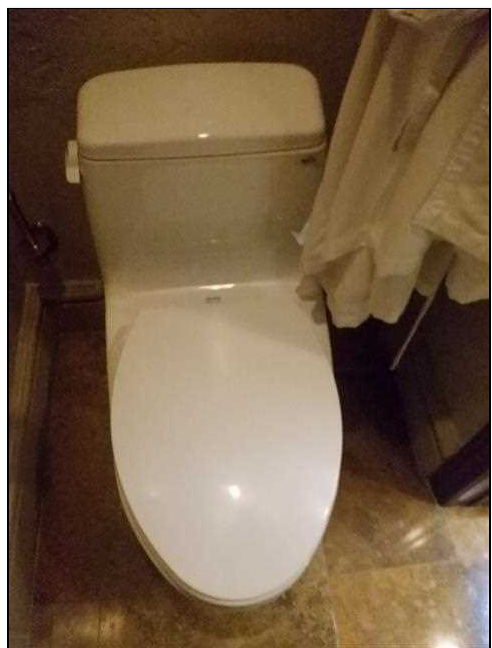
**6.7.B** These toilets are 1.6 gallons per flush toilets and these toilets appeared to be functioning properly..

6.7.B Item 1(Picture) Toilet 1 1.6 gpf Toilet
