# **Inspection Report**

**Property Address:**  
12136 St Andrews Dr  
Rancho Mirage CA 92270

**Livingston Home Inspections, Inc.**

<b>Date:</b> 4/27/2022	<b>Time:</b> 09:00 AM	<b>Report ID:</b> 20220427-12136-St-Andrews-Dr
<b>Property:</b> 12136 St Andrews Dr Rancho Mirage CA 92270	<b>Customer:</b> Garrett Saikley	<b>Real Estate Professional:</b> Jonathan Olow Big Block Realty

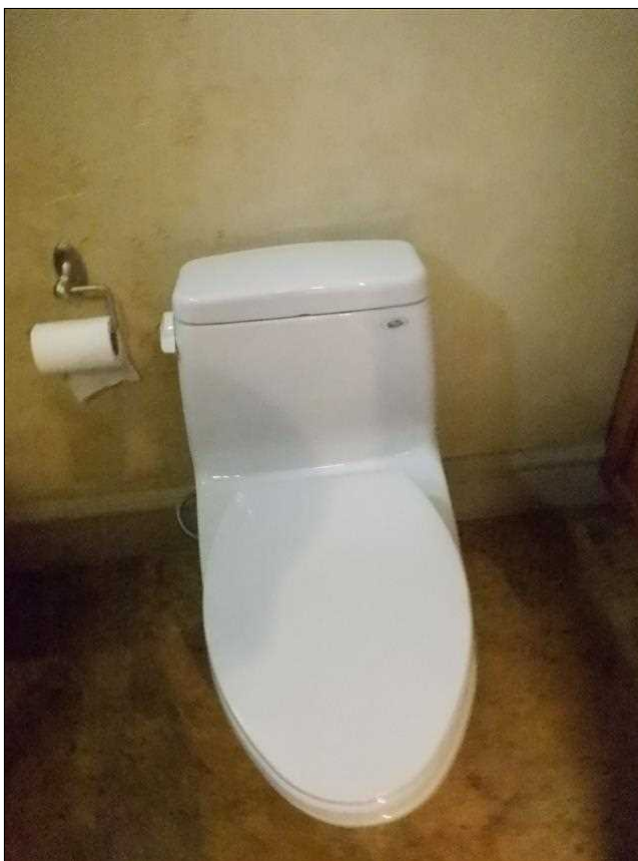
**6.7.B** These toilets are 1.6 gallons per flush toilets and these toilets appeared to be functioning properly..

6.7.B Item 2(Picture) Toilet 2 1.6 gpf Toilet

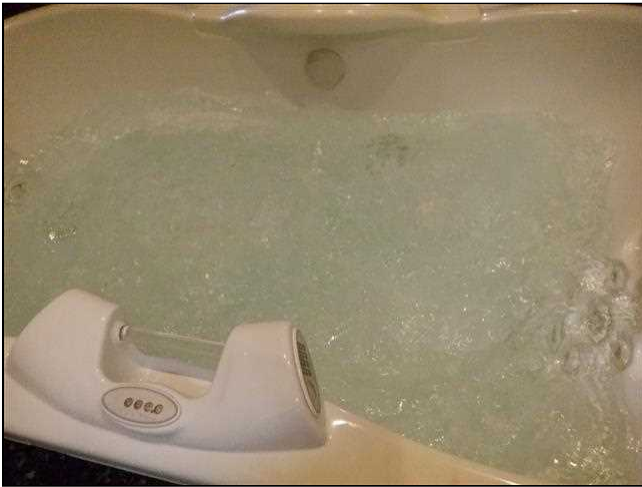
**6.11.B** Jetted bathtub appeared to be functioning properly at time of inspection.

6.11.B Item 1(Picture) Jetted Tub

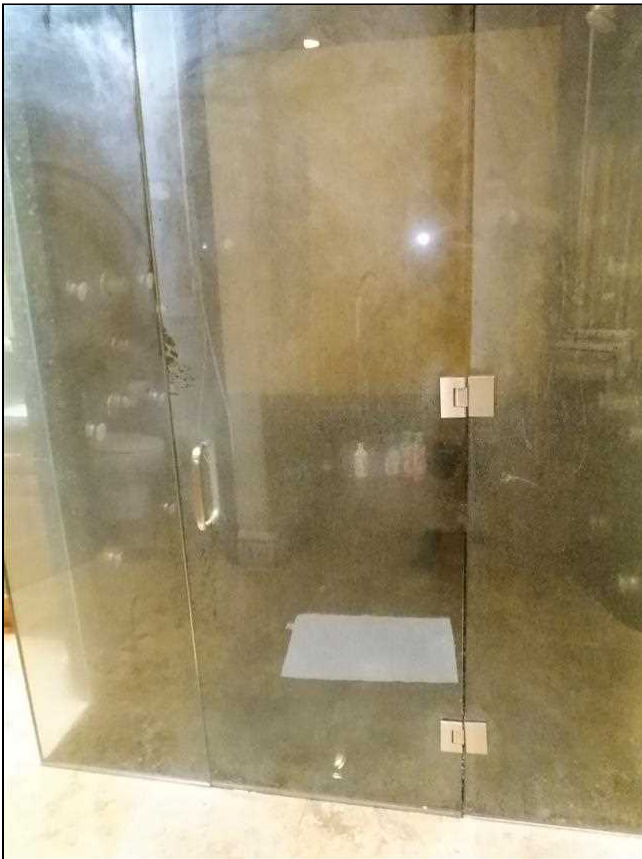
**6.12.B (1)** We noted upon activation of the shower that the water would creep out the shower opening onto the bathroom floor. We believe that this is caused by not enough pitch at the bottom of the shower towards the drain and shower head type/excessive pressure. Recommend evaluation by a licensed contractor to come up with a solution to this issue.

6.12.B Item 1(Picture) Shower

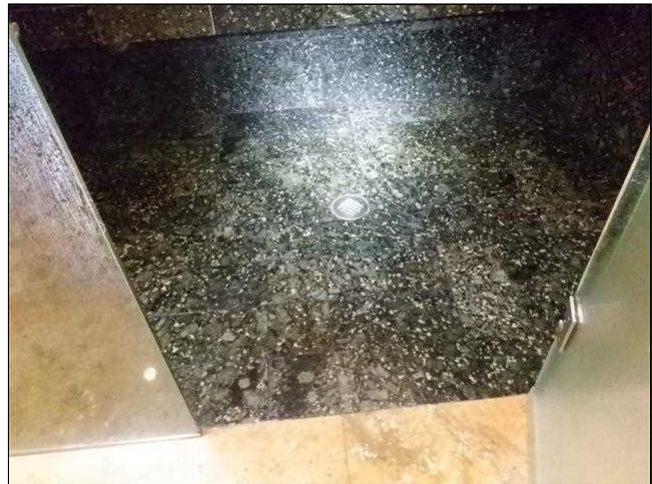
6.12.B Item 2(Picture) Shower Interior Not Enough Pitch

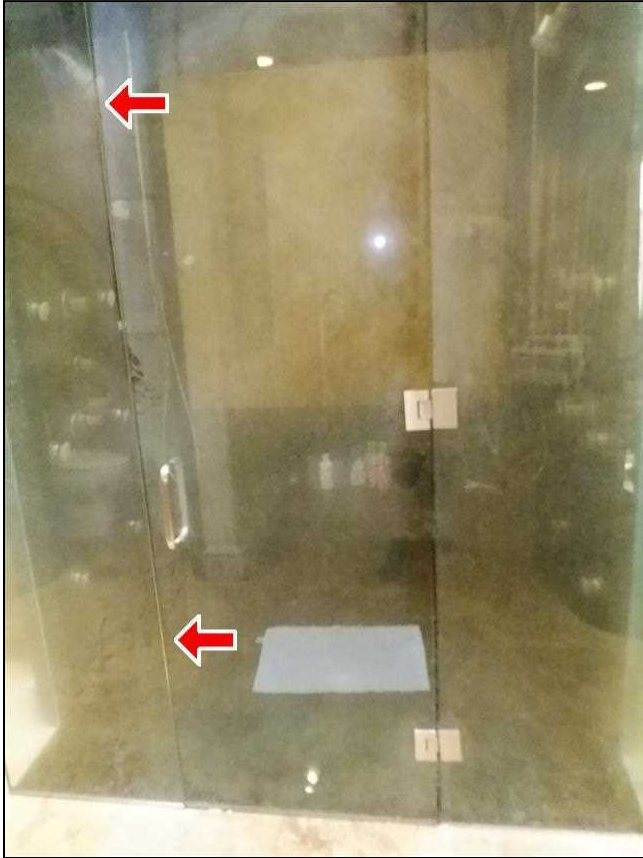
**6.12.B (2)** We noted that the shower door appears to be rubbing on the glass surround when opening and closing. Recommend evaluation by a licensed contractor to adjust or repair as needed. .

6.12.B Item 4(Picture) Shower Door Rubbing

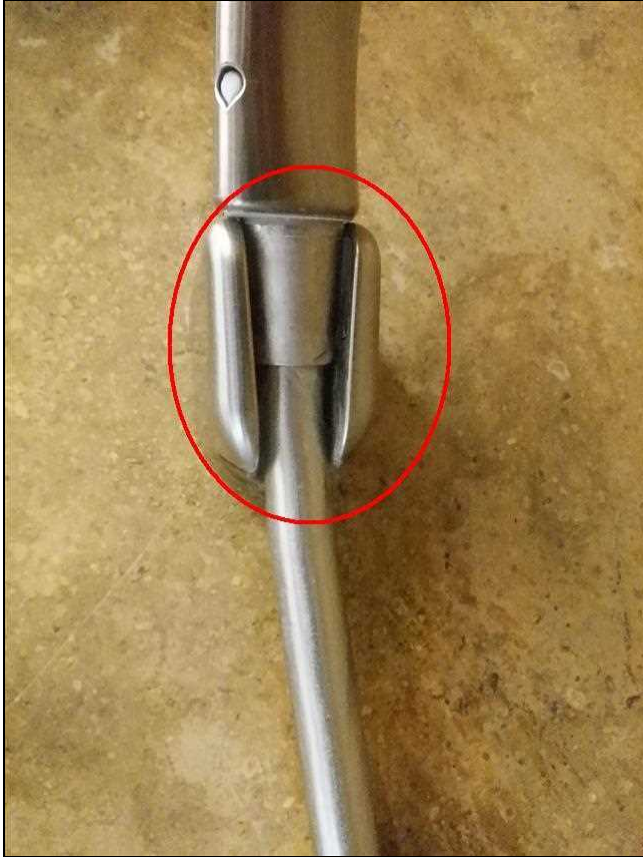
**6.3.C** We noted a leak at the top of the shower head fitting at the time of inspection. Recommend repair/replace as needed by a licensed plumbing contractor.

6.3.C Item 1(Picture) Shower Head Fitting Leak

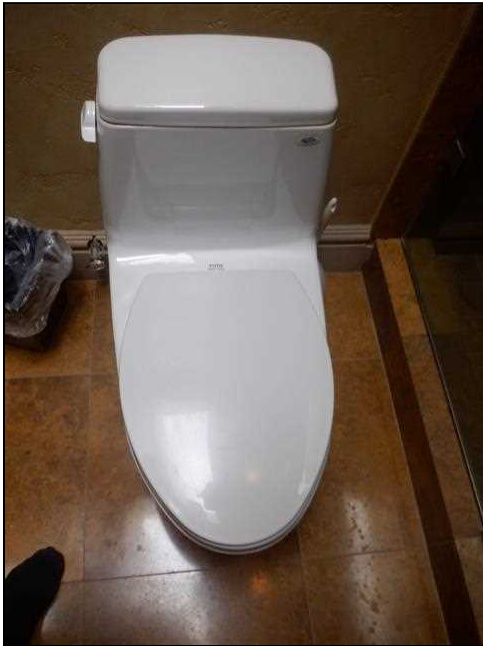
**6.6.C** This toilet is a 1.6 gallons per flush toilet and this toilet appeared to be functioning properly..

6.6.C Item 1(Picture) 1.6 gpf Toilet

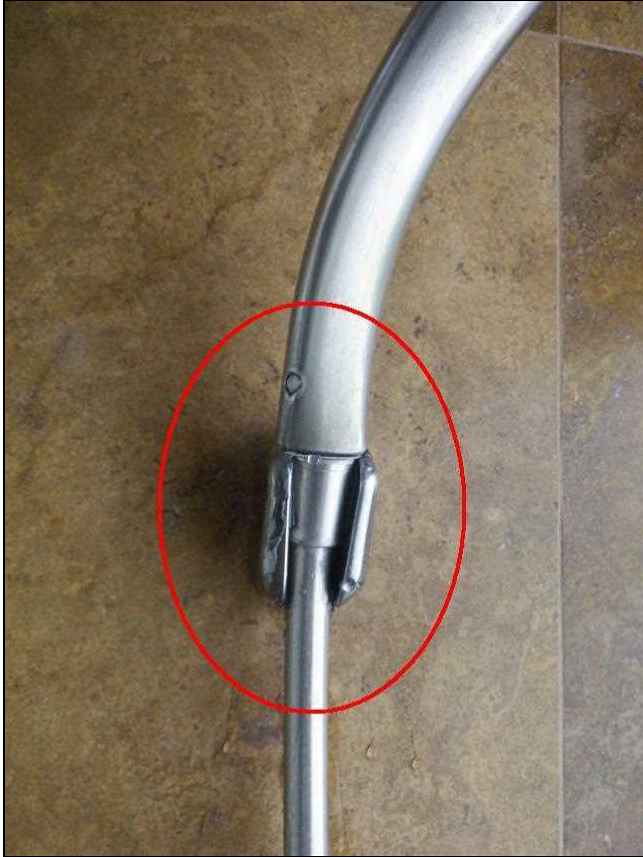
**6.4.D** We noted a leak at the top of the shower head fitting at the time of inspection. Recommend repair/replace as needed by a licensed plumbing contractor.

6.4.D Item 1(Picture) Shower Head Fitting Leak

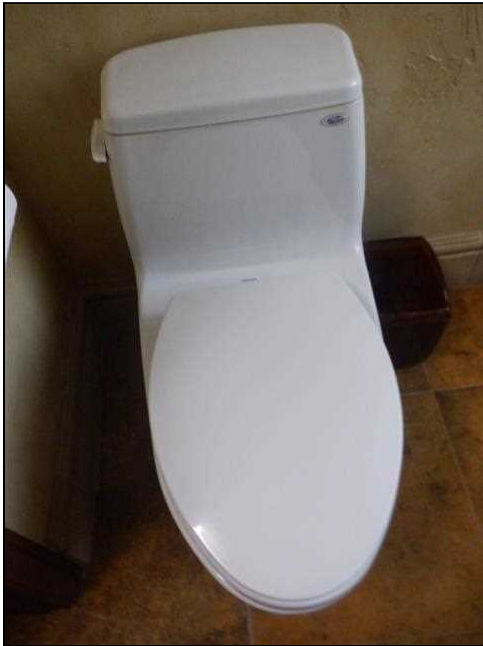
**6.7.D** This toilet is a 1.6 gallons per flush toilet and this toilet appeared to be functioning properly..

6.7.D Item 1(Picture) 1.6 gpf Toilet

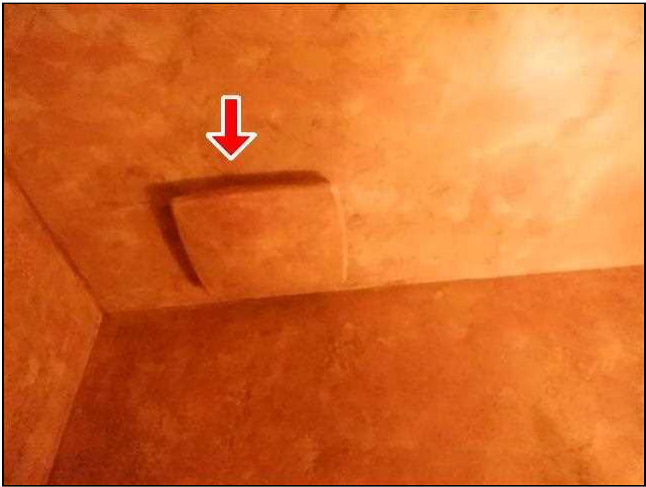
6.5.E We noted that the exhaust fan was very noisy when operating. Recommend evaluation repair replace as needed.

6.5.E Item 1(Picture) Noisy Fan

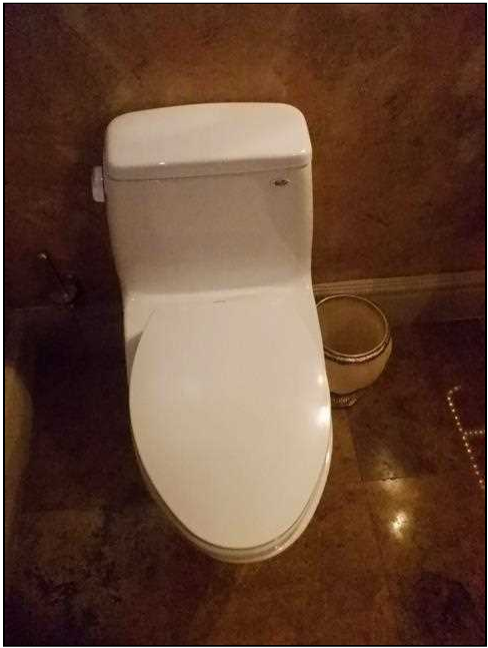
**6.6.E** This toilet is a 1.6 gallons per flush toilet and this toilet appeared to be functioning properly..

6.6.E Item 1(Picture) 1.6 gpf Toilet

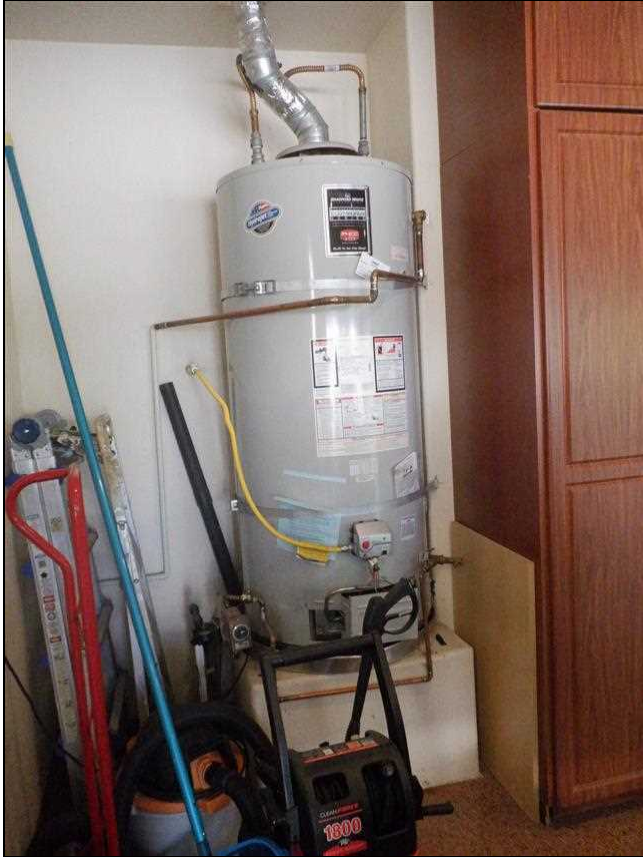
**8.2** Although this water heater was functioning properly at time of inspection we noted that there was no sediment trap (Drip Leg) installed on the fuel line. The installation of fuel line sediment traps have been required for many years. We highly recommend installation of sediment traps (Drip Legs) on all gas fired tankless and tank type water heaters they are installed per manufactures requirements to help prevent sediment in the gas piping from getting into the gas valve or burner area of an appliance and causing safety issues with combustion. The installation of sediment traps may extend the life of an appliance. Recommend evaluation and installation of sediment trap by a licensed plumbing contractor. This unit has a 100 gallon tank it is 8 years old.

8.2 Item 1(Picture) Water Heater

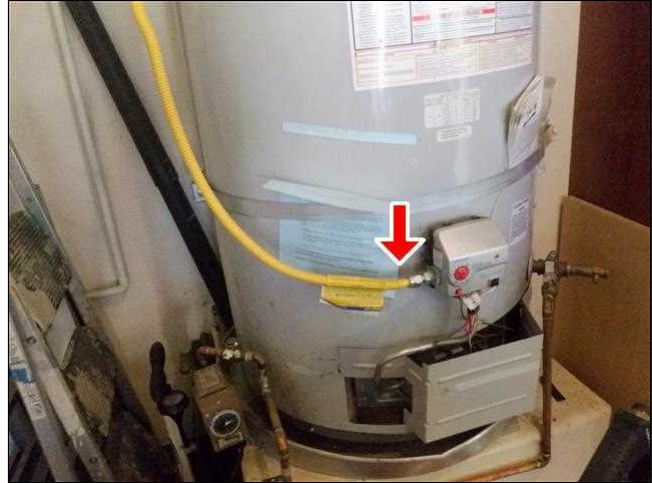
8.2 Item 2(Picture) Water Heater Fuel Line Missing Sediment Trap

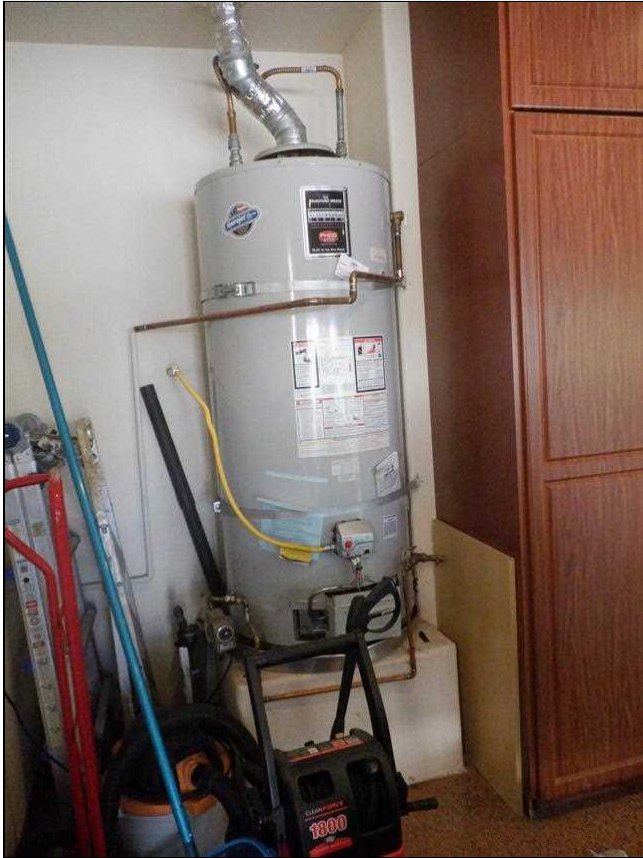
**8.3** We noted that this water heater only had 2 seismic strap at time of inspection. All tank type water heaters that are over 80 gallons require a third seismic strap, these seismic straps must be installed in the upper one third, center and lower one third of the unit, this is a hazard that should be corrected. Recommend evaluation and installation of third strap as needed by a licensed plumbing contractor.

8.3 Item 1(Picture) Water Heater 2 Seismic Straps Only

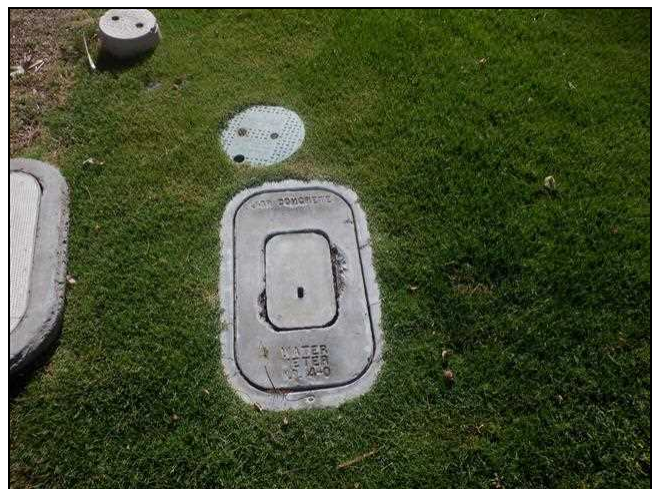
8.4 (2) The main water shut is located at the meter by the street.

8.4 Item 2(Picture) Main Water Shut Off

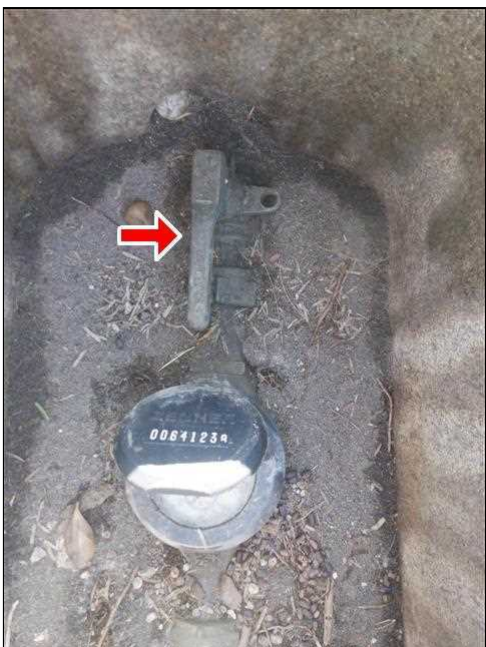
8.4 Item 3(Picture) Main Water Shut Off

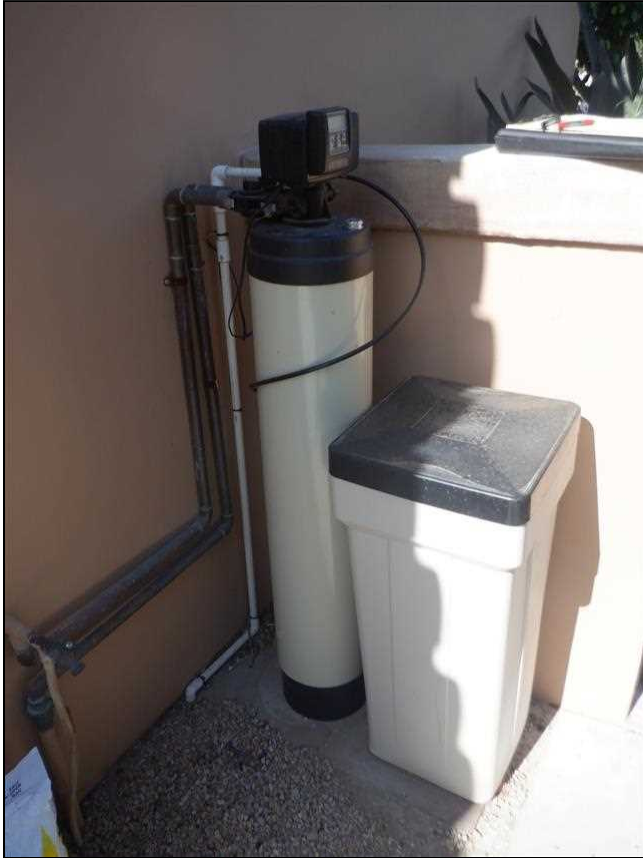
**8.5** Our company dose not inspect water filtration system. FYI these systems do need regular maintenance, see your licensed filtration specialist.

8.5 Item 1(Picture) Water Filtration System

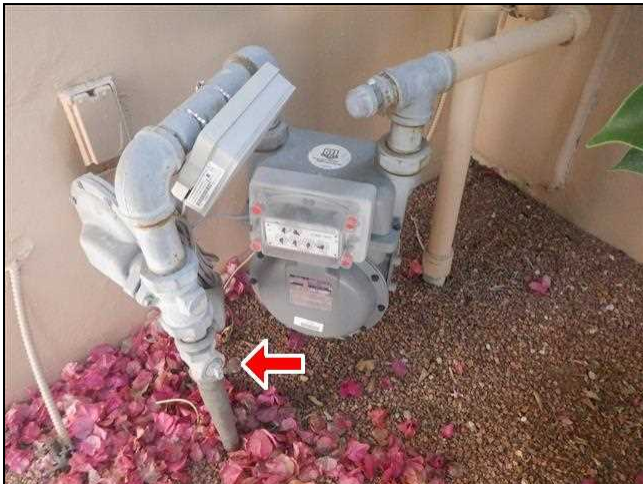
**8.6** Gas meter/shut off is located on the south side of the garage. FYI main gas shut off wrenches are usually available at your local hardware store

8.6 Item 1(Picture) Main Gas Shut Off

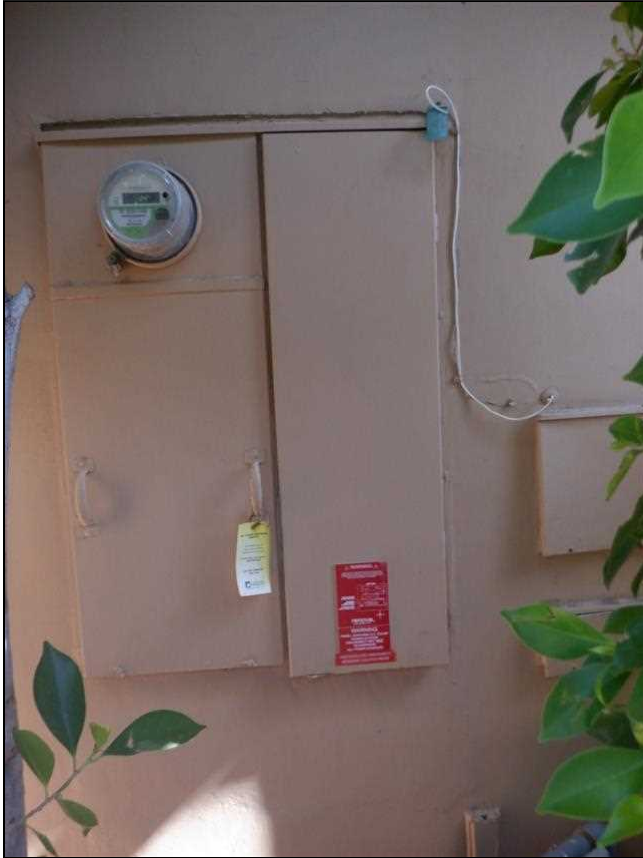
**9.1 (1)** The electrical panel is located on the south side of the garage. This panel has 2 200 amp disconnects and although we did not find any irregularities in this panel we noted that not all of the circuit breakers were labeled. Recommend evaluation and labeling of all circuits for proper identification and ease of use by a licensed electrician.

9.1 Item 1(Picture) Main Electrical Panel

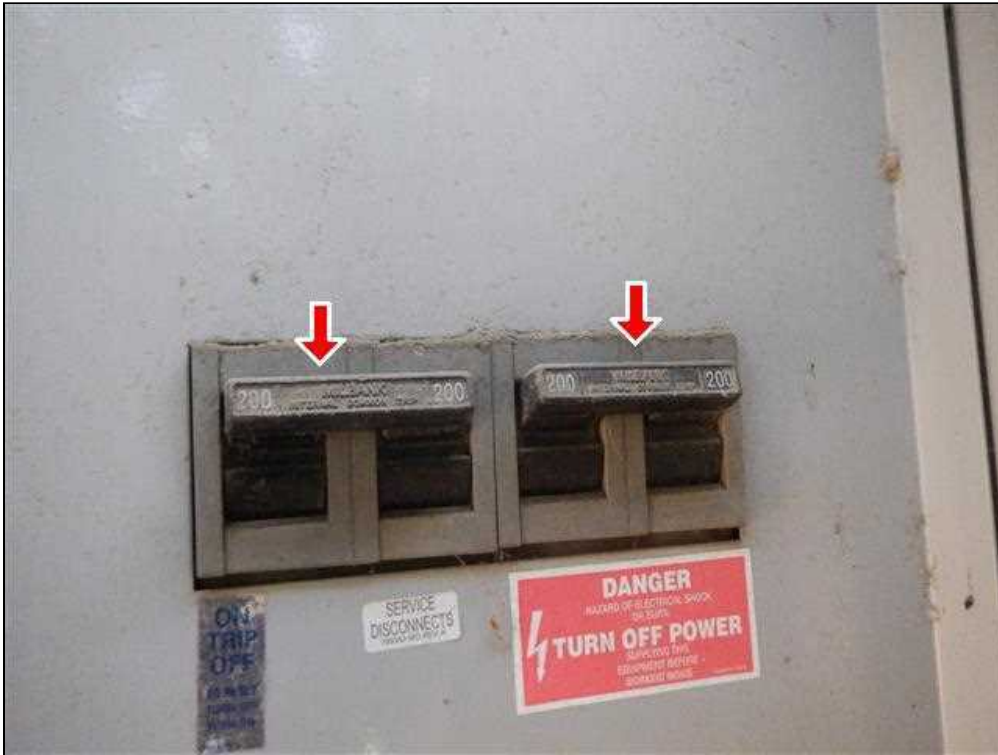
9.1 Item 2(Picture) Main Electrical Panel Disconnects 2 X 200

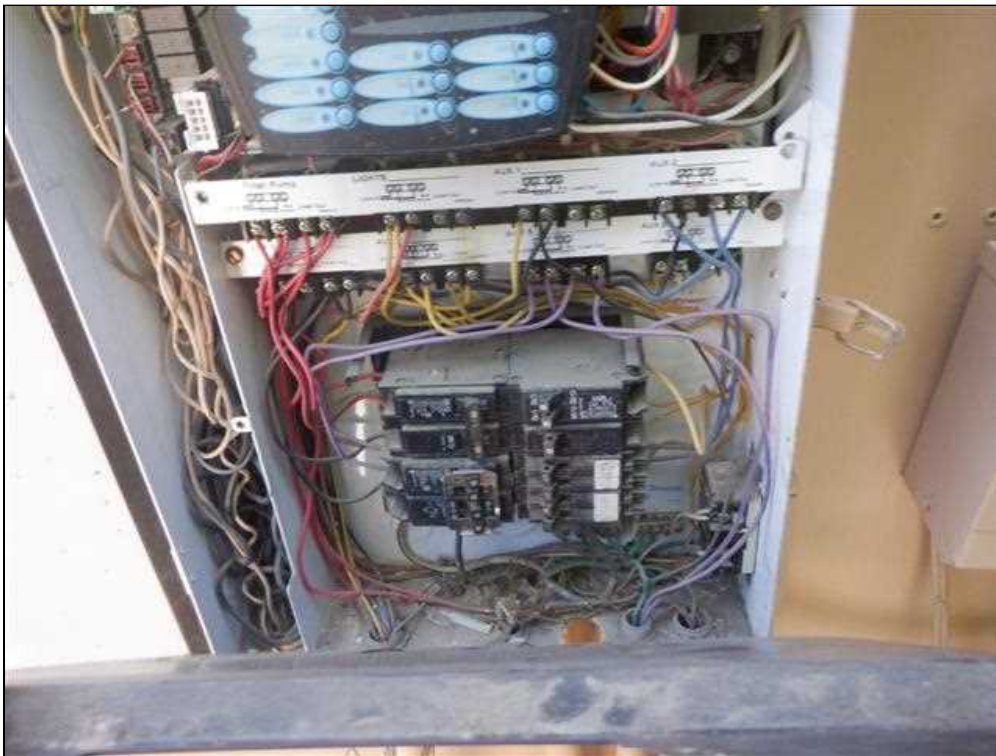
**9.1 (2)** The pool electrical sub panel is located on the north side of house by the pool equipment. Although we did not find any irregularities in this panel we noted that the circuit breakers were not labeled. Recommend evaluation and labeling of all circuits for proper identification and ease of use by a licensed electrician.

9.1 Item 6(Picture) Pool/Spa Sub Panel Breakers/Conductors

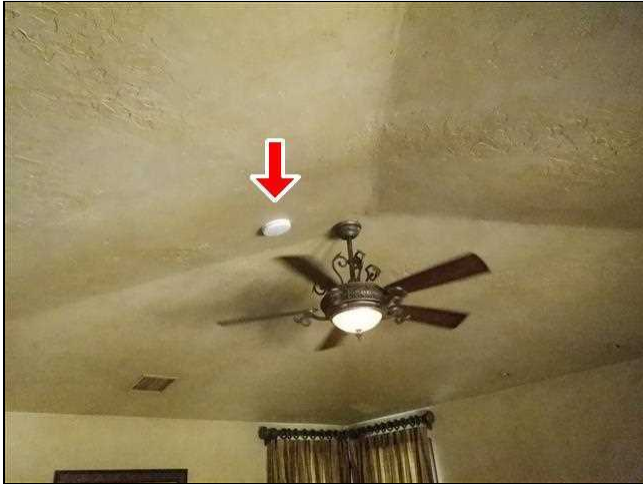
**9.7** Although this home had smoke detectors in all the required areas we noted that the detector in the primary bedroom was not installed correctly, this smoke detector is installed too close to the ceiling fan, all smoke and carbon detectors must be installed at least 36 inches from any ceiling fan or HVAC registers, this will be considered a safety issue if not corrected. Recommend evaluation, removal and relocation of this smoke detector.

9.7 Item 1(Picture) Smoke Detector Too Close To Ceiling Fan

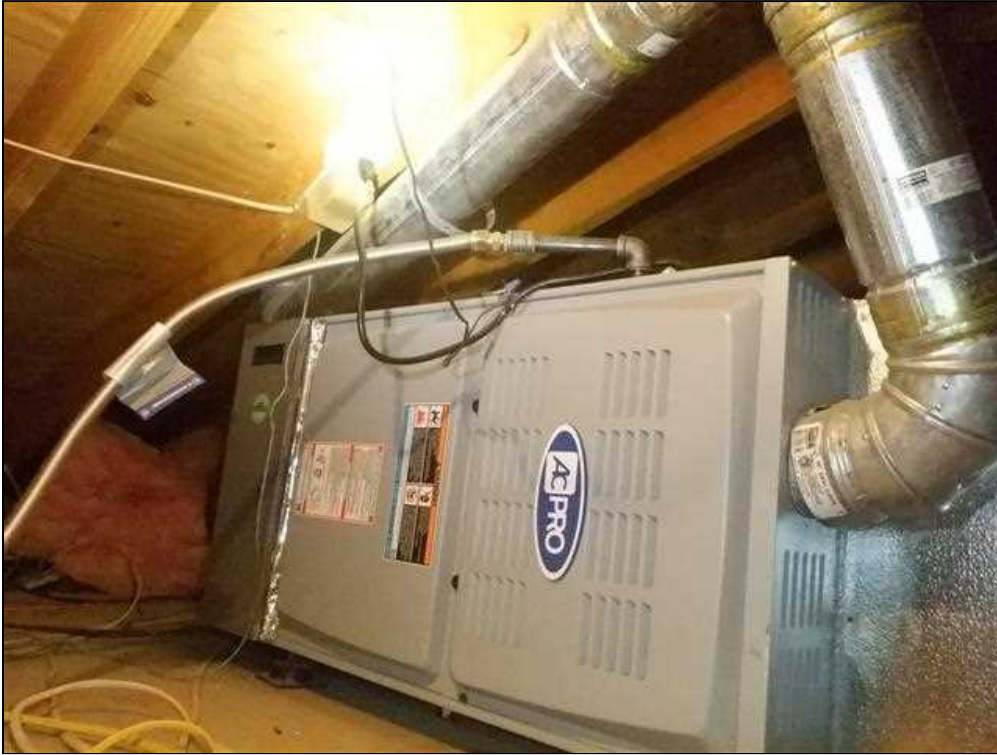
**10.0.A** Although this heater was functioning properly at the time of inspection we noted that there was no sediment trap (Drip leg) installed on the fuel line. We highly recommend the installation of sediment traps (Drip legs) on all gas fired furnaces as they are installed, per manufactures requirements, to help prevent sediment in the gas piping from getting into the gas valve or burner area of an appliance and causing safety issues with combustion. Sediment trap (Drip legs) are now required on all gas fired heaters. The installation of sediment traps will extend the life of an

appliance. Recommend evaluation and installation of a sediment trap by a licensed plumbing contractor. This unit is 5 years old.

10.0.A Item 1(Picture) Heating Unit South

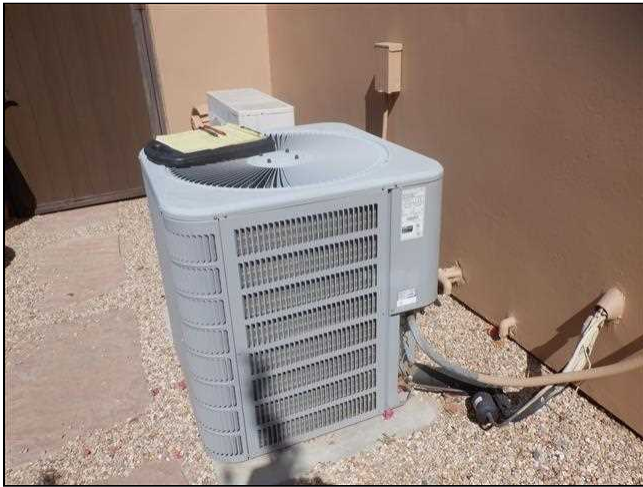
**10.5.A** This AC unit is 5 years old and although this unit appeared to be functioning properly due to age and lack of service records we would recommend servicing this unit by a licensed HVAC contractor. FYI the refrigerant in this unit is the newer R-410A.

10.5.A Item 1(Picture) Cooling Unit South

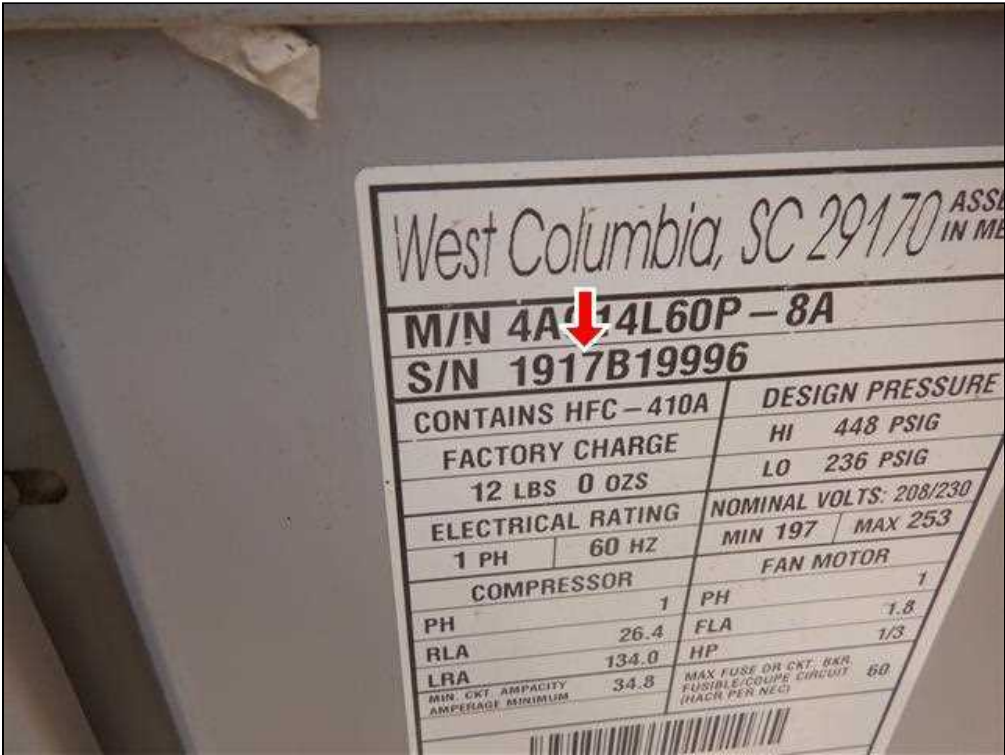
10.5.A Item 2(Picture) Cooling Unit South MFG Date 2017

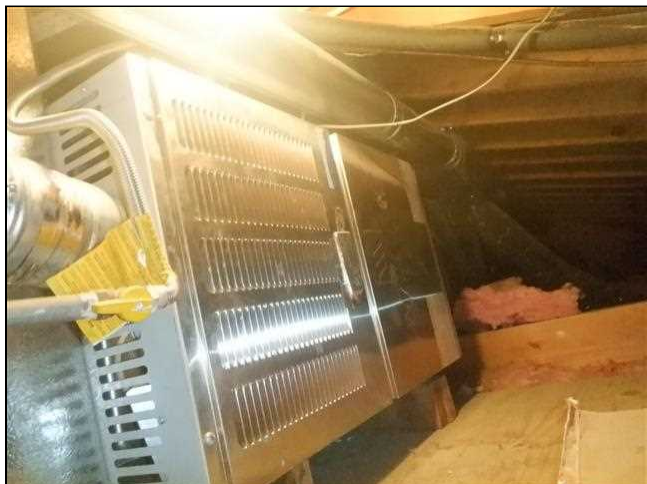
**10.0.B** This heater is 18 years old and it was functioning properly at the time of inspection.

10.0.B Item 1(Picture) Heating Unit North

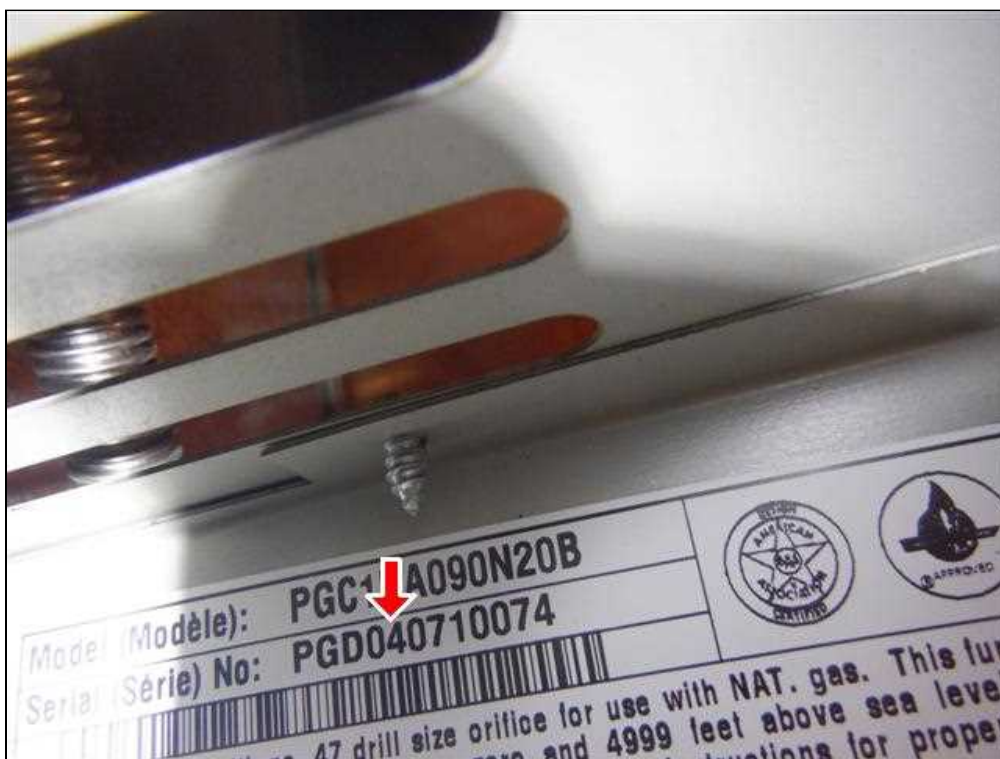
10.0.B Item 2(Picture) Heating Unit North MFG Date 2004

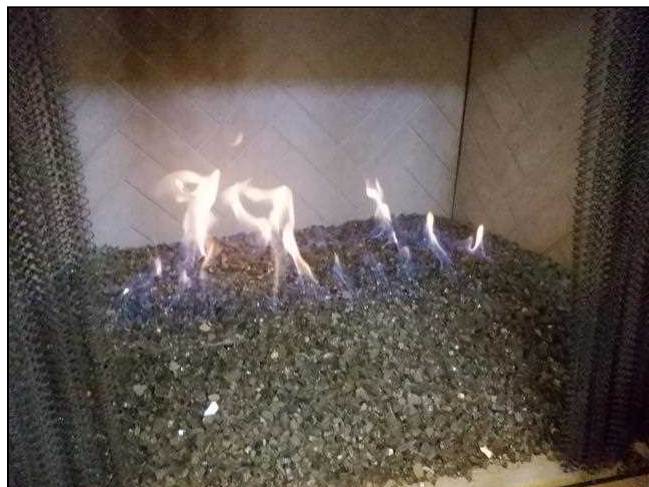
**10.5.B** Level 2 fireplace inspection should be conducted upon the sale or transfer of a property or after an operation malfunction or external event that is likely to have caused damage to the chimney. Building fires, chimney fires, seismic events as well as weather events are all indicators that this level of inspection is warranted. There are no specialty tools (i.e. demolition equipment) required to open doors, panels or coverings in performing a Level 2 inspection. A Level 2 inspection shall also include a visual inspection by video scanning or other means in order to

examine the internal surfaces and joints of all clay or metal flue liners incorporated within the chimney. No removal or destruction of permanently attached portions of the chimney or building structure or finish shall be required by a Level 2 inspection. We highly recommend a level 2 fireplace inspection by a licensed fireplace specialist. Call All Seasons Fireplaces at 760.365.6668 Rick Newsom. FYI these fireplaces (2 total) are located in the living room and primary bedroom.

10.5.B Item 1(Picture) Living Room Fireplace

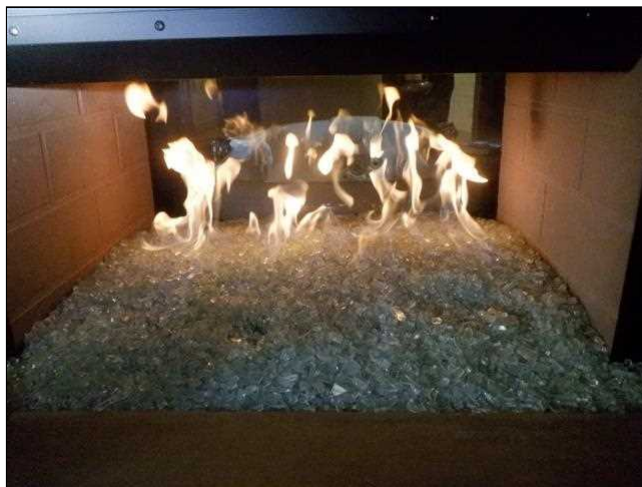
10.5.B Item 2(Picture) Bedroom Fireplace

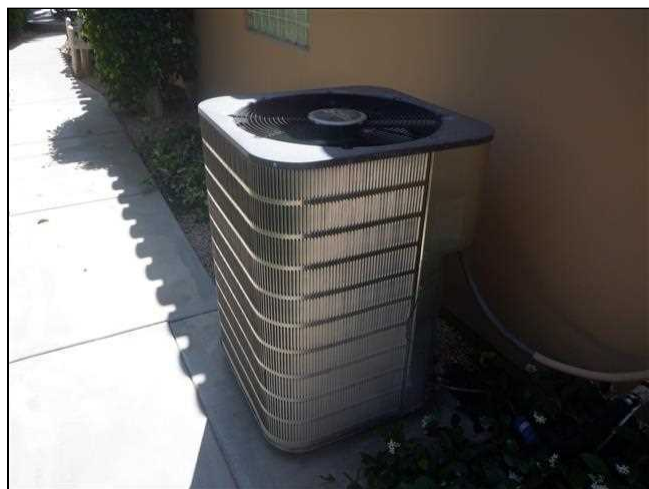
**10.6.B** This AC unit is 18 years old and although this unit appeared to be functioning properly due to age and lack of service records we would recommend servicing this unit by a licensed HVAC Contractor. FYI we believe that this unit is charged with the older refrigerant R-22.

10.6.B Item 1(Picture) Cooling Unit 2

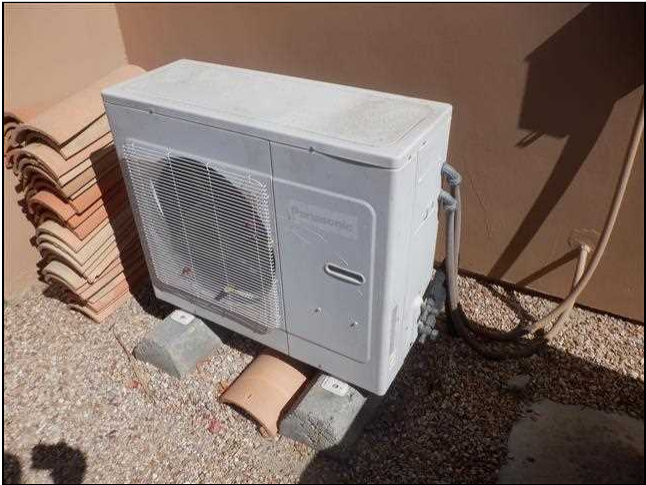
**10.0.C** These units are called mini split systems they provide cooling and heating in one compact unit. These units are approximately 18 years old, they are charged with the older refrigerant R-22. Although these units appeared to be functioning properly we would recommend servicing by a licensed HVAC contractor.

10.0.C Item 1(Picture) Garage Heating/Cooling Unit

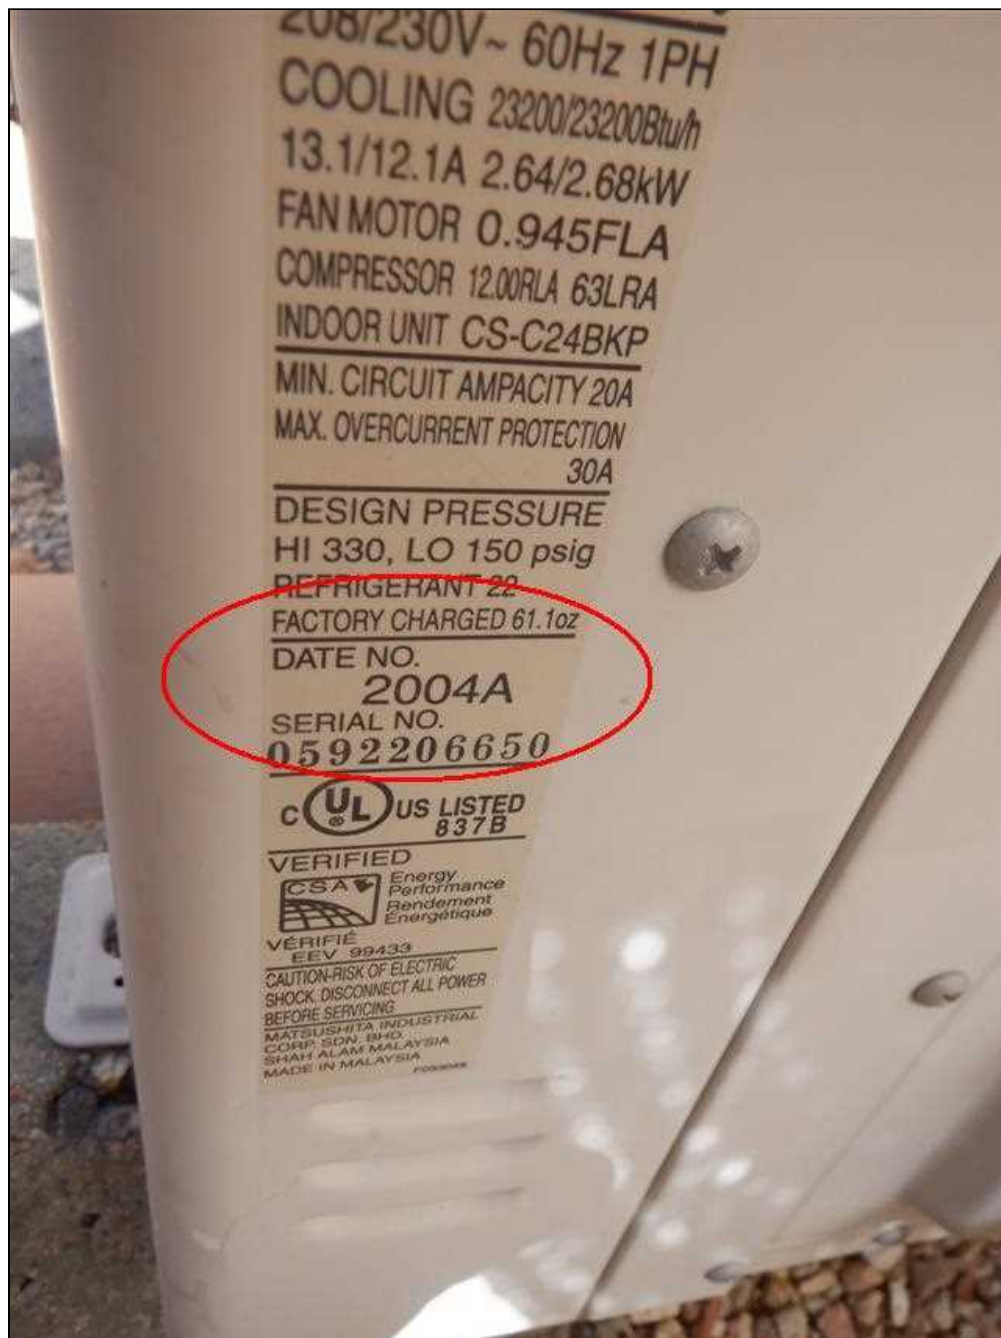
10.0.C Item 2(Picture) Garage Heating/Cooling Unit MFG Date 2004

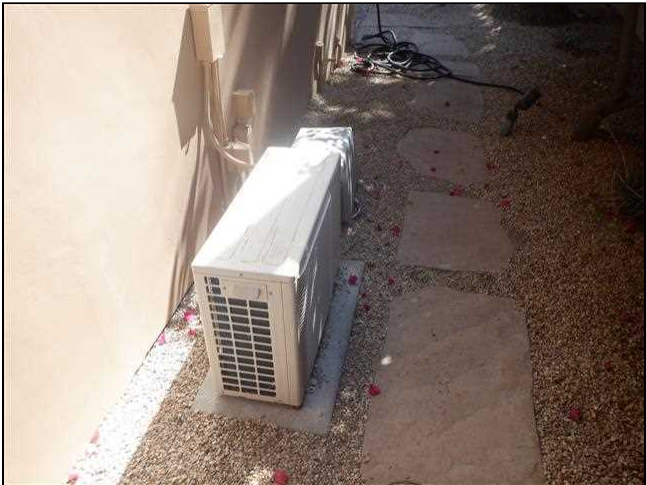
10.0.C Item 3(Picture) Outside Bathroom Heating/  
Cooling Unit

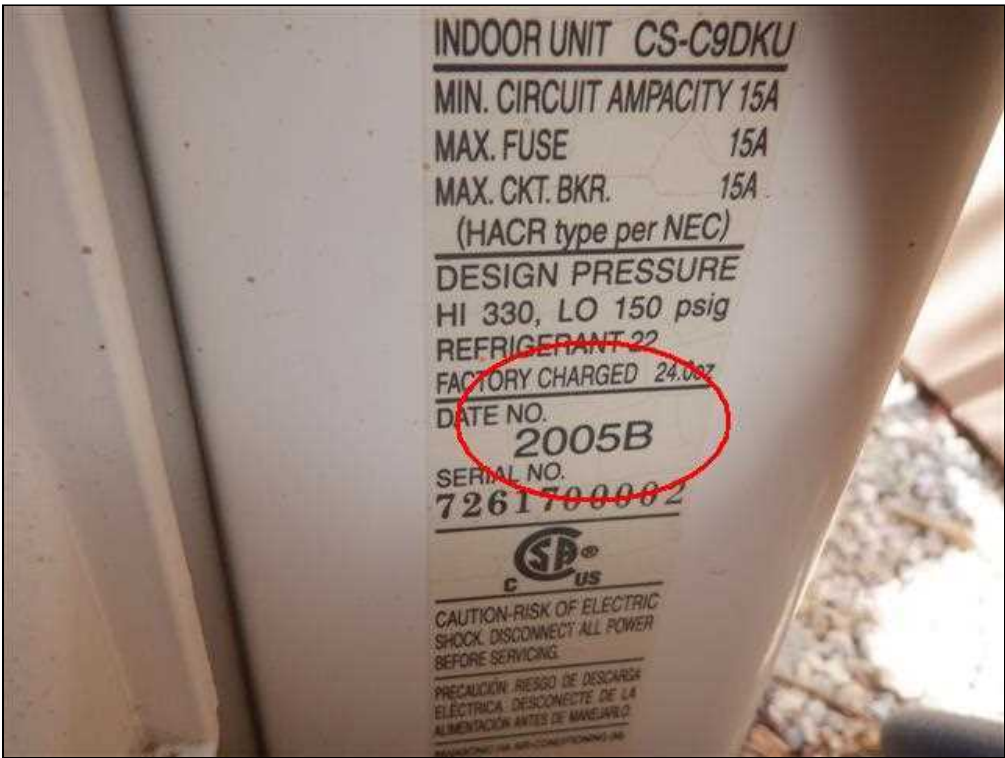
10.0.C Item 4(Picture) Outside Bathroom Heating/Cooling Unit MFG Date 2005

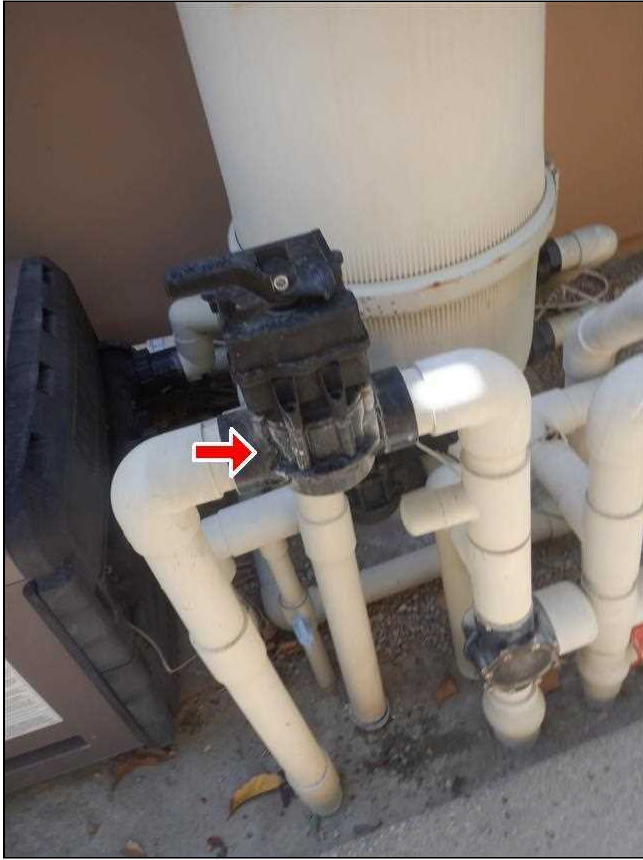
**11.9** Our company does not inspect pool for leaks or seepage, only components readily accessible are inspected. We noted leaks in the plumbing at one of the fittings and valves. Recommend evaluation repair replace as needed by a pool contractor.

11.9 Item 1(Picture) Actuator Valve Leak

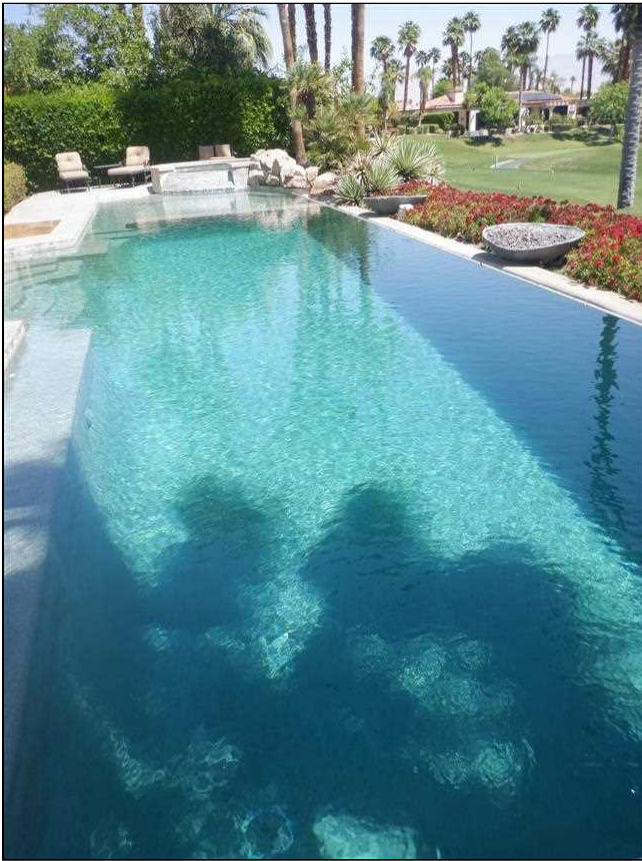
**11.10** The pool and spa liners appeared to be in good condition at the time of inspection.

11.10 Item 1(Picture) Pool Liner

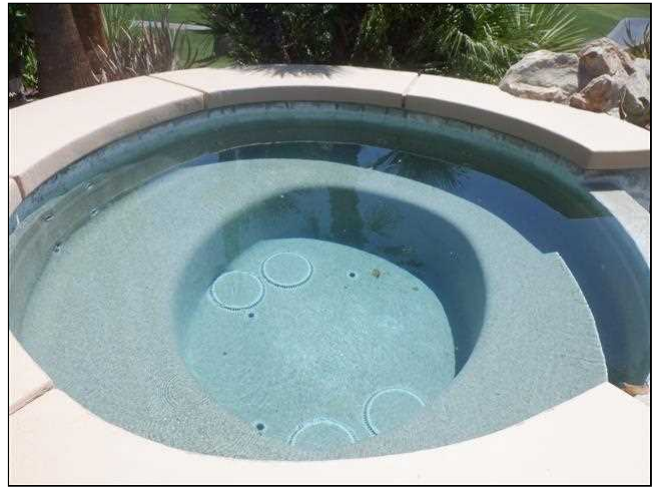
11.10 Item 2(Picture) Spa Liner

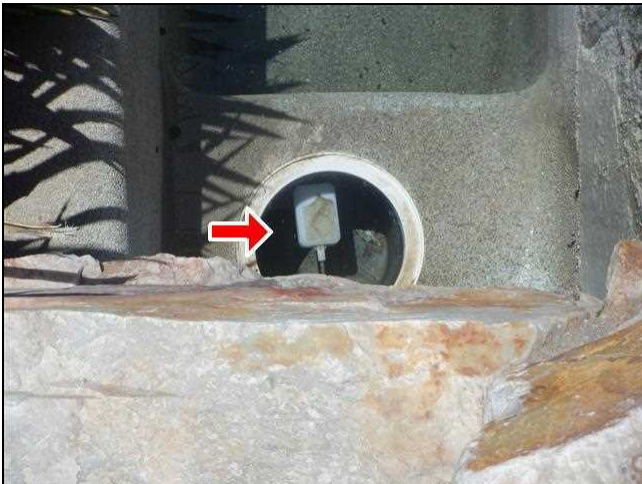
**11.12** Although the auto fill appeared to be functioning properly we were unable to locate its backflow preventer. All pools with an auto fill are required to have a backflow preventer. Recommend evaluation by a licensed pool contractor to install the required backflow preventer.

11.12 Item 1(Picture) Pool Auto Fill

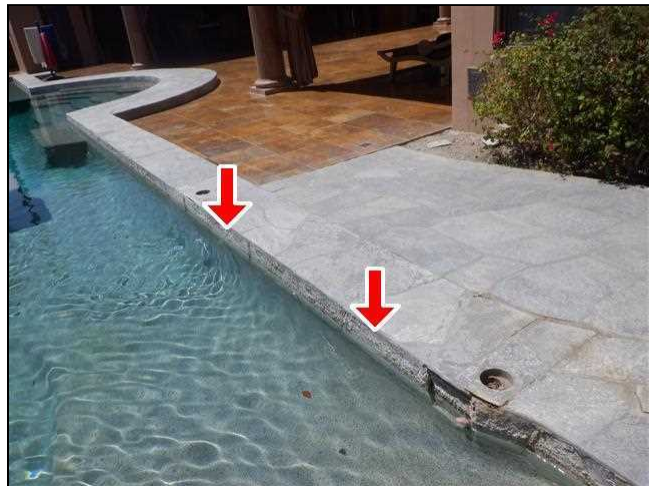
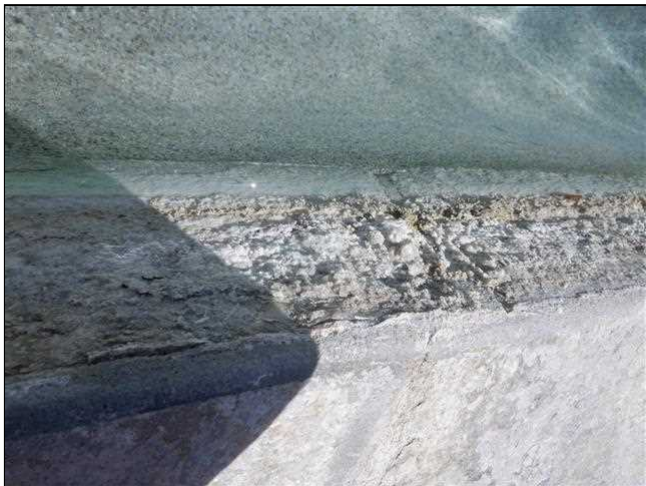
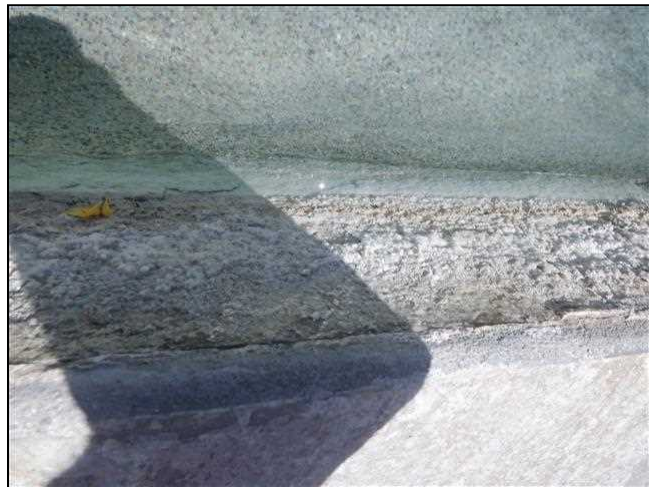
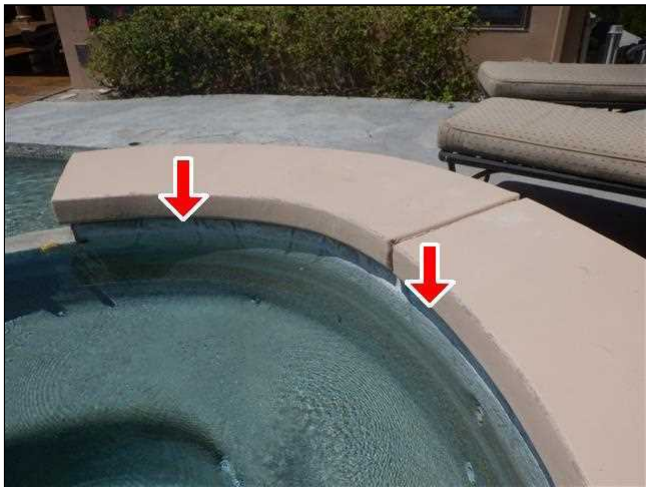
**11.13 (1)** We noted heavy calcium build up on the pool/spa stone. Recommend evaluation and cleaning by a pool contractor as needed.

11.13 Item 1(Picture) Pool Stone Calcium Build Up

11.13 Item 2(Picture) Pool/Spa Stone Calcium Build Up

11.13 Item 3(Picture) Pool/Spa Stone Calcium Build Up

11.13 Item 4(Picture) Pool/Spa Stone Calcium Build Up

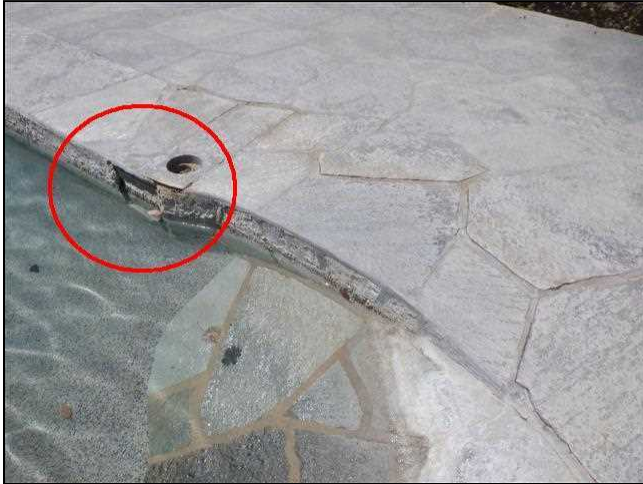
**11.13 (2)** We noted at least one missing pool siding stone at time of inspection. Recommend evaluation repair replace by a licensed pool contractor as needed.

11.13 Item 5(Picture) Missing Pool Siding Stone

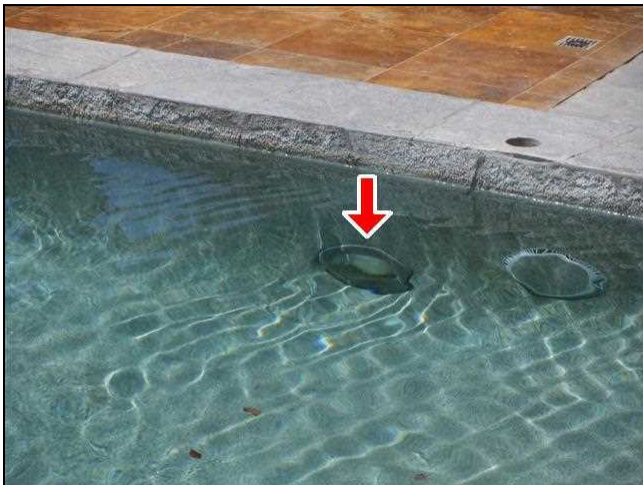
**11.15** Although the spa light appeared to be functioning we noted that at least one of the 4 pool lights was not. Recommend evaluation repair replace as needed by a licensed pool contractor.

11.15 Item 1(Picture) Pool Light Out
