# **Inspection Report**

**Property Address:**  
12136 St Andrews Dr  
Rancho Mirage CA 92270

**Livingston Home Inspections, Inc.**

<b>Date:</b> 4/27/2022	<b>Time:</b> 09:00 AM	<b>Report ID:</b> 20220427-12136-St-Andrews-Dr
<b>Property:</b> 12136 St Andrews Dr Rancho Mirage CA 92270	<b>Customer:</b> Garrett Saikley	<b>Real Estate Professional:</b> Jonathan Olow Big Block Realty

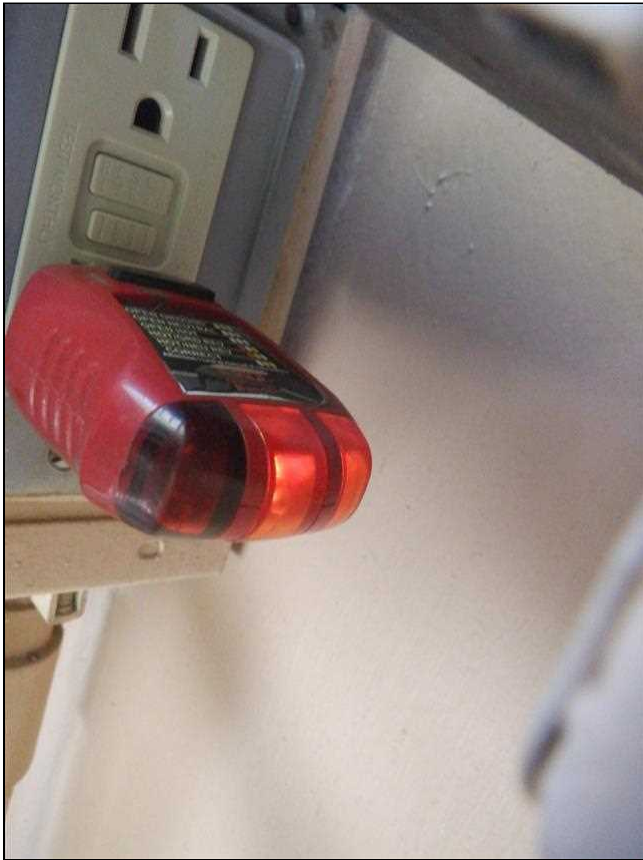
**11.16** We noted that the pool/spa light GFCI failed to trip when tested. This is a possible shock hazard that should be corrected. Pool/spa lights must be GFCI protected at all times. Recommend evaluation and replacement of GFCI as needed by a licensed pool electrical contractor.

11.16 Item 1(Picture) Pool/Spa Light GFCI Failed To Reset

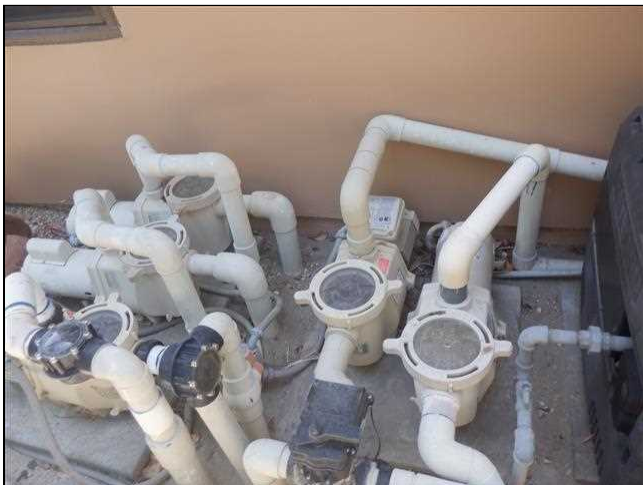
**11.17** This pool/spa and its water features are equipped with 5 pumps/motors and we noted that at least one of the pumps was not functioning at time of inspection (fountain nozzles). Recommend evaluation by a licensed pool contractor repair replace as needed.

11.17 Item 1(Picture) Pool Pumps/Motors

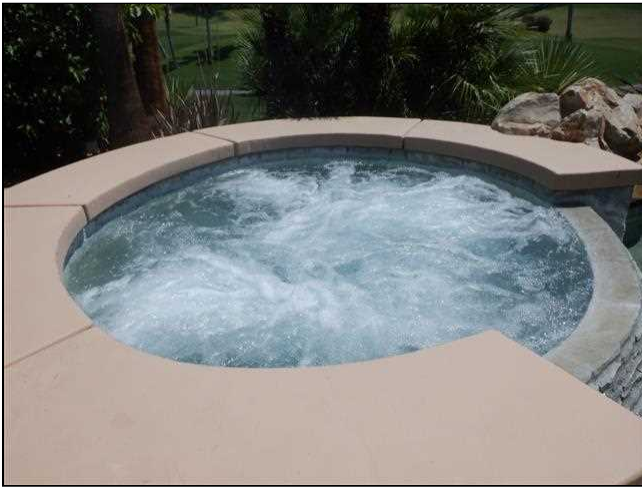
**11.24** All features of spa appeared to be functioning properly.

11.24 Item 1(Picture) Spa Jets

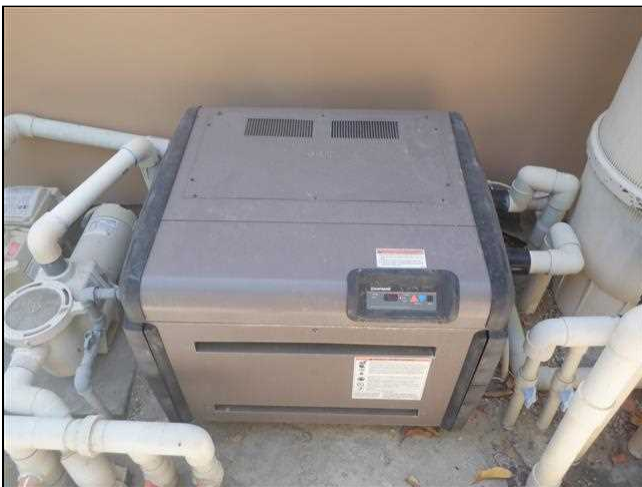
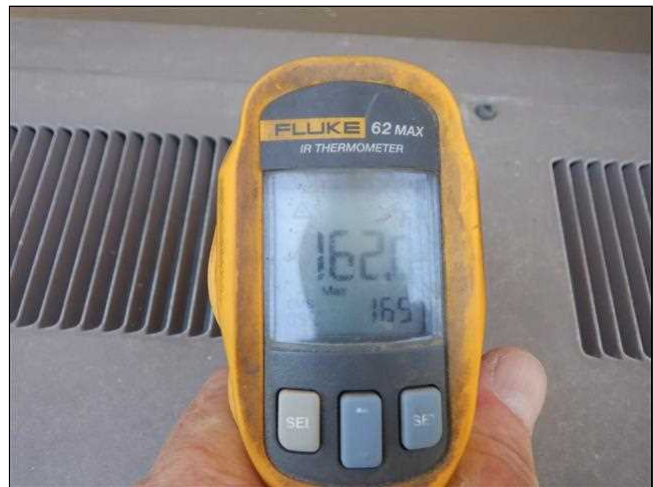
**11.25** Pool/Spa heater appeared to be functioning properly at the time of inspection. This heater was operated for no less that 15 minutes without interruption.

11.25 Item 1(Picture) Pool/Spa Heater

11.25 Item 2(Picture) Pool/Spa Heater Functioning Properly

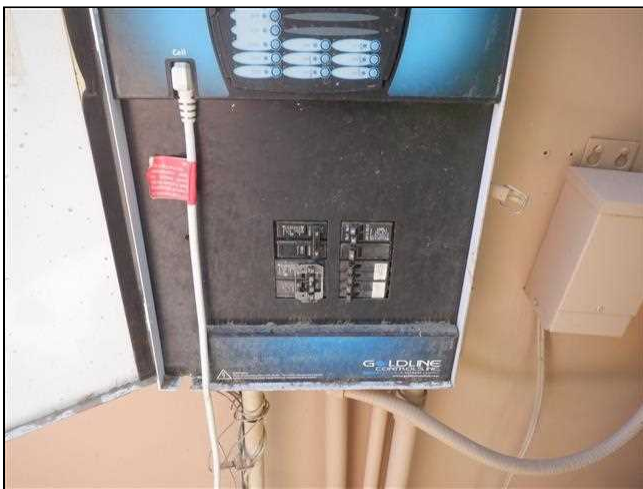
**11.26 (1)** Although we noted a bond wire present it was not connected to at least 2 of the pumps or the exterior controller/electrical sub panel box. This is a possible shock hazard that should be corrected. All metal parts of pool/spa pumps, motors, heaters, pool sub panels, junction boxes, timer clocks and control panels of any kind should be bonded together and bonded to the pools bonding grid. Recommend evaluation/repair/replace as needed by a licensed pool contractor.

11.26 Item 2(Picture) Controller/Sub Panel Not Bonded

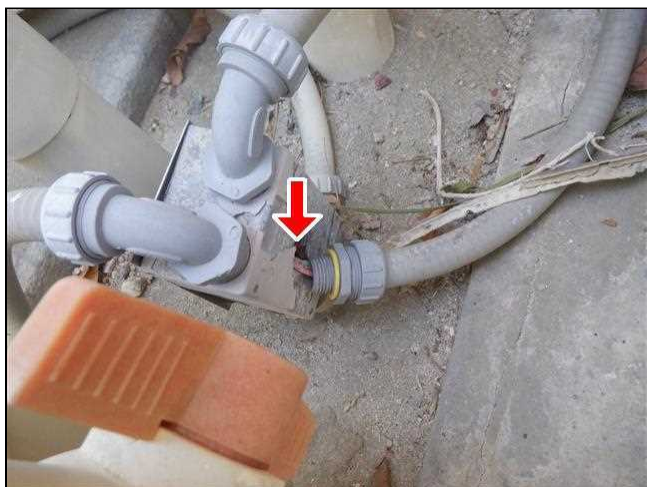
**11.26 (2)** We noted loose conduit and exposed wires at the main filtering pump at time of inspection. These exposed wires are creating a safety issue the should be corrected. Recommend evaluation by a licensed electrical contractor repair replace as needed.

11.26 Item 3(Picture) Loose Conduit/Exposed Wires

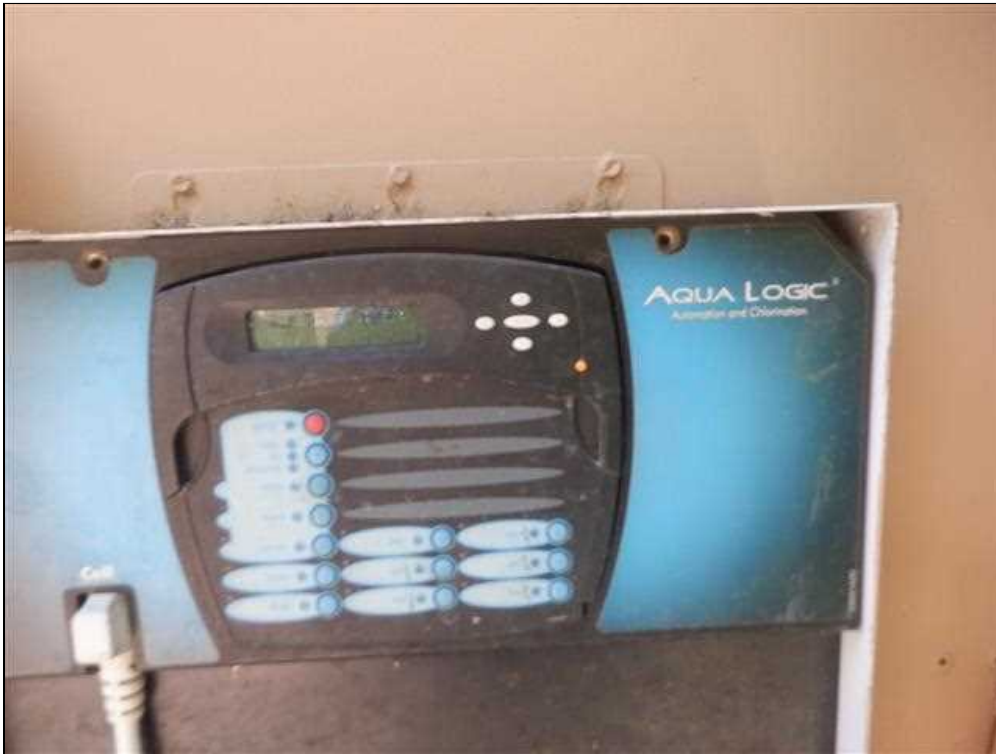
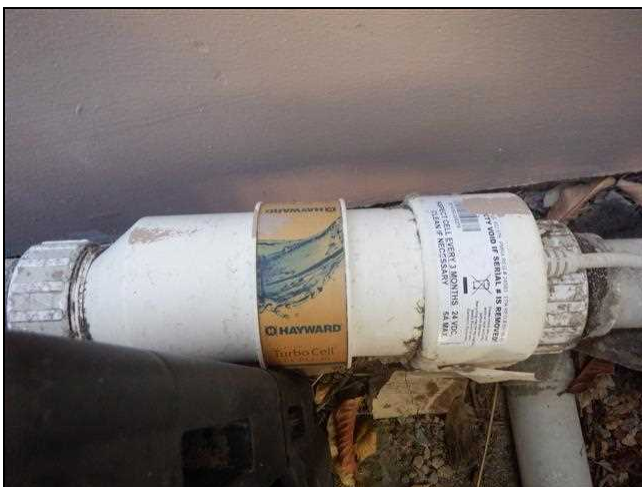
**11.30** We believe that this pool is equipped with a electronic salt/chlorine generating system. We have no way of testing these units for proper operation or even knowing if there functioning properly. This unit should be evaluated for proper operation by a licensed pool contractor repair replace as needed. FYI we were told that this equipment is no longer functioning.

11.30 Item 1(Picture) Chlorine Generator

11.30 Item 2(Picture) Turbo Cell

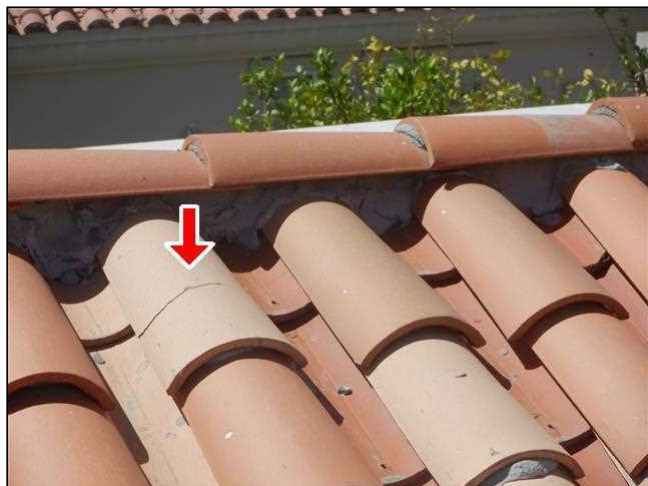
(1) We noted several damaged and slipped tiles on the gable portion of this roof at time of inspection. Damaged roofing materials can lead to roof leaks. Recommend evaluation and replacement of all damaged tiles by a licensed roofing contractor.

1.0 Item 1(Picture) Damaged Tile

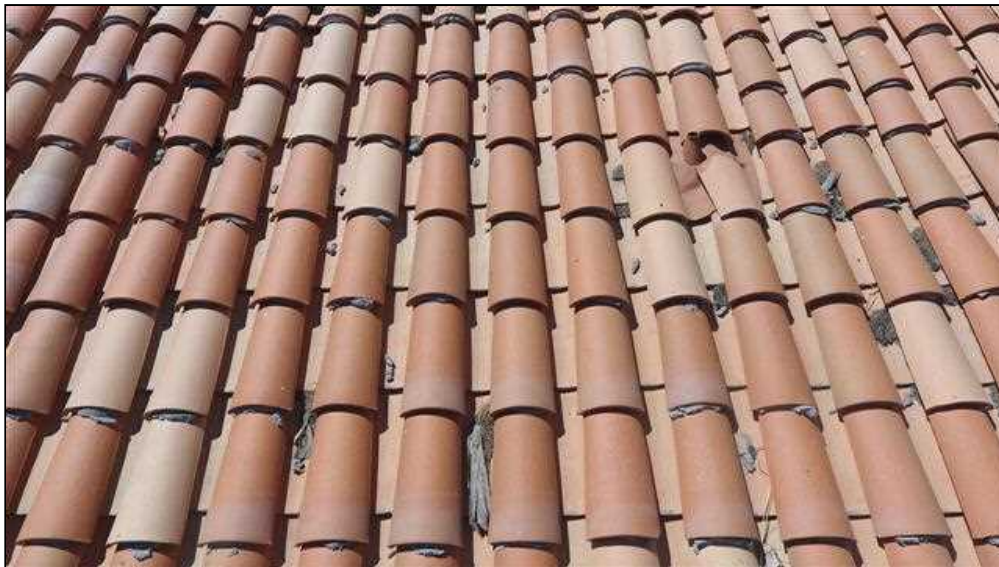
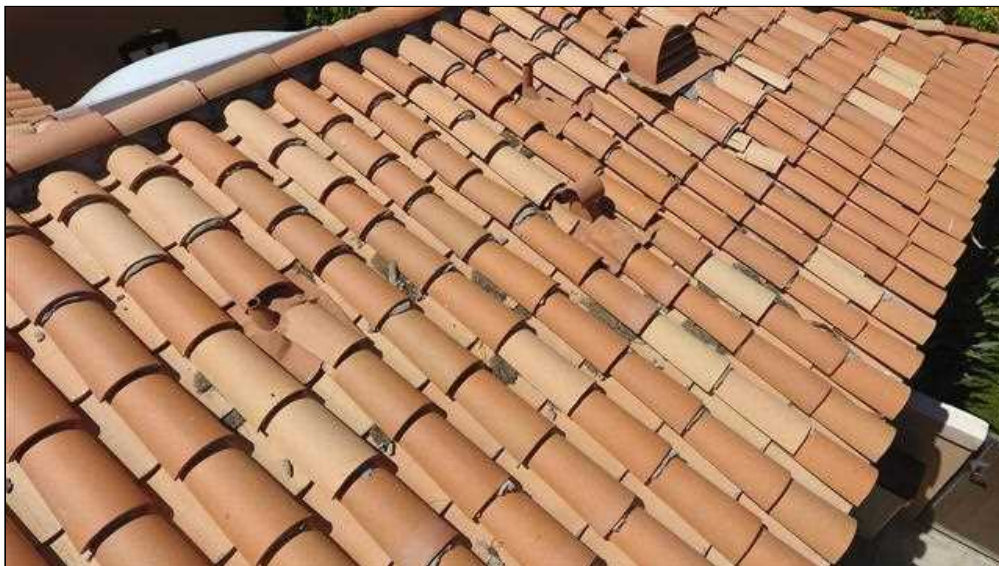
1.0 Item 9(Picture) Gable Roof Covering

1.0 Item 10(Picture) Gable Roof Covering

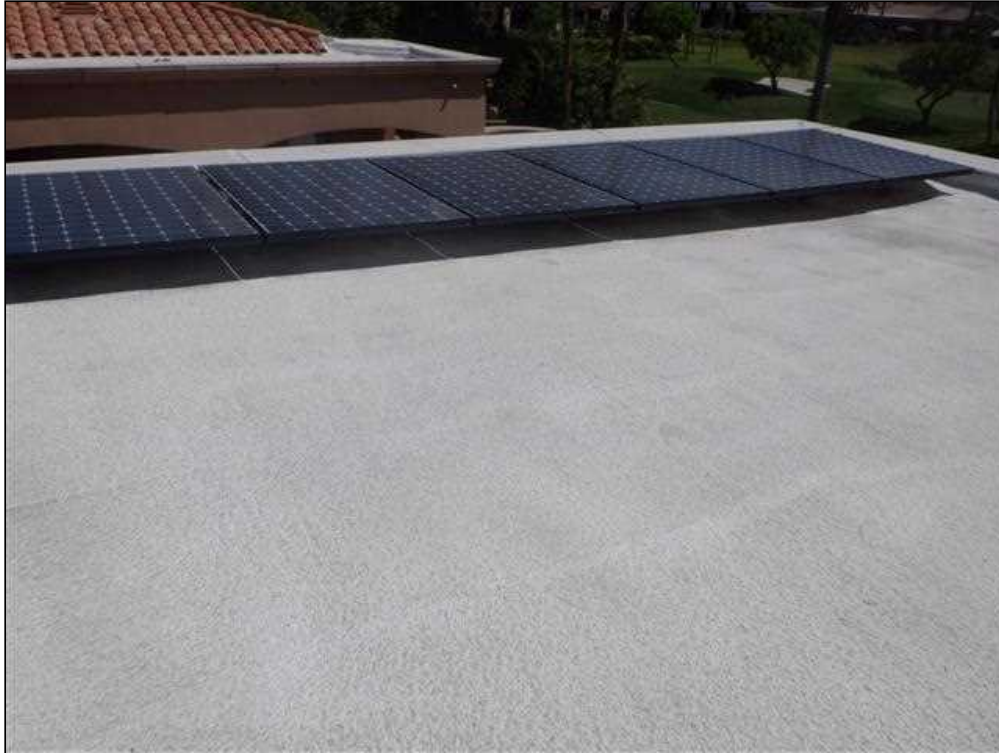
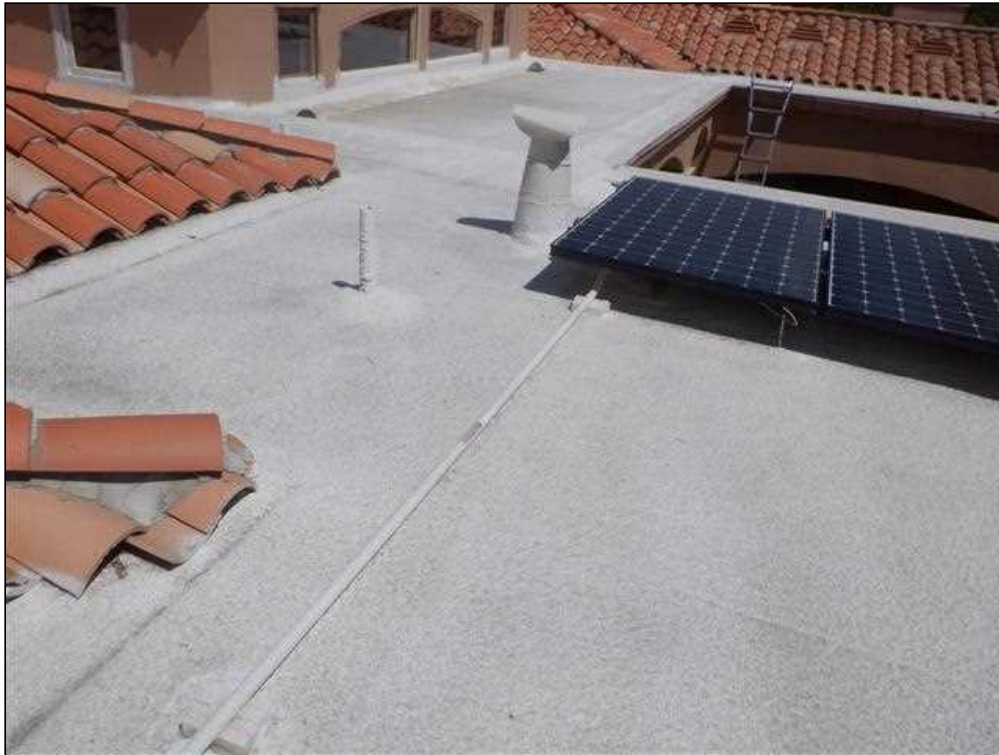
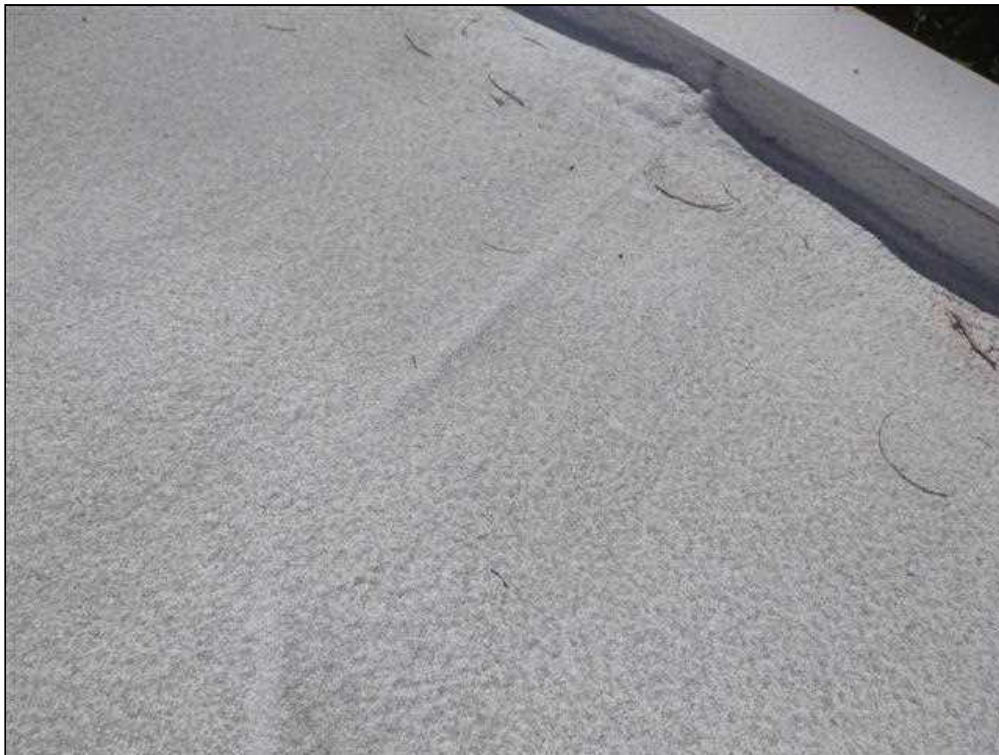
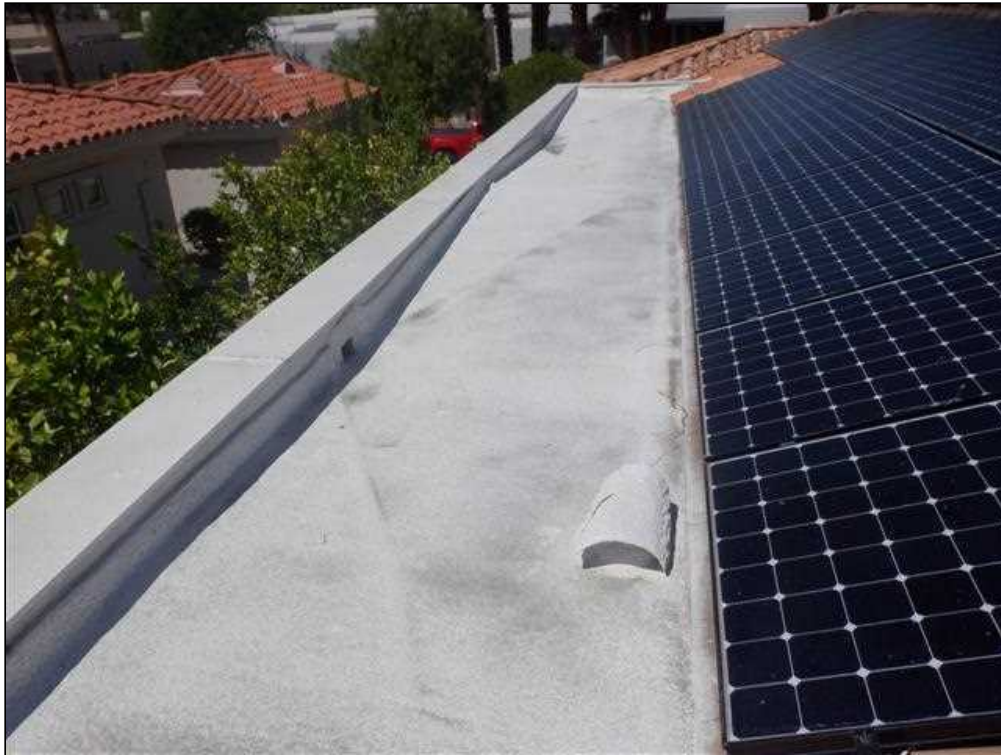
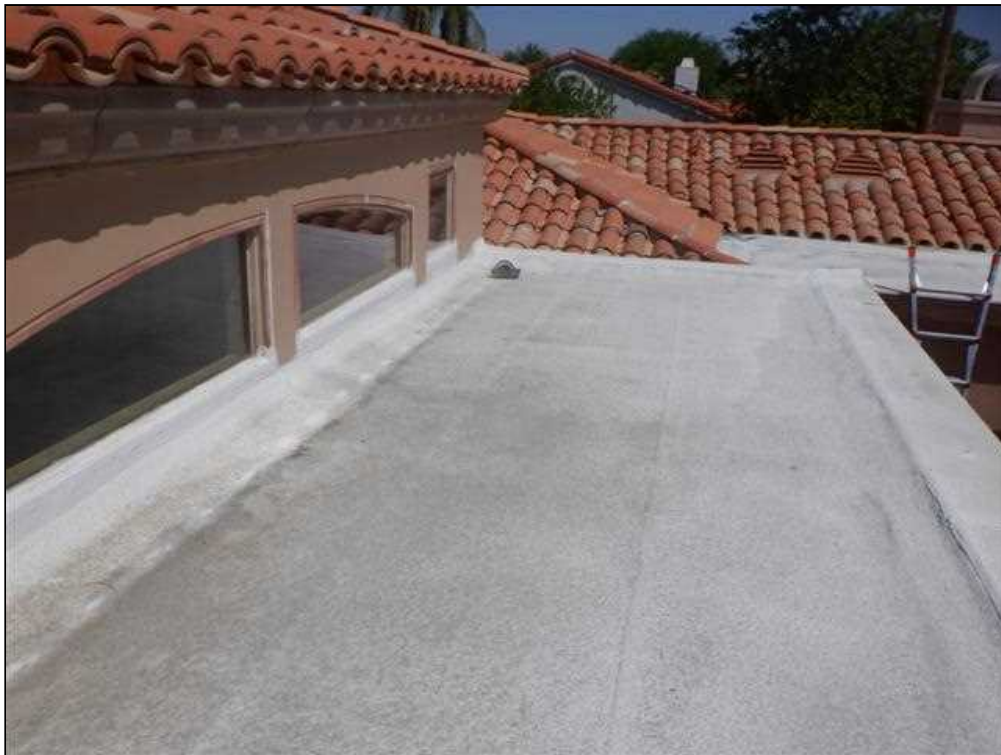
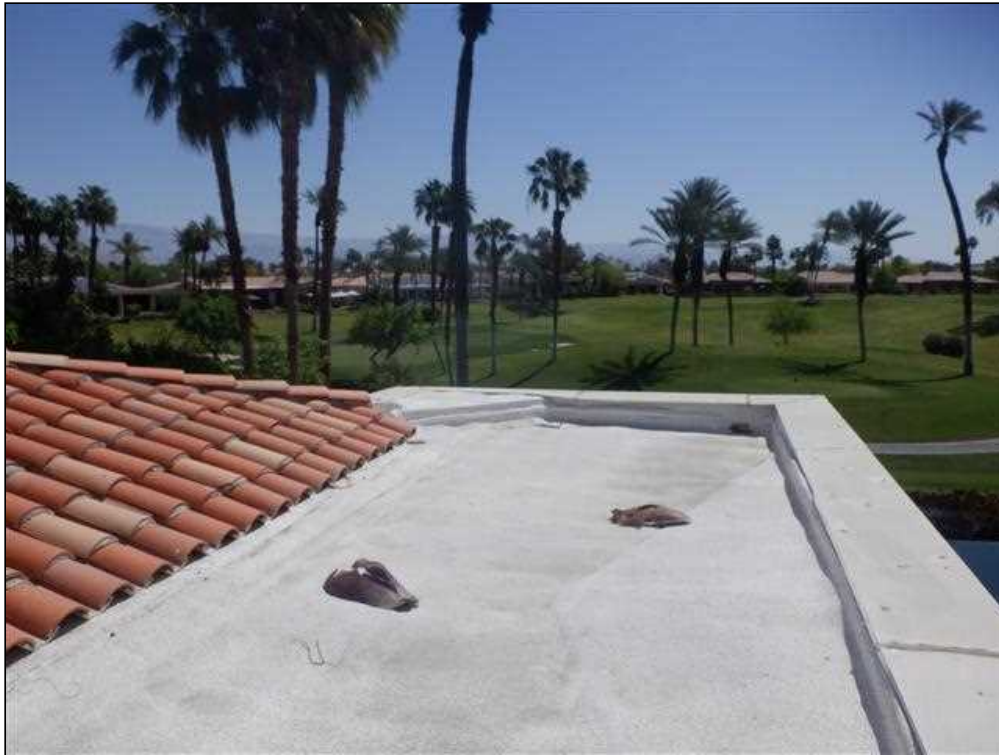
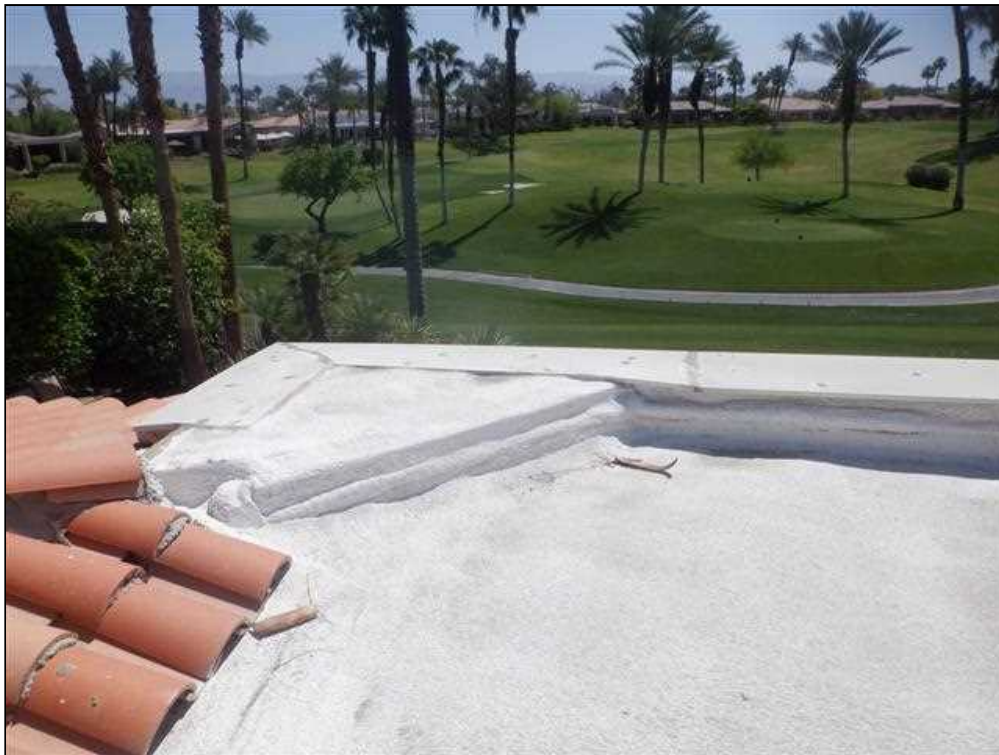
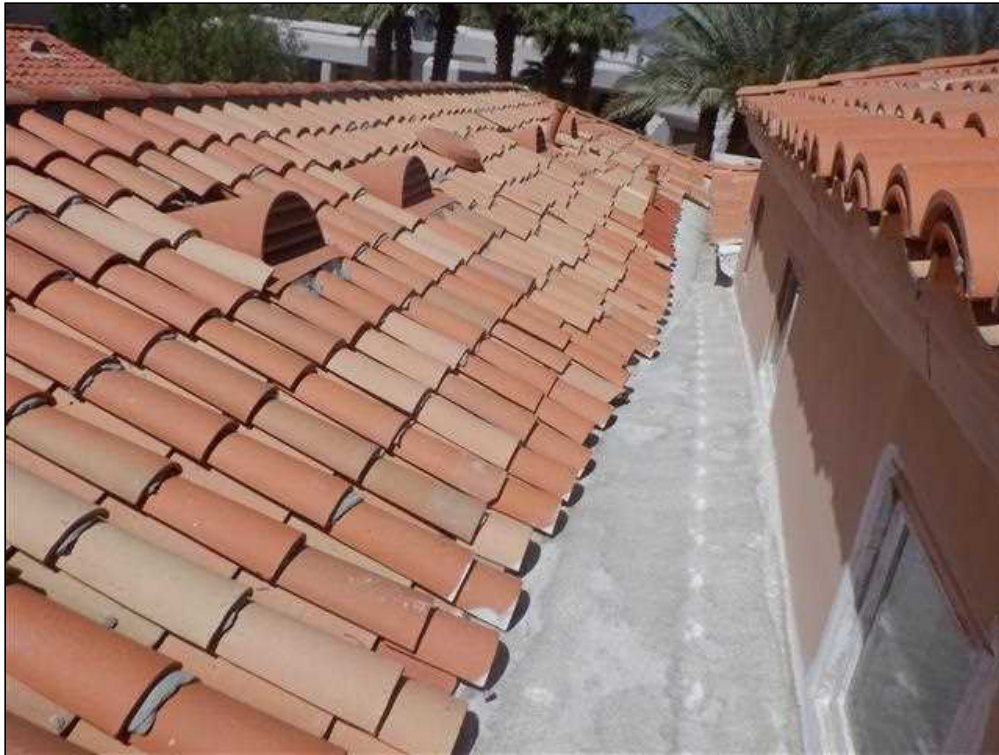
(2) Low slope and flat roofs are prone to leakage however we did not note any irregularities in this roof at time of inspection. This roof consist of polyurethane foam with a coating and this roof appeared to be in good condition.

1.0 Item 11(Picture) Flat Roof Covering

1.0 Item 12(Picture) Flat Roof Covering

1.0 Item 13(Picture) Flat Roof Covering

1.0 Item 14(Picture) Flat Roof Covering

1.0 Item 15(Picture) Flat Roof Covering

1.0 Item 16(Picture) Flat Roof Covering

1.0 Item 17(Picture) Flat Roof Covering

1.0 Item 18(Picture) Flat Roof Covering

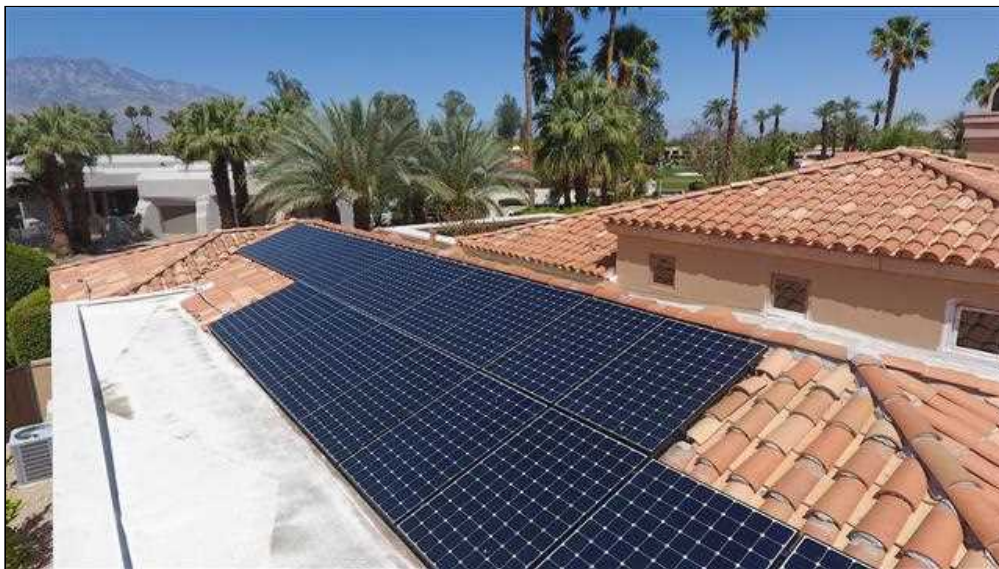
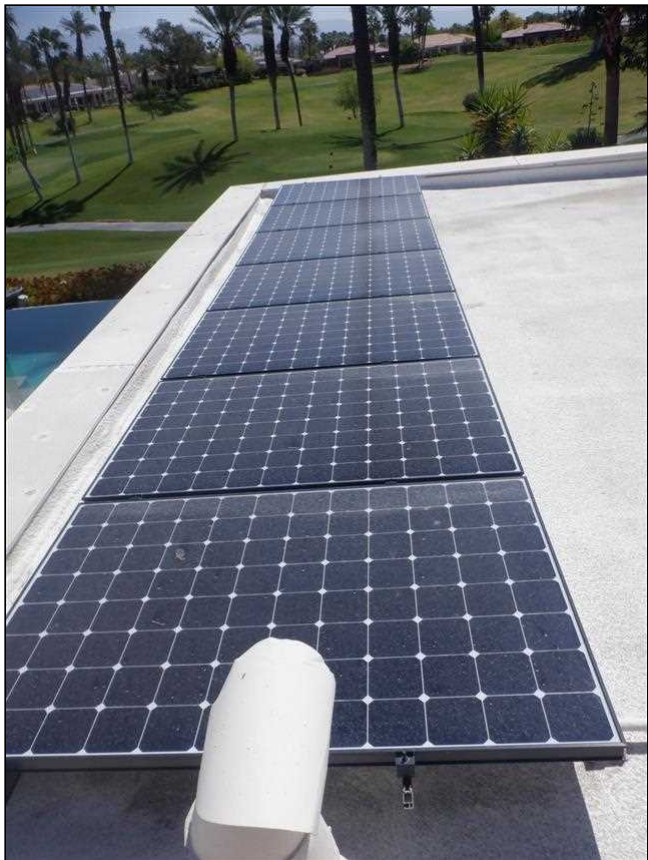
We noted that this house is equipped with solar panels. Our company dose not inspect solar panels and we have no way of telling if they are functioning properly or if they were installed correctly. Improperly installed solar panels can lead to roof leaks. This solar equipment should be evaluated by a licensed specialist.

1.9 Item 1(Picture) Solar Panels

1.9 Item 2(Picture) Solar Panels

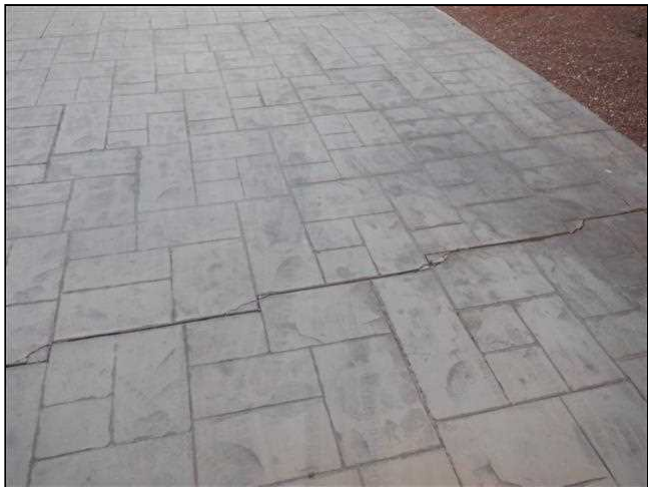
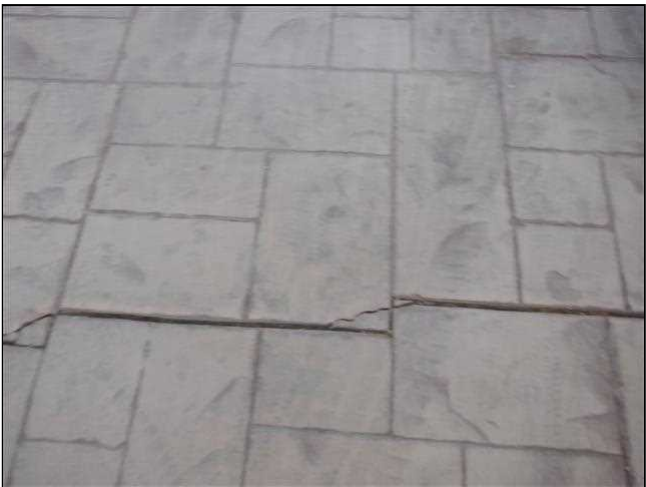
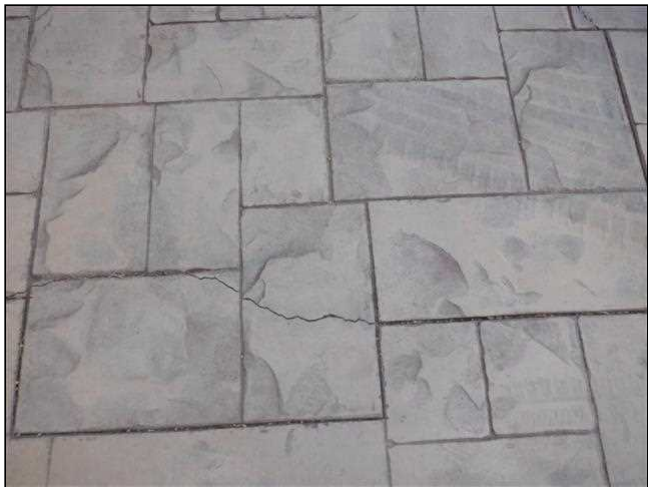
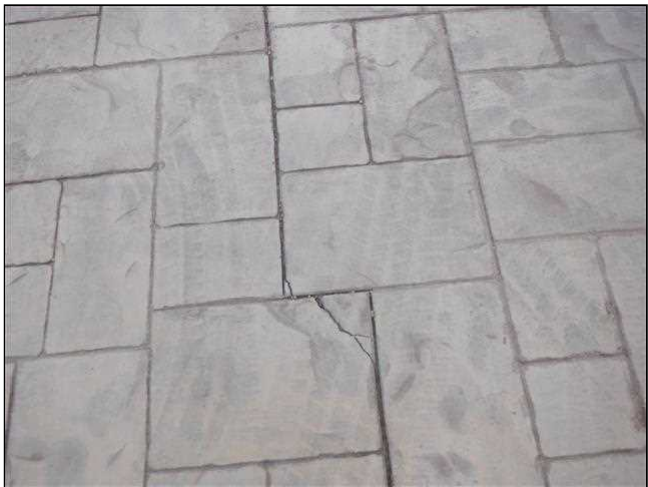
(1) Settlement cracks were noted in the concrete driveway and walkway. These slab cracks are normal settlement cracks for a home this age, no uplift or trip hazards were noted. Recommend evaluation and repair as needed.

2.4 Item 1(Picture) Driveway Settlement Cracks

2.4 Item 2(Picture) Driveway Settlement Cracks

2.4 Item 3(Picture) Driveway Settlement Cracks

2.4 Item 4(Picture) Driveway Settlement Cracks

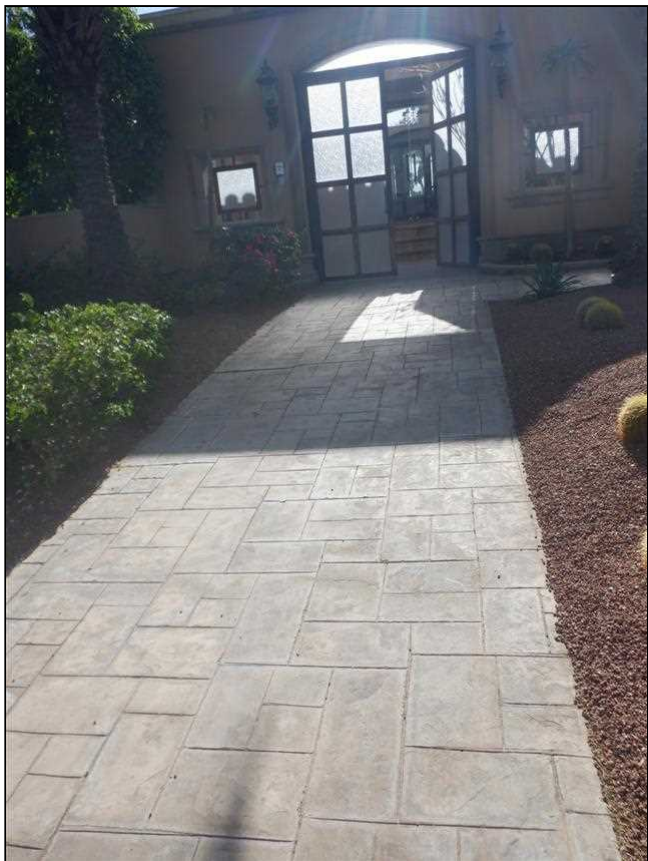
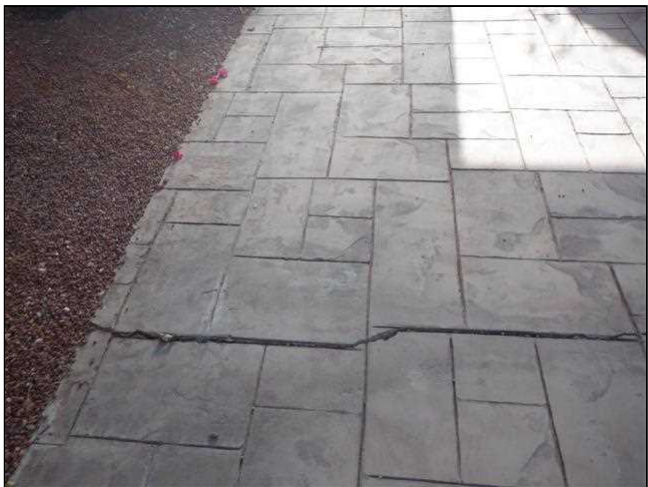
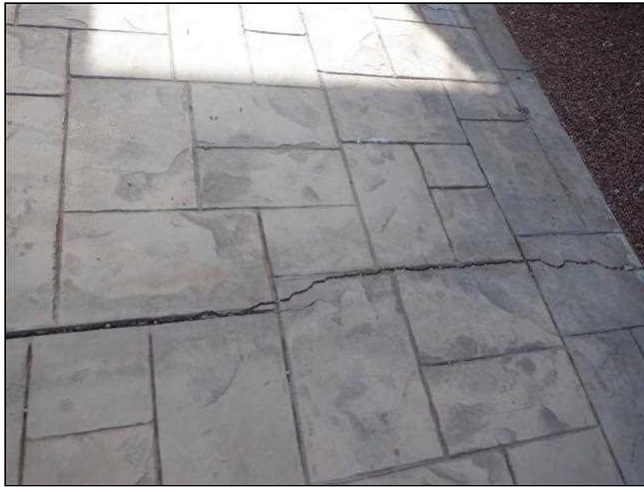
2.4 Item 5(Picture) Walkway Settlement Cracks

2.4 Item 6(Picture) Walkway Settlement Cracks

2.4 Item 7(Picture) Walkway Settlement Cracks

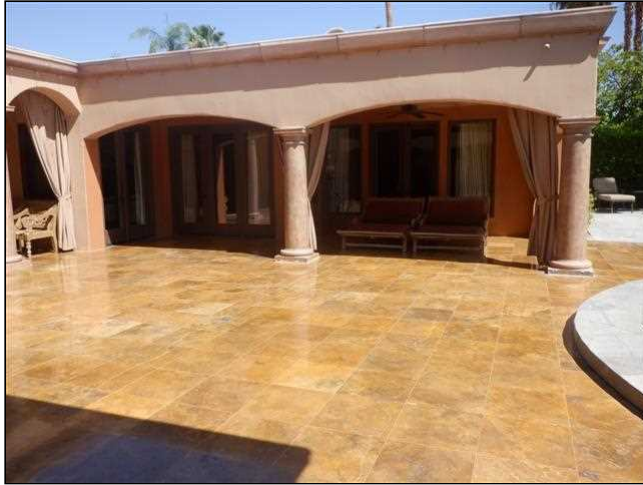
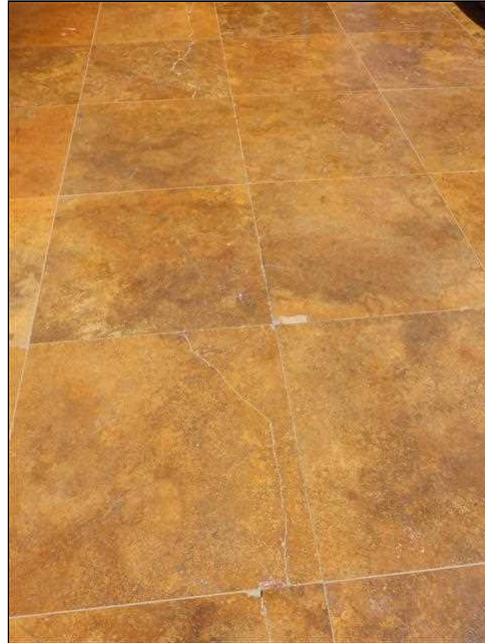
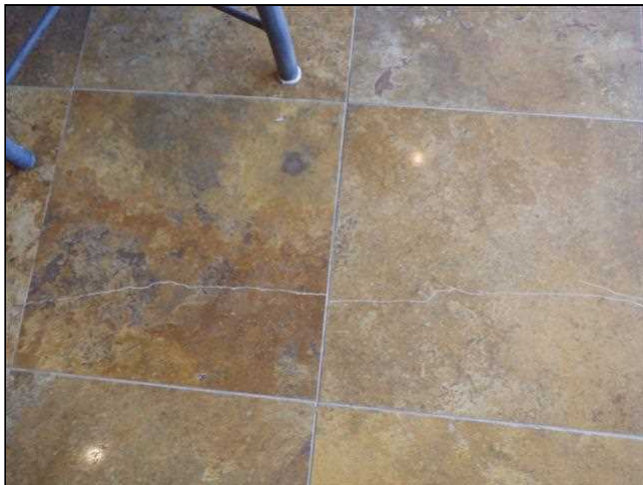
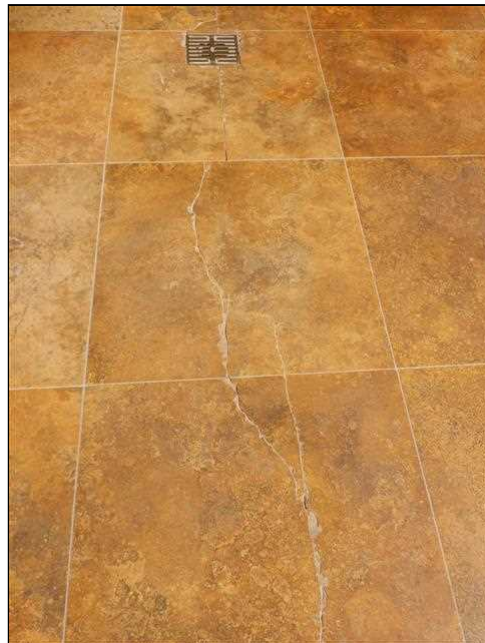
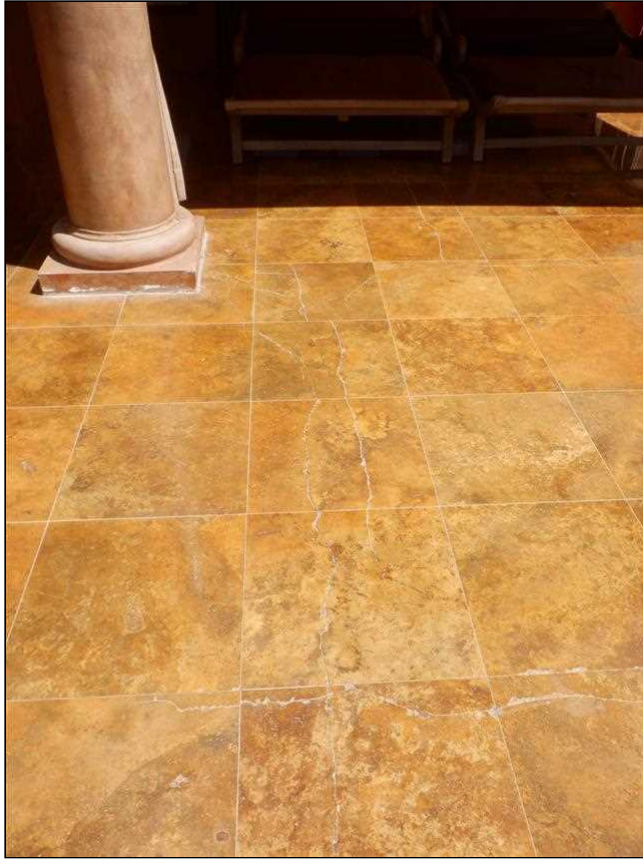
(3) We noted several cracked tiles on the exterior of the house (patio) at time of inspection. We believe that these damaged tiles are a cosmetic issue. Recommend replacement of any damaged tiles by a licensed contractor..

2.4 Item 9(Picture) Cracked Patio Tiles

2.4 Item 10(Picture) Cracked Patio Tiles

2.4 Item 11(Picture) Cracked Patio Tiles

2.4 Item 12(Picture) Cracked Patio Tiles

2.4 Item 13(Picture) Cracked Patio Tiles

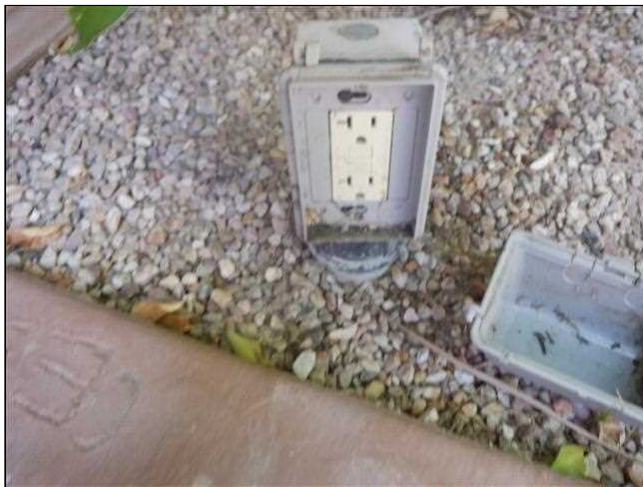
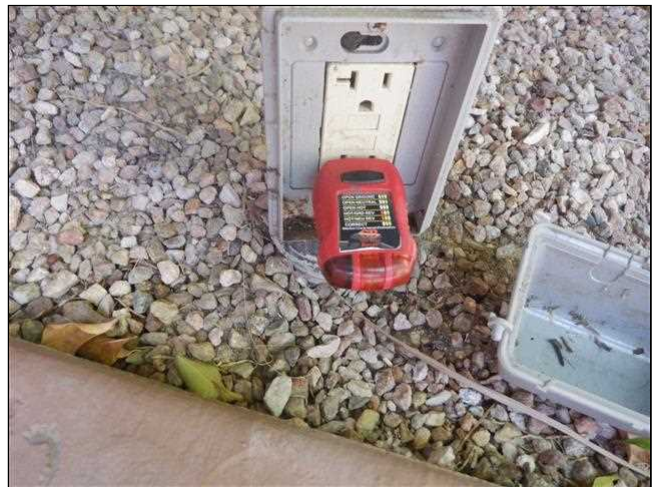
Although exterior outlets are GFCI protected we noted that the GFCI outlet in the upper courtyard failed to re-set upon testing. Recommend replacing GFCI outlet as needed by a licensed electrical contractor.

2.7 Item 1(Picture) Upper Courtyard GFCI Failed To Reset

2.7 Item 2(Picture) Upper Courtyard GFCI Failed To Reset

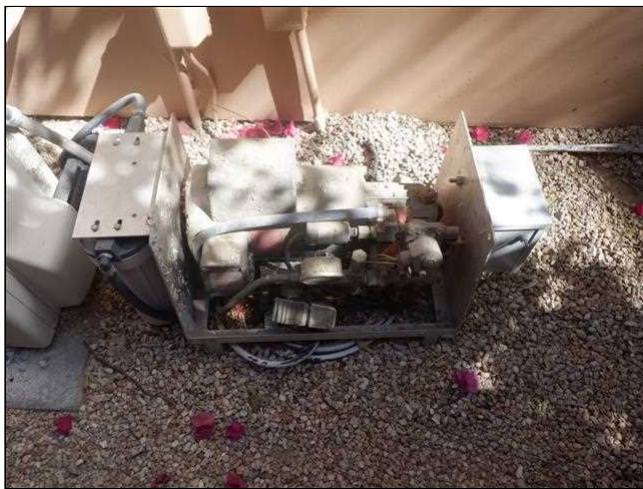
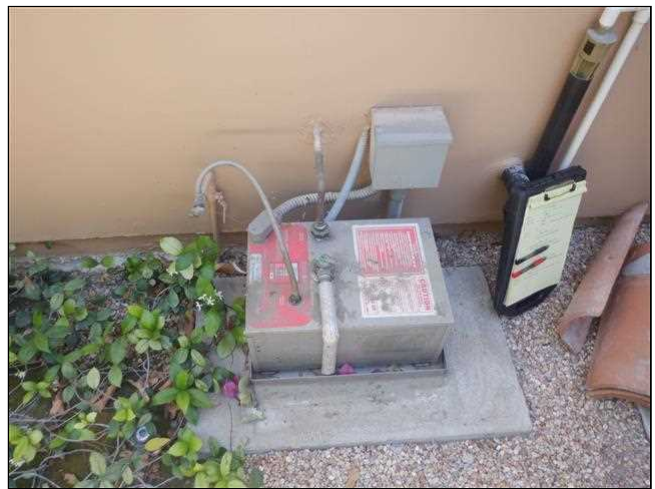
These misting system (2 pumps total) were not functioning at time of inspection. Recommend evaluation and repair by a licensed contractor.

2.17 Item 1(Picture) Misting System Pump 1

2.17 Item 2(Picture) Misting System Pump 2

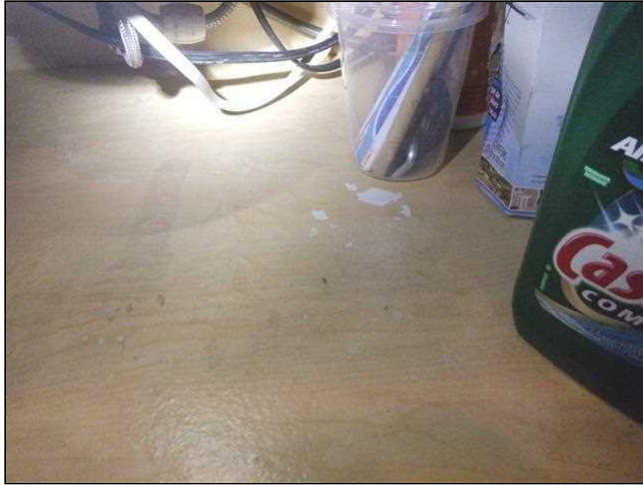
We noted that the main sink and small (bar) base cabinet appeared to have past water damage at the bottom. No active leaks or moisture noted at time of inspection. Recommend repair replace as needed by a licensed contractor.

4.5 Item 2(Picture) Main Sink Base Moisture Damage

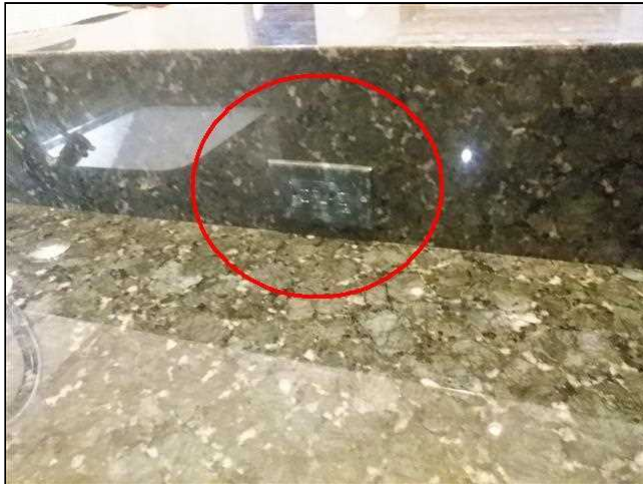
Although all countertop outlets in this kitchen are GFCI protected we noted that they all have been painted over. We also noted that the GFCI outlet next to the small bar sink failed to reset after testing, we believe that the test buttons are damaged (stuck) due to this paint. Recommend replacement of this damaged GFCI outlet by a licensed electrical contractor. FYI electrical outlets should never be painted for obvious reasons. All the outlets for this countertop are not functioning due to this bad GFCI.

4.8 Item 2(Picture) Bad GFCI Outlet

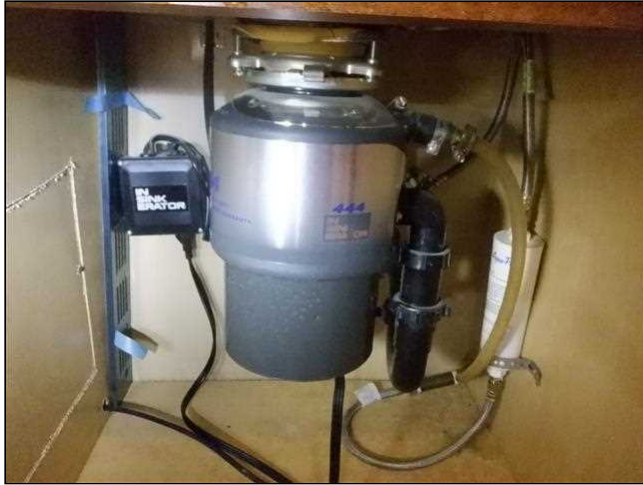
We noted that this kitchen is equipped with 3 food waste disposers and we noted that the disposer for the small sink (bar) was frozen at time of inspection. Recommend evaluation repair replace as needed by an appliance contractor.

4.12 Item 1(Picture) Small Sink Disposer

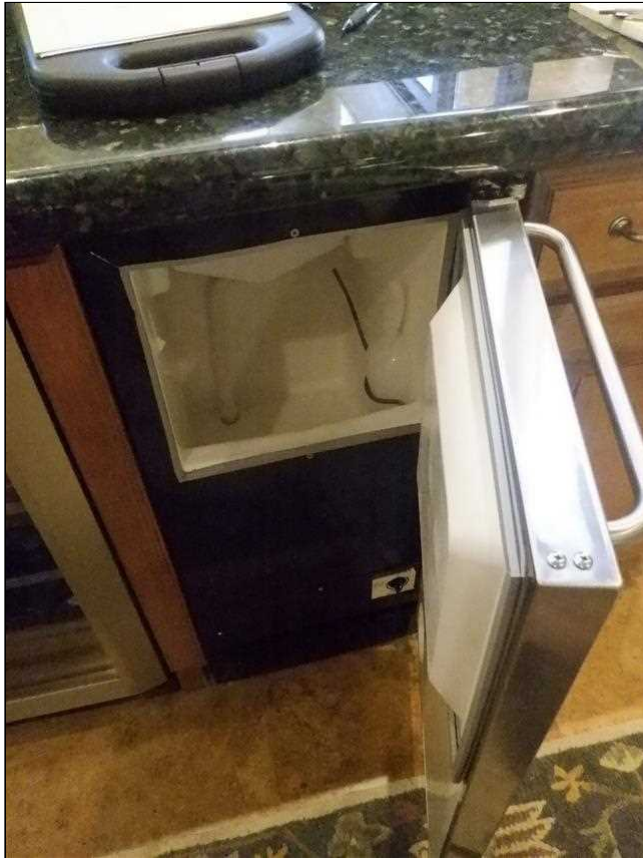
(1) We noted that the bar ice maker was off at time of inspection. Recommend activating unit and confirming proper operation before close of escrow.

4.16 Item 1(Picture) Ice Maker Off

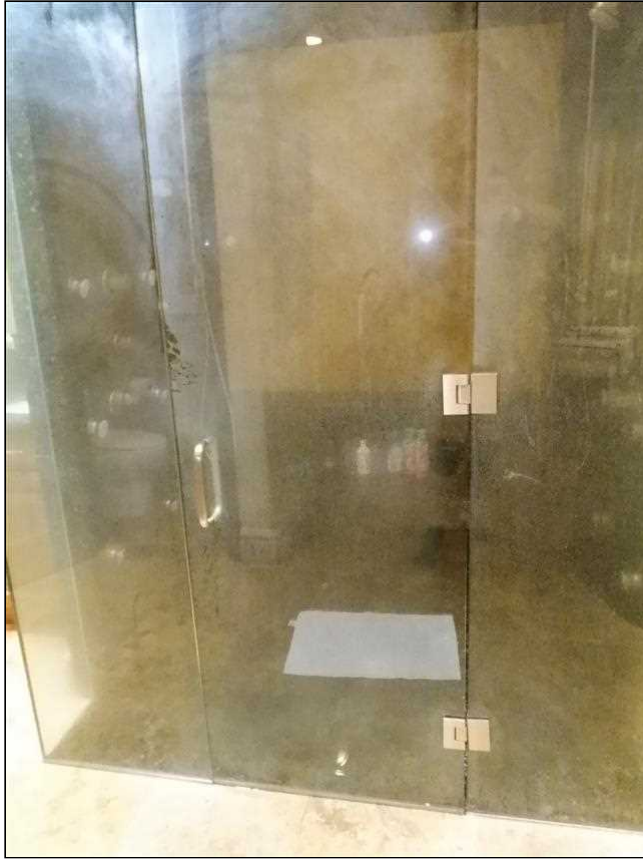
6.12.B Item 1(Picture) Shower

(1) We noted upon activation of the shower that the water would creep out the shower opening onto the bathroom floor. We believe that this is caused by not enough pitch at the bottom of the shower towards the drain and shower head type/excessive pressure. Recommend evaluation by a licensed contractor to come up with a solution to this issue.

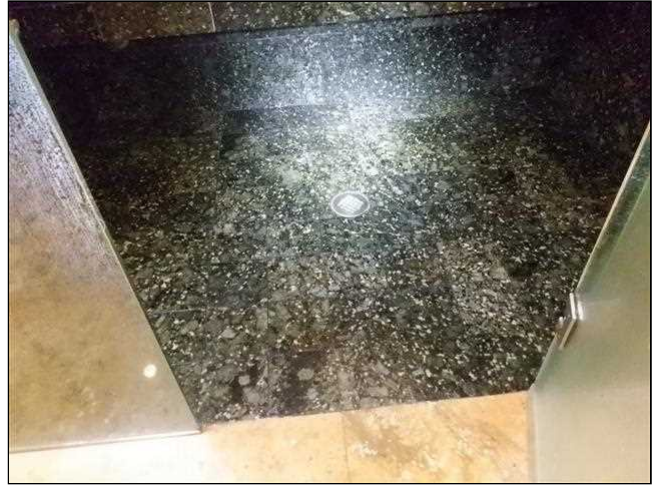
6.12.B Item 2(Picture) Shower Interior Not Enough Pitch

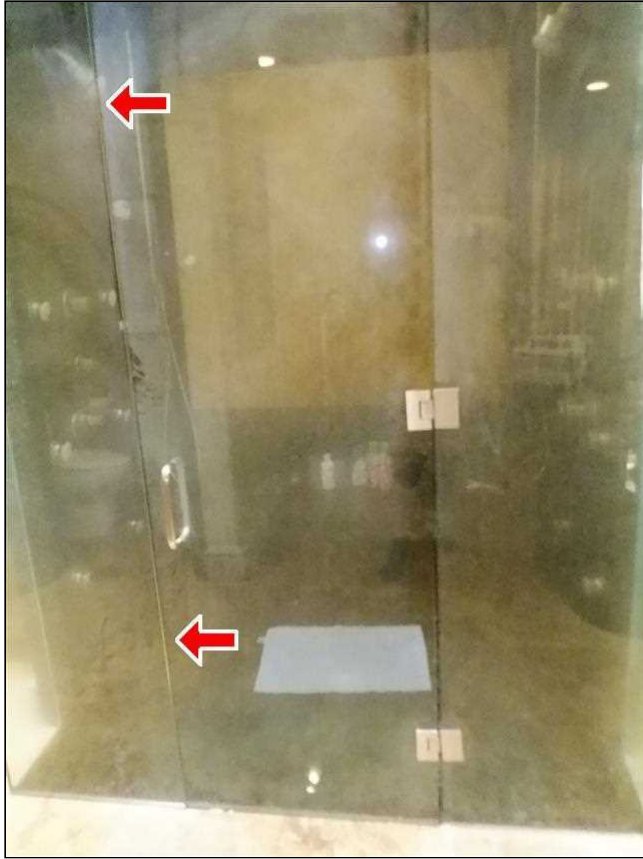
(2) We noted that the shower door appears to be rubbing on the glass surround when opening and closing. Recommend evaluation by a licensed contractor to adjust or repair as needed. .

6.12.B Item 4(Picture) Shower Door Rubbing
