# **Inspection Report**

**Property Address:**  
12136 St Andrews Dr  
Rancho Mirage CA 92270

**Livingston Home Inspections, Inc.**

<b>Date:</b> 4/27/2022	<b>Time:</b> 09:00 AM	<b>Report ID:</b> 20220427-12136-St-Andrews-Dr
<b>Property:</b> 12136 St Andrews Dr Rancho Mirage CA 92270	<b>Customer:</b> Garrett Saikley	<b>Real Estate Professional:</b> Jonathan Olow Big Block Realty

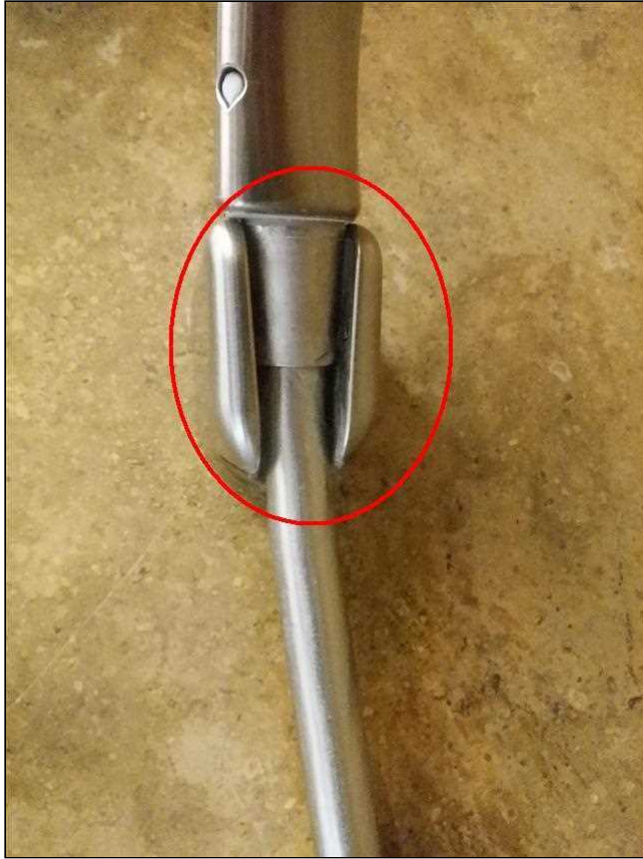
We noted a leak at the top of the shower head fitting at the time of inspection. Recommend repair/replace as needed by a licensed plumbing contractor.

6.3.C Item 1(Picture) Shower Head Fitting Leak

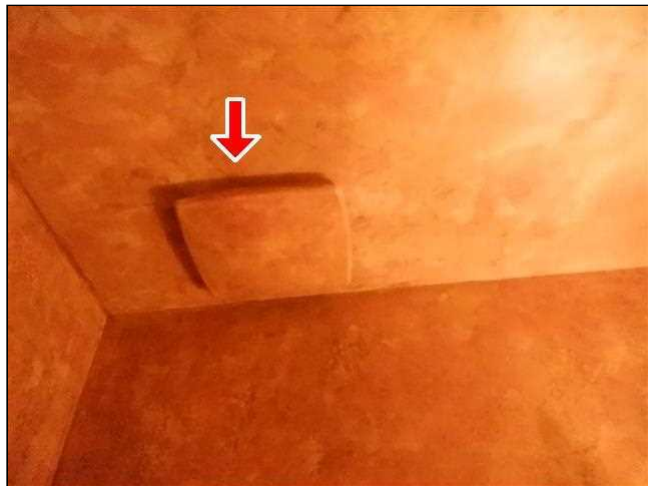
We noted that the exhaust fan was very noisy when operating. Recommend evaluation repair replace as needed.

6.5.E Item 1(Picture) Noisy Fan

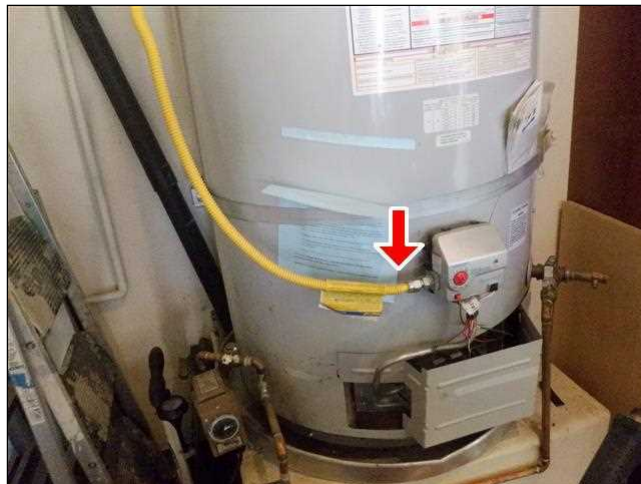
Although this water heater was functioning properly at time of inspection we noted that there was no sediment trap (Drip Leg) installed on the fuel line. The installation of fuel line sediment traps have been required for many years. We highly recommend installation of sediment traps (Drip Legs) on all gas fired tankless and tank type water heaters they are installed per manufactures requirements to help prevent sediment in the gas piping from getting into the gas valve or burner area of an appliance and causing safety issues with combustion. The installation of sediment traps may extend the life of an appliance. Recommend evaluation and installation of sediment trap by a licensed plumbing contractor. This unit has a 100 gallon tank it is 8 years old.

8.2 Item 2(Picture) Water Heater Fuel Line Missing Sediment Trap

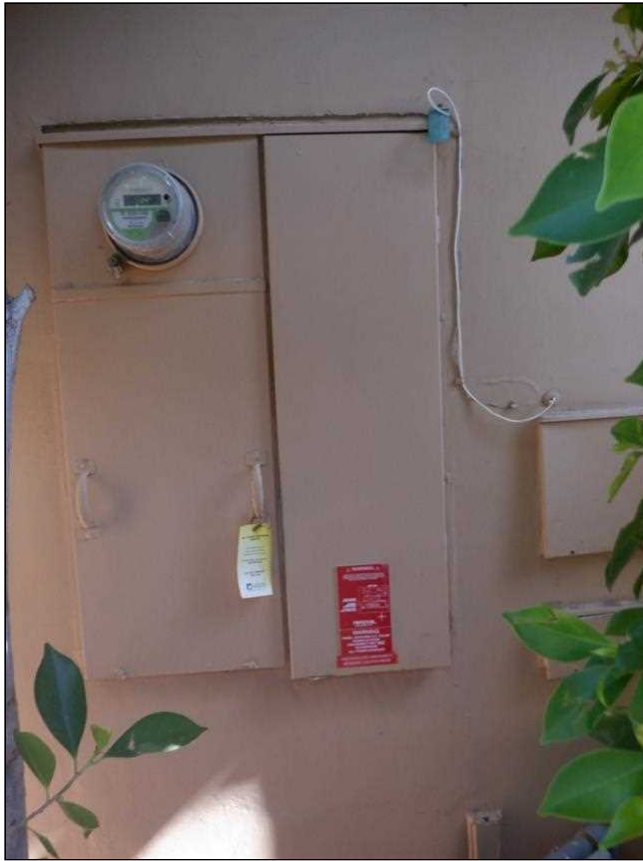
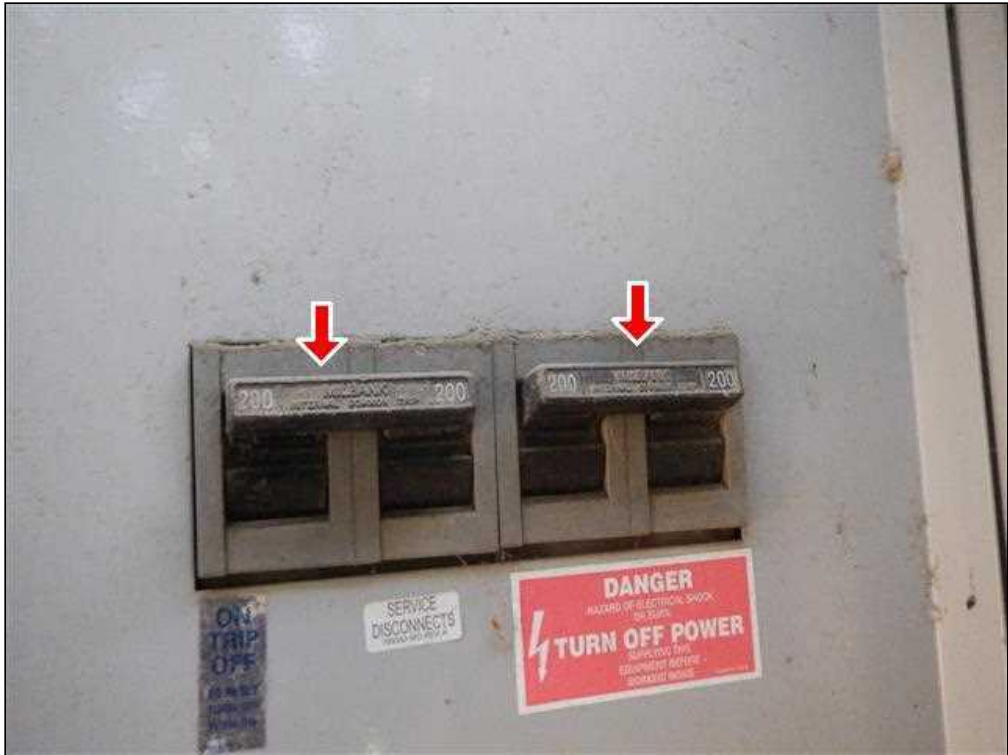
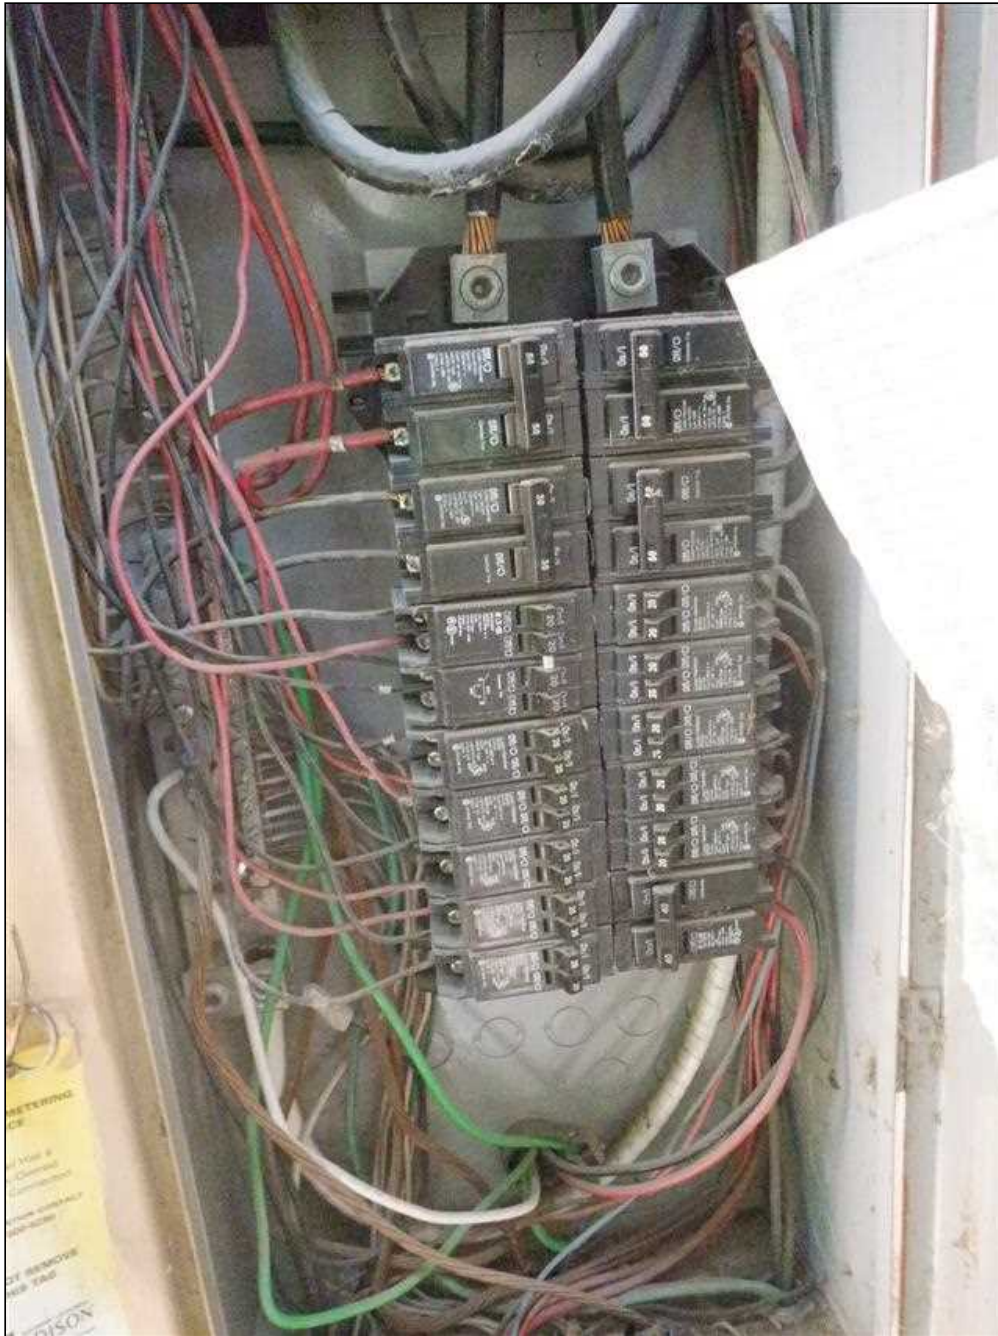
(1) The electrical panel is located on the south side of the garage. This panel has 2 200 amp disconnects and although we did not find any irregularities in this panel we noted that not all of the circuit breakers were labeled. Recommend evaluation and labeling of all circuits for proper identification and ease of use by a licensed electrician. FYI we also could not determine the size of the breaker for the pool/spa sub panel due to this panels circuits not being labeled.

9.1 Item 1(Picture) Main Electrical Panel

9.1 Item 2(Picture) Main Electrical Panel Disconnects 2 X 200

9.1 Item 4(Picture) Main Electrical Panel Breakers/Conductors

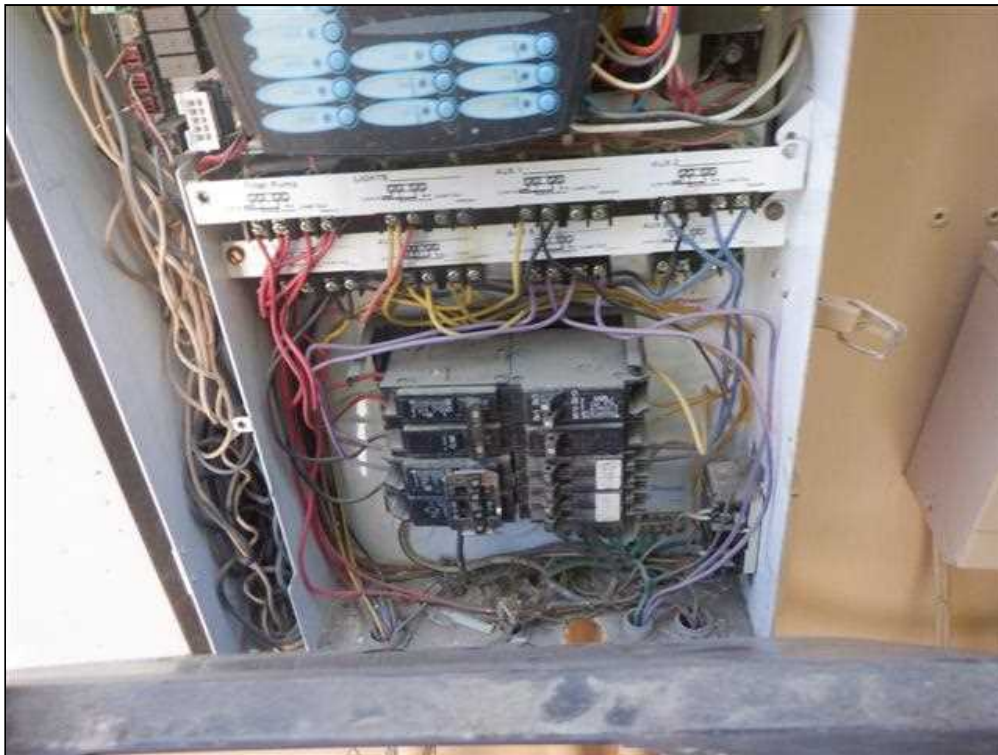
(2) The pool electrical sub panel is located on the north side of house by the pool equipment. Although we did not find any irregularities in this panel we noted that the circuit breakers were not labeled. Recommend evaluation and labeling of all circuits for proper identification and ease of use by a licensed electrician.

9.1 Item 6(Picture) Pool/Spa Sub Panel Breakers/Conductors

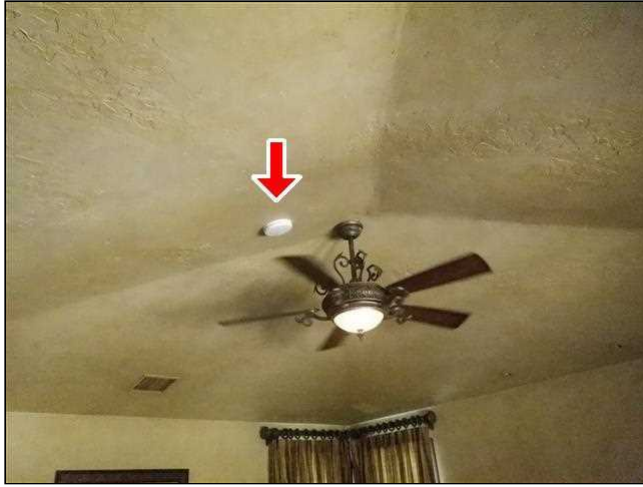
Although this home had smoke detectors in all the required areas we noted that the detector in the primary bedroom was not installed correctly, this smoke detector is installed too close to the ceiling fan, all smoke and carbon detectors must be installed at least 36 inches from any ceiling fan or HVAC registers, this will be considered a safety issue if not corrected. Recommend evaluation, removal and relocation of this smoke detector.

9.7 Item 1(Picture) Smoke Detector To Close To Ceiling Fan

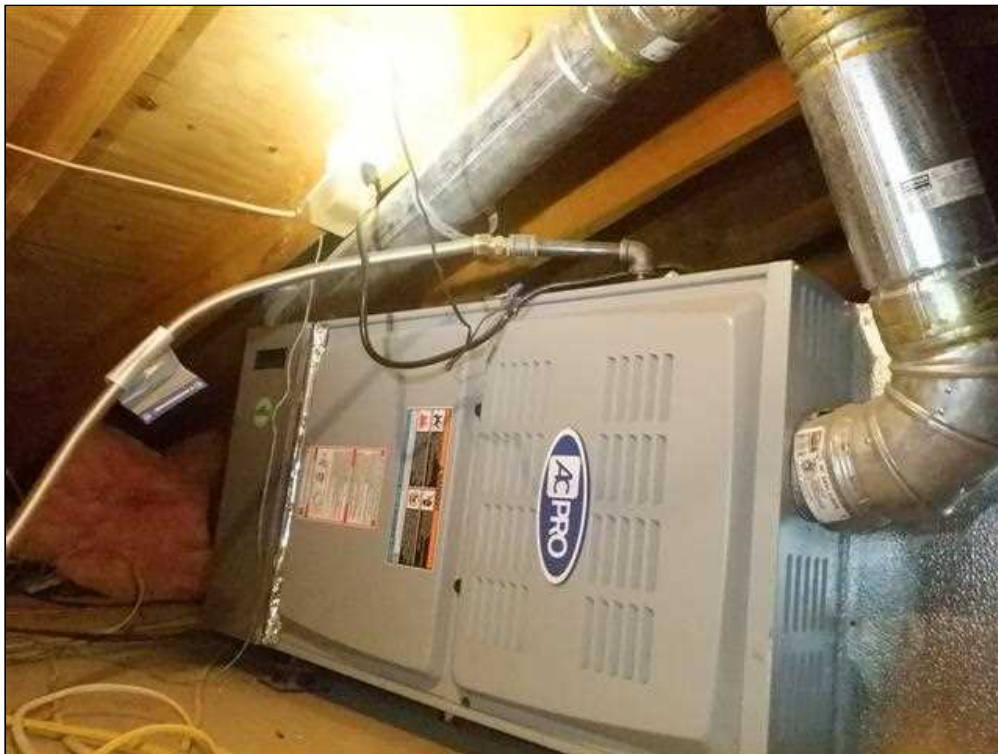
10.0.A Item 1(Picture) Heating Unit South

Although this heater was functioning properly at the time of inspection we noted that there was no sediment trap (Drip leg) installed on the fuel line. We highly recommend the installation of sediment traps (Drip legs) on all gas fired furnaces as they are installed, per manufactures requirements, to help prevent sediment in the gas piping from getting into the gas valve or burner area of an appliance and causing safety issues with combustion. Sediment trap (Drip legs) are now required on all gas fired heaters. The installation of sediment traps will extend the life of an appliance. Recommend evaluation and installation of a sediment trap by a licensed plumbing contractor. This unit is 5 years old.

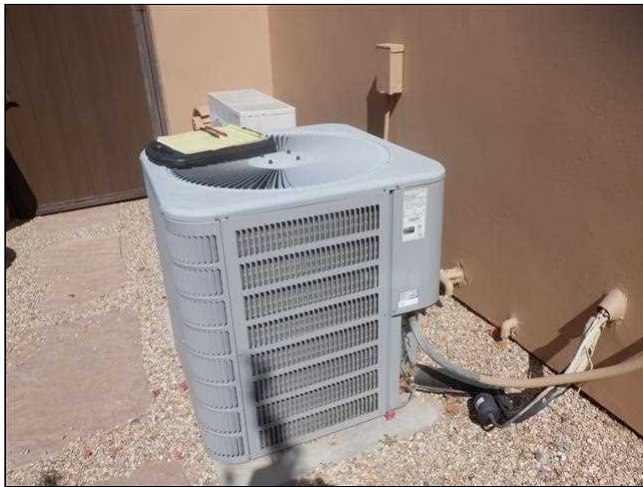
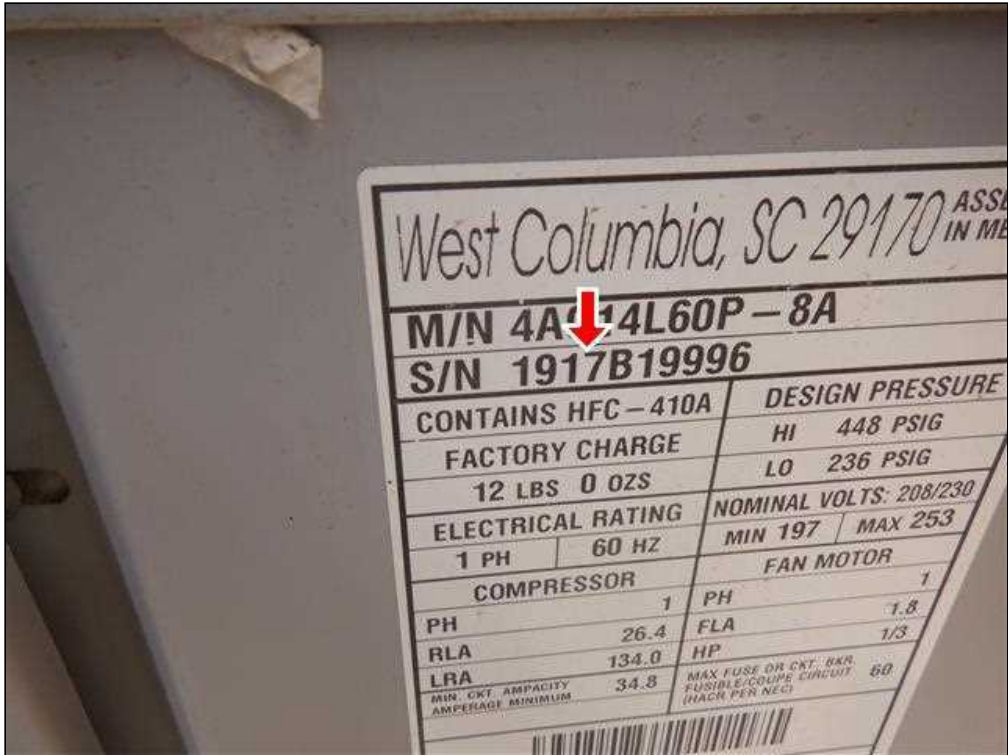
This AC unit is 5 years old and although this unit appeared to be functioning properly due to age and lack of service records we would recommend servicing this unit by a licensed HVAC contractor. FYI the refrigerant in this unit is the newer R-410A.

10.5.A Item 1(Picture) Cooling Unit South

10.5.A Item 2(Picture) Cooling Unit South MFG Date 2017

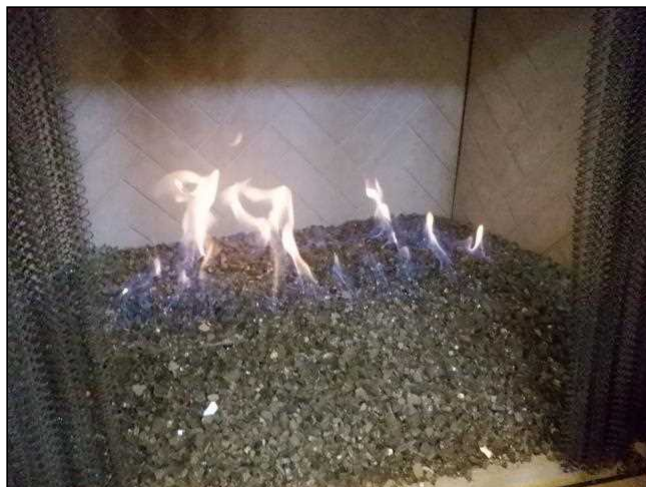
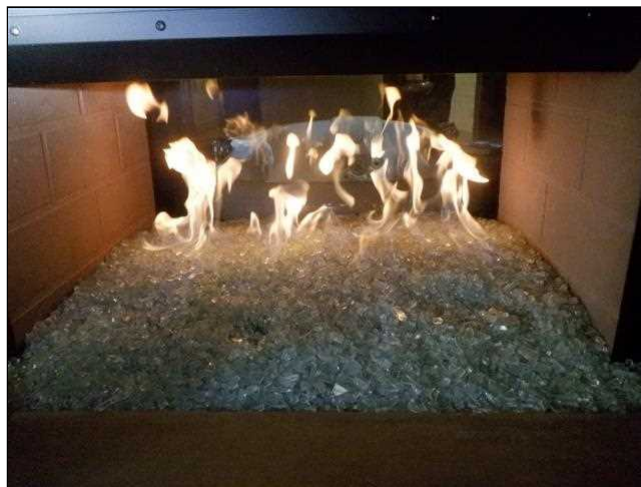
Level 2 fireplace inspection should be conducted upon the sale or transfer of a property or after an operation malfunction or external event that is likely to have caused damage to the chimney. Building fires, chimney fires, seismic events as well as weather events are all indicators that this level of inspection is warranted. There are no specialty tools (i.e. demolition equipment) required to open doors, panels or coverings in performing a Level 2 inspection. A Level 2 inspection shall also include a visual inspection by video scanning or other means in order to examine the internal surfaces and joints of all clay or metal flue liners incorporated within the chimney. No removal or destruction of permanently attached portions of the chimney or building structure or finish shall be required by a Level 2 inspection. We highly recommend a level 2 fireplace inspection by a licensed fireplace specialist. Call All Seasons Fireplaces at 760.365.6668 Rick Newsom. FYI these fireplaces (2 total) are located in the living room and primary bedroom.

10.5.B Item 1(Picture) Living Room Fireplace

10.5.B Item 2(Picture) Bedroom Fireplace

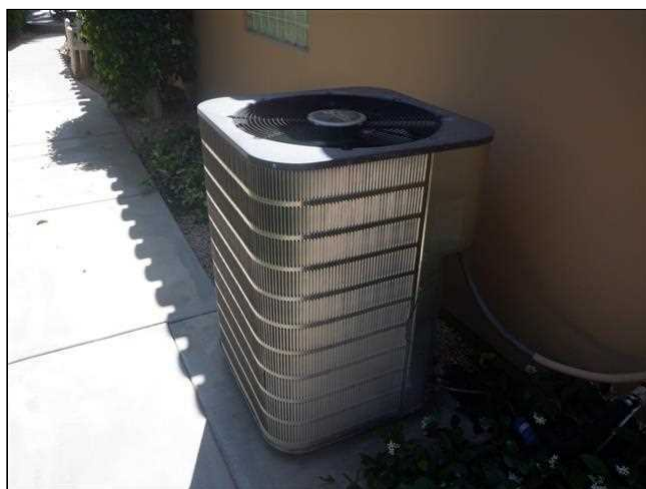
This AC unit is 18 years old and although this unit appeared to be functioning properly due to age and lack of service records we would recommend servicing this unit by a licensed HVAC Contractor. FYI we believe that this unit is charged with the older refrigerant R-22.

10.6.B Item 1(Picture) Cooling Unit 2

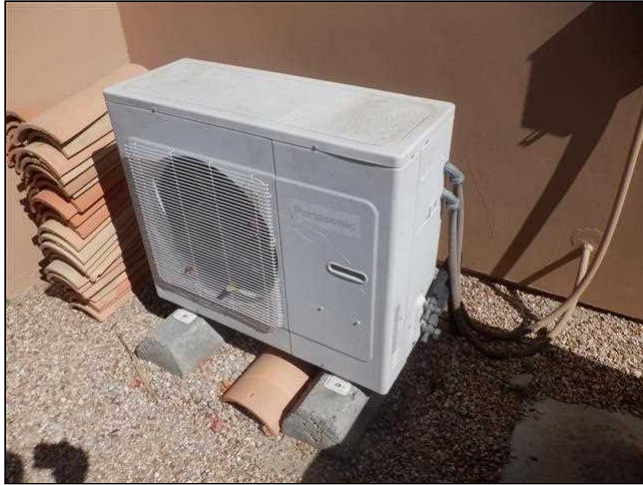
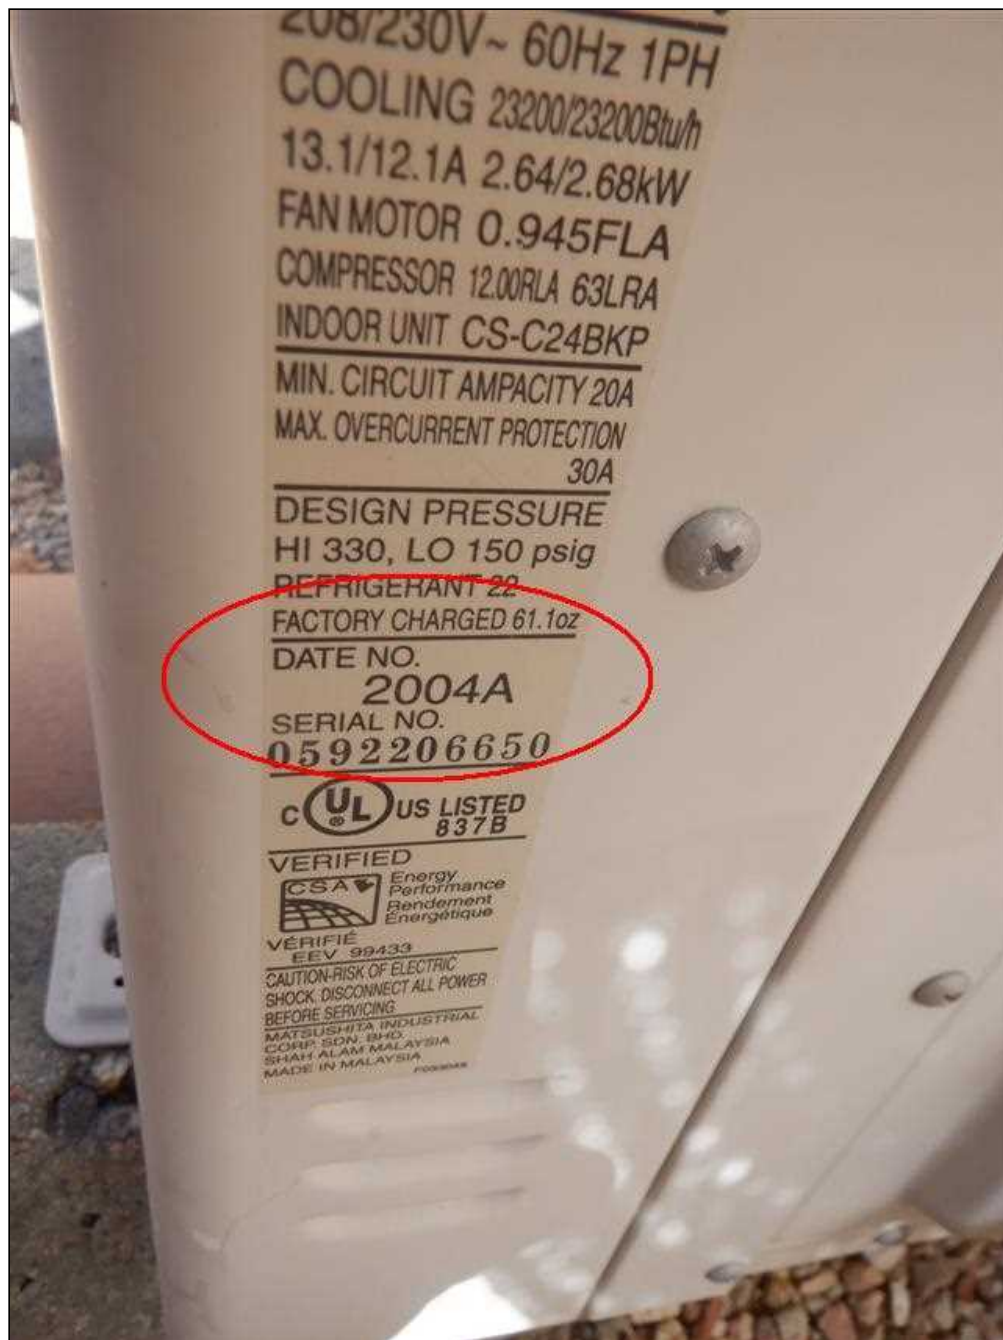
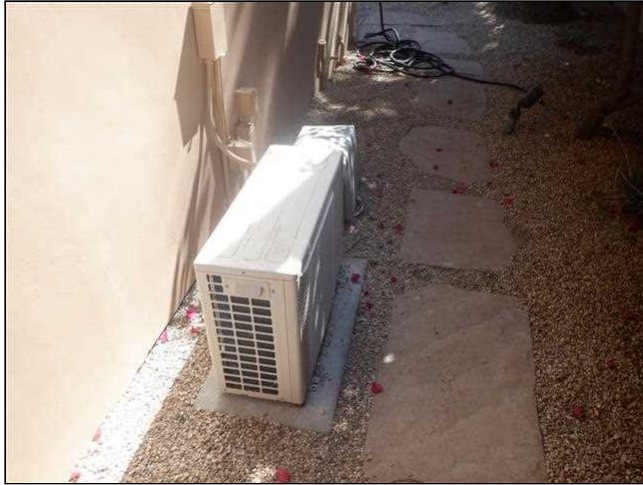
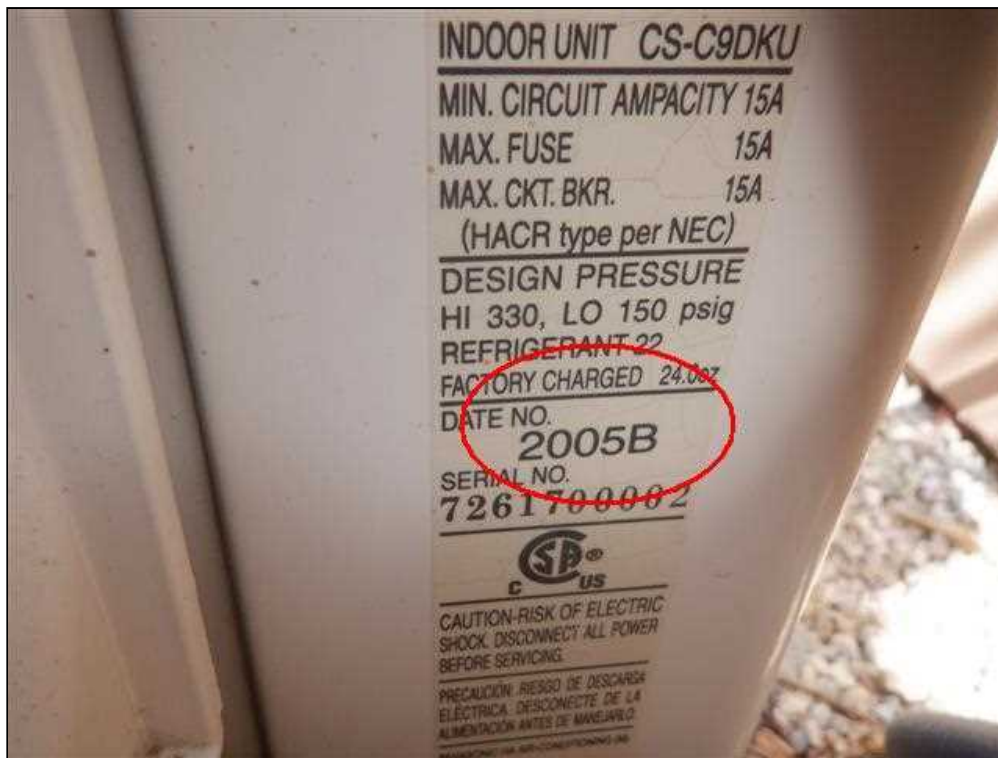
These units are called mini split systems they provide cooling and heating in one compact unit. These units are approximately 18 years old, they are charged with the older refrigerant R-22. Although these units appeared to be functioning properly we would recommend servicing by a licensed HVAC contractor.

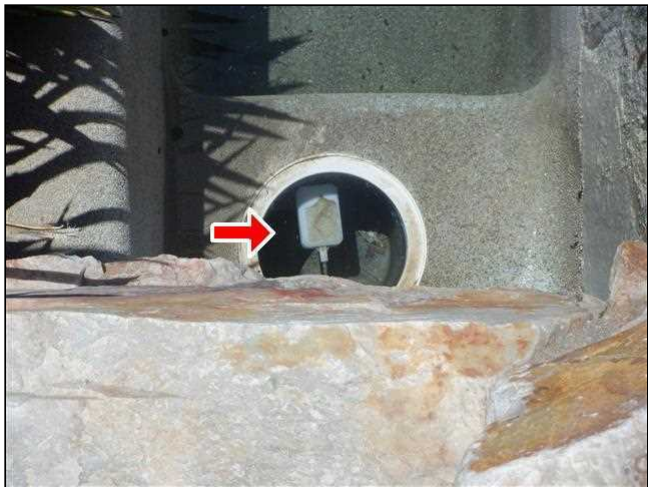
11.12 Item 1(Picture) Pool Auto Fill

Although the auto fill appeared to be functioning properly we were unable to locate its backflow preventer. All pools with an auto fill are required to have a backflow preventer. Recommend evaluation by a licensed pool contractor to install the required backflow preventer.

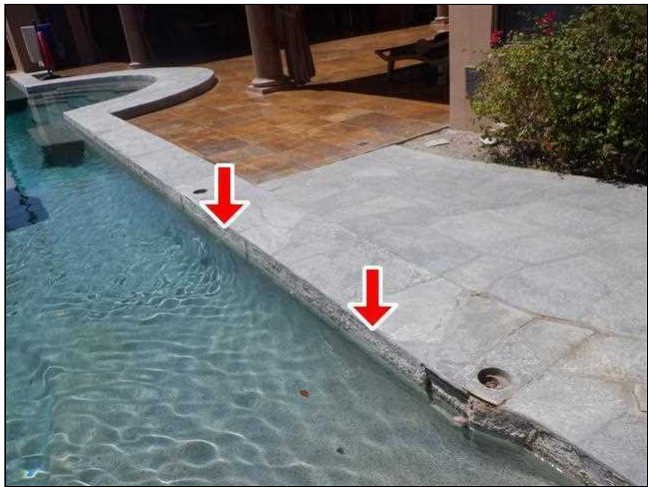
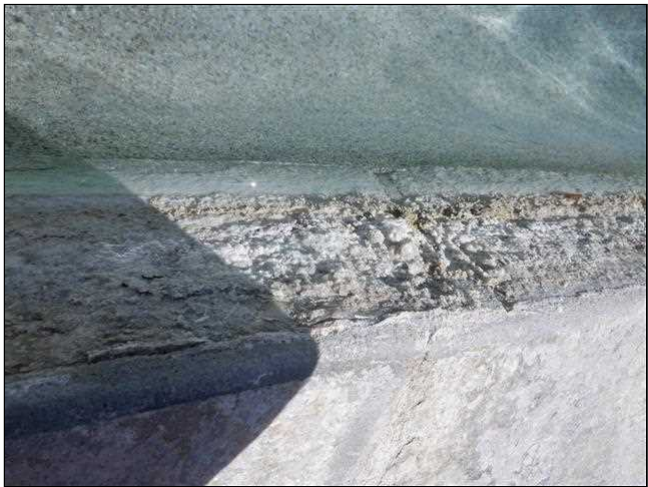
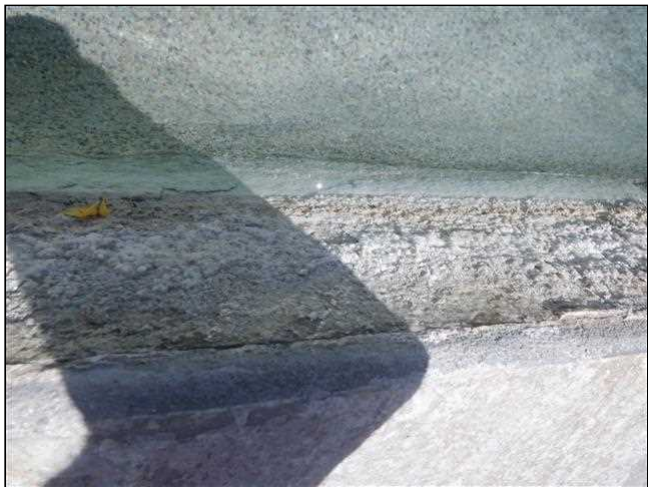
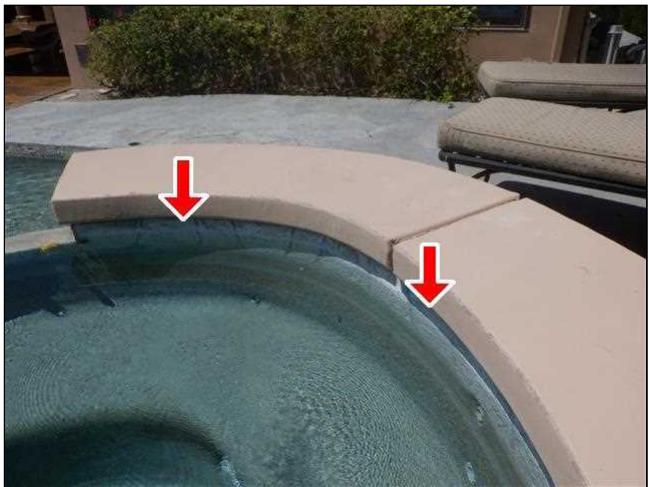
(1) We noted heavy calcium build up on the pool/spa stone. Recommend evaluation and cleaning by a pool contractor as needed.

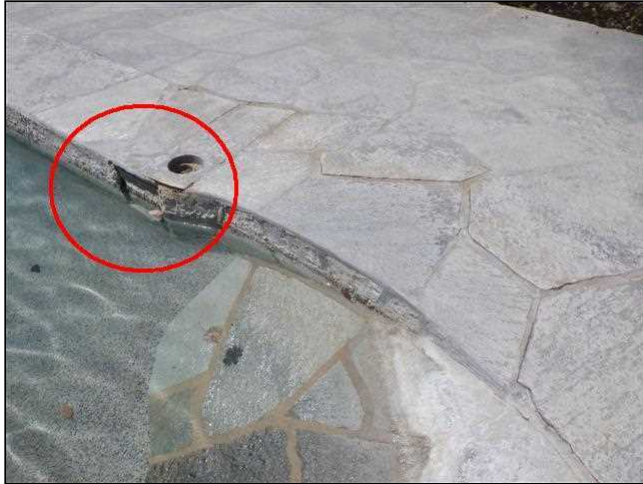
11.13 Item 5(Picture) Missing Pool Siding Stone

(2) We noted at least one missing pool siding stone at time of inspection. Recommend evaluation repair replace by a licensed pool contractor as needed.

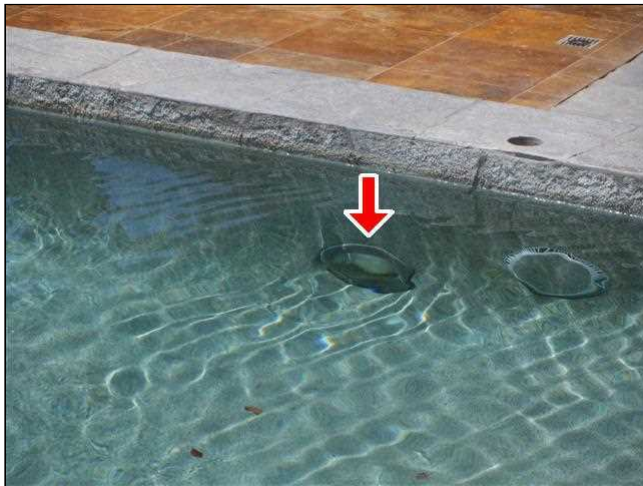
11.15 Item 1(Picture) Pool Light Out

Although the spa light appeared to be functioning we noted that at least one of the 4 pool lights was not. Recommend evaluation repair replace as needed by a licensed pool contractor.

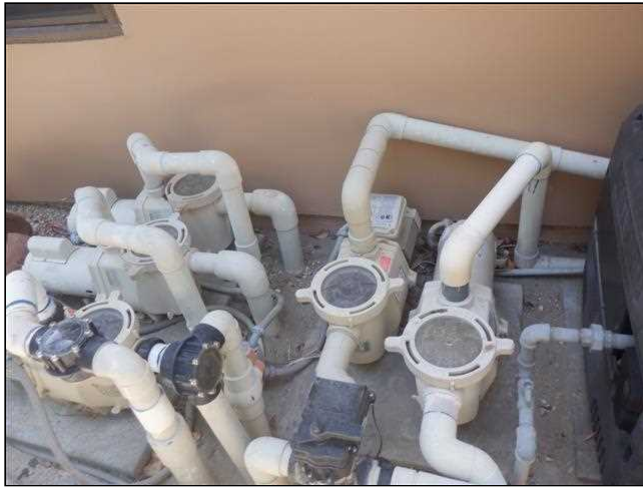
11.17 Item 1(Picture) Pool Pumps/Motors

This pool/spa and its water features are equipped with 5 pumps/motors and we noted that at least one of the pumps was not functioning at time of inspection (fountain nozzles). Recommend evaluation by a licensed pool contractor repair replace as needed.

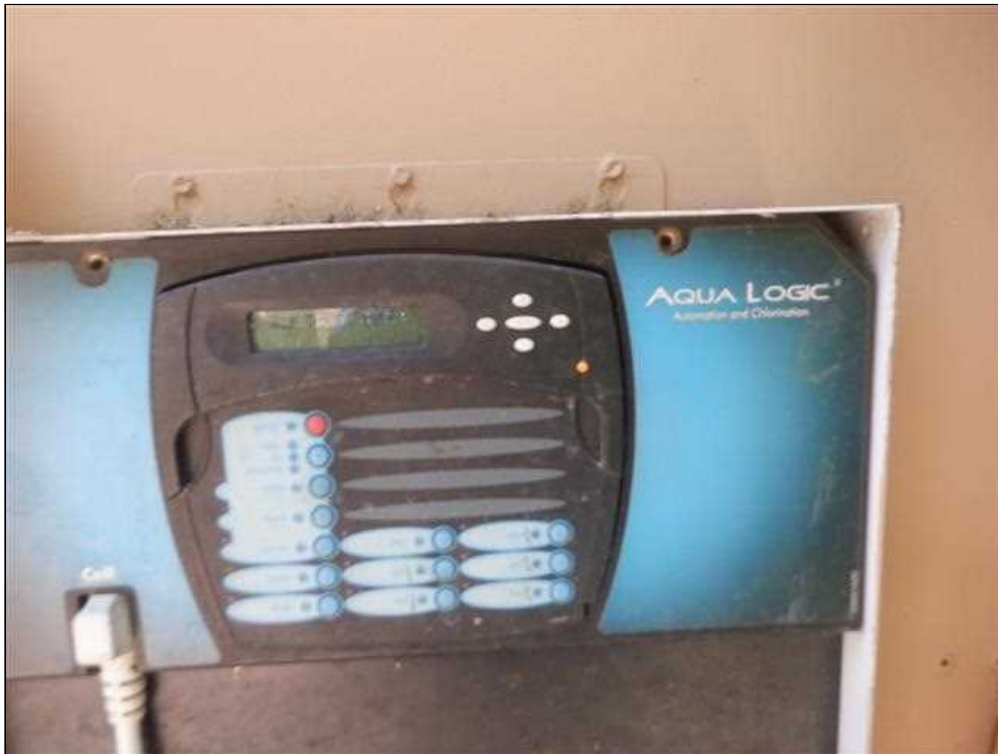
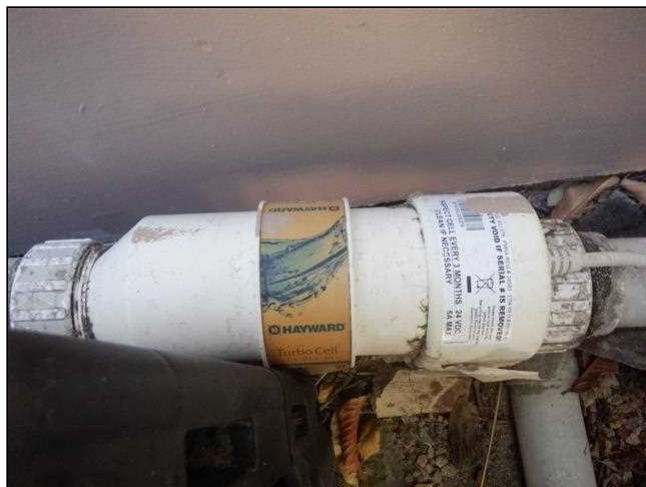
We believe that this pool is equipped with a electronic salt/chlorine generating system. We have no way of testing these units for proper operation or even knowing if there functioning properly. This unit should be evaluated for proper operation by a licensed pool contractor repair replace as needed. FYI we were told that this equipment is no longer functioning.

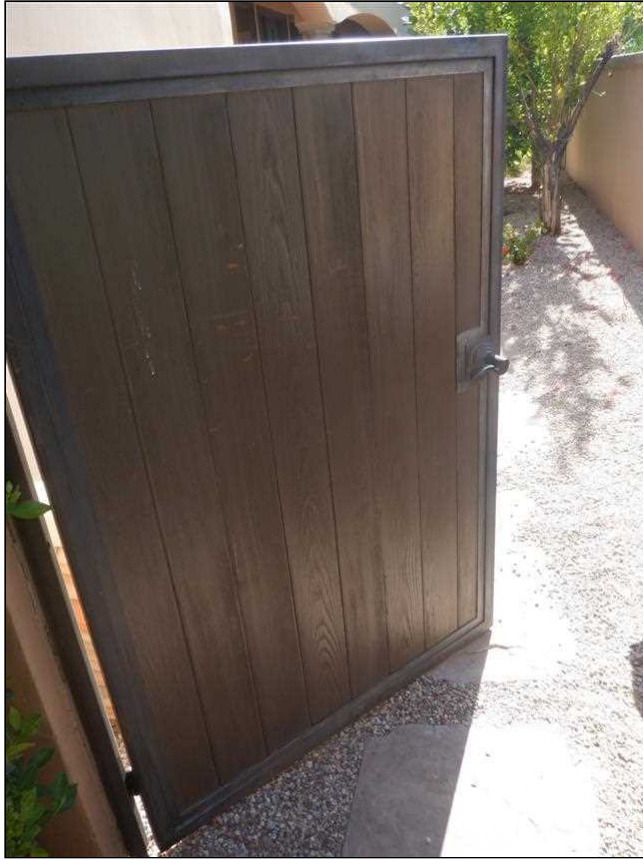
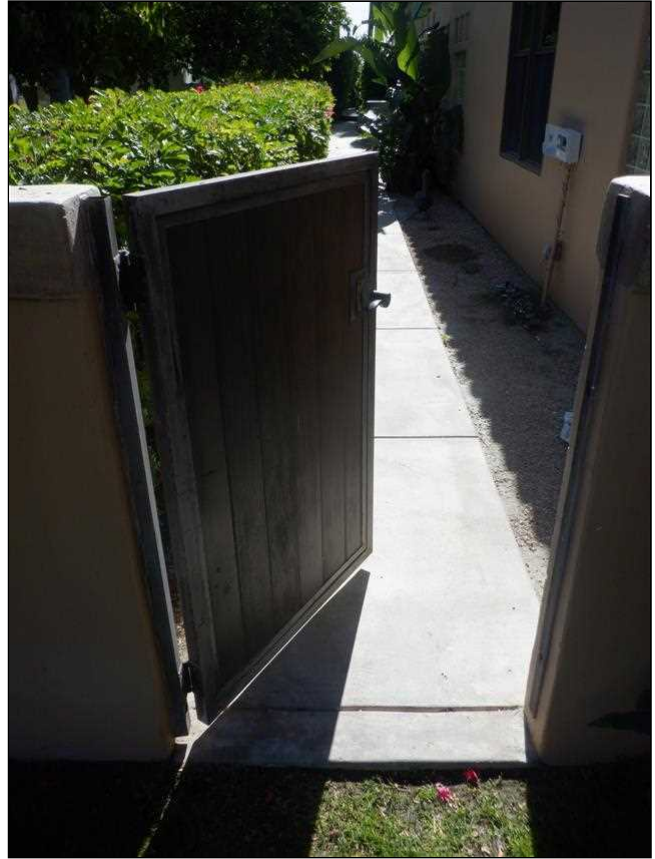
The gates to the backyard from the street do not have the required self closing hardware, we also noted that these gates open inward which by code is incorrect and although these gates have the required self latching hardware they appeared a little low, the self latching hardware must not be lower than 54 inches from grade. These are safety issues that should be corrected. Recommend evaluation by a licensed contractor repair replace as needed to bring these gates up to current code. FYI the rules for gates that will allow access to the pool from the street are as follows, all gates must have self closing self latching hardware, all gates must open outwards towards the street and all self latching hardware must not be lower than 54 inches.

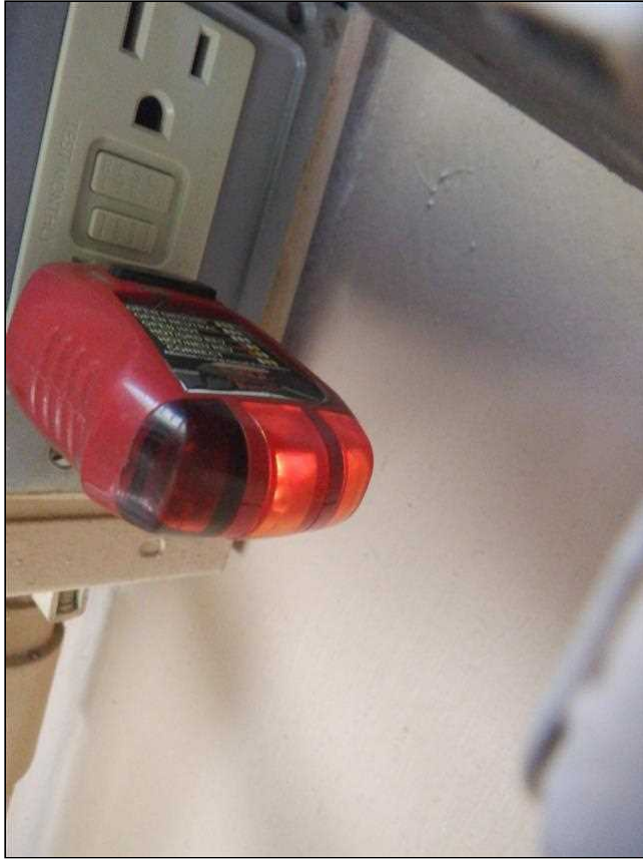
We noted that the pool/spa light GFCI failed to trip when tested. This is a possible shock hazard that should be corrected. Pool/sap lights must be GFCI protected at all times. Recommend evaluation and replacement of GFCI as needed by a licensed pool electrical contractor.

11.16 Item 1(Picture) Pool/Spa Light GFCI Failed To Reset

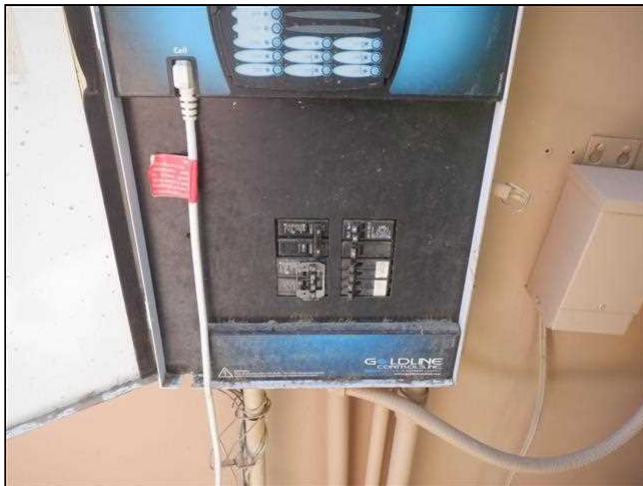
(1) Although we noted a bond wire present it was not connected to at least 2 of the pumps or the exterior controller/ electrical sub panel box. This is a possible shock hazard that should be corrected. All metal parts of pool/spa pumps, motors, heaters, pool sub panels, junction boxes, timer clocks and control panels of any kind should be bonded together and bonded to the pools bonding grid. Recommend evaluation/repair/replace as needed by a licensed pool contractor.

11.26 Item 2(Picture) Controller/Sub Panel Not Bonded

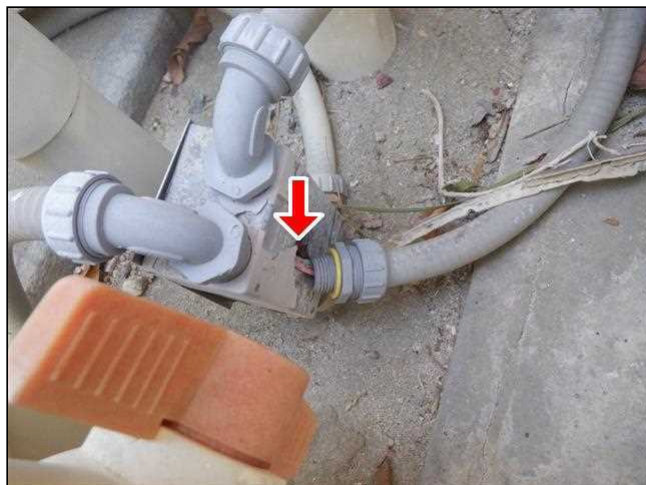
(2) We noted loose conduit and exposed wires at the main filtering pump at time of inspection. These exposed wires are creating a safety issue the should be corrected. Recommend evaluation by a licensed electrical contractor repair replace as needed.

11.26 Item 3(Picture) Loose Conduit/Exposed Wires
