Kevin Kelpin  
7177 Sunny Place  
Yucca Valley, CA 92284

Date of Inspection: 3/20/2025 - 2:00pm

Inspection type: General Home Inspection

Year Built: 1963

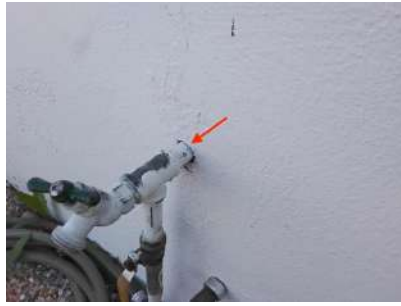
Unsealed Wall Penetration - North

There is an unsealed hole at the siding on the south side. There is an unsealed wall penetration at the spigot on the north side. It is recommended that all wall penetrations are properly sealed to avoid water penetration and pest intrusion. Recommend handyman repair.

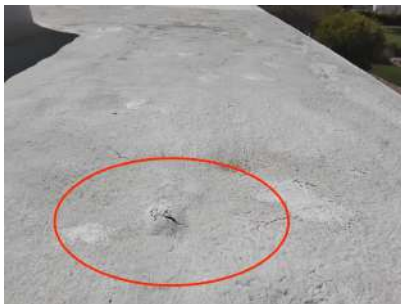
**SPF (Spray Polyurethane Foam)** - The exact age of the roof could not be determined at time of inspection, but appears to be approximately 20-25 years old. The overall condition of the roof was not satisfactory. There are blisters and holes in the foam throughout, indicating the roofing is at the end of its service life and needs to be replaced. Patchwork was observed in several areas throughout. The elastomeric sealer is cracking/deteriorating and leaving the foam layer exposed in several areas throughout. Recommend licensed roofing contractor evaluate further/repair/replace as needed to avoid water penetration.

Blistering + Holes In Foam

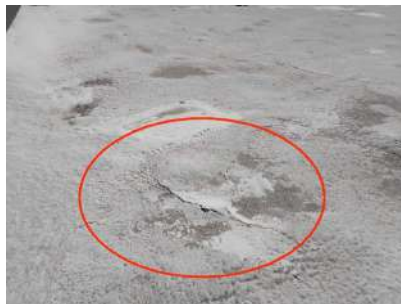
Blistering + Holes In Foam

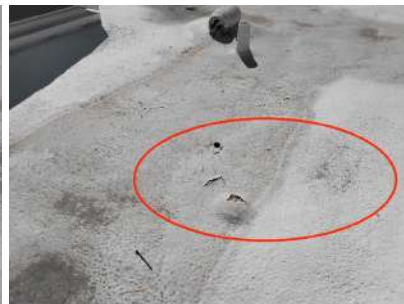
Blistering + Holes In Foam

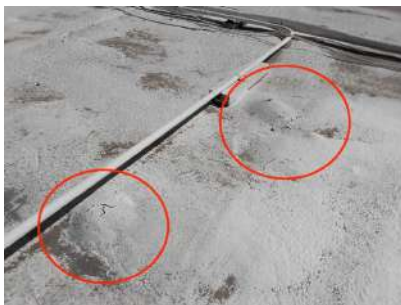
Blistering + Holes In Foam

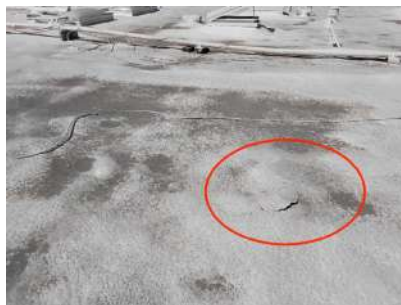
Blistering + Holes In Foam

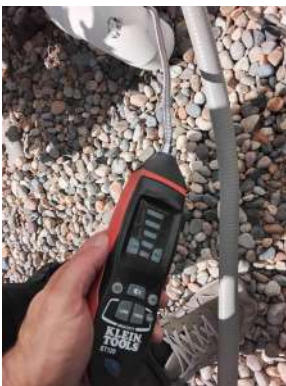
A gas leak was detected near the ground between the house and gas meter at time of inspection (combustion gas tester). The exact origin of the leak was not located. Recommend contacting SoCalGas Company and/or a licensed plumbing contractor for further evaluation and immediate repairs.

Gas Leak Detected

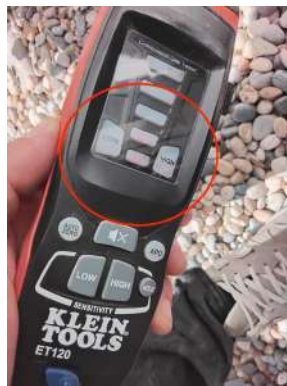
Gas Leak Detected

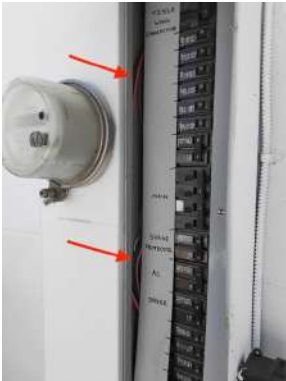
Numerous circuits are missing labels. Main service disconnect was present (200amp). The dead front cover is a make shift installation (not from electrical manufacturer), leaving gaps and exposed wires accessible.

Inadequate Dead Front Cover

Recommend replacing dead front cover with an exact duplicate from the same manufacturer to comply with the UL rating. There was rust on the ground/neutral bus bar inside the panel. Note: Corrosion inside a panel is an indication of unwanted moisture and can lead to poor connections and overheating. Recommend licensed electrician repair noted items and clearly label all circuits.
