## SUMMARY

15718 Creek Hills Rd, El Cajon, CA

Hardev Shergill  
07/31/2025

Christopher Tausaga  
Certified Commercial & Residential  
Inspector  
PROproperty Inspection and Services  
Inc.  
6194939557

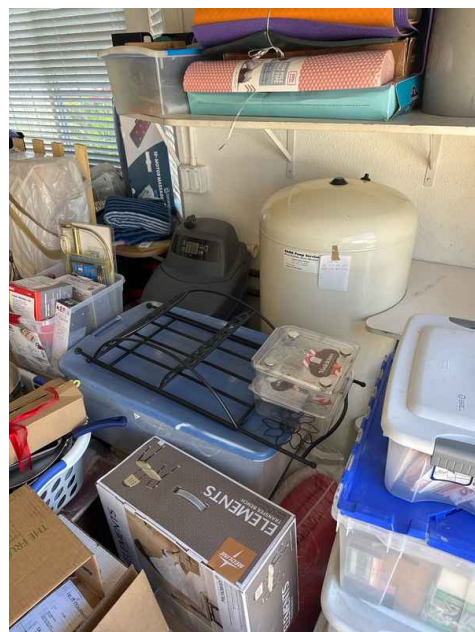
**Note:** A water softener system / water treatment device was installed on the premises. These are specialty systems and are excluded from this inspection. Comments in this report related to this system are made as a courtesy only and are not meant to be a substitute for a full evaluation by a qualified specialist. Water softeners typically work by removing unwanted minerals (e.g. calcium, magnesium) from the water supply. They prevent build-up of scale inside water supply pipes, improve lathering while washing, and prevent spots on dishes. Recommend consulting with the property owner about this system to determine its condition, required maintenance, age, expected remaining life, etc.

Contact a qualified professional.

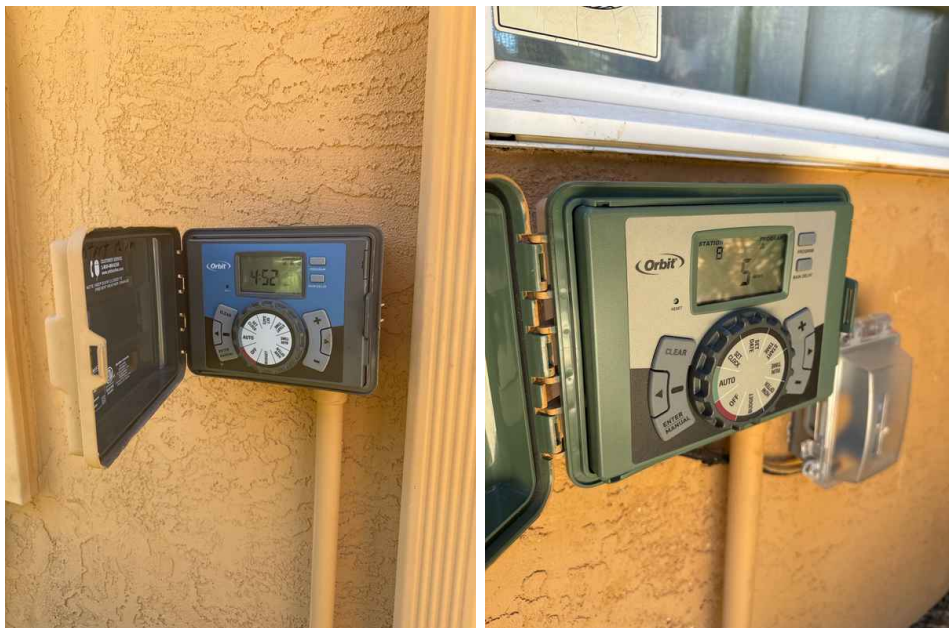
### IRRIGATION / SPRINKLERS

**Note:** This property appeared to have a yard irrigation (sprinkler) system and is excluded from this inspection. Comments in this report related to this system are made as a courtesy only and are not meant to be a substitute for a full evaluation. When this system is operated, recommend verifying that water is not directed at building exteriors, or directed so water accumulates around building foundations. Sprinkler heads may need to be adjusted, replaced or disabled. Consider having a qualified plumber verify that a backflow prevention device is installed per standard building practices to prevent cross-contamination of potable water. Recommend that a qualified specialist evaluate the irrigation system for other defects (e.g. leaks, damaged or malfunctioning sprinkler heads) and repair if necessary.

Contact a qualified professional.

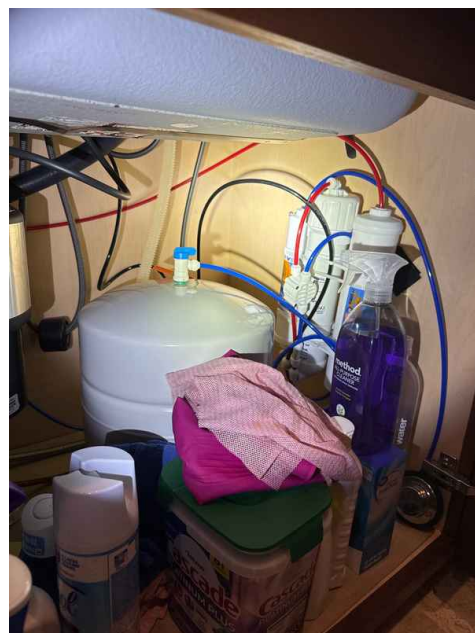
#### **WATER FILTER / REVERSE OSMOSIS**

**Note:** A water filtration / reverse osmosis system was installed on the premises. These are specialty systems and are excluded from this inspection. Comments in this report related to this system are made as a courtesy only and are not meant to be a substitute for a full evaluation by a qualified specialist. Filter cartridges typically need replacing periodically. Cleaning and other maintenance may also be needed. Recommend consulting with the property owner about this system to determine its condition, required maintenance, age, expected remaining life, etc.

Contact a qualified professional.
