Davidson Inspection

Inspection Date: 06/11/2024

File #-24-1355 Hewlett

Subject Property:
5410 Hewlett Dr.

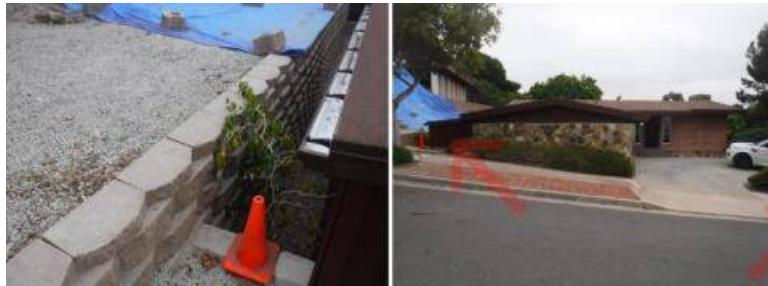
1.18 Verify Permit:

Addition(s) were present. Recommend verifying if the construction was permitted. The owner should be aware of the ramifications of ownership concerning an unpermitted addition.

The structure was not setback a minimum of 5 feet from the perimeter fence. There is a concern that the structure is encroaching within the lot setback requirement. Recommend verifying if the construction was permitted and if it meets the lot setback requirement.

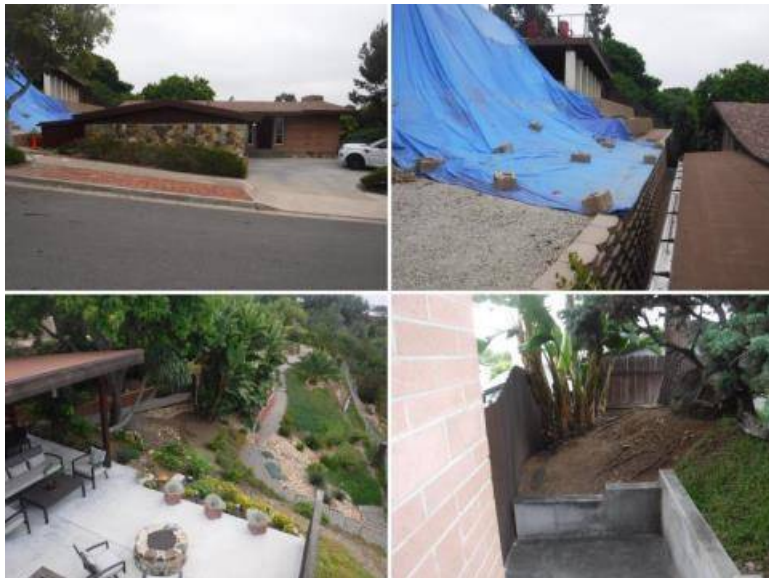
3.1 Site Grading:

Further Evaluation - The building was situated within a hillside setting. Evaluation of soil stability is beyond the scope of the inspection. The potential for earth movement, soil properties, such as clayey or expansive soil, the effectiveness of grading and soil preparation, are best evaluated by an engineer. You may wish to geological conditions evaluated by a geotechnical engineer. We advise evaluation of geological conditions by a geotechnical engineer.

Steep sloping terrain.

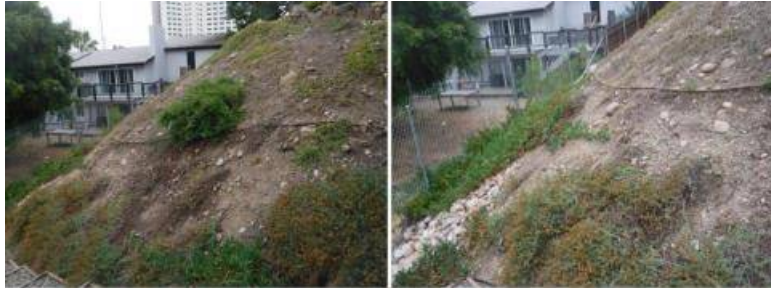
3.3 Slope(s):

Maintenance - Surface erosion or sloughing was observed on slopes. Vegetation was sparse on sections of slopes. Vegetation is important to prevent erosion and maintain slope soil stability.

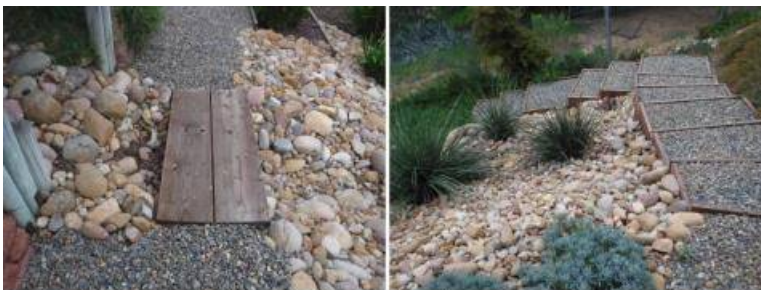
3.15 Trip Hazards:

Advisory - A trip or injury hazard was present at one or more locations. Loose bridge should be secured to prevent tripping and various trip hazards are present in the garden areas. Paving surfaces were irregular or raised; and/or steps or landings were not conforming to standard construction practices. Potential trip hazards should be corrected for enhanced safety.

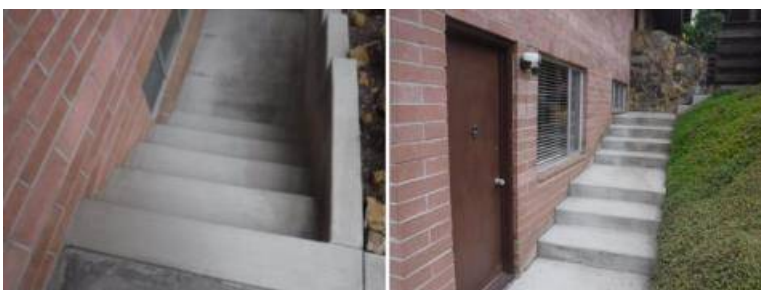
3.16 Steps On-grade:

Safety - Handrails were missing. Handrails are required where 4 or more risers are present.

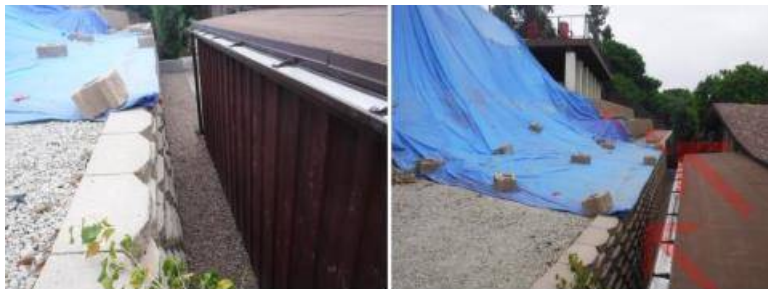
3.21 Structure:

Advisory - Retaining walls 3 ft. and shorter are considered a minor landscaping feature and do not require a permit. Retaining walls more than 3 ft. tall require a permit for their construction. We recommend asking the neighbor to the left about engineer's reports and permits for the large walls that are so close to the structure/ property line. It is

Advisory - Retaining walls 3 ft. and shorter are considered a minor landscaping feature and do not require a permit. Retaining walls more than 3 ft. tall require a permit for their construction. We recommend asking the neighbor to the left about engineer's reports and permits for the large walls that are so close to the structure/property line. It is important these walls were constructed correctly to a permitted/engineered design.

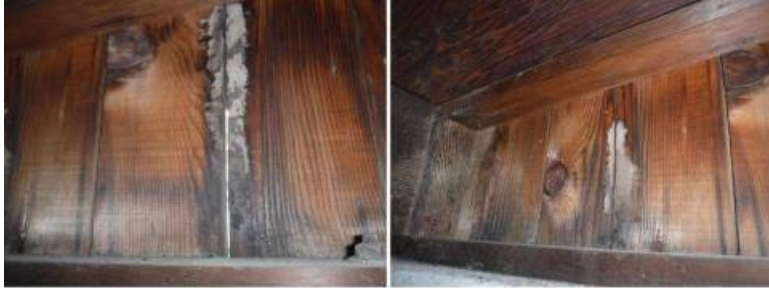
4.8 Old System:

Marginal - The paper flashing was not present in the garage and gaps are present that could allow water in. Paper flashing is for protecting the interior and structure from moisture. This component is the water protective element behind the siding material. Staining was noted inside the garage. Recommend consultation with a qualified siding contractor.

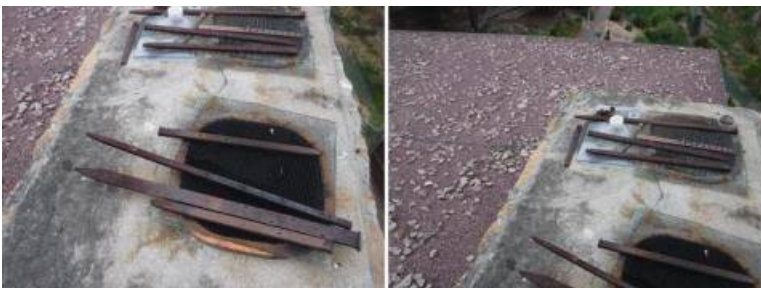
5.9 Spark Arrestor / Cap:

Safety - A substandard or makeshift spark arrestor is present. All fireplaces are required to have an approved spark arrestor with openings no larger than 5/8" to contain embers. Correction is needed for safety.

Upgrade - A rain cap is not installed and is not required on a masonry chimney; however, it helps to protect the chimney and firebox moisture and deterioration. We recommend installing them on all chimneys.

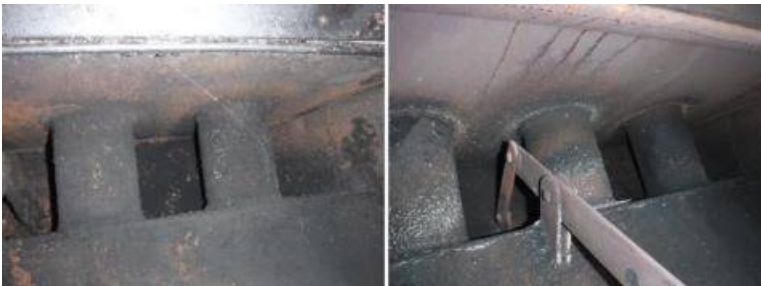
5.12 Fireplace, General:

Advisory - This fireplace is a type unit that has a metal firebox designed to transmit heat to the air in the room from vents at the top of the fire box. It is very important to maintain a tight seal between the firebox and the heated air so that carbon monoxide does not disperse into the room. Inspection is recommended now and at regular intervals in the future by a F.I.R.E. certified chimney sweep.

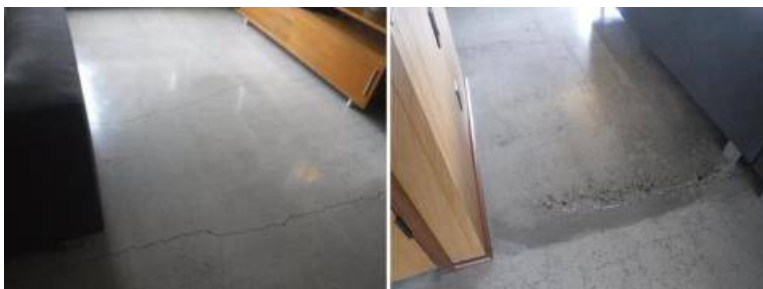
6.4 Condition:

Functional - Narrow/ normal crack(s) were observed in the floor slab. All concrete experiences some degree of cracking due to shrinkage. The cracks we observed did not appear to be unusual.

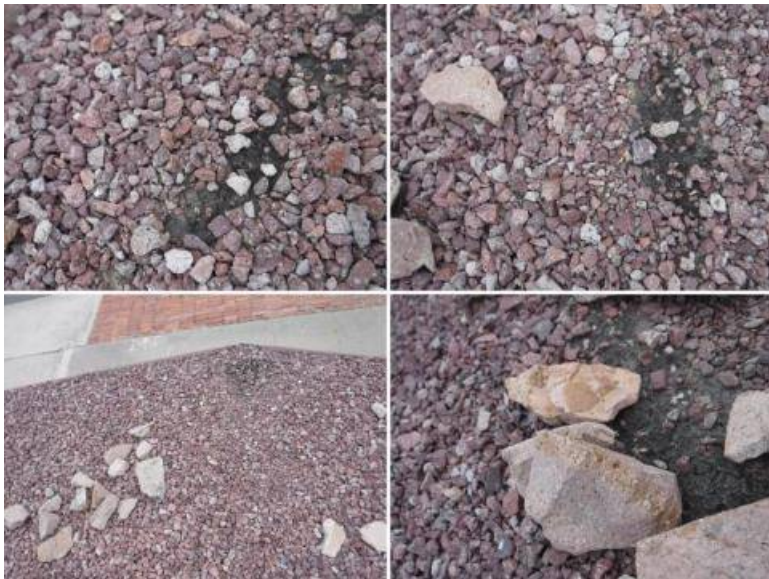
7.9 Flat Roof Damage :

Repair - Bare spots or thin areas in the protective gravel cap were observed. Cracking and blistering of underlying felts has occurred due to exposure to UV light. Repair is recommended in these areas at this time.

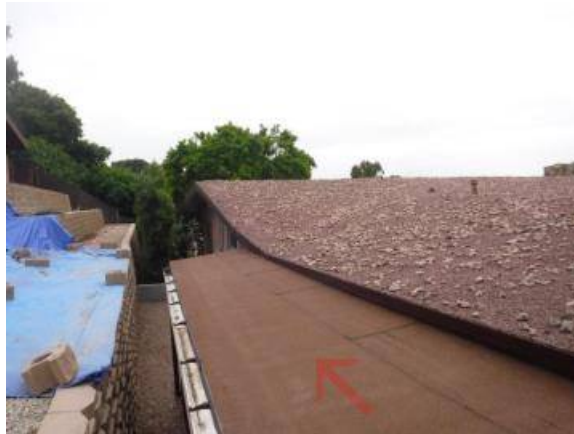
7.14 Condition:

Functional - Visible portion(s) of the roof appear in normal condition, laying smooth, and within its useful life.

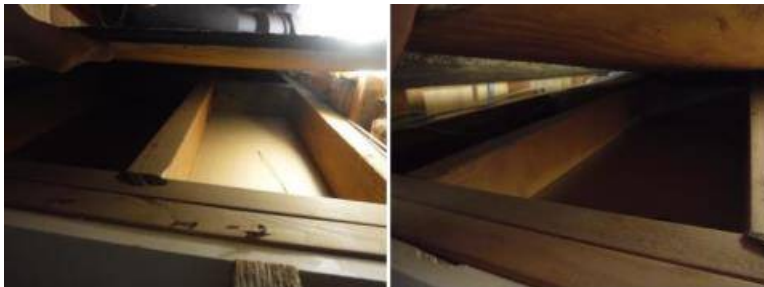
Upgrade - Insulation was not installed in much of the attic. Suggest upgrading by adding insulation in the attic.

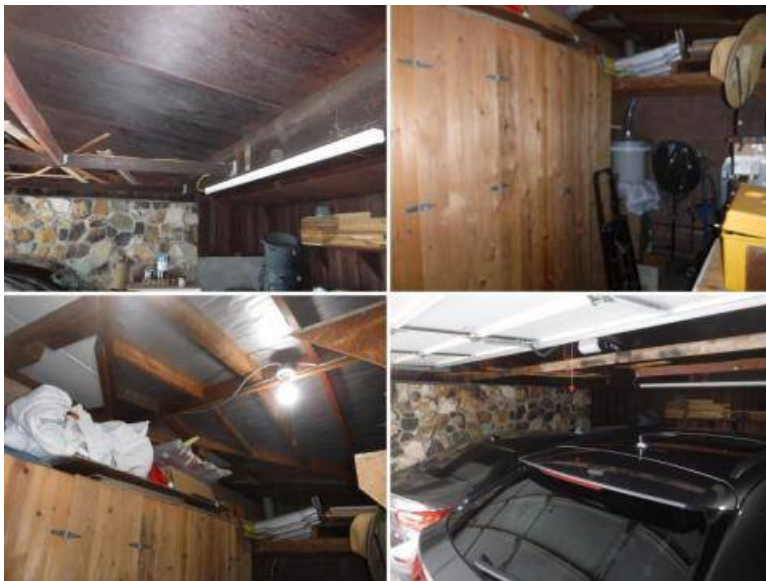
9.2 Limited Inspection:

Stored items restricted viewing of the garage interior.

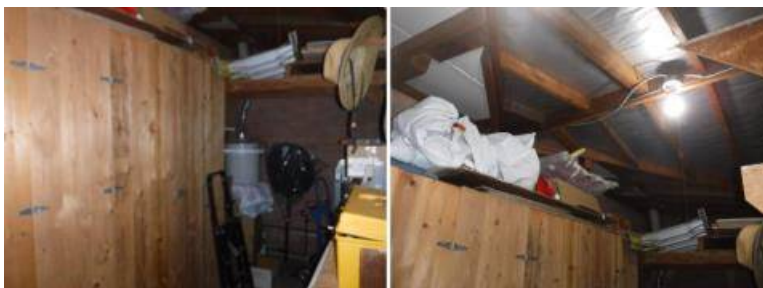
9.6 Fire Separation:

Stored items and shelving restricted viewing of the garage interior firewall. If any openings through the block wall of the house are present from the garage, the openings should be sealed for a correctly constructed firewall.

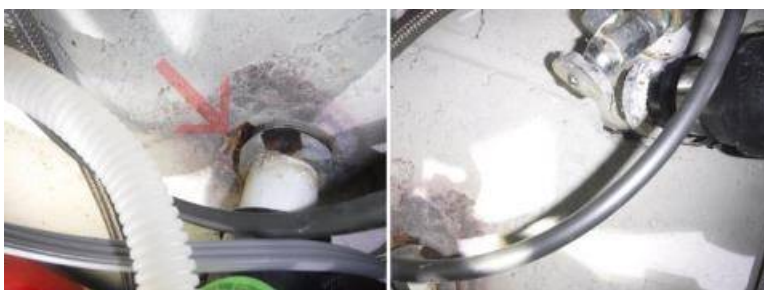
10.12 Wastewater Pipes:

Marginal - The cast iron drain pipes were old. Corrosion was present. Ongoing repairs should be anticipated as this older system continues to age. Replacing the entire system will eventually need to be undertaken.

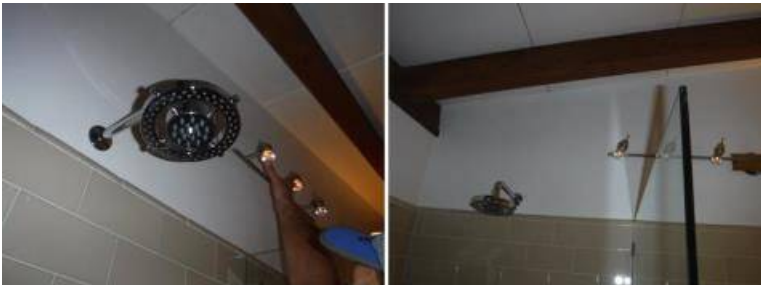
13.25 Lights Hazardous:

Safety - An 'open' light fixture was installed over a tub/shower where the light bulb(s) was touchable. The present condition should be considered extremely hazardous.

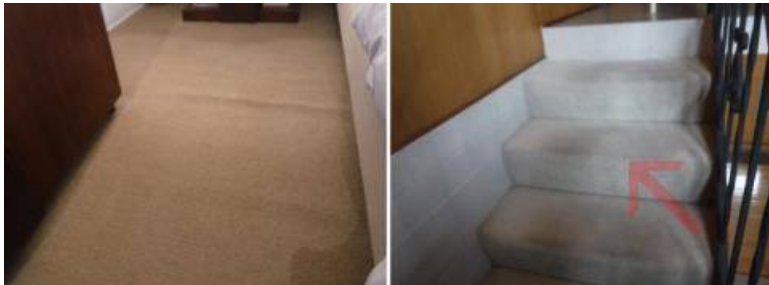
14.11 Carpeting:

Maintenance - Carpet is loose at some locations. This can be a trip hazard.

Maintenance - Carpet wear/ damage noted at the stairs.

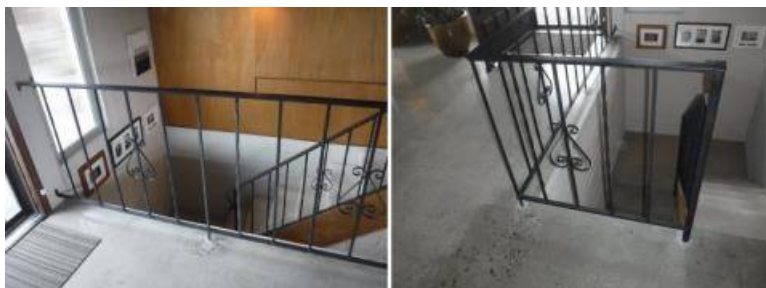
14.19 Guardrails:

Safety - Wide openings in railings were present. Railings provide inadequate protection for infants, small children, and pets. This should be considered an injury hazard. The current requirement is for openings to be no wider than 4".

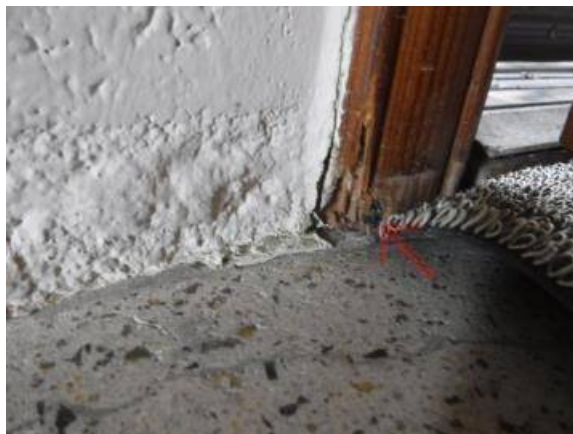
14.21 Pest Activity:

Further Evaluation - There was evidence of a past insect infestation at the entry door trim. See Pest Inspection Report or have one performed.

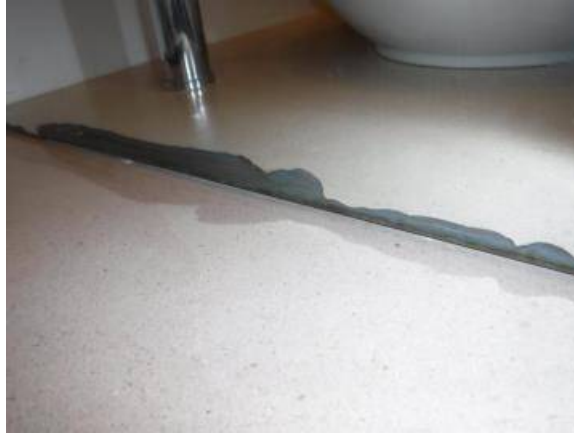
17.7 Cabinets:

Maintenance - The mirror is older/ worn. This wear may continue or spread.

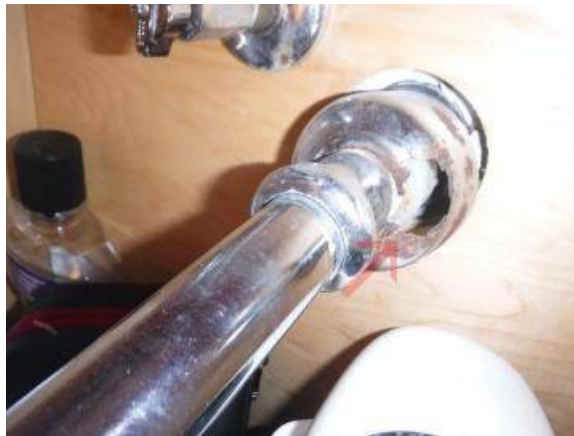
17.8 Sink Drain Plumbing:

Maintenance - The drain was slow/clogged. Corrective action recommended.

Maintenance - Wall cover for the drain line is corroded and can be replaced.

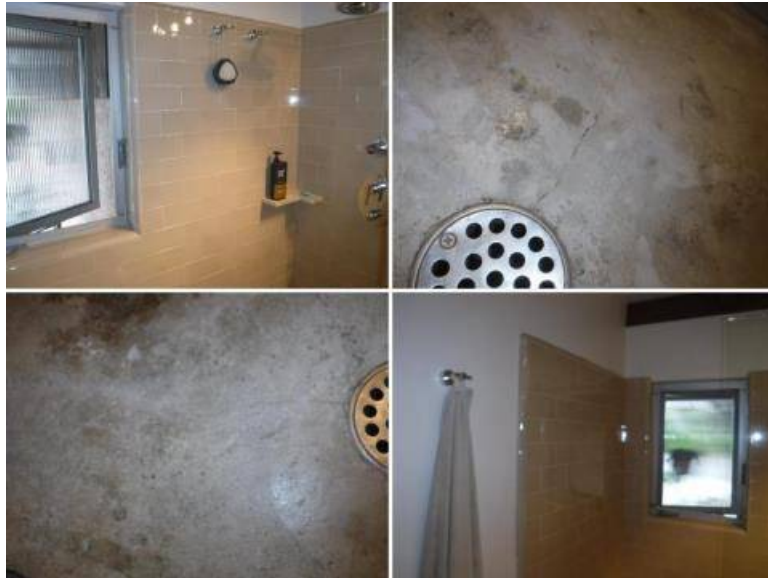
17.10 Shower Enclosure:

Marginal - A low window is installed in the shower enclosure. This is a bad design that is prone to water infiltration/ extra maintenance.

Maintenance - Small hairline crack(s) on the pan can be sealed to prevent further cracking.

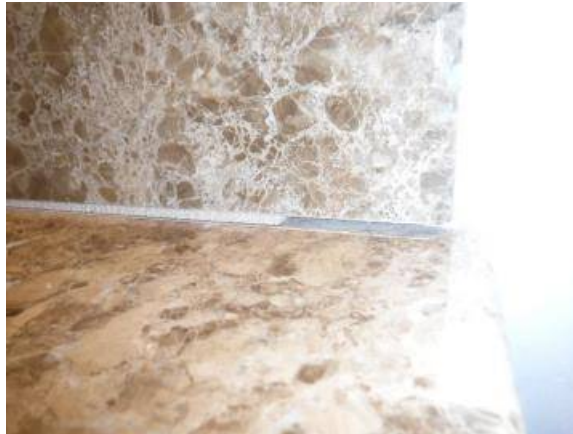
17.16 Countertops:

Maintenance - Grout is missing in some areas.

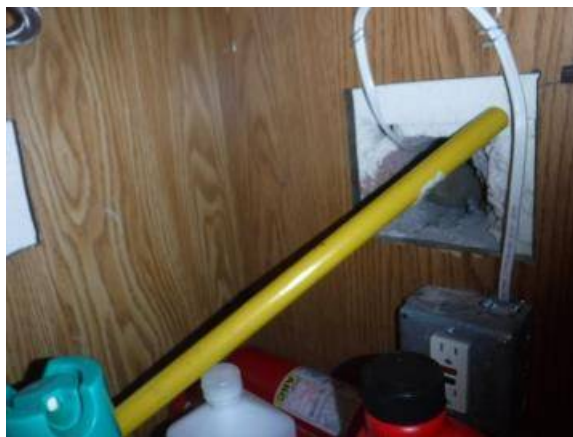
17.17 Cabinets:

Maintenance - Wall finishes are missing under the cabinet. This is a health issue because all surfaces in this area need to be cleanable / washable.
