# PROPERTY INSPECTION REPORT

489 E San Jose Rd.  
Palm Springs, Ca

Prepared for: Doug Bayer (6-4-25)

Prepared by: CTS Inspections

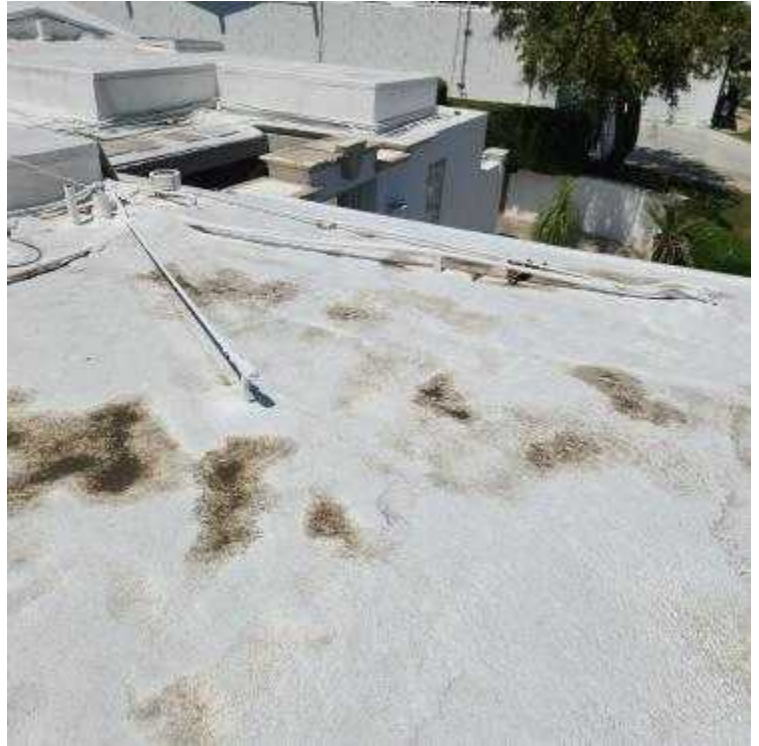
Roof GV-Standing water present (Rained overnight on 6-3-25)

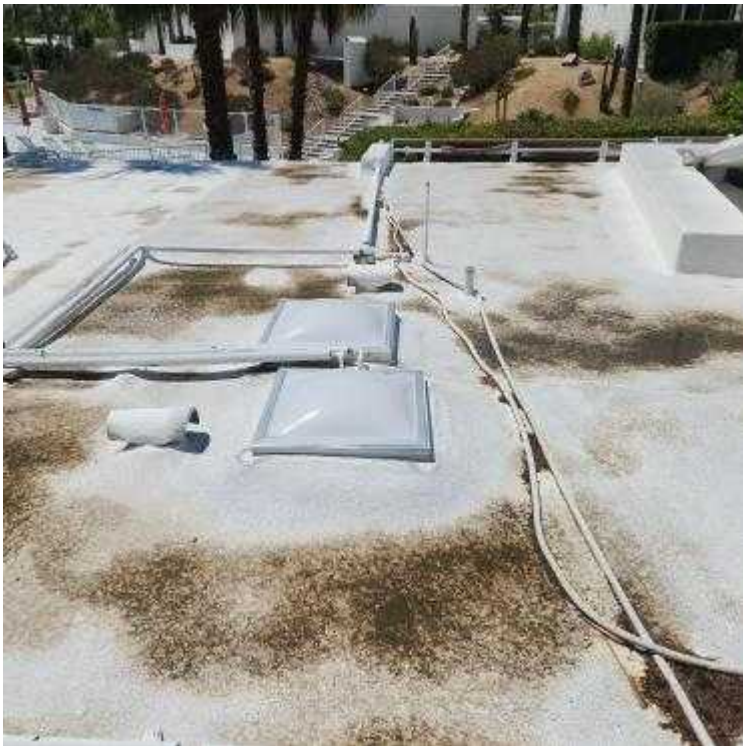
Roof GV-Standing water present (Rained overnight on 6-3-25)

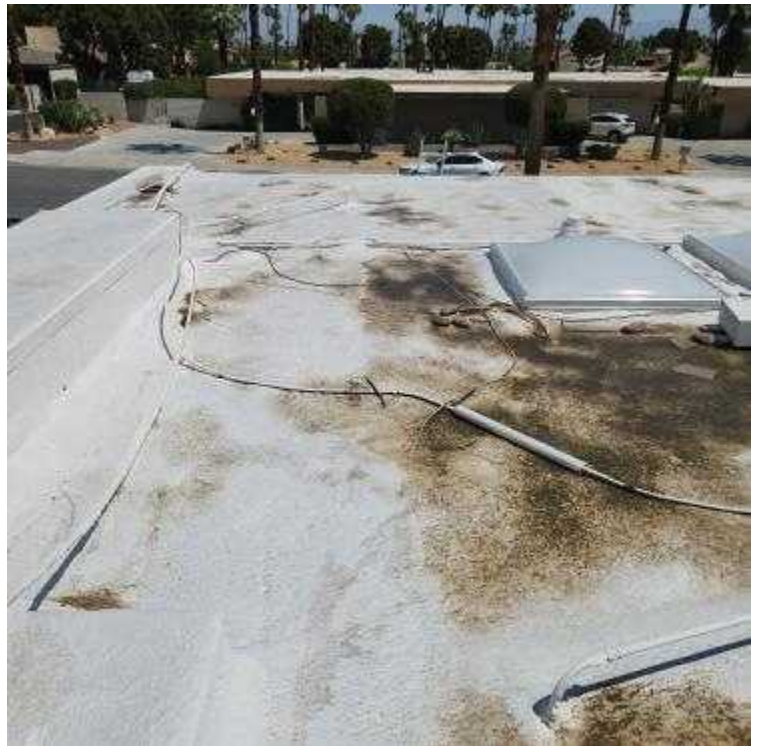
Roof GV-Standing water present (Rained overnight on 6-3-25)

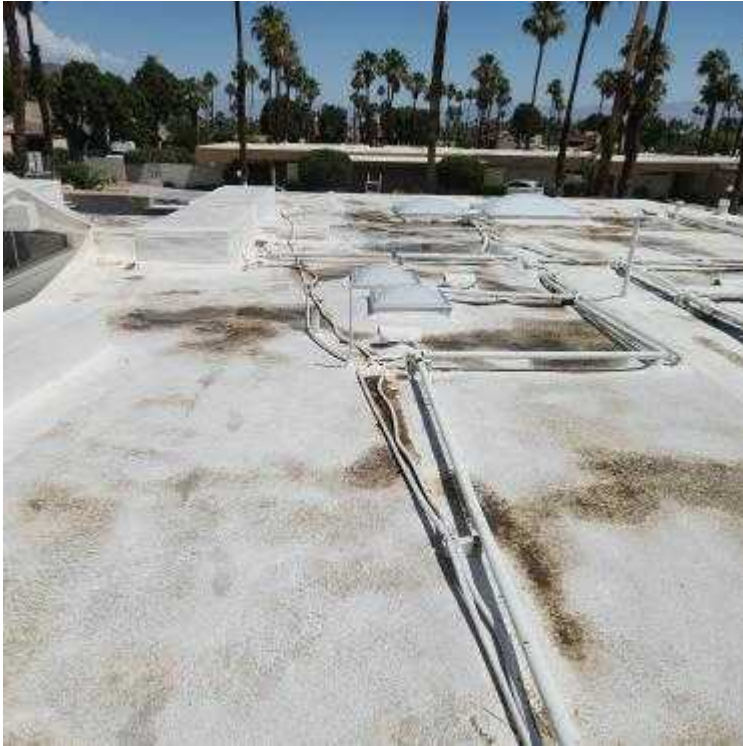
Roof GV-Standing water present (Rained overnight on 6-3-25)

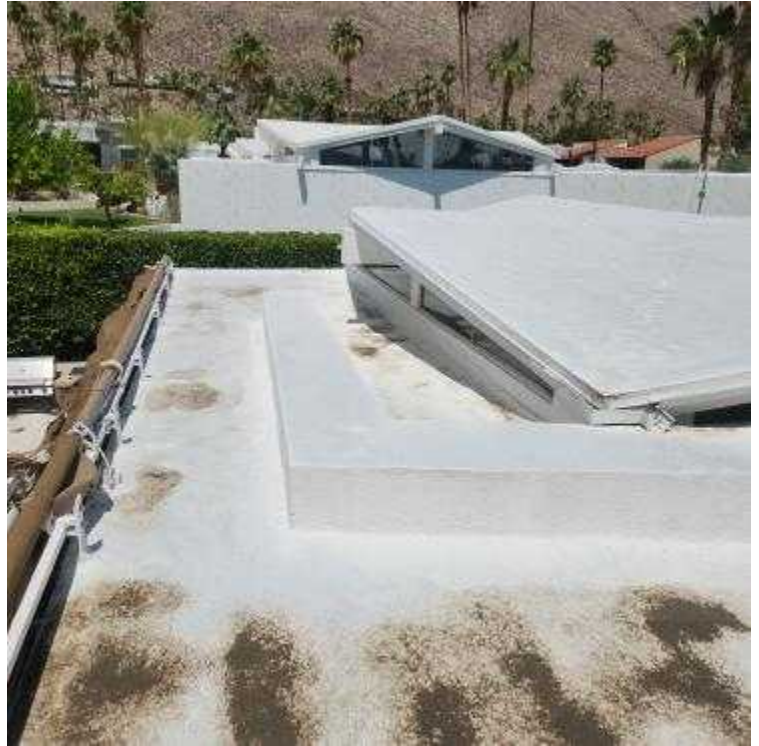
Roof GV-Standing water present (Rained overnight on 6-3-25)

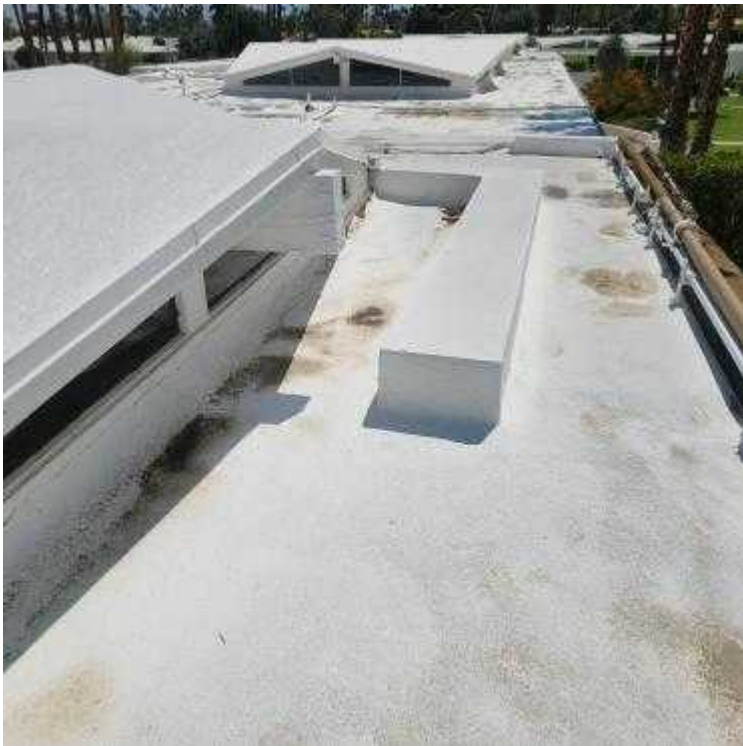
Roof GV-Standing water present (Rained overnight on 6-3-25)

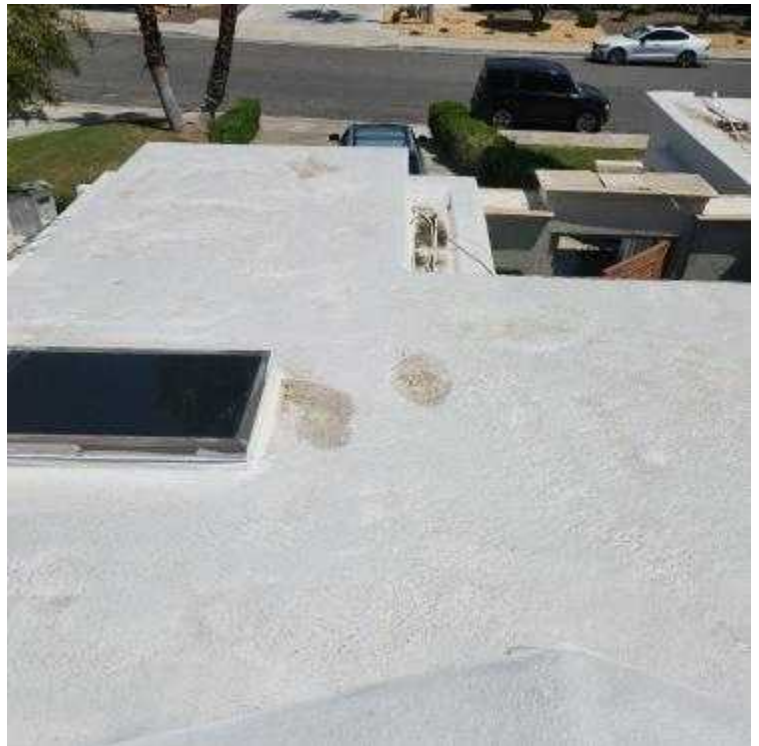
Roof GV-Standing water present (Rained overnight on 6-3-25)

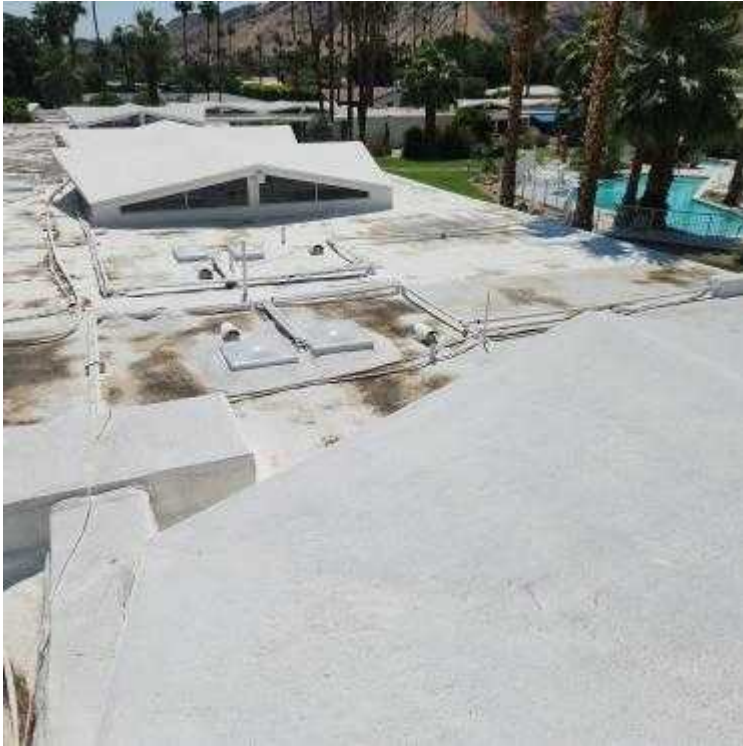
Roof GV-Standing water present (Rained overnight on 6-3-25)

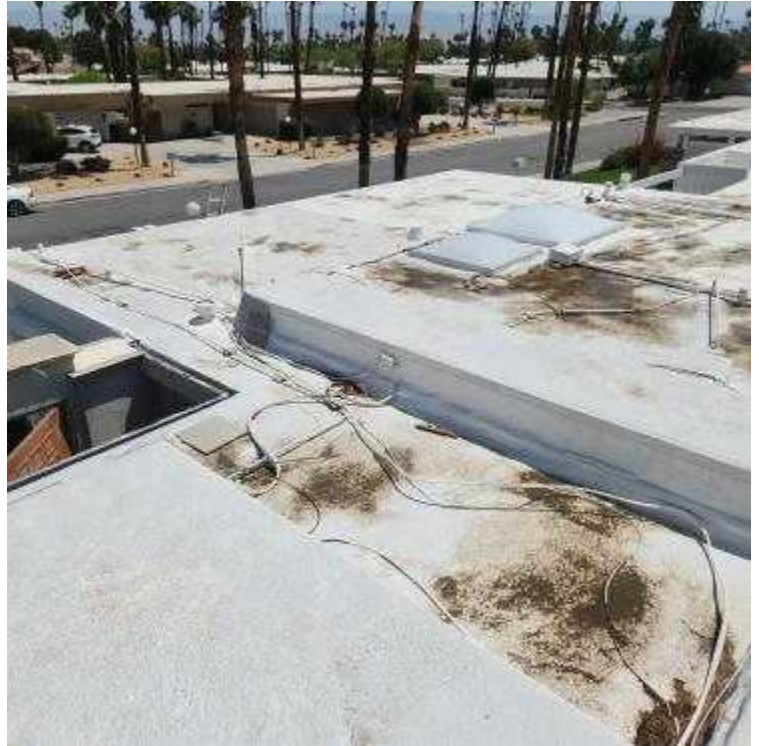
Roof GV-Standing water present (Rained overnight on 6-3-25)

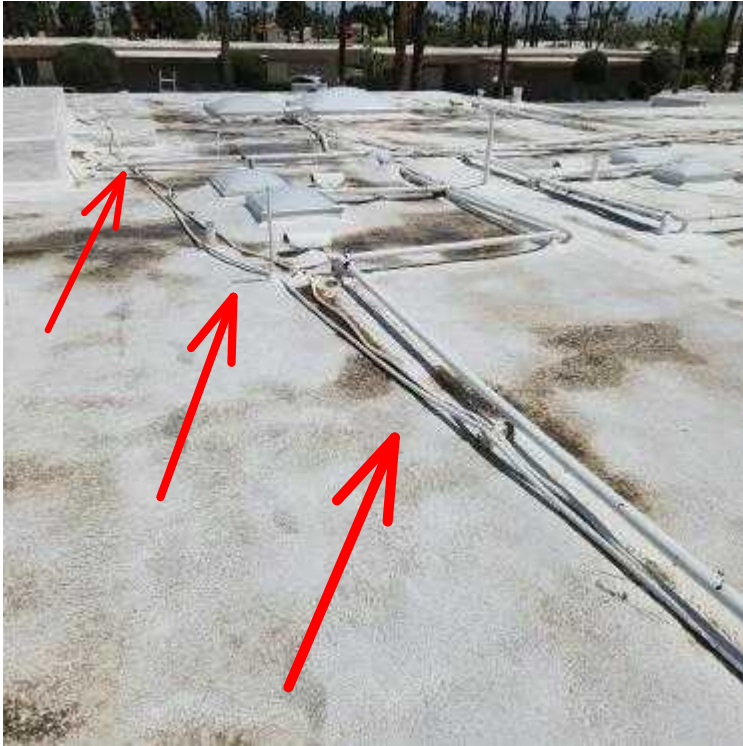
☐ ☒ ☐ ☐ Material- Foam Missing roofing material/Exposed sheathing over portico, Multiple electrical conduit laying on roof surface-NTBS, (Rained overnight on 6-3-25)

Multiple electrical conduit laying on roof surface-NTBS

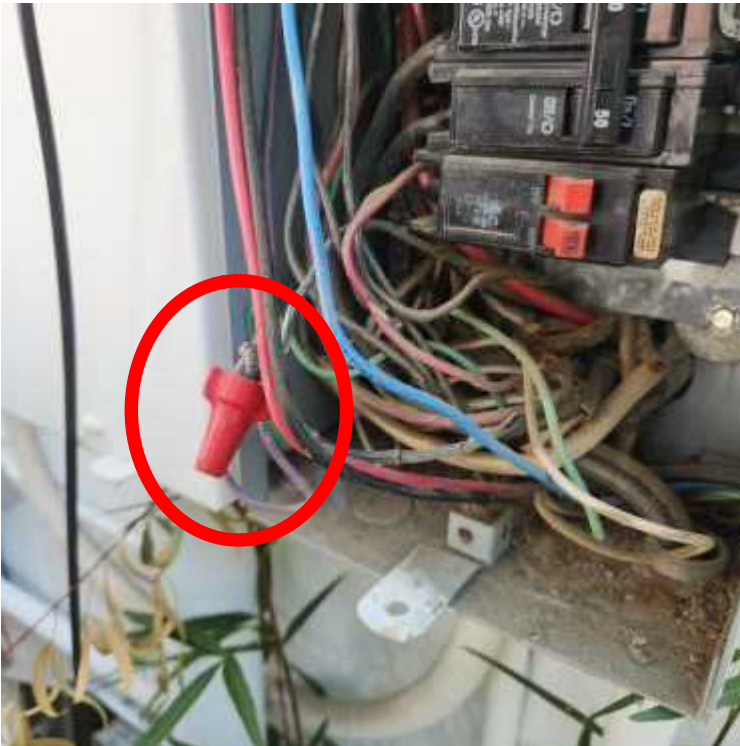
☐ ☒ ☐ ☐ Wiring Type- Romex Double tap load wires present inside electrical panel-NTBS, Damaged insulation to (1) wire with evidence of arcing inside electrical panel

Double tap load wires present inside electrical panel-NTBS

- Double tap load wires present inside electrical panel, Damage insulation to (1) wire with evidence of arcing inside electrical panel.
- Missing anti-chafe bushing around wires inside electrical panel, Interior cover to electrical panel missing knockout insert.

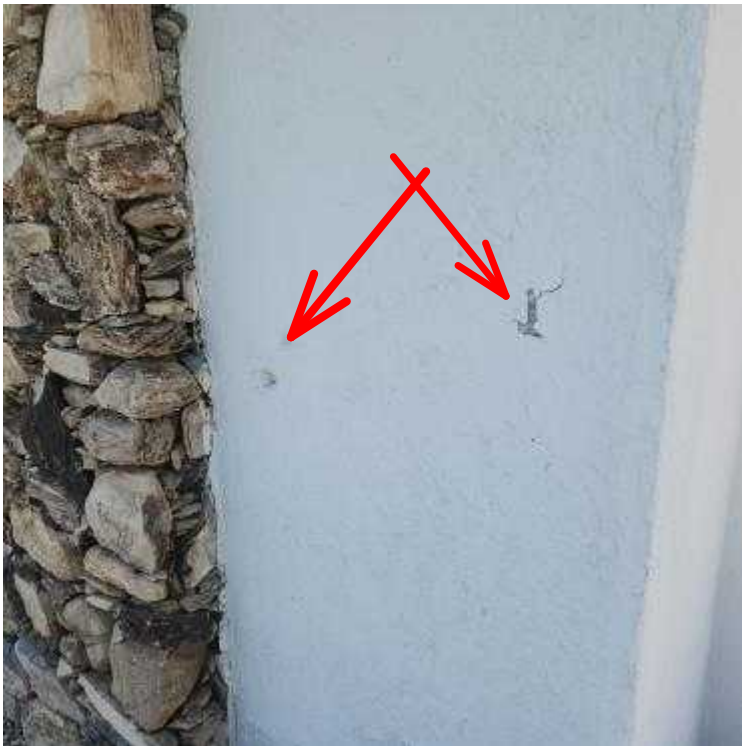
Chipped window trim/Exposed foam on west wall in courtyard

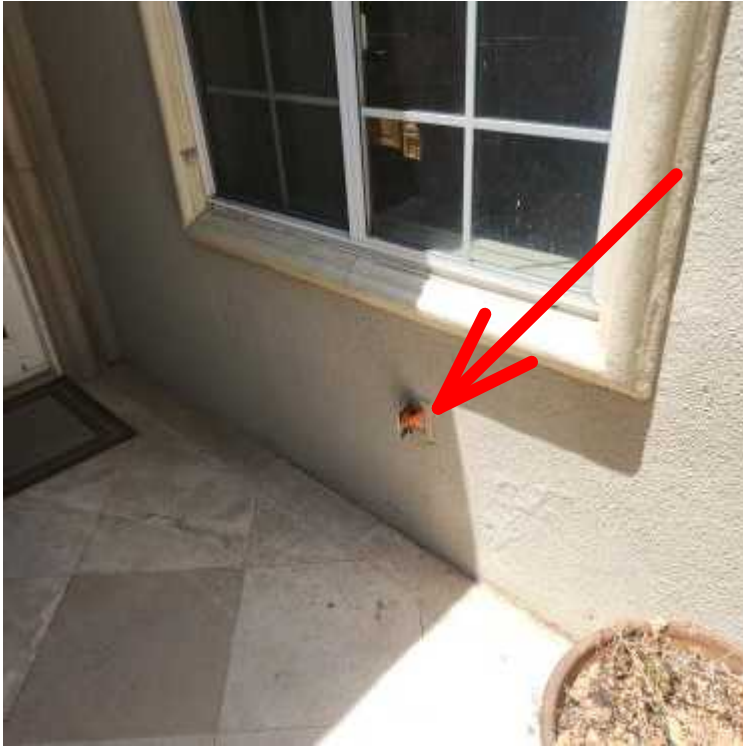
North exterior outlet on west side of house not GFCI protected-NTBS

- North exterior outlet on west side of house not GFCI protected, GFCI outlet on west wall in courtyard did not trip.
- GFCI outlet on south wall on south patio did not trip, GFCI outlet on north wall on south patio hot-wired in reverse/did not trip, Dead north outlet on north wall on south patio.

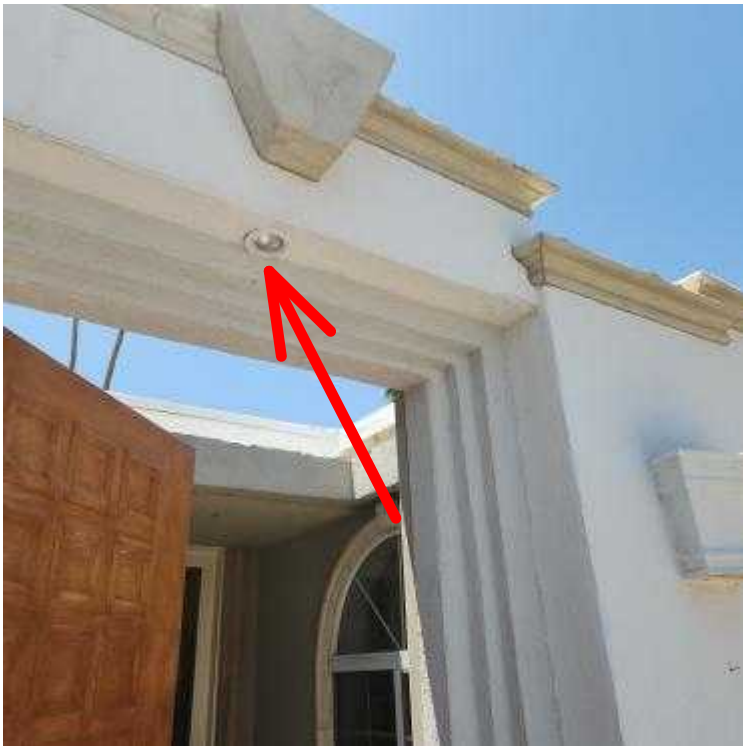
Inoperative fixture/bulb on north patio ceiling

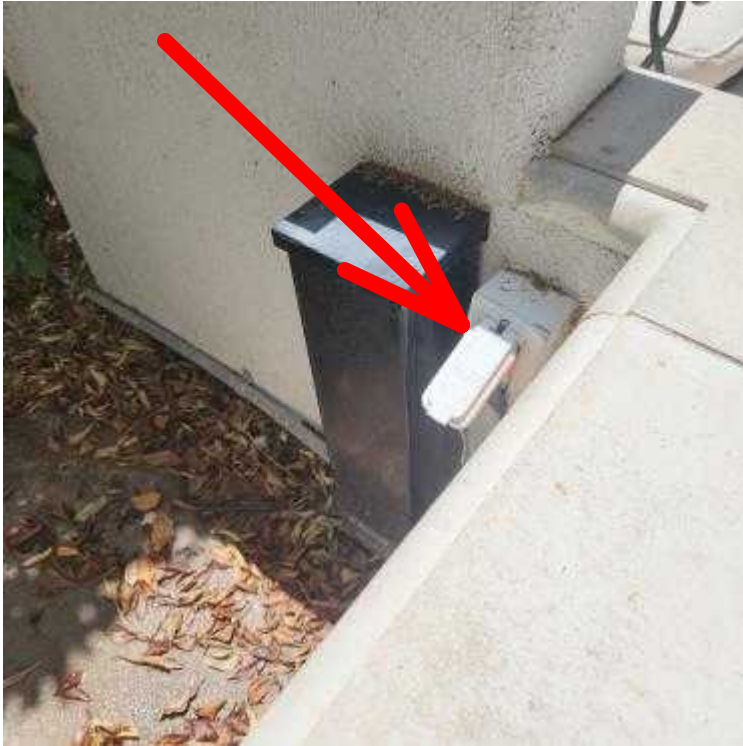
GFCI outlet on south wall on south patio did not trip-NTBS

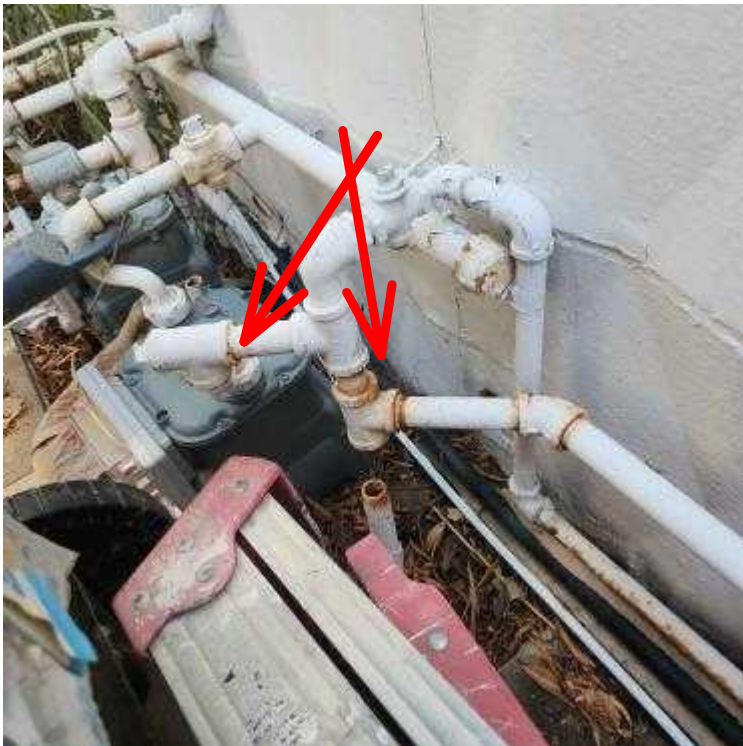
- GFCI Operated ☒ Yes ☐ No ☐ Not Present
- ☐ ☒ ☐ ☐ Gas Meter- Exterior surface mount on west side of house-South meter Rusted pipes on/from gas meter
- Seismic Shut Off Present- ☐ Yes ☒ No

Rusted pipes on/from gas meter

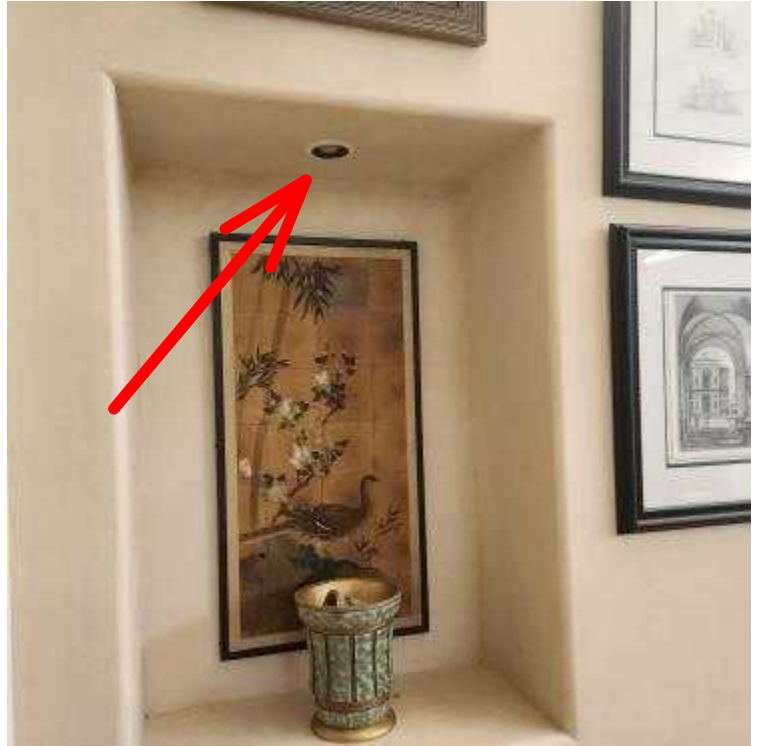
(2) Inoperative fixtures/bulbs on ceiling in living room

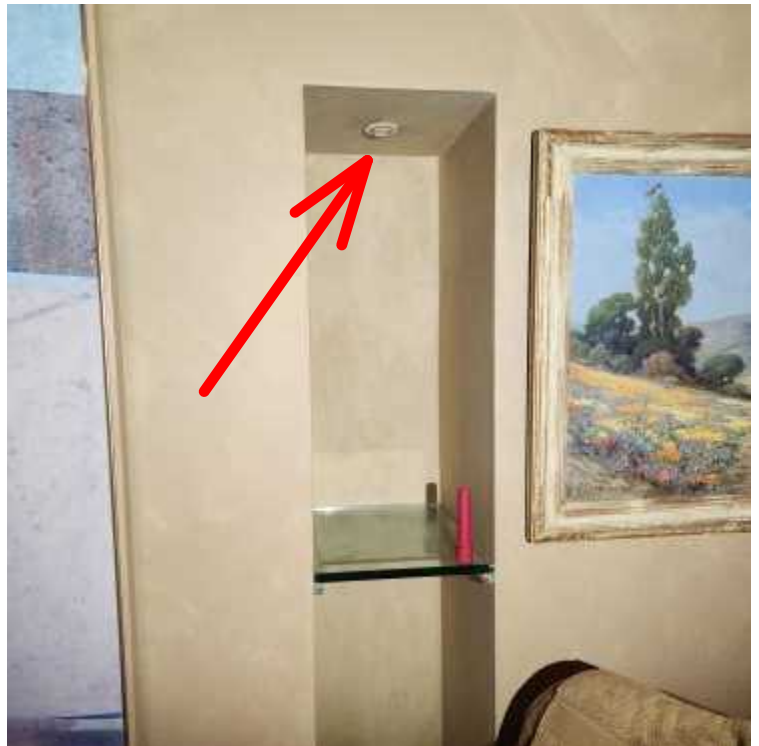
(3) Inoperative fixtures/bulbs on ceiling in primary bathroom

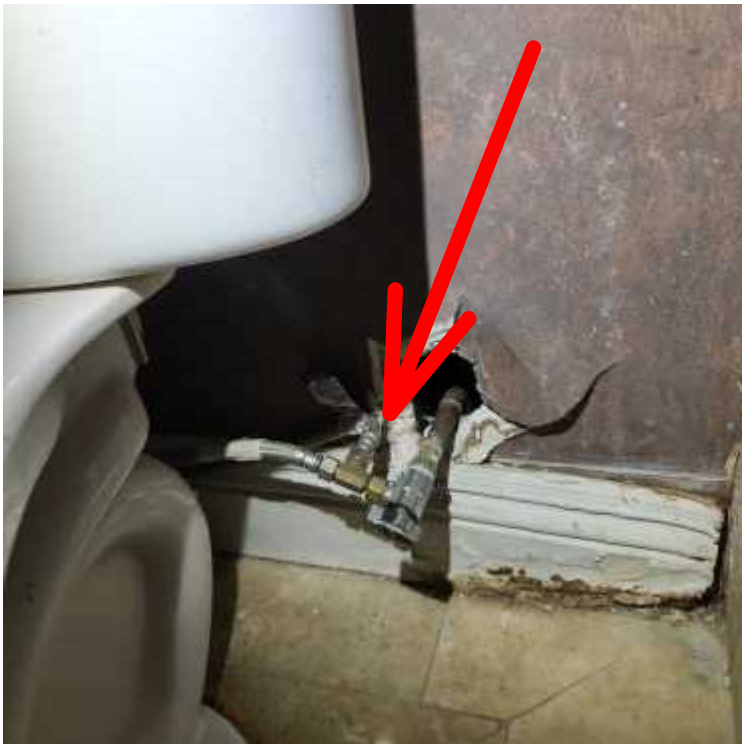
Cold water supply to north bathroom sink faucet has been abandoned-Using toilet supply pipe for cold water water to sink

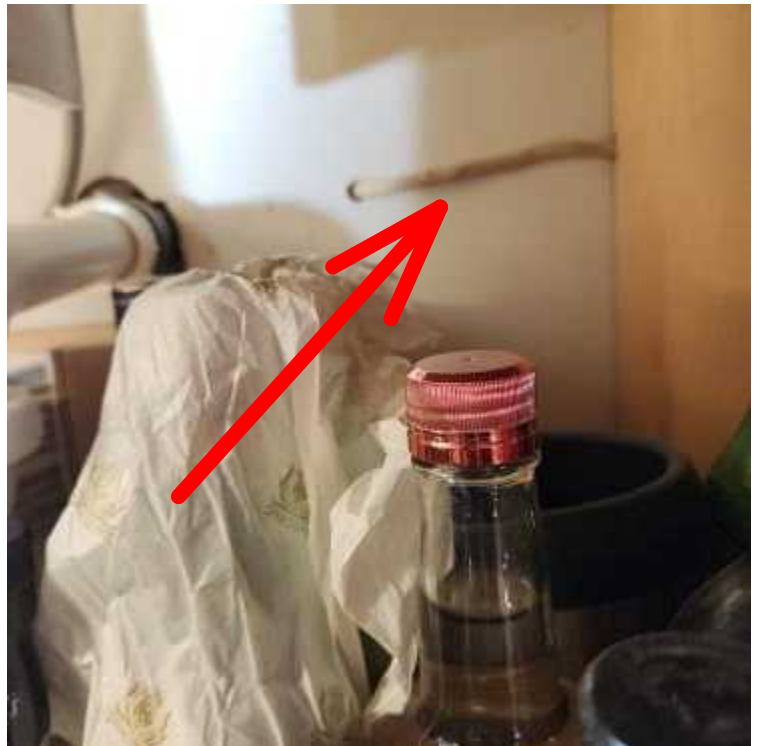
Outlet on south wall in kitchen not GFCI protected-NTBS

- Dimmer in front entry for living room ceiling light doesn't always work behind mirror).
- Kitchen: Outlet on south wall not GFCI protected (unable to install GFCI outlet due to limited space due to the custom cabinetry), Exposed wiring on east wall inside cabinet below sink
