Davidson Inspection
619.435.0845 Office
Lonny@DavidsonInspection.com
www.DavidsonInspection.com

Re: 5002 Dubois Dr., San Diego, CA 92117
Inspection Date: 09/08/2025
File #-25-1569 Dubois

SUMMARY REPORT

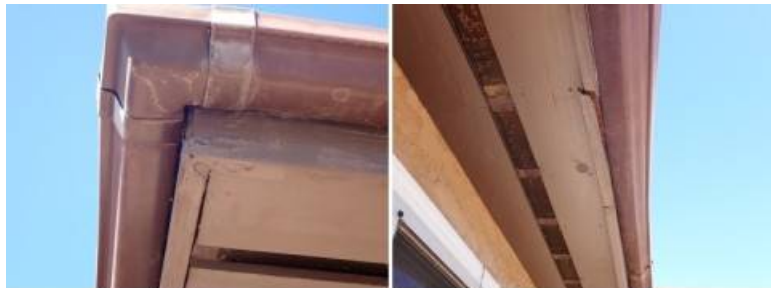
4.4 Pest Activity:

Further Evaluation - There was evidence of wood destroying organisms in various locations. See Pest Inspection Report or have one performed.

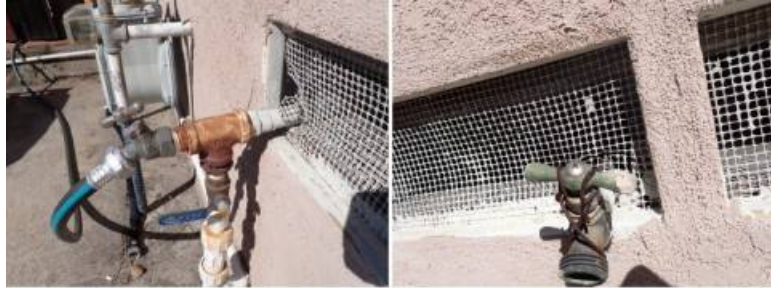
5.16 Ventilation:

Maintenance - Vent screen(s) were damaged or missing. Openings were present where pests/rodents could enter.

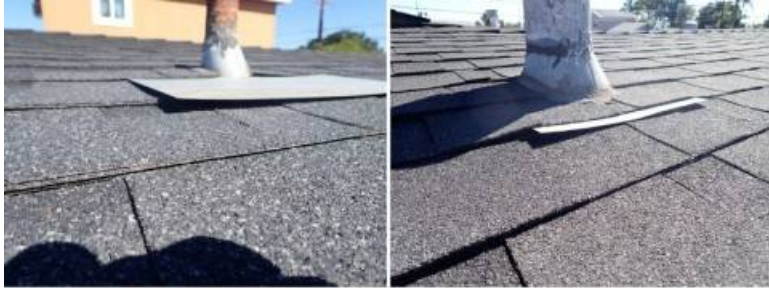
6.10 Maintenance:

Maintenance - Flashing hoods/jacks had lifted. Gaps were present that can allow wind blown rain to infiltrate. Correction recommended.

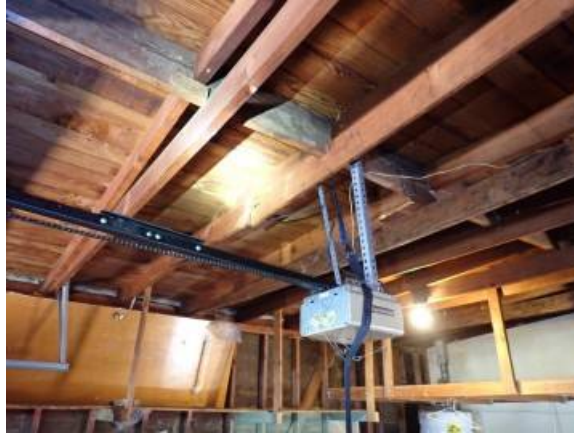
8.9 Garage Door(s):

Marginal - The component was old and likely would have limited remaining life.

Maintenance - Adjustment or service is needed to improve the operation. Additionally door balances should be checked and maintained to prevent overburdening the garage door opener.

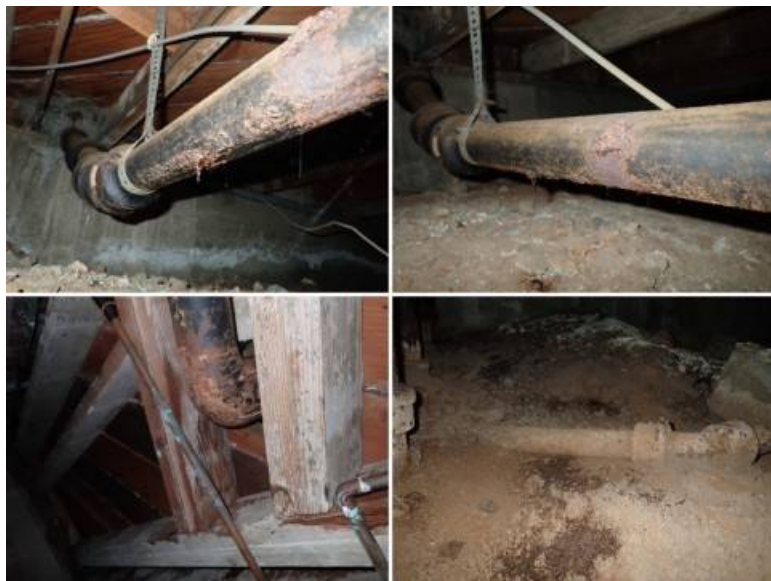
9.15 Wastewater Pipes :

Repair - The cast iron drain pipes were old. Excessive rust/corrosion was present. Ongoing repairs should be anticipated as this older system continues to age. Replacing the entire system will eventually need to be undertaken. We recommend further evaluation of the cast Iron system and needed repairs made at this time by a

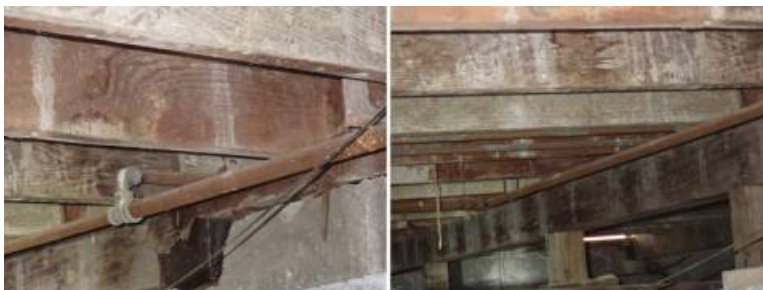
9.21 Corrosion Issues:

Maintenance - Corrosion was noted on iron gas pipe(s). Routine maintenance is needed. A rust inhibitor should be applied to prevent further deterioration.

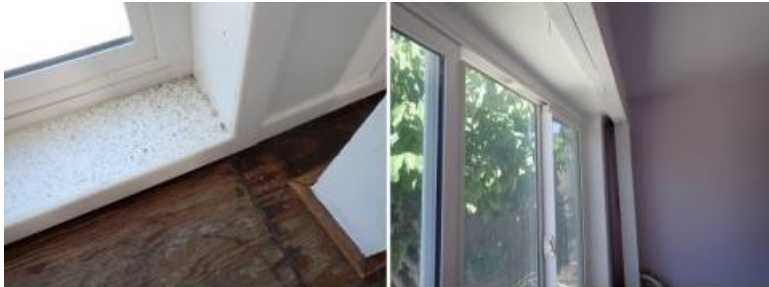
MOISTURE INTRUSION**13.1 Water Stains/Leaks:**

Further Evaluation - Water stains and/or water damage was noted at interior walls, windows or door openings in the enclosed patio room. This suggests there has been a past leak. The stains or patched areas were tested and found to be dry at the time of our inspection. This condition could be from an active or intermittent leak or a leak that has already been repaired. Recommend asking the seller as to the history of leaks and any subsequent repairs. The source of the moisture should be corrected as well as any damaged materials.

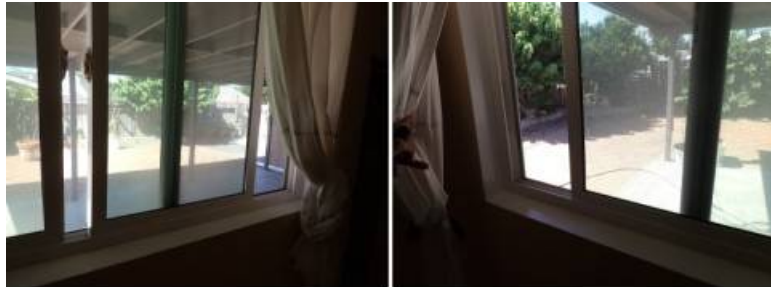
13.13 Windows:

Advisory- The windows cannot both be opened fully at the same time in various locations due to size.

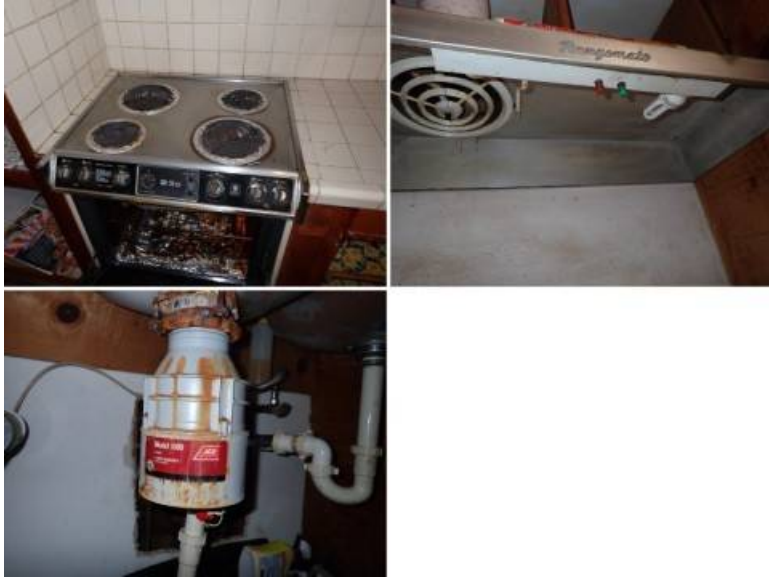
14.4 Old Appliances:

Marginal - Older and/or heavily used appliances were present. Appliances may have a limited remaining service life.

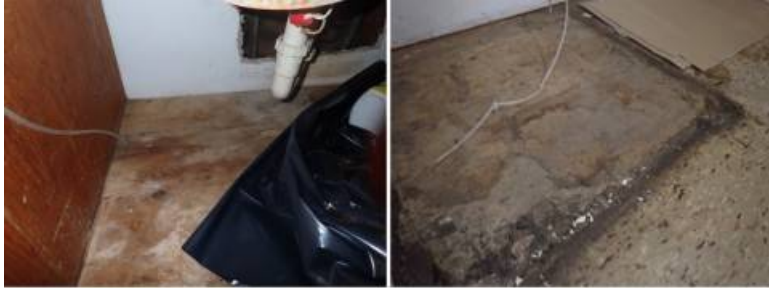
14.8 Cabinets:

Repair - Moisture damage found under the sink. We recommend correcting the source of the moisture as well as replacing any damaged materials. Additionally past stains/ damage noted in the fridge zone that should be repaired/ replaced.

Marginal - Excessive or heavy wear noted.

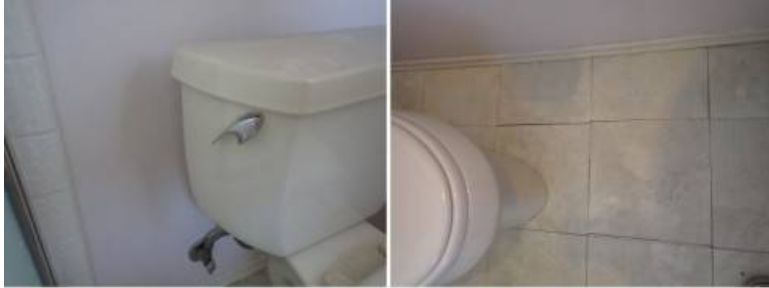
16.9 Toilet:

Maintenance - The toilet was loose at the floor. Recommend pulling the toilet, checking for damage, and then installing a new wax ring and caulking around the base of the toilet for added stability.

Maintenance - The toilet did not flush properly. The tank controls need adjustment or repair. The handle sticks.

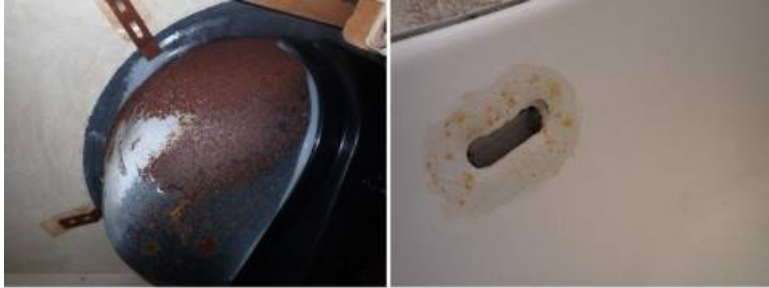
16.21 Sink / Basin:

Marginal - The sink had heavy wear.

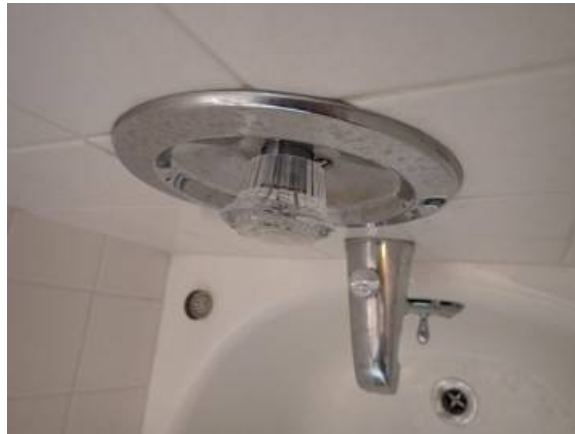
16.24 Tub/Shower Plumbing:

Maintenance - The drain stopper was not working/not installed.

Maintenance - Missing or deteriorated caulking around the fixtures. Caulking as needed to prevent water infiltration.

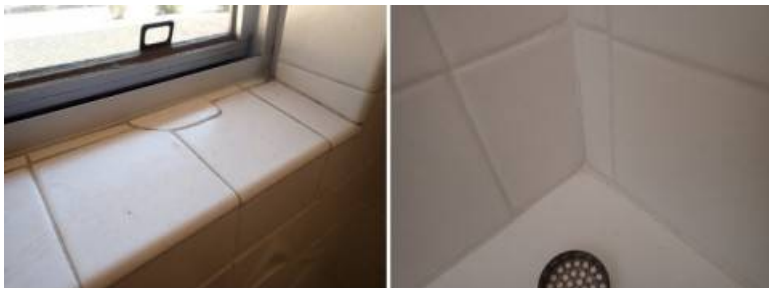
16.25 Tub/Shower Enclosure:

Repair - Tile(s) are cracked / damaged at the sill. Cracks may allow moisture into the wall causing hidden damage and the edges can be sharp. Repair / replacement is recommended by a tile contractor.

Maintenance - Re-grouting around tiles is needed to prevent water infiltration.
