# Confidential Inspection Report

LOCATED AT:  
1805 Nichols Canyon Rd  
Los Angeles, CA 90046

INSPECTED ON:  
Tuesday, December 15, 2015

Inspector, Rick Sailors  
AAA Property Inspection Services

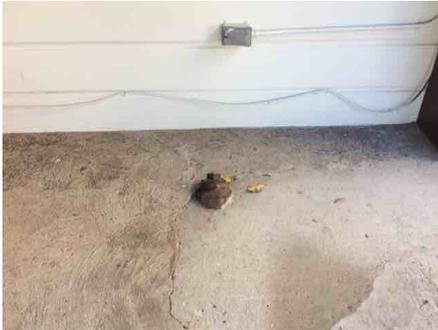
77: - The plumbing waste line clean out(s) were located: Front side

78: - A combination of ABS plastic, cast iron and galvanized piping.

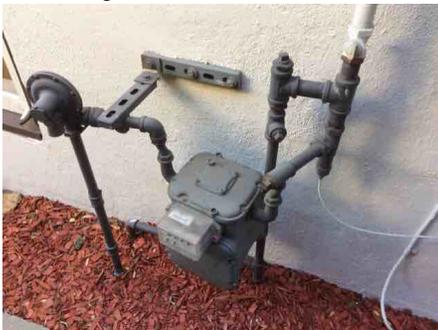
79: - The gas meter and shutoff valve are located at the right side of the building

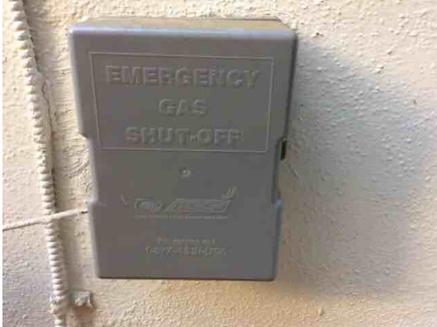
90: - There was an automatic/seismic shutoff valve installed. Automatic seismic shutoffs are required for LA Cities.

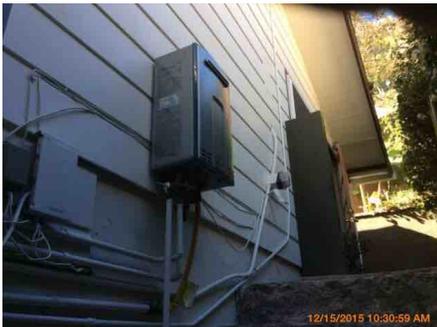
92: - Exterior wall

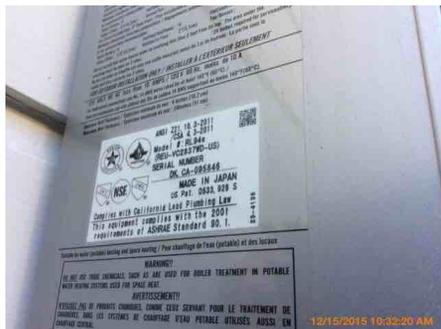
93: - Rinnai, Tankless

94: - 2009

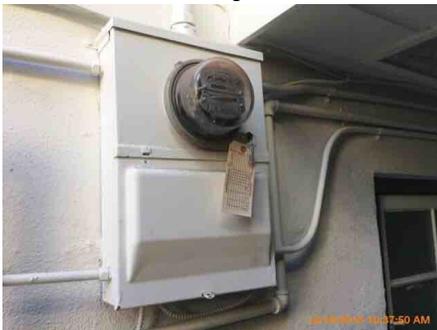
106: - Located at the right side of the building

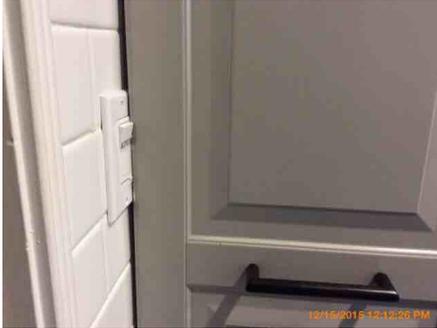
**CR** 174: - The door/drawer did not operate smoothly or close properly. Blocked by electrical wall switch.

RECOMMENDATION: We recommend proper repair as necessary by a qualified tradesperson.

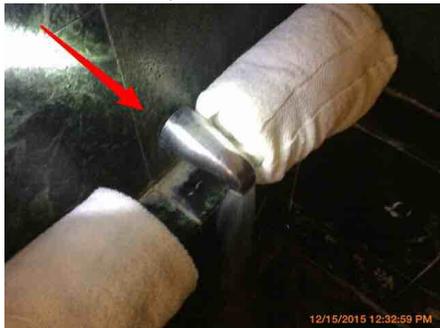
**CR** 207: - The control valves/spout were not sealed to the wall/deck. This is a potential leak source. Suggestion: We recommend correcting this condition to prevent moisture intrusion into concealed spaces.

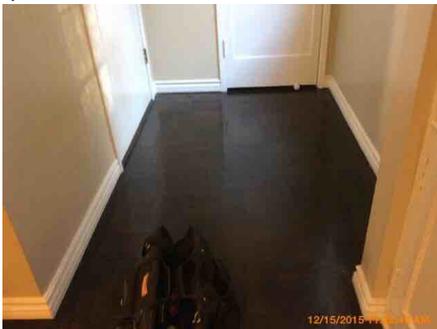
**CR** 230: - There is a soft or weak floor area beneath the carpet in the hallway. Recommend further evaluation to determine cause by a qualified licensed Contractor.

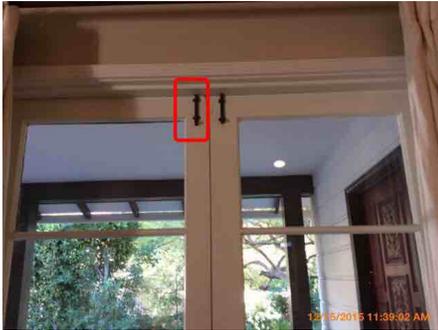
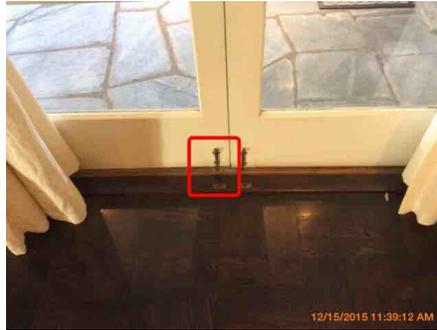
**CR** 233: - The door did not latch to the jamb top and/or bottom.

RECOMMENDATION: We recommend adjustment of the latch plate to restore proper operation.

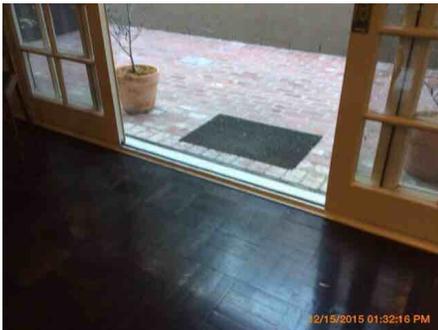
**CR** 234: - The sliding glass door(s) did not operate smoothly, probably because of worn or poorly adjusted rollers. RECOMMENDATION: We recommend the track be cleaned and the rollers adjusted or replaced as needed to restore proper operation.

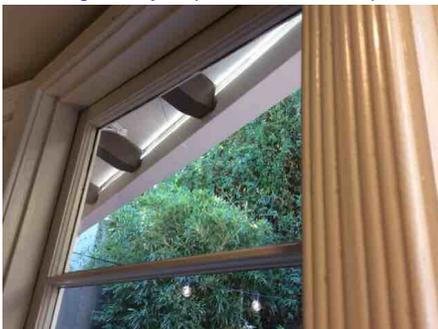
**CR** 236: - The rear bay crank window have cracked or broken glass. RECOMMENDATION: We recommend replacement of all cracked or broken glass by a qualified window specialist.

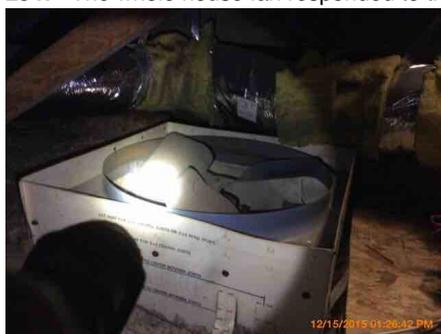
**254:** - The whole house fan responded to the switch located inside the furnace closet.

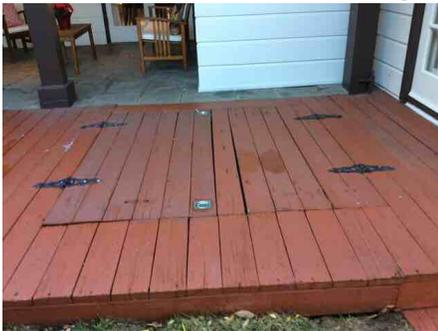
**259:** - Located at the front of the building
