# REAL ESTATE INSPECTION REPORT

709 Wilson Ct Burbank, CA 91501

DATE OF INSPECTION: 6/5/2024  
INSPECTION TIME: 3:00 PM

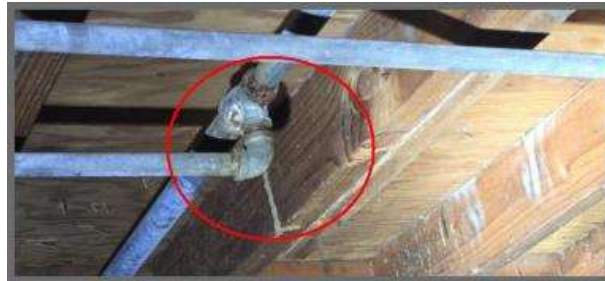
**NEEDS ATTENTION.** There are copper and galvanized pipes joined without the proper connectors. Copper and Galvanized piping in contact will react and the galvanized piping will rust and corrode prematurely. Since any repair that leaves galvanized piping in the system is a temporary repair, consult with a plumber for a full evaluation of the system.

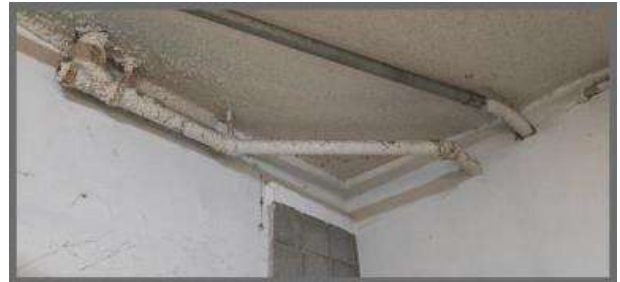
**NOT ACCEPTABLE.** There are leaks in the waste pipes. These lines should be fully evaluated and repaired/replaced as needed. Such as in the crawl space.

Some of the drain lines in the crawl space appear to be cracked.

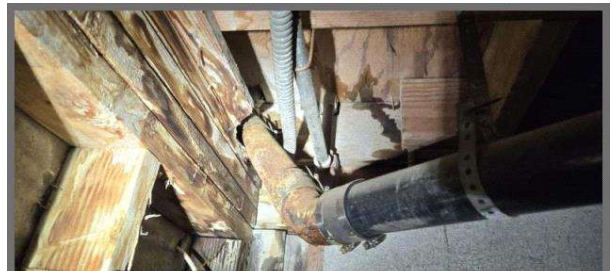
BLISTERS AND LEAK

**NEEDS ATTENTION.** There are areas with significant rust and deterioration, with rust blisters on the exterior of the lines. These may seep and leak or could break in the future and allow for flooding under the building.

**These sections of lines have essentially failed. A plumbing specialist should evaluate the waste line system fully to determine the extent of needed repairs and/or replacement.**

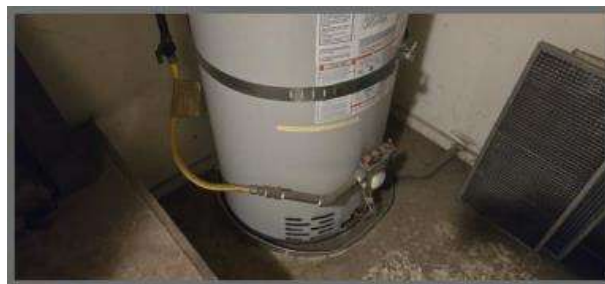
**NEEDS ATTENTION.** There is no 'Drip Leg' or 'sediment trap' noted on the gas connection for the water heater. This component is recommended and may be a manufacturer and/or city requirement for safe operation. Consult with a qualified plumber for more information.

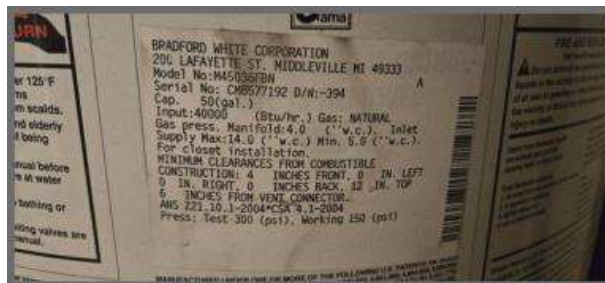
The water heater is about 18 years old. Water heaters have an average life of 8 - 12 years.

**NEEDS ATTENTION.** The water heater is old and at or beyond the end of its expected life span. It is beyond this inspection to determine how long it will last. It will likely need replacement.

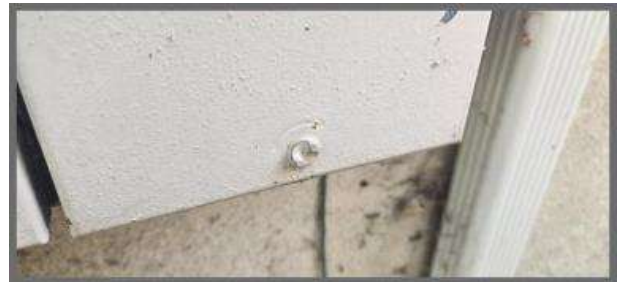
**NEEDS ATTENTION.** The panel couldn't be opened. It has a security type of screw that can be close but can not be opened. No representation can be made as to its condition.

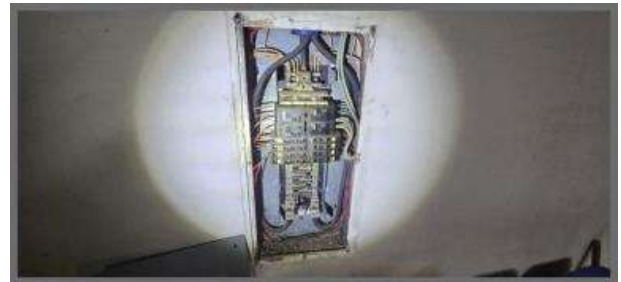
**NEEDS ATTENTION.** This is an older sub panel and it may be considered limited. It may be more prone to failure due to its age, and repair or replacement parts may be difficult to obtain.

An electrician may recommend replacing and upgrading this system. Further evaluation is recommended.

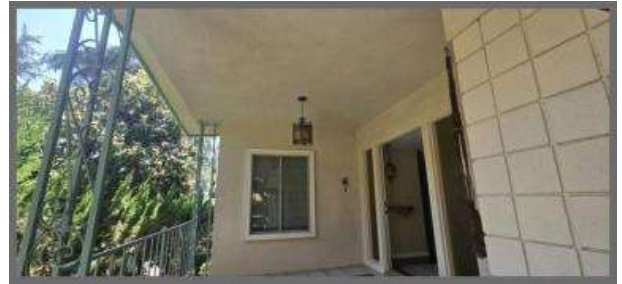
**SAFETY ALERT.** The light fixture at the entrance appears low.

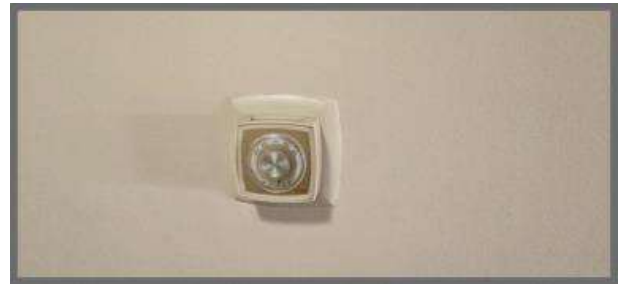
**NEEDS ATTENTION.** The thermostat is older.

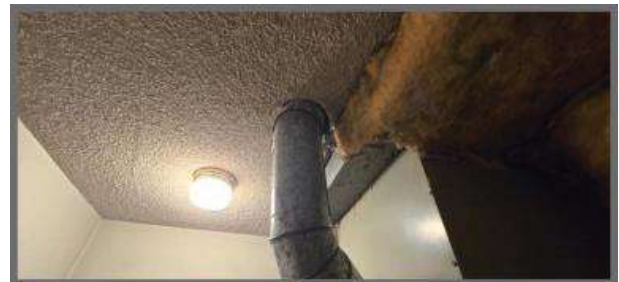
**SAFETY ALERT.** The furnace vent pipe is too close to combustibles/building materials. This is a potential fire hazard and the vent line needs to be corrected so as to have the proper clearances and the vent ensured as being installed correctly.

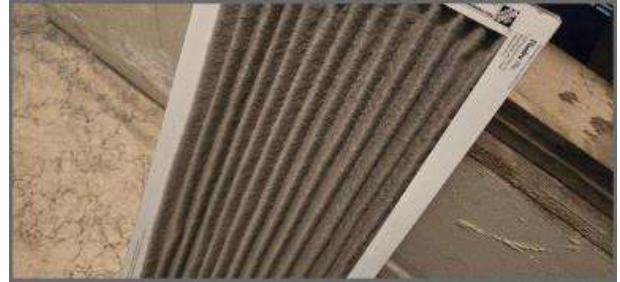
**AIR FILTER-RETURN AIR DUCTING**  
**NEEDS ATTENTION.** The air filters are dirty and would generally be replaced. Consult with a qualified HVAC contractor to determine the exact needs for this system.

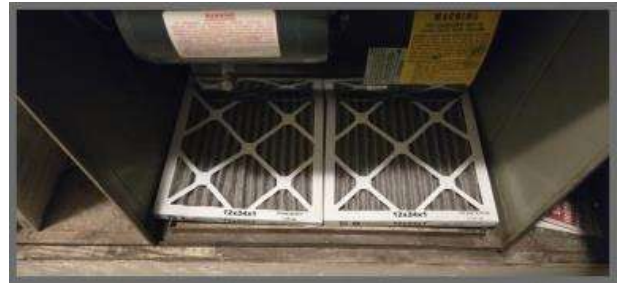
**NEEDS ATTENTION.** The filter is not secured in position and will 'float' out of place. This will not filter the air well and should be repaired.

Also they are the wrong size.

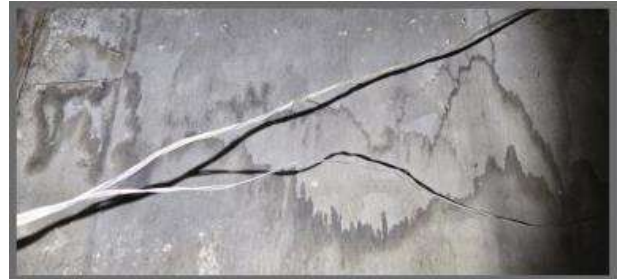
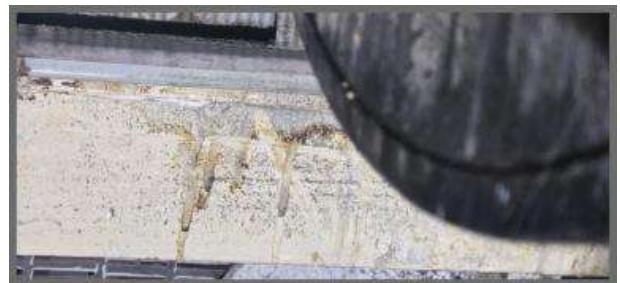
**NEEDS ATTENTION.** there is moisture deterioration inside the return air plenum.

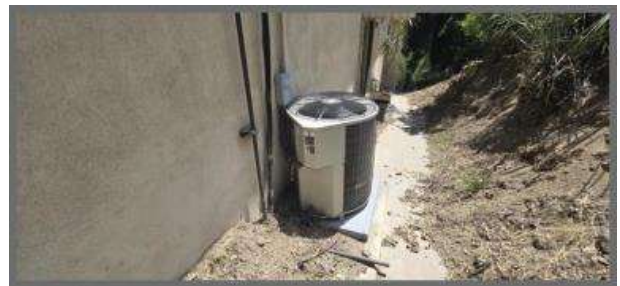
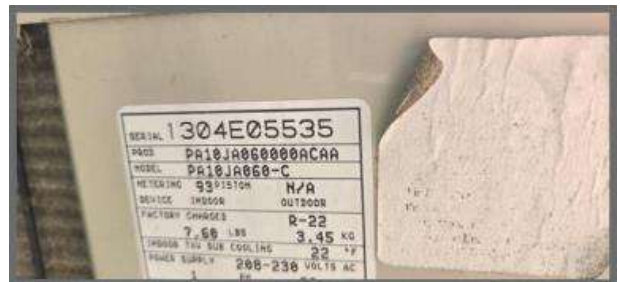
**NEEDS ATTENTION.** The Unit is older. While still working at this time, it is nearing the end of its expected life span and will need to be replaced in the future. Consult with a specialist for further evaluation. About 18 years old.

The condenser and the air handler by the furnace are of different age. Consult with an HVAC to see if they are compatible.

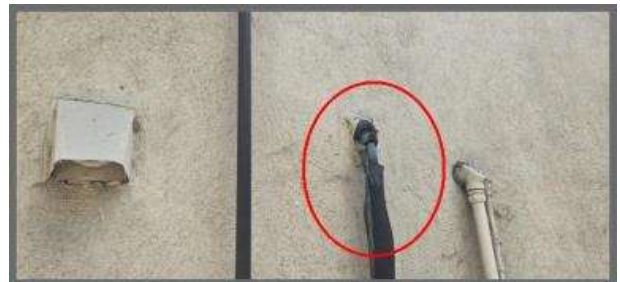
**NEEDS ATTENTION.** The refrigerant lines have damaged insulation on them. This will cause them to be less efficient.

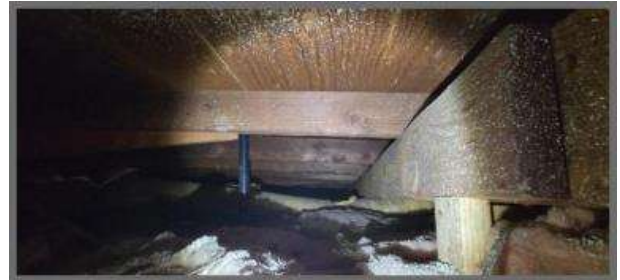
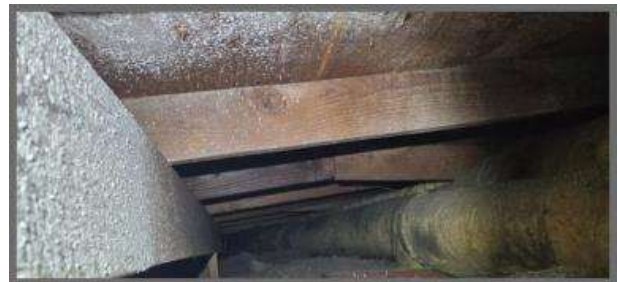
**NEEDS ATTENTION.** There are areas of staining noted to the framing lumber that may be due to roof leaks. It is not determined if the staining is from a past or current condition.

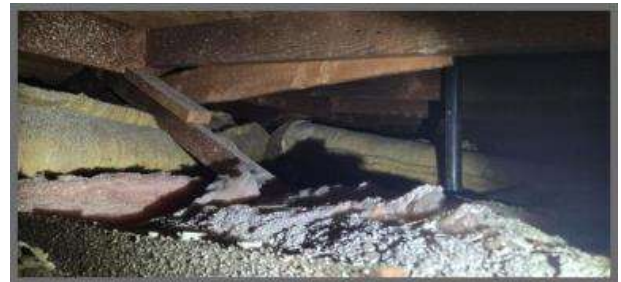
**NEEDS ATTENTION.** The insulation is older and likely no longer meeting its original standard. Consult with a specialist for more information.

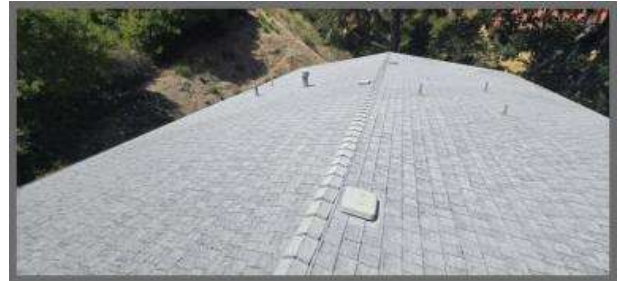
**PRESENT.** Flashings are somewhat hidden by surface materials. Based on my limited observation I discovered no apparent issues with the flashings. It is however not possible during a general visual inspection to determine how well the flashings will perform during all conditions.

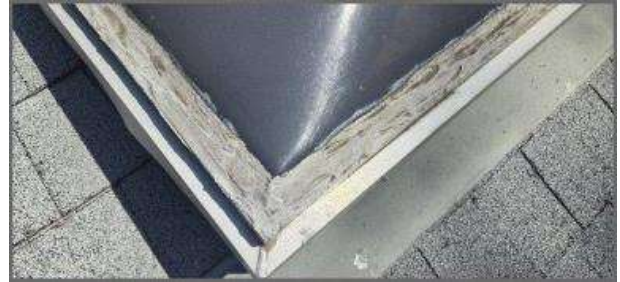
**NEEDS ATTENTION.** It appears the skylight was repaired with silicone. This repair may be temporary.

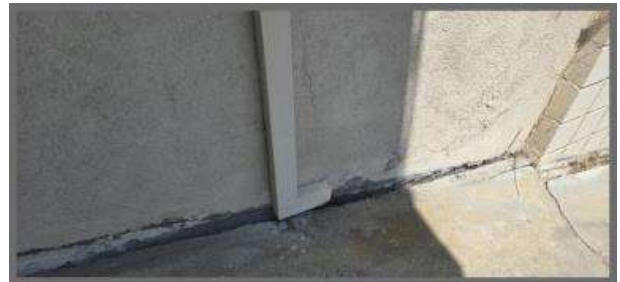
**NEEDS ATTENTION.** The downspouts do not route the water away from the building but instead deposit it next to the structure which commonly causes problems to the foundation over time. These should be extended away from the building.

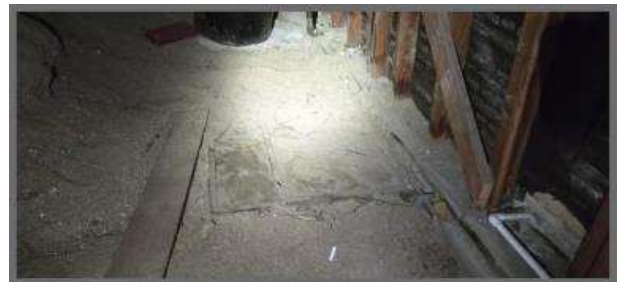
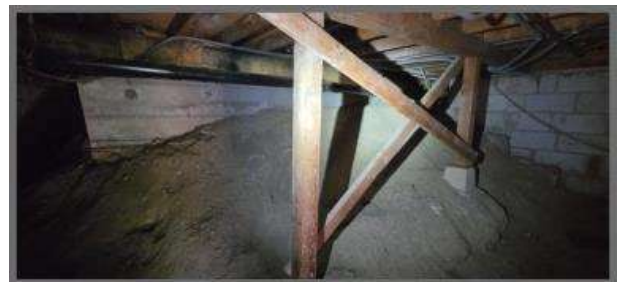
**SAFETY ALERT.** There are cracked windows stored in this crawl space. This is an injury hazard.

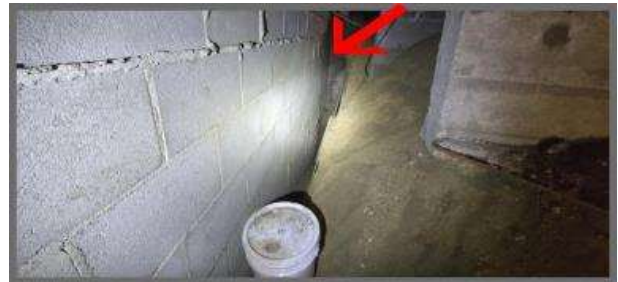
**NEEDS ATTENTION.** ON the other side of the crawl space wall to the right is the rooms located in the lower floor. The side of this wall facing the rooms has moisture deterioration. Please alert of this condition to the foundation specialist.

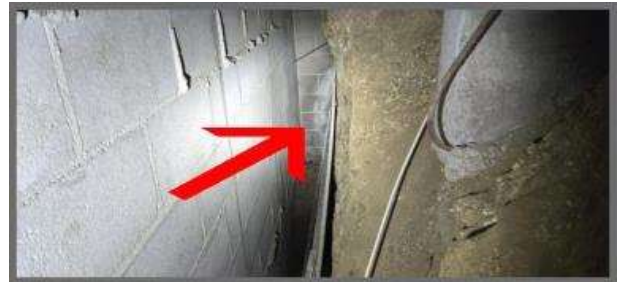
**NEEDS ATTENTION.** There is white staining and powder that may be efflorescence, indicating moisture in / through the foundation. This can damage any steel 'rebar' in the foundation and is not ideal

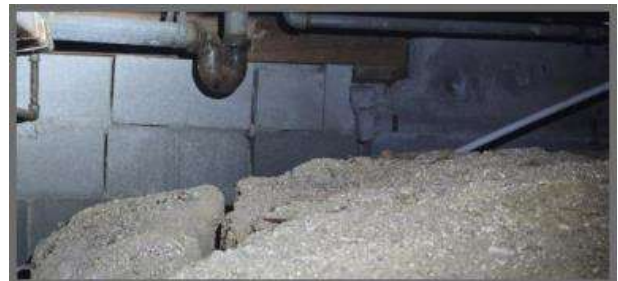
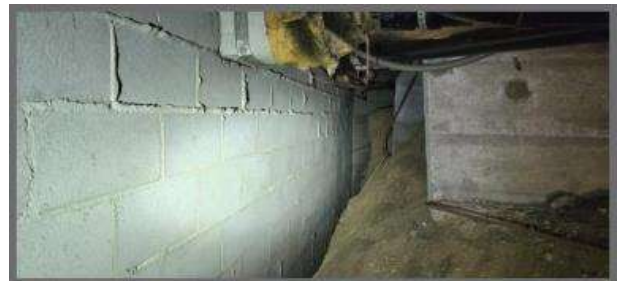
**SAFETY ALERT.** This is a concrete block foundation. It is advised that a foundation specialist verifies that these blocks are reinforced with rebar. This sometimes requires intrusive inspection.

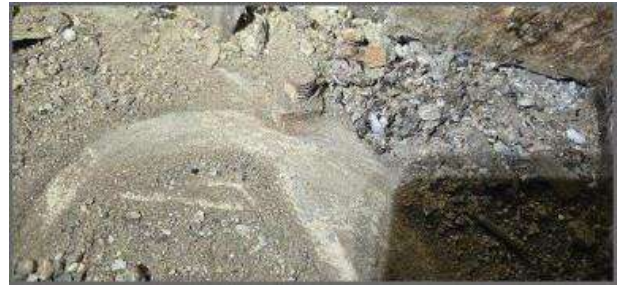
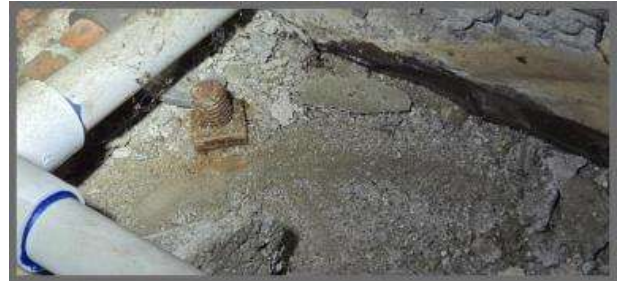
The structure has some original anchor bolts. These bolts are farther apart and smaller than current established bolting standards would dictate.

For more information, further evaluation would be needed by a foundation specialist to determine what additional upgrades could be undertaken to help increase this foundations' ability to withstand seismic activity.

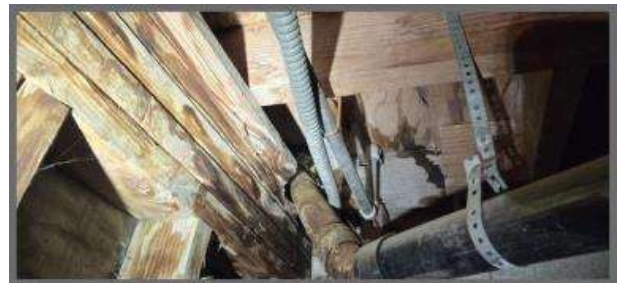
**NEEDS ATTENTION.** There are damaged and deteriorated areas of floor framing - it is advisable to consult the structural pest control operator report for more information on this situation

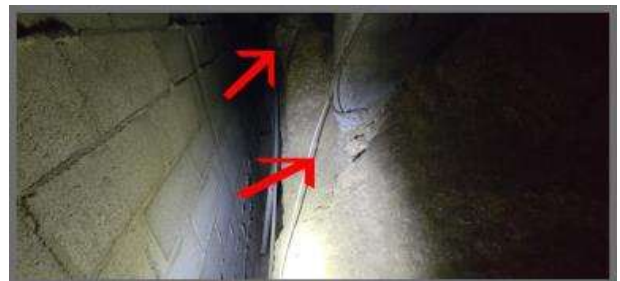
**SAFETY ALERT.** The interior stem walls that hold up the structure are undermined in areas where the earth under them has been removed. They do not have full bearing on the soil and cannot give full support.

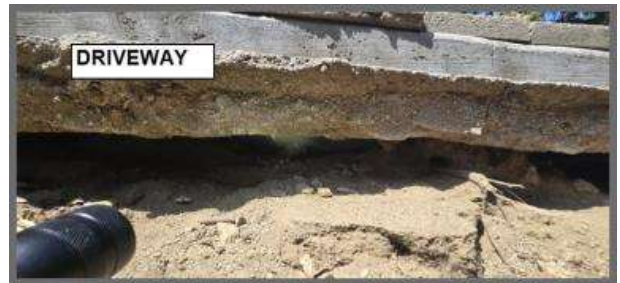
**NOT ACCEPTABLE.** It appears that a good portion of the driveway loss the soil from underneath, which would support it.

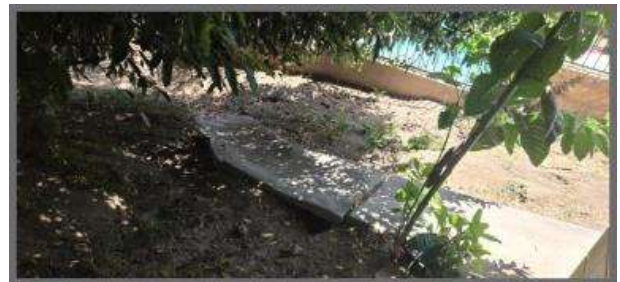
**SAFETY ALERT.** The walkway surfaces are uneven in areas, which can pose a trip and fall hazard.

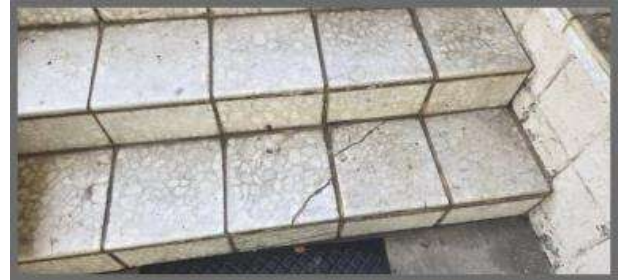
**NEEDS ATTENTION.** There are raised and shifted areas of the front steps that appear to be a trip hazard.

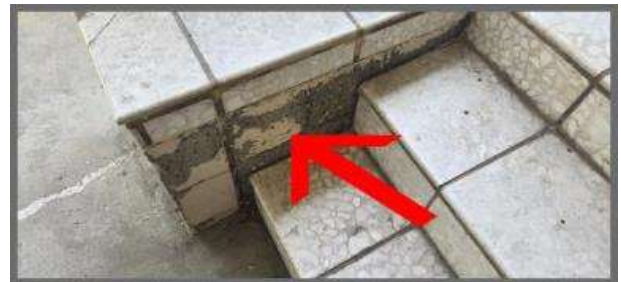
**NEEDS ATTENTION.** There is deterioration to the steps area as from moisture.

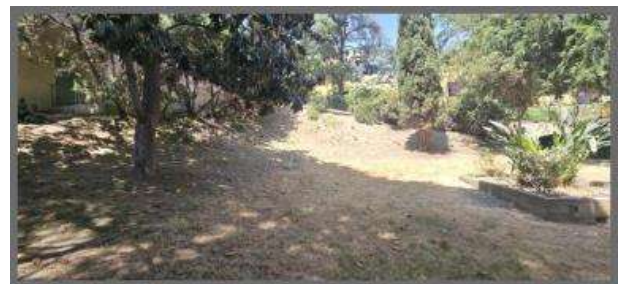
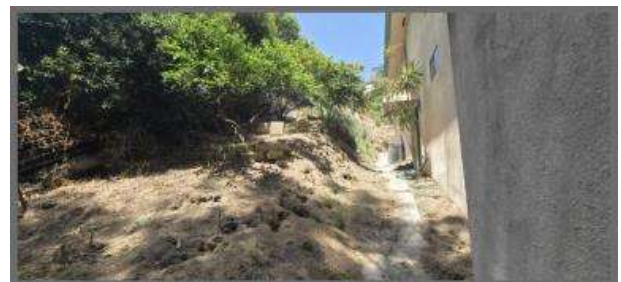
**NEEDS ATTENTION.** As this is a hillside site, brush clearance rules may apply.

The grounds on the property are very overgrown and neglected, and will need clean up and maintenance. This also can limit a complete view of areas of the yard and building exterior.

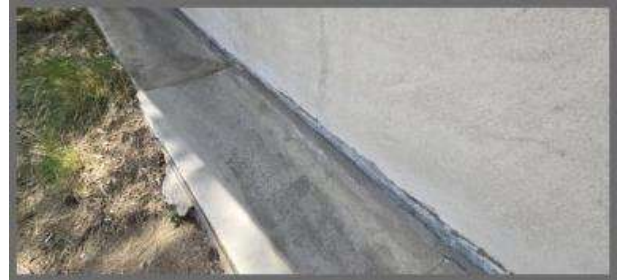
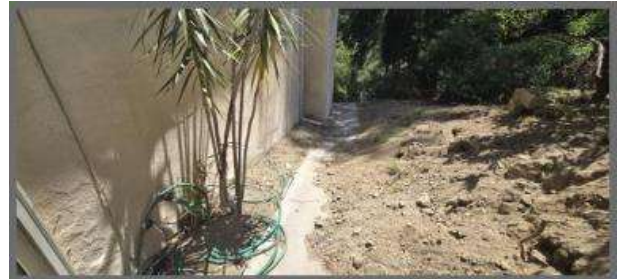
**NEEDS ATTENTION.** There is a concrete swale surrounding some areas of the house. This swale has large cracks and gaps next to the wall and in the swale itself which would allow moisture intrusion.

There is evidence of improper drainage on the site causing erosion of the soil.

**DRAINAGE:** It is my recommendation that a drainage specialist examine the site and perform all needed corrections.

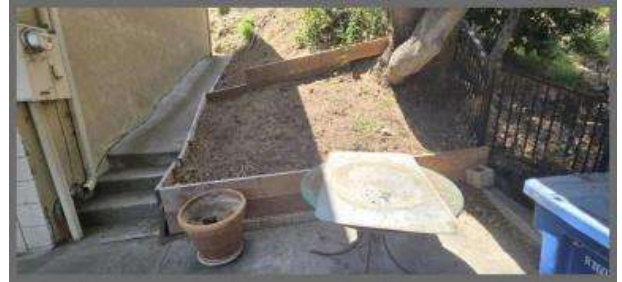
**NEEDS ATTENTION.** A wooden garden wall is being used to retain the soil, on the right side of the house. This may be inadequate over a long period of time.

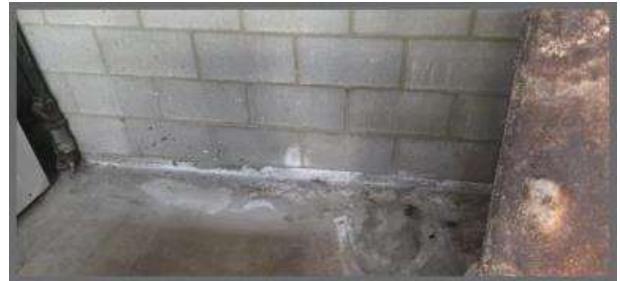
**NEEDS ATTENTION.** The garage floor may not be raised sufficiently above the earth grade and drive to prevent water entry in some weather conditions. There are moisture stains indicating water may have entered in the past.

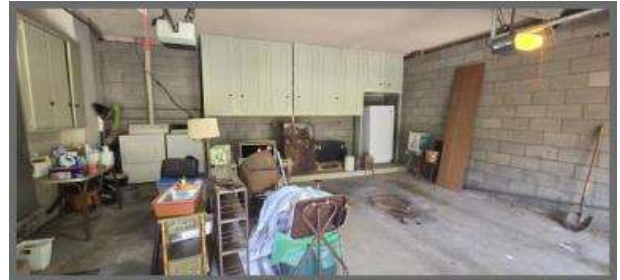
**NEEDS ATTENTION.** The garage interior has areas of moisture stains.

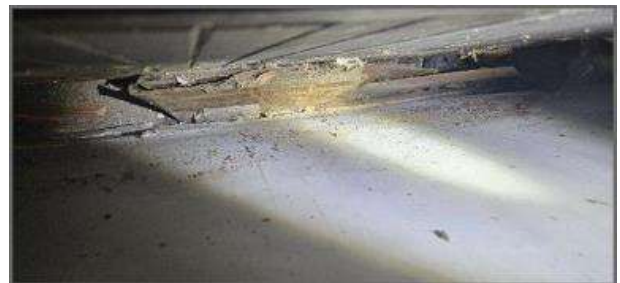
**NEEDS ATTENTION.** The garage interior has areas of damage.

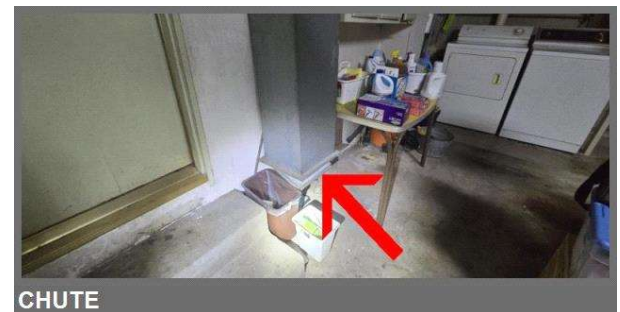
**SAFETY ALERT.** The wall between the house and the garage is a fire separation safety wall between the parking area and the living space. It is supposed to give someone 20 minutes to get out of the building in case of fire. There are not supposed to be any gaps or openings in it to maintain this rating. It has been compromised.

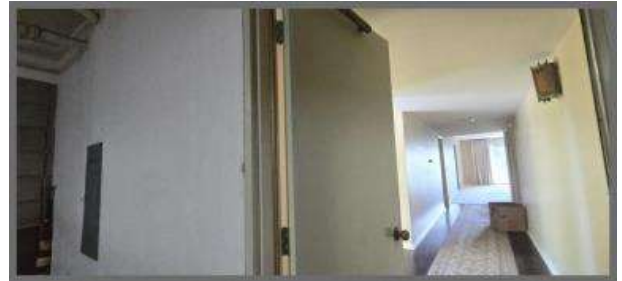
**SAFETY ALERT.** The door between the living space and the garage is not a solid core door or fire-rated for fire safety.

The door between the garage and the living space is not self closing for fire safety. It needs a spring hinge or a closer on it that will fully close and latch it.

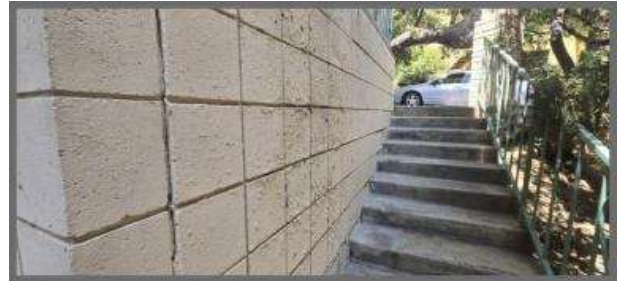
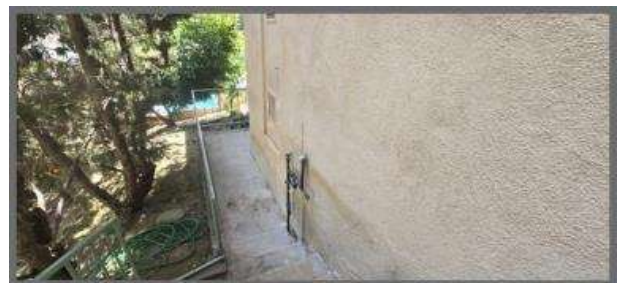
**There is significant cracking in the stucco and repairs are needed to help prevent water intrusion.**

**There is damage to the walls in the some areas.**

**This is an older house and the recommended stucco 'weep screed' flashing installed near the grade line to help prevent water from wicking up into the walls. Consult with a qualified specialist to determine if the installation of a weep screed would assist in moisture prevention.**

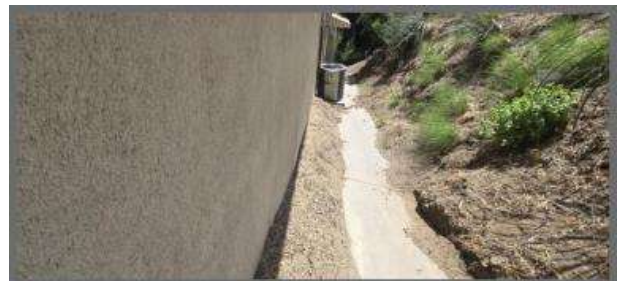
**NEEDS ATTENTION.** The earth against the side of the house is higher than it should be, and can transfer moisture to the wall, which can cause damage, deterioration, and can lead to mold or other problems. The earth should be 4 - 6 inches below the level of the house siding or stucco.

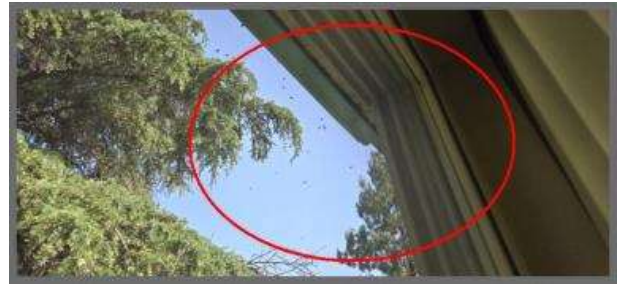
**NOT ACCEPTABLE.** There is a bee hive on the left corner of the house, off the dining area.

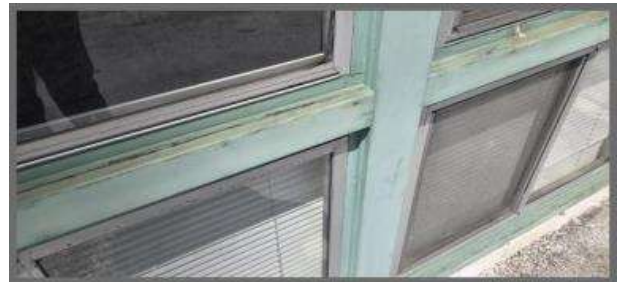
**NEEDS ATTENTION.** There are areas of damage to the exterior of the windows.

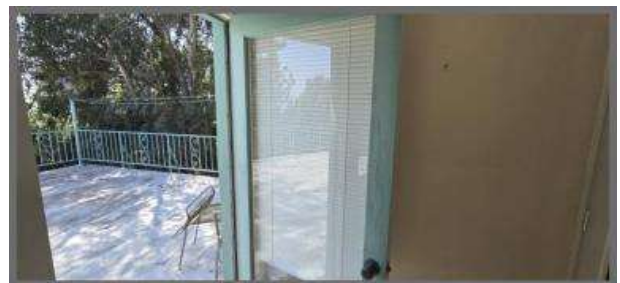
**SAFETY ALERT.** The exterior doors do not seem to have tempered glass.

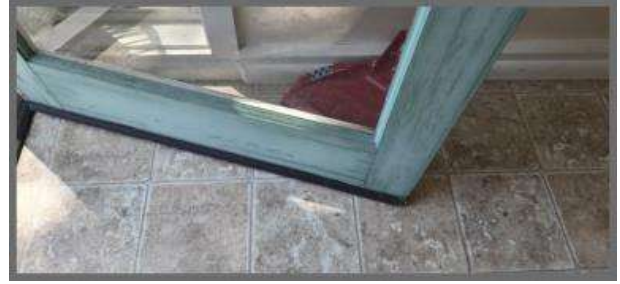
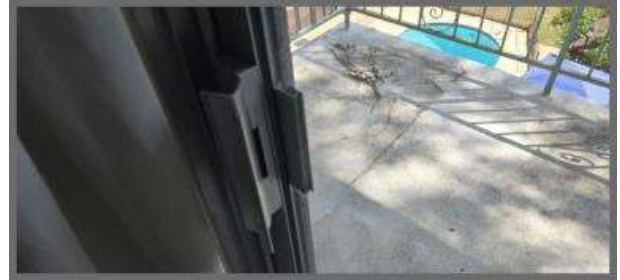
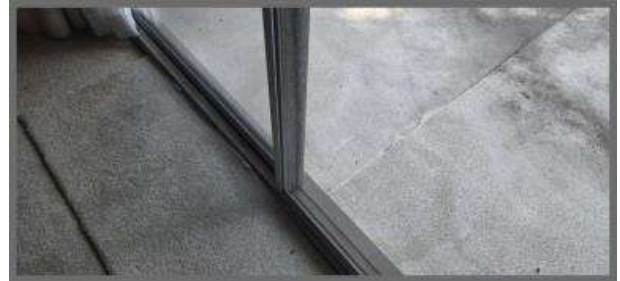
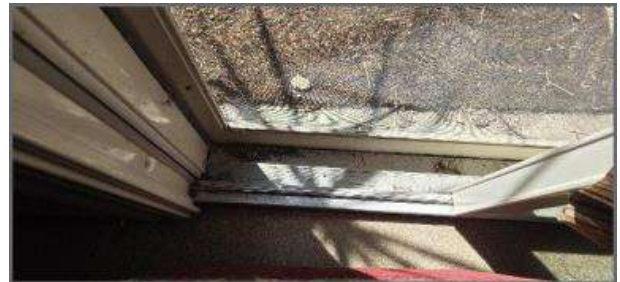
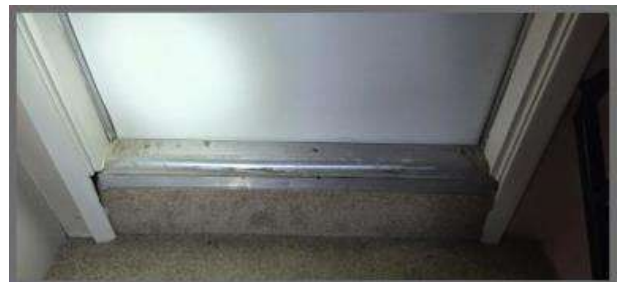
**NEEDS ATTENTION.** There are door thresholds that appear to be incorrectly sloped or damaged and may allow water to be directed to under the door and into the building in some weather conditions.

There are gaps between thresholds and frames where moisture could get in.

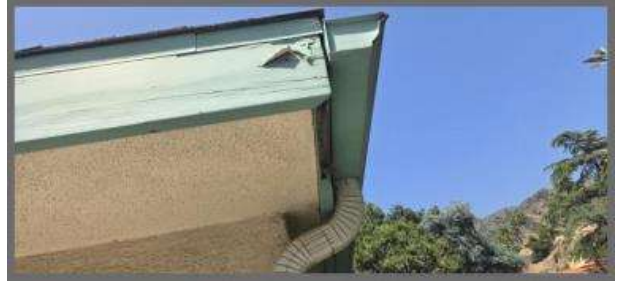
**NEEDS ATTENTION.** The trim has areas of damage.

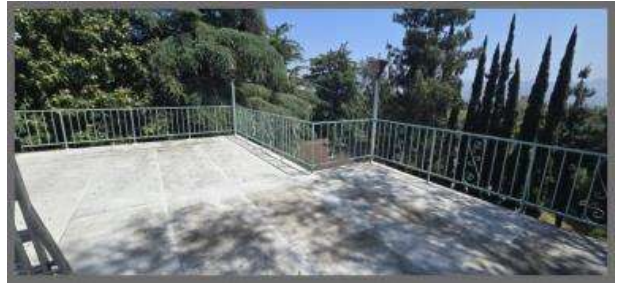
The deck surface appears to be covered with roofing material.

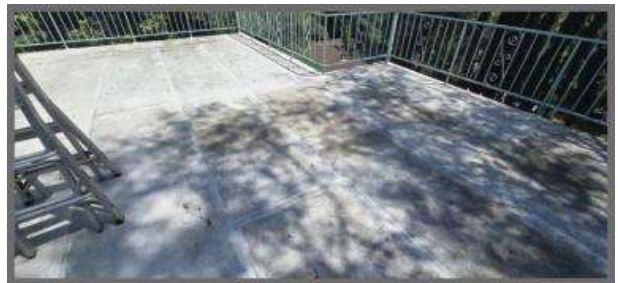
**NEEDS ATTENTION.** The deck and balcony have roofing material installed that is not suitable for foot traffic.

The decks and balconies should be inspected by a deck specialist.

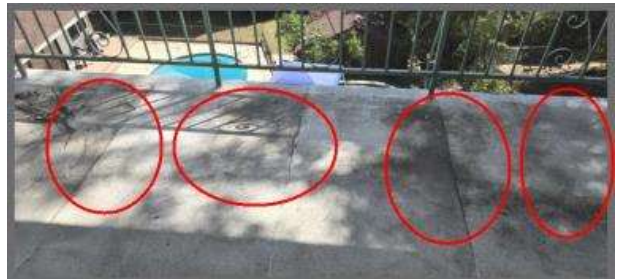
**NEEDS ATTENTION.** The balcony may not be properly sloped and may pool water in certain areas.

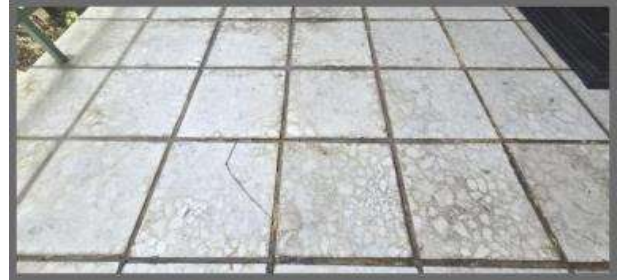
**SAFETY ALERT.** There are stress crack on tile on the deck by the main door.

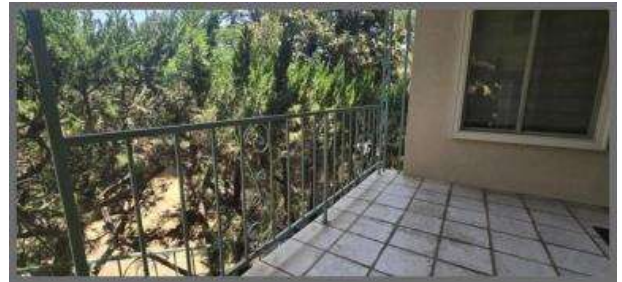
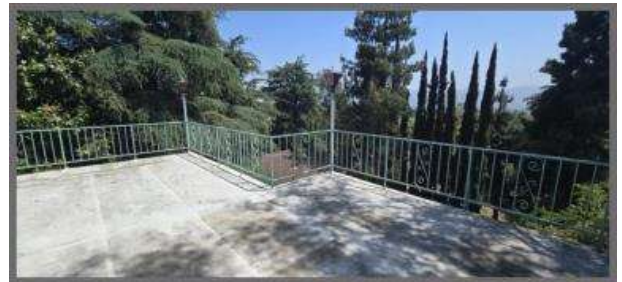
**SAFETY ALERT.** The guard railing is not tall enough to meet the current safety standard of 42 inch minimum height.

The railings do not meet current safety standards. It is recommended that there is no opening greater than four inches in any portion of the railing for child safety.

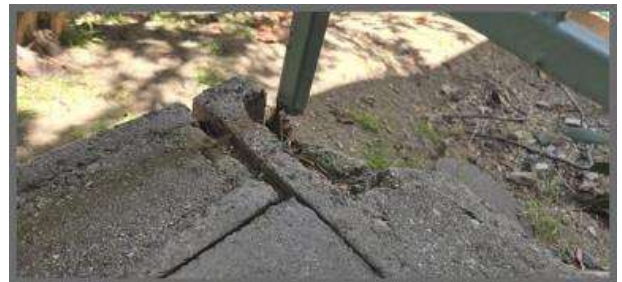
**NEEDS ATTENTION.** There is damage to some of the posts.

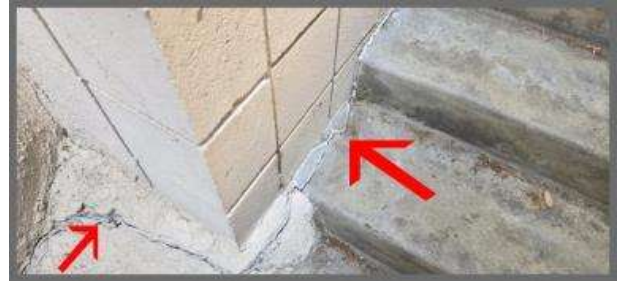
**NEEDS ATTENTION.** There are stress cracks between walls and stairs where moisture could go in.

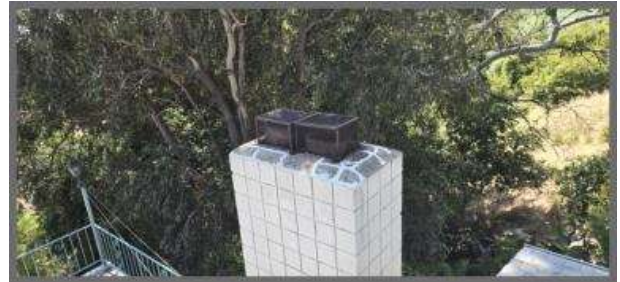
**NEEDS ATTENTION.** There are cracks in the concrete chimney cap.

**FURTHER EVALUATION:** It is recommended that the fireplaces and chimney/s be fully evaluated by a qualified specialist. This inspection should be performed by an unbiased fireplace and chimney specialist that only performs inspections.

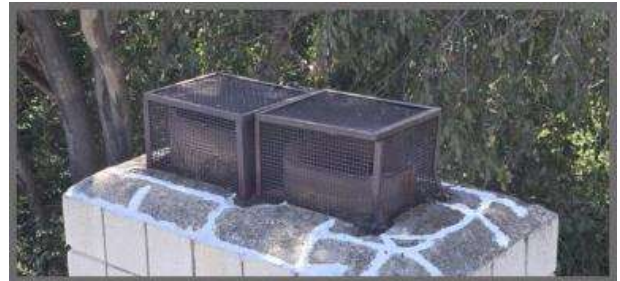
**SAFETY ALERT.** The weather cap is missing.

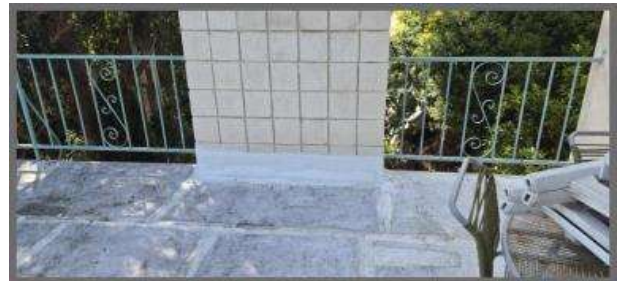
**NEEDS ATTENTION.** The flashing is not standard in areas and may not be reliable installations. The flashings will require regular maintenance to ensure that they remains leak free.

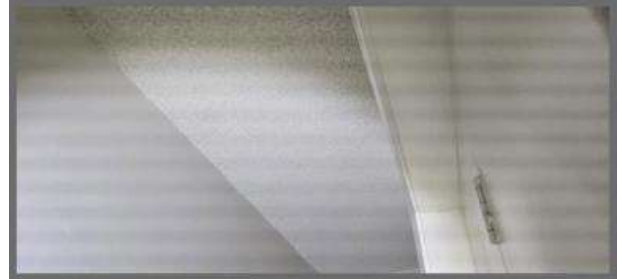
**There are areas of textured ceilings (acoustic) in the building, these may contain asbestos but samples would have to be tested in a certified laboratory to determine if this was in fact the case.**

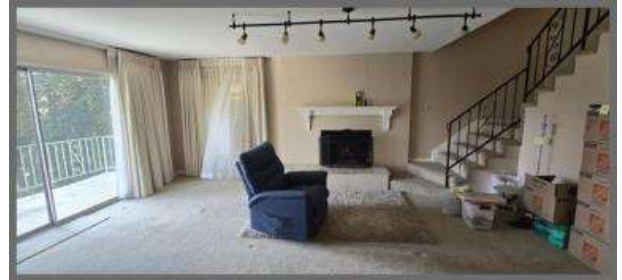
## LIVING ROOM

**NEEDS ATTENTION.** There are areas of moisture stains, on the wall.

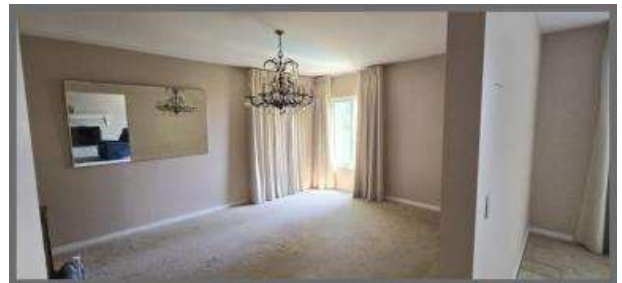
## DINING AREA

**NEEDS ATTENTION.** There are areas of moisture stains on the wall.

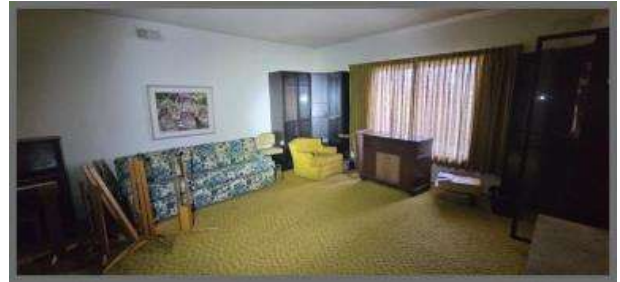
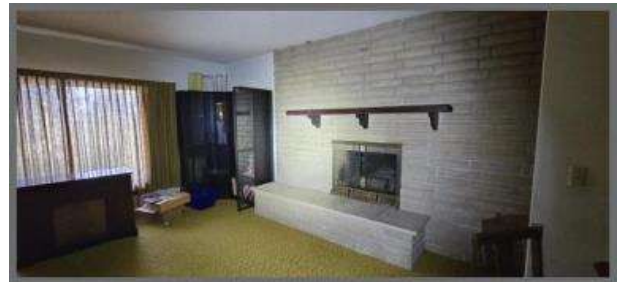
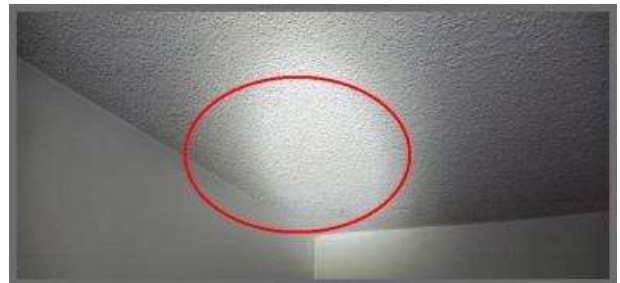
FAMILY ROOM  
DOWNSTAIRS

**NEEDS ATTENTION.** There are areas of moisture stains on the ceiling, on the wall.

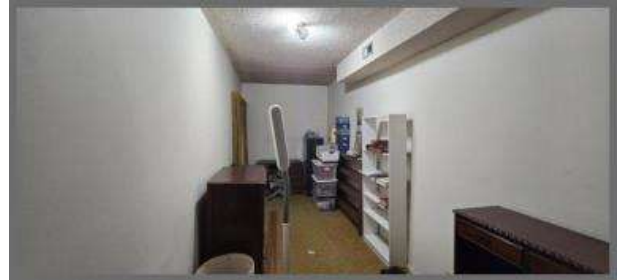
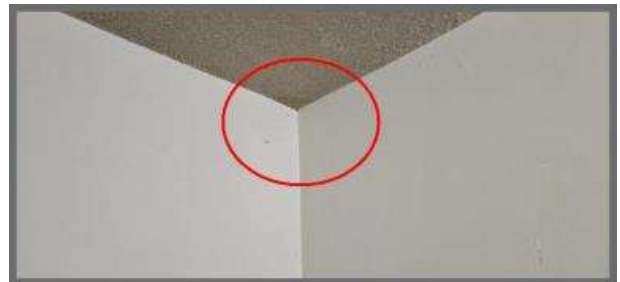
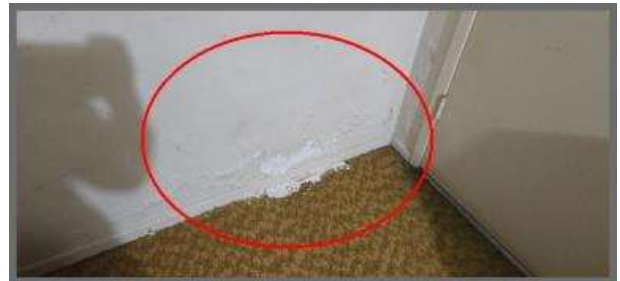
## OFFICE

**NEEDS ATTENTION.** There are areas of moisture stains on the ceiling, on the wall.

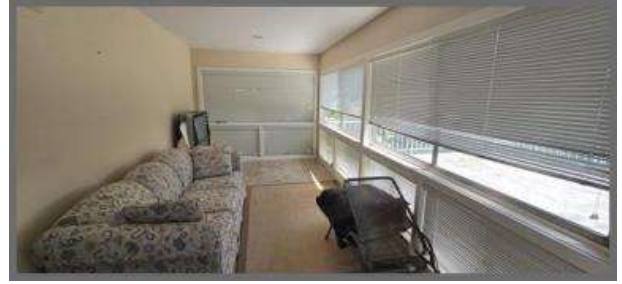
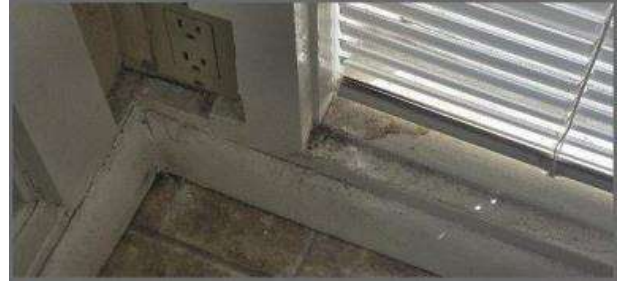
COVERED PATIO:

**NEEDS ATTENTION.** There are areas of moisture stains around the floor, on the wall.

It is advised to consult with the owner regarding the modifications done to this area. It is possible that this area was roof that eventually had a deck and covered patio put on. It is advised to collect any and all information regarding this area, including permits.

It appears that floor may be at the similar height with the floor outside, which may contribute to moisture intrusion.

It is advised that a deck specialist checks the connection between the floor outside and the floor inside.

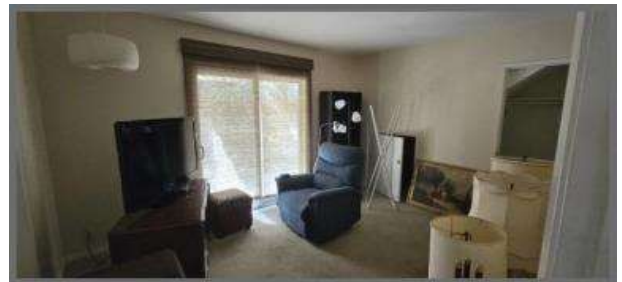
**NEEDS ATTENTION.** There are areas of moisture stains and deterioration, such as in the closet.

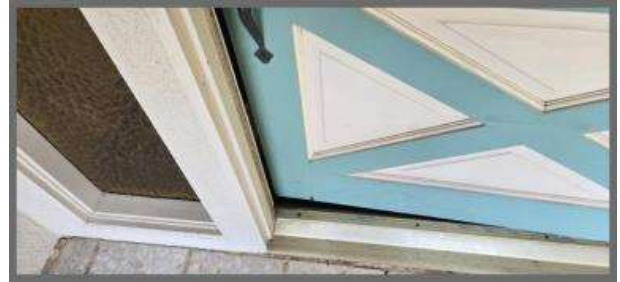
**NEEDS ATTENTION.** The front door is out of adjustment and needs repair to operate properly, it is sagging and rubbing the threshold.

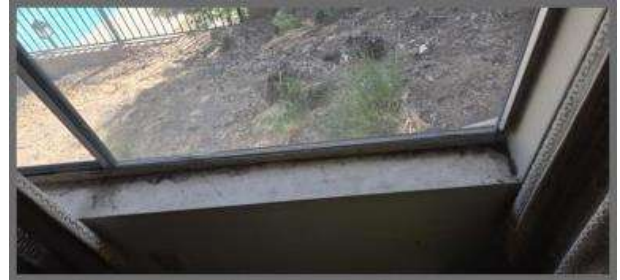
**NEEDS ATTENTION.** There is moisture staining on the window sill in some of the windows.

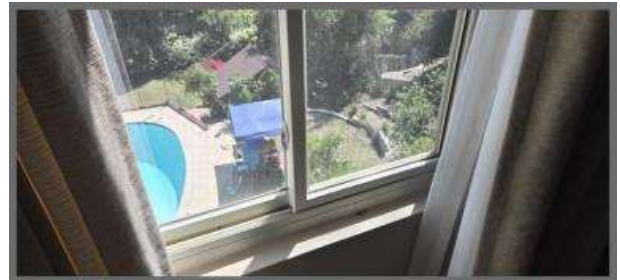
**NEEDS ATTENTION.** The window hardware is older and may need some adjustment/repairs to work properly.

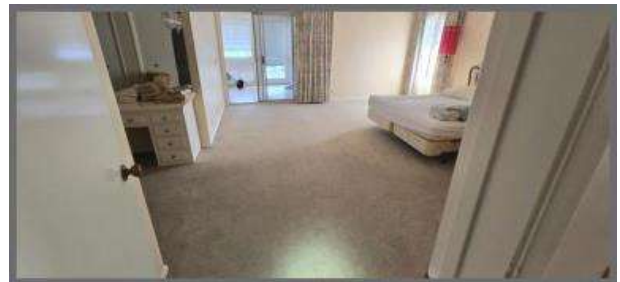
**NEEDS ATTENTION.** The linoleum in the covered patio is worn or damaged in areas. with some peeling at the seams. Sometimes this is caused by moisture intrusion.

The carpeting has areas of soiling and wear.

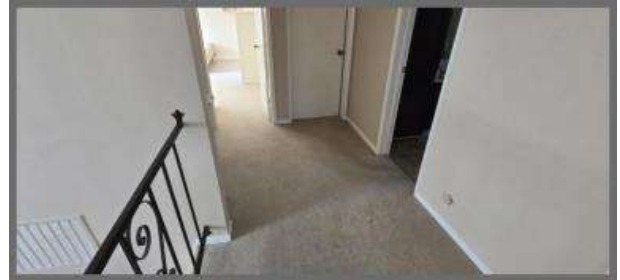
**NEEDS ATTENTION.** The floor/s squeaks/creaks in areas, which can be typical for a building of this age.

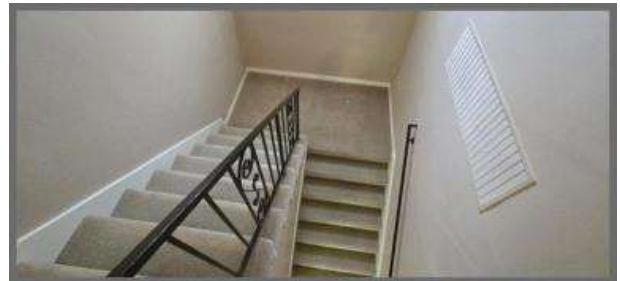
**NEEDS ATTENTION.** There are gaps between the stairs and the walls, on the stairs going to the downstairs area. Separation of material sometimes is related to moisture exposure.

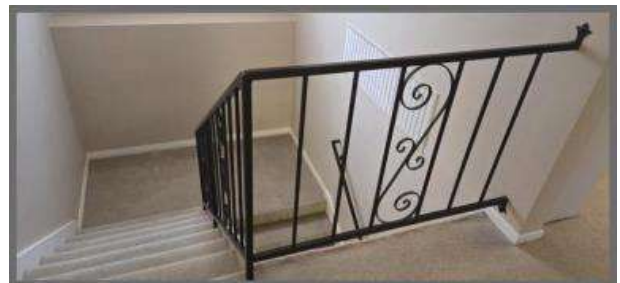
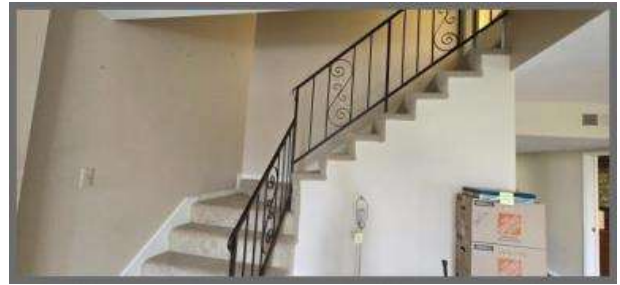
**SAFETY ALERT.** The space between the rails is greater than is currently recommended for child safety. The railing currently should not have any space greater than four inches in any portion of them. this is not a mandatory upgrade at the time of sale, though we do note it for your information

**SAFETY ALERT.** The handrail does not 'return' to the wall. The end can act as a hook to catch clothing and can be a trip and fall hazard.

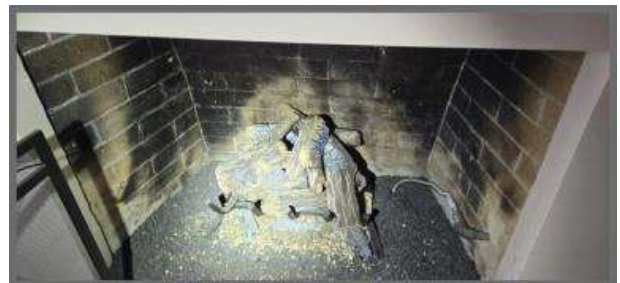
**PRESENT.** Determining the condition of the fireplace and respective flue/chimney is beyond a generalist inspection. This is a specialty item and should be properly evaluated by a fireplace and chimney specialist.

It is recommended that a full evaluation of this system be performed at this time.

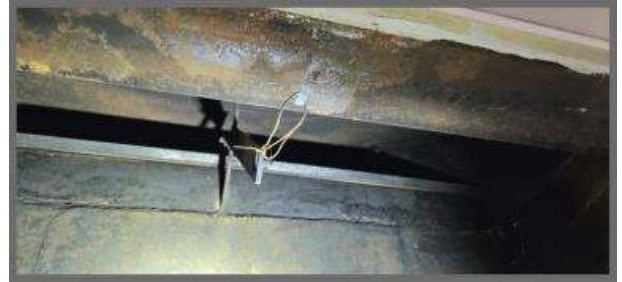
**SAFETY ALERT.** The fireplace has a gas log "set" and the damper was not modified to hold the damper fully open, usually a simple clamp can be installed to meet this requirement (This is a safety concern because if the damper is not fully open and the gas is turned on, the gas or the products of combustion fumes will enter the living space).

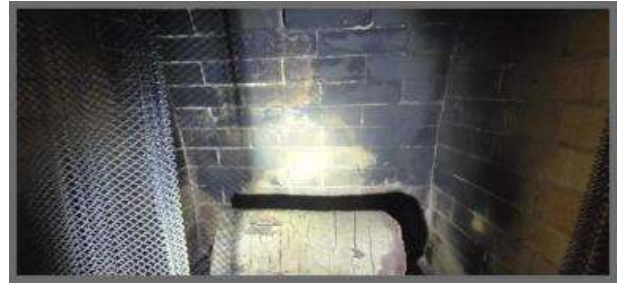
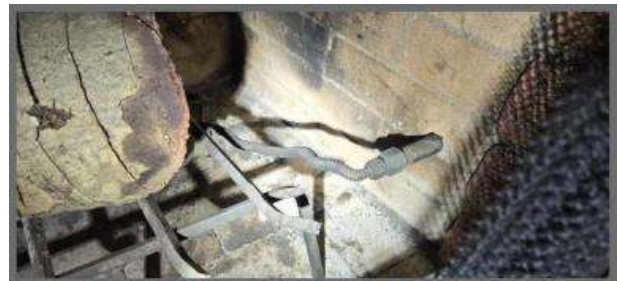
**SAFETY ALERT.** Where the gas line enters the firebox there is a gap that is not sealed, this can allow heat and fire into the wood framing behind the firebox. This gap needs to be sealed. It is typically an inexpensive repair to fill and seal this opening with approved heat rated caulk.

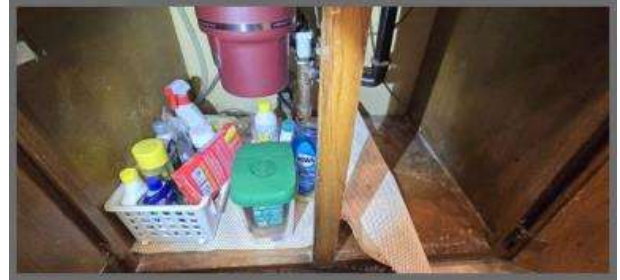
**NEEDS ATTENTION.** There is moisture staining and damage to the shelf area under the kitchen sink. There is black staining that may indicate mold and should be further evaluated by a mold specialist.

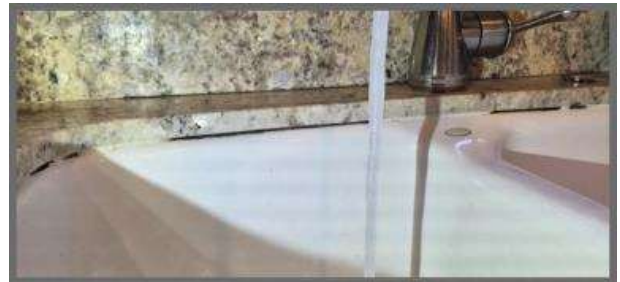
**NEEDS ATTENTION.** The seal between the sink and counter top is deteriorated. This can allow water to enter into the cabinet areas.

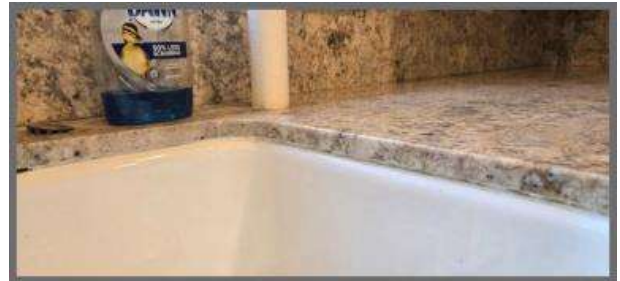
**NEEDS ATTENTION.** The sink appears to be a top mount sink, not designed to be mounted below the counter.

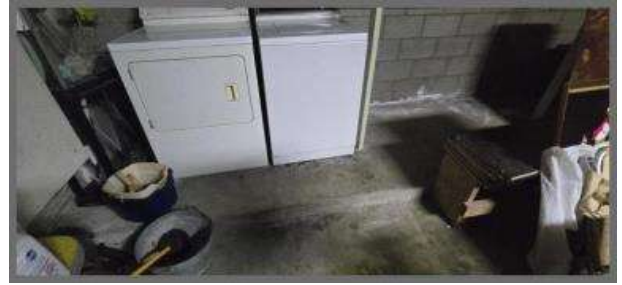
A gas clothes dryer in a garage is required to be raised so that the clothes dryer burner is 18 inches above the garage floor.

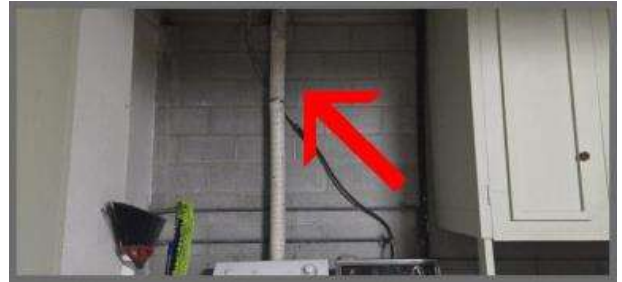
**SAFETY ALERT.** This dryer duct passes up and into the wall or concealed spaces. This duct can be more likely to fail due to lint build up, etc.

This duct should be evaluated and/or cleaned on a regular maintenance schedule. It is recommended that this duct be fully evaluated and corrected as needed.

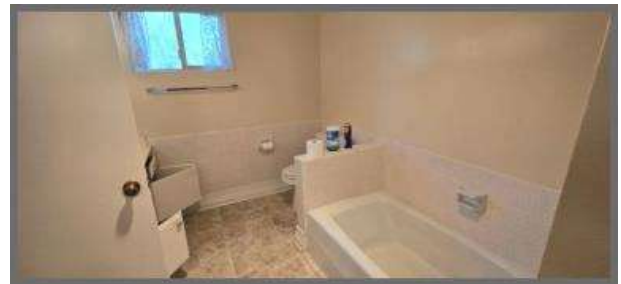
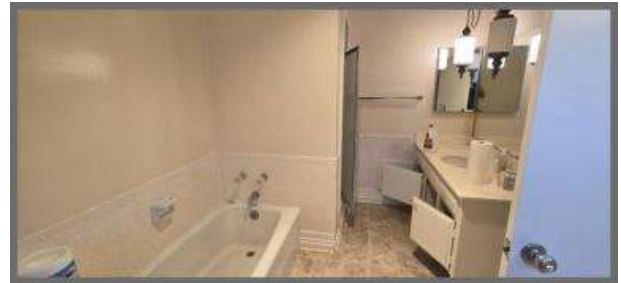
**NEEDS ATTENTION.** The volume of water coming out of the fixtures drop when there is more than one fixture being used.

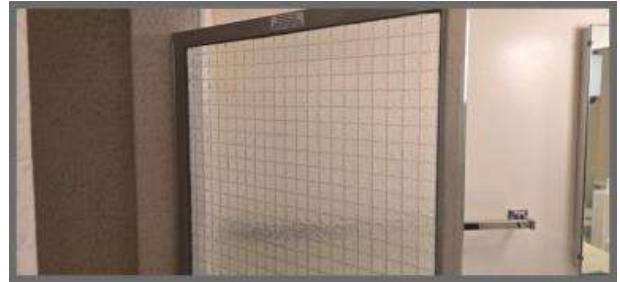
**SAFETY ALERT.** The shower enclosure is made of glass with embedded wire, which was considered 'safer' but is not safety glass and it can break creating sharp glass shards. It is strongly recommended this be replaced with tempered or other safety material before you use this shower.

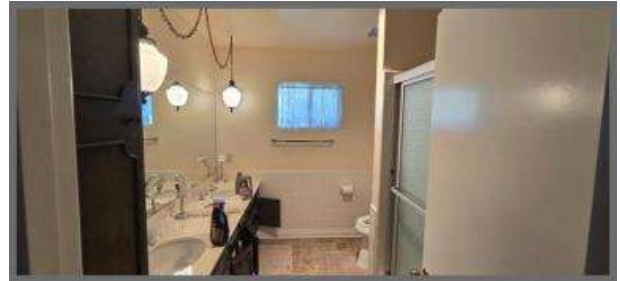
**NEEDS ATTENTION.** The volume of water coming out of the fixtures drop when there is more than one fixture being used.

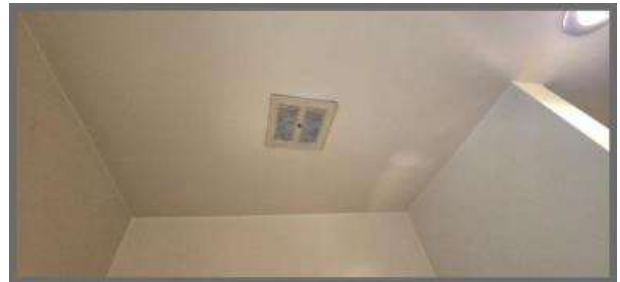
**NEEDS ATTENTION.** The fan is noisy while in operation. It may need replacement or repairs.

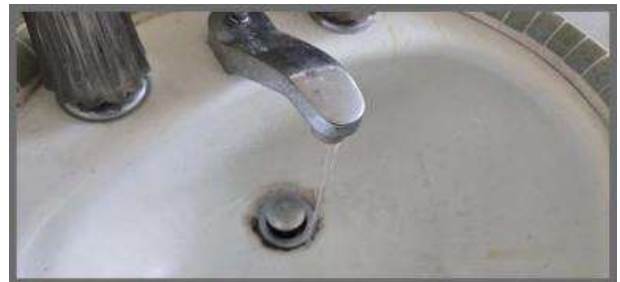
**NEEDS ATTENTION.** The volume of water coming out of this fixture is low.
