## Inspection Report

**Dong & Justina Nguyen**

840 Paula St  
Escondido CA 92027

**All Pro Property Inspection**

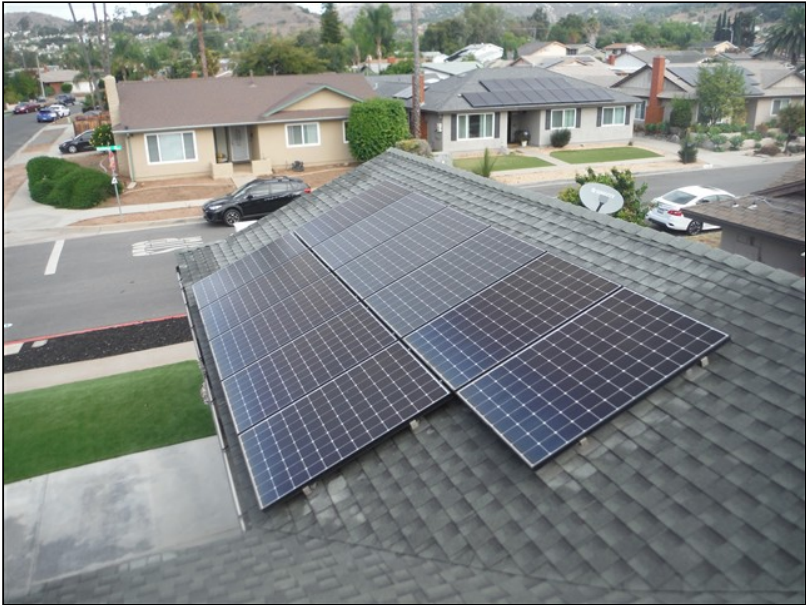
1.0 Item 1(Picture)

(1) The roof was not fully visible due to the electric solar equipment/ panels. We recommend that you have these areas inspected by a qualified licensed roof contractor if you are concerned that there may be damaged shingles.

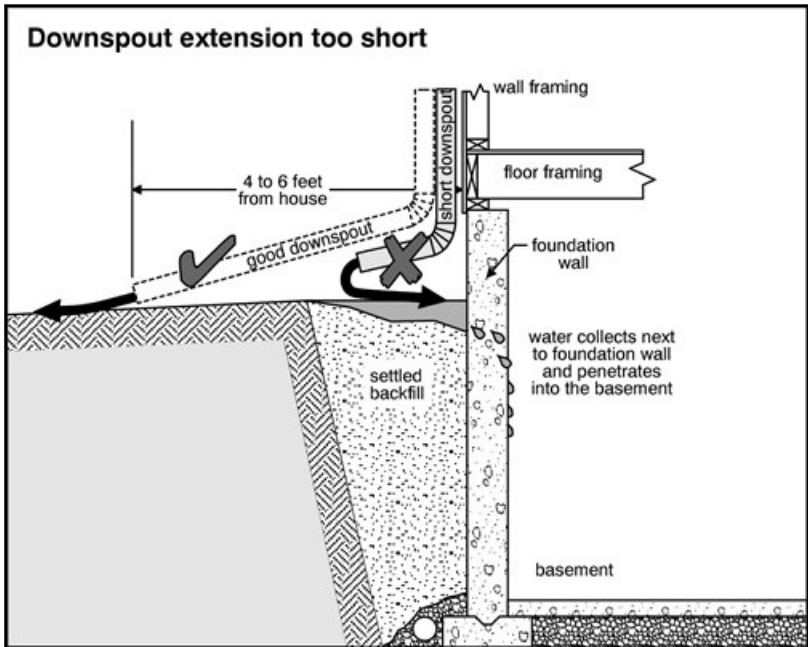
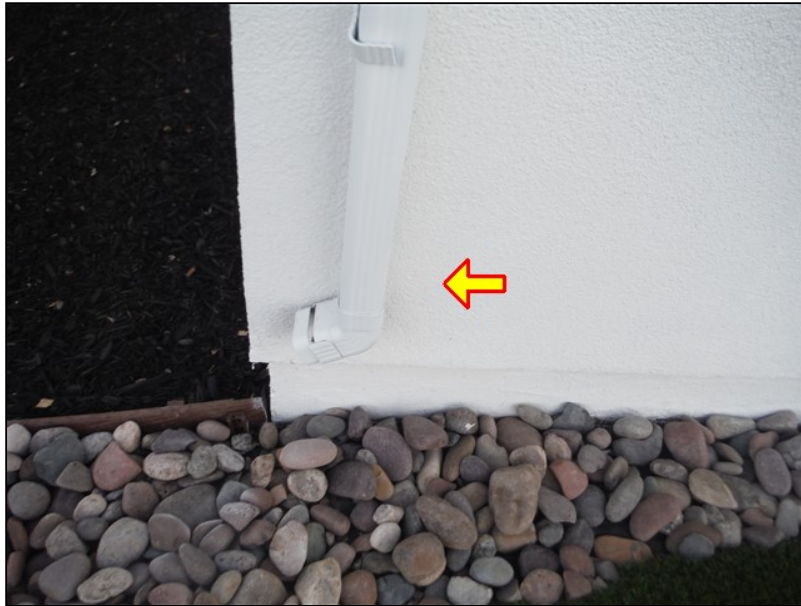
**Findings**  
(1) Downspouts need extensions and/or buried drain lines to carry water away from the home at several locations around the home. We recommend necessary corrections where needed by a qualified licensed contractor.

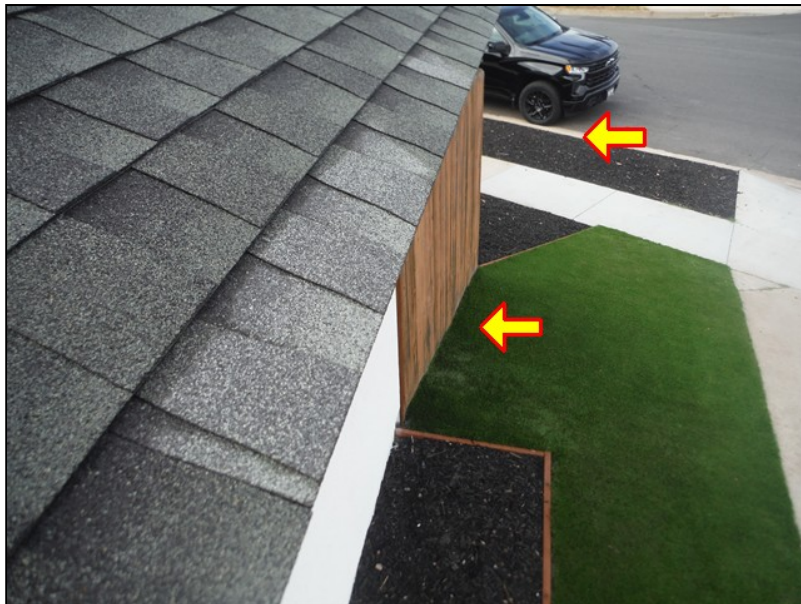
1.2 Item 3(Picture)

(2) Some rain gutters and downspouts are present/ installed. A complete rain gutter system helps control water flow and keeps moisture away from the foundation/ structure. We recommend having additional gutters and downspouts installed where needed by a qualified licensed contractor as an upgrade.

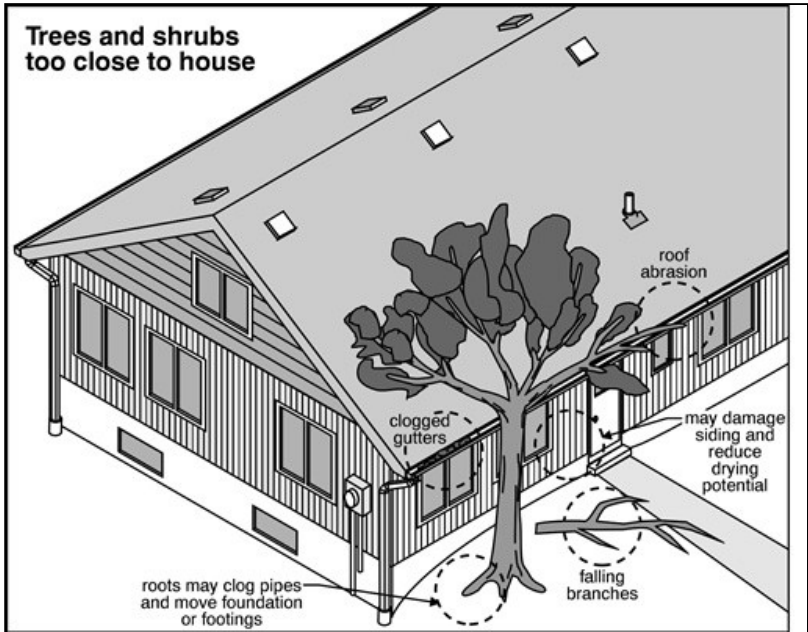
2.1 Item 2(Picture)

Tree(s) and/or large plants are located too close to the house. Tree limbs/vegetation that are too close to the house can cause damage in several ways. Limbs or vines in contact with roof or hanging near roof should be trimmed to prevent damage to roof and/or to prevent rodent infestation. Also, as the plants grow, damage can occur to the siding, concrete flat work and to the foundation. We recommend having the foliage removed or trimmed by a qualified professional to prevent damage to the house as soon as possible.

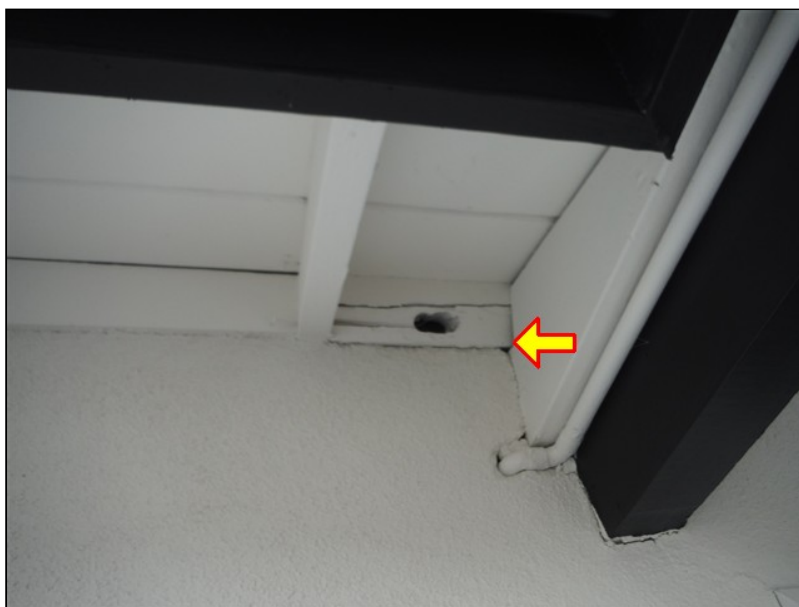
#### 2.4 Item 1(Picture)

Some damaged wood was observed at the eaves and fascia boards at one or more areas. Determining if this damage was caused by termites is beyond the scope of a home inspection. Home inspectors do not have the authority to comment on termites or dry rot, which is the responsibility of a state licensed pest inspector. We recommend referring to the pest inspection report for a full evaluation and necessary repairs made by a qualified licensed contractor.

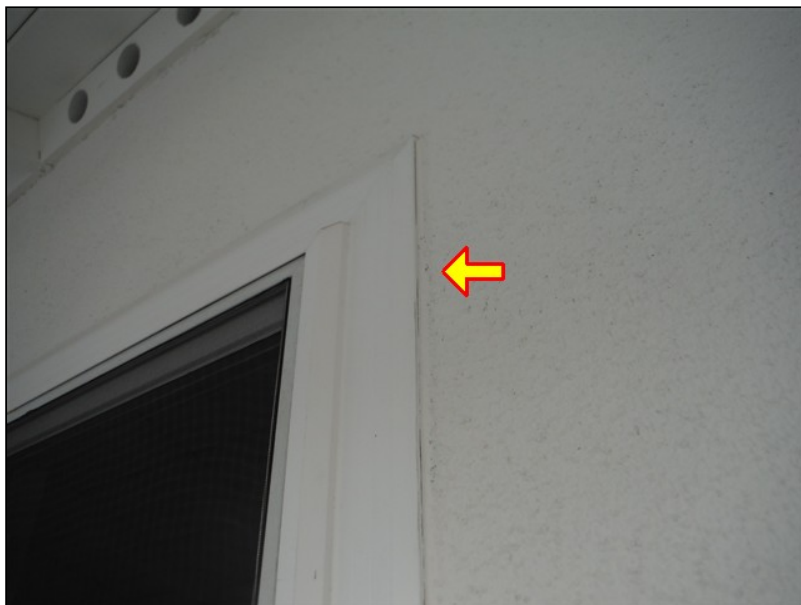
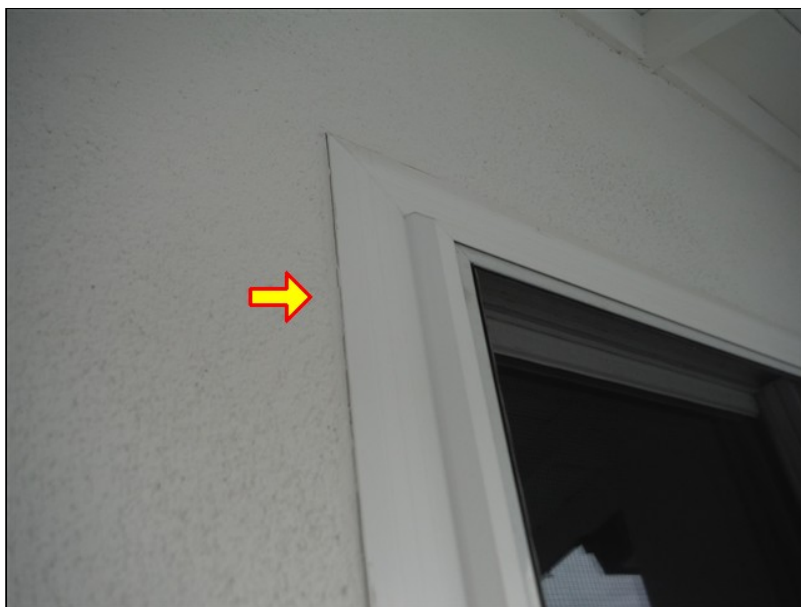
(1) Damaged/ deteriorated sealant noted at several of the retrofit windows. We recommend resealing the top and sides of these windows by a qualified person to prevent moisture intrusion.

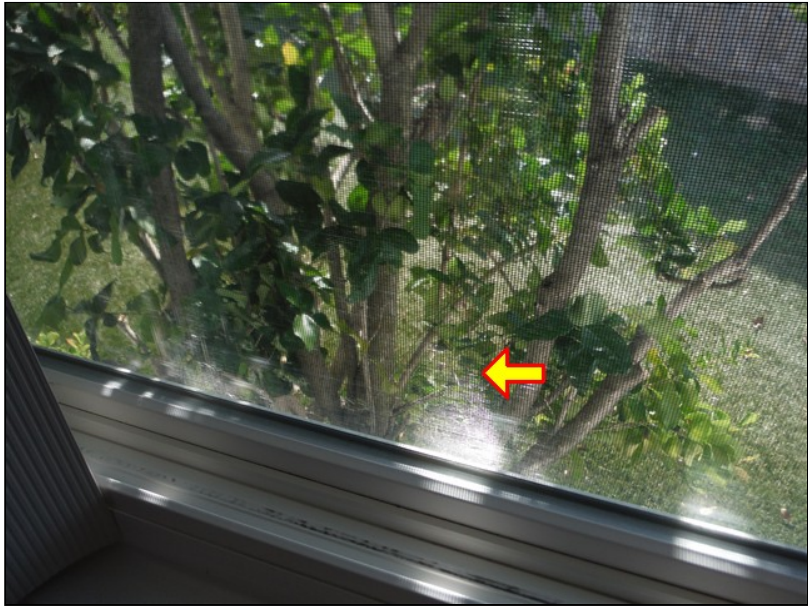
2.6 Item 4(Picture)

(2) There are several damaged window screens throughout the house. We recommend repair or replace as needed by a qualified person.

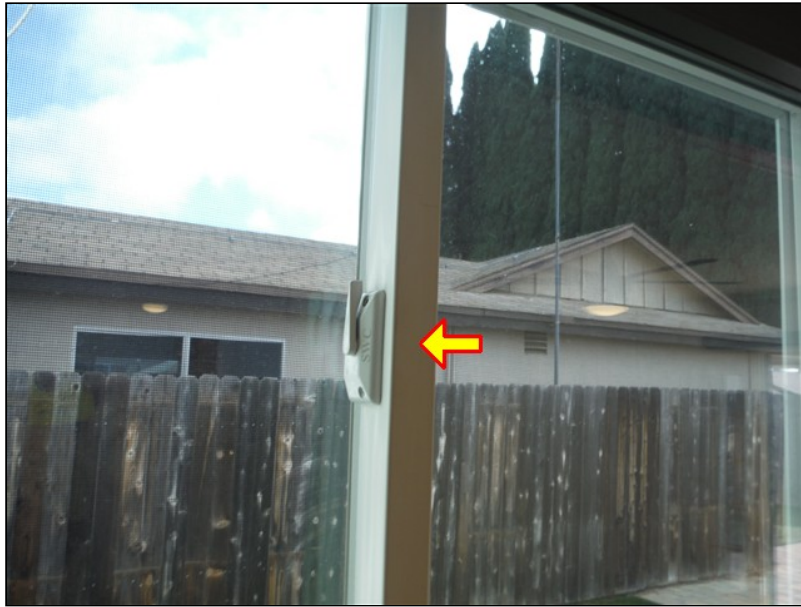
2.6 Item 5(Picture)

(3) A window latch was found to be difficult to operate. We recommend necessary repair or replacement by a qualified licensed window contractor.

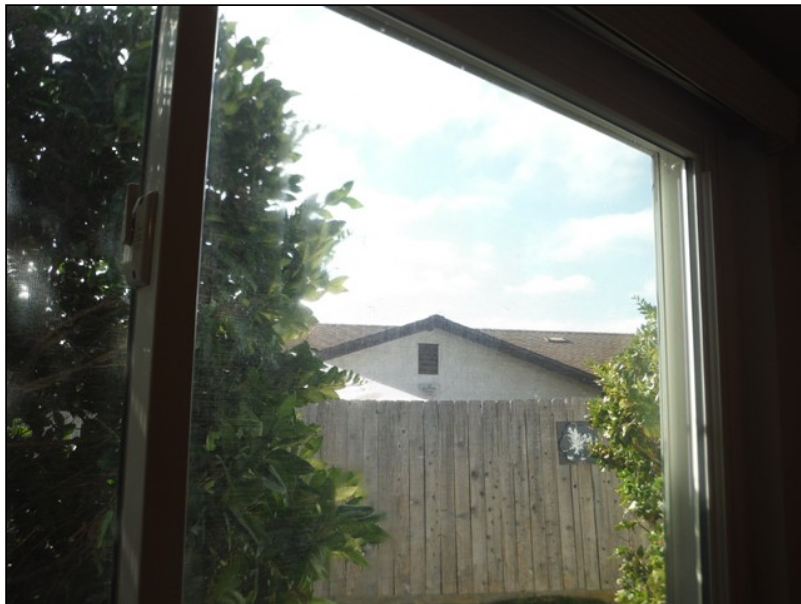
2.6 Item 6(Picture)

(4) Condensation was observed between the panes of glass at one or more window(s). This occurs when the seal has failed between the panes of glass, and ambient air has entered the assembly. Replacement of the glass is required. Since some failed windows may not be easily found due to changing ambient conditions (heat, humidity, etc). We recommend having all of the windows reviewed by a licensed window contractor to determine how many windows require repair/replacement. We recommend repairing or replacing all windows that have failed window seals by a qualified licensed window contractor.

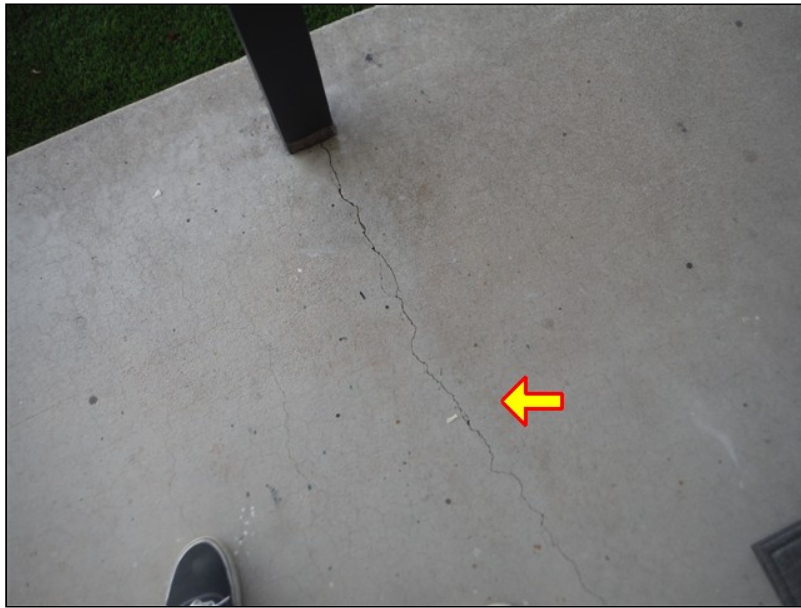
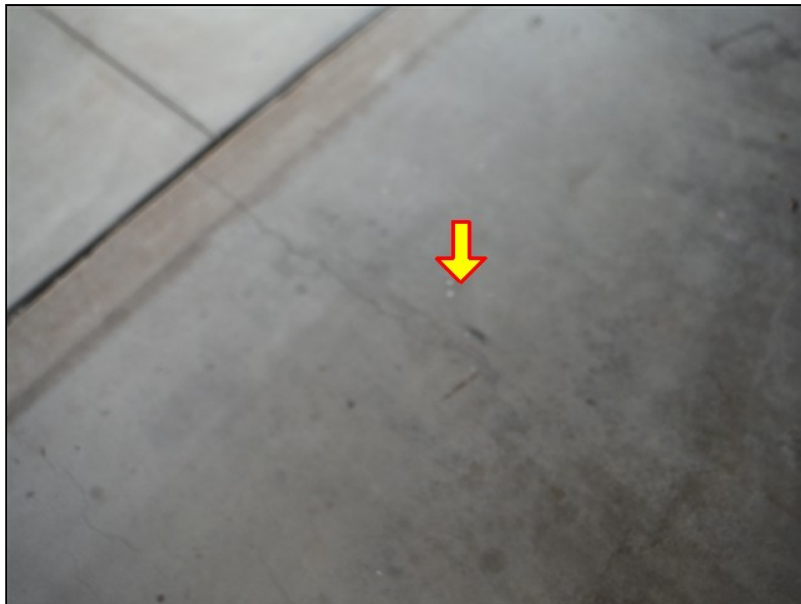
(1) Several stress and/ or settling cracks observed in the concrete driveway, walkways and rear patio. This may indicate that soil movement is occurring, there may be root encroachment, or the concrete was installed without proper re-enforcement. These areas may deteriorate further. We recommend repairs as needed using a qualified licensed contractor.

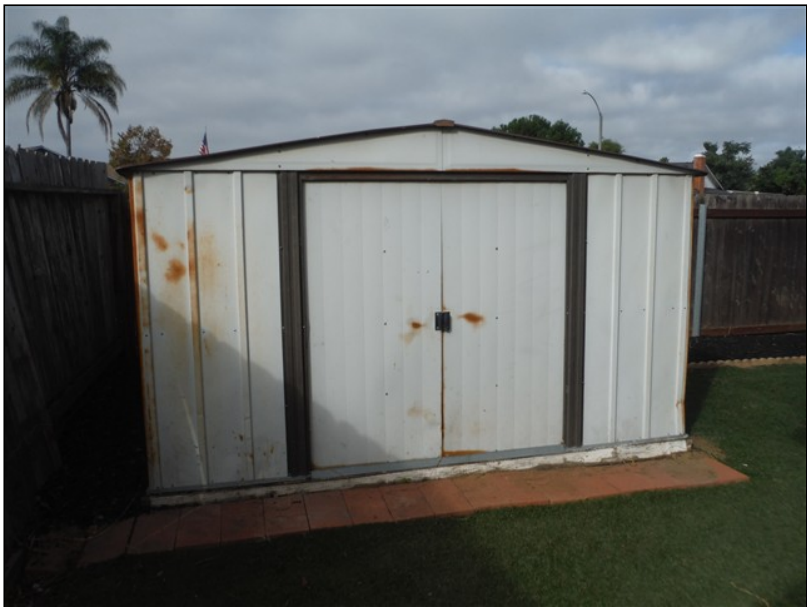
2.12 Item 1(Picture)

Our company makes no representation to the condition of these structures or building (s). We do recommend that any and all additional buildings on the property be inspected prior to the end of your contingency period.

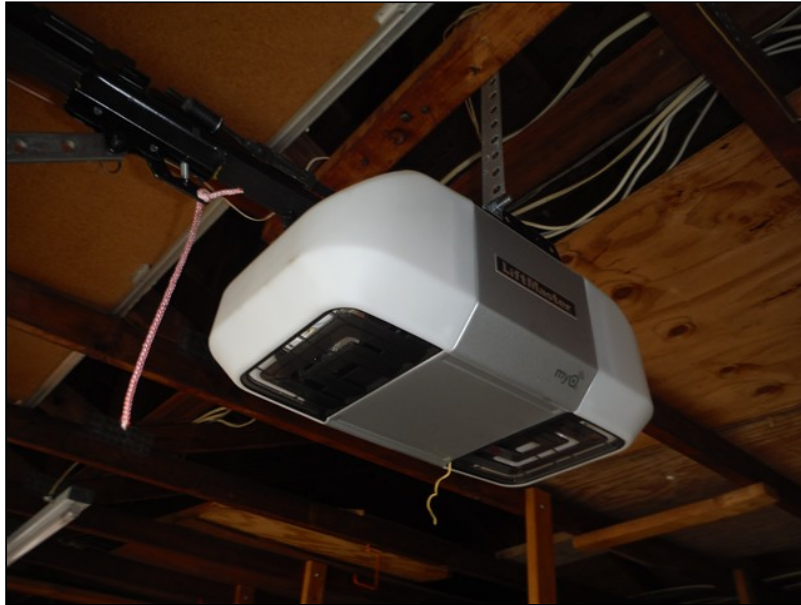
3.1 Item 1(Picture)

(1) One or more of the lights did not work when the garage door opener was tested. The lights built in the garage door opener are a safety device. We recommend replacing the bulbs and testing again. If the bulbs fail to light we recommend necessary repairs or replacement by a qualified licensed garage door contractor.

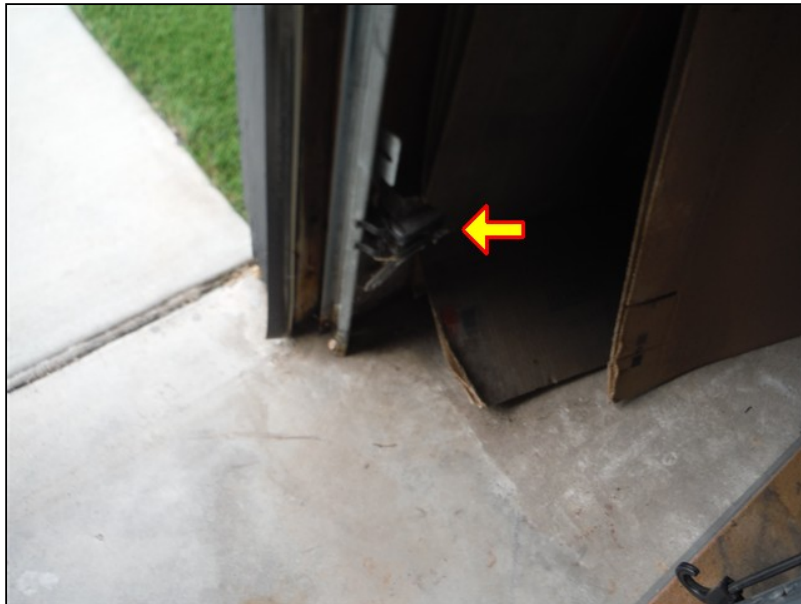
3.1 Item 2(Picture)

(2) The safety reverse photo-eye is mounted at an incorrect height from the ground. Most manufacturers recommend mounting these devices at about 4"-6" from the ground for safety. We recommend necessary corrections by a qualified licensed garage door contractor.

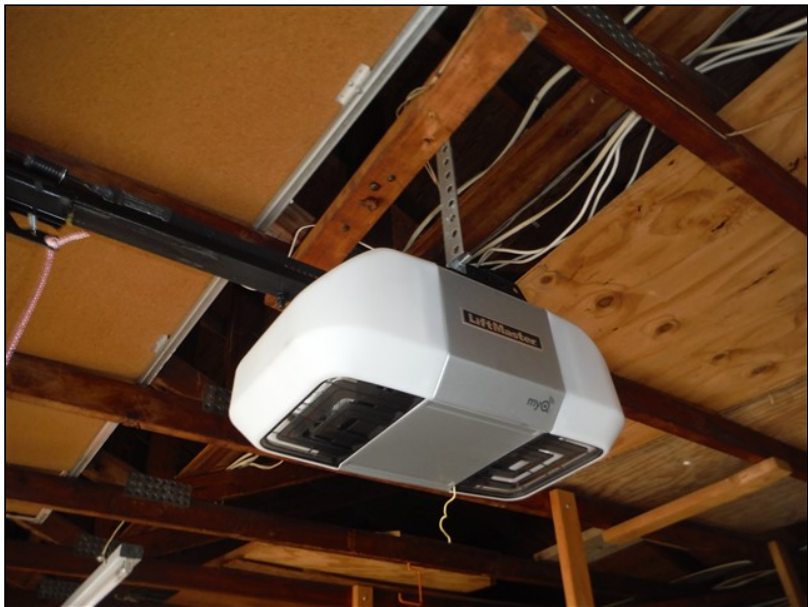
3.1 Item 3(Picture)

(3) The garage door opener was tested and will reverse when met with resistance.

Note: Photo eye sensors are in place and will reverse the garage door.

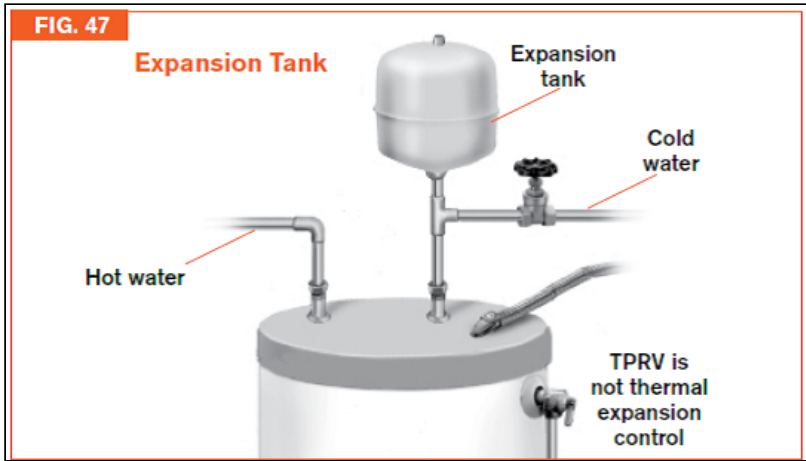
4.0 Item 1(Picture)

(1) The water heater does not have a "Thermal Expansion Tank" installed to prevent a possible leak at the T&P or "pop-off" valve. Recent changes in code require one when a new water heater is installed. This change is not retroactive on older previously installed Gas/LP water heaters. In addition, this requirement is subject to your local municipal code. There were no leaks or drips at the T&P valve during inspection. If your water heater does begin to drip or leak, then a thermal expansion tank may be needed. We recommend installing a thermal tank by a qualified licensed plumber as an upgrade.

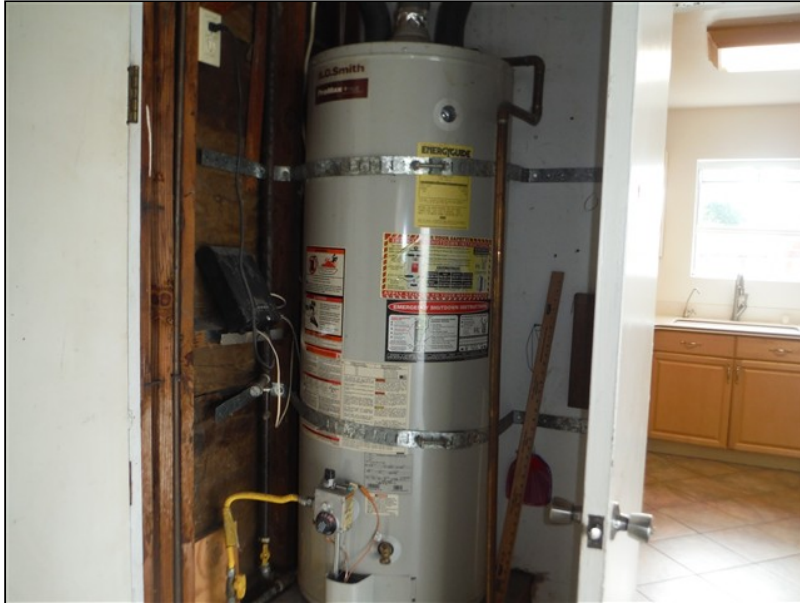
4.0 Item 2(Picture)

(2) The water heater is an older unit/ 10 plus years, and repairs or even failure can be expected. Based on manufacture's statistics the average life of a water heater is 7-10 years. We recommend replacing the water heater by a qualified licensed plumber.

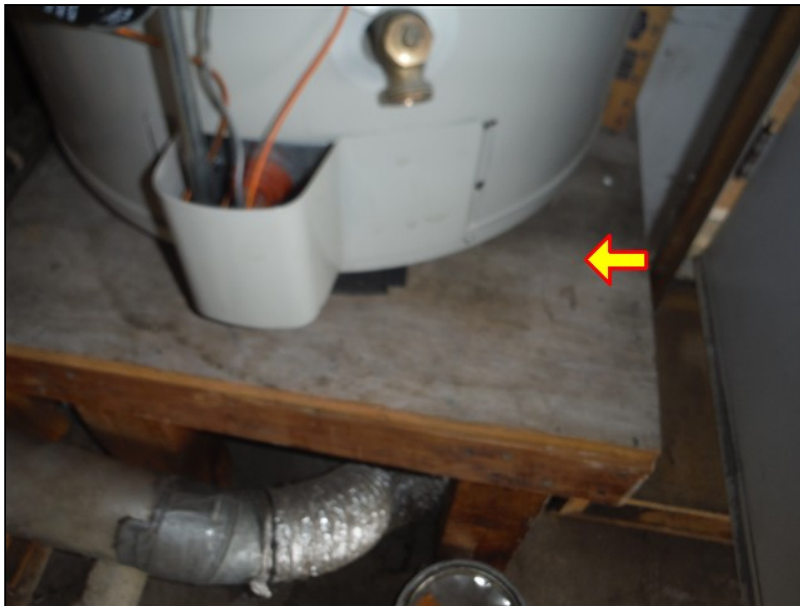
4.0 Item 3(Picture)

(3) A leak pan is not installed under the water heater. We recommend installing a leak pan under the water heater by a qualified licensed plumber.

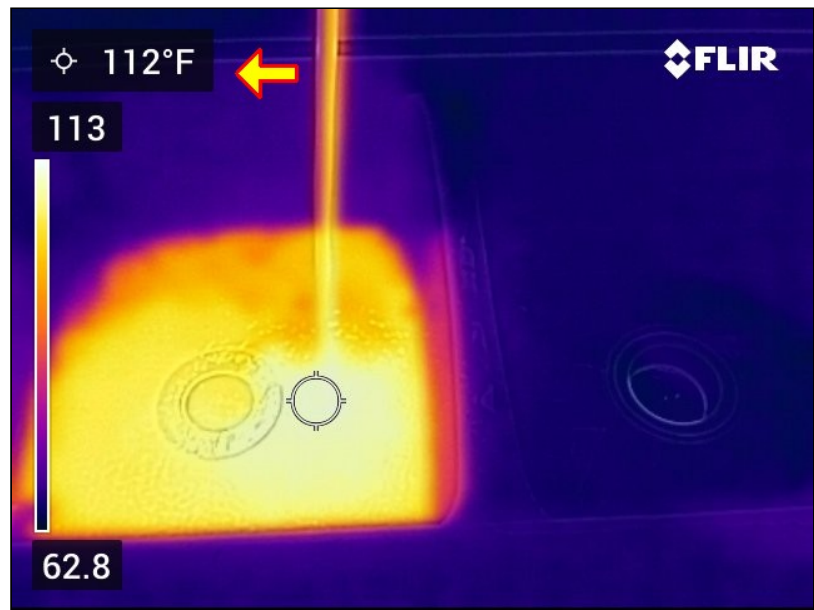
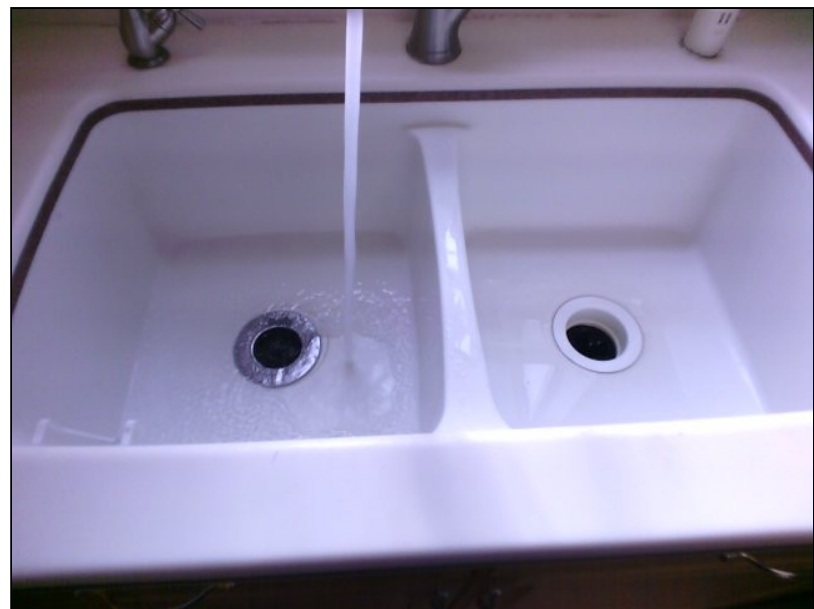
(4) The water heater was inspected and was found to be operational at the time of the inspection. We did not evaluate the efficiency or recover rate of the water heater which is beyond the scope of a general home inspection. If concerned we recommend you consult a qualified licensed plumber. We recommend flushing the water heater routinely as regular maintenance.

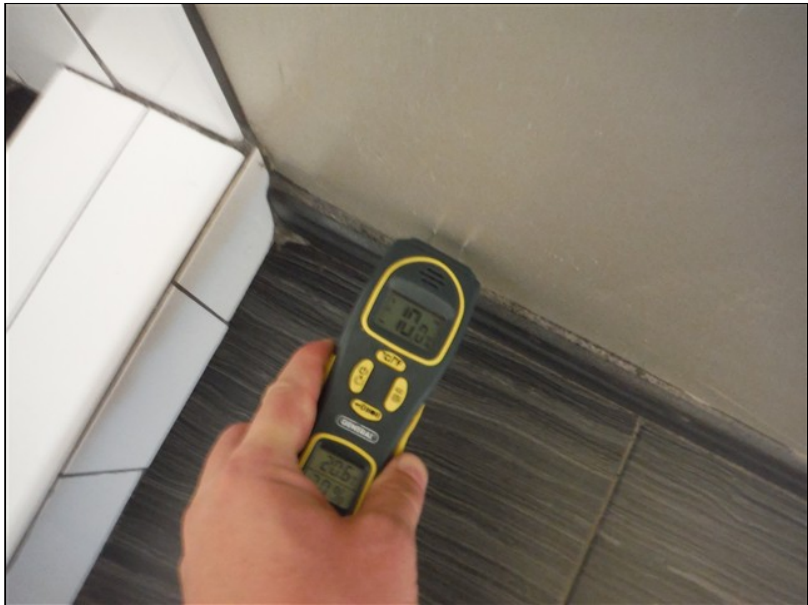
5.0 Item 1(Picture)

(1) A representative sampling for moisture was preformed at accessible interior walls using a moisture meter. (*areas prone to moisture, such as kitchens, bathrooms, below grade walls, exterior walls with doors/windows*). An elevated moisture was not detected at the time of the inspection.

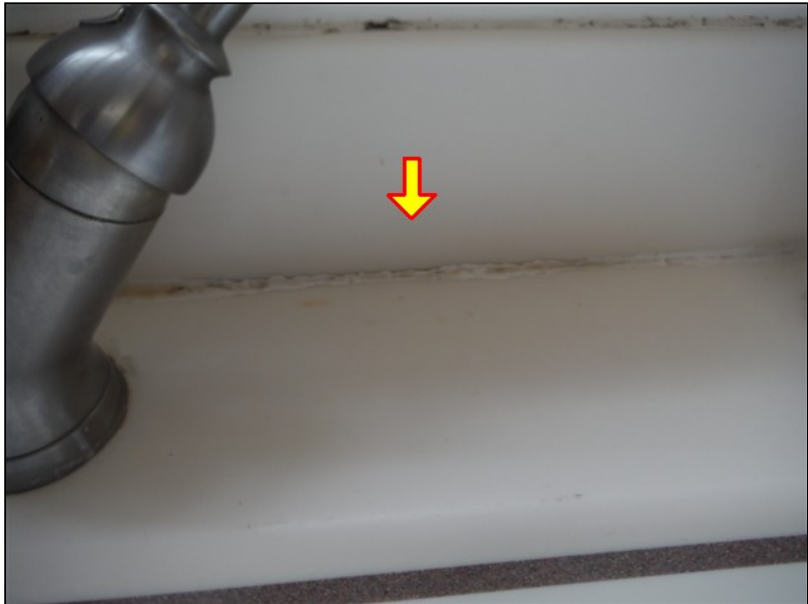
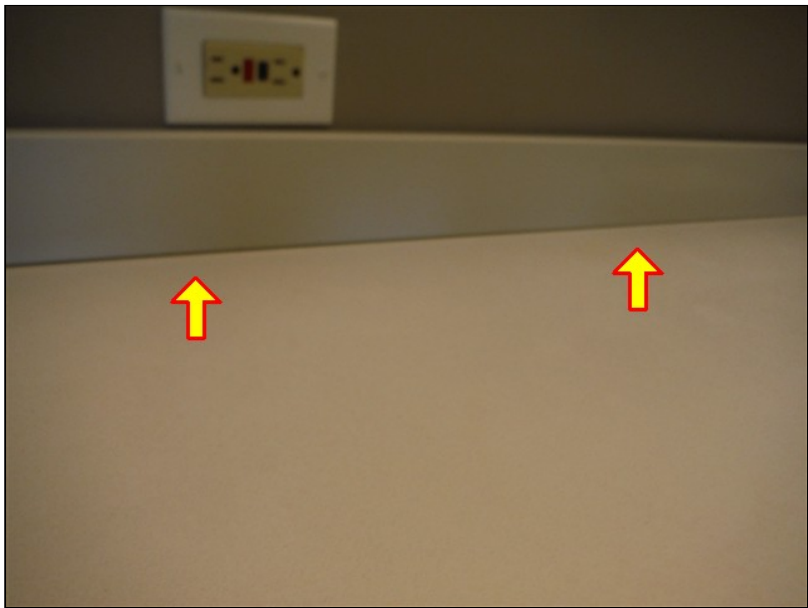
(1) Recommend resealing the counters and backsplash at the bathrooms and kitchen locations to prevent moisture intrusion.

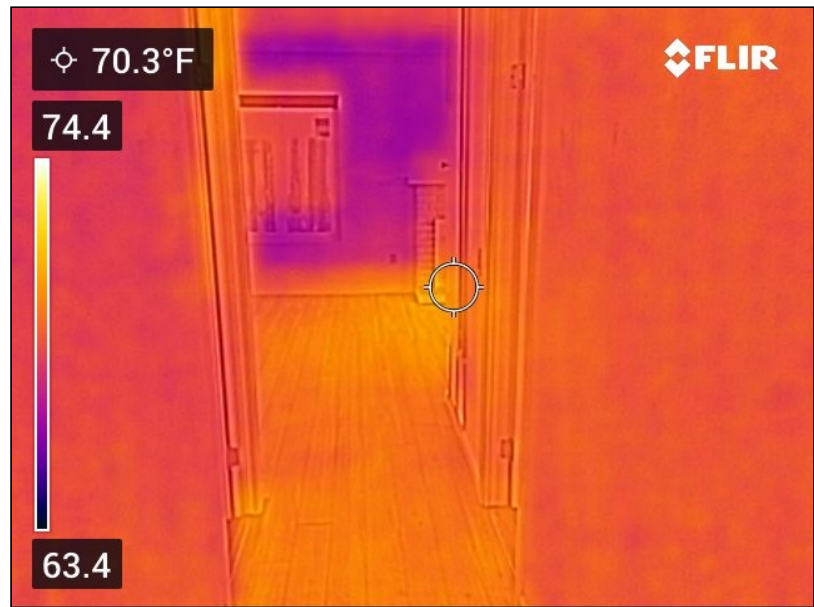
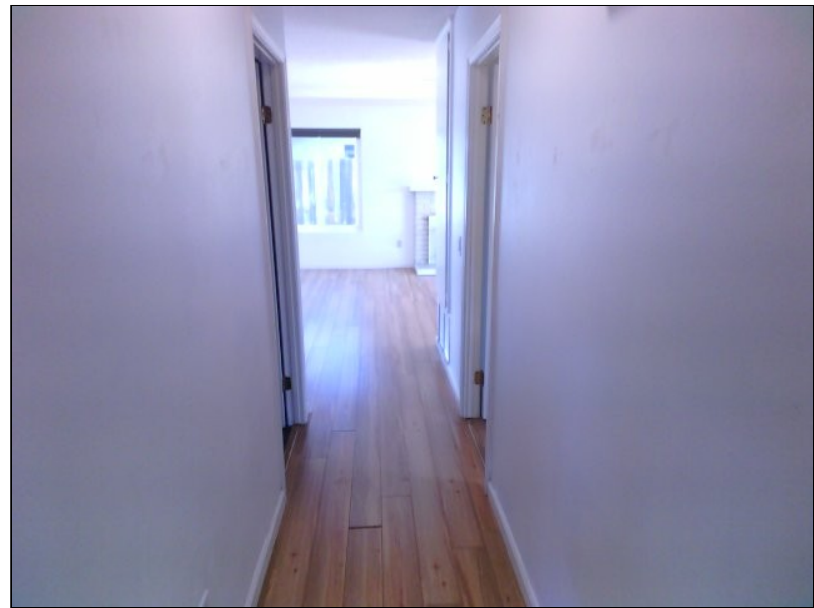
An infrared (thermal imaging) scan was performed throughout the house and garage at the time of the inspection using a hand held infrared (thermal imaging) inspection camera. No anomalies were found at the time of the inspection using this camera.

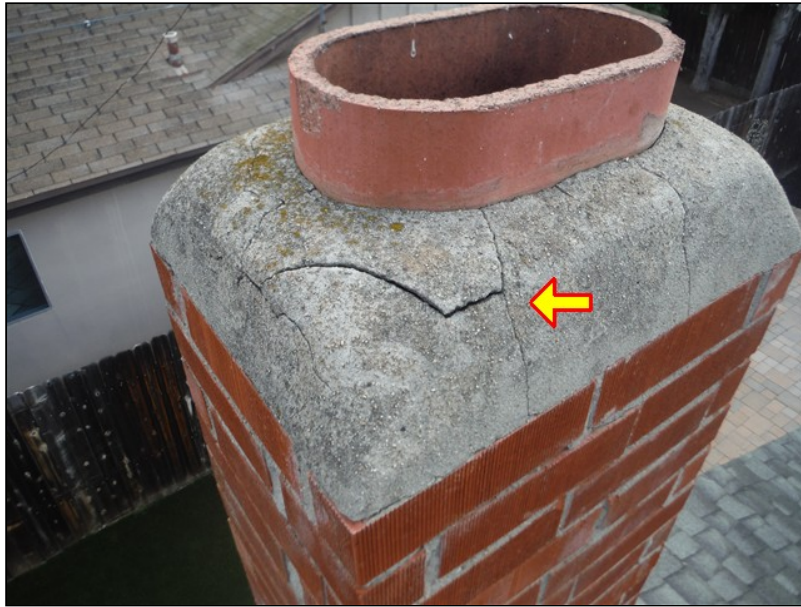
6.0 Item 3(Picture)

help prevent moisture intrusion and further deterioration by a qualified licensed chimney contractor.

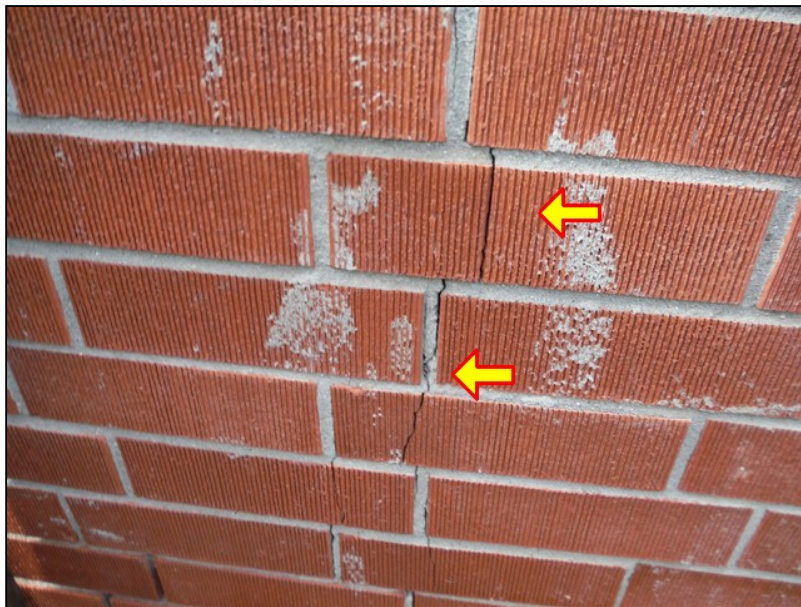
6.0 Item 4(Picture)

(3) Cracks are observed in the bricks of the chimney. The cracks do not appear to extend through the chimney, but are present in the bricks. To help prevent further cracking or water intrusion, the cracks should be repaired/ sealed. We recommend necessary repairs by a licensed chimney contractor.

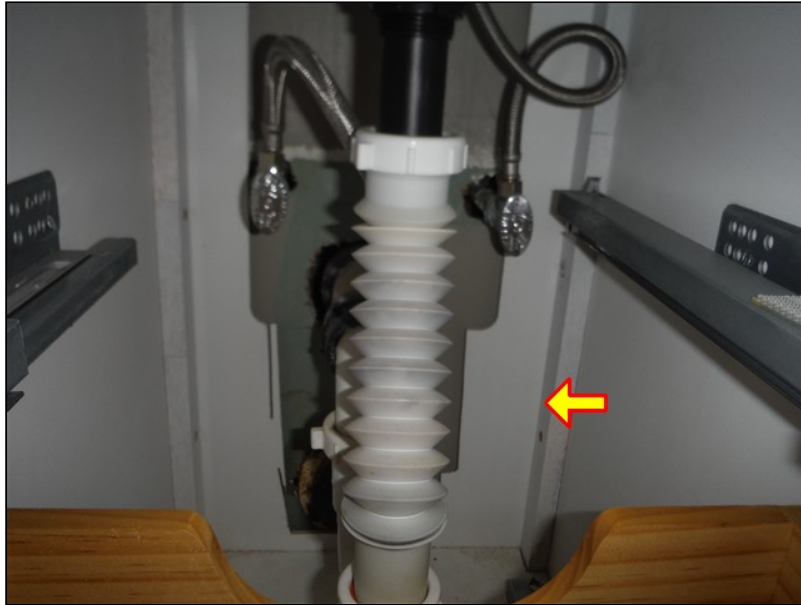
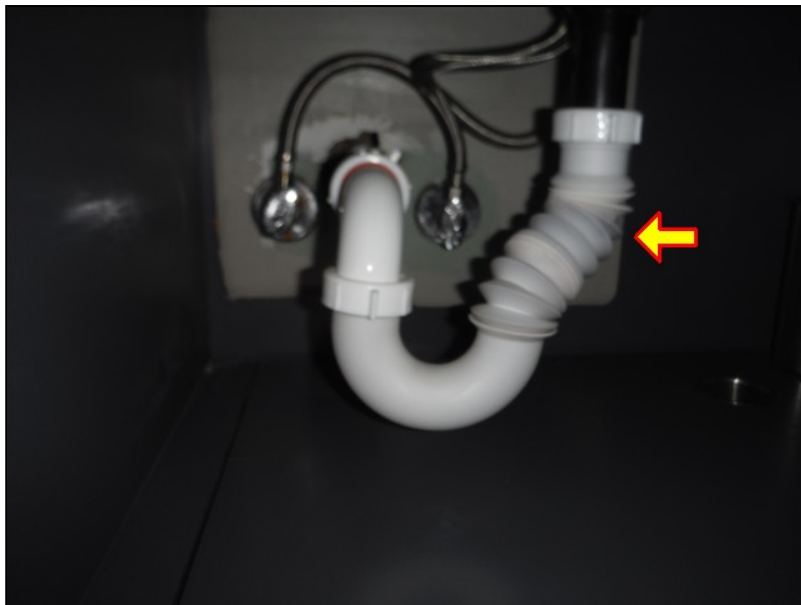
(1) A corrugated (flexible) waste pipe is installed at several sinks. This is a non standard installation because this type of material may hold bacteria and is more likely to become clogged. We recommend replacing these corrugated (flexible) waste pipe by a qualified licensed plumber.

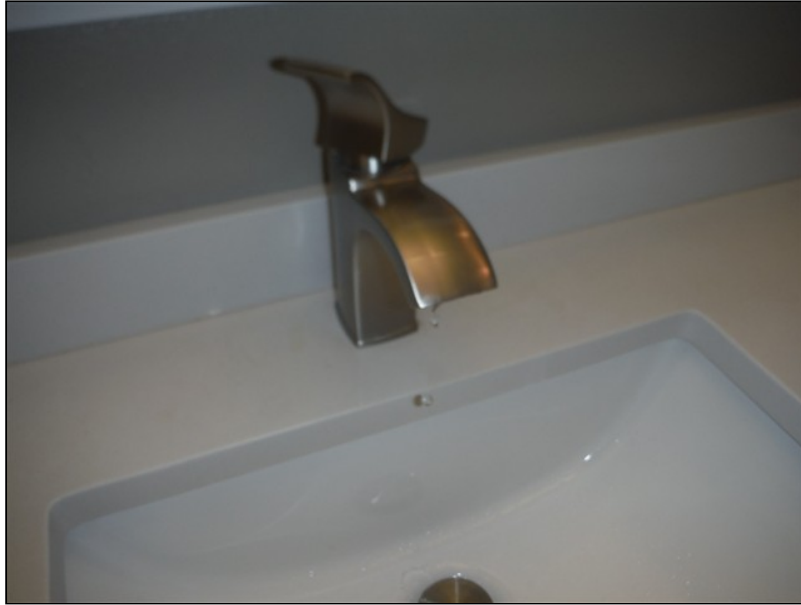
8.1 Item 1(Picture)

(1) There was no water flow at hot water at the hall bathroom when tested. This is non standard. We recommend further evaluation by a qualified licensed plumber prior to the end of your contingency period and necessary repairs made as needed.

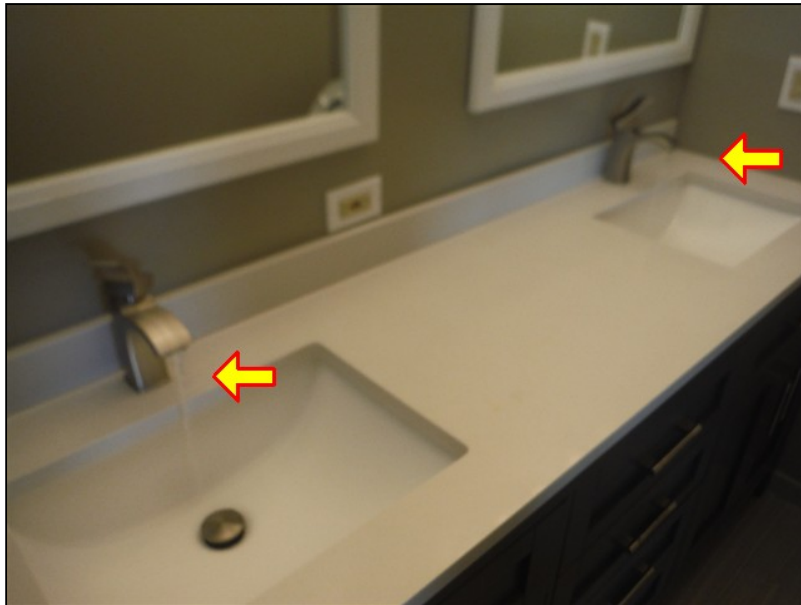
8.1 Item 2(Picture)

(2) Water pressure was observed to be reduced when multiple faucets where operated at the same time. We recommend further evaluation by a qualified licensed plumber and necessary repairs made.

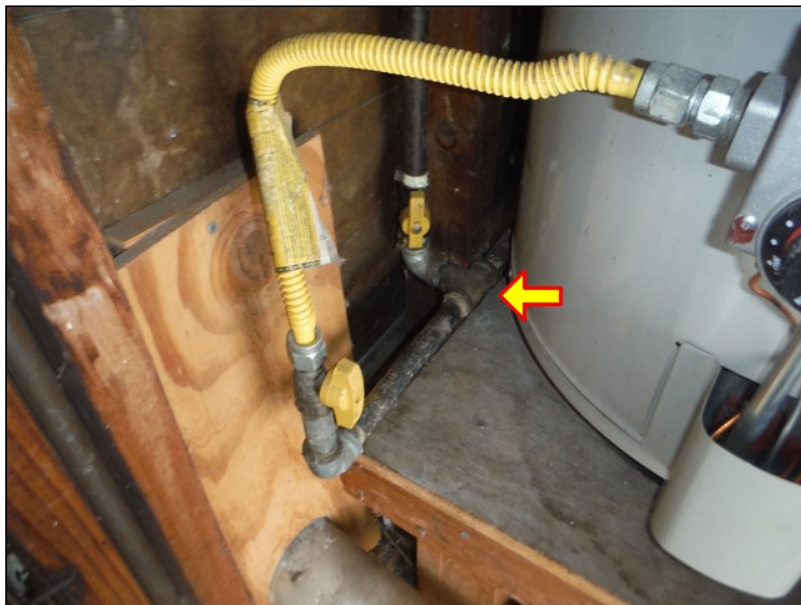
8.7 Item 1(Picture)

(1) A 1/2" diameter gas pipe appears to feed more than one gas appliance. This is non-standard. Current standards require a 3/4" or larger gas pipe when servicing multiple gas appliances. We recommend further evaluation by a licensed plumber and necessary corrections as needed.

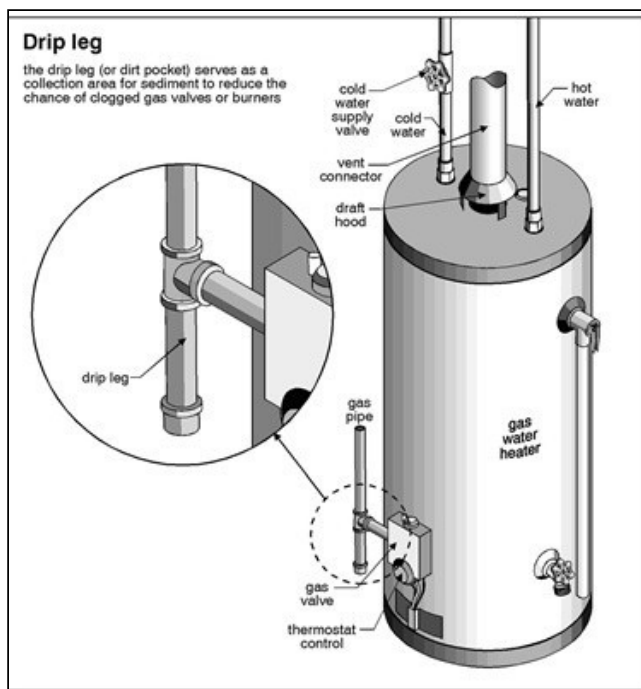
8.7 Item 2(Picture)

(2) The gas supply pipe at the water heater did not contain a drip leg/ sediment trap. This may have been standard at the time of installation but now is highly recommended. The purpose of a drip leg is to prevent sediment/ debris from entering and clogging the water heater gas valve which could cause the water heater to shut down. We recommend having a drip leg installed by a qualified licensed plumber.

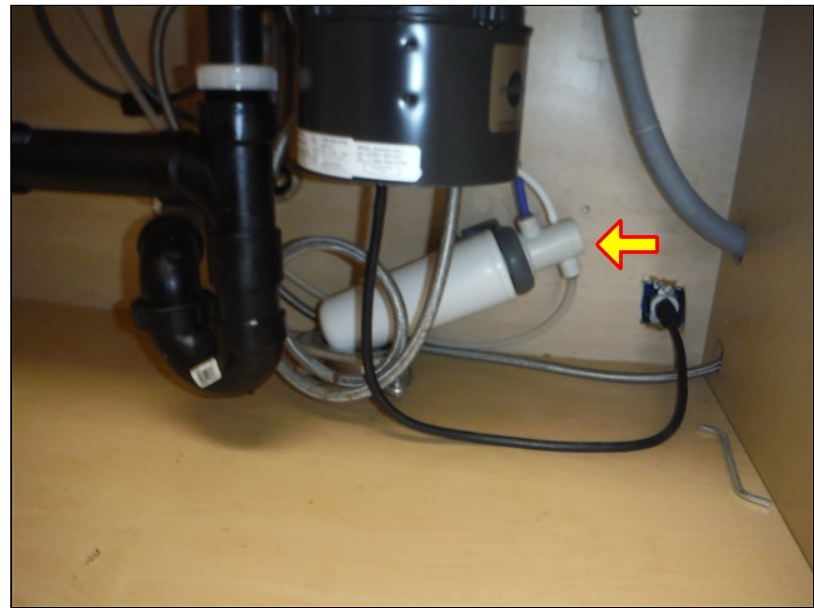
8.8 Item 1(Picture)

**Findings**  
There is a water filter installed which we did not inspect. Water filters are out of the scope of a general home inspection. We recommend further evaluation by a qualified person if concerned.

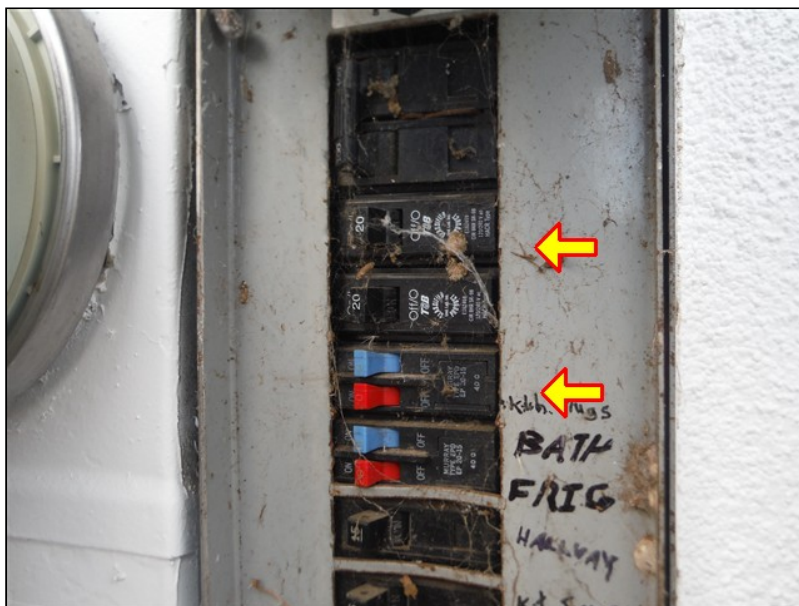
9.2 Item 1(Picture)

(1) Breakers were observed in the main panel which are from a manufacturer that is different than the panel manufacture. Most panel manufacturers require like-kind breakers to be installed from the same manufacture. Having breakers from another manufacturer could void the UL listing. We recommend further evaluation by a qualified licensed electrician and necessary corrections as needed.

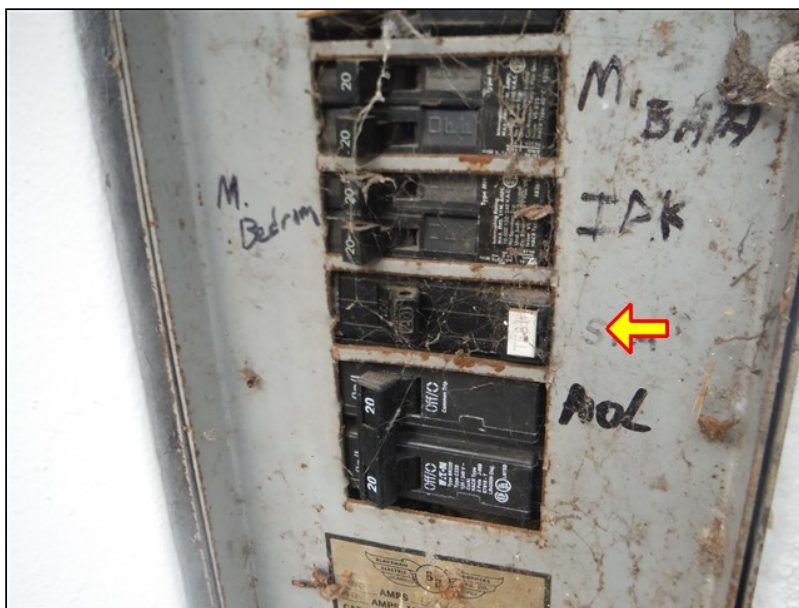
9.2 Item 2(Picture)

(2) One or more circuit breakers in the main panel were off at the time of the inspection. Home inspectors do not turn on, operate or re set circuit breakers. Circuit breakers that are off could indicate a failure of that circuit or other problems. Turning on or re setting circuit breakers that are off can be a safety hazard. We recommend asking the seller or further evaluation by a qualified seller licensed electrician to determine why the breakers have been turned off.

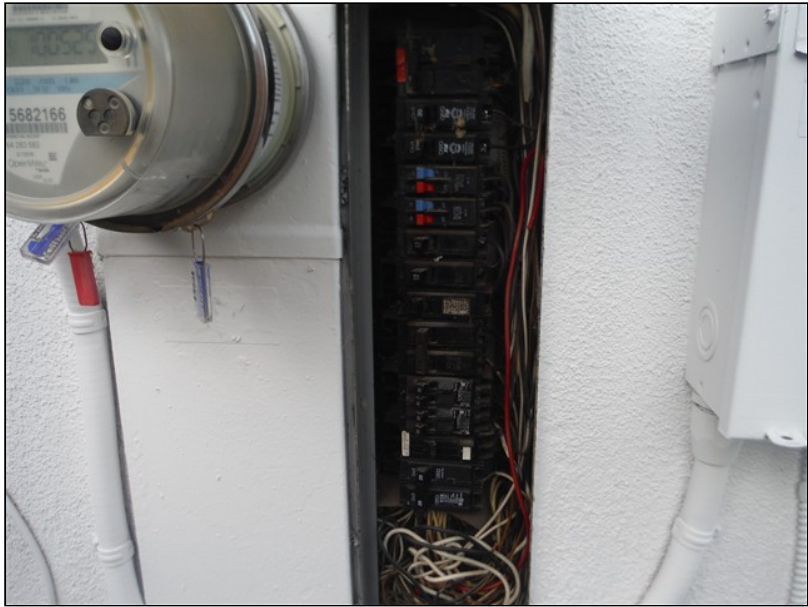
9.2 Item 3(Picture)

(3) Picture inside of the main electrical panel. The dead front cover was removed at the

time of the inspection and the breakers, wiring and grounding were inspected. Appears to be functioning as intended.

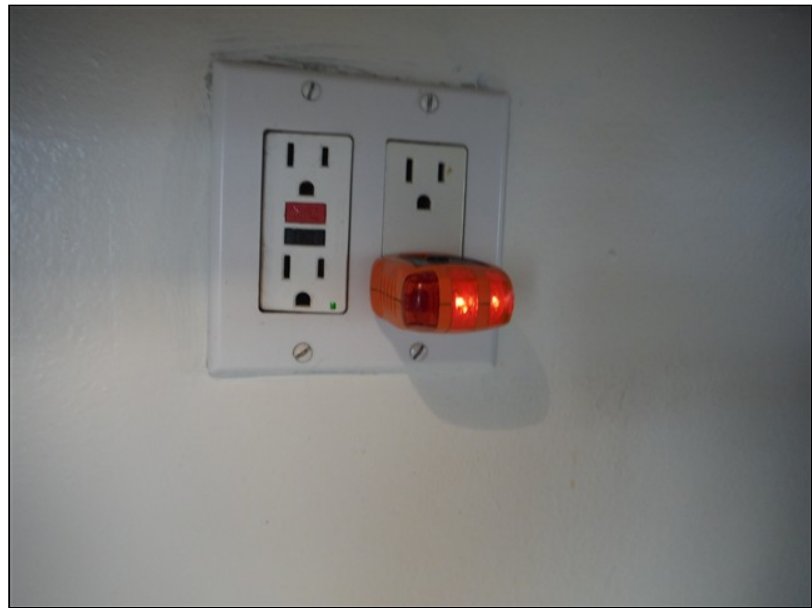
9.5 Item 1(Picture)

A representative number of receptacles throughout the house and garage were tested for power, polarity and grounding according to our standards-of-practice. These receptacles observed to be ok at the time of the inspection unless otherwise noted.

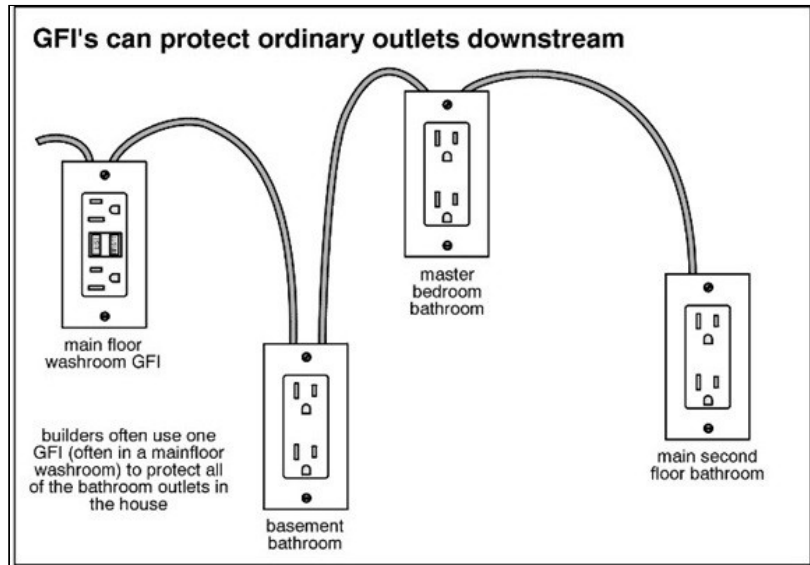
9.6 Item 1(Picture)

All accessible GFCI receptacles were tested and were functioning properly at the time of the inspection unless otherwise reported. Sometimes a tripped GFCI receptacle may be difficult to find. If you do not have power at certain receptacles please check all GFCI's and reset the tripped GFCI receptacle. If the GFCI doesn't reset than replacement of the GFCI receptacle will be required.

Note: We recommend upgrading all receptacles within 6 feet of any plumbing fixtures, outside/ exterior, in the garage, and any non fixed appliance receptacles in the kitchen to GFCI protected receptacles by a qualified licensed electrician for safety.
