## Inspection Report

**Dong & Justina Nguyen**

840 Paula St  
Escondido CA 92027

**All Pro Property Inspection**

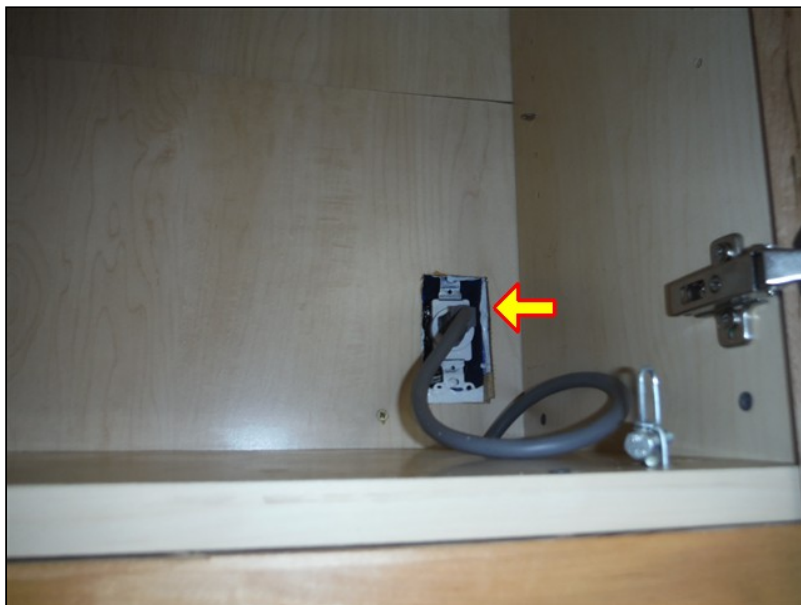
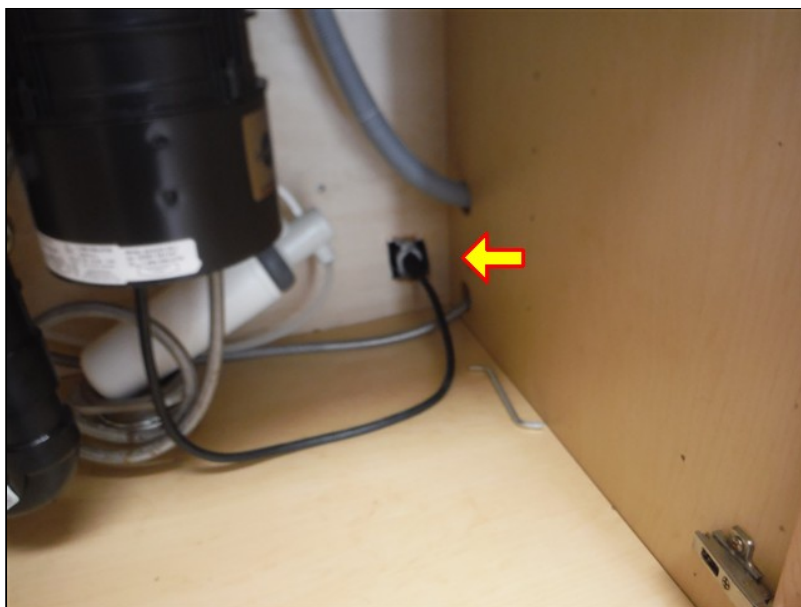
(1) There are several receptacle covers missing at several areas. This is non standard and a potential shock hazard. We recommend installing receptacle plates by a qualified person where needed for safety.

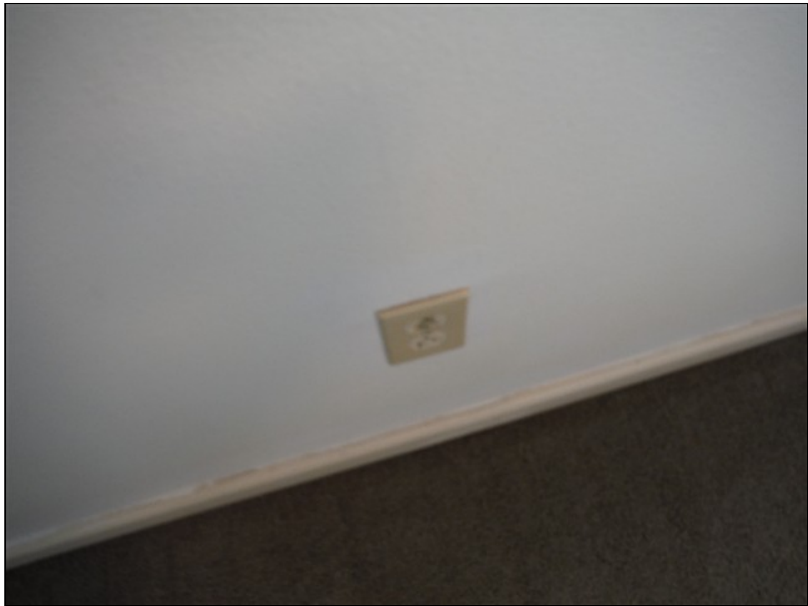
9.8 Item 4(Picture)

(2) Several junction boxes are loose in the wall. This condition could put stress on the conductors which can lead to loose connections. We recommend having these junction boxes secured by a qualified person.

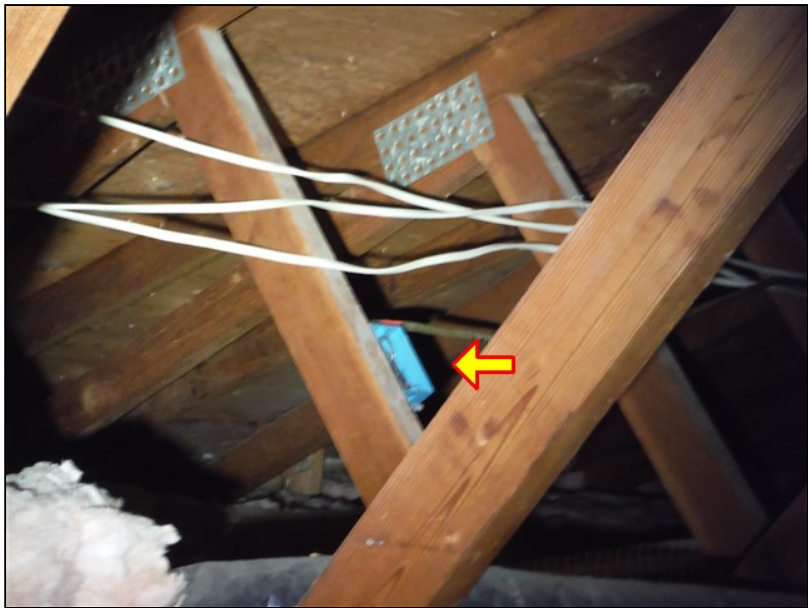
9.8 Item 6(Picture)

(4) An open junction box is observed in the attic. All electrical splices must be enclosed in a junction box. We recommend necessary repairs by a qualified person for safety.

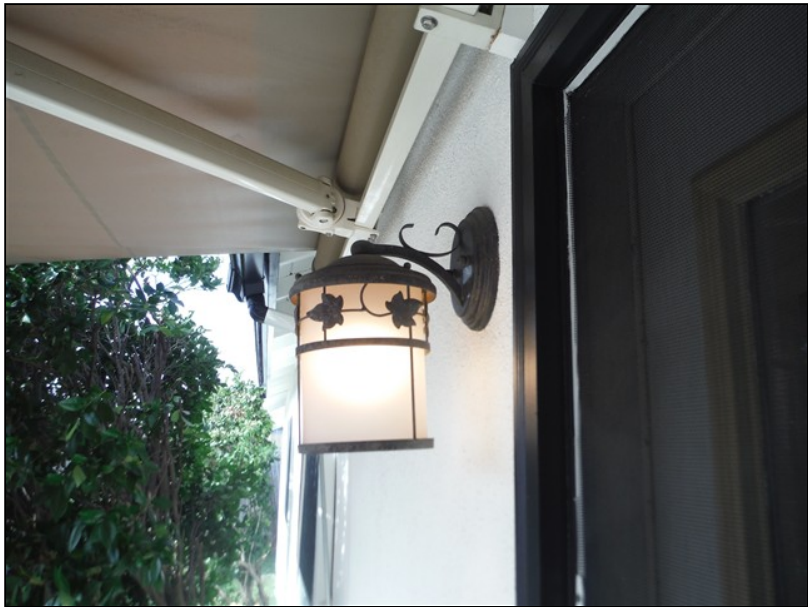
9.9 Item 1(Picture)

A representative number of exterior lights were tested and were found to be functional at the time of the inspection.

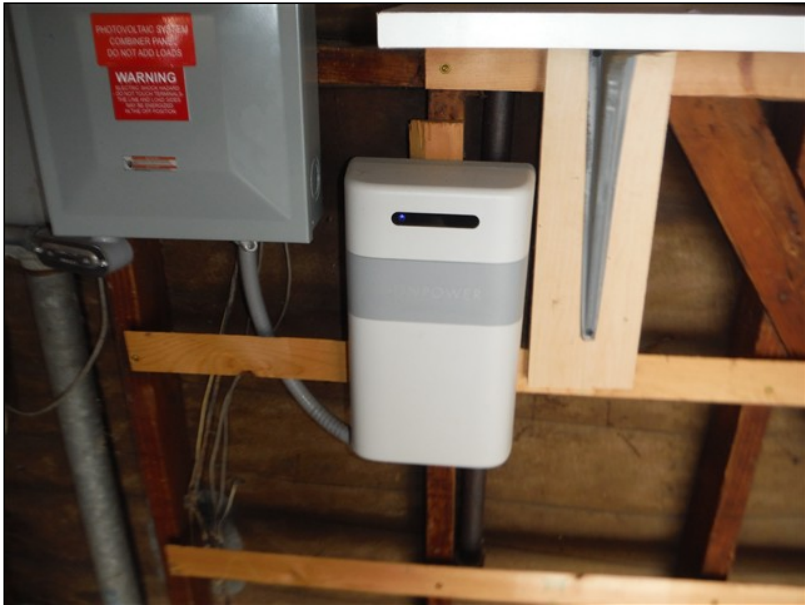
9.10 Item 1(Picture)

The electric solar system is beyond the scope of the home inspection and was not inspected. We recommend verifying that the electric solar system is operational prior to the end of your contingency period.

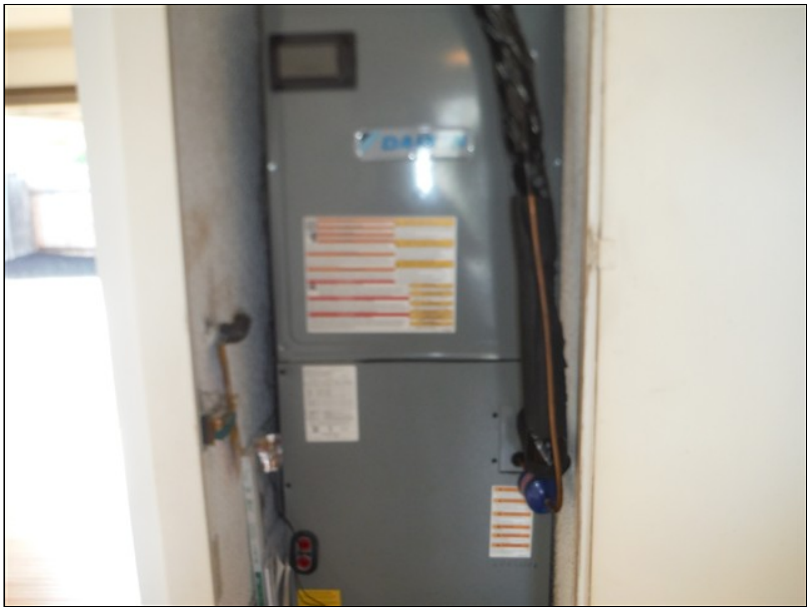
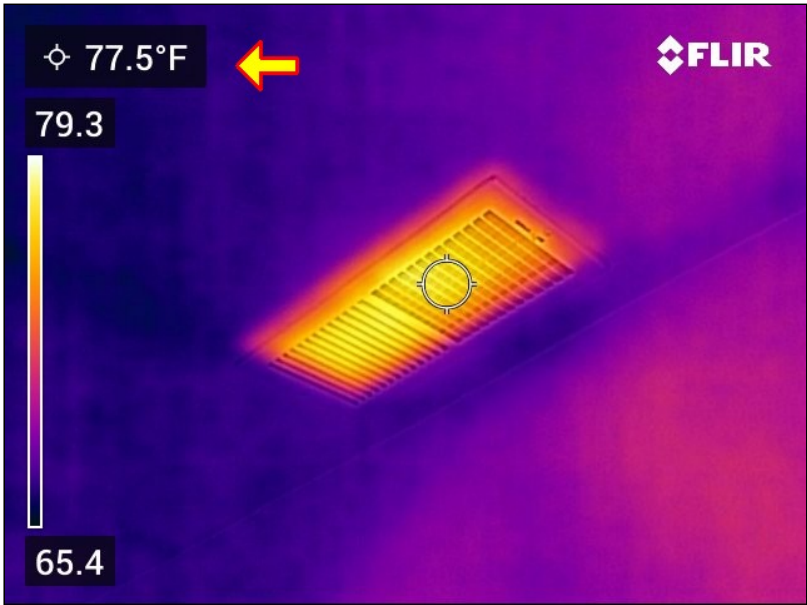
**Findings**  
The heat pump was tested and was functional/ operated in the heat mode at the time of the inspection. This is not original and documentation should be provided that this unit was installed per manufacturers specifications by a licensed HVAC contractor, if the buyer is concerned.

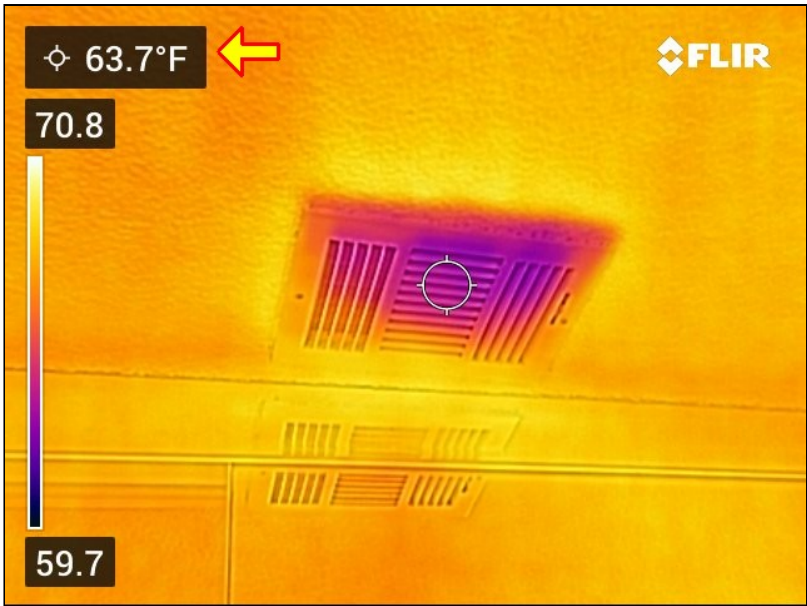
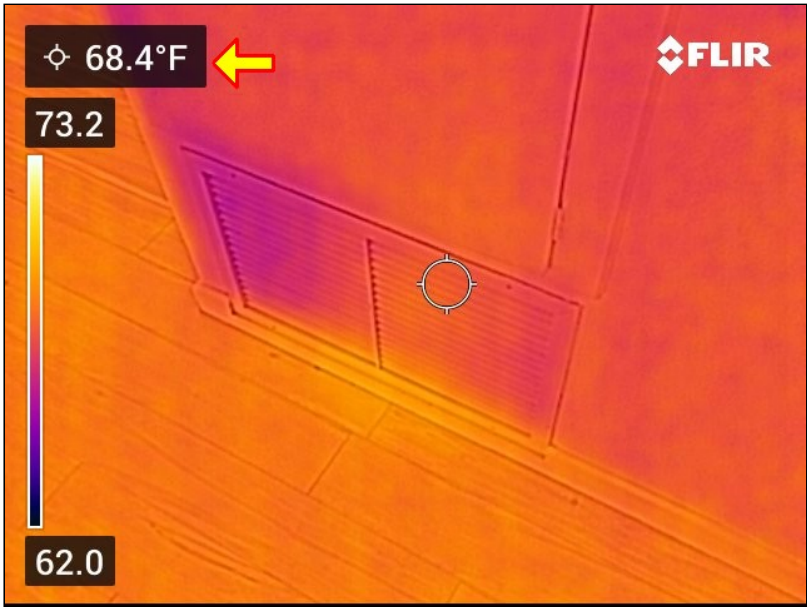
The air conditioner did operate but failed to produce an adequate amount of cold air. The temperature drop measured from the supply air and return air was under the minimum requirement of 14 degrees, which indicates that this system is not cooling as intended. We recommend a qualified licensed HVAC inspect and repair as needed prior to the end of your contingency period.

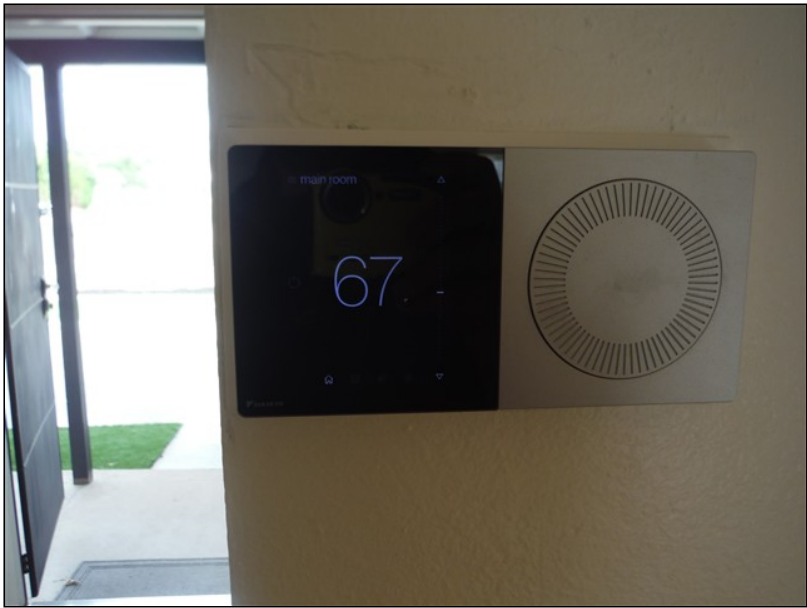
10.2 Item 1(Picture)

The thermostat was operational when used to operate the HVAC system at the time of the inspection. Programmable thermostats are not adjusted and no testing is done to check the accuracy or programmed settings of the thermostat. If concerned we recommend verifying proper operation of the programmable settings prior to the end of your contingency period by a qualified person.

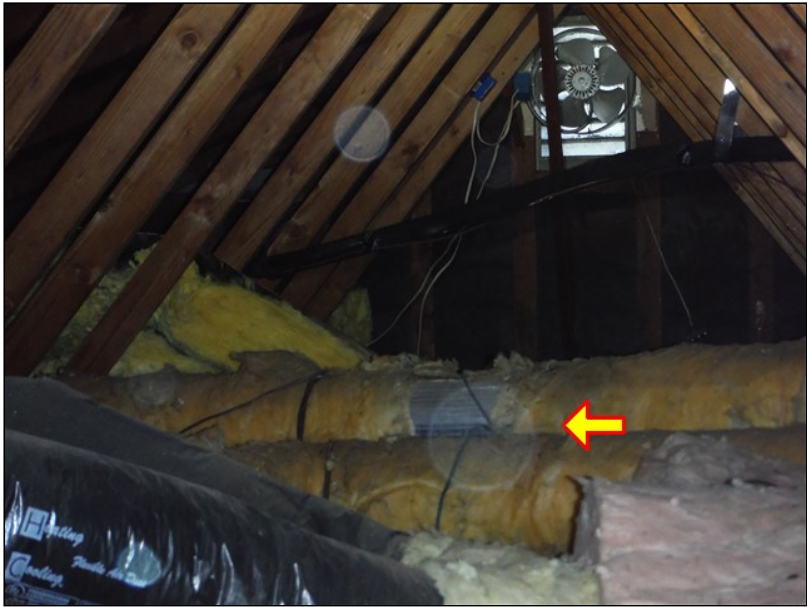
10.3 Item 1(Picture)

The outer insulation covering on several of the air ducts in the attic space missing/ damaged. We recommend repairs or replacing as needed by a qualified licensed HVAC contractor.

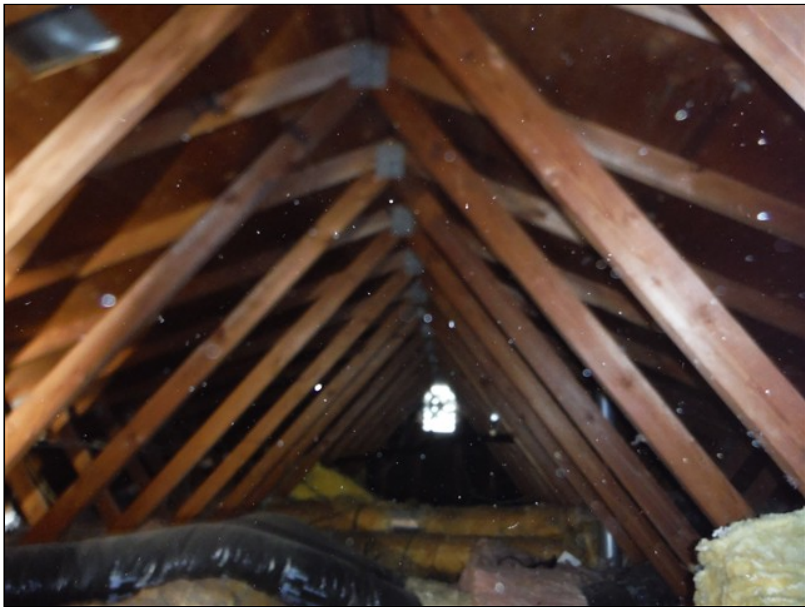
11.1 Item 1(Picture)

**Findings**  
Due to the structure of the roof/ framing and forced air handling components, some areas of the attic space could not be inspected.

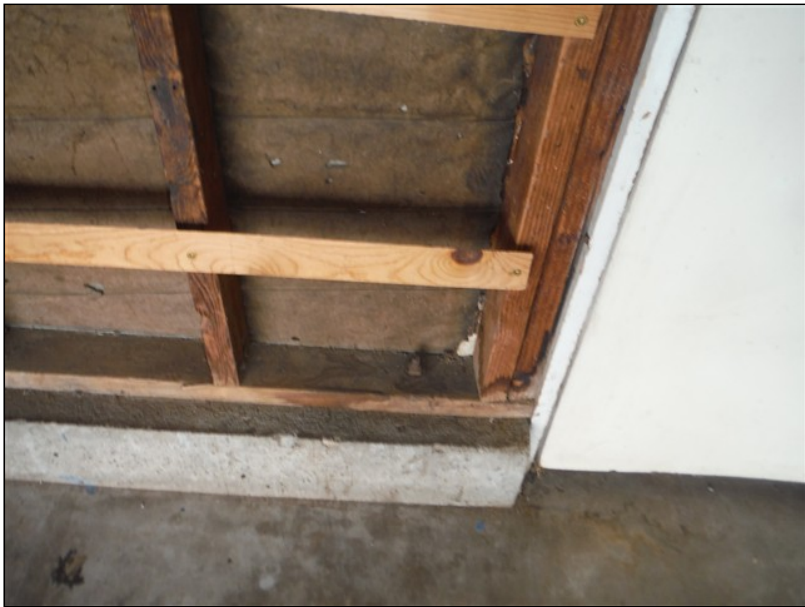
11.4 Item 1(Picture)

**Findings**  
Foundation bolts are visible in the garage.

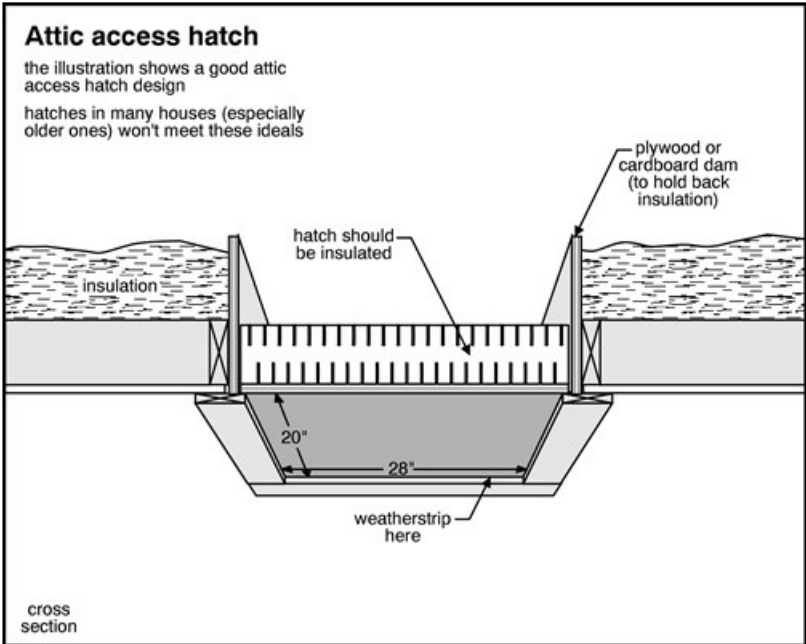
12.0 Item 1(Picture)

(1) The attic space access hatch cover is not insulated. We recommend insulating the attic access hatch cover to reduce unwanted heat loss/gain by a qualified person.

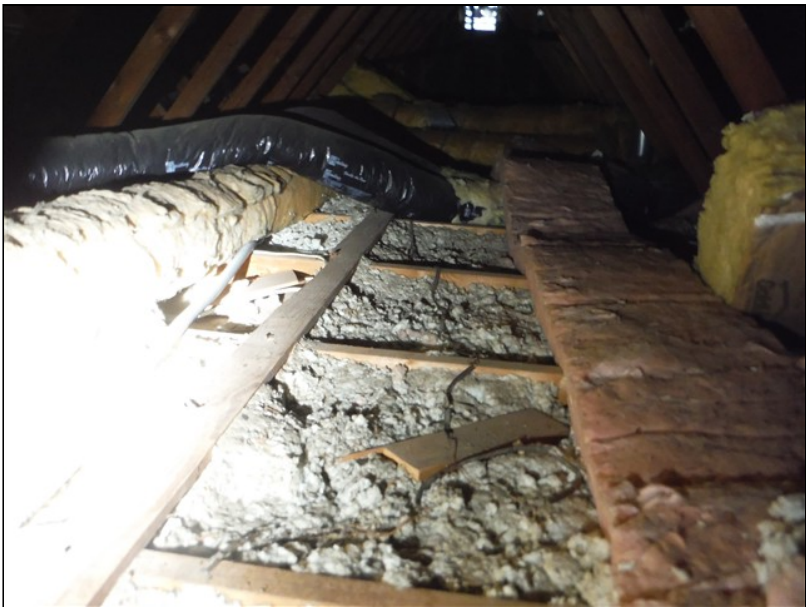
12.0 Item 2(Picture)

(2) View of the insulation in the attic. Appears to be functioning as intended unless otherwise reported.

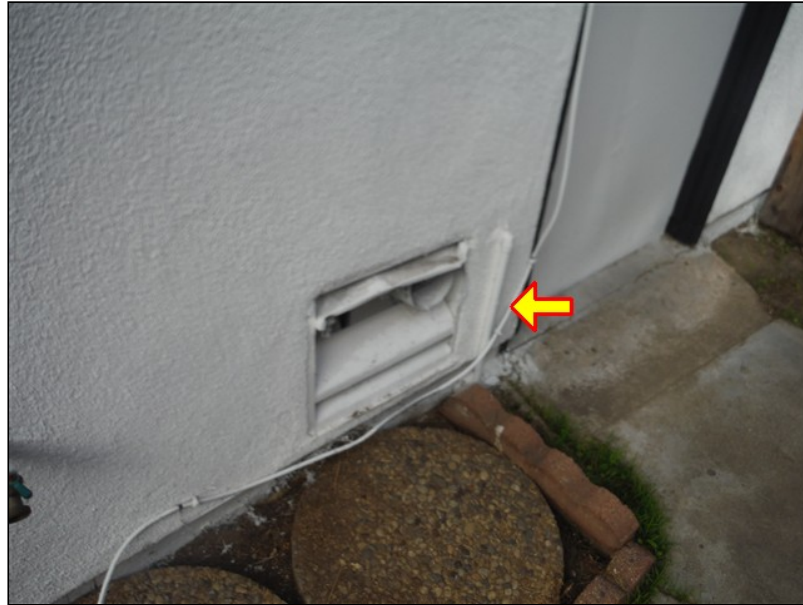
12.1 Item 1(Picture)

(1) The dryer vent duct cap is missing. We recommend replacement.

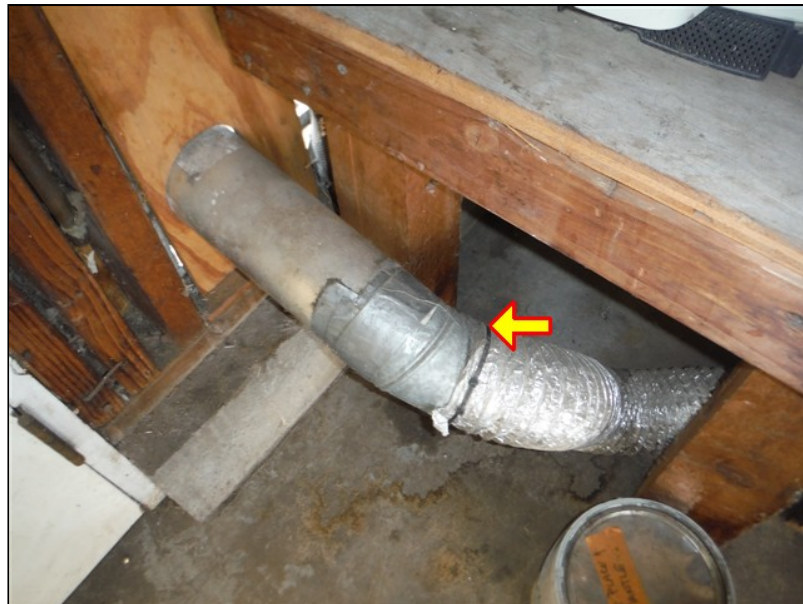
12.1 Item 2(Picture)

(2) The laundry duct fitting is connected with tape. This is non-standard. We recommend properly installing the laundry dryer duct with a spring clamp or hose clamp.

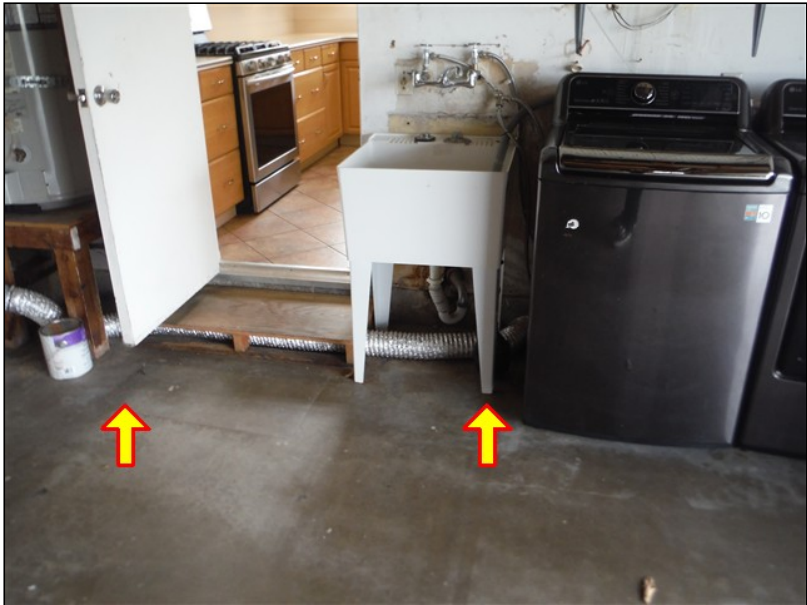
12.1 Item 3(Picture)

(3) Only the first 8' of dryer duct should be the corrugated type. When concealed behind the wall, in crawlspace or attic a rigid metal pipe should be used. Improper installation can be a fire hazard. We recommend necessary corrections by qualified person.

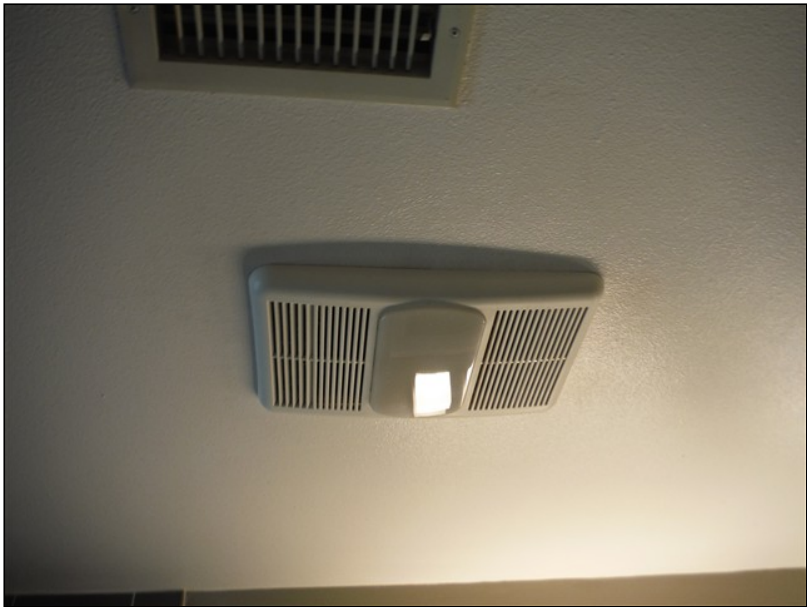
12.2 Item 1(Picture)

(1) The bathroom vent in the primary bathroom did not work when tested. It is important to have a functional vent to remove humid air. We recommend necessary repairs or replacement by a qualified licensed contractor.

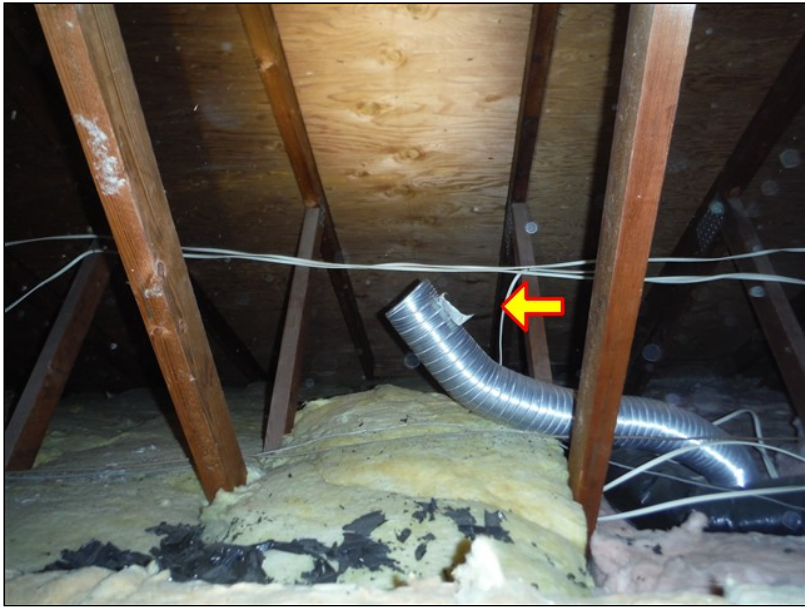
12.2 Item 2(Picture)

(2) The primary bathroom exhaust vent does not terminate to the exterior. This can allow excessive moisture to be introduced into the attic space which can lead to

moisture related issues. We recommend properly ducting the bathroom vent(s) to the exterior of the attic space by a qualified licensed contractor.

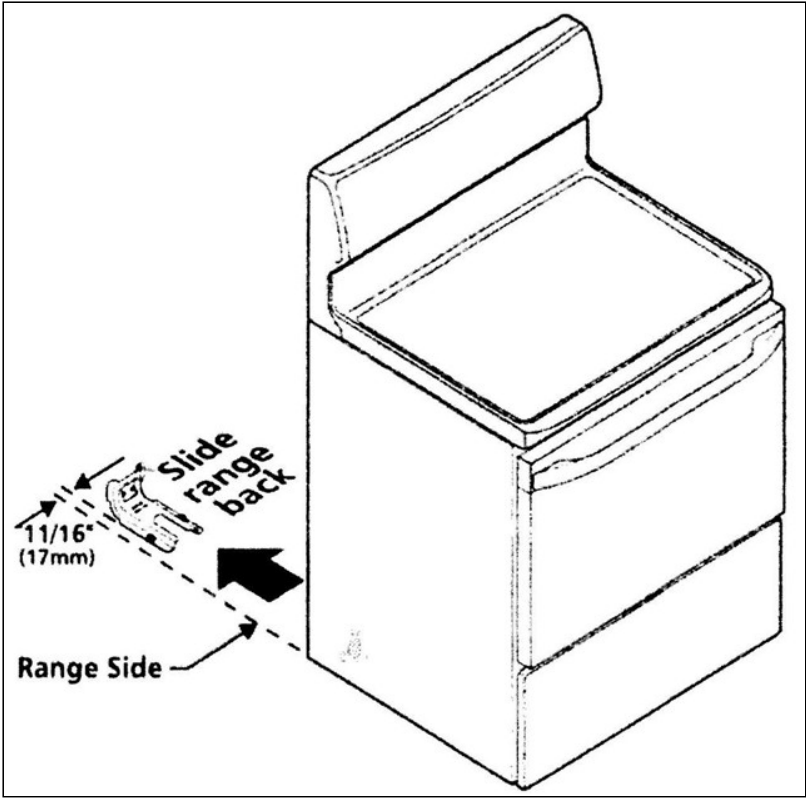
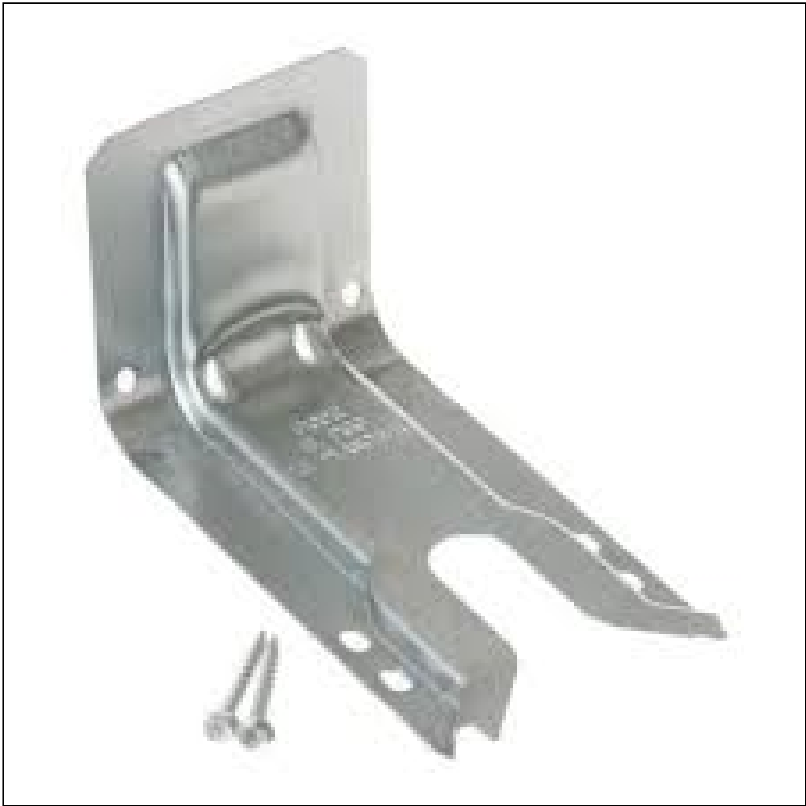
(1) An anti tip bracket was not installed at the range. This bracket prevents the range from tipping forward which could cause the range to fall over. We recommend installation of an anti tip bracket by a qualified person for safety and to help prevent injury.

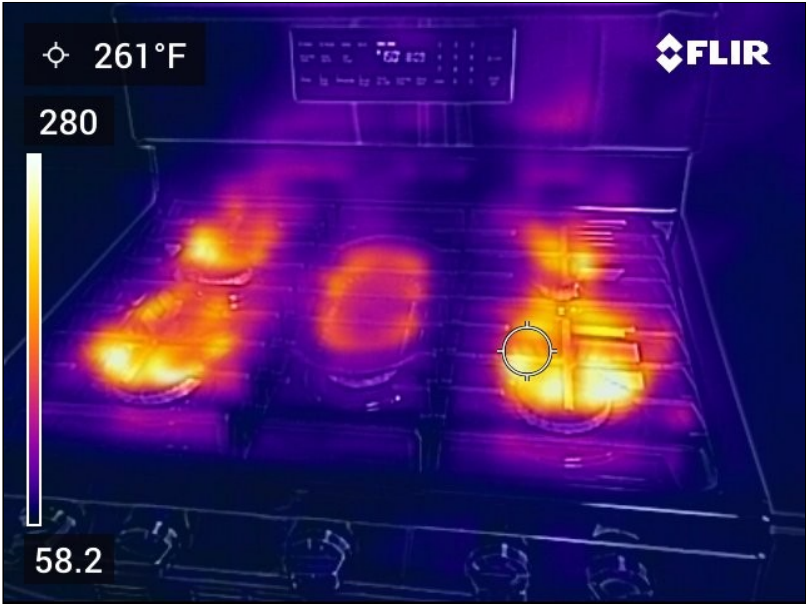
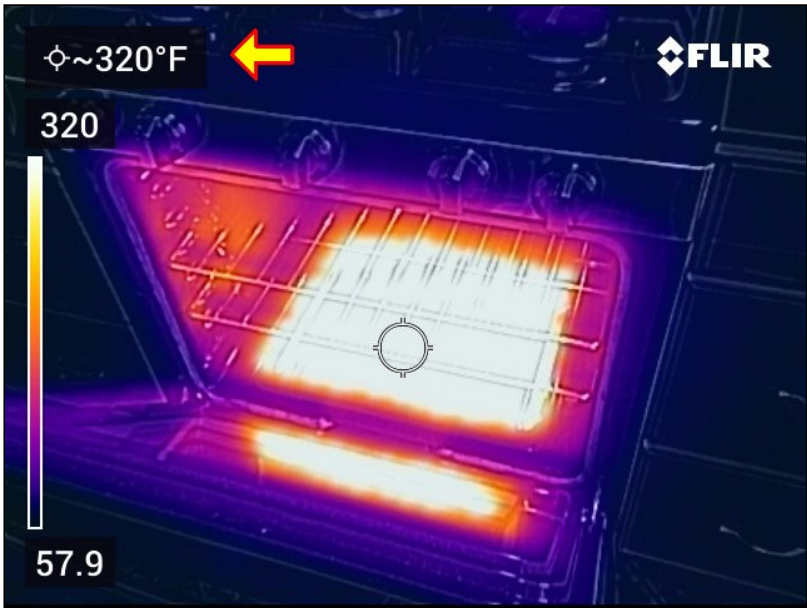
(2) The range/oven was tested and was functional at the time of the inspection. This test is not exhaustive and does not confirm the performance, accuracy, or effectiveness of the oven.

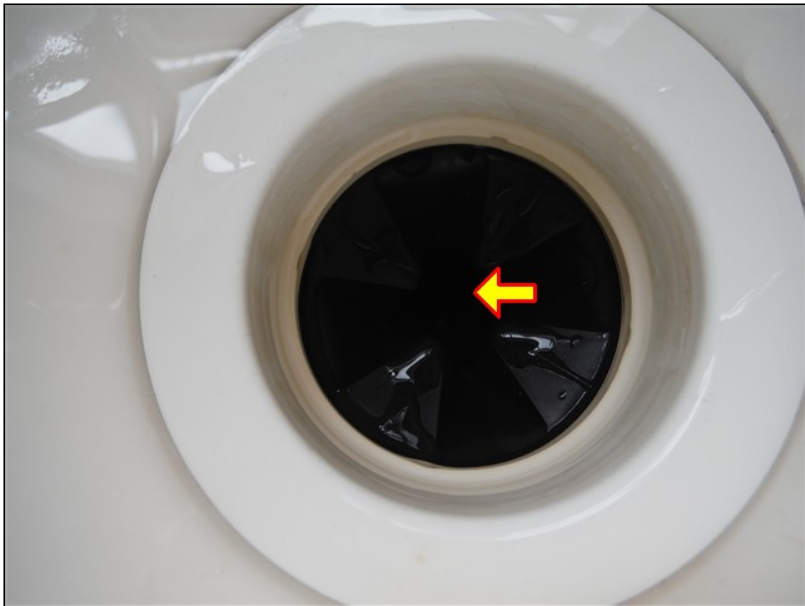
13.3 Item 1(Picture)

The food waste disposer cutting plates are rusted. We recommend replacing as needed by qualified person.

Note: The food waste disposer was tested and functioned properly at the time of the inspection. This is not an exhaustive test and does not verify the efficiency of the unit.

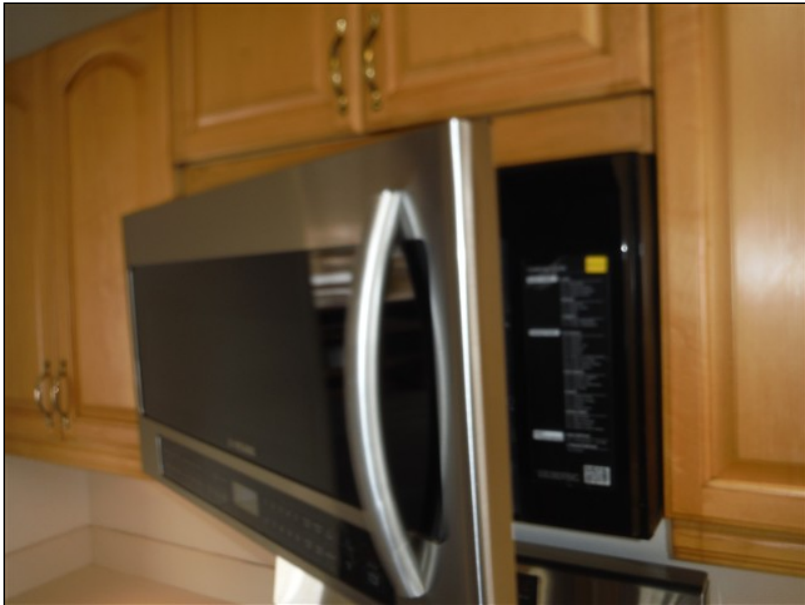
13.4 Item 1(Picture)

(1) The microwave is loose in the cabinet. We recommend necessary repairs by a qualified appliance contractor.

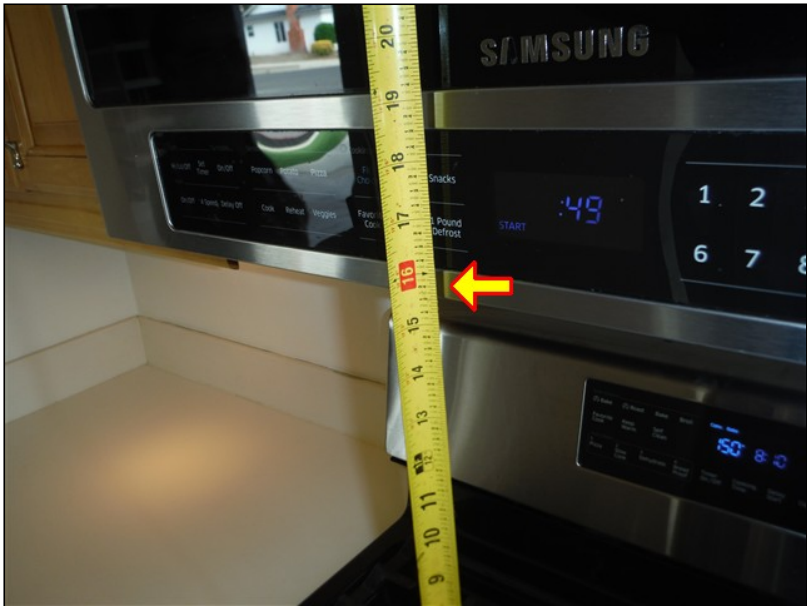
13.4 Item 2(Picture)

(2) The built in microwave was installed too close to the cooktop burners. This condition

could cause damage to the plastic covering and the electronic control panel due to excessive heat. We recommend replacing the microwave with a low-profile microwave or relocating it which would allow at least 18 inches of clearance between the bottom of the microwave and the cooktop burners. Lower clearances may be allowed per manufacturers listing.

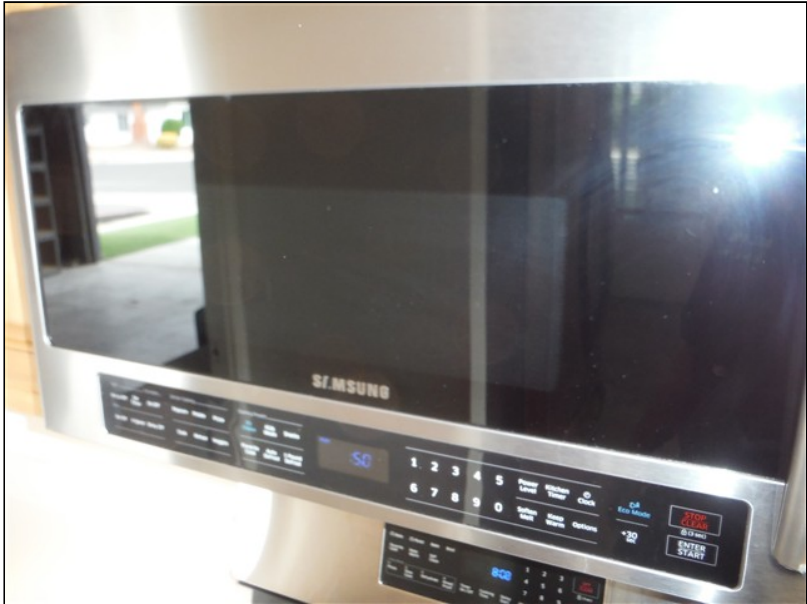
13.4 Item 3(Picture)

(3) The built in microwave was tested with a microwave testing device and was functional at the time of the inspection. This is not an exhaustive test, and does not predict the performance of the microwave.

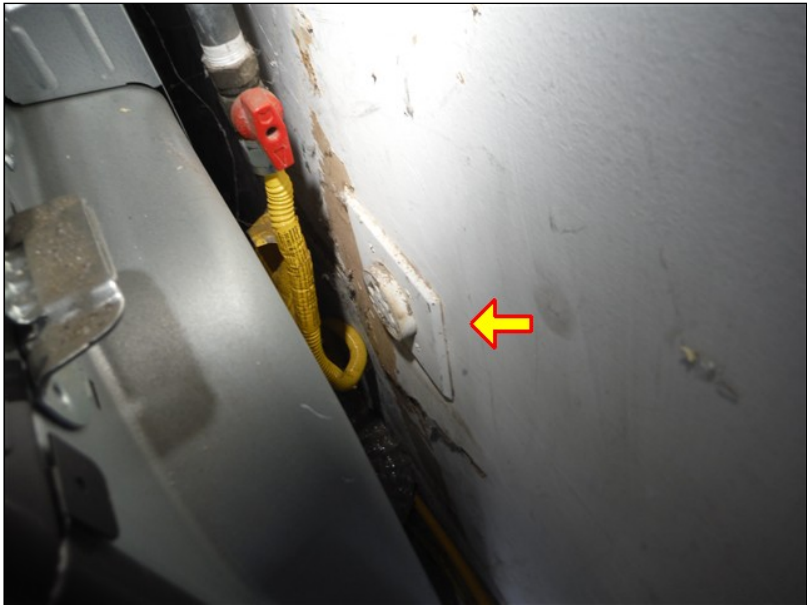
13.5 Item 1(Picture)

(1) There is a three prong 220 volt receptacle installed for the dryer. Most new electric dryers require a four prong receptacle. If you install an electric dryer, you may need to upgrade the receptacle or the dryer power cord. We recommend necessary corrections by a qualified licensed electrician.

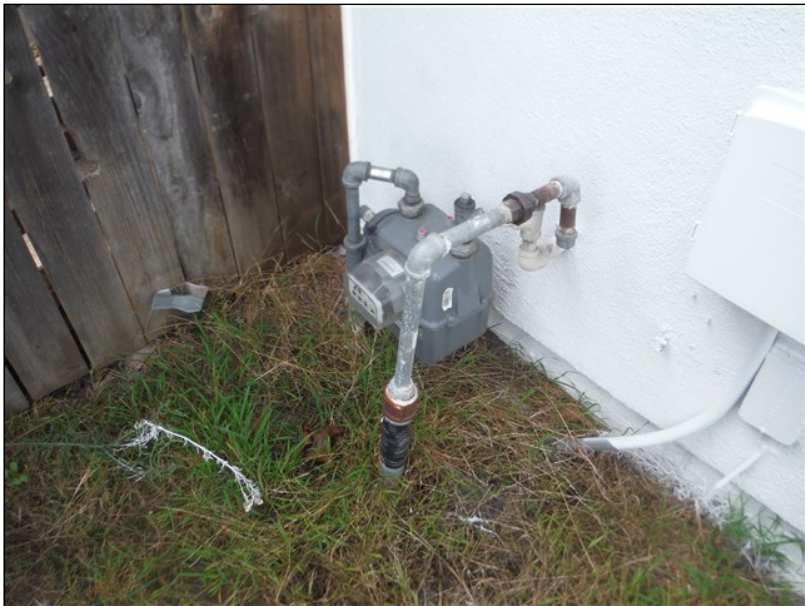
14.0 Item 1(Picture)

**Findings**  
The main gas shut off valve is located at the gas meter at the left exterior side of the house (facing front).

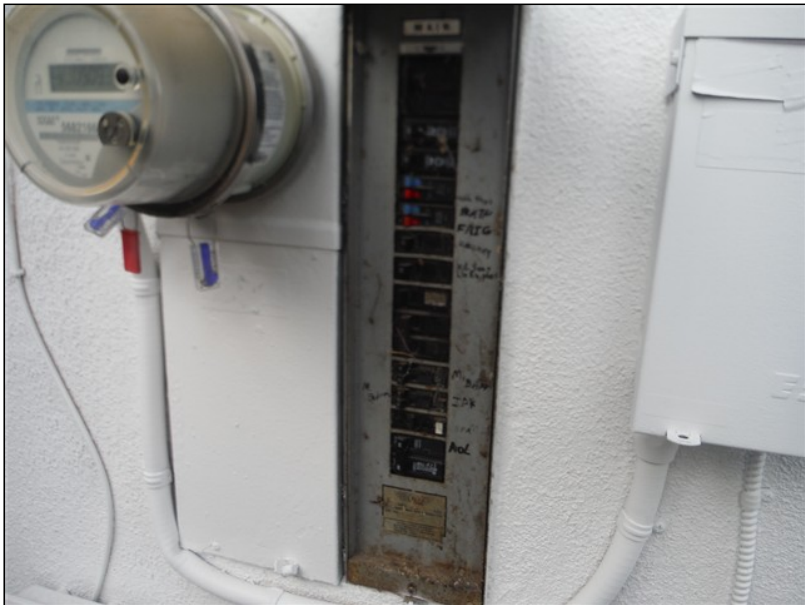
14.1 Item 1(Picture)

**Findings**  
The Main Electrical panel is located at the left exterior side of the house (facing front).

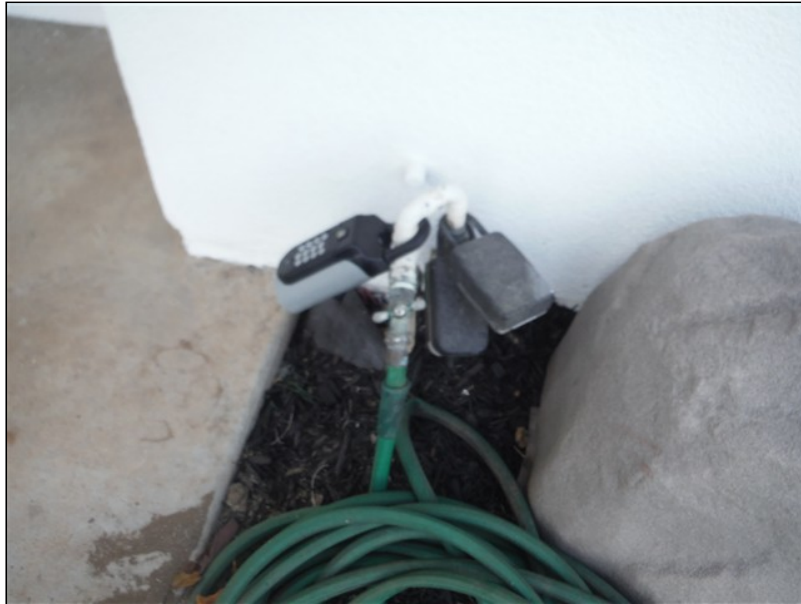
14.2 Item 1(Picture)

The main water shut-off valve is located at the front exterior side of the house (facing front).
