## Confidential Inspection Report

LOCATED AT:  
2016 Lake Morena Dr.  
Campo, California 91906

INSPECTED ON:  
Wednesday, September 9, 2026

Inspector, Ken Mitchell  
East County Star Home Inspections

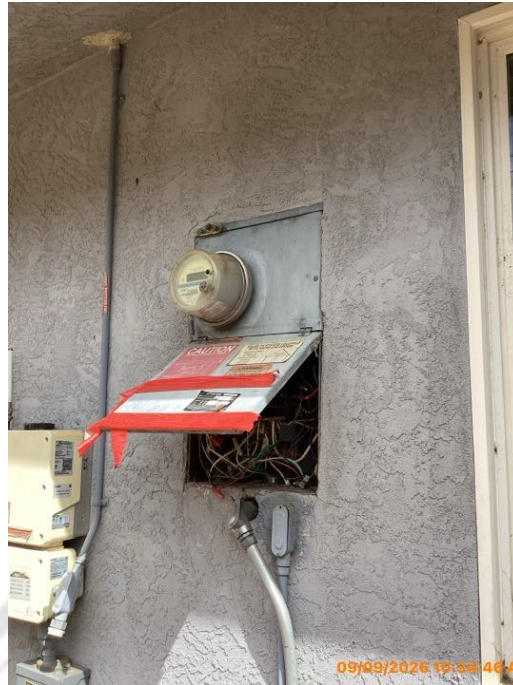
**WARN DANG 13:** Electric meter is located on rear of the house facing south. The dead front is off of the panel and laying on the ground, exposed wires were observed through the open panel, which is a safety hazard. Service panel had been taped shut with red tape capacity was not visible. Recommend services of qualified electrician.

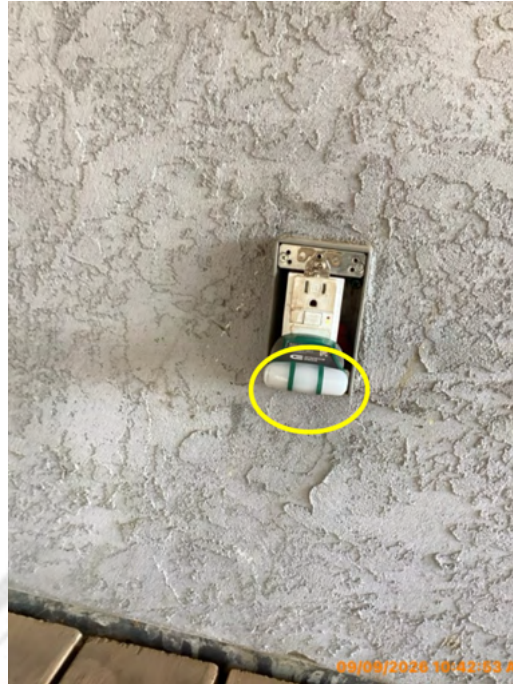
**WARN 15:** There is a three prong receptacle installed on south side of house approximately 18 inches above top of sliding door. The outlet is not operational and missing cover plate recommend services a qualified electrician.

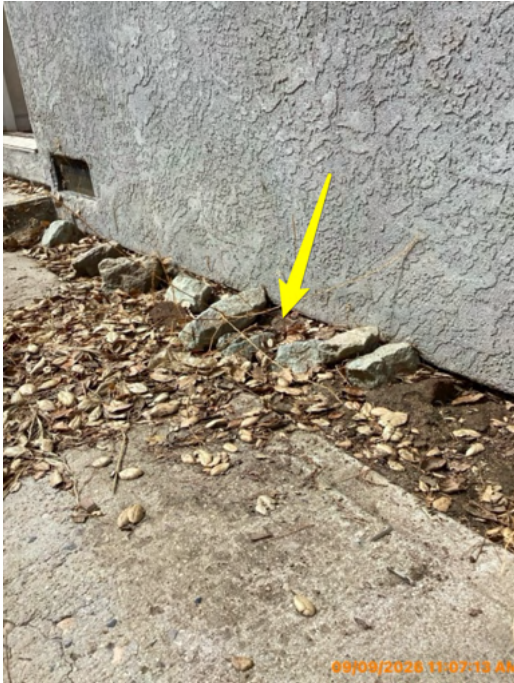
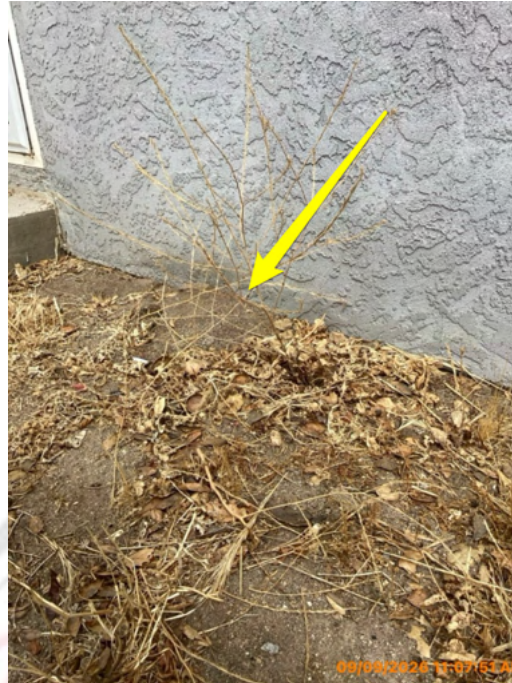
**MAIN 23:** Proper hard and/or soft scape to weep screed clearances have not been maintained. This may lead to moisture intrusion. Review further for possible moisture issues. Clearance between weep, screed and ground should be 6 to 8 inches.

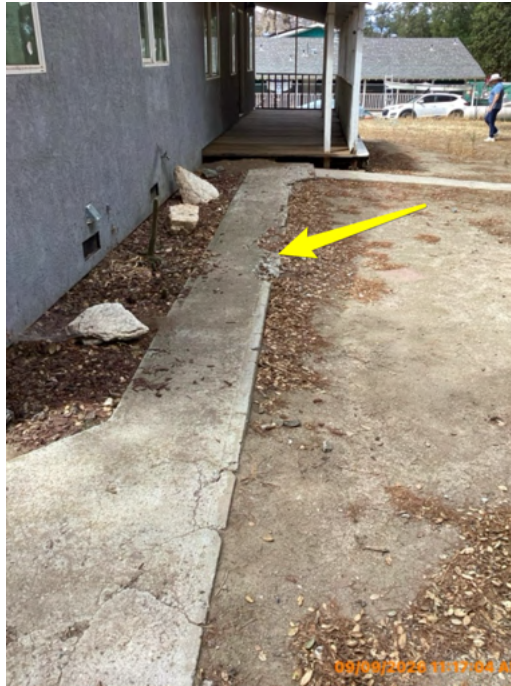
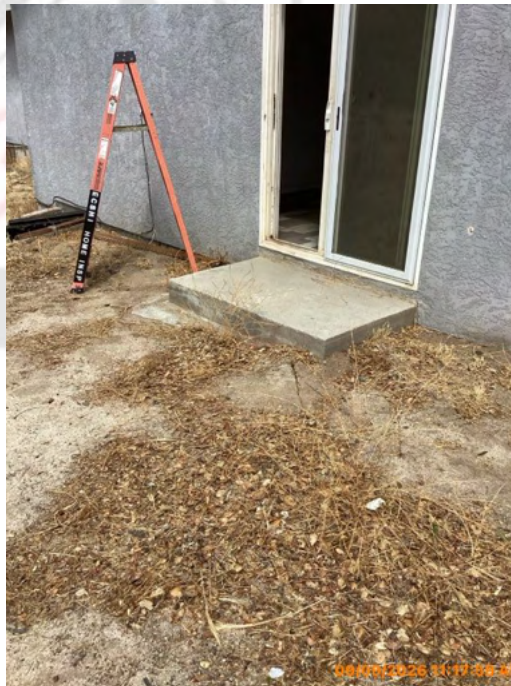
**26:** Walkways are concrete and are in need of some repair

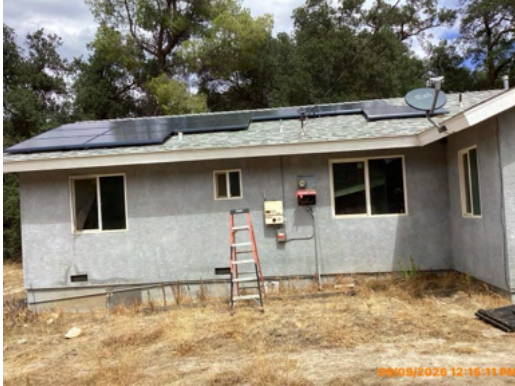
**55:** Inspection of the solar collector panels is beyond the scope of this inspection. For information regarding the panels and the operation of the solar system, we suggest consultation with an expert in this field. Leakage at these panels is common. We recommend further review. While doing the roof inspection, the panels were observed from the edge of the roof. The glazing appears to be intact and no readily apparent problems were observed. Recommend maintenance to clear debris underneath panels.

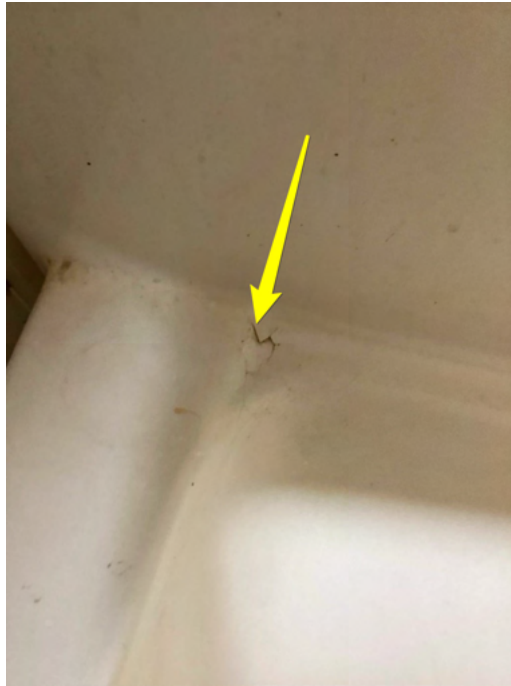
**117:** The surface finish of the bathtub is chipped. We recommend refinishing or replacement.

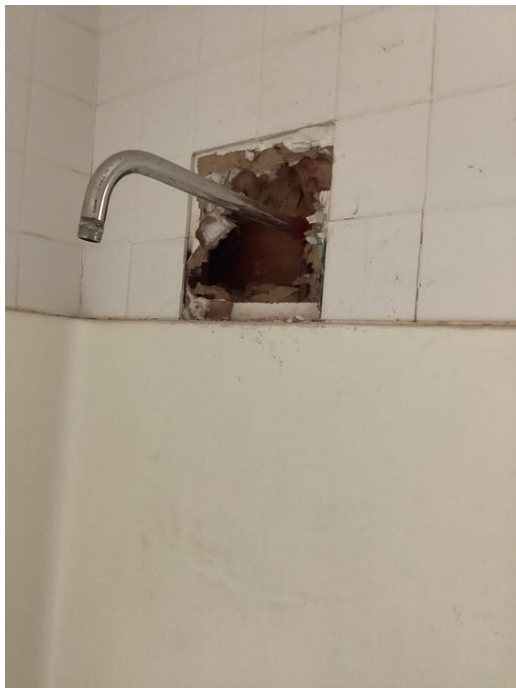
m two is fiberglass and incorporated with the bathtub. The recommend refinishing or replacing.

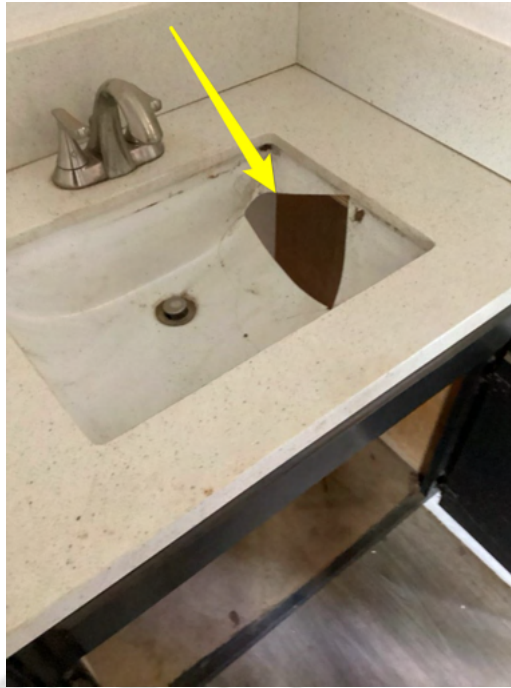
**132:** The wash basins are deteriorated and the basin on the right has a large piece broken out, replace. Remaining useful life is limited.

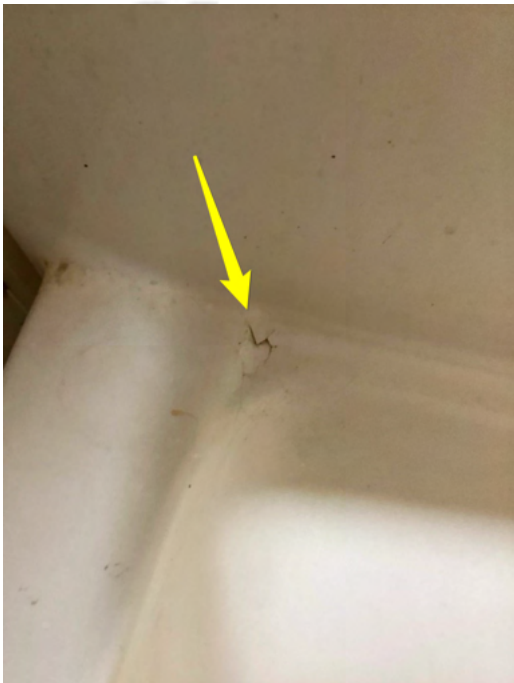
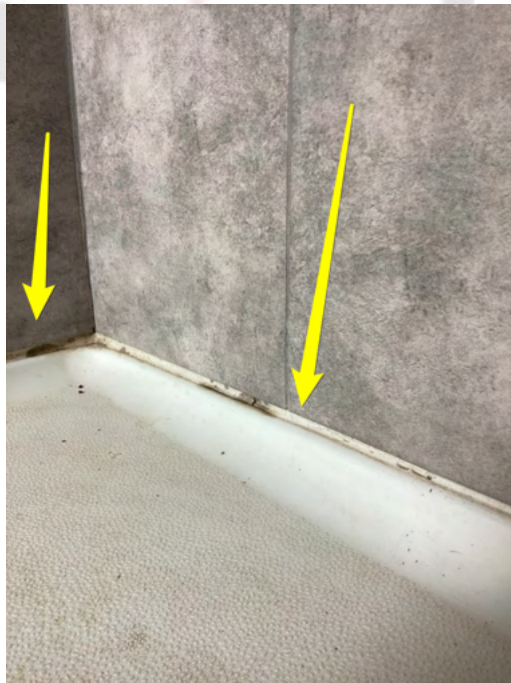
**133:** A water test of the shower pan is beyond the scope of this inspection. This test is often performed as a part of a standard pest inspection. The shower pan is constructed of fiberglass and shows signs of wear and tear and damage. Recommend refinishing or replacing. Also recommend removing and replacing old caulking at bottom of shower surround.

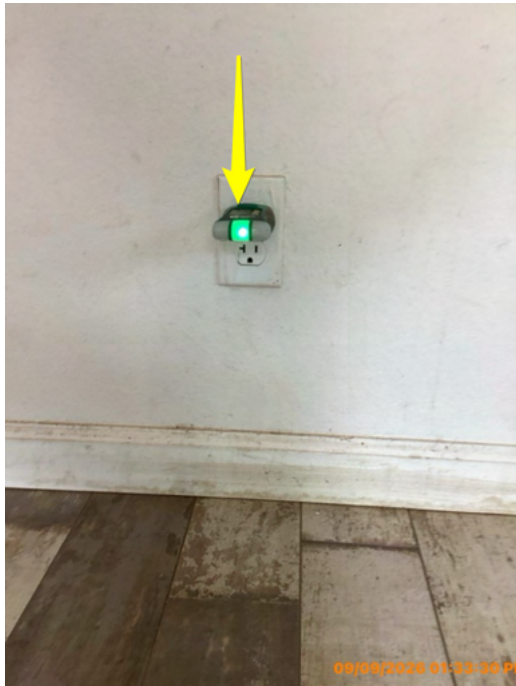
**MAIN** **138:** The east receptacle cover plate is missing We recommend it be replaced during the course of normal maintenance.

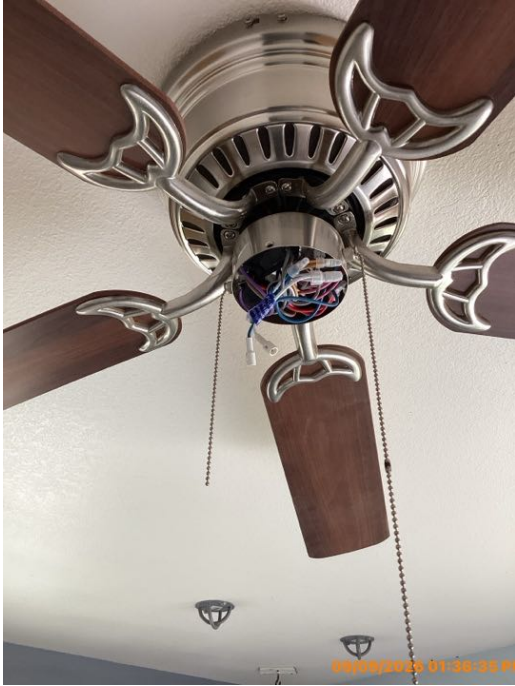
**MAIN 140:** The switches for the fan operated normally and energized the fan. The light in the fan was not installed and it is unknown if the light switch operates normally.

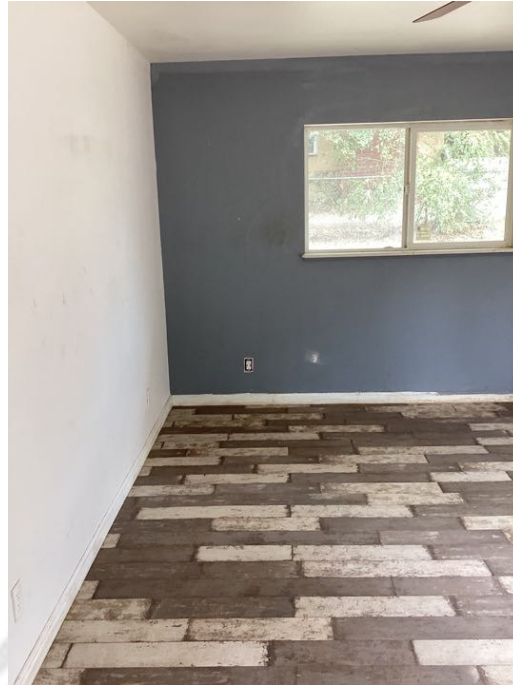
**MAIN 142:** The walls are generally serviceable, except for the item(s) noted. painting in the master bedroom and patching in the master closet are required. In picture #1 below is what would be considered the closet area.

**MAIN s-142:** The walls are generally serviceable, except for the item(s) noted. painting in the master bedroom and patching in the master closet are required. In picture #1 below is what would be considered the closet area.

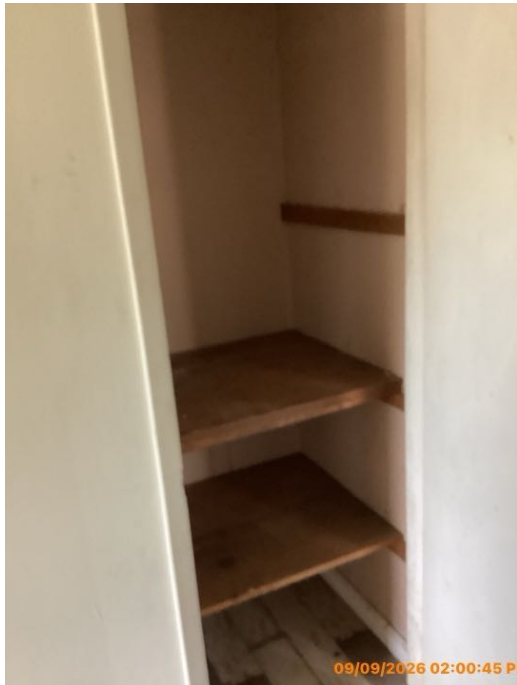
**MAIN 162:** The West bedroom closet door is intact, but rubs. Maintenance or adjustment is required.

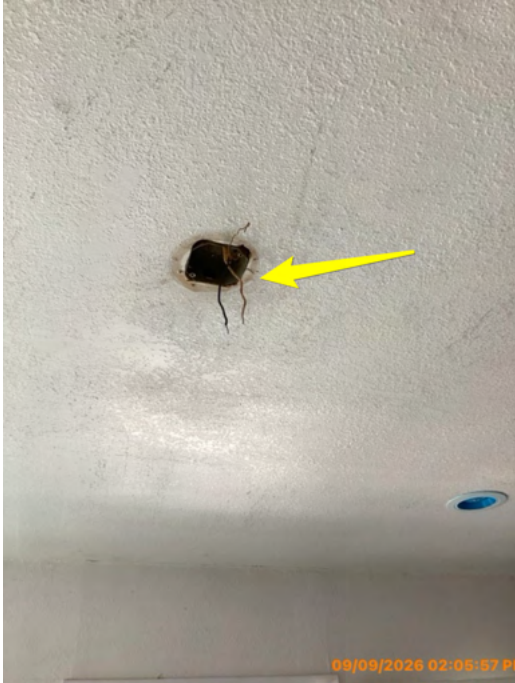
**175:** Bare wires noted at ceiling in living room where a device or fixture has been removed, bare wires are shown hanging out of electric box, repair or replace.

**MAIN** **UPGR** **DANG** **s-175:** Bare wires noted at ceiling in living room where a device or fixture has been removed, bare wires are shown hanging out of electric box, repair or replace.

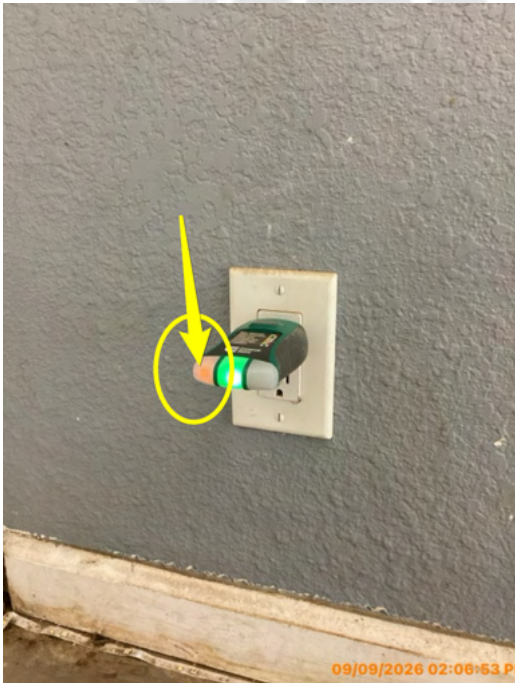
**176:** The receptacles were found to be properly installed and in serviceable condition. One receptacle on west wall of living room shows neutral connection missing, as shown by the picture below. Recommend repair or replace. The number of receptacles is considered adequate for this size room.

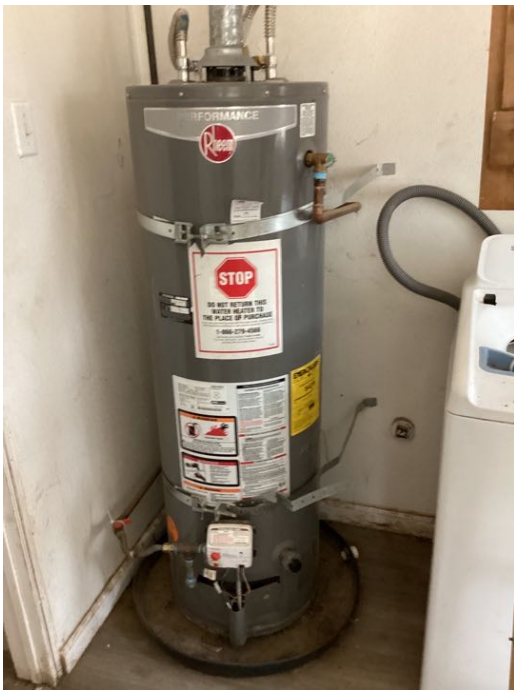
**ACC 184:** The water fixtures consist of hot and cold supply serving the washer, and the cold and hot pipes at the water heater appeared to be in serviceable condition at the time of inspection.

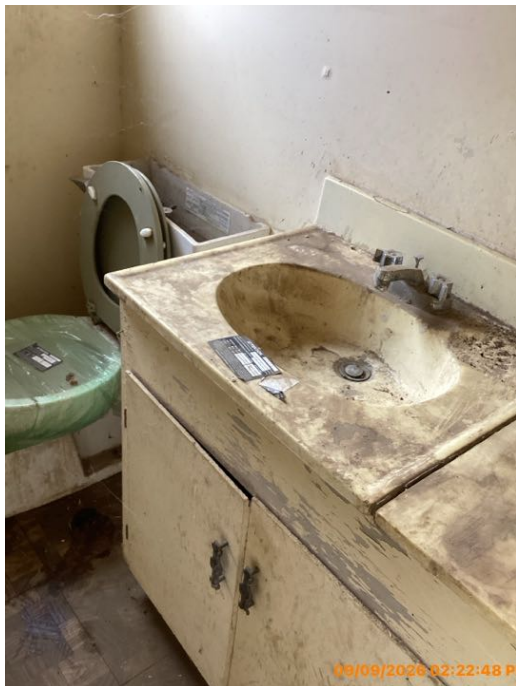
**201:** Toilet and fixtures could not be operated due to lack of water. See comments in previous sections..

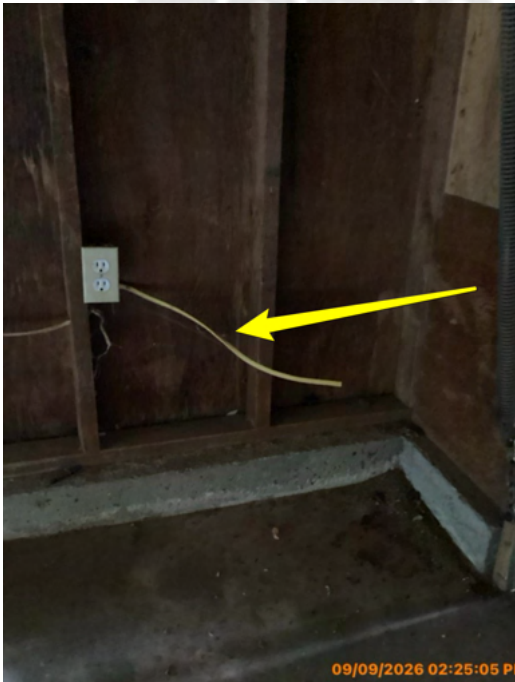
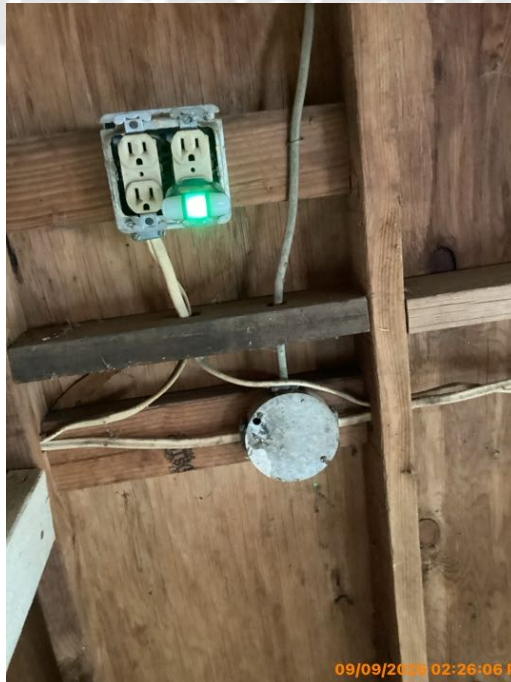
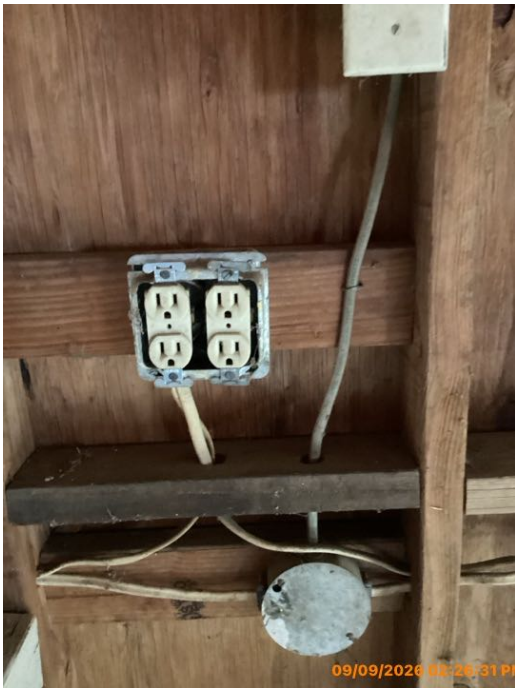
**MAIN** **203:** The receptacles along the west facing wall in the garage are not energized and there is an open wire extending out of the last receptacle, (as seen in picture number one) Receptacles on south and east facing walls are all energized and appear to be wired correctly. duplex receptacle on South wall is missing cover plate.

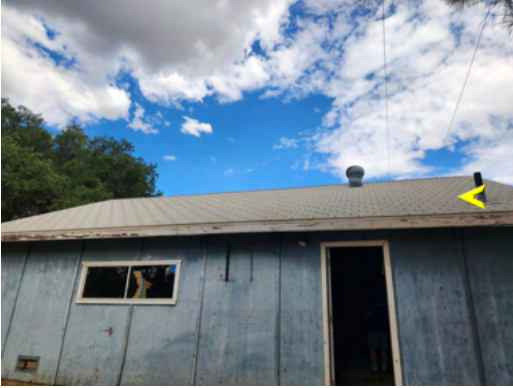
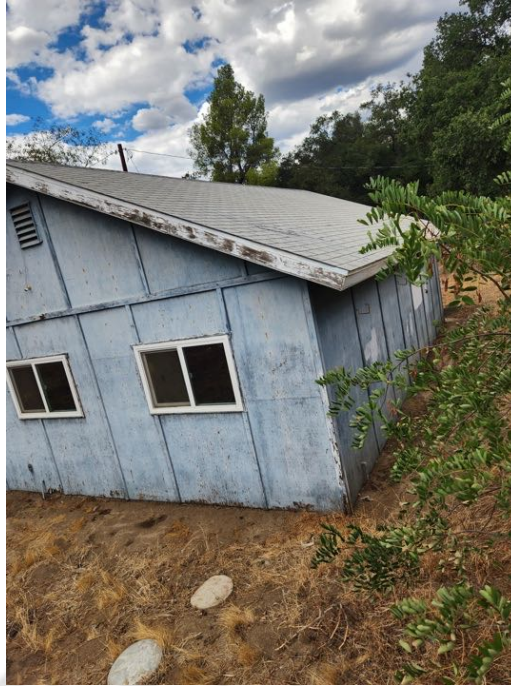
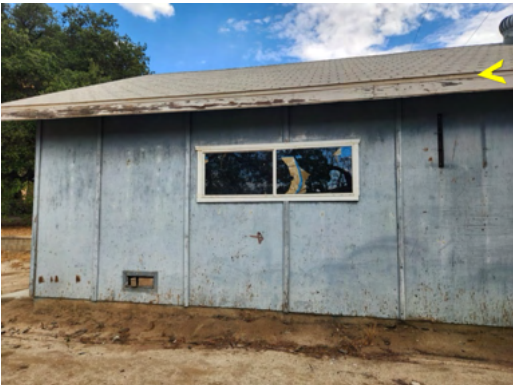
**MAIN 211:** The garage appears to be in an acceptable condition for the age of the structure. The roofing appears to be in serviceable condition, but in need of paint and routine maintenance

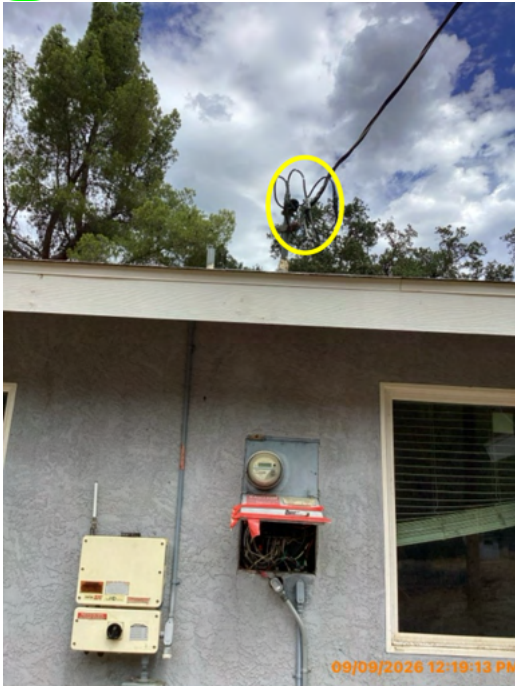
**ACC** s-53: The service drop appears to be properly installed and in good condition.

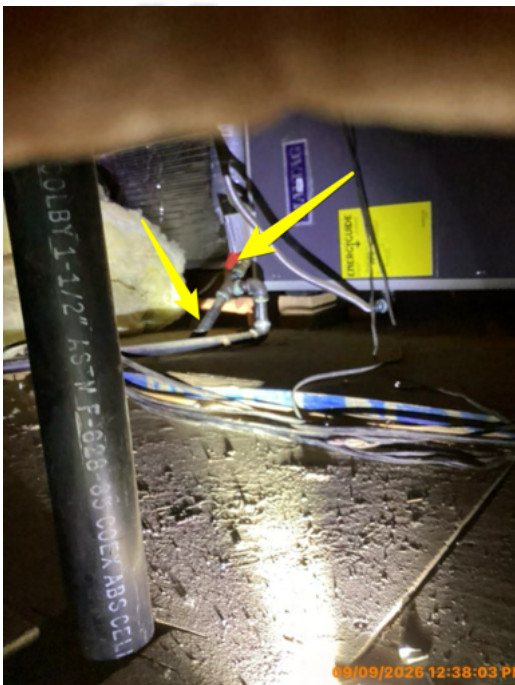
**ACC** s-58: The gas piping includes a 90 degree shutoff valve for emergency use and drip leg. The valve was not tested at the time of inspection. The age and style of valve is normally found to be operable by hand and generally trouble free.

Picture shows shut off to heating unit and drip lead shone by arrows.

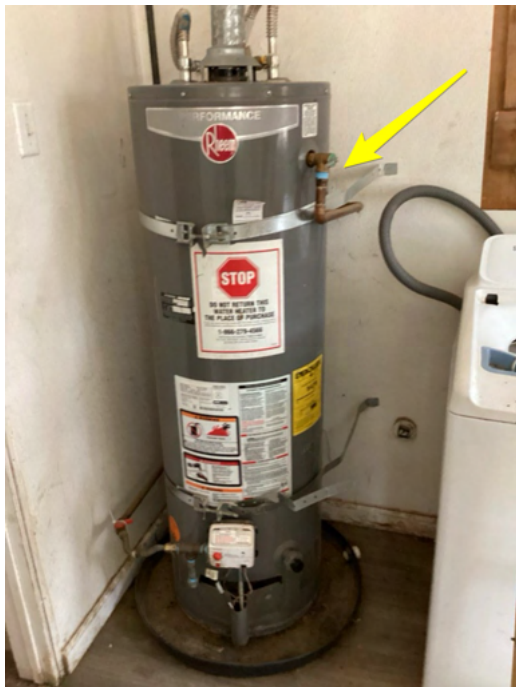
**ACC** s-68: The water heater is equipped with a temperature and pressure relief valve. This device is an important safety device and should not be altered or tampered with. We observed no adverse conditions.

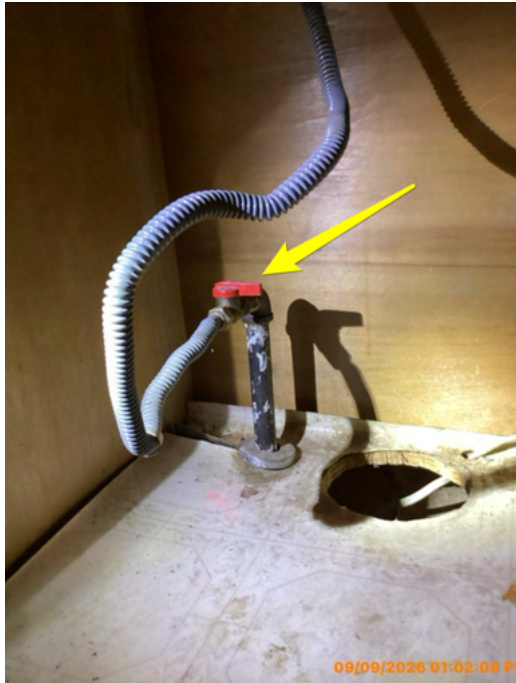
**s-97:** The gas piping for the appliance includes a local 90 degree shut-off valve for use in an emergency. The valve was not tested at the time of inspection, but is of a type usually

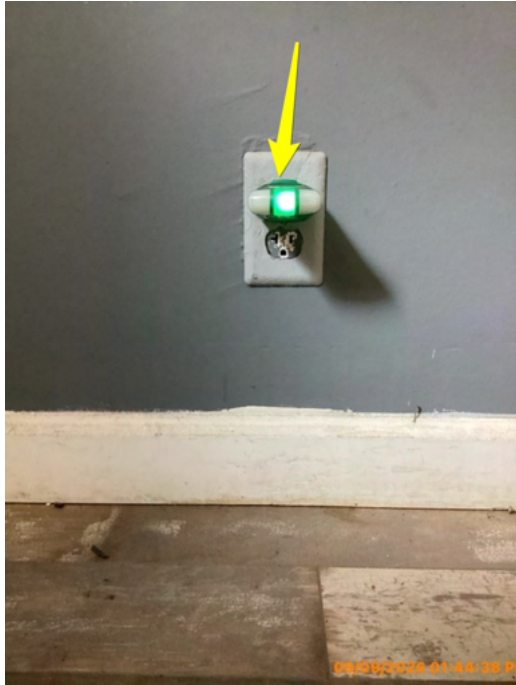
**ACC s-148:** The receptacles were found to be properly installed and in serviceable condition. The number of receptacles is considered adequate for the size of the room. The tester in the outlet shows correct wiring in this room.

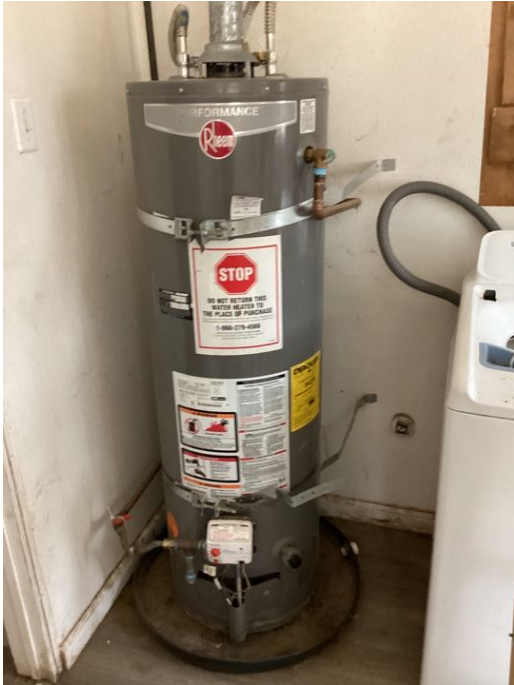
**ACC** s-184: The water fixtures consist of hot and cold supply serving the washer, and the cold and hot pipes at the water heater appeared to be in serviceable condition at the time of inspection.

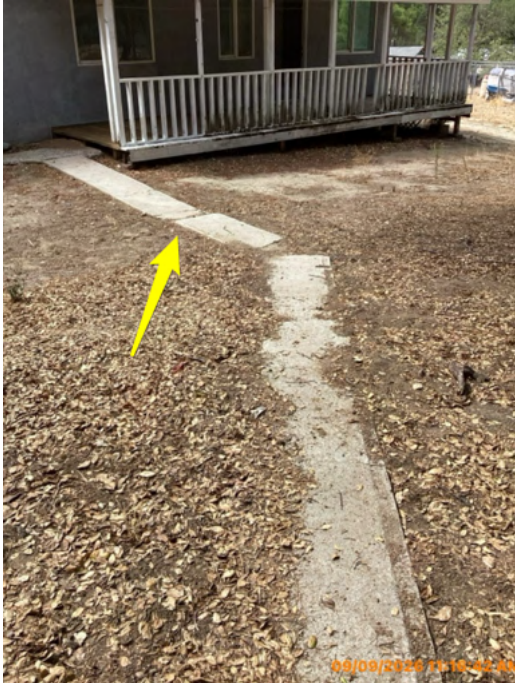
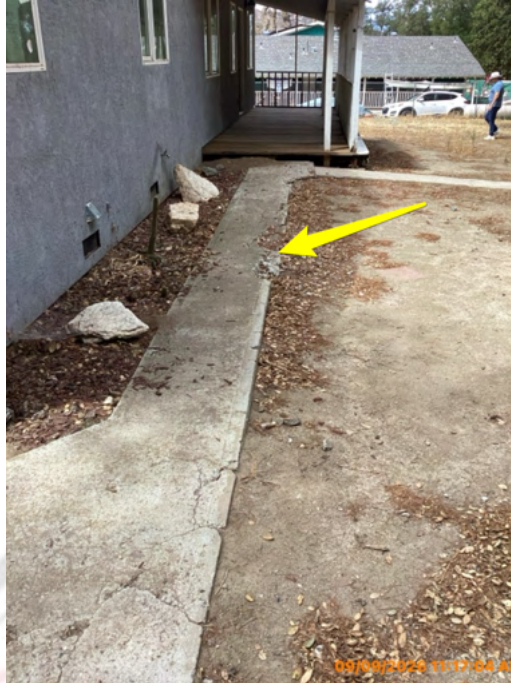
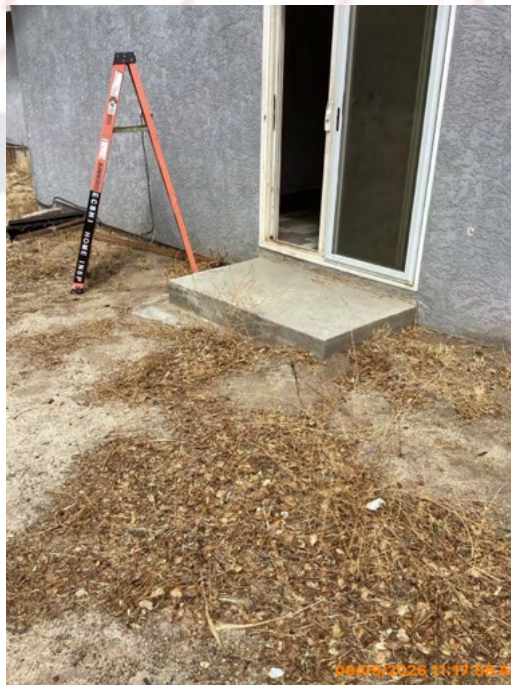
**MAIN** **UPGR** **s-26:** Walkways are concrete and are in need of some repair

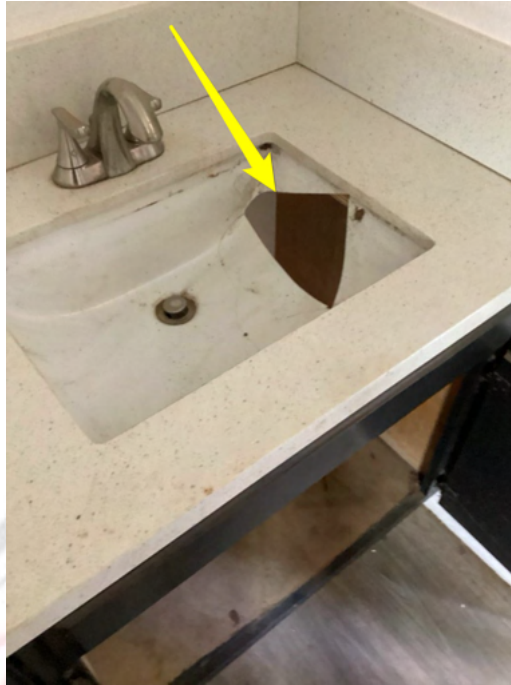
**MAIN** **UPGR** **s-132:** The wash basins are deteriorated and the basin on the right has a large piece broken out, replace. Remaining useful life is limited.

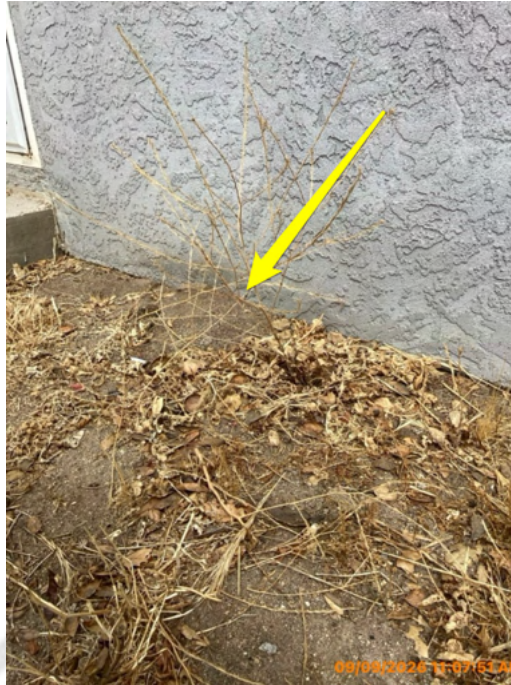
**MAIN s-23:** Proper hard and/or soft scape to weep screed clearances have not been maintained. This may lead to moisture intrusion. Review further for possible moisture issues. Clearance between weep, screed and ground should be 6 to 8 inches.

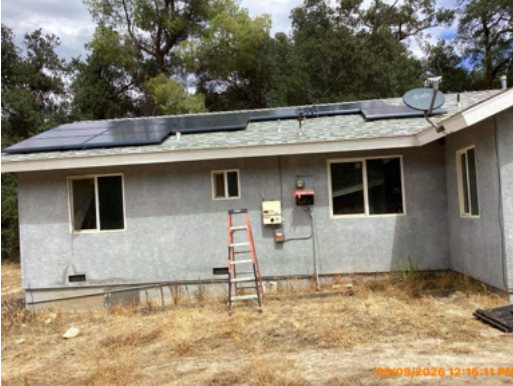
**MAIN s-55:** Inspection of the solar collector panels is beyond the scope of this inspection. For information regarding the panels and the operation of the solar system, we suggest consultation with an expert in this field. Leakage at these panels is common. We recommend further review. While doing the roof inspection, the panels were observed from the edge of the roof. The glazing appears to be intact and no readily apparent problems were observed. Recommend maintenance to clear debris underneath panels.

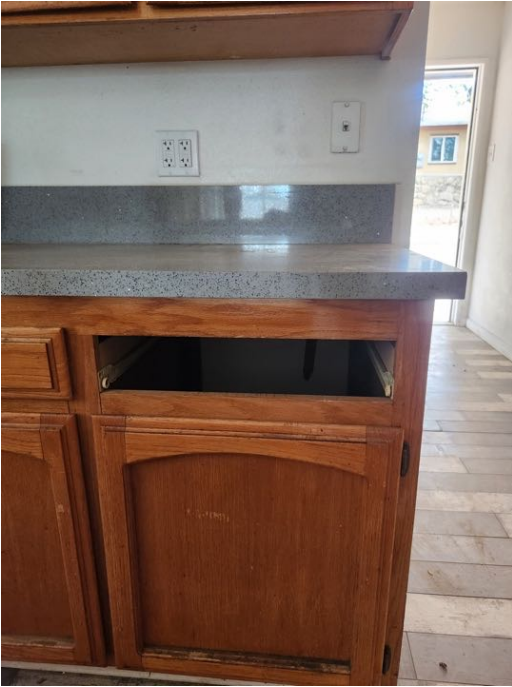
**MAIN** **s-102:** Cabinets and counter show heavy wear from use overtime and there is a drawer missing on the east corner of the cabinets, replace. These conditions could be addressed through regular maintenance.

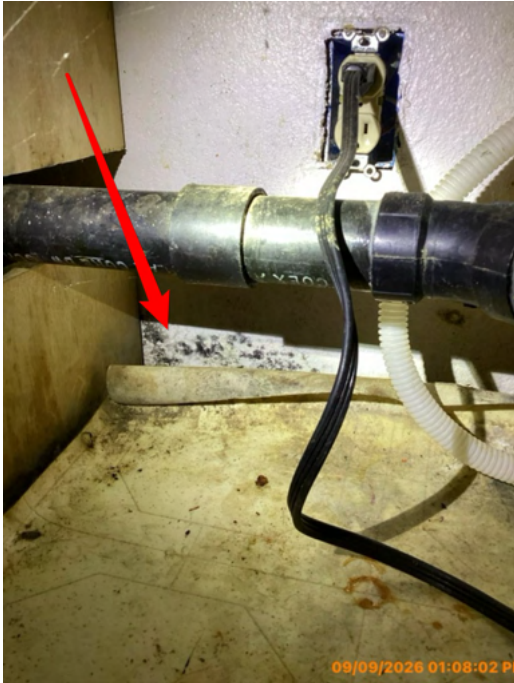
**MAIN s-112:** Organic growth was observed under the kitchen sink next to the back wall recommend testing by qualified individual.

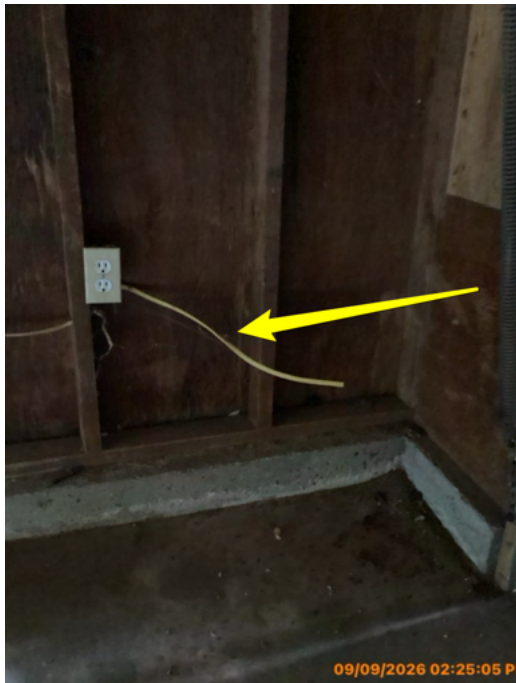
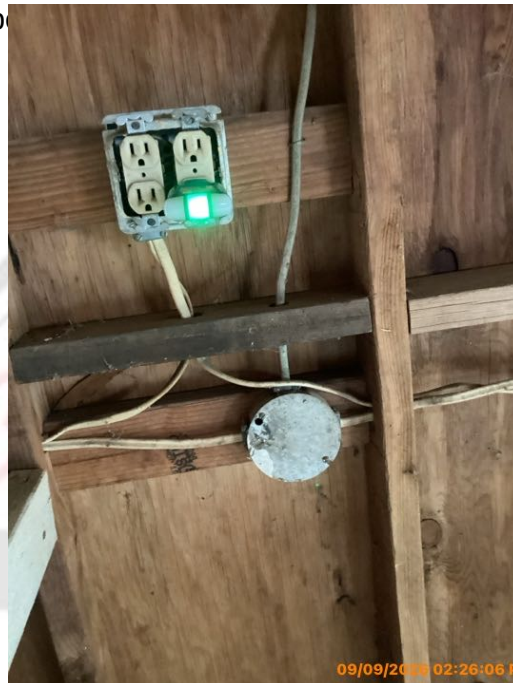
**s-203:** The receptacles along the west facing wall in the garage are not energized and there is an open wire extending out of the last receptacle,(as seen in picture number one)Receptacles on south and  
app  
Receptacle on South wall is

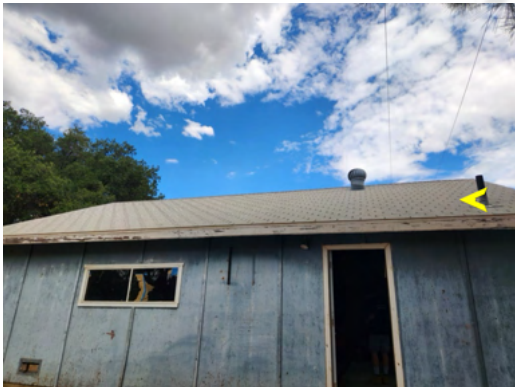
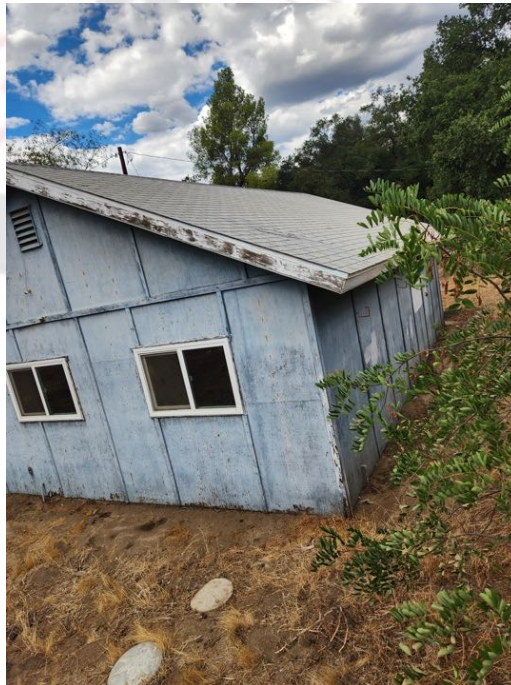
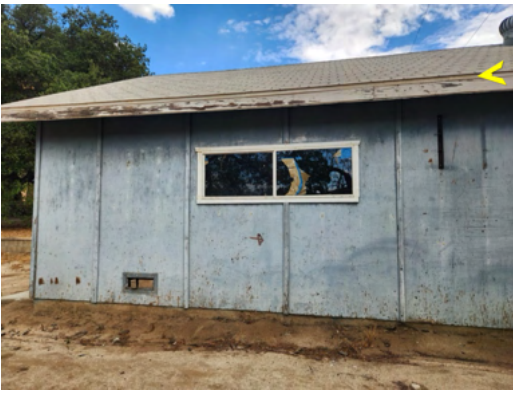
**MAIN** s-211: The garage appears to be an acceptable condition for the age of the structure. The roofing appears to be in serviceable condition, but in need of paint and routine maintenance

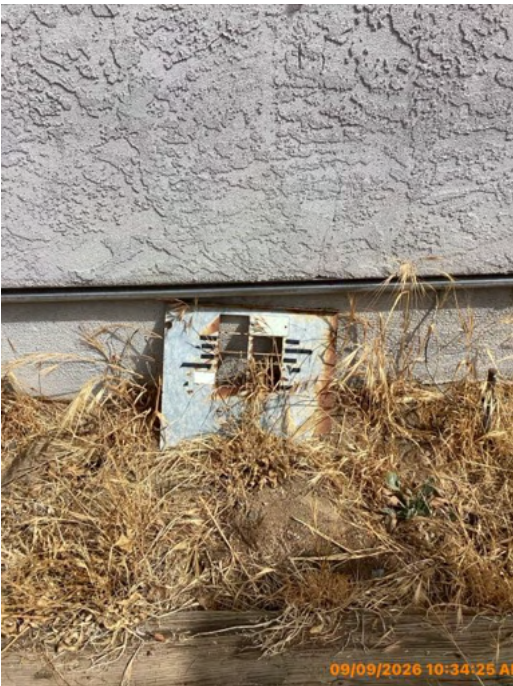
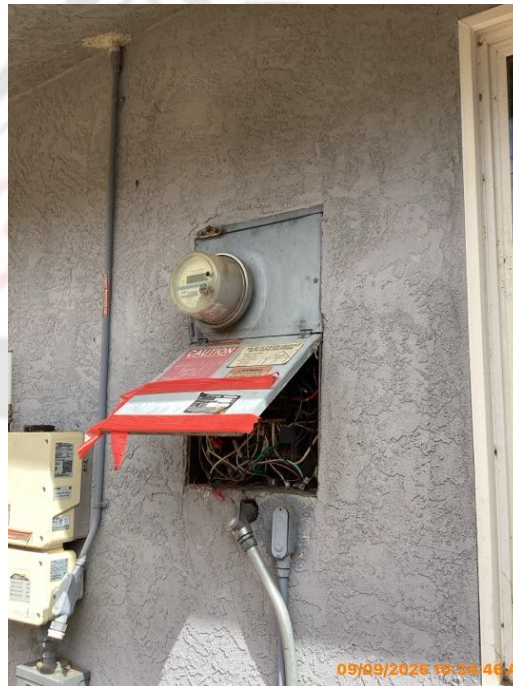
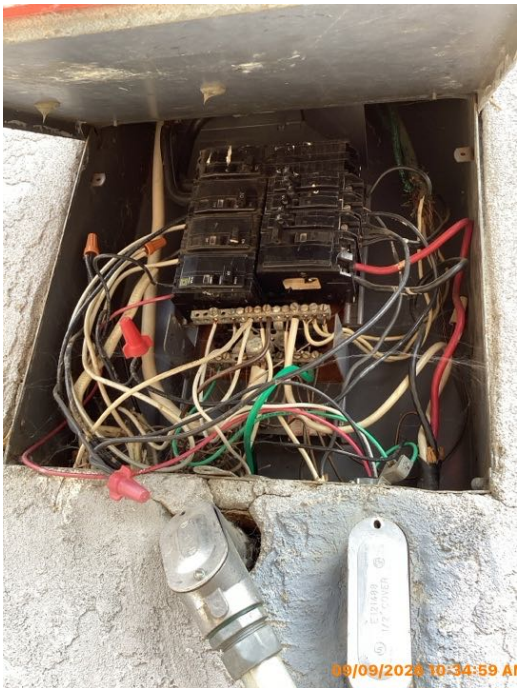
**WARN** **DANG** **s-13:** Electric meter is located on rear of the house facing south. The dead front is off of the panel and laying on the ground, exposed wires were observed through the open panel, which is a safety hazard. Service panel had been taped shut with red tape capacity was not visible. Recommend services of qualified electrician.
