## HOME INSPECTION

8167 Vista Dr  
La Mesa, CA 91941

09/10/2024

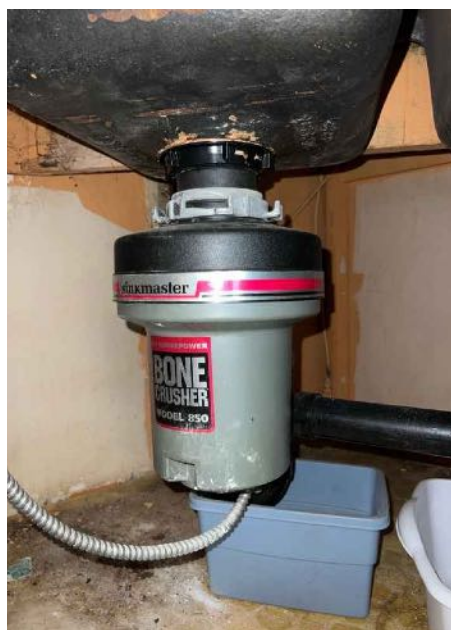
**FOOD WASTE DISPOSER: Disposer - INSPECTED**

The disposer was tested and was functional at the time of inspection.

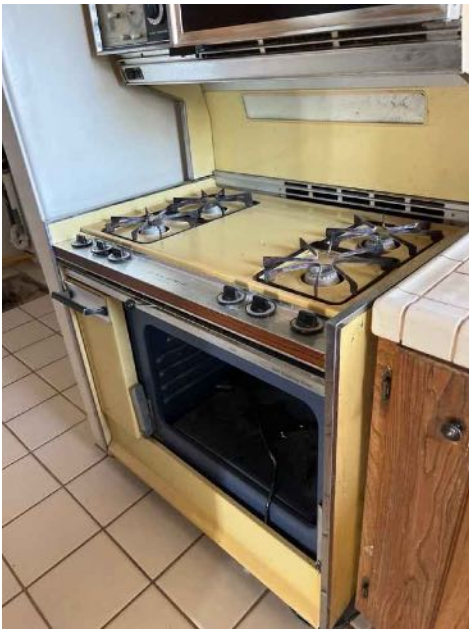
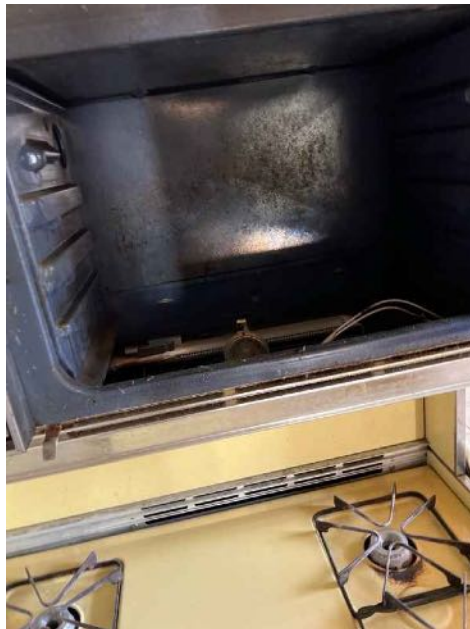
### 2.3.1 RANGES/COOKTOP

#### **GAS BURNER INOPERABLE**

Recommendation or Safety Upgrade

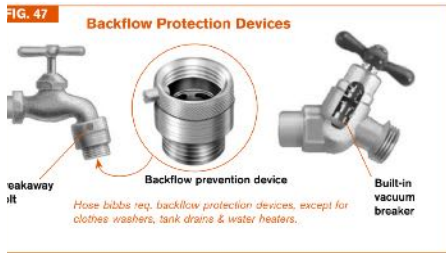
**HOSE SPIGOT: Anti-Siphon - None**

Anti-siphon or anti-backflow valves are not present at the exterior hose spigots. These are safety devices that prevent contaminated water from flowing into the house water supply. Current standards require the installation of anti-siphon valves to keep your drinking water clean. We recommend installation for your health and safety.

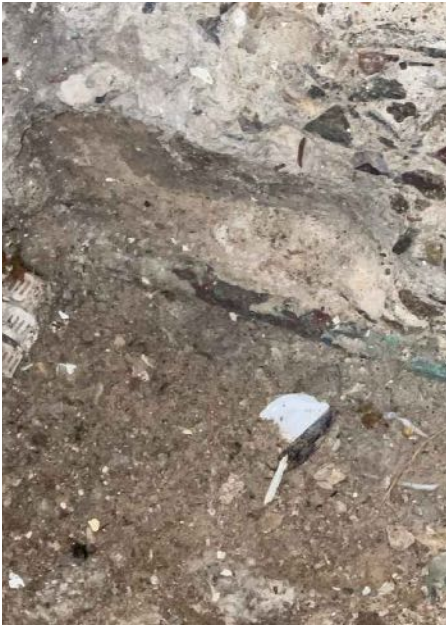
**WATER SUPPLY AND DISTRIBUTION SYSTEM: Copper Pipes - In Slab**

Note: This home appears to have some portions of the plumbing distribution system that run through the concrete slab. Copper pipes in direct contact with concrete have been known to deteriorate and result in "slab leaks". We attempt to determine if slab leaks exist, however they may go undiscovered particularly if the water to the house has been turned off recently. If a leak occurs at pipes running through the slab, plumbing must be re-routed or lined with epoxy.

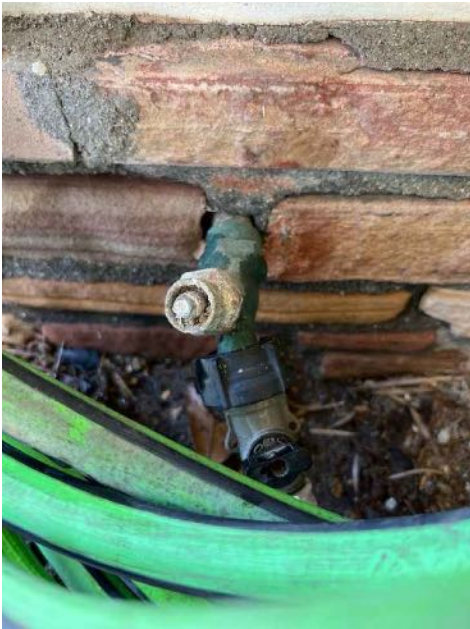
3.5.2 HOSE SPIGOT

**HOSE SPIGOT**

Recommendation or Safety Upgrade

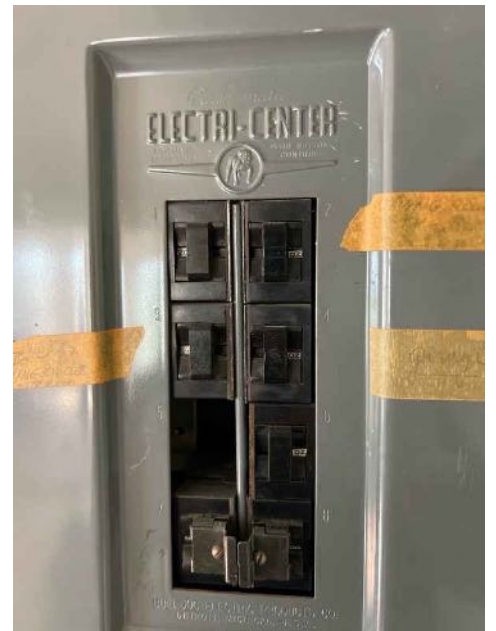
The main panel is a Bulldog brand (PushMatic) panel. These panels use old technology push button circuit breakers that are no longer considered reliable. We recommend upgrading the electric panel to a modern 100 AMP (minimum) panel by a licensed electrician.

Contact a qualified electrical contractor.

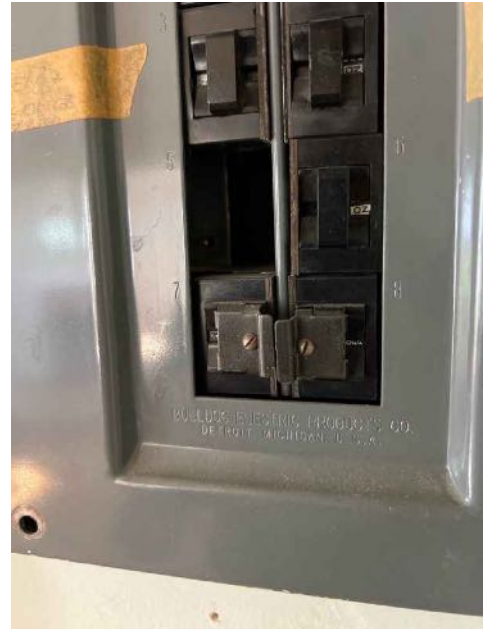
### **TWIST-OUT MISSING**

"Twist outs" are missing from the dead-front cover on the main panel. Whenever a twist out is removed and no breaker is present, a cover insert is required to be installed to prevent shocks or rodent intrusion. We advise installing cover insert(s) for safety.

Contact a qualified professional.

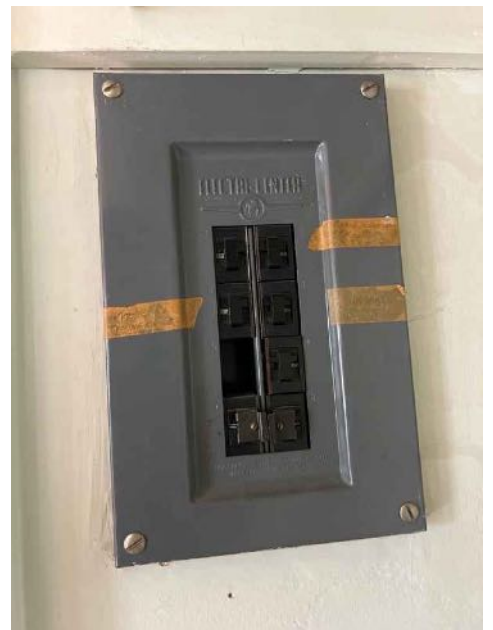
When six or more breakers are located in the main panel, a main disconnect must be installed to comply with current electrical standards and regulations. We recommend further evaluation and having a main disconnect be added by a licensed electrician.

Contact a qualified electrical contractor.

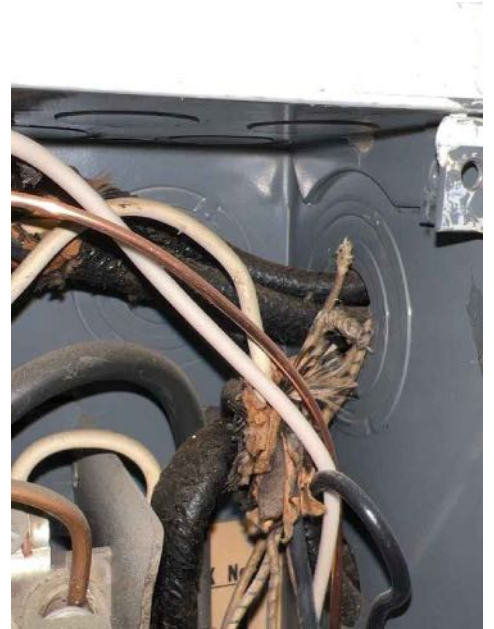
Wire clamp(s) was missing at the main panel. A plastic bushing or wire clamp protects and secures the wiring as it enters the electric box. We recommend corrections by a licensed electrician.

Contact a qualified electrical contractor.

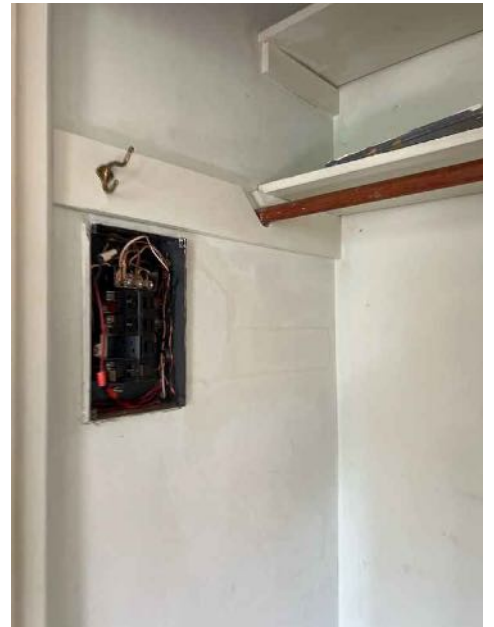
Note: Sub-panel was located in a closet. Because of the combustible nature of clothing and inadequate clearances, sub-panels are no longer allowed to be installed in closets. While this installation was acceptable years ago, you may wish to consult a qualified electrical contractor to discuss options and costs for moving this sub-panel to a proper location.

Contact a qualified electrical contractor.

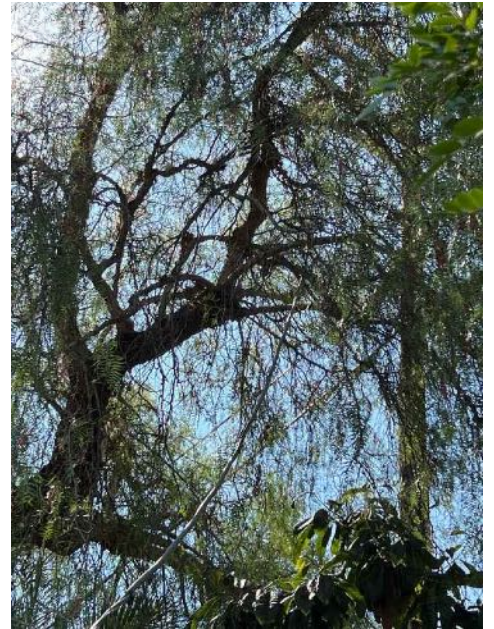
The service entrance conductors are in contact with tree branches. This can damage the wires, or cause power outage in high wind. We recommend trimming trees away from service entrance conductors.

Contact a qualified landscaping contractor

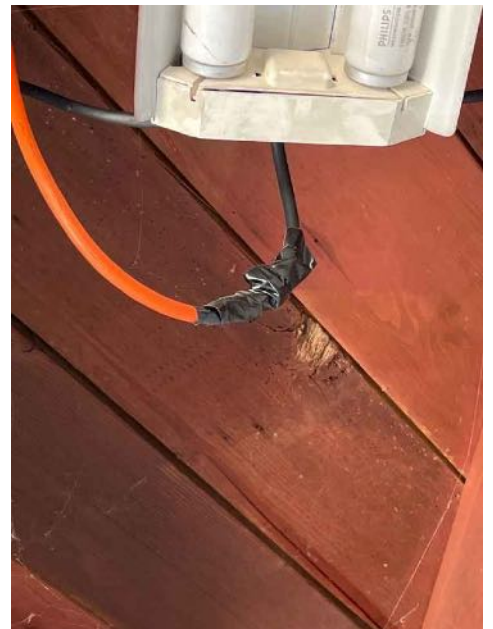
Open wire splices were noted. All splices must be enclosed inside a junction box with a cover. We advise correction by a licensed electrician.

Contact a qualified electrical contractor.

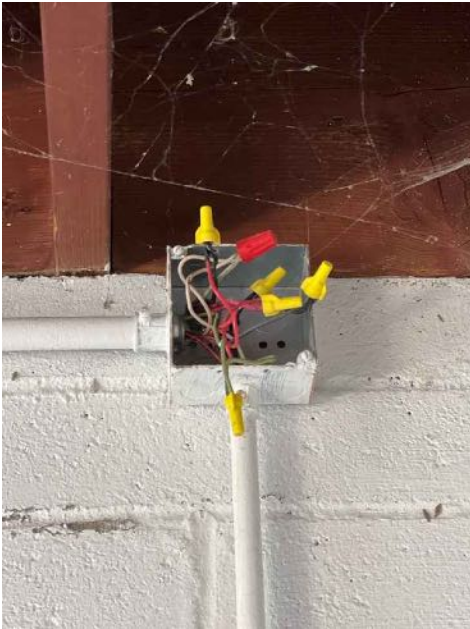
Open junction box noted. Whenever wires are joined together the junction box must have a cover for safety. We advise installing an approved cover plate for safety.

Contact a qualified electrical contractor.

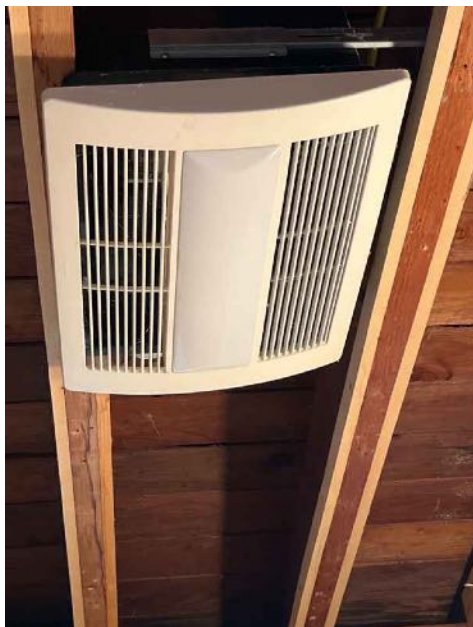
The lights did not function possibly due to bad bulb. Occasionally there is something wrong with the fixture which cannot be determined without working bulbs. We recommend asking the seller to demonstrate that the light is working prior to the end of the inspection contingency period, or changing the bulb and testing again.

Contact a qualified professional.

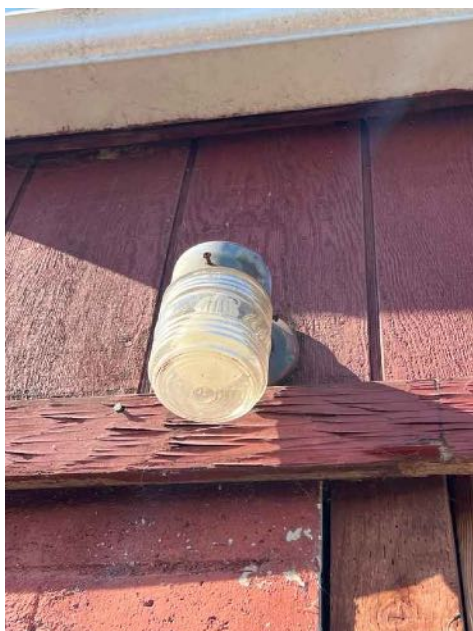
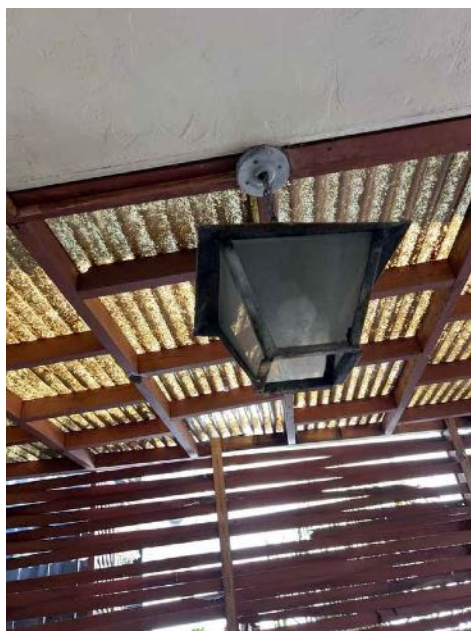
**EXTERIOR LIGHT INOP**

The exterior light fixture(s) did not function when tested. This may be due to a bad bulb or possible electrical problems. Advise changing the bulb and testing. If light fails to work, further repairs may be required by an electrician.

Contact a qualified professional.

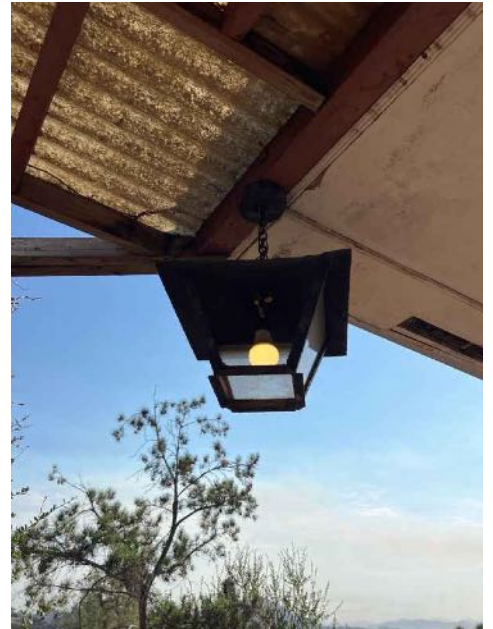
**EXTERIOR FIXTURE DAMAGED**

Damaged exterior light fixture observed. We recommend replacement for safety.

Contact a qualified professional.

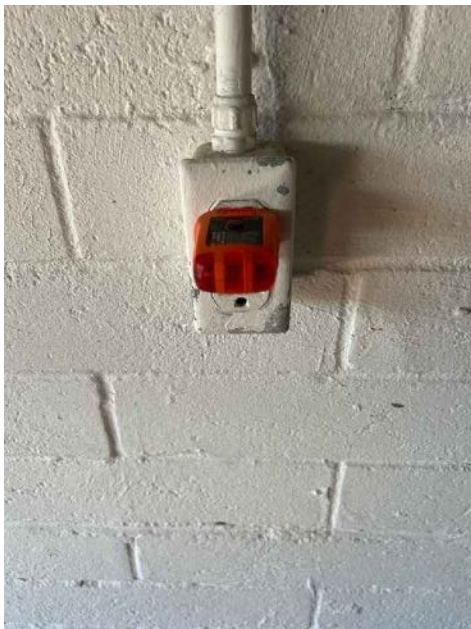
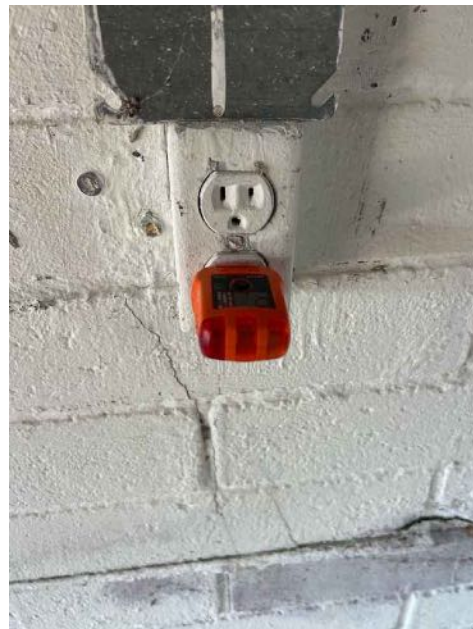
**RECEPTACLE - NO POWER**

A receptacle was not energized at the time of the inspection. We recommend further evaluation and necessary repairs.

Contact a qualified electrical contractor.

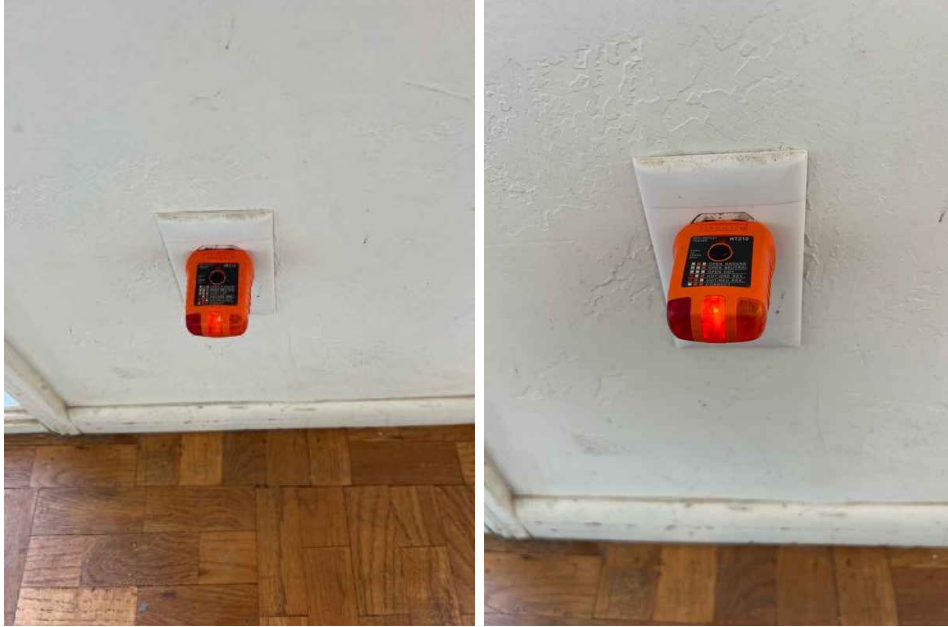
**RECEPTACLES - 2-PRONG AND 3-PRONG - MIXED**

Some of the original two-pronged outlets are still present, and some have been upgraded to three-prong outlets. Most houses built before 1963 will not have 3 prong receptacles in all locations. Appliances/electronics with 3-prong cords are designed to be used only with grounded 3-hole receptacles. A GFCI can provide shock hazard protection for 2-conductor circuits, however, without a ground it may not protect sensitive electronic equipment. You may wish to consult a licensed electrician for an estimate to upgrade the electrical system.

Contact a qualified electrical contractor.

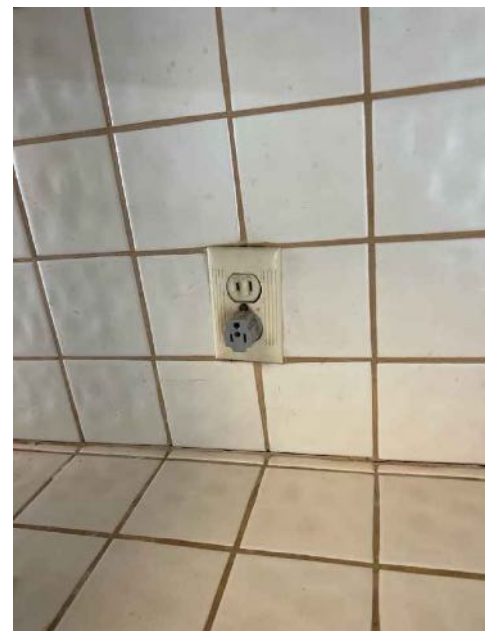
We recommend upgrading all non-fixed appliance receptacles in the kitchen to GFCI-protected receptacles by a licensed electrician.

Contact a qualified electrical contractor.

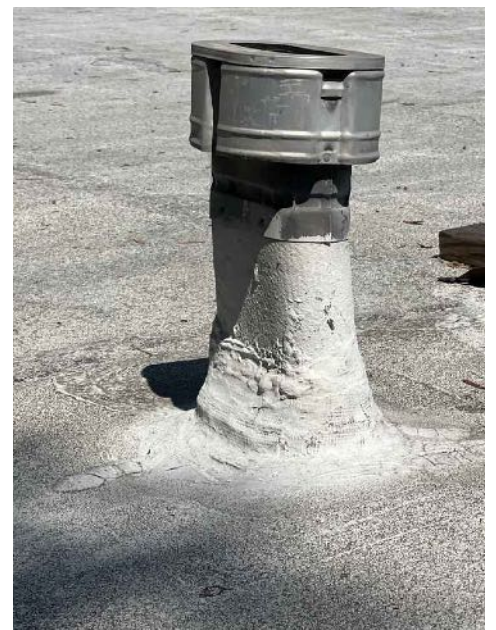
The flue for the furnace may contain asbestos. It is beyond the scope of a home inspection to test for the presence or absence of asbestos. If the flue contains asbestos, there may be additional costs to remove the flue if you upgrade the flue to metal. Inspecting the Transite flue should be part of an annual furnace servicing until it is replaced. We recommend replacement of the Transite flue upon replacement of the furnace, replacement of the roof, or if you are concerned about asbestos.

Contact a qualified professional.

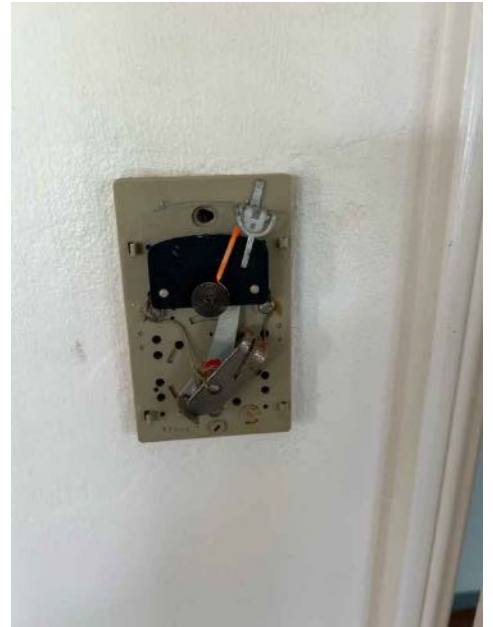
The thermostat was not usable at time of inspection. Due to the inoperability of the thermostat, the HVAC system could not be tested. We recommend repair or replacement.

Contact a qualified heating and cooling contractor

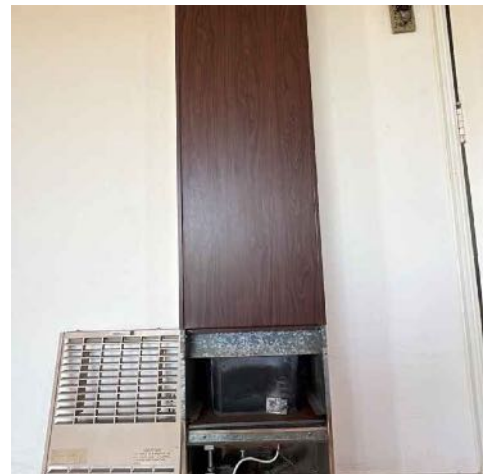
The wall heater did not operate when tested at the time of the inspection. We recommend further evaluation and necessary repair or replacement by a licensed HVAC contractor prior to the end of your contingency period.

Contact a qualified professional.

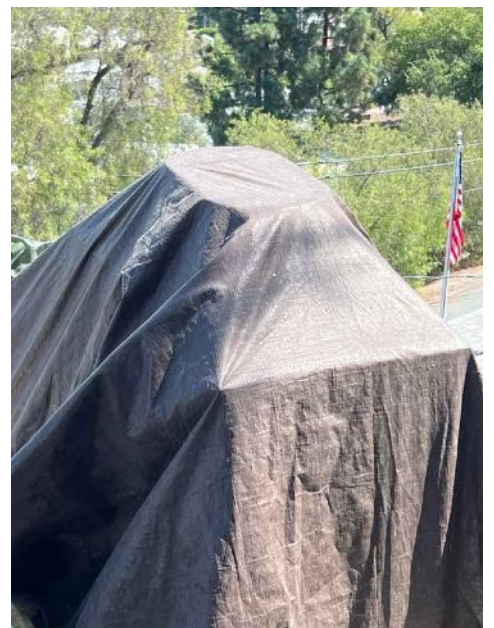
No spark arrester/ rain cap was present. Spark arresters prevent cinders from falling onto the roof which is a fire hazard. The rain cap prevents water from entering the chimney flue. We recommend installing a spark arrester/ rain cap by a qualified person.

Contact a qualified professional.

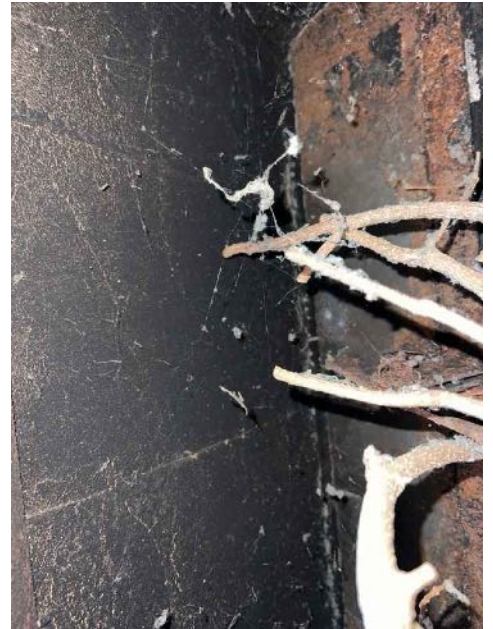
Creosote/soot build-up was noted at the chimney. We advise obtaining professional cleaning.

Contact a qualified chimney sweep.

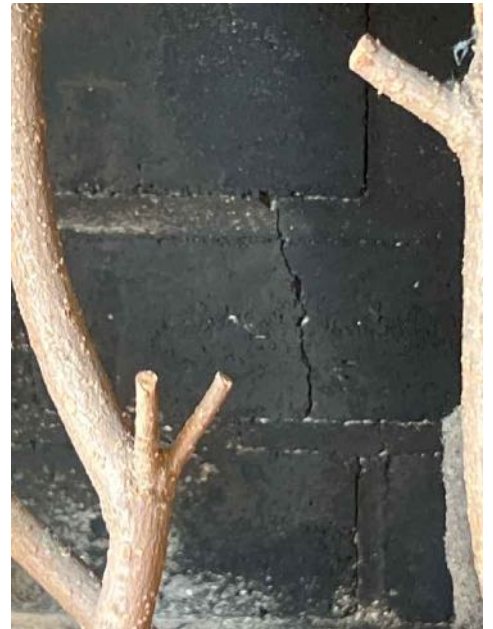
### CRACKS - IN FIREBOX

Cracks were observed in the bricks inside the fireplace. We recommend having these cracks sealed for safety.

Contact a qualified chimney sweep.

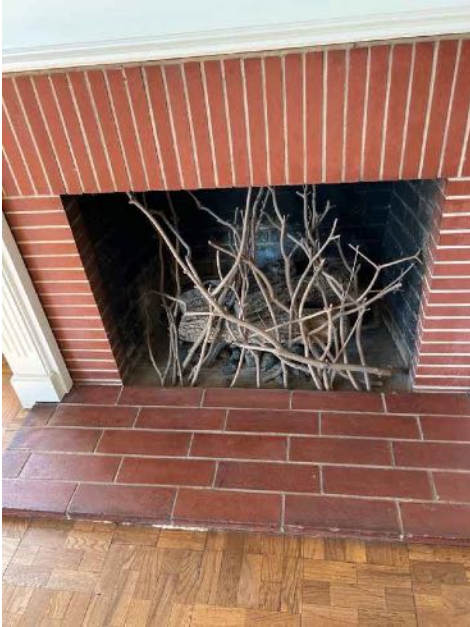
The wood-burning fireplace lacked a spark barrier (screen). This condition is a potential fire hazard as it may allow hot sparks to be deposited on the combustible floor-covering material. We recommend providing a means for containing fireplace sparks such as a screen.

Contact a qualified professional.

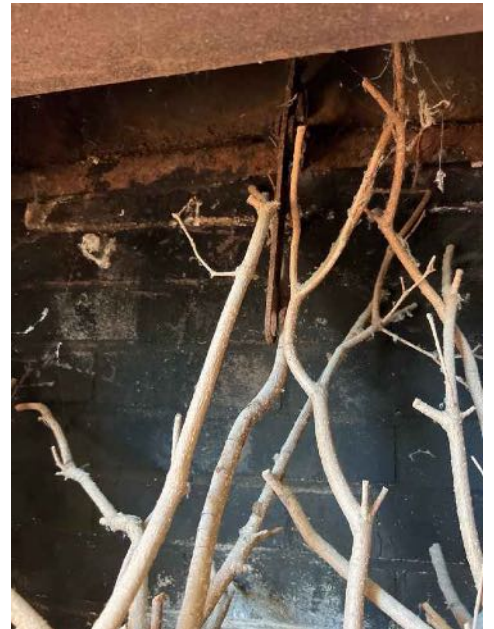
#### **DAMPER - INOP/DAMAGED**

The damper was inoperable or damaged. We recommend repair by a licensed or Chimney contractor.

Contact a qualified fireplace contractor.

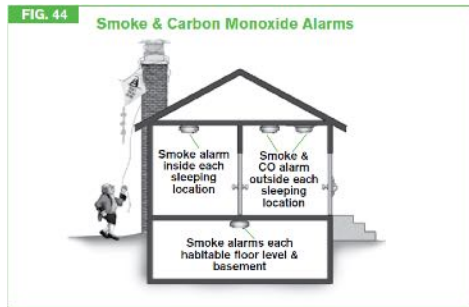
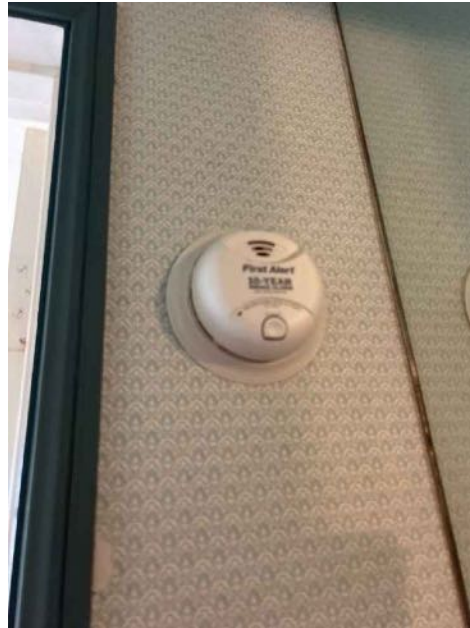
Recommendation or Safety Upgrade
**IN HALLWAY(S) ONLY - MORE NEEDED**

One smoke detector was present in the common hallway. California State Law SB 745 requires additional smoke detectors to be installed in all bedrooms and on each level in the common hallways in multi-story homes when modifications have been performed including alterations, repairs, or additions exceeding \$1,000 in value. Additional smoke detectors are also required in all dwellings intended to be used as rentals regardless of modifications.

Contact a qualified professional.

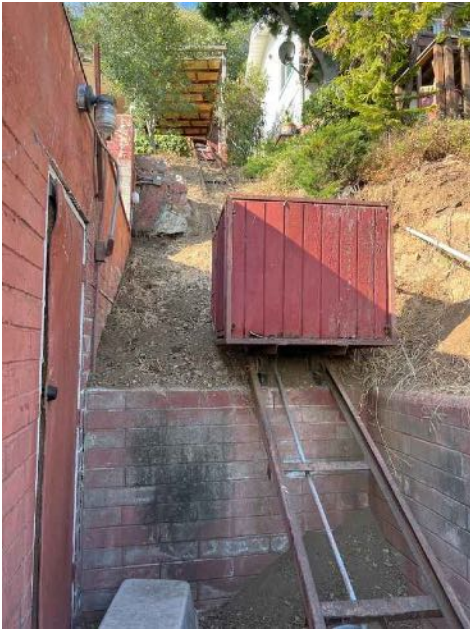
### **ELEVATOR - NOT INSPECTED**

The elevator and its equipment was not inspected or tested. We advise having the system checked by a qualified elevator specialist before the close of your contingency period.

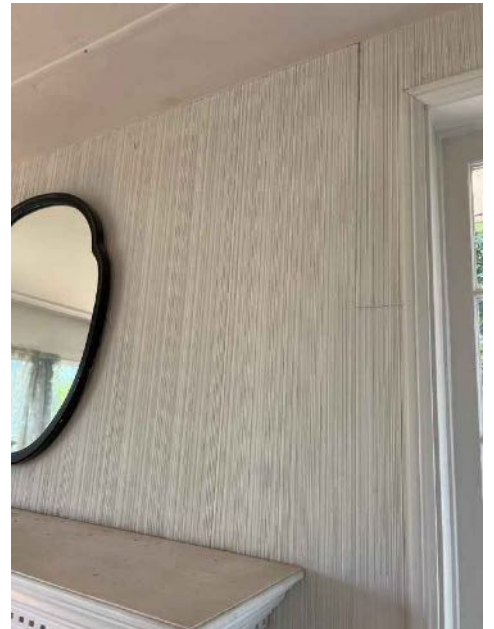
Note: Several areas of interior walls were covered in wood paneling or wallpaper, therefore much of the drywall was not observable for stains, water damage, water intrusion, mold, cracks or other hidden defects that may warrant a further evaluation. Do to the concealed nature of the walls, much of the drywall and surrounding areas were not visible.

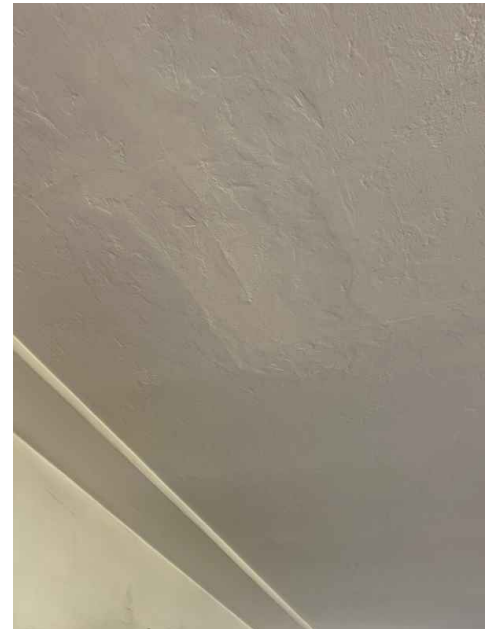
### **PATCHING - NOTED DRY**

Patching was noted at the ceiling. The area was tested for moisture and found to be dry at time of inspection. We recommend asking seller if they have knowledge of the repair or cause.

Contact the seller for more info

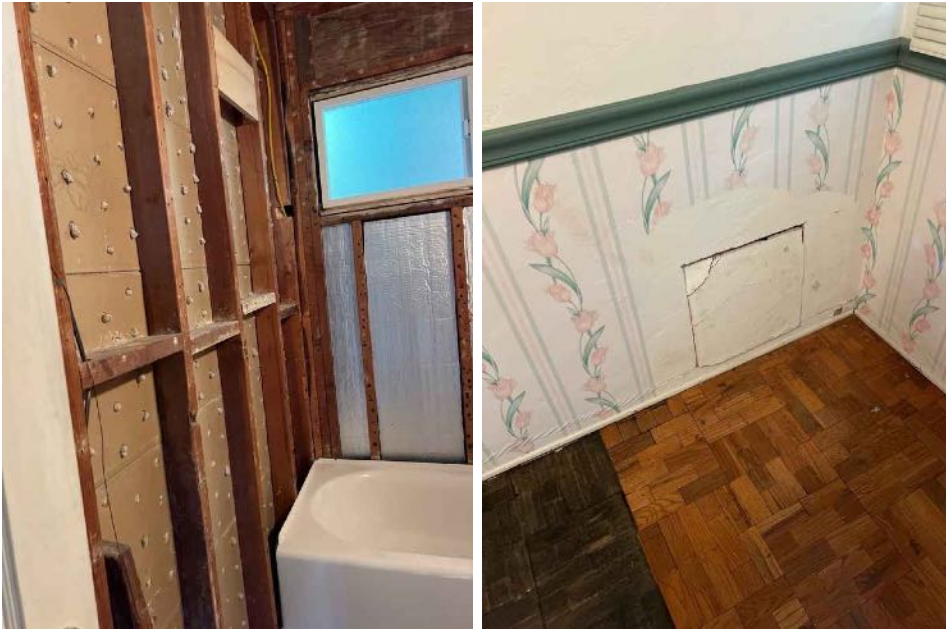
### **DRYWALL DAMAGED**

Drywall was damaged. We advise repair with qualified person.

Contact a qualified drywall contractor.

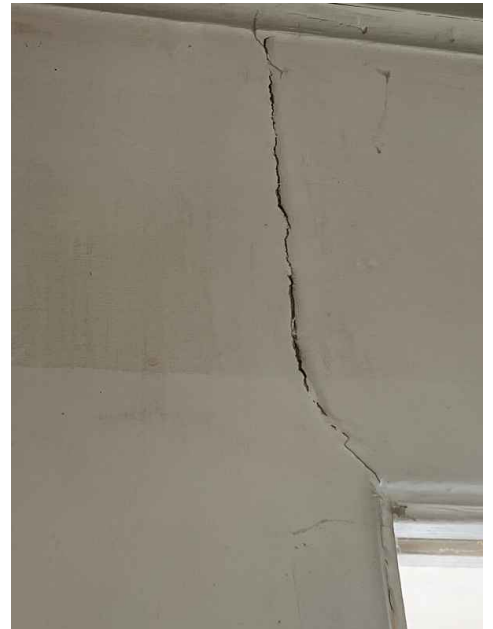
**CRACKS - HAIRLINE**

Hairline cracking was observed on the wall(s). These hairline cracks are likely due to material shrinkage or settlement of the structure. We recommend patching and painting with a qualified person.

Contact a qualified professional.

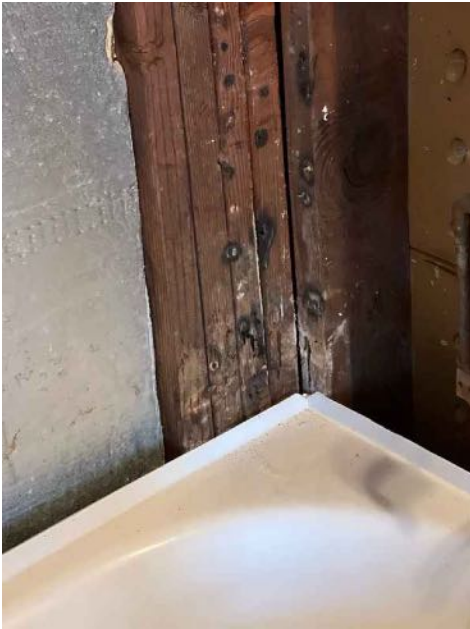
**STAIN DRY - UNKNOWN**

Staining was noted on the wall. The staining was tested for moisture and found to be dry at the time of the inspection. The inspector was unable to determine the cause.

Contact a qualified professional.

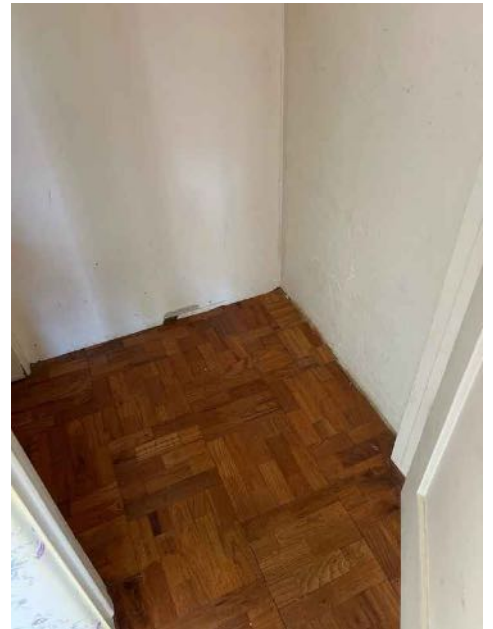
### BASE BOARDS - MISSING

Baseboards are missing in several areas throughout the house. We recommend replacing where needed by a qualified person.

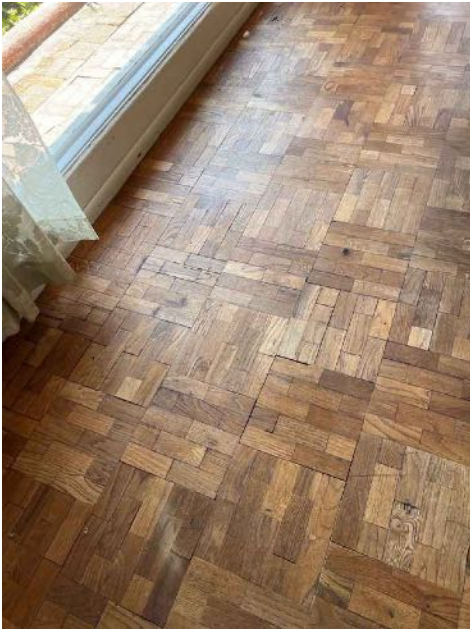
### FLOORS-WORN

Wood floors in the home exhibited severe surface wear along major paths of travel. We recommend that before the expiration of your contingency period you consult with a qualified flooring contractor to discuss repair and costs for replacement.

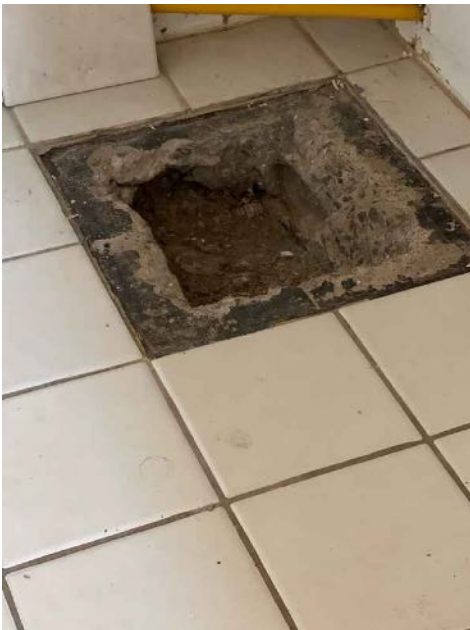
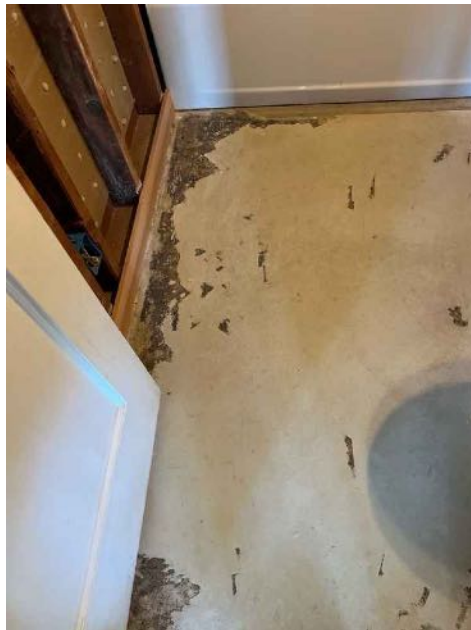
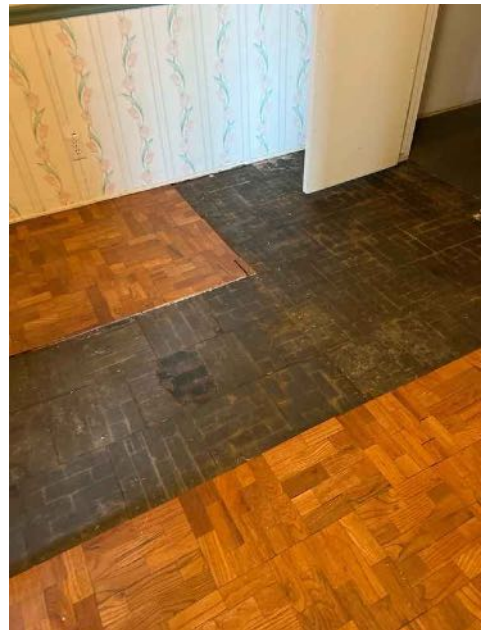
**POORLY INSTALLED OR INCOMPLETE FLOORING**

Flooring in several locations has gaps and missing thresholds. This is typically caused by a poor or incomplete installation of the floor. We recommend correction or replacement by a licensed flooring contractor.

Contact a qualified flooring contractor

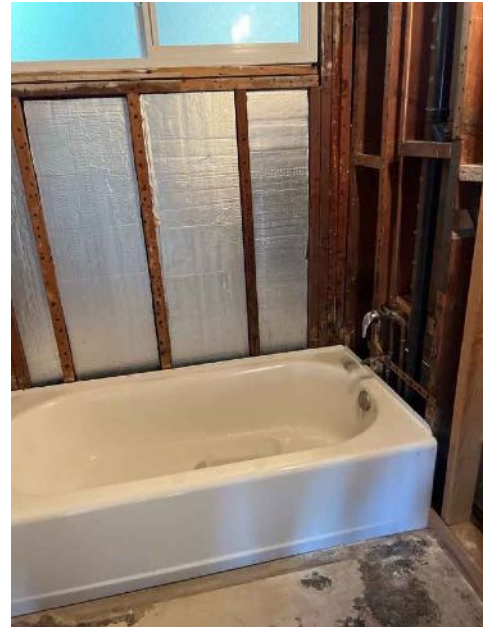
HALL BATHROOM

The tub/shower enclosure was incomplete at the time of inspection.

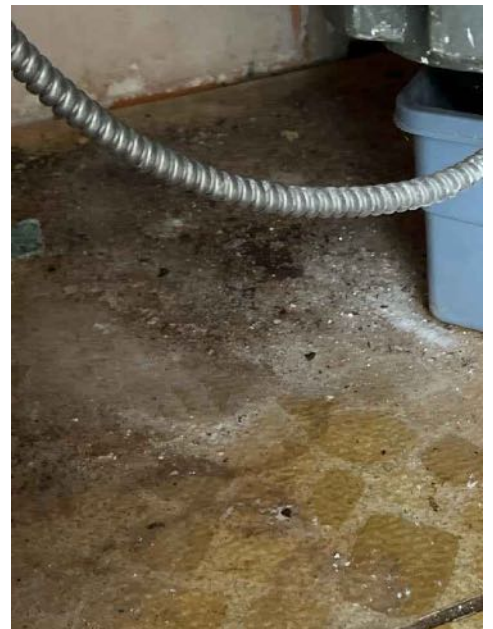
**STAINS DRY - CABINET - PAST LEAK**

Staining was noted in the cabinet below the sink. The staining was tested for moisture and found to be dry at the time of the inspection. Appears to be caused by a past leak. Under certain conditions or regular use, the leak may become active. We advise reviewing with the seller for repair history.

Contact the seller for more info

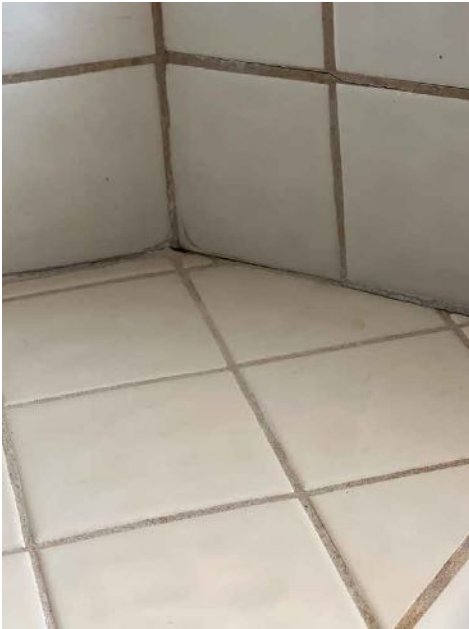
We recommend caulking along the counter and back splash.

Contact a handyman or DIY project

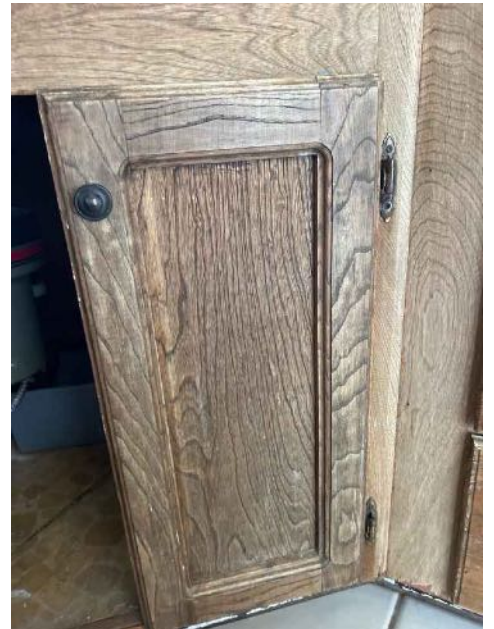
**FINISH WORN - CABINETS**

The cabinets are worn, delaminating or show signs of water damage. Recommend review by a qualified cabinet professional.

Contact a qualified cabinet contractor.

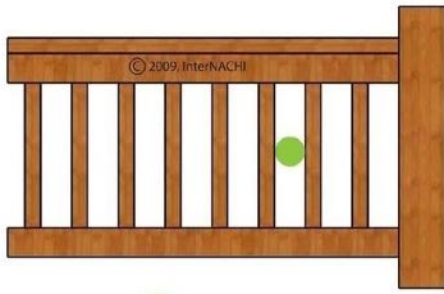
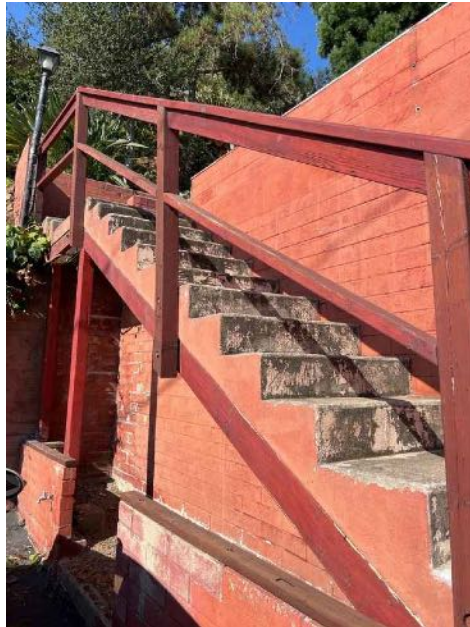
**RAILING - SPACING**

While the railing/baluster spacing may have been standard at time of construction, it does not comply with current safety standards. The large openings can allow pets or children to fall through, or become entrapped. We recommend installing additional balusters, or other form of barrier to prevent injuries.

Contact a qualified professional.

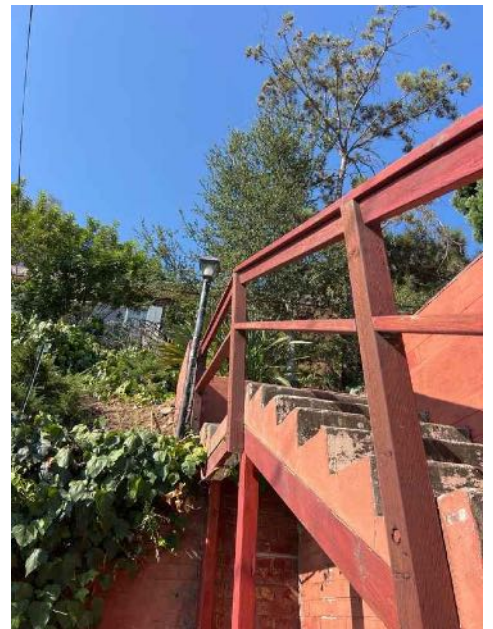
**GUARDRAIL - HORIZONTAL**

Horizontal guardrail components make the guardrail assembly climbable. Generally-accepted modern safety standards mandate that the guardrails should not be climbable. This condition may be hazardous to small children. We recommend further review and correction by a qualified contractor.

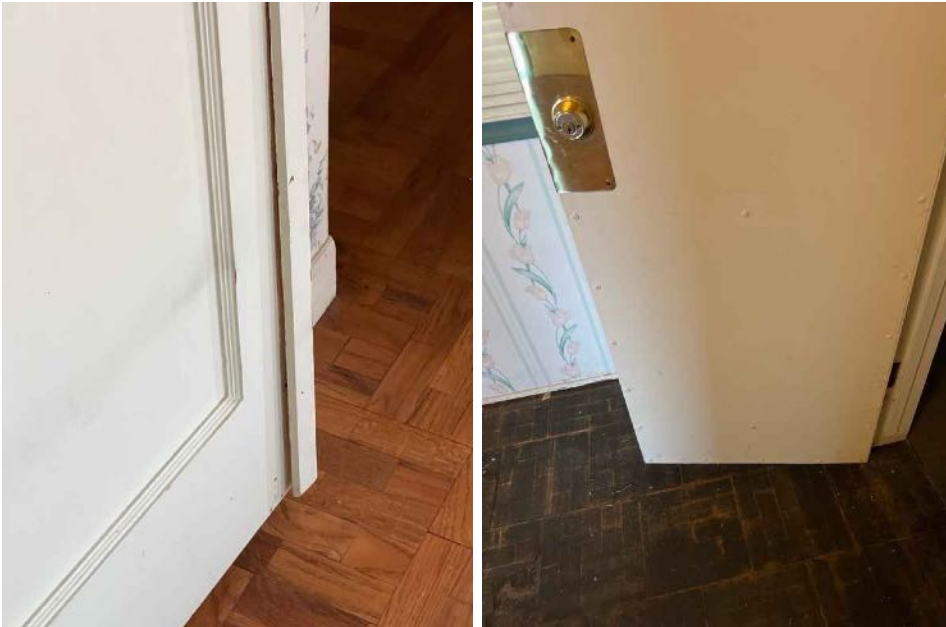
**HOLE DAMAGE**

A hole or damage was noted in door. We advise replacing.

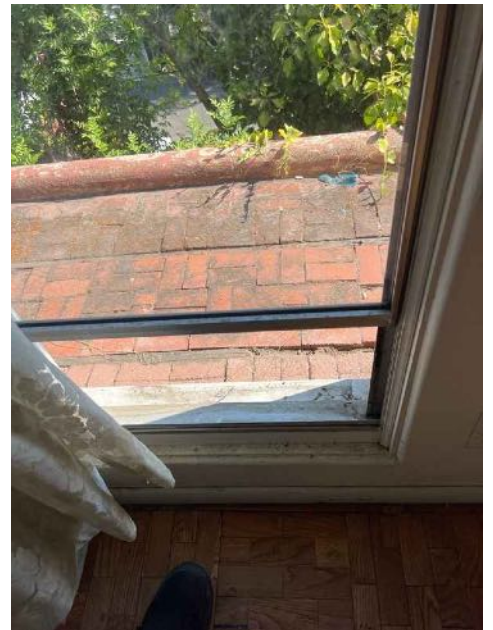
**SCREENS - MISSING**

Several screens are missing or damaged. We recommend repair or replace as needed by a qualified person.

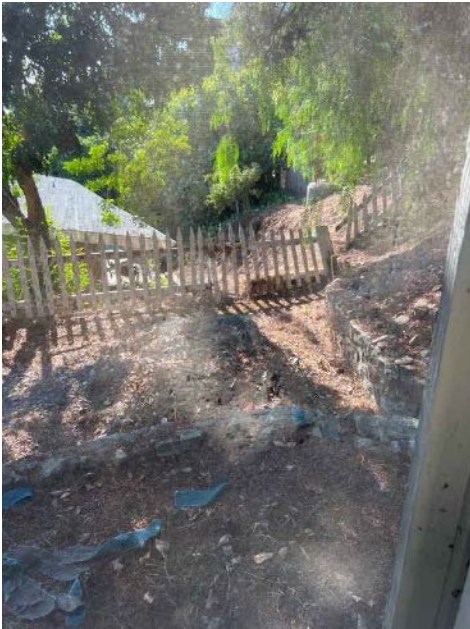
**SCREEN - TORN OR DAMAGED**

The window screen was observed torn or damaged. We recommend repairs or replacement

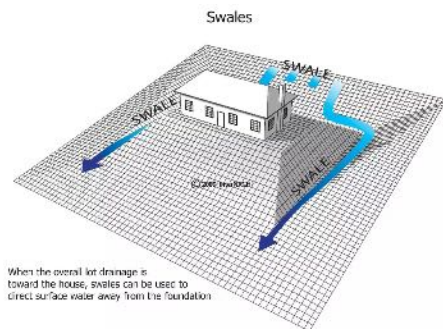
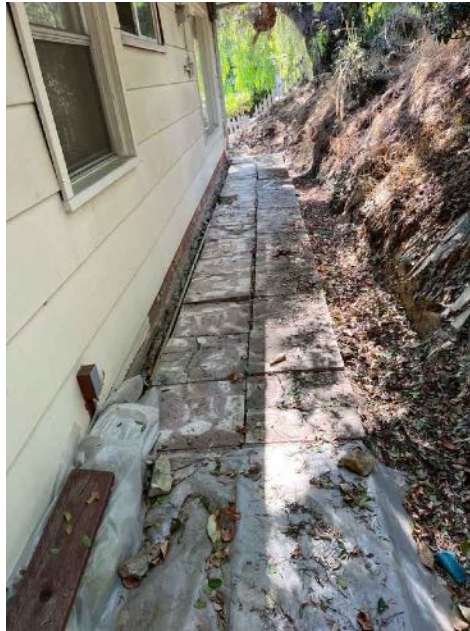
Low areas were observed at the grading which will cause water to pond during rain or extended irrigation. Standing water can be detrimental to the integrity of the foundation of the house. It is important to prevent or minimize standing water around the house. This can be accomplished by properly sloping the ground away from the house, or adding yard drains to carry water away from the low-lying areas. Rain gutters should also be installed and drained away from the house. We recommend further evaluation by a qualified landscape contractor.

Contact a qualified landscaping contractor

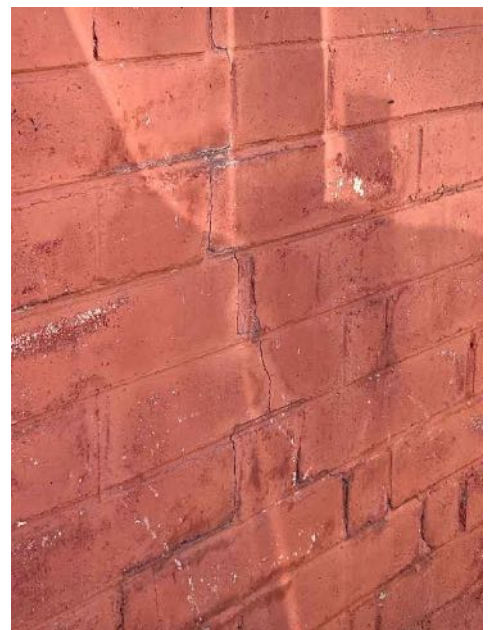
## RETAINING WALL -SMALL CRACKS

Typical shrinkage/settlement crack(s) was observed at the retaining wall. Cracks can appear in a retaining wall for a wide variety of reasons, some of which may not be apparent at the time of the inspection. Cracks less than 1/8-inch that do not exhibit displacement are typically not considered to be an issue unless they appear in conjunction with another condition. Note: The inspector can not observe the footings and is unable to determine if the wall is properly constructed/permitted or determine the potential for future movement.

Recommend monitoring.

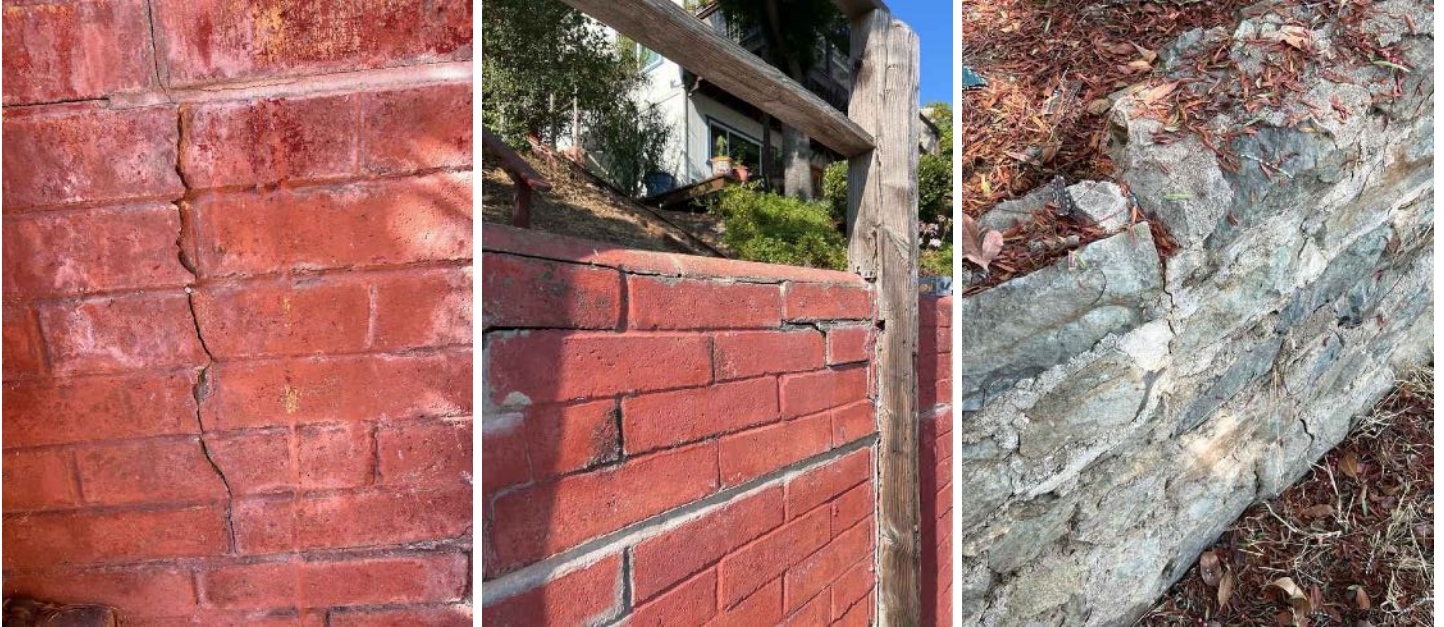
The retaining wall shows some settlement cracks. Cracks in a retaining wall can be caused by many reasons which may include improper design or ground movement. Determining the cause of the settlement cracks is beyond the scope of a home inspection. We recommend further evaluation by a qualified contractor or a structural engineer prior to the end of your contingency period.

Contact a qualified professional.

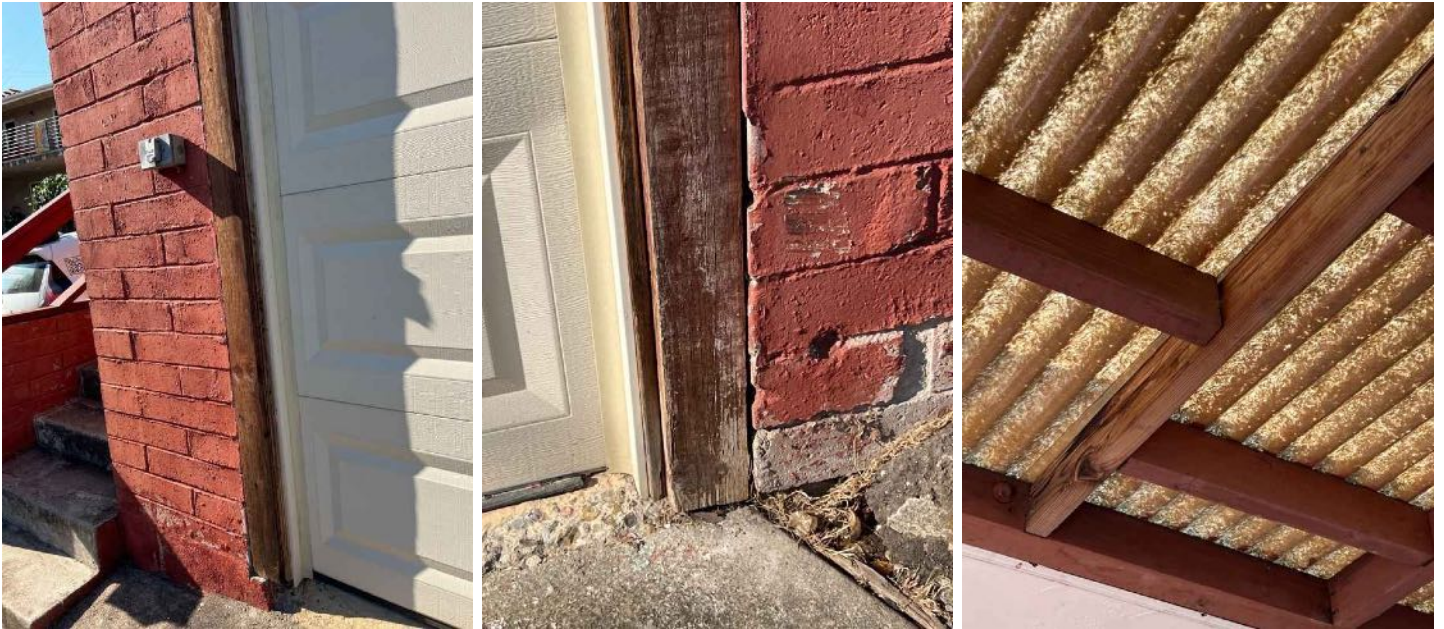
### BARE WOOD OR PEELING PAINT

Bare wood or peeling paint was observed and needs primer and paint. Maintaining paint is essential to preventing the wood from damage.

Contact a qualified painting contractor.
