## HOME INSPECTION

8167 Vista Dr  
La Mesa, CA 91941

09/10/2024

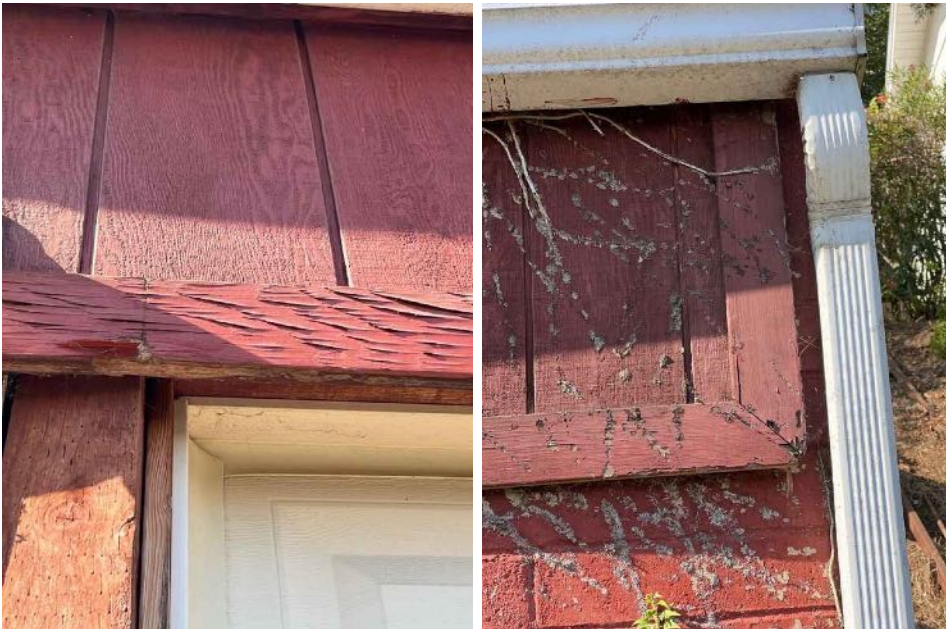
**DAMAGED WOOD TRIM**

Some damaged wood was observed at the exterior. We recommend referring to the pest inspection report for a detailed evaluation of the wood and repair with qualified contractor.

Contact a qualified pest control specialist.

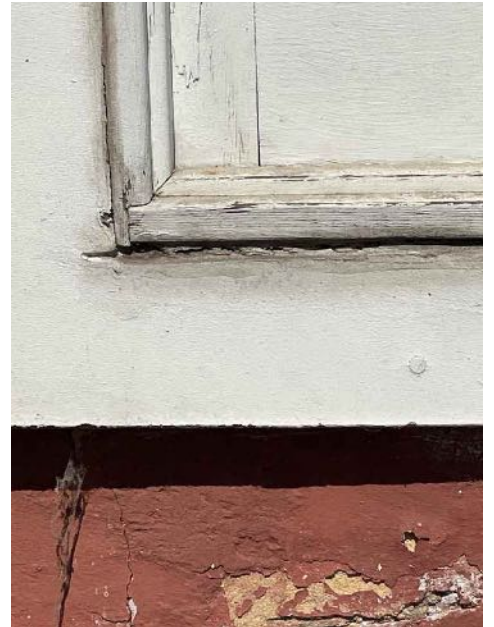
**SIDING - FAILING**

Siding is failing at nail heads and end cuts. Water absorption is present and blisters and deterioration are observed. We recommend repair or replacement as necessary.

Contact a qualified siding specialist.

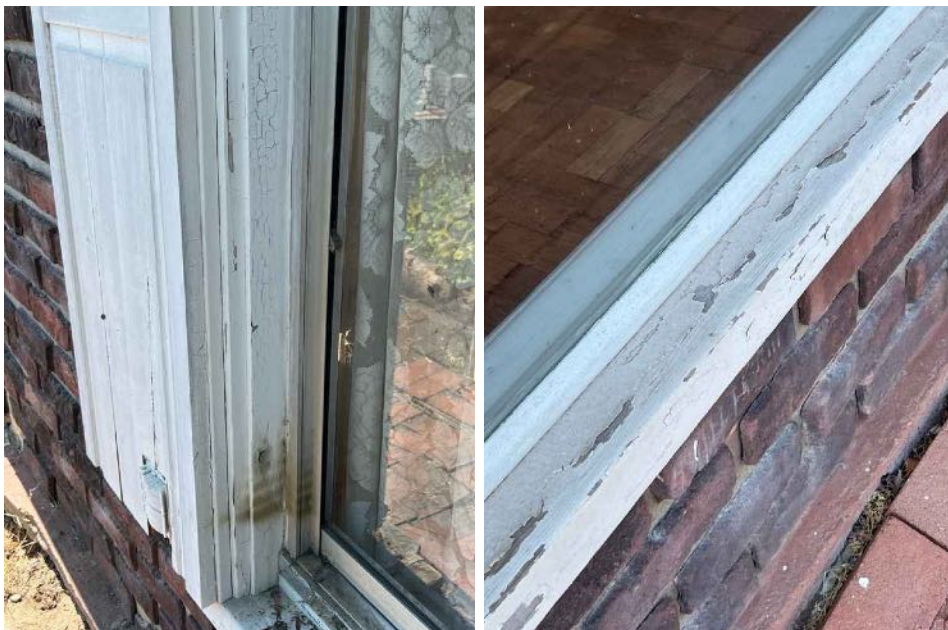
##### **SIDING/TRIM - PAINT FAILING**

Paint is worn and failing on siding/trim. We recommend prep and paint as needed to protect the siding by a qualified paint contractor.

Contact a qualified painting contractor.

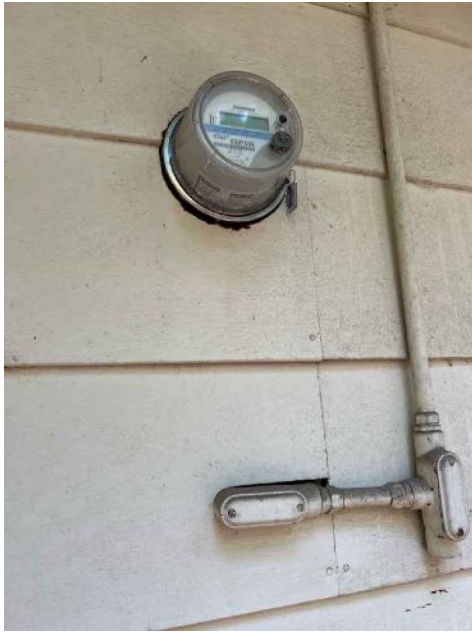
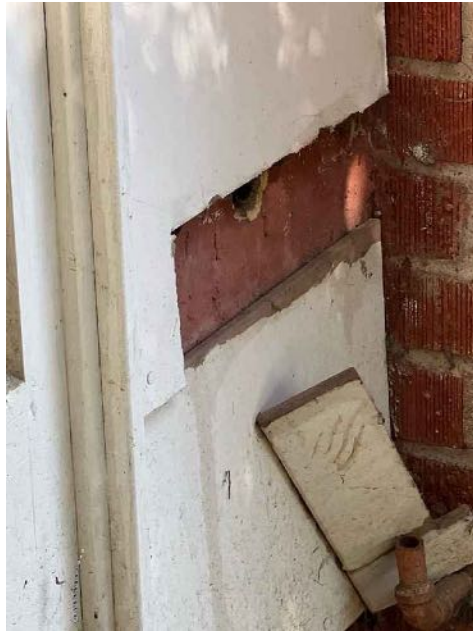
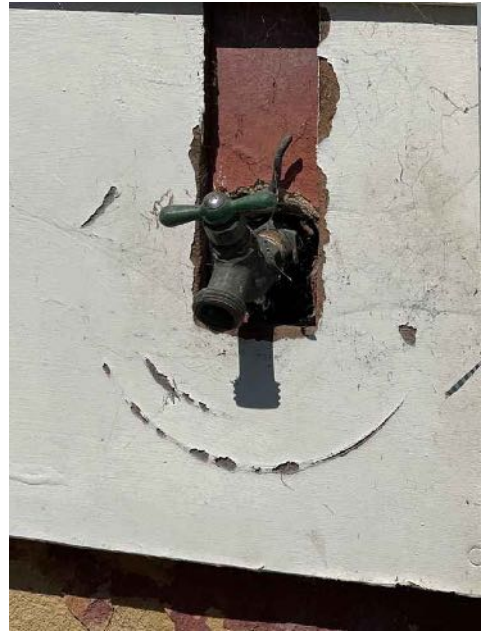
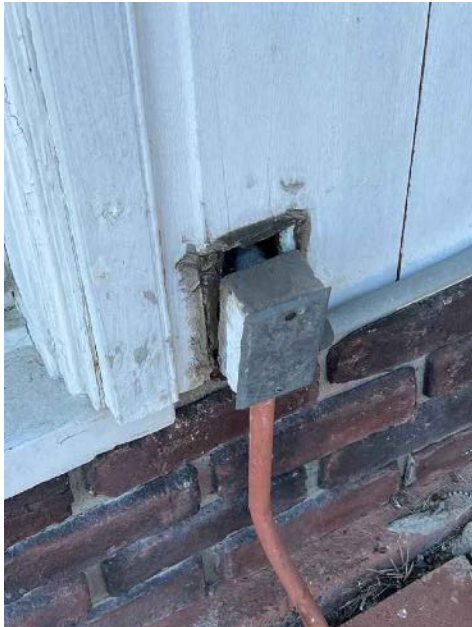
##### **SIDING - HOLE**

A hole or gap was observed in the siding. We recommend sealing the hole(s) to prevent rodent or water intrusion.

Contact a qualified professional.

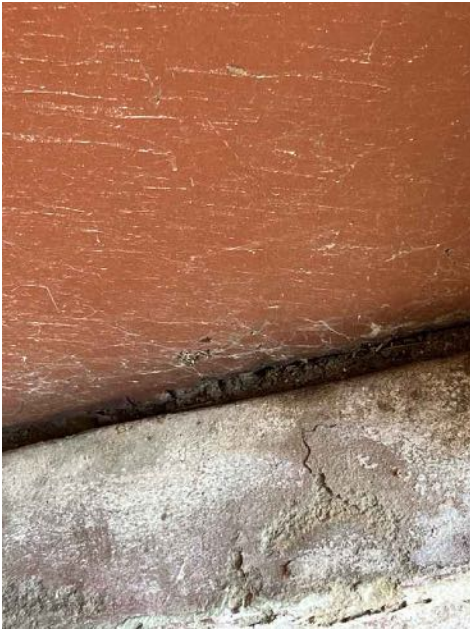
**WOOD DAMAGE  
DOOR(S)/FRAME**

Some damaged wood was observed at the exterior door(s)/frames. We recommend referring to the pest inspection report for a detailed evaluation of the wood.

Contact a qualified pest control specialist.

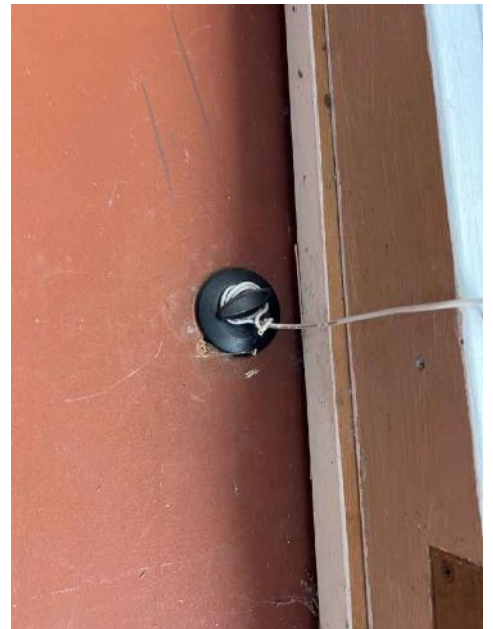
**HARDWARE - MISSING/DAMAGED**

Contact a qualified professional.

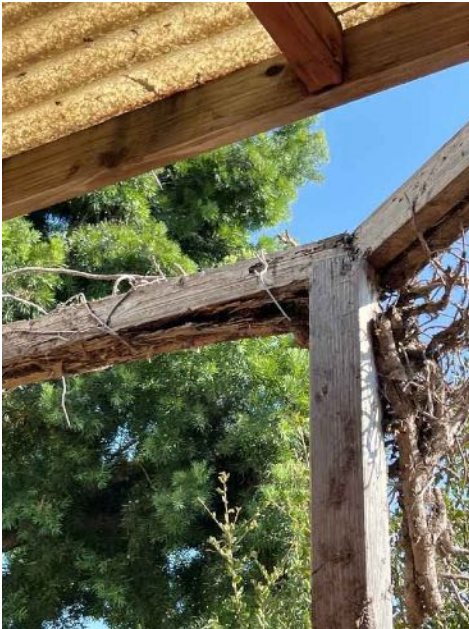
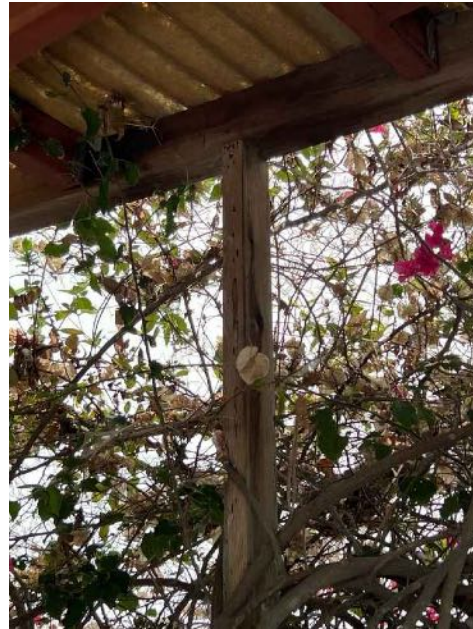
10.10.2 DRIVEWAYS, PATIOS, WALKWAYS

### **PATIO COVER- ROT/FUNGUS/TERMITE**

Dry rot/wood damage or fungus-like growth was observed at the wood patio cover. Home inspectors do not have the authority to comment on termites or dry rot, which is the responsibility of a state licensed pest inspector. However, we recommend further review and repair by a qualified licensed contractor for safety. An estimate of repair should be obtained before the close of your contingency period.

Recommendation

Contact a qualified pest control specialist.

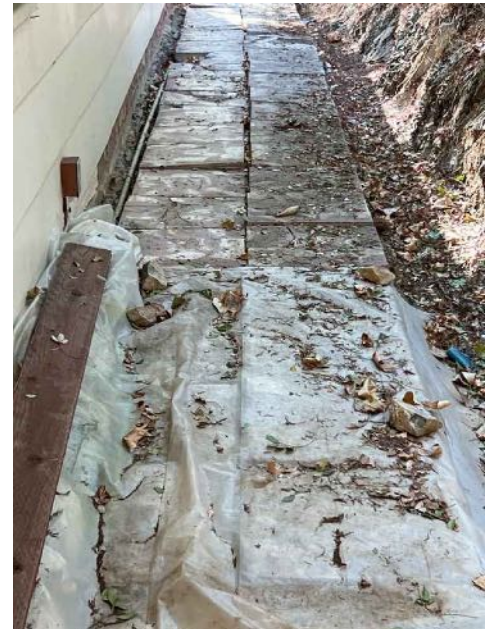
10.10.3 DRIVEWAYS, PATIOS,  
WALKWAYS

**PATIO - TILES - LOOSE**

Tiles on the patio are loose and/or deteriorated. Loose tiles can be a tripping hazard. We recommend repair by a qualified person.

Recommendation

Contact a qualified professional.

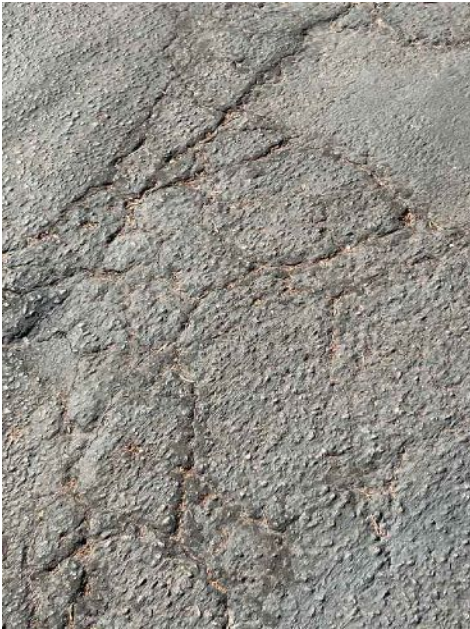
10.10.4 DRIVEWAYS, PATIOS,  
WALKWAYS

**ASPHALT DETERIORATED**

The asphalt driveway is cracked and deteriorated. We recommend that you obtain a quotation for repair prior to the end of your contingency period.

Recommendation

Contact a qualified professional.

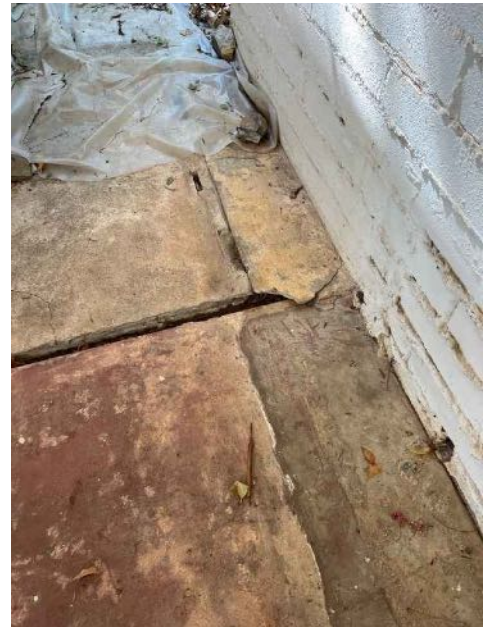
10.10.5 DRIVEWAYS, PATIOS,  
WALKWAYS

### **PATHWAY - TRIP HAZARD**

Tripping hazard exists at the pathway. We recommend repair to avoid injuries.

Recommendation

Contact a qualified professional.

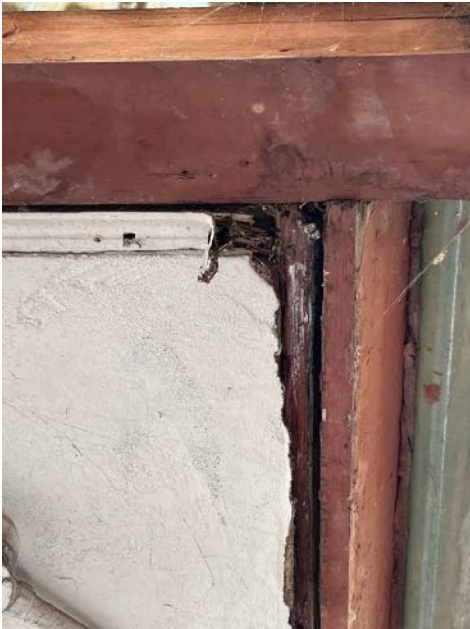
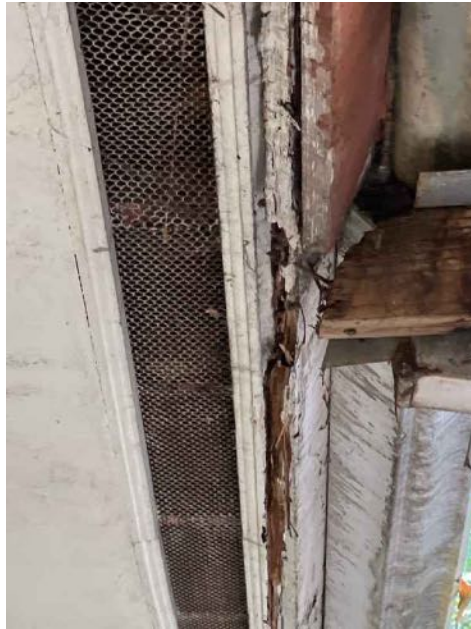
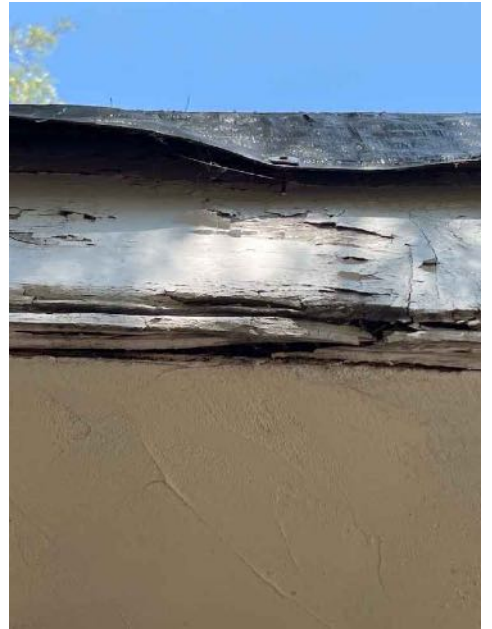
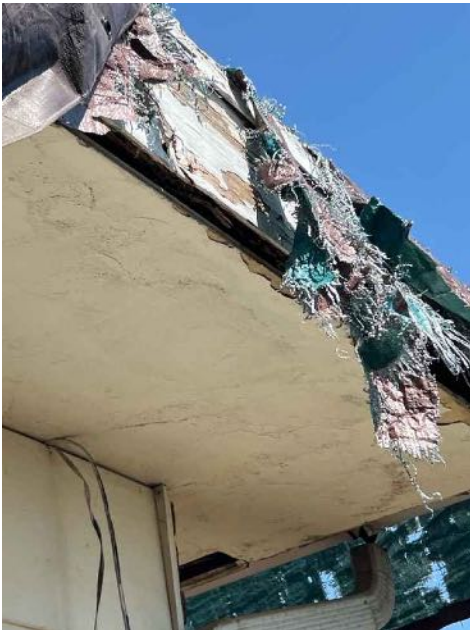
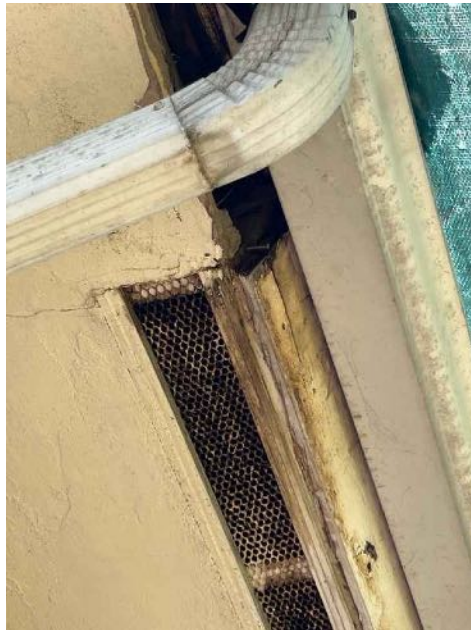
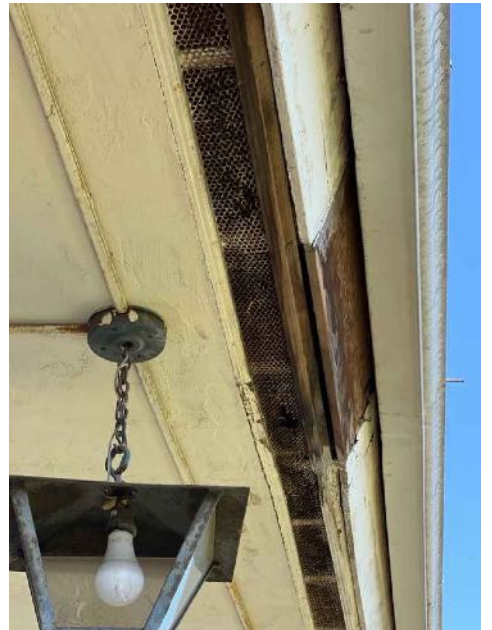
10.11.1 EAVES, SOFFITS AND FASCIAS

### **FASCIA/EAVES - TERMITES/ROT**

Some damaged wood was observed at the eaves or fascia boards. Determining if this damage was caused by termites is beyond the scope of a home inspection. Home inspectors do not have the authority to comment on termites or dry rot, which is the responsibility of a state-licensed pest inspector. We recommend referring to the pest inspection report for a full evaluation and necessary repairs made by a qualified licensed contractor.

Recommendation

Contact a qualified pest control specialist.

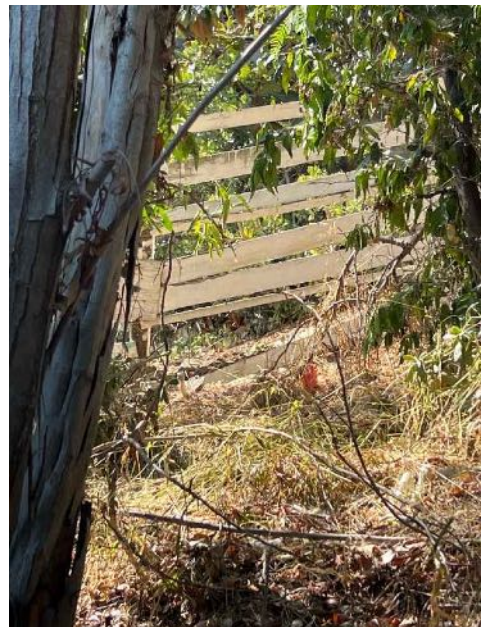
10.12.1 FENCE, LANDSCAPE WALLS, BOUNDARY WALLS

**FENCE LOOSE**

The fence is loose, leaning, and deteriorated in several areas. We advise necessary repairs or replacing as needed by a licensed contractor.

Recommendation

Contact a qualified fencing contractor

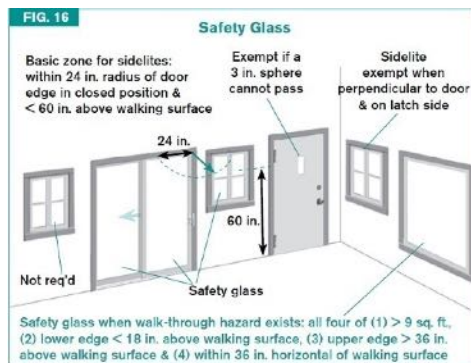
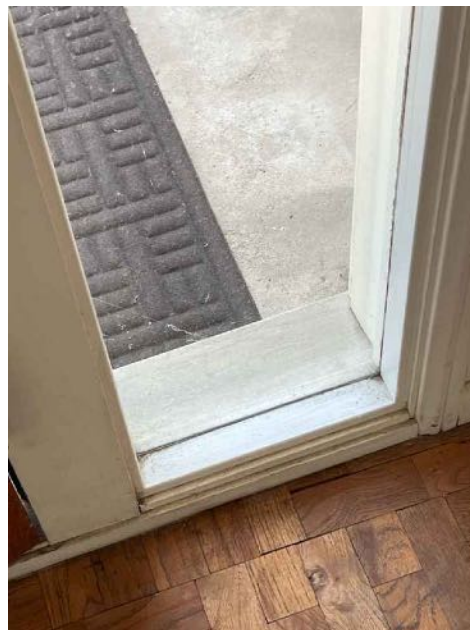
## 10.13.1 SAFETY GLASS

Recommendation or Safety Upgrade
**OLDER HOME - NO SAFETY GLASS**

Homes built before 1979 may not have safety glazing (glass) where it is required in newer homes. Regular plate glass that is subject to human impact can cause injuries. Locations that have a higher probability of human impact are now required to have safety or tempered glass. These areas include sliding glass doors, windows or glass doors around tubs and showers, windows at stairwell landings, windows low to the ground, and windows that may be damaged either by a swinging door or by someone being pushed into the glass by a swinging door. Therefore glass inserts at doors and adjacent to doors should be safety glass.

Since plate glass was acceptable at time of construction, home inspectors can only recommend upgrades for safety, but sellers do not have to bring an old house up to today's building code. Also some safety glass cannot be identified without specialty testing equipment which home inspectors do not use. We recommend that you read "[Safety Glazing](#)" by Douglas Hansen for more information, and upgrade windows as needed for safety.

## Recommendation

Contact a qualified window repair/installation contractor.

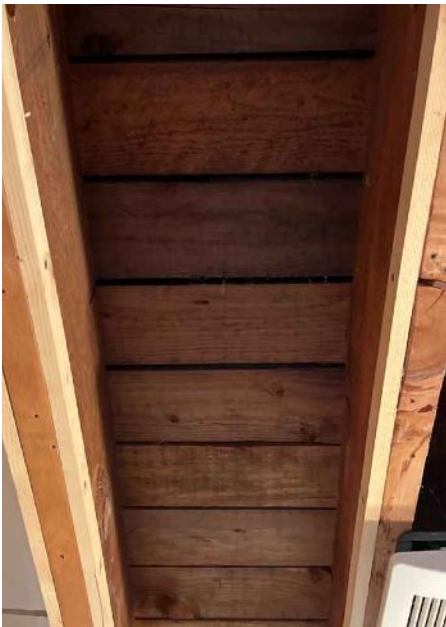
**ROOF SHEATHING (As observable from attic): No Solid Sheathing**

No roof sheathing was present. For a future re-roof one major cost may be the need to re-sheet your entire roof deck with plywood, so that it is a solid wood deck, which is currently required by building standards. The original roof was installed over what's called an open-spaced deck. Typically it's composed of 1×6 deck boards spaced about 4-5 inches apart. These gaps don't work with some more modern materials, such as concrete tiles.

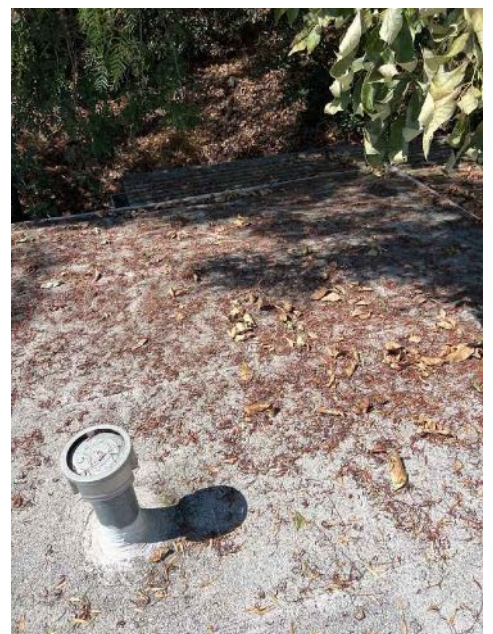
11.2.1 ROOF COVERINGS (Surface of roofing materials)

Excessive leaves and debris were noted on the roof. Leaves and debris can hold unwanted moisture on the roof. We advise professional cleaning.

Recommendation

Contact a qualified professional.

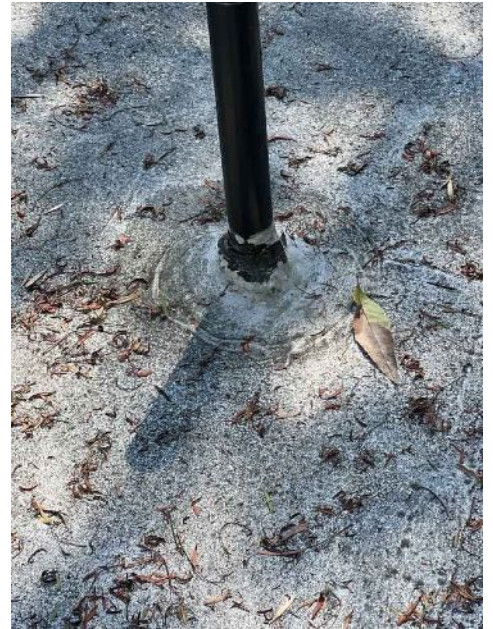
### 11.3.1 FLASHINGS/ROOF PENETRATIONS

#### SEALANT CRACKED - VENTS

The sealant around flashings is cracked. We advise further corrections by a licensed roofer.

Recommendation

Contact a qualified roofing professional.

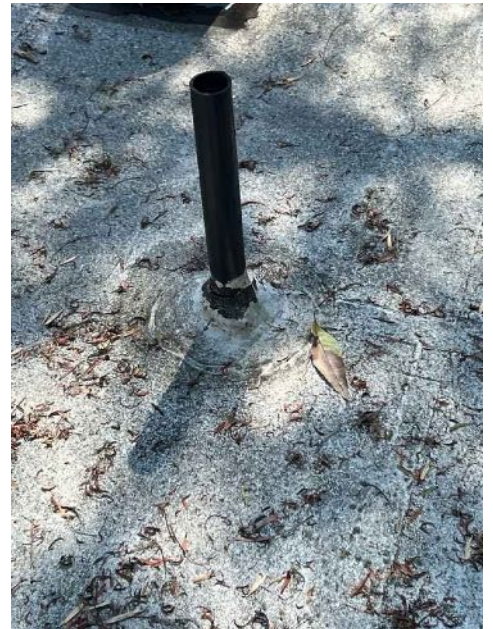
### 11.3.2 FLASHINGS/ROOF PENETRATIONS

Sheet metal flashings and ABS plumbing vents were not painted. Paint is required at the ABS vents and recommended at exterior sheet metal. We advise corrections with qualified painter.

Recommendation

Contact a qualified painting contractor.

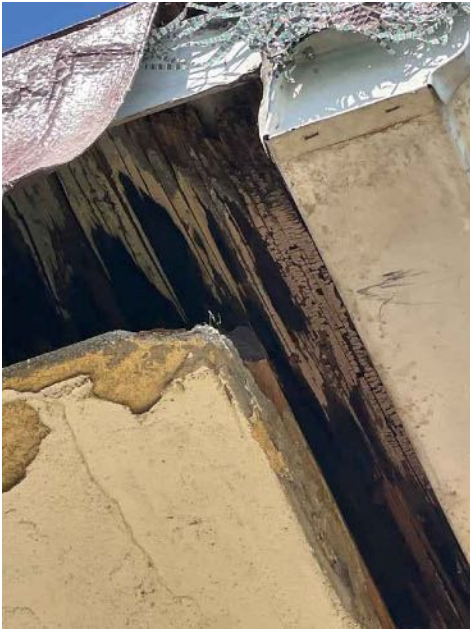
### 11.4.1 ROOF SHEATHING (As observable from attic)

#### SHEATHING - DRY ROT

Damaged wood was noted at the roof sheathing in the attic. This may indicate that a leak did or still does exist. We recommend evaluating the pest inspection report for a detailed evaluation of the wood, and also having a licensed roof contractor inspect the roof to determine the integrity of the roof prior to the end of your contingency period.

Recommendation

Contact a qualified roofing professional.

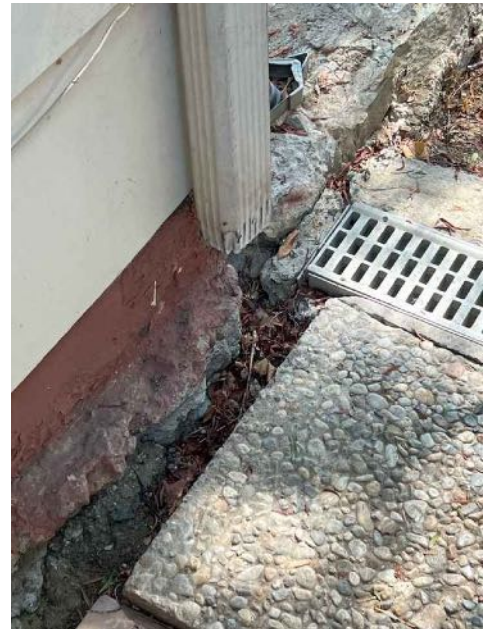
### 11.5.1 ROOFING DRAINAGE SYSTEMS (Rain Gutters, Scuppers)

#### **DNSPOUT ELBOW**

Maintenance Item

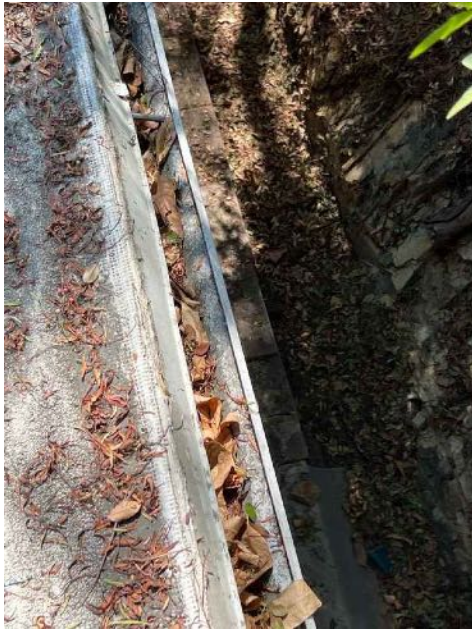
### 11.5.2 ROOFING DRAINAGE SYSTEMS (Rain Gutters, Scuppers)

#### **GUTTERS - DEBRIS 1**

Gutters are full of debris in areas and need to be cleaned. The debris in gutters can also conceal rust, deterioration, or leaks that are not visible until cleaned, and I am unable to determine if such conditions exist. We recommend having them cleaned and checked by a qualified person.

Maintenance Item

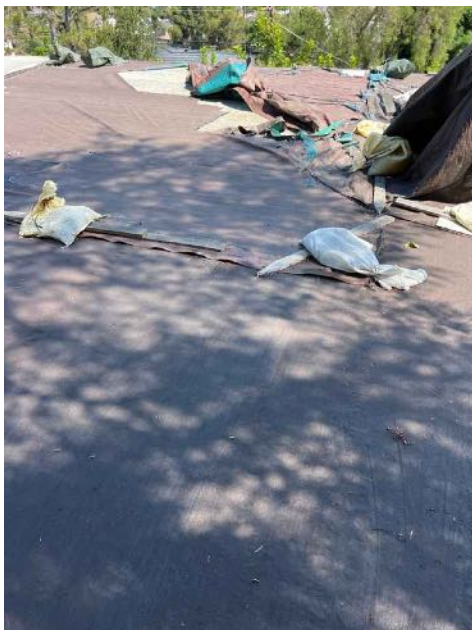
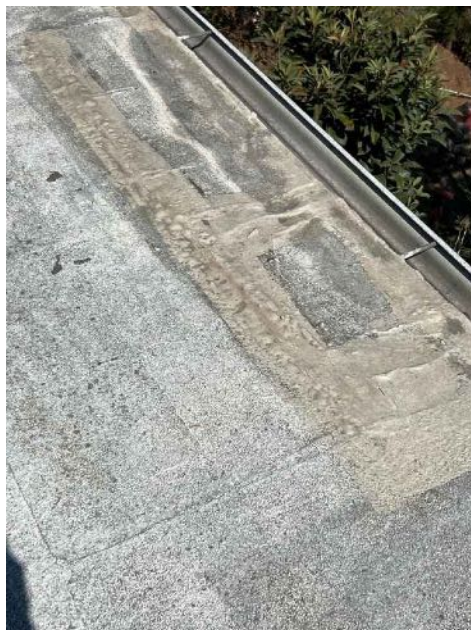
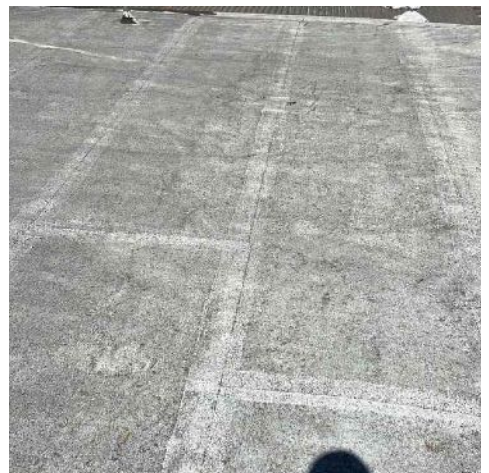
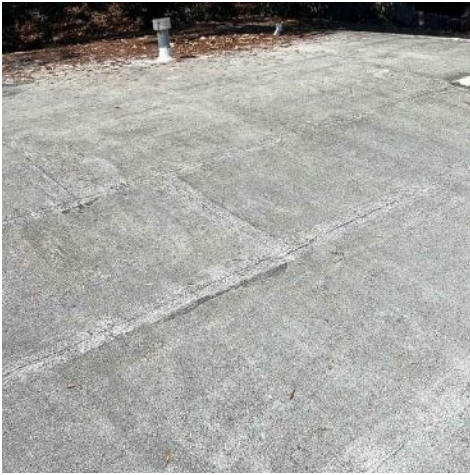
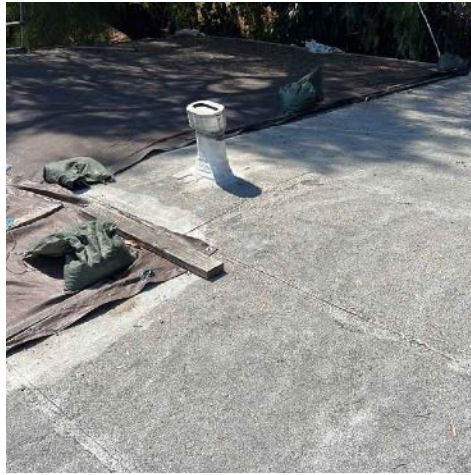
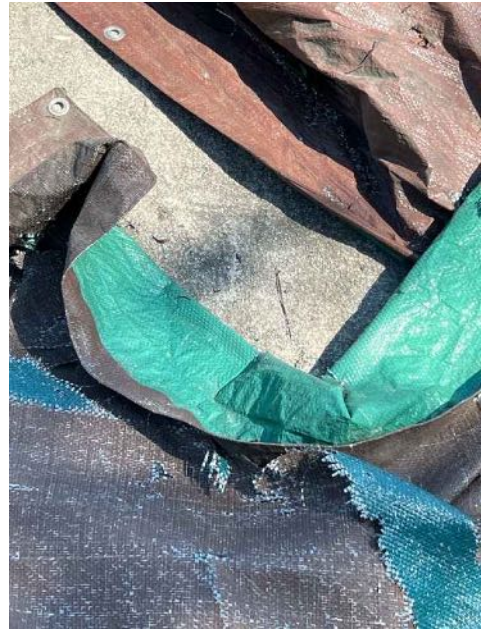
11.6.1 FLAT ROOF

**ROOF OLD - REPLACE**

The roof covering is old, and the life of the covering has expired. The covering does need to be replaced.

Recommendation

Contact a qualified roofing professional.

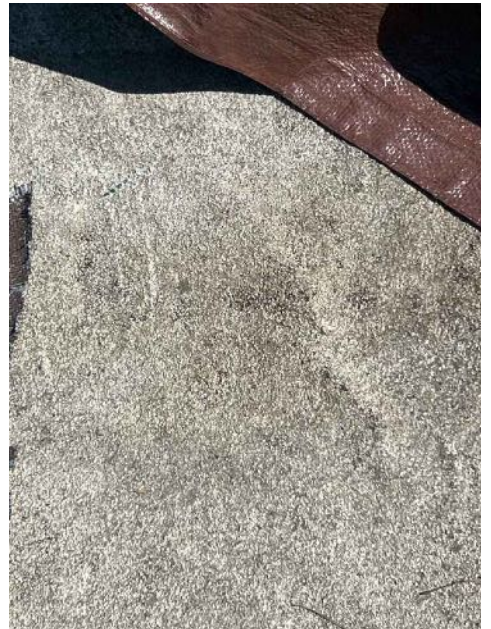
11.6.2 FLAT ROOF

**ROOF MUMPS**

Roof covering shows a mump-like appearance indicating a possible manufacturer defect. These areas will eventually blister and roof will need replacing.

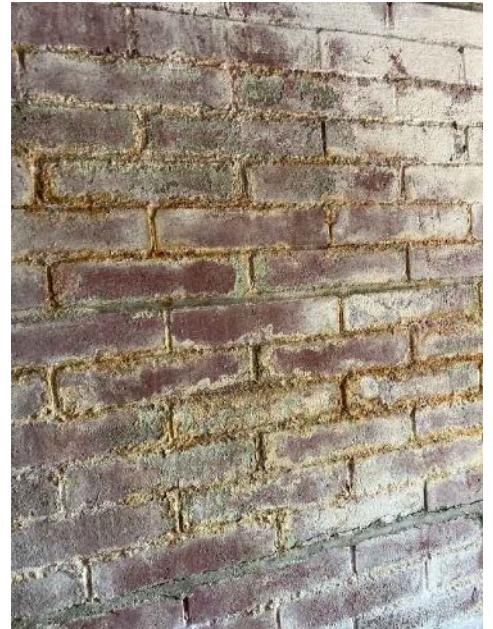
12.3.1 FOUNDATIONS (Observable Evidence of Structural Defects)

White efflorescence (powder substance) on the foundation wall indicates moisture is in contact with the masonry. This does not necessarily mean that intrusion will occur. This condition can be related to negative grade or irrigation located to the exterior of the affected portions of the foundation walls. We recommend correction of any negative grade, over-irrigation, or downspouts discharging around the home. We also recommend checking any drain lines for proper operation. Efflorescence is found in many homes without water intrusion occurring inside the home/crawlspace. But, it should alert you to the possibility that future steps may be needed.

Recommendation

Recommend monitoring.

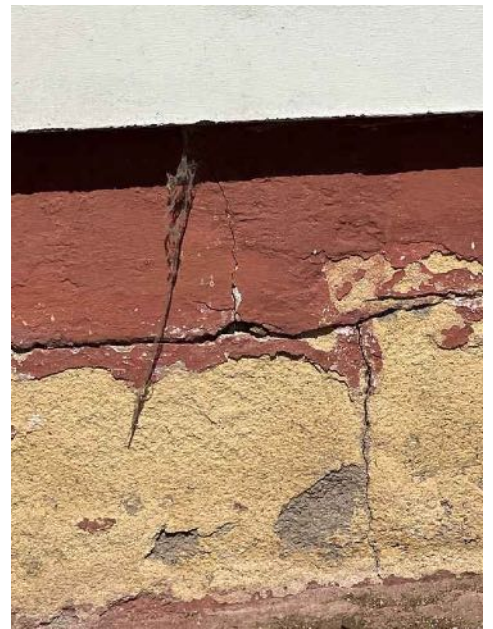
12.4.1 SLAB (Observable Evidence of Structural Defects - Concrete Floors)

### **CRACK IN PERIMETER FOOTING**

A crack was noted in the foundation perimeter. It is undeterminable if this crack goes into the slab because the slab is not visible.

Recommendation

Contact a foundation contractor.

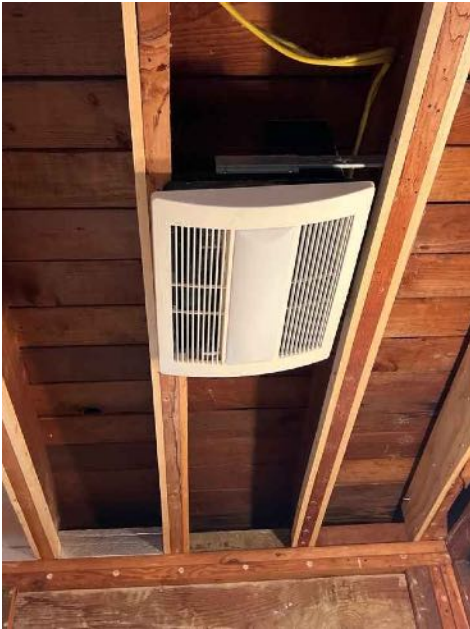
### 13.5.1 BATHROOM VENTING

#### **BATH VENT - INOPERABLE**

Contact a qualified professional.

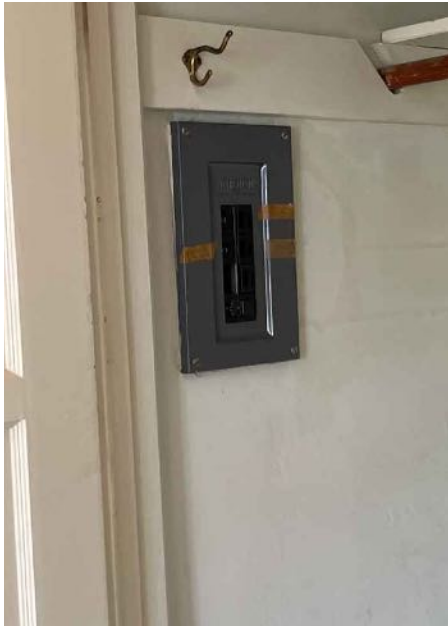
Master Bedroom

Sub-panel located in the bedroom closet.

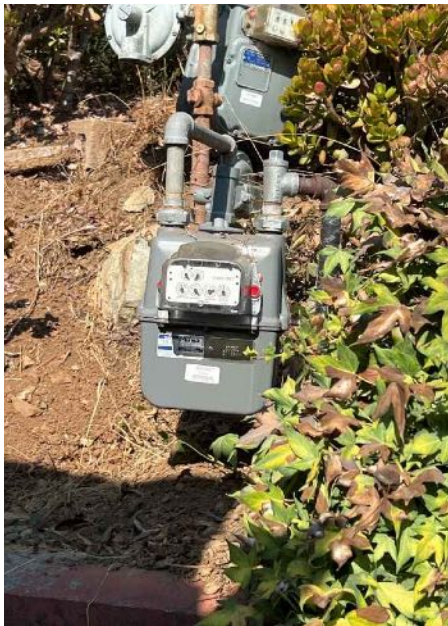
**MAIN GAS SHUT OFF VALVE: Gas Shut Off - Front**

The main gas shut-off valve is located at the gas meter at the front of the house.
