Home Inspection Report

22234 Prospect Street #1-3, Hayward

Jose Lares
June 26, 2024

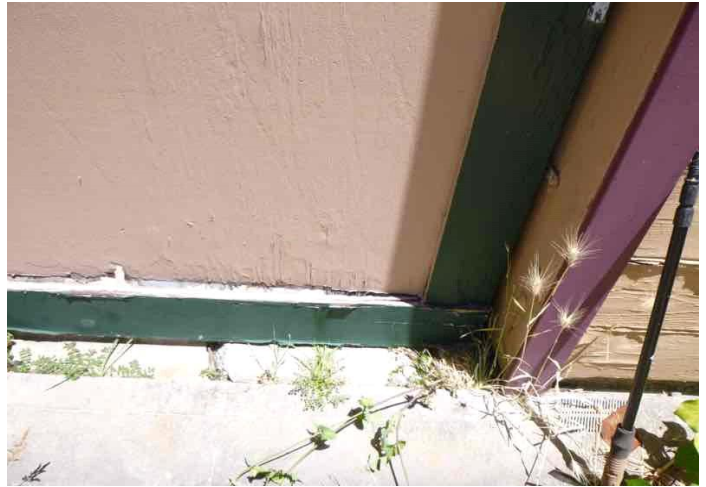
Photo 02

4. The main garage door is water damaged. We recommend the services of a licensed general contractor and/or structural pest control company regarding repairs. (See Photo 2)

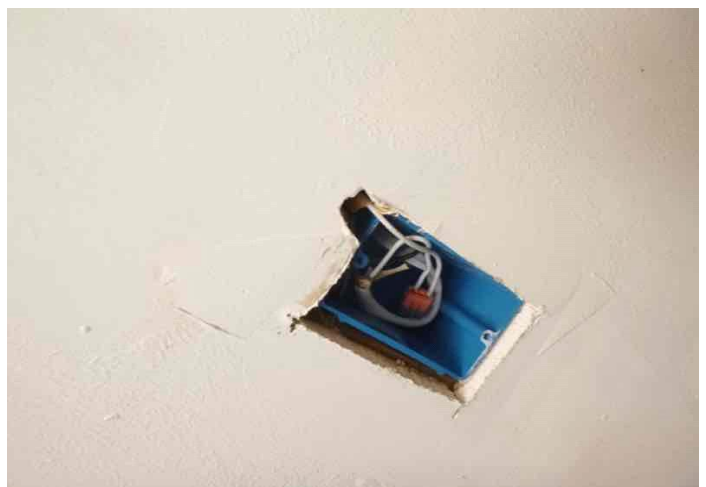
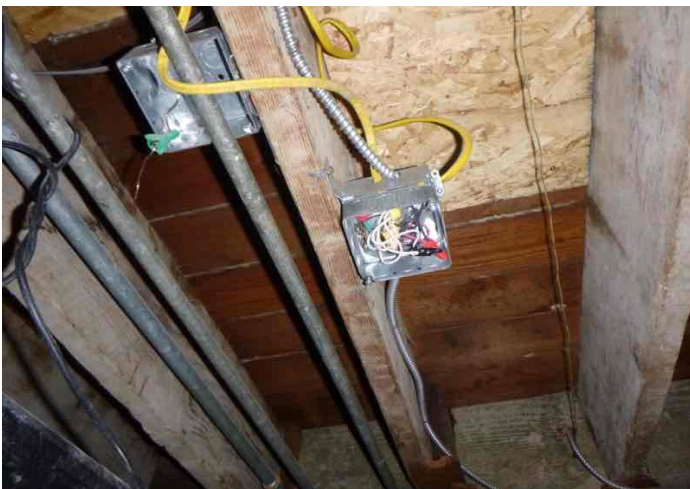
Photo 06

22. Exposed electric connections or open junction boxes at the rear left downstairs bedroom, hallway and basement area should be corrected. All electric connections should be made inside approved junction boxes fitted with proper cover plates. (See Photo 6) (See Photo 27)

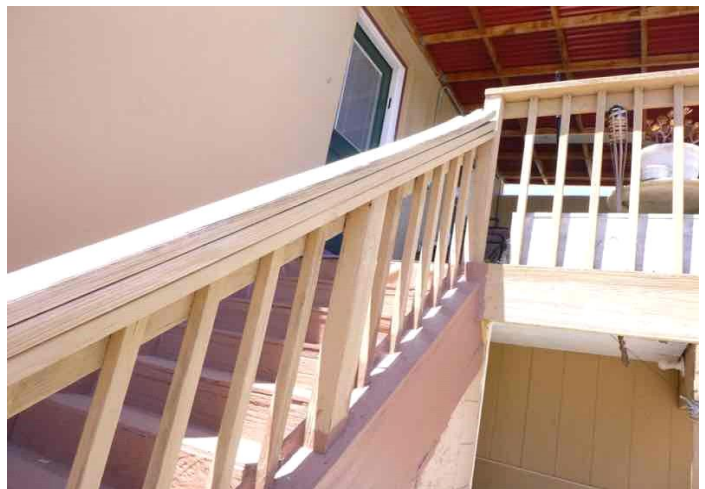
Photo 16

7. The openings in the rear staircase railing(s) are larger than 4" inches. It is recommended that this be corrected for improved safety. (See Illustration 3N) (See Photo 16)

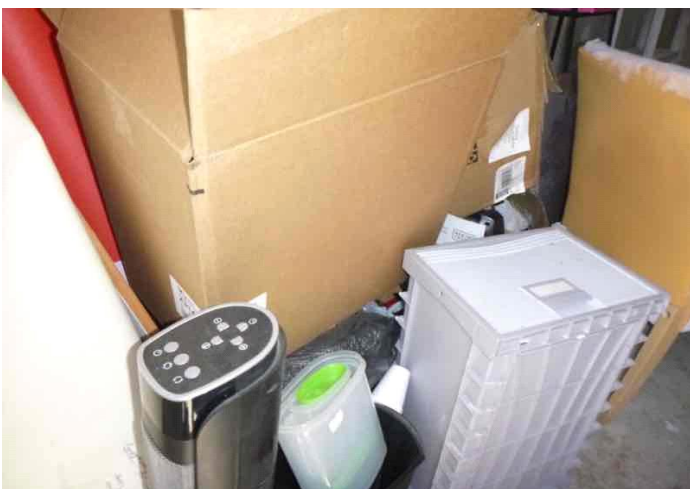
Photo 17

5. Personal storage was blocking access to the interior of the garage. Therefore, the area is considered inaccessible and was not fully inspected. With access and an opportunity for complete inspection, conditions in need of attention may be discovered. Ideally, the personal belongings should be removed so the area may be inspected. (See Photo 17)

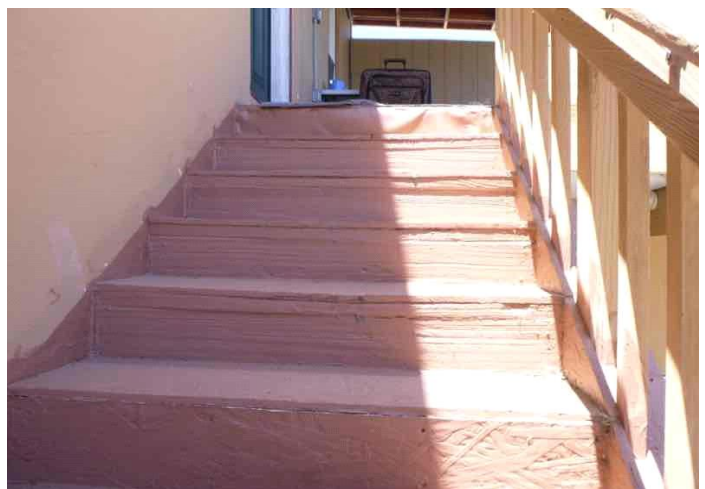
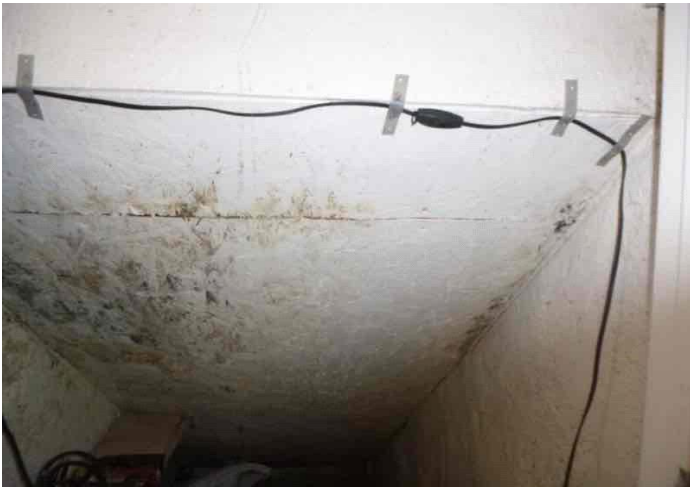
Photo 18

20. Water damage was noted at the rear deck staircase. All damaged wood members should be repaired or replaced as necessary. We recommend the services of a licensed general contractor and/or structural pest control company. (See Photo 18) (See Photo 7)

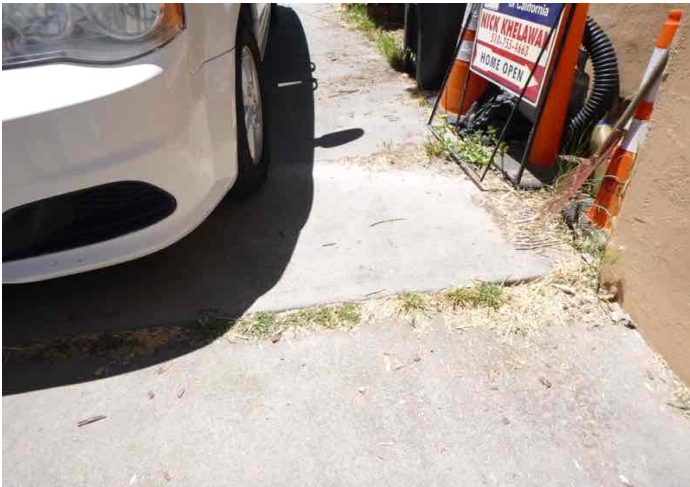
Photo 19

10. The cracked and heaved sections of the driveway present a trip hazard. This condition should be corrected for improved safety. (See Photo 19)

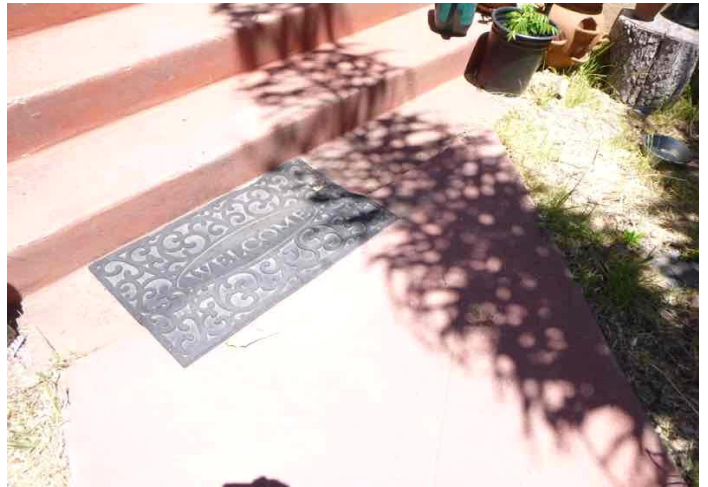
Photo 20

11. The cracked and heaved walkway section(s) at the front present a trip hazard. This condition should be corrected for improved safety. (See Photo 20)

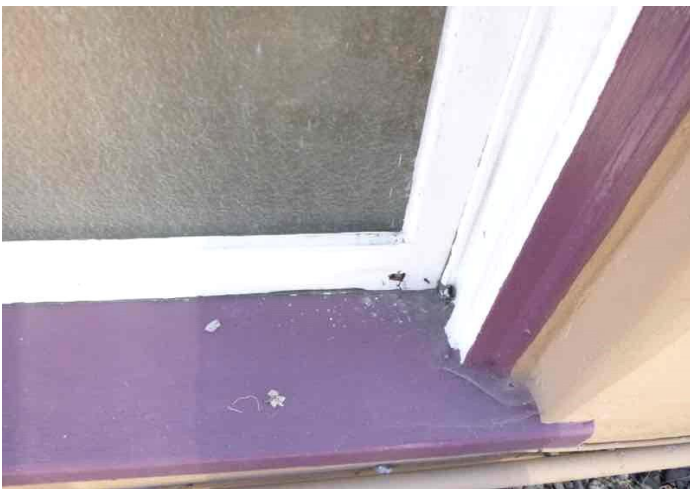
Photo 21

9. Multiple window frames/sashes show evidence of water damage. We recommend the advice and services of a general contractor and/or structural pest control company regarding repairs. (See Photo 21)

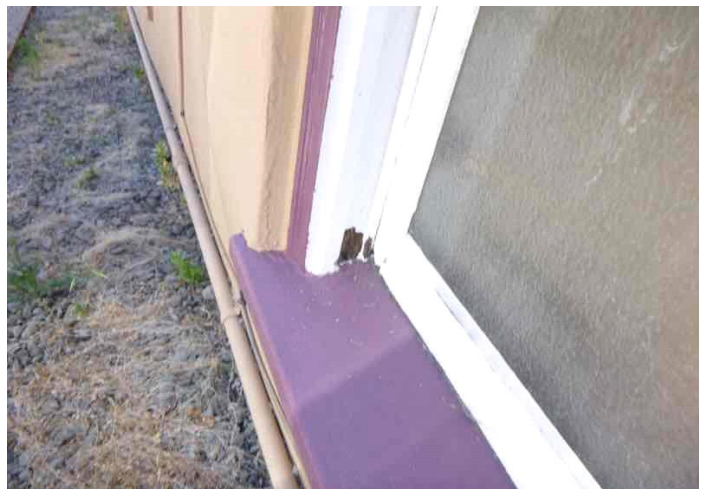
Photo 22

8. One or more windows show evidence of water damage to the sill/jamb. We recommend the advice and services of a general contractor and/or structural pest control company regarding repairs. (See Photo 22)

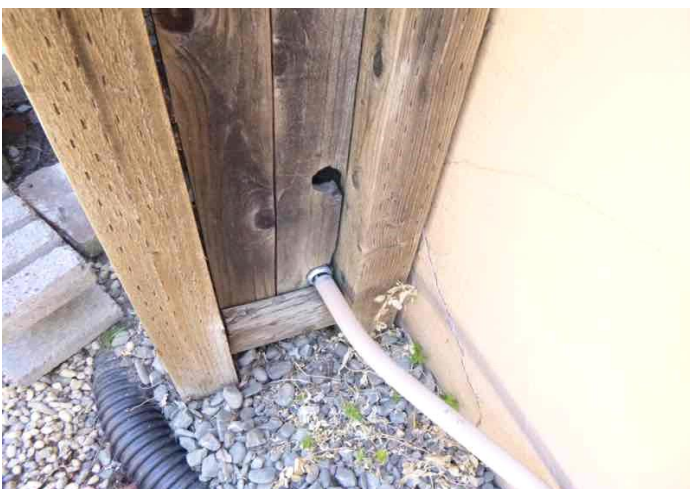
Photo 23

23. The conduit installed at the left exterior wall is damaged. We recommend that this conduit be repaired or replaced. (See Photo 23)

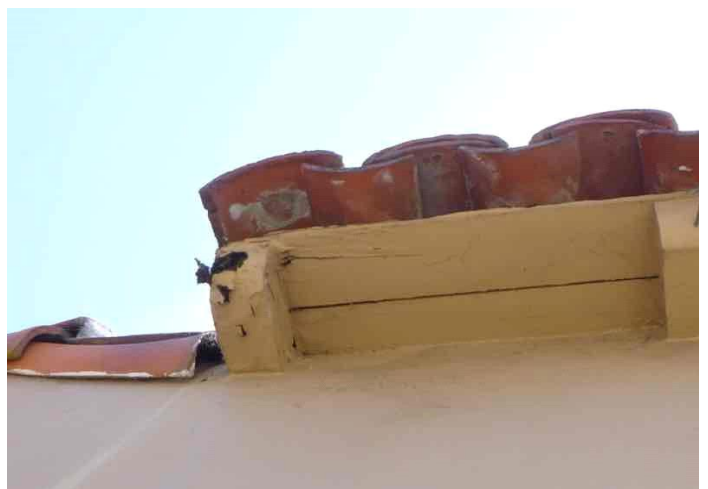
Photo 24

12. Water damage was observed to the roof eaves/sheathing at the left side of the structure. We recommend the services of a licensed general contractor and/or structural pest control company. (See Photo 24)

13. Water damage was observed to the rafters at the left side of the structure. We recommend the services of a licensed general contractor and/or structural pest control company. (See Photo 24)

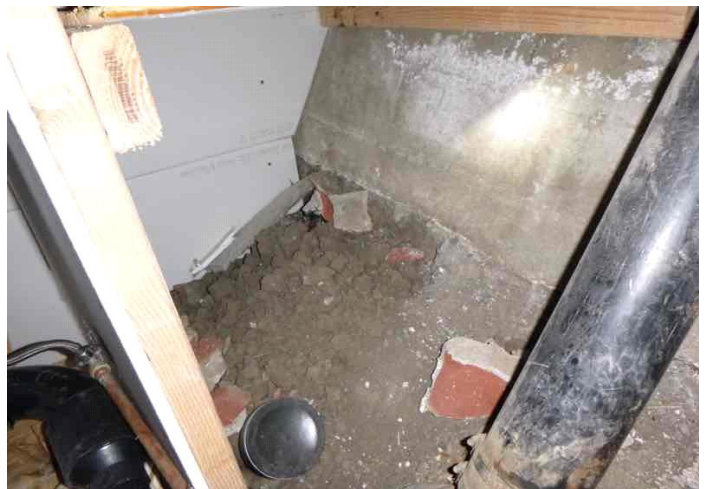
Photo 28

1. Sections of the foundation at the left side of the basement have been undermined. If not addressed, should the soil give way under this area, a significant structural failure could develop. The owner is advised to contact the appropriate tradesperson. (See Photo 28)

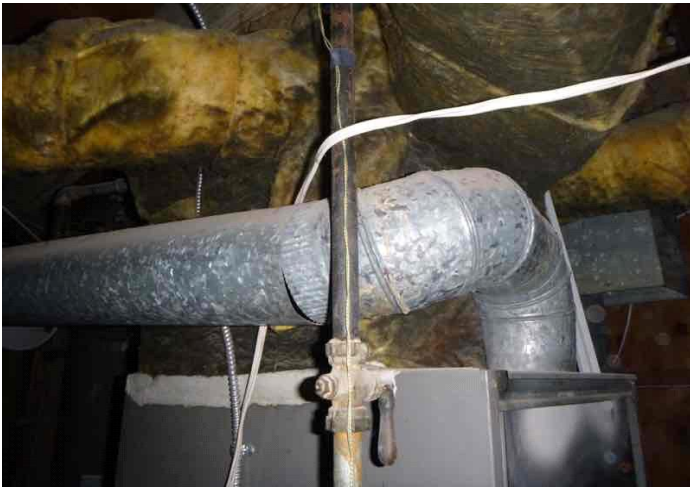
Photo 31

27. For enhanced safety, it is recommended that the loose and leaking connections of the furnace exhaust flue system be corrected. (See Photo 31)

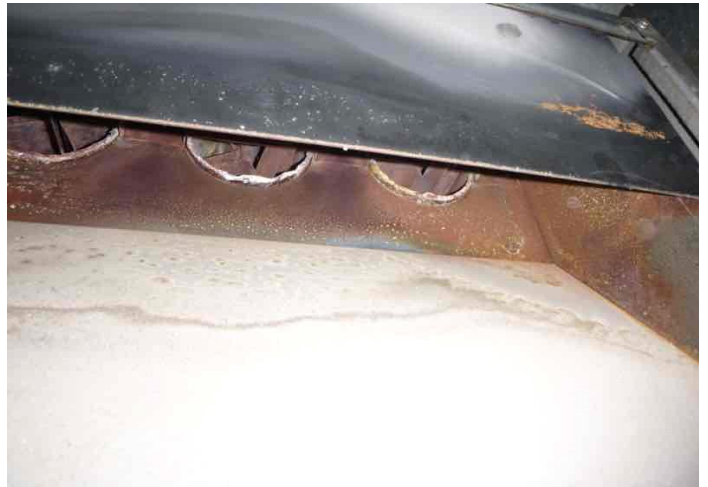
Photo 32

26. The heat exchanger is rusted, streaked and worn where visible from the exterior. These conditions indicate that it is at or near the end of its service life. We recommend inspections of the unit by the local utility company or a licensed heating contractor, to determine if repairs or replacement is necessary. (See Photo 32)

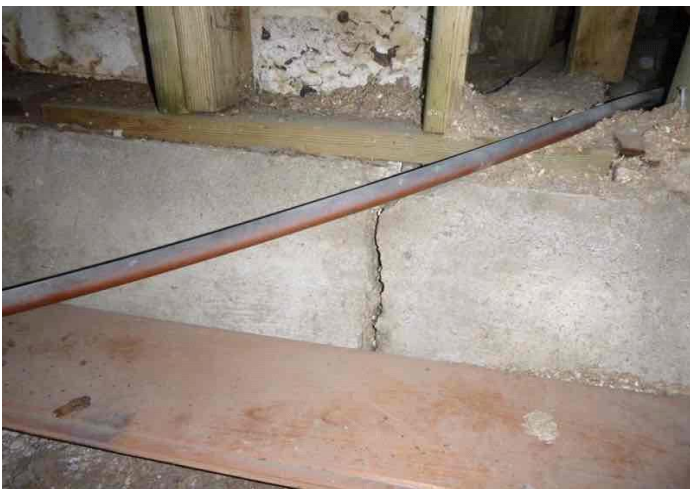
Photo 33

2. Vertical cracking was observed in the foundation walls of the structure indicating movement and/or settlement of the structure may have occurred. The rate of movement cannot be predicted during a one-time inspection. A thorough evaluation of this condition is beyond our qualifications. For additional information we recommend contacting a licensed foundation contractor for further evaluation. (See Photo 33)

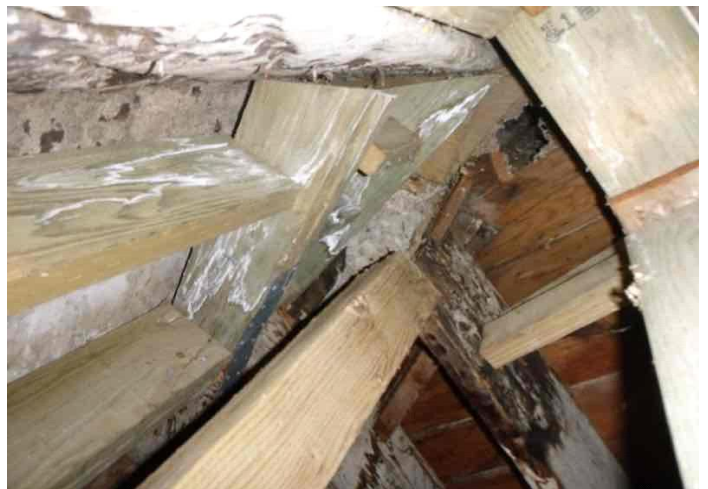
Photo 34

6. Water damage was noted at the front porch. We recommend the services of a licensed general contractor and/or structural pest control company. (See Photo 34)

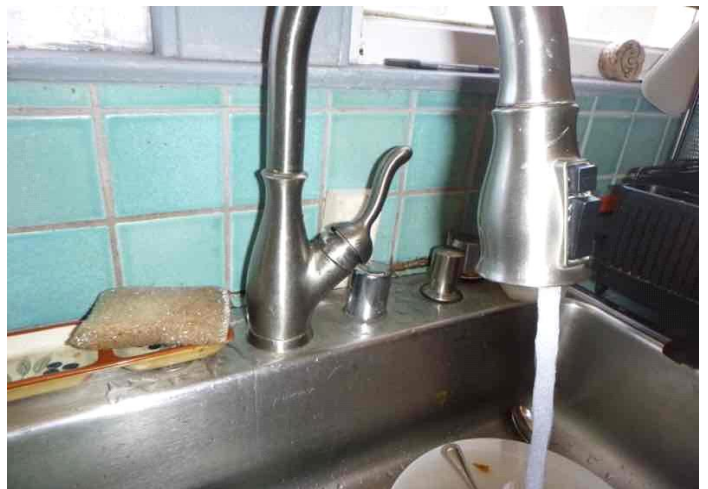
Photo 39

- ! 4. The drain systems at the rear downstairs kitchen sink and upstairs laundry sink were improperly installed. We recommend the drains be reconfigured according to industry standards. (See Photo 13) (See Photo 39)

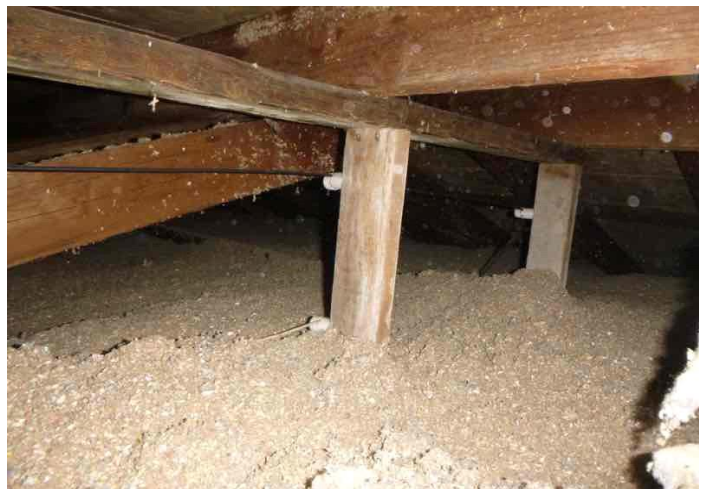
Photo 45

- ! 6. Evidence of vermin activity was observed within the structure. It is likely this evidence will extend into inaccessible areas. The owner is advised to contact the appropriate trade for further evaluation and remedial measures if necessary. (See Photo 45)

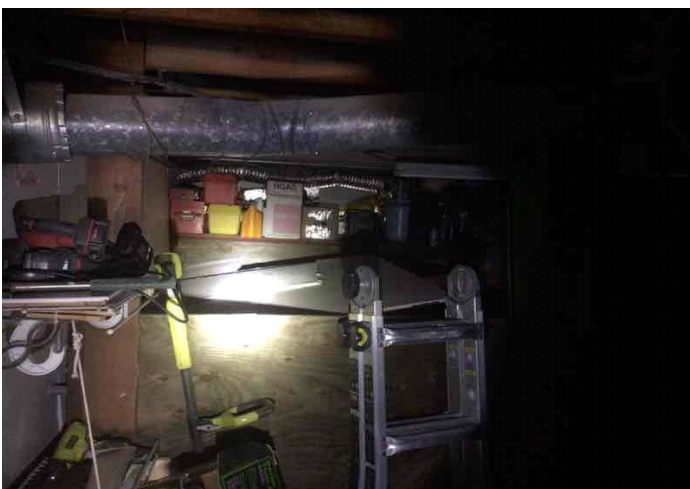
Photo 46

- ! 8. Older knob and tube wiring in the attic should not be covered with insulation. Insulation should be pulled back or the knob and tube wiring be replaced. (See Photo 46)
