CAL-WEST PROPERTY INSPECTIONS

CAL-WEST PROPERTY INSPECTIONS HOME MAINTENANCE REPORT

9641 Follett Dr
Santee, CA 92071

Knute Brookshier
JANUARY 15, 2025

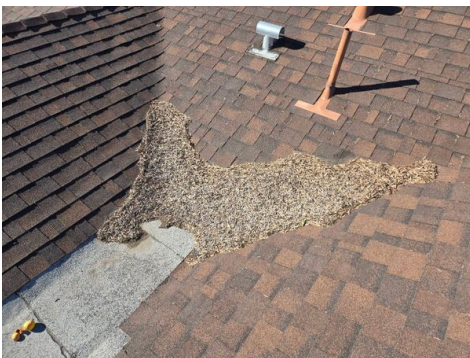
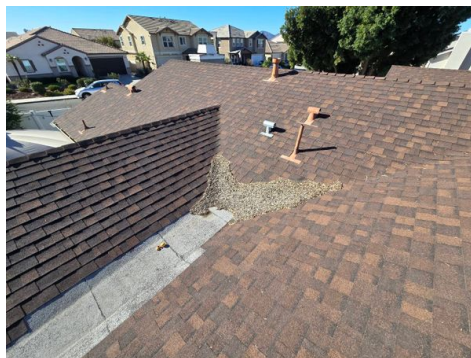
3.1.1 Roof Coverings

LOOSE DEBRIS ON ROOF COVERING AFFECTING SURFACE DRAINAGE

Deferred Maintenance - Minor Repair

Loose debris is on the roof and affecting the drainage of rain water as well as holding additional moisture against the roof covering which accelerates wear and deterioration.

Contact a handyman or DIY project

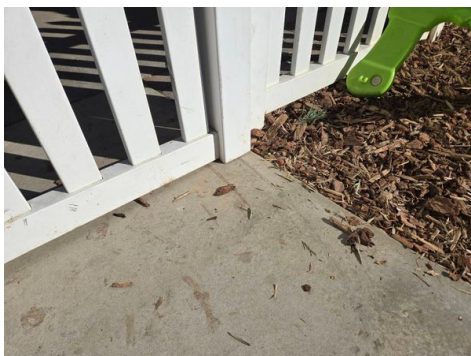
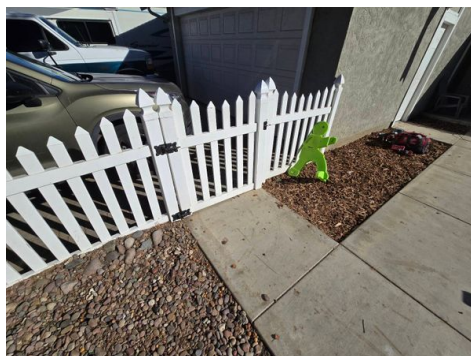
5.7.2 Fencing

GATE NEEDS ADJUSTMENT

Contact a qualified professional.

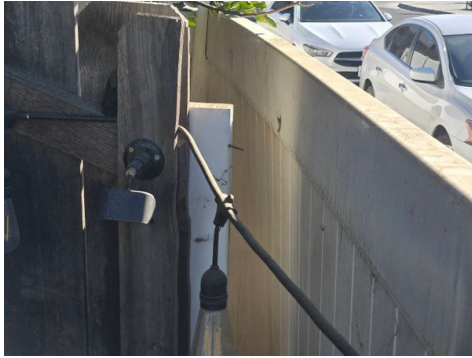
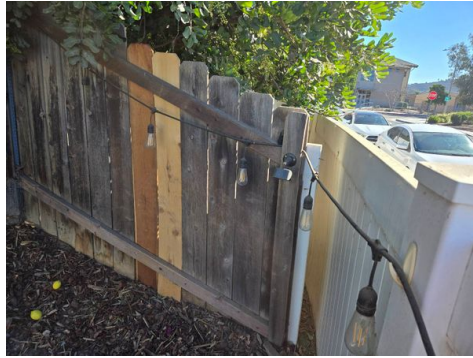
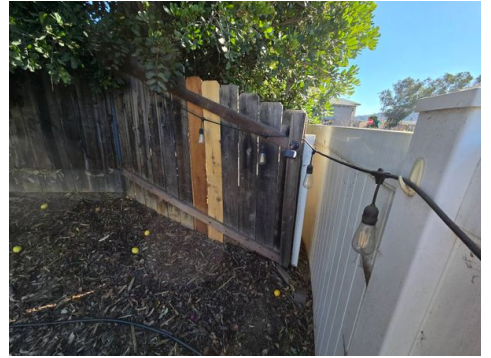
5.7.3 Fencing

UNSECURE FENCE

Deferred Maintenance - Minor Repair

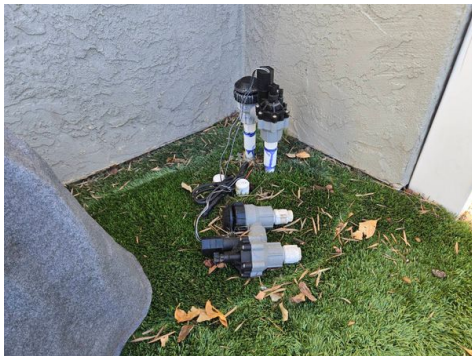
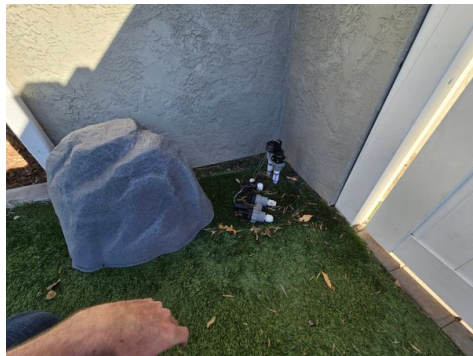
5.10.1 Sprinkler/Irrigation System

IRRIGATION VALVE DAMAGE

Deferred Maintenance - Minor Repair

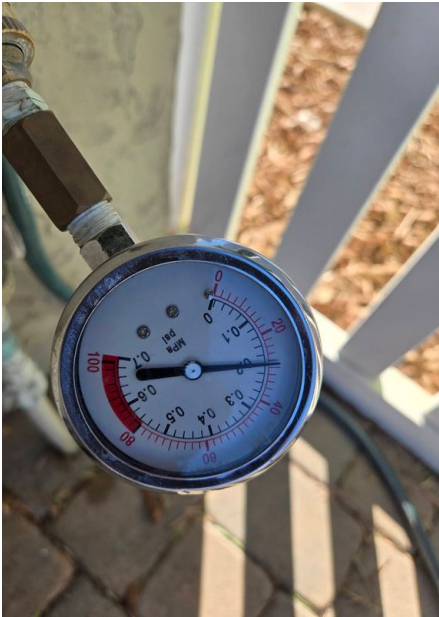
30 PSI Or Below

The recommended water pressure is between 40-80 PSI

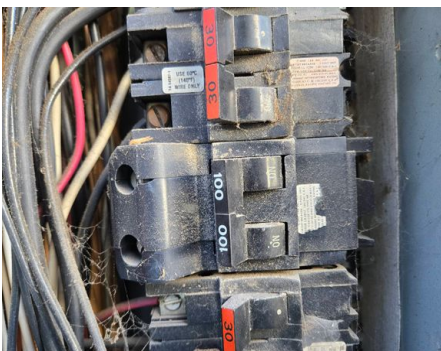
8.1.1 Main Breaker Panel/Meter

MISSING/INACCURATE LABELS ON PANEL

At the time of inspection, panel was missing appropriate circuit labeling or labeling was inaccurate. Recommend a qualified electrician identify circuit locations.

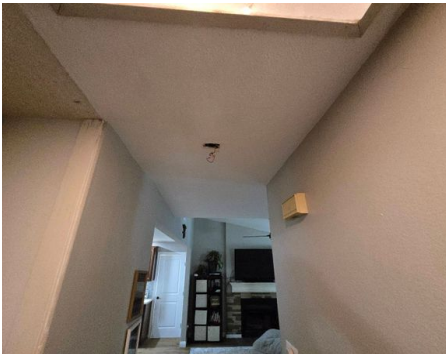
Smoke & Carbon Monoxide Alarm: Incorrect Locations - Fail

INCORRECT - Missing Or Incorrect Smoke and Carbon Monoxide Alarm Location

At the time of the inspection one or more smoke and or carbon monoxide detectors were not present at the appropriate locations within the common areas of the building.

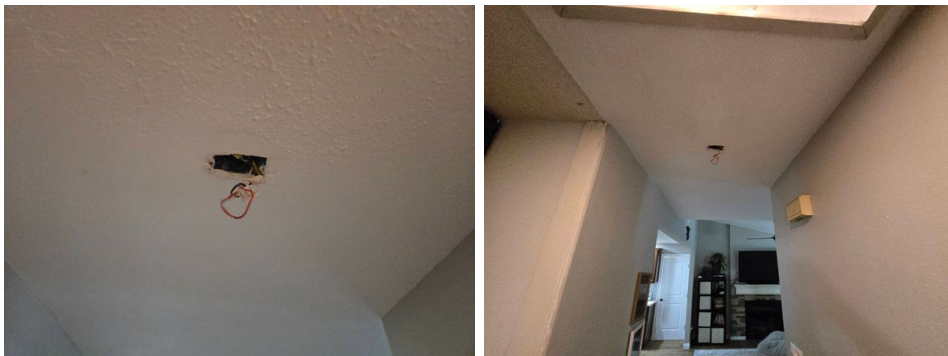
At the time of inspection one or more smoke detectors and carbon monoxide detectors were missing at the required locations.

Current CA residential building codes state that smoke detectors must be installed near the kitchen, any room with a fireplace, all sleeping rooms, and hallways leading to sleeping rooms. CO detectors must be installed on each level of the property, a 15 feet maximum distance from each and all fuel burning appliances and also any hallway leading to sleeping rooms.

Contact a qualified professional.

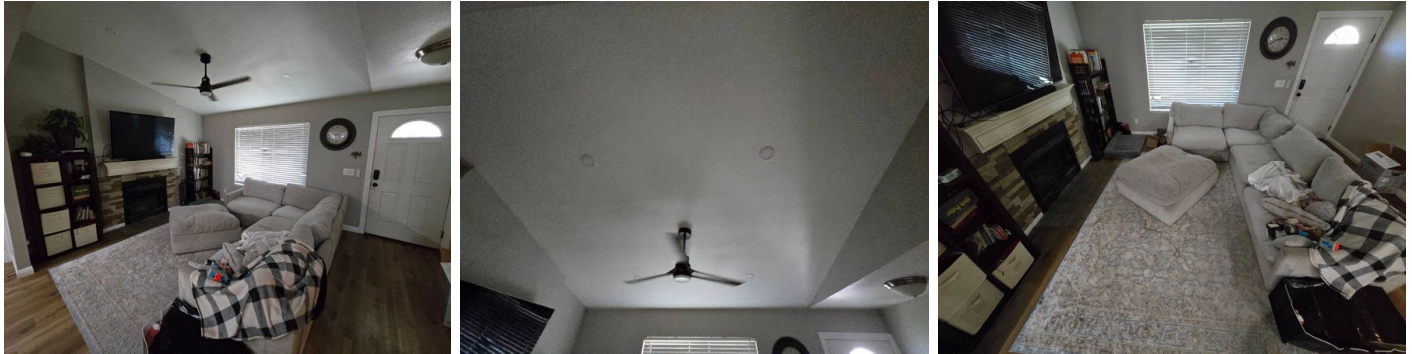
Living Room Identification Pictures

At the time of the inspection the living room pictured above was functional and serviceable but showed signs of moderate wear and was in need of minor to moderate repairs.

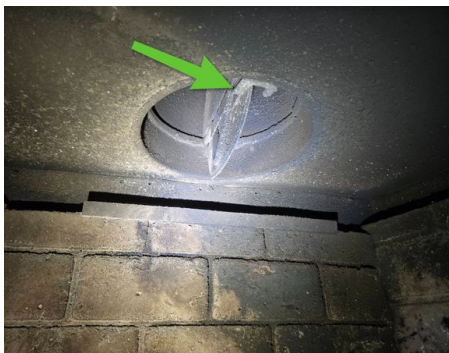
At the time of the inspection the required damper clamp for gas burning fireplaces was correctly installed and properly functioning. The damper clamp prevents the damper from going to the fully closed position.

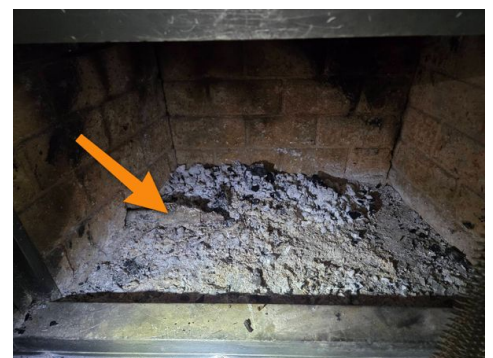
12.1.1 Fireplace General

BURNER DETERIORATION

At the time of the inspection the gas burner for the fireplace was deteriorated and in need of replacement.

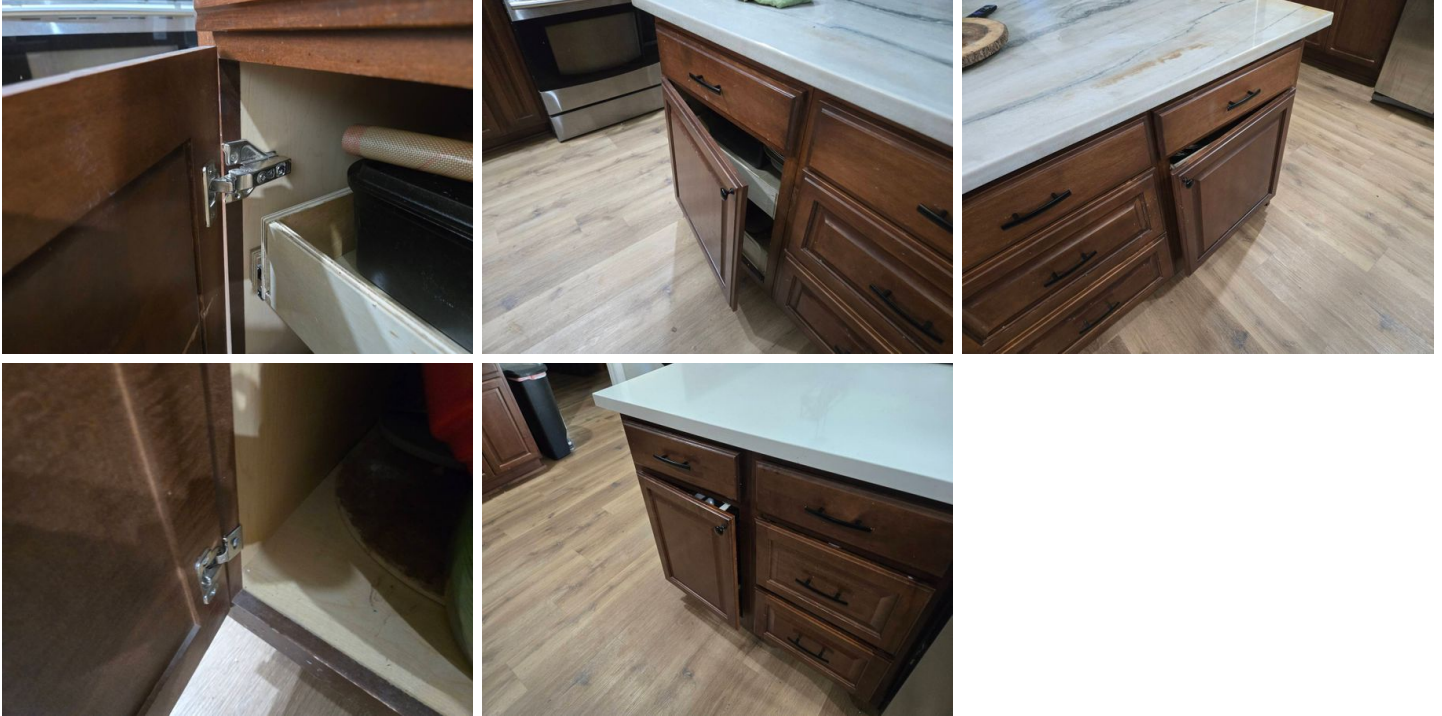
CABINET HINGE REPAIR NEEDED

At the time of the inspection one or more of the cabinet door hinges was in need of repair or replacement. Correction is advised.

Contact a qualified professional.

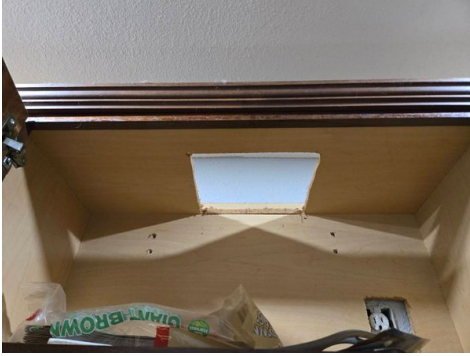
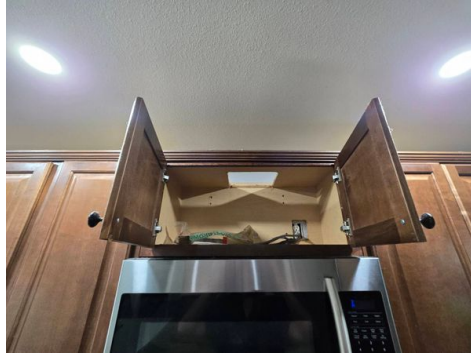
CABINET DAMAGE

At the time of the inspection the cabinets suffered from damage in one or more areas. Correction is advised.

Contact a qualified professional.

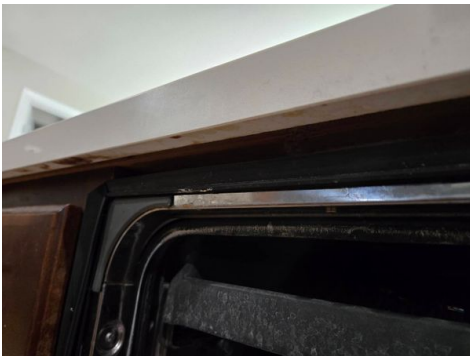
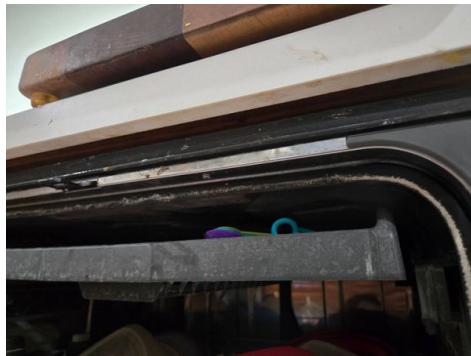
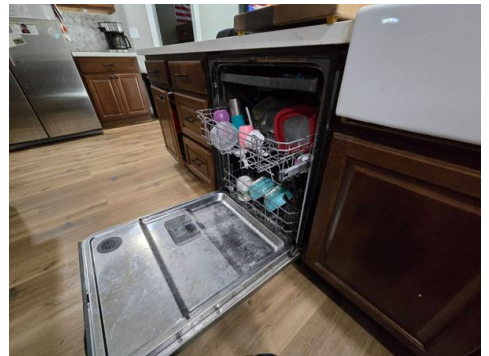
13.5.1 Dishwasher

DISHWASHER NOT PROPERLY SECURED TO CABINETS

Contact a handyman or DIY project

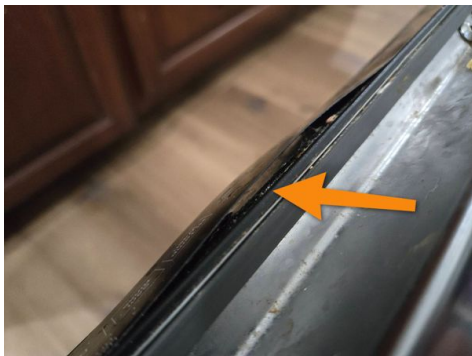
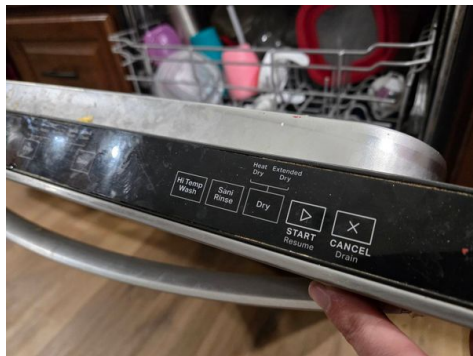
13.5.3 Dishwasher

DISHWASHER CONTROL PANEL DAMAGED

At the time of the inspection one or more areas of the control panel were damaged. Correction or replacement is advised.

Contact a qualified professional.

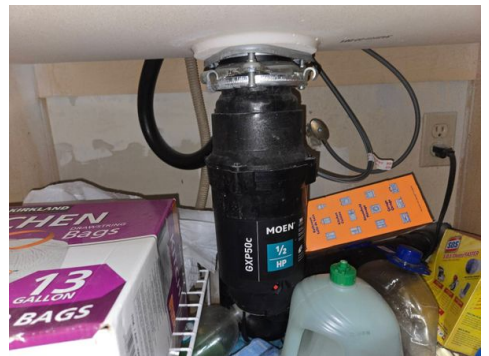
13.6.1 Garbage Disposal

At the time of inspection when the garbage disposal was tested it was noisy and sounded as though something was possibly in the blade area making the noise. It is possible that the blades have been damaged and is in need of replacement.

Contact a qualified plumbing contractor.

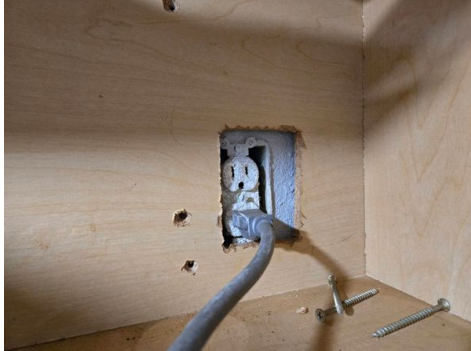
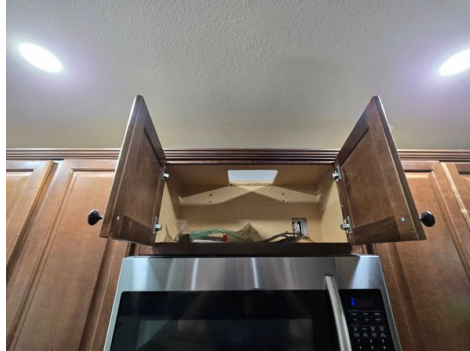
13.12.1 Receptacles, Switches and Circuits

COVER PLATES MISSING

At the time of the inspection one or more receptacles were missing the appropriate cover plate. Recommend installation of cover plates to prevent accidental electrocution and or damage to the receptacle or light switch. Correction is advised.

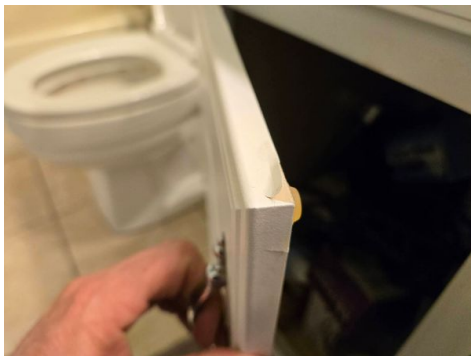
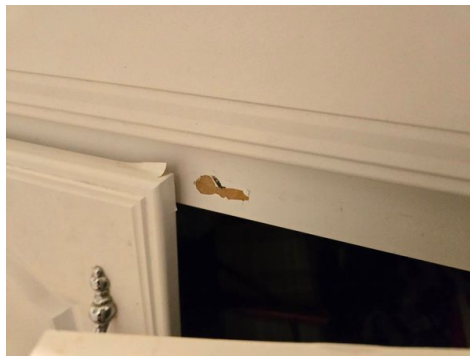
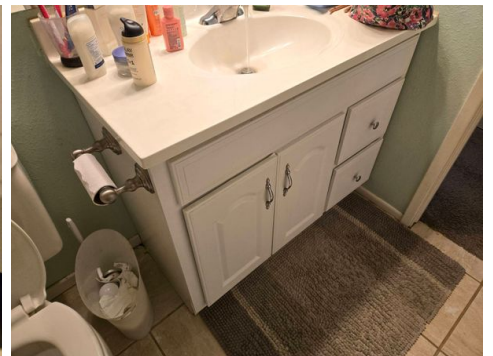
CABINET FINISH DAMAGE

At the time of the inspection there were one or more areas of the cabinet finish suffering from damage. Correction is advised.

Contact a qualified professional.

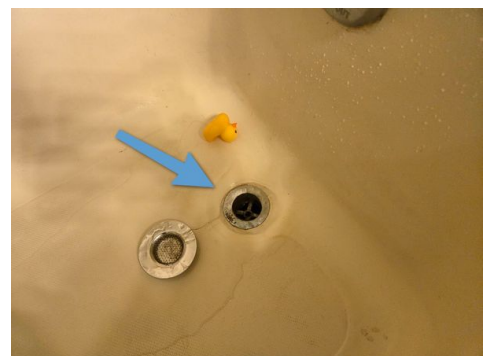
14.4.1 Showers/Bathtubs

DRAIN PLUG MISSING

At the time of the inspection one or more of the drain plugs for the bathtub were missing or not functioning correctly. Correction is advised.

Contact a qualified professional.

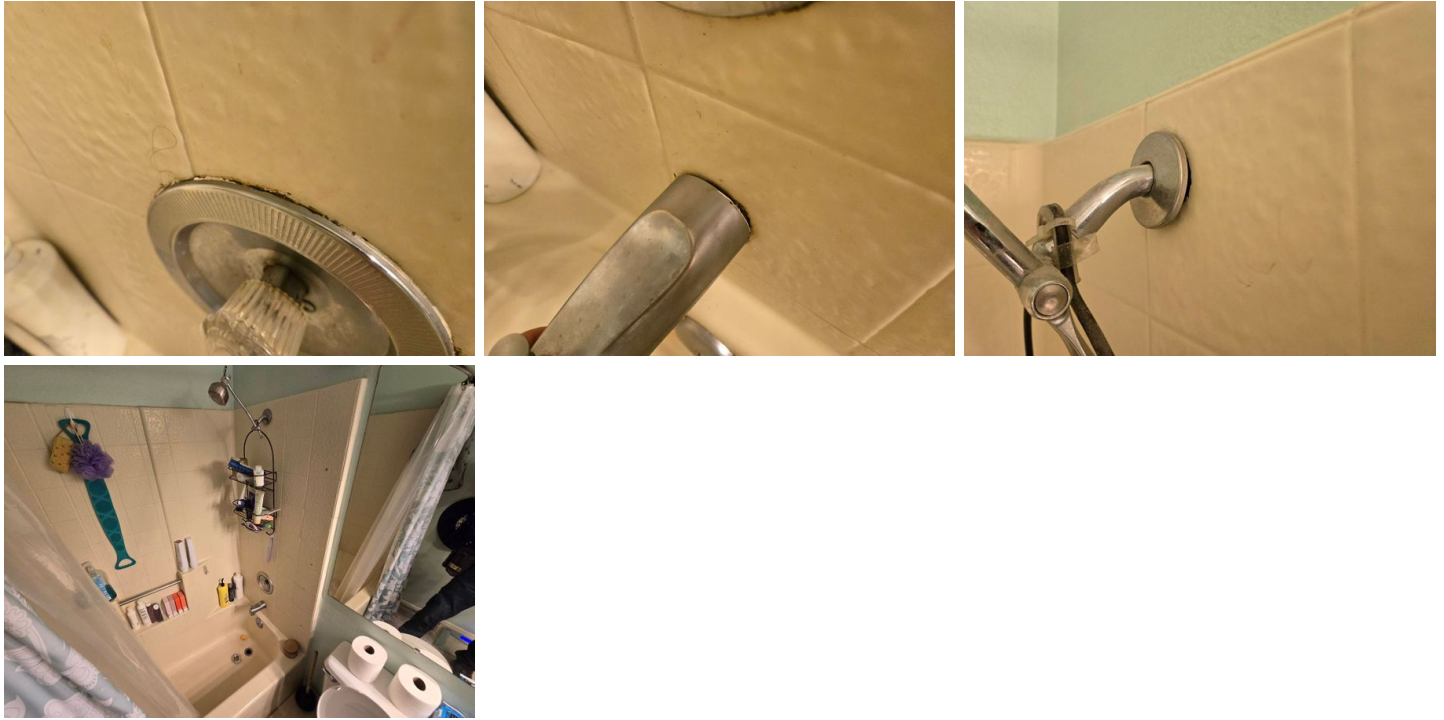
14.4.2 Showers/Bathtubs

At the time of the inspection there were one or more areas of the shower/bathtub in need of caulking repair or replacement. Correction is advised.

Contact a qualified professional.

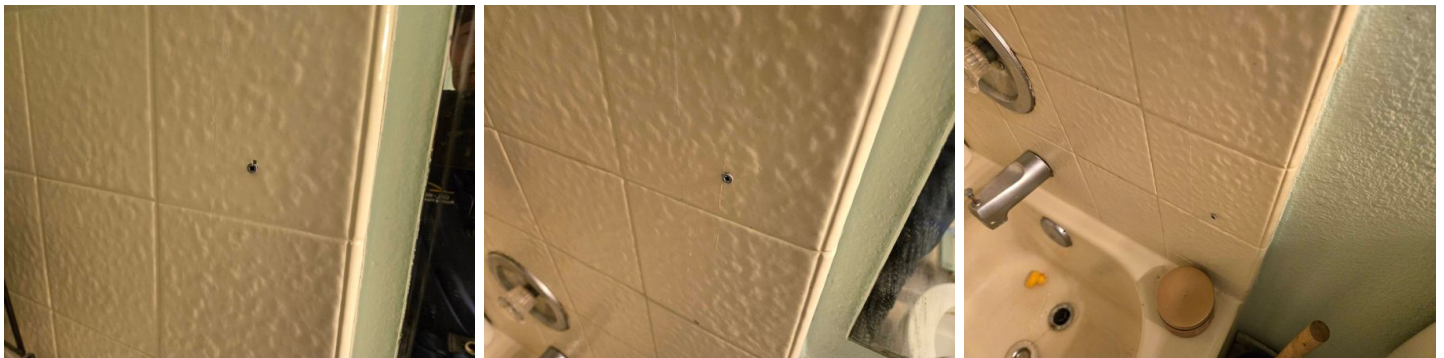
14.4.3 Showers/Bathtubs

SHOWER DOOR TRACK MISSING

At the time of the inspection one or more parts of the sliding shower door track were missing making it possible for the shower door to come off the track. The shower door could cause serious injury if it were to fall during occupants use of the shower. Correction is advised

Contact a qualified professional.

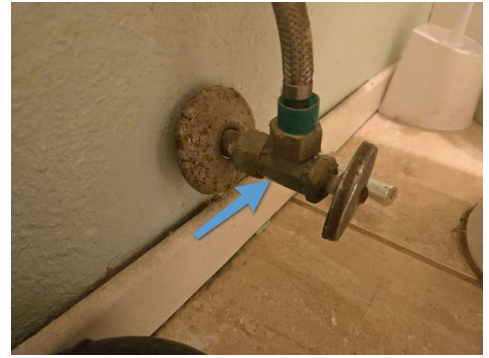
14.5.1 Toilets

CORROSION AT ANGLE STOP VALVE

At the time of the inspection heavy corrosion was noted at the angles stops for one or more toilets. Correction is advised.

Contact a qualified plumbing contractor.

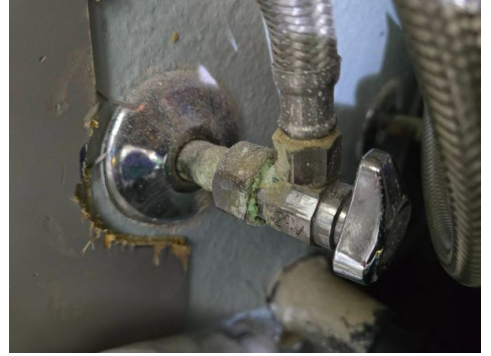
ANGLE STOP CORROSION

At the time of the inspection corrosion was present at the angle stop. It is advised to monitor and replace corroded angle stops before they begin leaking. Correction is advised.

Contact a qualified plumbing contractor.

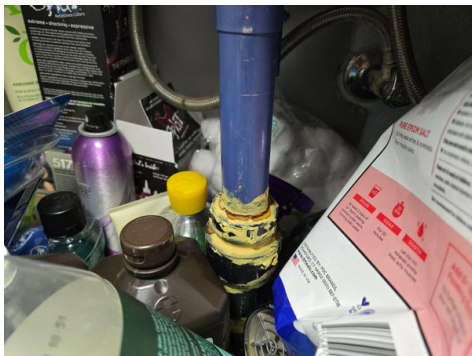
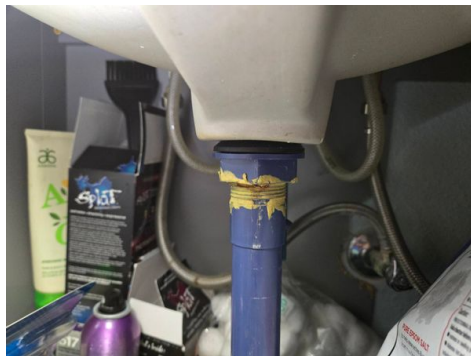
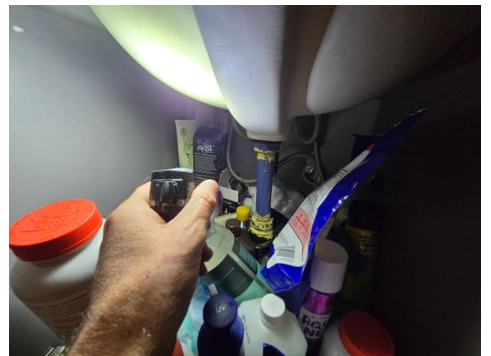
15.2.2 Sinks

IMPROPER PLUMBING REPAIR

At the time of the inspection there were one or more repairs made with insufficient materials or poor workmanship. Correction is advised.

Contact a qualified swimming pool contractor

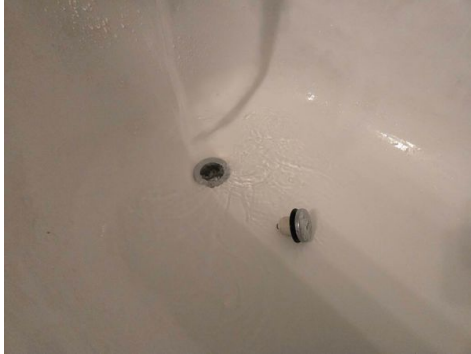
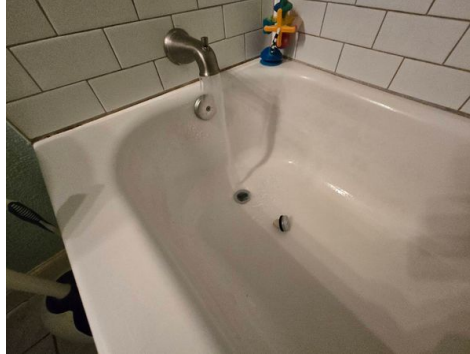
15.4.1 Showers/Bathtubs

At the time of the inspection the bathtub drain plug was not operational due to corrosion and deterioration. Correction is advised.

Contact a qualified professional.

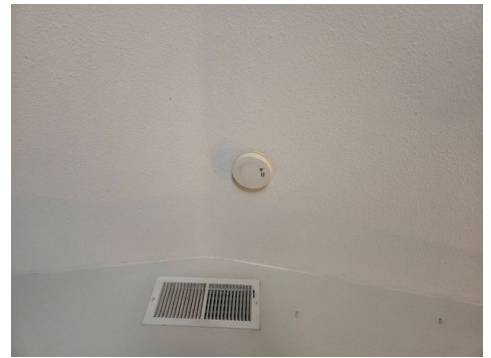
16.2.1 Smoke & Carbon Monoxide Detectors

At the time of the inspection there were one or more smoke detectors present that were outdated. Smoke detectors turn yellow at roughly the 10 year mark, which indicates they are beyond the time of the intended use, and require replacement. Correction is advised.

Contact a handyman or DIY project

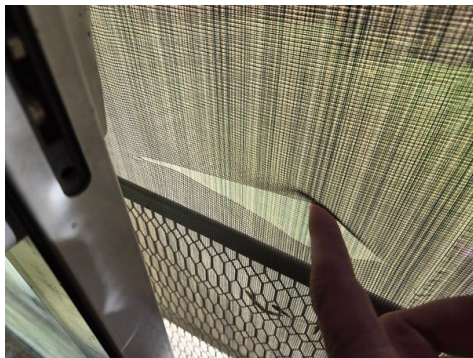
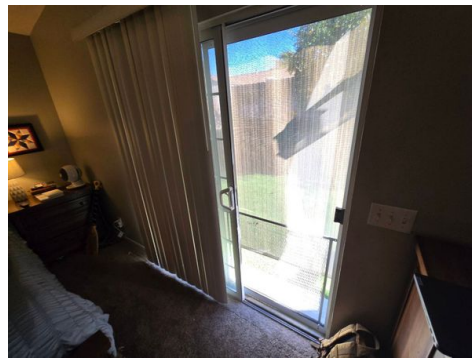
16.5.1 Doors

SLIDING DOOR SCREEN DAMAGE

Sliding door screen material was damaged at the time of inspection. The screen door its self worked properly however the screen should be repaired to keep bugs and pest out as intended.

Contact a handyman or DIY project

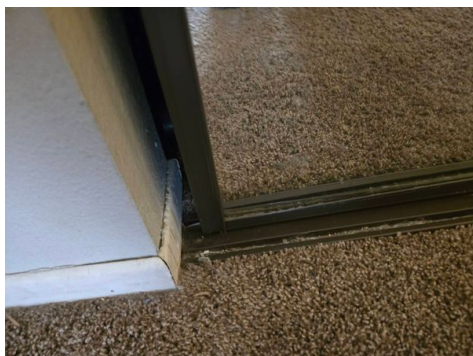
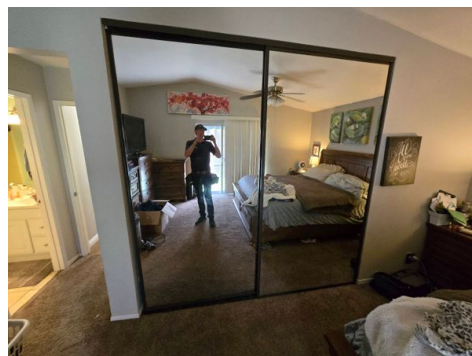
16.6.1 Closets

CLOSET TRACK DAMAGE

At the time of the inspection the closet track suffered from moderate-to-severe wear.

Contact a qualified professional.

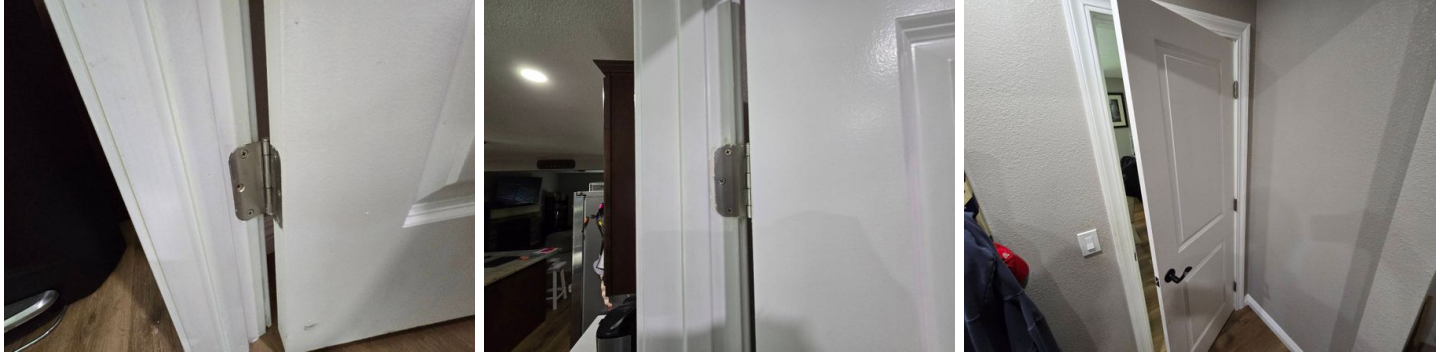
20.5.1 Doors

HINGE ADJUSTMENT/REPAIR

At the time of the inspection there were one or more door hinges in need of repair. Correction is advised.

Contact a qualified professional.

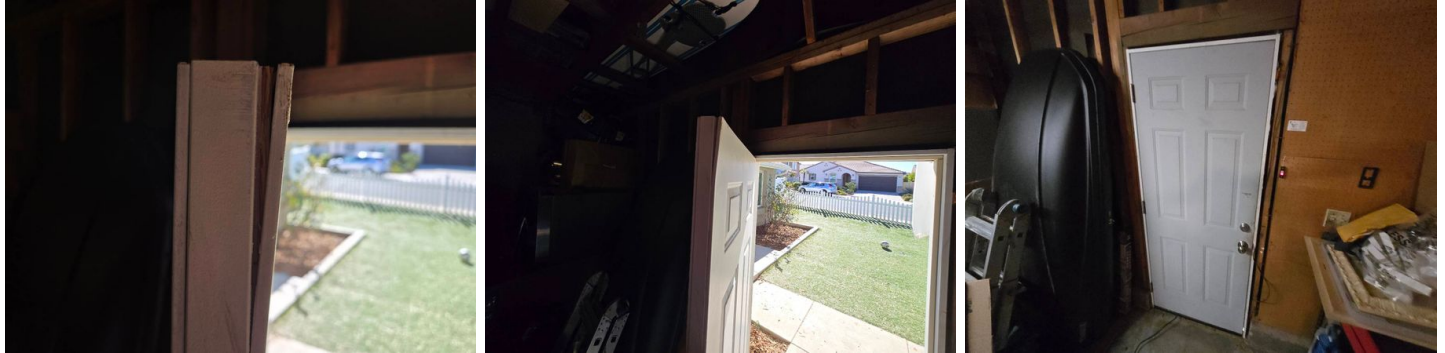
DAMAGED DOOR

At the time of inspection the garage door for pedestrian traffic was damaged and in need of replacement.

Contact a qualified professional.

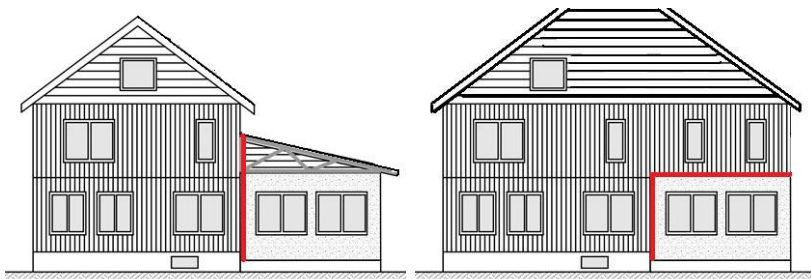
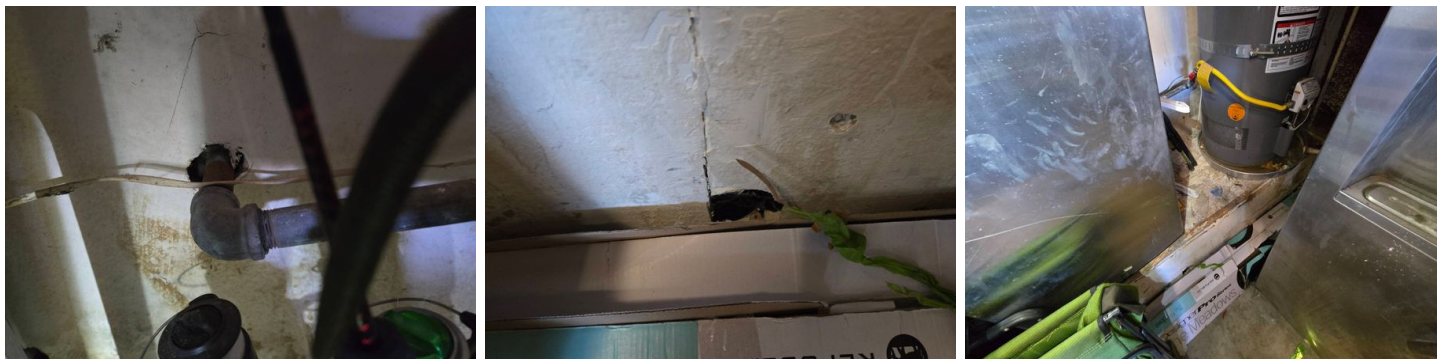
22.5.1 Garage Walls & Firewalls

At the time of the inspection, one or more penetrations in the firewall were observed. Firewall penetrations pose a potential hazard to the occupants inside the living area if there is ever a fire in the garage. Firewalls are designed to have a longer burn rating to slow the spread of fires that originate in the garage.

Contact a qualified professional.

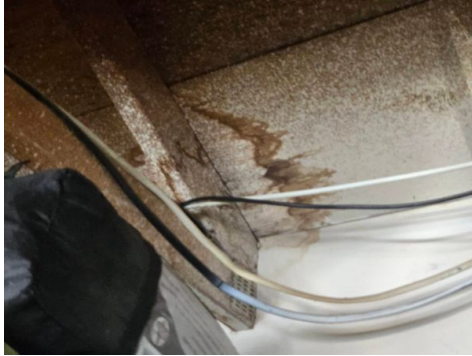
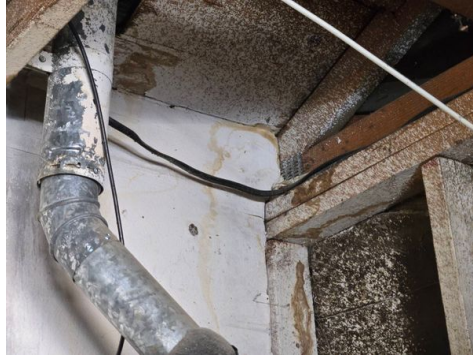
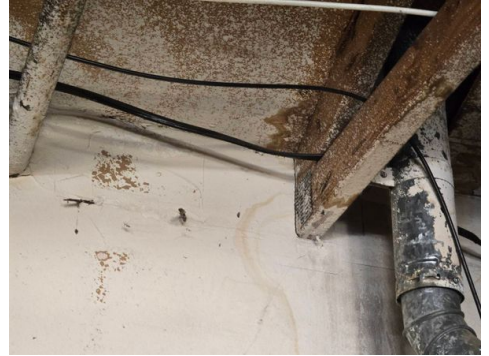
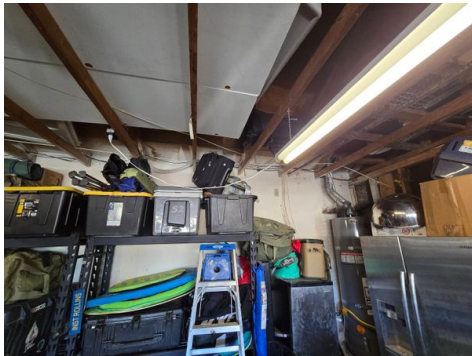
22.6.1 Garage Ceiling

WATER STAINS ON GARAGE CEILING - ROOF

At the time of inspection there were one or more water stains on the ceiling of the garage. Likely caused from roof leaks and water intrusion. It is advised to ask the seller for disclosures related to any leaks or previous repairs.

Contact a qualified professional.

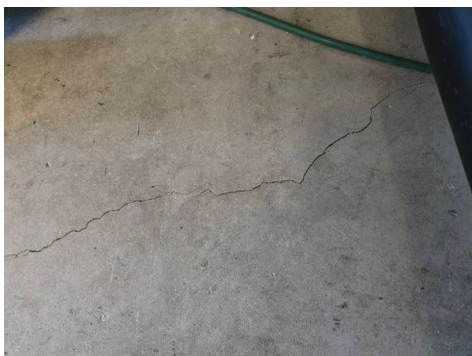
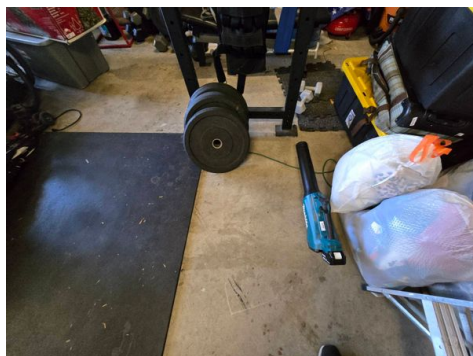
22.7.1 Garage Floor

MINOR CONCRETE CRACKING

At the time of the inspection minor concrete cracking was observed in the garage. Minor cracking is typically not cause for concern. Recommend monitoring for continued cracking and increases in crack width/gaps.

Contact a qualified professional.
