SUBJECT PROPERTY:
1175 Camino Del Sol, San Marcos, CA 92069

INSPECTION DATE:
02/12/2025

INSPECTOR:
Greg Campbell, CCI
Cell: 858.335.1279
Email: greg@InspectRite.com

InspectRite

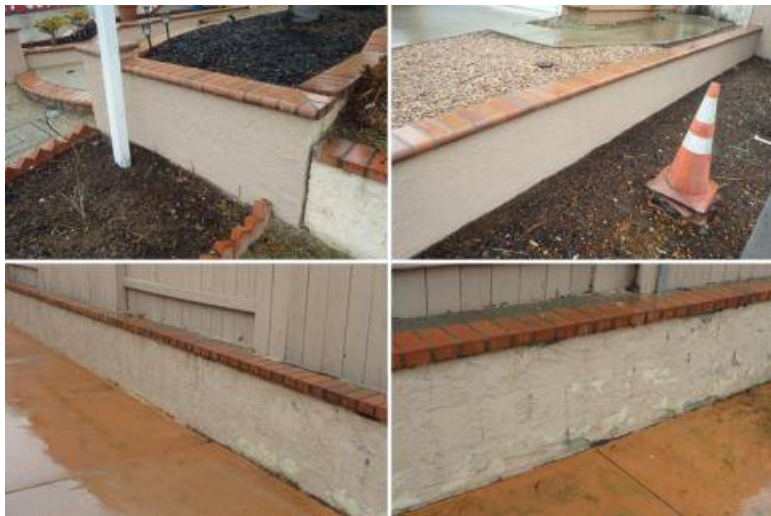
3.22 Material/Type:

Further Evaluation - Displacement / rotation of the wall was present. Recommend further evaluation and repair of this condition by a masonry contractor. Condition was observed at: Front.

Further Evaluation - Displacement / rotation of the wall was present along with stair step cracks indicating differential settlement. Recommend further evaluation and repair of this condition by a masonry contractor. Condition was observed at: along right side.

Concrete block with stucco finish.

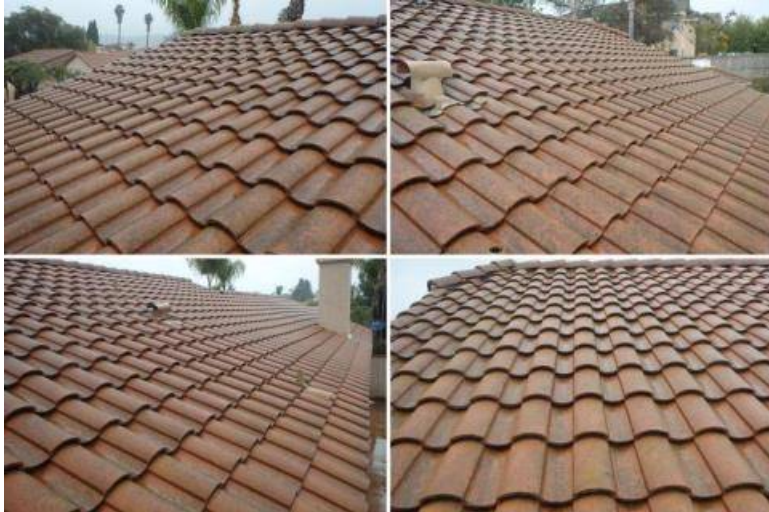
7.1 Material/Type:

Repair - Broken tile (1) were observed. This condition allows rain water and/or UV light to infiltrate under the roof covering, which over time can prematurely erode/damage the roof underlayment. Any opening in the roof covering is considered an active leak. Corrections are needed to ensure adequate weather protection. Condition was observed at: Left side.

Concrete tiles.

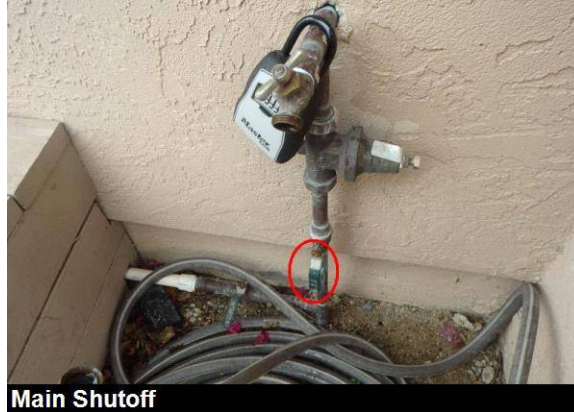
10.3 Water Main & Shutoff:

Located at exterior right side. The main shutoff valve was tested.

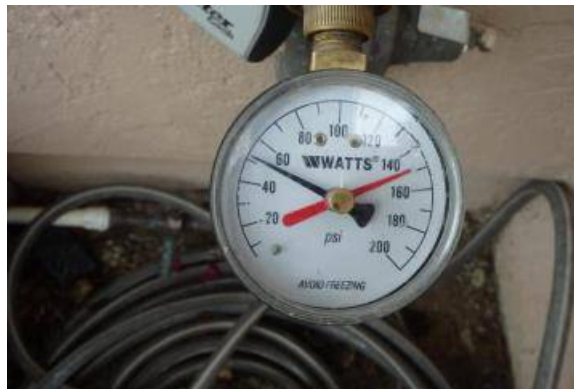
10.4 Water Pressure:

50 psi. A pressure regulator was installed.

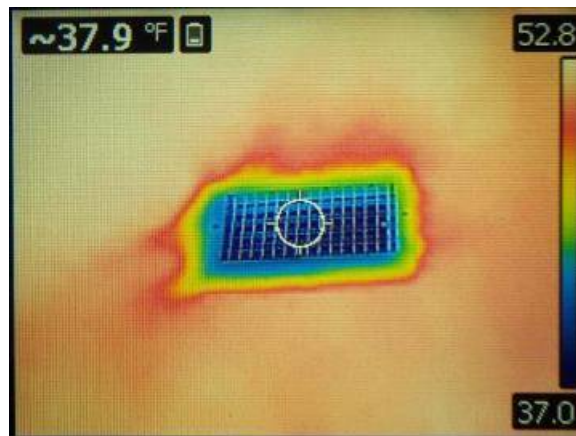
12.17 A/C Tempt. Drop:

+15 degrees F. Satisfactory.

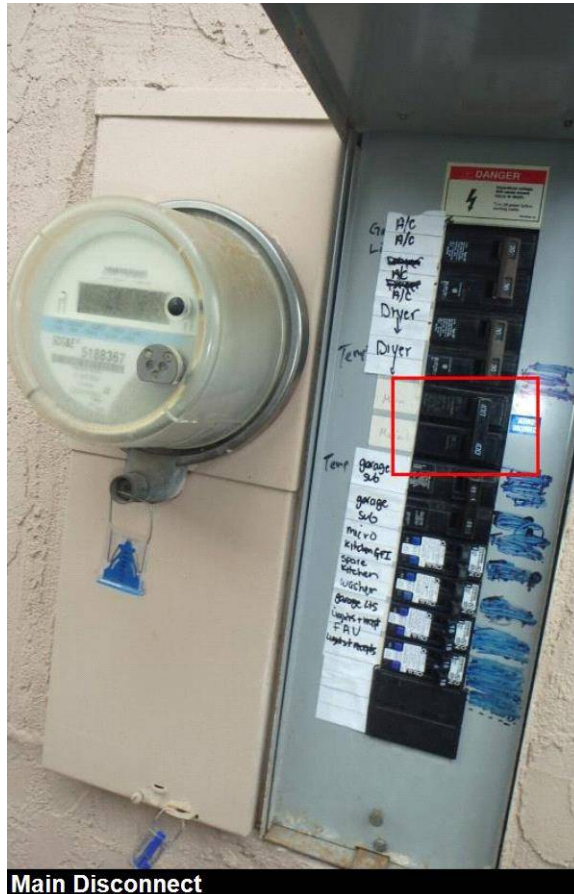
13.4 Main Panel:

Located at the exterior left. Capacity - 100 Amp. Original panel. Main service conductors were metal bars. 120 Volt and 240 Volt branch circuits were installed. The panel had available slots for additional breakers.

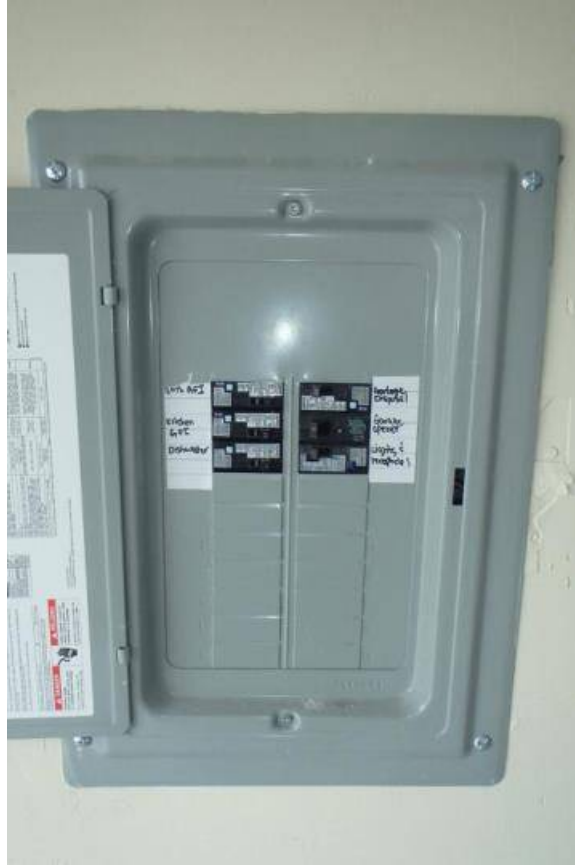
13.5 Subpanel -1:

Located in the garage. Capacity - 60 Amp. A replacement panel was installed. Copper main service conductors. 120 Volt branch circuits were installed. The panel had available slots for additional breakers.
