## RESIDENTIAL INSPECTION REPORT

1325 5th St  
Imperial Beach, CA 91932

07/25/2025

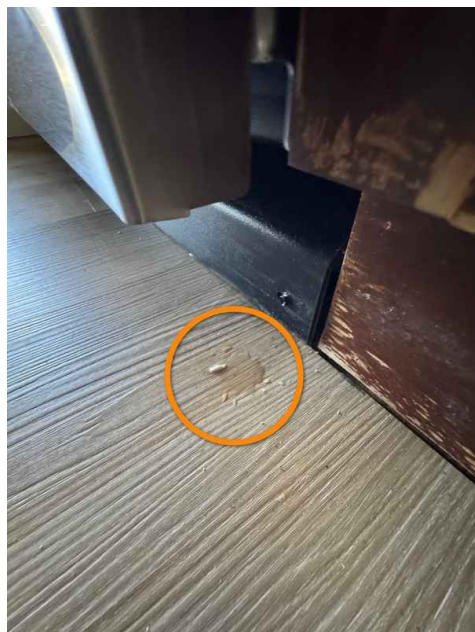
Water noted below unit

Contact a qualified plumbing contractor.

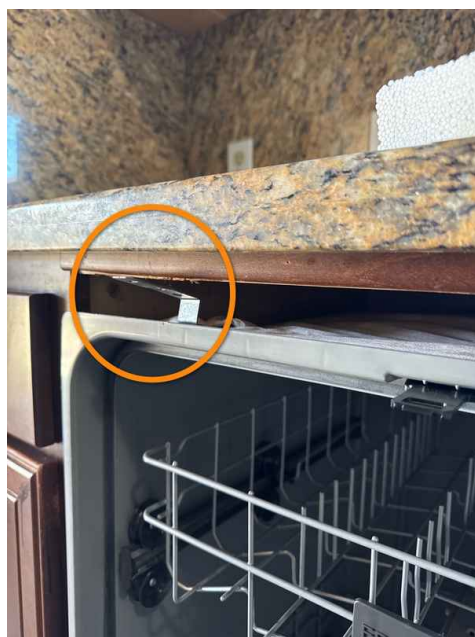
Unit not secured

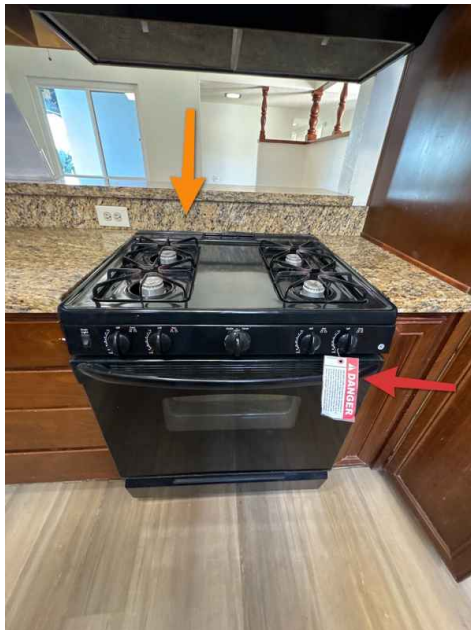
Kitchen, anti-tip bracket also missing

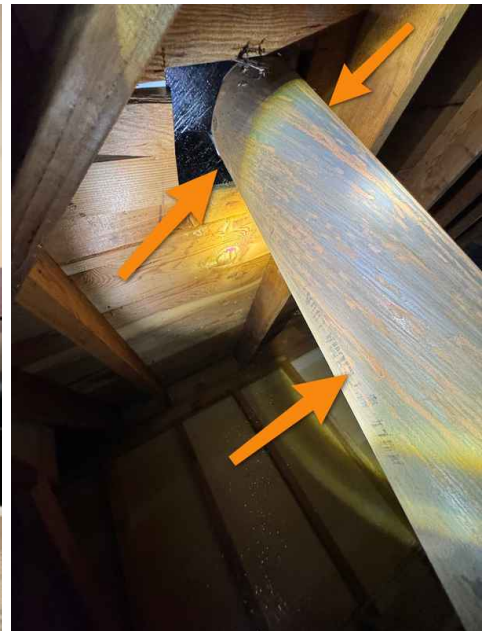
Example of moisture staining at duct noted at Attic

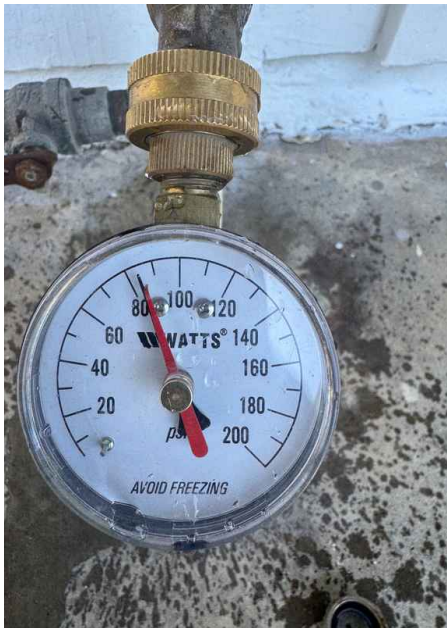
80-85 PSI, Too High

Water Pressure Gauge used

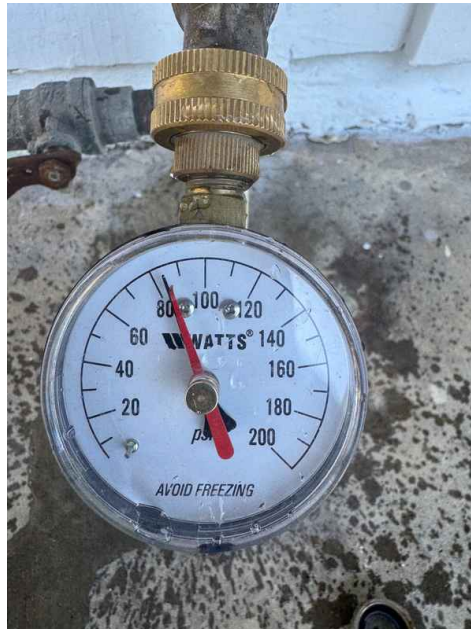
80-85 PSI, Water Pressure Gauge used

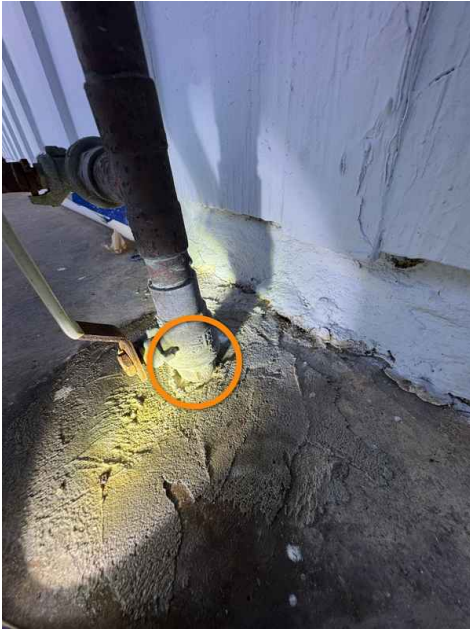
Main Water Shut-off pipe material  
undetermined

Contact a qualified plumbing contractor.

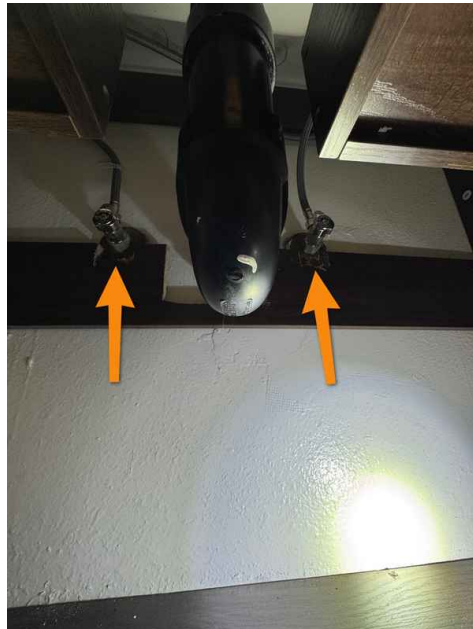
Example noted at Hall Bathroom Sink, loose

Contact a qualified plumbing contractor.

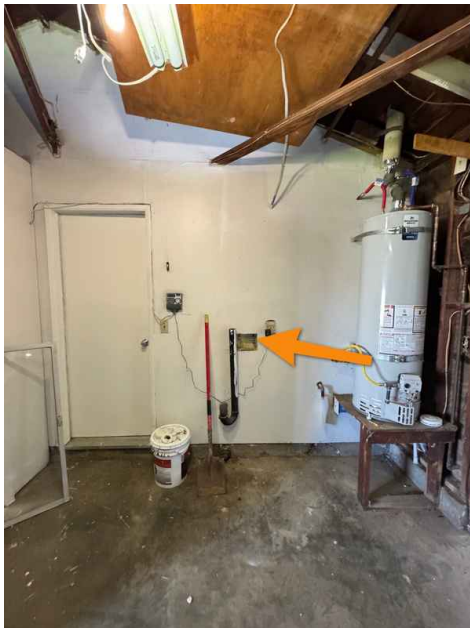
Example noted at Garage Rear, Laundry Area

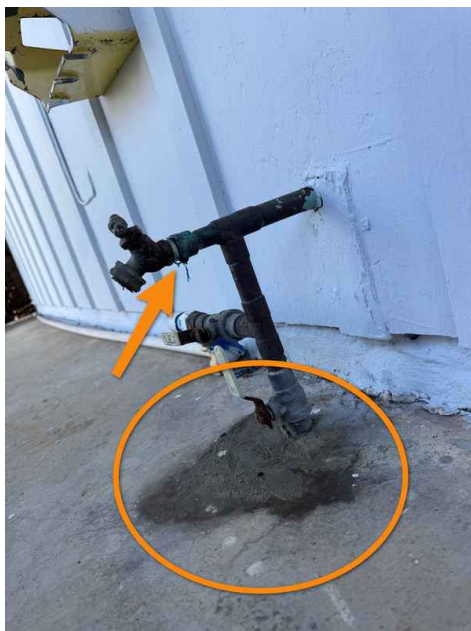
Appeared to be leaking from here

Contact a qualified plumbing contractor.

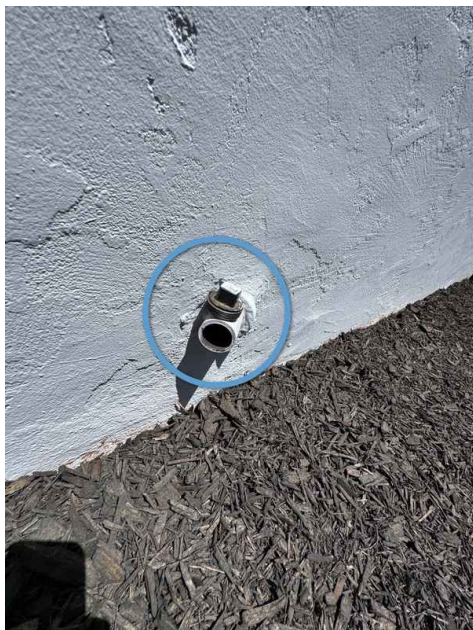
Cleanout cap not installed

Contact a qualified plumbing contractor.

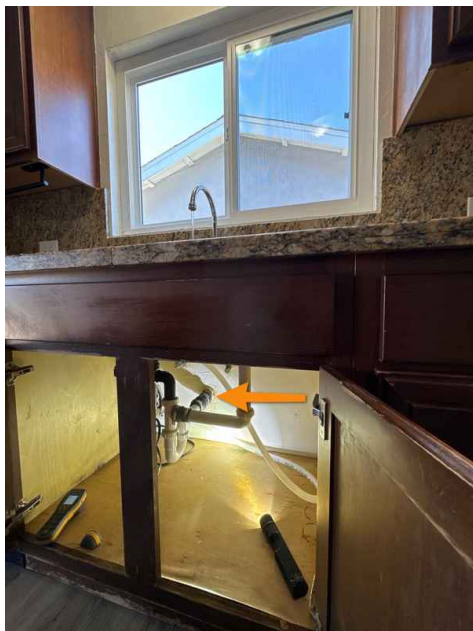
Example of rust noted

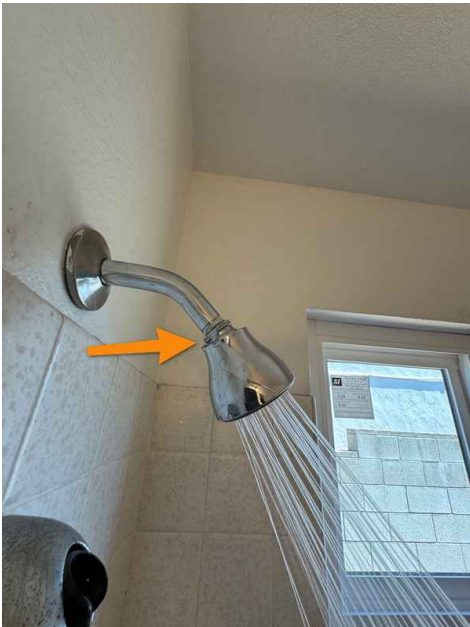
#### **SHOWER HEAD(S) LEAK**

Shower head(s) leak while in use. Recommend further evaluation by a licensed plumbing contractor to determine repairs as necessary to ensure proper function.

Hall Bathroom Shower, Appeared to be leaking from here

Contact a qualified plumbing contractor.

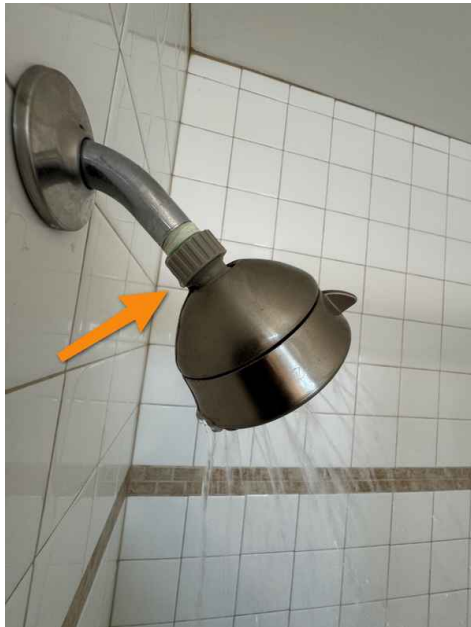
Primary Bathroom Shower, Appeared to be leaking from here

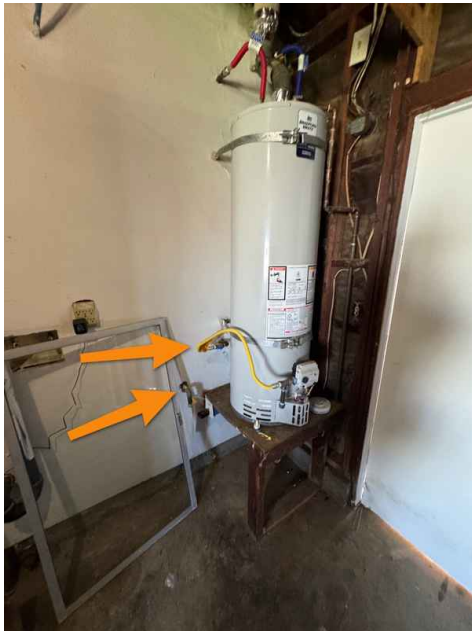
#### **LOOSE GAS PIPE(S)**

Gas pipe appeared loose/improperly supported at several locations. This condition is conducive to gas leaks developing. No active gas leak detected at time of inspection using a gas leak detector. Recommend further evaluation by a licensed plumbing contractor to determine any repairs necessary.

Example noted at Garage Rear

Contact a qualified plumbing contractor.

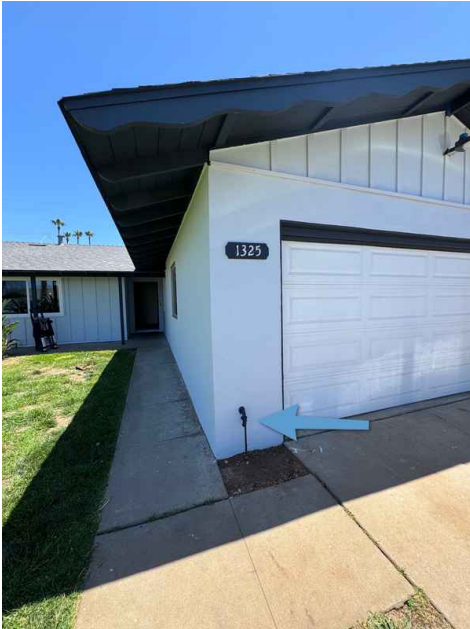
Evidence of a gas plumbing re-pipe, or modifications to gas pipes, noted at one or more locations. These modifications may have required a permit. Recommend inquiring with the seller for any information and/or work receipts to determine these modifications were completed by a licensed plumbing contractor. It is also advisable to consult a licensed plumbing contractor for further evaluation and to determine if any latent defects exist.

Example noted at Front of Home

Contact a qualified plumbing contractor.

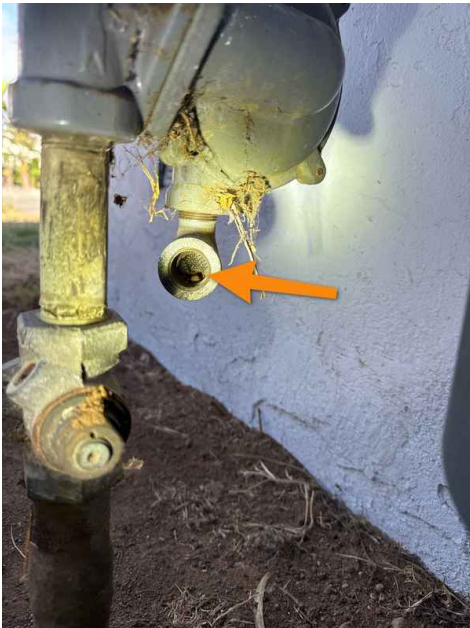
**MISSING COMPONENT - LOOSE PIPE AT MAIN GAS METER**

Gas pipe component appeared to be missing, loose pipe also noted at the main gas meter/shut-off location. This can lead to gas leaks which are a potential health and safety concern. No active gas leak detected at time of inspection. Recommend further evaluation by the local gas provider company, or by a licensed plumbing contractor to determine any measures necessary to forestall further damage and gas leaks.

Cap or pipe appeared to be missing

Contact a qualified plumbing contractor.

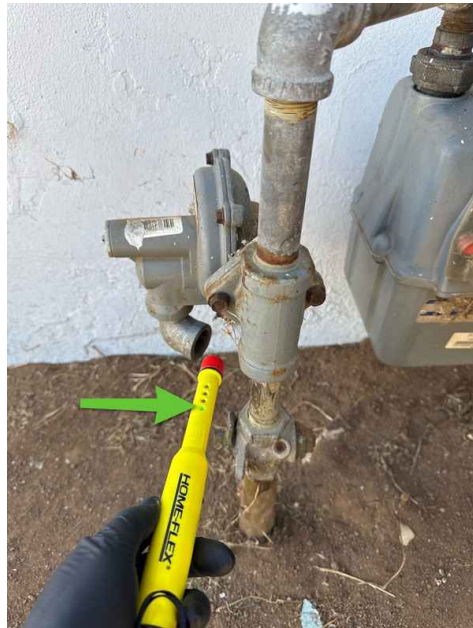
No gas leak detected at time of inspection

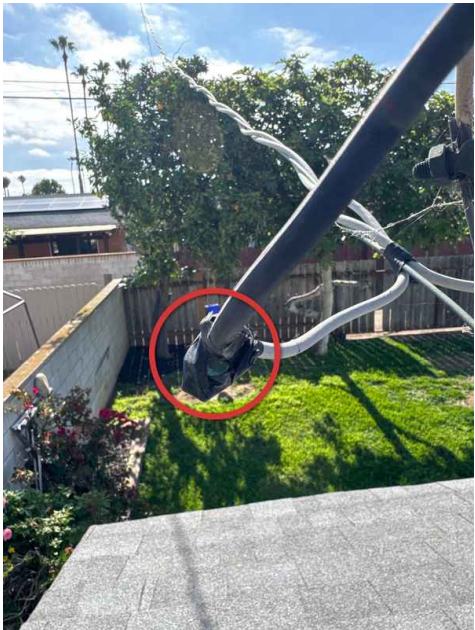
There did not appear to be sufficient clearance from the tree at the overhead electrical service entrance conductors at the rear yard. This can be an electrical safety hazard. Also, protective insulation on service entrance conductors appeared to be damaged in one or more areas. Wires should not be exposed to sunlight, unless rated. Recommend further evaluation by a licensed electrical contractor to determine corrections necessary at this time for safety.

Example of damaged insulation noted, Rear Left Side Roof

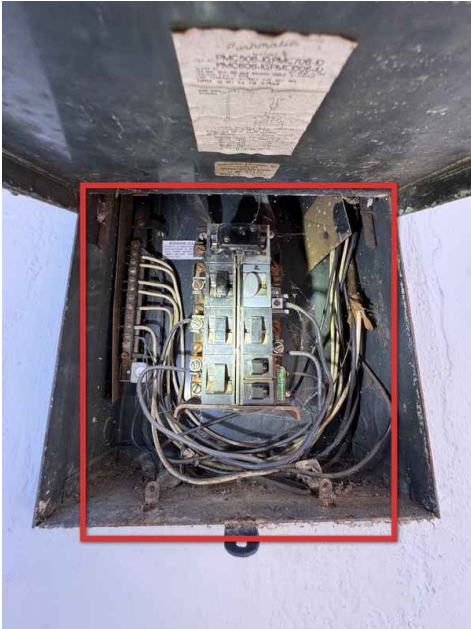
Dirt/Debris noted Inside Main Panel

Contact a qualified electrical contractor.

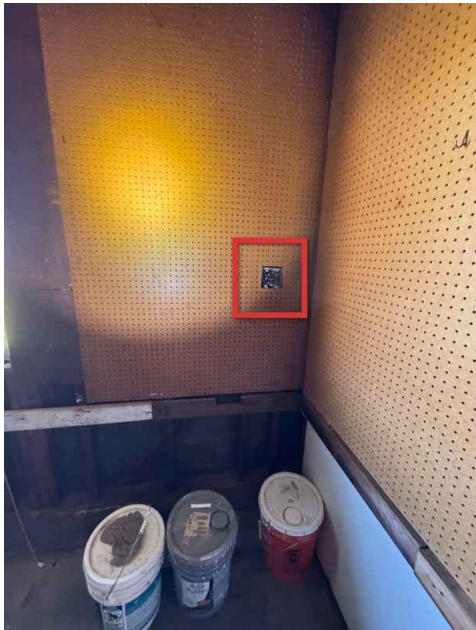
Electrical receptacles (outlets/switches) in several locations in the home and/or at the exterior noted excessively loose, damaged and/or missing adequate faceplates. These conditions are an electrical safety concern, if left uncorrected. Recommend further evaluation of all electrical receptacles throughout the home and exterior by a licensed electrical contractor to determine any repairs or replacement as necessary for safety.

Example noted at Garage, Right Side facing outwards, missing faceplate

Recommendation  
Contact a qualified electrical contractor.

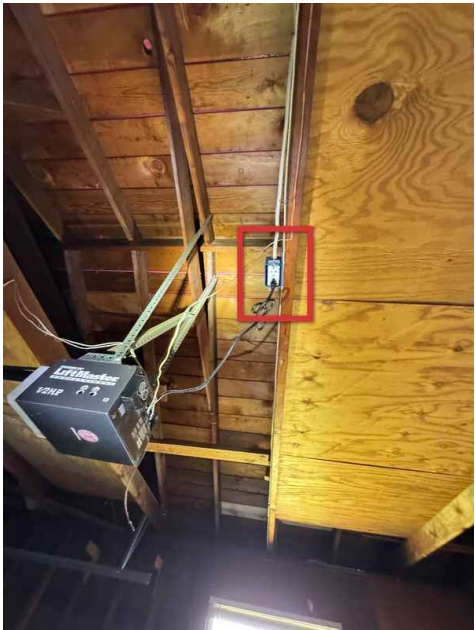
Example noted at Garage, missing faceplate

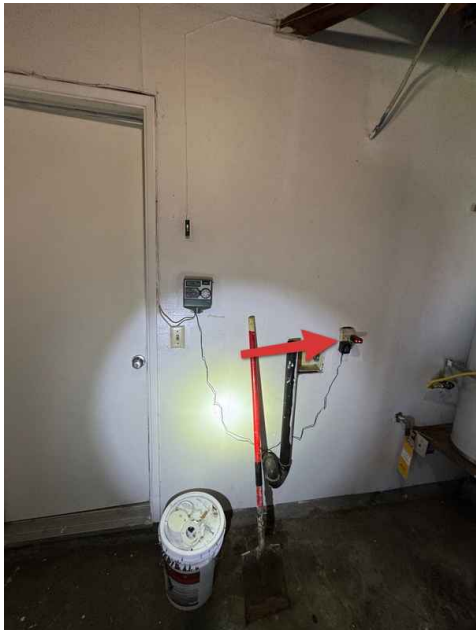
Example noted at Garage, Rear Left Side facing outwards, missing faceplate

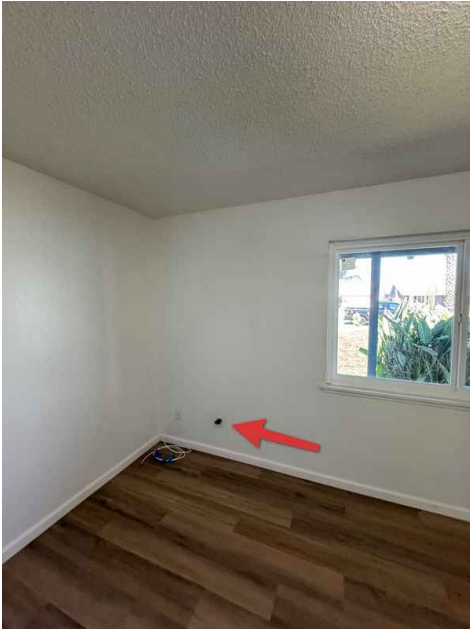
Example noted at Living Room, damaged

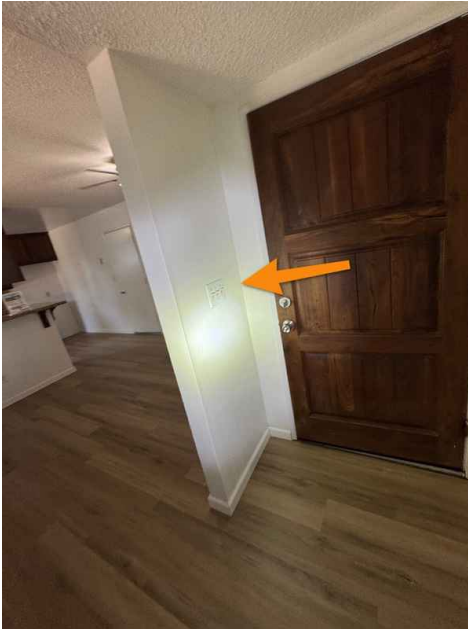
Example noted at Dining Room, loose

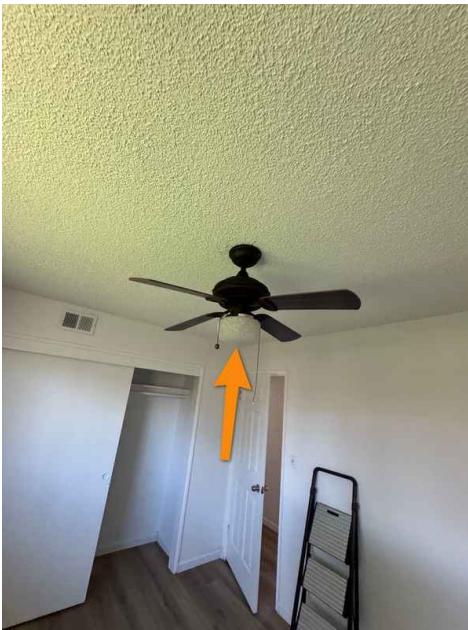
Example noted at Bedroom #2

One or more lights appeared to be inoperable at the time of the inspection. Recommend replacing the light bulb and re-testing the light(s). If the light fails to work, recommend further evaluation by a licensed electrical contractor to determine repairs or replacement necessary.

Contact a qualified electrical contractor.

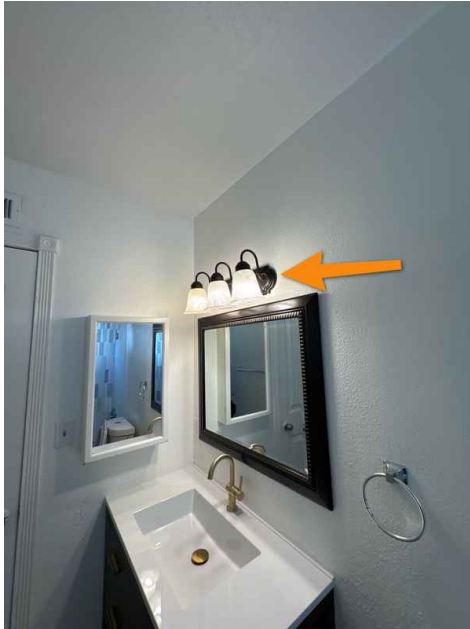
Example noted at Hall Bathroom

Several loose light fixtures noted. This condition can lead to loose electrical wiring which can be an electrical hazard, if not corrected. Recommend further evaluation by a licensed electrical contractor and repair as necessary.

Contact a qualified electrical contractor.

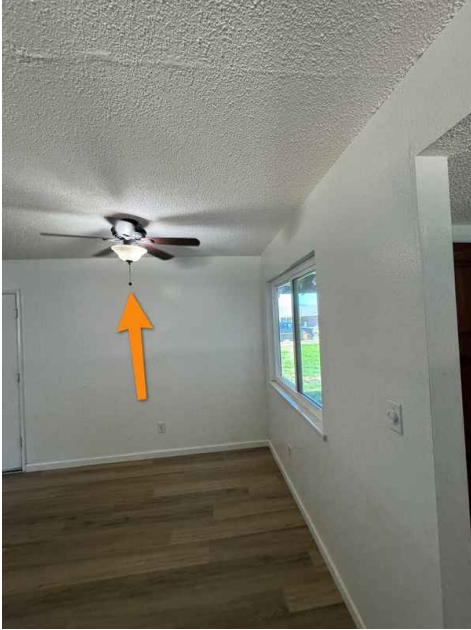
Example noted at Dining Room

One or more ceiling fans appeared to be unbalanced and/or rocked when turned on. Recommend further evaluation by a licensed electrical contractor to determine any repairs necessary.

Contact a qualified electrical contractor.

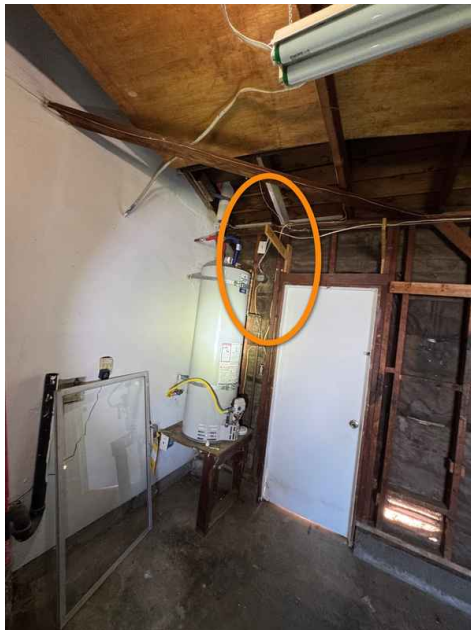
Example noted at Garage Rear

Aged wiring appeared to be in active use in the home and may not be as reliable or safe as modern wiring. There also appeared to be modifications and/or previous repairs at the electrical wiring in areas. Recommend inquiring with the seller for work receipts to verify work was completed by a licensed electrical contractor to today's standards, I also recommend further evaluation by a licensed electrical contractor to determine any repairs or upgrades as necessary to ensure continued function and safety.

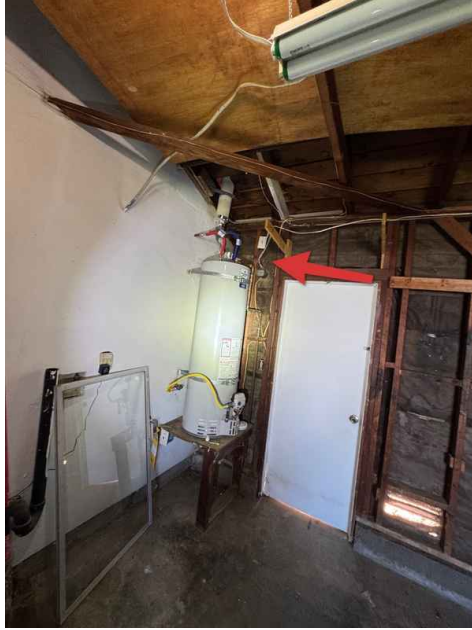
Example noted at Garage Rear

Wires appeared to be improperly terminated at one or more locations. The wire in the garage appeared to be powered or "live". This is a potential electrical shock safety concern. Other wires appeared unpowered, however, verifying this is beyond the scope of this inspection. Recommend further evaluation by a licensed electrical contractor to determine corrections necessary for safety.

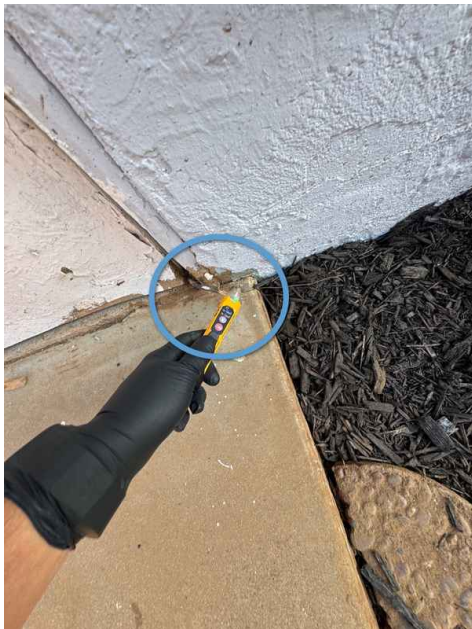
Wires did not appear powered

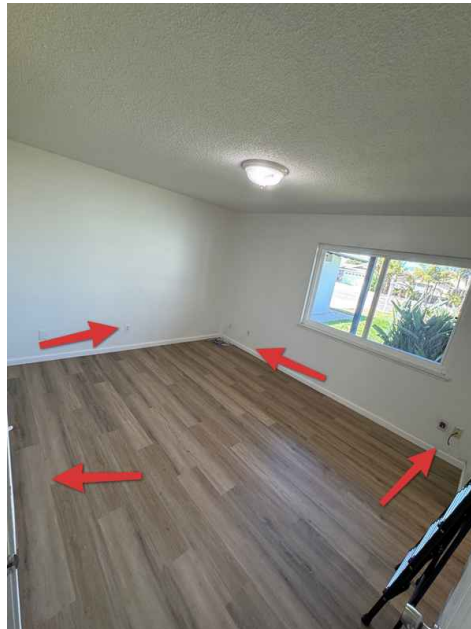
Example noted at Primary Bedroom

Most electrical receptacles throughout the home appeared "open" or ungrounded. This is an electrical safety concern. Recommend further evaluation by a licensed electrical contractor to determine repairs necessary at this time to ensure proper grounding and safety in the home.

Contact a qualified electrical contractor.

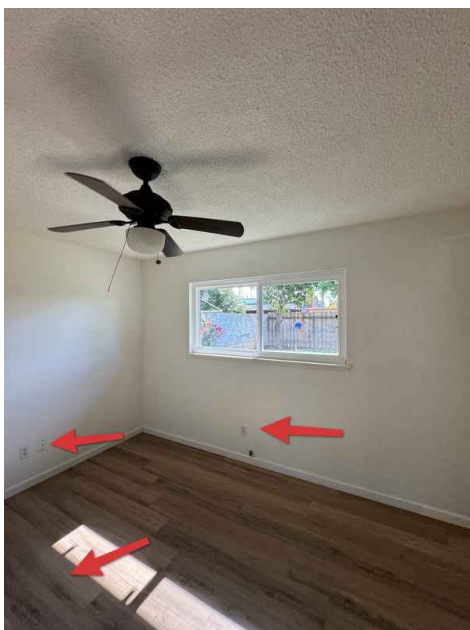
Example noted at Bedroom #2

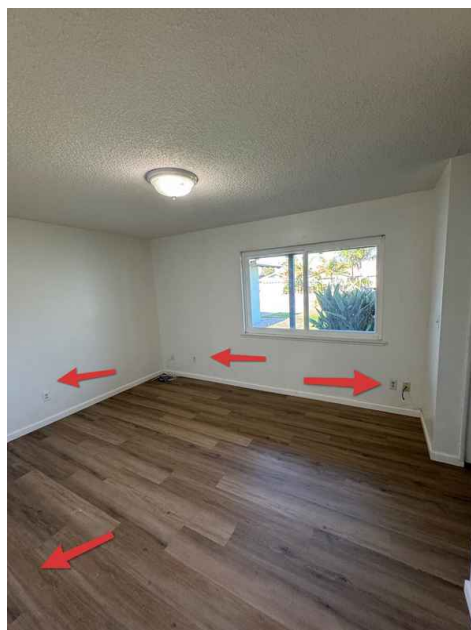
Example noted at Primary Bedroom

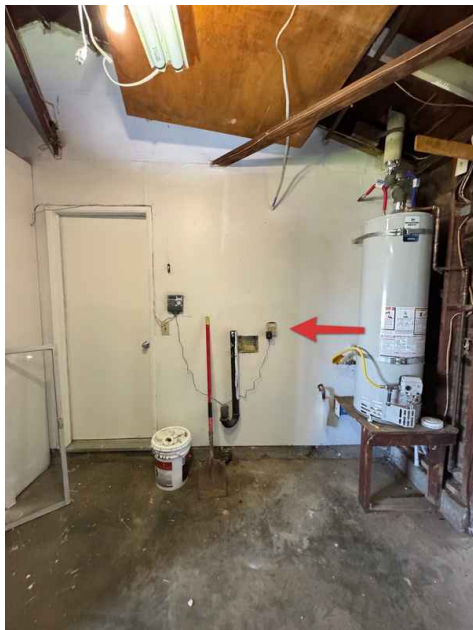
This home was built prior to the requirement for the installation of GFCI receptacles in certain locations throughout the home. The locations where GFCI protection is required has increased due to known safety hazards, however, it is not generally required to retrofit older homes unless a substantial remodel takes place. No exterior receptacles found, recommend adding as an upgrade to comply with today's electrical safety standards. I highly recommend a licensed electrical contractor further evaluate and upgrade all required receptacles, including but not limited to; receptacles located within 6 feet of a plumbing fixture, in the garage, all receptacles serving the kitchen counter top, laundry receptacle, and all exterior receptacles, to GFCI protected receptacles.

Example noted at Garage Laundry Area

Contact a qualified electrical contractor.

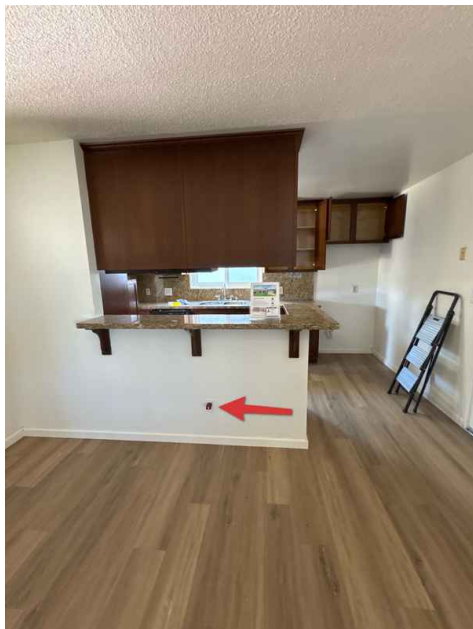
Example noted at Kitchen

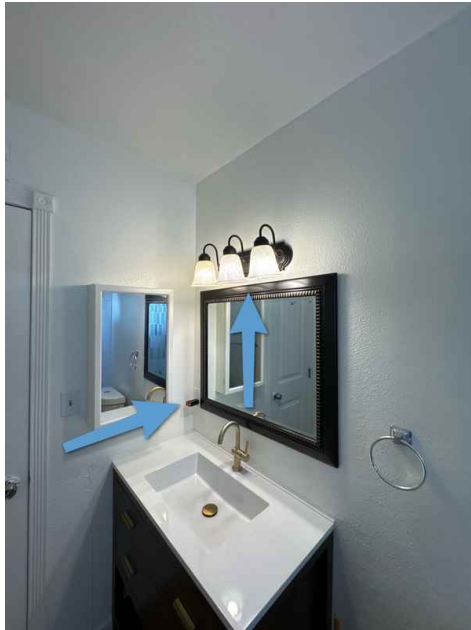
Lights noted connected to GFCI electrical receptacles. The light switches may also sometimes trip the GFCI receptacle. This may be considered a-typical or non-standard by today's electrical standards. It may also sometimes indicate electrical wiring that was not completed by a licensed electrical contractor. Recommend further evaluation by a licensed electrical contractor to determine any corrections as necessary at this time to comply with today's standards.

Example noted at Hall Bathroom

Contact a qualified electrical contractor.

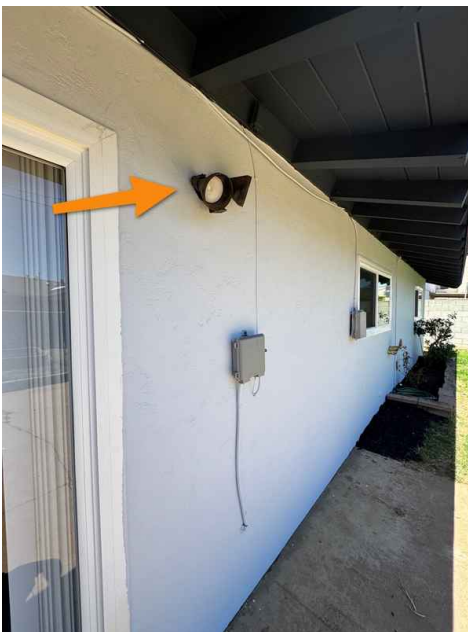
Exterior light fixtures noted loose/not adequately sealed to the exterior walls in several locations around the home. This condition can become an electrical safety concern if the wiring becomes loose and/or if water enters in behind the fixtures. Recommend further evaluation of the exterior fixtures by a licensed electrical contractor to determine any repairs necessary.

Example noted at Rear of Home

Contact a qualified electrical contractor.

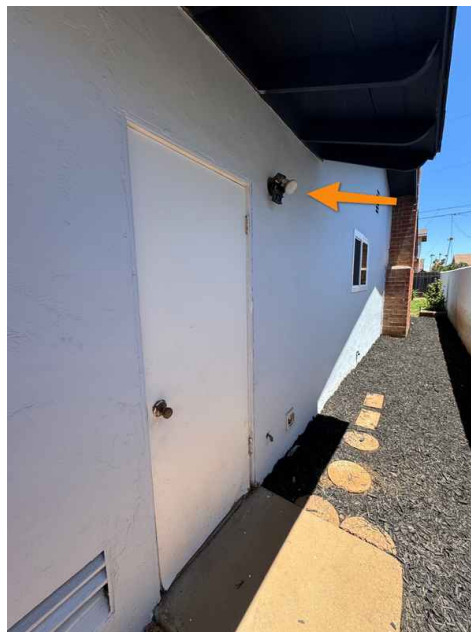
Example noted at Right Side of Home

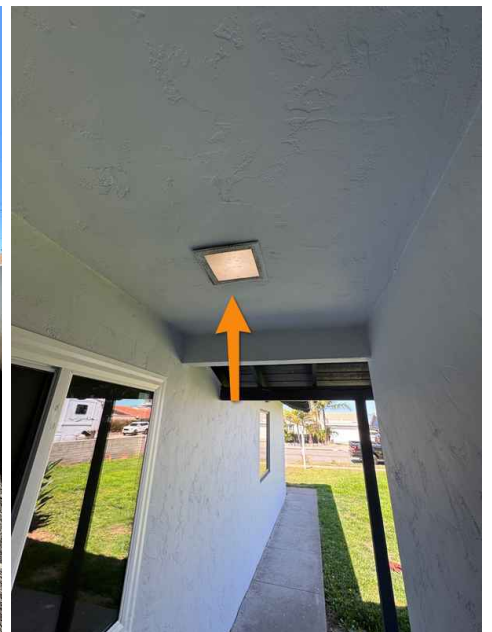
Example noted at Front Entry, loose

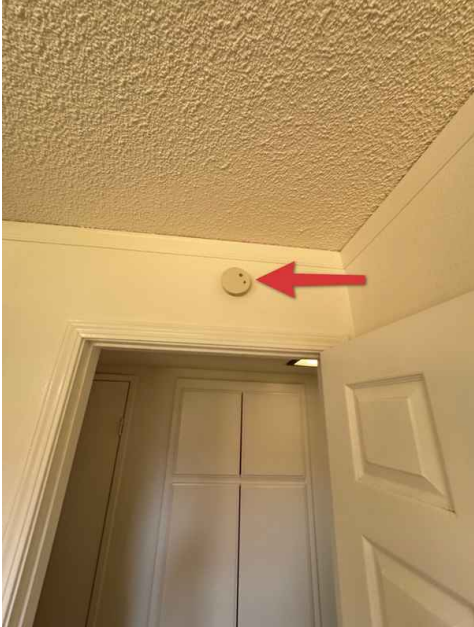
Smoke detectors did not appear to be installed in the required locations, in bedrooms, and one or more units appeared inoperable when tested using test button at time of inspection. Aged units should be replaced. Recommend a qualified person install smoke detectors where necessary to comply with today's safety standards. You can view more information [here](#).

Example noted at Bedroom #3, inoperable

Recommendation  
Contact a qualified professional.

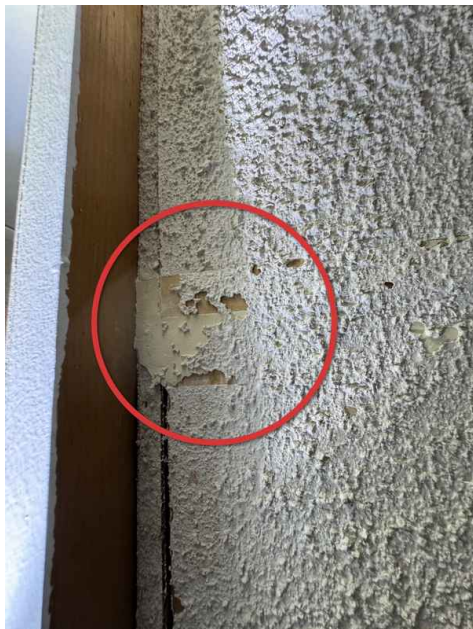
Example of damage noted

Contact a qualified professional.

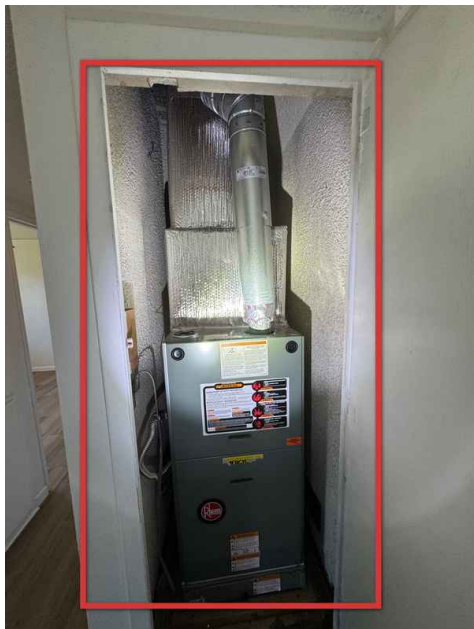
Example noted at Hallway Utility Closet

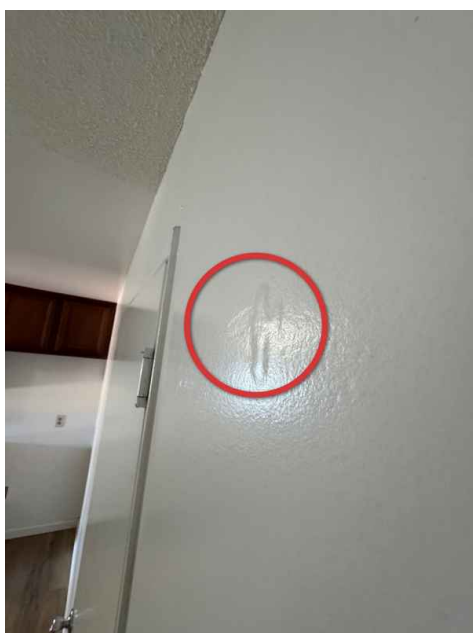
Example of failing paint noted

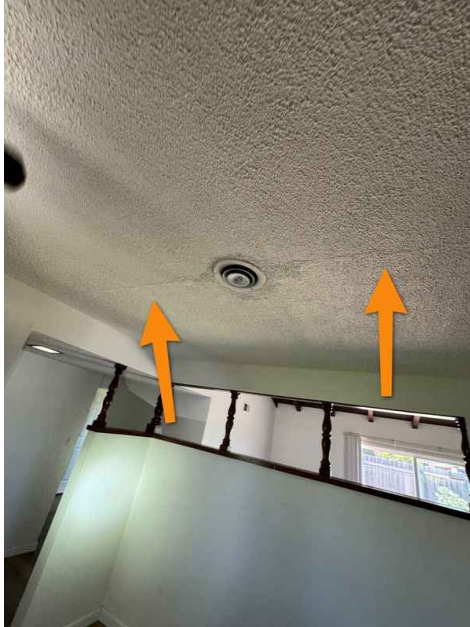
Example noted at Dining Room

Contact a qualified general contractor.

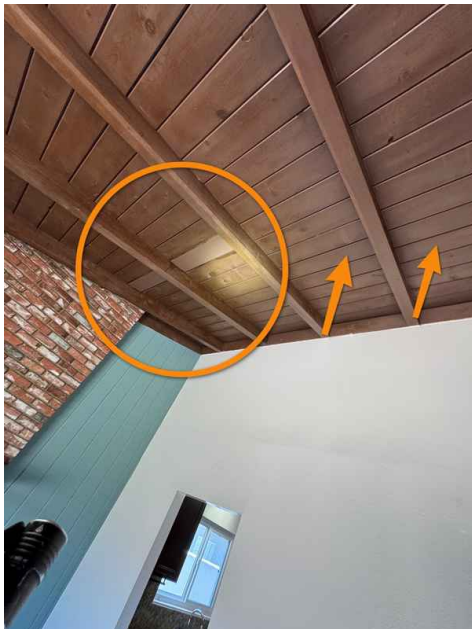
Example of repairs and staining noted at Living Room

Contact a qualified professional.

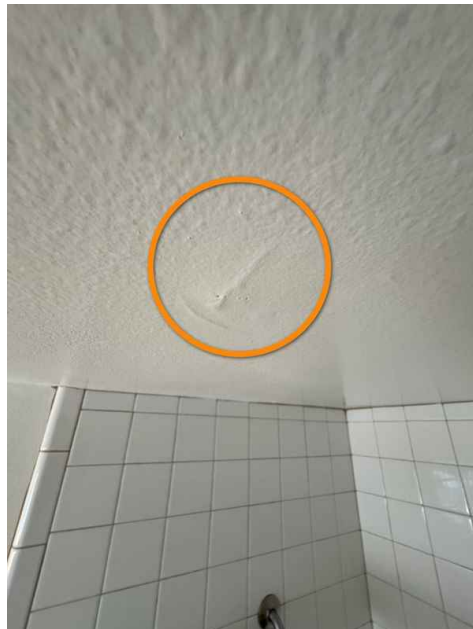
Example of moisture damage noted

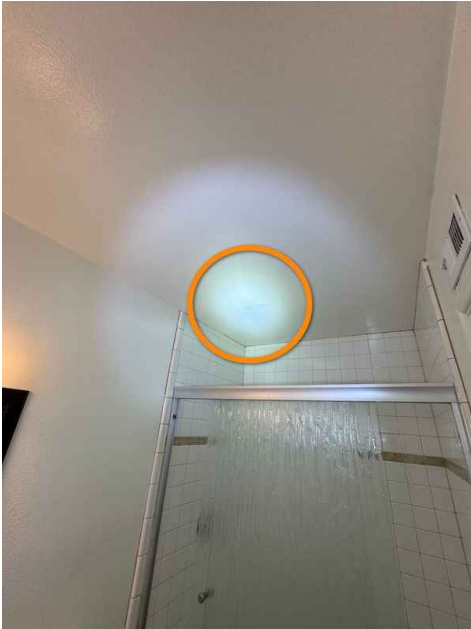
Example noted at Primary Bathroom Above Shower

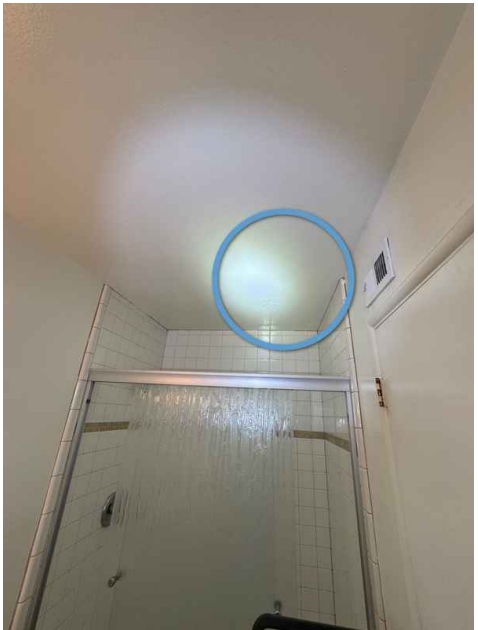
Example noted at Primary Bathroom Above Shower

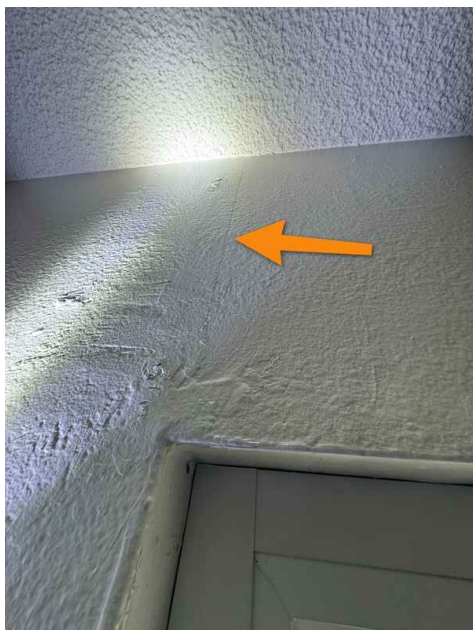
Example of crack noted

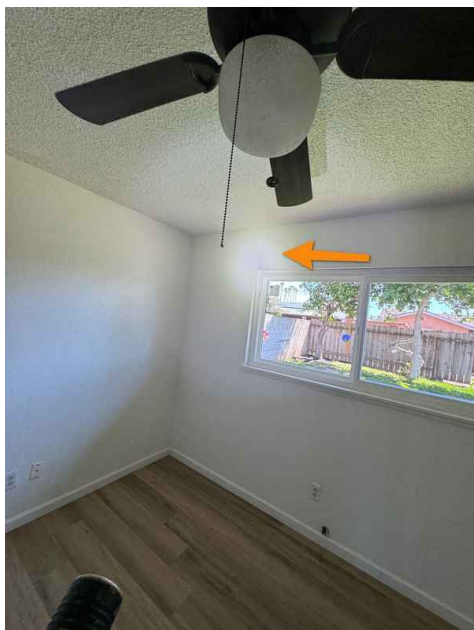
Example noted at Bedroom #2

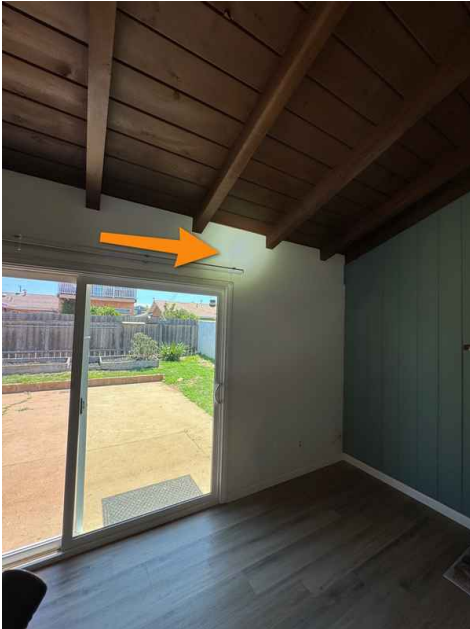
Example noted at Living Room

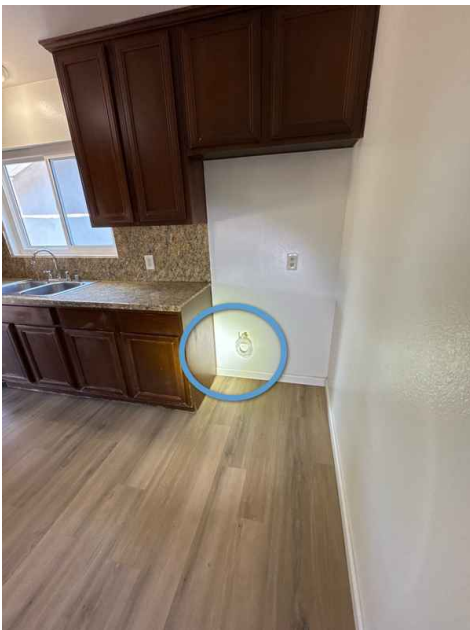
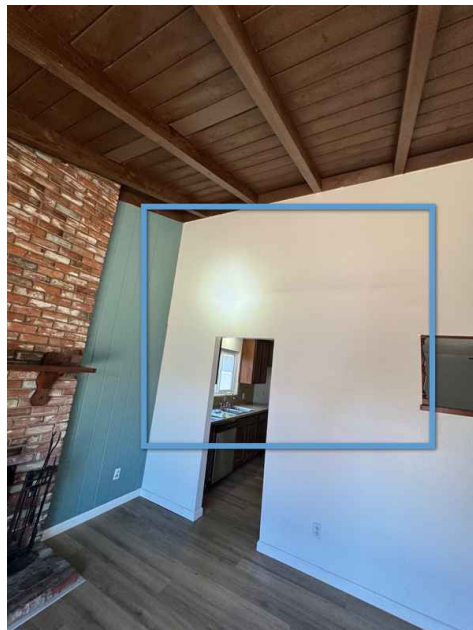
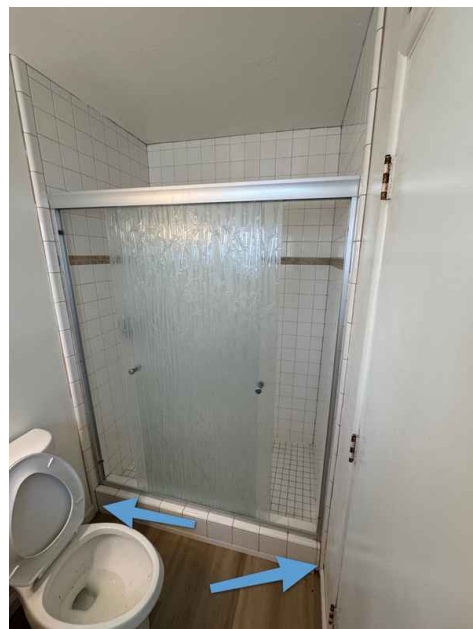
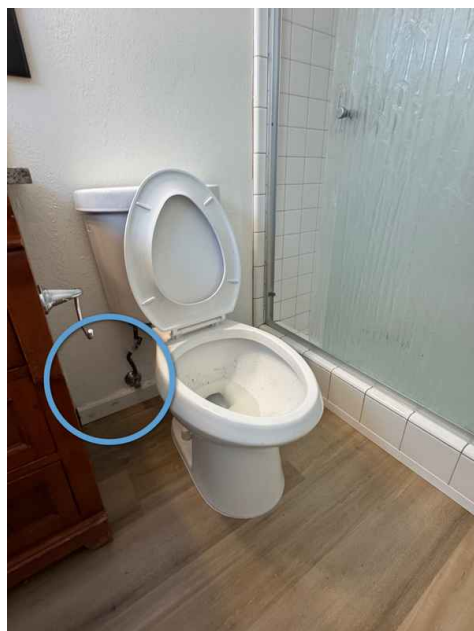
#### PREVIOUS REPAIRS - WALLS

Mis-match paint and/or patching/evidence of previous repairs noted at the walls in areas. Determining the cause is outside the scope of this inspection. Should the client have concerns, we recommend asking the seller for any information regarding previous repairs, and/or further evaluation by a qualified professional as necessary.

Example noted at Kitchen

Example noted at Living Room

Example noted at Primary Bedroom

Example noted at Dining Room

Example noted at Bedroom #2

Example noted at Primary Bathroom

The area appeared to be dry

Contact a qualified professional.

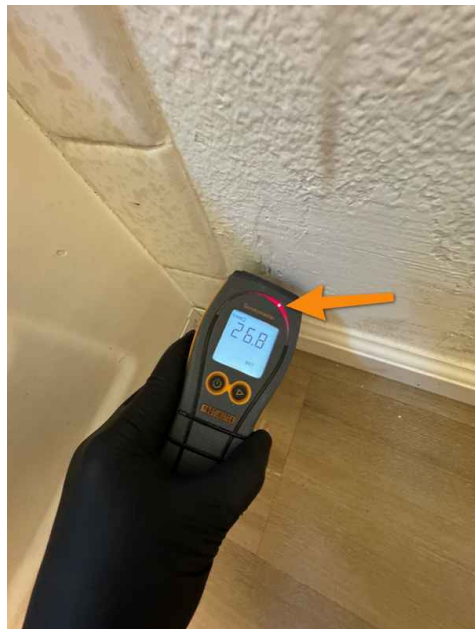
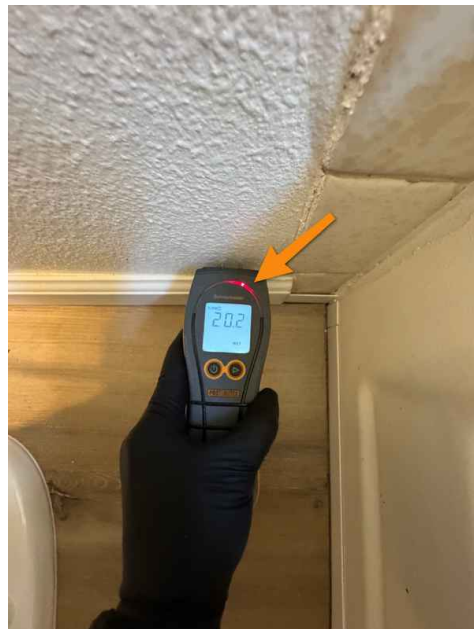
Hall Bathroom

## MOISTURE AT WALL BY SHOWER/BATHTUB

Elevated levels of moisture detected at the wall/baseboard by the shower/bathtub at the bathroom(s). This is often the result of water spilling out of the shower/bathtub enclosure. This condition is conducive to moisture damage, such as mold growth. Recommend further evaluation by a licensed restoration contractor to verify cause and any repairs necessary. Note: Determining if damage (such as mold growth) exists beyond the surface is beyond the scope of this inspection.

Elevated levels of moisture detected

Contact a qualified professional.

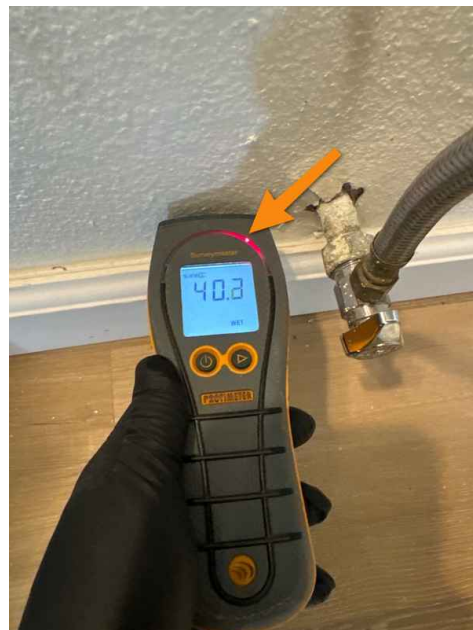
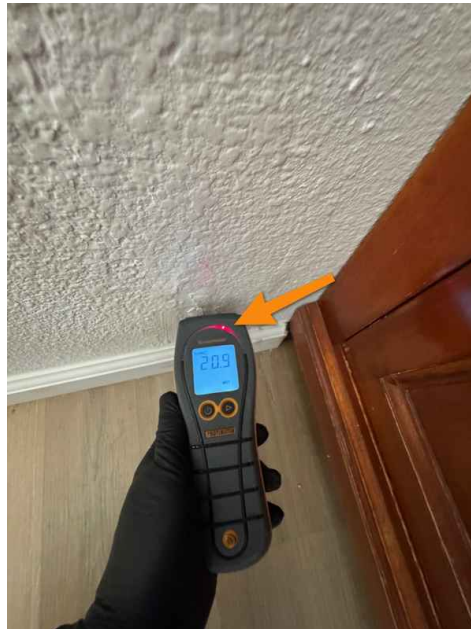
**MOISTURE AT WALL - UNKNOWN CAUSE**

Elevated levels of moisture noted at the walls in several locations. Unable to determine the exact cause. This condition is conducive to moisture damage, such as mold growth. Recommend further evaluation by a licensed restoration contractor to determine the cause and any repairs necessary to forestall further damage. Note: Determining if damage (such as mold growth) exists beyond the surface is beyond the scope of this inspection.

Elevated levels of moisture detected

Kitchen, Inside Sink Cabinet

Hall Bathroom, next to Toilet

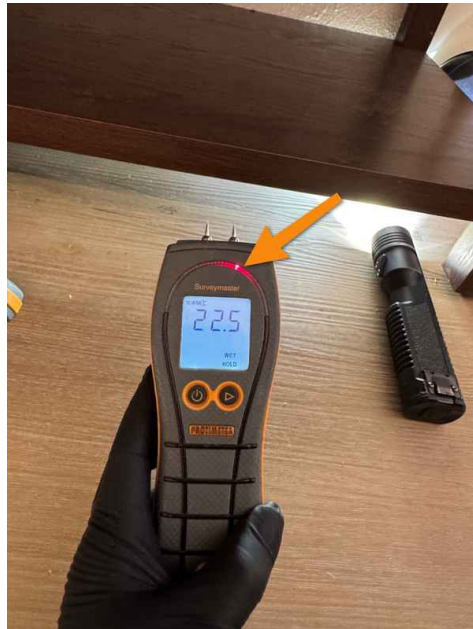
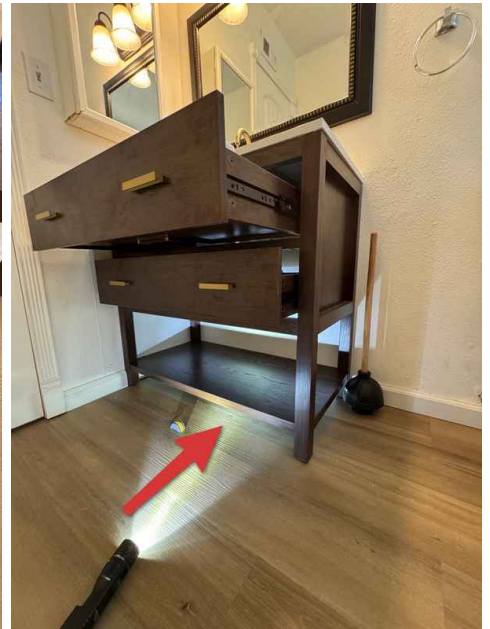
Dark staining, possible organic growth (mold), noted at the wall in one or more location. An elevated level of moisture was also detected. Determining the cause and if any organic growth may be a health concern requires specialized testing, which is beyond the scope of this inspection. Recommend further evaluation by a licensed restoration contractor to determine the cause and any repairs necessary. I also recommend a licensed environmental contractor to further evaluate the area(s) to determine if additional measures are necessary at this time to ensure proper air quality in the home and for health and safety of any occupants.

Example noted

Elevated levels of moisture detected

Example noted at Hall Bathroom, Below Sink

Contact a qualified environmental contractor

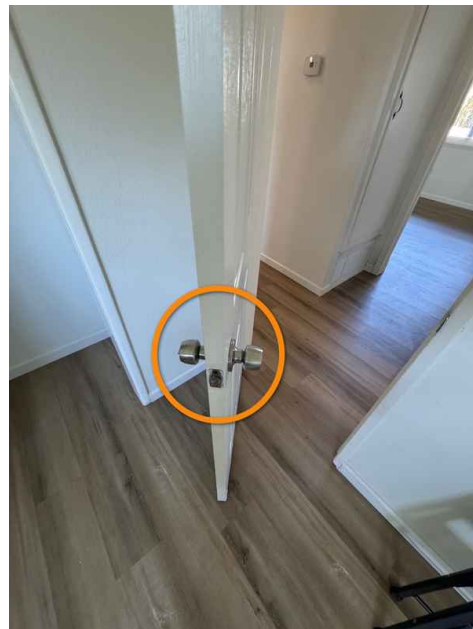
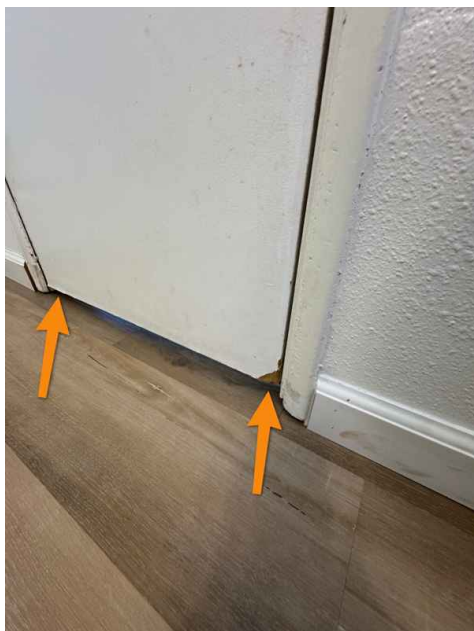
**INTERIOR DOORS/DOOR HARDWARE REQUIRE FURTHER EVALUATION & REPAIR**

Loose door handles, Door stopper(s) missing/inadequate, Door lock installed on outside of room

Interior doors/door hardware noted loose and or did not operate properly. Door lock noted installed at exterior side of bedroom, this condition may prevent egress in the case of a Door lock noted installed at exterior side of bedroom #3, this may prevent egress in the case of an emergency, if the door is locked from the exterior side. Door stoppers noted inadequate at most doors. Missing door stops at glass doors can lead to damage. Due to the Discovery Items listed here, I recommend further evaluation of the doors by a licensed door contractor and repair or replacement as necessary to ensure proper function.

Example noted at Bedroom #3, lock on exterior side

Example noted at Bedroom #3, loose hinge, missing stopper

Example noted at Bedroom #2, handle loose, missing stopper

Example noted at Primary Bedroom, loose handle

Example of damage noted, Primary Bathroom, stopper missing

Contact a qualified door repair/installation contractor.
