## RESIDENTIAL INSPECTION REPORT

1325 5th St  
Imperial Beach, CA 91932

07/25/2025

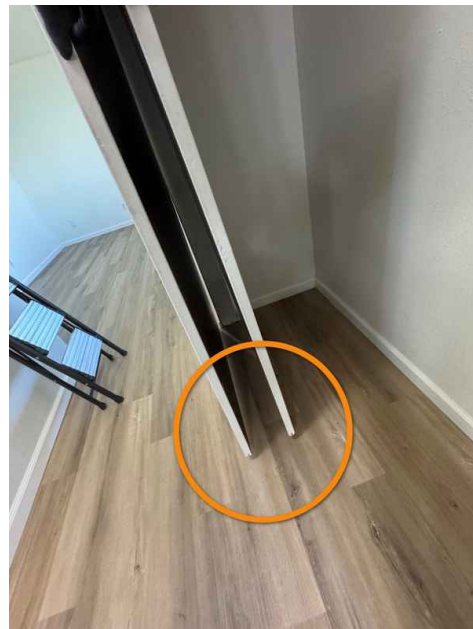
### CLOSET DOOR TRACKS MISSING - DAMAGE NOTED

Closet door track(s) noted missing at the floor. This condition can allow the doors to swing when operated, which can be a potential pinching hazard. Damage also noted at the closet doors in areas. Recommend further evaluation by a qualified professional to determine repair or replacement necessary to ensure proper function.

Bedroom #2 Closet

Example of damage noted, Bedroom #2 Closet

Primary Bedroom Closet

Bedroom #3 Closet

Contact a qualified professional.

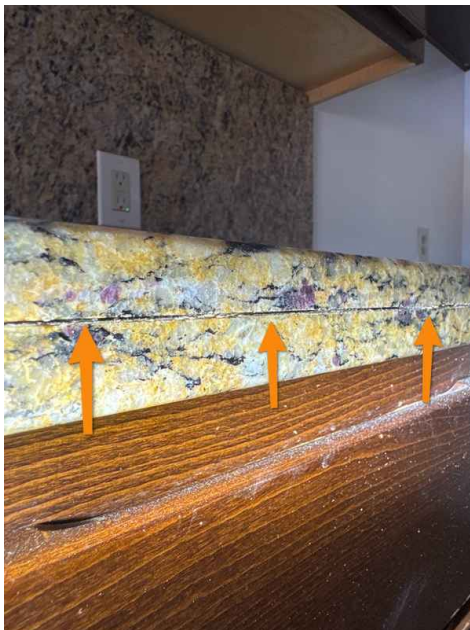
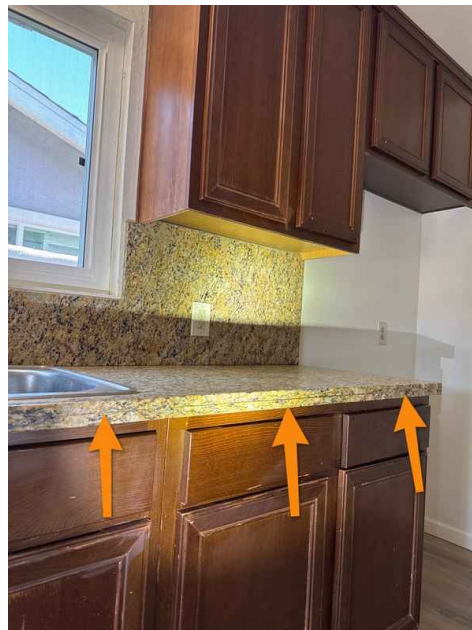
### **CRACKED/CHIPPED COUNTERTOPS - MISSING GROUT**

Cracking/chips noted at the countertop(s) in one or more areas. This can allow debris like food and bacteria to collect and prevent the countertop from being properly cleaned (or food-safe in kitchen). Missing or failing grout also noted at the countertop(s). Recommend further evaluation by a licensed countertop contractor to determine any repairs necessary at this time. The sinks and counters should be resealed as necessary by a qualified person.

Example of cracking noted

Example noted at Kitchen

Contact a qualified countertop contractor.

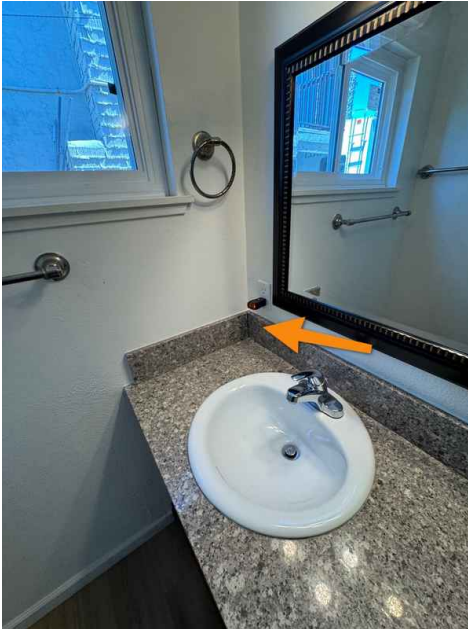
Example of missing grout noted

Example noted at Primary Bathroom Sink

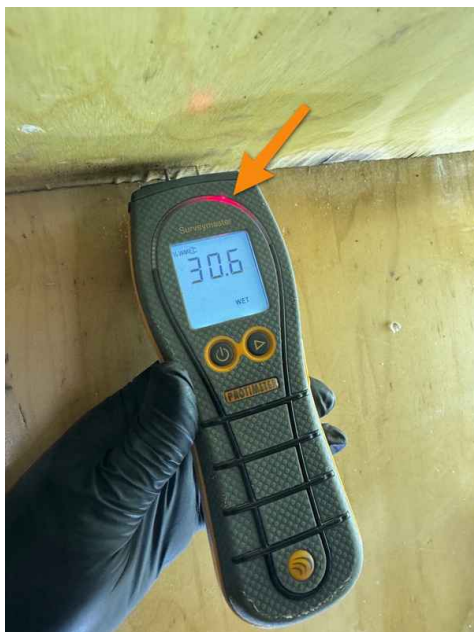
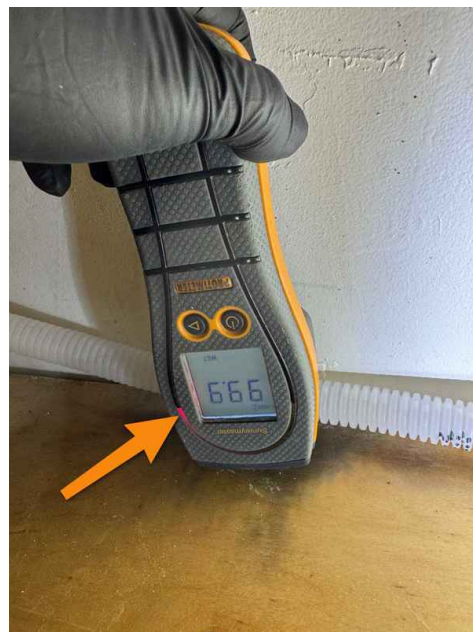
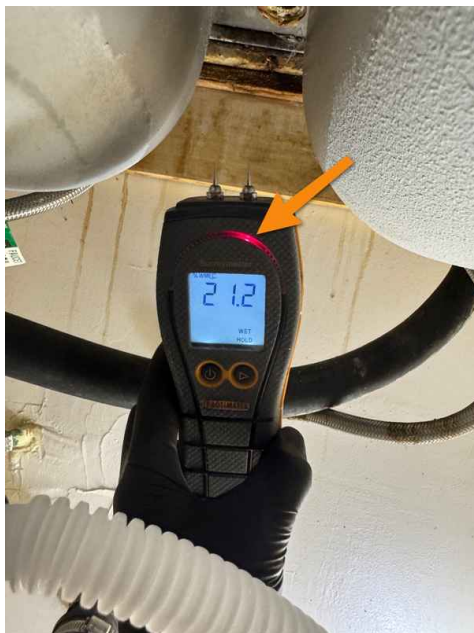
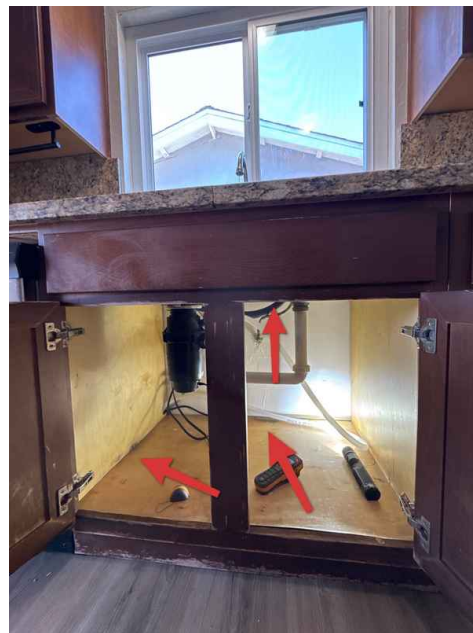
Dark staining, possible organic growth (mold), noted in areas of the sink cabinet. An elevated level of moisture was also detected in the areas. This can be indicative of failing seals at the above sink counter, or it may indicate a leak at the sink plumbing. Determining the exact cause, and if any organic growth may be a health concern, requires specialized testing, which is beyond the scope of this inspection. Recommend further evaluation by a licensed restoration contractor to determine the cause and any repairs necessary. I also recommend a licensed environmental contractor to further evaluate the area(s) to determine if additional measures are necessary at this time to ensure proper air quality in the home and for health and safety of any occupants.

Example noted

Elevated levels of moisture detected

Example noted at Kitchen Sink

Contact a qualified environmental contractor

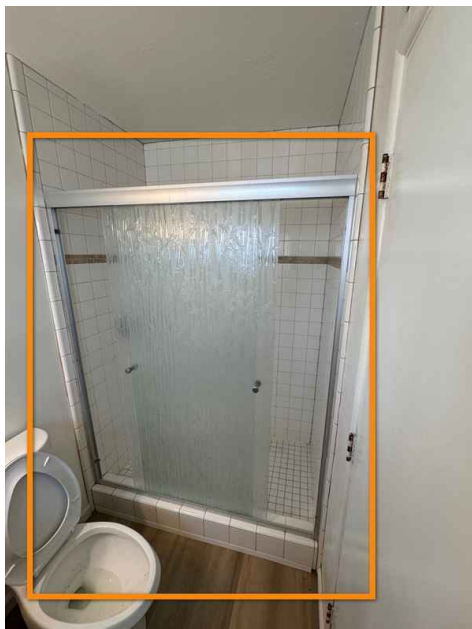
Recommend the shower/tub enclosures, fixtures and floor to tub/shower junctions be cleaned and re-caulked/sealed by a qualified professional as necessary to prevent moisture intrusion beyond the tub and shower enclosure(s).

Example noted

Half Bathroom Shower Bathtub

Example noted at Primary Bathroom Shower

Contact a qualified professional.

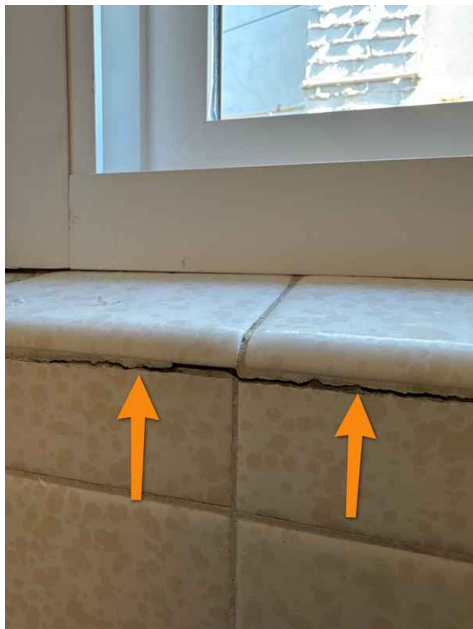
Loose tile(s) noted at the shower/tub surround at the bathroom(s). Repairs noted at the tile enclosure(s). Failing/cracked grout also noted at the enclosures. This condition is conducive to moisture intrusion/damage beyond the shower walls. Determining if the repairs are adequate is beyond the scope of this inspection. Recommend further evaluation by a licensed tile contractor to determine any repairs necessary to forestall further damage, or if latent defects exist. Inquire with the seller regarding any past repairs. Note: Determining if further damage or leaks exist beyond any surface is beyond the scope of this inspection.

Example of loose tiles noted

Contact a qualified tile contractor

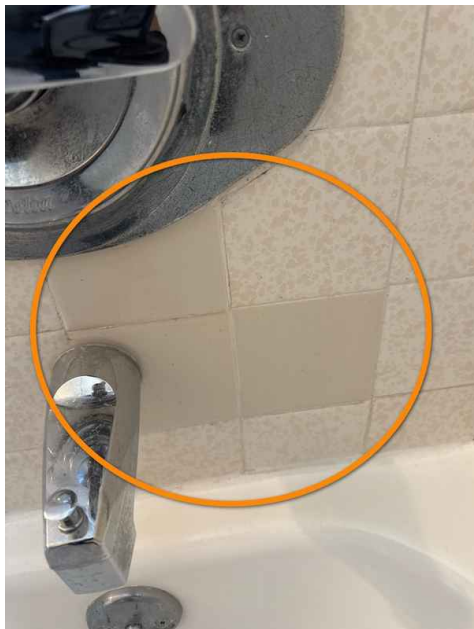
Example of Repairs noted at Hall Bathroom Shower

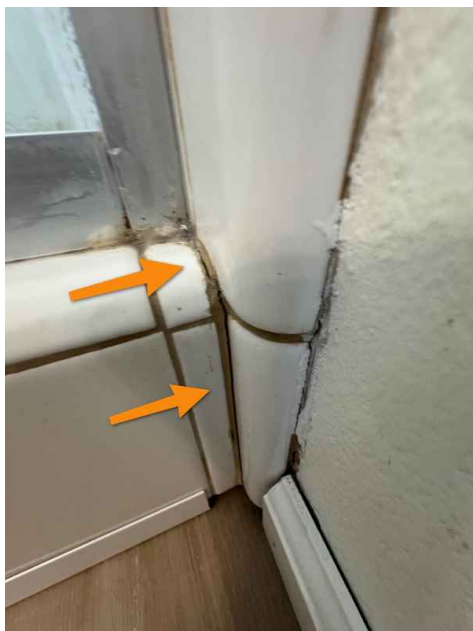
Example of failing grout noted

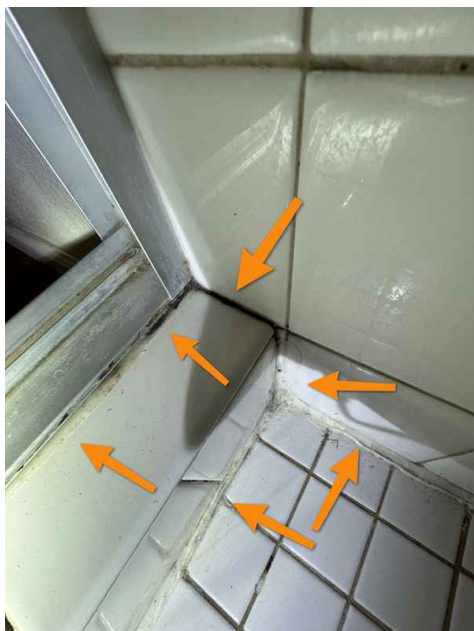
Example of Possible Repairs noted at Primary Bathroom Shower

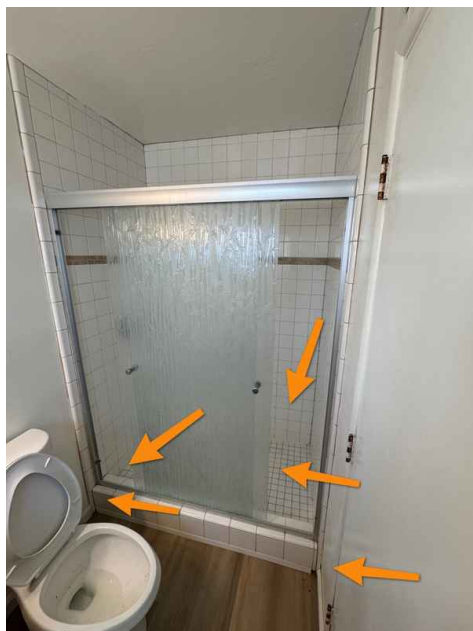
Example noted at Primary Bathroom Shower

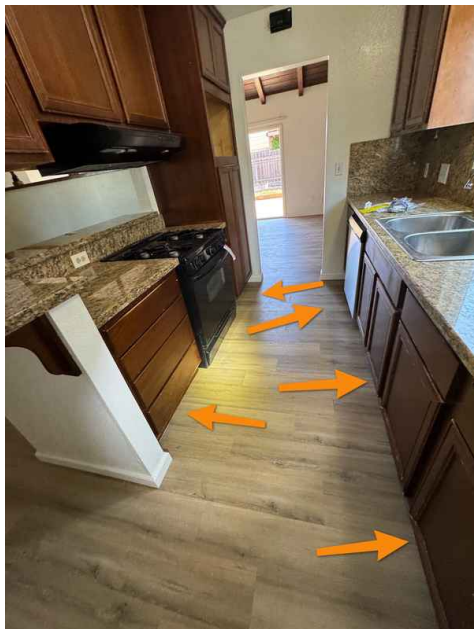
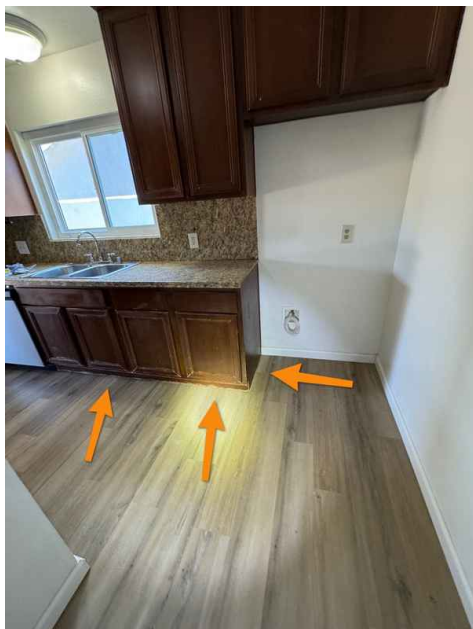
The installed flooring did not appear adequately secured in several locations, this condition can lead to flooring becoming loose or even damaged over time. This condition is also generally considered unworkmanlike finish, and can sometimes be indicative of work that was not completed by a licensed contractor. Recommend inquiring with the seller if any warranty exists for the replaced flooring installation, and/or further evaluation by a licensed flooring contractor to determine any corrections possible to ensure proper function.

Example noted

Example noted at Kitchen

Example noted at Bedroom #3

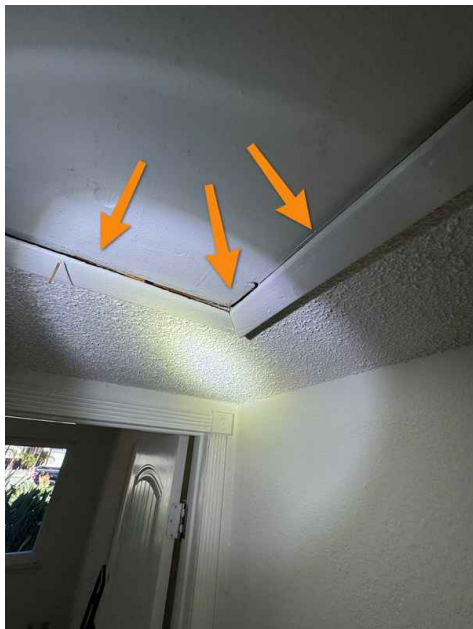
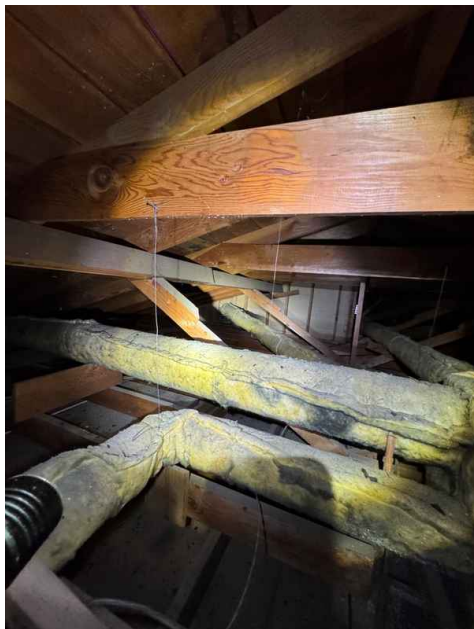
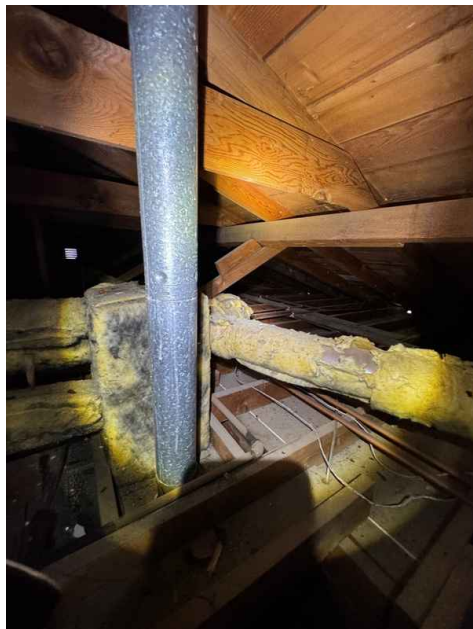
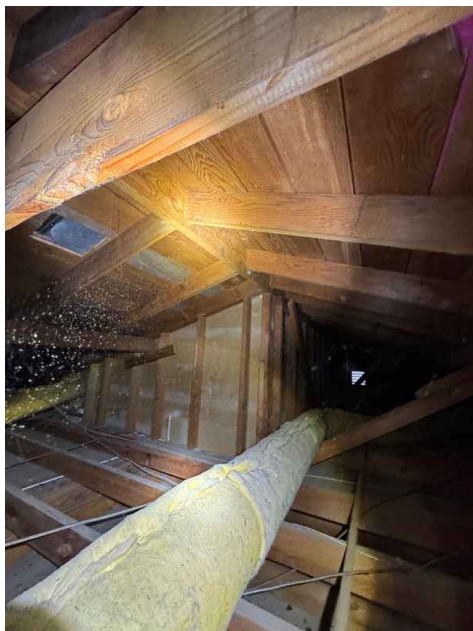
The attic access cover did not appear adequately sized and/or did not seal the attic hatch. Recommend repair or replacement by a qualified professional to ensure a tight seal from the untreated attic space air to the home. Note: Due to the roof structure, framing members, insulation, storage items, forced air handling and/or other components, some areas of the attic space were not accessible or visible at the time of the inspection. These areas could not be fully inspected.

Attic hatch, Hallway

Example noted at Attic

Contact a qualified professional.

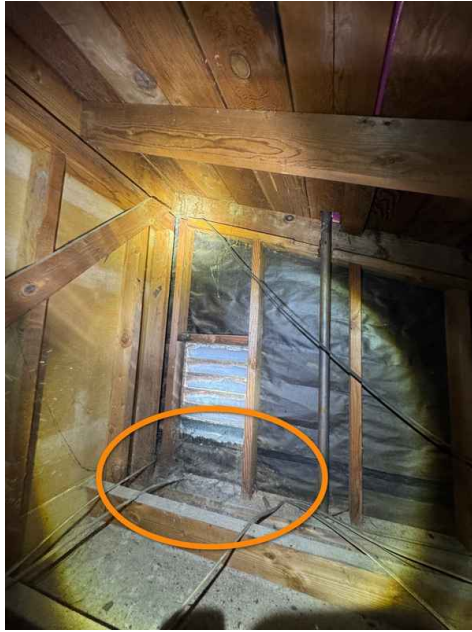
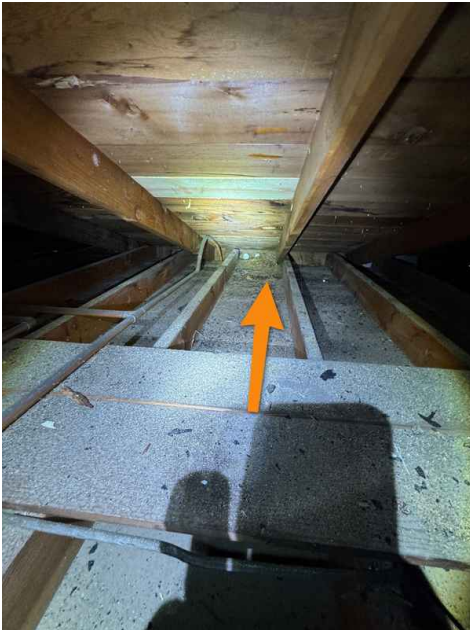
They appeared to be pest nests noted in several areas of the attic space. Evidence of possible recent wood boring organism activity and/or moisture damaged wood also noted in the attic in several areas. The accessible areas appeared dry, however, this is a very limited test and due to a lack of recent heavy rain at time of inspection I am unable to determine if any roof leaks exist at this time. Recommend a licensed termite inspector or licensed pest control company be consulted to determine any preventative measures and/or repairs necessary. Note: Home inspectors are not licensed termite or pest inspectors and are therefore not qualified to verify the presence of termites or any pests, or to evaluate the extent of possible damage that may be the result of termites or other wood boring organism activity, please refer to the pest inspection report (if one exists).

Example noted

Example noted at Attic, Right Side

Example noted at Attic, Front

Contact a qualified pest control specialist.

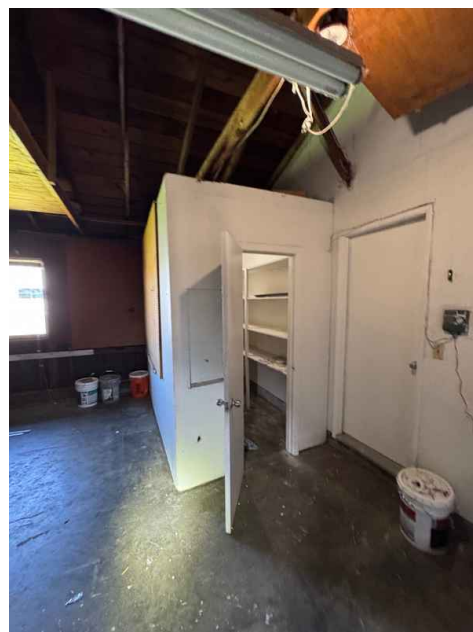
The original structure appears to have been added to or possibly modified. Determining if any additions or modifications were completed by a licensed contractor, and/or if any required permits may exist, is beyond the scope of this general home inspection. Recommend inquiring with the seller for any information regarding additions or modifications made to the home/structure. If information is not available, we recommend you inquire with the local city office having jurisdiction regarding this property. We also recommend further evaluation by a licensed general contractor to determine if additional repairs are necessary at this time. Note: Home inspectors do not inspect for building codes, nor determine property lines or boundaries.

Example noted at Garage

Contact a qualified professional.

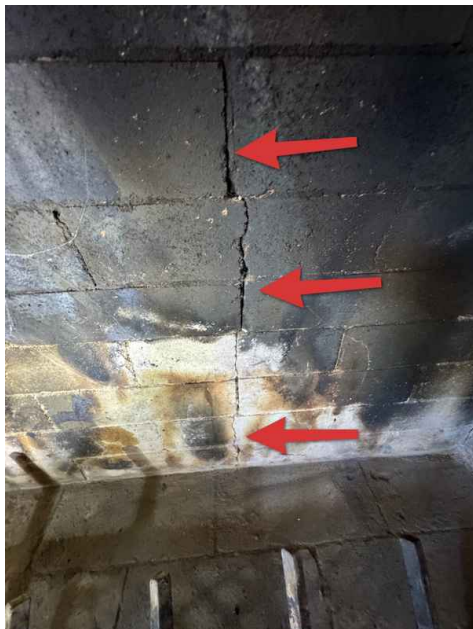
Cracking and/or gaps noted in the firebox at the fireplace. This can be a fire safety concern. The solid/wood burning fireplace was also noted missing a permanently installed screen. A installed screen cover is generally required to prevent embers from escaping the fireplace. Loose brick(s) noted at hearth extension. Our company does not inspect the shape or design of any fireplace to determine if it has proper drafting/air draw. Recommend the fireplace be further evaluated by a licensed fireplace contractor to determine proper air draw at the fireplace and any repairs or replacement as necessary, prior to using the fireplace.

Example of cracking noted

Contact a qualified fireplace contractor.

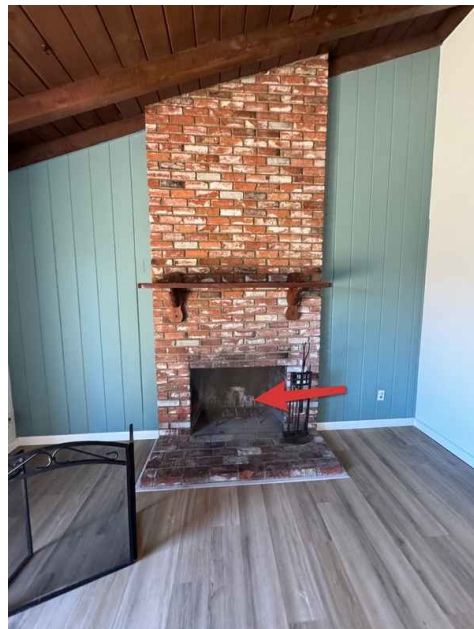
Example noted at Living Room Fireplace, missing permanent screen

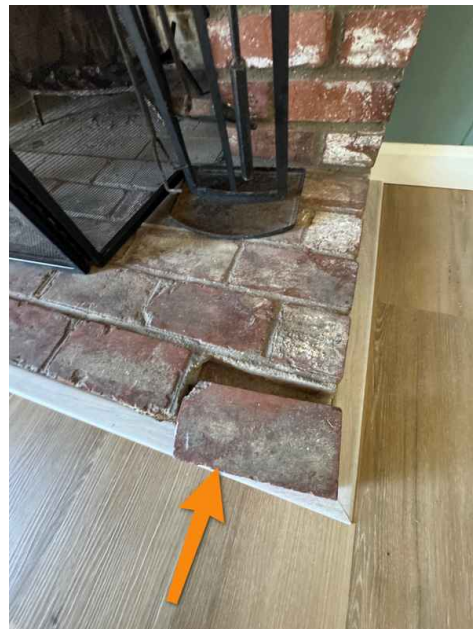
Example of loose brick noted at Fireplace

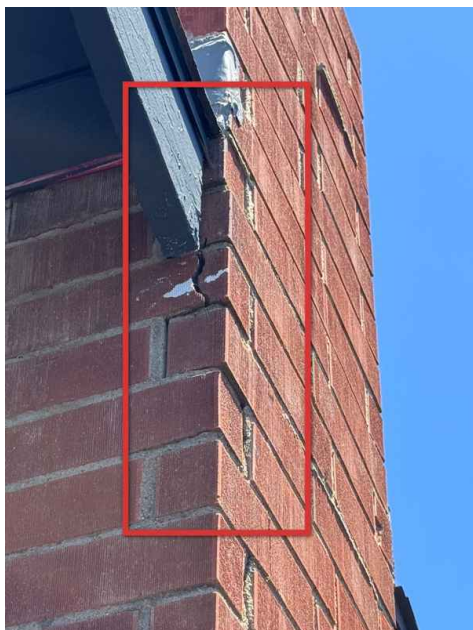
Example of cracking noted, Right Side of Home

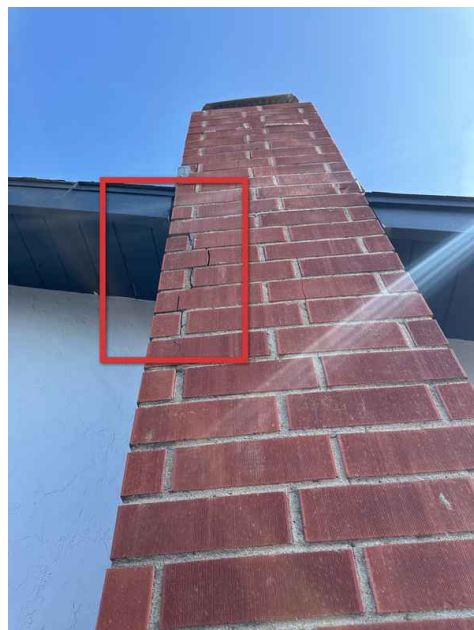
Example noted at Chimney, Right Side of Home

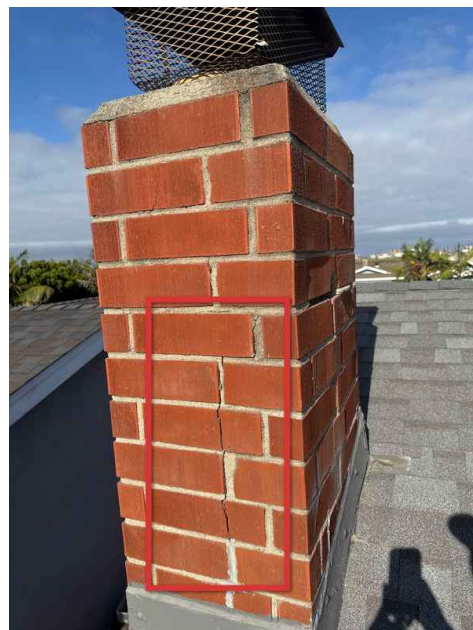
Example of cracking noted, Rear Roof

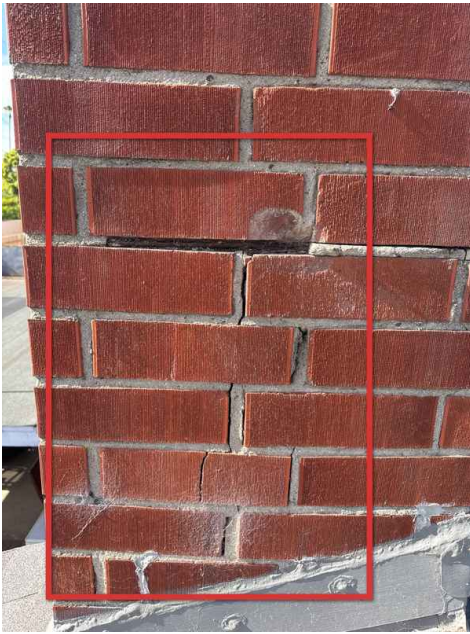
Example of cracking noted

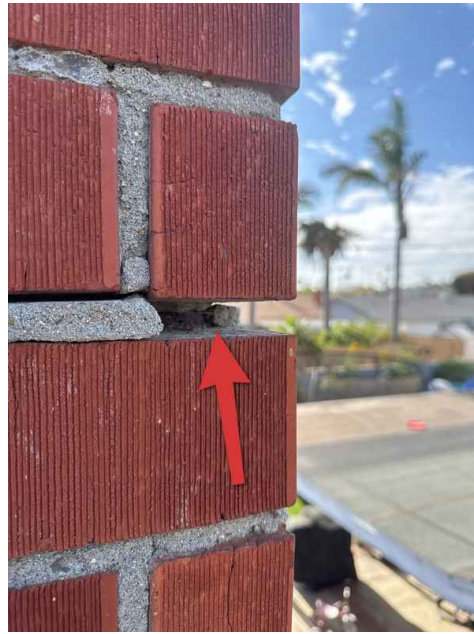
Example of missing mortar noted, Rear Roof

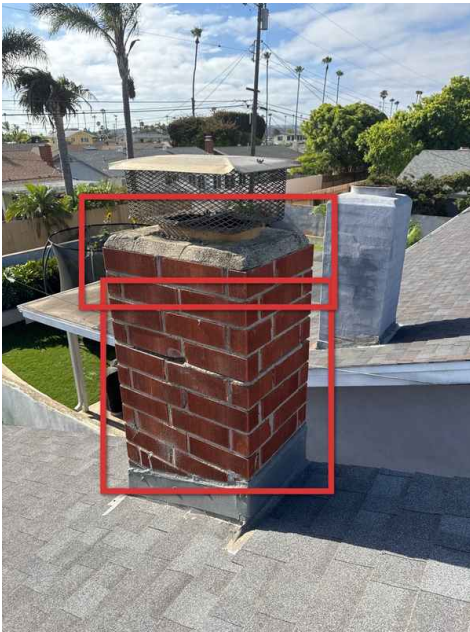
Example noted at Chimney, Rear Right Side Roof

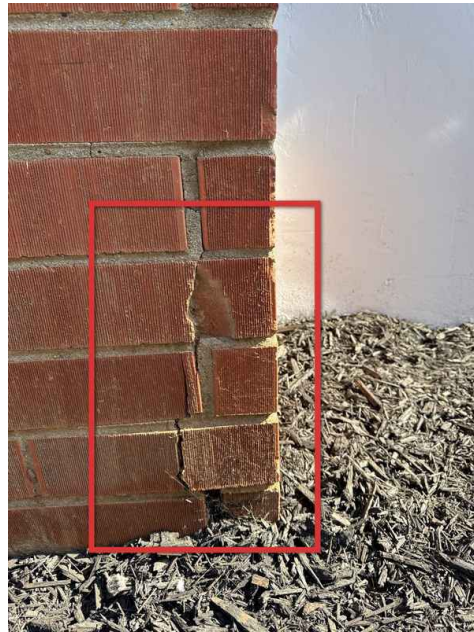
Example of damage noted, Rear Right Side of Home

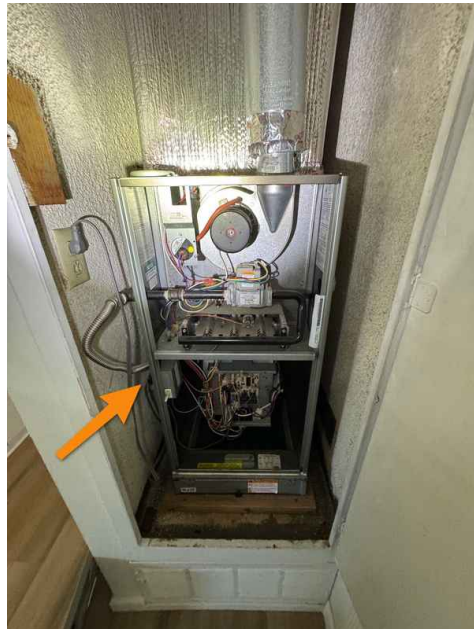
The furnace appeared to produce heat when tested using standard controls. However, the unit is aging and appeared noisy when turned on, often indicative of aged components. There did not appear to be a gas sediment trap installed as required. The unit also does not appear original to the home. Recommend further evaluation and repair as necessary by a licensed HVAC contractor, also, recommend inquiring with the seller for documentation showing the unit was installed by a qualified professional according to manufacturer's requirements.

Missing Gas Sediment Trap

Contact a qualified heating and cooling contractor

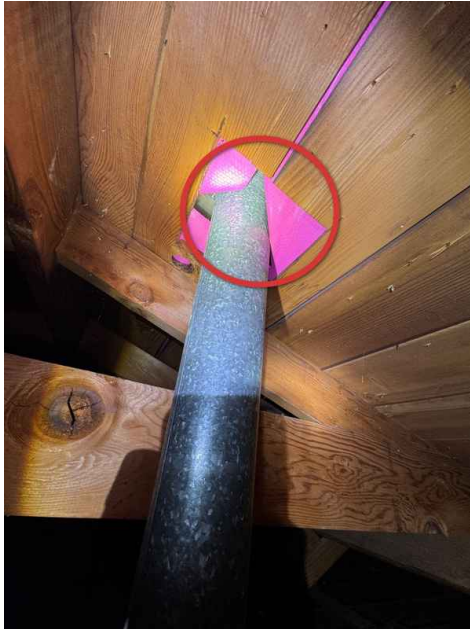
There appeared to be inadequate clearance from combustible materials noted at the furnace flue pipe in the attic. This condition can prove to be a fire safety concern. Typically, a double wall metal flue (Type B) requires a 2" clearance to combustibles, while a single wall metal vent requires a 6" clearance. Moisture stains also noted at the flue pipe. This condition can be indicative of previous roof leaks in this area. However, this can also be indicative of poor venting. Recommend further evaluation by a licensed HVAC contractor to determine any corrections necessary at this time for safety.

Example noted at Attic, Above HVAC Unit

Contact a qualified heating and cooling contractor

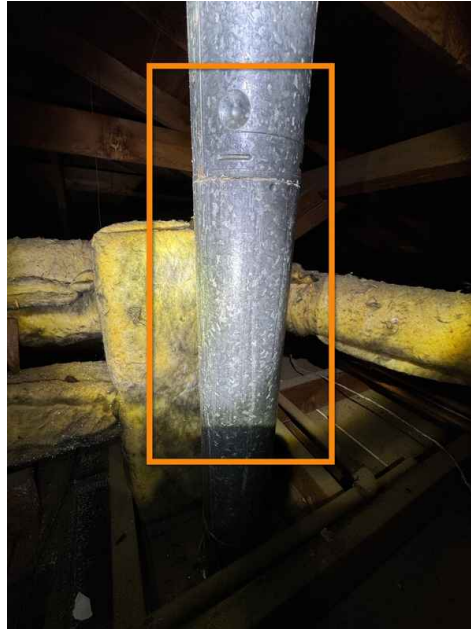
Example of moisture staining noted at flue in Attic

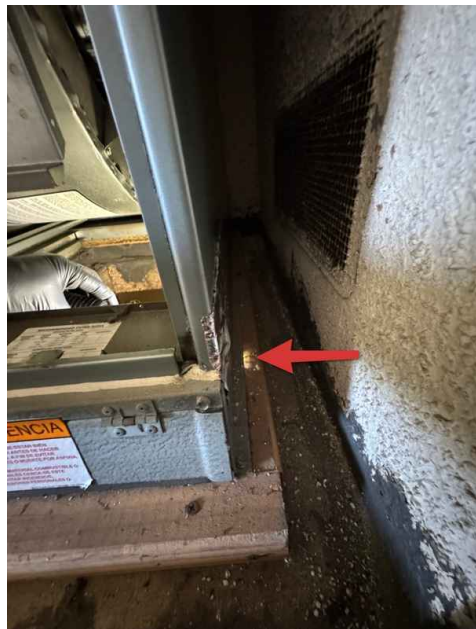
The furnace cabinet appeared to be inadequately sealed at the base/return air compartment. This condition can allow heated air to escape and also may be a carbon monoxide health and safety concern, if not corrected. Dirt/debris also noted in the return air compartment. Recommend further evaluation by a licensed HVAC contractor to determine any repairs necessary, and to clean/service the return.

Example of inadequate seal noted

Contact a qualified HVAC professional.

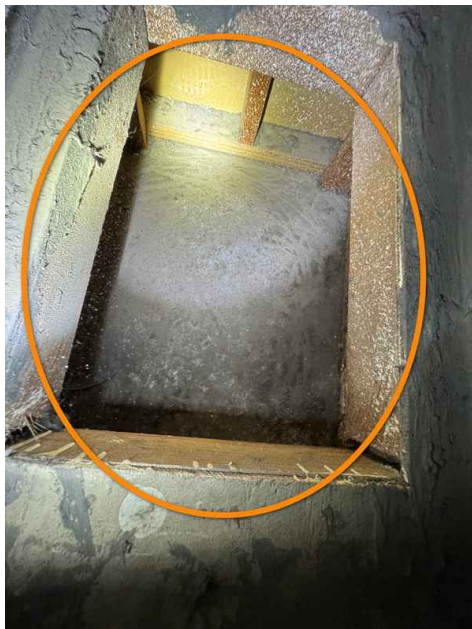
Dirt/Debris noted Inside return

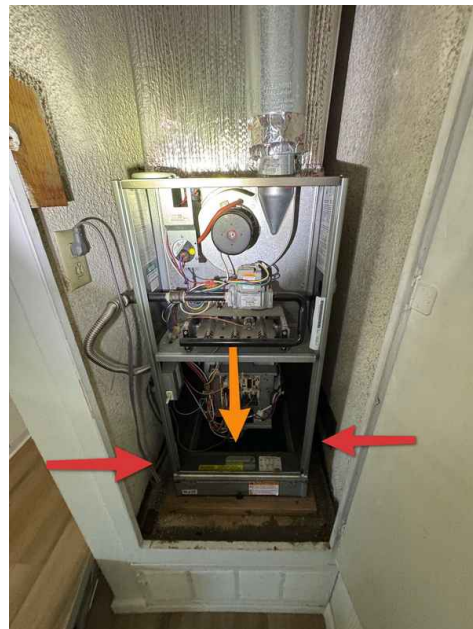
Example noted Below HVAC Unit,  
Hallway Utility Closet

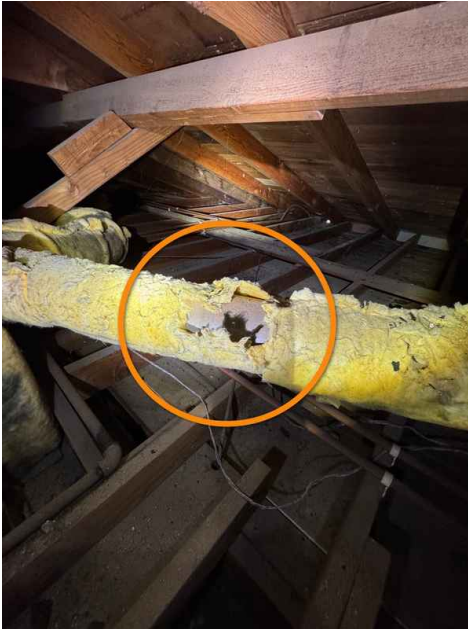
Insulation around the air supply ducting was noted damaged in areas. Aged duct tape/seals noted at the ducts. Old style duct tape is no longer recommended for use at air ducts. This condition may be conducive to heat/energy loss and moisture related issues from warm air escaping the ducts. Condensation may develop on the uninsulated sections of the metal ducts, also leading to moisture related issues in the attic. The HVAC unit in this home appeared newer, however, the ducting in the home appeared aged. Generally, when an HVAC unit is replaced, or significant HVAC work has been completed (on or after October 1, 2005) then duct leakage testing is required. Recommend asking the seller for any duct testing reports, if any exist, and further evaluation and testing of the ducting in this home by a licensed HVAC contractor, to determine repairs or replacement as necessary to comply with today's HVAC standards.

Example of damaged insulation noted, Attic

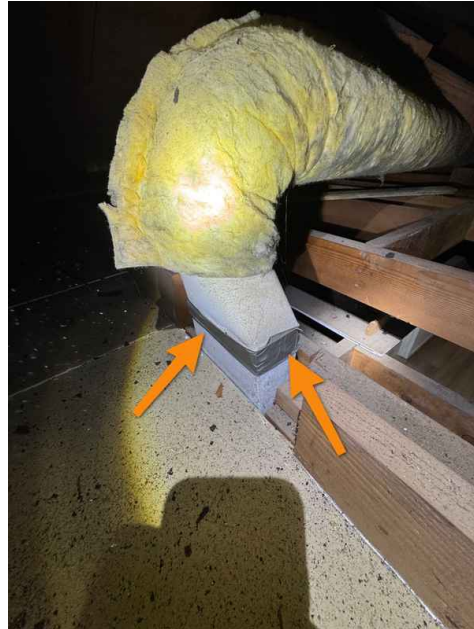
Example of aged duct tape noted at Attic

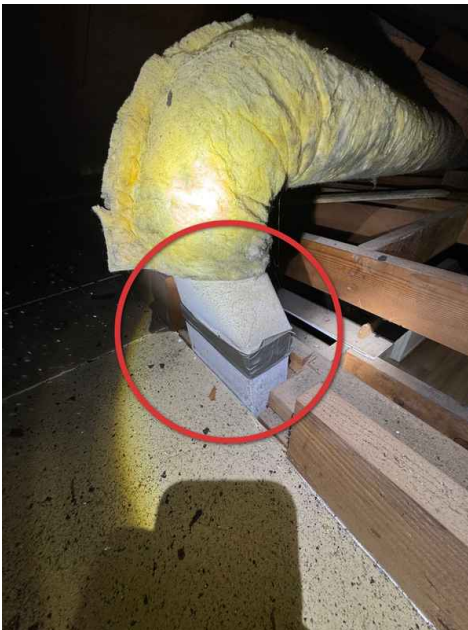
The air ducts appeared to be made of a material that may incorporate asbestos. Asbestos is known to be a possible health and safety hazard, especially if improperly handled or if it becomes damaged/friable. Only a licensed professional using specialized testing can confirm the presence of asbestos. Recommend further evaluation by a licensed environmental contractor or qualified professional to determine any corrective measures as necessary at this time for safety.

Example noted at Attic

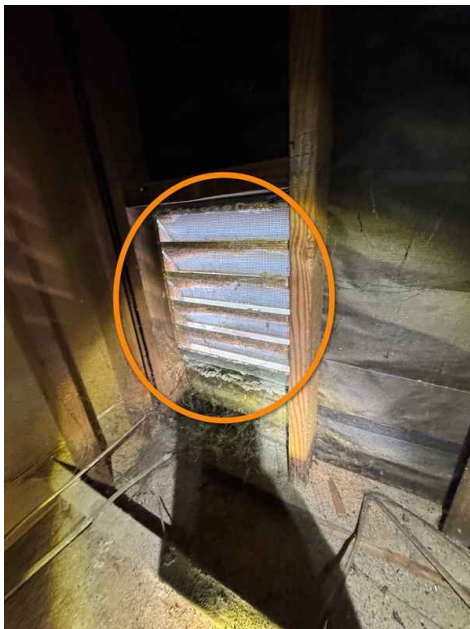
Example noted at Attic, Right Side

Contact a qualified pest control specialist.

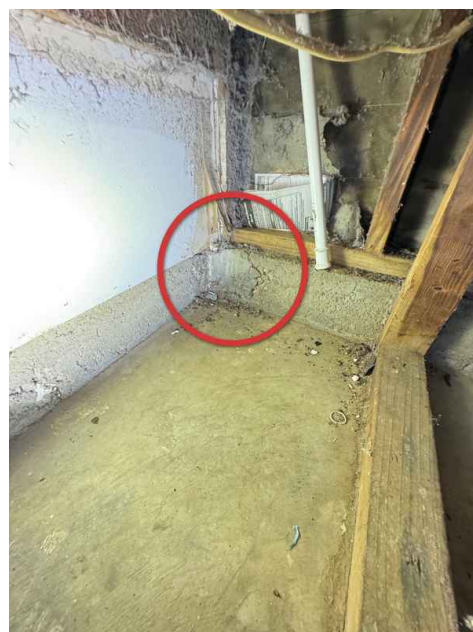
Example noted at Garage, Rear Left Side Below Water Heater

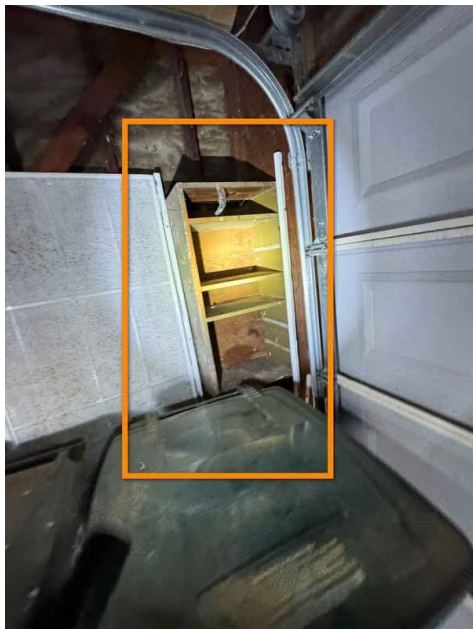
Example noted at Garage, Left Side facing outwards

Contact a qualified professional.

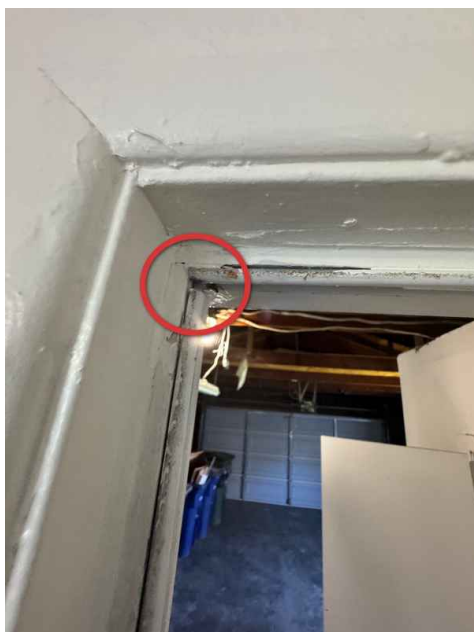
Example of inadequate seals noted at occupant doorway

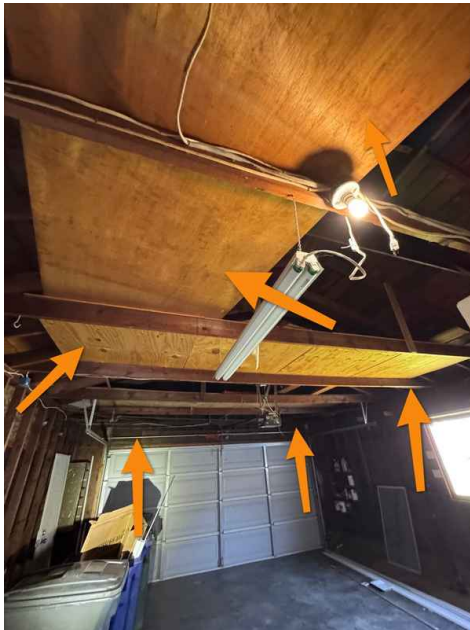
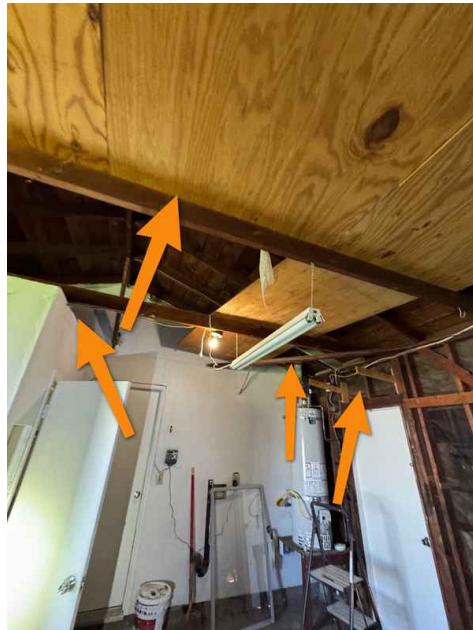
Example noted at Garage

Contact a qualified general contractor.

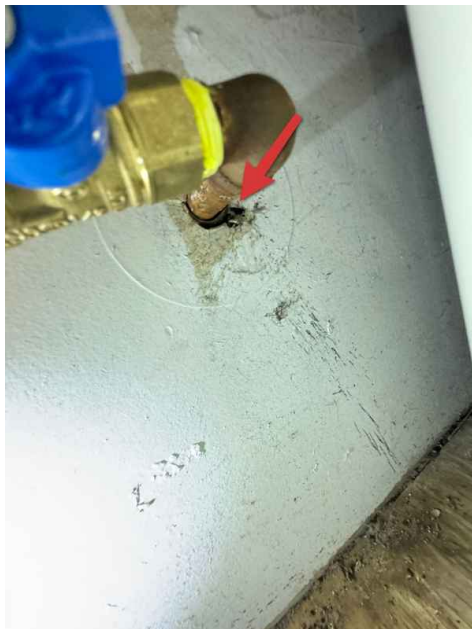
Example of gap noted

Contact a qualified drywall contractor.

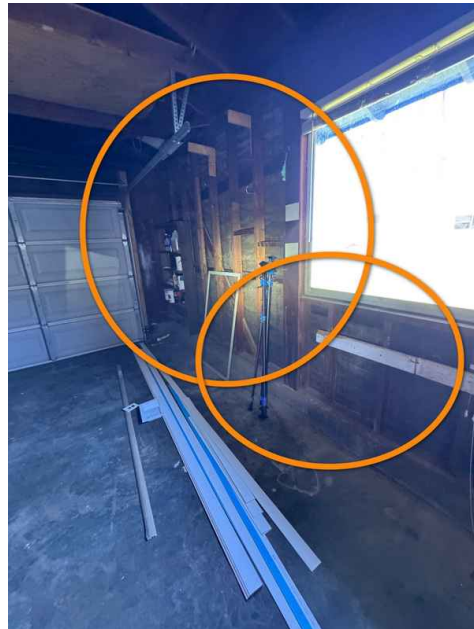
Example noted at Garage, Right Side facing outwards

Moisture staining/damage noted at the garage walls in several areas. The areas appeared dry at the time of the inspection. Determining the exact cause is beyond the scope of this inspection. Recommend further evaluation by a licensed restoration contractor to determine any repairs necessary. Note: Determining if hidden damage (such as organic growth) exists beyond the surfaces is beyond the scope of this inspection.

Contact a qualified professional.

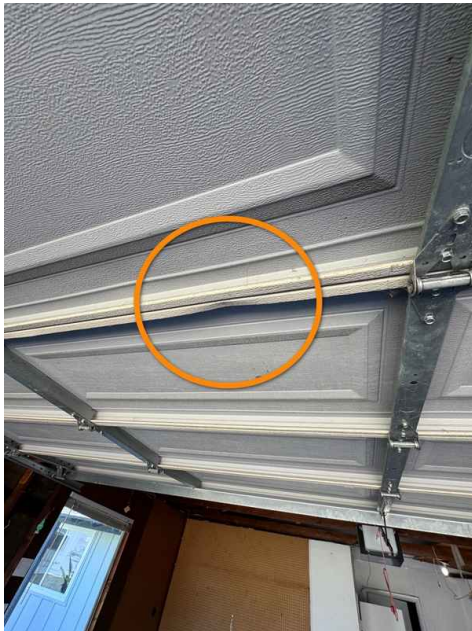
Damage noted at the garage vehicle door in one or more areas. This damage may worsen over time, and may even lead to failure of the door system, which can be a safety concern. Determining the extent of damage is beyond the scope of this inspection. Damaged weather stripping and/or door trim also noted at the door/doorway. This condition can be conducive to moisture and pest intrusion. Recommend further evaluation of the vehicle door and door opener by a licensed garage door contractor, prior to using the door, to determine any repairs or replacement necessary to ensure proper function and safety.

Example of damage noted

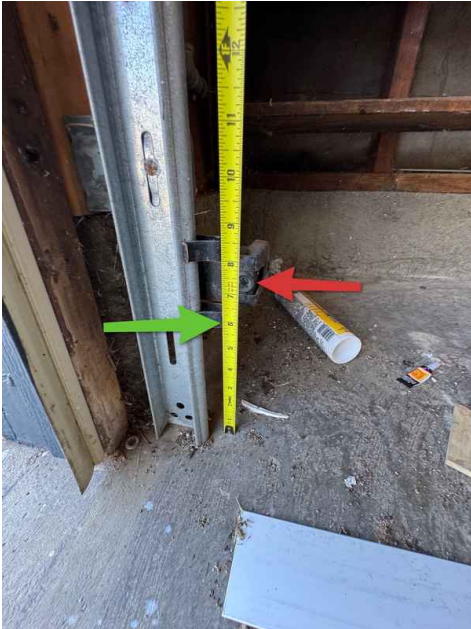
The photoelectric eye sensors at the garage vehicle door did not reverse the door travel when tested. The sensors also should typically be installed no more than 6" from the garage floor. This condition can be a potential safety hazard, particularly for small children or pet pets. The auto door opener also did not appear to be equipped with battery backup. Battery backups are now required by California state law for new or replaced garage door opener installations. Recommend further evaluation by a licensed garage door contractor to determine corrections or upgrades necessary at this time for safety.

Example noted at Garage door photo eye sensors

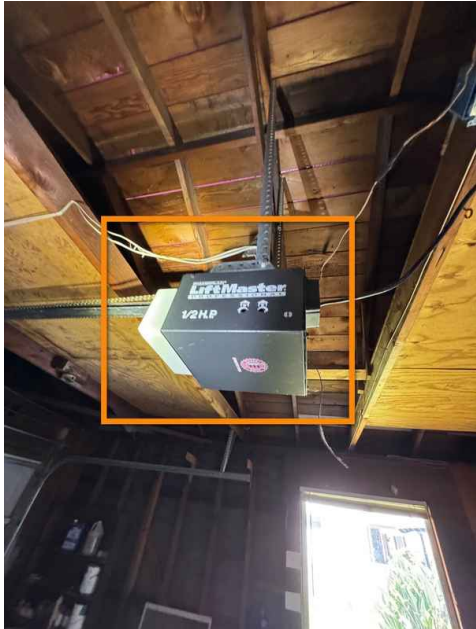
Garage automatic door opener missing battery backup

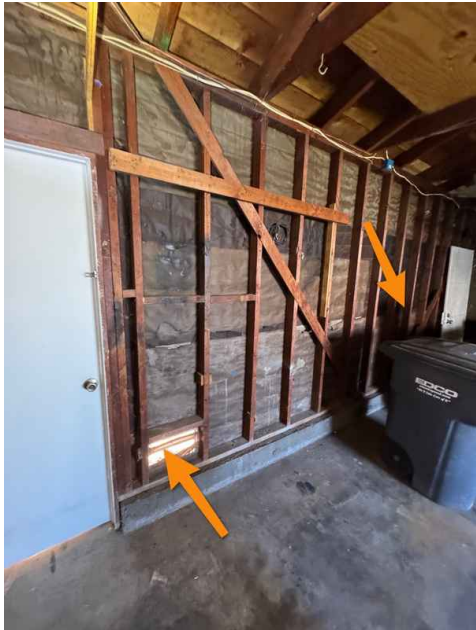
Garage, Left Side facing outwards

Damaged screen(s) noted at garage vents. This condition can allow pest intrusion. Pests can cause damage to the home. Recommend further evaluation by a licensed pest control contractor and repair as necessary to forestall pest intrusion.

Contact a qualified professional.

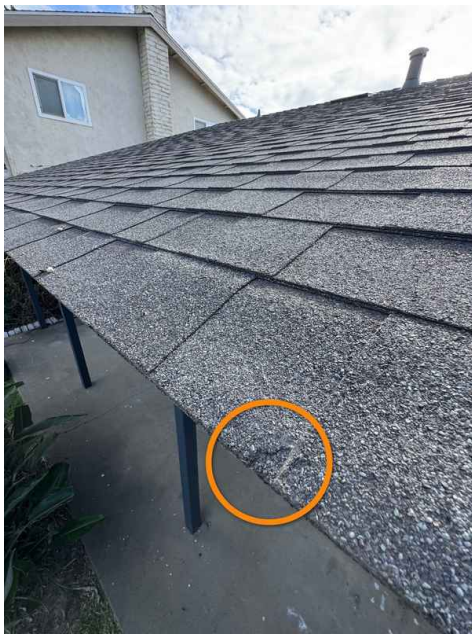
Replaced Roof - Inquire with seller for work receipts and roof warranty, Damage at shingles, Exposed nail heads at shingles/flashings - Conducive to moisture intrusion

Example of damage noted, Front Left Side Roof

Contact the seller for more info

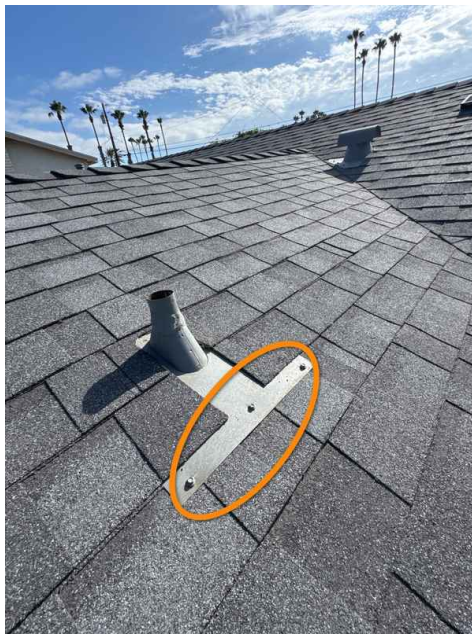
Example of expose nail heads noted

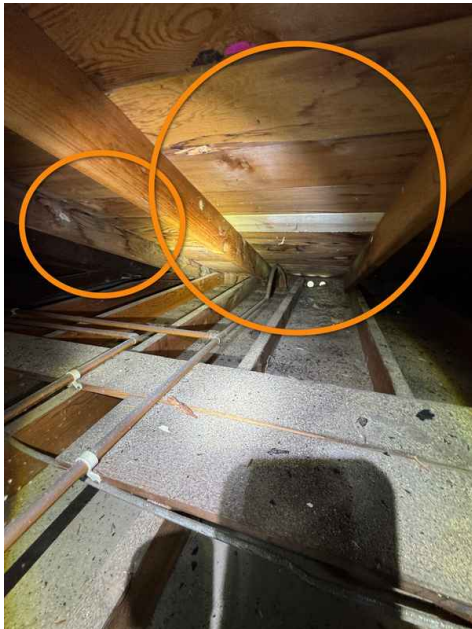
**WATER STAINING AT ROOF SHEATHING/FRAMING - DAMAGE/REPAIRS AT SHEATHING**

Example of staining and repairs noted at Attic

Contact a qualified roofing professional.

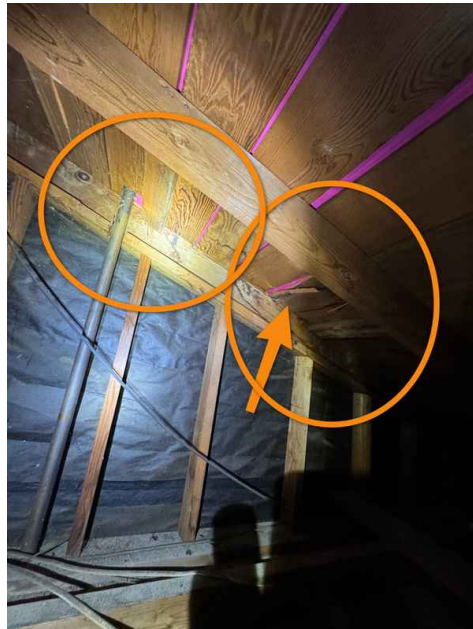
Example of damage, staining noted at Attic

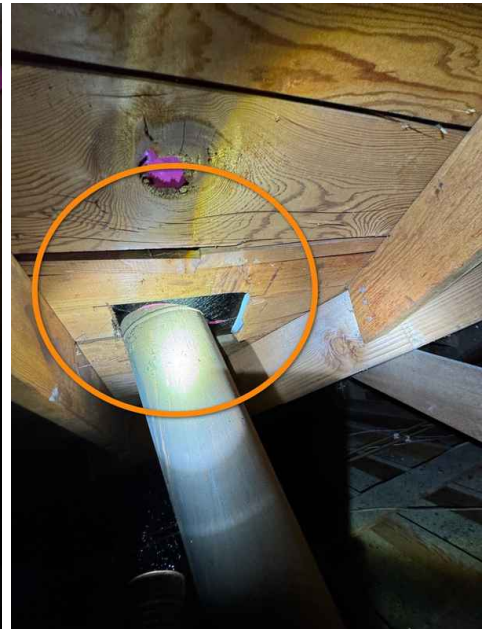
Example of damage noted, Attic

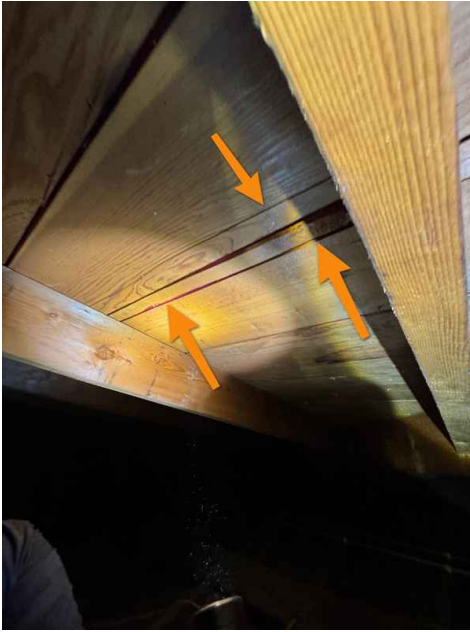
Example of damage noted, Attic

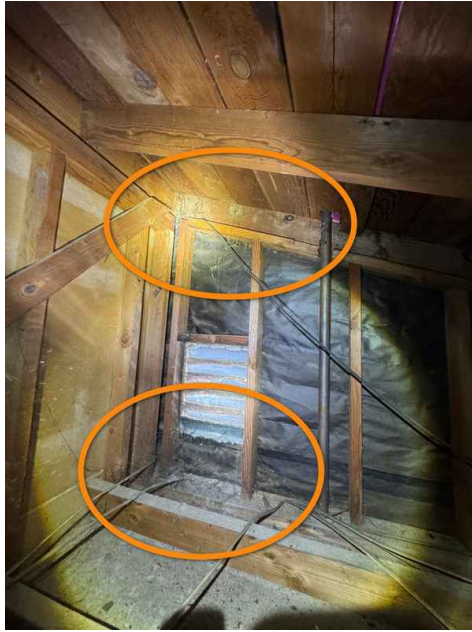
Example of staining noted at Attic

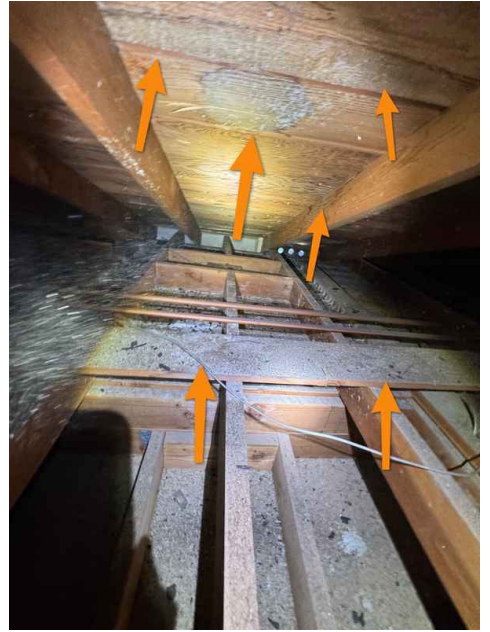
Example of staining noted at Attic

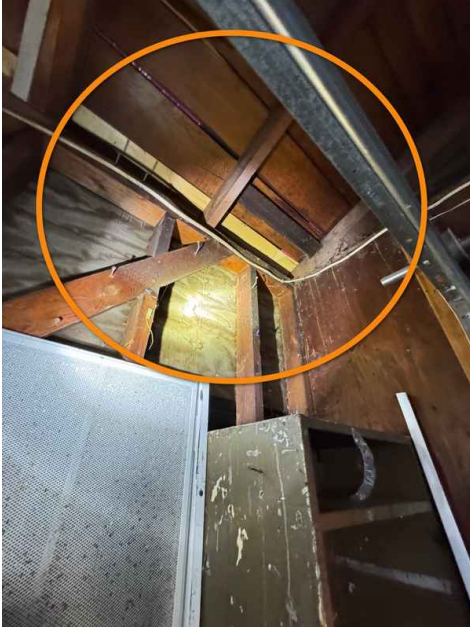
Example of staining, damage and repairs noted at Garage, Front Left Side facing outwards
