## RESIDENTIAL INSPECTION REPORT

1325 5th St  
Imperial Beach, CA 91932

07/25/2025

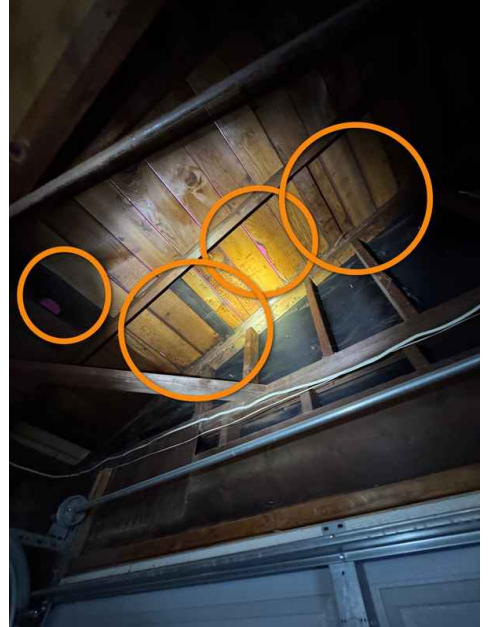
Example noted at Garage

**WATER STAINING AT ROOF SHEATHING/FRAMING - DAMAGE/REPAIRS AT SHEATHING**

Contact a qualified roofing professional.

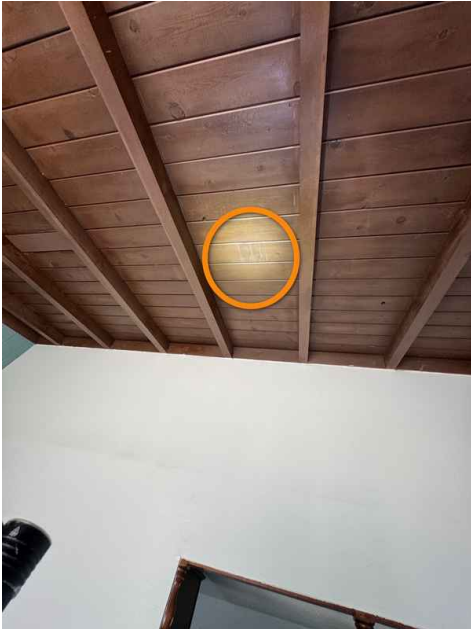
Example of staining noted at Living Room

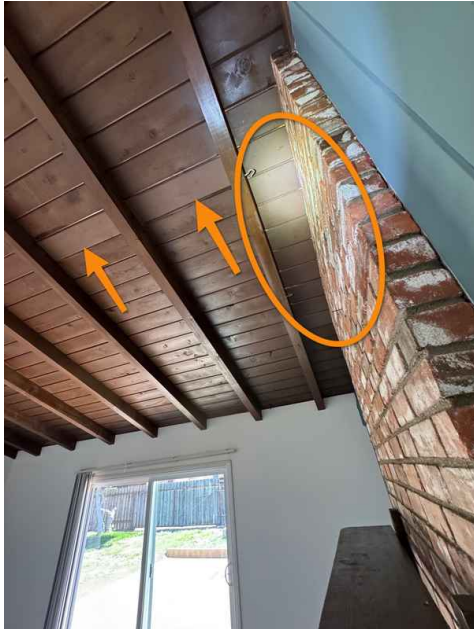
Example of Possible Repairs noted at Living Room

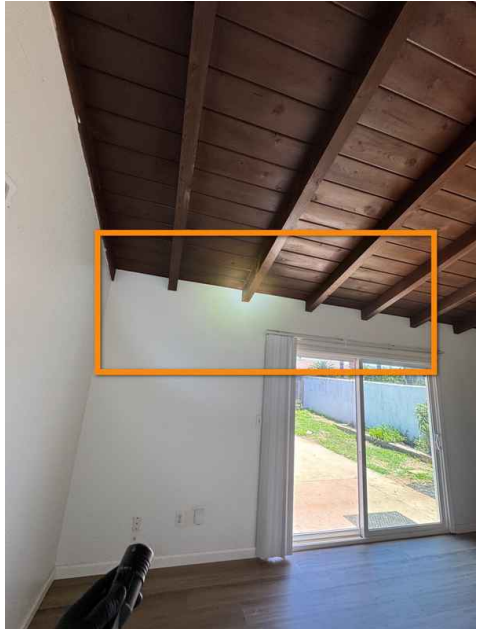
Example of Possible Repairs noted at Living Room

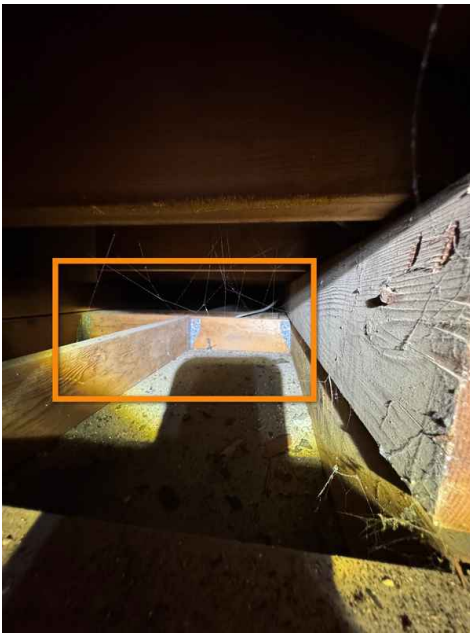
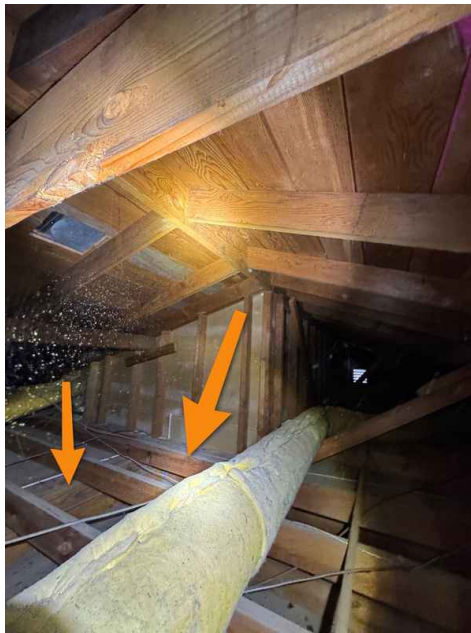
Evidence of previous possible repairs and/or modifications noted at the ceiling structure in one or more areas. Recommend inquiring with the seller for any repairs completed and any work receipts or permits, if applicable. I also recommend further evaluation by a licensed general contractor to determine if the repairs are adequate.

Example noted at Attic

Example noted at Attic, Rear

Contact a qualified general contractor.

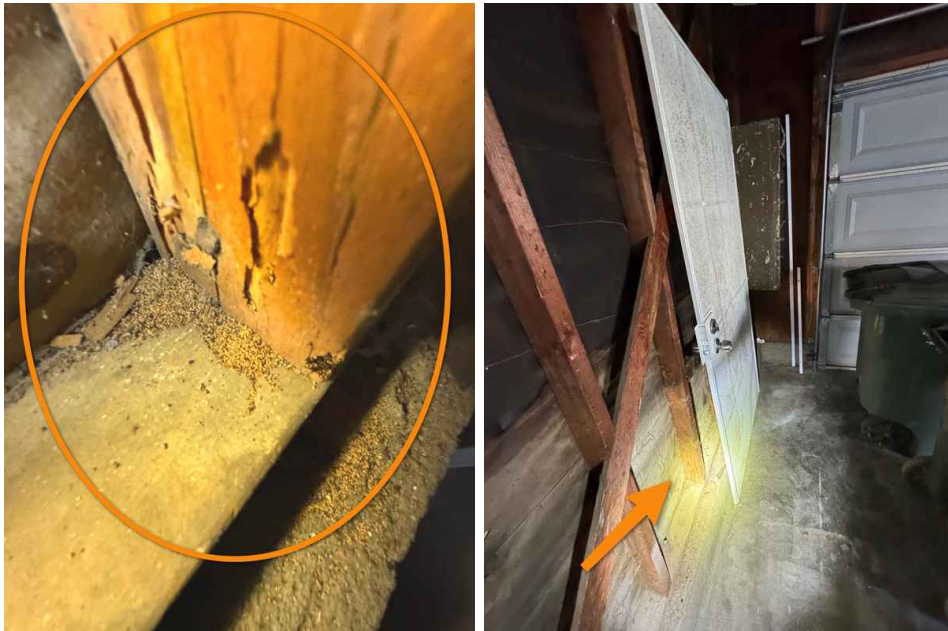
Moisture damage and/or evidence of possible wood boring organism activity noted at the wall structure in one or more locations. Recommend a licensed termite inspector or licensed structural engineer be consulted to further evaluate and to determine any preventative measures and/or repairs necessary at this time. Note: Home inspectors are not licensed termite inspectors and are therefore not qualified to verify the presence of termites, or to evaluate the extent of possible damage that may be the result of termites or other wood boring organism activity, please refer to the pest inspection report (if one exists).

Example noted at Garage, Front Left  
Side facing outwards

Contact a qualified professional.

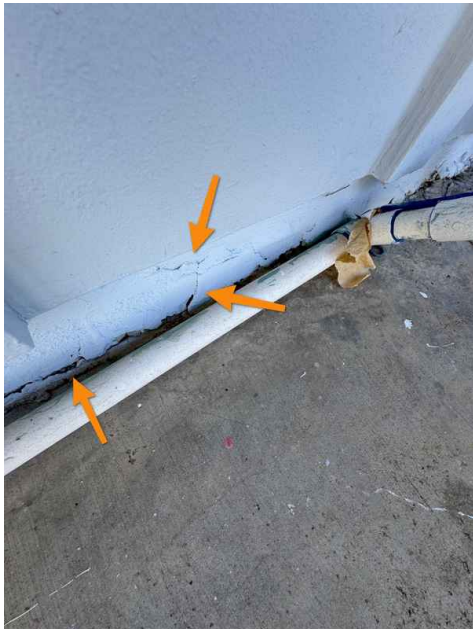
There appeared to be cracks and spalling/deterioration noted at the foundational walls in areas. Evidence of past repairs noted. Efflorescence (white powder-like substance) was noted, which occurs when moisture is in contact with the concrete. This condition may be indicative of excessive irrigation and moisture in the area and can lead to further deterioration. Determining the cause or extent of damage is beyond the scope of this inspection. Recommend further evaluation by a licensed foundation contractor to determine the cause and any repairs as necessary. Inquire with the seller regarding any past repairs to the foundation.

Example of cracking noted

Contact a foundation contractor.

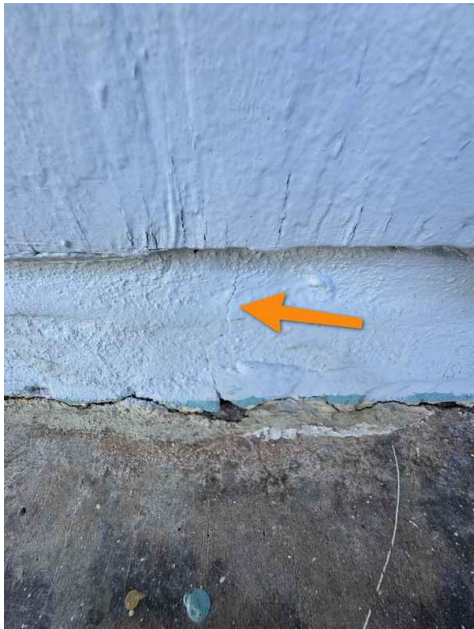
Example of crack noted

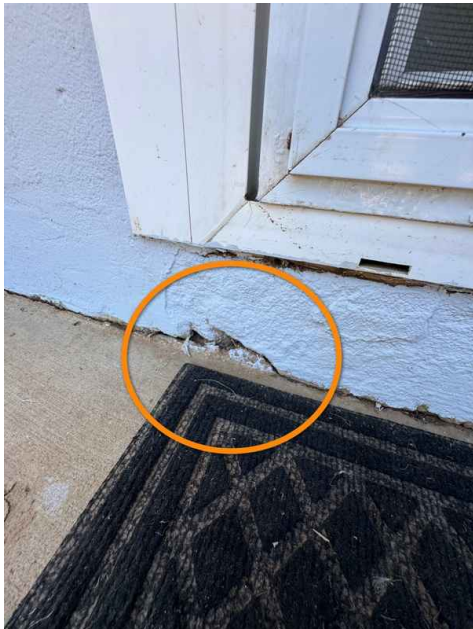
Example of damage noted

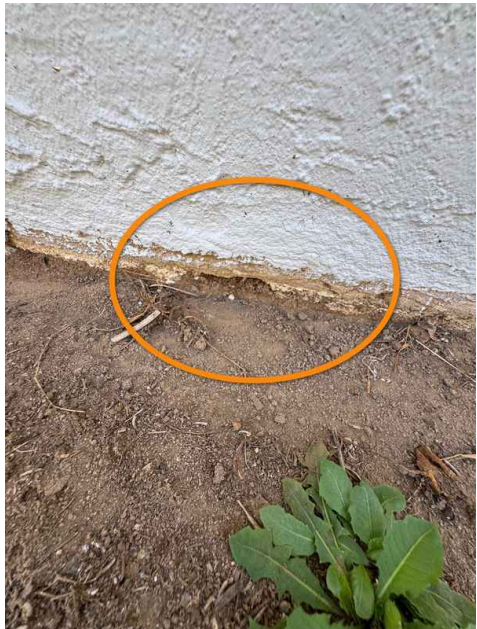
Example of damage noted

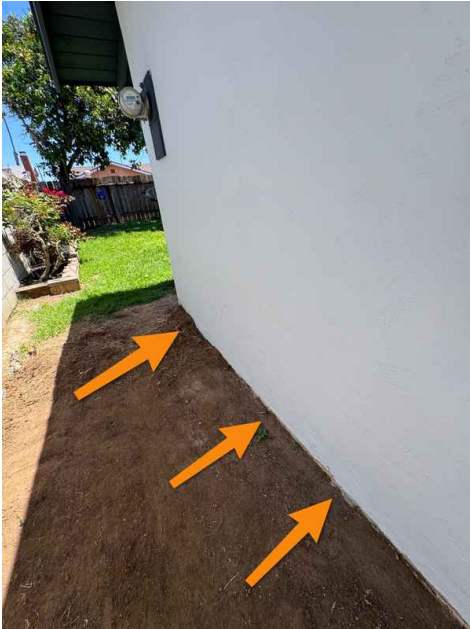
Example of damage and repairs noted,  
Rear Left Side of Home

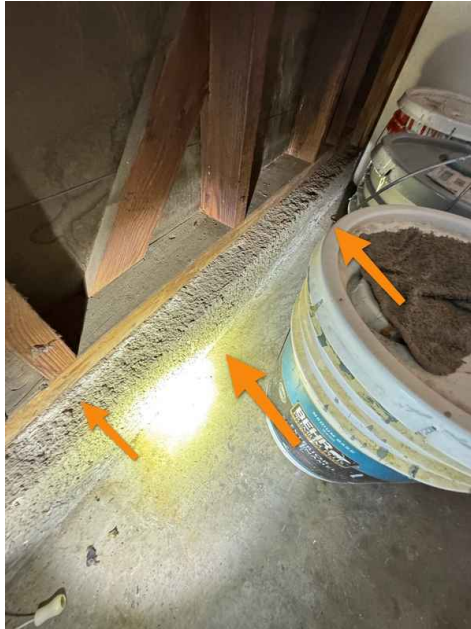
Example of efflorescence noted,  
Garage, Left Side facing outwards

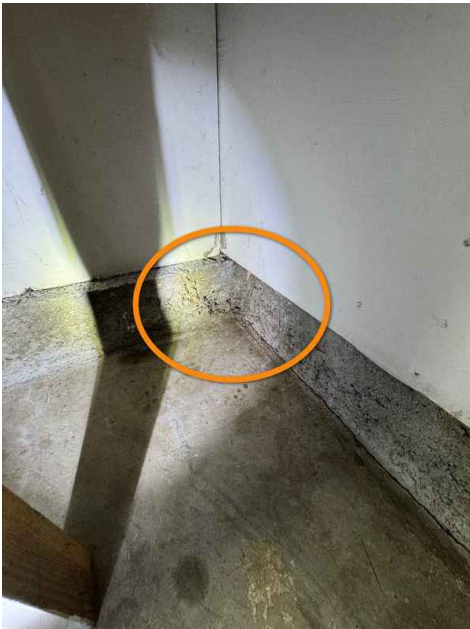
Example of spalling noted

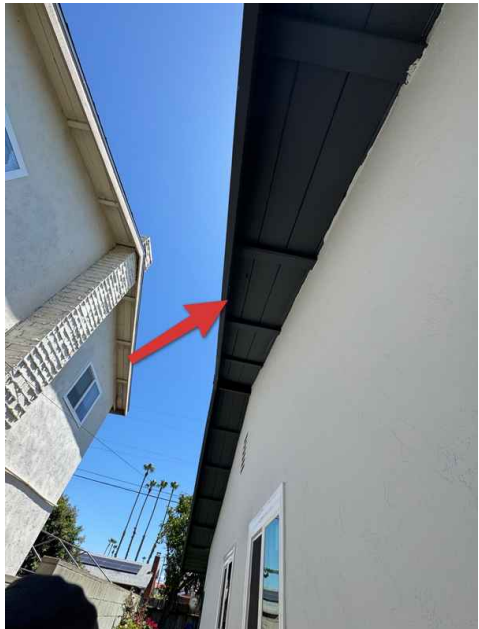
Failing paint noted in several areas at the exterior of the home. This home appears to have been built prior to 1978. Homes built before 1978 may contain lead-based paint. Lead from paint, paint chips, and dust can pose a health and safety hazard, if not managed properly. Recommend a qualified professional be consulted for further evaluation and to ensure proper health and safety measures are taken, particularly if the client chooses to remove or alter existing paint. Note: Sellers in the state of California are required to disclose any information regarding lead paint in a home. I recommend referring to the seller disclosures for any applicable information regarding the paint in this home.

Example noted

Example noted at Left Side of Home

Contact a qualified professional.

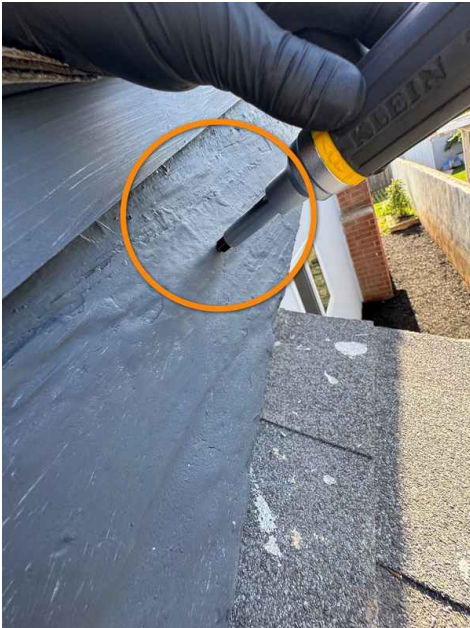
Moisture damage/possible wood boring organism activity, Previous repairs at eaves/fascia - Inquire with seller, Failing paint at eaves/fascia

Example of moisture damage noted

Contact a qualified professional.

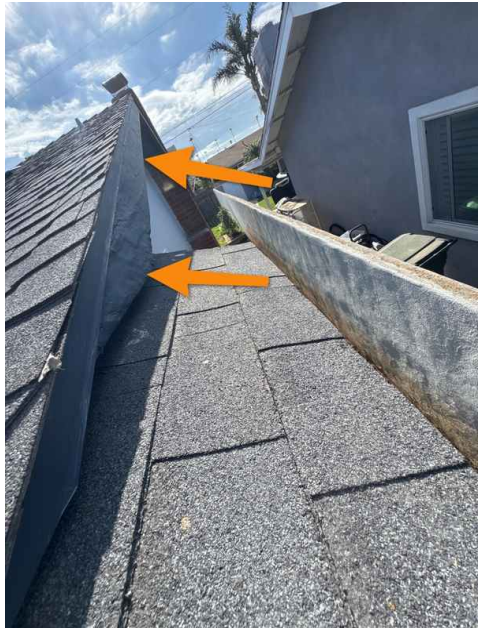
Example of damage and repairs noted, Right Side Roof

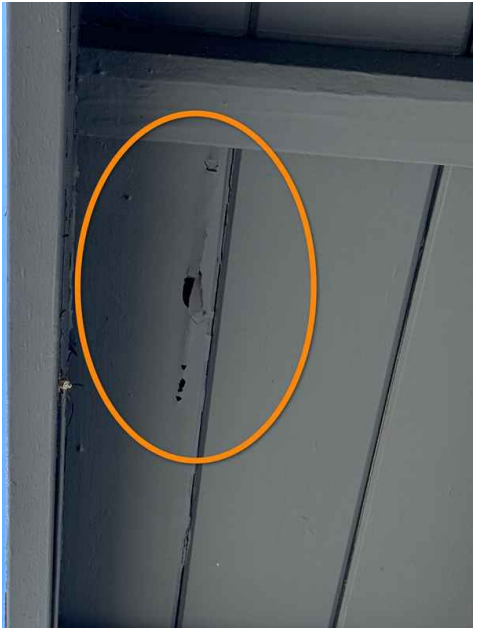
Example of damage noted

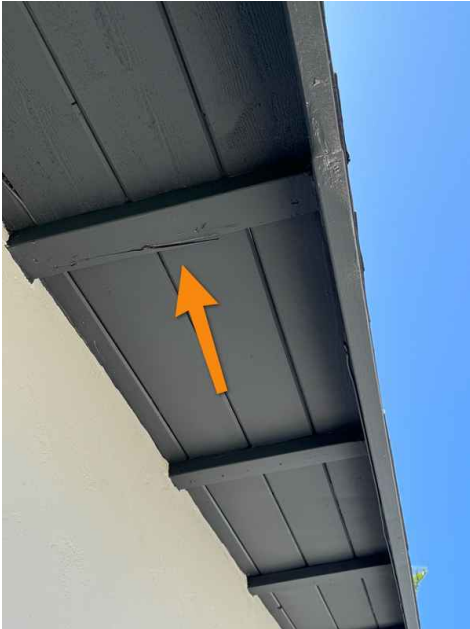
Example of damage noted

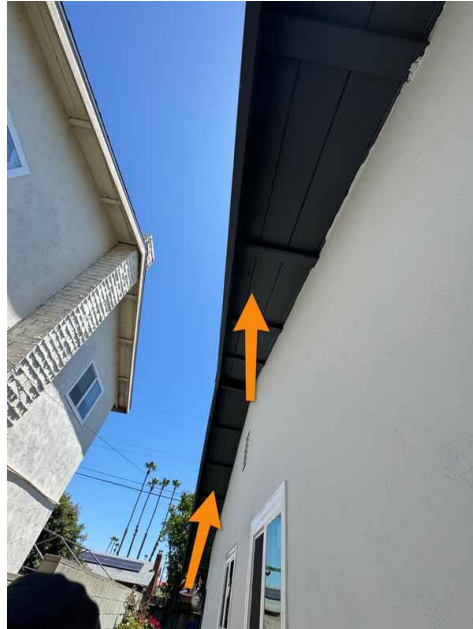
Example noted at Left Side Roof

Example noted at Front Left Side of Home

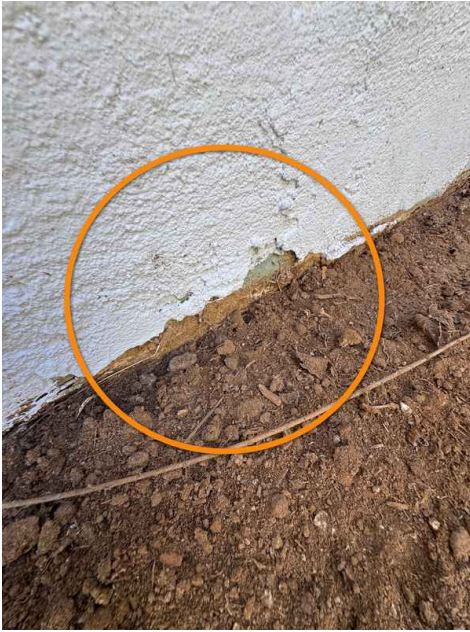
Example of moisture damage noted

Contact a stucco repair contractor

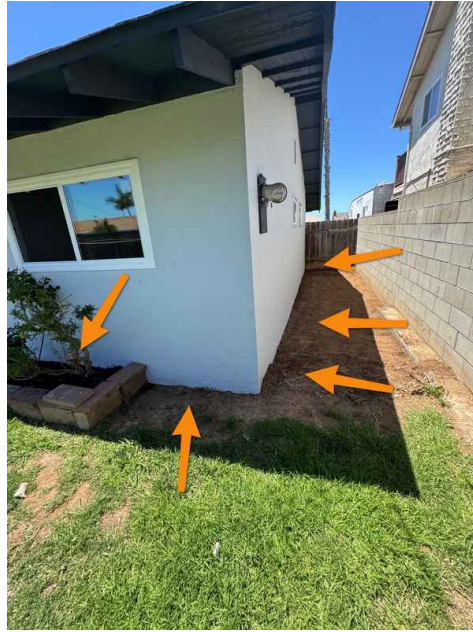
Example of damage, siding at grade noted at Rear, Left Side

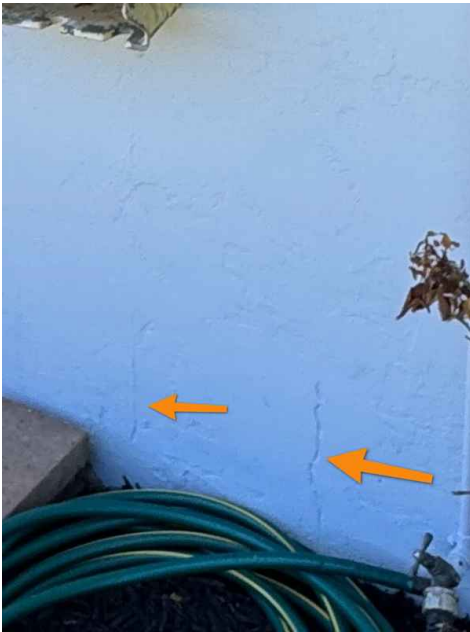
Example of cracks noted

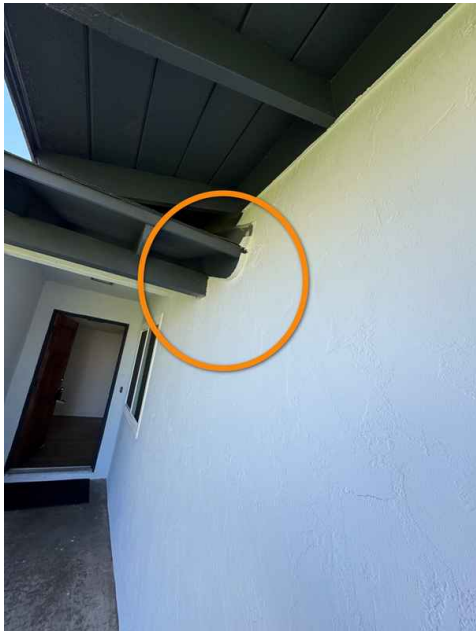
Example of repairs noted at Front

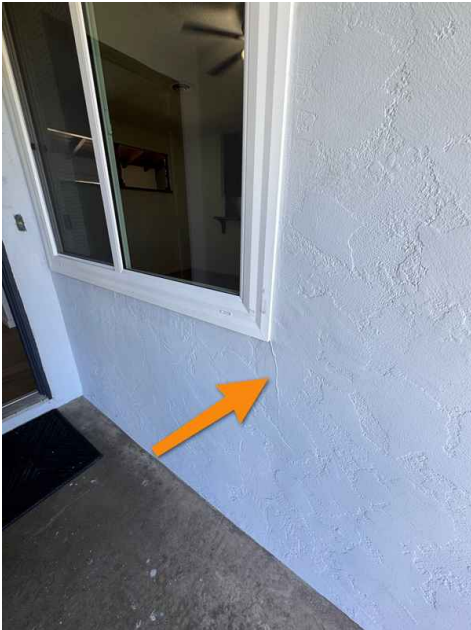
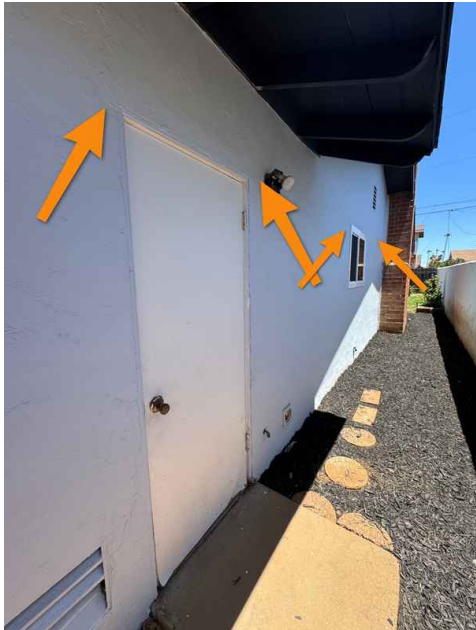
Example noted at Front Entry

Example noted at Right Side of Home

Example noted at Rear of Home

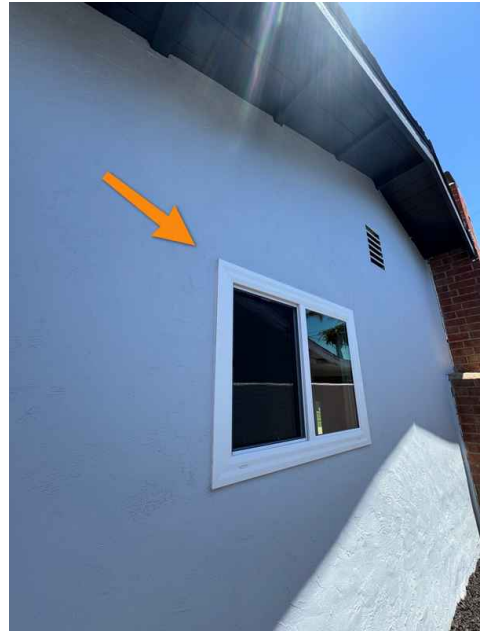
Example noted at Front Left Side of Home

Example noted

Example noted at Right Side of Home

Contact a qualified window repair/installation contractor.

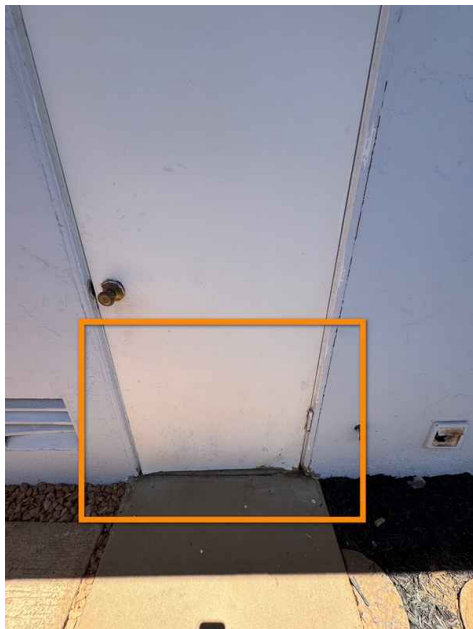
Example of moisture damage noted, Garage pedestrian door

Contact a qualified door repair/installation contractor.

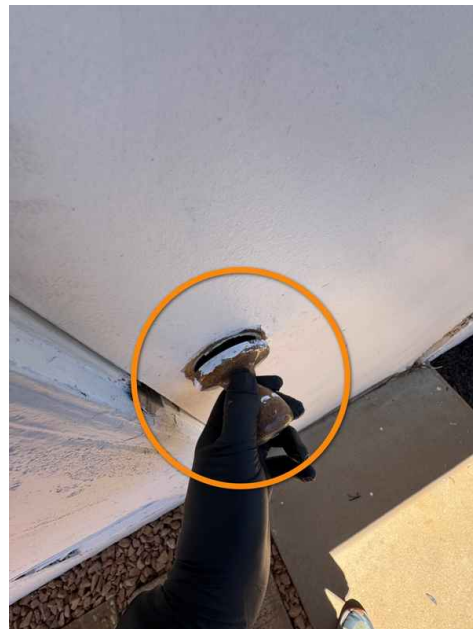
Garage pedestrian door handle loose

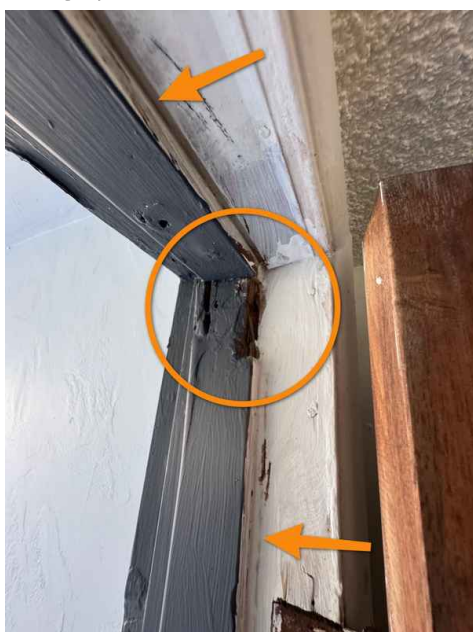
Dry moisture damage noted at garage pedestrian exterior door, indicative of moisture intrusion. Inadequate weather stripping also noted at several doors, which is conducive to moisture/pest intrusion. The sliding living room door appeared retro-fit, inquire with the seller to determine the door was properly installed by a licensed contractor. Due to the multiple Discovery Items listed here, I recommend further evaluation of the exterior doors by a licensed door contractor and repair as necessary to ensure proper function.

Example of damage, missing weather stripping noted

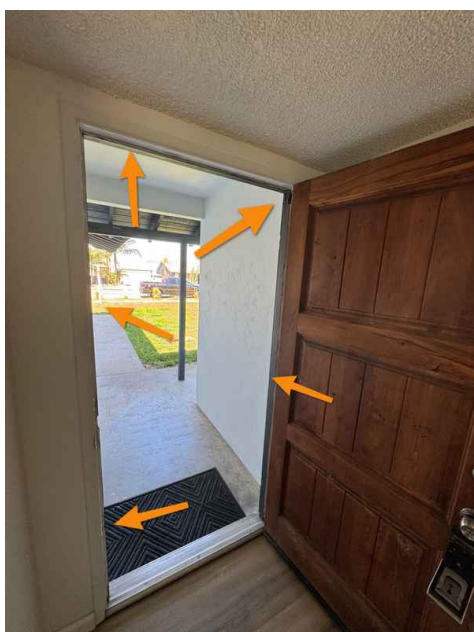
Example noted at Front Entry

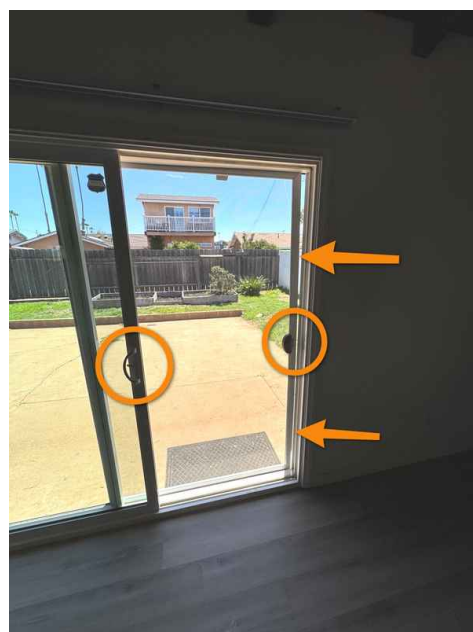
Example noted at Living Room, screen does not glide/latch, glass sliding door latch loose when closed

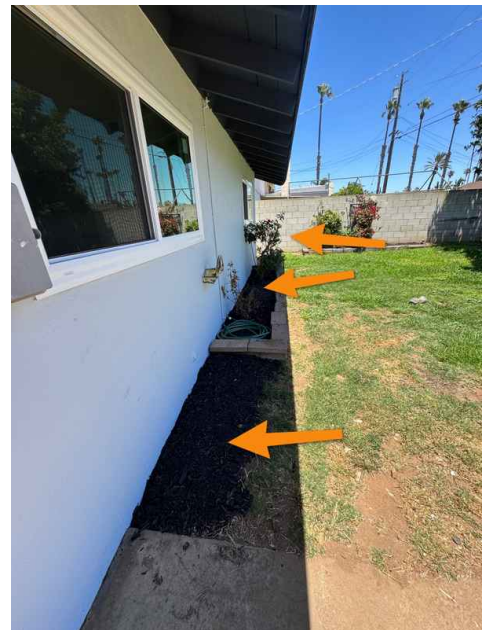
Large plants and planters are located next to the home. This condition is conducive to moisture intrusion and damage to the home and its foundation, particularly if proper drainage does not occur. Vegetation growing too close to the home can cause damage in several ways. Vegetation in contact with and/or hanging near the roof and/or siding should be trimmed to prevent damage to the building, as well as to prevent pest infestation. Roots and limbs can also cause damage to the siding, hardscape, plumbing, and the foundation as they grow. This condition also limited my view of the home exterior. Recommend further evaluation by a licensed landscaping contractor or qualified arborist to determine any corrections necessary, and if latent defects exist.

Example noted at Rear of Home

Contact a qualified landscaping contractor

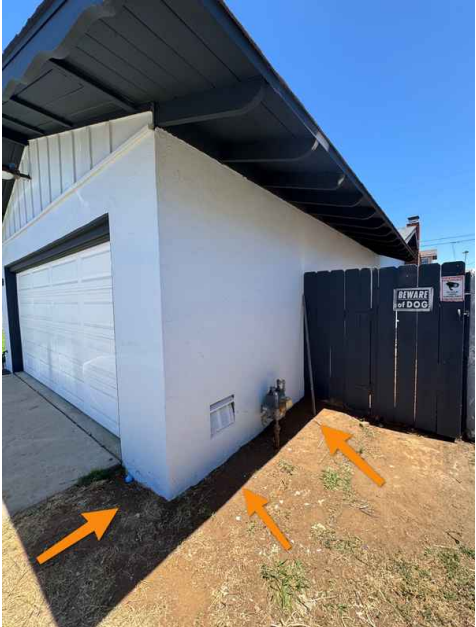
There appeared to be low/neutral areas at the grading next to the home, however, subsurface drainage was visible in just one or more areas at the exterior. Determining if further drains are present, and if drains are functional is beyond the scope of this inspection. Moisture intrusion and deterioration to the home remains a possibility if drainage is inadequate. Recommend further evaluation and monitoring of the grading and any existing drains around the home by a licensed landscaping contractor, and any corrections as necessary.

Example noted at Front, Right Side of Home

Recommendation  
Contact a qualified landscaping contractor

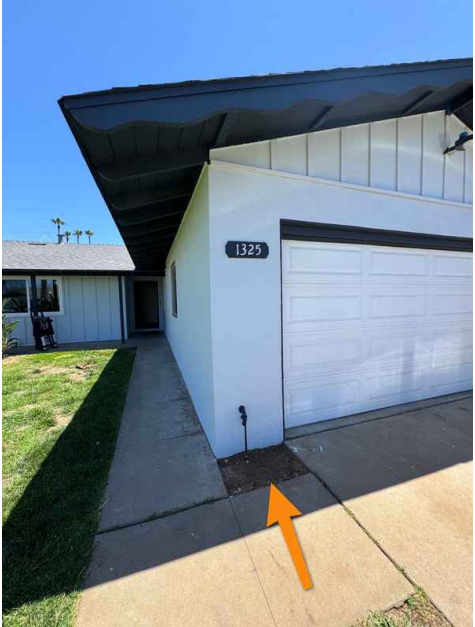
Example noted at Front of Home

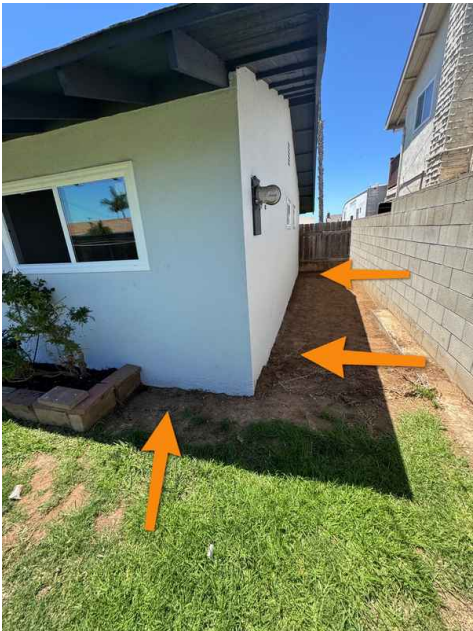
Example noted at Rear, Left Side of Home

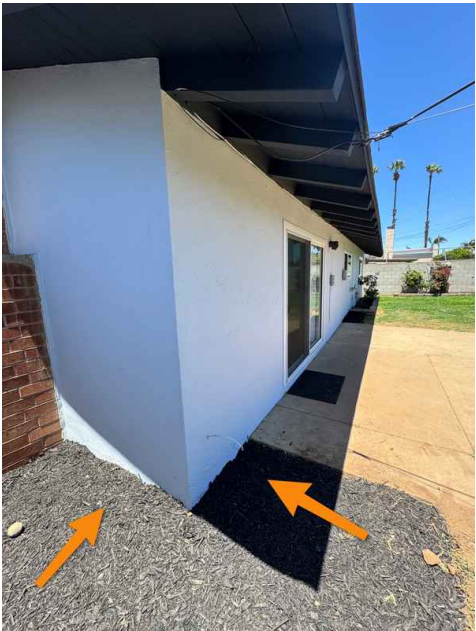
Example noted at Rear, Right Side of Home

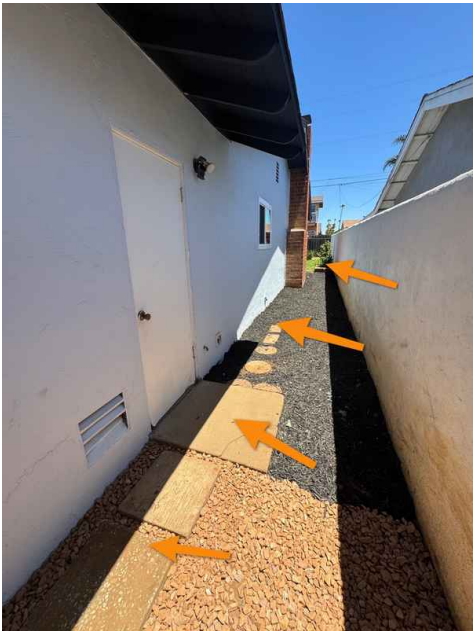
Example of low areas noted at Right Side of Home

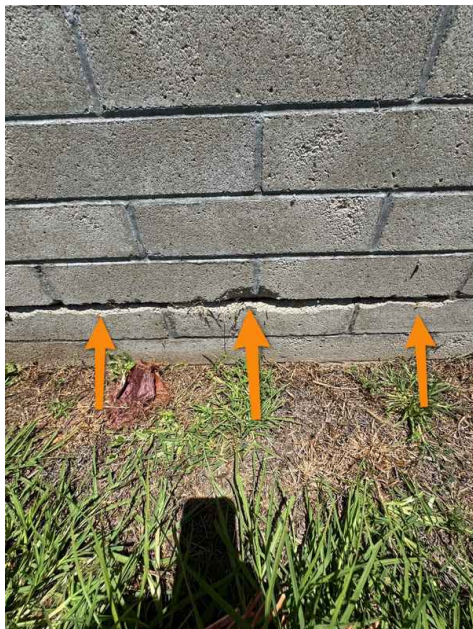
Cracking and separation sections visible at the retaining wall(s) in several areas. Moisture damage also noted. Damage in retaining walls can be caused by many reasons, including ground movement or improper design. The wall(s) did not appear to have weep holes, which allow water to drain from behind the walls. Determining the cause of damage is beyond the scope of this inspection. Recommend further evaluation of the retaining/yard walls by a licensed masonry contractor to determine any repairs necessary. Note: The retaining walls appeared to be shared with the neighboring properties, recommend to inquire with the seller to determine client's responsibility regarding the walls.

Example of cracking noted

Contact a qualified masonry professional.

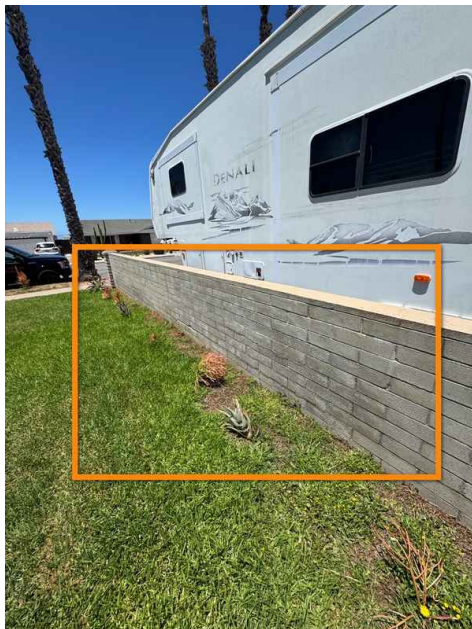
Example noted at Front Left Side Yard, no weep holes visible

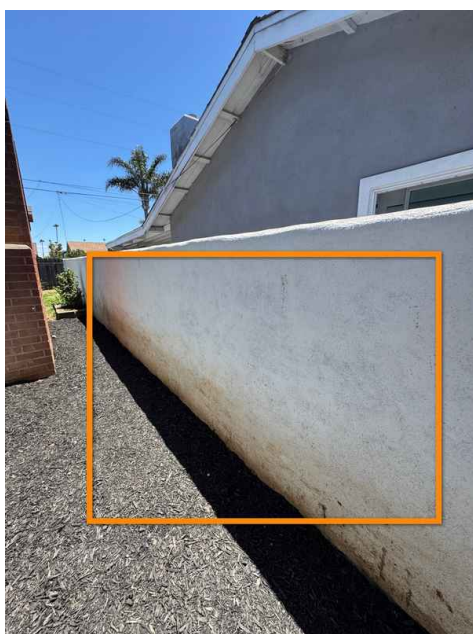
Example noted at Right Side wall, cracking noted, no weep holes visible

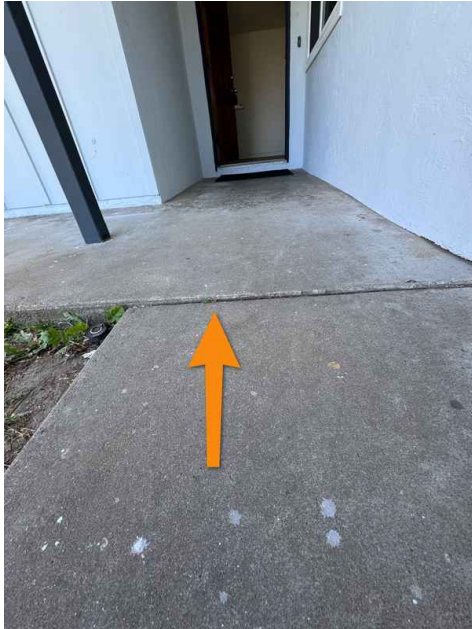
Several sections of the hardscape noted cracking and damaged. Hardscape noted uneven or heaving in one or more locations, this can result in a potential trip and fall safety concern. General settlement is normal and can be expected, however, determining the nature or cause of the cracking/damage and any possible affect on the home is beyond the scope of this inspection. Recommend further evaluation of the hardscape and grading around the home by a licensed grading contractor to determine the cause, and any repairs as necessary to forestall further damage.

Example of heaving, possible tripping concern noted at Front of Home

Contact a qualified grading contractor.

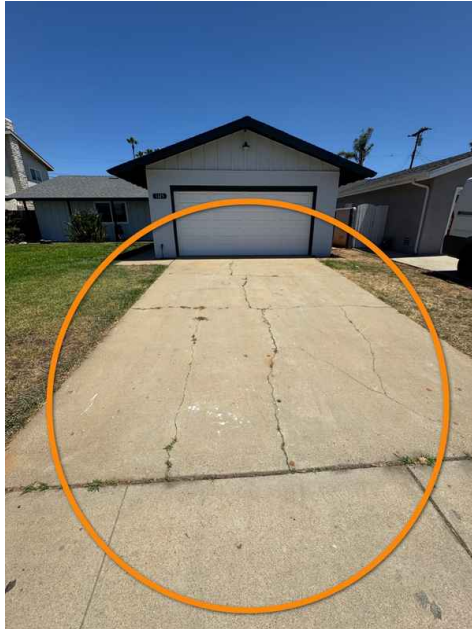
Example of cracks noted at Front driveway

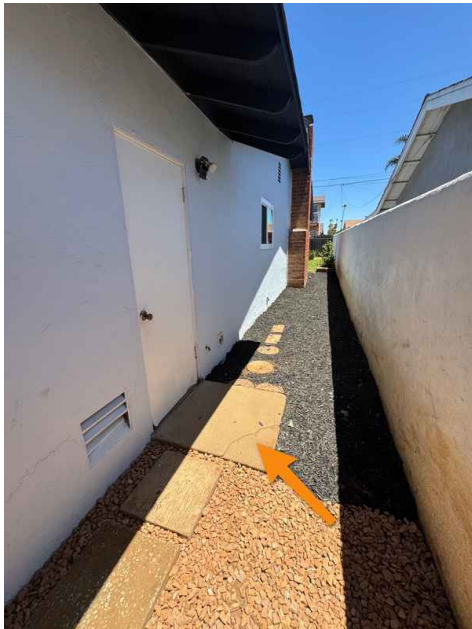
Example of crack noted at Right Side of Home

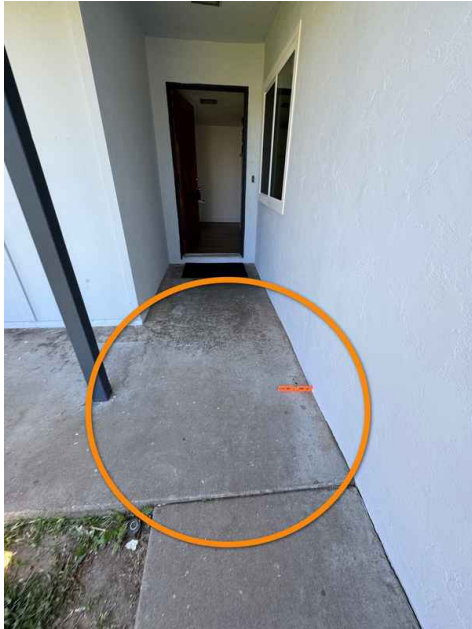
The slope at the patio/walkway directly next to the home appeared to be neutral, or even slightly negative in areas, which may be considered inadequate for proper drainage. This condition may prevent water from properly draining away from the home, particularly during periods of heavy rain. Water next to, or draining towards, the home can lead to damage. Recommend further evaluation and monitoring by a licensed concrete contractor, and any corrections as necessary.

Example noted at Front of Home

Contact a qualified concrete contractor.

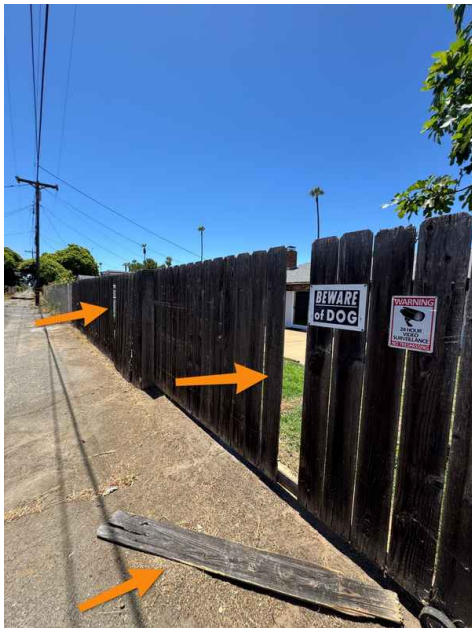
Leaning and damaged fencing noted in several locations. Rusty metal noted at the rear gate, the gate did not appear to operate smoothly. Fencing was also not fully visible due to vegetation, unreasonable access and/or other obstructions limiting my view. Failing paint at wood fencing can lead to termite damage and premature deterioration. Recommend further evaluation of all fencing and repair as necessary by a licensed fence contractor.

Example of damage noted, Rear Yard

Contact a qualified fencing contractor

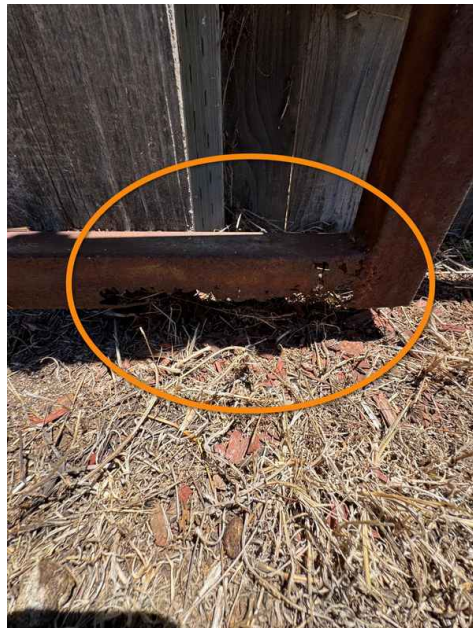
Example of rust and damage noted
