KEEN EYE PROPERTY INSPECTIONS

## KEEN EYE PRE-LISTING INSPECTION

5643 Bloch St  
San Diego, CA 92122

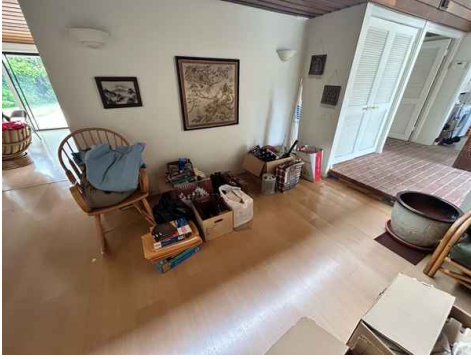
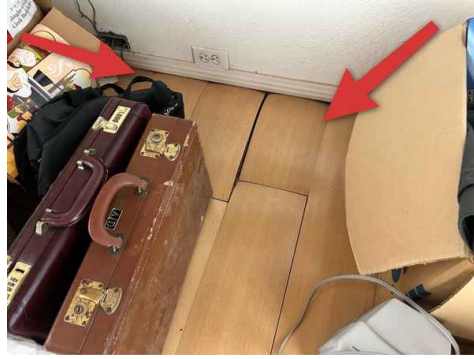
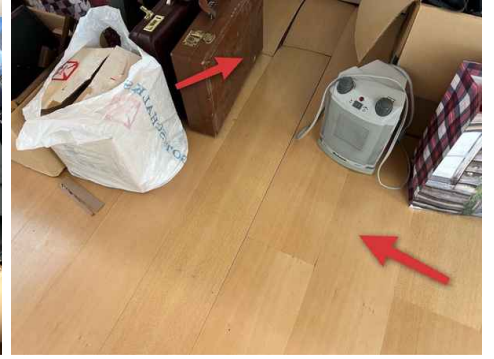
#### MOISTURE DAMAGE- INTERIOR FLOORING

## Recommendation

Contact a qualified professional.

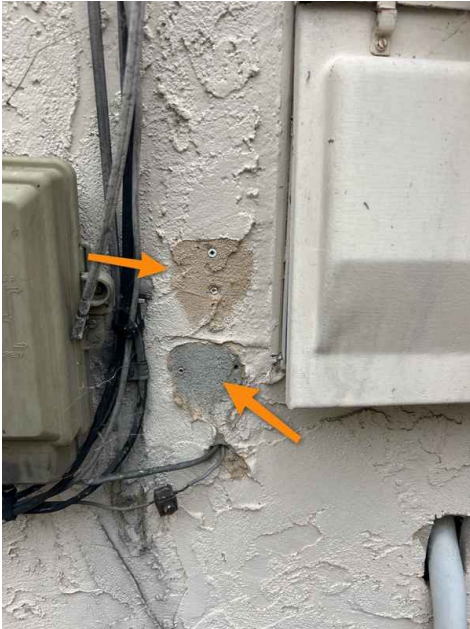
#### 2.4.8 Exterior Walls / Trim

### TERMITE DROPPINGS

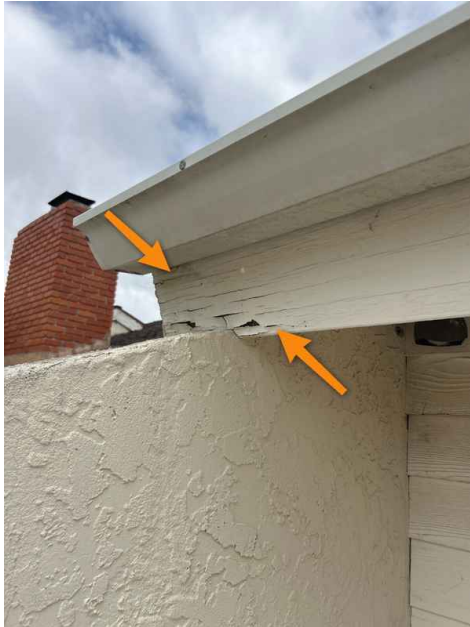
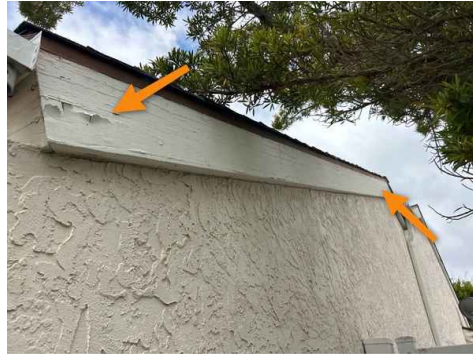
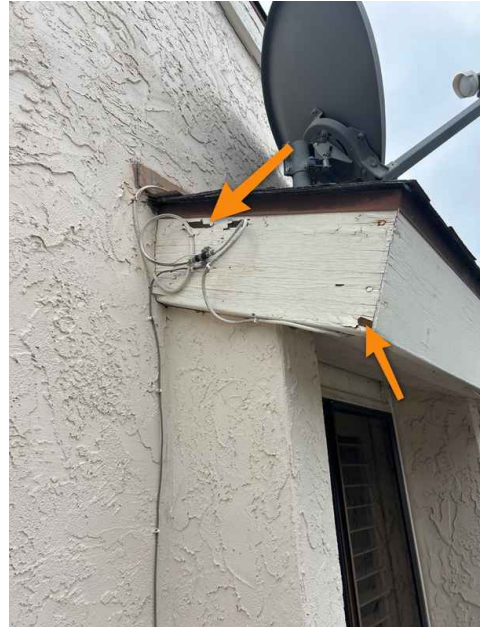
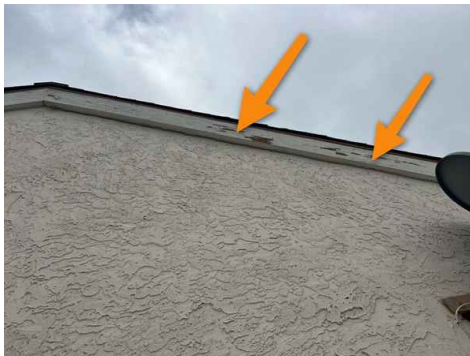
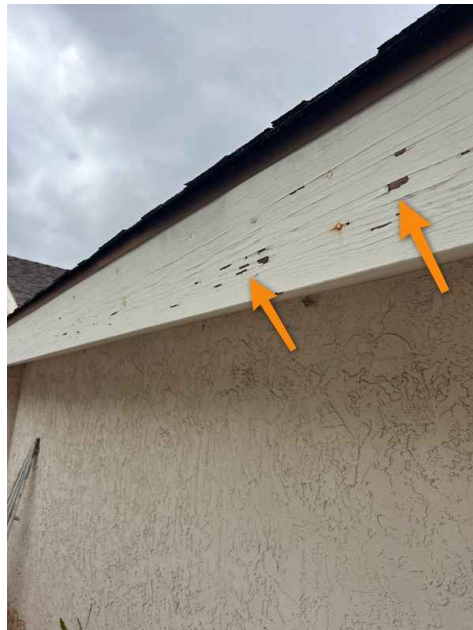
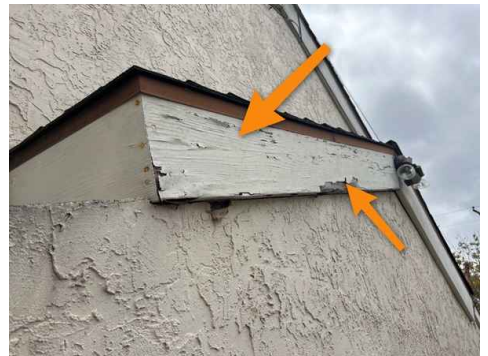
## 2.5.2 Eaves / Soffits

**PAINT FAILING**

Attention Required

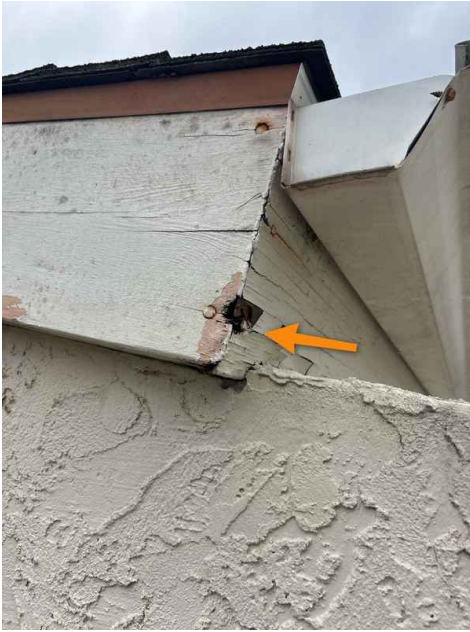
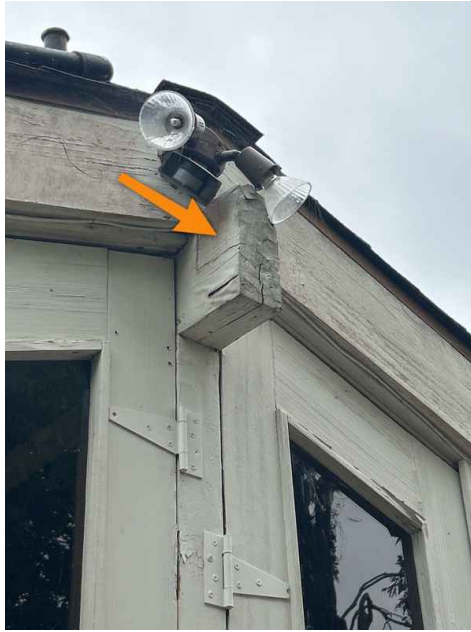
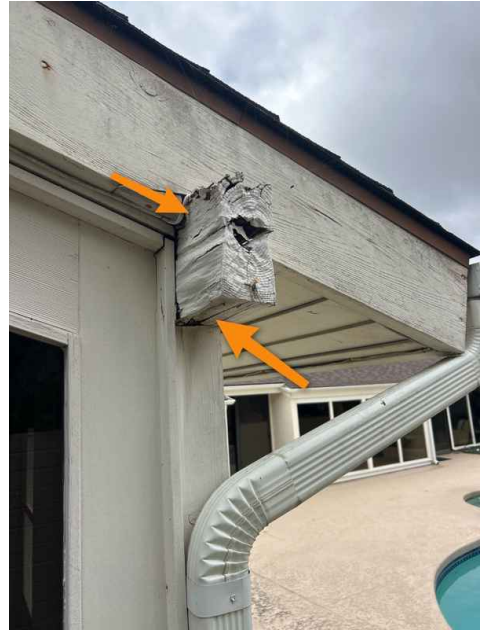
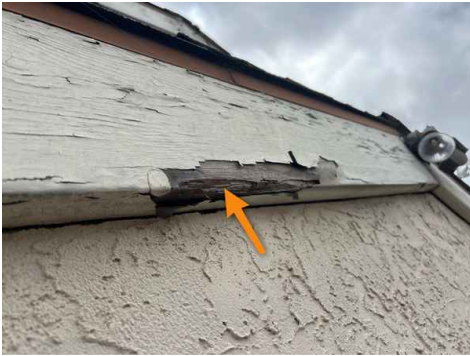
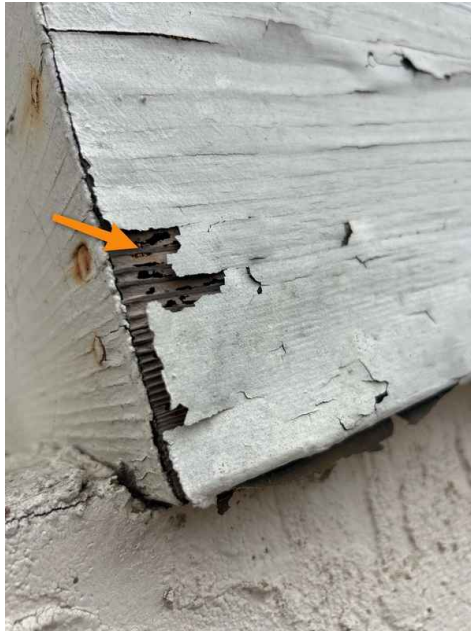
## 2.5.3 Eaves / Soffits

**TERMITE DAMAGE**

Attention Required

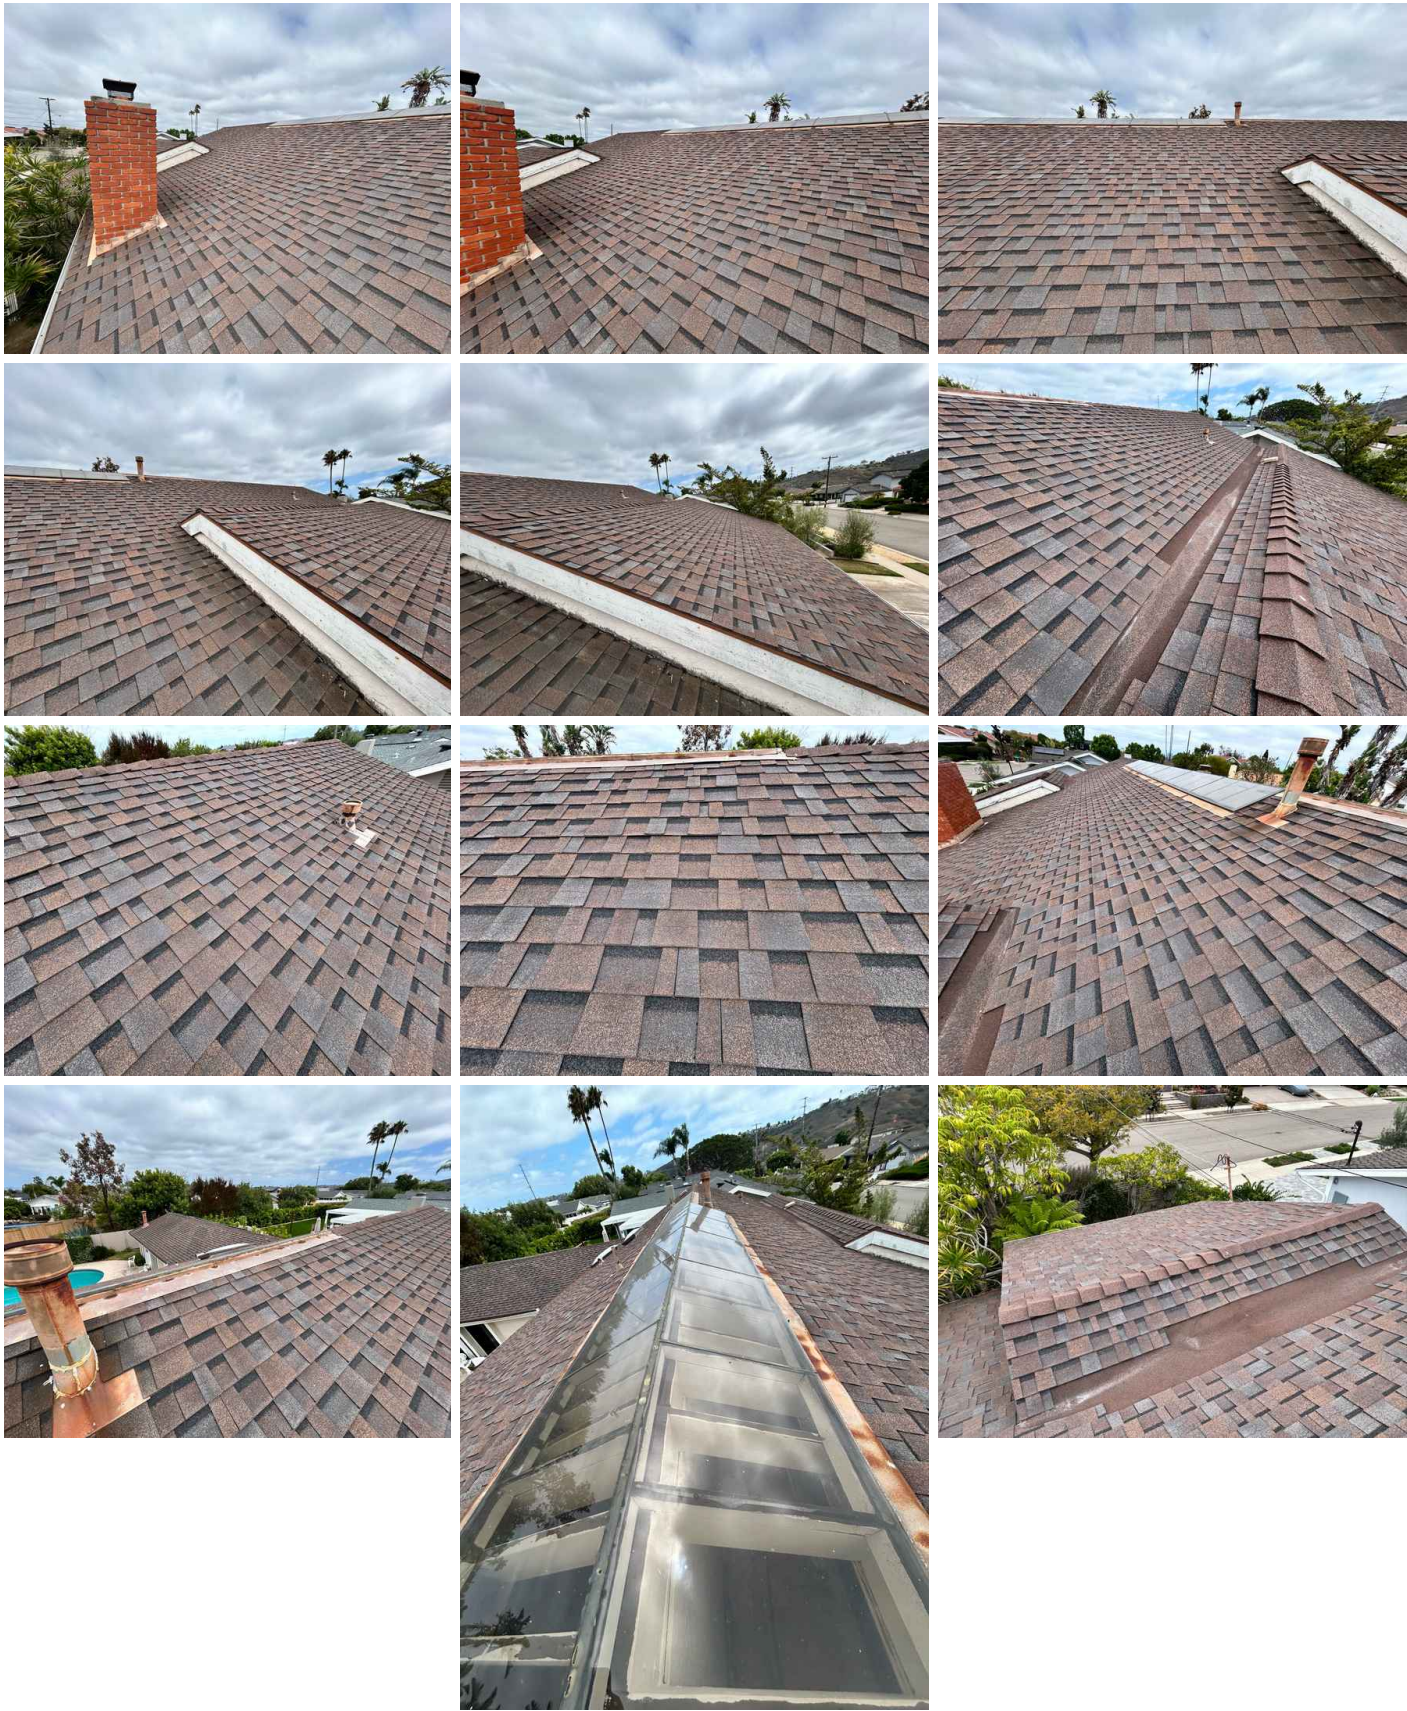
General: View of Roof

View of roof.

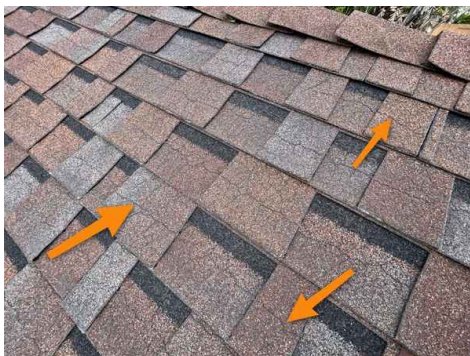
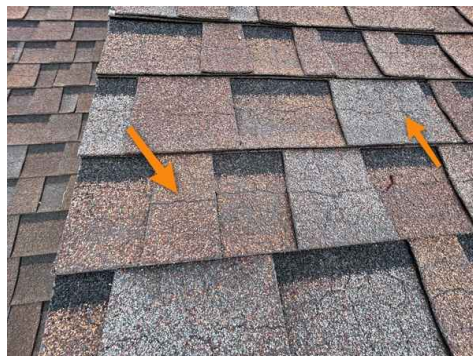
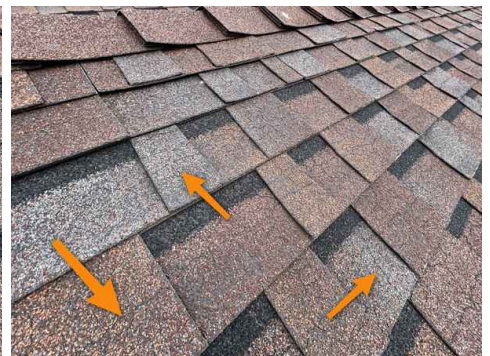
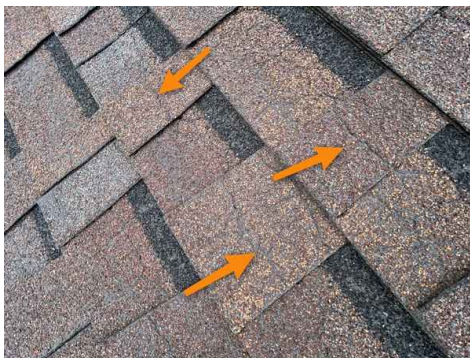
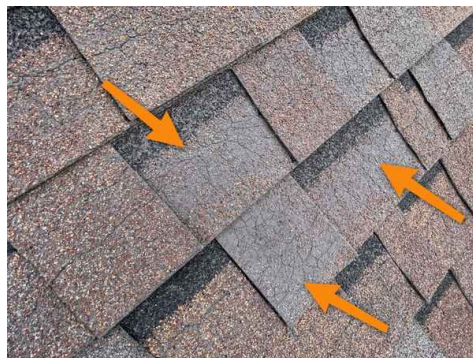
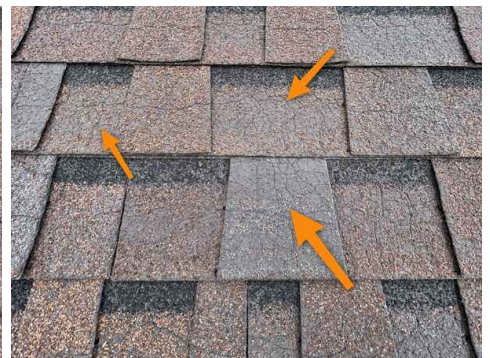
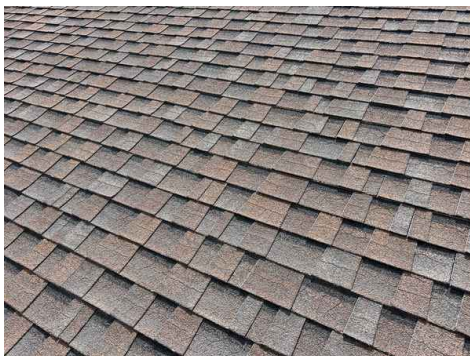
#### COMPOSITION ROOF SHINGLE CRAZING CRACKS

Composition roof shingles showing signs of crazing cracks. This will shorten the life expectancy of the roof. Seek a licensed roofing contractor for further evaluation to determine life expectancy.

Monitoring for signs of future damage/deterioration is recommended.

Contact a qualified roofing professional.

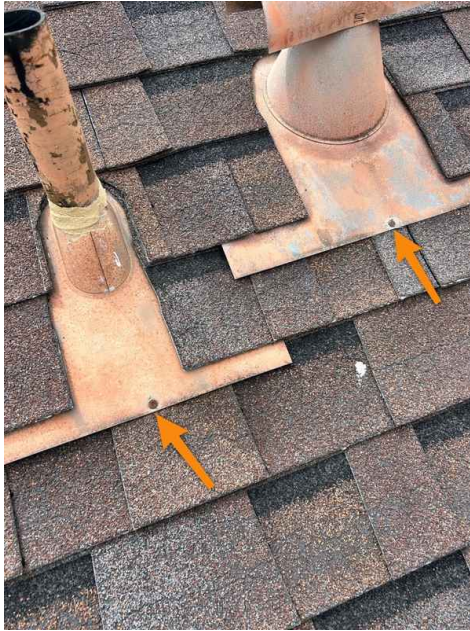
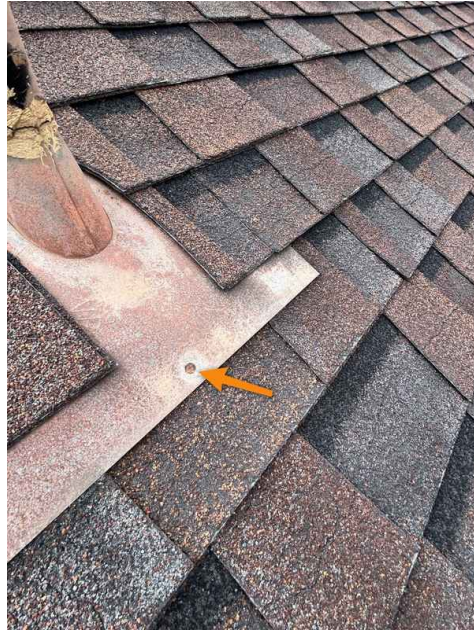
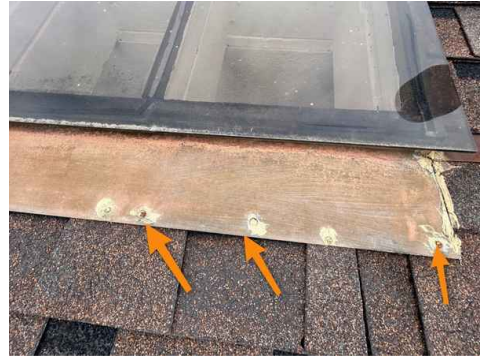
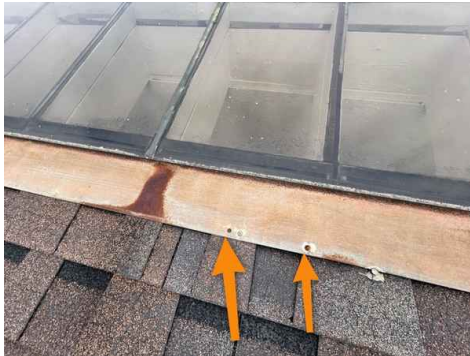
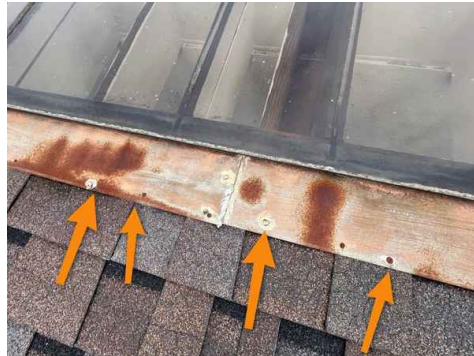
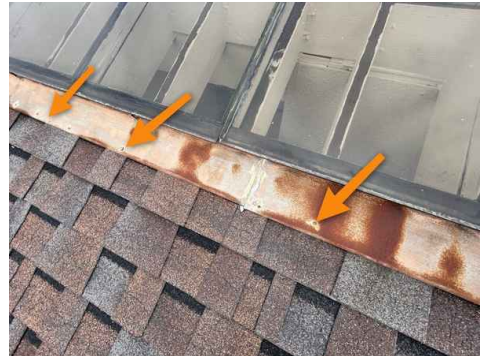
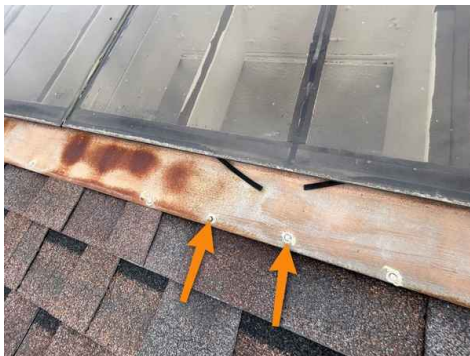
## 4.2.2 Coverings

**EXPOSED STAPLE / SCREW HEAD(S) AND/OR NAIL HEAD(S)**

Nails, screws, and/or staple heads were exposed at one or more shingles. A qualified roofing professional is recommended to apply an approved sealant over exposed fasteners now and as necessary in the future to prevent leaks.

Contact a qualified professional.

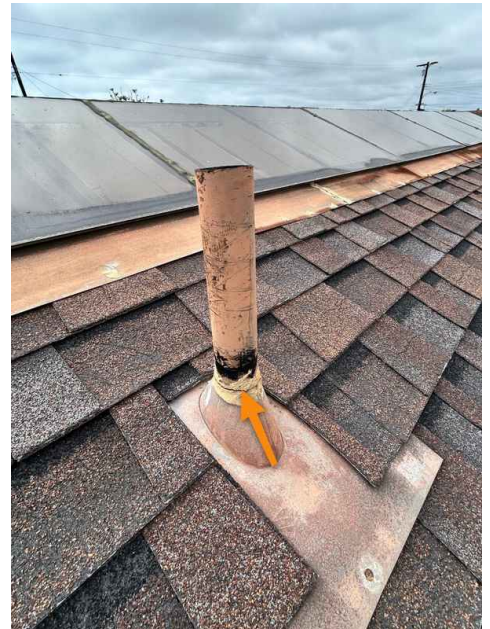
## 4.4.1 Skylights, Chimneys &amp; Other Roof Penetrations

One or more roof jacks in need of tar maintenance at pipes and/or other penetrations. Leaks can occur as a result. This is a conducive condition for wood-destroying organisms. Recommend that a qualified contractor seal roof jack flashing where necessary.

Contact a qualified roofing professional.

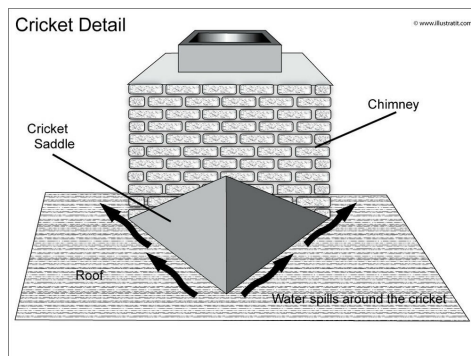
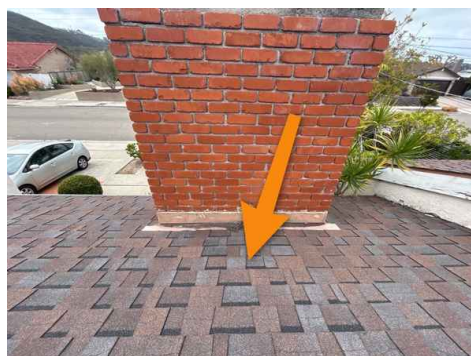
#### 4.4.2 Skylights, Chimneys & Other Roof Penetrations

##### **CRICKET NOT INSTALLED**

A cricket is a peaked saddle behind the chimney/skylight that diverts water around the sides of the chimney. Without a cricket, debris such as leaves, needles or moss is likely to accumulate above the chimney, and can cause leaks. At a minimum, monitor this area and its flashings for accumulated debris, and clean debris as necessary. Consideration should be given to contacting a qualified roofing professional to install a cricket as a preventative maintenance measure.

Contact a qualified roofing professional.

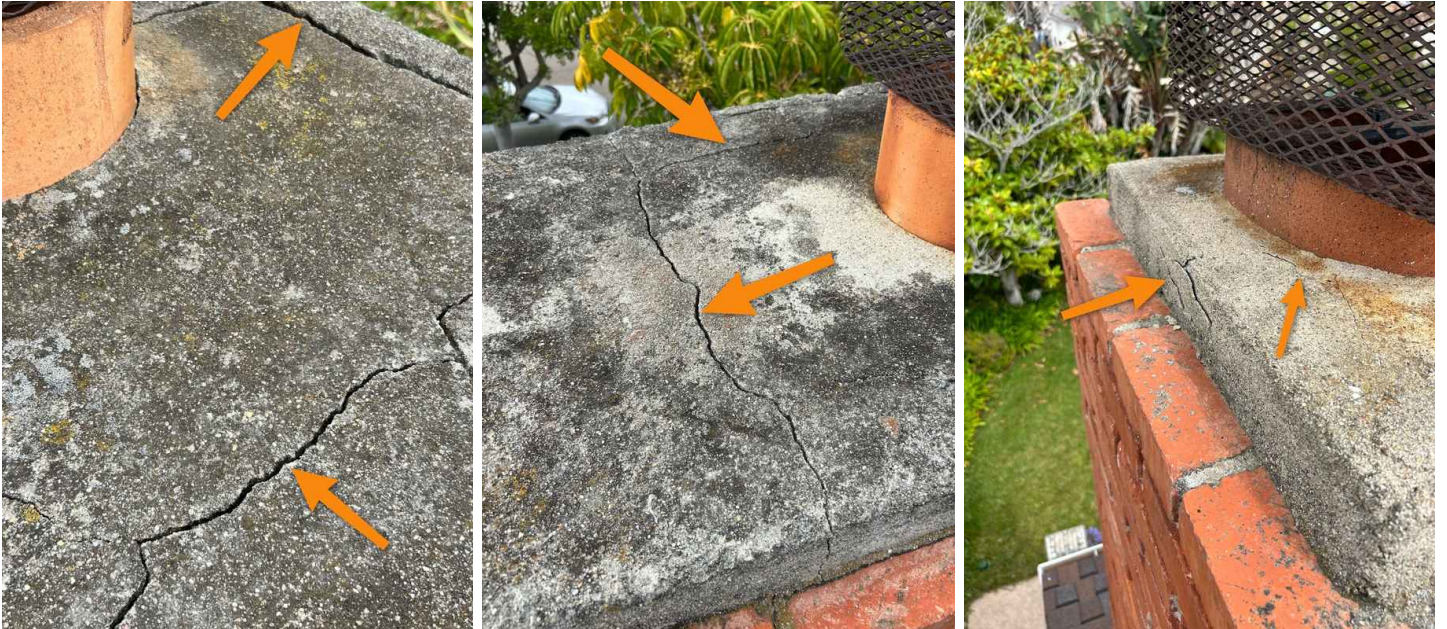
#### 4.4.3 Skylights, Chimneys & Other Roof Penetrations

##### **CROWN CRACKED/DETERIORATED**

The top portion of a masonry chimney is referred to as the chimney crown. The crown at one or more areas was cracked, worn and/or substandard. This could allow moisture intrusion behind the chimney. A qualified tradesperson is recommended to repair or replace crowns as needed.

Contact a qualified chimney contractor.

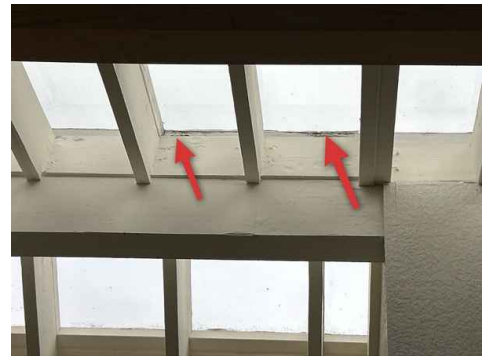
#### 4.4.4 Skylights, Chimneys & Other Roof Penetrations

##### **SKYLIGHT(S) DRY STAINS**

Dry water stains were found around one or more skylights. It is unknown if these stains are due to an active leak. If available, inquire with the seller in this regard. It's possible these stains are from a previous leak that has since been addressed. Consideration should be given to having a qualified roofer further evaluate and determine if repairs are needed at this time.

Contact a qualified roofing professional.

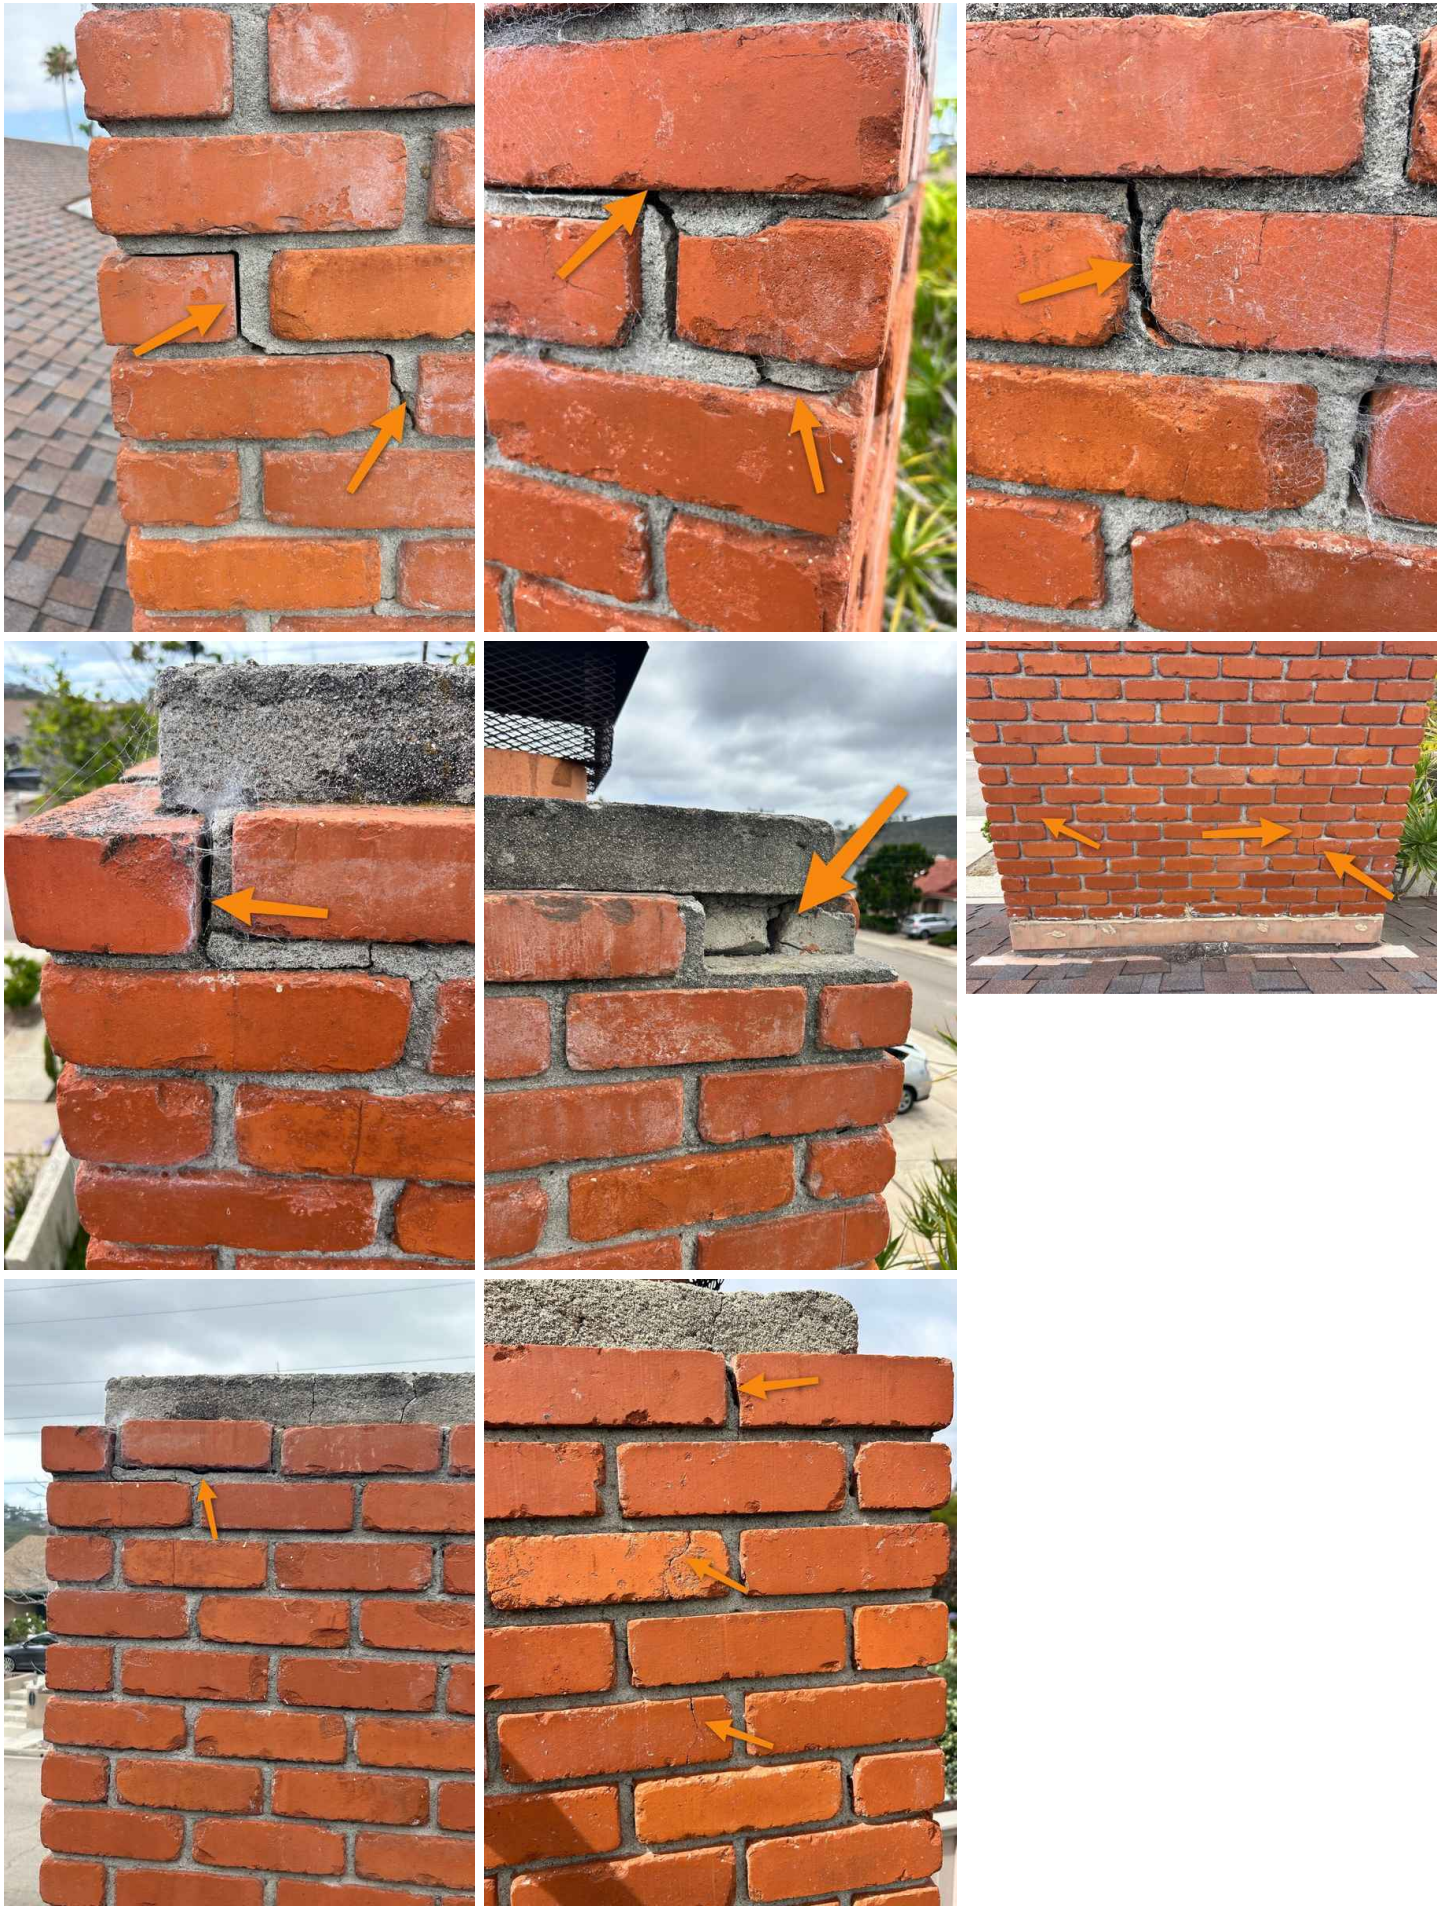
#### 4.4.5 Skylights, Chimneys & Other Roof Penetrations

##### **CHIMNEY BRICK/GROUT CRACK(S) / DAMAGE NOTED**

Cracks and or damage were noted in one or more areas. Correction is recommended.

Contact a qualified professional.

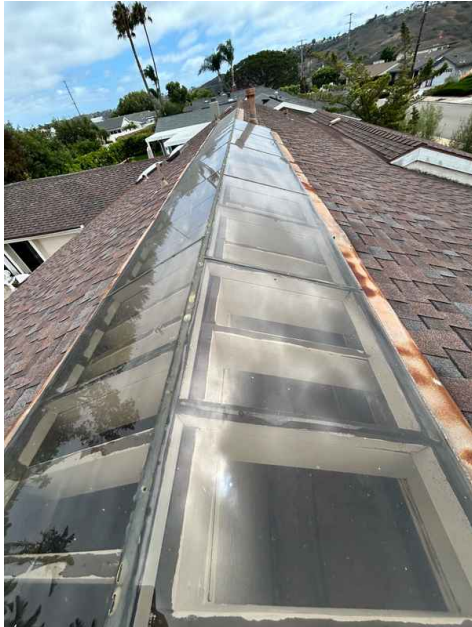
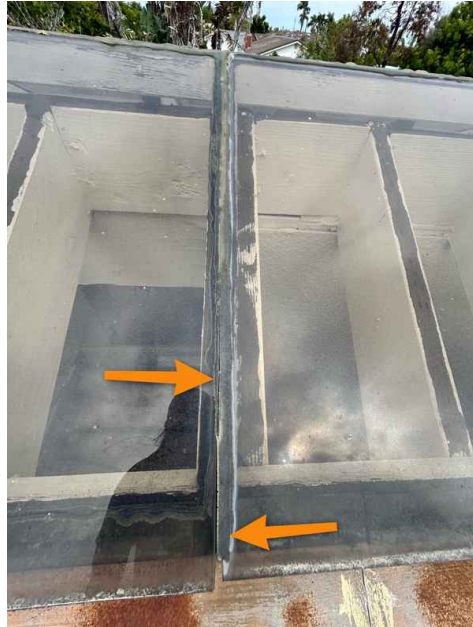
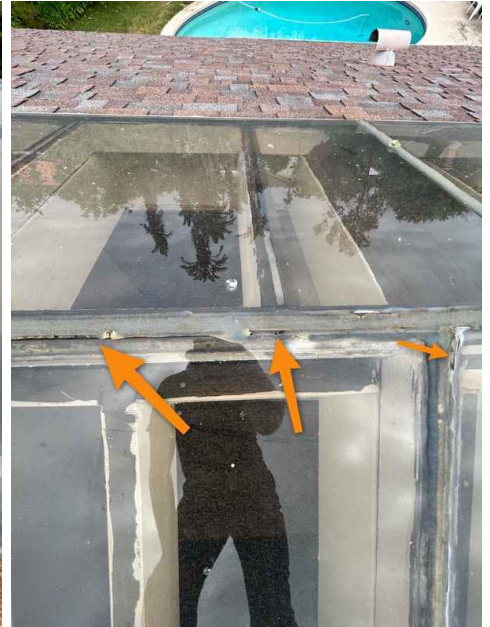
## 4.4.6 Skylights, Chimneys &amp; Other Roof Penetrations

**SKYLIGHT TRIM SEALANT**

The sealant for the skylight trim was deteriorated and/or substandard. A qualified professional is recommended to make repairs as needed.

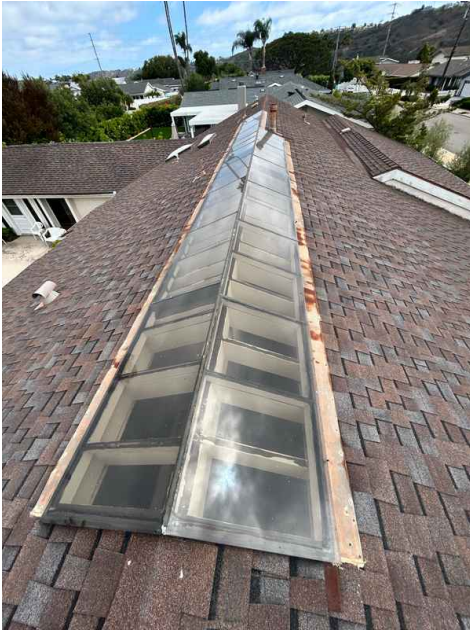
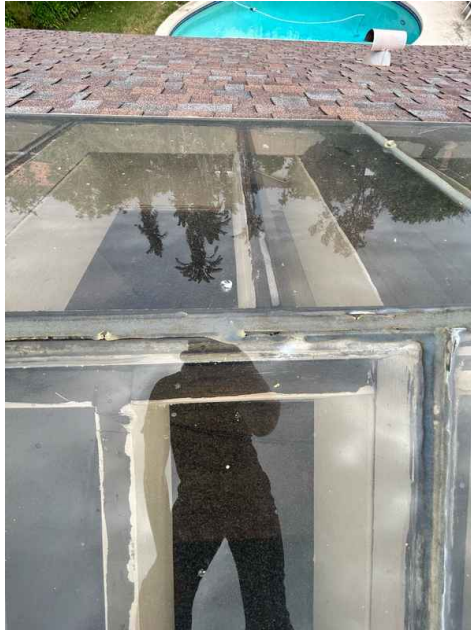
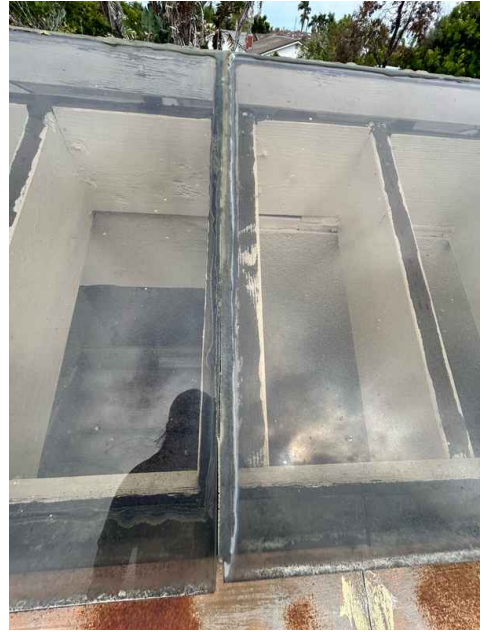
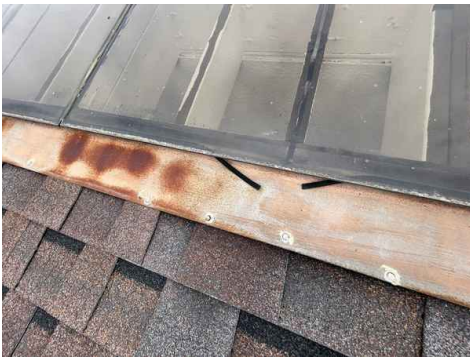
## 4.4.7 Skylights, Chimneys &amp; Other Roof Penetrations

**RIDGE SKYLIGHT SUBSTANDARD**

We observed what appears to be a skylight installed in a substandard manner. Observed glass panes glued down on roof joists, sealant damages and flashing that needs to be evaluated. We recommend the area to be further evaluated by a licensed roofer to determine if the installation method is acceptable and water tight. Also the roofer is to determine the scope of repairs that are needed at this time.

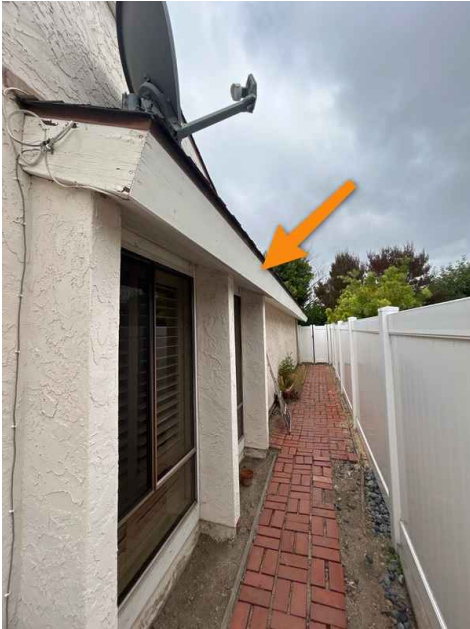
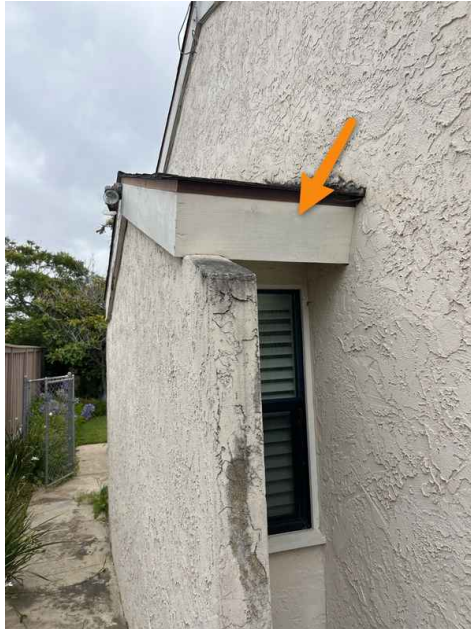
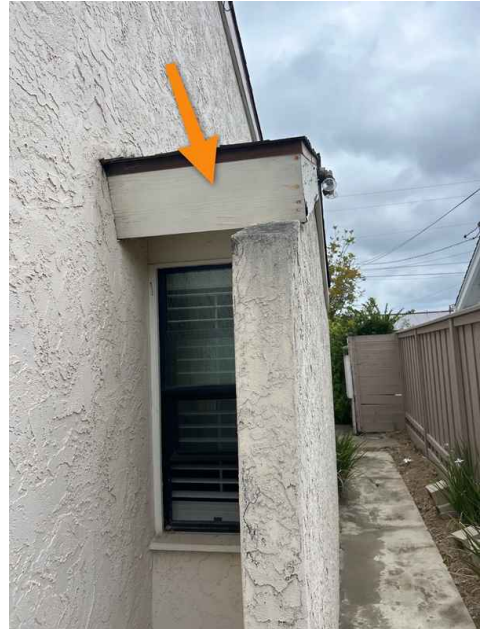
#### 4.5.1 Roof Drainage Systems

##### **PARTIAL GUTTERS NOTED**

A partial gutter system was noted. A qualified professional is recommended to add full gutters for improved drainage.

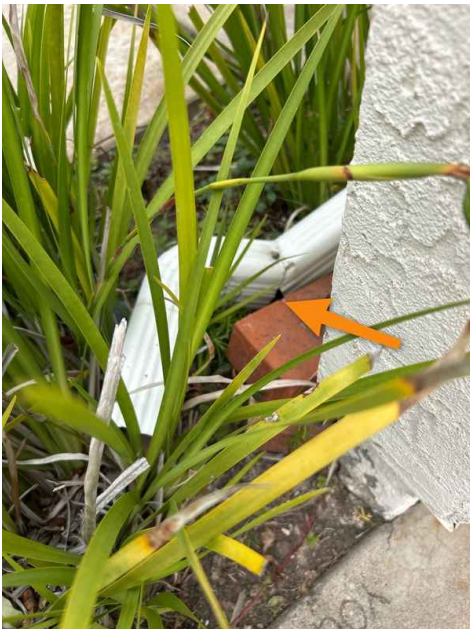
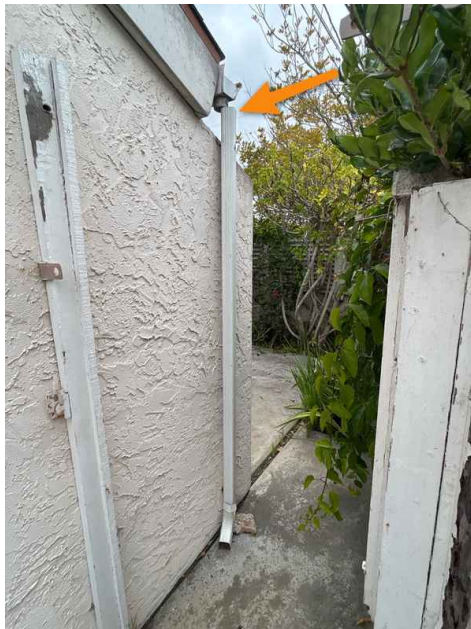
#### 4.5.2 Roof Drainage Systems

##### **GUTTER(S) AND/OR DOWNSPOUT(S) SECTIONS SEPARATED / DAMAGED / LOOSE**

Gutters and/or downspouts at one or more areas were separated, buried, loose and/or substandard. Repairs are needed to ensure proper function and direct water away from the home. A qualified professional is recommended to repair gutters and/or downspouts as needed

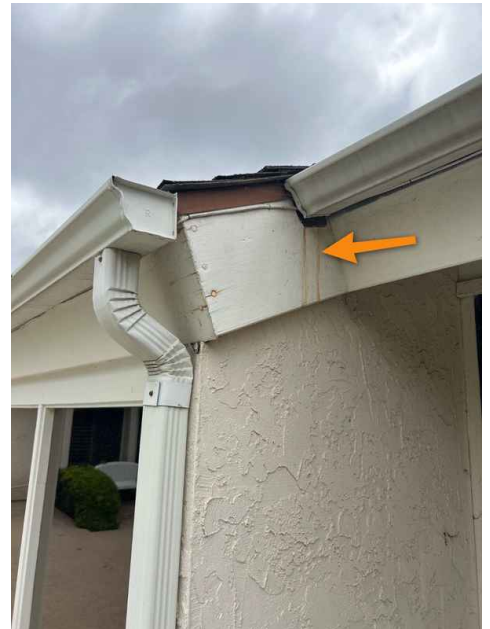
#### 4.5.3 Roof Drainage Systems

##### **LEAKING BEHIND**

The gutters at one or more areas were leaking or showed evidence due to improper connection, failed sealant or substandard installation. A qualified handyperson is recommended to repair gutters as needed.

Contact a qualified gutter contractor

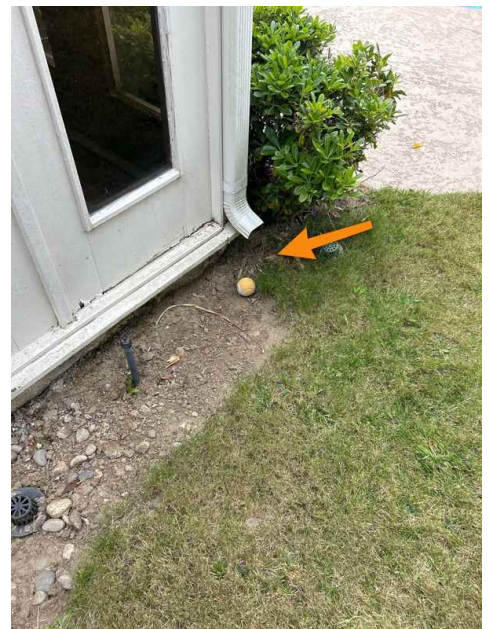
#### 4.5.4 Roof Drainage Systems

##### **IMPROPER DOWNSPOUT TERMINATION**

The downspout terminations were improper and/or substandard. Terminating the downspouts directly next to the home will typically create and/or accelerate issues with moisture intrusion, erosion, and can lead to abnormal settlement of the foundation. This is because roof run-off is now concentrated into a specific area. Recommend having elbows and splashblocks installed where possible, some areas may need a buried drainline to properly divert water away from home.

Contact a qualified gutter contractor

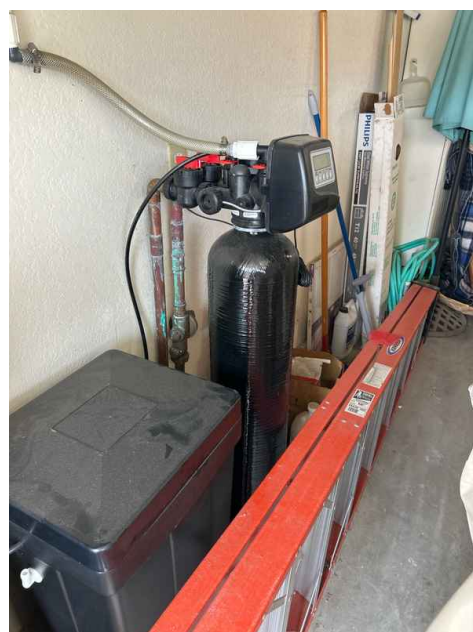
A water softener system / water treatment device / water filter was installed on the premises. These are specialty systems and are excluded from this inspection. Comments in this report related to this system are made as a courtesy only and are not meant to be a substitute for a full evaluation by a qualified specialist. Water softeners typically work by removing unwanted minerals (e.g. calcium, magnesium) from the water supply. Recommend consulting with the property owner about this system to determine its condition, required maintenance, age, expected remaining life, etc.

**Note:** Water from a water softener system is not recommended for drinking due to its increased sodium content. If the system installed is a water softener (as opposed to a water treatment or filtration system), then we recommend confirming that a water filter is installed in conjunction with this device so that drinking water is present in the house.

## Recommendation

Contact a qualified professional.

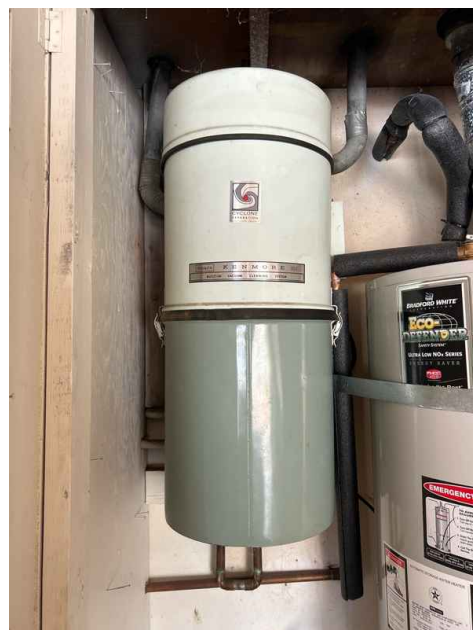
## 6.1.2 Excluded Items

**WHOLE HOUSE VACUUM**

Whole house vacuum systems are outside the scope of a home inspection. Recommend having seller demonstrate proper function of this system.

## Recommendation

Contact a qualified professional.

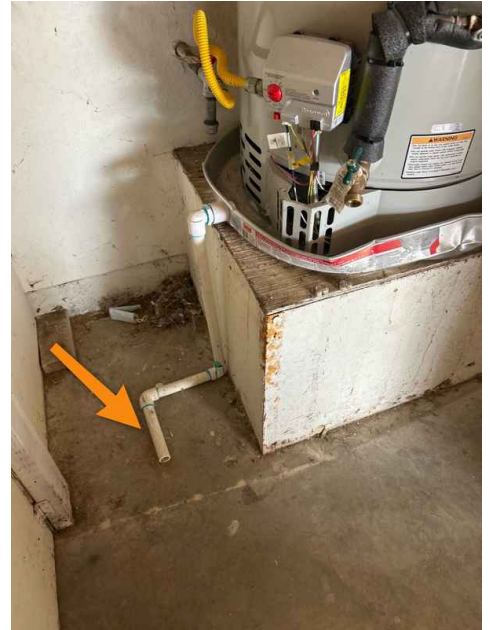
The catch pan underneath the water heater did not terminate at the exterior. Newer building standards require catch pans to be drained to an exterior point to prevent damage. Adding a drain to exterior is recommended. At a minimum a water alarm should be installed.

Recommendation

Contact a qualified plumbing contractor.

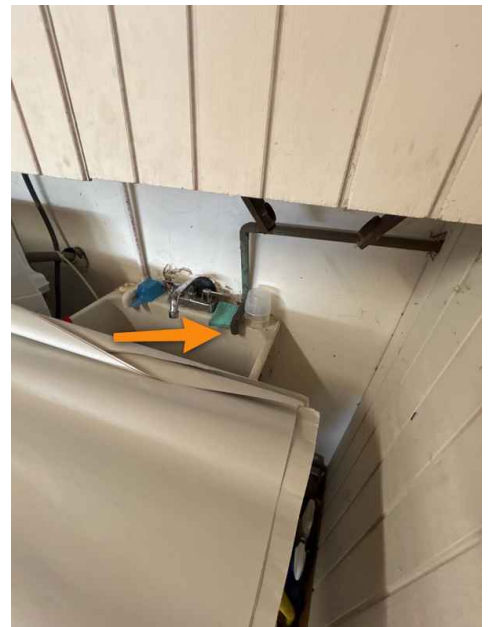
## 6.5.2 Water Heater(s)

The drain for the temperature pressure relief (TPR) valve does not terminate to the exterior of the building. These valves often leak over time. If this valve leaks, significant amounts of water can accumulate where the drain line terminates. Recommend that a qualified plumber repair per standard building practices, and so the drain line terminates outside at a readily accessible location.

Recommendation

Contact a qualified plumbing contractor.

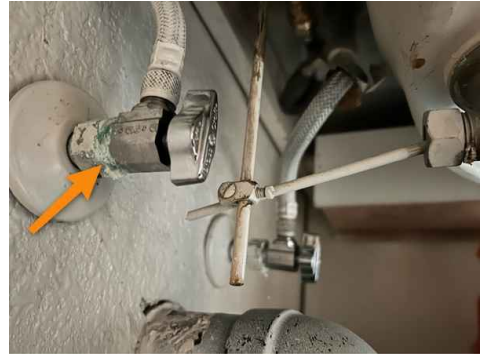
## 6.6.1 Sinks / Fixtures

**CORROSION / DAMAGE - ANGLE STOPS**

Some of the angle stops, shut off valves or supply lines under the sinks or behind the toilets appear to be corroding, damaged, or have mineral deposits or rust. This is indicative of a previous leak that has sealed itself. Monitoring this situation is recommended. A qualified plumbing contractor is recommended for further evaluation and repairs.

## Recommendation

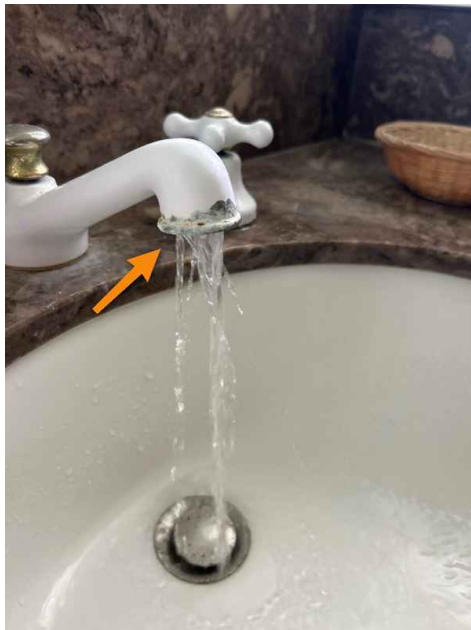
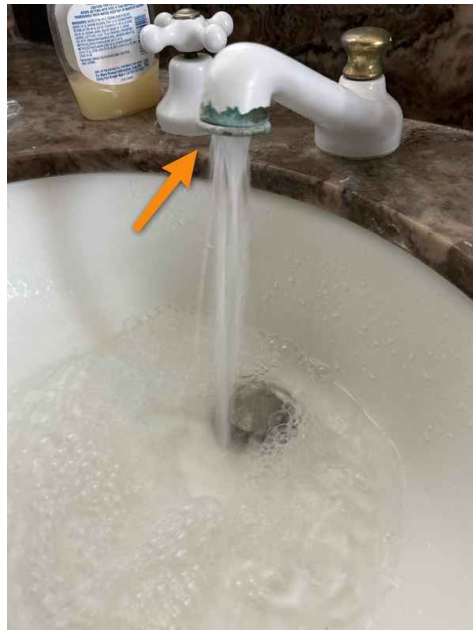
## 6.6.2 Sinks / Fixtures

**CORRODED SINK FIXTURE**

Corroded sink fixture noted at one or more location. Monitoring this situation and replace the fixture as needed.

## Recommendation

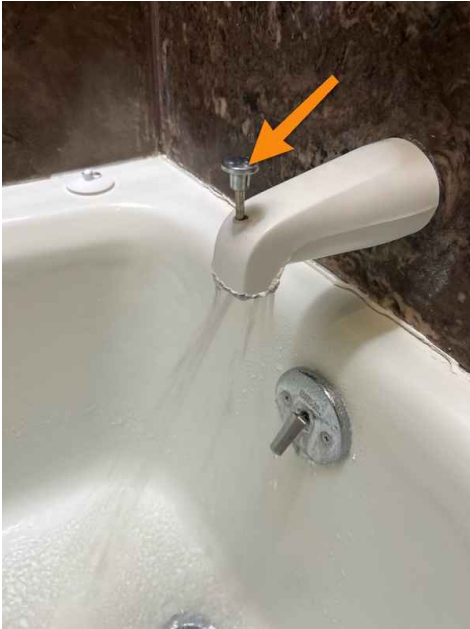
## 6.7.1 Bathtubs / Showers

**TUB DIVERTER**

The tub diverter(s) did not function properly at the time of the inspection. Water sprays from shower head and tub spout at the same time. This is typically due to corrosion and or hard water build-up. A qualified professional is recommended for repairs.

## Recommendation

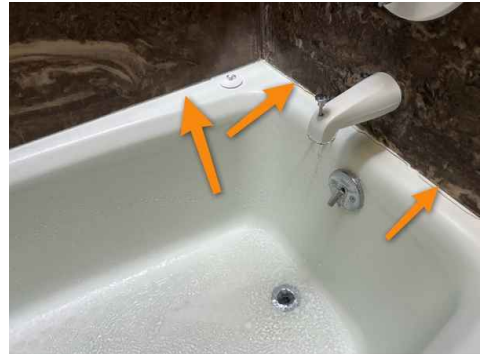
## 6.7.2 Bathtubs / Showers

**RE-CAULK SHOWER/TUB ENCLOSURE**

The tub/shower enclosures need to be cleaned and re-caulked to prevent moisture intrusion beyond the shower enclosure walls.

Recommendation

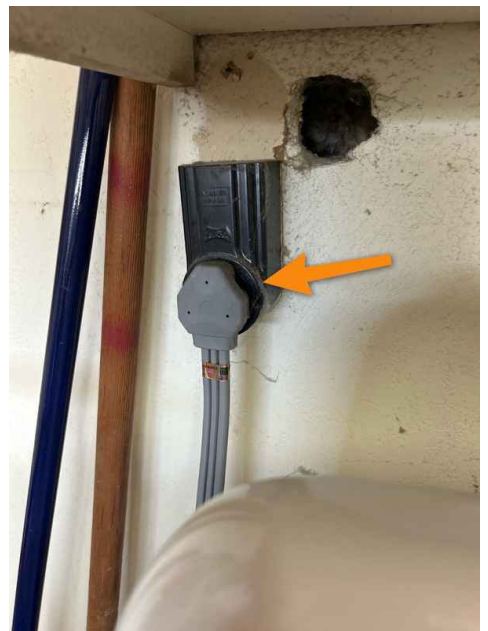
## 6.9.1 Laundry

**UPGRADE 240 OUTLET**

A 3-slot receptacle was installed for the clothes dryer but most modern clothes dryers use a 4-slot receptacle. While 3 wire clothes dryer circuits were allowed prior to 1996 and are commonly still in use; they are not up today's safety standards. Note that this may require installing a new circuit wire. A qualified electrician is recommended for further evaluation and/or repairs.

Recommendation

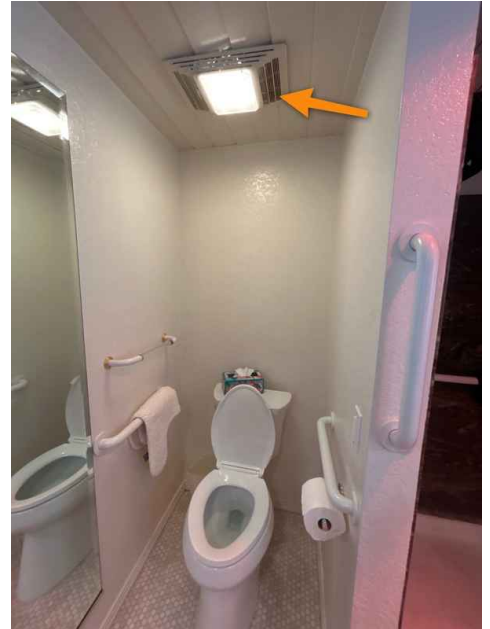
## 6.10.1 Exhaust Fans / Ventilation

**EXHAUST FAN NOISY**

Recommendation

Contact a qualified handyman.

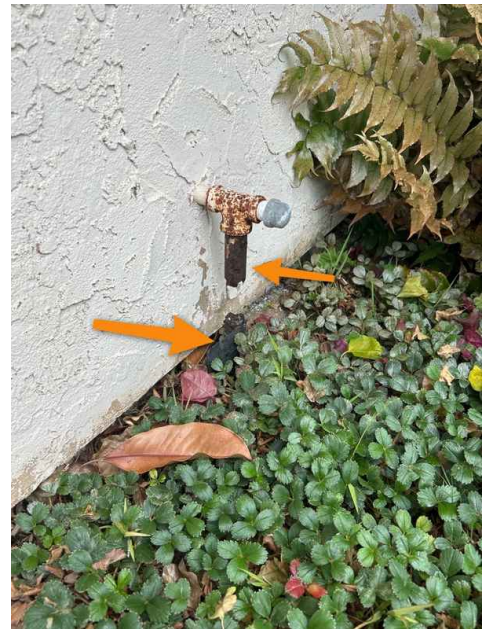
#### 6.11.1 Fuel Systems

##### **CUT PIPING**

Recommendation
