KEEN EYE PROPERTY INSPECTIONS

## KEEN EYE PRE-LISTING INSPECTION

5643 Bloch St  
San Diego, CA 92122

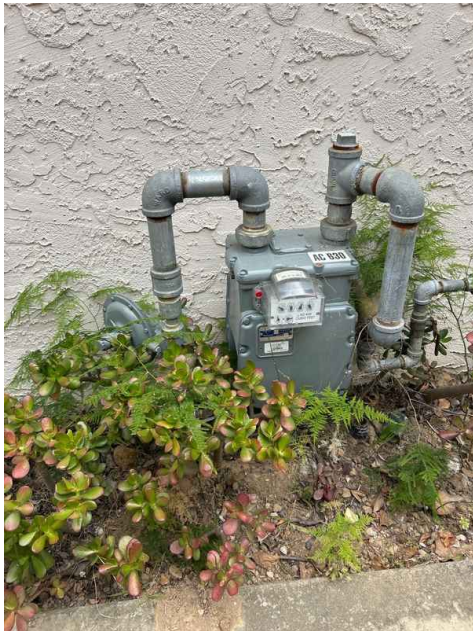
#### 6.11.2 Fuel Systems

##### **VEGETATION AROUND UNIT**

Recommendation

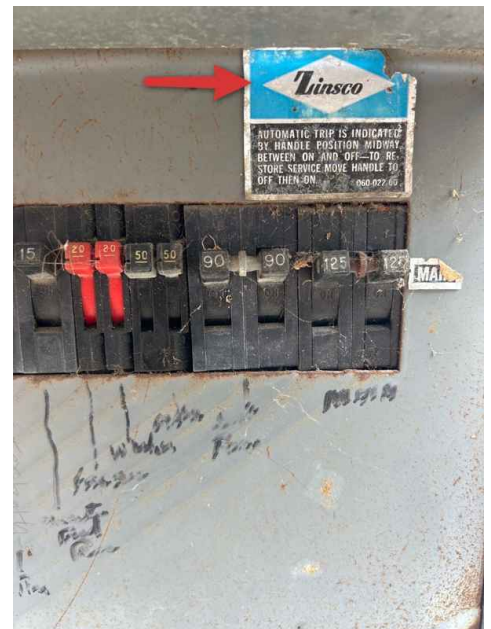
### 7.3.1 Electrical Panel(s)

#### ZINSCO / SYLVANIA PANEL

#### Recommendation

Contact a qualified electrical contractor.

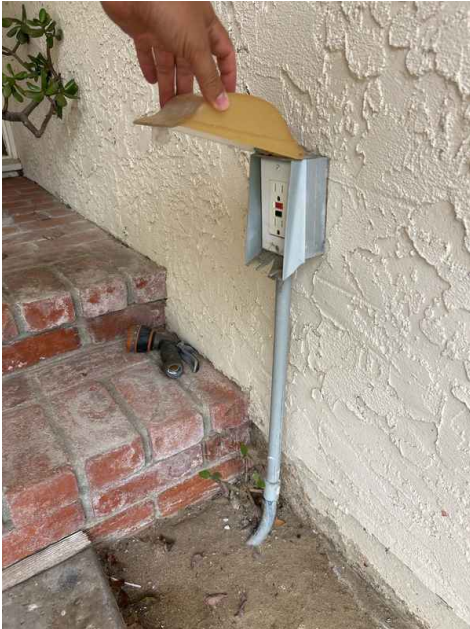
### 7.5.1 GFCI / AFCI Protection

#### GFCI ISSUES

#### Recommendation

Contact a qualified electrical contractor.

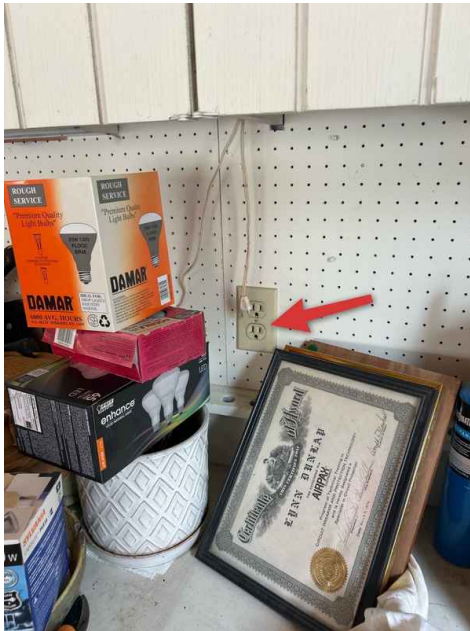
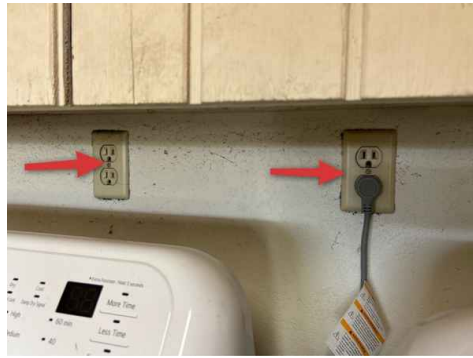
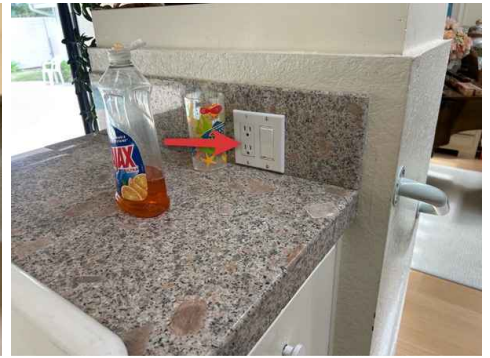
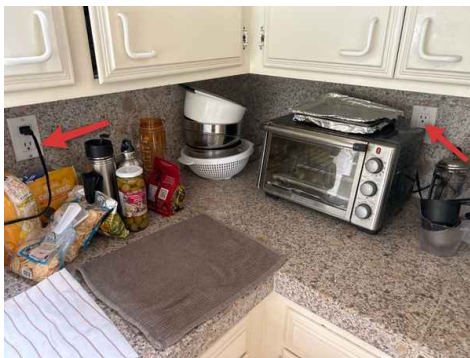
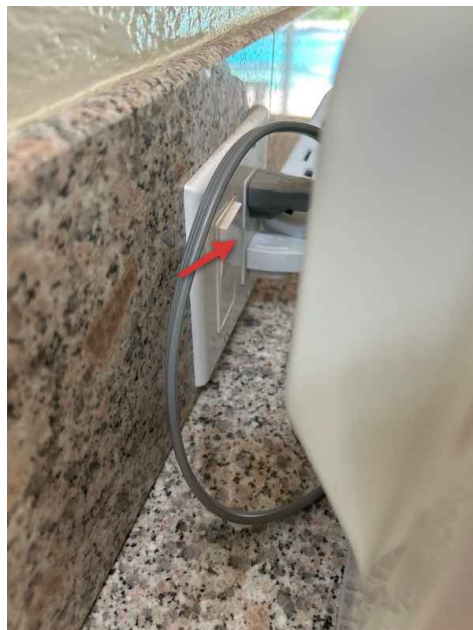
### 7.5.2 GFCI / AFCI Protection

#### **MISSING GFCI PROTECTION**

#### Recommendation

Contact a qualified electrical contractor.

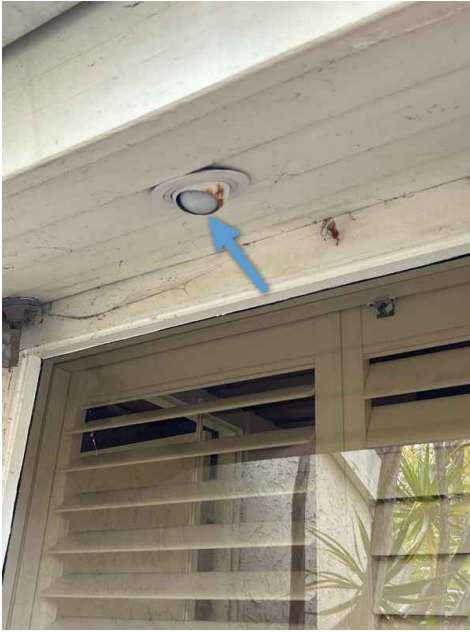
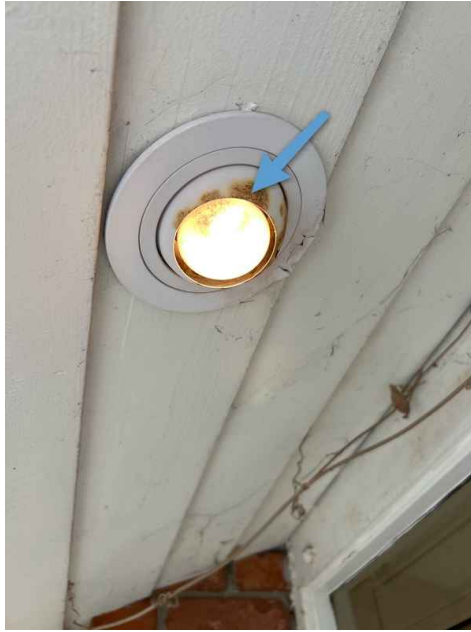
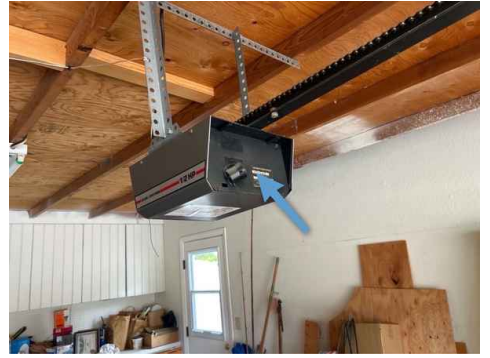
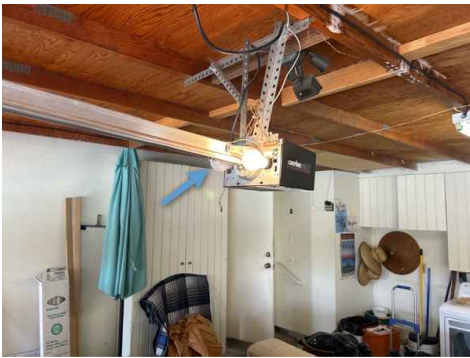
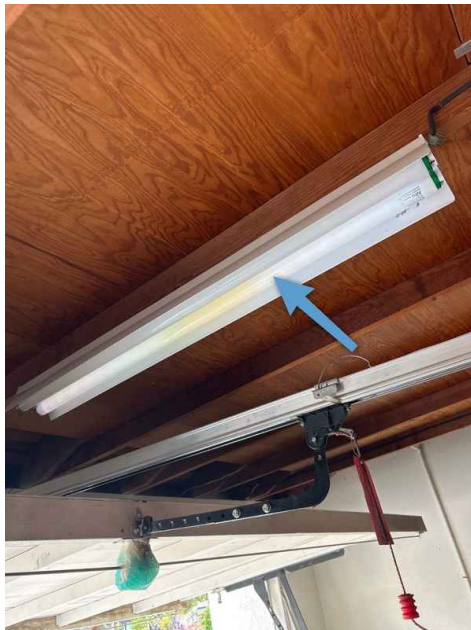
#### 7.7.1 Outlets / Switches / Lighting / Fans

### **BULB(S) INOPERABLE AND/OR MISSING**

#### Recommendation

Contact a qualified professional.

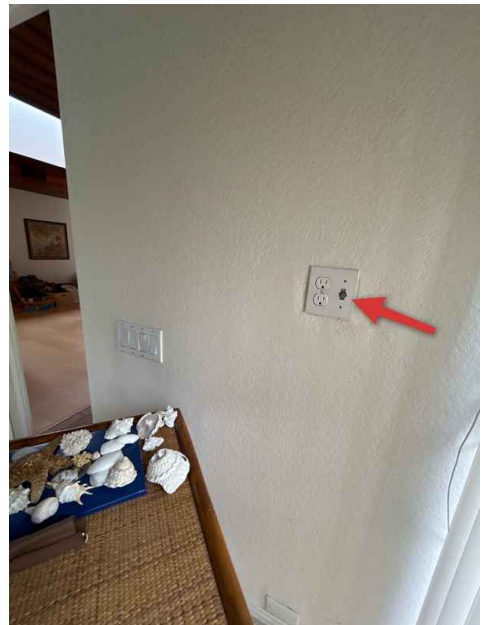
#### 7.7.2 Outlets / Switches / Lighting / Fans

#### **RECEPTACLE / SWITCH DAMAGED**

Recommendation

Contact a qualified electrical contractor.

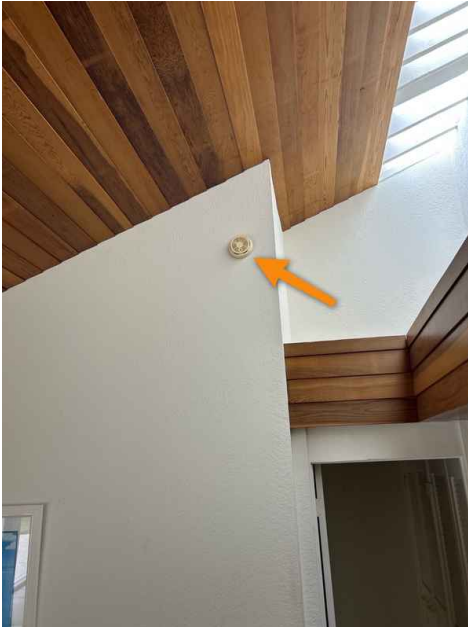
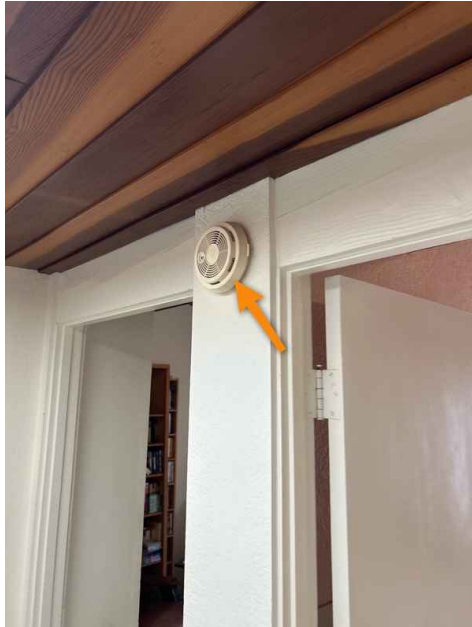
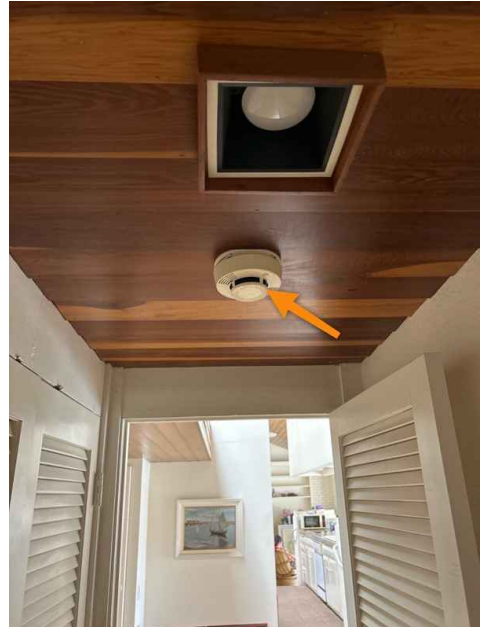
### 7.8.2 Smoke Detectors / CO Alarms / Door Bell

#### **UPDATING DETECTORS RECOMMENDED**

Updating the detectors to the newer style with an internal 10-year battery is recommended. A qualified handyperson is recommended to update detectors where needed for added safety.

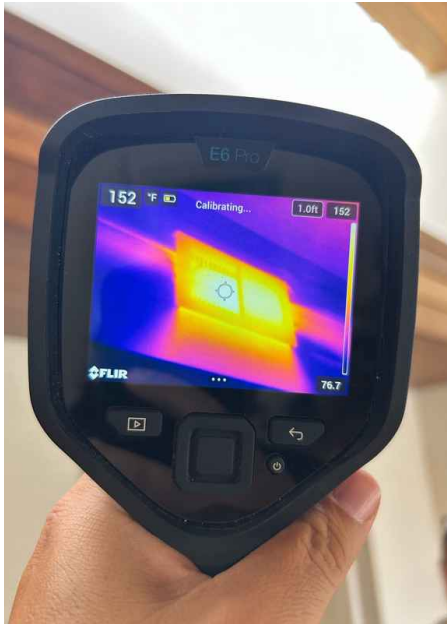
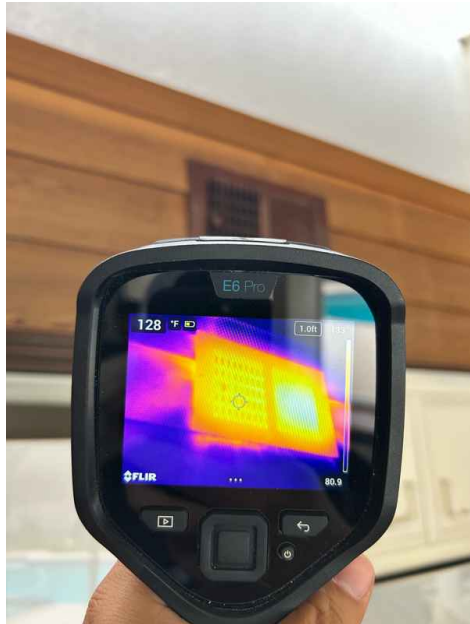
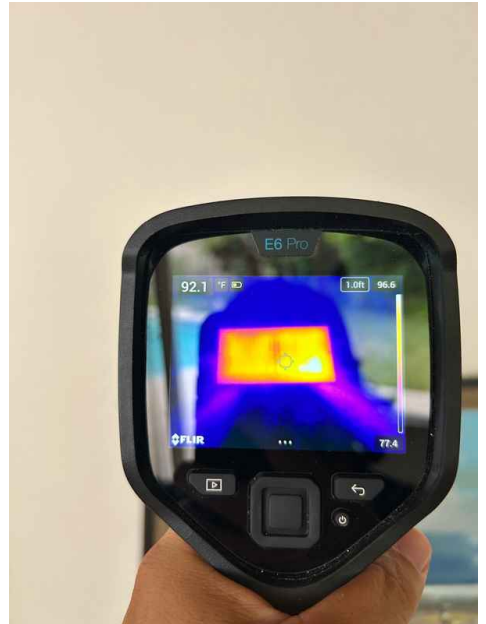
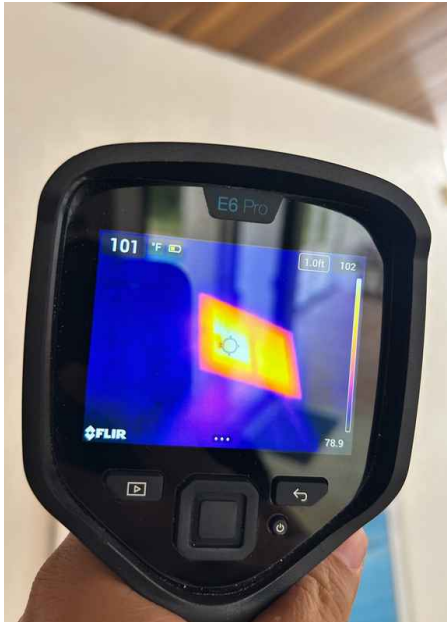
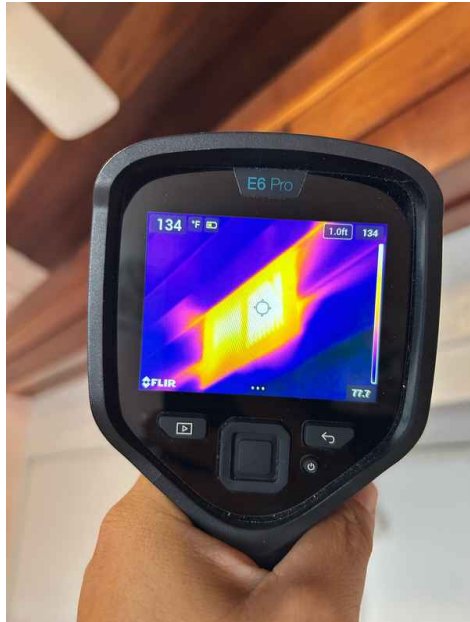
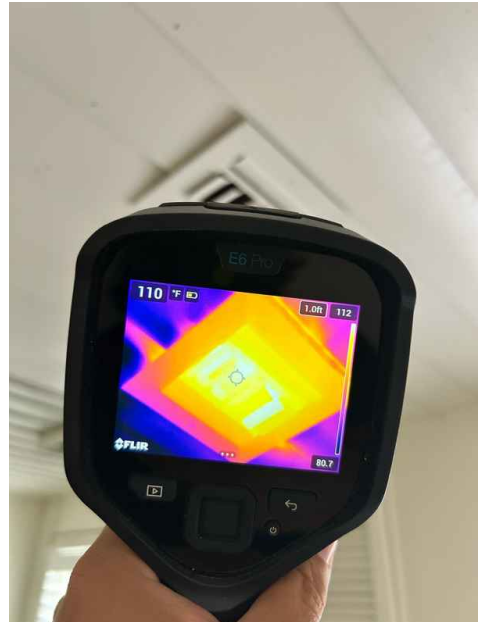
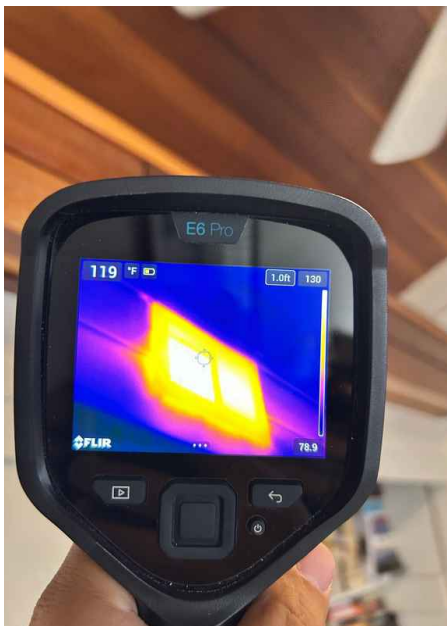
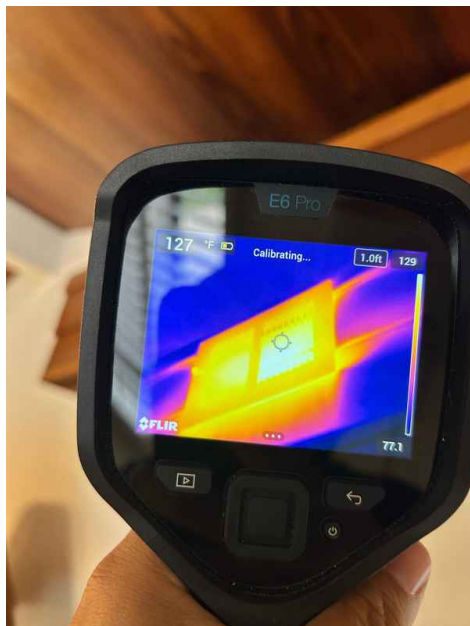
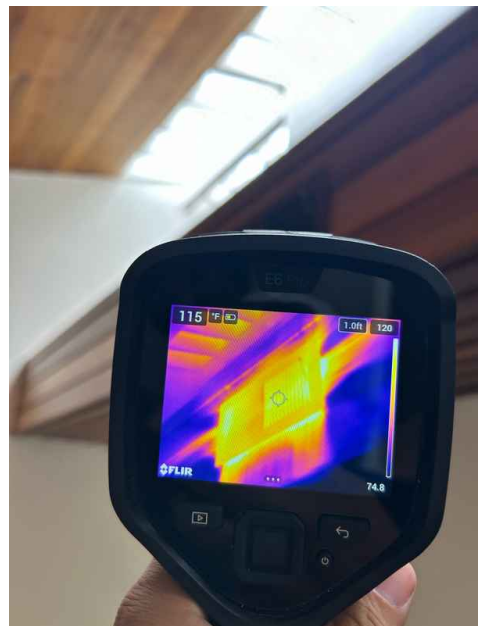
## Heating (Forced Air): Appears Functional - Thermal Image(s) During Operation

Heat system appears to be in working order.

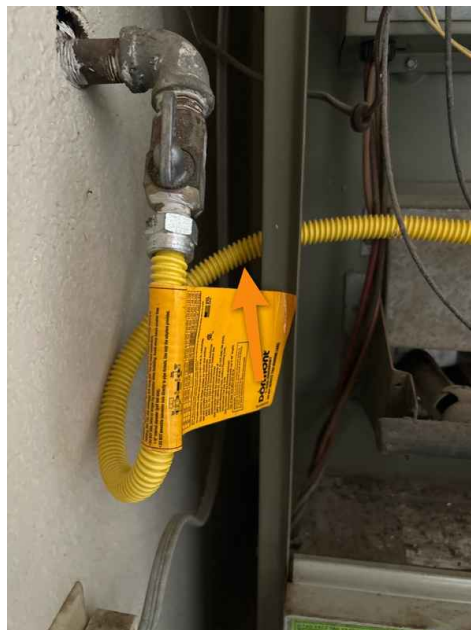
#### SEDIMENT TRAP MISSING

The furnace is not equipped with a sediment trap. A qualified professional is recommended to install a sediment trap where needed.

Contact a qualified HVAC professional.

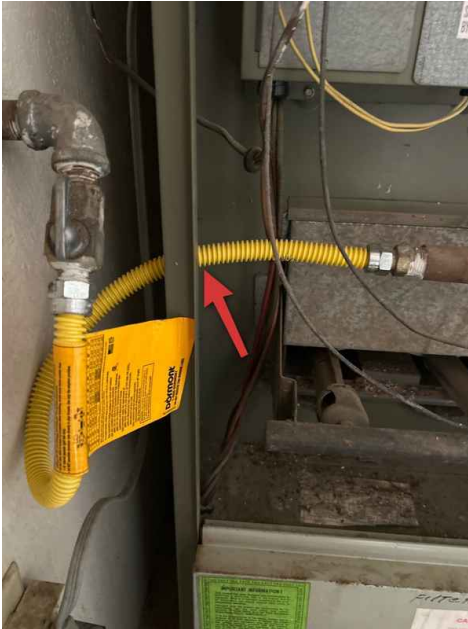
### 8.2.2 Heating (Forced Air)

#### FLEXIBLE GAS LINE INTO UNIT

⚠ Defective/Safety Hazard

The flexible gas line passes through the sidewall of the furnace. This soft flex gas line is easily damaged if it contacts the sharp edge of the furnace wall. A qualified HVAC professional is recommended to repair per standard building practices.

Contact a qualified HVAC professional.

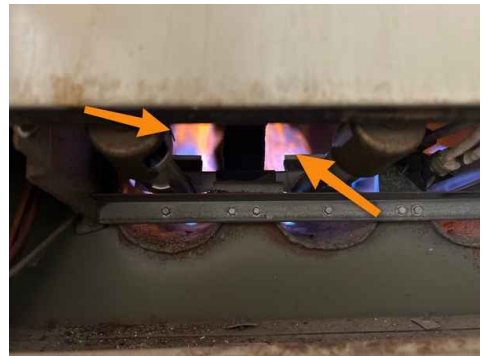
### 8.2.3 Heating (Forced Air)

#### **YELLOW/ORANGE FLAME**

The furnace appeared to turn on and produce heat at time of inspection. However, the flame color was not a consistent blue, which may indicate inefficient combustion, this is most commonly caused by rust or dirt on the burners, but may also indicate cracks in the heat exchanger, which is a potential CO hazard and safety concern. This cannot be determined within the scope of a home inspection. I recommend further evaluation/safety check be performed by a licensed HVAC contractor or the local gas company before the end of your contingency period.

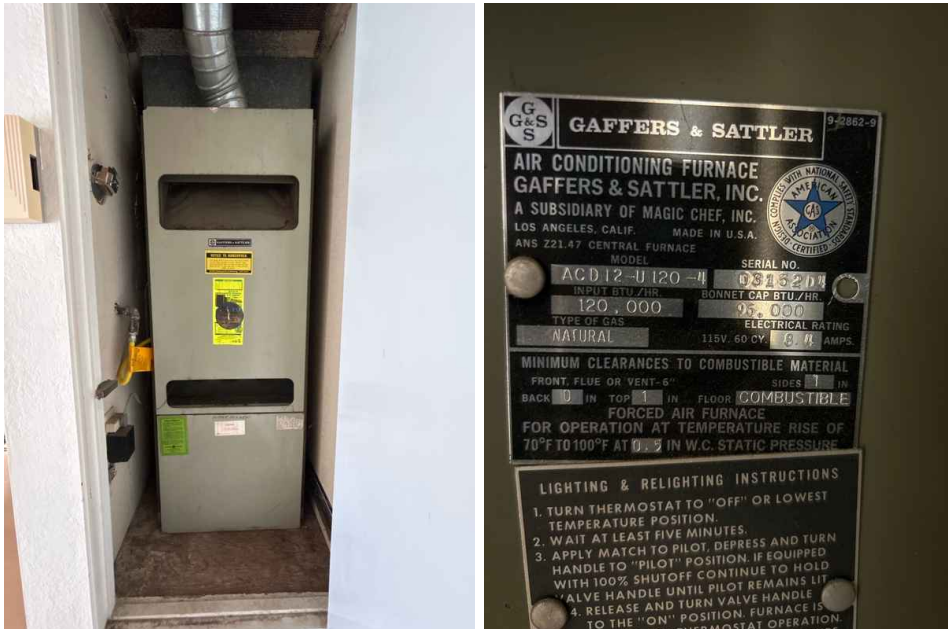
### 8.2.4 Heating (Forced Air)

#### **NEAR OR AT LIFESPAN (FORCED AIR)**

The estimated useful life for most forced air furnace(s) is typically 15-20 years, but they often exceed this in Southern California's mild climate. This furnace seems to be nearing or past its lifespan. Consider budgeting for replacement and have a qualified HVAC professional further evaluate the system. A home warranty is also advisable.

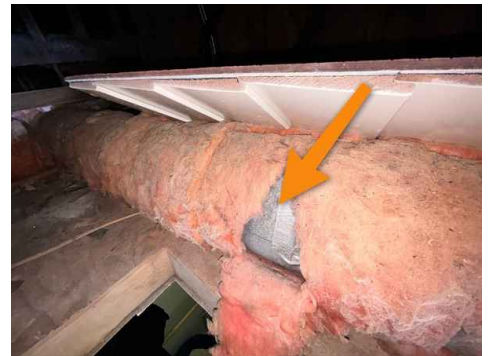
### 8.3.1 Ducts and Registers

#### OLD METAL

Older metal ductwork was noted in the attic. This type of ducting is generally viewed as not as energy efficient as modern plastic flexi insulated ducts. Condensation can often occur on these ducts, occasionally resulting in water staining on ceiling areas. These ducts often are also not sealed, reducing efficiency. Recommend a qualified HVAC company evaluate the entire duct system and bid for replacement to more modern flexible insulated and properly sealed ducts.

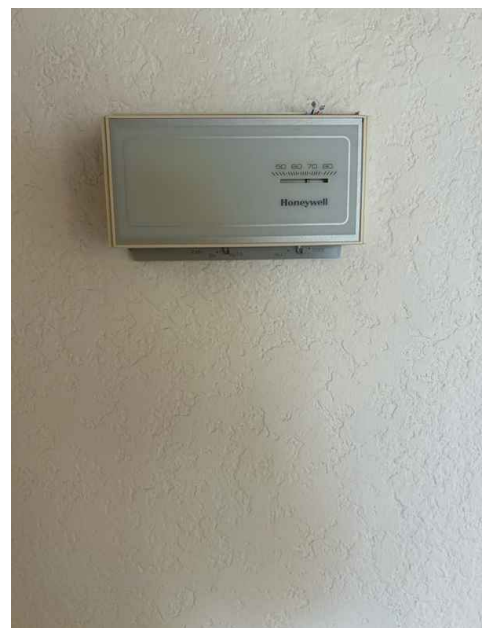
### 8.4.1 Filter(s) & Thermostat(s)

#### OLD THERMOSTAT

The thermostat is nearing the end of its lifespan and replacement is recommended.

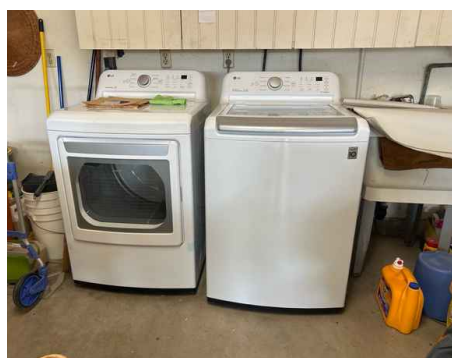
#### Floor, Walls, Ceiling: Laundry Hook-Ups in Garage

Washer/dryer or laundry hookups were present in the garage. This is a standard building practice. However, it is recommended that the equipment be installed 18" above the garage floor since vapors from gas or other flammable liquids heavier than air may be present. Motors or circuitry in laundry equipment are a potential source of spark, or flame in a gas dryer. Recommend modification as necessary by a qualified person for added safety.

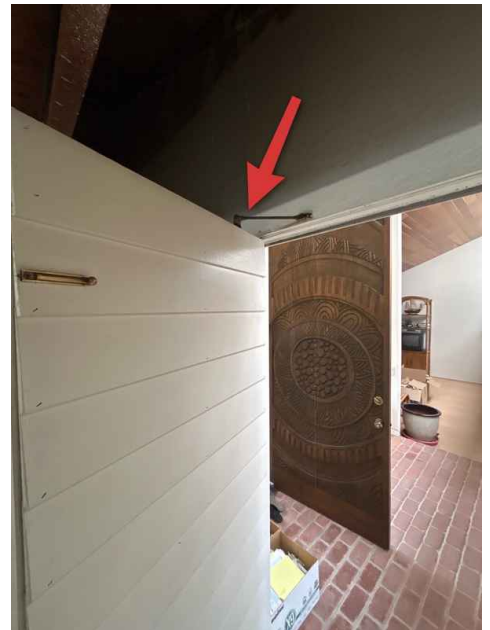
**SELF-CLOSING DEVICE NEEDS REPAIR OR REPLACEMENT**

The self-closing mechanism on the door between the garage and dwelling did not close and/or latch the door. The mechanisms are designed to keep the door closed to prevent spread of fire and fumes from the garage to the dwelling. A qualified professional is recommended to make repairs per standard building practices.

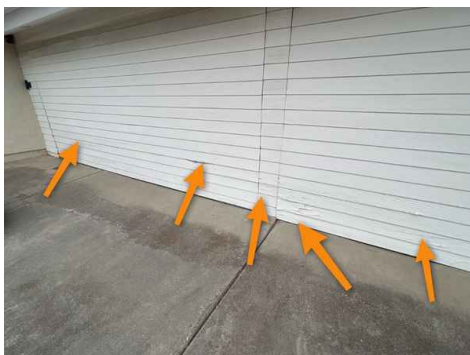
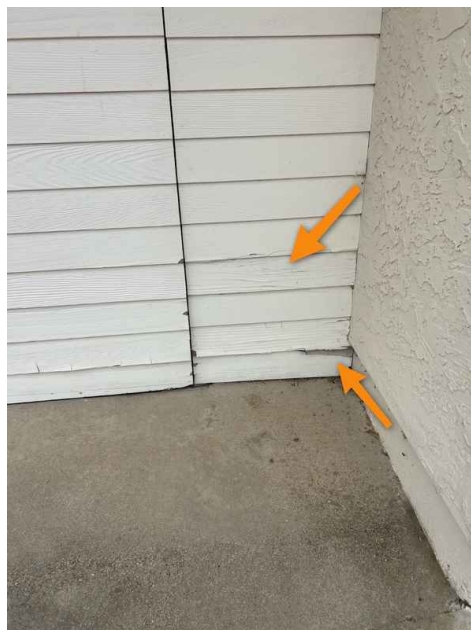
## 9.4.1 Vehicle Door(s)

**PAINT DAMAGE / DETERIORATION - REPAIR**

Damage and or deterioration was present at one or more areas. Correction is recommended.

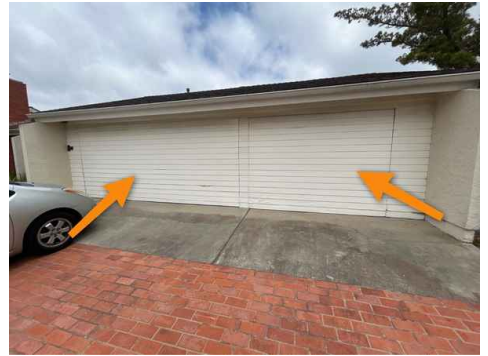
## 9.4.2 Vehicle Door(s)

Attention Required**WOOD DOOR(S) NOTED**

The original wood door(s) were noted which is unusually heavy based on today's standards. Upgrading the door may be desired for added safety.

Contact a qualified professional.

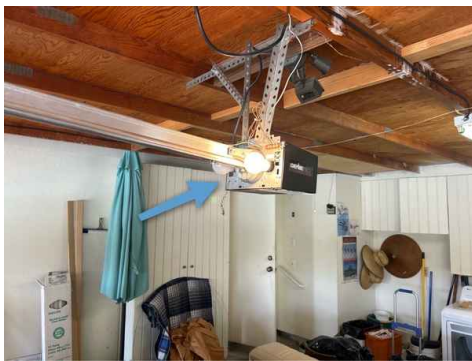
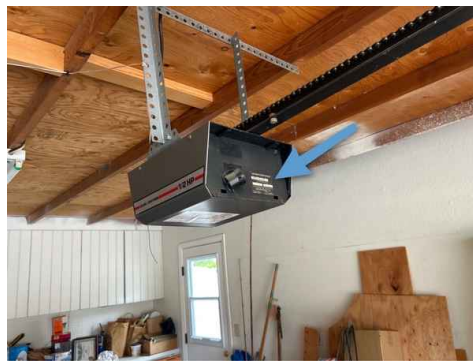
## 9.5.1 Automatic Opener(s)

Observation**COVER MISSING / DAMAGED**

The cover was missing and/or damaged at one or more areas. A qualified person is recommended to replace as needed.

Contact a qualified professional.

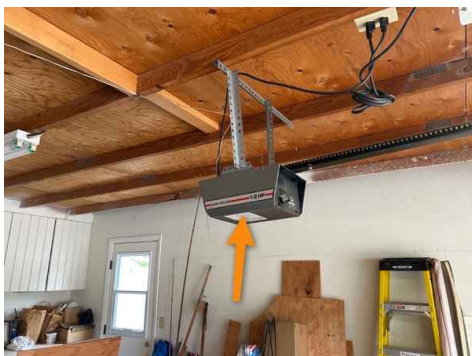
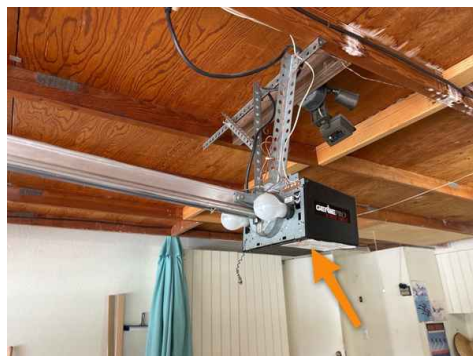
## 9.5.2 Automatic Opener(s)

Attention Required**AGE - NEARING THE END**

One or more unit(s) appear to be nearing the end of their useful life spans. Budgeting for replacement is recommended.

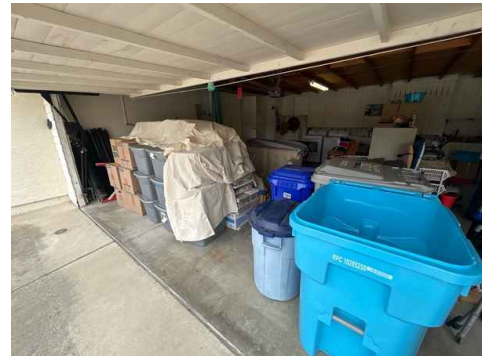
## 9.6.1 Floor, Walls, Ceiling

**FLOORS / WALLS OBSCURED**

Floor and/or wall areas were obscured by stored items and couldn't be fully evaluated.

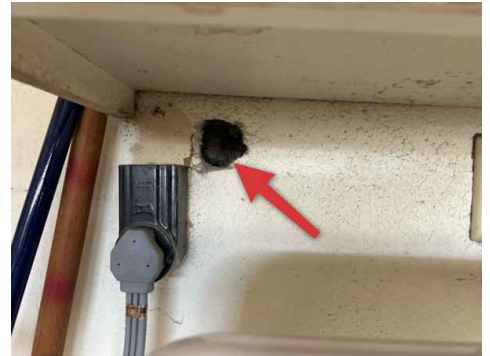
## 9.6.2 Floor, Walls, Ceiling

**FIRE WALL GAPS, HOLES, DAMAGE**

Gaps, holes or openings were present at the attached garage walls or ceilings. Walls and ceilings between the garage and house are required to provide limited fire resistance rating to prevent the spread of fire between the garage and house. A qualified contractor is recommended to repair per standard building practices.

Contact a qualified drywall contractor.

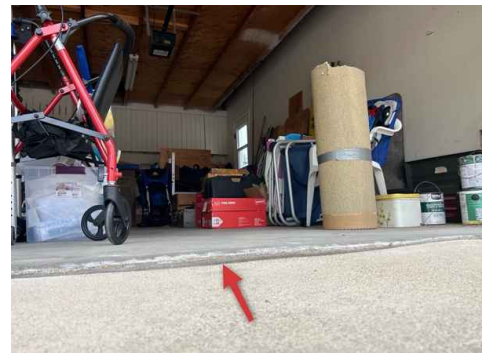
## 9.6.3 Floor, Walls, Ceiling

**TRIPPING HAZARD**

Uneven surface was noted at one or more areas. This is considered a trip / fall hazard. A qualified professional is recommended to make repairs for safety reasons.

Contact a qualified professional.

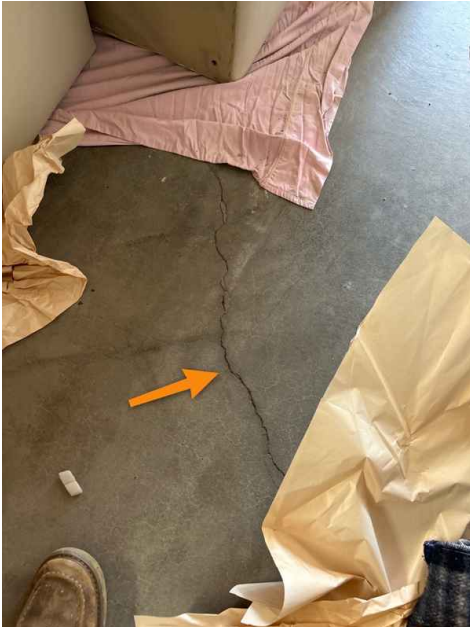
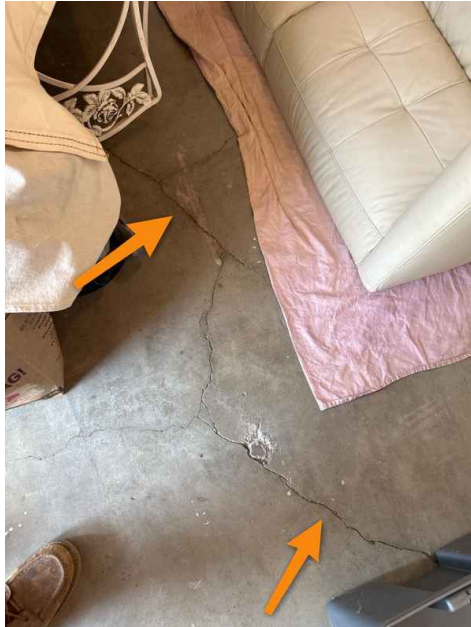
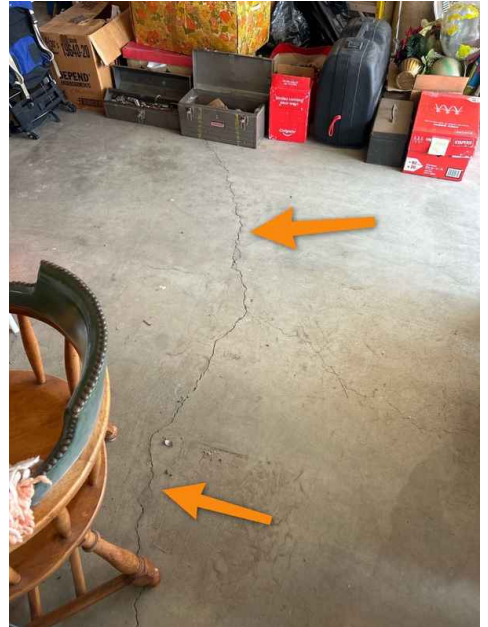
**CRACKING NOTED**

One or more hairline cracks (1/8 inch or less) were observed in the concrete slab. These do not currently appear to pose a structural concern. However, sealing the cracks is recommended to help prevent moisture intrusion and further deterioration. Suitable products include hydraulic cement, non-shrinking grout, flexible caulks, or epoxy sealants. Continued monitoring is advised, and further evaluation and repair by a qualified professional is recommended.

Contact a qualified professional.

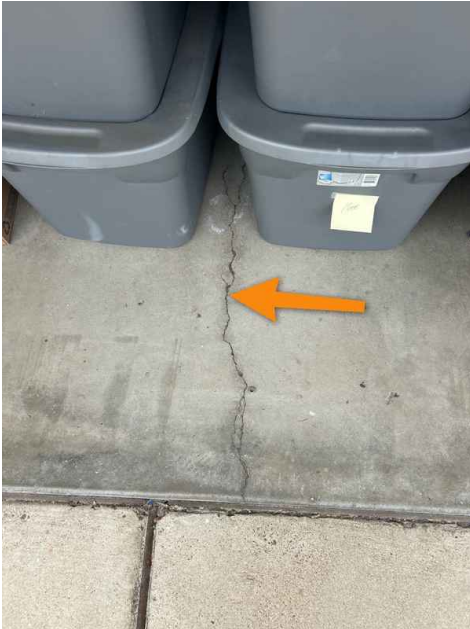
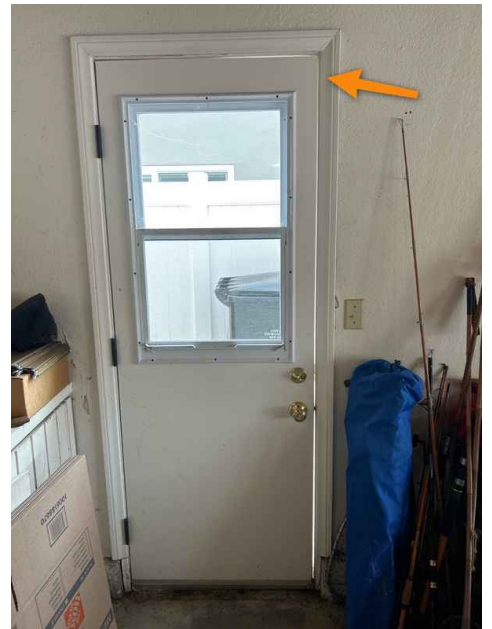
#### 9.7.1 Exterior Door(s)

##### **RUBS IN JAMB**

The door rubs in the jamb and/or floor in one or more areas. Correction is recommended.
