HomePro Inspections

Residential Pre-Listing Inspection Address:

3828 Keswick Road

Report Prepared for: Sonia Chang

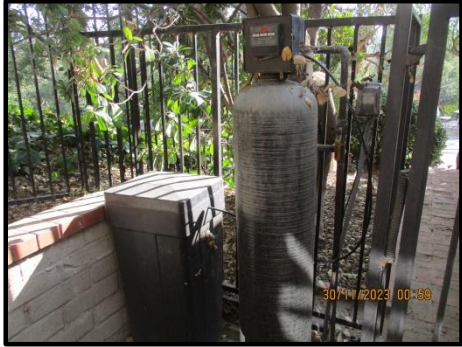
The plumbing system has a filter system installed. Filter systems require regular servicing and maintenance. Failure to maintain the filter system can result in low water pressure and water hammer. Leaks can also develop at the filter water line connections. I would recommend that drip pan be installed under the filter to catch water in the event of leaks.

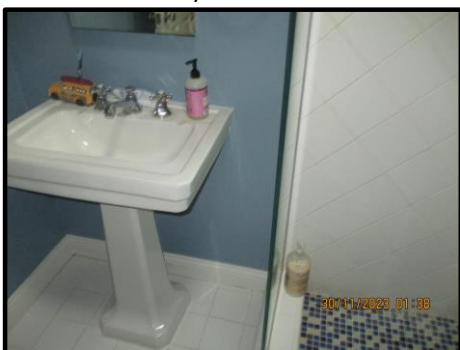
Please note that the area beneath the kitchen and bathrooms sinks was restricted by stored items. Home inspectors are prohibited to remove items stored below sinks per the California Real Estate Inspection Associations (CREIA) Standards of Practice.

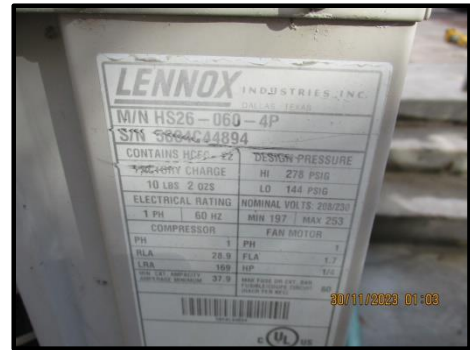
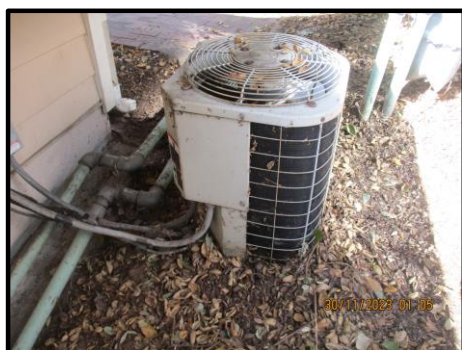
Guesthouse: The proper temperature split between supply and intake air in an air conditioner is 14 to 20°F. This system is operating within specified temperature limits.

Guesthouse: The refrigerant line that runs from the exterior coil condenser to the evaporator system is in need of servicing. The refrigerant line's insulation wrap is deteriorated and missing in some sections. Recommend that the refrigerant line be properly insulated as necessary at this time.

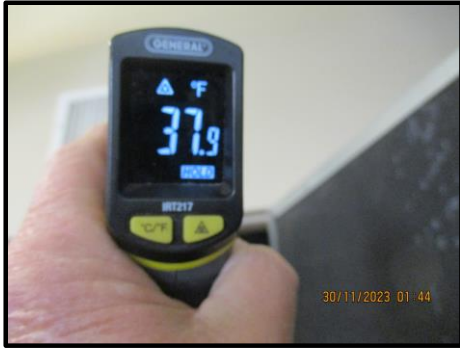
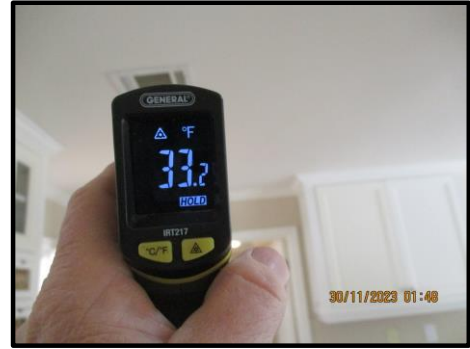
Guesthouse: The drip pan located beneath the evaporator was inspected for debris, rust and water. The drip pan was clean with no debris, rust or standing water. This indicates that the evaporator is free of leaks (at the air handler) and that the drip line itself is in proper working condition.

All rooms were checked for a cooling source (delivery register) and no defects were observed.

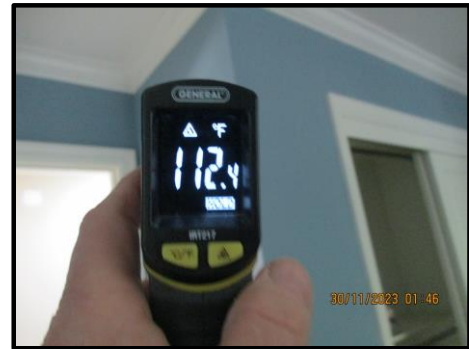
Day & Night #2: Temperature readings at all delivery and return

registers were found to be within normal tolerances.

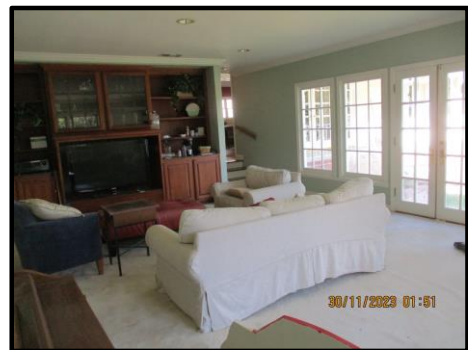
The interior exhibits common damage and wear from age and use. This type of damage is known as "rash" and includes small cosmetic damage. The visible damage was not excessive or significant in scope.

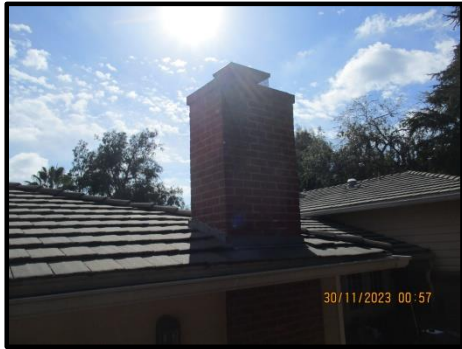
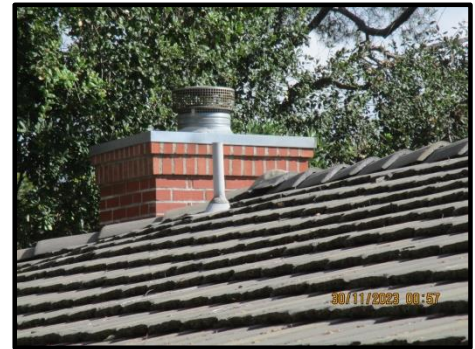
Both Fireplace Systems: There is no lockout clamp installed on the fireplace damper. This unit has been retrofitted with a gas-log set. The gas-log set uses a pilot light that is always on, therefore it is necessary to install a clamp on the damper to keep it open, in order to vent carbon monoxide and other combustion byproducts from the home. It is not advisable to use this fireplace until the lockout clamp has been reinstalled.

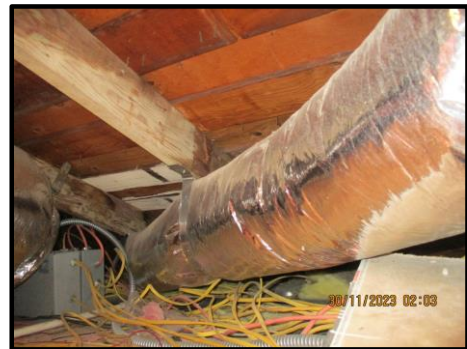
The attic area has no floor or service paths installed. The attic area should have a floor or service paths installed for safety considerations for servicing, maintenance or repairs to the structure or any mechanical systems that are in the attic space.

There is no seal at the attic access hatch. This will result in some loss of energy as heated air from the home leaks into the attic space(s). It is recommended that the hatch be fitted with a tight-fitting seal.

Since it is uninsulated, the attic hatch can result in some energy loss through convection, and some staining of the hatch area may eventually result, when warm house air condenses on the cold hatch and captures dust particles from the air. It is recommended that the hatch be insulated to the same approximate R value as the rest of the attic.

If the attic is to be used for storage, I would recommend that a pull-down access ladder be installed. A pull-down ladder makes it easier and safer to access the attic area and any stored items.

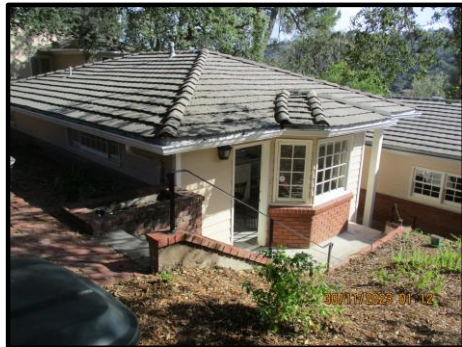
The exterior woodwork and painted surfaces appear in satisfactory condition (with some exceptions on the trim, door and window casings and fascia boards). No unusual or severe deterioration was observed in the exterior paint/stain finishes. It is important that all exposed wood surfaces are kept well protected to ensure a

maximum service life. Subsequent paint maintenance can be carried out as the usual signs of failure such as cracking, peeling or blistering of the painted surface become evident. Typically this would occur at intervals of five to seven years.

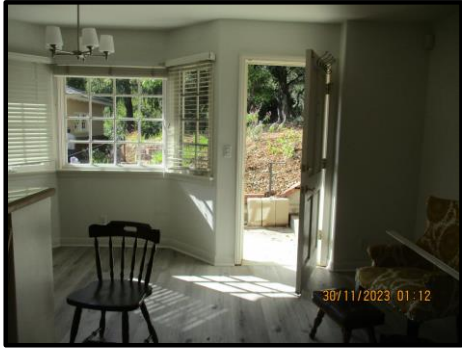
NEEDS SERVICING: *One or more of the interior/exterior light bulbs are burned out and will need to be replaced at this time.*

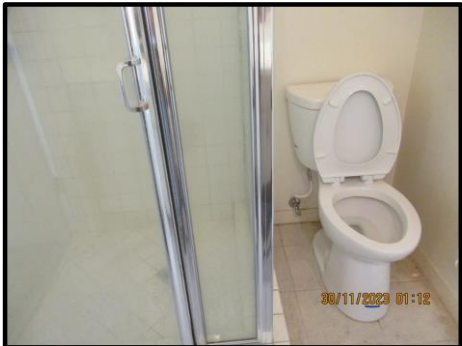
NEEDS SERVICING: *One or more of the showerheads are loose and need to be serviced. Recommend repair/service as appropriate.*
