# REAL ESTATE INSPECTION REPORT

**Henry Wisch**

16256 Horace St. Granada Hills CA 91344

DATE OF INSPECTION: 04/12/2023.

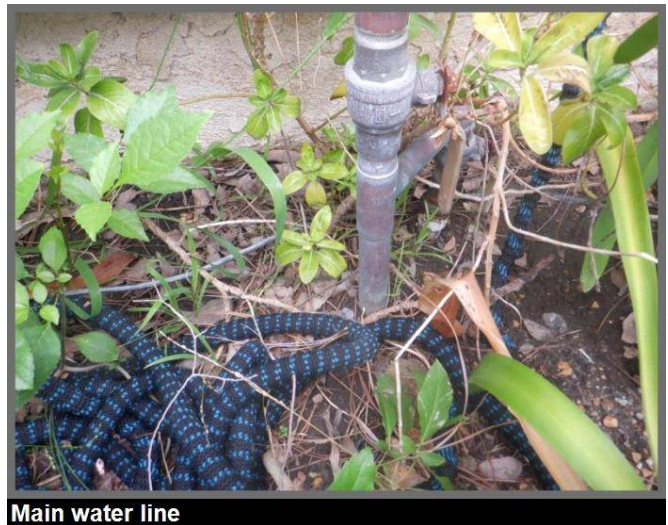
The main water line is at the front of the building.

Copper piping was viewed coming out of the ground. Since the underground portion is not observable, no representation is made as to its condition or type of material.

**SERVICEABLE.** The viewable portion of the water supply displayed no outward appearance of failure. The main water supply is almost fully underground and hidden from view (no representation is made or implied as to its condition or type of material), its condition cannot be determined during a general visual inspection. If more information is desired it is recommended to consult with a qualified plumber.

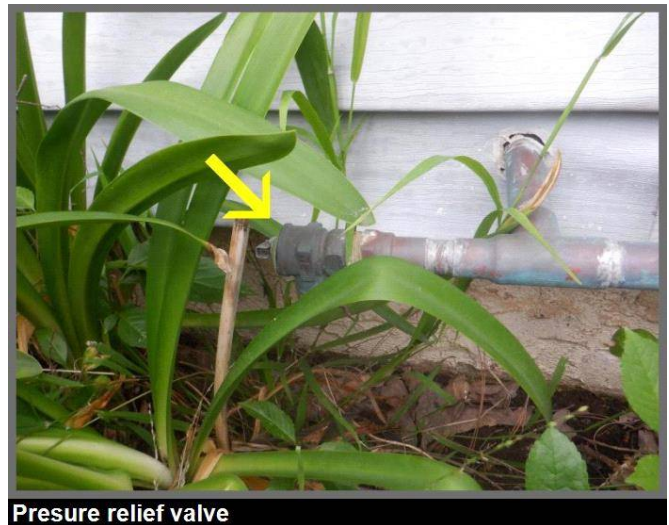
The safety Pressure Relief valve was located near the main water line.

**PRESENT.** A safety pressure relief valve required to reduce the risk of pipes bursting and potential flooding of the building. This valve is not tested or operated as part of a general visual inspection. Ideally, this valve would be tested by a qualified plumber.

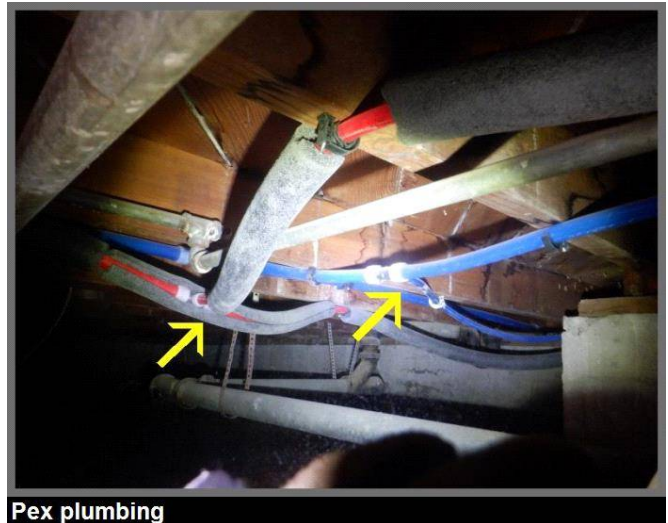
The water piping appears to be a combination of copper and PEX plastic piping where visible.

**NEEDS ATTENTION.** There are abandoned pipes still in place under the building. During a general inspection it is not possible to tell which are still connected and in use (if any), and which are removed from the system. It is difficult to tell how much of the piping system is re-piped, and how much is older and worn. A plumbing contractor should evaluate this further if desired and ideally the abandoned pipes would be removed.

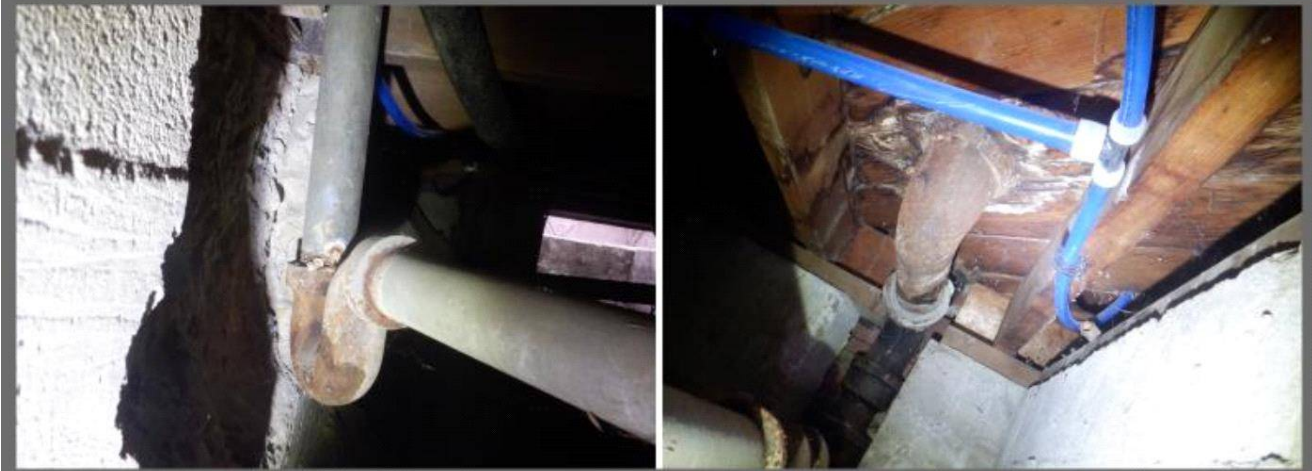
**Galvanized steel & Cast iron piping**

**NOT ACCEPTABLE.** There are areas of rust blistering that are now beginning to leak in the waste pipes. These lines should be further evaluated and or replaced by a licensed plumber at this time. This is seen under the kitchen and under the hallway bathroom.

**NEEDS ATTENTION.** The waste line system is older and appears to be original. These systems have an expected life span and it appears as though these older lines have reached their expected life. Further evaluation by a qualified plumber would be needed to determine whether or not it is time for waste line replacements at this time.

The piping that takes the waste water out to the sewer system is made of Cast Iron and galvanized steel pipe where visible.

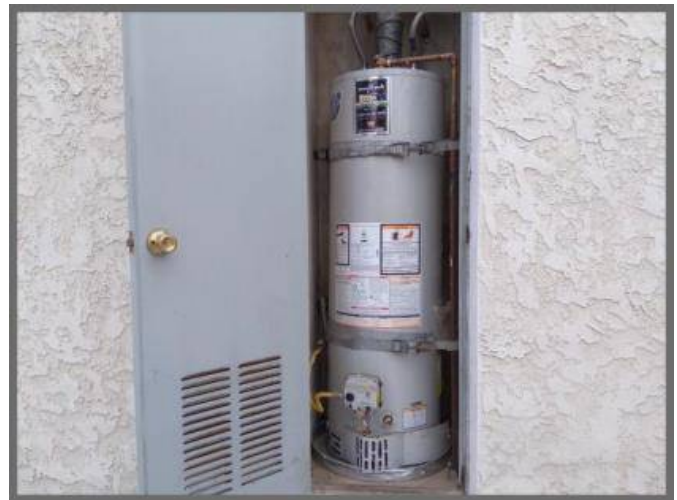
The water heater is located in an exterior closet.

**NEEDS ATTENTION.** There is moisture staining noted in the closet. Consult with a moisture mold specialist regarding this.

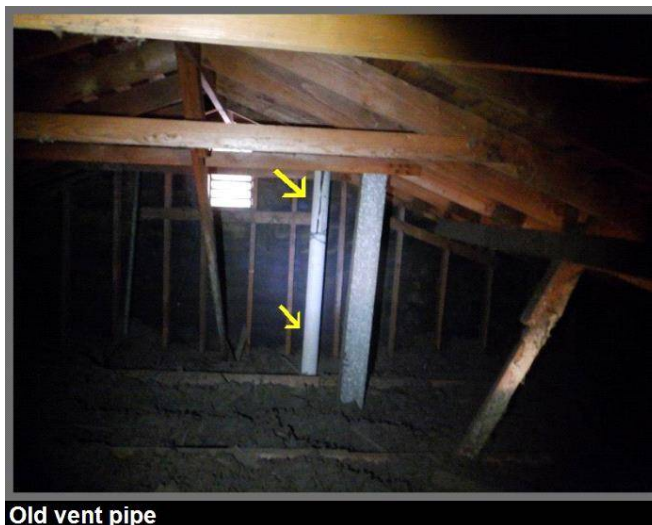
Old vent pipe

**SAFETY ALERT.** The water heater vent line goes into an older vent system. Manufacturers generally require a new metal vent (or appropriate) pipe be installed when the new system is installed. The old piping may allow condensation to run back into the water heater causing it to rust prematurely, or allow the exhaust gasses to back up in the building.

If a proper vent is not installed, the gas company may not light the water heater due to the possibility of the older vent to prevent proper drafting. Consult with the qualified specialist for more information.

This material may contain Asbestos, it would require additional testing to verify this.

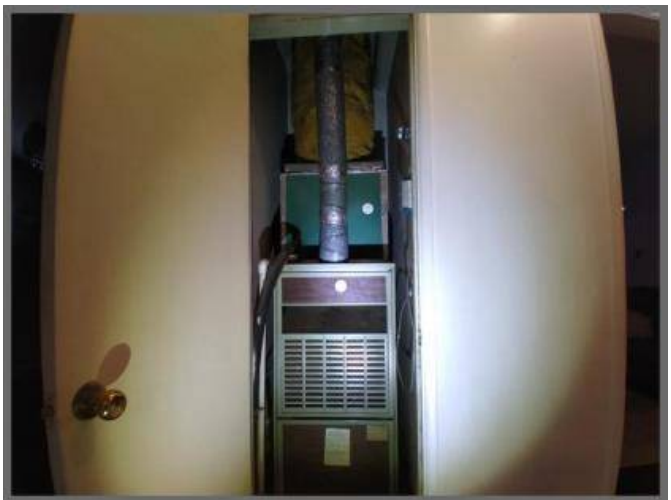
FURNACE LOCATION: In the hall closet.

**SAFETY ALERT.** The closet area is dirty with a large amount lint and dust. This could be a potential fire hazard and should be cleaned out.

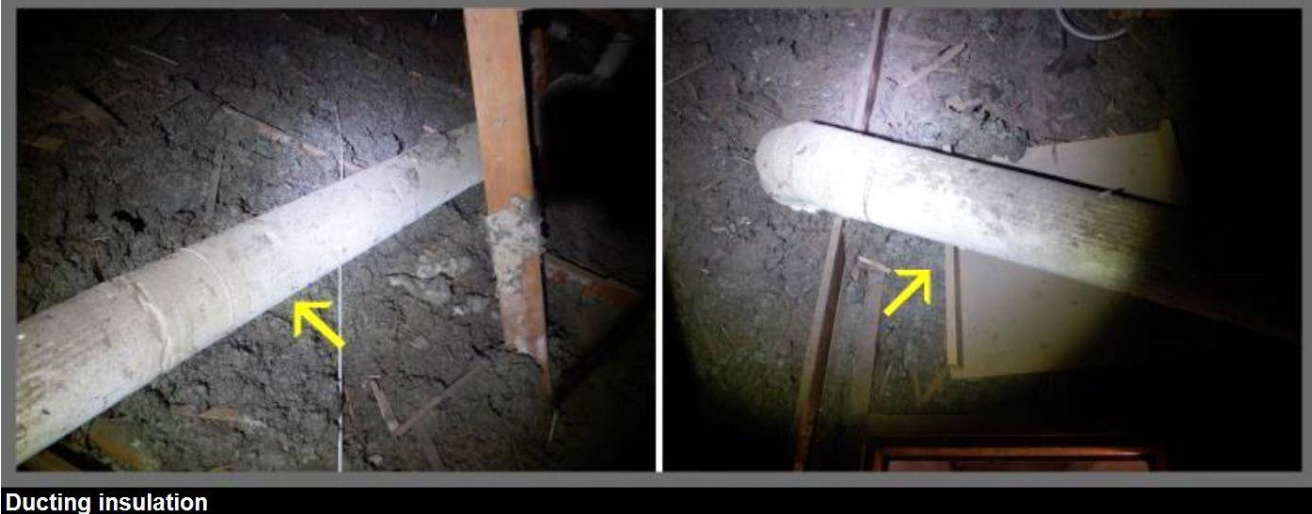
Ducting insulation

**SAFETY ALERT.** The insulation on the outside of many of the ducts in the attic is a material that is usually found to contain asbestos. It would have to be tested in a laboratory to confirm if it is asbestos or not. Ideally this ducting would be replaced. Further evaluation of this ducting is recommended to determine its true condition.

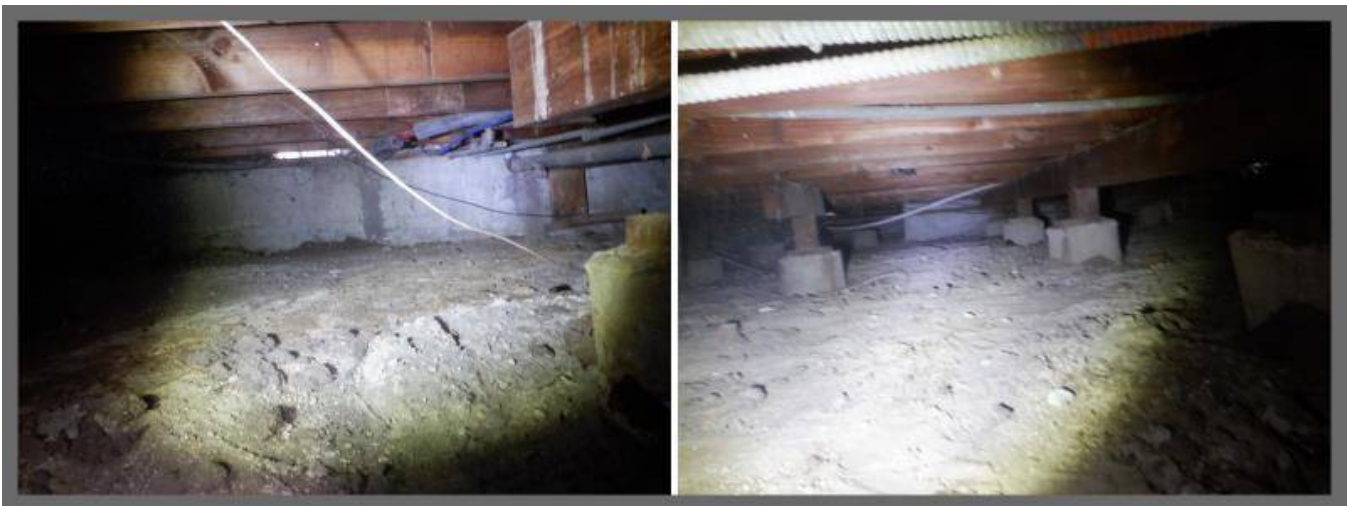
**NOT ACCEPTABLE.** There are areas of excessive damp soil under the house. This is near the crawl space opening and along the front side of the crawl space.

There is dampness in the crawl space that may be drainage related.

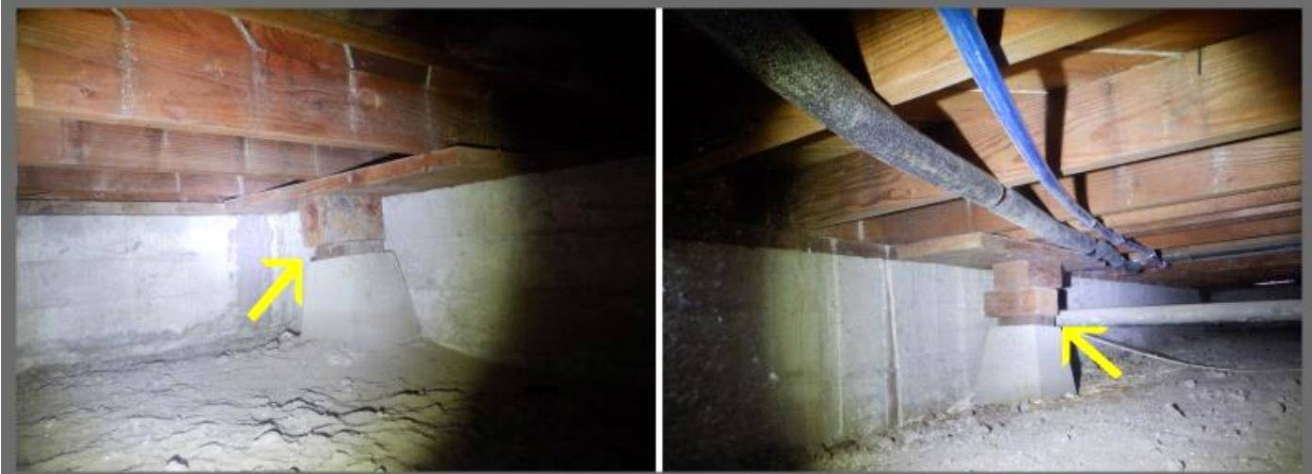
Non- standard bracing.

**NEEDS ATTENTION.** A number of pieces of wood such as shims or bracing being used in place of a single support post in areas. These tend to fall out during seismic activity and are not attached to each other or the framing of the structure.

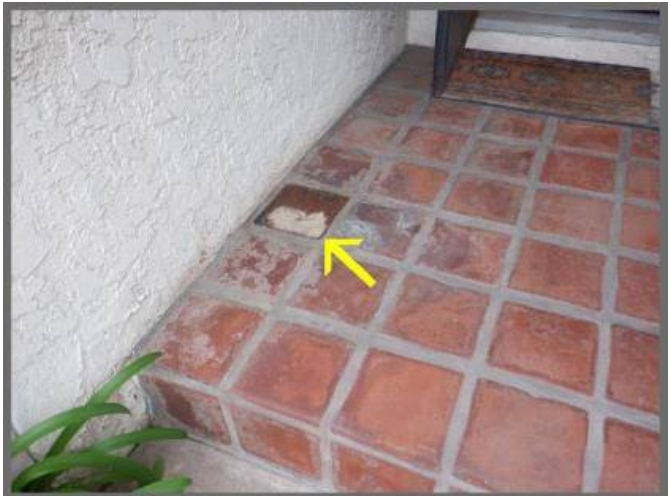
**NEEDS ATTENTION.** There are areas of the front steps that are missing bricks and should be repaired.

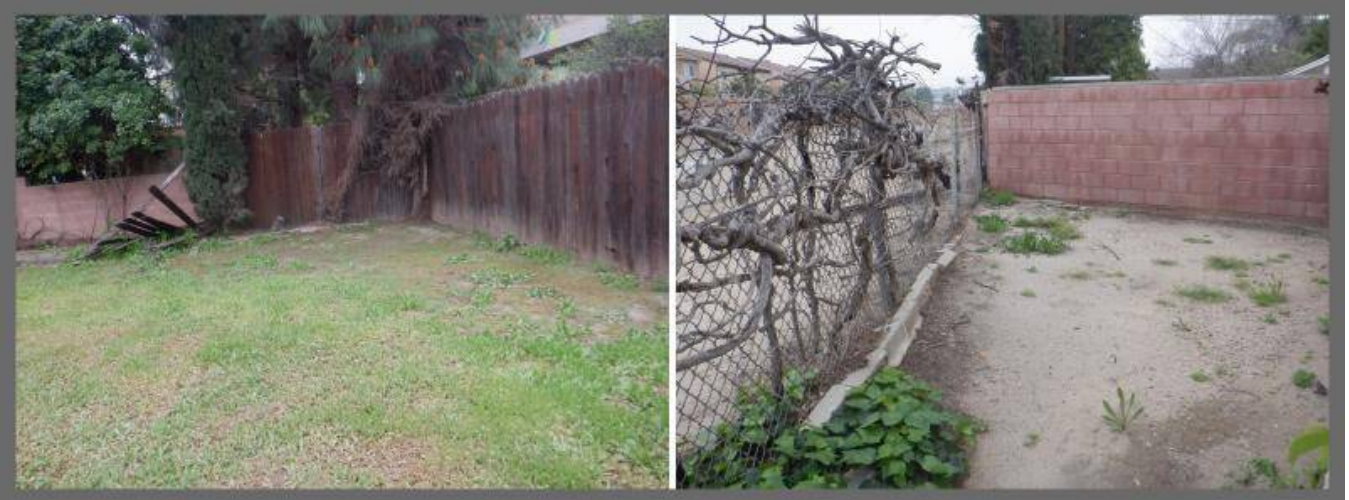
**NEEDS ATTENTION.** The grounds on the property need maintenance and have areas of neglect.

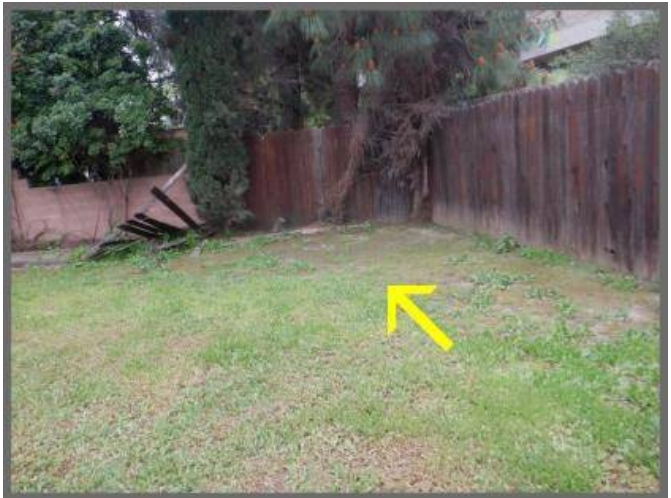
**NEEDS ATTENTION.** The site is a relatively flat site, it is expected that there will be some areas where water will pool during rainy periods, such as at the back corner of the property.

**DRAINAGE:** It is my recommendation that a drainage specialist examine the site and perform all needed corrections.

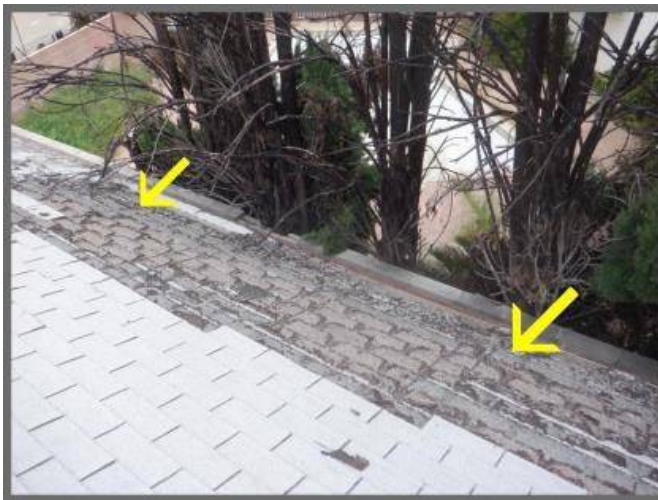
**NOT ACCEPTABLE.** There is apparent fire damage to the right side of the roof. This should be further evaluated by a roofing specialist.

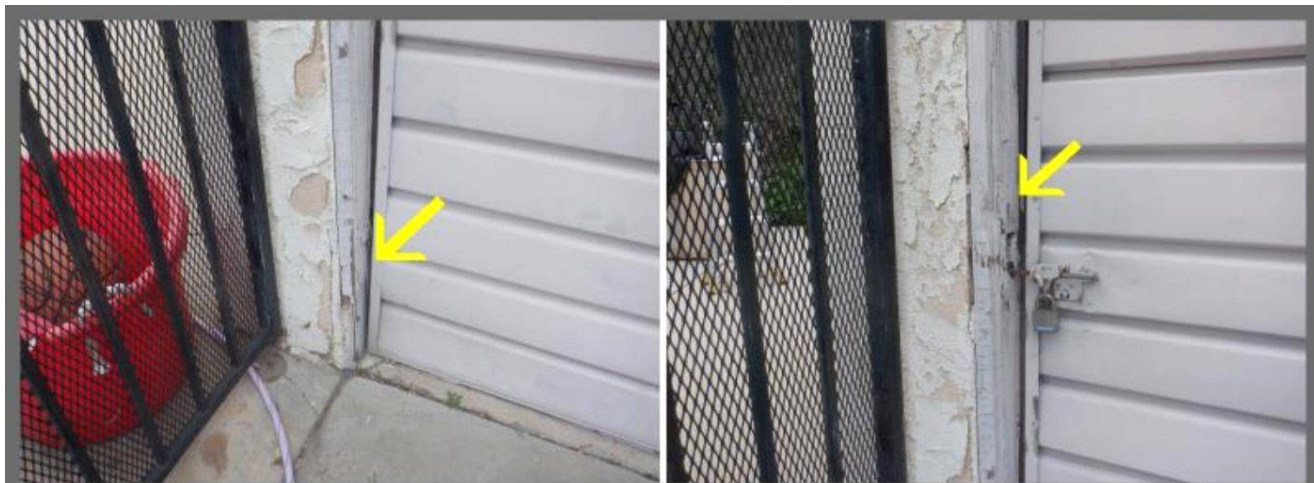
Door jamb & frame

**NEEDS ATTENTION.** There are areas of the garage door jamb that are deteriorated. Consult with a pest control specialist regarding this.

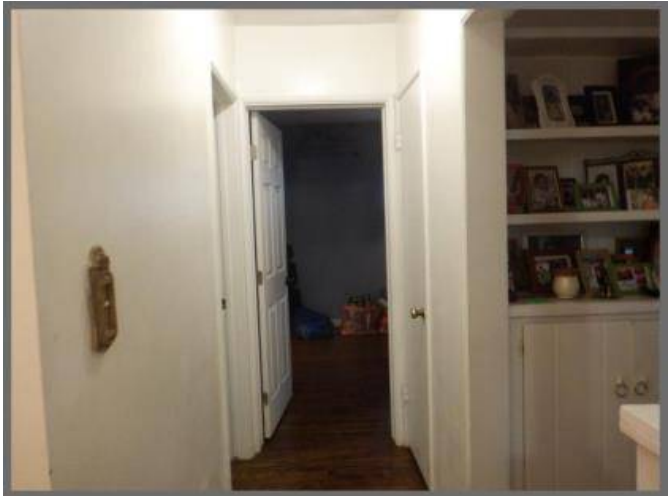
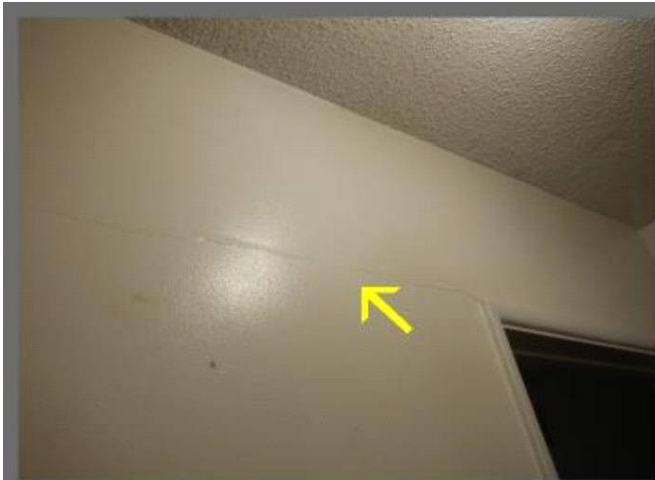
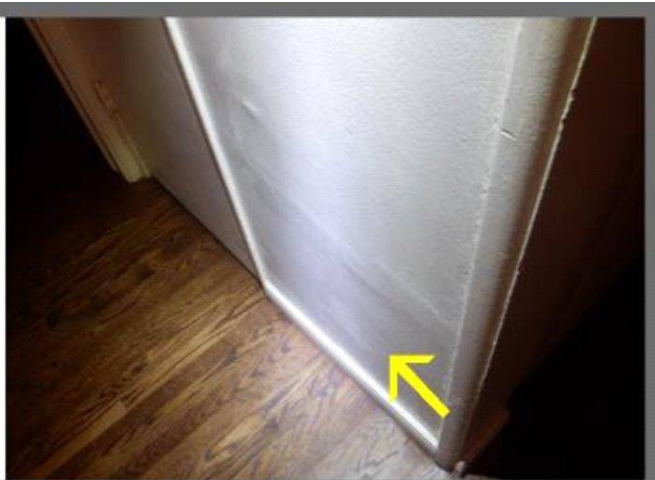
Cracks & rough patching

**NEEDS ATTENTION.** There are areas of stress cracks in the walls and ceilings.

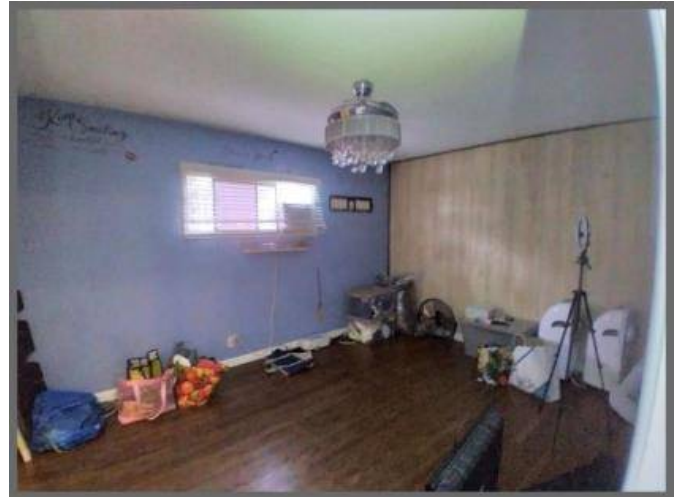
**NEEDS ATTENTION.** There are areas of patching and apparent repairs on the wall surfaces, such as at the window frame. Consult with the seller regarding this.

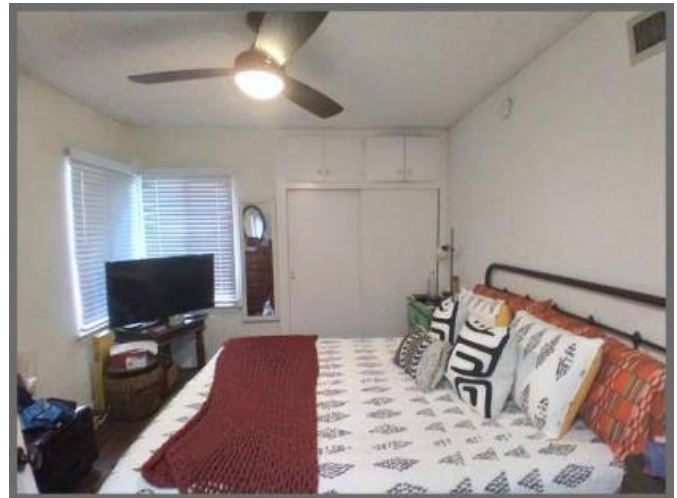
**NEEDS ATTENTION.** There are areas of stress cracks in the ceiling.

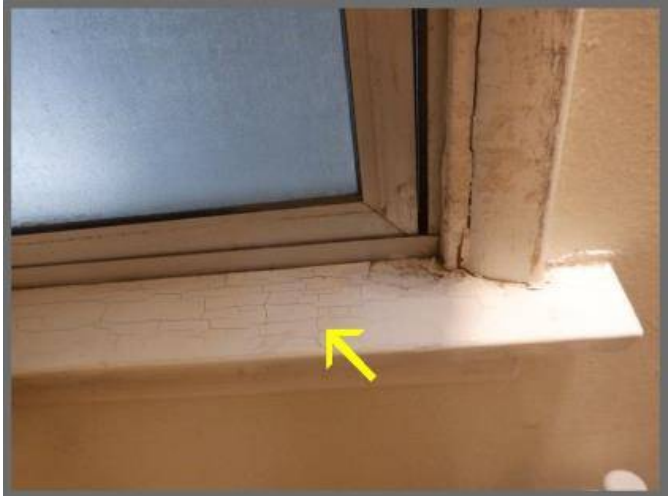
**NEEDS ATTENTION.** There is moisture damage noted in the window frame of the hallway bathroom.

The windows do not work well and are generally difficult to operate. They will need adjustments/repairs to operate properly.

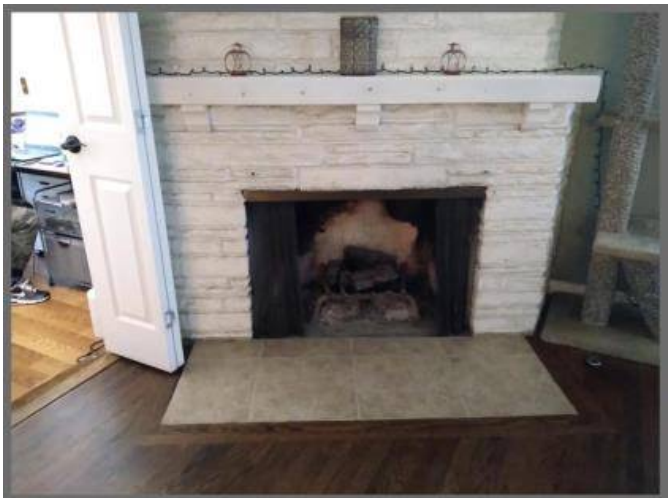
**LIVING ROOM:** All fireplaces should be cleaned and inspected on a regular basis to make sure that they are safe and structurally sound.

**It is beyond the scope of this inspection to determine the existence of defects or damage to the fireplace, chimney or its flue. This can only be determined by a specialty chimney inspection which should be performed at this time.**

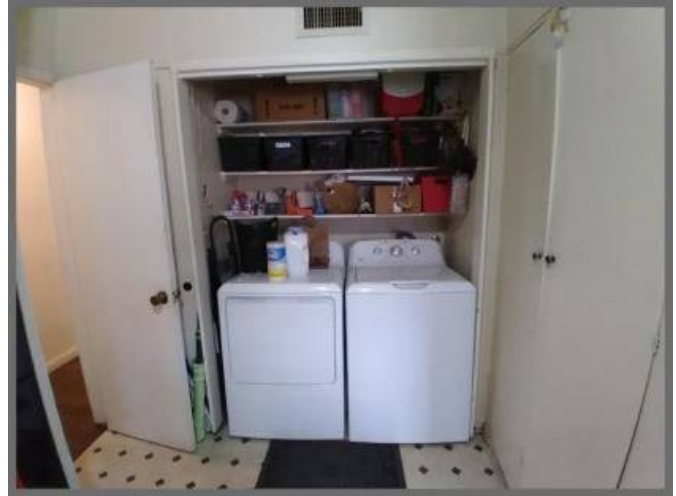
**NEEDS ATTENTION.** There is no 'drip pan' under the washing machine as is currently recommended to prevent leaks from damaging the floor.

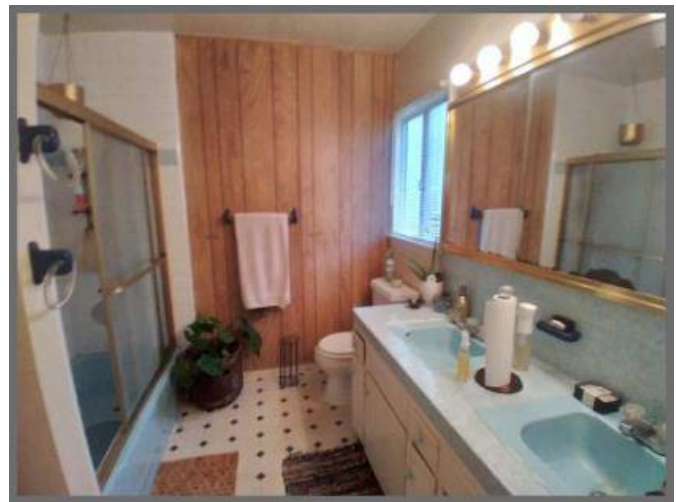
**This appears to be an addition to the original structure. It is advised to check that permits were signed off for the work.**

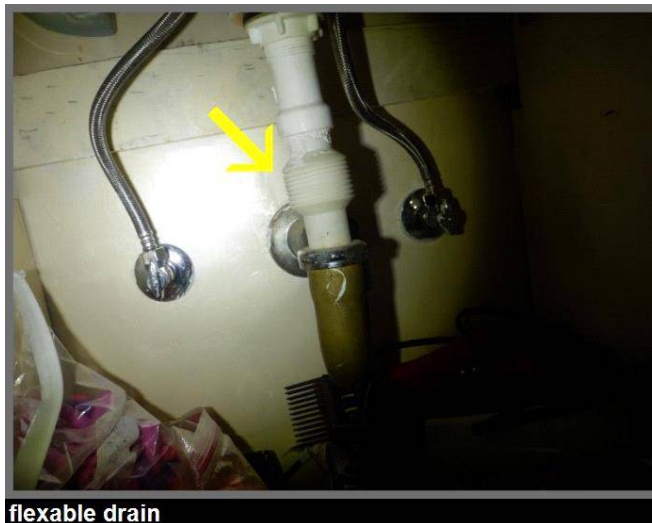
**NEEDS ATTENTION.** A flex drain connector has been installed below the sink. Only a smooth inner wall drain line is supposed to be used in this case.

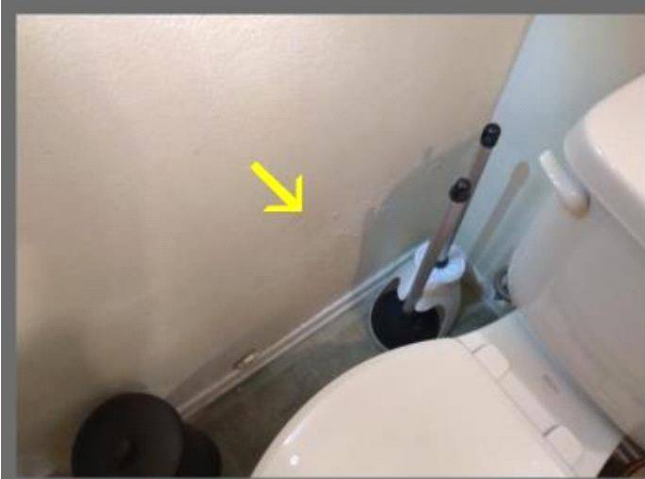
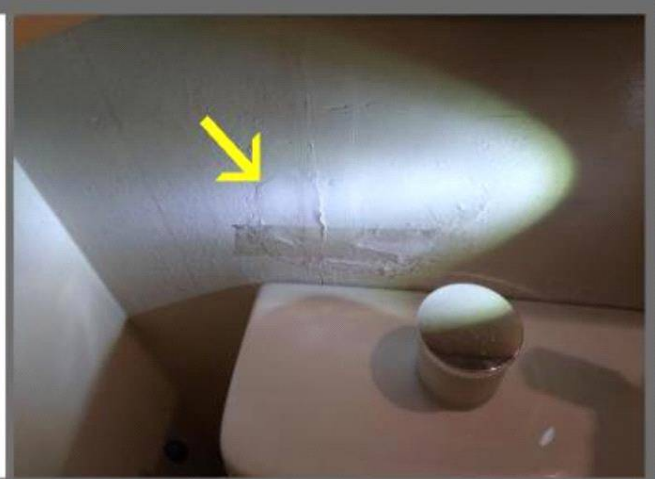
Damage & rough patching.

**NEEDS ATTENTION.** There are areas of moisture damage & rough patching to the walls, such as around the toilet.

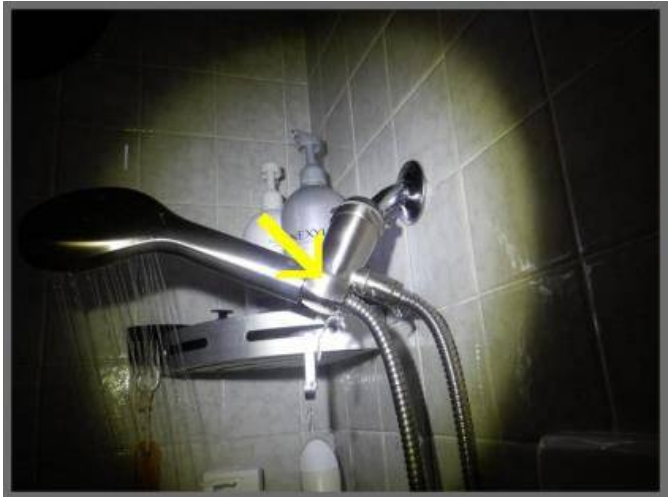
**NEEDS ATTENTION.** The shower head leaks at the connections.

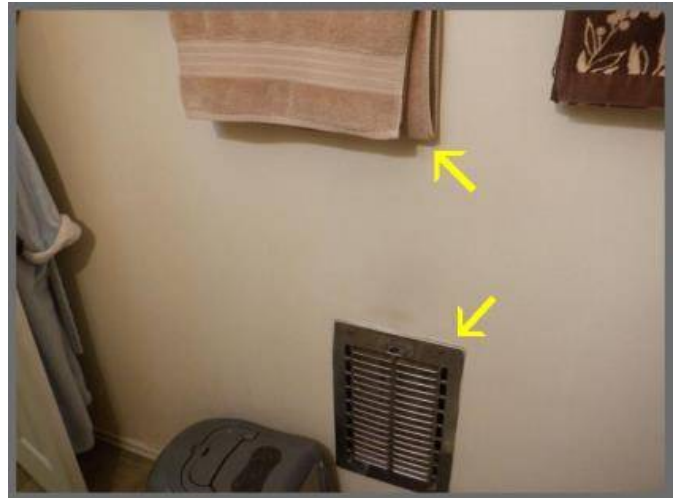
**SAFETY ALERT.** There is a towel bar near and over the electric heater, if used this poses a risk of fire.
