WOOD DESTROYING PESTS AND ORGANISMS INSPECTION REPORT

BUILDING NO. / STREET 45150 CASPAR POINT ROAD	CITY CASPAR	ZIP 95420	Date of Inspection 02/20/2023	# OF PAGES 1 of 7
--	----------------	--------------	----------------------------------	----------------------

GENERAL DESCRIPTION: Two story main residence and attached garage with wood shake roofing.	Inspection Tag Posted: Water Heater Closet
	Other Tags Posted:

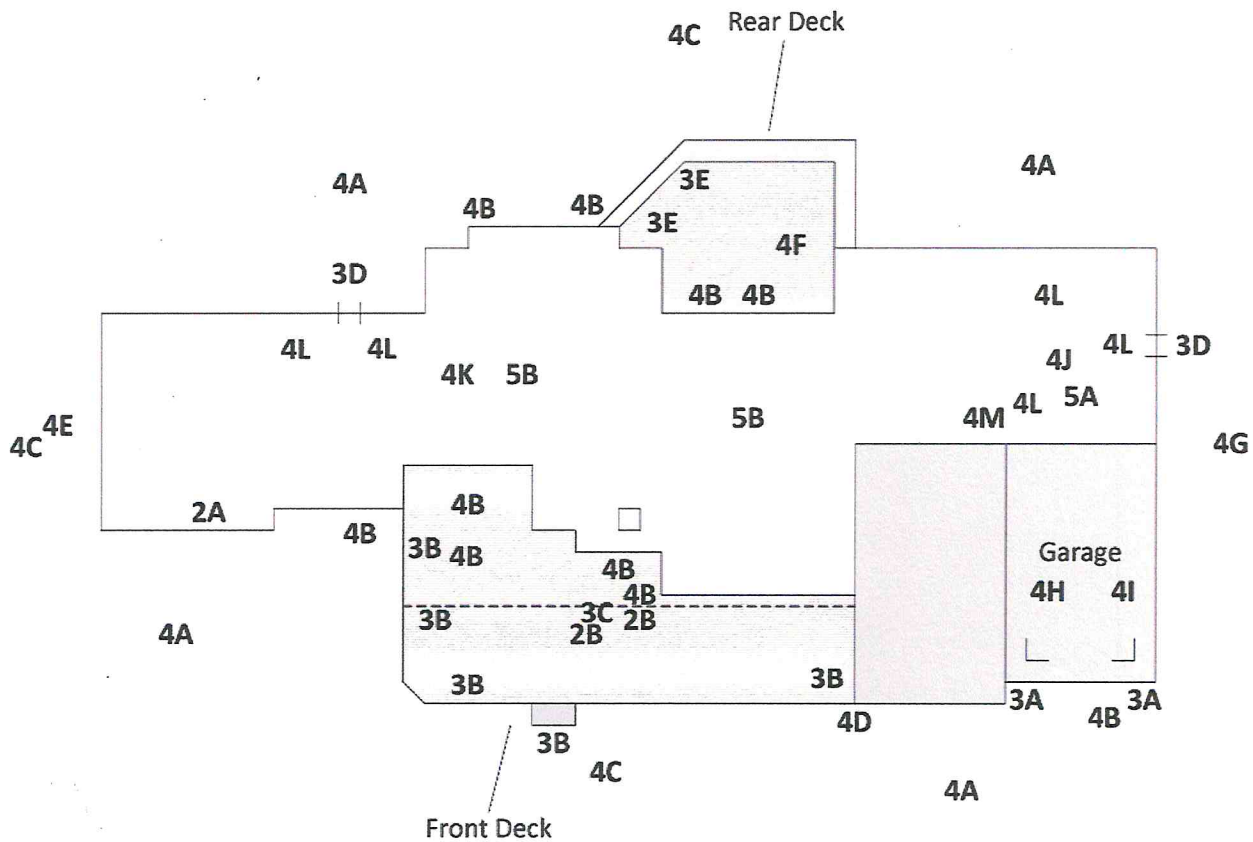
An inspection has been made of the structure(s) on the diagram in accordance with the the Structural Pest Control Act. Detached porches, detached steps, detached decks and any other structures not on the diagram were not inspected.

Evidence of drywood termite infestation was noted at/in interior beam in laundry room where marked on diagram.
