## HOME INSPECTION

9827 Edgar Pl  
La Mesa, CA 91941

07/27/2026

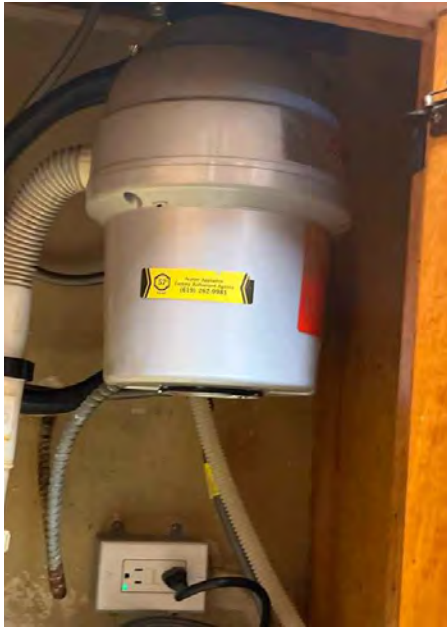
**FOOD WASTE DISPOSER: Disposer - Aged**

The food waste disposer appears to be beyond its expected service life. The average life of a food waste disposer is 10 years. Some units may last for more or less than 10 years depending on quality and usage. To see a complete list of life expectancies for just about every component in a house, please visit our list of Life Expectancy.

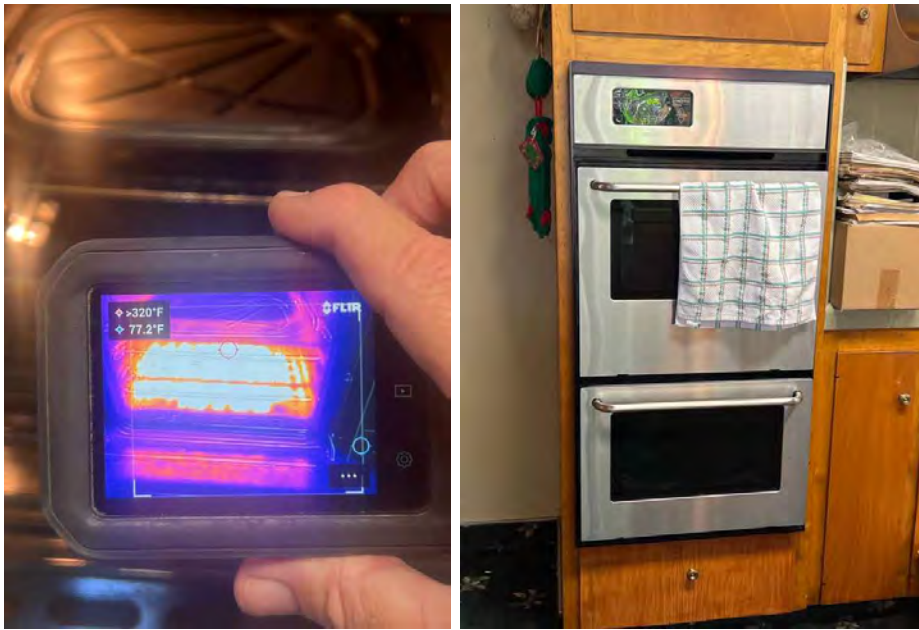
**WALL OVEN: Wall Oven - Aged**

Note: The wall oven appears to be older than its expected service life. According to InterNACHI the average life of a gas oven is 10-18 years and an electric range is 13-15 years. Some units may last for more or less time depending on quality and usage. To see a complete list of life expectancies for just about every component in a house, please visit our list of Life Expectancy.

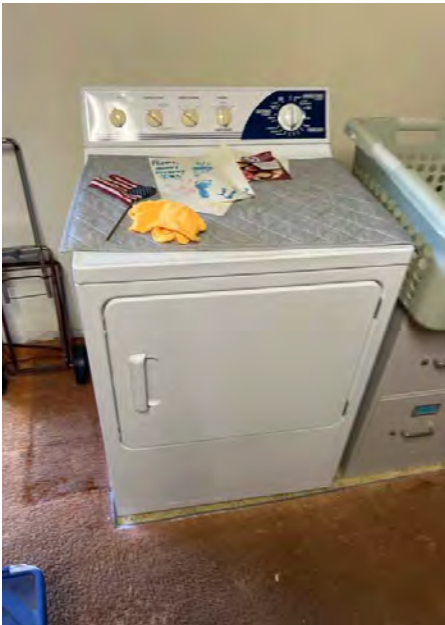
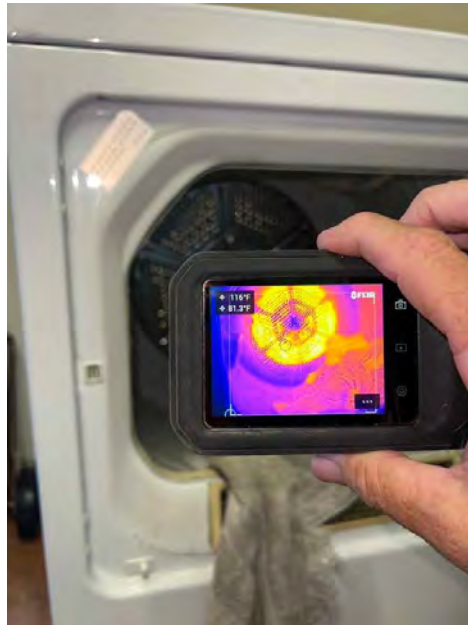
### WASHER/DRYER: Washer/Dryer- AGED

Note: The clothes washer/dryer appears to be older than its expected service life. The average life of expectancy of a clothes dryer is 13 years and a clothes washer is 5-15. Some units may last for more or less time depending on quality and usage. To see a complete list of life expectancies for just about every component in a house, please visit our list of Life Expectancy.

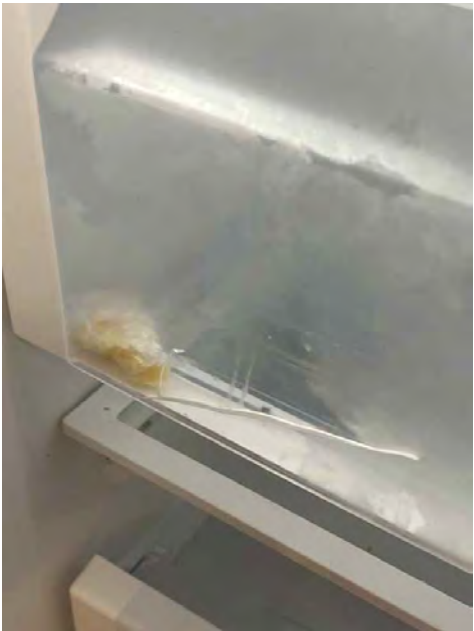
## 2.8.1 REFRIGERATOR

A defect/damage was observed at interior of the refrigerator (cabinet or components damaged).

Recommendation  
Contact a qualified appliance repair professional.

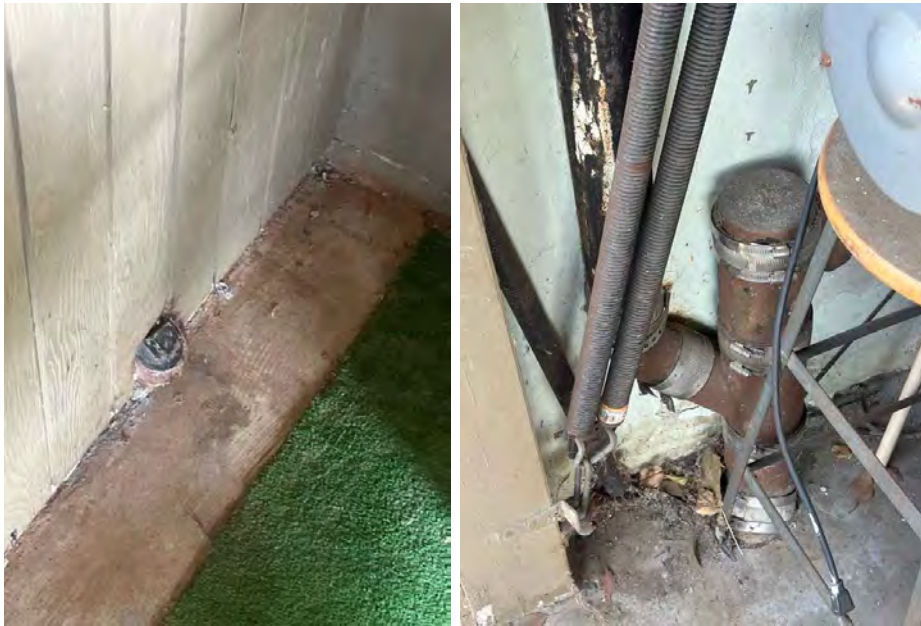
## INTERIOR DRAIN, WASTE AND VENT SYSTEMS: CAST IRON - INFORMATION & SCOPE

The drain lines are older cast iron lines. These lines rust from the inside and fail. The average life of cast iron drains is 50-60 years. This home has the original cast iron drain lines, so repairs and/or replacement are likely. We advise having a video/sewer scope inspection by The Real Estate Inspection Company. This is especially important to determine the inside condition of the main drain line between the house and the street. The actual life remaining and cost to replace can only be determined by a licensed plumber.

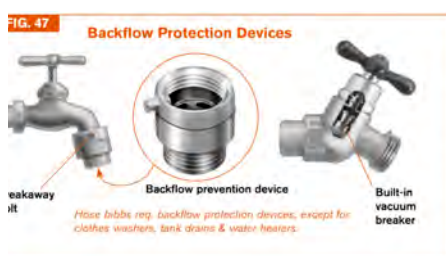
## HOSE SPIGOT: Anti-Siphon - None

Anti-siphon or anti-backflow valves are not present at the exterior hose spigots. These are safety devices that prevent contaminated water from flowing into the house water supply. Current standards require the installation of anti-siphon valves to keep your drinking water clean. We recommend installation for your health and safety.

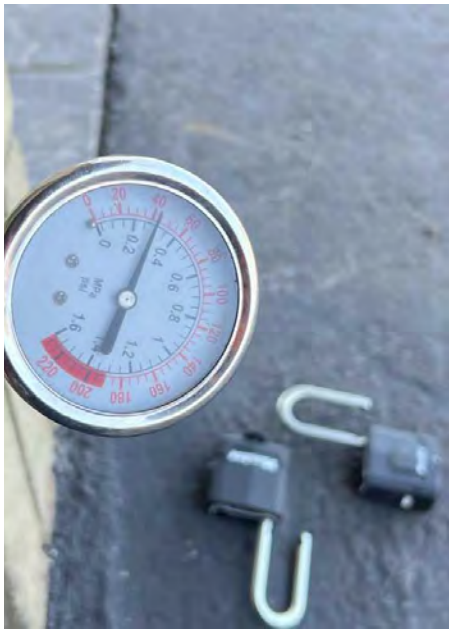
The water pressure was checked with a pressure gauge and was measured within the normal range. (40-80PSI)

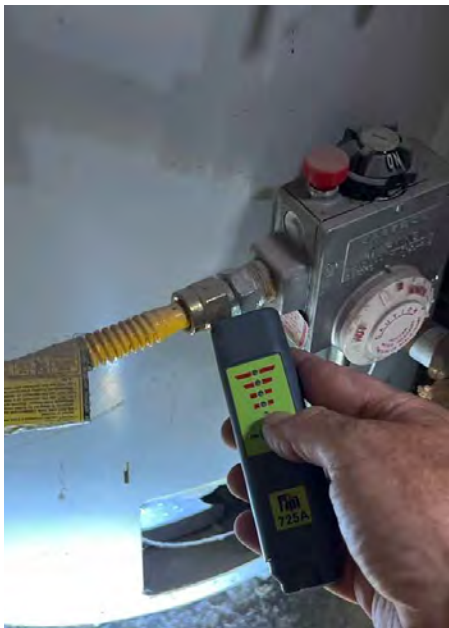
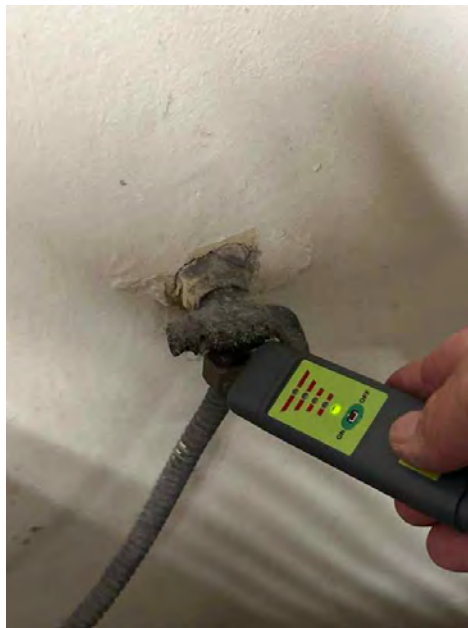
During the inspection, a gas leak test was performed using a hand-held combustible gas leak detector. Readily accessible gas fittings/appliances were tested. No gas leaks were observed. Note: This is not a guarantee against leaks.

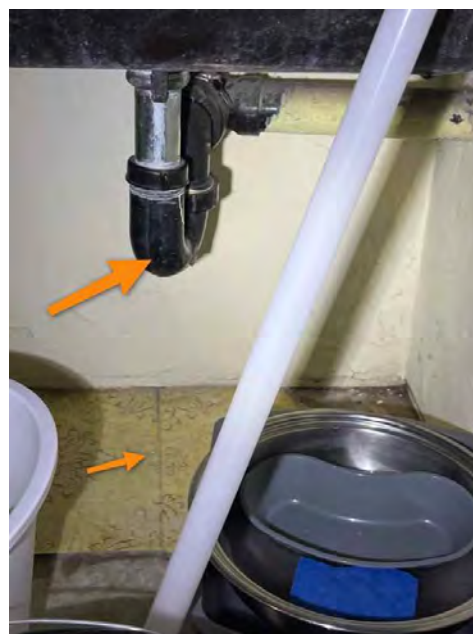
A small leak was observed at the drain line under the sink. We recommend repair by a licensed plumber to prevent damage.

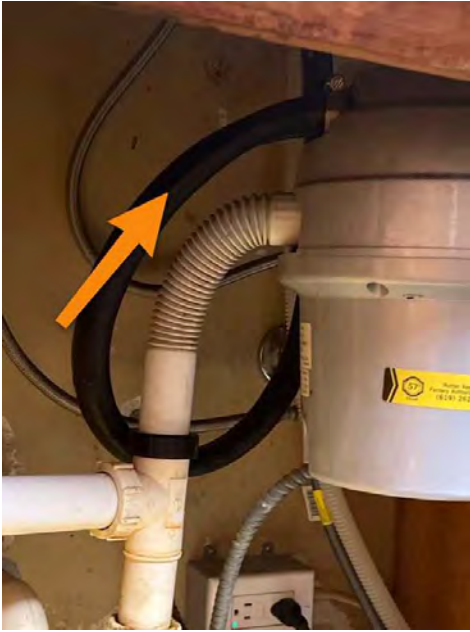
The drain hose for the dishwasher slopes upward. This hose should slope downward to the drain without collecting water. We recommend adjusting the hose so that it slopes properly to avoid collecting water and debris, which may eventually result in a clog.

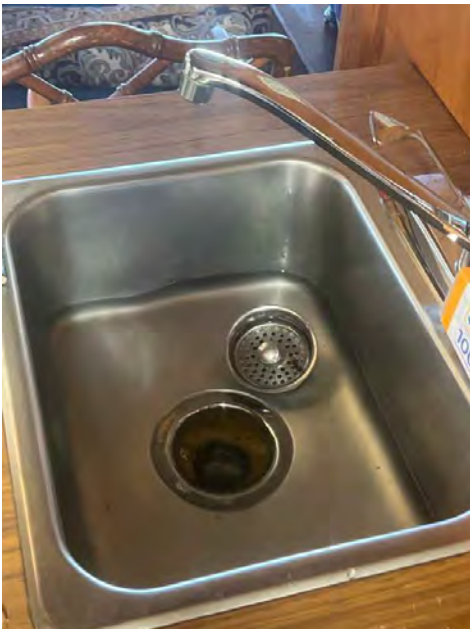
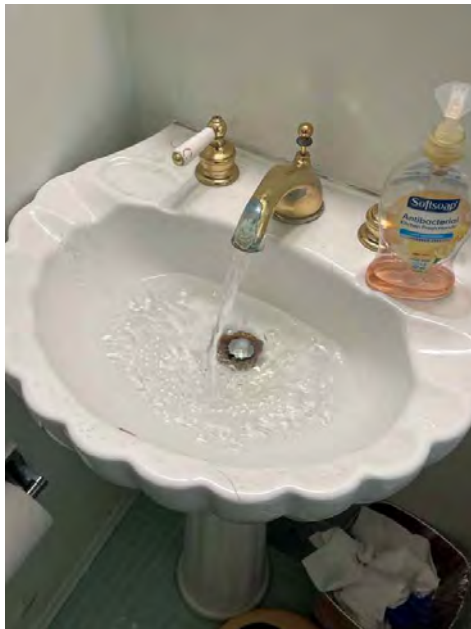
Slow drainage was noted at the sink. We advise professional cleanout or necessary corrections by a licensed plumber. Some slow drains may be caused by a more serious blockage further down the drain line.

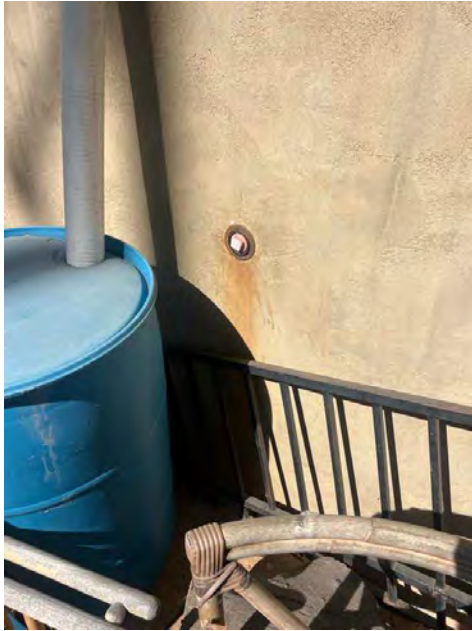
Kitchen

Leaking was observed below the cleanout caps outside of the downstairs bathroom. I was unable to determine the exact source of the leaks. Additionally, stains and vegetation growth at a couple of the clean outs indicates that leaks have occurred. We recommend further evaluation by a qualified plumber and repair as needed to avoid damage.

Contact a qualified plumbing contractor.

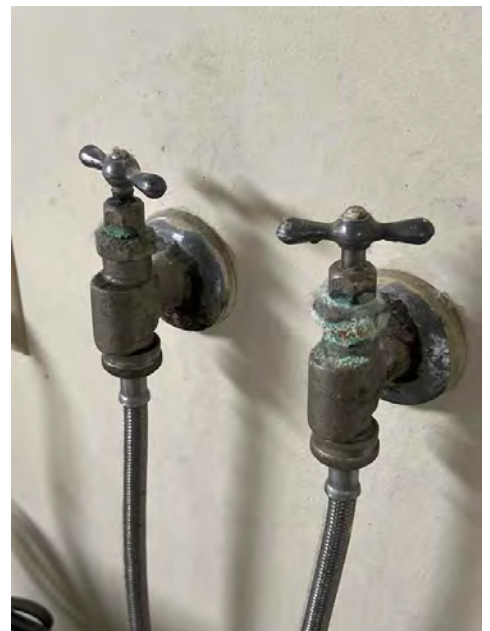
The hot and cold water shut-off valves at the laundry have calcium deposits around the valve stem. This is due to water seeping out of the valve and evaporating, leaving behind calcium deposits. When this condition exists, it is very likely that the faucets will leak after being shut off and turned back on after the change of ownership. We recommend replacing these valves as preventive maintenance.

Contact a qualified plumbing contractor.

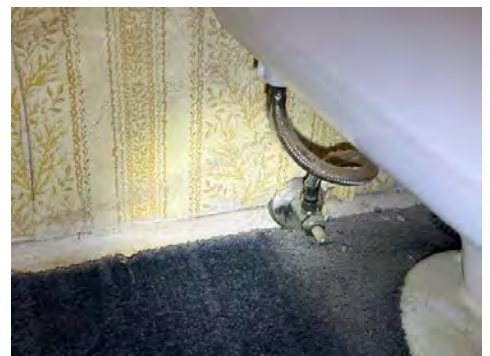
Handle was missing at angle stop valve. Recommend repair by a qualified person.

Contact a qualified professional.

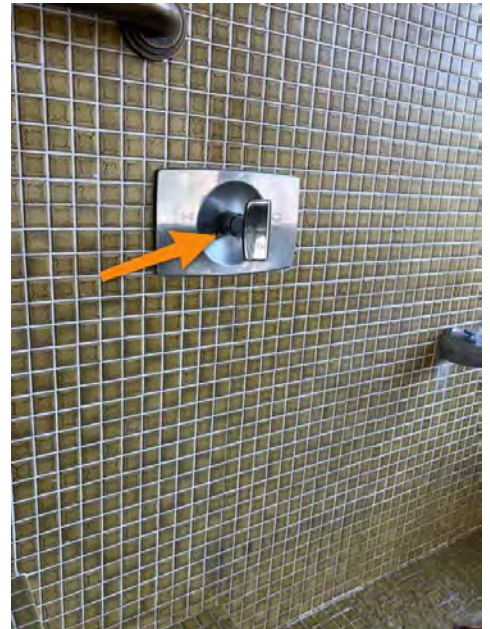
Master Bathroom

The faucet handle leaks at the base when the water is running. We recommend repair or replacement by a qualified plumber.

Contact a qualified professional.

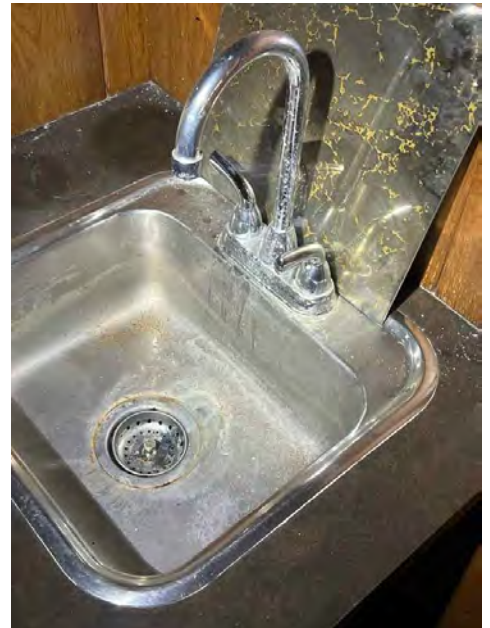
The cold water supply was shut off at the sink faucet. Many times this indicates a drip or a leak. The angle stop is heavily corroded as well. Home inspectors are not allowed to turn valves to verify function. We advise repair as necessary by a qualified person.

Contact a qualified professional.

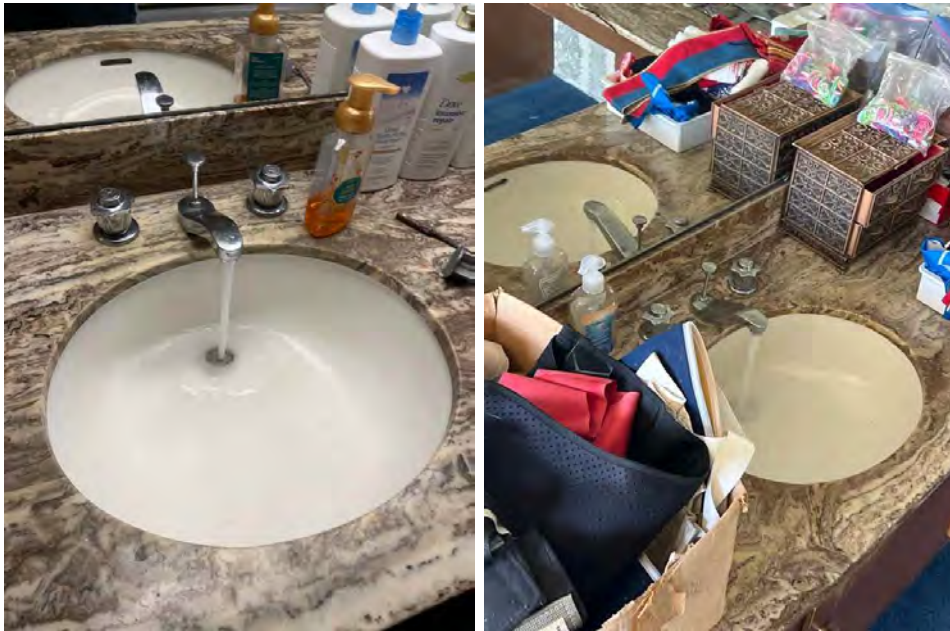
Master Bathroom

The sink stopper was inoperable. We recommend necessary corrections.

Contact a qualified professional.

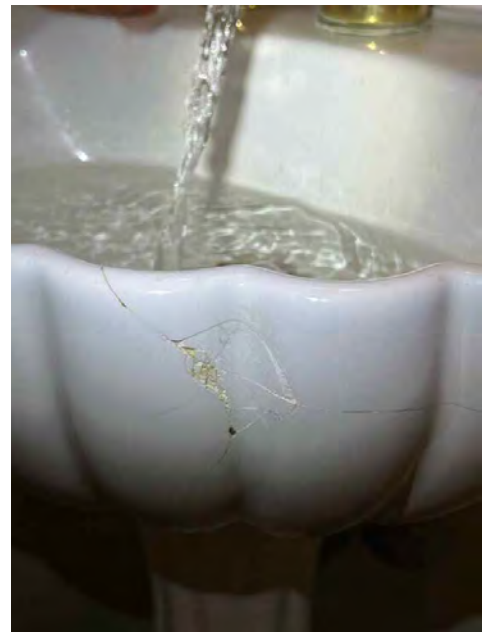
The sink was cracked. We recommend replacement to avoid leaks.

Contact a qualified professional.

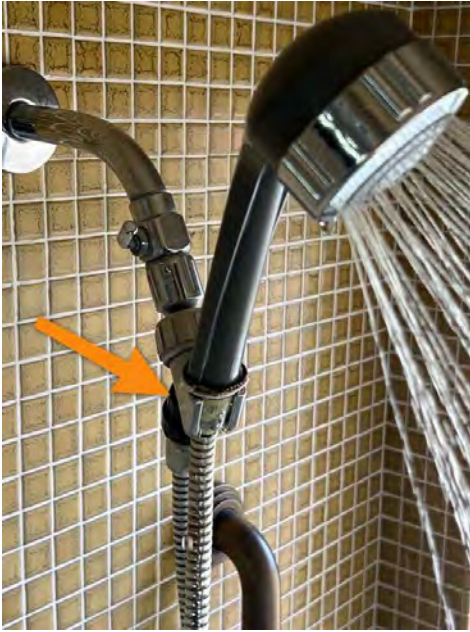
Water leaks from the shower head connection to the hose or shower arm when operated. We recommend repair as needed by a qualified plumber to prevent excessive amounts of water from exiting the shower enclosure.

Contact a qualified professional.

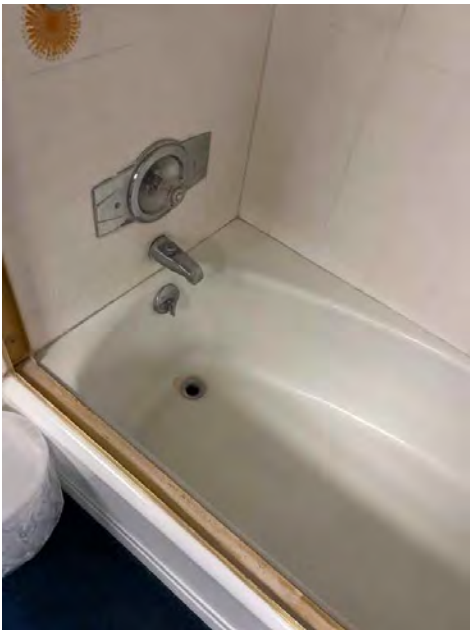
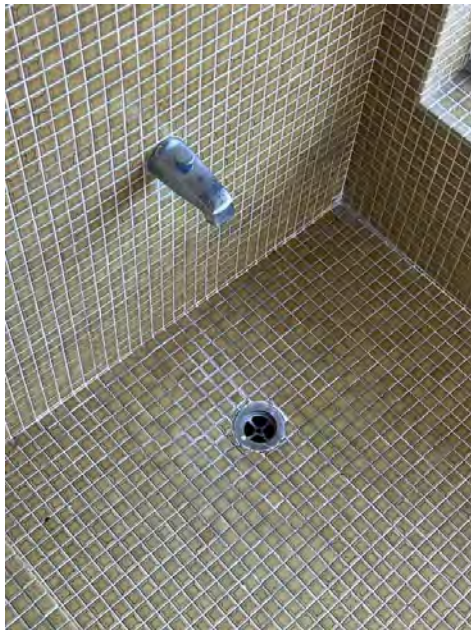
The tub stopper is missing. We recommend replacement.

Contact a qualified professional.

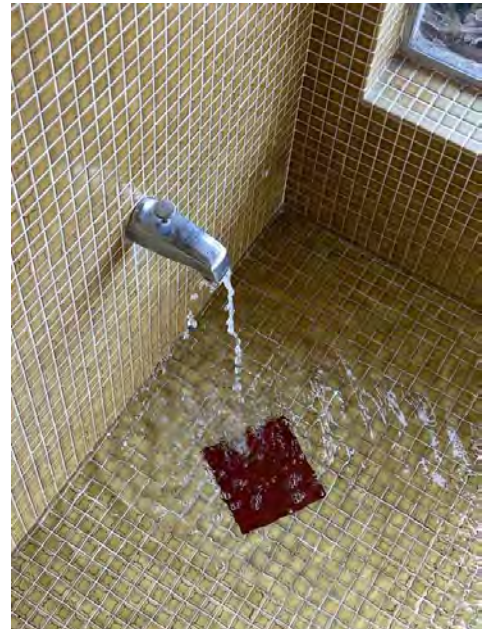
The tub diverter was defective; likely due from hard water deposit build-up on the tub spout mechanism. Water sprays from shower and tub spout simultaneously. We recommend necessary corrections by a qualified person.

Contact a qualified professional.

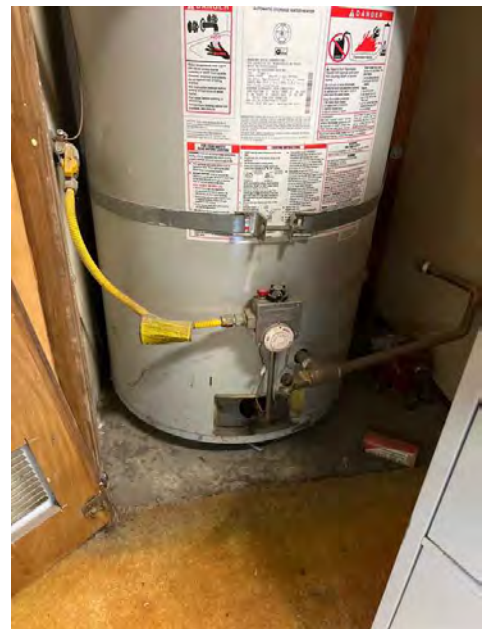
Due to the location inside the home, we recommend installing a leak pan under the water heater by a licensed plumber to avoid future damage to the home if the water heater leaks.

Contact a qualified professional.

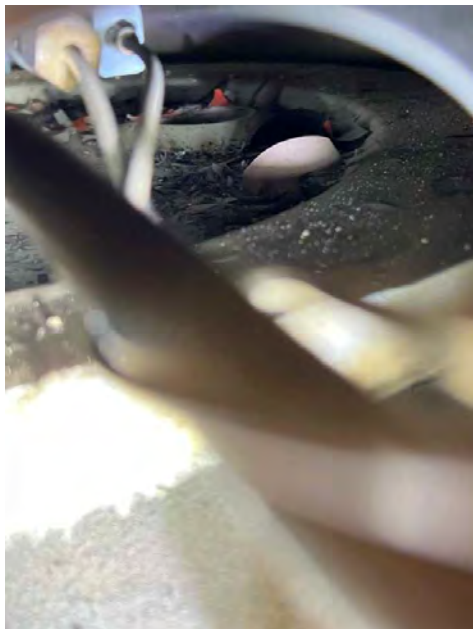
The bottom of water heater burn chamber exhibited a moderate accumulation of metal flakes that are typically the product of corrosion of the water tank. This indicates that the water tank has suffered some corrosion. Water heater may be at or near the end of its useful life.

Contact a qualified professional.

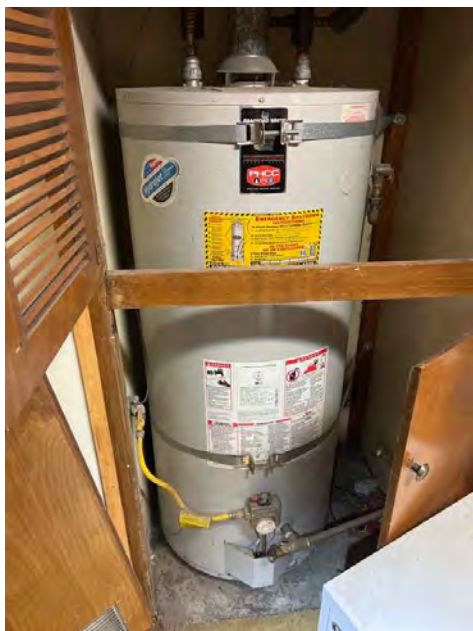
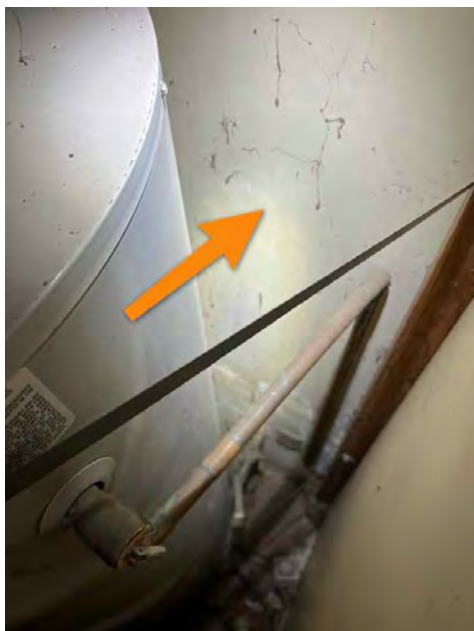
Water heaters with a capacity of over 50 gallons require 3 straps in earthquake regions 3 and 4 which includes San Diego County. While this may not be required in some areas, we recommend installing additional straps by a qualified person for seismic safety. Additionally, the gap between the wall and tank can allow excessive movement during earthquakes. Recommend installing blocking to fill this gap.

Contact a qualified professional.

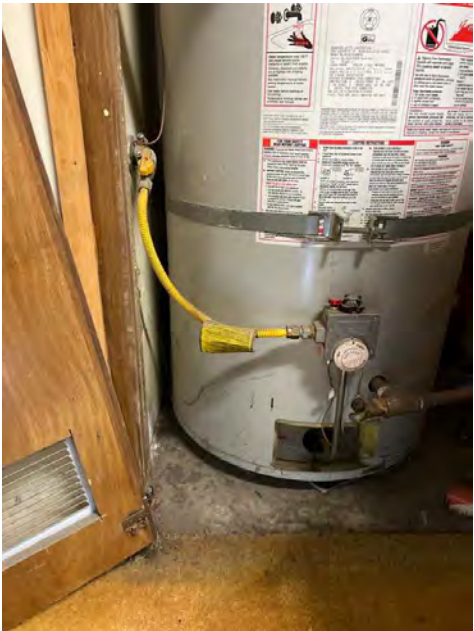
The gas supply pipe (at the water heater and/or furnace) contained no sediment trap. A sediment trap is generally recommended by the manufacturer. The purpose of a sediment trap is to prevent particulates or moisture from condensation from entering and clogging the water heater/furnace gas valve, which can cause the water heater/furnace to shut down.

Recommendation  
Contact a qualified professional.

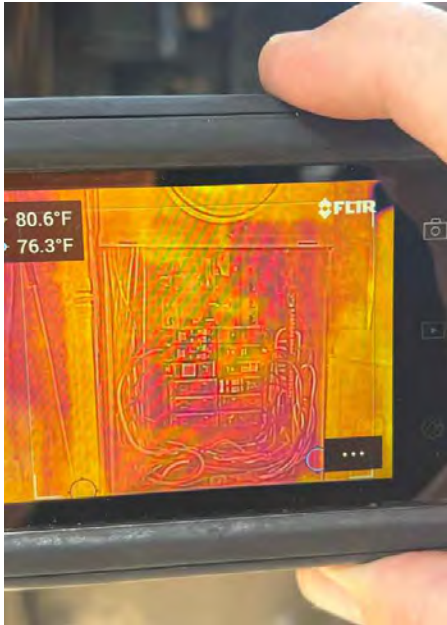
A thermal scan was performed on the electrical panel(s). The panel, circuit breakers, and wiring were found to be operating within normal temperature range which indicates the system was functioning as intended with the conditions present at the time of inspection.

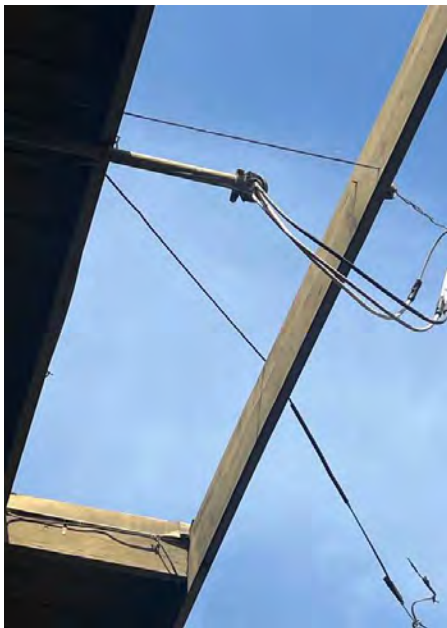
At the time of the inspection, the Inspector observed no deficiencies in the condition of the service drop. Components inspected include the service conductors, splice, drip loop, and point of attachment to the home.

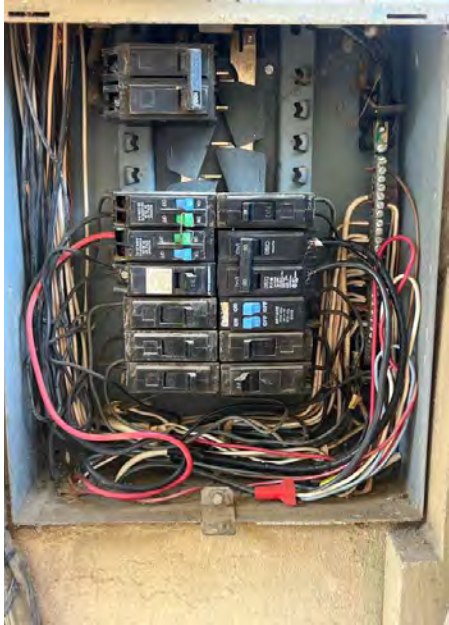
The dead front cover was removed and breakers, wiring, and grounding were inspected. Appears to be functioning as intended. Electrical panels are visually inspected only, the inspector does not perform a load calculation to determine service capacity adequacy. Breakers are visually inspected only. The inspector does not perform any electrical stress tests on the system to determine if a breaker trips properly, including AFCI and GFCI breakers (consult an electrician for further evaluation, if this is a concern)

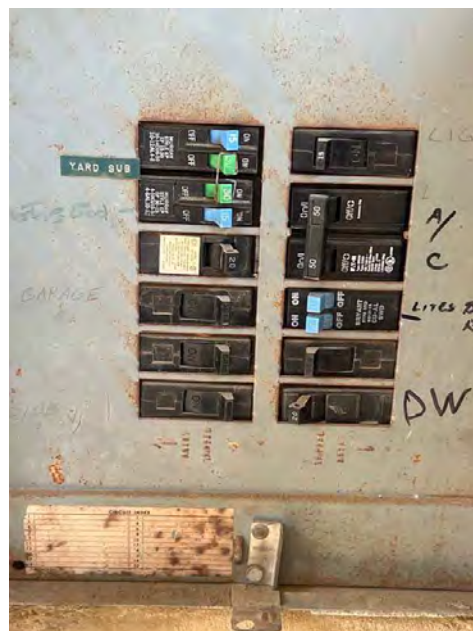
#### 4.2.2 MAIN AND DISTRIBUTION PANELS

##### **LABELS - ILLEGIBLE**

The labels in the electrical panel(s) are illegible or incomplete, and they may not be accurate. We recommend correcting for safety reasons in the event that someone has to work on the electrical system.

Contact a qualified professional.

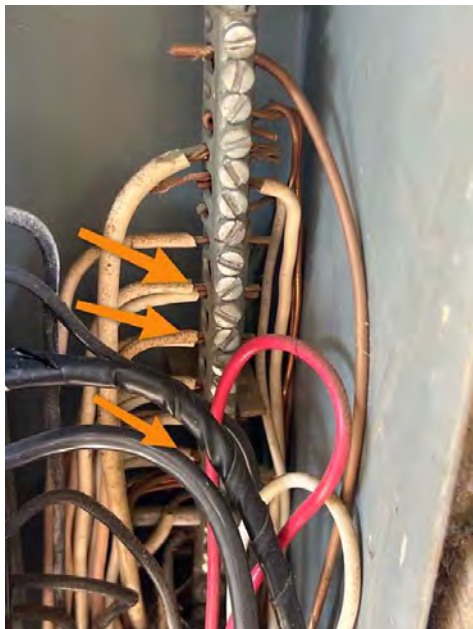
#### 4.4.1 SYSTEM GROUNDING AND GROUNDING EQUIPMENT

Neutral conductors in electrical panel were observed with double tapping. This is a practice of connecting two or more neutral wires to one lug, which is not allowed. We recommend correction by a licensed electrician.

Contact a qualified electrical contractor.

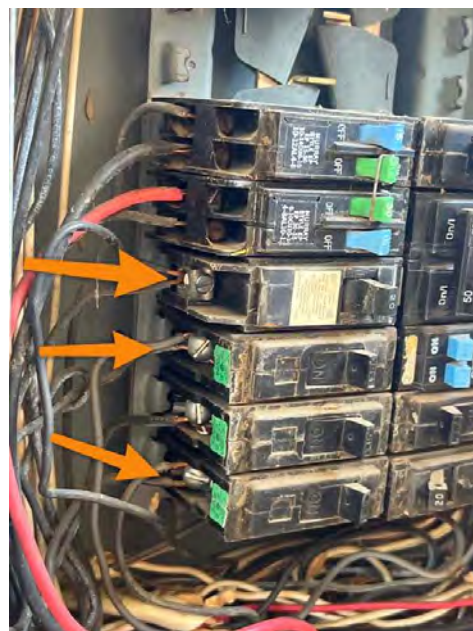
#### 4.5.1 OVERCURRENT DEVICES (Circuit Breakers, Fuses) AND COMPATIBILITY OF THEIR AMPERAGE AND VOLTAGE

Double-tapping was observed inside an electrical panel. This is a practice of connecting two wires to one circuit breaker, which is not allowed.

Contact a qualified electrical contractor.

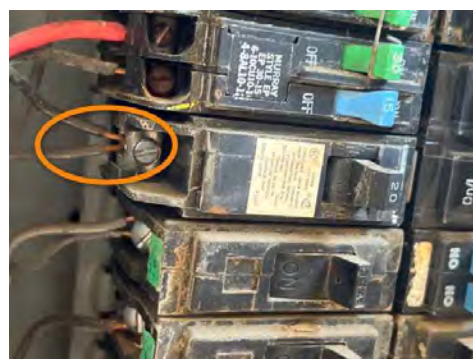
#### 4.5.2 OVERCURRENT DEVICES (Circuit Breakers, Fuses) AND COMPATIBILITY OF THEIR AMPERAGE AND VOLTAGE

The wire size and breaker rating are not compatible at the 20 AMP circuit breaker. This is considered a fire hazard. We recommend correction by a licensed electrician.

Contact a qualified electrical contractor.

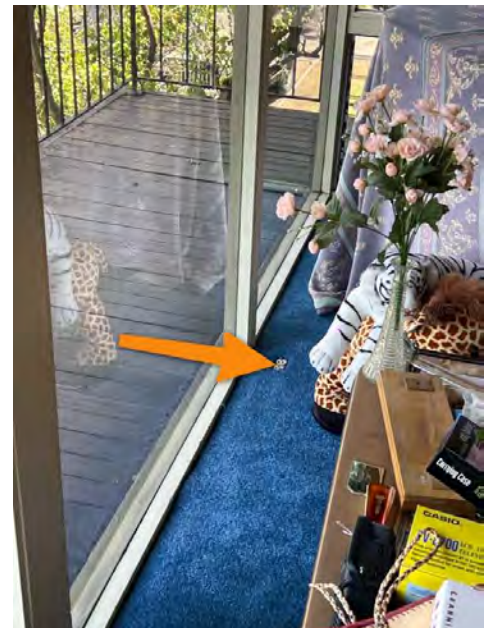
#### 4.7.1 JUNCTION BOXES (Observable)

##### **PLATE COVERS MISSING**

Switchplate/ Receptacle covers are missing. This is a shock hazard. We recommend replacing as necessary for safety.

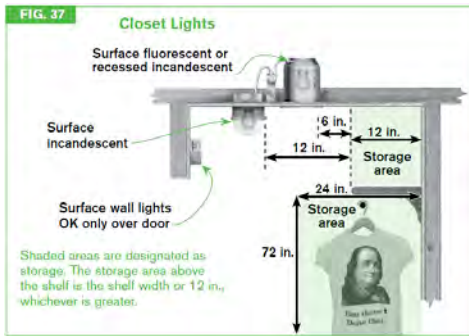
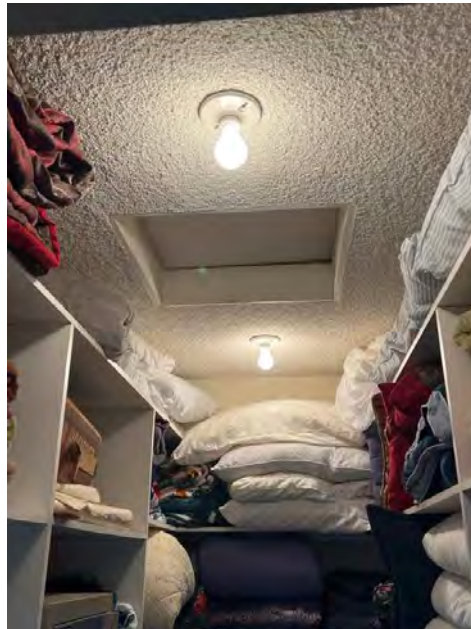
#### 4.8.1 CONNECTED DEVICES AND FIXTURES (Representative number, excluding low-voltage items)

##### **LIGHT - BARE BULB IN CLOSET**

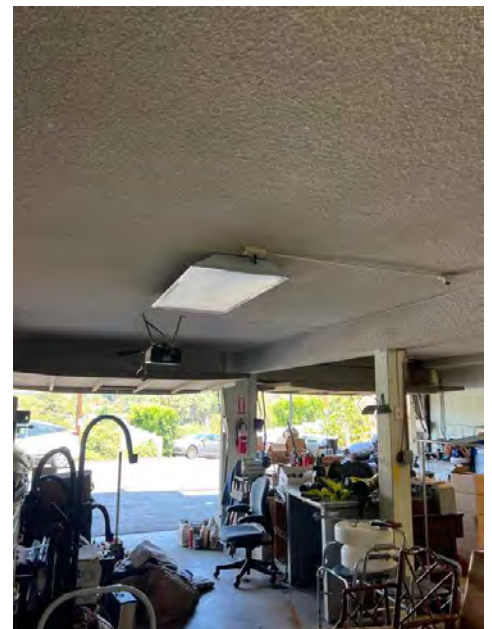
4.8.2 CONNECTED DEVICES AND FIXTURES  
(Representative number, excluding low-voltage items)

The lights did not function possibly due to bad bulb. Occasionally there is something wrong with the fixture which cannot be determined without working bulbs. We recommend asking the seller to demonstrate that the light is working prior to the end of the inspection contingency period, or changing the bulb and testing again.

Contact a qualified professional.

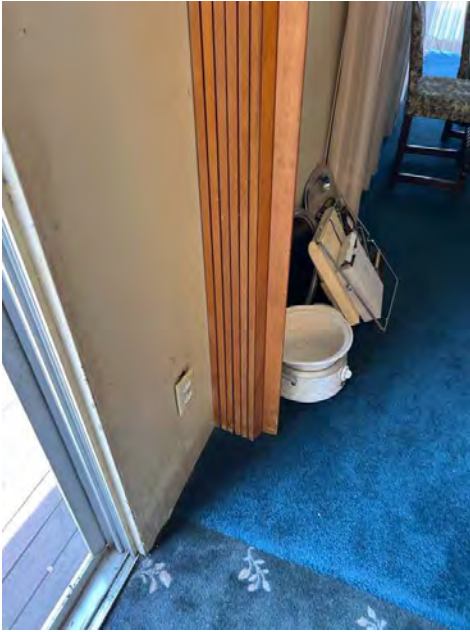
4.8.3 CONNECTED DEVICES  
AND FIXTURES (Representative  
number, excluding low-voltage items)

### RECEP - LOOSE

Receptacle was loose in the wall. This puts stress on the circuit wires which should not be moved. We recommend securing the junction box properly in the wall by a qualified person.

Contact a qualified professional.

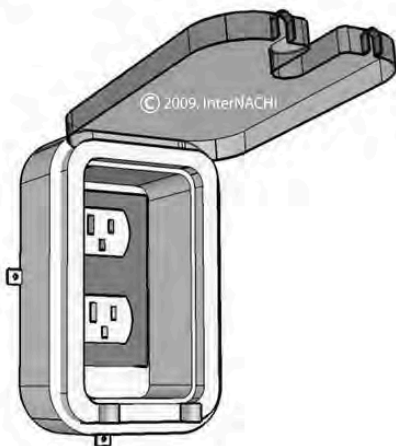
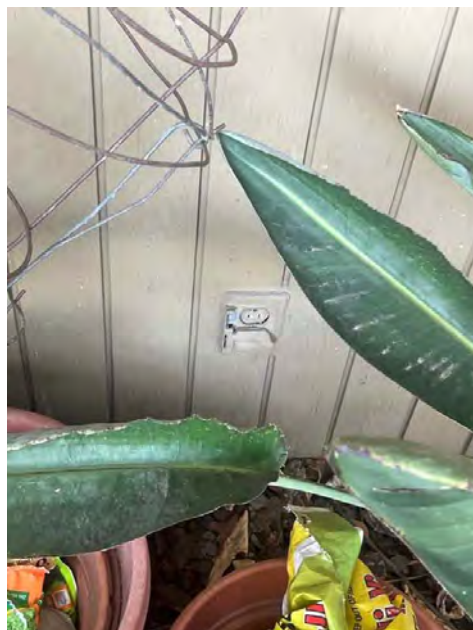
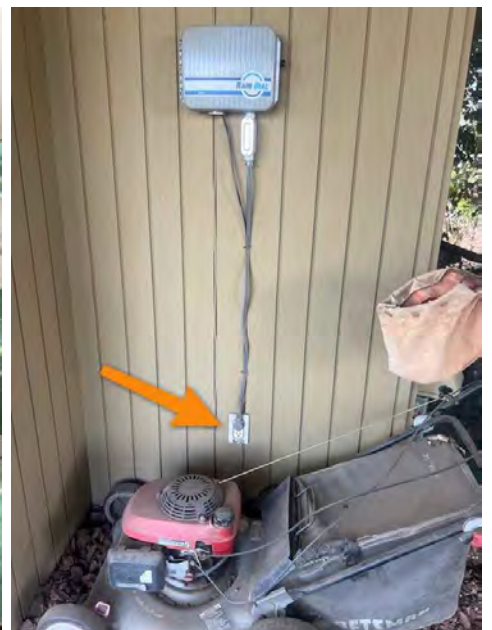
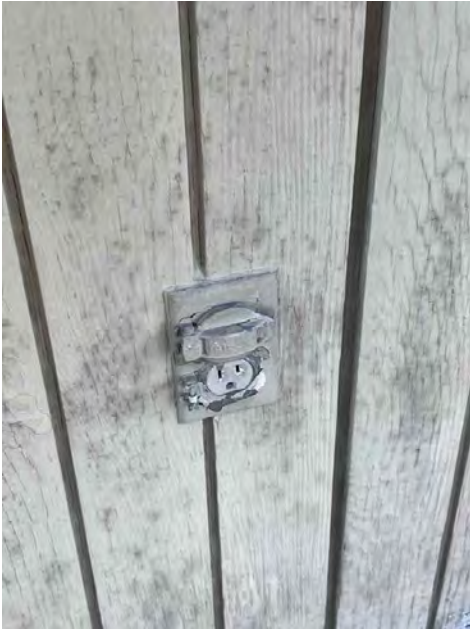
#### 4.8.4 CONNECTED DEVICES AND FIXTURES (Representative number, excluding low-voltage items)

Weatherproof Receptacle Cover

Contact a qualified professional.

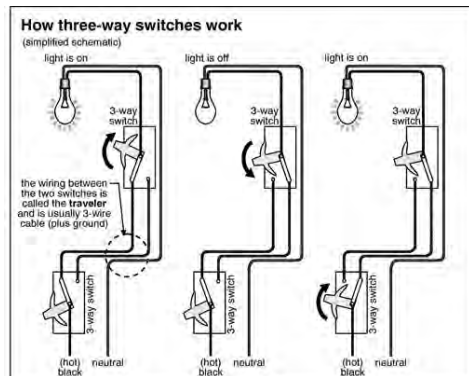
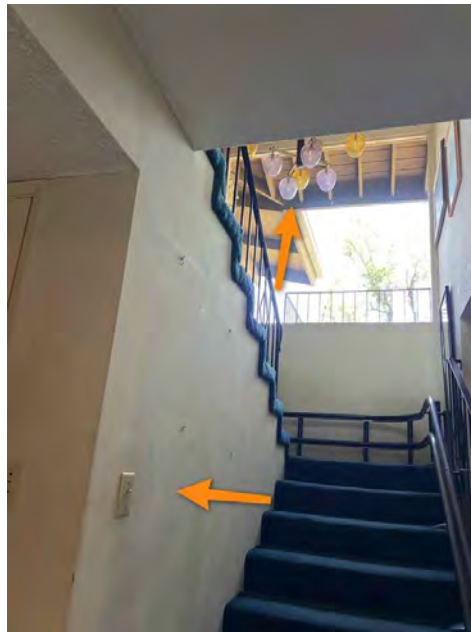
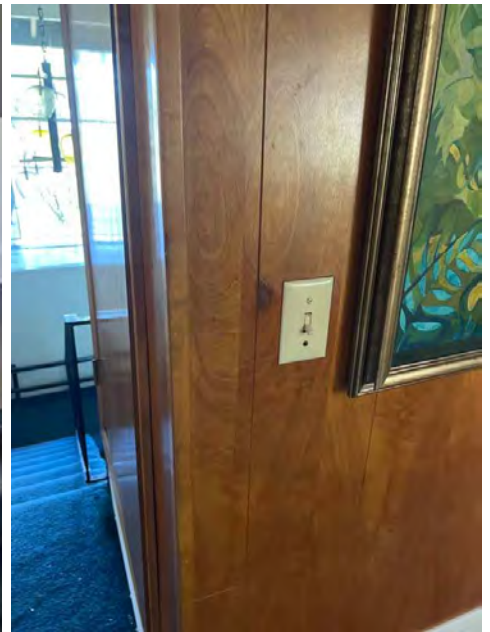
4.8.6 CONNECTED DEVICES AND FIXTURES (Representative number, excluding low-voltage items)

The three-way light switch function is inoperable in the stairwell. This is a safety issue. We recommend correction by a licensed electrician.

Contact a qualified electrical contractor.

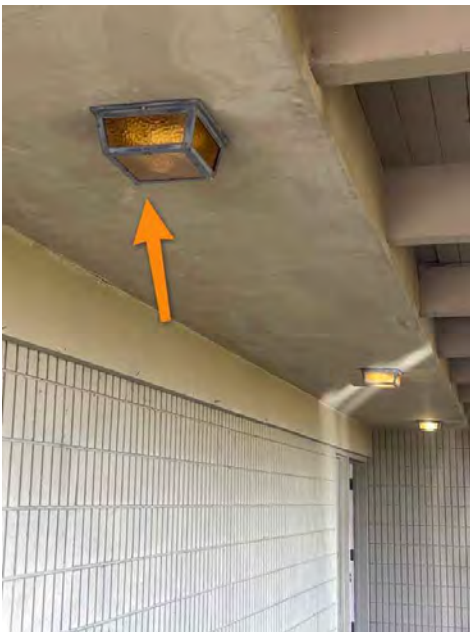
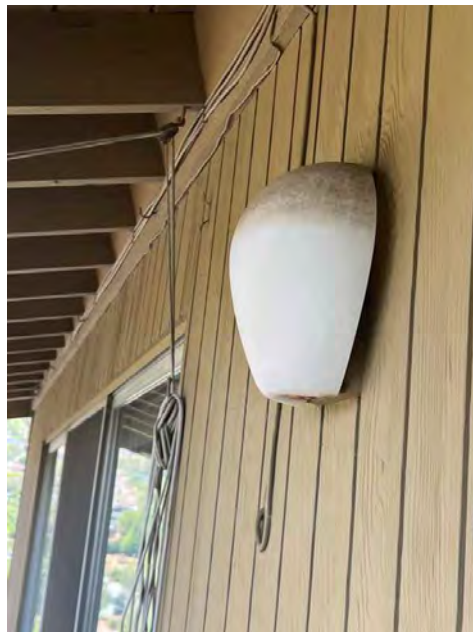
#### 4.9.1 EXTERIOR LIGHTING

##### **EXTERIOR LIGHT INOP**

The exterior light fixture(s) did not function when tested. This may be due to a bad bulb or possible electrical problems. Advise changing the bulb and testing. If light fails to work, further repairs may be required by an electrician.

Contact a qualified professional.

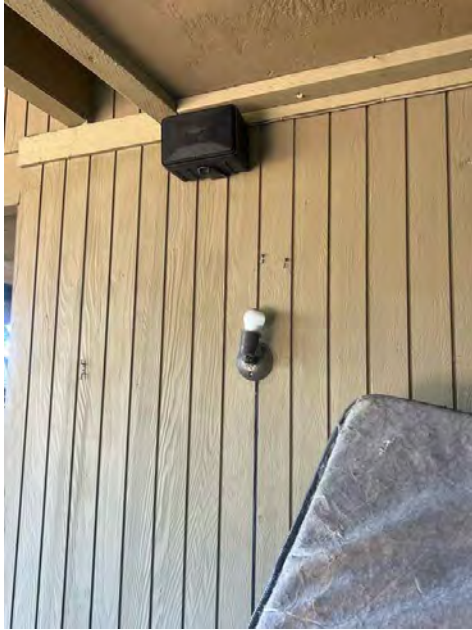
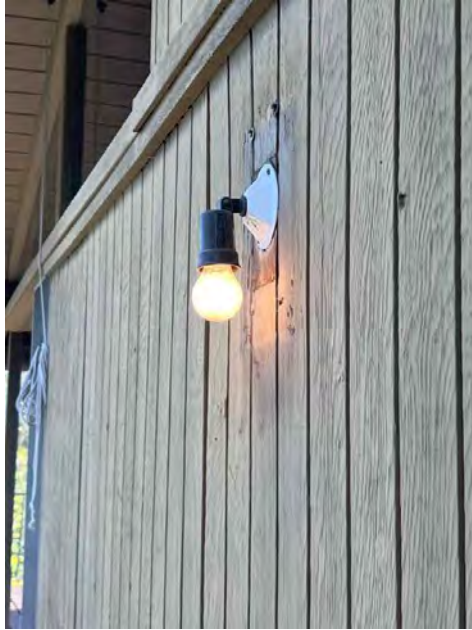
#### 4.9.2 EXTERIOR LIGHTING

##### **LIGHT COVER MISSING**

Light bulb cover(s) missing. This cover protects the bulb from damage and from water. We recommend installing a light cover.

Contact a qualified professional.

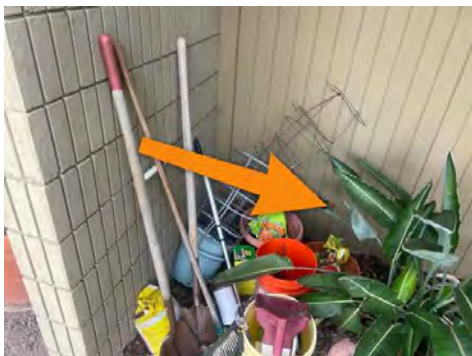
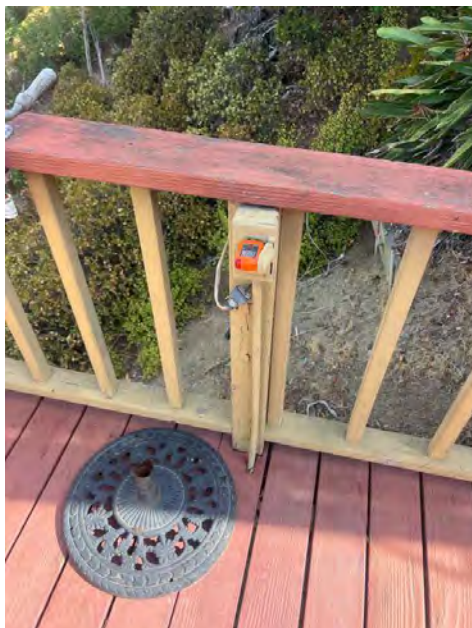
## 4.10.1 POLARITY AND GROUNDING OF RECEPTACLES

**RECEPTACLE - NO POWER**

A couple of receptacles were not energized at the time of the inspection. We recommend further evaluation and necessary repairs.

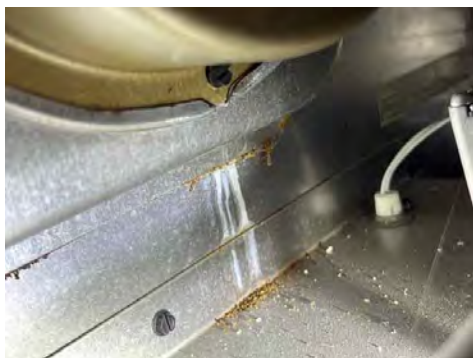
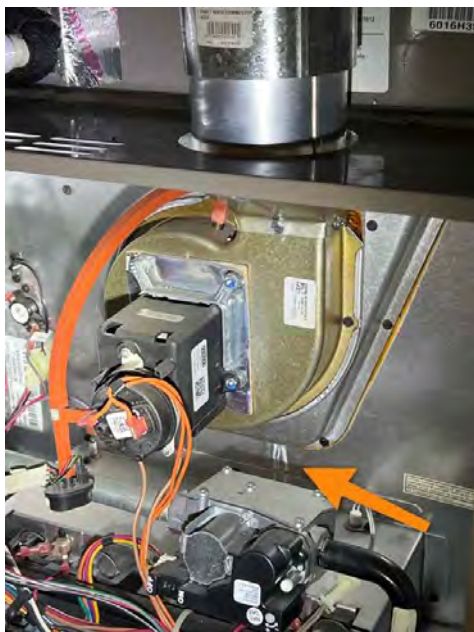
### 5.3.1 FLUES AND VENTS (For heating system)

#### RUST-BACKDRAFTING

Rusting/Scorching/Corrosion was observed at draft hood/ flue connection inside furnace. This can indicate improper drafting, which is a safety hazard. We advise further review with a licensed heating contractor.

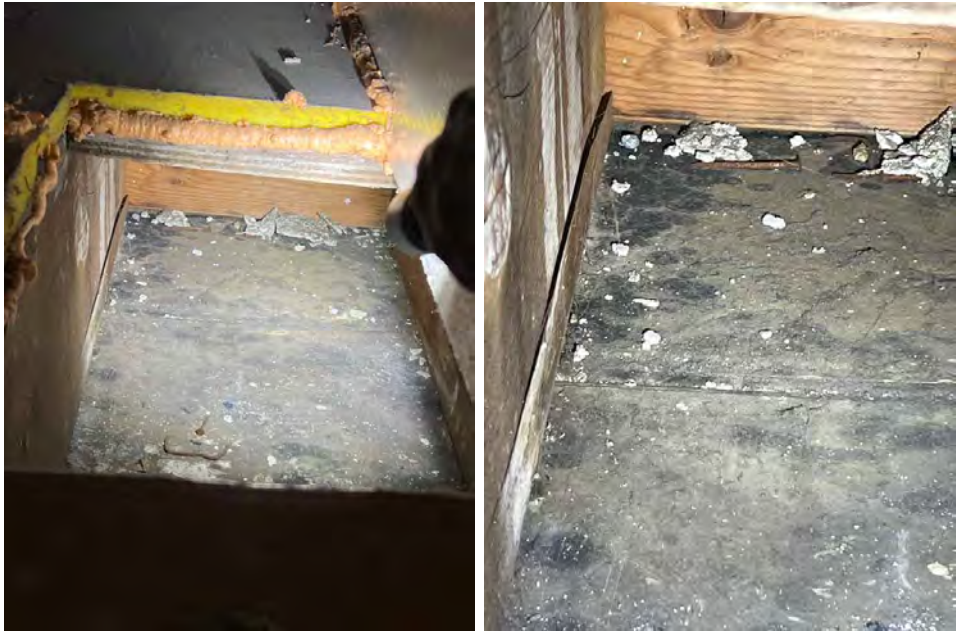
5.5.1 DISTRIBUTION SYSTEMS (including ducts and piping, with supports, insulation, air filters, registers)

The interior HVAC air return plenum contained what appeared to be microbial growth. The presence of mold can only be determined by testing. We recommend that the HVAC system be serviced by a qualified HVAC contractor and the system/ducts be cleaned by an environmental hygienist.

Contact a qualified mold remediation contractor

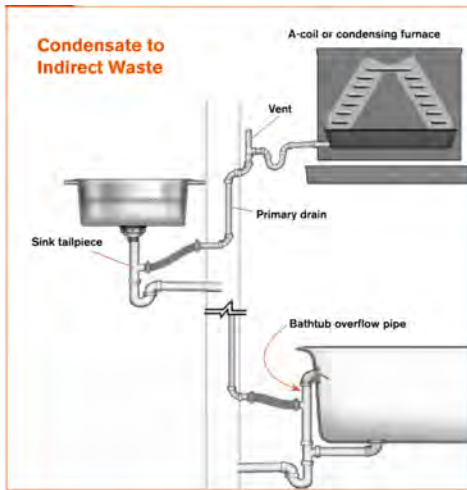
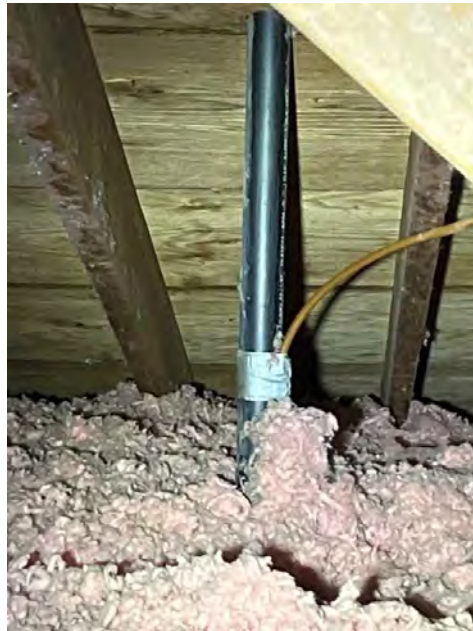
### 6.3.1 CONDENSATE HANDLING EQUIPMENT

The AC condensation drain discharges into a plumbing vent in the attic. This is not an approved installation. While this may be functional, we advise review with a licensed HVAC contractor for repair options.

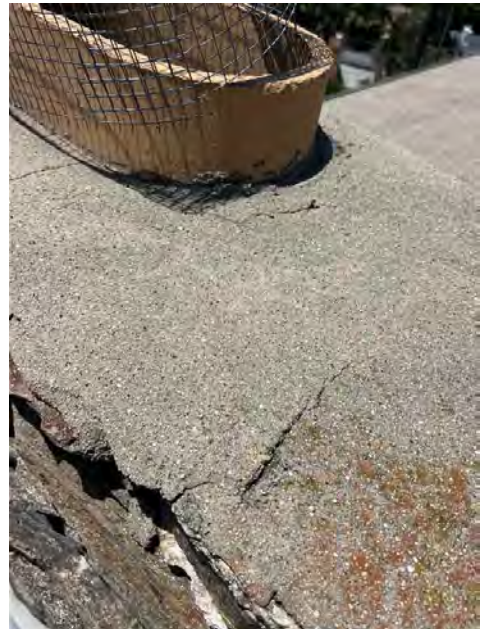
### 7.2.1 FIREPLACES (including Gas/LP firelogs) AND CHIMNEYS

#### **CHIMNEY CROWN/CAP CRACKED**

The chimney crown (mortar cap) is cracked. We advise repair to avoid moisture intrusion and further deterioration.

Contact a qualified chimney contractor.

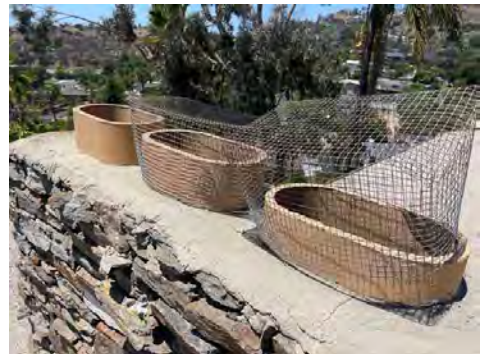
### 7.2.2 FIREPLACES (including Gas/LP firelogs) AND CHIMNEYS

No rain cap was present. The rain cap prevents water from entering the chimney flue. We recommend installing a spark arrester/ rain cap by a qualified person.

Contact a qualified professional.

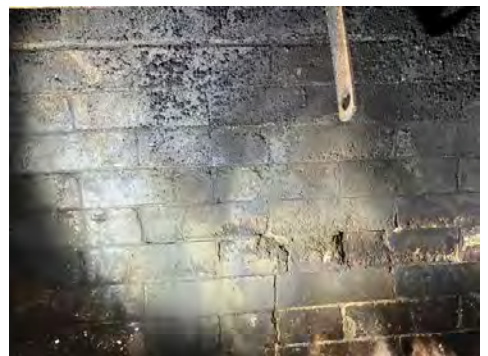
### 7.2.3 FIREPLACES (including Gas/LP firelogs) AND CHIMNEYS

Creosote/soot build-up was noted at the chimney. We advise obtaining professional cleaning.

Contact a qualified chimney sweep.

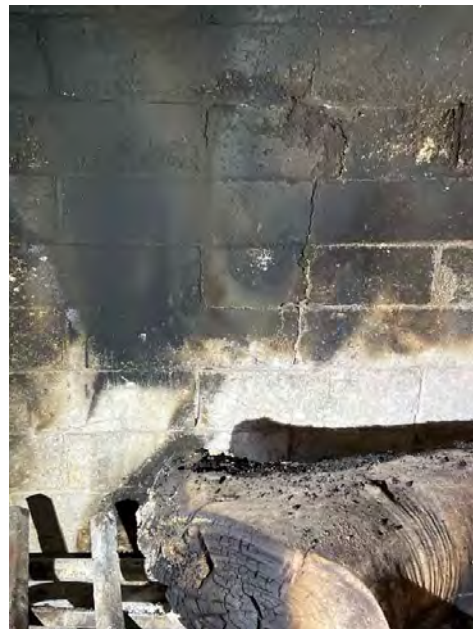
### 7.2.4 FIREPLACES (including Gas/LP firelogs) AND CHIMNEYS

#### **CRACKING - FIREBOX - MORTAR**

Cracking and some deterioration was noted in the fireplace. We advise sealing all cracks with fireplace mortar.

Contact a qualified chimney contractor.

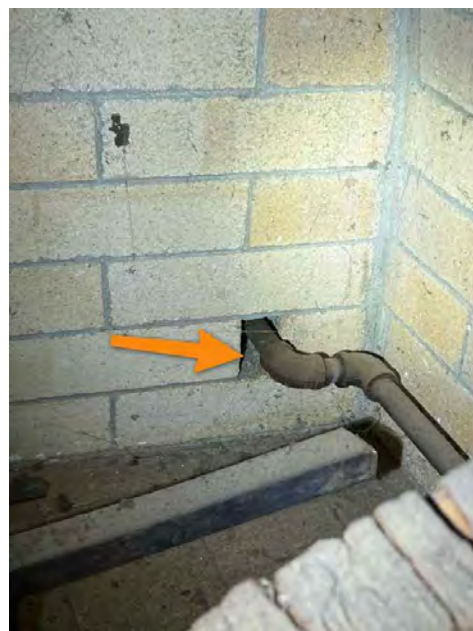
#### 7.2.5 FIREPLACES (including Gas/LP firelogs) AND CHIMNEYS

Gaps were observed which could allow flames to exit the fireplace. This is a fire hazard. We recommend sealing the gaps or holes with fireplace-rated sealant or mortar.

Contact a qualified fireplace contractor.
