## HOME INSPECTION

9827 Edgar Pl  
La Mesa, CA 91941

07/27/2026

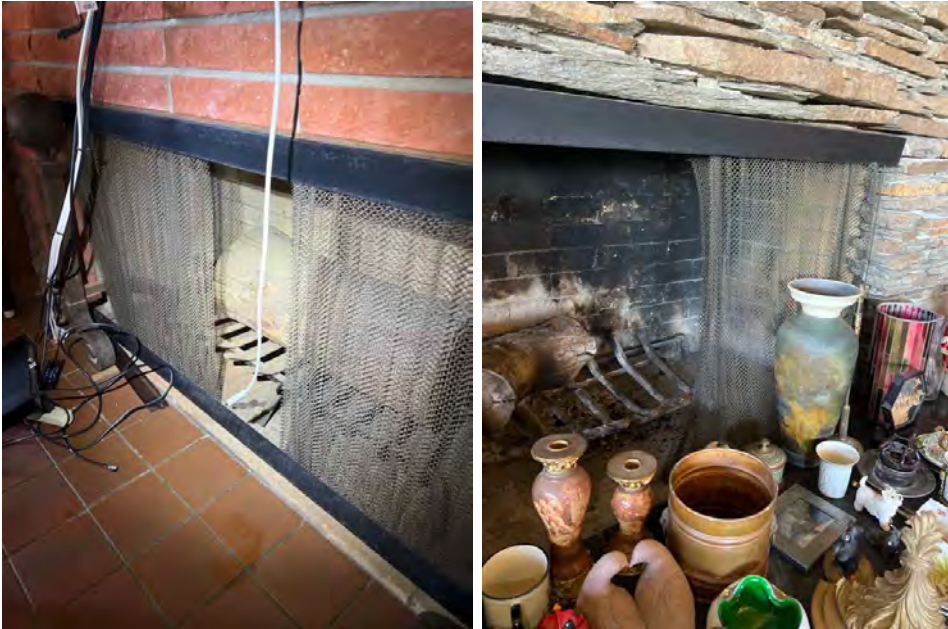
#### 7.2.6 FIREPLACES (including Gas/LP firelogs) AND CHIMNEYS

##### **SPARK SCREEN - DAMAGED**

The spark screen at the fireplace is in poor condition, and difficult to operate. We recommend replacement.

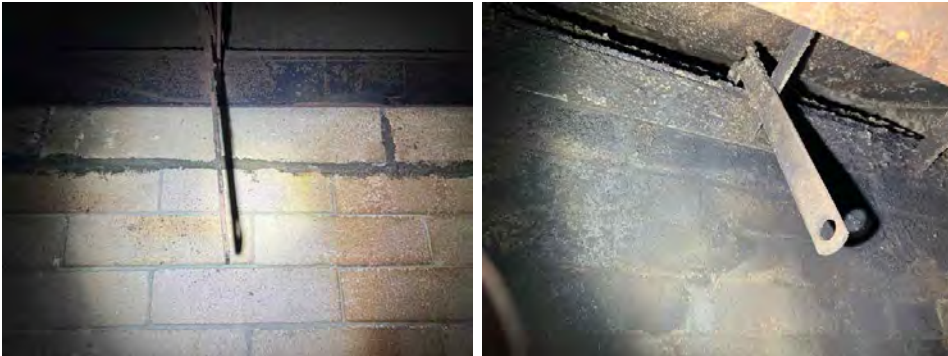
### 7.3.1 DAMPER AND/OR DAMPER CLAMP

#### **DAMPER CLAMP - NONE**

A damper clamp is required when there is a gas supply to the fireplace(s). This damper clamp prevents the damper from closing all the way as a safety precaution. If the damper is closed, Carbon Monoxide gas can enter the living space which is odorless. We recommend the installation of a damper clamp.

Contact a qualified professional.

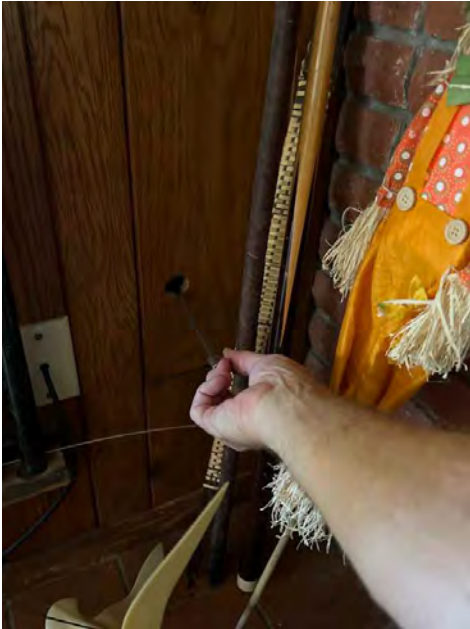
### 7.5.1 OPERATING CONTROLS

#### **GAS VALVE - STUCK**

The gas valve was difficult to turn and was not tested to avoid damage. We recommend further evaluation and repair by a licensed plumber.

Contact a qualified plumbing contractor.

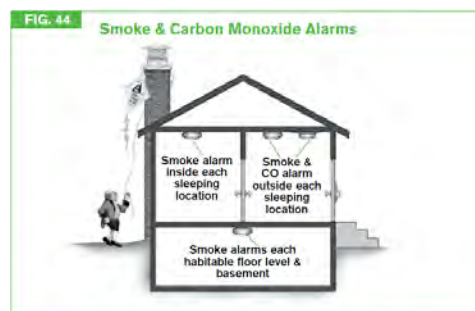
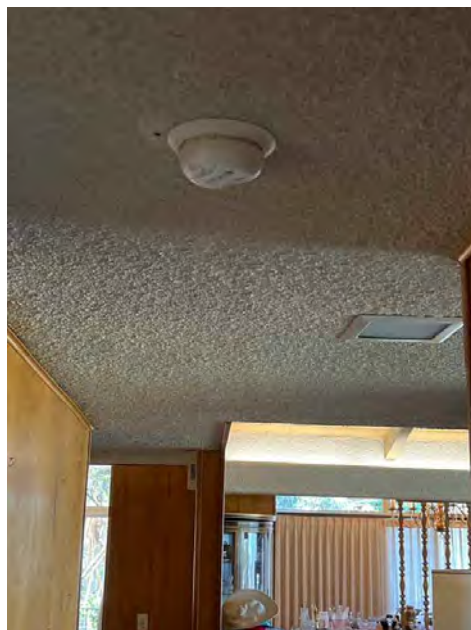
One smoke detector was present in the common hallway. California State Law SB 745 requires additional smoke detectors to be installed in all bedrooms and on each level in the common hallways in multi-story homes when modifications have been performed including alterations, repairs, or additions exceeding \$1,000 in value. Additional smoke detectors are also required in all dwellings intended to be used as rentals regardless of modifications.

Contact a qualified professional.

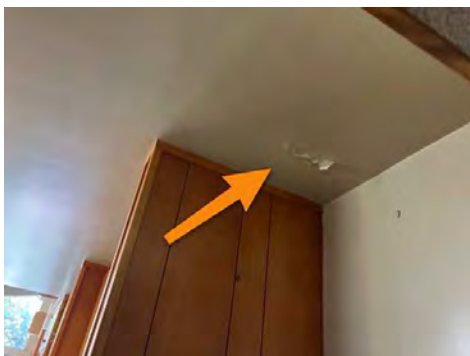
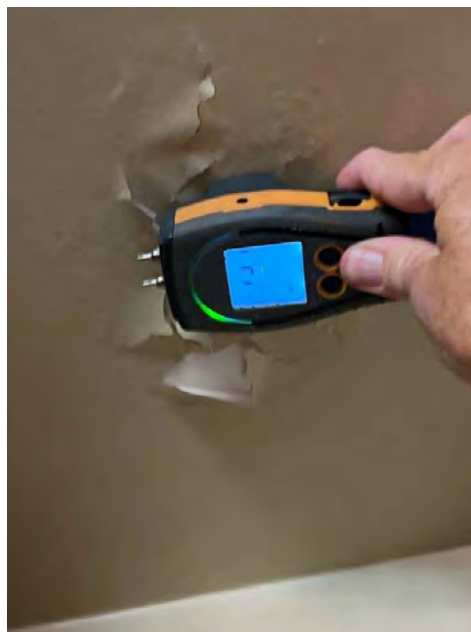
Kitchen

**CRACKS - POSSIBLE LEAK**

Hairline cracking with peeling texture was observed on the ceiling. This appears to be due to moisture or a leak that did or still does exist. The area was tested with a moisture meter and found to be dry. We recommend review of the plumbing and roofing sections for possible causes and patching and painting with qualified person.

Moisture Meter Dry Reading

Contact a qualified professional.

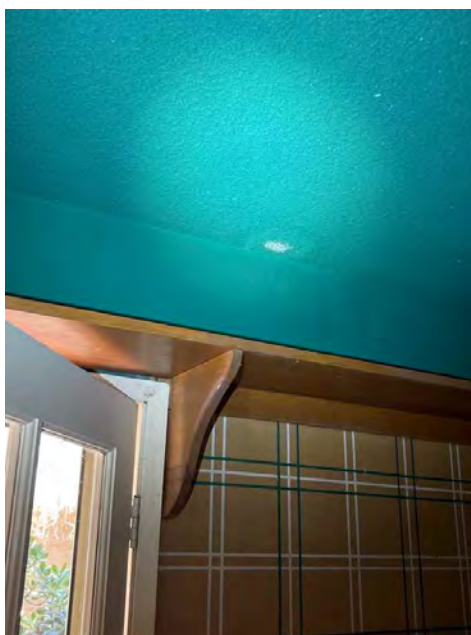
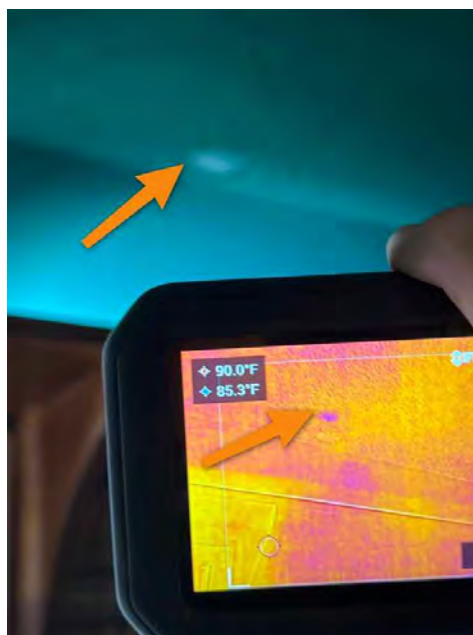
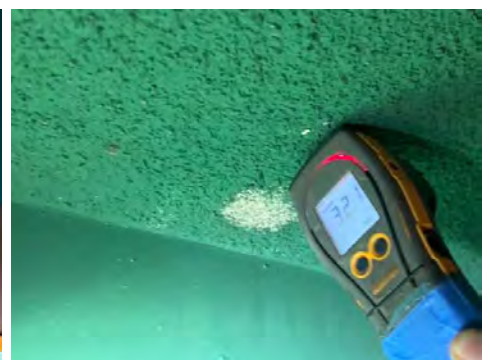
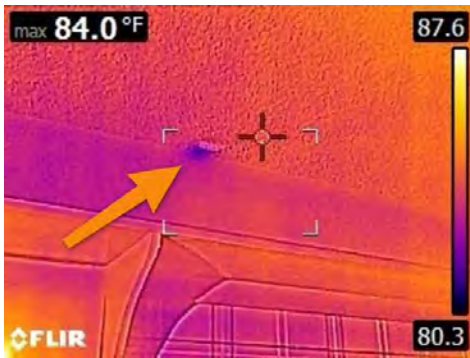
**MOISTURE/APPARENT LEAK - BELOW HALL BATHROOM**

An elevated level of moisture/apparent plumbing leak was detected at the ceiling. The exact cause of the moisture/apparent leak, or the presence of damage, cannot be determined without more destructive testing. There may be moisture damage behind the drywall which is concealed and cannot be identified within the scope of a home inspection. To determine if moisture damage exists inside the walls, a more invasive inspection is required. In some cases, destructive testing may be needed to determine what repair is needed. We recommend further evaluation by a licensed plumber, or remediation contractor prior to the end of your contingency period. Note: Moisture/apparent leak was found using a thermal camera and verified with a moisture meter.

Wet

Moisture Meter Wet Reading

Contact a qualified professional.

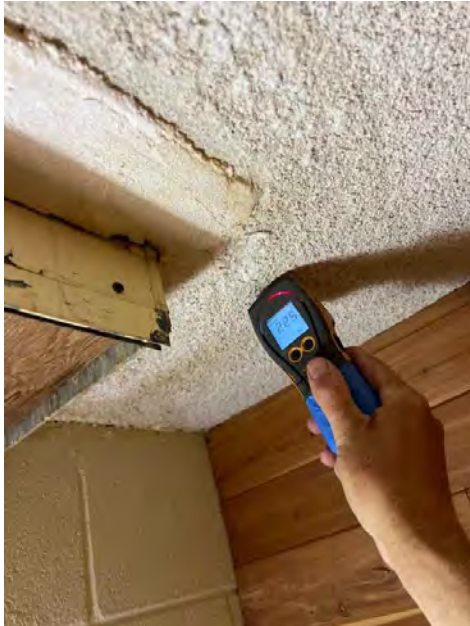
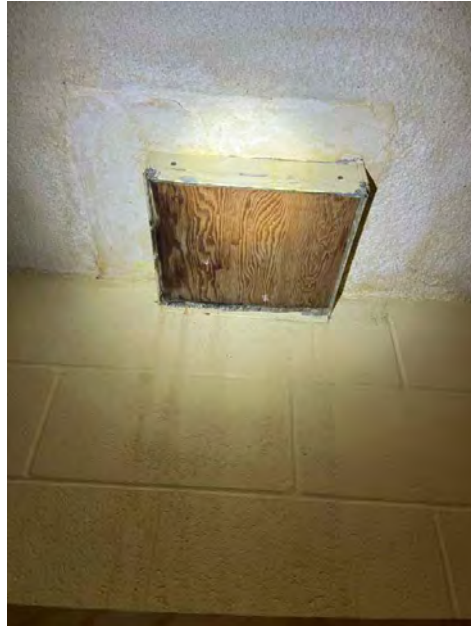
## MOISTURE/APPARENT LEAK - BELOW KITCHEN

An elevated level of moisture/apparent plumbing leak was detected at the ceiling. The exact cause of the moisture/apparent leak, or the presence of damage, cannot be determined without more destructive testing. There may be moisture damage behind the drywall which is concealed and cannot be identified within the scope of a home inspection. To determine if moisture damage exists inside the walls, a more invasive inspection is required. In some cases, destructive testing may be needed to determine what repair is needed. We recommend further evaluation by a licensed plumber, or remediation contractor prior to the end of your contingency period. Note: Moisture/apparent leak was found using a thermal camera and verified with a moisture meter.

Moisture Meter Wet Reading

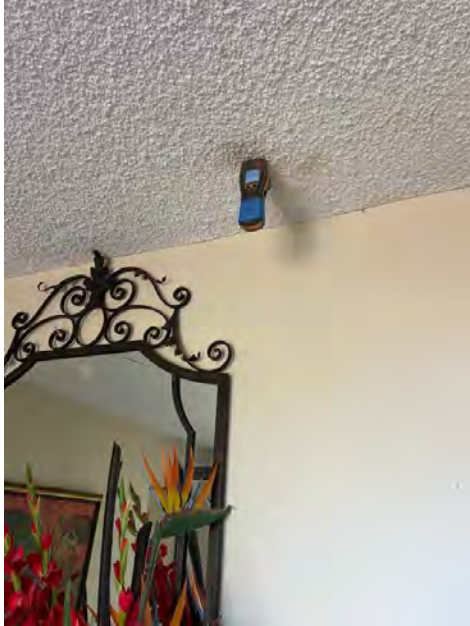
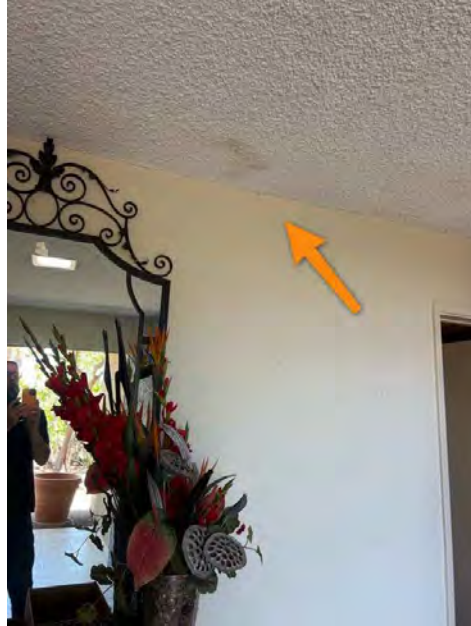
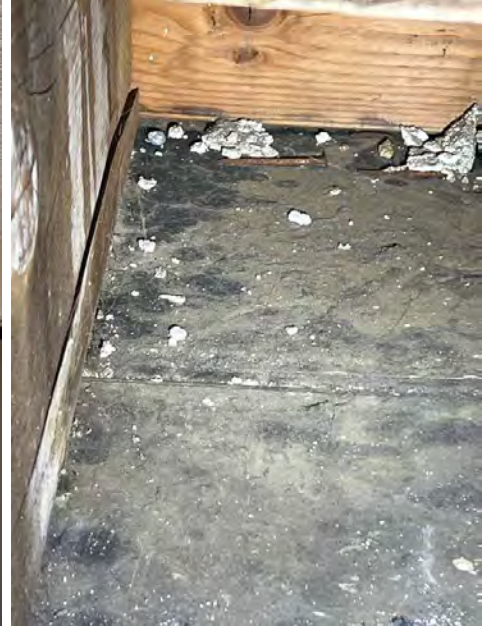
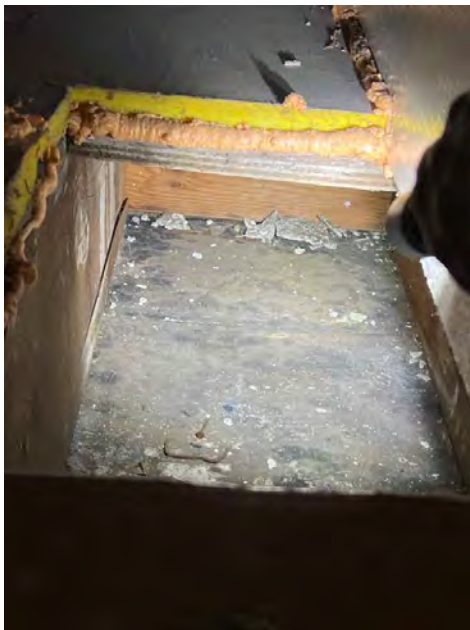
## MOISTURE/APPARENT LEAK

An elevated level of moisture/apparent leak was detected at the ceiling approximately below the furnace. Apparent mold growth was noted in the return plenum above this area, indicating possible condensation leaks have occurred. The exact cause of the moisture/apparent leak, or the presence of damage, cannot be determined without more destructive testing. There may be moisture damage behind the drywall which is concealed and cannot be identified within the scope of a home inspection. To determine if moisture damage exists inside the walls, a more invasive inspection is required. We recommend further evaluation by a licensed roofer and remediation contractor prior to the end of your contingency period. Note: Moisture/apparent leak was found using a thermal camera and verified with a moisture meter.

Moisture Meter Wet Reading

Contact a qualified professional.

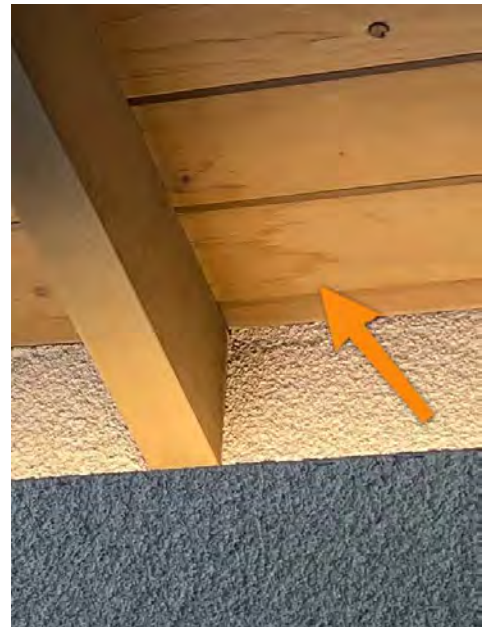
#### STAINS - DRY UNDER ROOF

Water stains were noted on the ceiling which can be from a roof leak. These stains were tested for moisture and were found to be dry at the time of the inspection. Due to lack of recent rain, determining the presence of an active roof leak was not possible. We recommend asking the seller if leaks exist, or if repairs have been performed. Otherwise, a licensed roof contractor should be consulted to perform a roof service and inspection prior to the end of the contingency period.

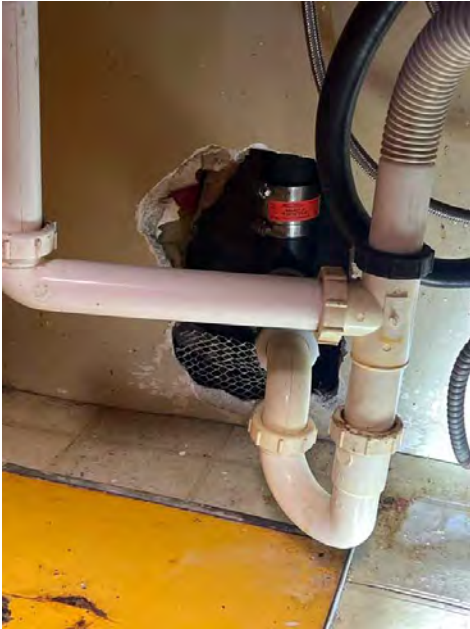
#### HOLE - UNDER SINK

There is a hole/ opening observed in the wall below the sink from previous plumbing repairs. We recommend having this hole/ opening patched by a qualified person.

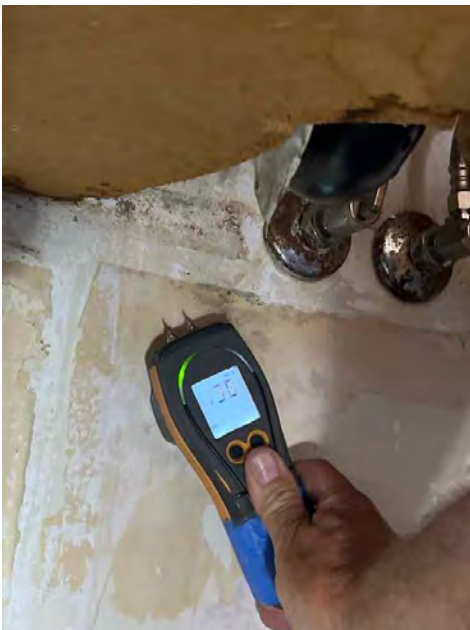
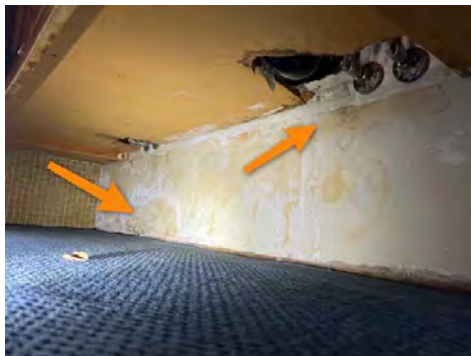
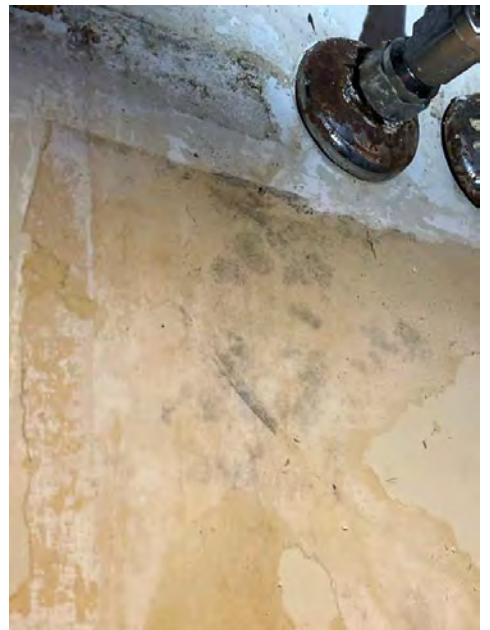
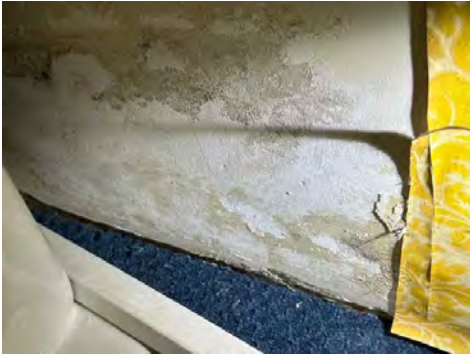
### APPARENT MOLD

Moisture Meter Dry Reading

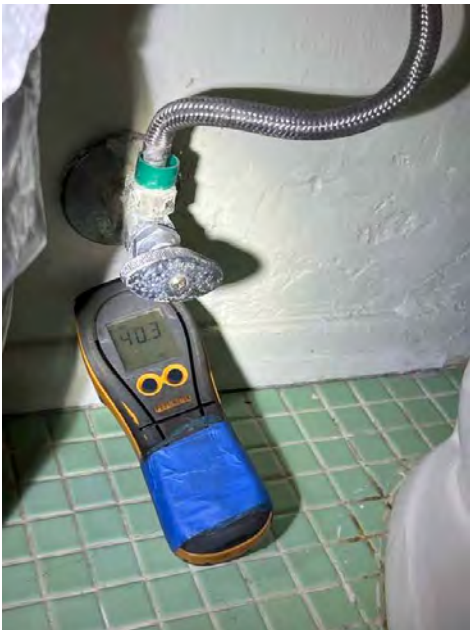
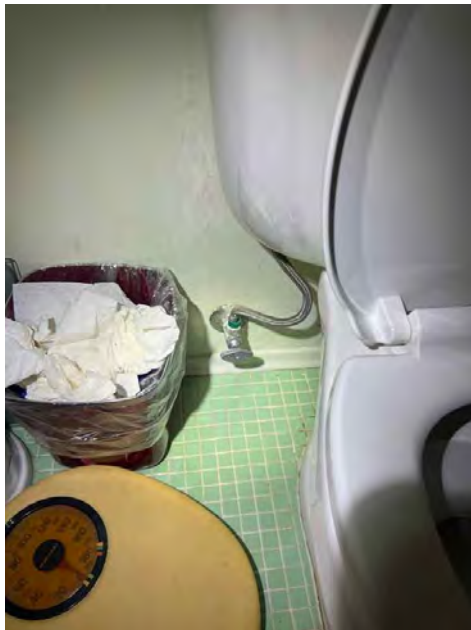
### MOISTURE - BEHIND TOILET

Moisture Meter Wet Reading

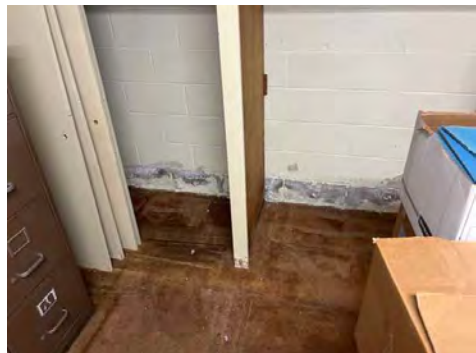
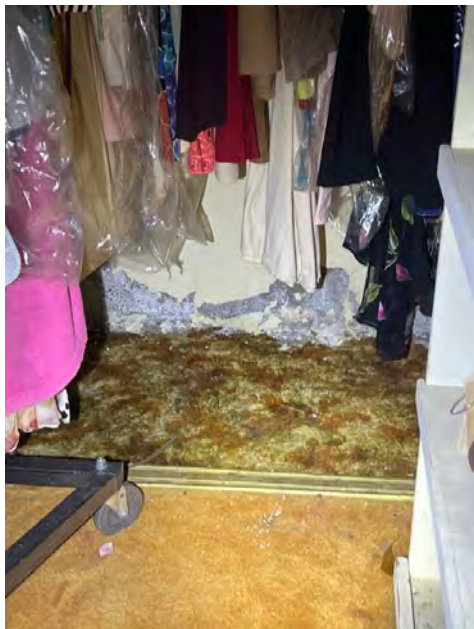
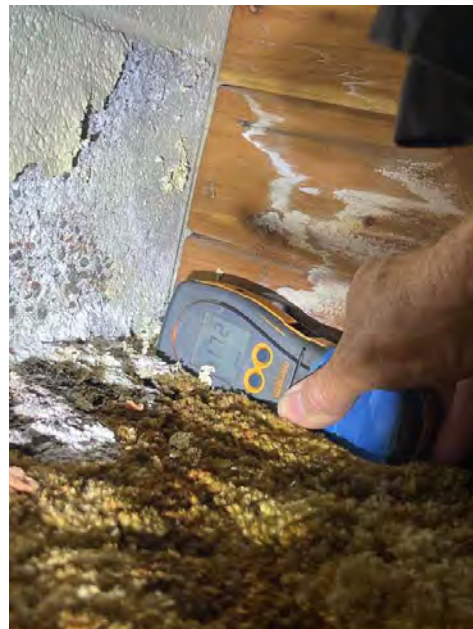
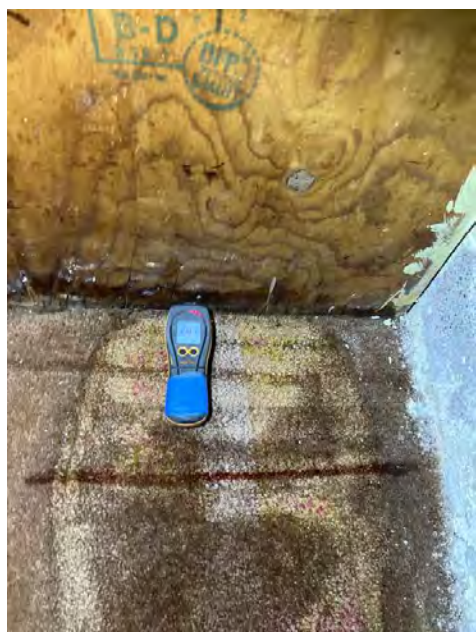
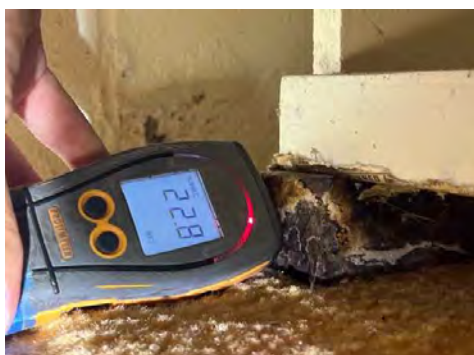
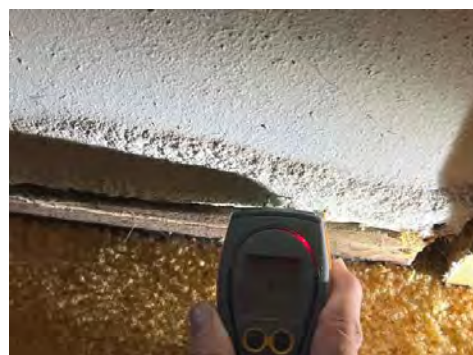
### WALLS BELOW GRADE - MOISTURE

Moisture Meter Wet Reading

Contact a qualified professional.

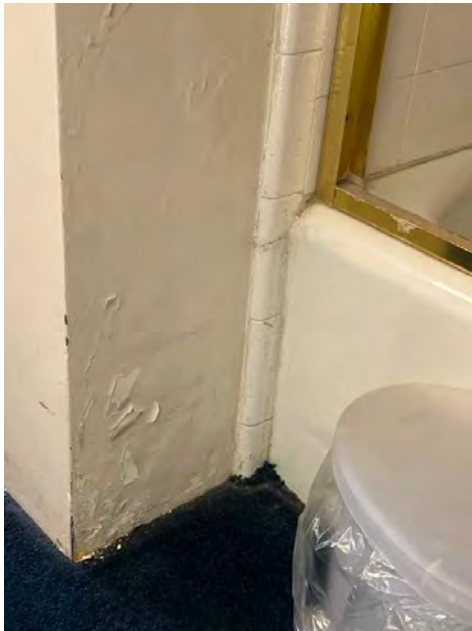
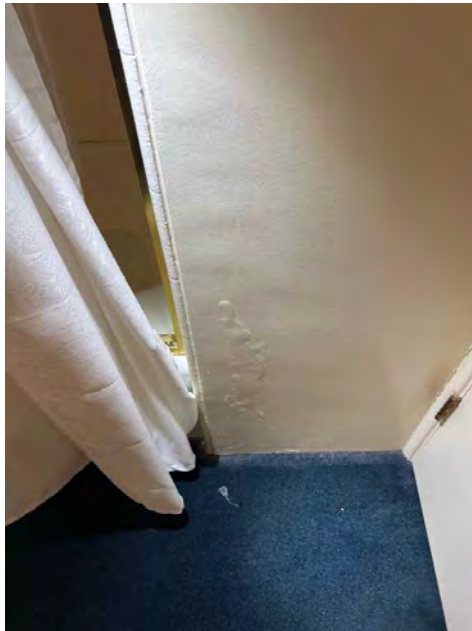
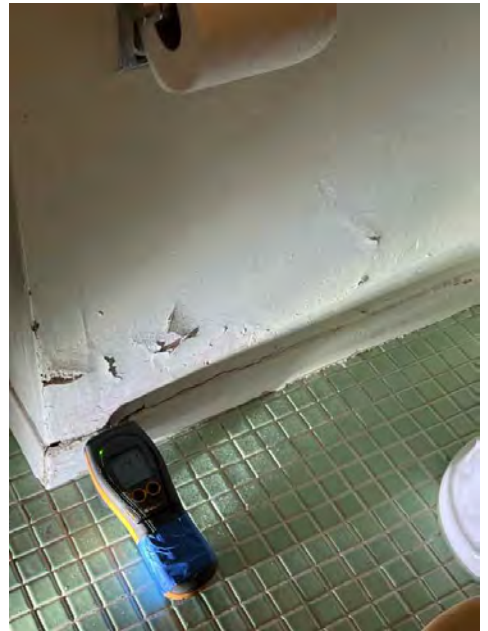
**BASEBOARD SWOLLEN - BATH**

Downstairs Bathroom Moisture Meter Dry Reading

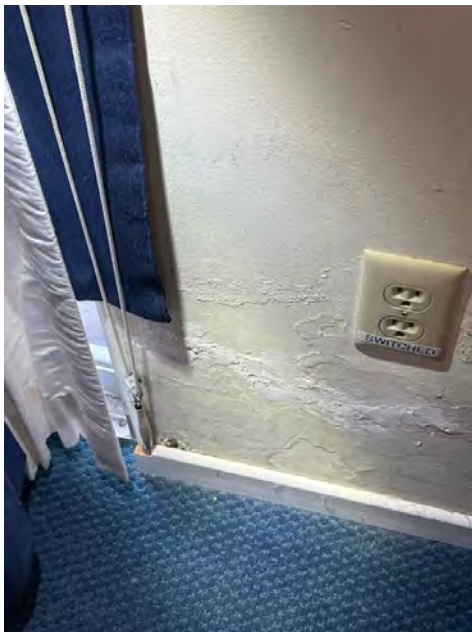
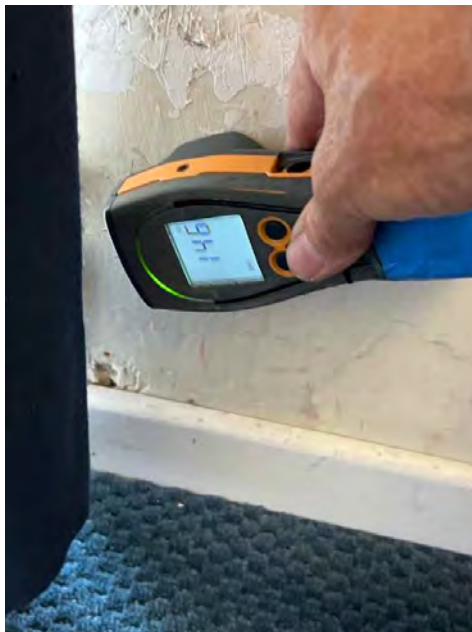
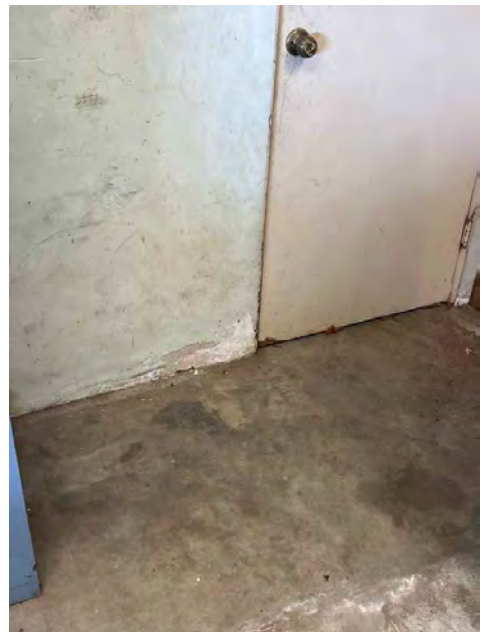
The plaster was damaged/swollen or patched in several areas at the base of the doors. Swelling observed was consistent with moisture damage and possibly moisture intrusion. This may be caused by rain or irrigation leaking through a door/window or exterior wall. I was unable to determine the exact cause. We advise further review with a licensed restoration contractor for repair. Note: There may be additional damage behind the wall which is not visible.

Moisture Meter Dry Reading

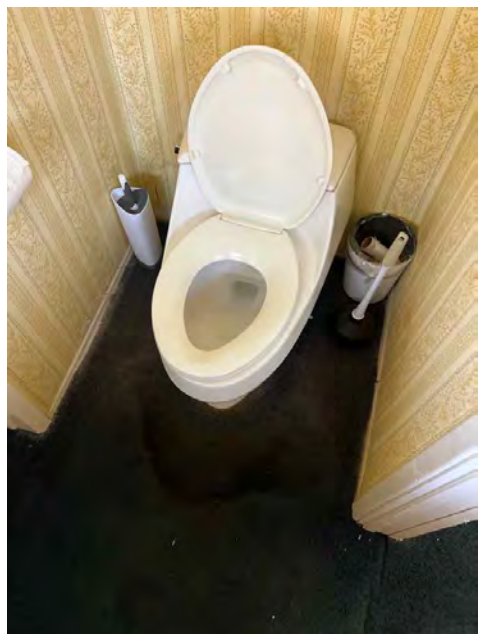
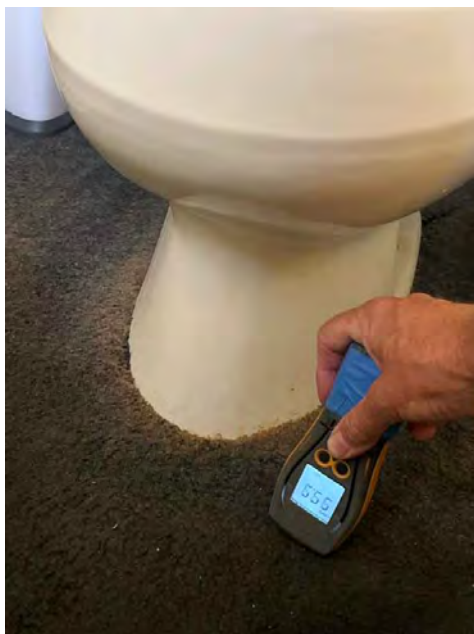
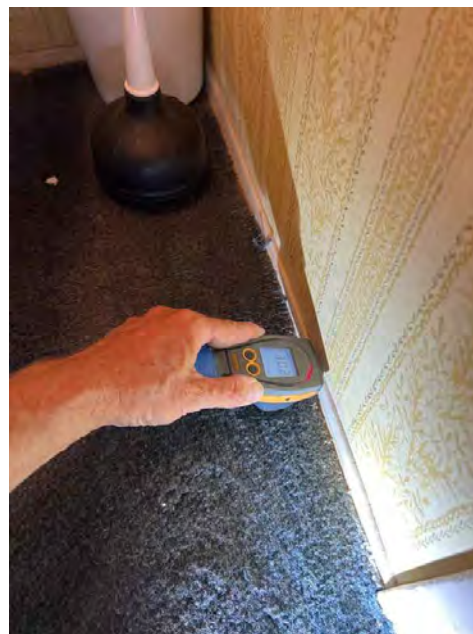
An elevated level of moisture was observed at the flooring around the toilets upstairs and apparent moisture was observed at the ceiling below the hall bathroom. (Using a moisture meter and infrared). This can indicate the toilet/wax ring may be leaking. Determining the exact cause of the moisture is beyond the scope of a home inspection. In some cases, repair or replacement of flooring is needed. We advise further review with a licensed restoration contractor for repair. Due to the concealed nature of any moisture damage, we recommend air sampling to confirm the presence or absence of mold.

Moisture Meter Wet Reading

Contact a qualified professional.

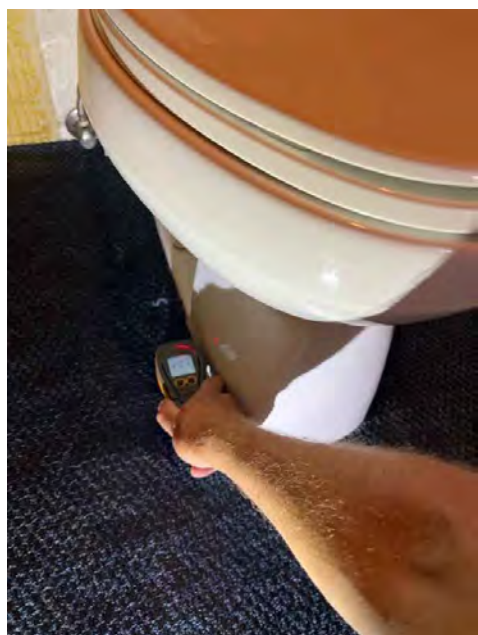
Master Bathroom Moisture Meter Wet Reading

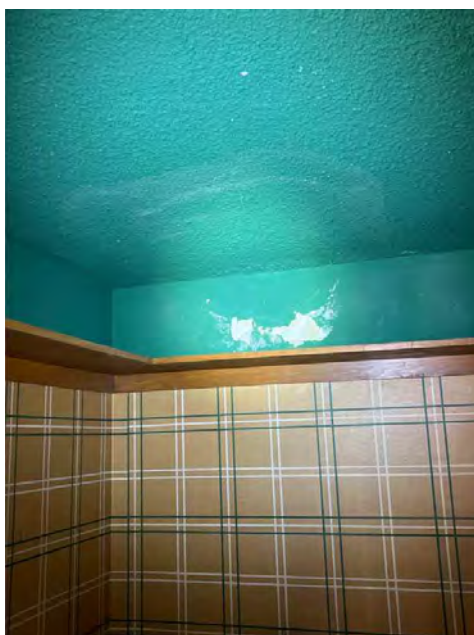
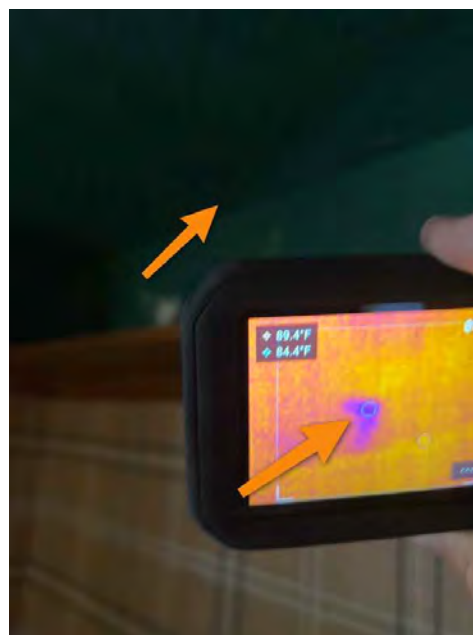
Wet

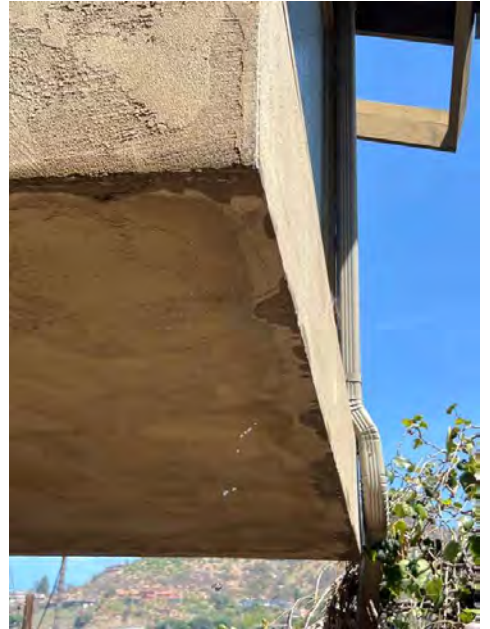
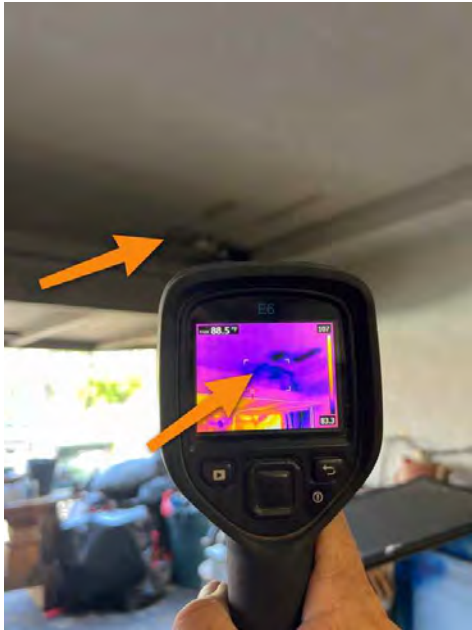
Wet-garage ceiling

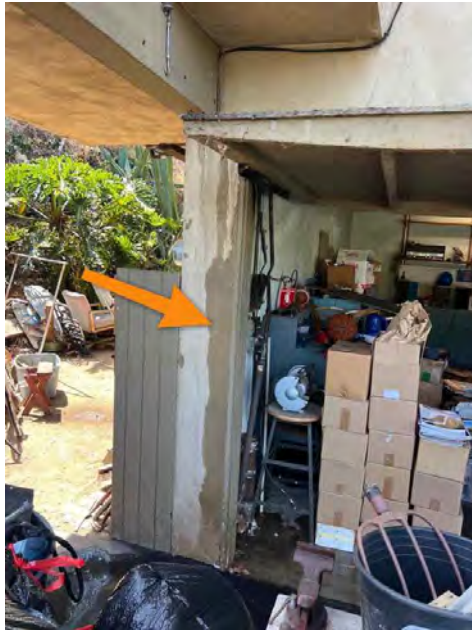
Wet

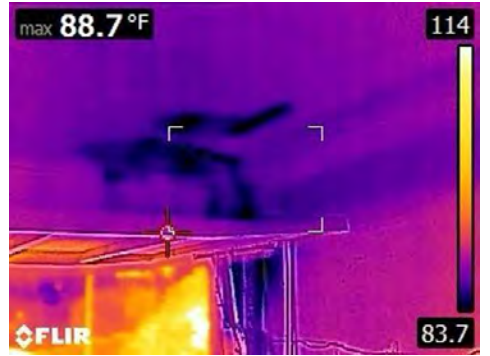
Garage-wet

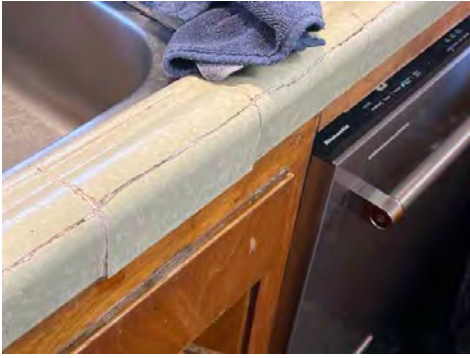
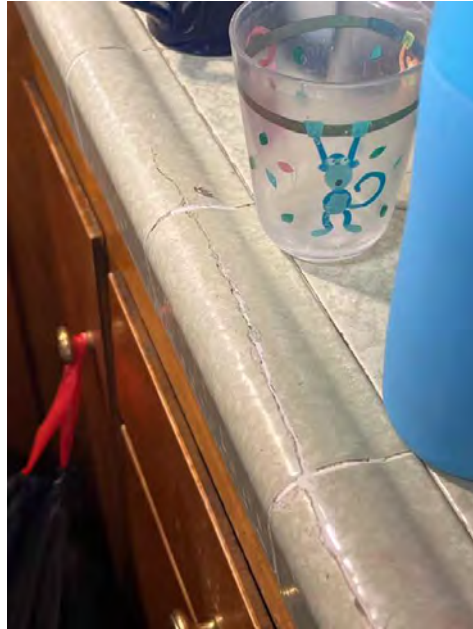
There are cracked and/or missing countertop tiles. We recommend necessary repairs by a qualified licensed contractor.

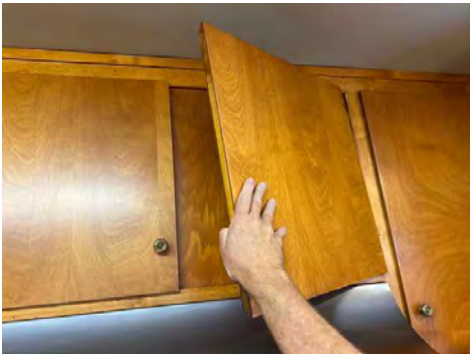
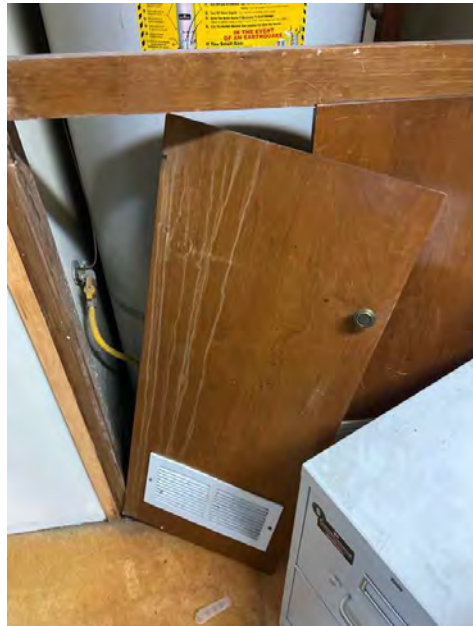
Cabinet door hardware noted loose or damaged. We advise necessary corrections with qualified person.

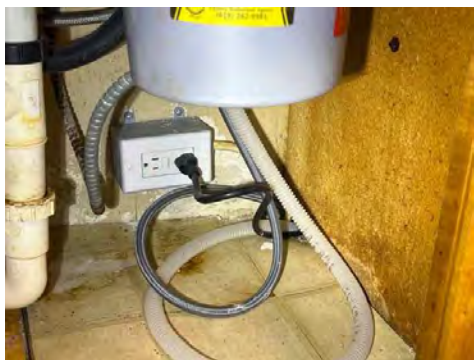
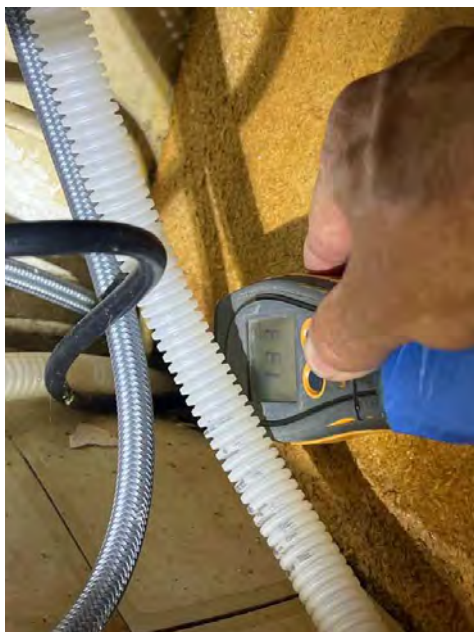
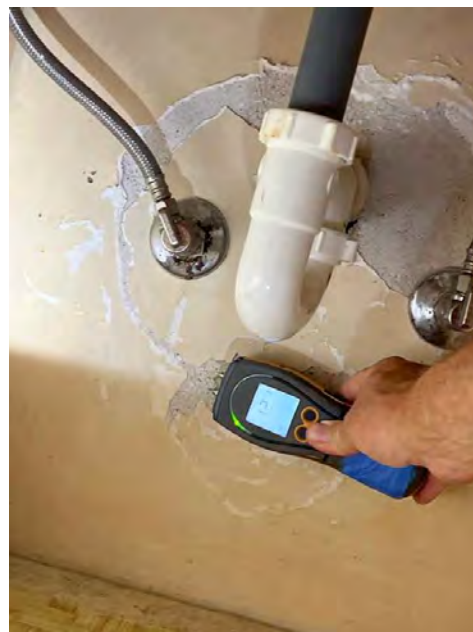
Moisture damage (swelling) was noted in the cabinet below the sink. The area was tested for moisture and found to be dry at the time of the inspection. Appears to be caused by a past leak. We recommend repair or replacement of the damaged material by a qualified contractor.

Upstairs Hall Bathroom Moisture Meter Dry Reading

Contact a qualified professional.

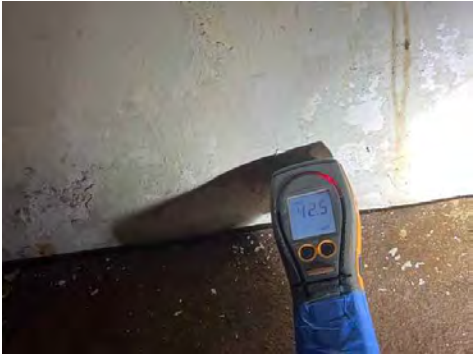
Evidence of leaks and elevated moisture readings were obtained at several locations around the bar sinks at both levels of the home as well as in the laundry area. There may be moisture damage behind the wall which is concealed and cannot be identified within the scope of a home inspection. To determine if moisture damage exists inside the walls, a more invasive inspection is required. If not corrected, water damage may occur and create an environment conducive to mold growth. We advise repair of the affected area with a licensed restoration or remediation type contractor which may include fixing the source of moisture, drying out the area.

Moisture Meter Wet Reading

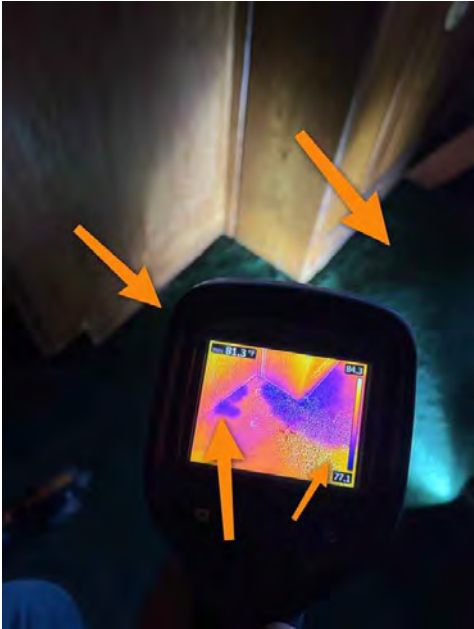
Wet

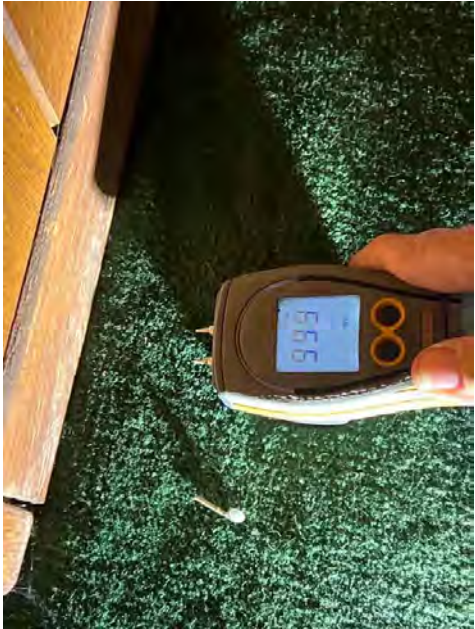
Moisture Meter Wet Reading

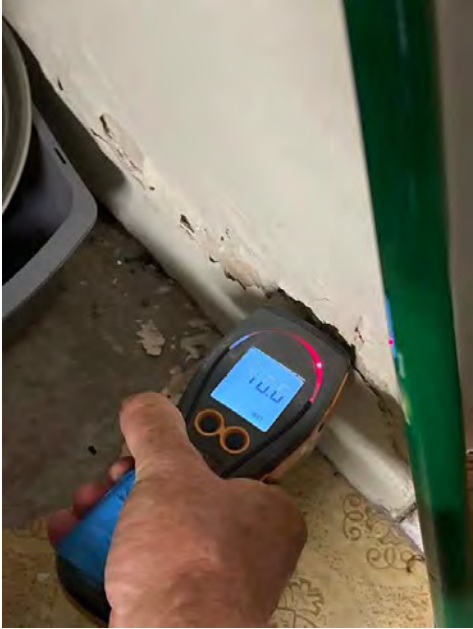
Laundry Room Moisture Meter Wet Reading

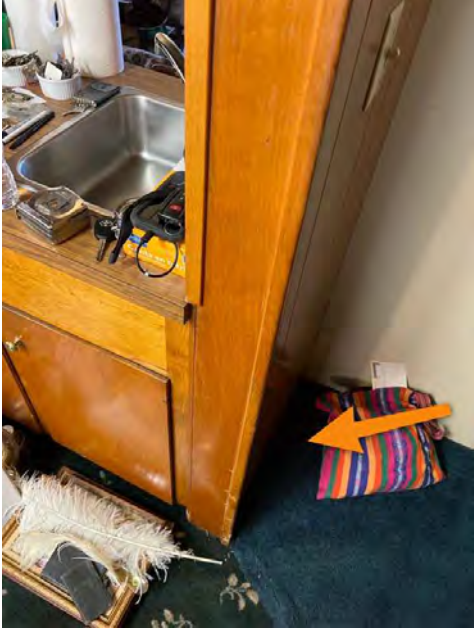
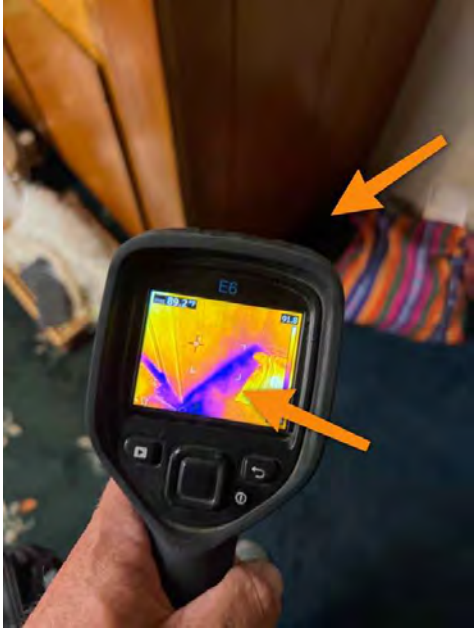
Wet

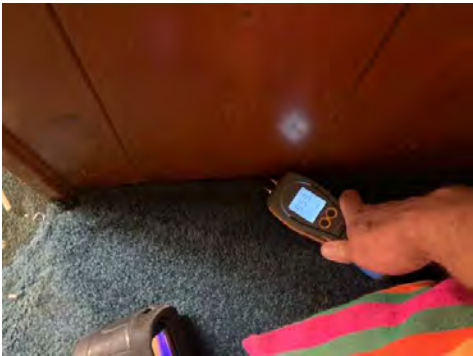
Moisture Meter Wet Reading

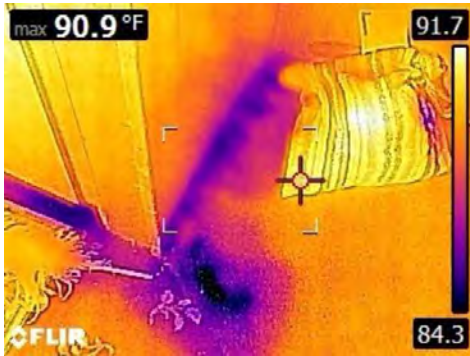
Carpet at upstairs bar sink

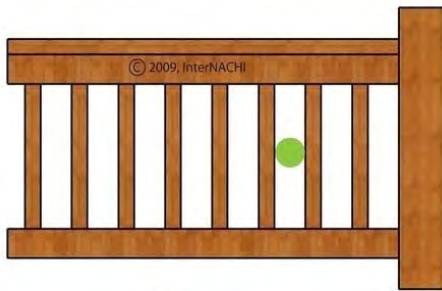
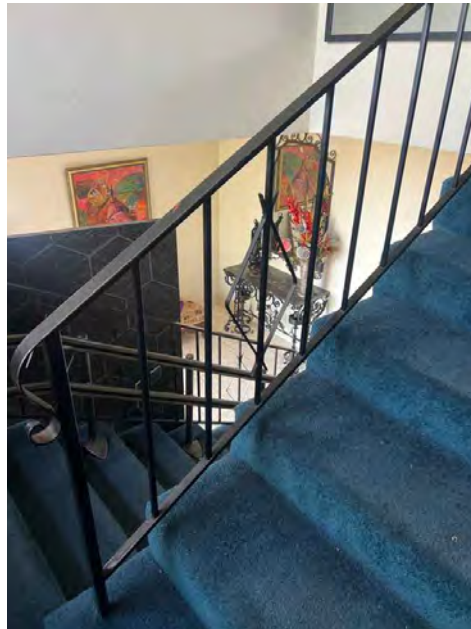
While the railing/baluster spacing may have been standard at time of construction, it does not comply with current safety standards. The large openings can allow pets or children to fall through, or become entrapped. We recommend installing additional balusters, or other form of barrier to prevent injuries.

4" Sphere

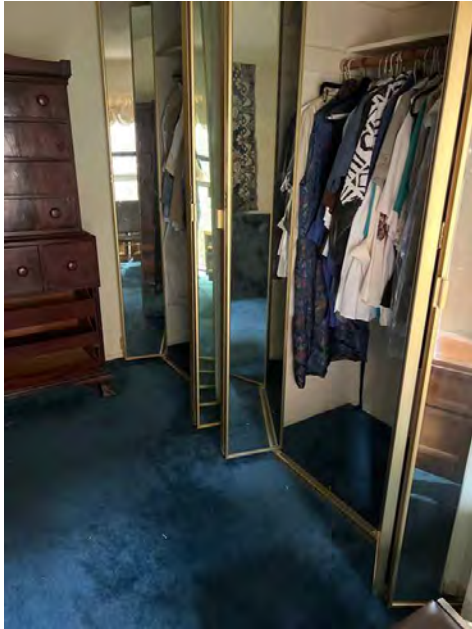
Closet door rollers are damaged. We advise repair or replacement.

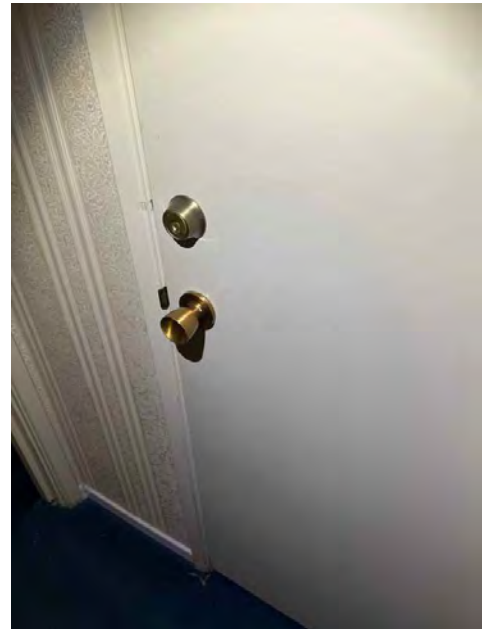
### 9.9.5 DOORS (REPRESENTATIVE NUMBER)

#### **STRIKE PLATE**

Contact a handyman or DIY project

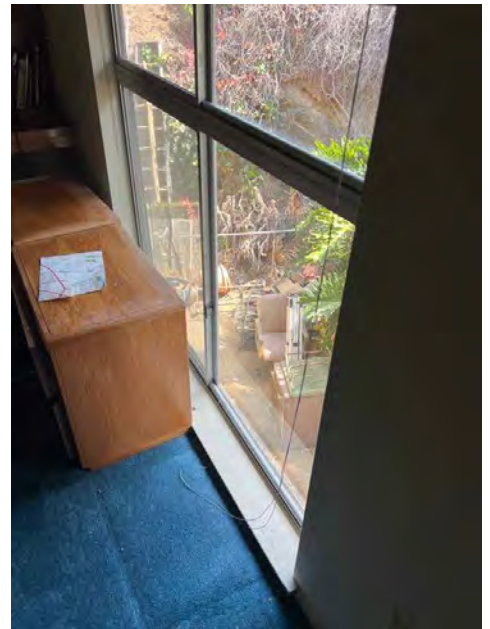
9.10.1 WINDOWS  
(REPRESENTATIVE NUMBER)

### LOW WINDOW- FALL HAZARD

Windows that are closer than 24" to the interior floor and more than 6 feet above exterior grade should be limited in their opening to avoid a fall hazard. Opening limiting devices can be installed to protect small children.

Contact a qualified window repair/installation contractor.

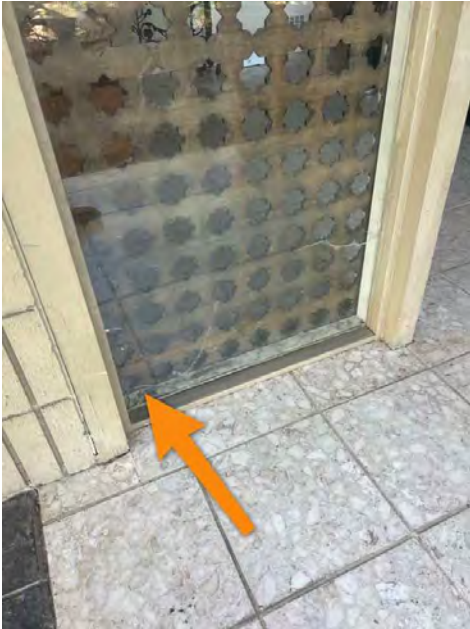
9.10.2 WINDOWS  
(REPRESENTATIVE NUMBER)

### GLASS CRACKED/BROKEN

A cracked/broken window was observed. We recommend repair or replacement by a licensed window repair company.

Contact a qualified window repair/installation contractor.

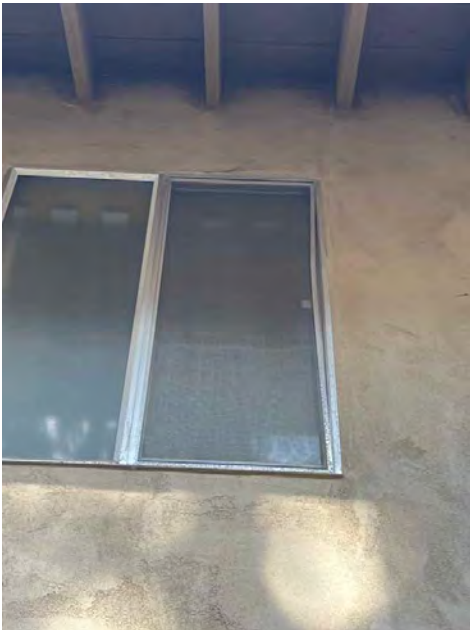
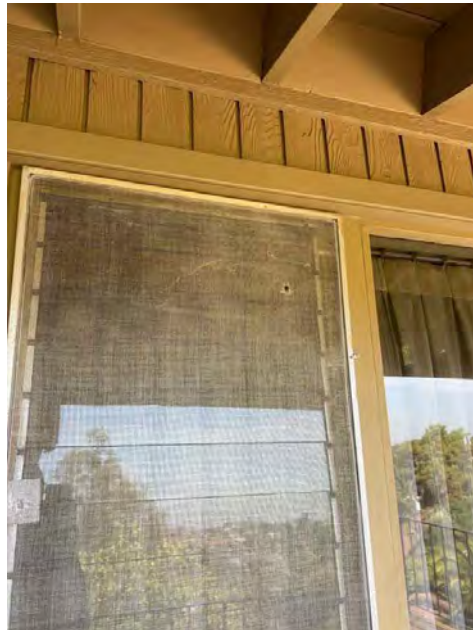
### 9.10.3 WINDOWS (REPRESENTATIVE NUMBER)

#### **SCREENS - TORN, DAMAGED**

Several screens are bent or torn. We recommend repair or replace as needed by a qualified person.

Contact a qualified professional.

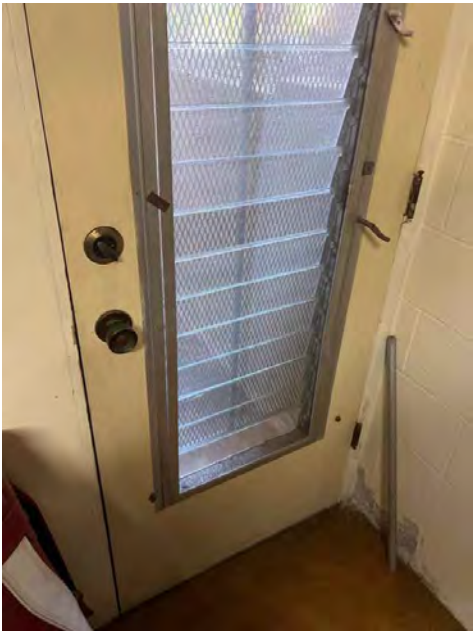
### 9.10.4 WINDOWS (REPRESENTATIVE NUMBER)

#### **CRANK - DAMAGED/INOPERABLE**

Jalousie (louvered) window(s) had a damaged crank (handle) that made operation difficult or window was inoperable. We recommend service by a qualified window repair contractor.

Recommendation  
Contact a qualified window repair/installation contractor.

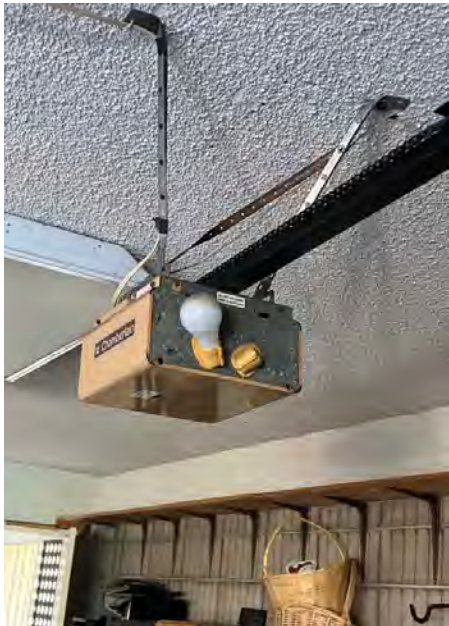
## GARAGE DOOR OPERATORS: AGE/OLD - Inspected

Note: The garage door opener was operable at time of inspection, but is an older unit and may be at or near the end of its useful life.(average life span is 12 years) Opener replacement is usually recommended rather than replacement of parts. Consider consulting with a qualified contractor to discuss options and costs for replacement of the garage door opener.
