## HOME INSPECTION

9827 Edgar Pl  
La Mesa, CA 91941

07/27/2026

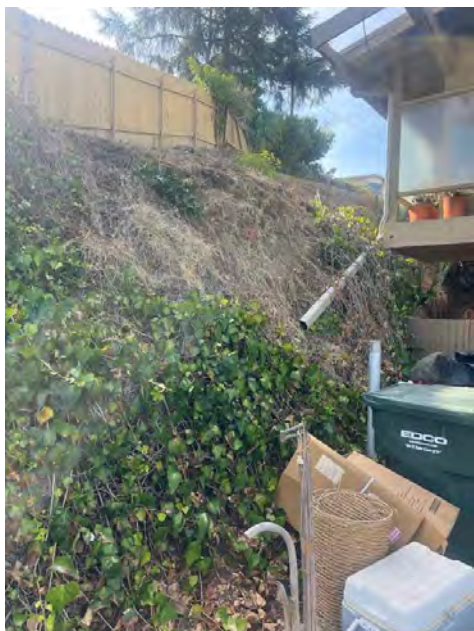
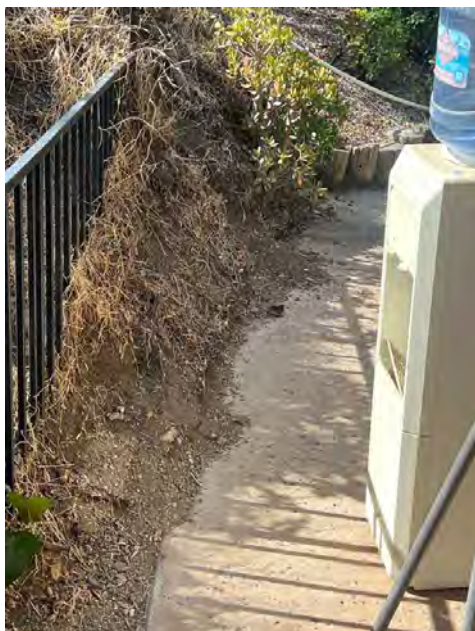
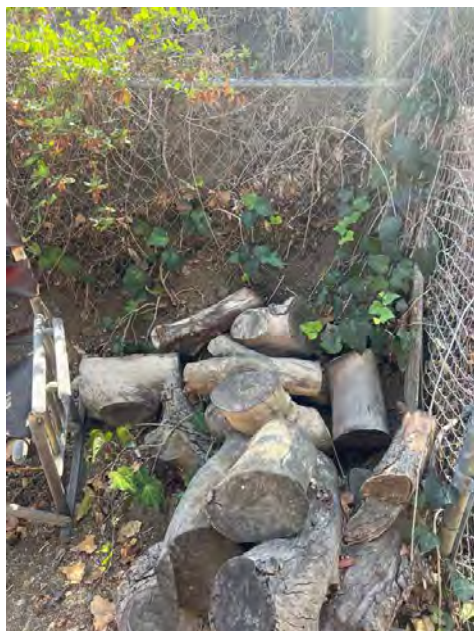
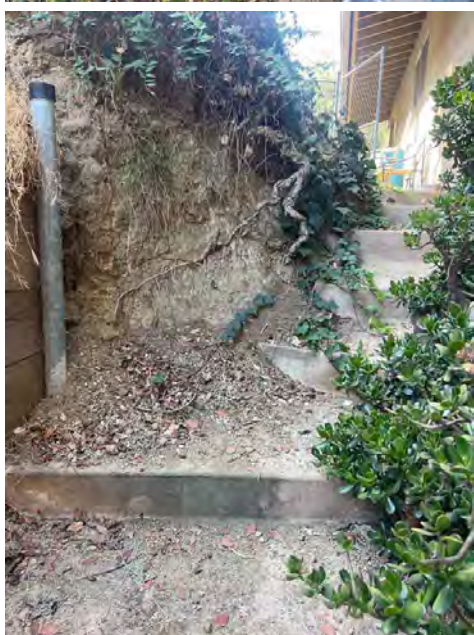
10.2.1 GRADING & DRAINAGE (With respect to their effect on the condition of the building)

The dirt bank is eroding. Silt travel is occurring and some form of ground cover or landscaping is needed. We recommend a qualified contractor inspect and provide an estimate for the necessary repair prior to the end of your contingency period.

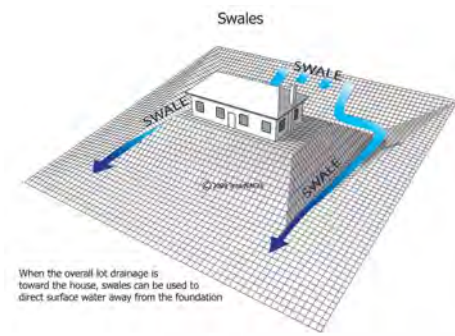
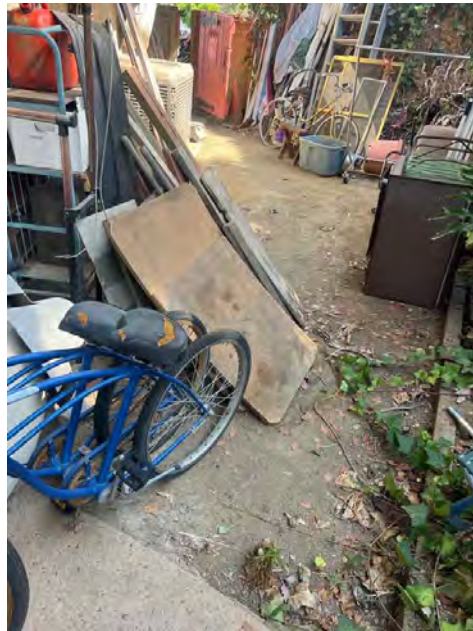
#### 10.2.2 GRADING & DRAINAGE (With respect to their effect on the condition of the building)

Low areas were observed at the grading which will cause water to pond during rain or extended irrigation. Standing water can be detrimental to the integrity of the foundation of the house. It is important to prevent or minimize standing water around the house. This can be accomplished by properly sloping the ground away from the house, or adding yard drains to carry water away from the low-lying areas. Rain gutters should also be installed and drained away from the house. We recommend further evaluation by a qualified landscape contractor.

Contact a qualified landscaping contractor

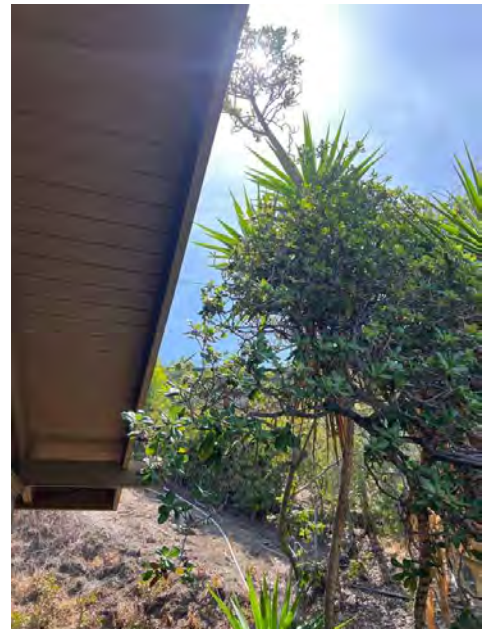
10.3.1 VEGETATION (With respect to its effect on the condition of the building)

Tree(s) and/or large plants are located too close to the house. Tree limbs/vegetation that are too close to the house can cause damage in several ways. Limbs or vines in contact with roof or hanging near roof should be trimmed to prevent damage to roof and/or to prevent rodent infestation. Also, as the plants grow, damage can occur to the siding, concrete flat work, and to the foundation. We recommend having the foliage removed or trimmed by a qualified professional to prevent damage to the house.

Contact a qualified professional.

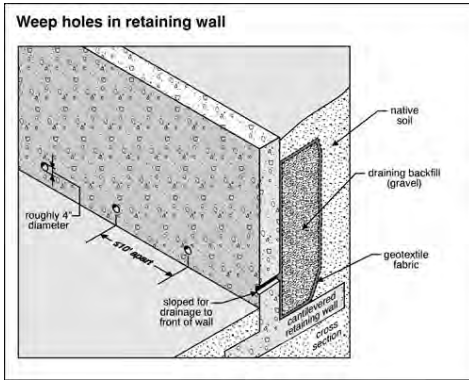
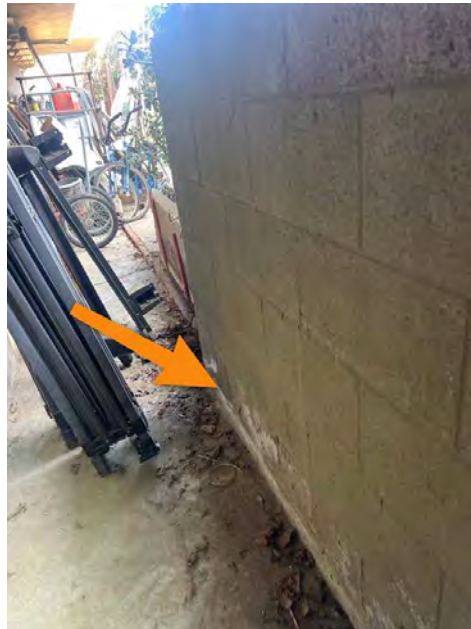
10.4.1 RETAINING WALLS (With respect to their effect on the condition of the building)

### RETAINING WALL - NO WEEPS - DAMAGE VISIBLE

Retaining wall does not appear to have weep holes. Weep holes allow water to drain from behind wall. Lack of weep holes can create excessive pressure on wall, soil movement, premature deterioration of wall material, and efflorescence which can damage stucco coating if drainage was not installed behind the wall. The weep holes may be too low (under top soil) or missing. Evidence of water build-up or surface damage was visible which indicates the wall does not have adequate drainage. We recommend having weep holes or drainage installed by a qualified contractor, you may wish to obtain an estimate of repair before the close of your contingency period.

Contact a qualified professional.

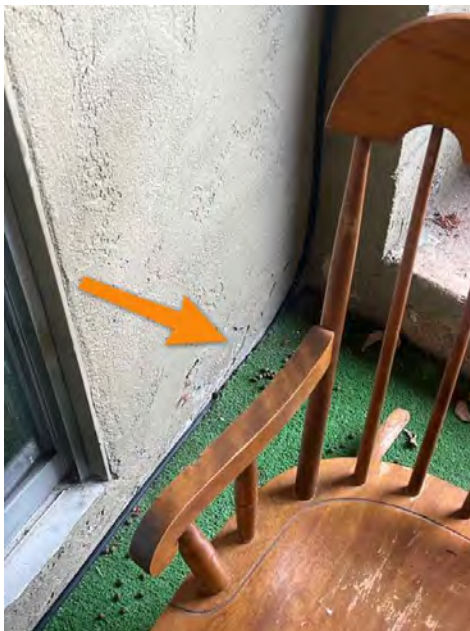
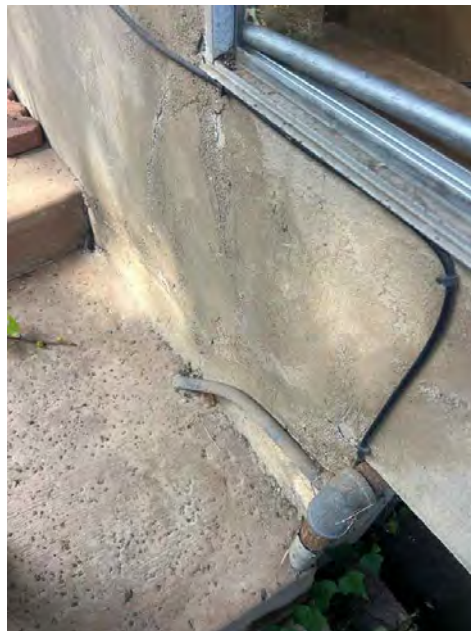
#### 10.5.1 WALL SIDING FLASHING AND TRIM

##### **STUCCO - DAMAGED**

There is damaged/ deteriorated stucco observed at small areas. We recommend necessary repairs by a licensed stucco contractor.

Contact a stucco repair contractor

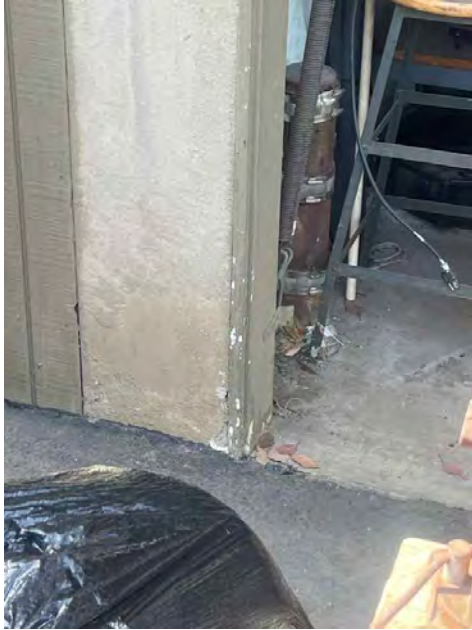
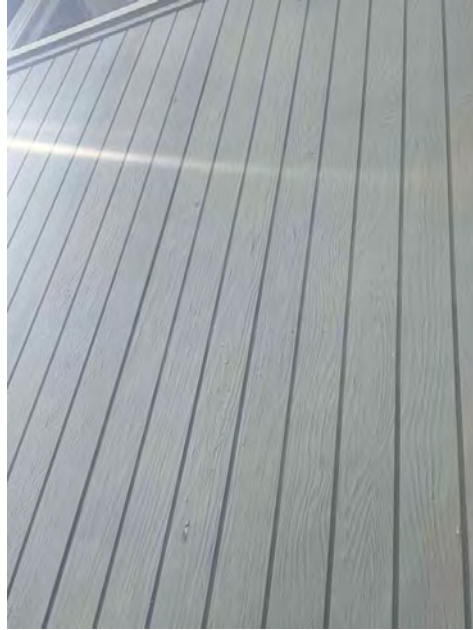
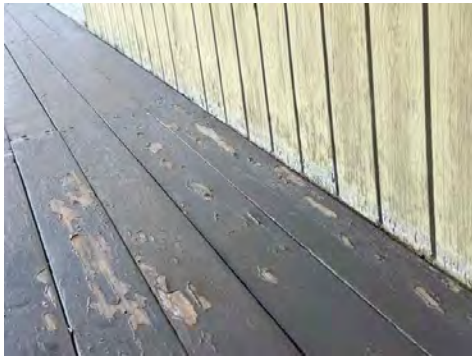
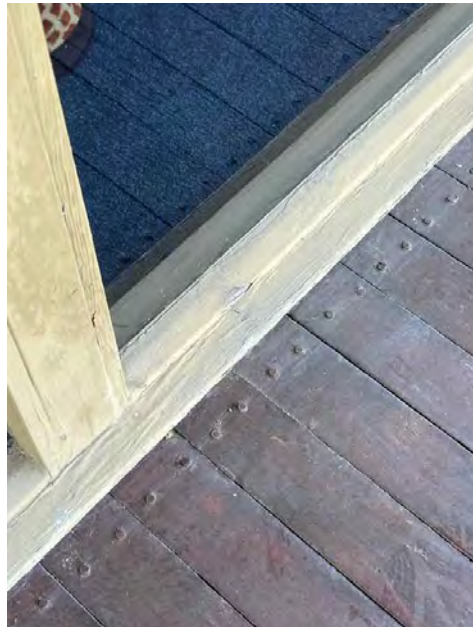
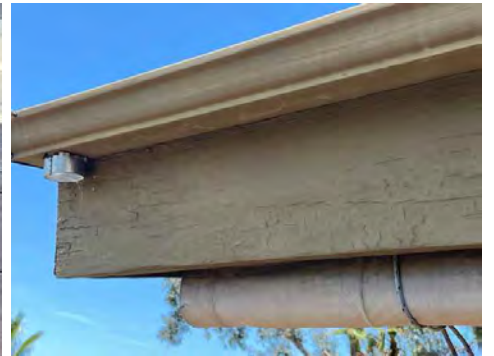
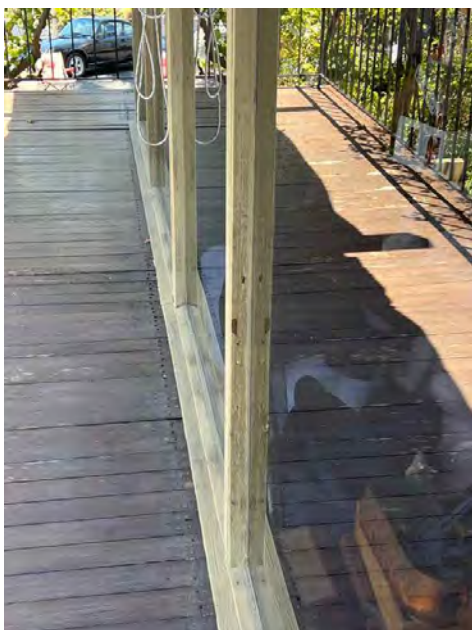
#### 10.5.2 WALL SIDING FLASHING AND TRIM

Bare wood or peeling paint was observed and needs primer and paint. Maintaining paint is essential to preventing the wood from damage.

Contact a qualified painting contractor.

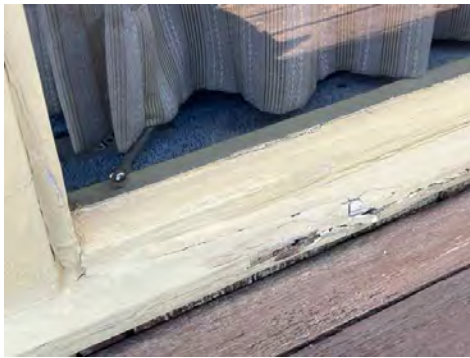
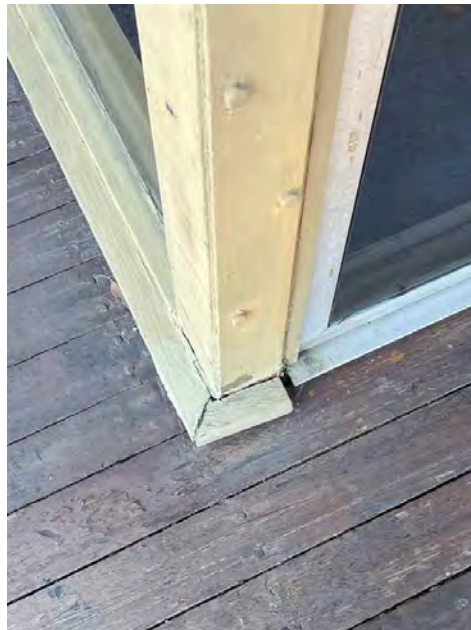
## 10.5.3 WALL SIDING FLASHING AND TRIM

**DAMAGED WOOD TRIM**

Some damaged wood was observed at the exterior. We recommend referring to the pest inspection report for a detailed evaluation of the wood and repair with qualified contractor.

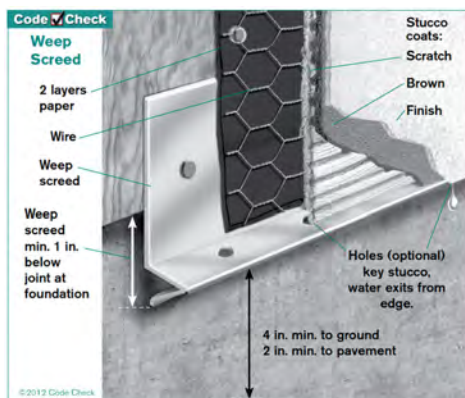
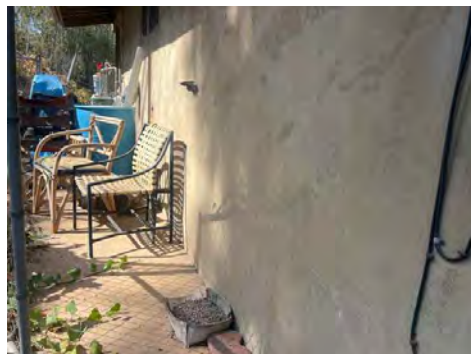
## 10.5.4 WALL SIDING FLASHING AND TRIM

**WEEP SCREED - ADD OLDER HOME**

Stucco on older homes built before the 1970s was installed without a weep screed. The weep screed is a metal band at the bottom of the stucco, which has holes to allow the stucco to "breathe" and water to "weep" from the stucco. Having the soil in contact with stucco will lead to stucco damage due to moisture. Installing a weep screed will be needed to avoid cracking and deterioration.

Contact a stucco repair contractor

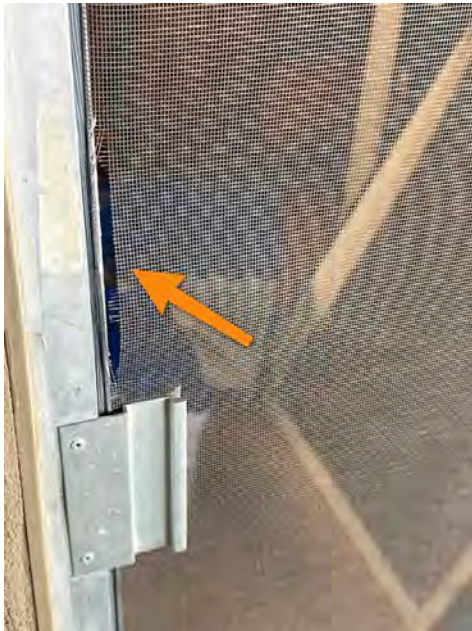
##### **SLIDER SCREEN - TORN/DAMAGED**

The sliding screen door has a torn or damaged screen. We recommend repair by a qualified person.

Contact a qualified professional.

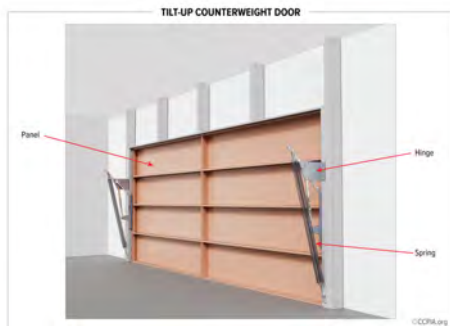
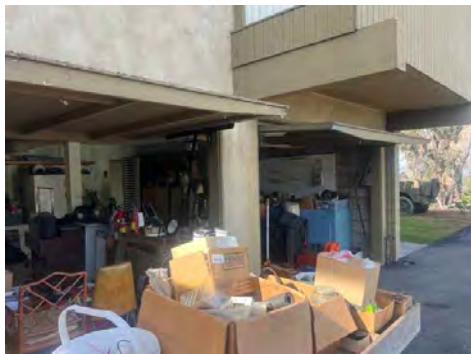
#### 10.7.1 GARAGE VEHICLE DOORS

##### WOOD TILT UP

Wood tilt-up doors are no longer installed in homes. Wood tilt-up doors are very heavy, and the hinges or springs can fail causing the door to fall and cause property damage and/or injury. While no garage door is 100% safe, we recommend upgrading the wood door to a modern metal or wood panel door for safety.

Contact a qualified garage door contractor.

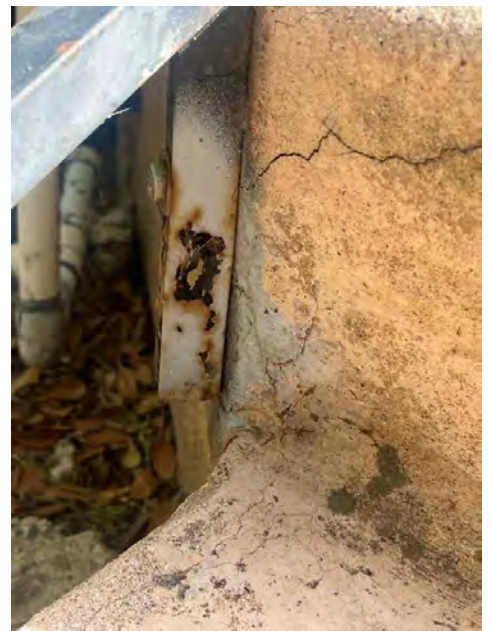
##### **RUSTED POST**

Some deterioration was noted at the metal railings. We recommend repair by a qualified contractor.

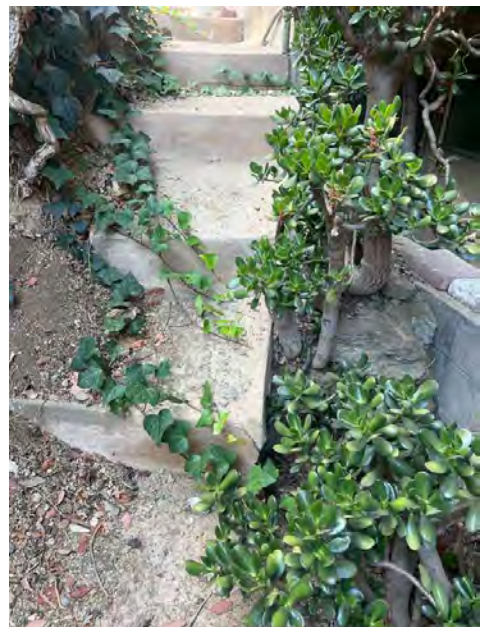
### 10.9.3 STOOPS, STEPS, PORCHES AND RAILINGS

## CONCRETE STAIRS DAMAGE

There is cracking and damage to concrete steep/stairs. Recommend repair or replacement as needed.

Contact a qualified concrete contractor.

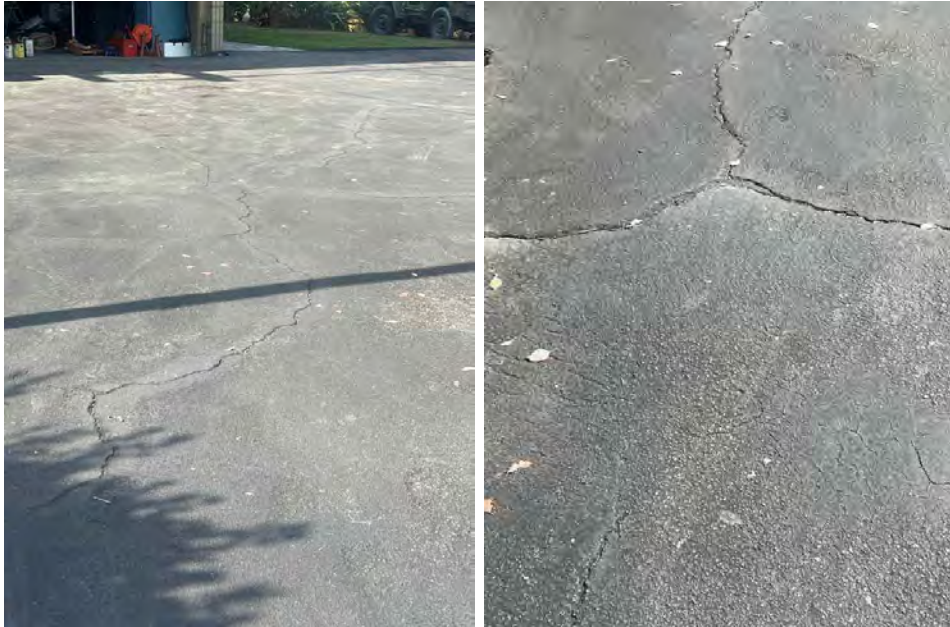
**ASPHALT DETERIORATED**

The asphalt driveway is cracked and deteriorated in some areas. We recommend that you obtain a quotation for repair prior to the end of your contingency period.

Contact a qualified professional.

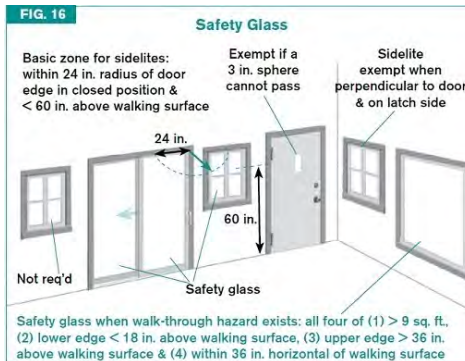
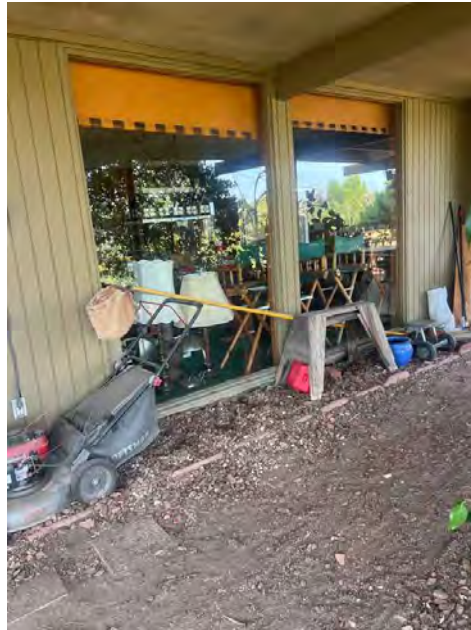
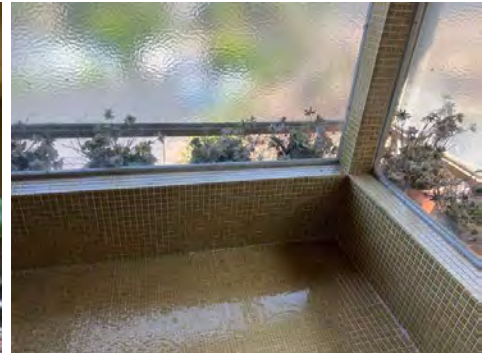
Homes built before 1979 may not have safety glazing (glass) where it is required in newer homes. Regular plate glass that is subject to human impact can cause injuries. Locations that have a higher probability of human impact are now required to have safety or tempered glass. These areas include sliding glass doors, windows or glass doors around tubs and showers, windows at stairwell landings, windows low to the ground, and windows that may be damaged either by a swinging door or by someone being pushed into the glass by a swinging door. Therefore glass inserts at doors and adjacent to doors should be safety glass.

Since plate glass was acceptable at time of construction, home inspectors can only recommend upgrades for safety, but sellers do not have to bring an old house up to today's building code. Also some safety glass cannot be identified without specialty testing equipment which home inspectors do not use. We recommend that you read "[Safety Glazing](#)" by Douglas Hansen for more information, and upgrade windows as needed for safety.

Contact a qualified window repair/installation contractor.

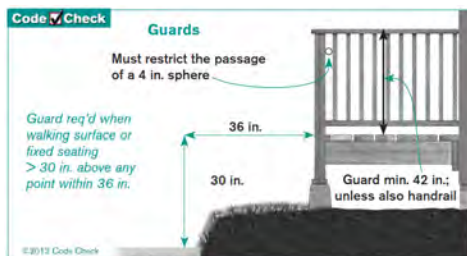
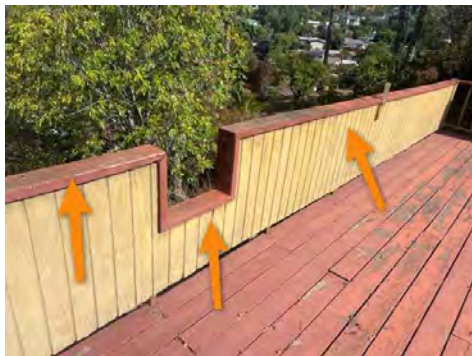
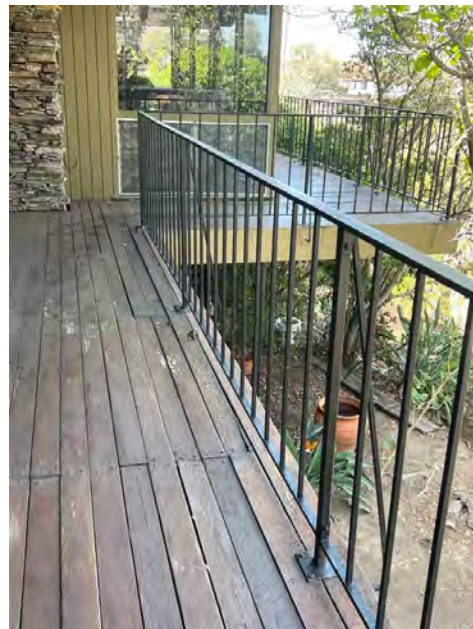
### 11.1.1 RAILINGS

The guardrails are too low to meet modern standards. The cut out in the pool deck rail is particularly hazardous. We recommend correction by a qualified contractor.

Contact a qualified deck contractor.

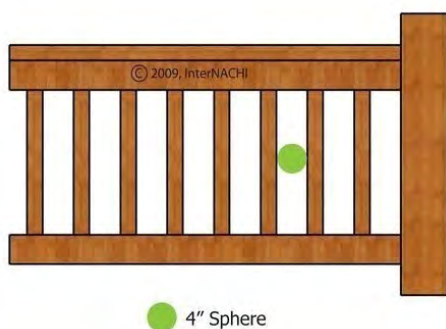
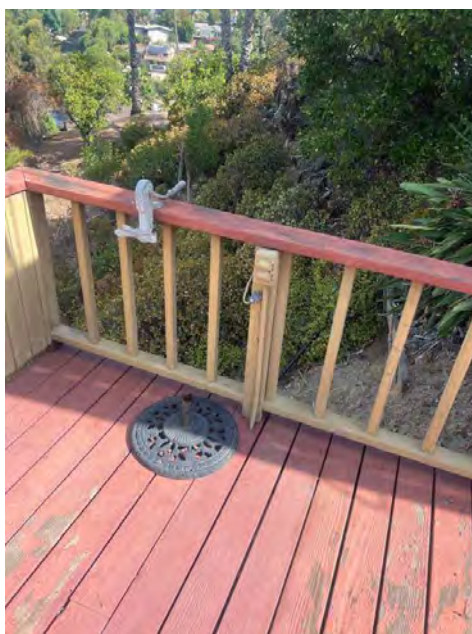
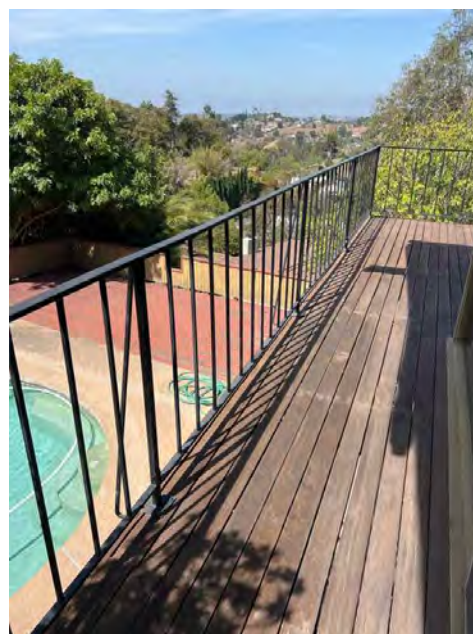
## 11.1.2 RAILINGS

**RAILING - SPACING**

While the railing/baluster spacing may have been standard at the time of construction, it does not comply with current safety standards. The large openings can allow pets or children to fall through, or become entrapped. We recommend installing additional balusters, or another form of barrier to prevent injuries.

Contact a qualified deck contractor.

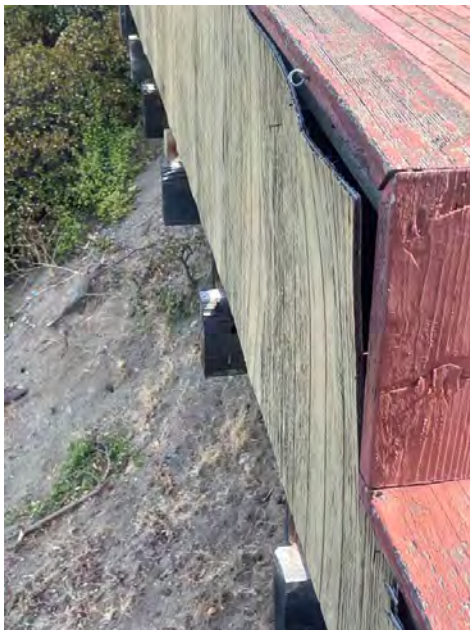
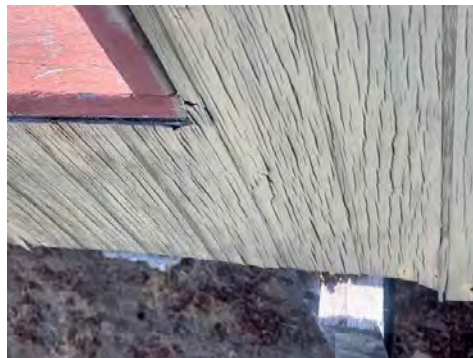
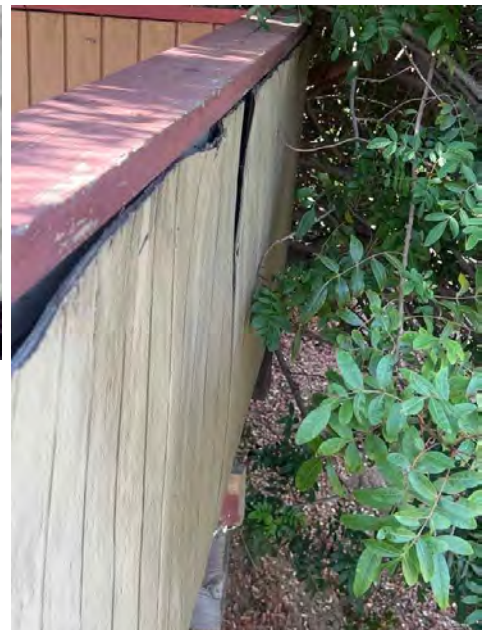
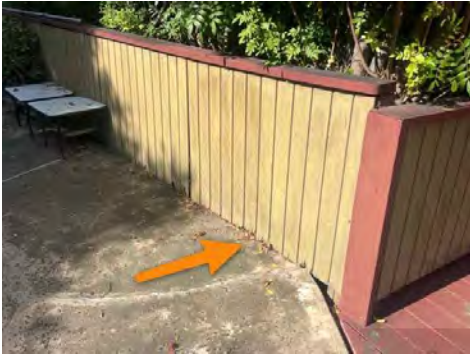
##### **DAMAGE - RAILING**

Wood damage was observed at the plywood covering the pool deck railing. Home inspectors do not have the to comment on termites or dry rot, which is the responsibility of a state licensed pest inspector. However, we recommend further review and repair by a qualified licensed contractor for safety.

Contact a qualified deck contractor.

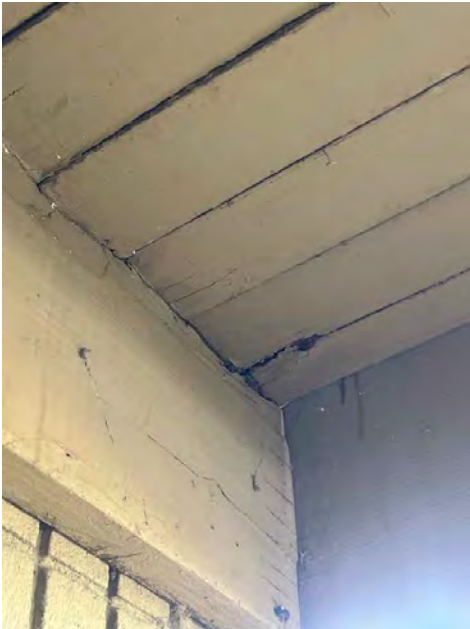
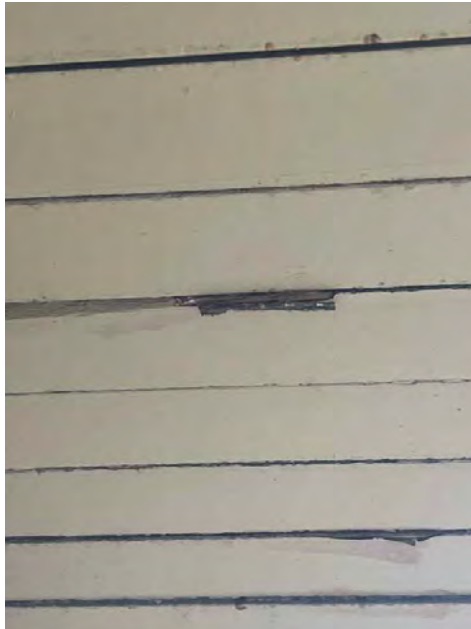
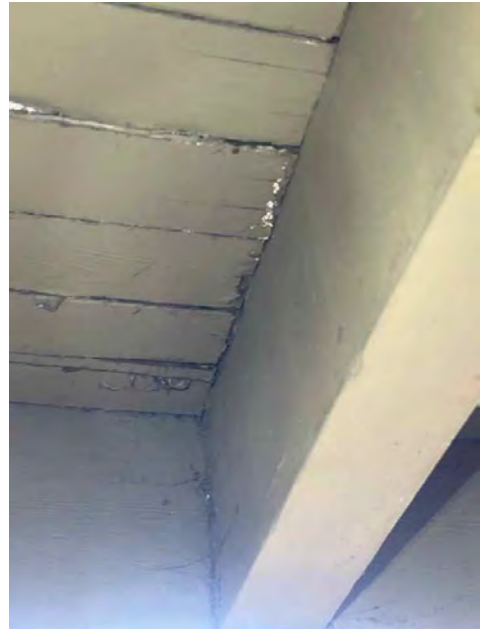
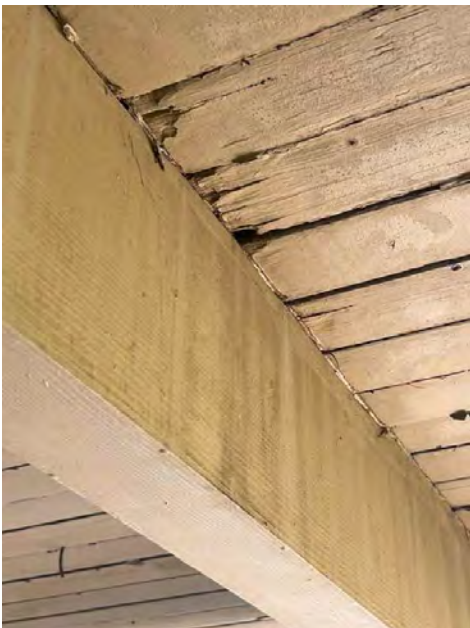
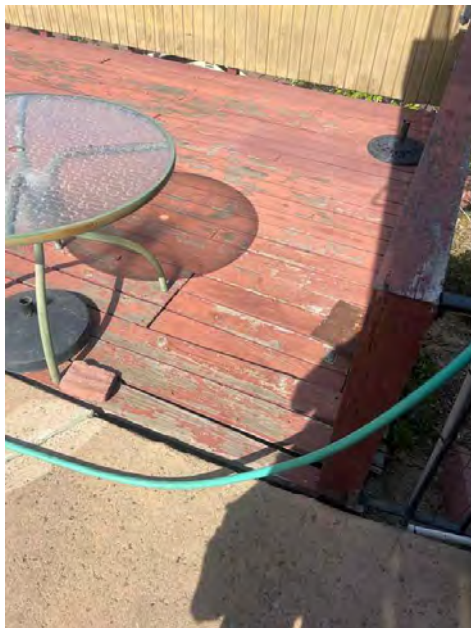
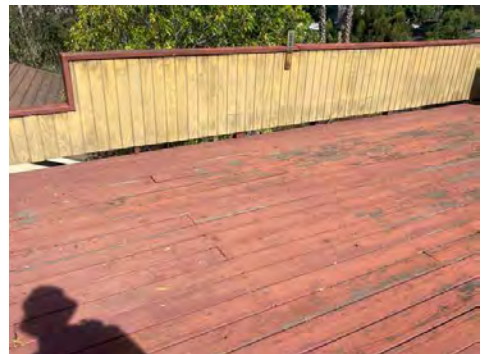
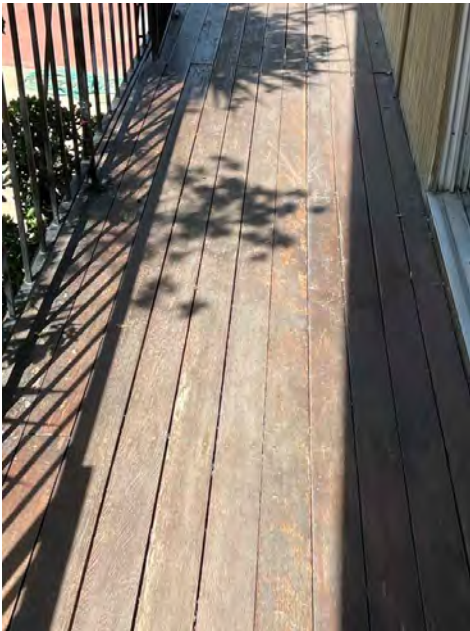
## 11.2.1 SURFACE

**DECK BOARDS DAMAGED**

Decking was showing signs of wood rot and damage. Recommend review by a professional contractor.

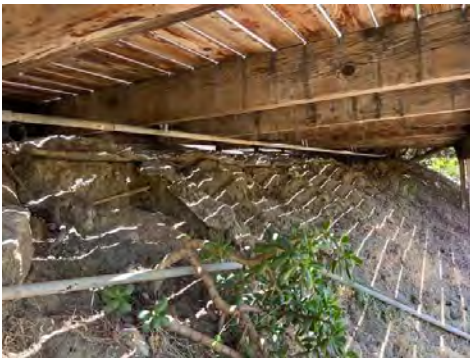
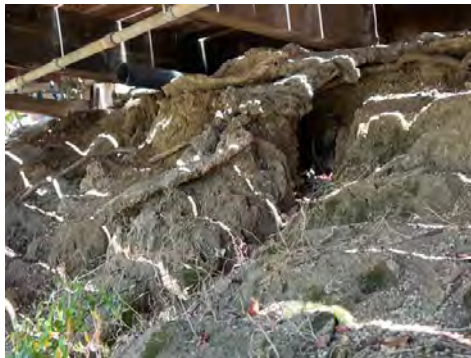
#### 11.3.1 DRAINAGE

### EROSION BELOW DECK

Soil movement was noted below the wood pool deck. Corrections should be made as needed to control water runoff from storms or the pool.

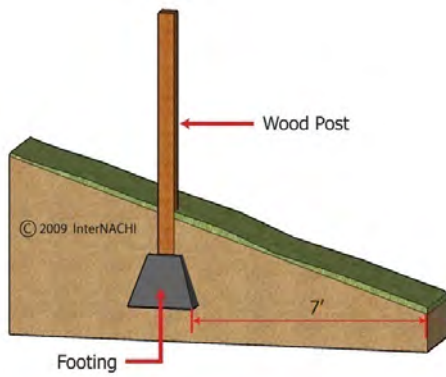
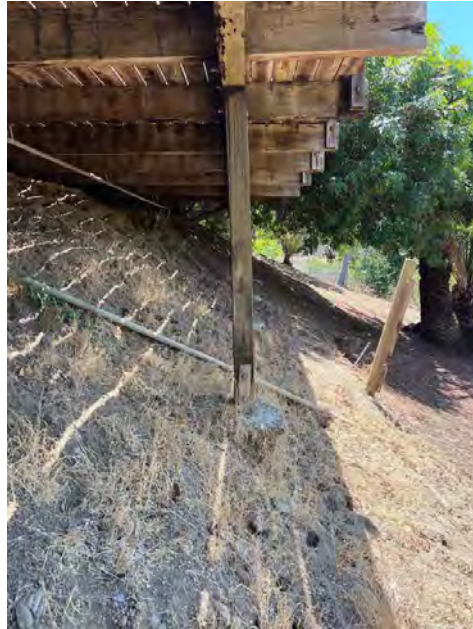
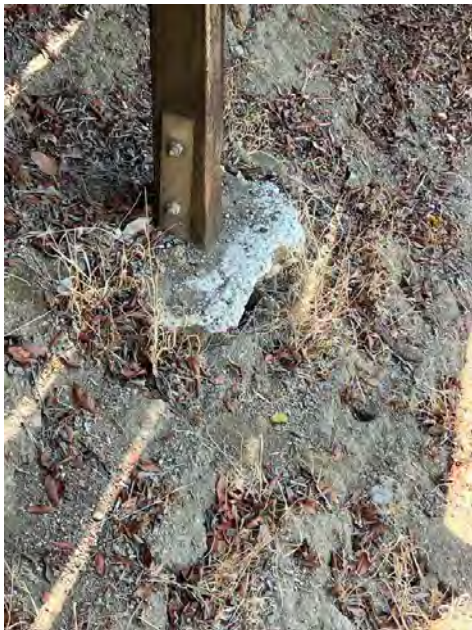
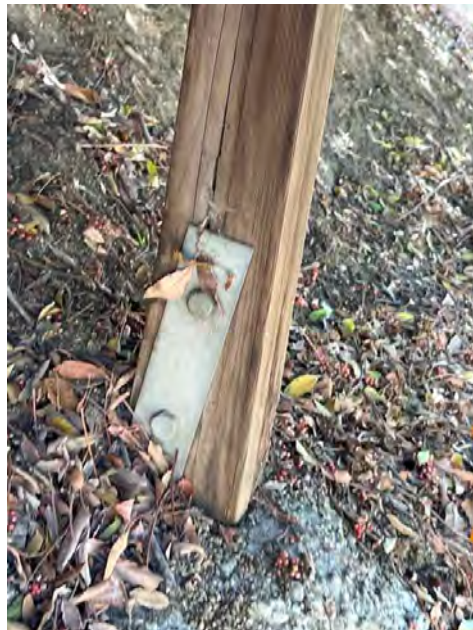
#### 11.4.1 FOOTINGS

### DECK FOOTING- UNDERMINED

Footings were observed below deck which does not appear to have adequate soil support. There should be no less than 7 feet between the footing and "daylight" when measured horizontally from the footing. Exposed footings were noted that indicate that the deck support is vulnerable to shifting. One of the posts and the beam above it appear to have shifted. This is a safety hazard. We advise further review with a licensed general contractor or qualified engineer before the close of your contingency period.

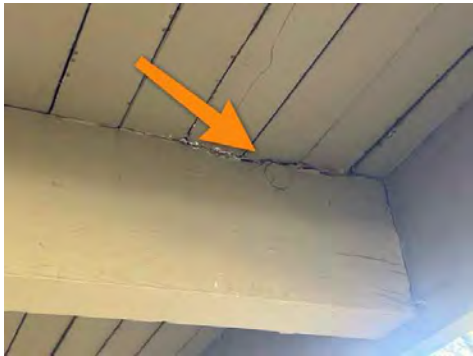
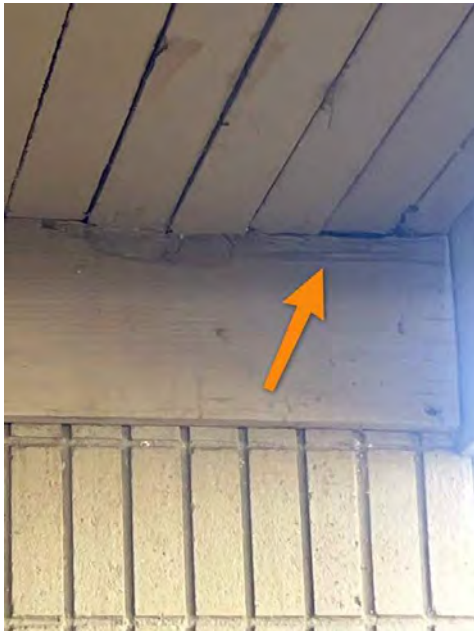
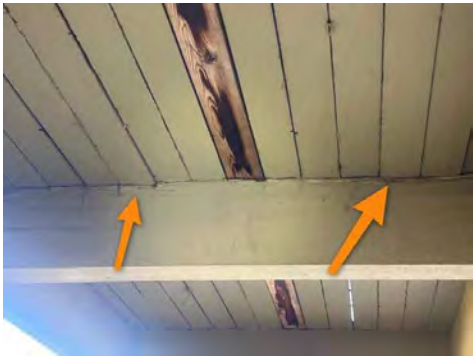
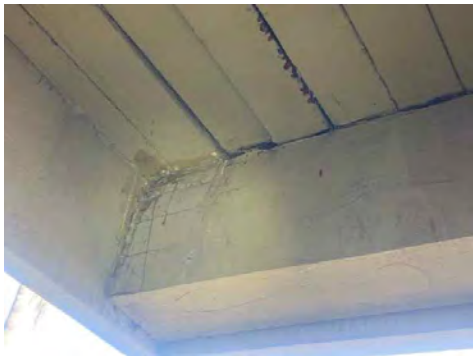
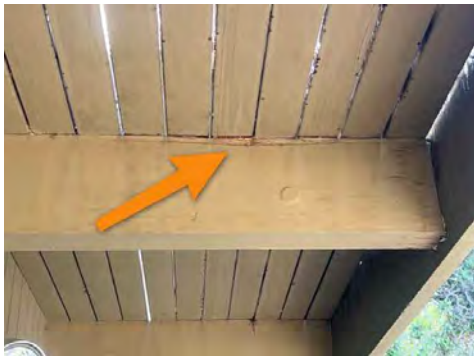
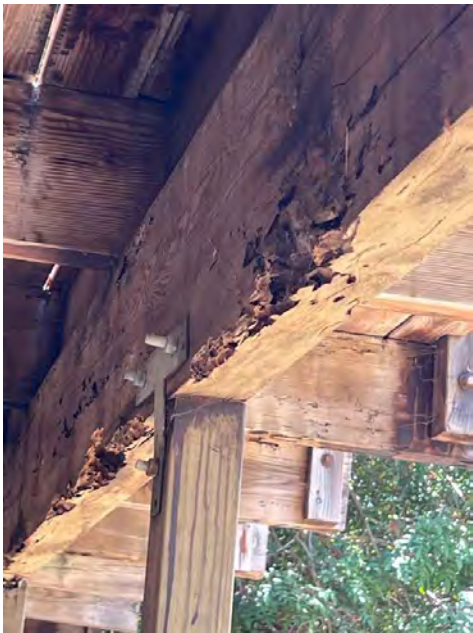
#### 11.5.1 STRUCTURE

##### **EXCESSIVE ROT - DECKS**

Excessive dry rot/ wood damage was observed at several areas of the deck structures, most significantly at the deck in the pool area. This deck appears to be in hazardous condition and requires immediate repair. (Home inspectors do not have the authority to comment on termites or dry rot, which is the responsibility of a state licensed pest inspector.) However, we recommend further review and repair by a qualified licensed contractor for safety. An estimate of repair should be obtained before the close of your contingency period.

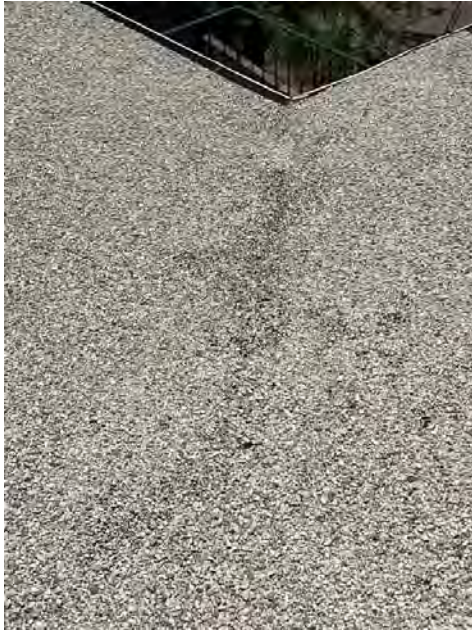
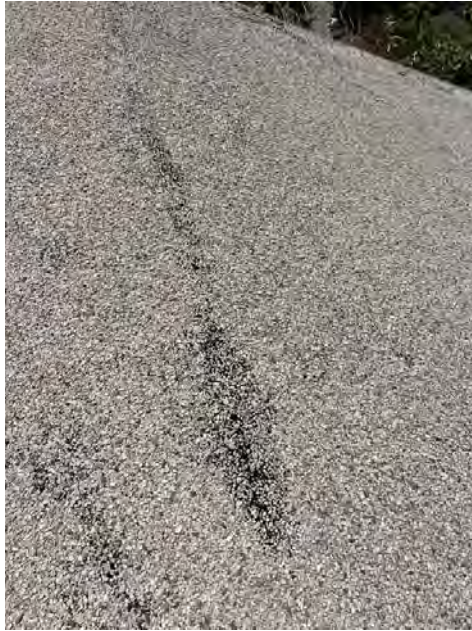
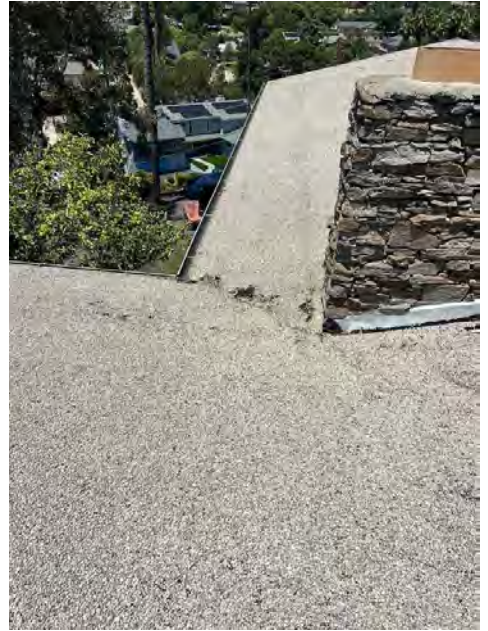
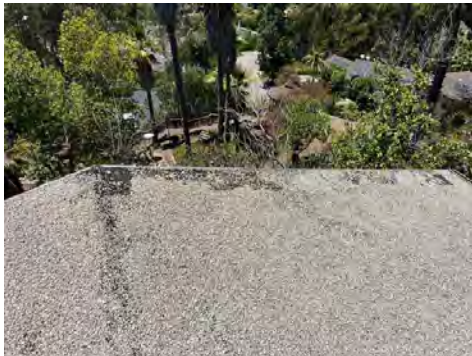
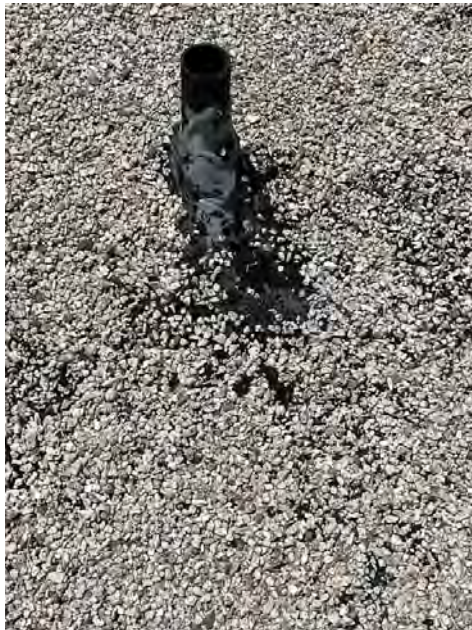
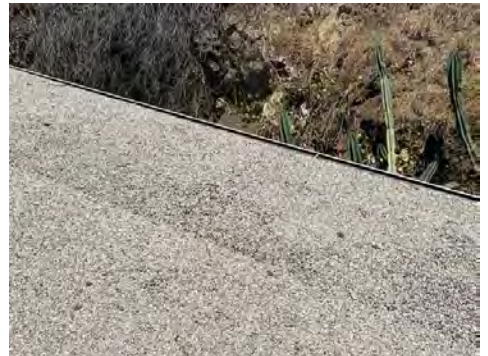
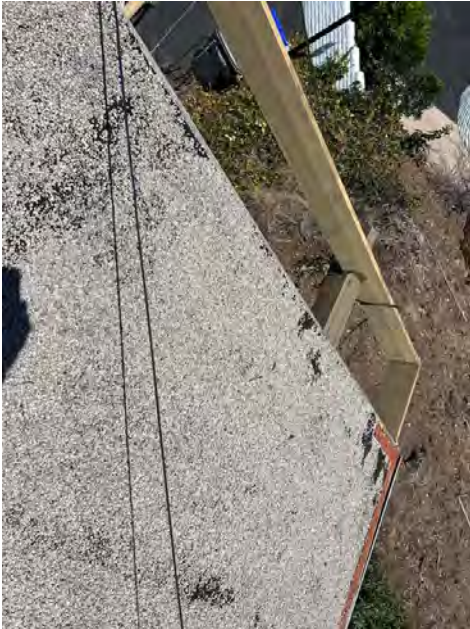
**12.2.1 ROOF COVERING****TAR AND GRAVEL ROOF - WORN**

The roof requires maintenance. Several areas of roof tar were exposed where the aggregate has worn thin. The aggregate is there to cover and protect the tar which becomes brittle and cracks when exposed to the sun. Due to lack of recent rain I cannot tell if the roof will leak. We recommend further evaluation and repair by a licensed roof contractor.

Contact a qualified roofing professional.

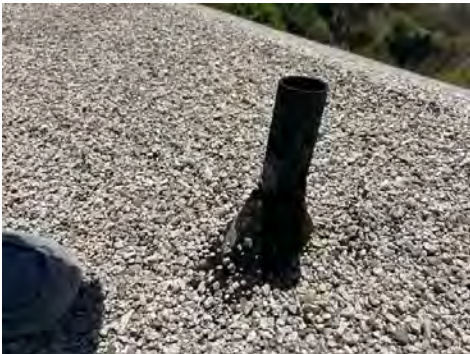
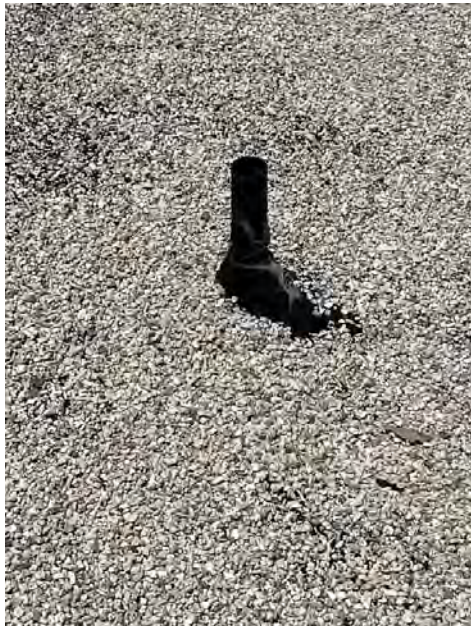
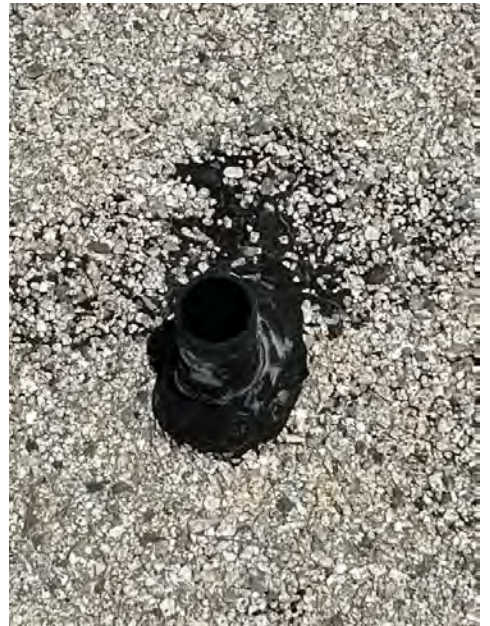
#### 12.3.1 FLASHINGS/ROOF PENETRATIONS

##### **SEALANT CRACKED - VENTS**

The sealant around flashings is cracked. We advise further corrections by a licensed roofer.

Contact a qualified roofing professional.

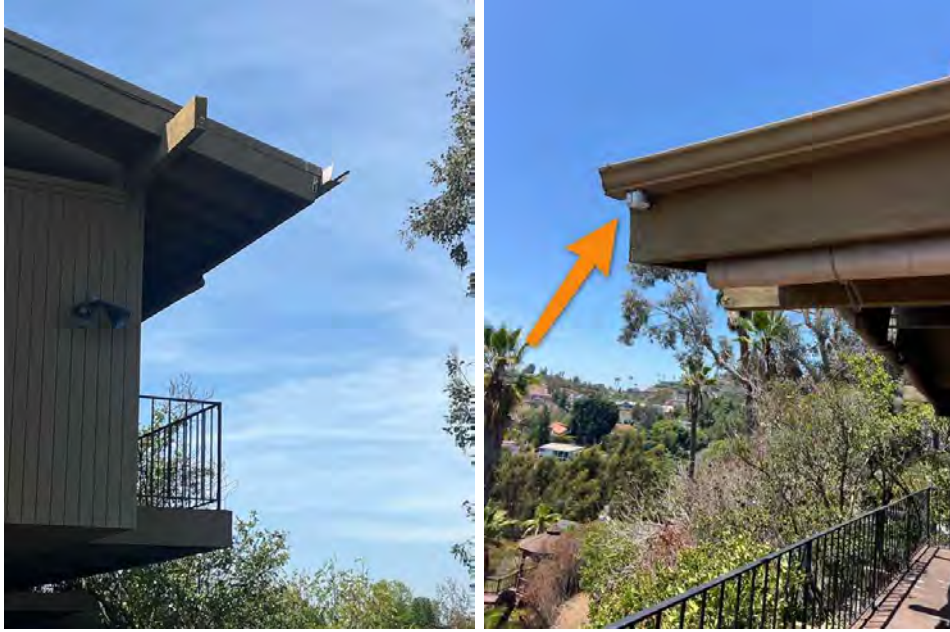
#### 12.5.1 ROOFING DRAINAGE SYSTEMS (Rain Gutters, Scuppers)

##### **DOWNSPOUT - MISSING**

A downspout is missing. We advise installing downspouts to properly divert water away from the roof and the structure. Missing downspouts can damage the house due to the quantity of water concentrated in this area. We advise replacement.

Contact a qualified gutter contractor

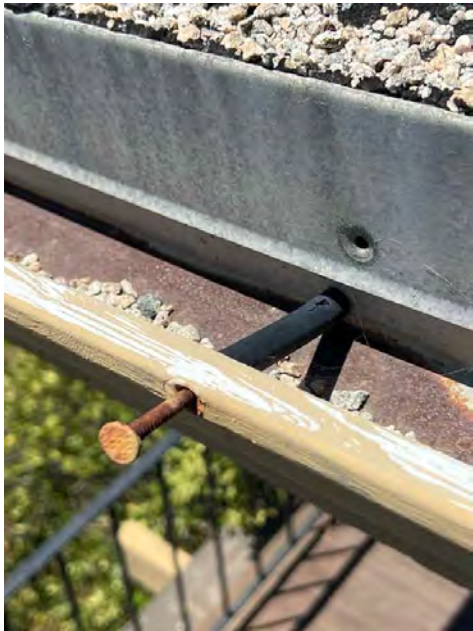
12.5.3 ROOFING DRAINAGE SYSTEMS (Rain  
Gutters, Scuppers)

**GUTTERS - RUSTED/DAMAGED**

Gutter is rusted and deteriorated. Repair is recommended to avoid further deterioration.

Contact a qualified gutter contractor

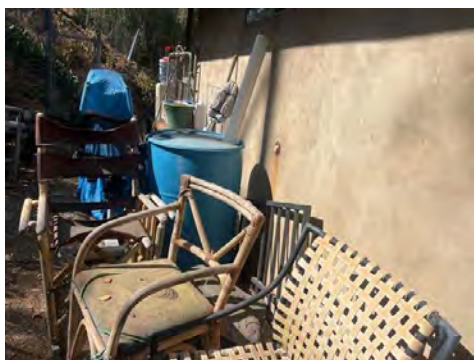
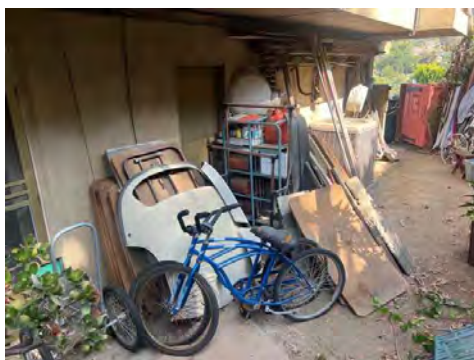
### FOUNDATION - CONCEALED ITEMS

Some areas of the exterior wall and foundation are not visible due to being blocked, concealed by stored items against the house. We recommend having these items removed and inspecting these areas for concealed defects prior to the end of your contingency period.

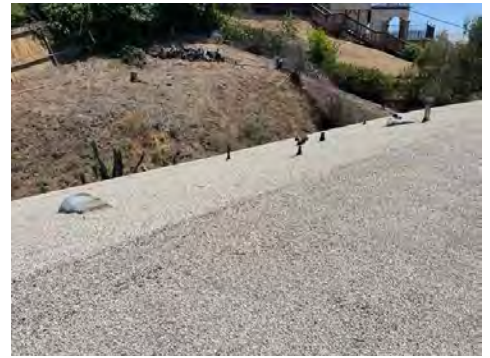
**Repair or replace****14.3.1 VENTILATION OF ATTIC  
LIMITED VENTILATION**

Attic ventilation appeared to be insufficient at the time of the inspection. The approximate rule of thumb is 1.5 sq. ft. of vent area for every 300 sq. feet of attic floor. We recommend increasing attic ventilation by installing appropriate ventilation devices.

Contact a qualified professional.

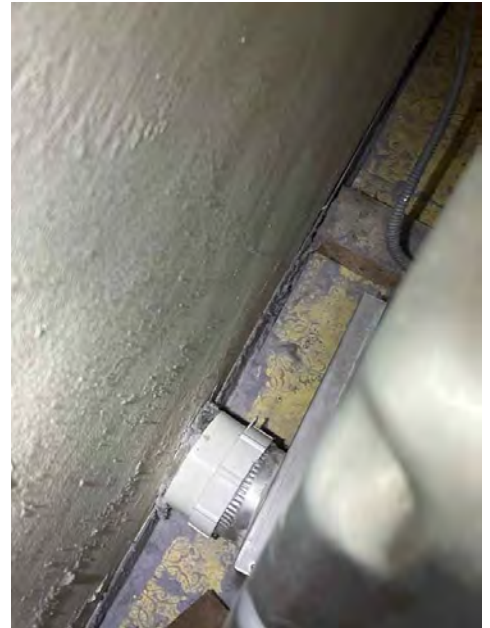
14.4.1 CLOTHES DRYER  
VENTING SYSTEM

Lint was observed in the laundry area. This condition is typically associated with a loose, clogged, or disconnected dryer duct. Lint is a fire hazard. The consumer product safety commission (CPSC) estimates that up to 16,000 home fires a year originate at clothes dryers. Common causes of these fires are lint buildup from improperly installed or maintained exhaust ducts. Screws should not penetrate into the interior of the duct as they accumulate lint, which leads to blockage. We recommend checking the integrity of the dryer duct and having the dryer duct cleaned by a qualified person.

Contact a qualified professional.

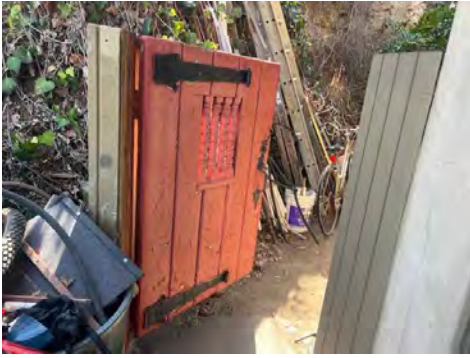
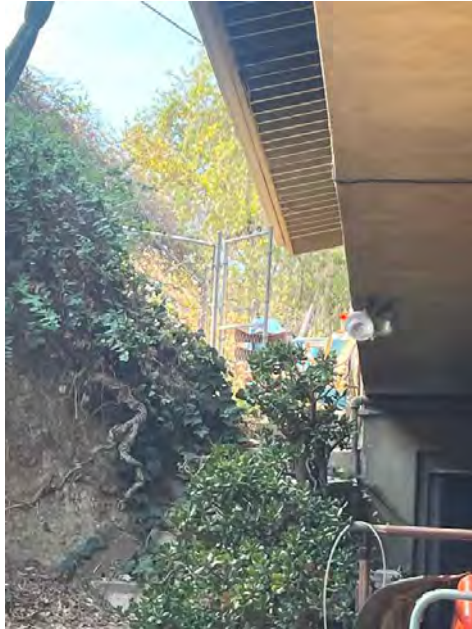
The gates that give pool access are not compliant with common safety standards, and should be corrected for safety. To prevent child drowning, pool/spa area fencing and gates should be sixty inches tall and non-climbable. Gates are required to self-close and include latches at forty-eight inches, and should open away from a pool or spa (so that a toddler could not push open an unlatched gate). We advise immediate repair with licensed contractor for safety.

Contact a qualified professional.
