# **INSPECTION REPORT SUMMARY**

March 5, 2024

Inspection Report Exclusively For: Aleksey and Tatyana Feldman

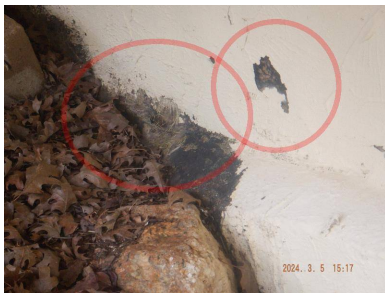
##### ***223 WALL CONDITION:***

**[FE]** The damp proofing on the exterior basement walls was damaged/deteriorated in some areas. These condition(s) are conducive to moisture intrusion and deterioration. We recommend further evaluation and corrections by a specialist in the appropriate trade.

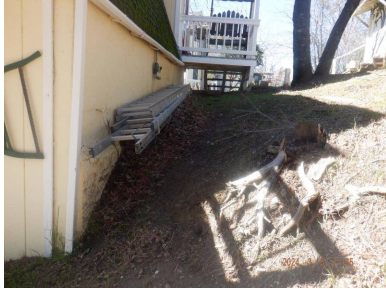
##### ***363 SITE GRADING:***

**[CR]** There were areas around the building where the grading sloped toward the foundation (both buildings). This condition is conducive to ponding and foundation damage. We recommend correcting the condition(s) noted.

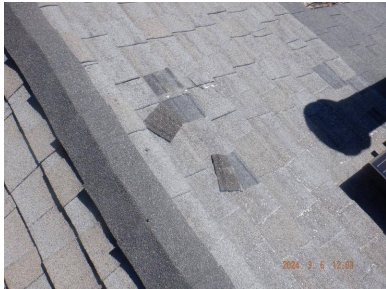
#### *407 COMP SHINGLE:*

[FE] There were damaged/missing shingle tabs. These condition(s) are conducive to moisture intrusion, **roof leaks** and deterioration. We recommend further evaluation and corrections by a specialist in the appropriate trade.

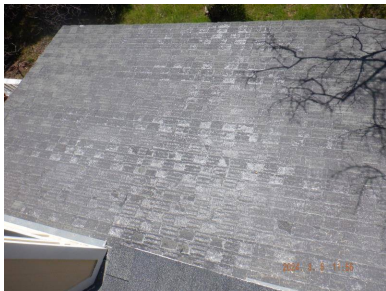
[FE] The shingles had extensive granulation loss, erosion and cracking throughout the shingled surface. These condition(s) are conducive to moisture intrusion, **roof leaks**, and deterioration. We recommend further evaluation and corrections by a specialist in the appropriate trade.

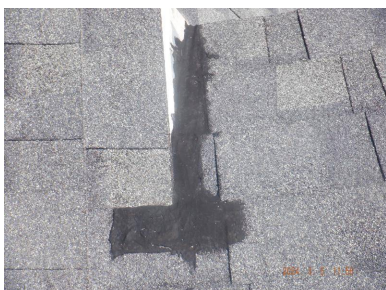
[FE] There were substandard past repairs performed in areas. These condition(s) are conducive to moisture intrusion and deterioration. We recommend further evaluation and corrections by a specialist in the appropriate trade.

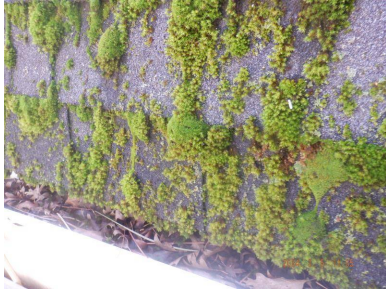
[CR] There was a lichen/algae growing on the roof in areas. We recommend correcting the condition(s) noted.

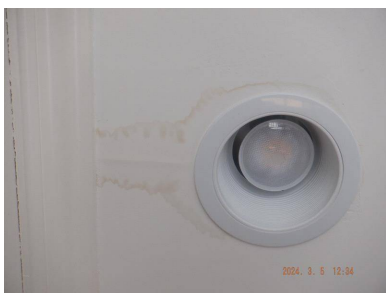
#### 1101 WALLS/CEILING:

[CR] Moisture/stains were noted on the ceiling. The area tested **actively wet** during the inspection. We recommend locating correcting the source as well as any damaged materials.

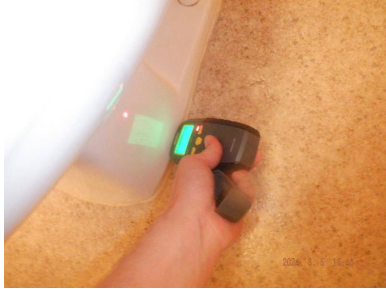
#### 1316 TOILETS:

[CR] The toilet showed evidence of **seepage/leakage** at the baseline/wax ring. These condition(s) are conducive to moisture intrusion and deterioration. We recommend correcting the condition(s) noted along with any and all damaged materials. (see other toilets in other bathrooms)

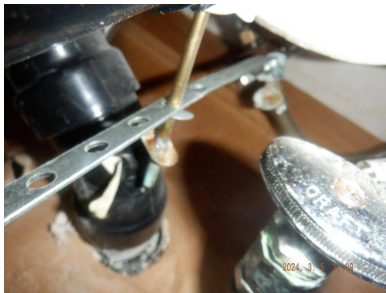
1315 SINK/PLUMBING:

[CR] **Active leaks** were noted at the handle connection under the sink on the right side. We recommend correcting the condition(s) noted.

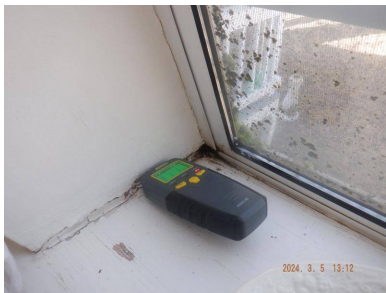
1416 WINDOWS:

[CR] There was evidence of moisture stains and damage in the window sill(s). The area tested **actively wet** during the inspection. We recommend locating and correcting the source as well as any damaged materials.

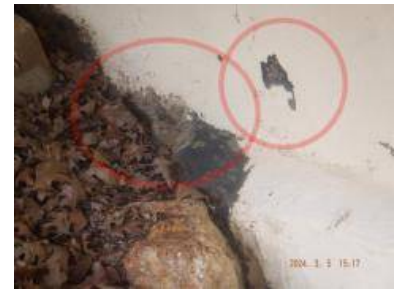
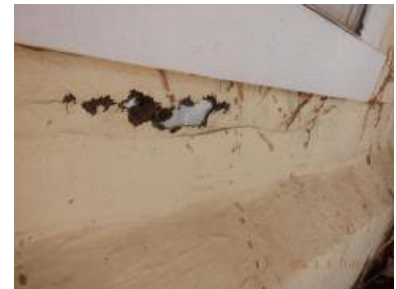
[FE] The damp proofing on the exterior basement walls was damaged/deteriorated in some areas. These condition(s) are conducive to moisture intrusion and deterioration. We recommend further evaluation and corrections by a specialist in the appropriate trade.

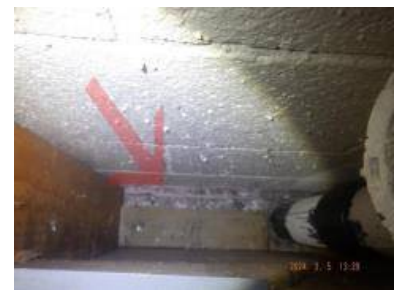
[CR] There was a condition known as efflorescence on portions of the foundation walls. This is a salt deposit left when moisture in the foundation evaporates. It indicates that the foundation is experiencing wet and dry cycles. Efforts should be made to identify the source of the moisture and correct this condition. We recommend the exterior grading and drainage be improved to divert moisture away from the foundation.

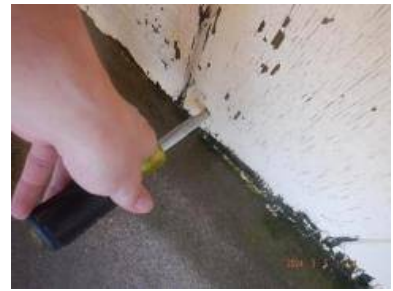
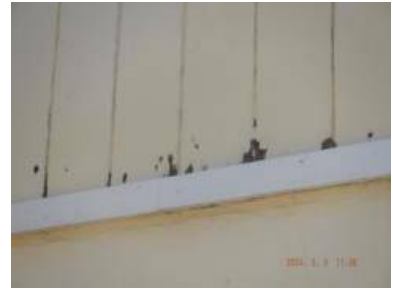
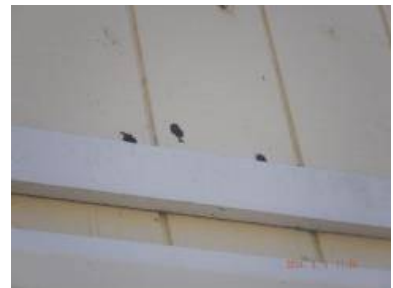
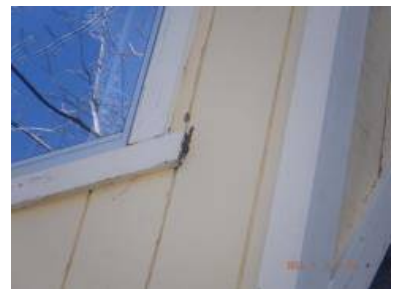
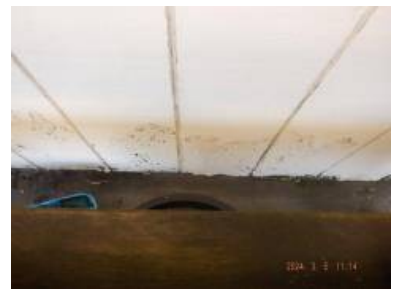
309 WOOD SIDING:

[CR] The wood siding was damaged/deteriorated at some areas of the building. These conditions are conducive to moisture intrusion/deterioration. We recommend correcting the condition(s) noted.  
[FE] There was evidence of conditions that require further evaluation by a pest control operator. We recommend further evaluation and corrections by a specialist in the appropriate trade.

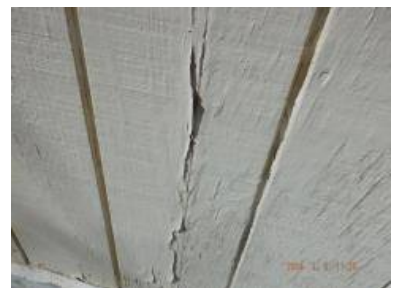
[CR] There were cracks/gaps in the wood siding. These conditions are conducive to moisture intrusion/deterioration. We recommend correcting the conditions noted.

[CR] The wood siding finish appeared worn/weathered/aging. We recommend correcting the condition(s) noted.

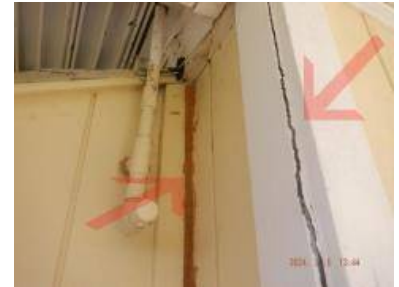
[CR] Sealant was present in the area between the well pump shed and the finished basement area. This seal needs to be maintained. These condition(s) are conducive to moisture intrusion and deterioration. We recommend correcting the condition(s) noted.

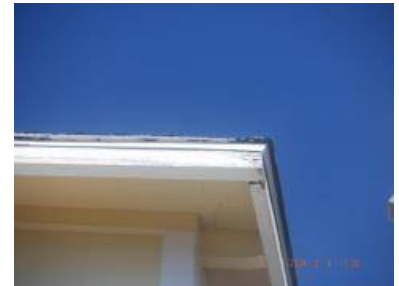
317 EXT TRIM:

[FE] There were damaged/deteriorated trim materials noted at some eave, fascia and trim areas. We recommend further evaluation and corrections by a specialist in the appropriate trade.

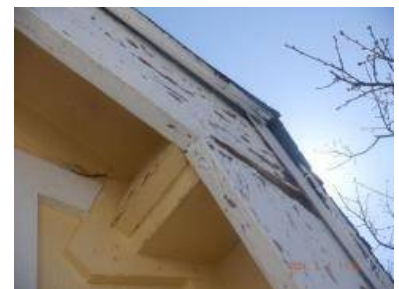
[FE] There was evidence of conditions that require further evaluation by a pest control operator. We recommend further evaluation and corrections by a specialist in the appropriate trade.

[CR] The exterior trim materials appeared worn/weathered/aging. We recommend correcting the condition(s) noted.

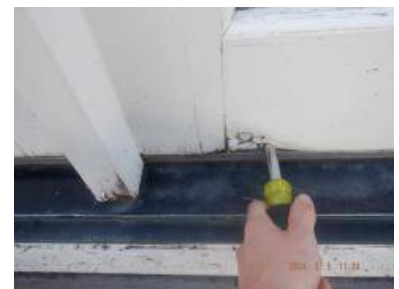
318 EXT DOORS:

[CR] Some exterior doors were damaged. We recommend correcting the condition(s) noted.

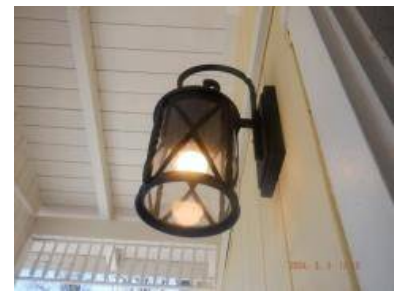
[CR] Some light(s) failed to function. We recommend correcting the condition(s) noted.

[NOTE] Some light(s) operated were serviceable.

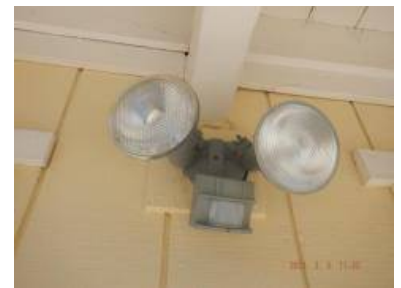
[FE] The motion detector light(s) could not be checked in the daytime. We recommend inquiring about the condition(s) noted.

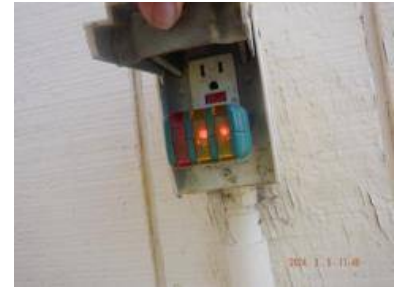
[SC] The GFCI receptacle was providing power, but failed to trip when tested. This condition is safety hazard. We recommend correcting the condition(s) noted.

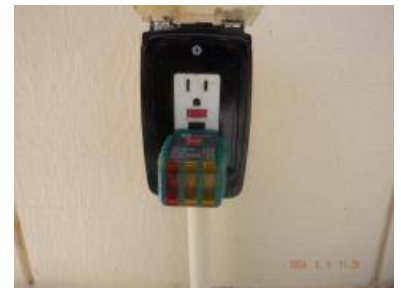
[CR] There was no power at the GFCI receptacle and it would not reset. We recommend correcting the condition(s) noted.

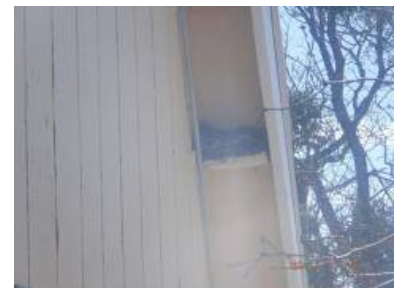
327 COMMENTS:

[FE] There was evidence of conditions that require further evaluation by a pest control operator. We recommend further evaluation and corrections by a specialist in the appropriate trade.

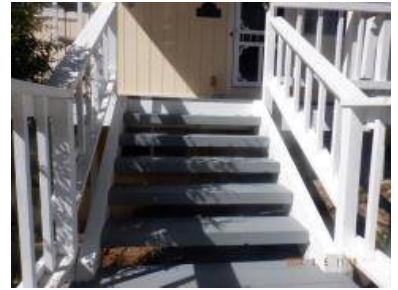
- 339 DRIVEWAY: [CR] There were cracks in the driveway. We recommend correcting this condition to prevent moisture intrusion into concealed spaces.
- 341 WALKWAYS: [CR] There were cracks in the walkways. We recommend correcting this condition to prevent moisture intrusion into concealed spaces.  
[SC] Evidence of ponding water was noted on the walkway(s). This condition is a slip and fall hazard. We recommend correcting the condition(s) noted.  
[SC] Uneven sections were noted in the walkway surface. This condition is a trip hazard. We recommend correcting the condition(s) noted.
- 342 HANDRAILS: [SC] The handrail(s) were present and serviceable and may have met the standards at the time of construction, however they are not considered to be grippable by today's standards. We recommend upgrading the handrail(s) to meet today's standards for added safety.

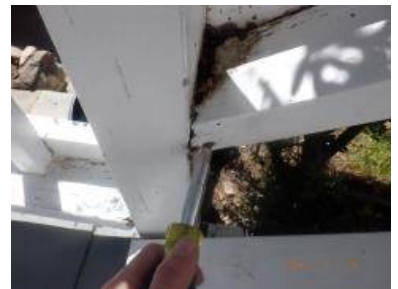
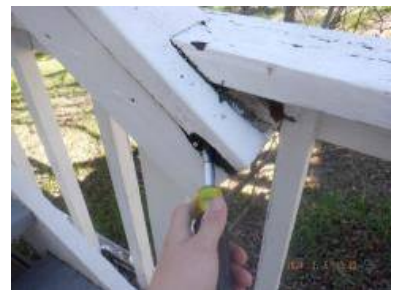
[SC] The handrail(s) were damaged/deteriorated. We recommend correcting the condition(s) noted.

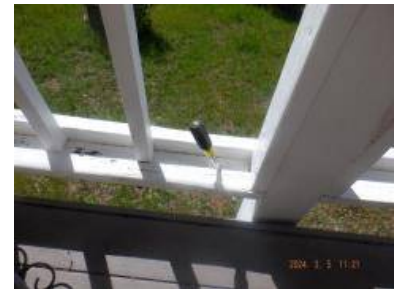
[SC] The guardrails were damaged/deteriorated in areas. We recommend correcting the condition(s) noted.

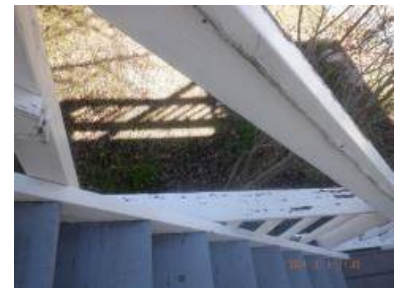
[SC] Some guard rails had large gaps with no balusters. This is a fall hazard. We recommend correcting the condition(s) noted.

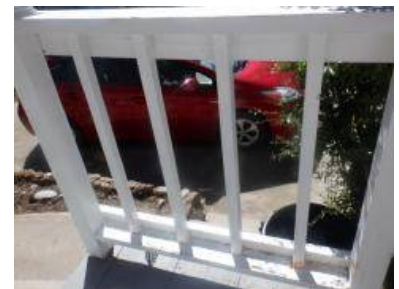
[RU] The guardrail(s) installed were in serviceable condition and appear to have meet the standards at the time of construction, however the wide spaces between the balusters pose a hazard for small children. Modern construction requires a maximum of 4 inch openings. While upgrading is not required, additional measures for child safety like netting or some other means is strongly recommended.

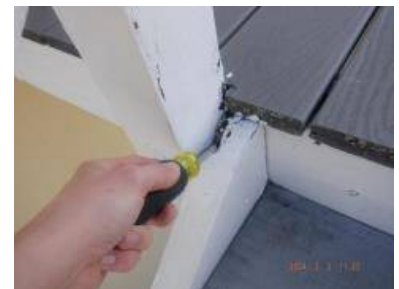
344 STEPS & STAIRS:

[CR] Damage framing was noted on the wood stairs throughout the area. We recommend correcting the condition(s) noted.

[SC] Some of the steps were loose/damaged. We recommend correcting the condition(s) noted.

[FE] There was evidence of conditions that require further evaluation by a pest control operator. We recommend further evaluation and corrections by a specialist in the appropriate trade.

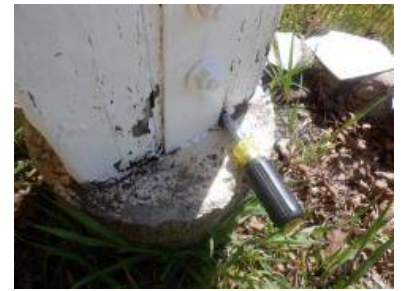
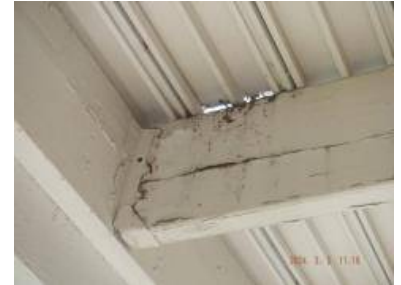
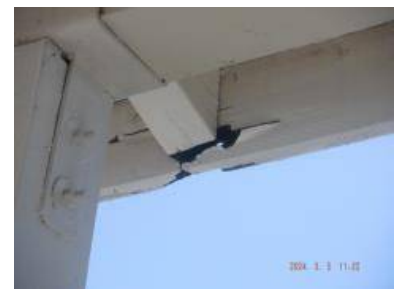
347 PATIO/BALCONY COVERS: [FE] Damage/deterioration was noted on the patio cover at the following locations: framing and supporting posts. We recommend further evaluation and corrections by a specialist in the appropriate trade.

[FE] There was evidence of conditions that require further evaluation by a pest control operator. We recommend further evaluation and corrections by a specialist in the appropriate trade.

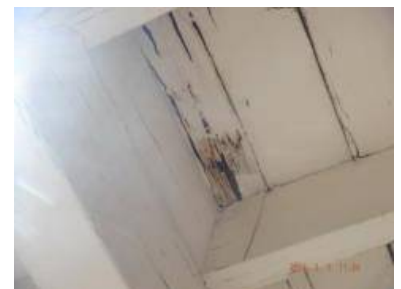
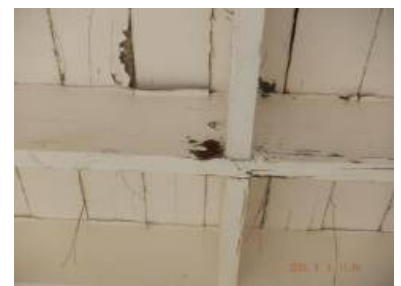
[FE] There was damage/deterioration noted on the deck surface boards and/or framing materials. We recommend further evaluation and corrections by a specialist in the appropriate trade.

[CR] Damage was noted on the wood deck. We recommend correcting the condition(s) noted.

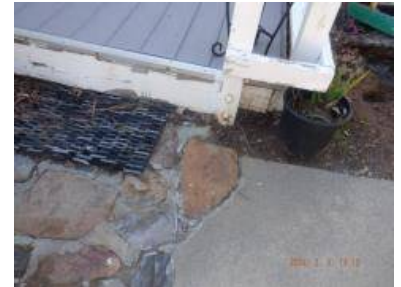
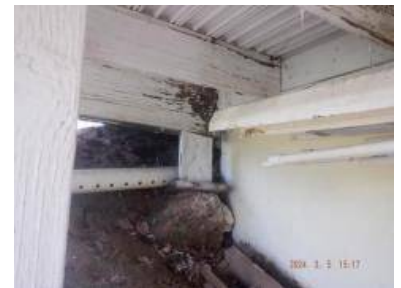
[CR] The deck was located too close too the ground. This condition is conducive to moisture damage and deterioration. We recommend correcting the condition(s) noted.

[CR] Earth to wood contact was noted on many of the wood posts for the elevated and ground level wood decks. We recommend correcting the condition(s) noted.

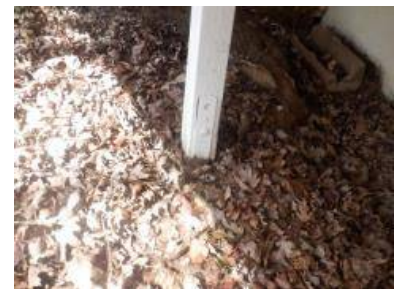
[NOTE] Some areas of the decking boards were in serviceable condition with signs of aging and wear.

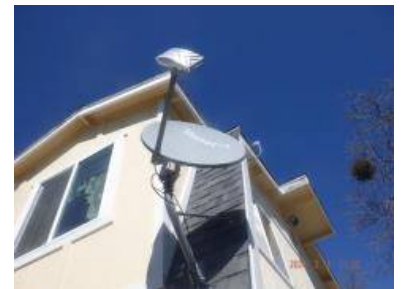
357 *COMMENTS:* [FE] There was dish equipment present/fastened to the structure. Inquire about this equipment.

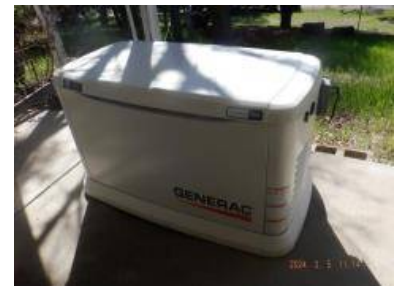
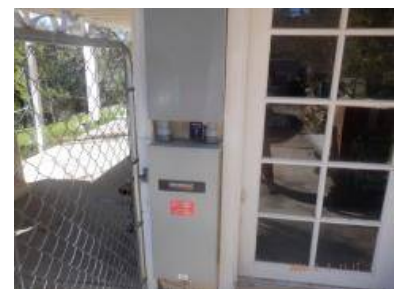
[FE] The generator is out of the scope of the inspection and was not inspected. We recommend further evaluation and corrections by a specialist in the appropriate trade.

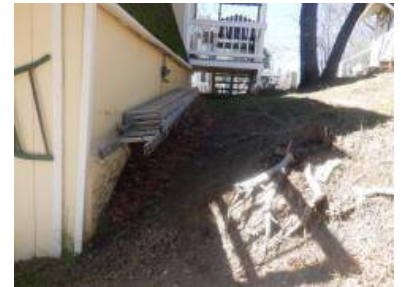
363 SITE GRADING:

[CR] The site grading appeared to have inadequate slope in areas to drain excess surface water away from the foundation. The grading should fall away from the foundation at a rate of 1 inch per foot for at least 6 feet to prevent moisture accumulation next the foundation. We recommend correcting the condition(s) noted.

[CR] There were areas around the building where the grading sloped toward the foundation (both buildings). This condition is conducive to ponding and foundation damage. We recommend correcting the condition(s) noted.

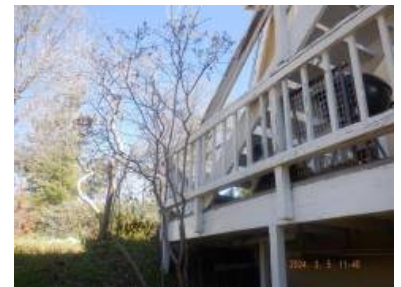
[CR] There was vegetation was growing in contact with the building. This condition limits the inspection, and is conducive to moisture intrusion/deterioration. We recommend correcting the condition(s) noted.

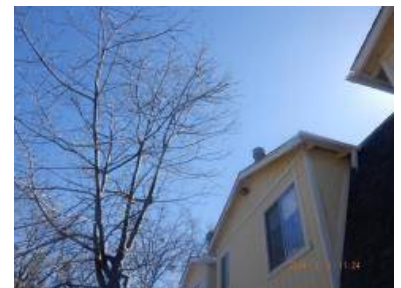
[CR] Trees were touching or overhanging the roof. We recommend they be trimmed to prevent damage to the roofing surface, and allow free flow of roof runoff.

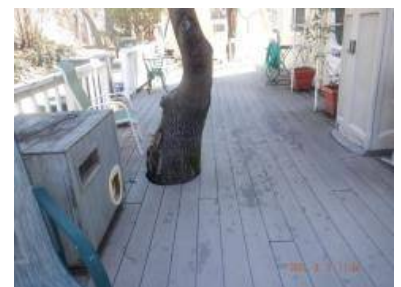
[CR] Tree(s) were planted too close to the building. We recommend considering removal, as trees continue to grow in size and damage may occur to the foundation, structure, plumbing system or roof. [NOTE] We recommend monitoring the conditions noted.

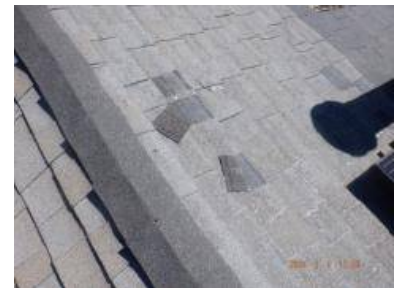
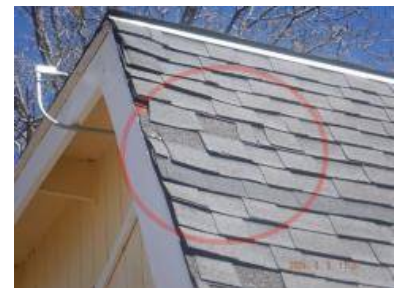
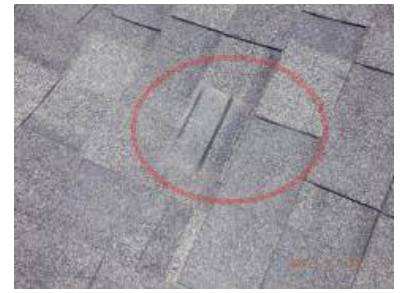
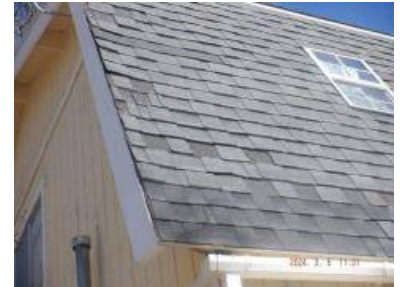
- 407 *COMP SHINGLE:* [FE] There were damaged/missing shingle tabs. These condition(s) are conducive to moisture intrusion, **roof leaks** and deterioration. We recommend further evaluation and corrections by a specialist in the appropriate trade.

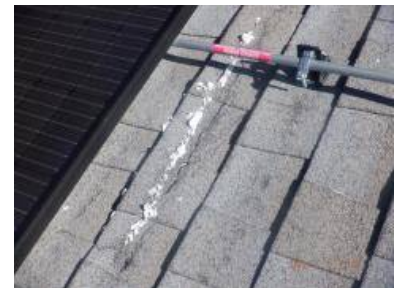
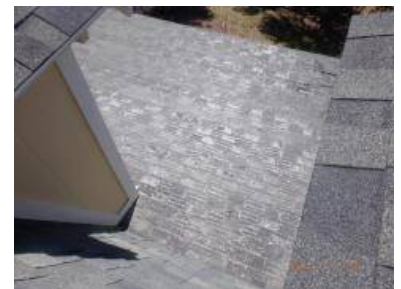
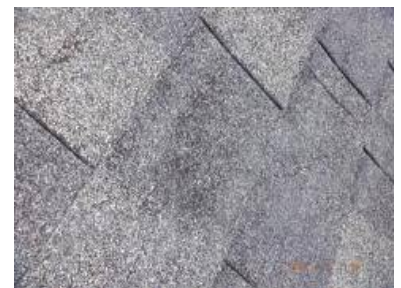
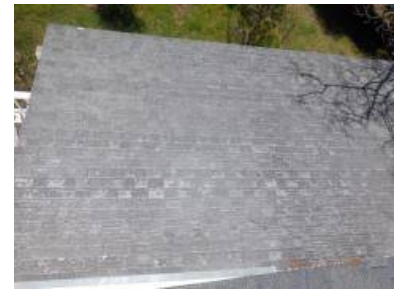
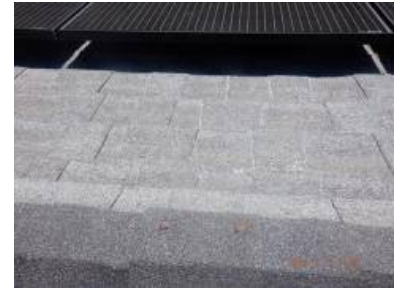
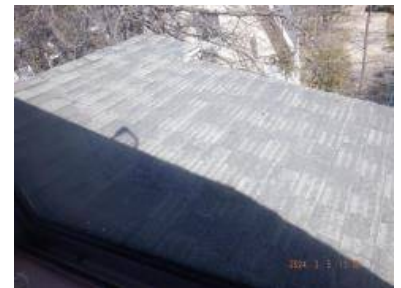
[FE] The shingles had extensive granulation loss, erosion and cracking throughout the shingled surface. These condition(s) are conducive to moisture intrusion, **roof leaks**, and deterioration. We recommend further evaluation and corrections by a specialist in the appropriate trade.

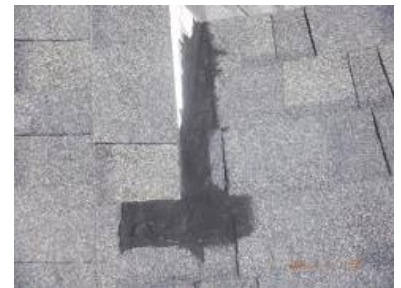
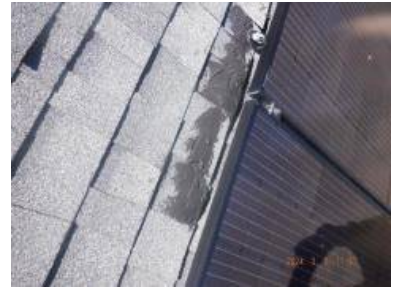
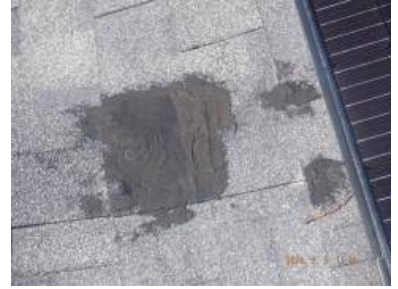
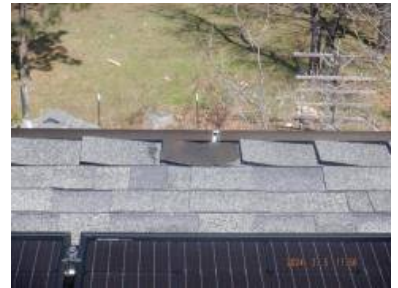
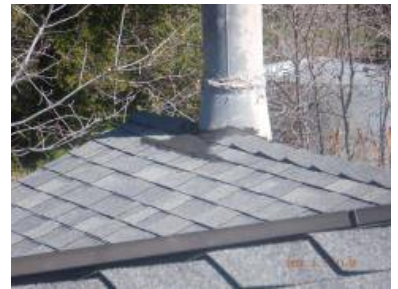
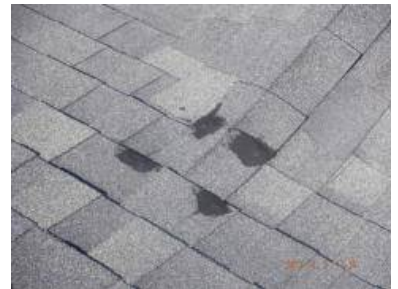
[FE] There were substandard past repairs performed in areas. These condition(s) are conducive to moisture intrusion and deterioration. We recommend further evaluation and corrections by a specialist in the appropriate trade.

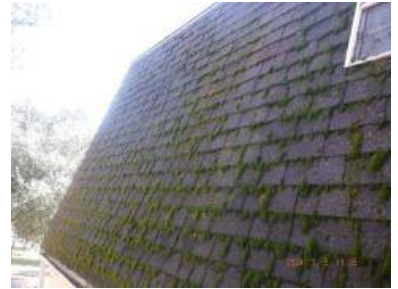
[CR] There was a lichen/algae growing on the roof in areas. We recommend correcting the condition(s) noted.

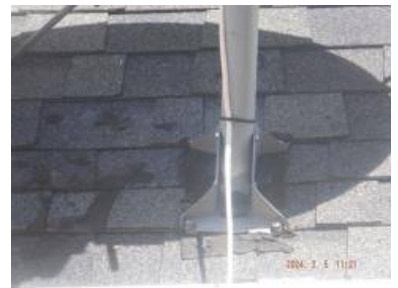
[CR] There was dish equipment mounted through the roofing material. These condition(s) are conducive to moisture intrusion and deterioration. We recommend correcting the condition(s) noted.

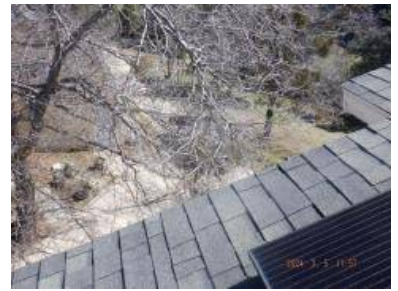
[CR] Trees were touching/overhanging the roof. We recommend they be trimmed and the debris removed to prevent **damage** to the roof and to prevent animal access.

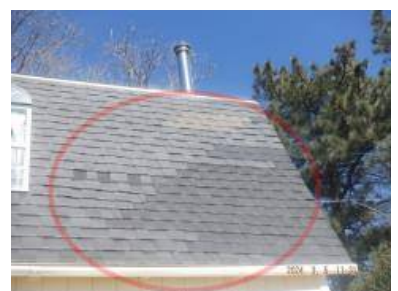
[CR] There was debris accumulating on the roof. Debris traps moisture on the materials which is conducive to deterioration and potential **leakage**. We recommend the debris be removed and the roof be inspected regularly.

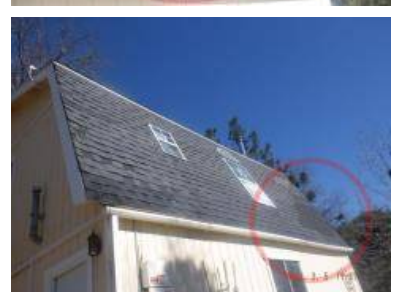
[FE] There was evidence of past repairs performed. Inquire about any previous work done.

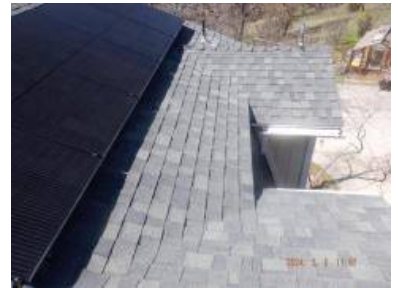
[NOTE] Some visible areas of the roof appeared serviceable with signs of weathering and aging. Periodic inspection and maintenance is recommended.

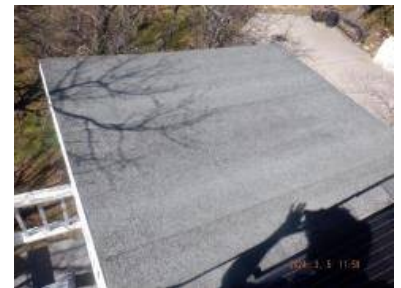
414 BUILT-UP ROOF:

[CR] While serviceable, there were areas of the roof that require maintenance. We recommend correcting the condition(s) noted.

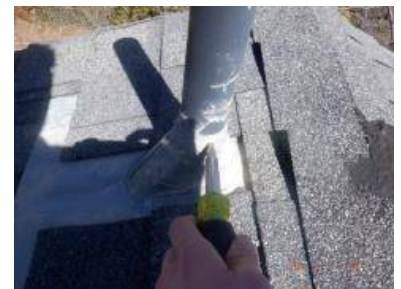
[NOTE] Flashings need to be re-sealed ideally on an annual basis to prevent moisture intrusion. Moisture inevitably causes deterioration, damage and decay.

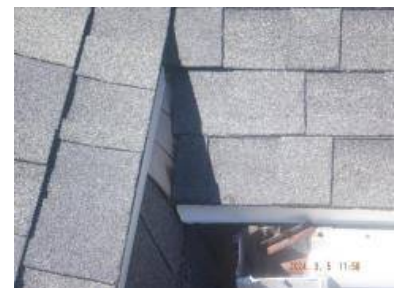
[CR] Some of the flashings were rusty. We recommend they be cleaned, painted and/or replaced as needed.

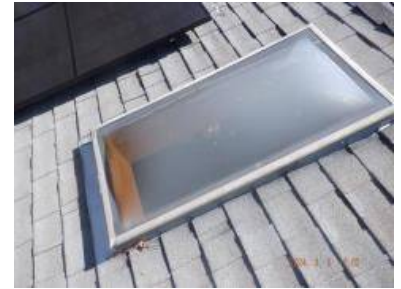
418 SKYLIGHTS:

The visible skylight(s) appeared serviceable, with no evidence of leakage.

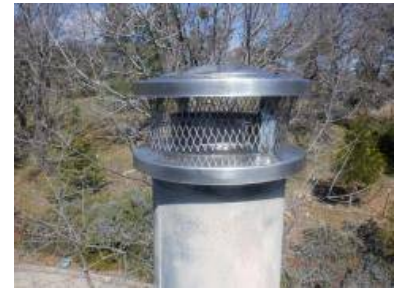
419 CHIMNEY / CAP:

The visible areas of the chimney [from the roof line up] appeared serviceable  
There was a spark arrester installed.

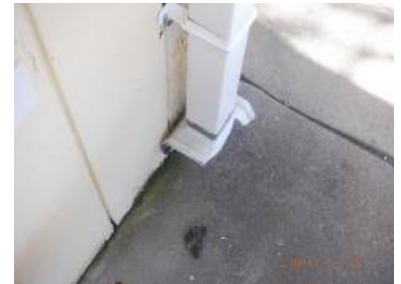
421 DOWNSPOUTS:

[CR] Runoff water from the roof discharged next to the building. We recommend the downspouts be routed sufficiently away from the building to prevent ponding, pooling, and saturation of the soil at the foundation.

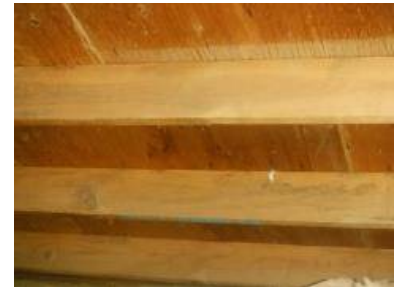
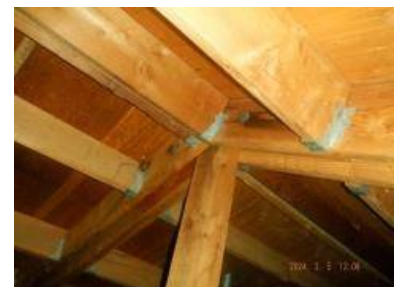
512 CEILING JOISTS: The visible areas of the ceiling joists appeared serviceable.

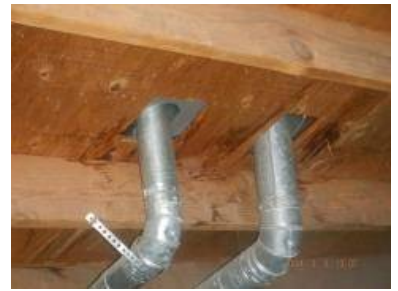
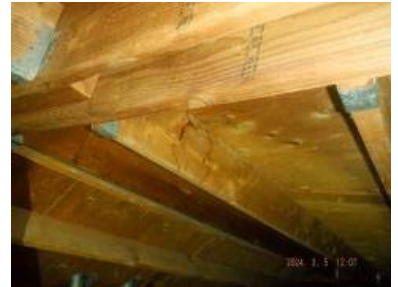
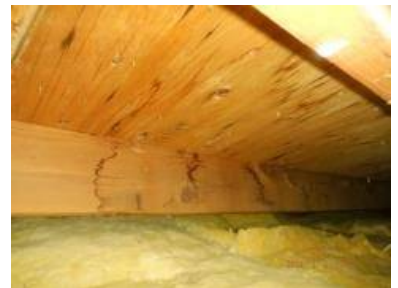
513 SHEATHING:

[FE] Moisture stains were noted on the sheathing and framing in areas. Some of the stains tested to be **actively wet** during the inspection. Some of the stains were dry during the inspection. We recommend locating repairing the source as well as any damaged materials.

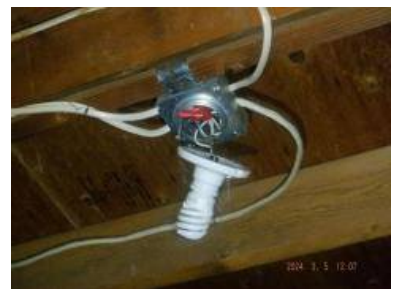
516 ELECT WIRING:

[SC] There was improper wiring in the attic in the form of open junction boxes with exposed wire connections. We recommend correcting the condition(s) noted.

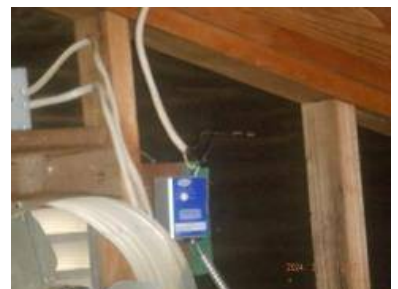
[SC] There was improper wiring in the attic in the form of splices in wiring that were not contained in approved/covered boxes. We recommend correcting the condition(s) noted.

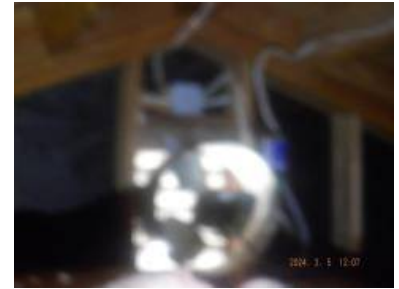
520 COMMENTS:

[NOTE] We recommend the vent fan system(s) be demonstrated/explained to the buyer(s).

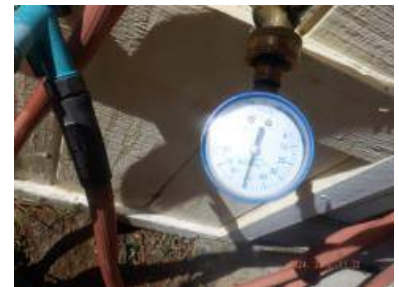
603 WATER PRESSRE:

50-60 PSI.

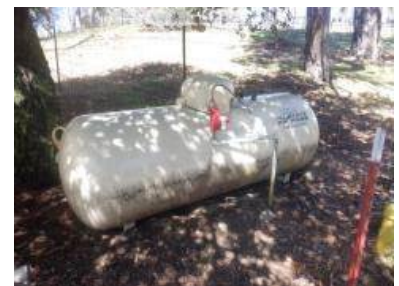
606 GAS SHUTOFF:

The propane tank, gas meter and shutoff valve are located at the front of the building.

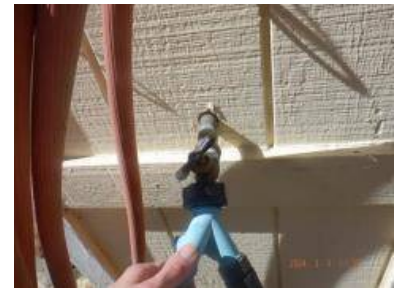
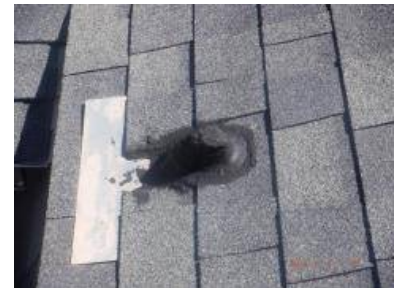
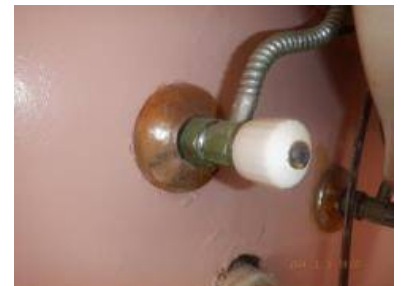
- 617 *GAS PIPING:* [CR] Areas of the visible gas piping were corroded. We recommend correcting the condition(s) noted.
- 619 *COMMENTS:* [CR] Corrosion was noted on the piping in areas. No leakage noted at this time unless otherwise specified in this report. Corroded valves can leak at any time. We recommend monitoring the conditions noted and correcting as needed.

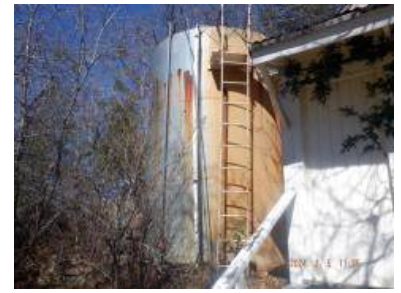
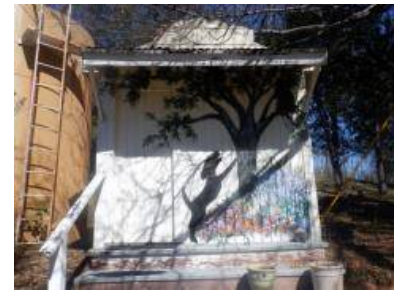
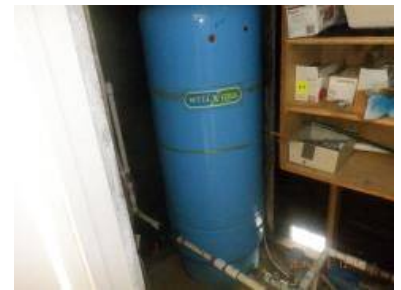
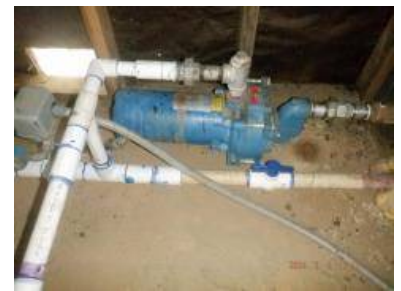
[FE] The well and all associated equipment is out of the scope of the inspection and was not inspected. We recommend further evaluation and possible corrections by a specialist in the appropriate trade.

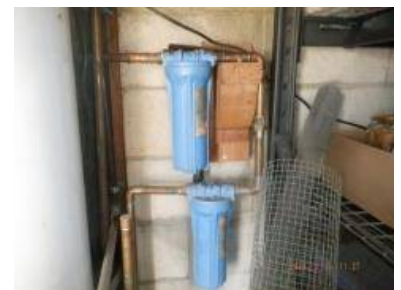
[NOTE] We recommend the filtration system(s) be demonstrated/explained to the buyer(s).

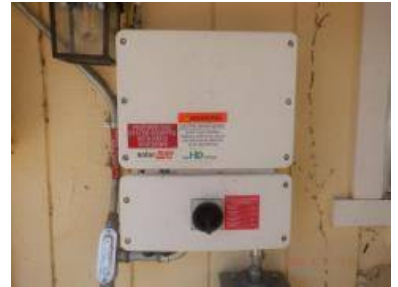
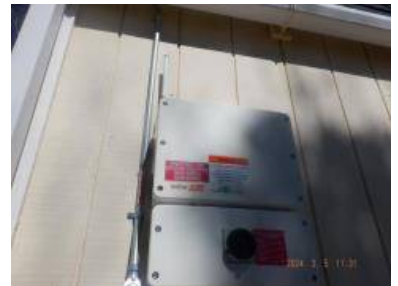
636 SYSTEM LOCATION:

[FE] This system is outside the scope of the inspection and was not inspected. We recommend consulting with a specialist regarding the operation and maintenance of this system.  
[NOTE] Two systems present.

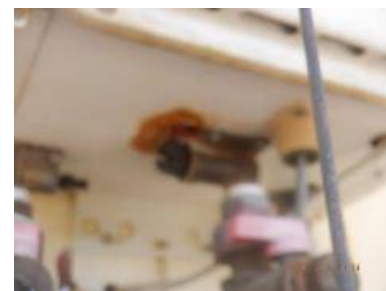
[NOTE] The water supply connectors were corroded, no leakage noted. We recommend monitoring the condition(s) noted.

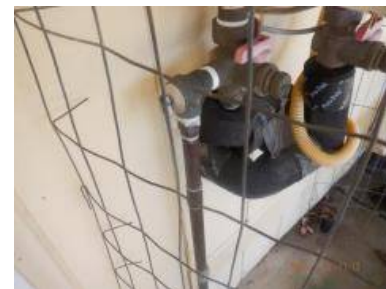
709 T&P VALVE:

A temperature and pressure relief (T&P) valve and discharge line were installed. The discharge line extended to the exterior and terminated close to the ground facing downward.

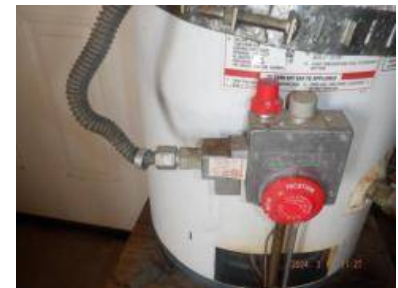
713 ENERGY SUPPLY: The gas shutoff valve and flexible gas connector appeared serviceable.

[RU] Recommend adding a sediment hard pipe to the gas line as an upgrade to the current standard. We recommend correcting the condition(s) noted as needed.

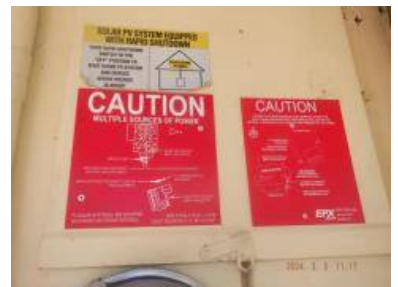
[FE] Please inquire to understand the proper method/procedure to shut off power to both sources for possible maintenance or emergency needs.

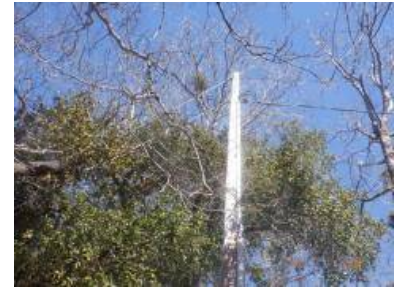
808 SERVICE WIRING:

[CR] Tree branches were in contact with the overhead service entrance cables. We recommend correcting the condition(s) noted.

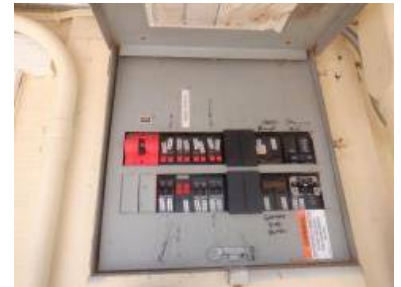
810 MAIN PANEL:

[SC] A number of breakers were not labeled clearly. We recommend they be accurately labeled to allow individual circuits to be shut off for maintenance or emergency needs. [NOTE] Labeling should be more detailed.

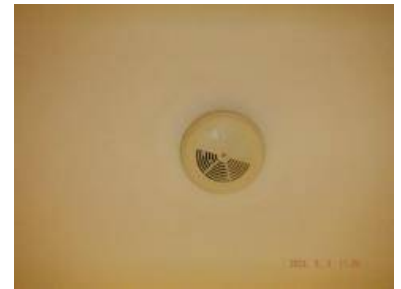
[CR] The smoke detectors appeared visibly older. We recommend upgrading to newer systems.

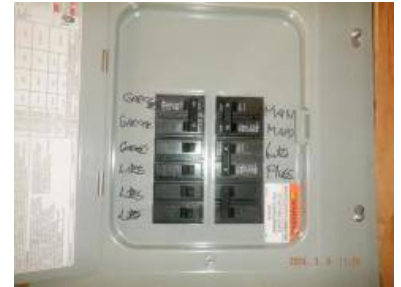
832 ELECTRIC PANEL: [SC] A number of breakers were not labeled clearly. We recommend they be accurately labeled to allow individual circuits to be shut off for maintenance or emergency needs. [NOTE] Labeling should be more detailed.

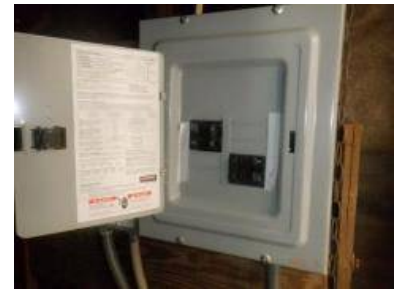
832 *ELECTRIC PANEL:*

[SC] A number of breakers were not labeled clearly. We recommend they be accurately labeled to allow individual circuits to be shut off for maintenance or emergency needs. [NOTE] Labeling should be more detailed.

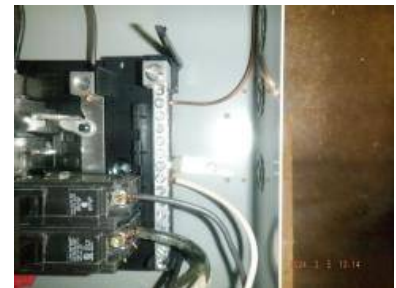
[SC] The neutral wires and the grounding wires were connected to the same busbar. This is an improper wiring arrangement in a subpanel. We recommend correcting the condition(s) noted.

[FE] We recommend further evaluation of the conditions noted by a specialist in the appropriate trade.

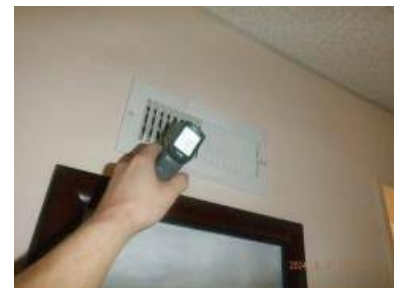
910 *HEATING UNIT:* [NOTE] The furnace was serviceable, but it was an older unit and nearing the end of its expected service life. We recommend budgeting for a replacement.

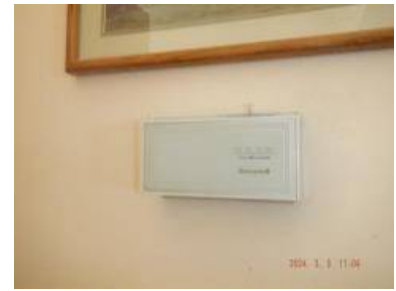
917 THERMOSTAT:

[FE] The thermostat was operated and the system responded. We recommend the system(s) be demonstrated/explained to the buyer(s).  
[NOTE] Located at: middle hallway

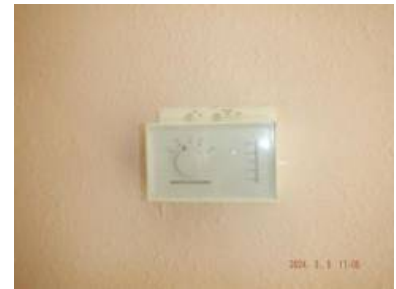
[CR] There was a thermostat in the upper hallway that did not respond to operating controls. We recommend correcting the condition(s) noted.

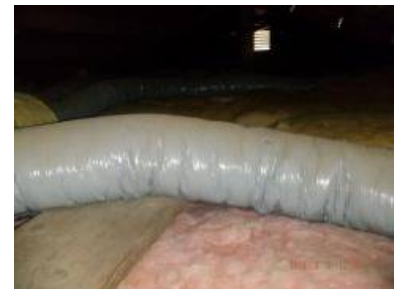
920 TYPE:

Materials: plastic-covered insulated flexible ducting.

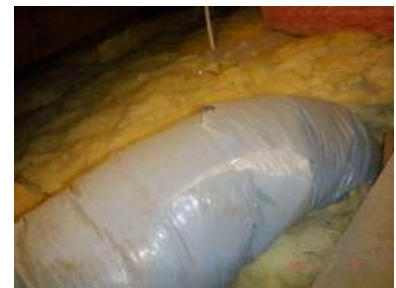
921 CONDITION:

[CR] The outer plastic covering on the conditioned air ducts was deteriorated. We recommend correcting the condition(s) noted.

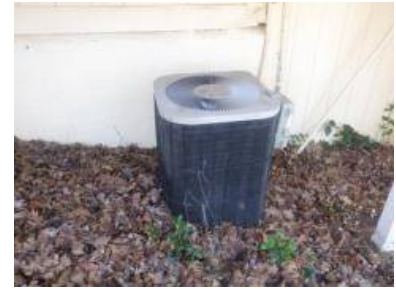
1001 LOCATION(S): The unit was located at the rear of the building.

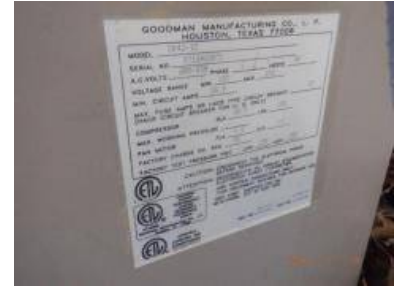
1006 UNIT NUMBER: [NOTE] Manufacturer Label.

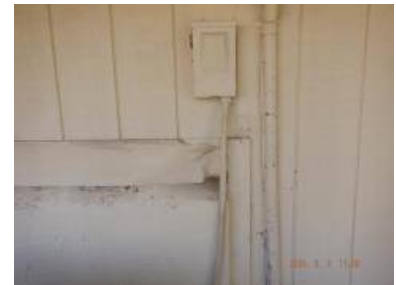
1007 ENERGY SUPPLY: [CR] The flex connector/conduit was not fastened to the wall after exiting the electrical disconnect panel. We recommend correcting the condition(s) noted.

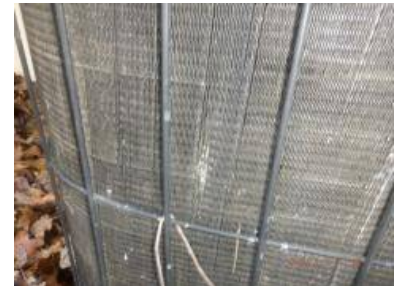
1008 CONDNSNG UNIT: [CR] A number of the coil fins of the condensing unit were damaged/deteriorated. This condition reduces the unit's overall performance We recommend correcting the condition(s) noted.

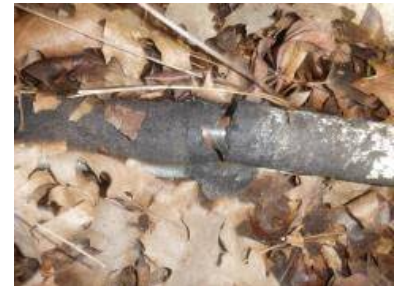
[CR] The insulation on the coolant lines was damaged/deteriorated/missing by the condensing unit. We recommend correcting the condition(s) noted.

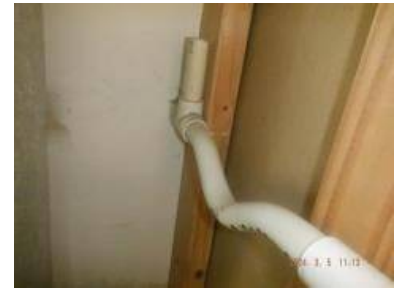
1010 CONDNSTE LINE:

The visible areas of the condensate drain line(s) appeared serviceable.

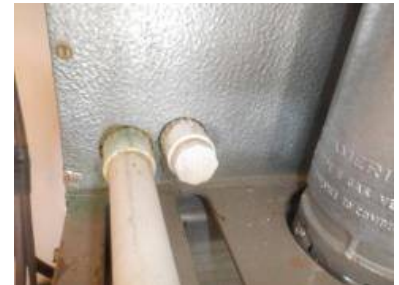
[RU] There was no secondary condensate line installed. We recommend correcting the condition(s) noted.

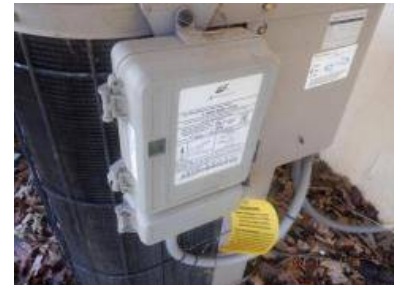
[FE] There was a device present on the condensing unit that allows the utilities company to shut off the equipment during high usage times. Inquire about this equipment.

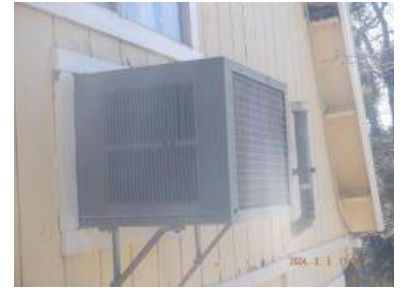
1016 WINDOW/WALL A/C UNIT: A window/wall unit was present. These units are outside the scope of the inspection and was not inspected.

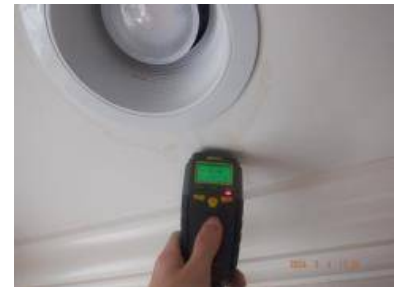
[CR] Moisture/stains were noted on the ceiling. The area tested **actively wet** during the inspection. We recommend locating correcting the source as well as any damaged materials.

[NOTE] Testing **actively wet**

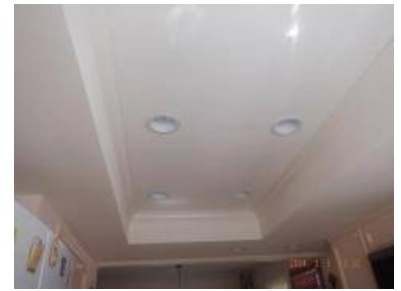
[NOTE] General image.

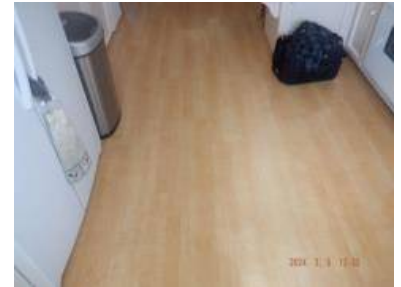
1105 WOOD FLOOR:

The visible areas of the simulated wood flooring appeared serviceable with signs of aging and wear.

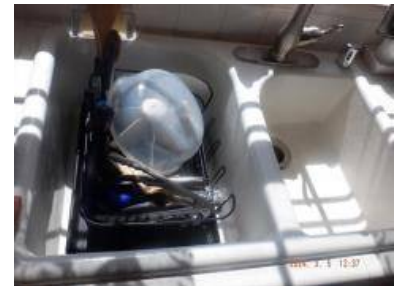
1114 SINK/PLUMBING:

The faucet(s), sink(s) and piping were serviceable, no leakage noted with signs of aging/wear.

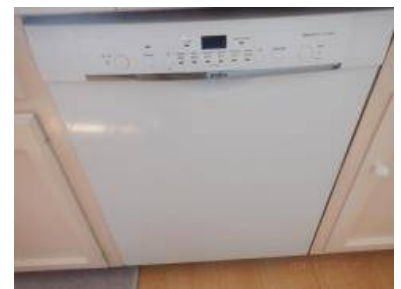
1116 DISHWASHER:

The dishwasher(s) functioned through the "Normal Cycle", no leakage noted with signs of aging/wear.

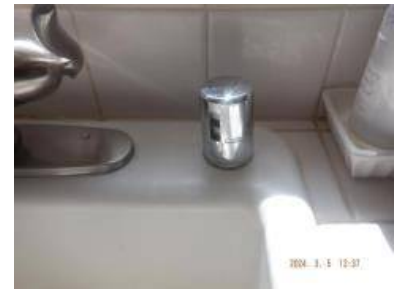
[NOTE] There was an air gap device present at the sink, no leakage noted at time of inspection.

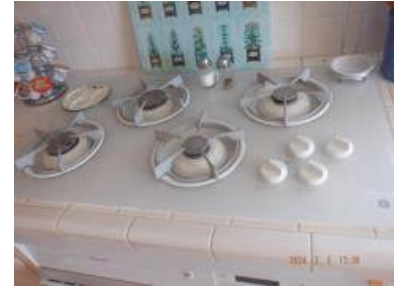
1119 COOKTOP:

Gas: The cooktop/range burners functioned.

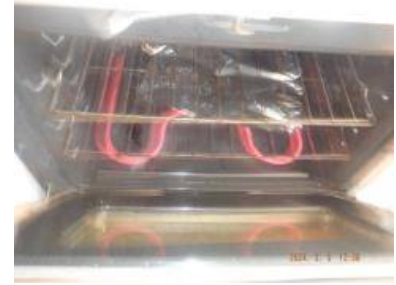
1120 OVEN(S):

[CR] The oven light failed to function. We recommend correcting the condition(s) noted.

Electric: The oven functioned with signs of aging/wear.

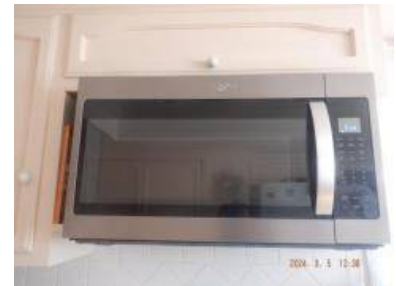
1121 MICROWAVE:

The microwave oven functioned and heated a glass of water with signs of aging/wear.

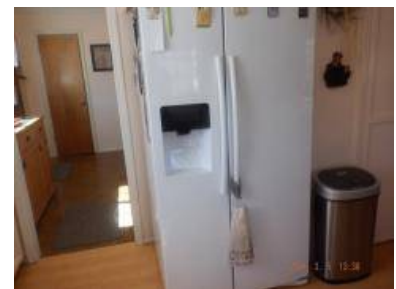
1124 REFRIGERATOR:

[FE] These system(s) are outside the scope of the inspection and are not inspected. We recommend consulting with a specialist regarding the operation and maintenance of this system.

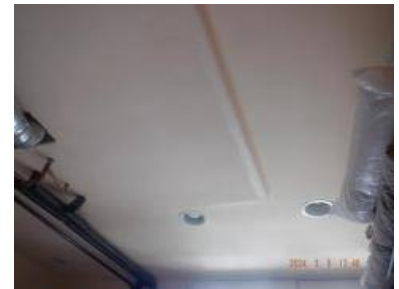
1202 WALLS/CEILING:

The visible areas of the walls and ceiling appeared serviceable with some cracks noted.

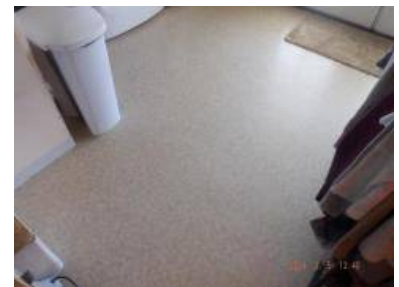
1205 VINYL FLOOR:

The visible areas of the vinyl floor appeared serviceable with signs of aging and wear.

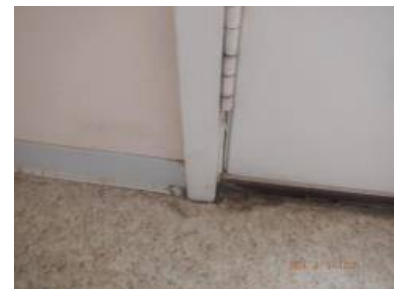
1209 EXT DOORS:

[CR] There was evidence of moisture intrusion at the base and threshold of the exterior exit door(s). We recommend locating and repairing the source as well as any damaged materials.

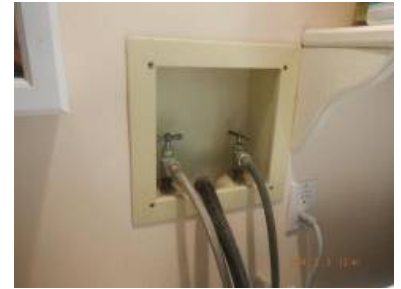
1217 WASHR SERVICE:

[NOTE] The laundry faucets were serviceable, no visible leaks, a machine was connected. We do not operate the faucets and cannot determine if there are leaks present from this system or piping.  
[RU] There was no visible leak pan/drain line for the washing machine in the laundry area. We recommend correcting the condition(s) noted.

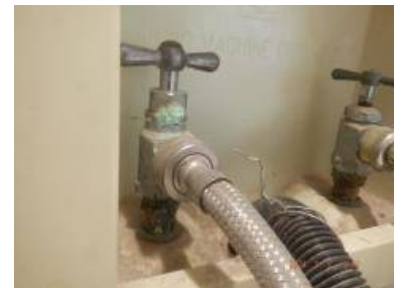
[CR] The laundry faucet(s) were corroded. We recommend correcting the condition(s) noted.

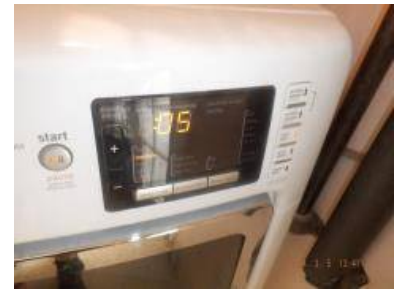
1218 DRYER SERVICE:

There was both gas and 220-volt electric hookups for a dryer. The 220-volt dryer receptacle was serviceable.

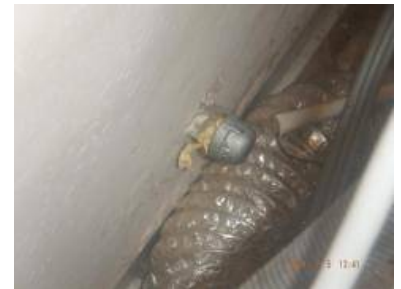
[NOTE] The gas service was capped off. An approved gas valve will need to be installed if you plan on using the gas service.

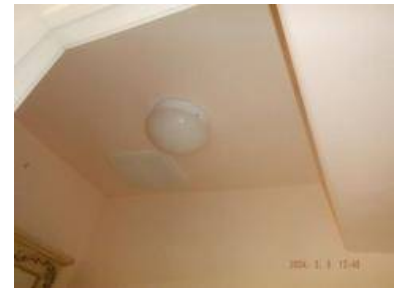
1301 WALLS/CEILING:

The visible areas of the walls and ceiling appeared serviceable with signs of aging and wear.

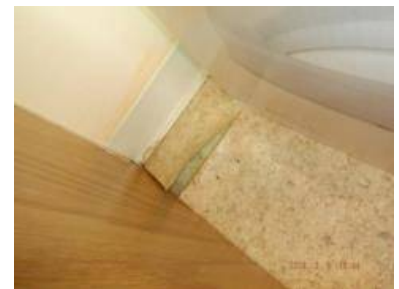
1304 VINYL FLOOR:

[CR] The vinyl flooring was damaged. We recommend correcting the condition(s) noted.

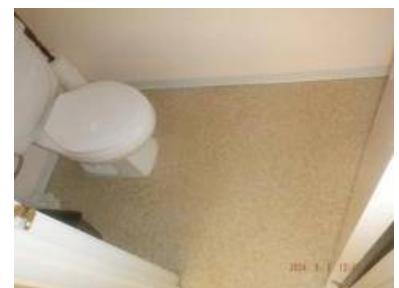
[NOTE] Additional image

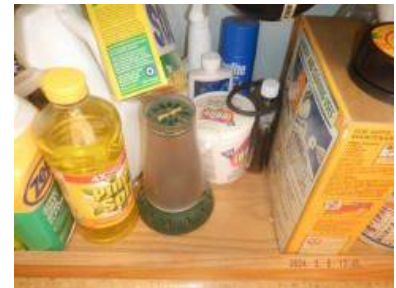
1314 CABINETS/TOPS: [FE] The interior of the cabinet was not visible due to stored personal items. We recommend correcting the condition(s) noted and viewing this area for damage prior to closing.

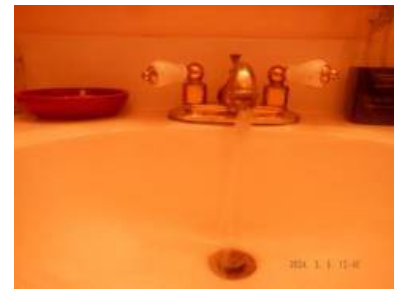
1315 SINK/PLUMBING: [CR] The faucet aerator was dirty/damaged/missing. We recommend correcting the condition(s) noted.

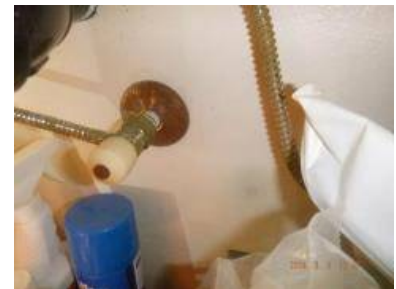
[CR] Corrosion was noted on the shutoff valves. No leakage noted at this time. We recommend correcting the condition(s) noted.
