# **INSPECTION REPORT SUMMARY**

March 5, 2024

Inspection Report Exclusively For: Aleksey and Tatyana Feldman

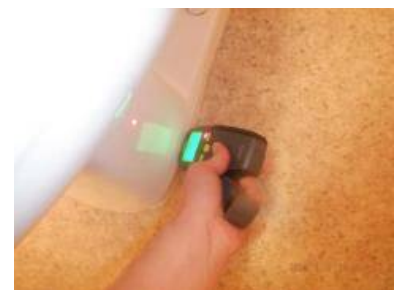
1316 TOILETS: [CR] The toilet showed evidence of **seepage/leakage** at the baseline/wax ring. These condition(s) are conducive to moisture intrusion and deterioration. We recommend correcting the condition(s) noted along with any and all damaged materials.

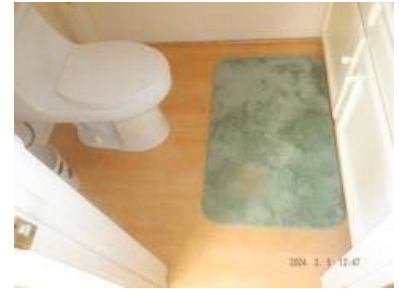
1305 WOOD FLOOR: The visible areas of the simulated wood flooring serviceable with signs of aging and wear.

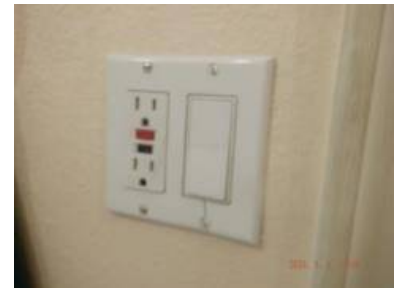
[SC] Switch cover plates were cracked. We recommend correcting the condition(s) noted.

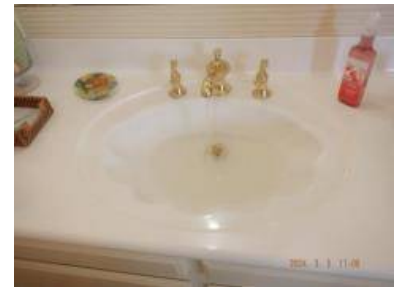
1315 SINK/PLUMBING: [CR] The sink drain was slow or blocked. We recommend correcting the condition(s) noted.

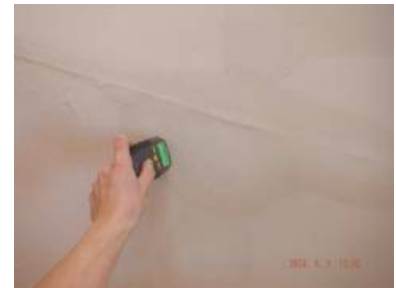
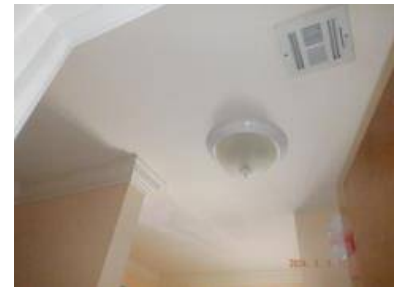
1301 WALLS/CEILING: [CR] Moisture/stains were noted on the walls and ceiling. The area tested dry during the inspection. We recommend locating and correcting the source as well as any damaged materials.

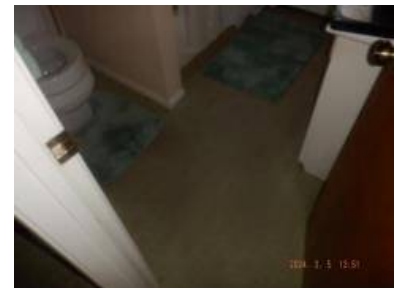
1302 CARPET FLOOR: [CR] The carpet was soiled. We recommend correcting the condition(s) noted. [NOTE] Carpeted bathrooms can trap moisture, urine, feces and other substances that can cause damage and health issues. It can also create conditions that may encourage the growth of microbes such as fungi-mold. It also reduces the accuracy for moisture testing around the toilet wax ring. This is not a sanitary or recommended practice and we recommend that all carpet be removed from bathroom areas.

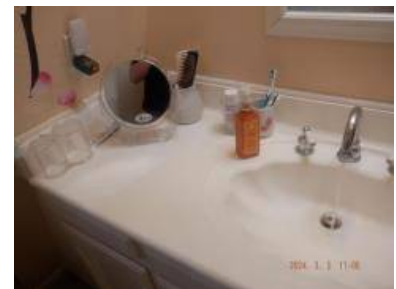
1312 RECEPTACLES: [SC] The accessible receptacles were not GFCI protected as required. This condition is a safety hazard. We recommend correcting the condition(s) noted.

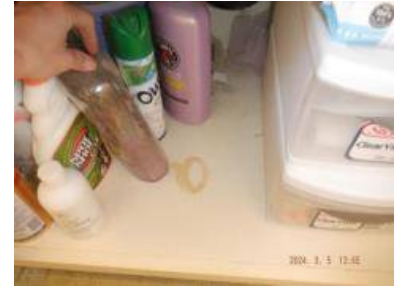
[CR] There was evidence of past moisture staining in the cabinet. The area tested dry at time of inspection. We recommend correcting the condition(s) noted.

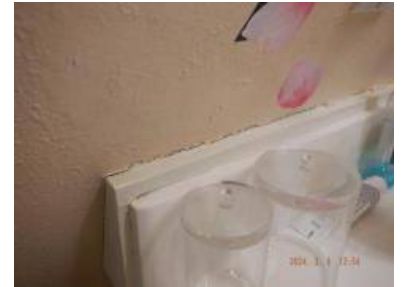
[CR] The grout/caulking was cracked, damaged or missing. This condition is conducive to moisture intrusion into concealed spaces. We recommend correcting the condition(s) noted.

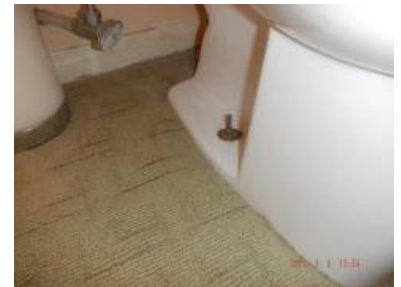
[CR] Toilet bolt covers were missing. We recommend correcting the condition(s) noted.

[CR] The toilet was not readily identifiable as a 1.6 gallon per flush [gpf] or low flush type. We recommend correcting the condition(s) noted.

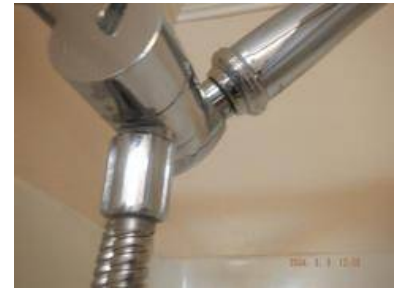
[CR] The faucet leaked at the shower head connection when operated. We recommend correcting the condition(s) noted.

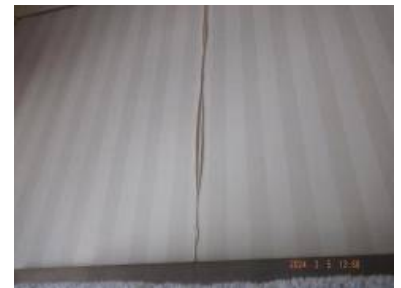
[CR] Damaged wall paper was noted in areas. We recommend correcting the condition(s) noted.

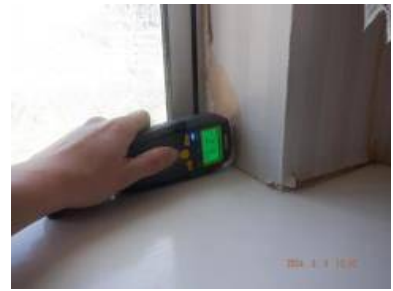
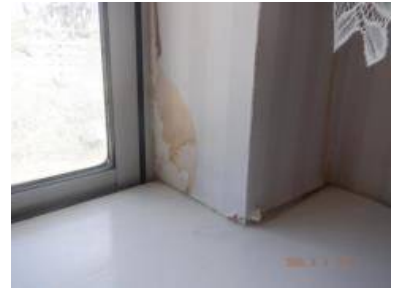
[CR] There was evidence of moisture stains in the window sill(s). The area tested dry during the inspection. We recommend locating and correcting the source as well as any damaged materials.

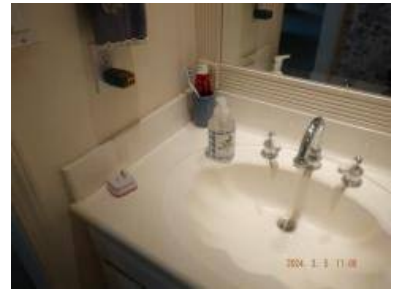
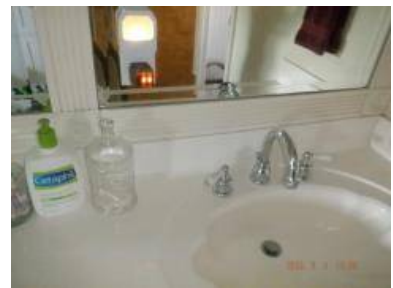
[SC] The accessible receptacles were not GFCI protected as required. This condition is a safety hazard. We recommend correcting the condition(s) noted.

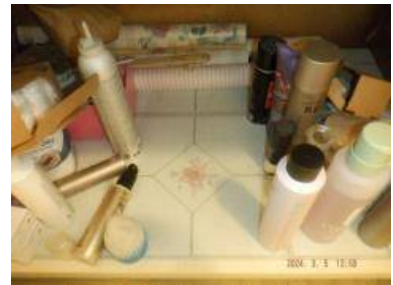
[CR] There was evidence of past moisture staining in the cabinet. The area tested dry at time of inspection. We recommend correcting the condition(s) noted.

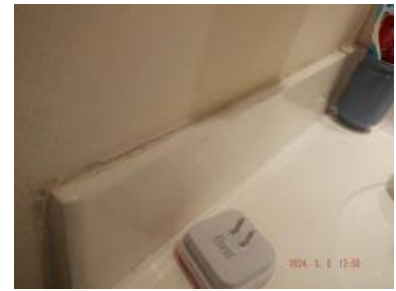
[CR] The grout/caulking was cracked, damaged or missing. This condition is conducive to moisture intrusion into concealed spaces. We recommend correcting the condition(s) noted.

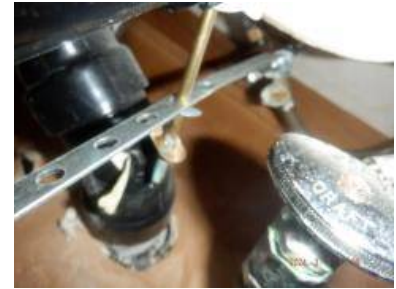
[CR] **Active leaks** were noted at the handle connection under the sink on the right side. We recommend correcting the condition(s) noted.

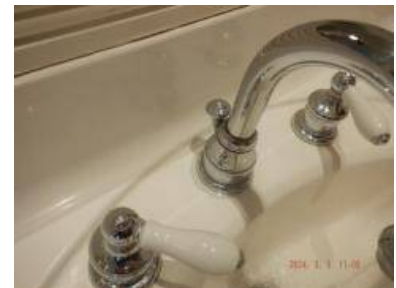
[CR] The faucet leaked at the handle(s). We recommend correcting the condition(s) noted.

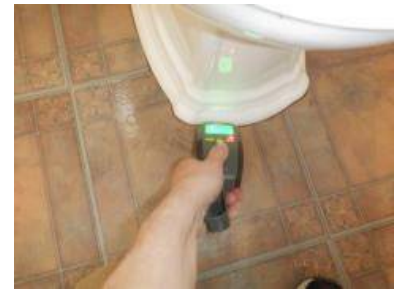
[CR] The toilet showed evidence of **seepage/leakage** at the baseline/wax ring. These condition(s) are conducive to moisture intrusion and deterioration. We recommend correcting the condition(s) noted along with any and all damaged materials.

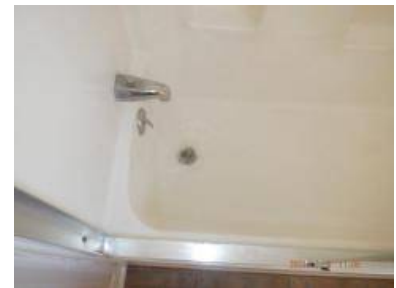
[CR] The stopper mechanism was defective/missing parts. We recommend correcting the condition(s) noted.

[CR] The faucet leaked at the handles when operated. We recommend correcting the condition(s) noted.

[CR] The faucet(s)/spout were not sealed to the wall/deck. This condition is conducive to moisture intrusion into concealed spaces. We recommend correcting the condition(s) noted.

[CR] The tub drain was slow/blocked. We recommend correcting the condition(s) noted.

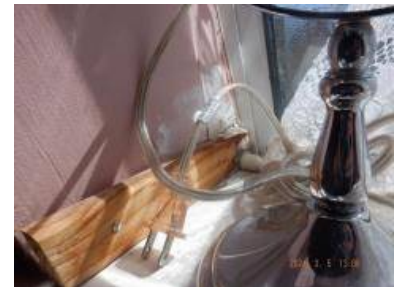
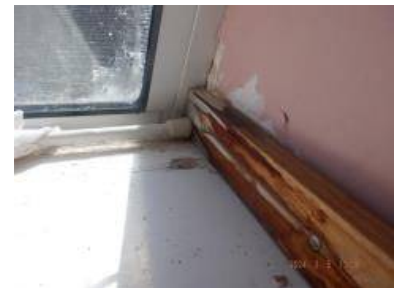
[CR] There was evidence of moisture stains and damage in the window sill(s). The area tested dry during the inspection. We recommend locating and correcting the source as well as any damaged materials.

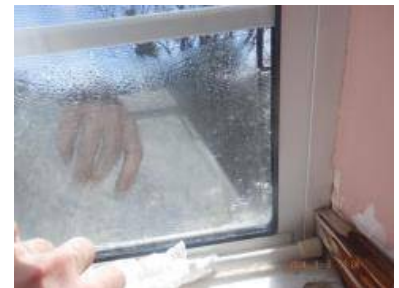
[FE] Condensation/stains were noted between the glass panes in the thermal window(s). We recommend having all of the doors and windows evaluated by a specialist in the appropriate trade.

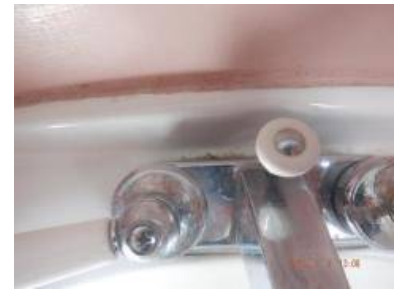
[CR] The sink/surface was cracked. We recommend correcting the condition(s) noted.

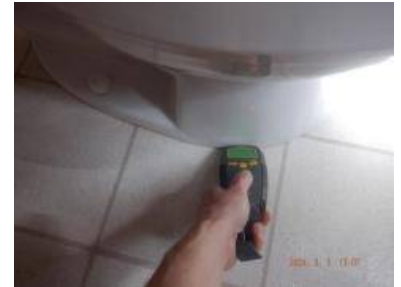
[CR] The toilet showed evidence of **seepage/leakage** at the baseline/wax ring. These condition(s) are conducive to moisture intrusion and deterioration. We recommend correcting the condition(s) noted along with any and all damaged materials.

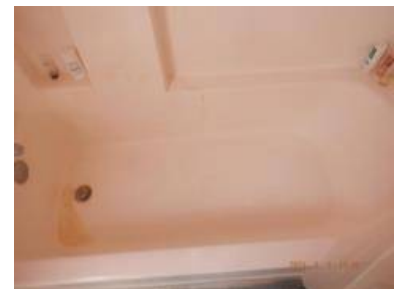
[CR] The tub drain was slow/blocked. We recommend correcting the condition(s) noted.

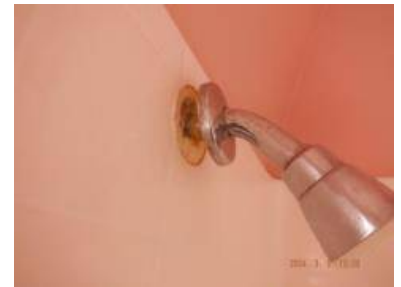
[CR] The faucet(s)/spout were not sealed to the wall/deck. This condition is conducive to moisture intrusion into concealed spaces. We recommend correcting the condition(s) noted.

[CR] The grout/caulking was cracked, damaged or missing. This condition is conducive to moisture intrusion into concealed spaces. We recommend correcting the condition(s) noted.

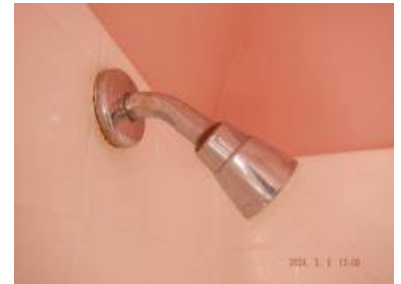
[CR] The faucet leaked at the shower head connection when operated. We recommend correcting the condition(s) noted.

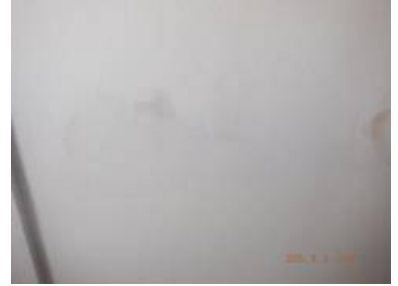
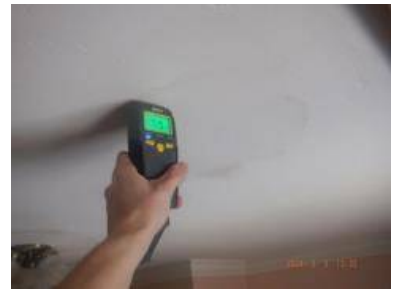
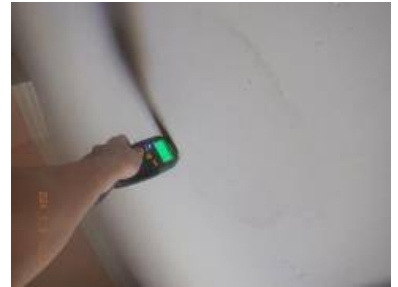
[CR] Moisture/stains were noted on the walls and ceiling. The area tested dry during the inspection. We recommend locating and correcting the source as well as any damaged materials.

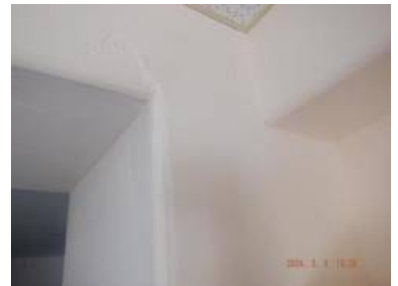
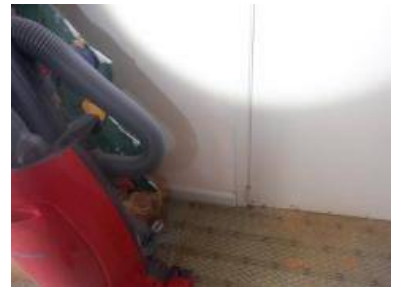
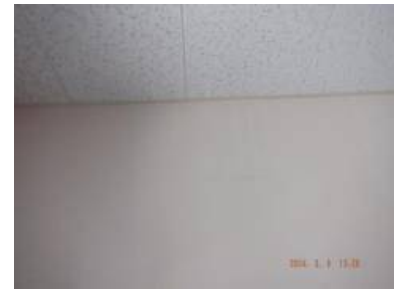
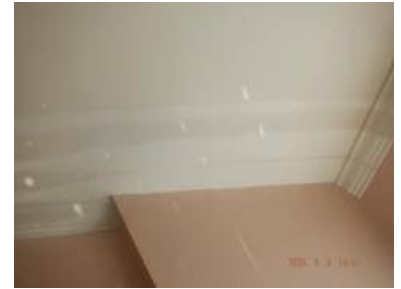
[FE] Past repairs were noted on the wall(s)/ceiling. We recommend inquiring about any previous work done and any moisture issues that may have occurred here.

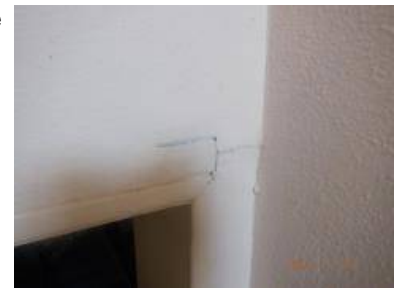
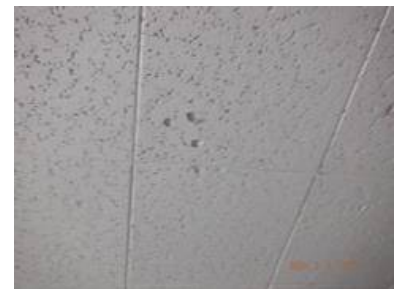
[CR] Damage was noted on the wall(s)/ceiling. We recommend correcting the condition(s) noted.

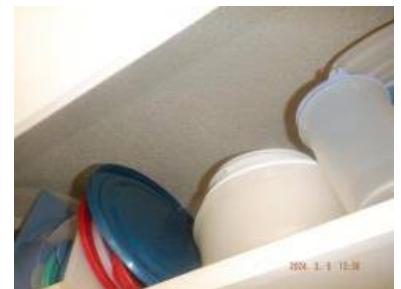
[FE] Some ceilings were made of the older "popcorn" material. Inquire about this condition.

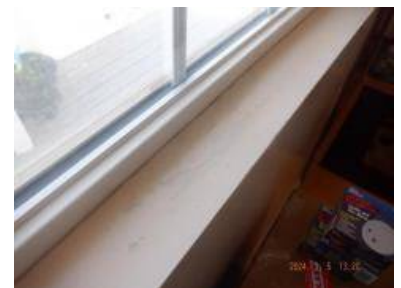
[CR] Minor cosmetic damage was noted throughout the building. We recommend correcting the condition(s) noted.

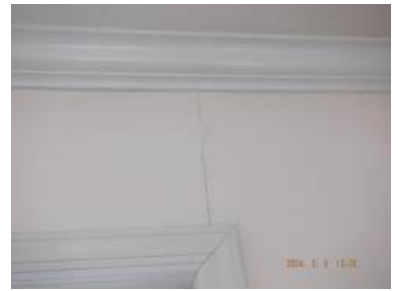
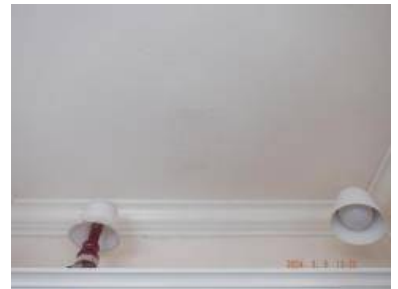
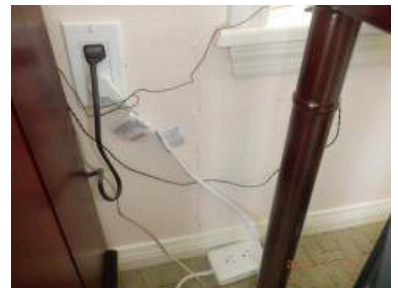
The visible areas of the walls and ceiling appeared serviceable with some cracks noted.

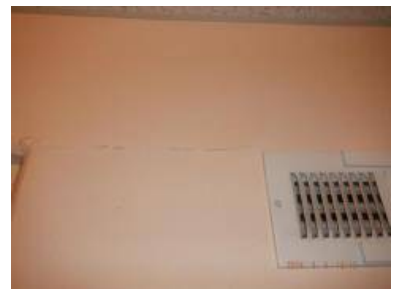
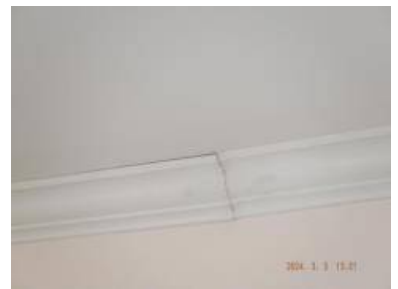
[CR] Some settlement cracks were noted. We recommend correcting the condition(s) noted.

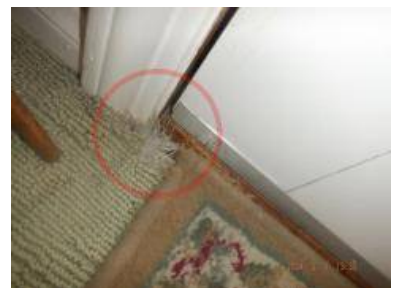
[CR] The carpet was damaged. We recommend correcting the condition(s) noted.

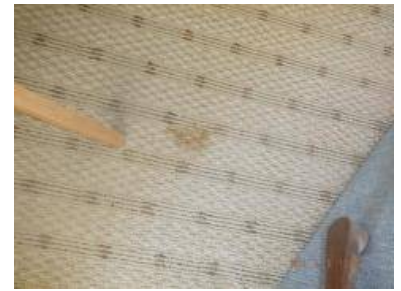
[CR] The carpet was soiled/stained in areas. We recommend correcting the condition(s) noted.

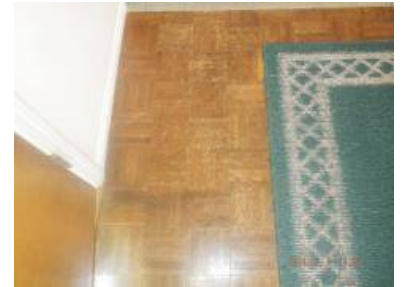
[CR] The wood floor was worn and scratched. We recommend correcting the condition(s) noted.

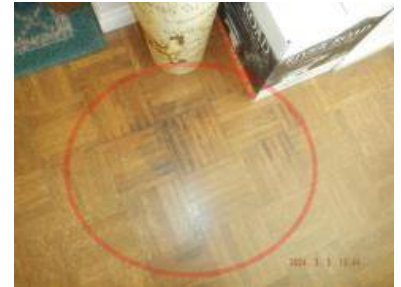
[CR] Moisture/stains were noted on the wood flooring. The area tested dry during the inspection. We recommend locating and correcting the source as well as any damaged materials.

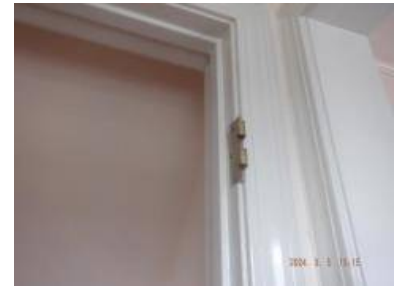
[CR] Some interior door(s) were removed. We recommend correcting the condition(s) noted.

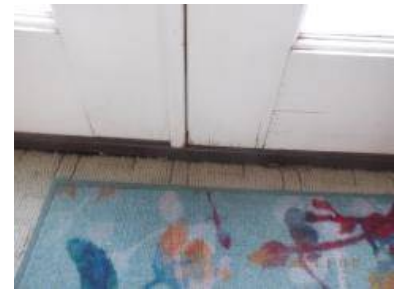
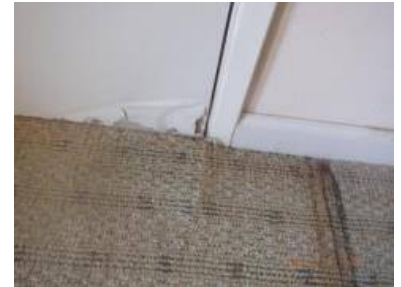
[CR] Some exterior door(s) were damaged/deteriorated. We recommend correcting the condition(s) noted.

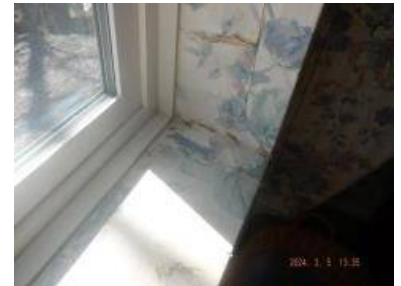
[CR] There was evidence of moisture stains and damage in the window sill(s). The area tested wet during the inspection. We recommend locating and correcting the source as well as any damaged materials.

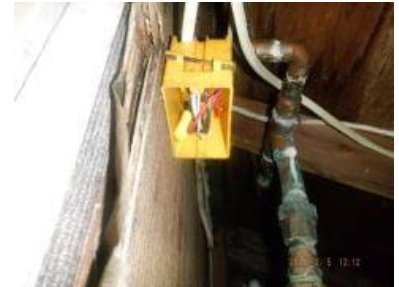
[SC] There was improper wiring in the form of an open junction box in the well equipment closet. We recommend correcting the condition(s) noted.

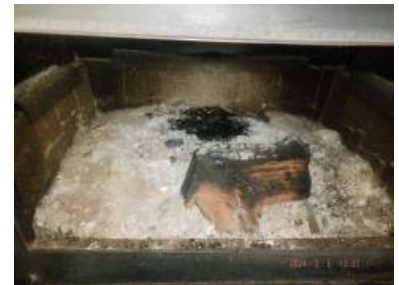
[CR] The woodstove and flue were dirty. We recommend the fireplace and flue be cleaned by a specialist in the appropriate trade.

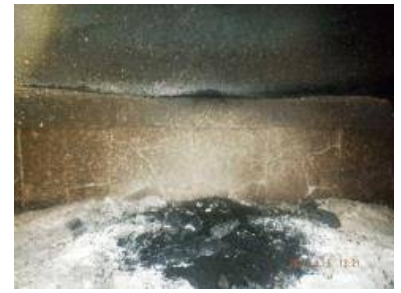
[CR] There were cracked blocks in the firebox. We recommend correcting the condition(s) noted.

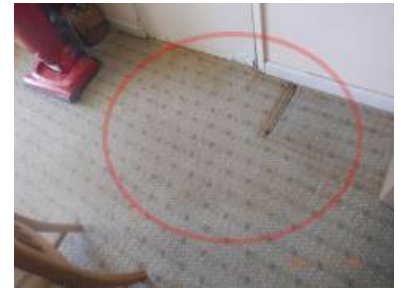
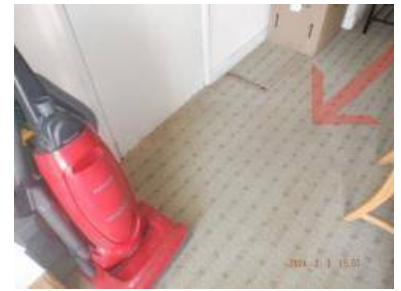
[FE] There was a moisture related odor present in the finished basement area. A large moisture stain was noted by the well pump equipment closet. The area was damp (12-15% moisture reading) at time of inspection. See grading in exterior section also. We recommend locating and correcting the source and any damaged materials.

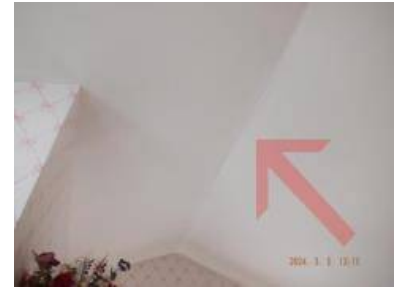
[FE] Past repairs were noted on the wall(s)/ceiling. We recommend inquiring about any previous work done and any moisture issues that may have occurred here.

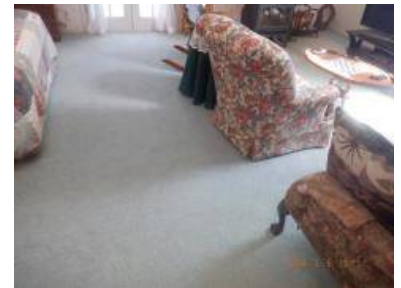
[CR] The carpet was soiled/stained in areas. We recommend correcting the condition(s) noted.

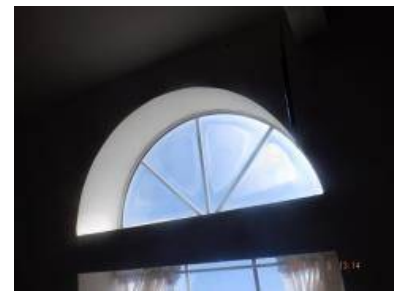
[FE] Condensation/stains were noted between the glass panes in the thermal window(s). We recommend having all of the doors and windows evaluated by a specialist in the appropriate trade.

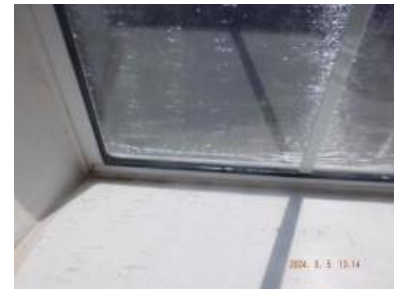
[CR] Some window screen(s) had damaged mesh/frames/latches or were missing. We recommend correcting the condition(s) noted.

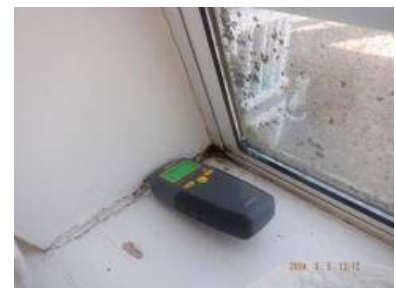
[CR] There was evidence of moisture stains and damage in the window sill(s). The area tested **actively wet** during the inspection. We recommend locating and correcting the source as well as any damaged materials.

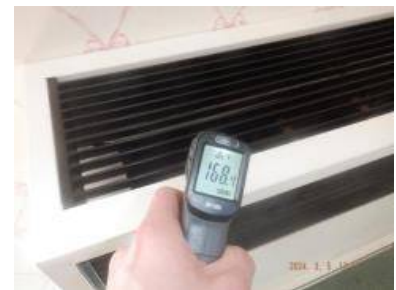
1417 HEAT & COOL:

The electric/gas wall heater was serviceable.

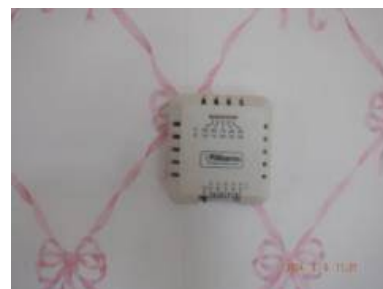
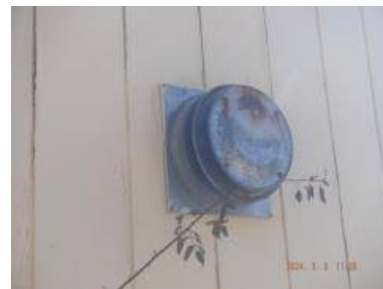
[CR] The flue for the studio heater was rusted. We recommend correcting the condition(s) noted.

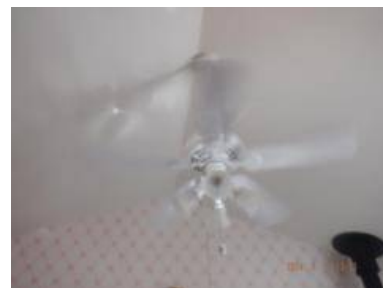
1418 LIGHTS/FIXTURES: The light(s) and ceiling fan were serviceable.

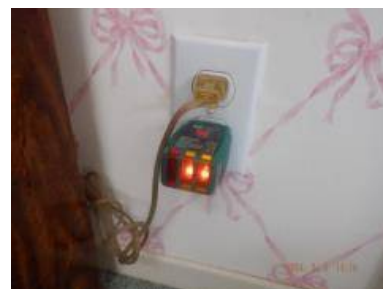
1419 RECEPTACLES: The accessible receptacles were serviceable.

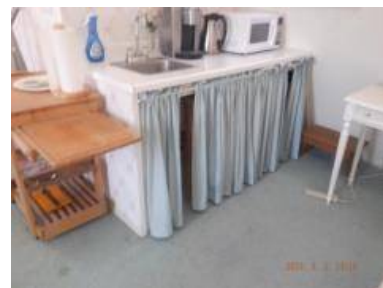
1422 CABINETS/TOPS: [CR] The cabinet doors were missing. We recommend correcting the condition(s) noted.

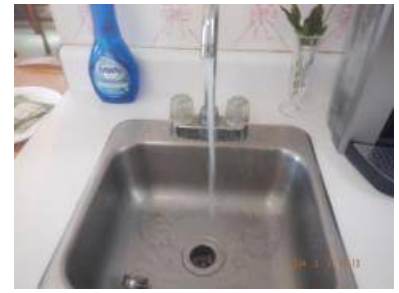
1423 SINK/PLUMBING:

The faucet(s), sink(s) and piping were serviceable, no leakage noted with signs of aging/wear.

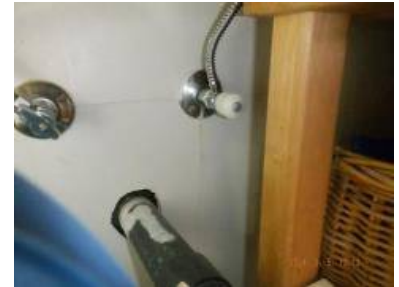
[NOTE] Evidence of past leakage was noted at the water supply piping/shutoff valves. We recommend monitoring this area for future leaks.

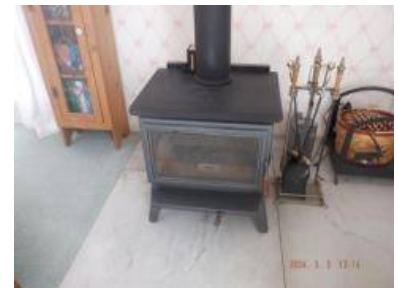
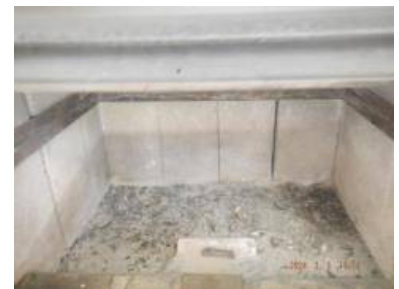
1427 WOODSTOVE:

[CR] The woodstove and flue were dirty. We recommend the woodstove and flue be cleaned by a specialist in the appropriate trade.

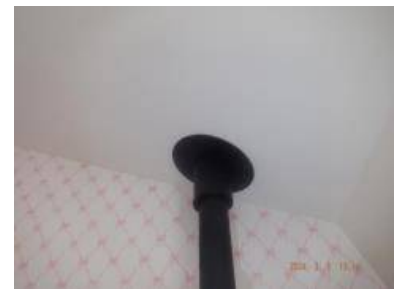
[NOTE] No moisture noted around ceiling connection.

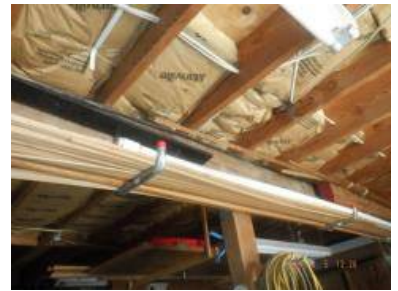
[SC] The garage ceiling/wall tie framing was being used for storage. The additional weight can damage the framing. We recommend it be engineered or removed.

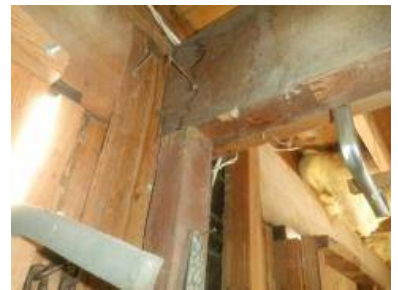
[RU] There was no seismic bracketing at some post to beam connections. We recommend correcting the condition(s) noted.

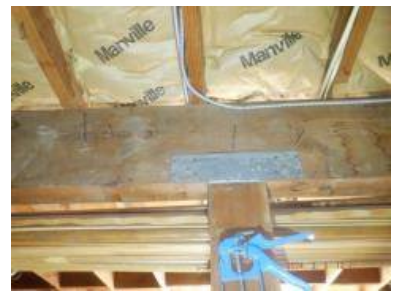
[NOTE] Some post-to-beam connections had seismic bracketing.

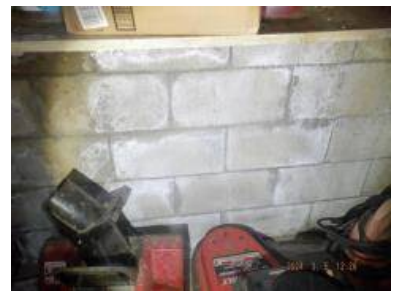
[FE] There were efflorescence (white mineral salts) stains on the walls (see grading in exterior). This condition is an indication of moisture intrusion. We recommend locating and correcting the source and any damaged materials.

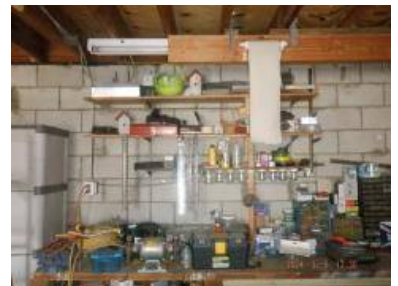
[SC] There were homeowner-built shelves hanging from the ceiling/walls. The additional weight can damage the framing. We recommend it be engineered or removed.

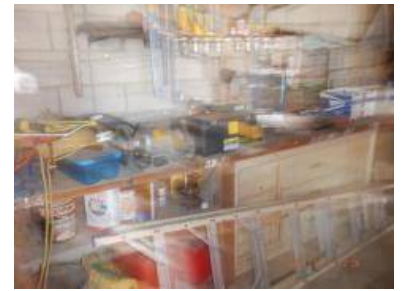
[FE] Portions of the interior walls and ceiling were not visible at this time due to stored personal items. We recommend checking these areas after the items have been removed.

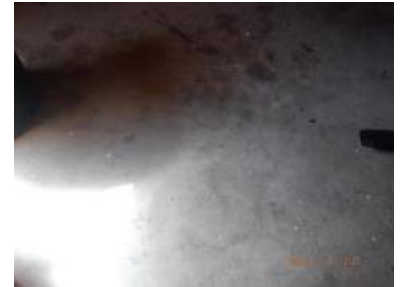
[FE] There were efflorescence (white mineral salts) stains on the floor. This condition is an indication of moisture intrusion. We recommend locating and correcting the source as well as any damaged materials.

[CR] Concrete was stained in areas. We recommend correcting the condition(s) noted.

[CR] There were cracks in the garage floor. We recommend correcting the condition(s) noted.

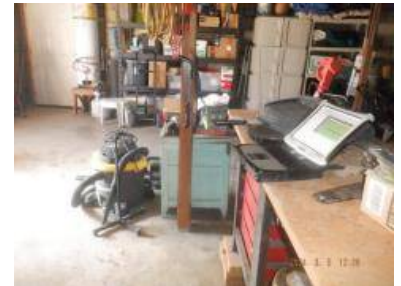
[FE] The floor was not fully visible, due to stored items. We recommend checking these areas after the stored items are removed.

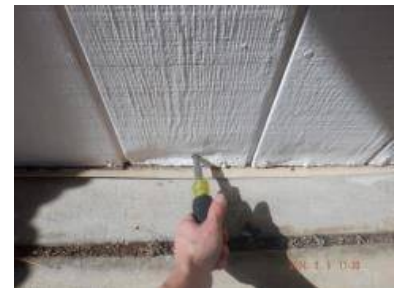
[CR] The car door(s) were damaged. We recommend correcting the condition(s) noted.

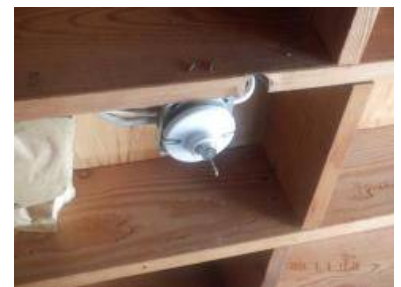
[CR] Some lights **failed** to function and were missing lenses/globes. We recommend correcting the condition(s) noted.

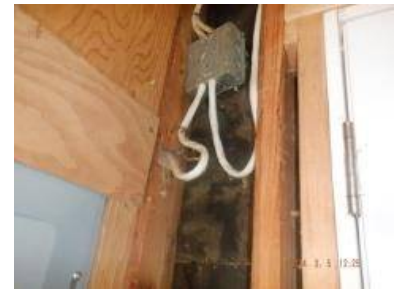
[SC] There was improper wiring installed in the form of nonmetallic sheathed wiring exposed to human contact and/or mechanical damage. We recommend correcting the condition(s) noted.

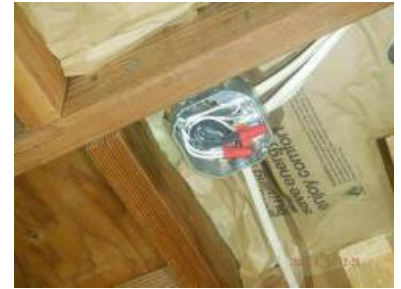
[SC] There was improper wiring installed in the form of open junction boxes. We recommend correcting the condition(s) noted.

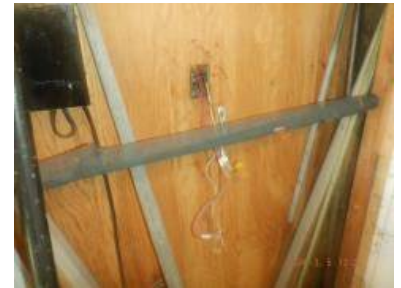
[SC] There was improper wiring installed in the form of improperly terminated wiring. We recommend correcting the condition(s) noted.

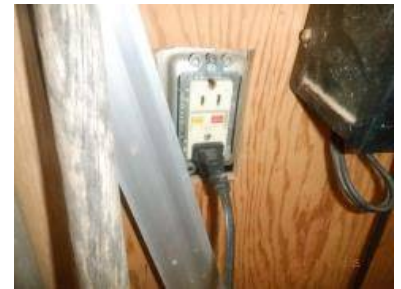
The accessible receptacles were serviceable and GFCI protected where required.

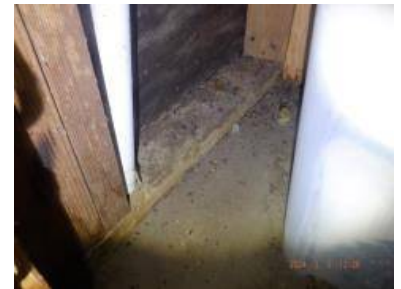
[FE] There was evidence of conditions that require further evaluation by a pest control operator. We recommend further evaluation and corrections by a specialist in the appropriate trade.

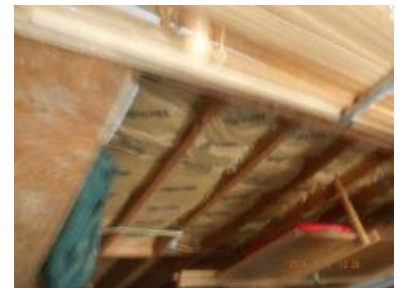
[CR] The insulation (for studio above) was installed upside down. The vapor barrier should be against the conditioned air space. We recommend correcting the condition(s) noted.
