## Home Inspection Report

**1177 Muirlands Vista Way, La Jolla**

**Carlos Arechiga**  
**October 8, 2025**

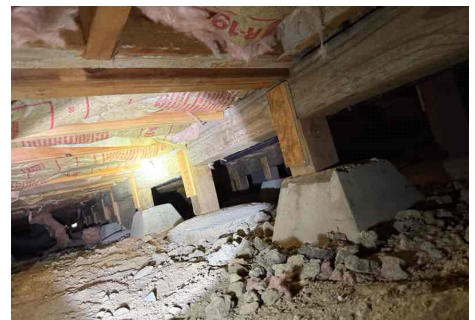
Photo 65

2. The installation of wooden hardware at the posts, piers and/or girders appears to be improper. We recommend further evaluation of their condition and repair or replacement of the hardware as necessary by a licensed contractor. (See Photo 65)

- ! 2. The installation of wooden hardware at the posts, piers and/or girders appears to be improper. We recommend further evaluation of their condition and repair or replacement of the hardware as necessary by a licensed contractor. (See Photo 65)

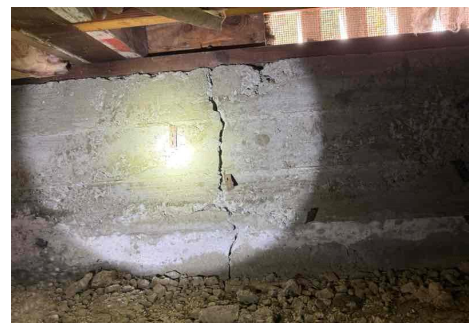
Photo 63

3. Large cracks, deterioration and/or movement was observed in the foundation of the structure at the right side. This implies that structural movement and/or settlement of the building has occurred. The rate of movement cannot be predicted during a one-time inspection. A thorough evaluation of this condition is beyond our qualifications. For additional information we recommend contacting a licensed foundation contractor for further evaluation. (See Photo 63)

- ! 3. Large cracks, deterioration and/or movement was observed in the foundation of the structure at the right side. This implies that structural movement and/or settlement of the building has occurred. The rate of movement cannot be predicted during a one-time inspection. A thorough evaluation of this condition is beyond our qualifications. For additional information we recommend contacting a licensed foundation contractor for further evaluation. (See Photo 63)

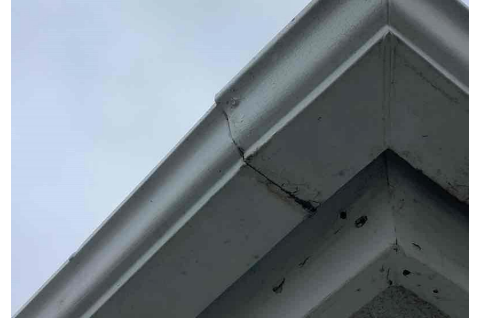
Photo 05

9. Leaks were noted in the downspouts and/or gutters at various areas. During wet weather conditions these areas are more obvious and during dry weather conditions they are noted from the stains at the areas where the leaks have occurred. We recommend all leaks be repaired. (See Illustration 2D) (See Photo 5)
10. Loose/disconnected downspouts at the rear should be repaired or replaced. (See Photo 10) (See Photo 71)

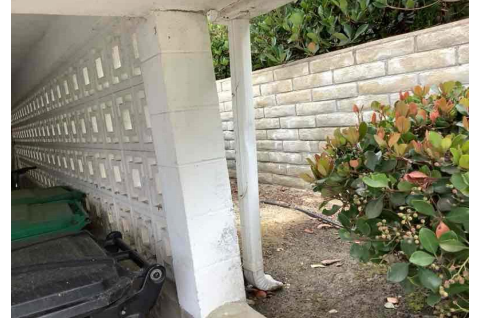
Photo 10

- ! 4. Loose/disconnected downspouts at the rear should be repaired or replaced. (See Photo 10) (See Photo 71)
5. A gap was observed at the top of some of the jack flashing. Gaps around all jack (cone) flashing should be sealed to prevent moisture entry.

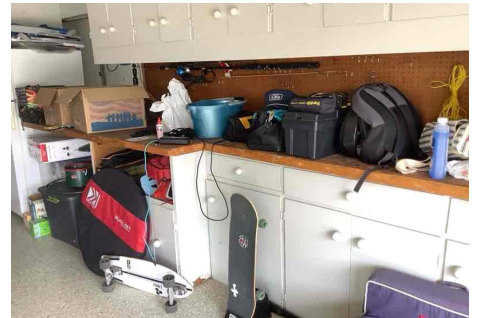
Photo 30

11. Storage of personal belongings within the interior of the garage prevented a full visual inspection of the area. Therefore, the area was not fully inspected. With removal of all personal items and a complete inspection, conditions in need of attention may be discovered. (See Photo 30)
12. Evidence of water damage was noted at the patio/rear carport cover. Consult a licensed structural pest company regarding necessary repairs. (See Photo 28)
13. The driveway has cracked, heaved, or uneven sections, creating a potential trip hazard. We recommend repairing or resurfacing the affected areas to improve safety and prevent further deterioration. (See Photo 9)

Storage of personal belongings within the interior of the garage prevented a full visual inspection of the area. Therefore, the area was not fully inspected. With removal of all personal items and a complete inspection, conditions in need of attention may be discovered. (See Photo 30)

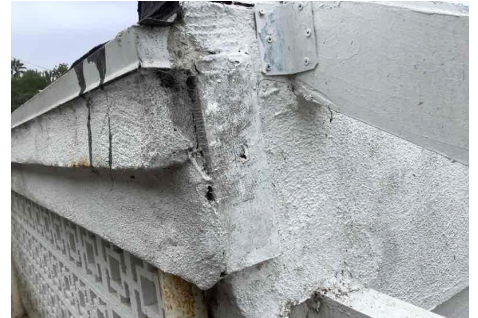
Photo 28

- ! 1. Evidence of water damage was noted at the patio/rear carport cover. Consult a licensed structural pest company regarding necessary repairs. (See Photo 28)

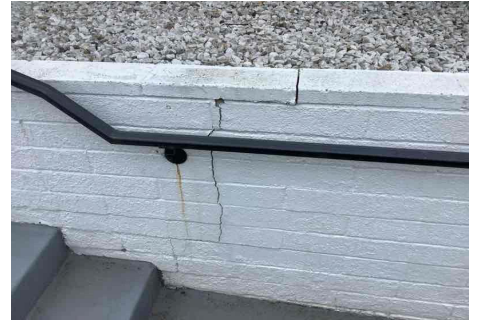
Photo 07

15. The retaining wall at the right, front, and rear shows evidence of movement and/or cracks. This condition should be monitored. It is impossible to determine the rate of movement during a one time visit to the property. (See Photo 7) (See Photo 70)

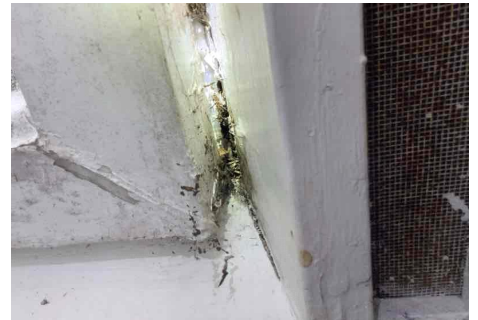
Photo 17

16. Water damage was observed to the roof eaves/sheathing at the rear. We recommend the services of a licensed general contractor and/or structural pest control company. (See Photo 17)

- ! 5. Water damage was observed to the roof eaves/sheathing at the rear. We recommend the services of a licensed general contractor and/or structural pest control company. (See Photo 17)

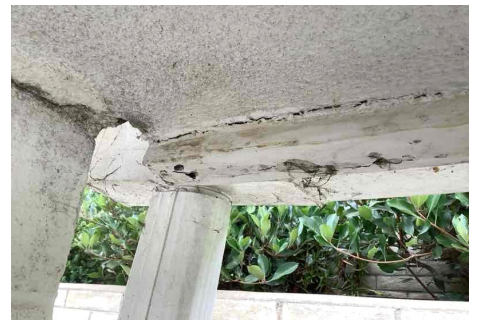
Photo 11

17. Water damage was observed to the fascia at various areas. We recommend the services of a licensed general contractor and/or structural pest control company. (See Photo 11)

- ! 6. Water damage was observed to the fascia at various areas. We recommend the services of a licensed general contractor and/or structural pest control company. (See Photo 11)

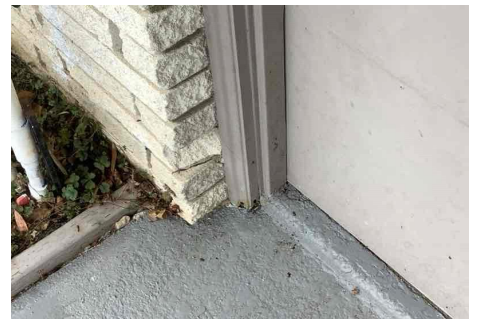
Photo 43

18. Water damage was observed to the exterior trim at various areas. We recommend the services of a licensed general contractor and/or structural pest control company. (See Photo 43)

- ! 7. Water damage was observed to the exterior trim at various areas. We recommend the services of a licensed general contractor and/or structural pest control company. (See Photo 43)

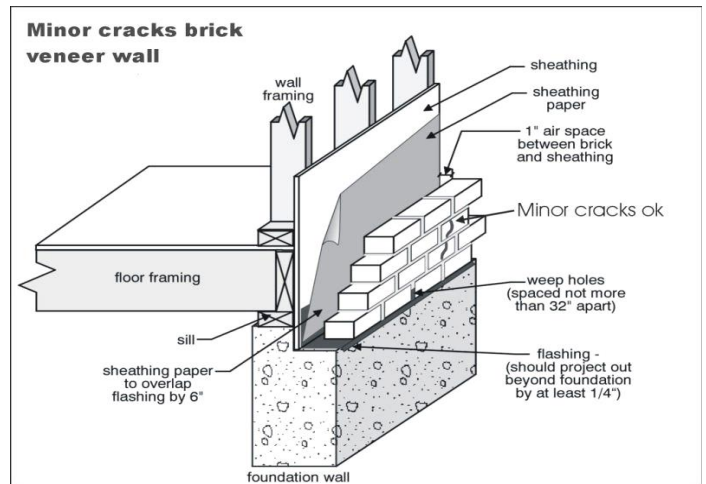
Illustration 3U

8. The exterior brick masonry walls are only a veneer over the basic wood frame construction, the masonry is not a structural element of the house. The veneer walls are cracked and slightly loose in one or more locations. The amount of movement does not suggest a serious structural problem and the rate of movement cannot be predicted during a one-time visit to the home. For a better appearance and to help prevent further deterioration, we recommend the cracks and/or loose bricks be repaired (See Illustration 3U) (See Photo 13)

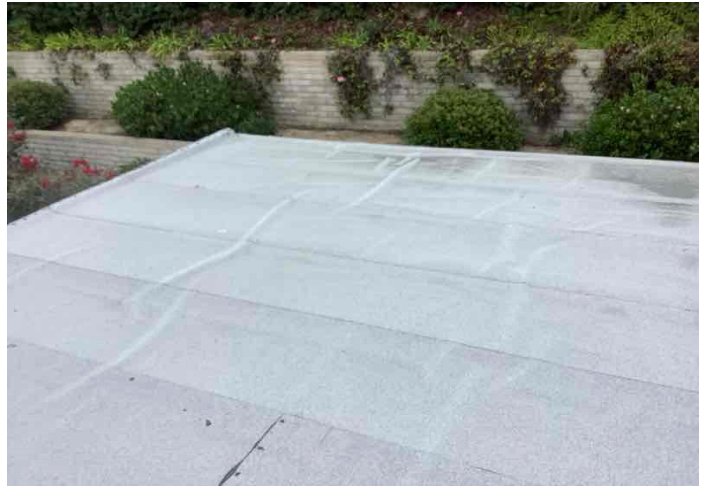
Photo 02

8. Repairs to the roof covering are recommended. Damaged, loose or missing roofing material at the rooftop should be repaired or replaced. All roof penetrations should be examined and sealed as necessary. For further evaluation of the condition of the roof we recommend you consult a licensed roofing contractor. (See Photo 1) (See Photo 2) (See Photo 3)

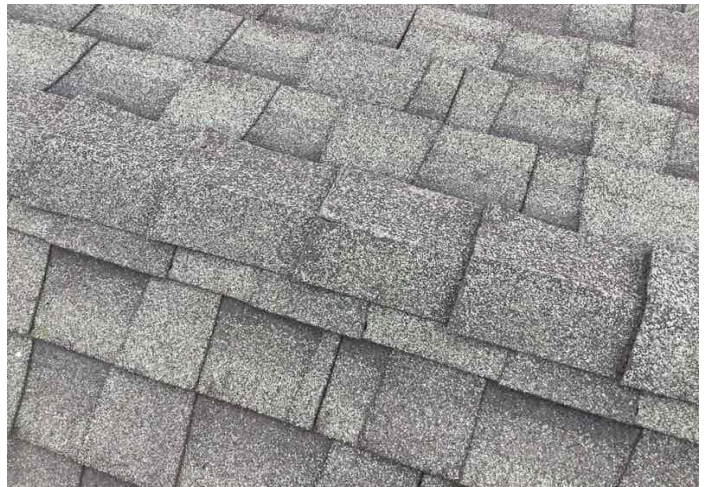
Photo 04

7. Portions of the surface granulation are deteriorated and minor surface cracks are developing. These may be normal signs of aging. For further evaluation of the condition of the roof we recommend you consult a licensed roofing contractor. (See Photo 4)

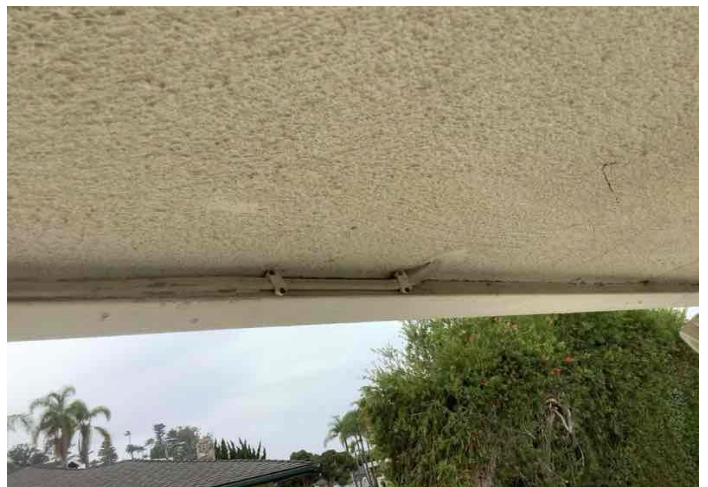
Photo 12

36. We found exposed wiring at the exterior right and left. Even if insulated, we recommend all wiring be encased in conduit or otherwise protected in accordance with present standards. (See Photo 12)

- ! 9. We found exposed wiring at the exterior right and left. Even if insulated, we recommend all wiring be encased in conduit or otherwise protected in accordance with present standards. (See Photo 12)

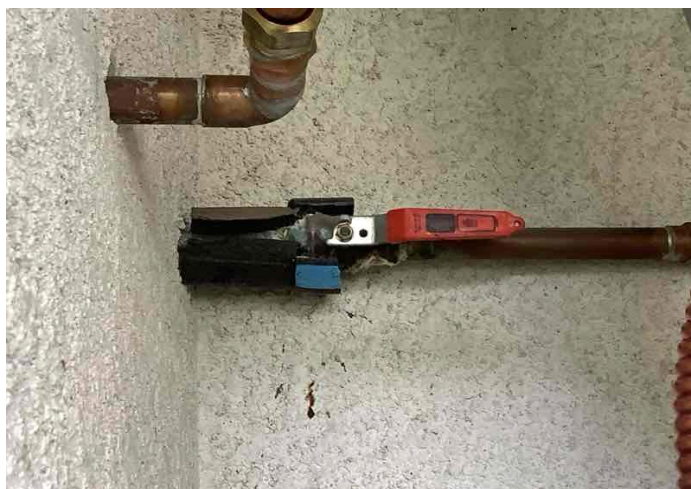
Photo 24

- ! 2. There is evidence of heavy corrosion and rust, but no leakage on the exterior of the exposed and accessible metal supply piping at the water heater. This piping should be monitored for leakage and repaired as necessary. Upgrading this piping and connections should also be considered. (See Photo 24)

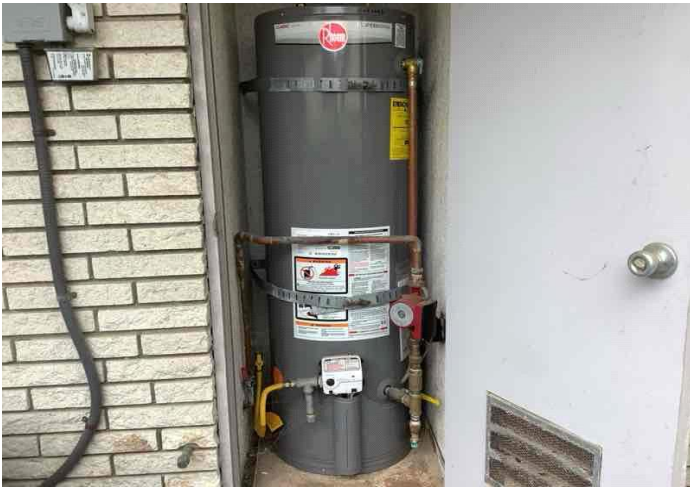
Photo 25

- ! 1. The water heater seismic straps are loose, this will allow movement of the tank in an earthquake. We recommend tightening the straps and/or adding bracing between the tank and wall to improve safety. (See Photo 25)

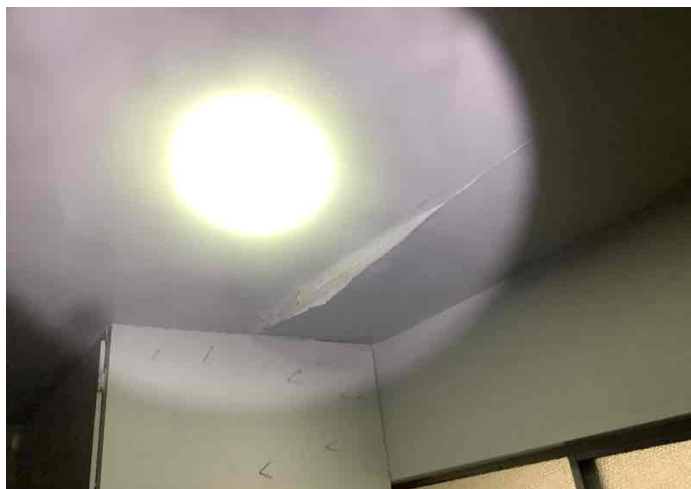
Photo 32

- ! 2. The ceiling in the garage is damaged. We recommend it be repaired. (See Photo 32)
- ! 3. The window at the front wall exhibits conditions and/or symptoms that indicate a possible breached seal or failed thermal pane. This has or can result in condensation and/or moisture developing between the panes of glass that will effect the cosmetic appearance of the windows and their insulating performance. We recommend all insulated glass units be further evaluated by a licensed glazier and repaired or replaced as required. (See Photo 54)

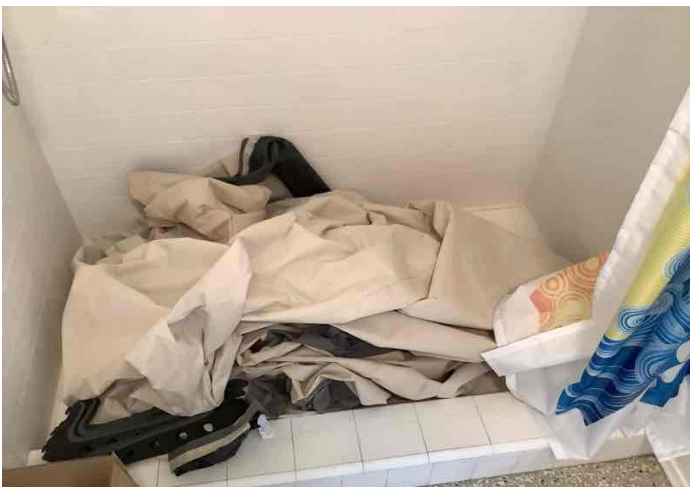
Photo 41

Personal storage was blocking access to the interior of the garage bathroom stall shower. Therefore, the area is considered inaccessible and was not fully inspected. With access and a opportunity for complete inspection, conditions in need of attention may be discovered. The personal belongings should be removed so the area may be examined. (See Photo 41)

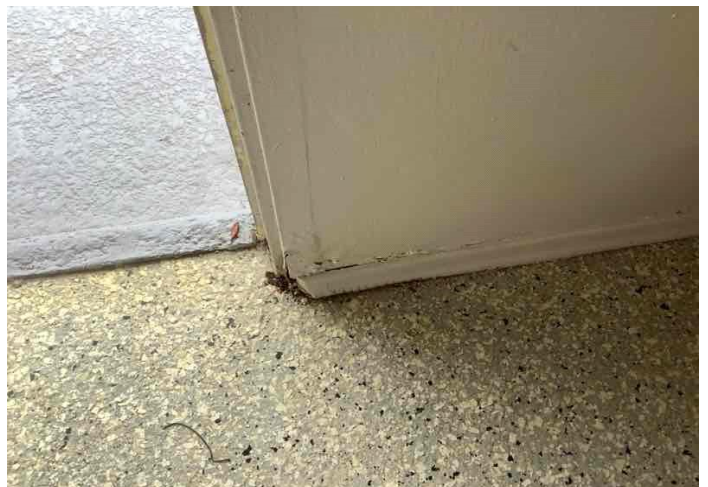
Photo 42

- ! 31. The wall at the garage bathroom shows evidence of water damage. We recommend the services of a licensed structural pest control company for investigation. (See Photo 42)**

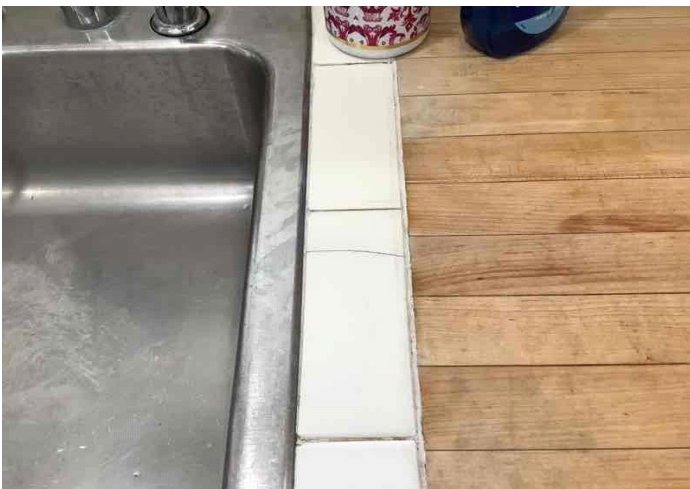
Photo 45

- ! 25. Cracked, damaged and loose kitchen countertop tiles should be replaced. Water leaking through non-sealed areas can cause damage. Damage caused by water seepage cannot be determined by this visual inspection. (See Photo 45)**

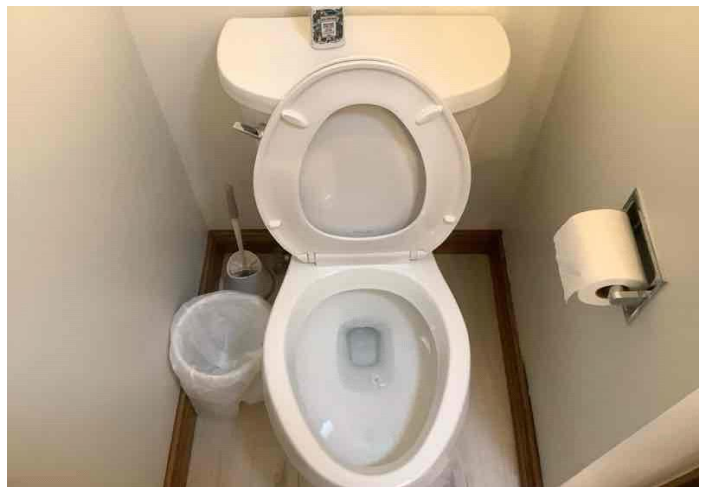
Photo 48

- ! 11. The toilet at all bathrooms is loose and should be properly re-secured, tightened and caulked. (See Illustration 8J) (See Photo 48)
12. The sink was observed to be slow-draining at the right side hall bathroom, indicating a potential obstruction within the drain line. We recommend further evaluation and necessary repairs by a qualified plumber to ensure proper drainage and full functionality of this area.

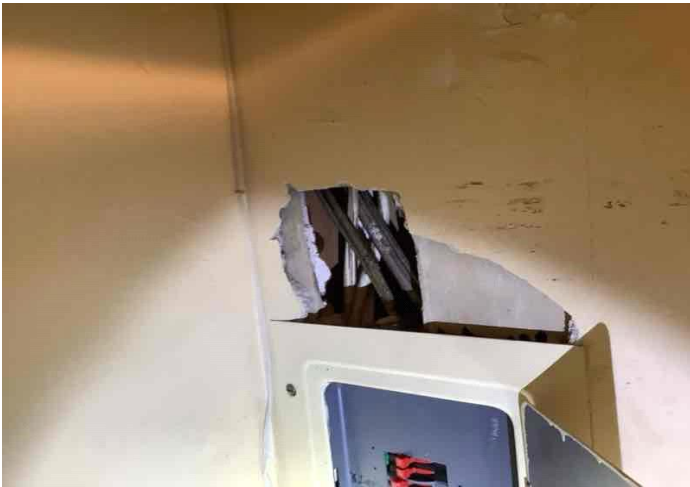
Photo 49

- ! 33. Holes in the hall bathroom closet drywall should be repaired as necessary. (See Photo 49)**
34. The tub drain stopper at the left side hall bathroom was not functioning properly or is missing. We recommend repair or replacement. (See Illustration 9E)

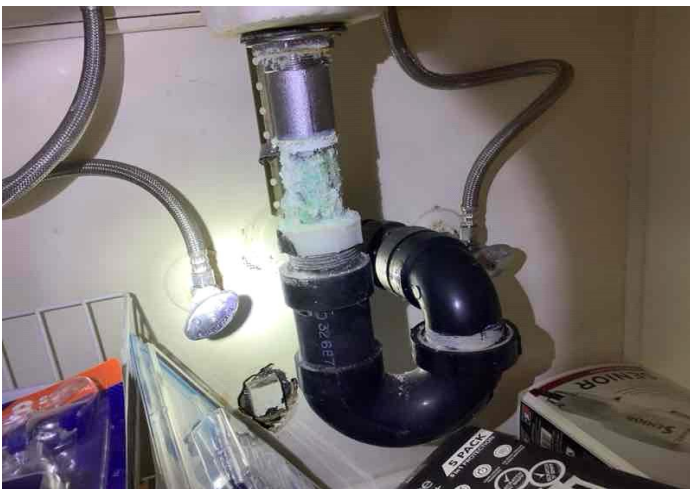
Photo 51

- ! 8. There is evidence of a past leaks and corrosion but presently no active leakage on the exterior of the bathroom and kitchen drain/supply lines. This area should be monitored for leakage and repaired as necessary. Upgrading this piping and connections should be considered. (See Photo 51)

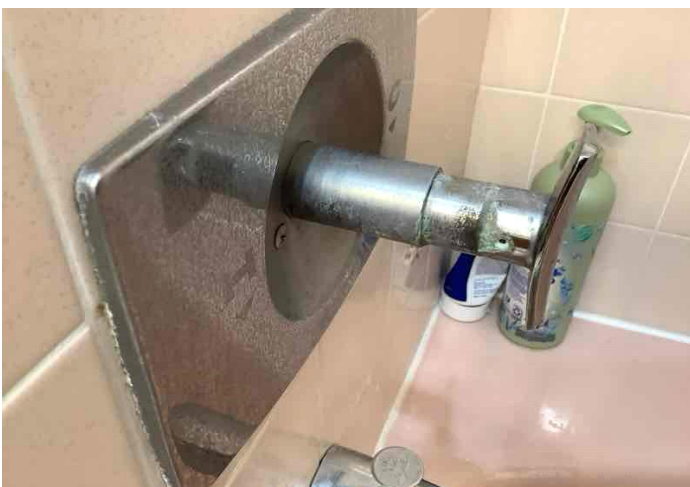
Photo 53

- ! 9. The tub faucet and/or handles are leaking at the left side hall bathroom. We recommend all leaks be repaired. (See Photo 53)
- ! 10. The drain is leaking into the crawl space under the master bathroom and left side hall bathroom. We recommend all leaks be repaired. (See Photo 56) (See Photo 67)
