Home Inspection Report

14029 Barlupi Cir

Sonora, CA 95370

Inspected on Thu, Feb 12 2026 at 9:00AM

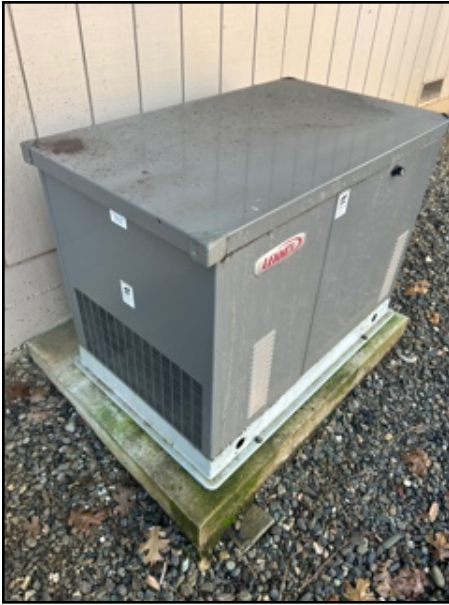
Figure 14-1

Comment 14:

Noted that the house is equipped with a whole house generator. This is outside the scope of the general home inspection and was not ran or tested by the inspector.

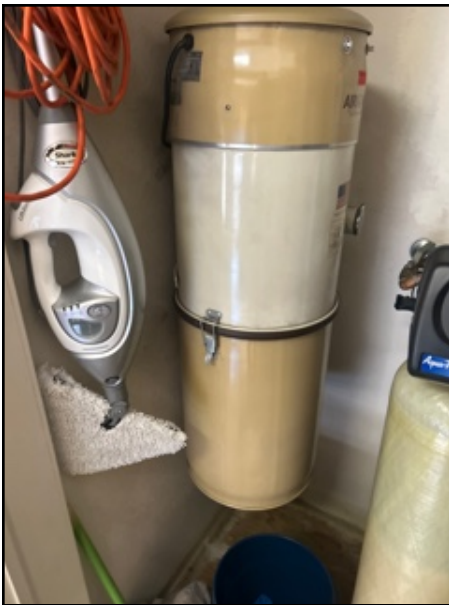
Figure 16-1

Comment 16:
Whole house vacuums are considered outside the scope of a general home inspection and was not tested.

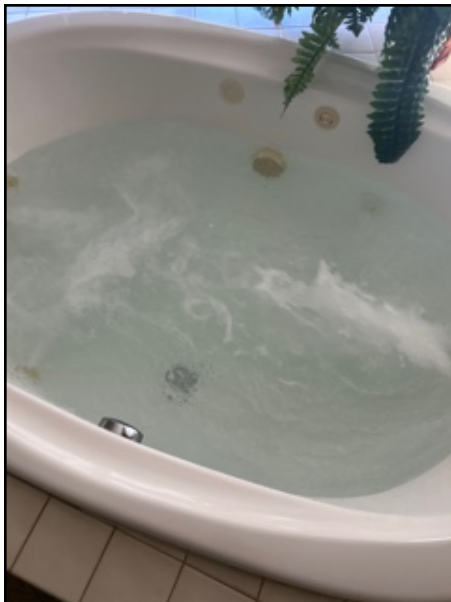
Figure 20-1

Comment 20:

The recirculating tub was tested and was fully functional at the time of inspection.
