# Your Inspection Report

3771 Texas Street  
San Diego, CA 92104

INSPECTION DATE:  
Tuesday, October 15, 2024

RE: Report No. 2563  
3771 Texas Street  
San Diego, CA  
92104

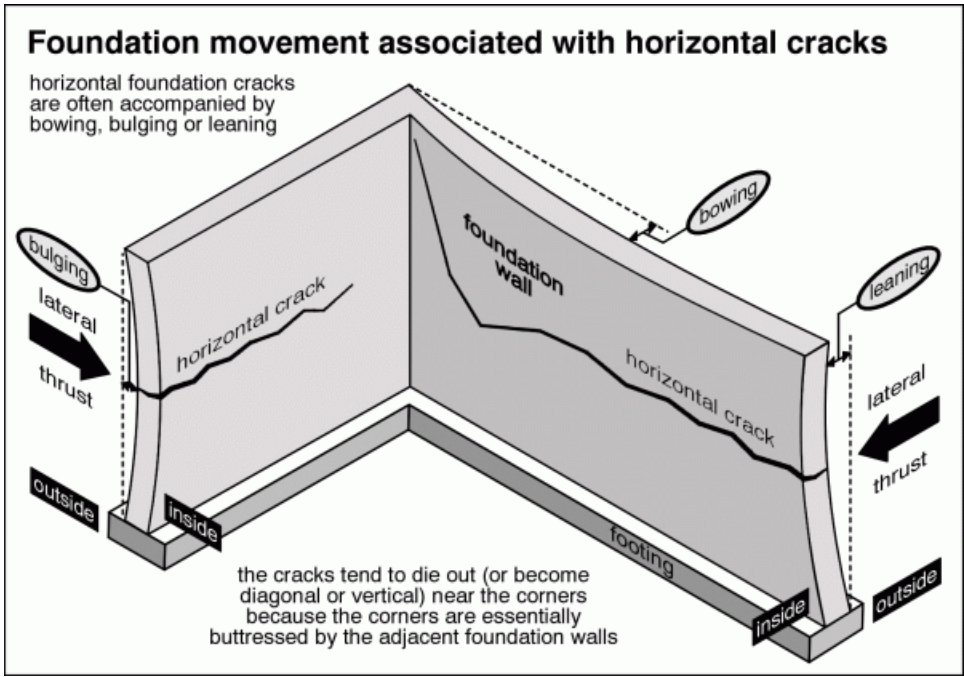
Cracking noted at the foundation wall. This is likely caused from rebar which is within the concrete and rusting, which causes the concrete to become loose, crack and spall. Contact a foundation repair person for price estimates prior to the end of clients contingency period. Approximately 15 lf. of repairs will be necessary in this inspectors opinion.

Foundation cracks
