## Cornerstone Home Inspections

## Home Inspection Report

**15984 Tomahawk**

**Sonora, CA 95370**

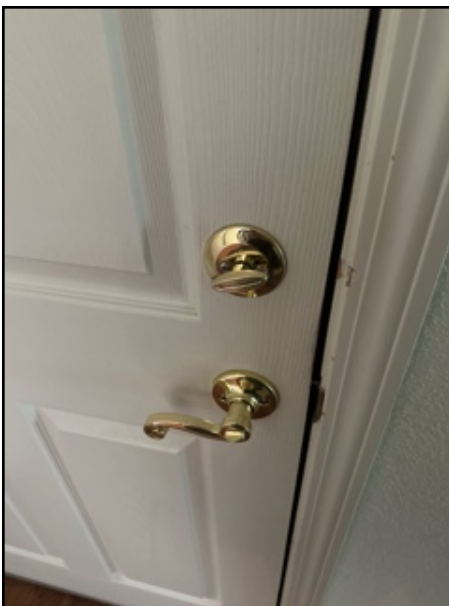
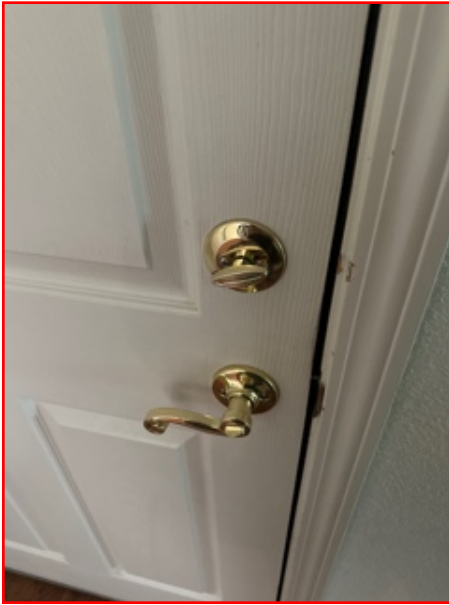
Figure 9-1

Comment 9:  
Garage door deadbolt does not enter the strike plate.

8) Garage door deadbolt does not enter the strike plate.

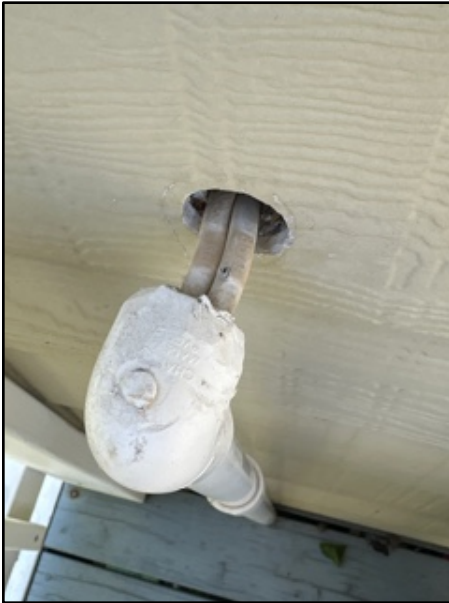
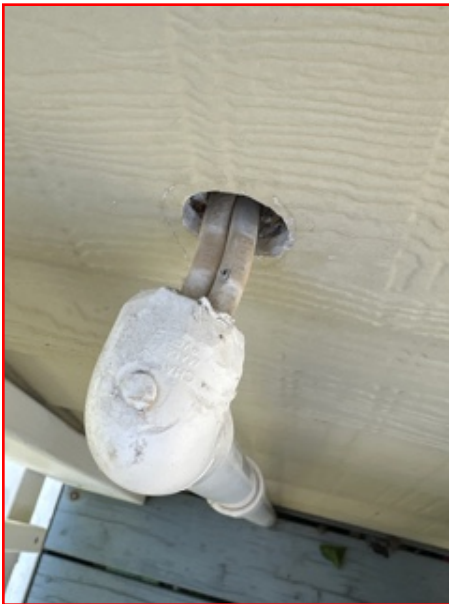
Figure 13-1

Romex is ran through a conduit on far side of deck. Refer to a licensed electrician.

12) Romex is ran through a conduit on far side of deck. Refer to a licensed electrician.

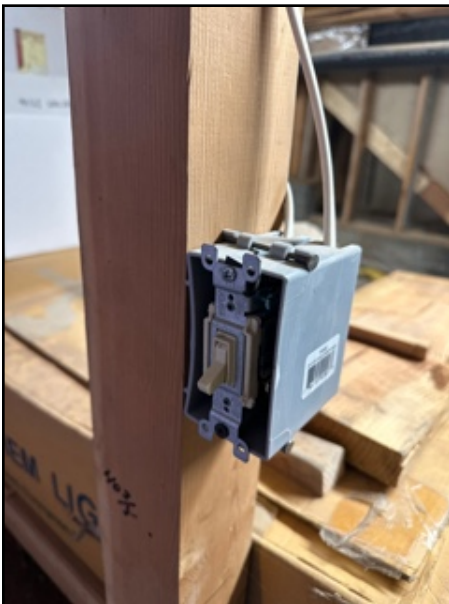
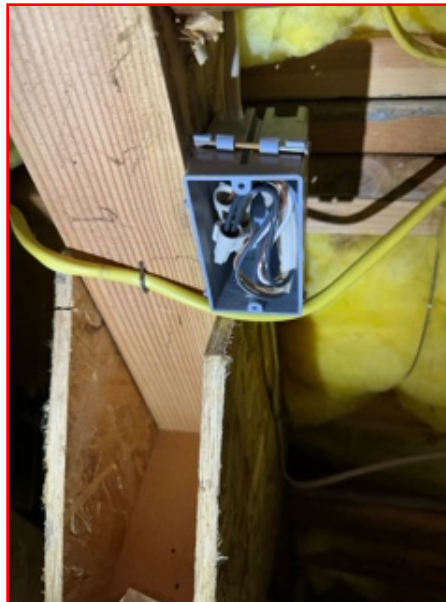
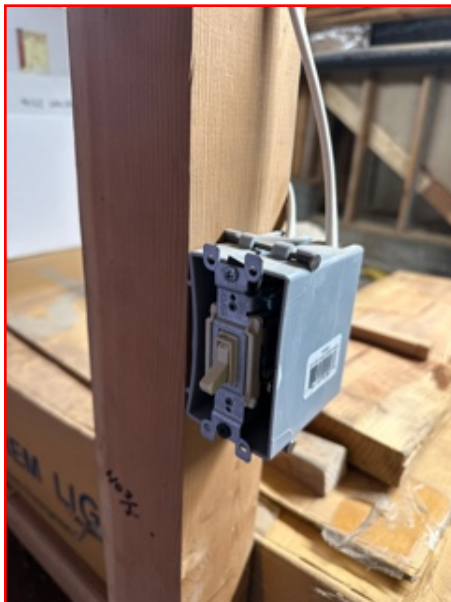
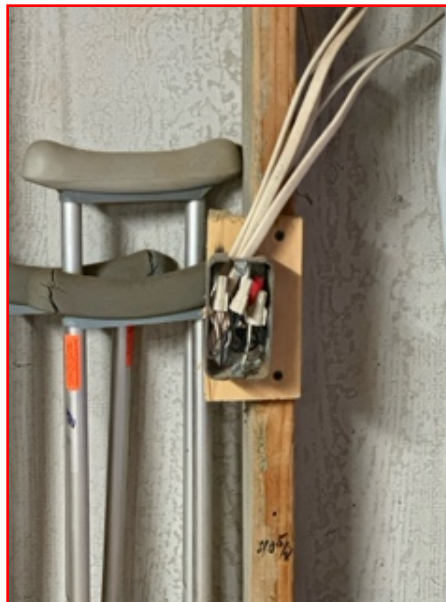
Figure 18-3

Multiple open junction boxes noted in various areas of crawl space. Recommend securing with faceplates.

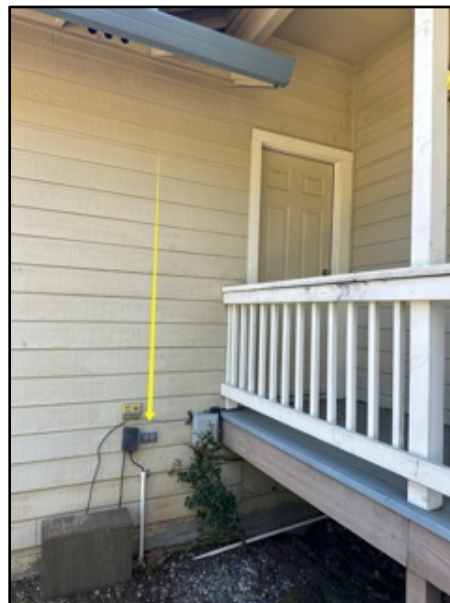
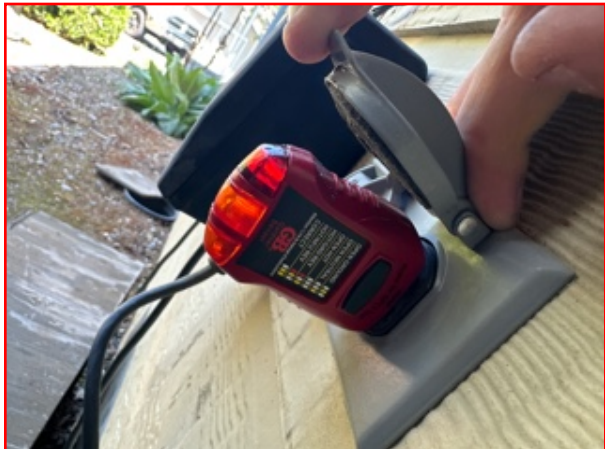
Figure 19-2

15) Receptacle near garage man door has hot & neutral wires reversed. Refer to a licensed electrician.

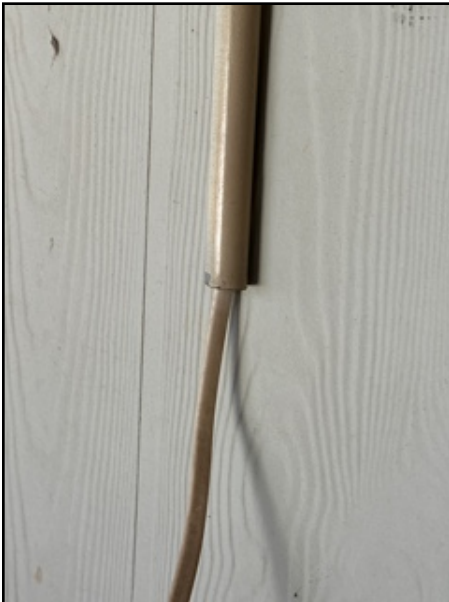
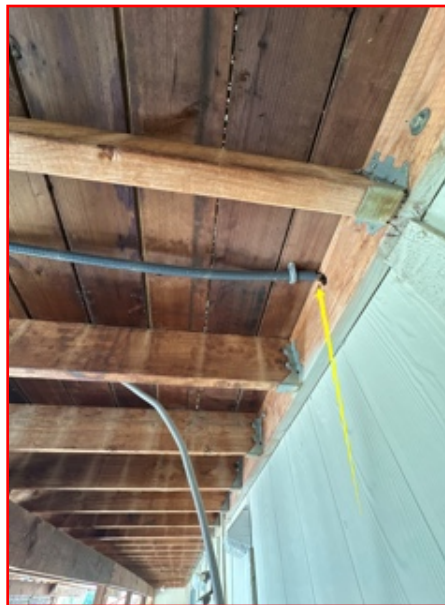
Figure 20-3

Romex wire has been installed in a conduit on the exterior of home below deck. Romex can not be installed in conduit in any areas outside, below ground, or areas of high moisture. Refer to a licensed electrician.

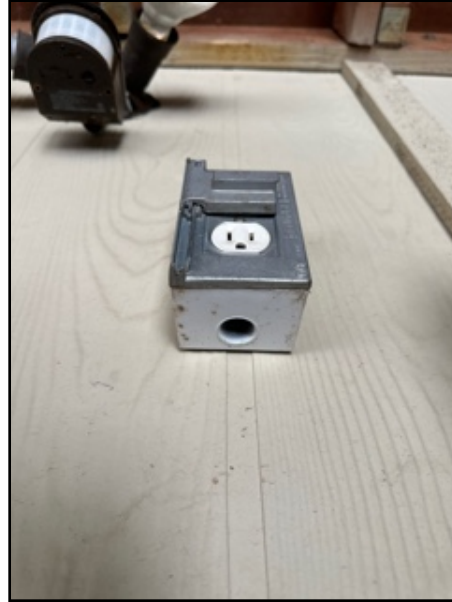
Figure 21-2

Receptacle below deck near light is missing part of the weatherproof cover & has an open hole in the base of the box. Recommend repair.

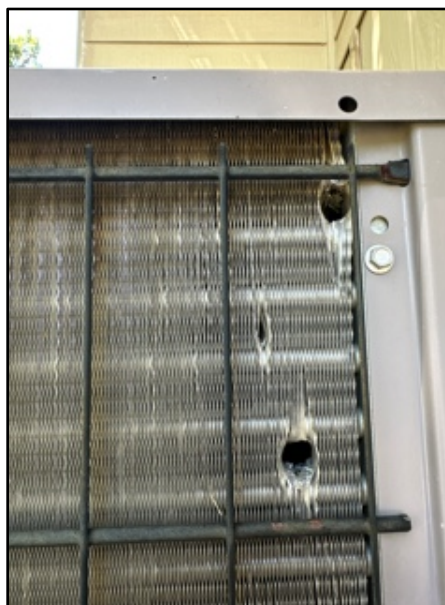
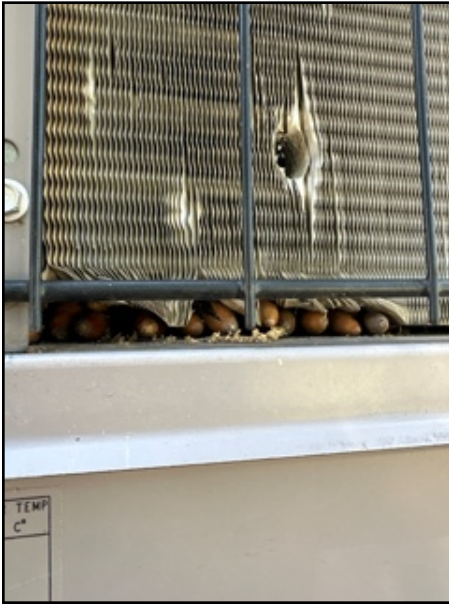
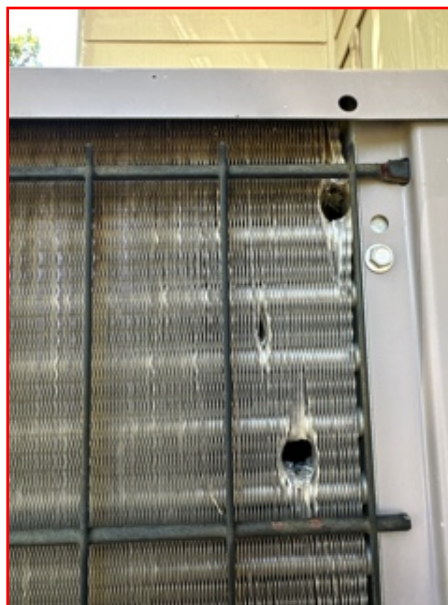
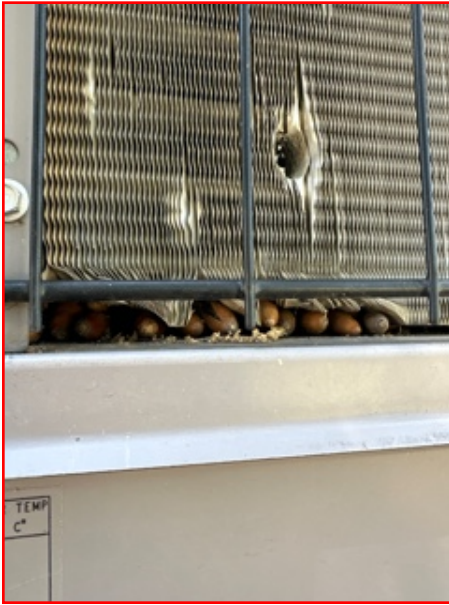
Figure 23-2

Woodpecker damage noted to the HVAC system installed on right side of home. Recommend having further inspected by a licensed HVAC technician.

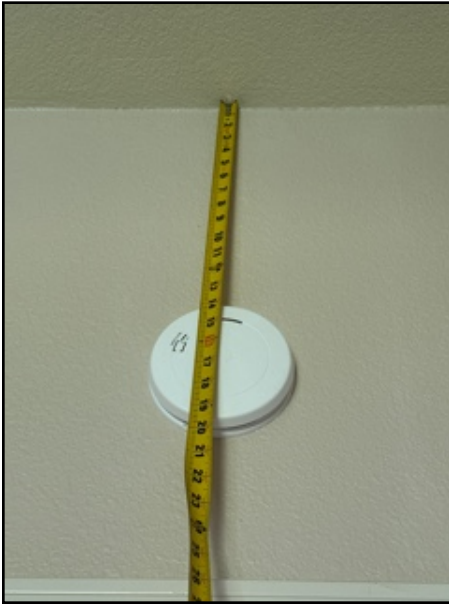
Figure 34-1

**Comment 34:**  
Recommend to raise smoke alarms to ceiling height as required.

Current CA fire code states: Smoke alarms should be mounted on the ceiling 4" from the wall; wall mounts should be 4-12" from the ceiling. Do not install near draft areas (windows, vents).
