HOME INSPECTION REPORT

13431-69 Hwy 8 Business
El Cajon, CA 92021

Kroon Family Trust c/o Ann and Ray Petta
07/25/2023

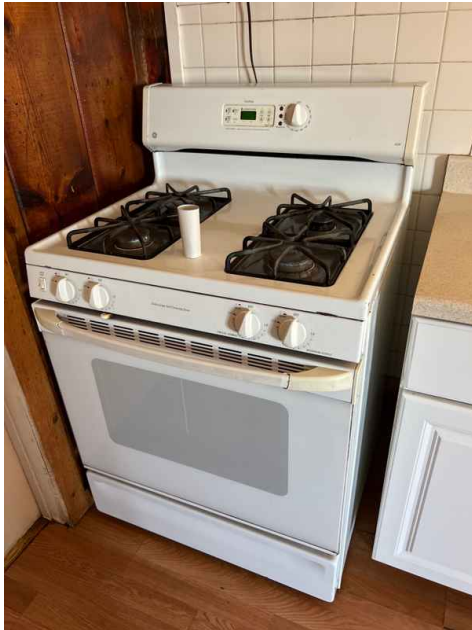
13431, 13469, 13429

The range could not be checked for proper operation. There was no gas service at time of inspection.

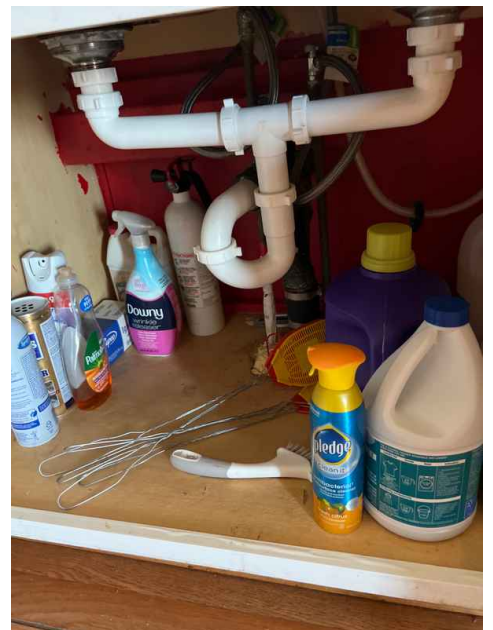
13431, 13469

There is no disposer installed.

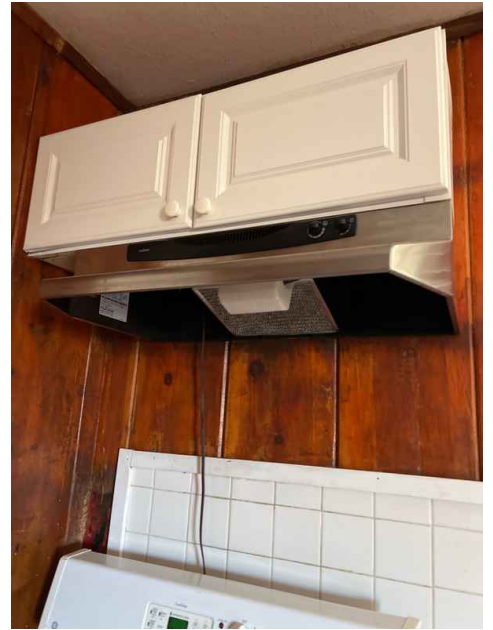
13431,

The range hood could not be tested. The electricity was off at time of inspection.

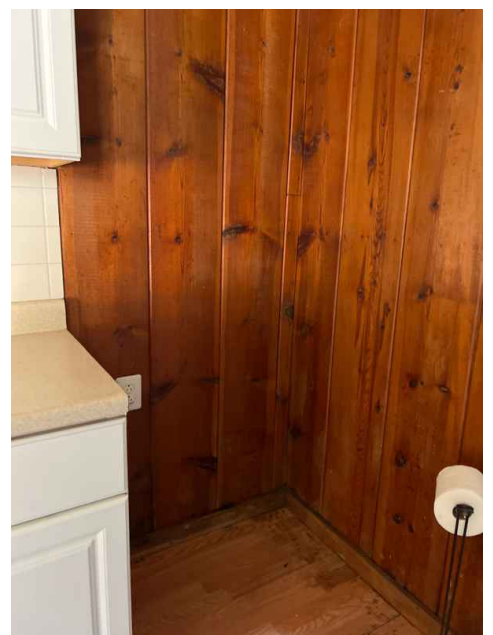
13431,13429, 13469

No refrigerator was present at time of inspection.

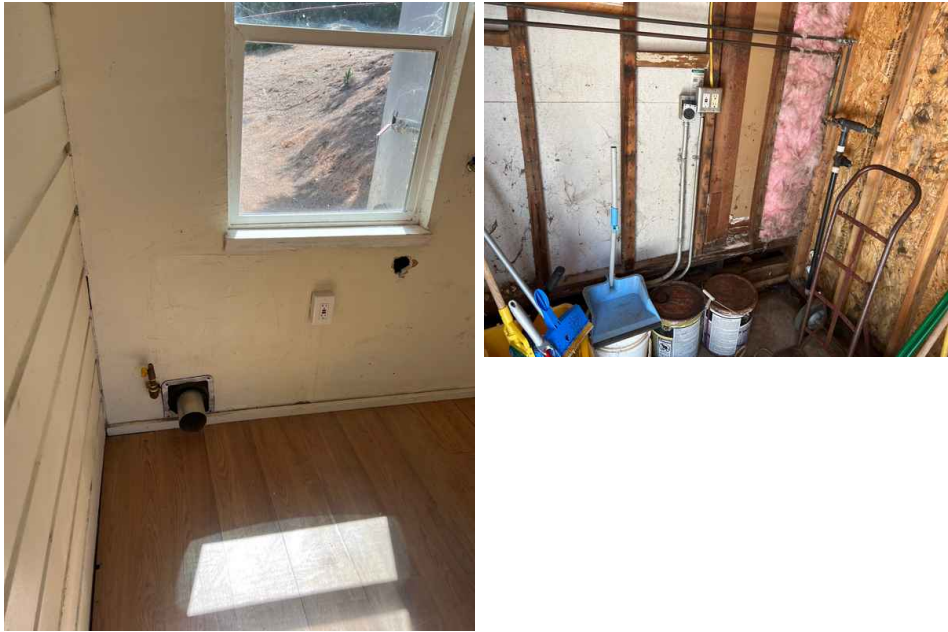
13431, 13429

No clothes washer or dryer was present at time of inspection.

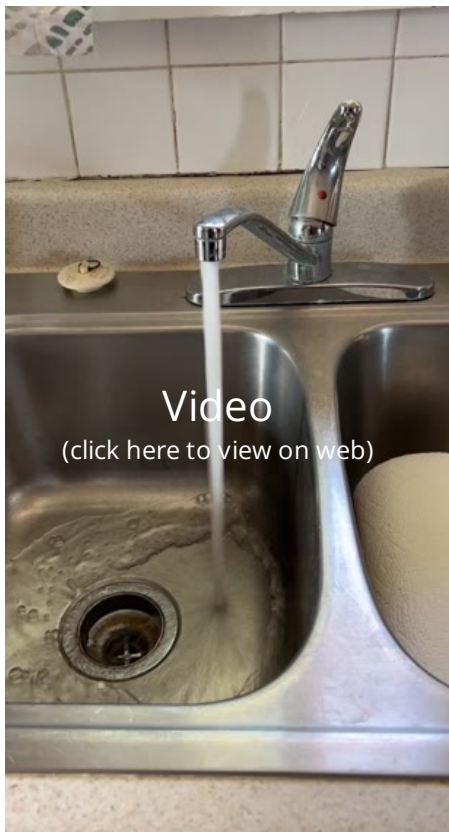
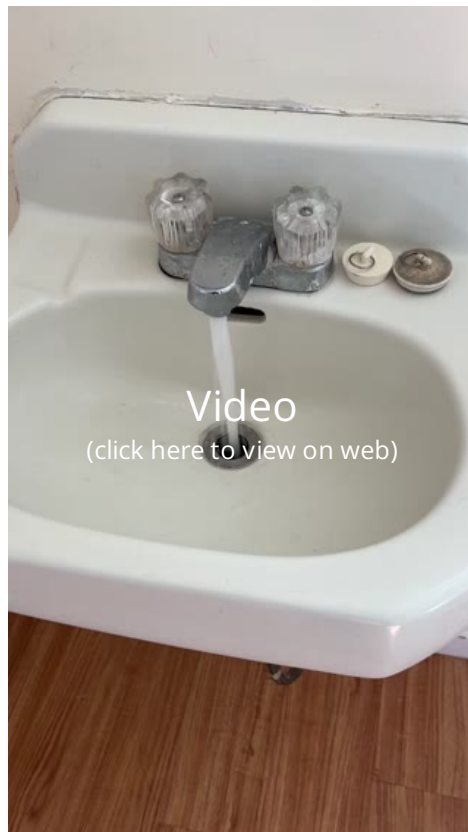
We attempt to evaluate drain pipes by flushing every drain that has an active fixture while observing its draw and watching for blockages or slow draining. All bathroom and kitchen fixtures were tested for an extended period of time during the inspection. Home inspectors only run clean water through the drains. This is not a conclusive test and flushing toilet paper, human waste, food debris or soap suds may cause drains to clog. Only a video-scan of the drains and main line would confirm its actual condition. We advise having a sewer camera inspection performed by The Real Estate Inspection Company to verify the condition.

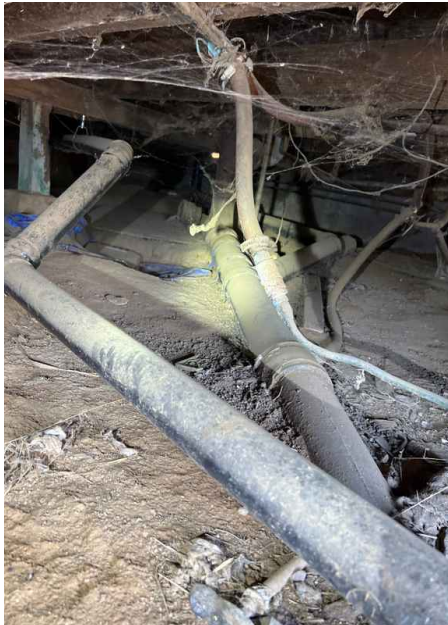
The drain lines are older cast iron lines. These lines rust from the inside and fail. The average life of cast iron drains is 50-60 years. This home has the original cast iron drain lines, so repairs and/or replacement are likely. We advise having a video/sewer scope inspection by The Real Estate Inspection Company. This is especially important to determine the inside condition of the main drain line between the house and the street. The actual life remaining and cost to replace can only be determined by a licensed plumber.

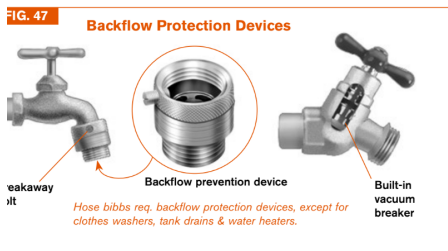
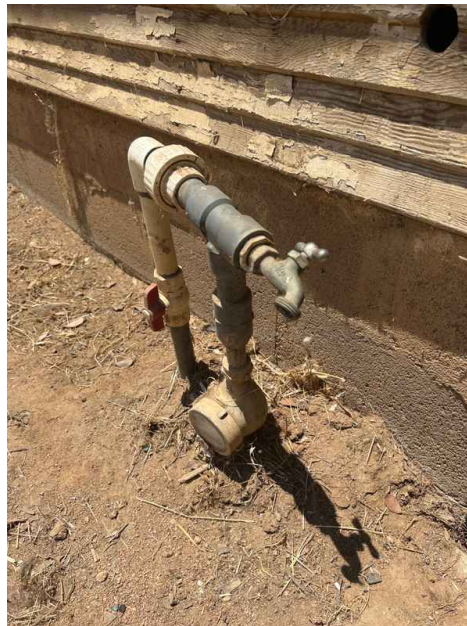
All units

Anti-siphon or anti-backflow valves are not present at the exterior hose spigots. These are safety devices that prevent contaminated water from flowing into the house water supply. Current standards require the installation of anti-siphon valves to keep your drinking water clean. We recommend installation for your health and safety.

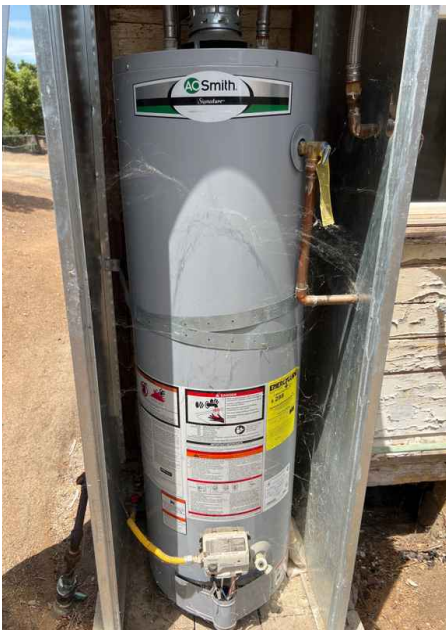
Note: This home has had a partial copper re-pipe which indicates past leaks may have occurred in the distribution piping. Some of the copper pipes running in the slab were abandoned and new pipes were routed overhead. Some of the original copper piping may still be present in the slab. We advise reviewing with the seller for repair history.

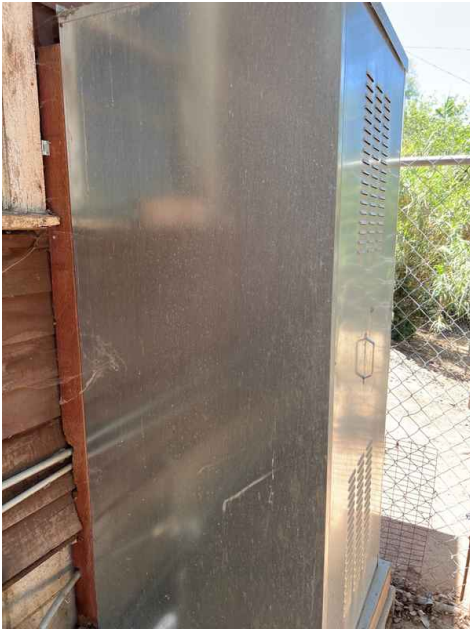
ALL UNITS

The water heater pilot was not lit at the time of inspection. Home inspectors are not allowed to light pilots. Due to a lack of hot water, we could not confirm that the faucets were plumbed properly (hot left, cold right). We recommend having the seller confirm proper plumbing prior to the end of your contingency period.

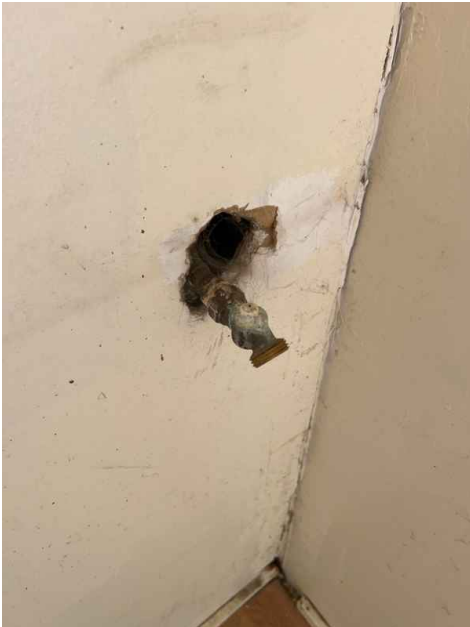
13431

Handle was observed as missing for the washer water valve. We recommend replacement with a Qualified plumber.

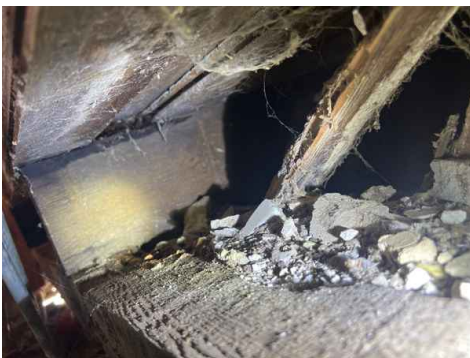
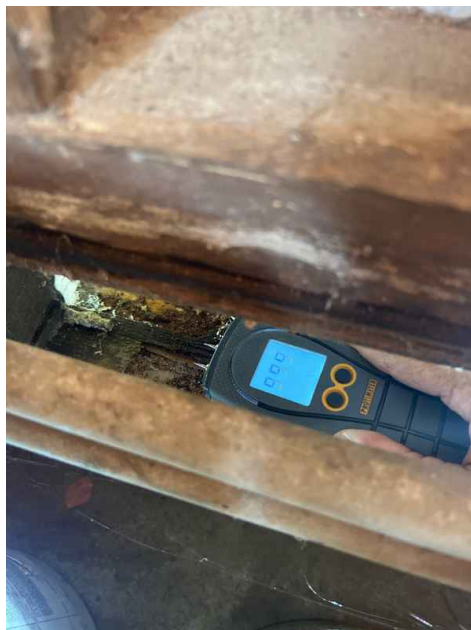
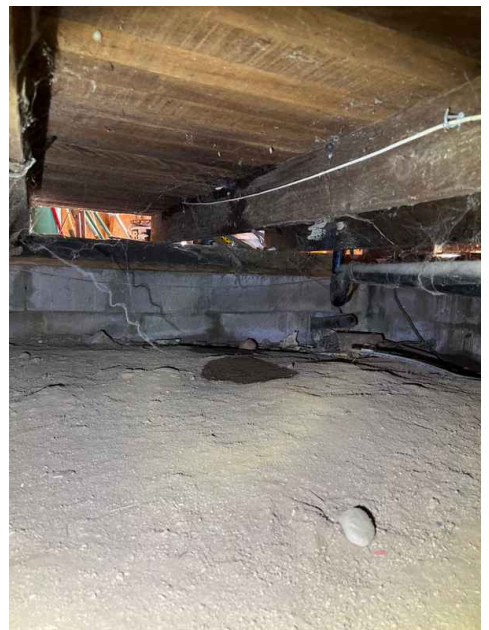
PAN - LEAKS

A flood test was performed on the tile shower pan. The shower pan was filled with about one inch of water and then observed for leaks. During the flood test leaking or moisture was observed. This indicates the waterproofing membrane behind the tiles is defective or not installed correctly. There may be water damage behind the wall that is not visible. We advise further review with a licensed general contractor or tile setter for an estimate to repair or repair options before the end of your contingency period.

Contact a qualified professional.

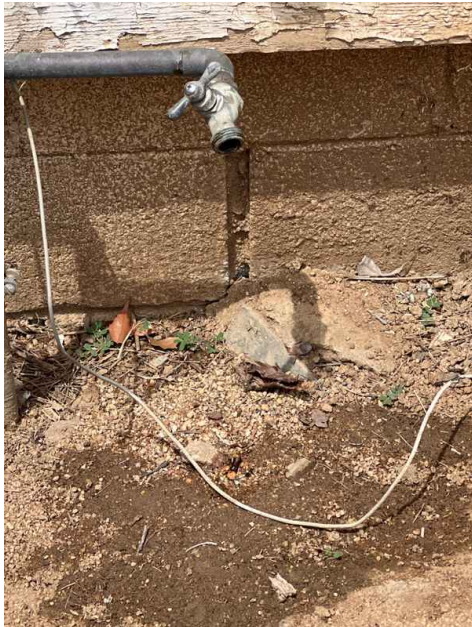
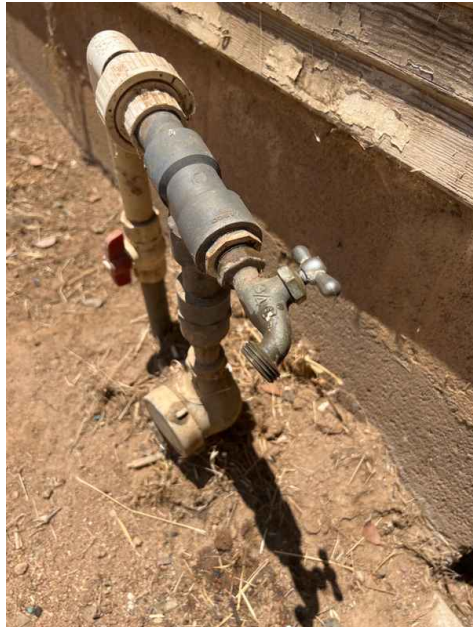
SPIGOT - LEAKING

A hose spigot is leaking.

Contact a qualified plumbing contractor.

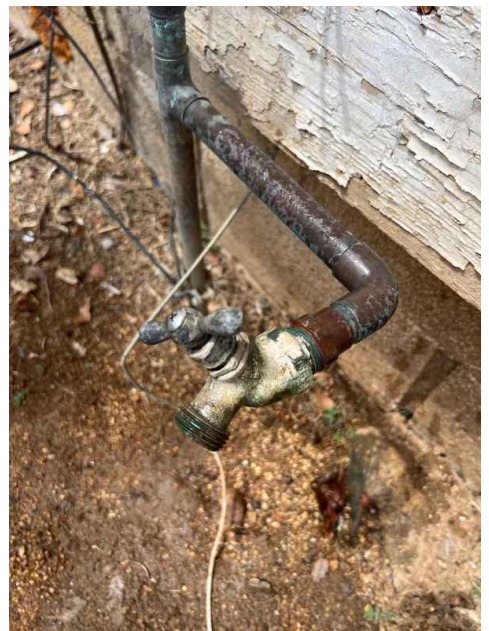
SPIGOT - LEAKING HANDLE

Hose spigot leaks from handle when operated.

Contact a qualified plumbing contractor.

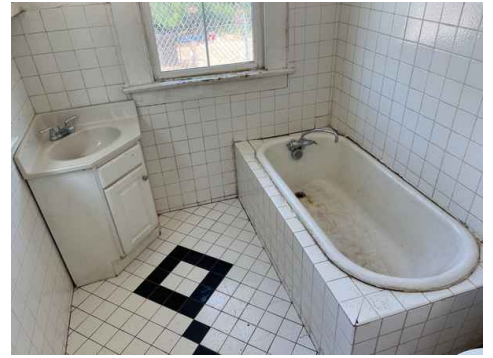
A water hammer (hydraulic shock) was noted when some faucets were shut off. This condition can be caused by loose pipes, high water pressure, or a lack of air chambers in the plumbing system. Without correction, this condition can cause damage to the plumbing system. We recommend having the plumbing system evaluated and corrected by a licensed plumber.

Contact a qualified plumbing contractor.

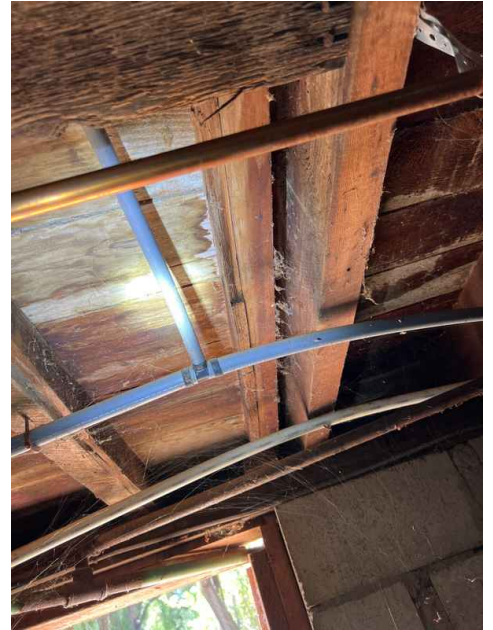
Polybutylene water distribution pipes (PB or QUEST) are installed in the subject house. Polybutylene has been used in this area for many years, but has had a higher than normal failure rate, and is no longer being installed. We recommend that you consult with a licensed plumber about this system, the potential for it to fail, and the cost of re-plumbing your house prior to the end of your contingency period.

Contact a qualified plumbing contractor.

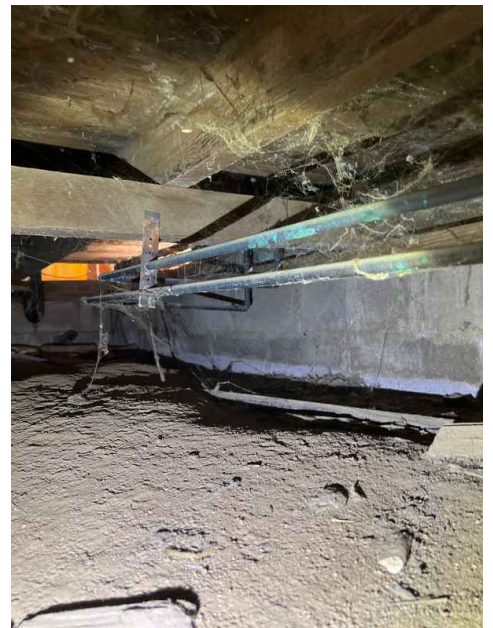
CORROSION - PIPING

Corrosion was observed in the water supply piping. We advise repair and preventive maintenance.

Contact a qualified plumbing contractor.

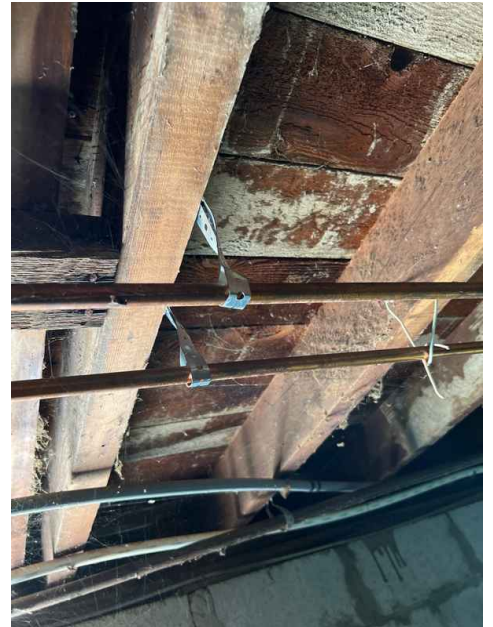
Copper water distribution pipes were hung from hardware made from a metal other than copper. This condition has resulted in galvanic corrosion of the copper pipes that- if not corrected- will cause premature failure of the pipes that will require their replacement.

Contact a qualified professional.

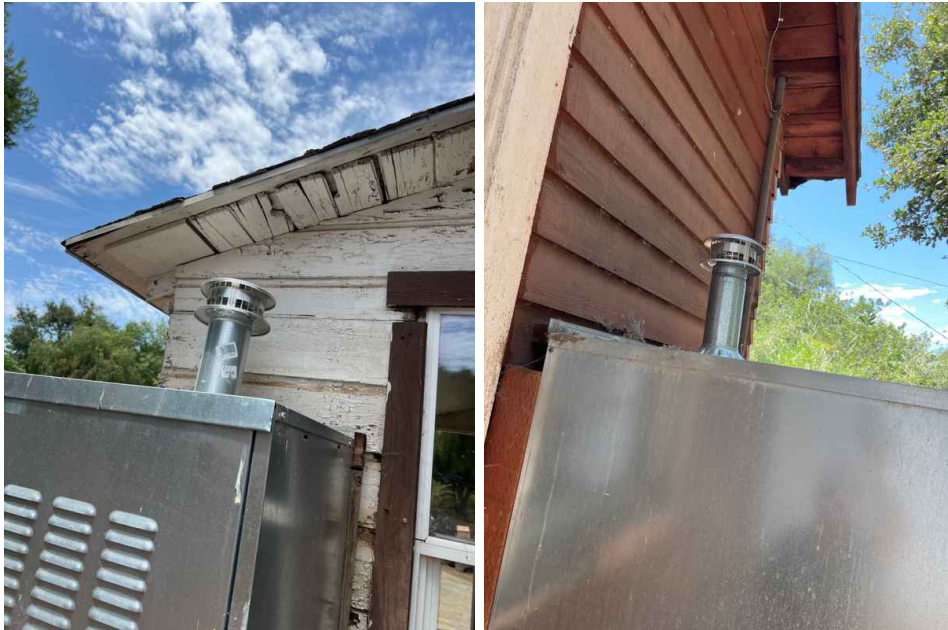
The termination point of the water heater flue is incorrect. We recommend further evaluation and correction by a licensed plumber.

Contact a qualified professional.

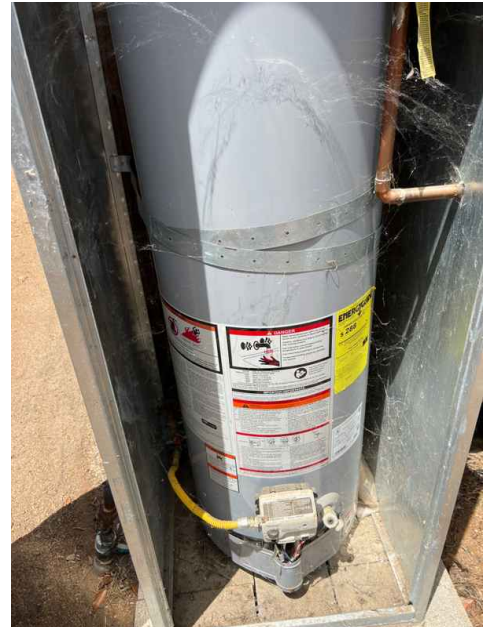
The water heater is improperly strapped. Seismic strapping is required to be installed 4 inches above the controls, and at the top 1/3 of the water heater. We recommend installation of a seismic strap kit by a qualified person. Proper installation can be found by visiting http://www.seismic.ca.gov/HOG/waterheaterbracing_08-11-04.pdf

Contact a qualified professional.

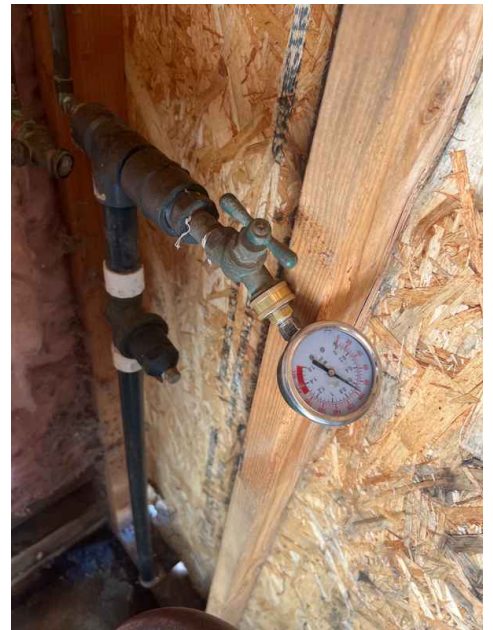
High water pressure noted. This can cause water lines, faucets and water supplied appliances to fail and leak. We advise having a licensed plumber repair or install a new pressure regulator, to allow a PSI range of 50-70.

Contact a qualified plumbing contractor.

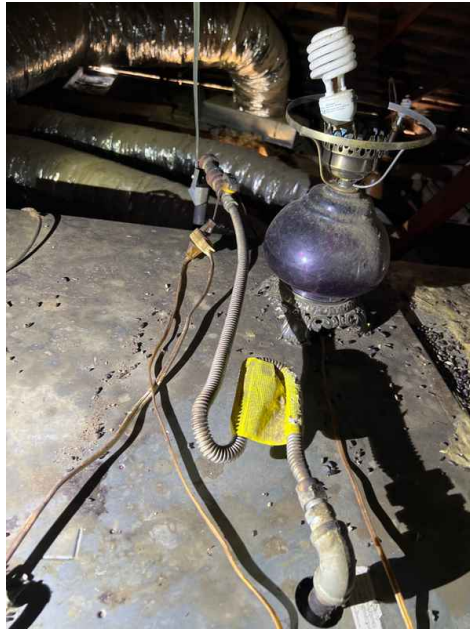
The gas supply pipe (at the water heater and/or furnace) contained no sediment trap. A sediment trap is generally recommended by the manufacturer. The purpose of a sediment trap is to prevent particulates or moisture from condensation from entering and clogging the water heater/furnace gas valve, which can cause the water heater/furnace to shut down.

Contact a qualified professional.

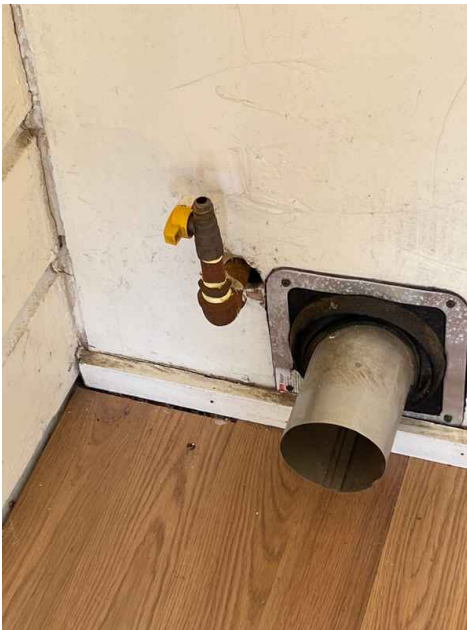
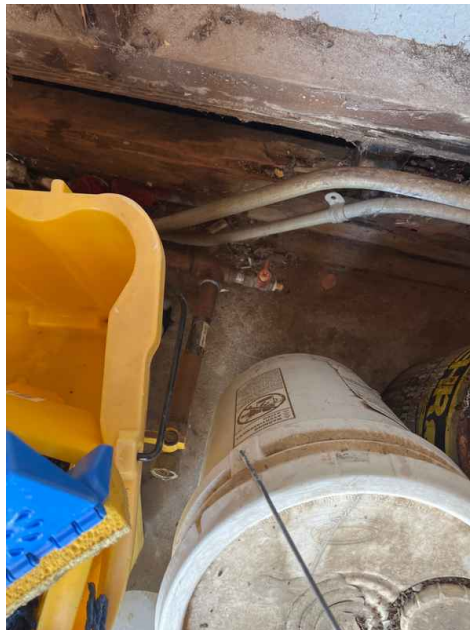
We recommend capping the unused gas supply for safety at the clothes dryer until a dryer is installed.

Contact a qualified professional.

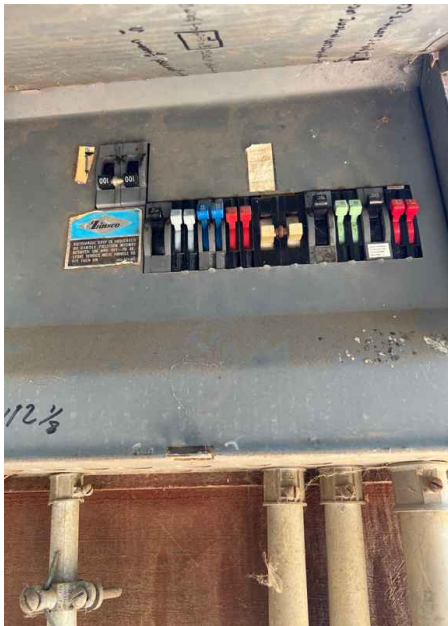
13431, 13469, 13429

Note: The main panel is full. Space is not provided for the addition of more breakers. We could not inspect the condition of the buss bars. If expansion is desired, we advise consulting with a licensed electrician.

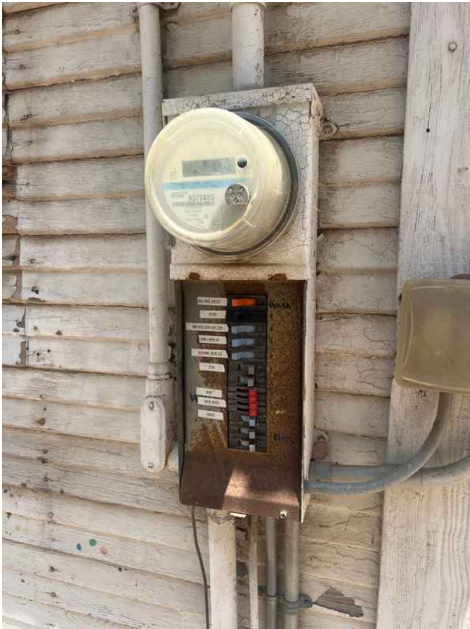
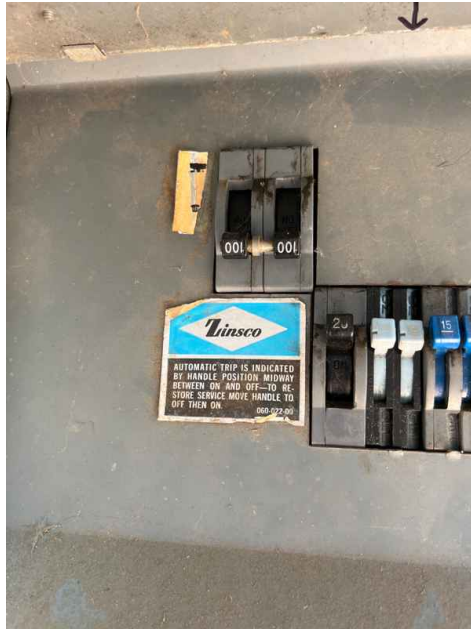
The panel was manufactured by Zinsco/Sylvania. These panels were made with alloy buss bars which are easily dented. Because of this, a poor connection with the circuit breakers sometimes develops. This can cause over-heating which is a fire hazard. We recommend that you consult with a licensed electrician as to the integrity of this electric panel before the close of your contingency period. More information can also be found at https://inspectapedia.com/electric/Zinsco_Electrical_Panels.php

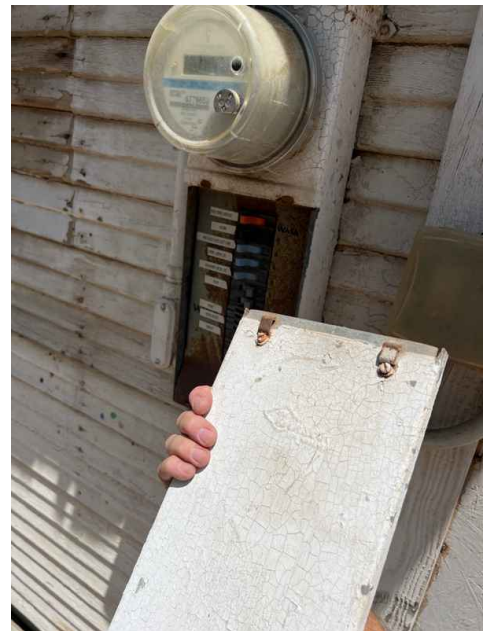
The hinges at the main panel are damaged or missing. We recommend repair by a qualified person for safety.

Contact a qualified professional.

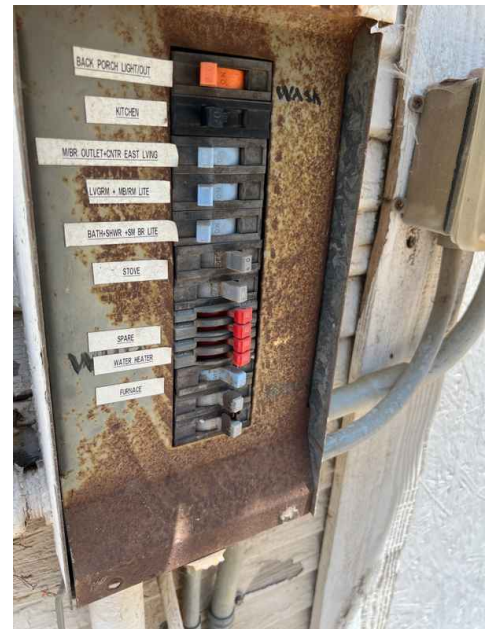
RUST IN PANEL

Rust noted in the main electric panel. Rust can cause breakers to become unreliable or cause poor connections. Unable to determine the source of the water. We advise further evaluation and necessary corrections by a licensed electrician.

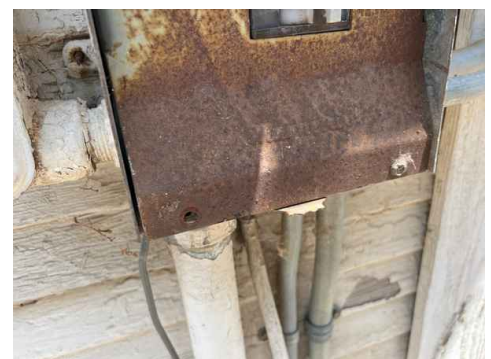
SCREWS - MISSING

The panel screw(s) are missing at the electric panel. We advise installing screw(s) for safety.

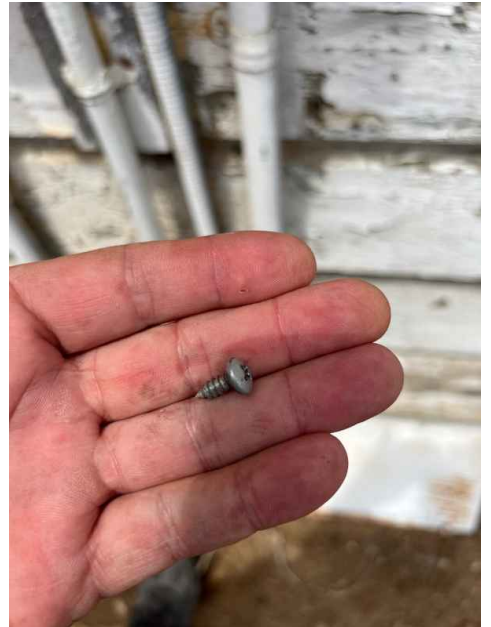
The cover screw(s) at the electric panel are pointed. Pointed screws are a safety concern because they can damage wires behind the cover and become energized. We recommend replacing the screws with those designed for electric panels.

Contact a qualified professional.

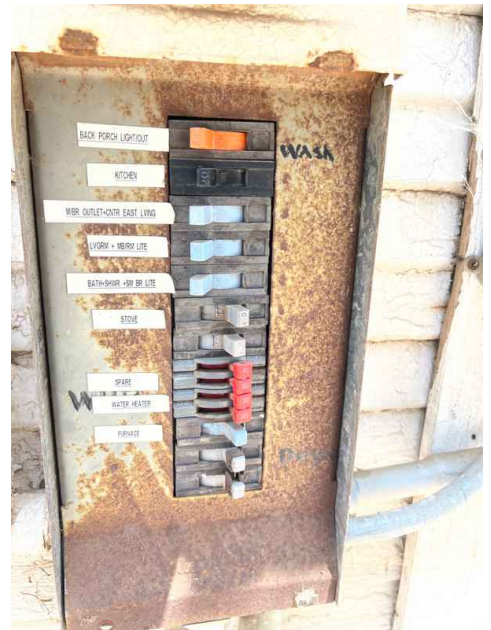
When six or more breakers are located in the main panel, a main disconnect must be installed to comply with current electrical standards and regulations. We recommend further evaluation and having a main disconnect be added by a licensed electrician.

Contact a qualified electrical contractor.

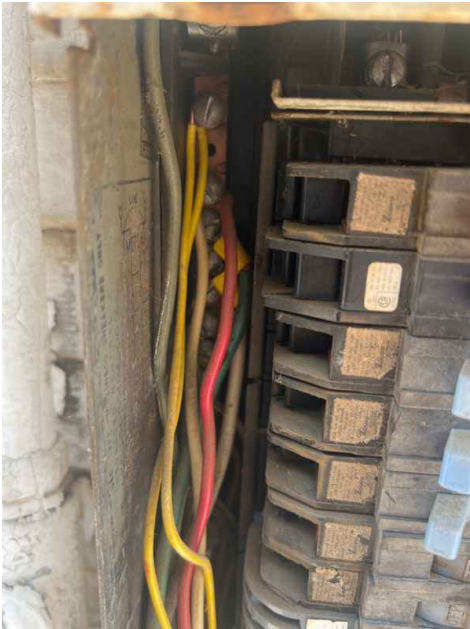
GROUNDS IMPROPERLY LABELED

Ground wires should be bare wire or green with colored insulation and neutrals should be white to indicate usage. Various non-standard colors were noted in the panel. Recommend evaluation by an electrician and properly labeling wiring inside the panel.

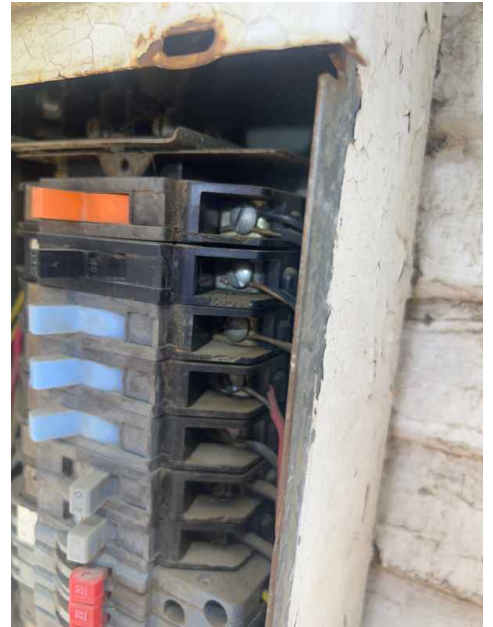
Double-tapping was observed inside an electrical panel. This is a practice of connecting two wires to one circuit breaker, which is not allowed.

Contact a qualified electrical contractor.

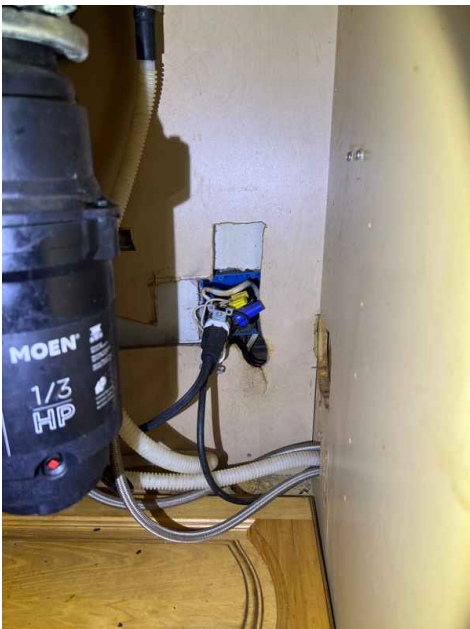
13429 Kitchen

OPEN JUNCTION BOX

Contact a qualified electrical contractor.

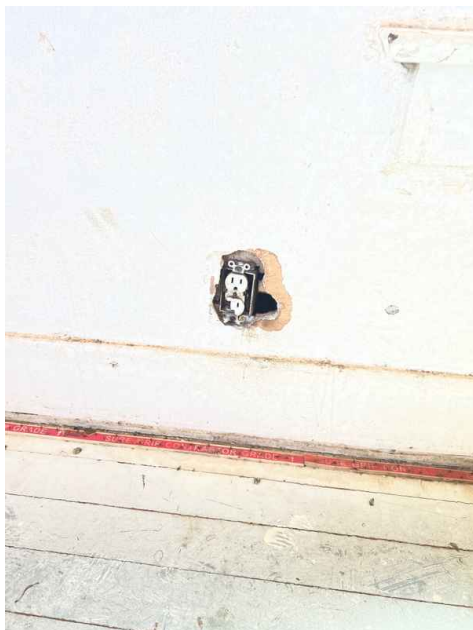
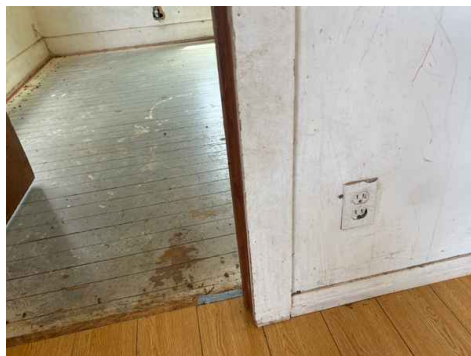
RECEP - CRACKED/DAMAGED

A receptacle has cracked/damaged plastic. The receptacle may continue to deteriorate, which creates a shock hazard. We recommend having the receptacle replaced by a licensed electrician.

Contact a qualified electrical contractor.

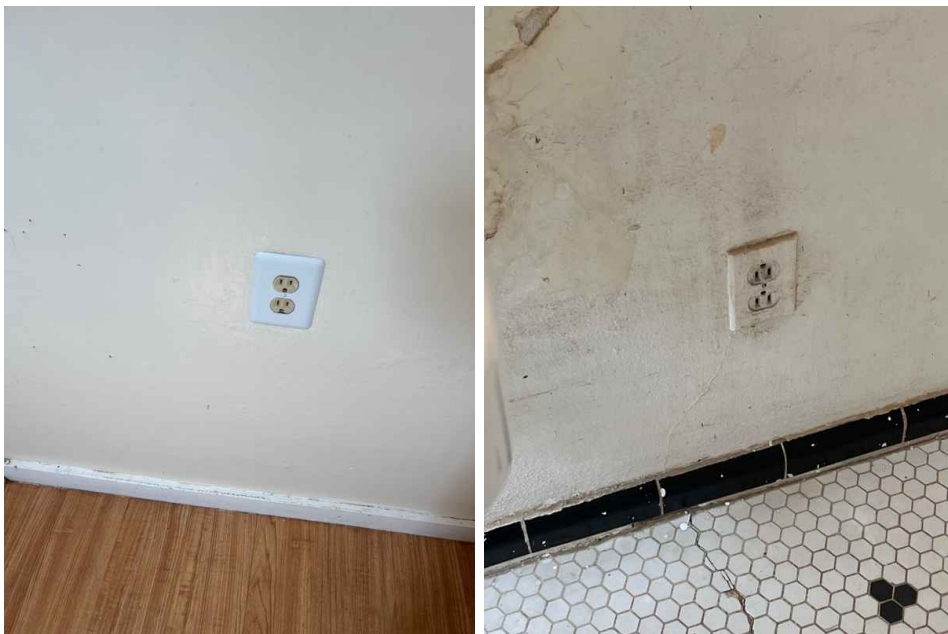
No receptacle was found in the bathroom. We recommend a duplex GFCI outlet be installed.

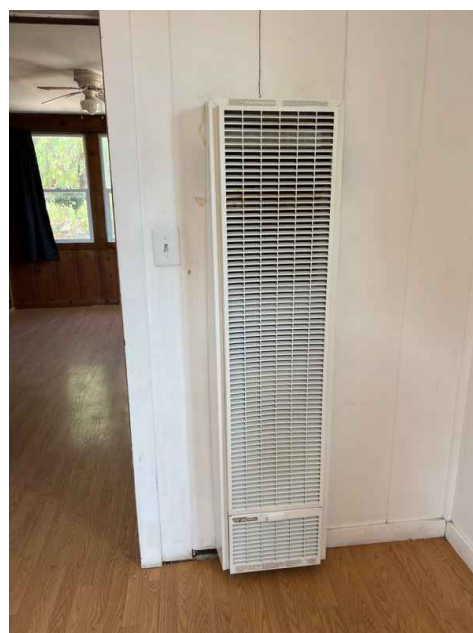
At the time of the inspection, fuel or power was off to the heating unit. We do not restore fuel or power to appliances that are shut off; therefore, our review is limited. Most utility companies, upon request, light pilots. We advise that you obtain verification of this system's performance prior to the end of your contingency period.

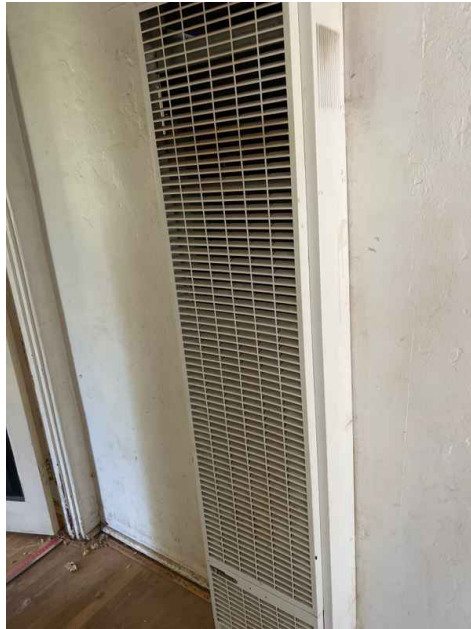
DUST DEBRIS

Excessive dust and debris were noted in the furnace. This can be a fire and/or health hazard and can cause the furnace to malfunction. We recommend having the furnace serviced and cleaned by a licensed heating contractor.

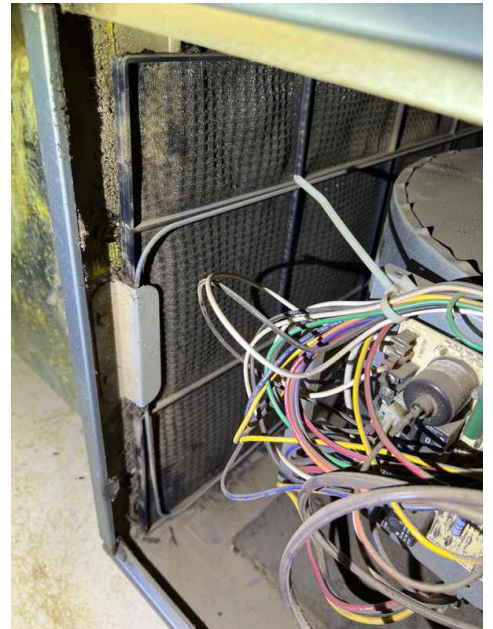
OLD GAS FURNACE - 20+ YEARS

The furnace is an older unit which may be nearing the end of its useful life. Most furnace contractors recommend replacing a furnace when it becomes 20 years old ([Table of Life Expectancy](#)). Since Southern California has a mild climate, furnaces can last longer than industry standards. Since this furnace is aged, we recommend having a licensed furnace contractor inspect the furnace for safety and provide an estimate of life remaining and cost of replacement prior to the end of your contingency period so that you may budget accordingly. Note: We specifically disclaim cracks in furnace heat exchangers because proper evaluation requires invasive, technically exhaustive measures that exceed the scope of the General Home Inspection.

Contact a qualified heating and cooling contractor

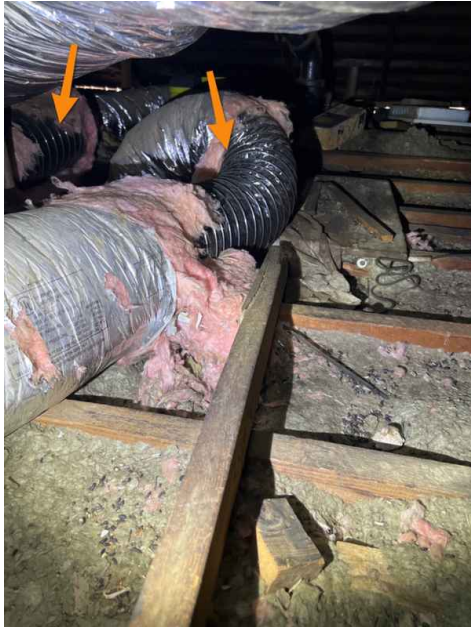
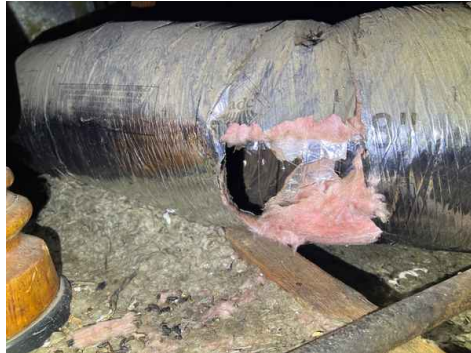
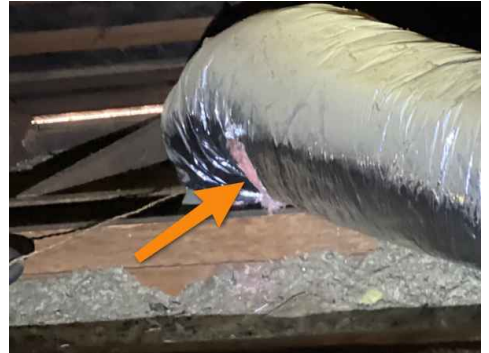
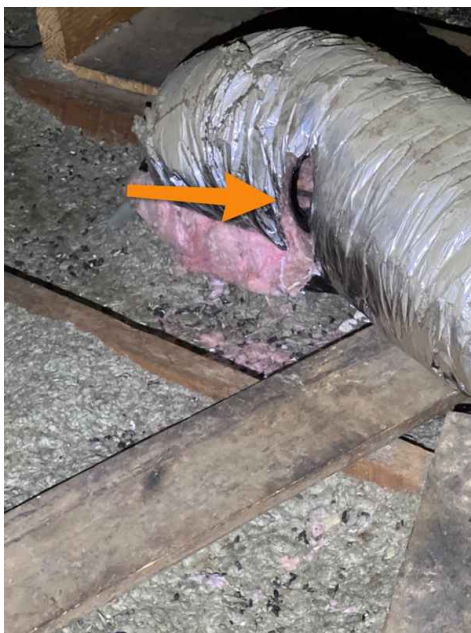
DUCTS DAMAGED

Some of the ductwork had loose/deteriorated insulation. Several holes were observed in the ducts that appear to be due to rodent activity. We recommend further evaluation and sanitizing and repair by a licensed HVAC contractor.

Contact a qualified heating and cooling contractor

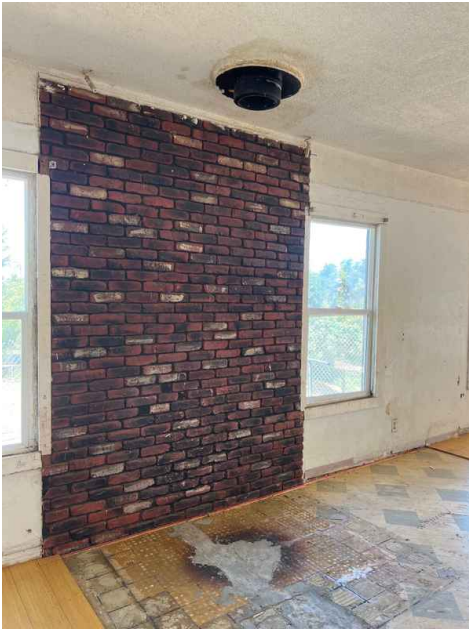
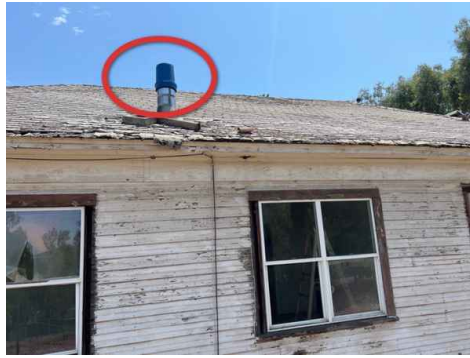
CHIMNEY CAP MISSING

1qThere appears to have been a free standing fireplace in the living room that has been removed. Chimney at the rooftop has been closed off at top with a plastic bucket. Evidence of leaking was observed at the attic and ceiling below. Recommend repairs as needed to prevent further damage.

Contact a qualified chimney sweep.

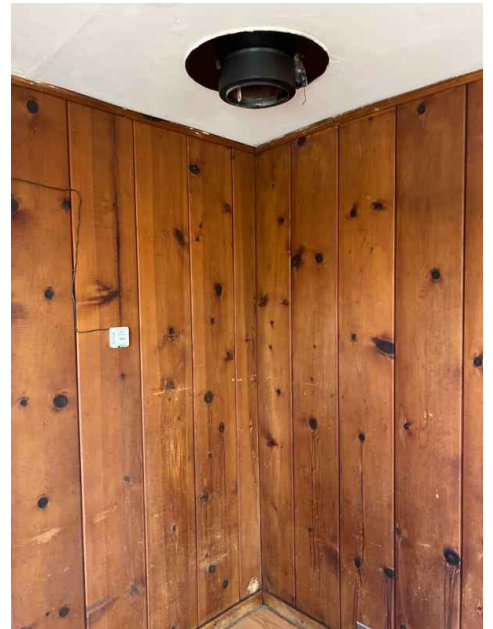
The freestanding fireplaces were removed.

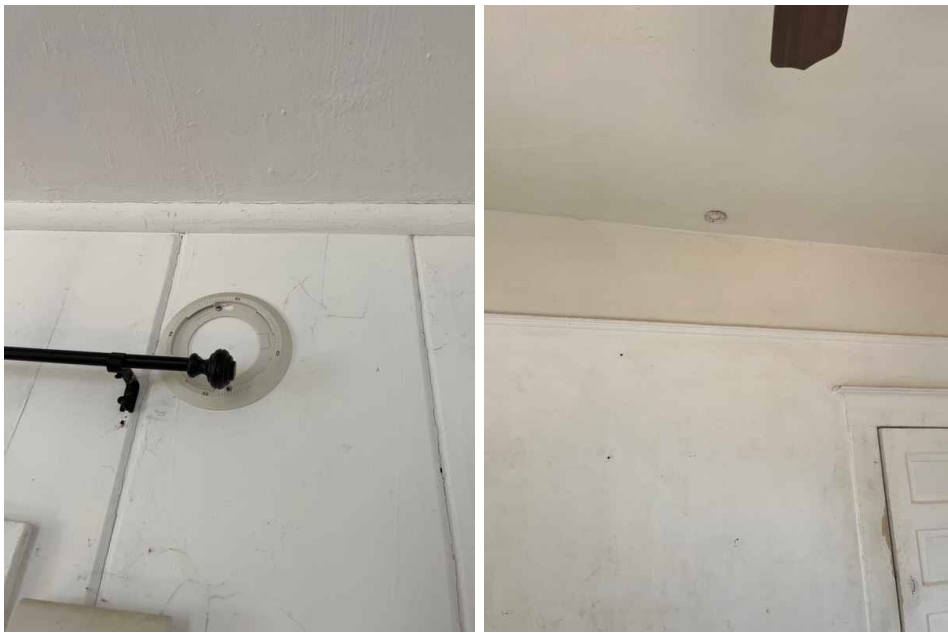
No operable smoke detectors were found in the home. California State Law SB 745 requires additional smoke detectors to be installed in all bedrooms and on each level in the common hallways in multi-story homes when modifications have been performed including alterations, repairs, or additions exceeding \$1,000 in value. Additional smoke detectors are also required in all dwellings intended to be used as rentals regardless of modifications.

Contact a qualified professional.

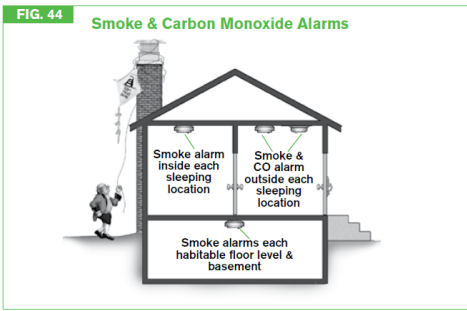
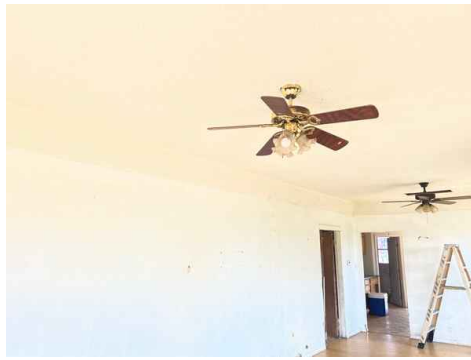
CO DETECTOR(S) - NONE

Carbon Monoxide detectors are required in homes with any gas burning appliances (furnace, range, water heater), fireplaces, or wood burning stoves and/or an attached garage. Please see the [new law regarding Carbon Monoxide detectors](#). This house does not have a CO detector as required. We recommend installing CO detectors according to manufacturer's directions (depending on brand) near each group of bedrooms. For added safety, additional CO detectors should be added to each sleeping room but this is not required by law.

Contact a qualified professional.

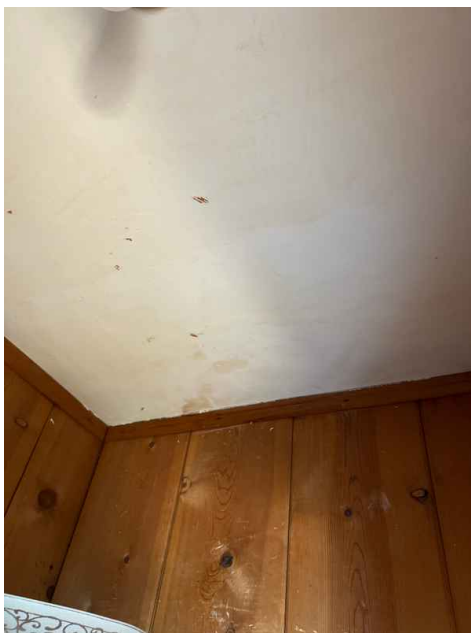
13431 closet,

STAINS - DRY UNDER ROOF

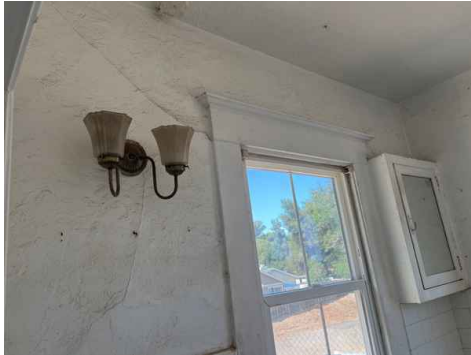
13429 bathroom

CRACKS - MODERATE

Contact a qualified professional.

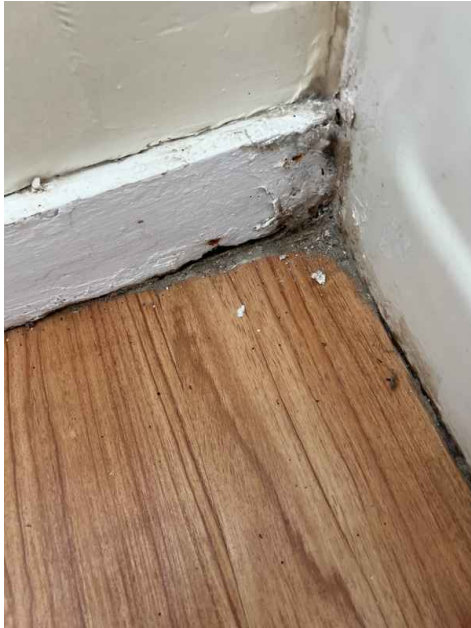
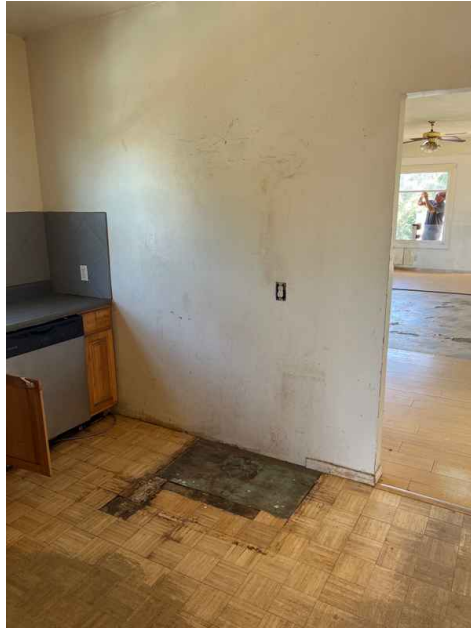
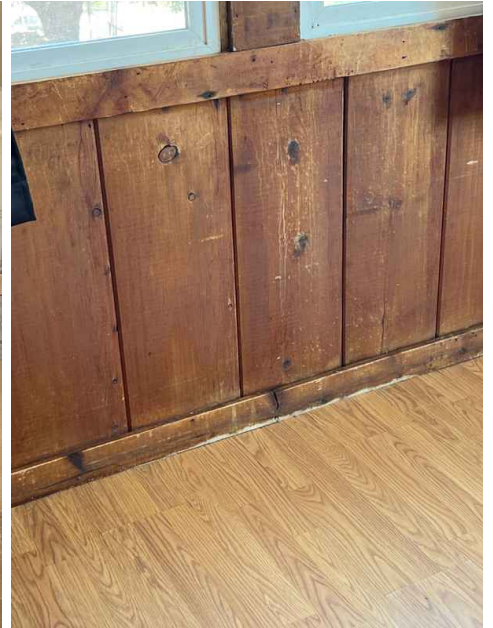
13431

Staining was noted on the wall. The staining was tested for moisture and found to be dry at the time of the inspection. The inspector was unable to determine the cause.

Contact a qualified professional.

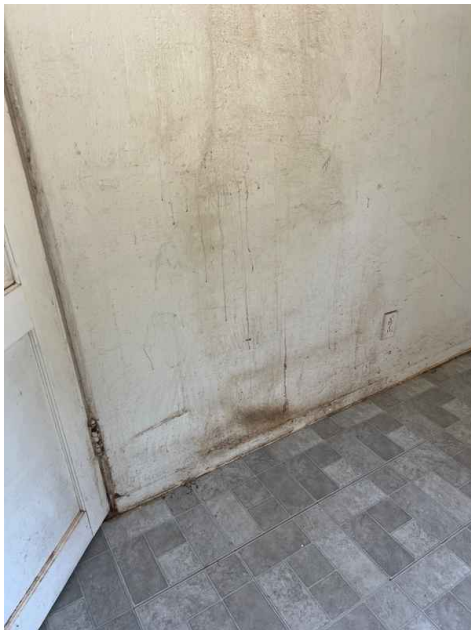
13469

Apparent mold was observed on the wall which may indicate that a leak occurred. The area was tested and found to be dry with a moisture meter. We advise repair of the affected area by a licensed restoration contractor. Note: If you are concerned about the air quality inside this house, you should have the area tested to confirm the presence or absence of mold.

Contact a qualified mold inspection professional.

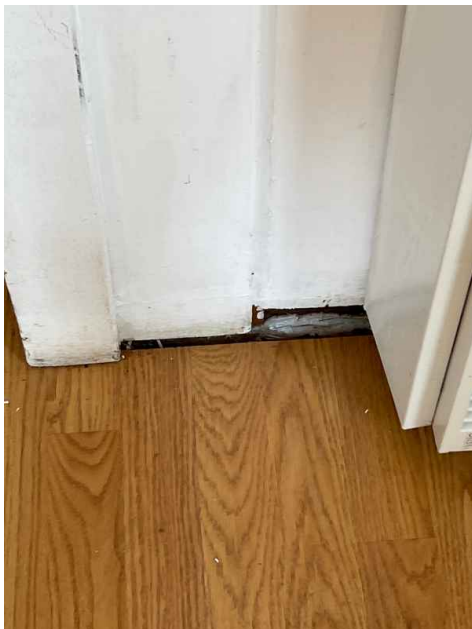
13431

The baseboard was damaged/swollen. The swelling was observed consistent with moisture damage. This may be caused by a leak or spill. We advise further review and repair with a qualified person.

Contact a qualified professional.
