HOME INSPECTION REPORT

13431-69 Hwy 8 Business
El Cajon, CA 92021

Kroon Family Trust c/o Ann and Ray Petta
07/25/2023

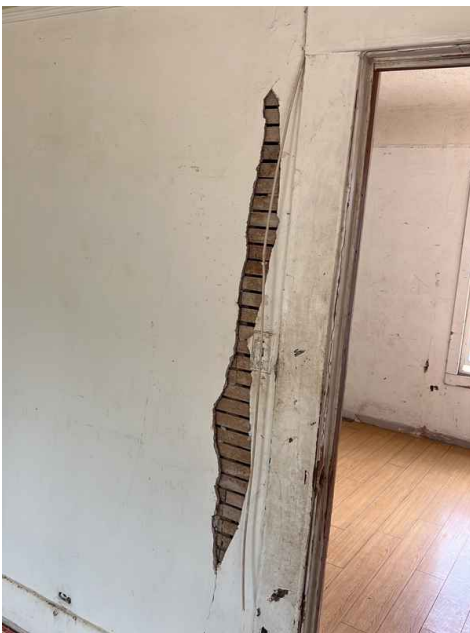
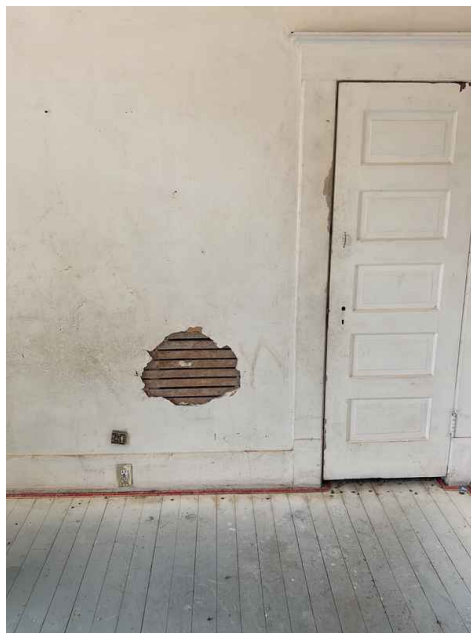
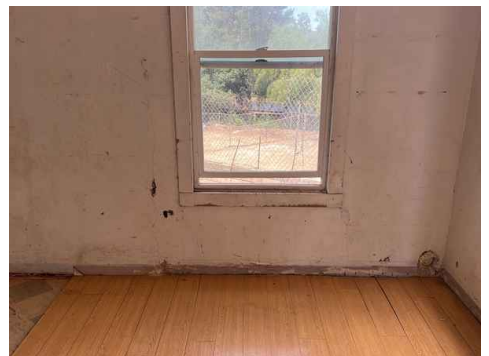
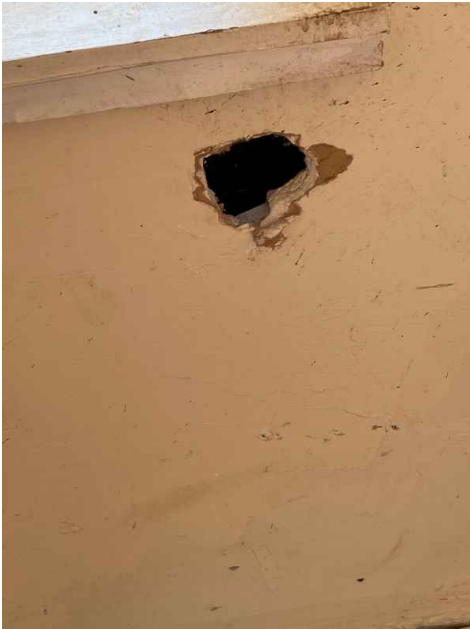
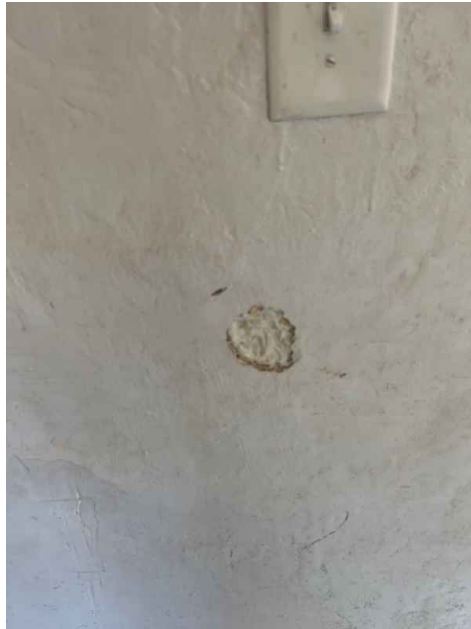
Wall board was damaged in several locations throughout the house. Recommend repair as needed

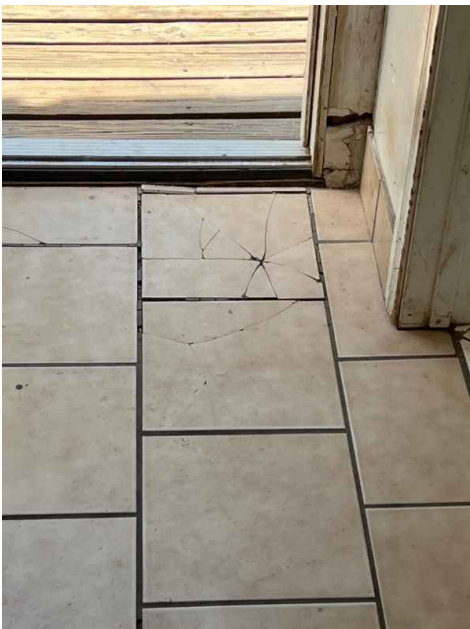
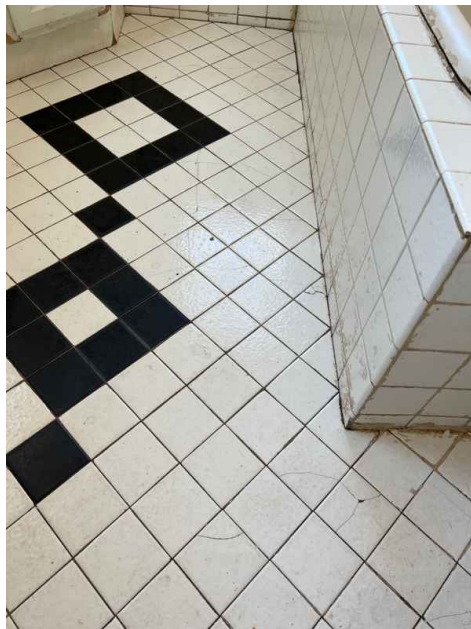
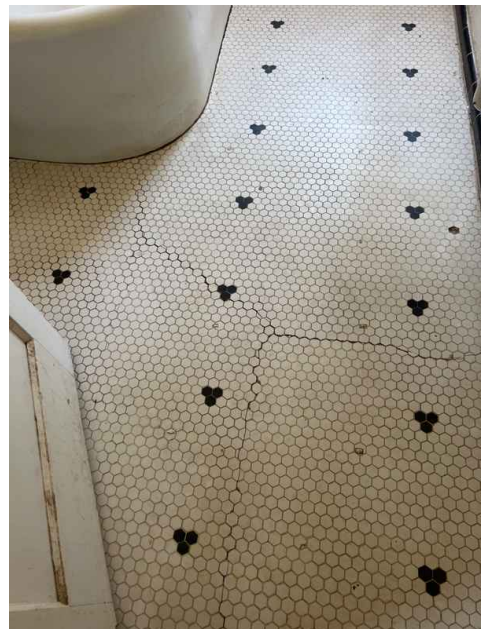
14329

Several cracked floor tiles are observed. We recommend necessary repairs or replacement by a licensed flooring contractor.

Contact a qualified flooring contractor

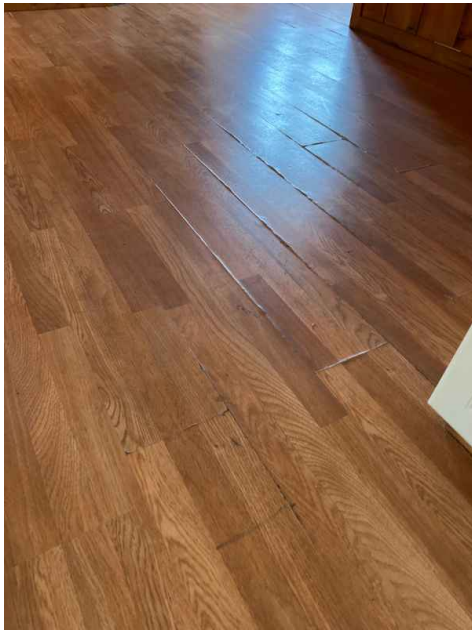
13431

Wood floors in the home exhibited severe surface wear along major paths of travel. We recommend that before the expiration of your contingency period you consult with a qualified flooring contractor to discuss repair and costs for replacement.

Contact a qualified flooring contractor

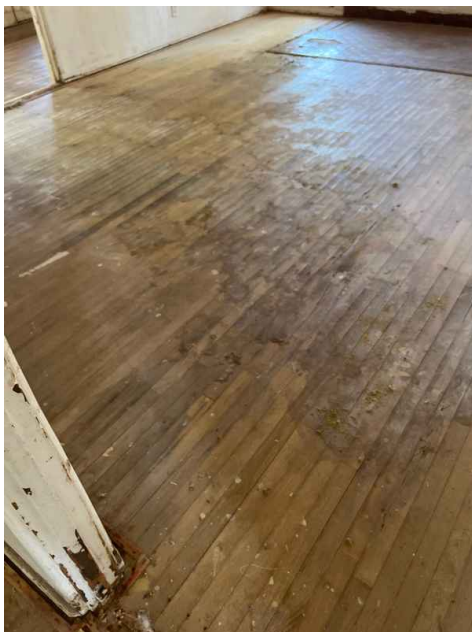
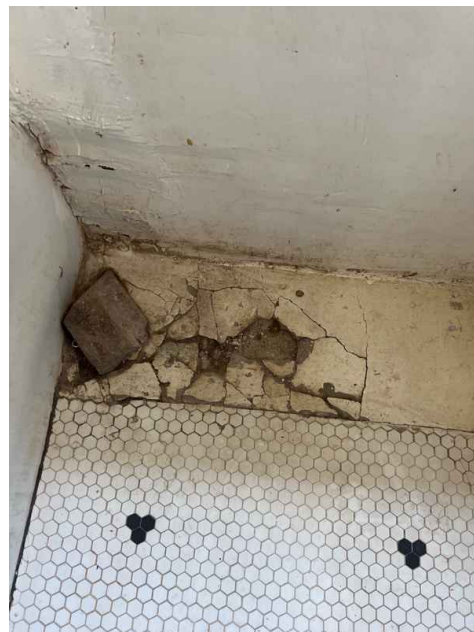
Flooring in several locations has gaps and missing thresholds. This is typically caused by a poor or incomplete installation of the floor. We recommend correction or replacement by a licensed flooring contractor.

Contact a qualified flooring contractor

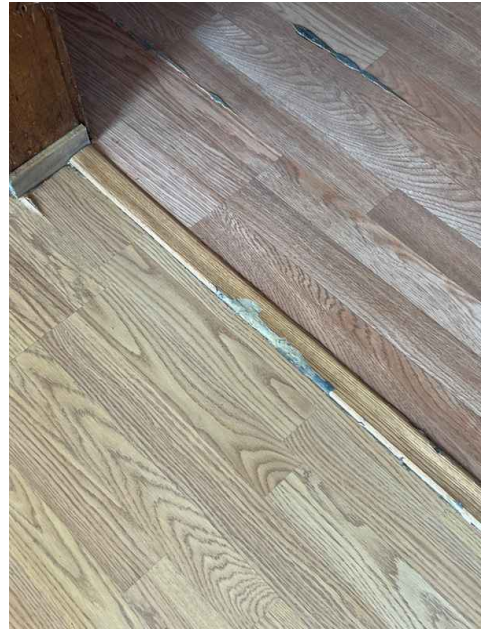
13431

Loose transition trim was noted. We advise repair.

Contact a qualified professional.

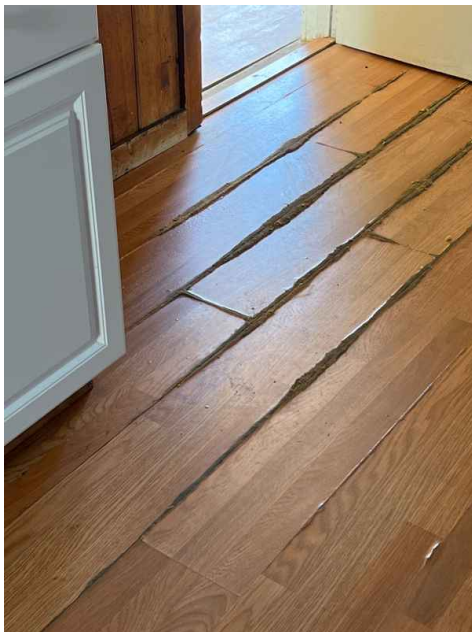
13431

Moisture damage was observed to the wood floors. We recommend replacement with a qualified contractor.

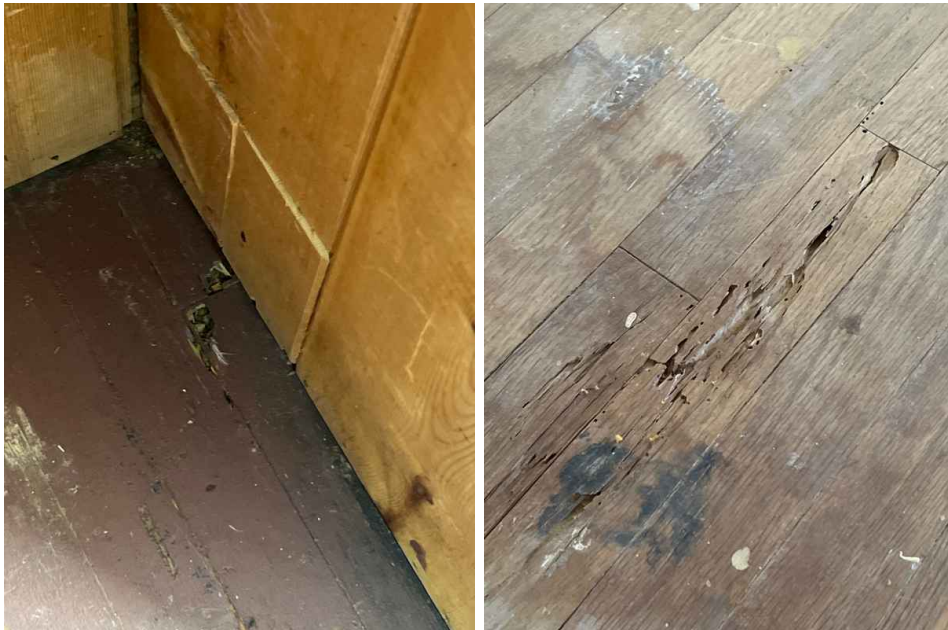
13431

Damaged wood floors were observed. We recommend further review and repair is with a Qualified flooring contractor.

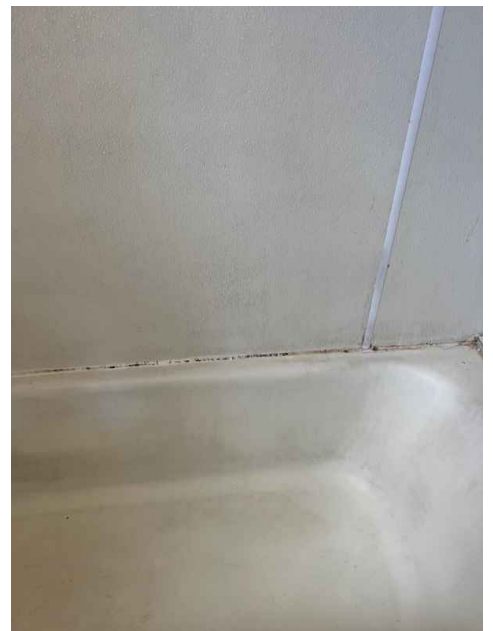
13431

We recommend caulking around the perimeter of the tub and tiles to prevent water intrusion.

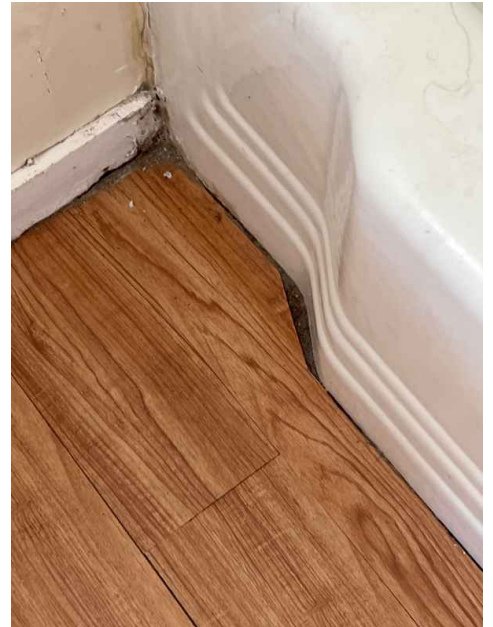
13431

We recommend installing silicone caulk along floor and tub to prevent water intrusion.

Contact a qualified professional.

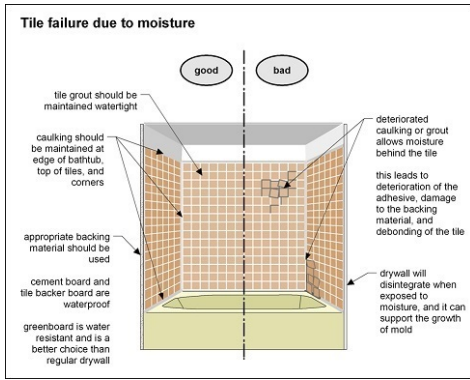
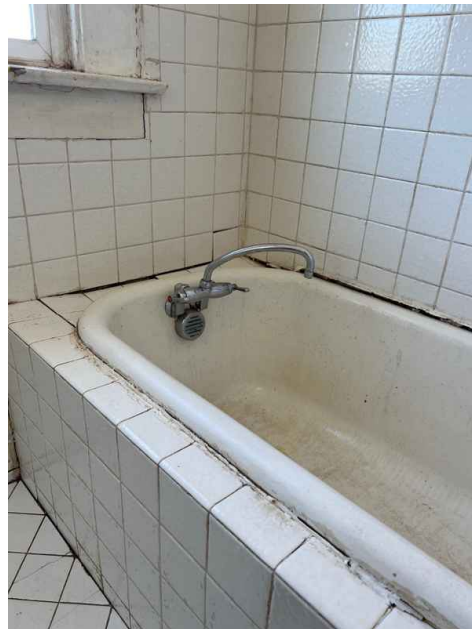
14329 left hand bathroom

The tile surround at the bathing area is deteriorated and needs repair or replacement. It appears that the tub is sinking indicating water damage to the wall and floor structure behind the tub which is not visible. An estimate of repair should be obtained before the close of your contingency period to fully understand the extent of repair needed. Note: If concerned about the air quality in this home, we recommend testing to confirm the presence or absence of mold.

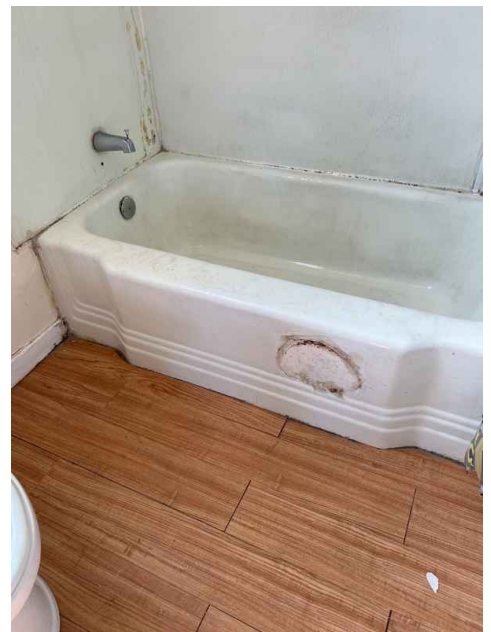
13431

The Cast Iron tub was chipped or had a damaged coating. We advise repair with a qualified person to avoid rusting.

Contact a qualified professional.

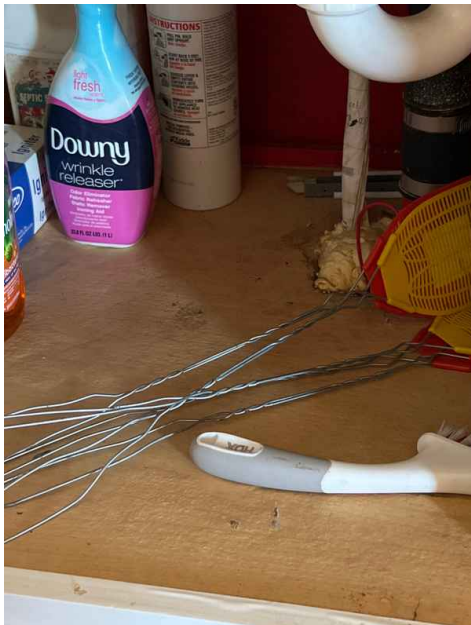
13431

Staining was noted in the cabinet below the sink. The staining was tested for moisture and found to be dry at the time of the inspection. Appears to be caused by a past leak. Under certain conditions or regular use, the leak may become active. We advise reviewing with the seller for repair history.

Contact the seller for more info

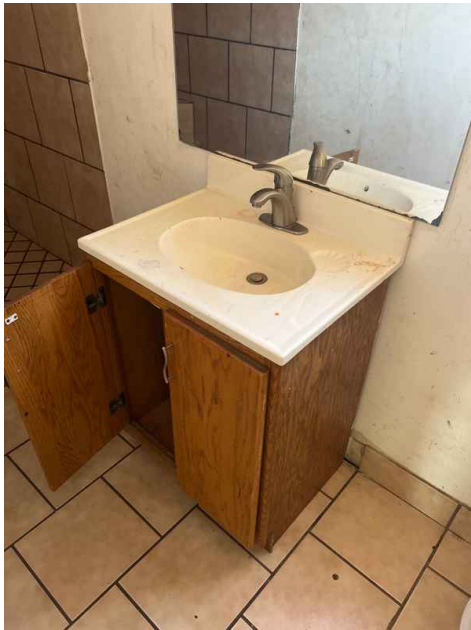
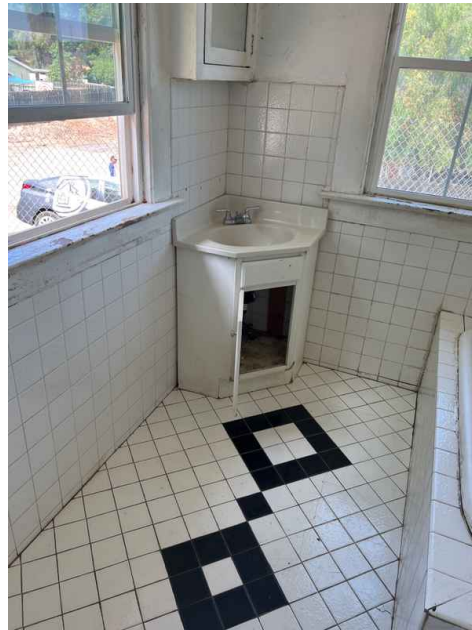
Sink cabinet was not secured to the wall. This is a safety hazard and could cause plumbing leaks. We advise having the cabinet secured to the wall studs by a qualified contractor.

Contact a qualified professional.

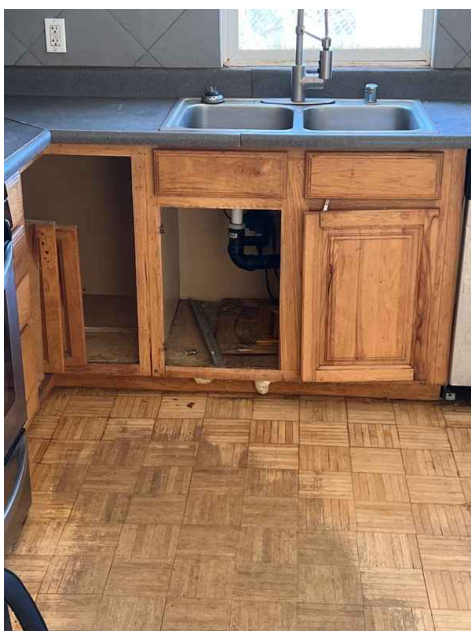
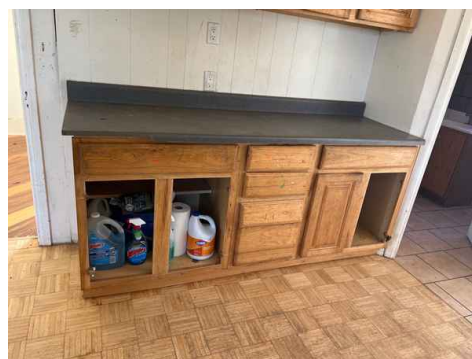
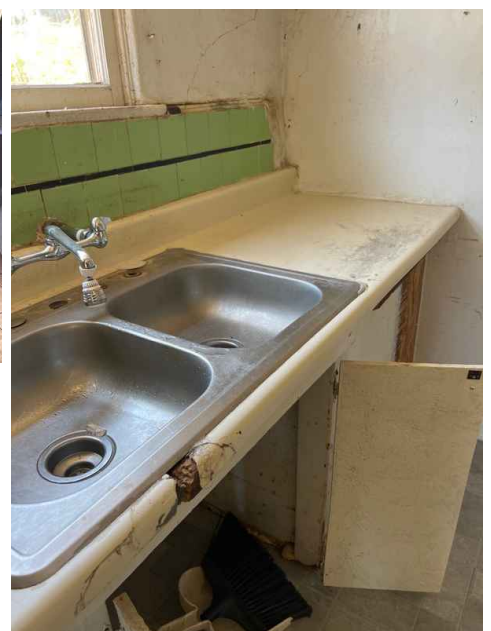
The closet door(s) are missing. We recommend replacing.

Contact a qualified professional.

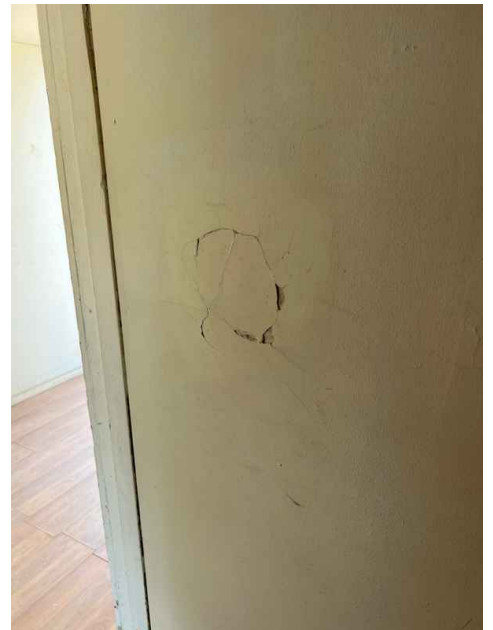
13431

Interior doors are out of square and/or fall open or closed, which can be due to poor installation or indicate that structural movement has occurred. Other evidence of significant structural movement was not observed at the time of inspection. Recommend further evaluation by a qualified contractor and repair as needed.

Contact a qualified professional.

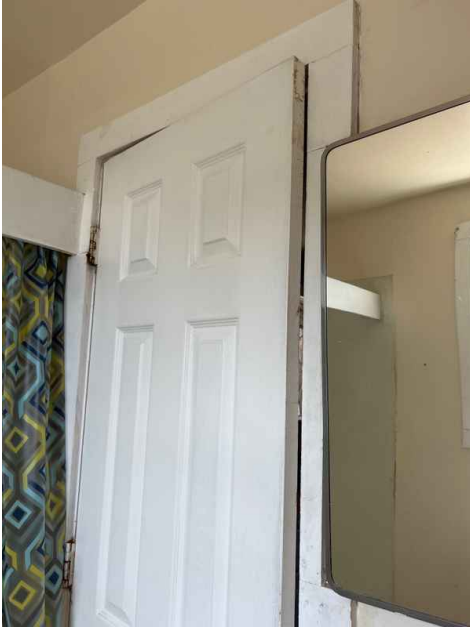
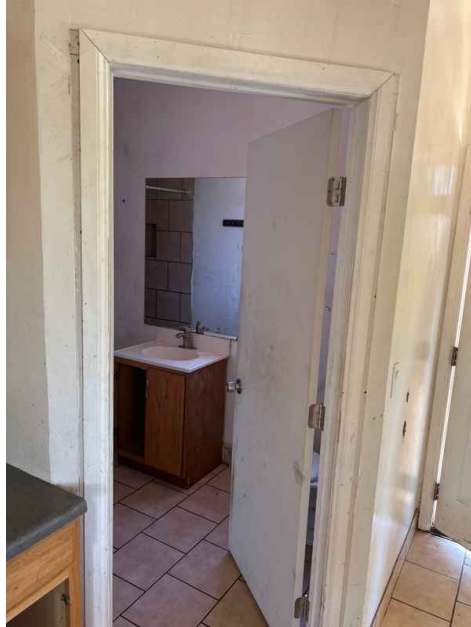
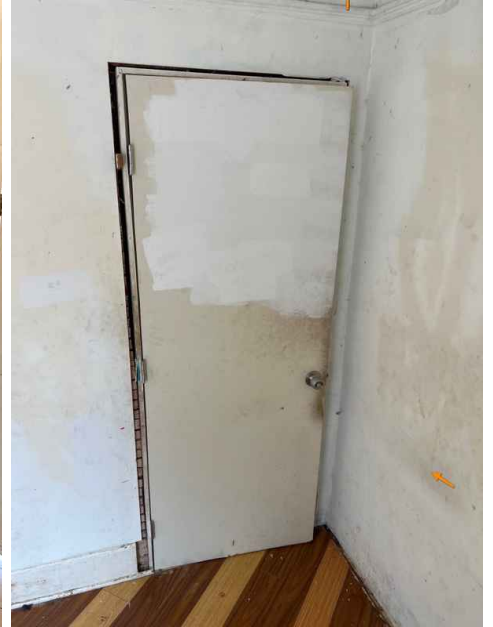
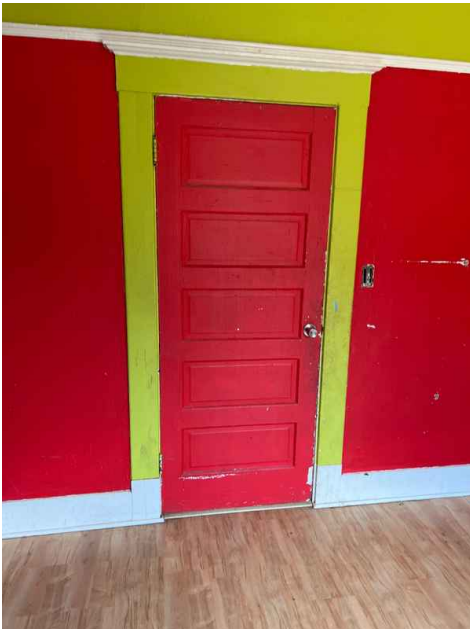
13429 front bedroom

The door latching hardware is not functioning properly. We recommend service or replacement by a qualified person.

Contact a qualified professional.

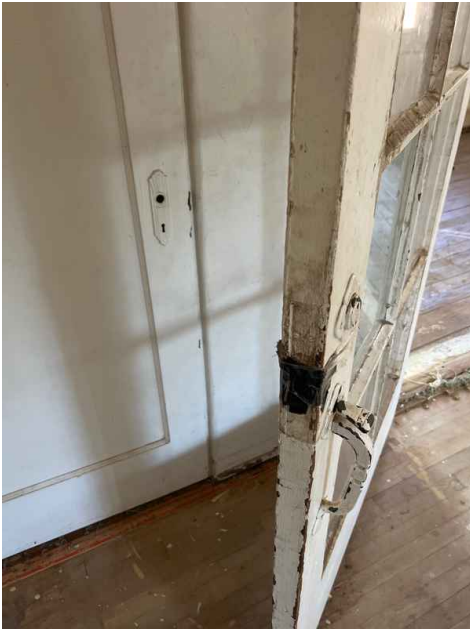
Door stoppers are recommended where the door handles contact walls. Damage can occur at drywall if door handle impacts the wall. We advise adding door stops as needed.

Contact a handyman or DIY project

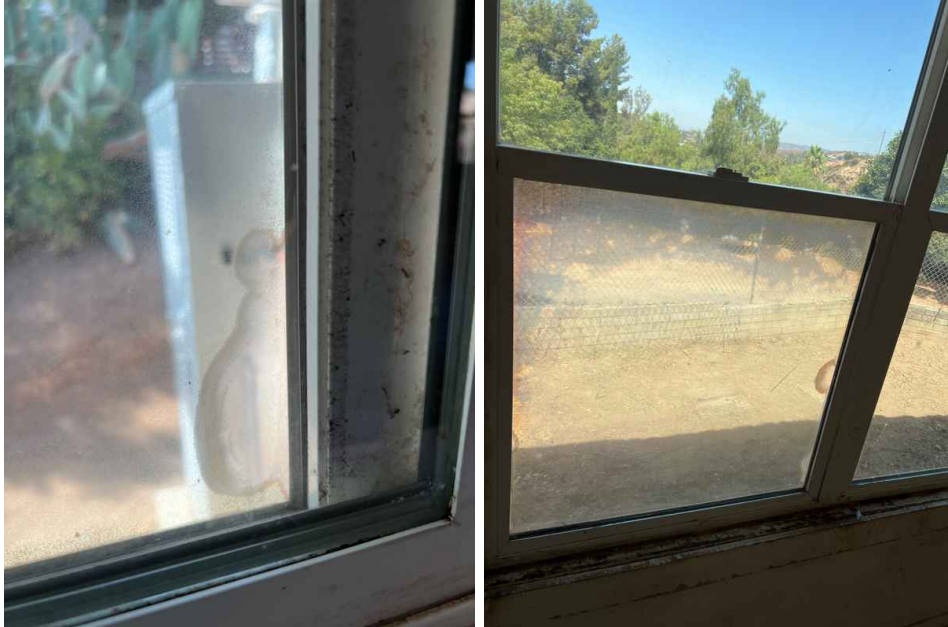
Kitchen 13431

Damaged Low-E glazing was observed. This can be caused by exposure to the sun (excessive heat) or a manufacturing flaw. Replacement of the insulated unit is needed to restore visibility. We recommend having all of the windows reviewed by a licensed window contractor to determine how many windows require repair/replacement.

Contact a qualified window repair/installation contractor.

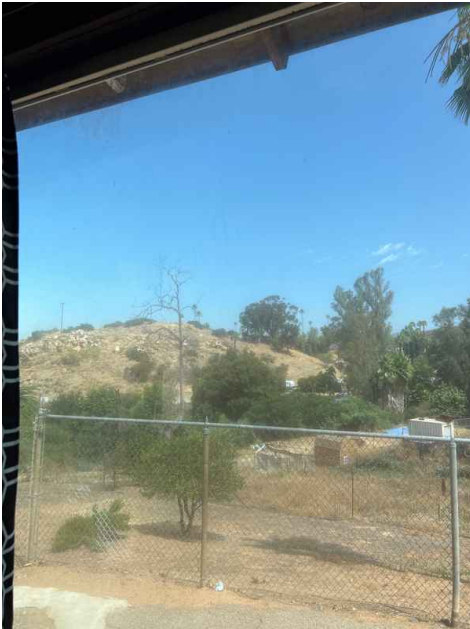
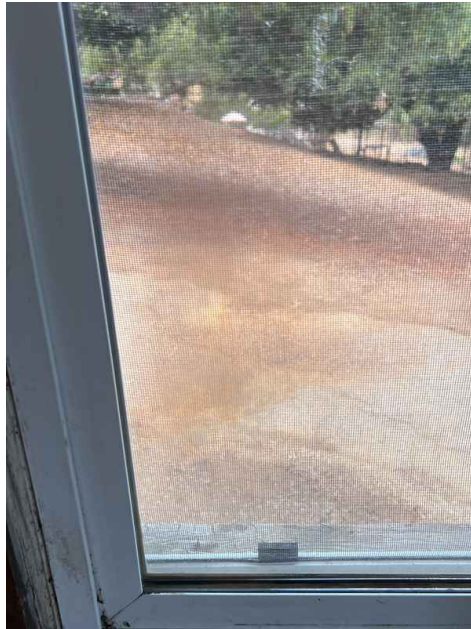
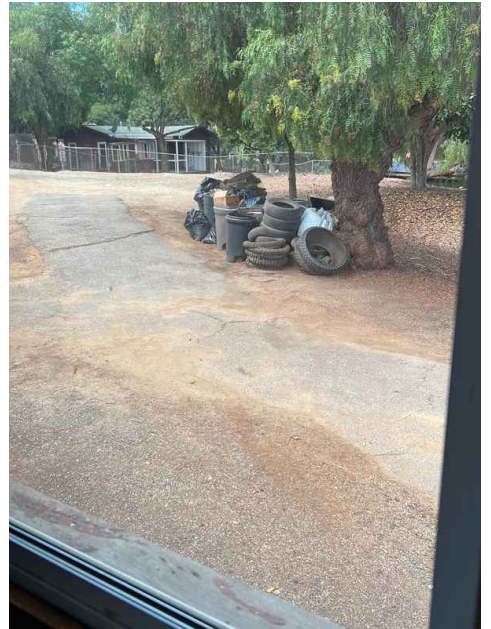
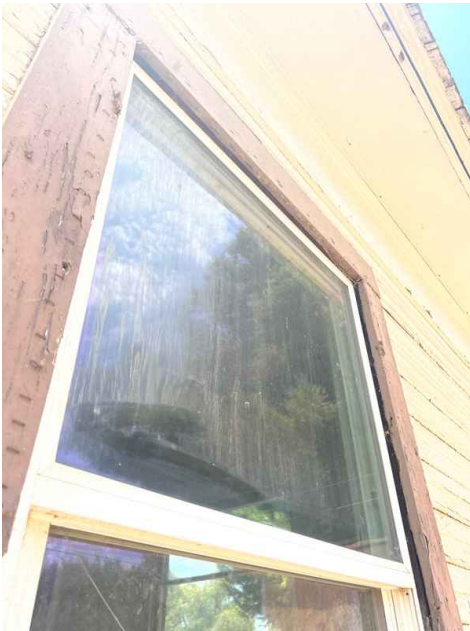
Windows in the home exhibited moderate deterioration/aging and appear to be original. Several windows were stuck shut/inoperable or otherwise damaged. Before the expiration of your contingency period, you may wish to consult with a qualified contractor to discuss repair options and costs for maintenance or potential cost to replace.

Contact a qualified window repair/installation contractor.

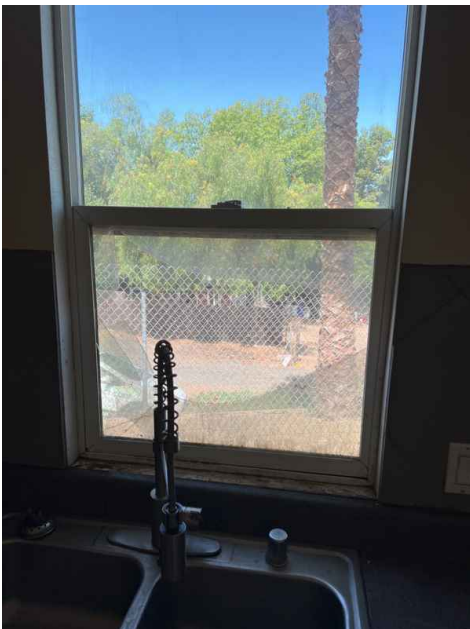
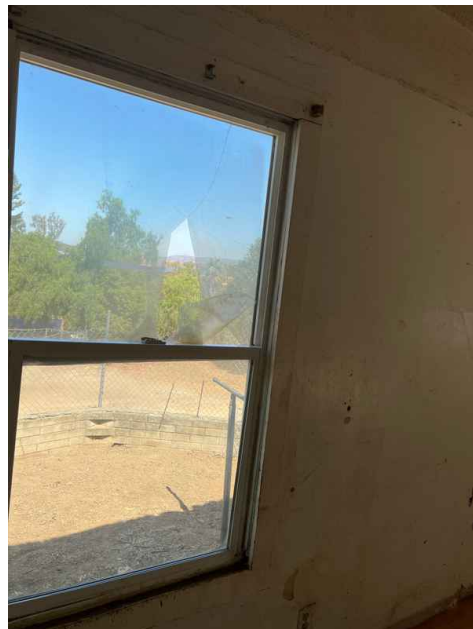
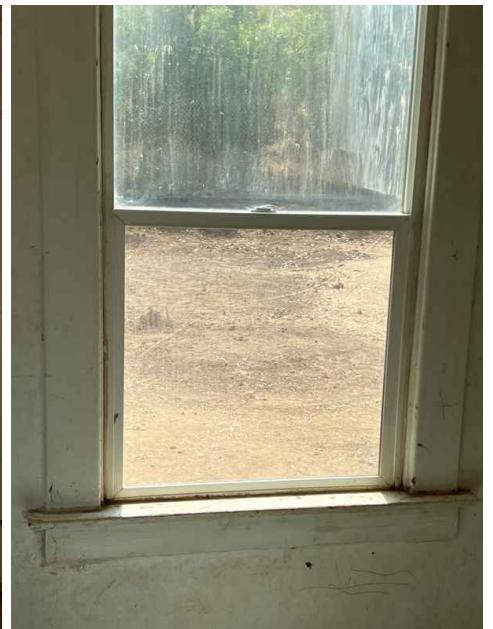
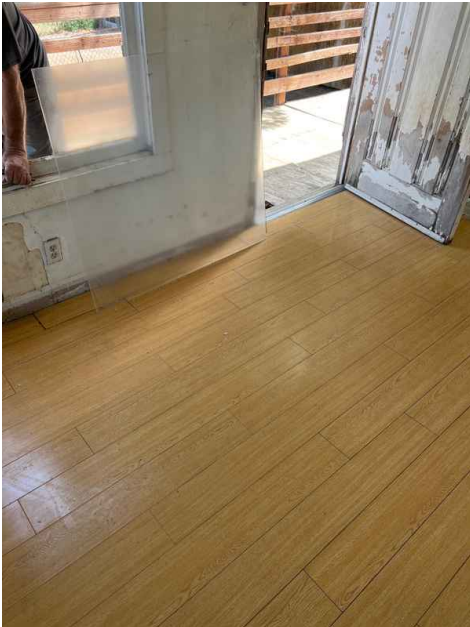
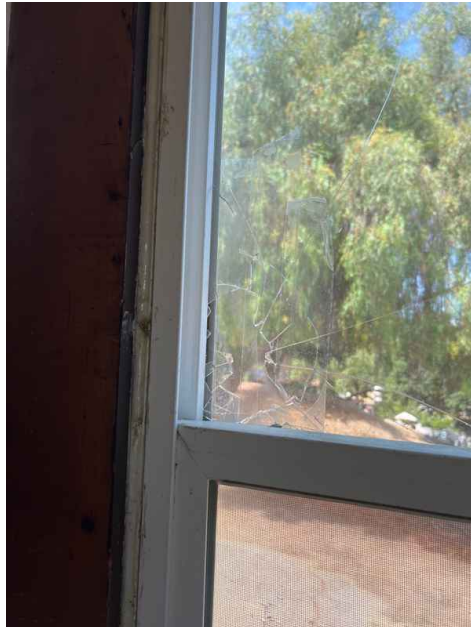
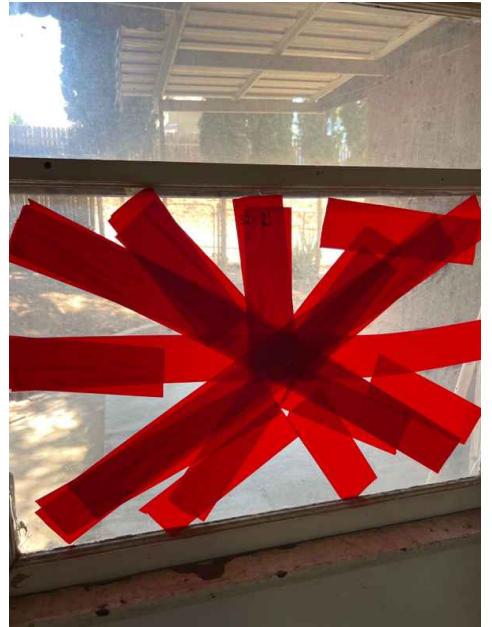
13431

A cracked/broken window was observed. We recommend repair or replacement by a licensed window repair company.

Contact a qualified window repair/installation contractor.

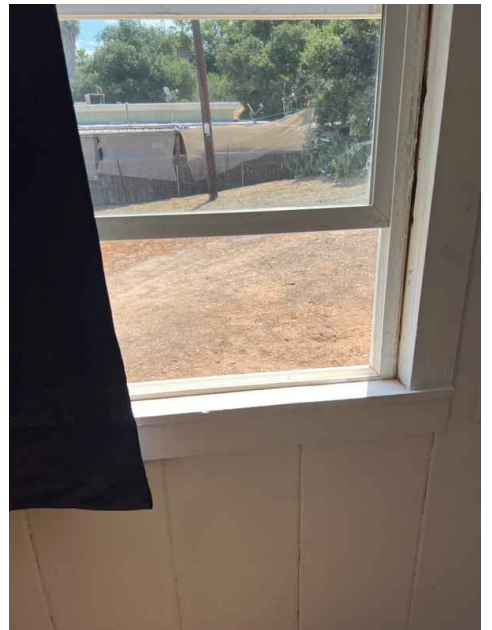
13431

Several screens are missing or damaged. We recommend repair or replace as needed by a qualified person.

Contact a qualified professional.

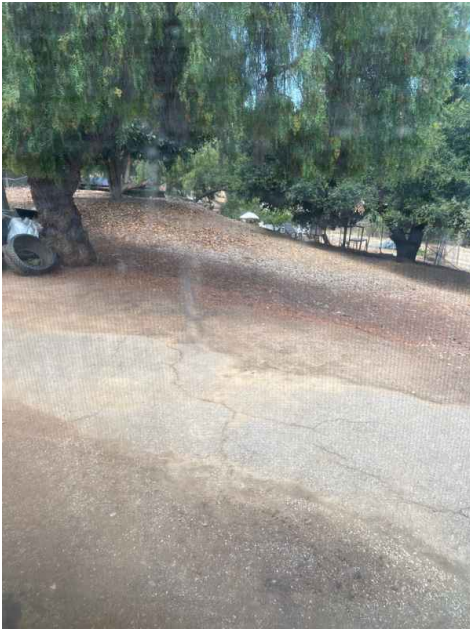
Several torn, bent and missing screens noted. We recommend repair or replace as needed by a qualified person.

Contact a qualified professional.

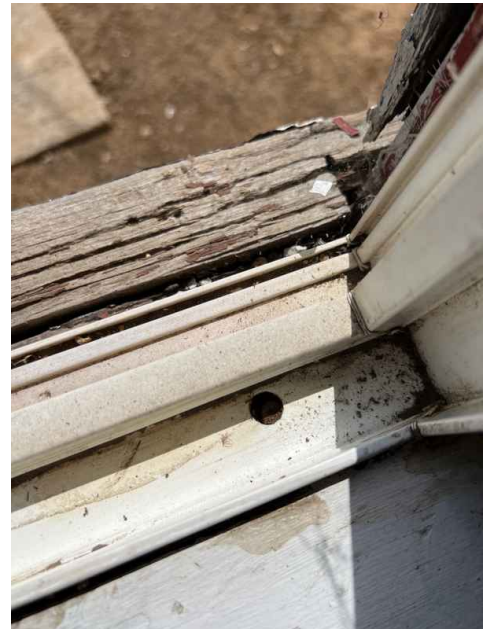
13431

Retrofit replacement windows were poorly installed with mounting screws penetrating the bottom sill. This can allow water to enter the wall and indicates a poor installation. We recommend having the retrofit window installation reviewed by a licensed window contractor.

Contact a qualified window repair/installation contractor.

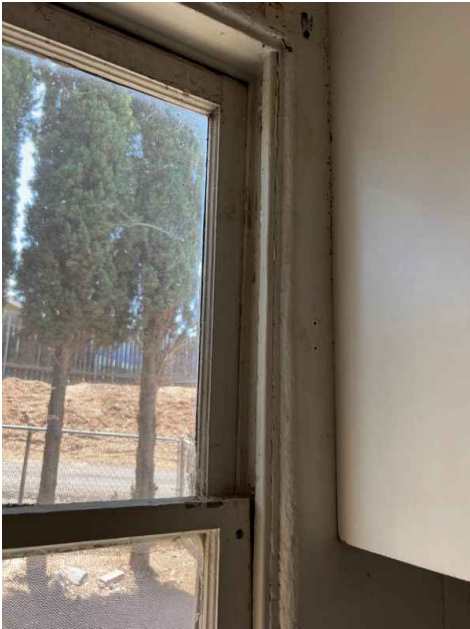
Sash cords are broken/missing at the sash windows. Without the sash cords, there is no counterweight and the windows can slam shut and break. We recommend repair or replacement by a qualified contractor.

Contact a qualified window repair/installation contractor.

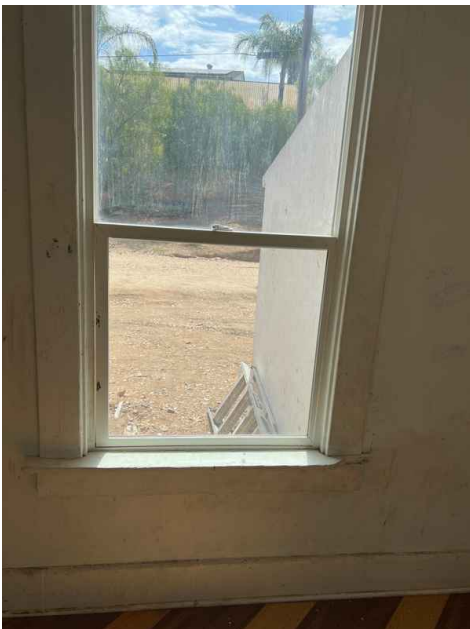
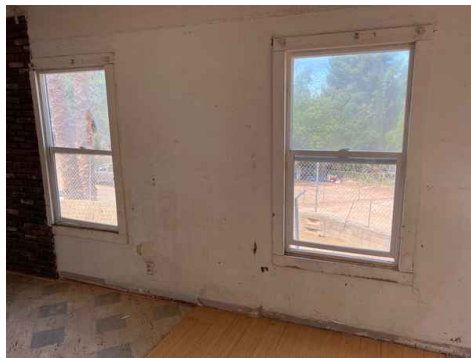
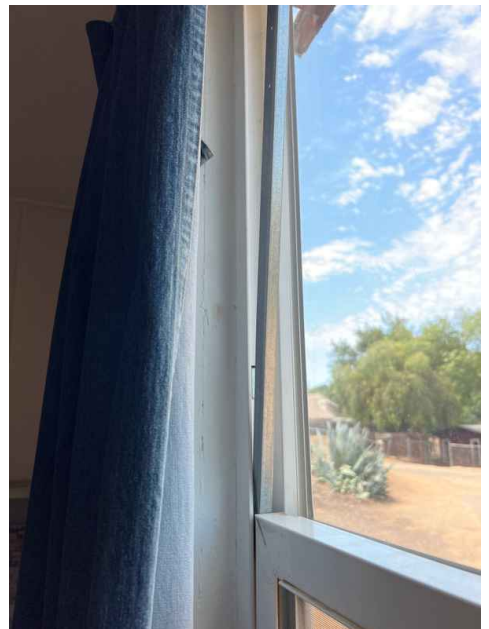
13431

Damaged counter-balance spring noted at sash windows. This makes the windows difficult to open/close. We advise review with a licensed window repair contractor for an estimate to repair.

Contact a qualified window repair/installation contractor.

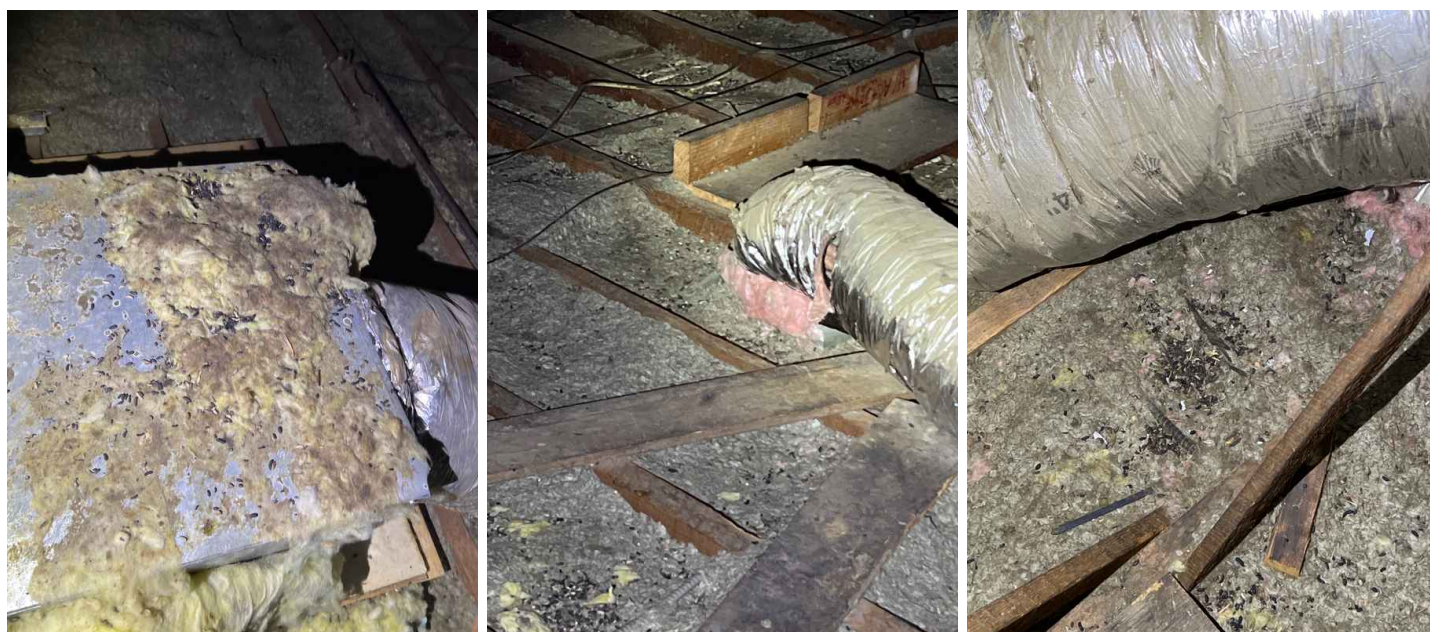
Material which may be rodent droppings was observed in the attic. If present, pest may chew, damage or contaminate components such as insulation and heating/AC ducts. Rodents have been found throughout San Diego County which have Hantavirus, which is a health hazard, according to [San Diego County Vector Control](#).

We advise consulting with a professional Level II pest exterminator for a complete review and removal of any pests, waste material, or contaminated components from the attic. If deemed necessary by the exterminator, some or all of the insulation may require replacement.

Contact a qualified pest control specialist.

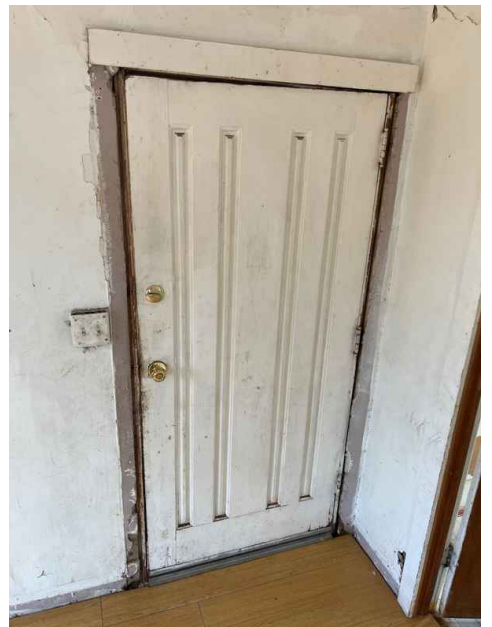
The exterior door weather-stripping is damaged. We advise replacement.

Contact a qualified professional.

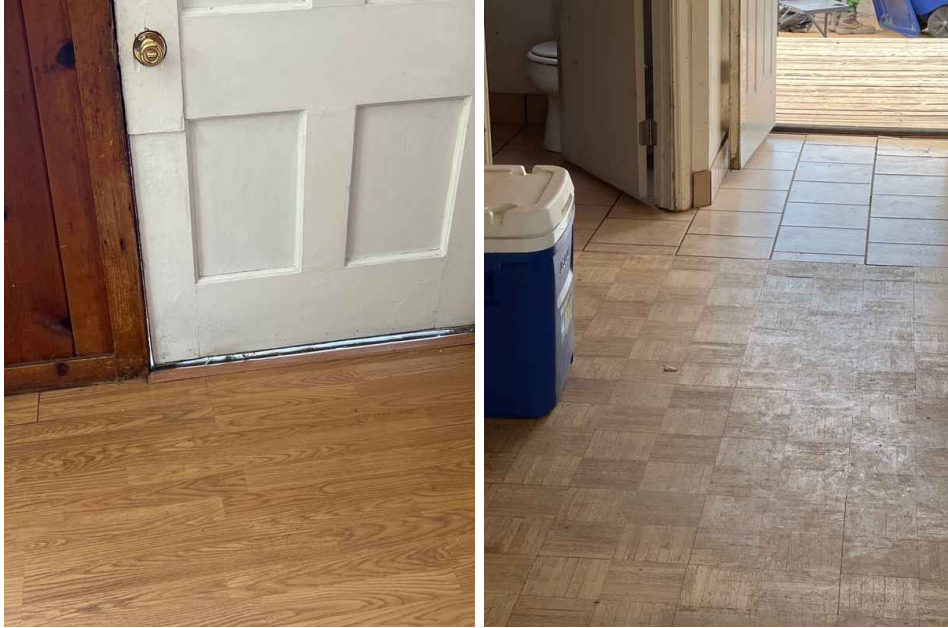
Entry door was observed, is damaged. We recommend replacement with a qualified contractor.

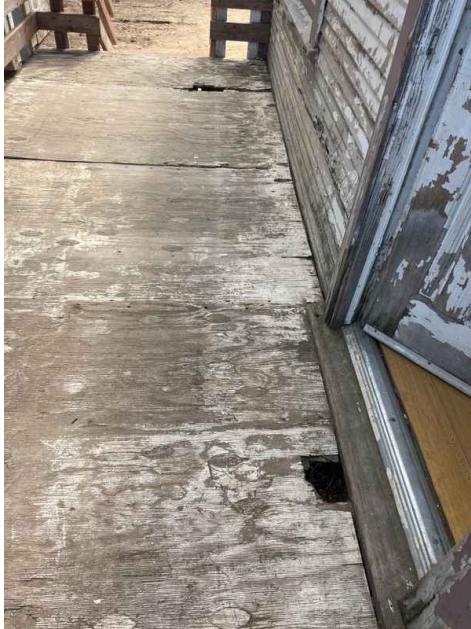
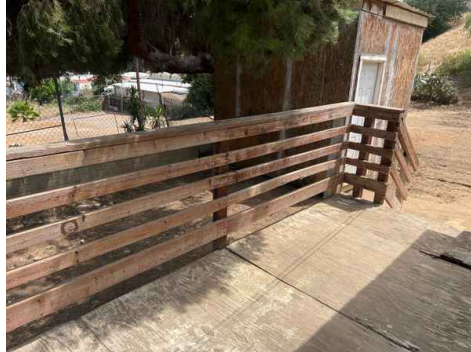
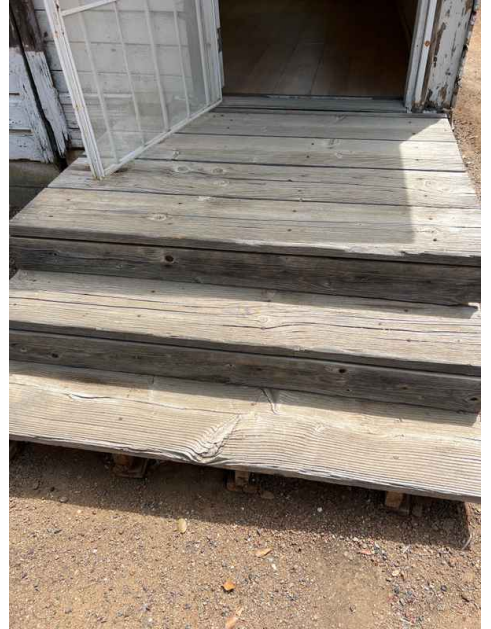
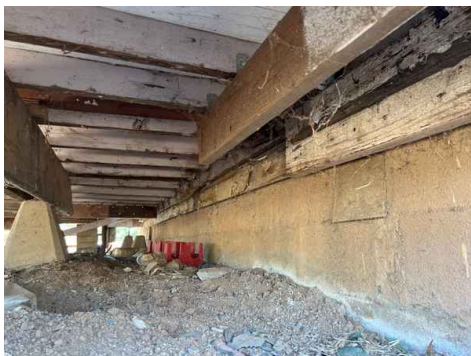
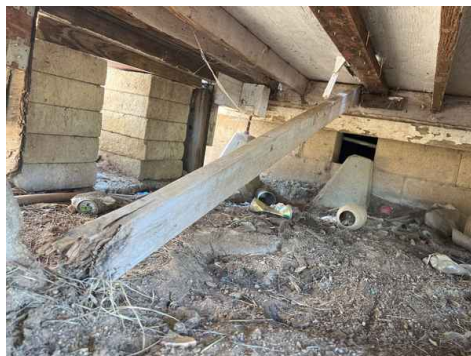
DECK DAMAGE

Extensive damage was observed on exterior decks. Missing, damaged or improperly built railings and underlying structures noted as well. This condition creates a safety hazard in several locations. Recommend repair or replacement as needed by a qualified contractor.

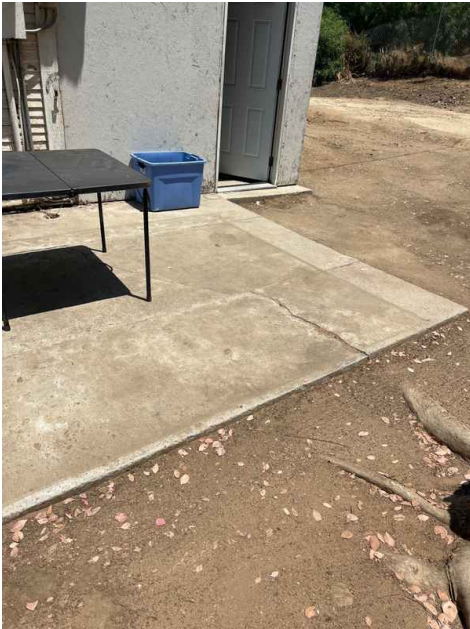
Stress and/ or settling cracks are noted in the flatwork. This may indicate that soil movement is occurring, there may be root encroachment, or the concrete was installed without reinforcement. This concrete may deteriorate further. We recommend obtaining a quote for repair/replacement by a licensed concrete contractor prior to the end of your contingency period.

Contact a qualified professional.

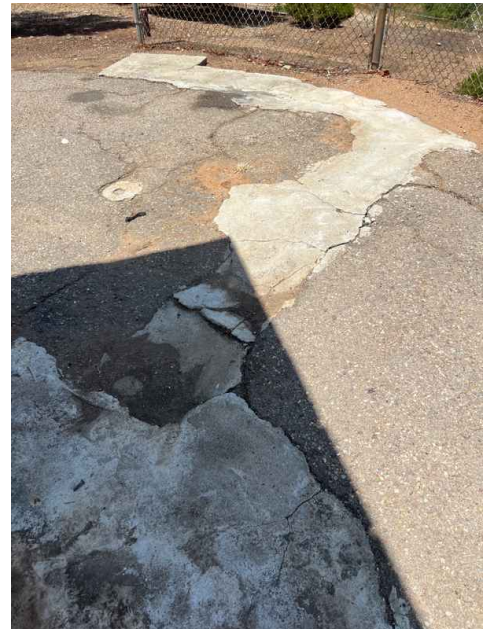
ASPHALT DETERIORATED

The asphalt driveway is cracked and deteriorated. We recommend that you obtain a quotation for repair prior to the end of your contingency period.

Contact a qualified professional.

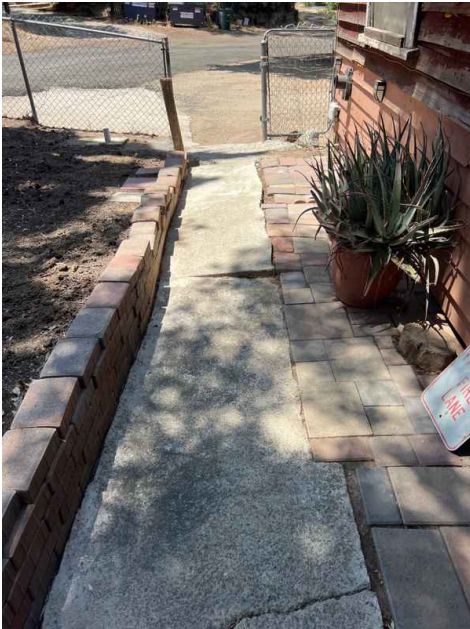
PATHWAY - TRIP HAZARD

Tripping hazard exists at the pathway. We recommend repair to avoid injuries.

Contact a qualified professional.

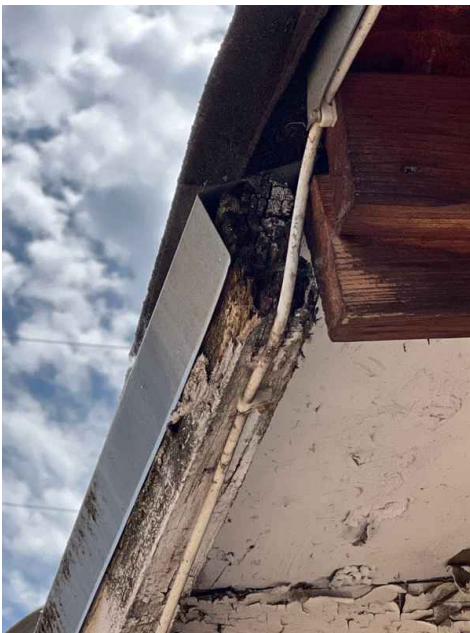
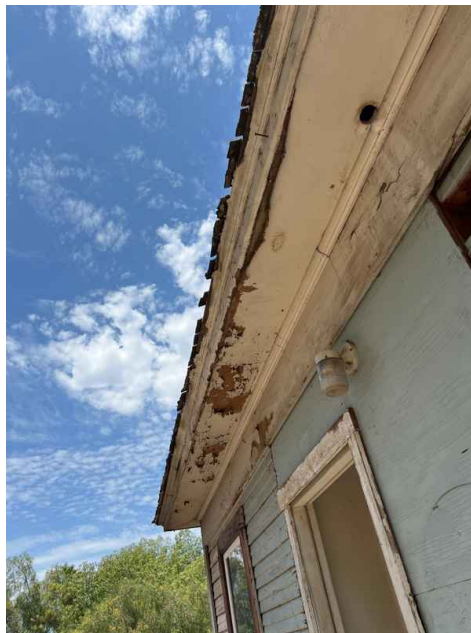
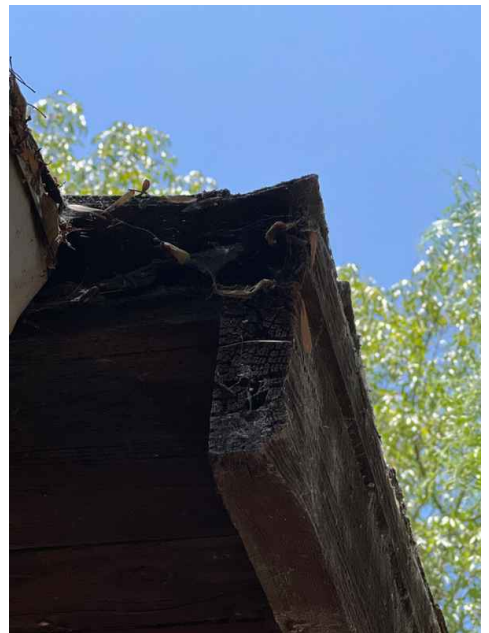
FASCIA - TERMITES

Some damaged wood was observed at the eaves and fascia boards. Determining if this damage was caused by termites is beyond the scope of a home inspection. Home inspectors do not have the authority to comment on termites or dry rot, which is the responsibility of a state licensed pest inspector. We recommend referring to the pest inspection report for a full evaluation and necessary repairs made by a qualified licensed contractor.

Contact a qualified pest control specialist.

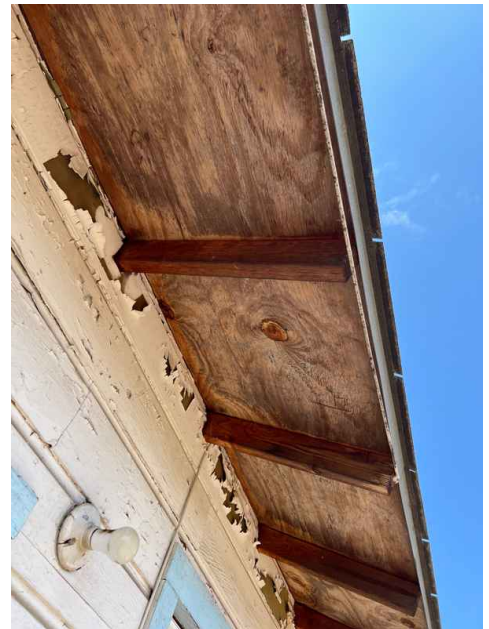
The exposed eave, soffit, or fascias needs primer and paint. We recommend prep and painting by a licensed paint contractor.

Contact a qualified painting contractor.

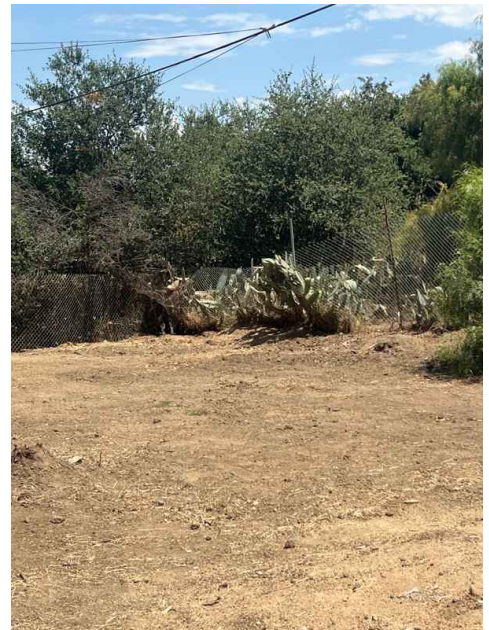
FENCE LOOSE

The fence is loose, leaning, and deteriorated in several areas. We advise necessary repairs or replacing as needed by a licensed contractor.

Contact a qualified fencing contractor

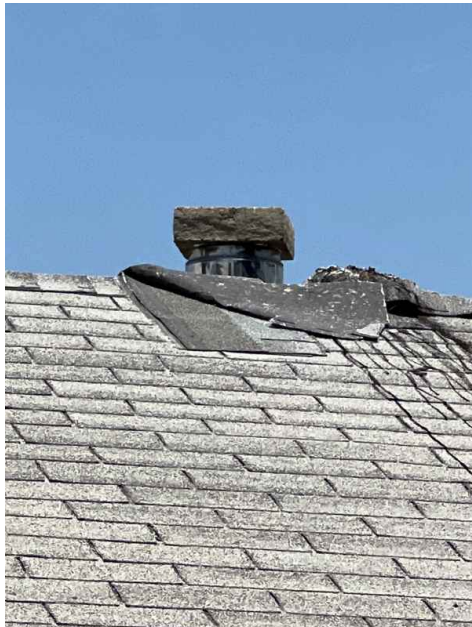
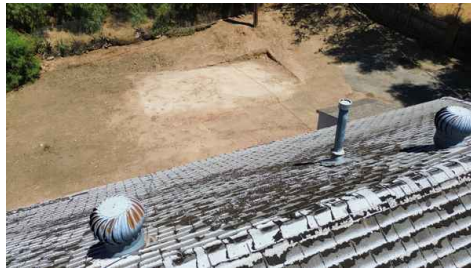
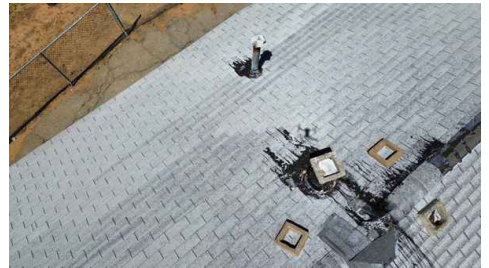
There are several missing and damaged roof shingles observed. We recommend necessary repairs by a licensed roof contractor.

Contact a qualified roofing professional.
